Inspection Report (Asphalt Paver)

Year	2016
Make	Leeboy
Model	8515C
Serial Number	134860
Hour Meter Reading	1,927 hours
Previous Application (e.g., earth moving, mining, demolition, etc)	Asphalt Paving Construction

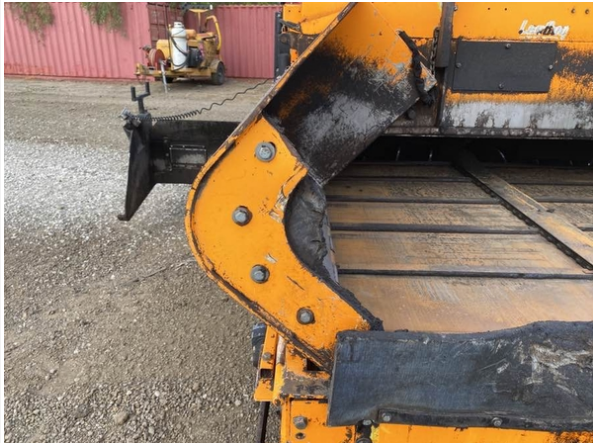
Front	3 - Normal Wear & Tear
Front Condition	Visible chipped paint or dents, Other (see comments), Large dents or cracks
Comments	Some dents and bent areas on hopper (normal wear)front hopper bumper cracked at corner welds
Front Photos

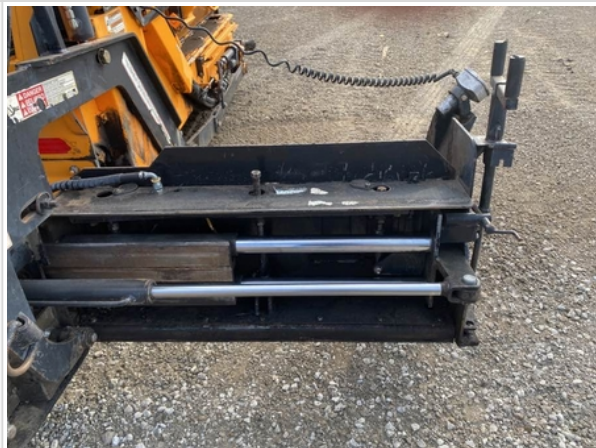
Rear	3 - Normal Wear & Tear	
Rear Condition	No visible damage, Other (see comments)	
Comments	Normal wear and tear	
Rear Photos

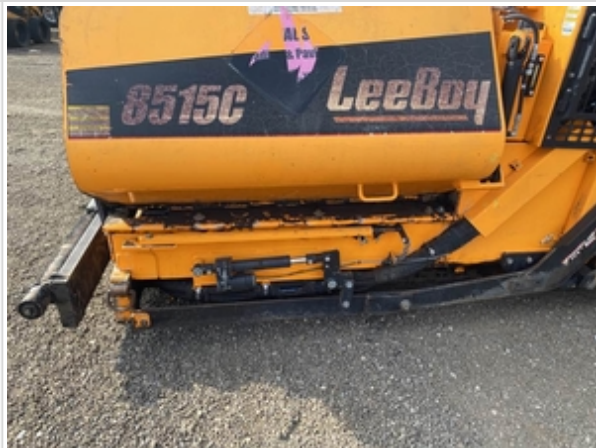
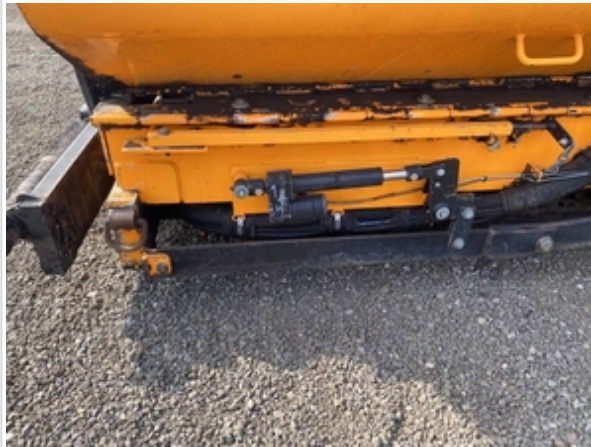
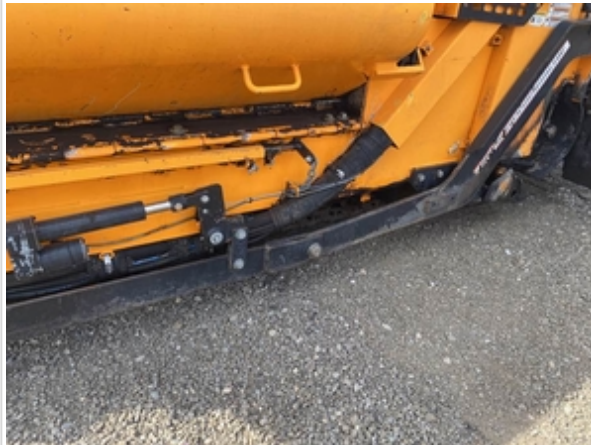
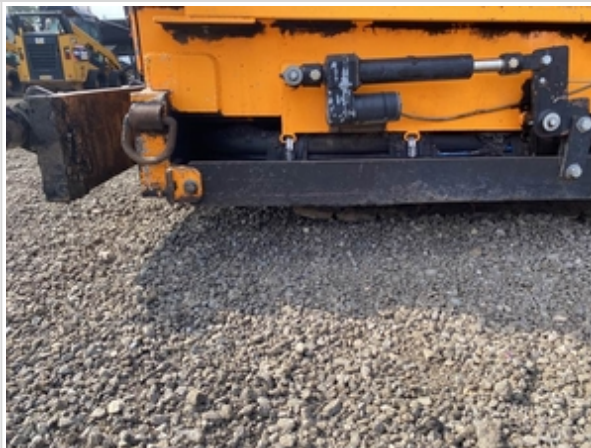
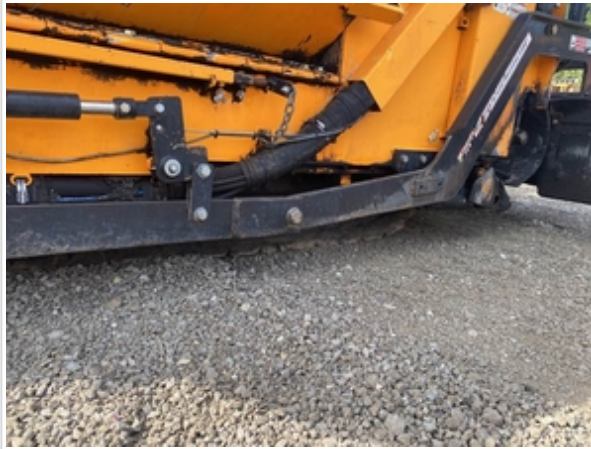
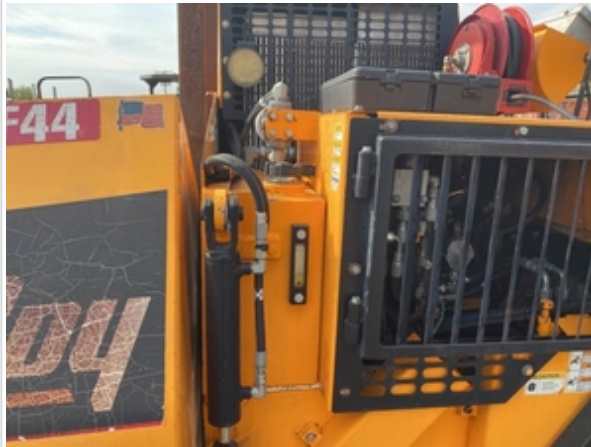
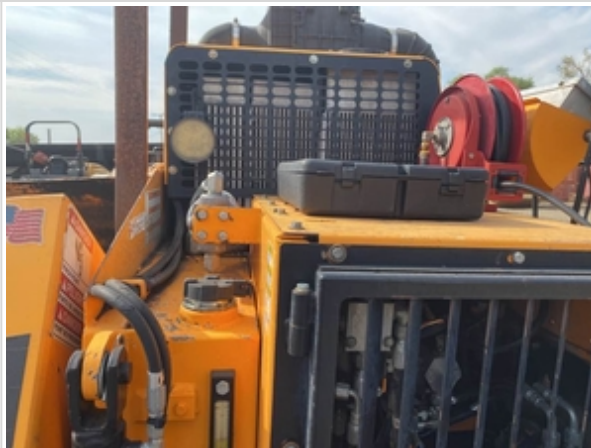
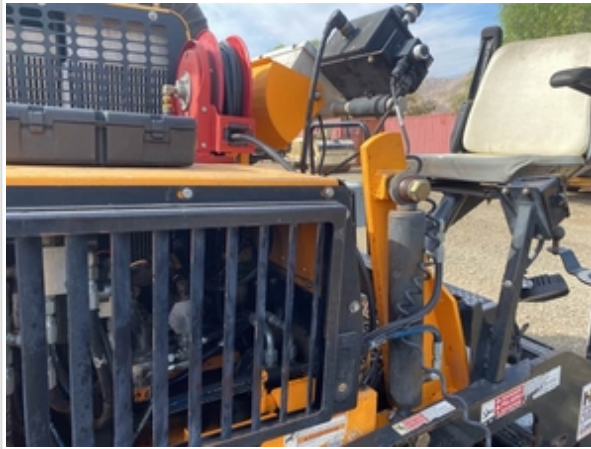
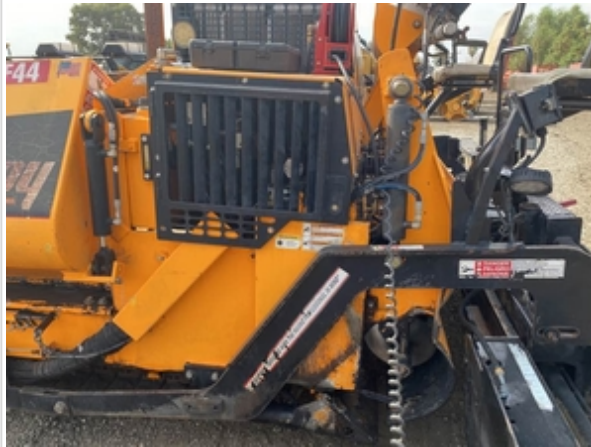
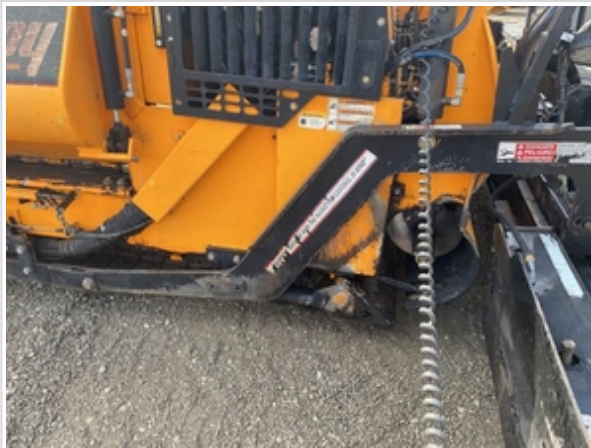
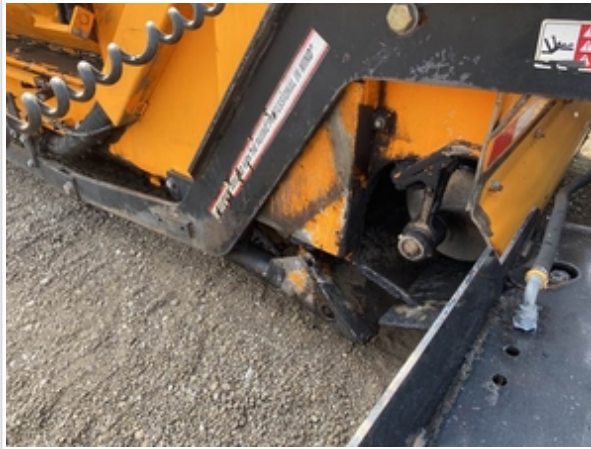
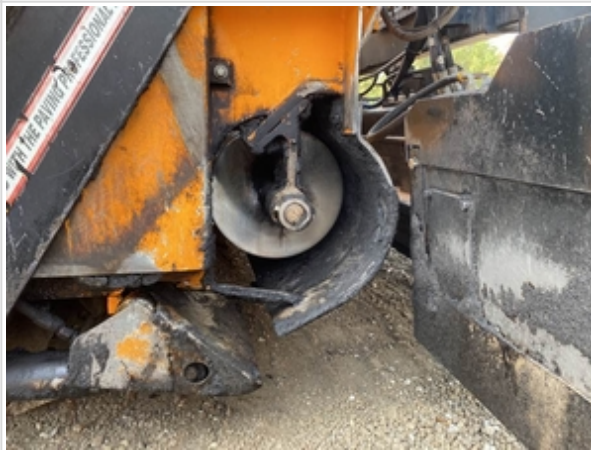
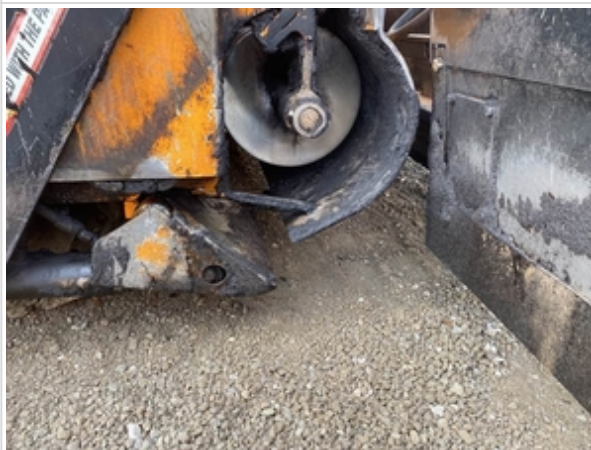
Left	3 - Normal Wear & Tear	
Left Condition	No visible damage, Other (see comments)	
Comments	Normal wear and tear	
Left Photos

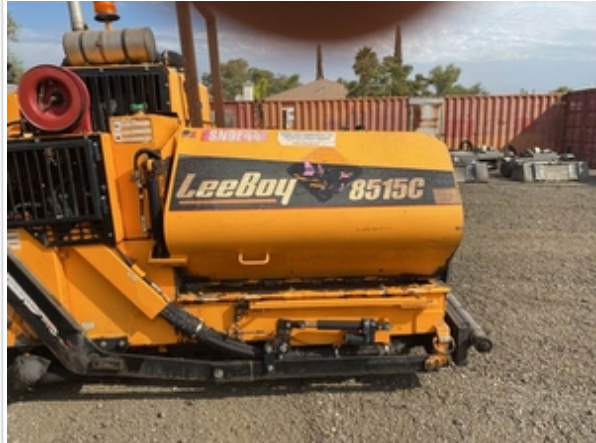
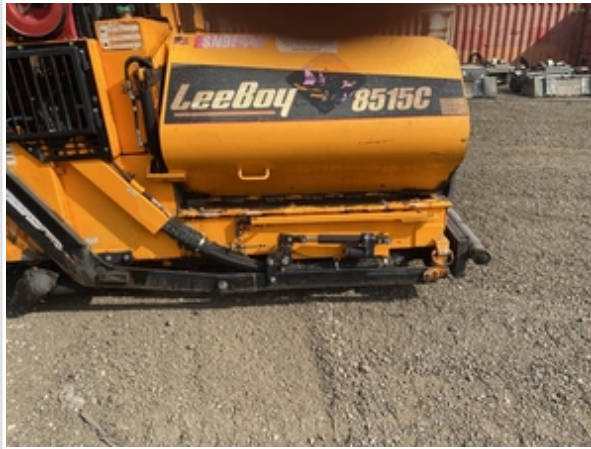
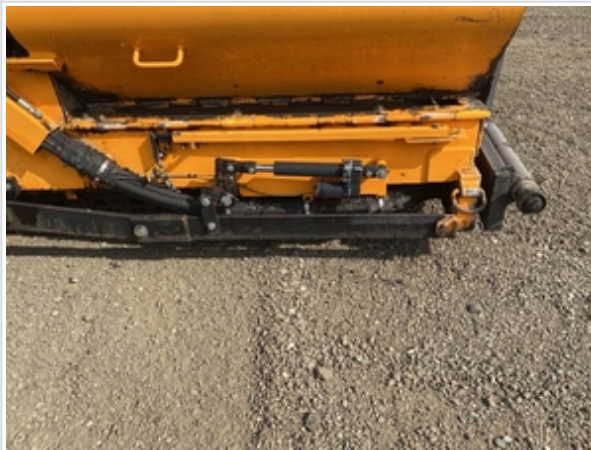
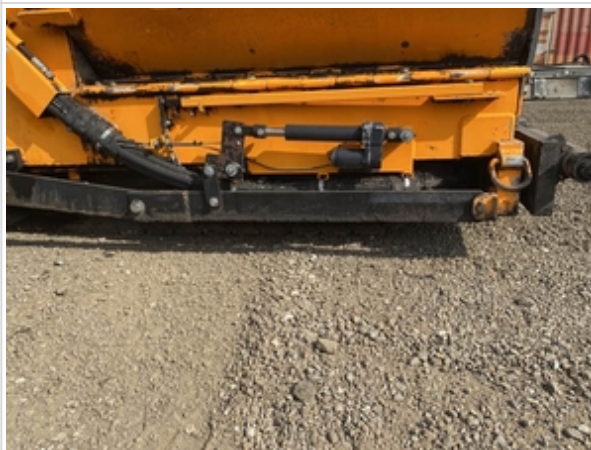
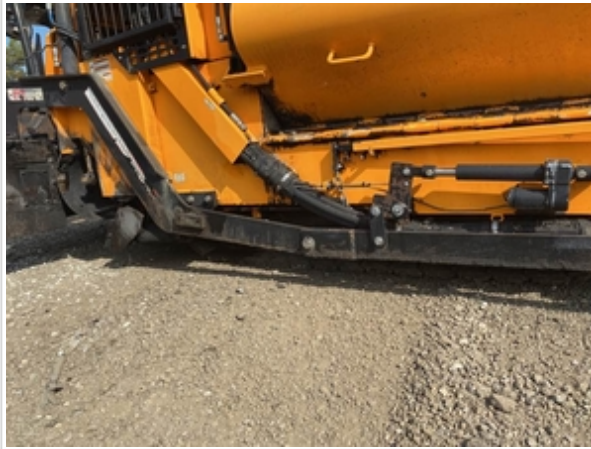
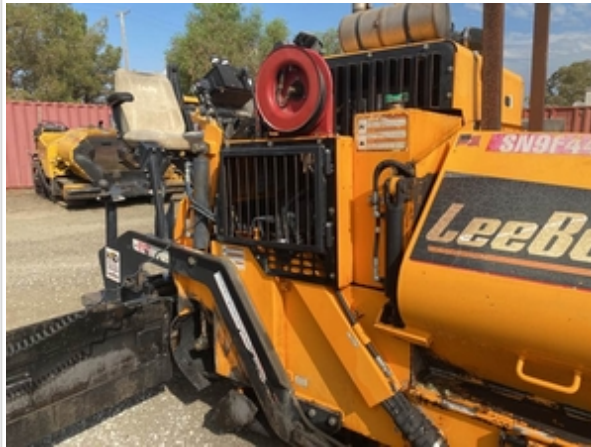
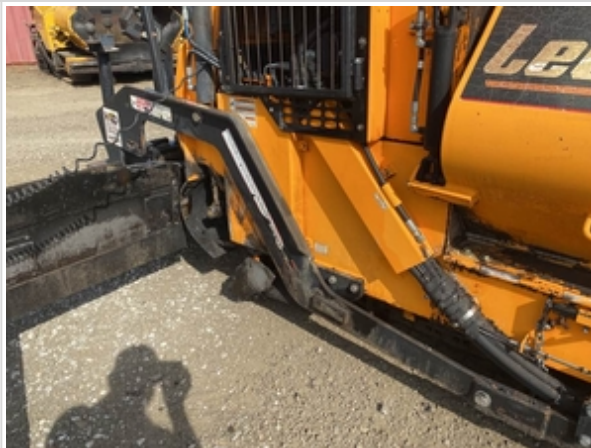
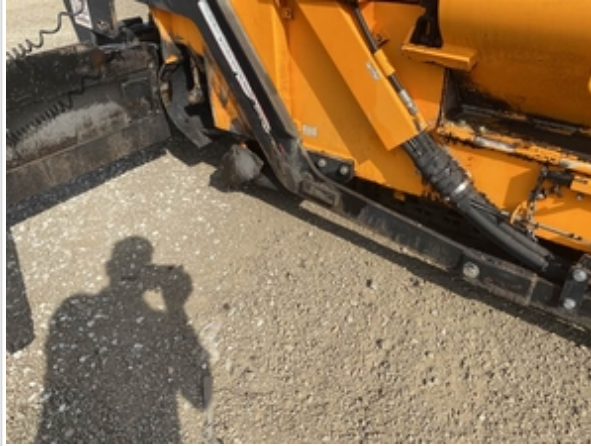
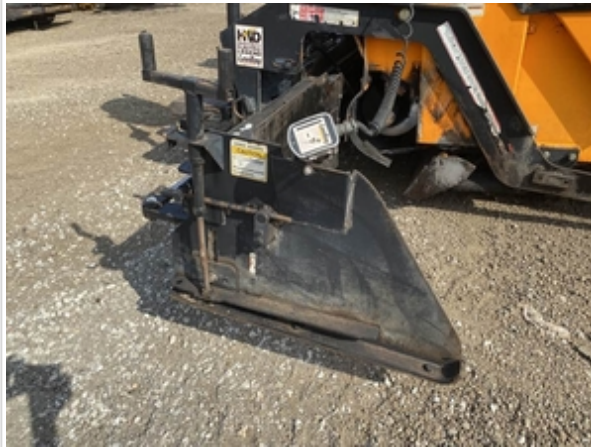
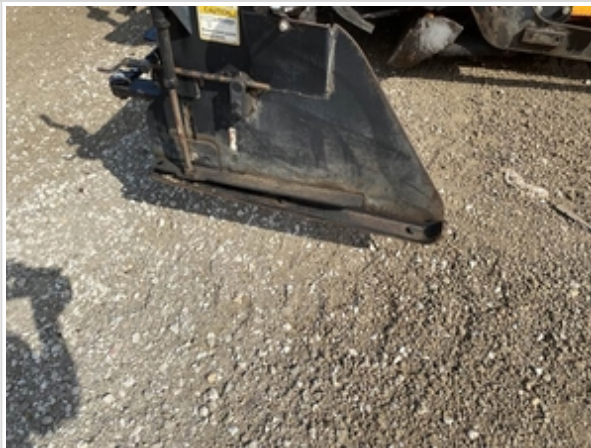
<p>Right</p>	<p>3 - Normal Wear & Tear</p>
<p>Right Condition</p>	<p>No visible damage, Other (see comments)</p>
<p>Comments</p>	<p>Normal wear and tear</p>
<p>Right Photos</p>

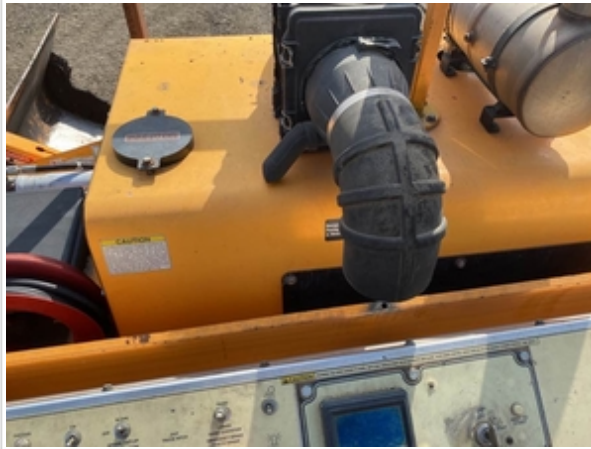
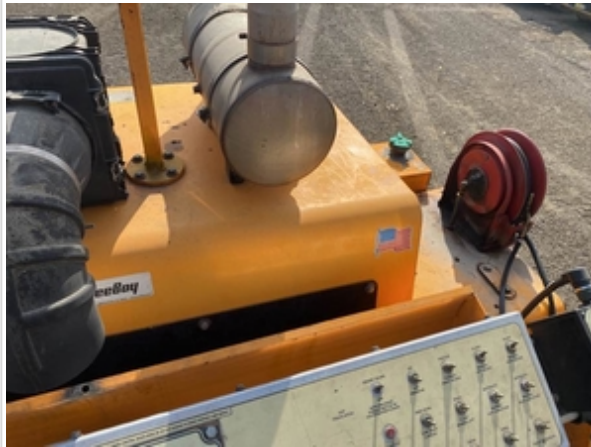
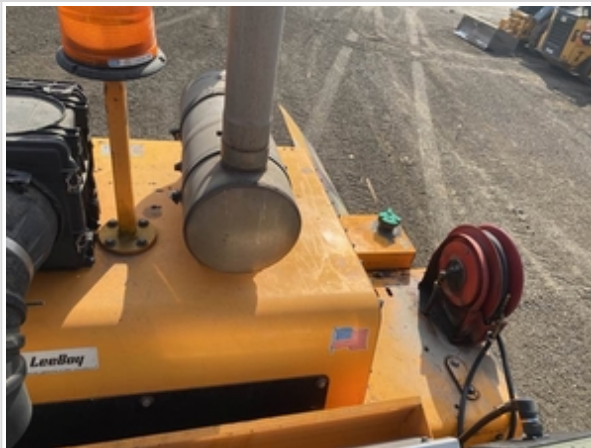
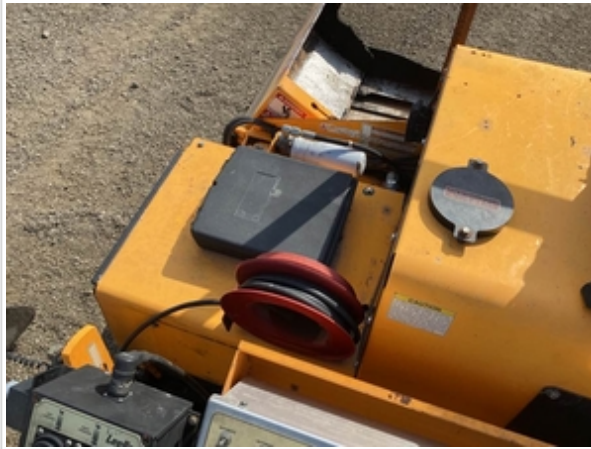
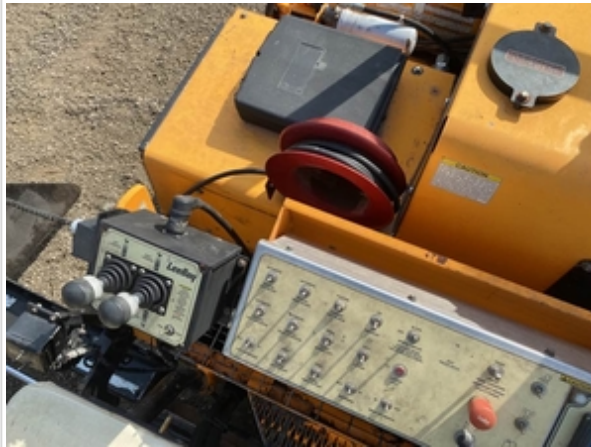
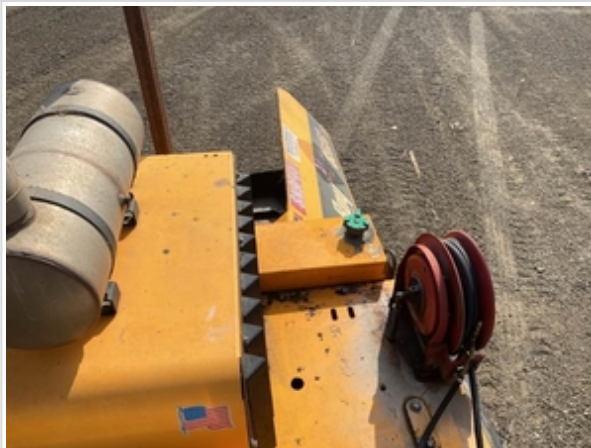
Upper	3 - Normal Wear & Tear
Upper Condition	No visible damage
Upper Photos

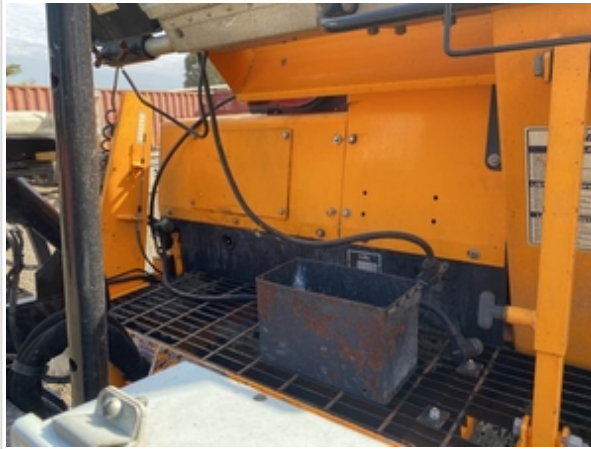
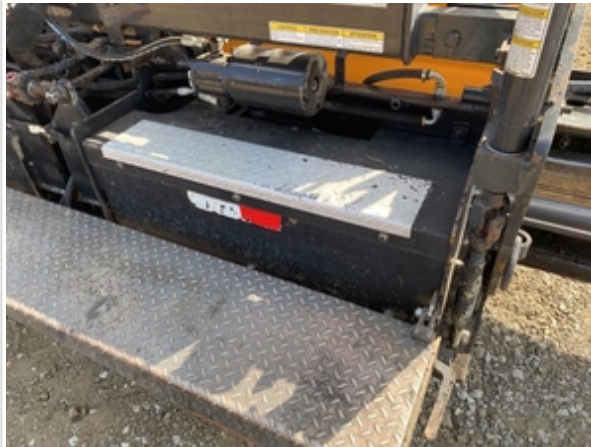
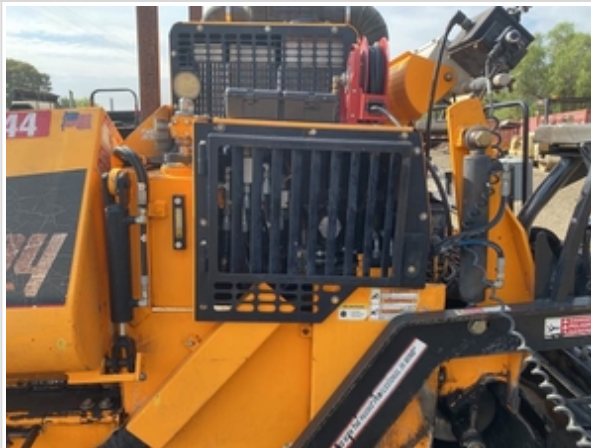
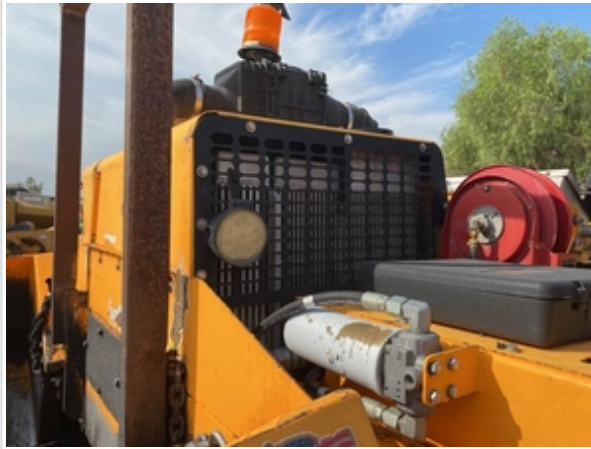
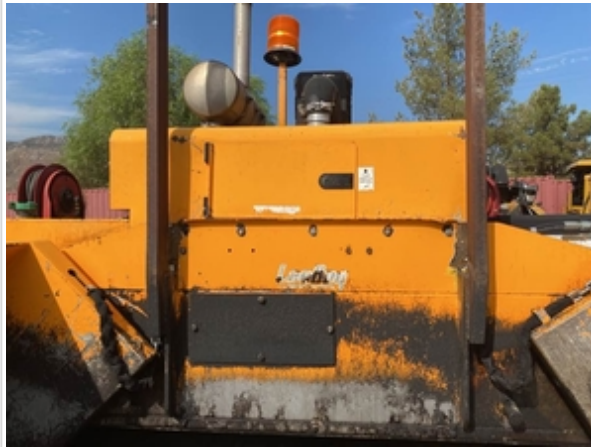
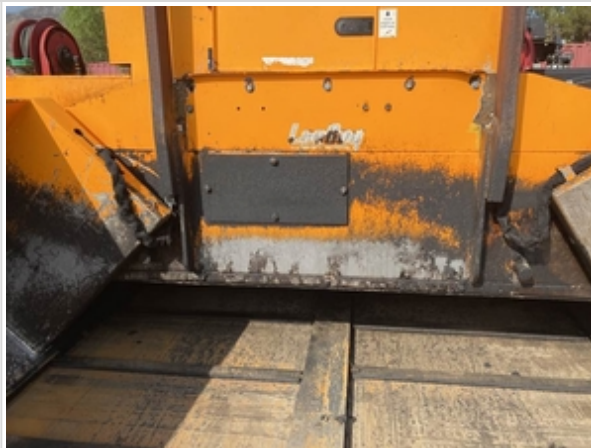
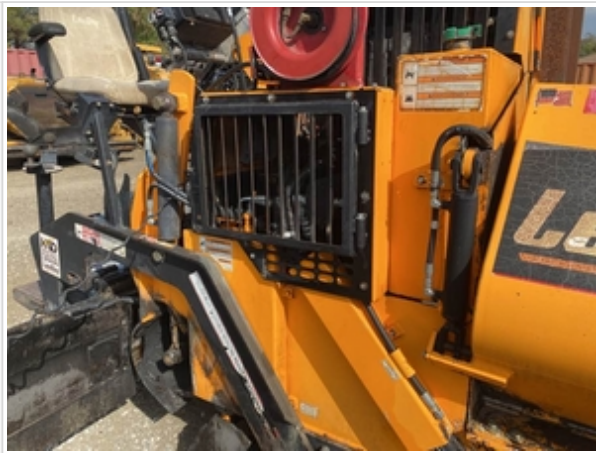
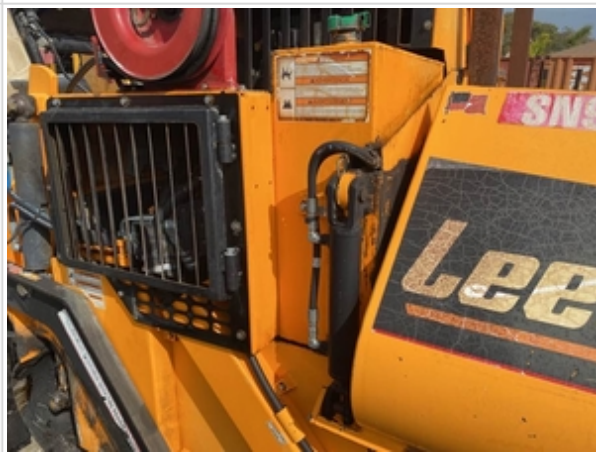
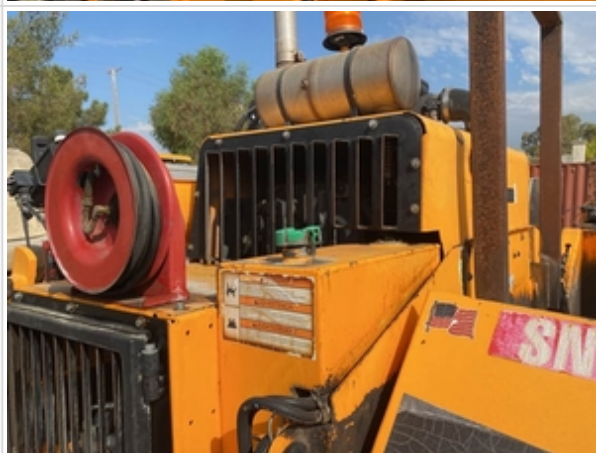
Body Panels (Any Rust Damage?)	3 - Normal Wear & Tear	
Body Panel Condition	No visible damage, good paint condition and panel fitment	
Body Panels Photos

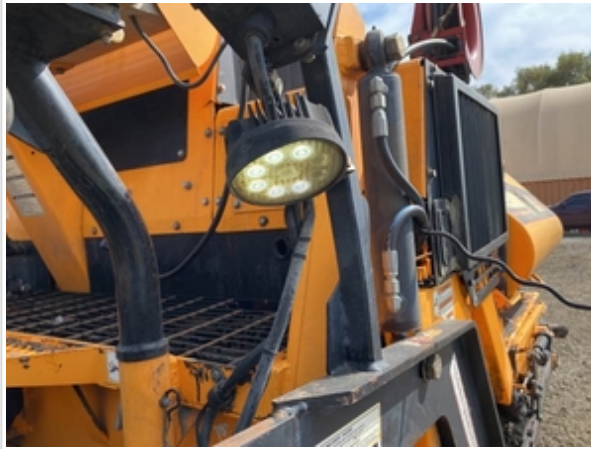
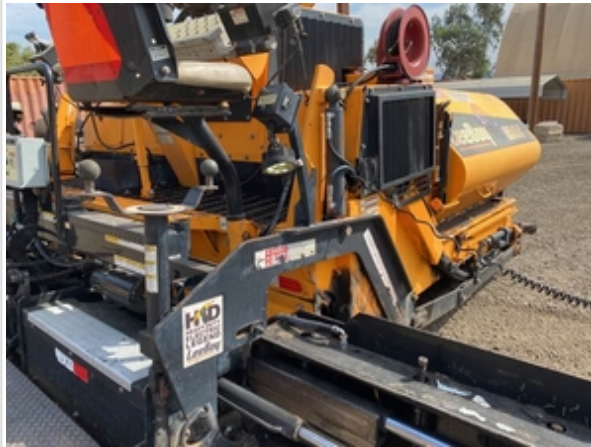
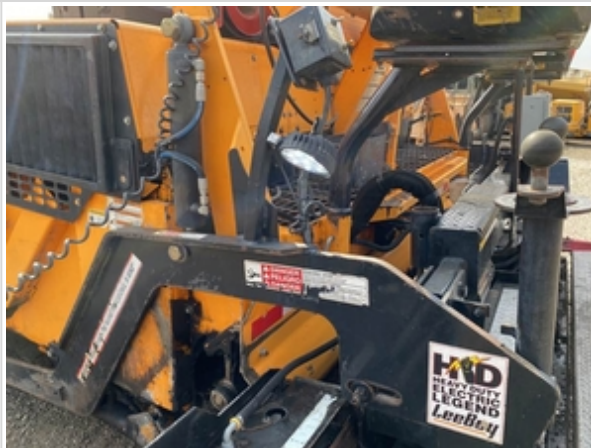
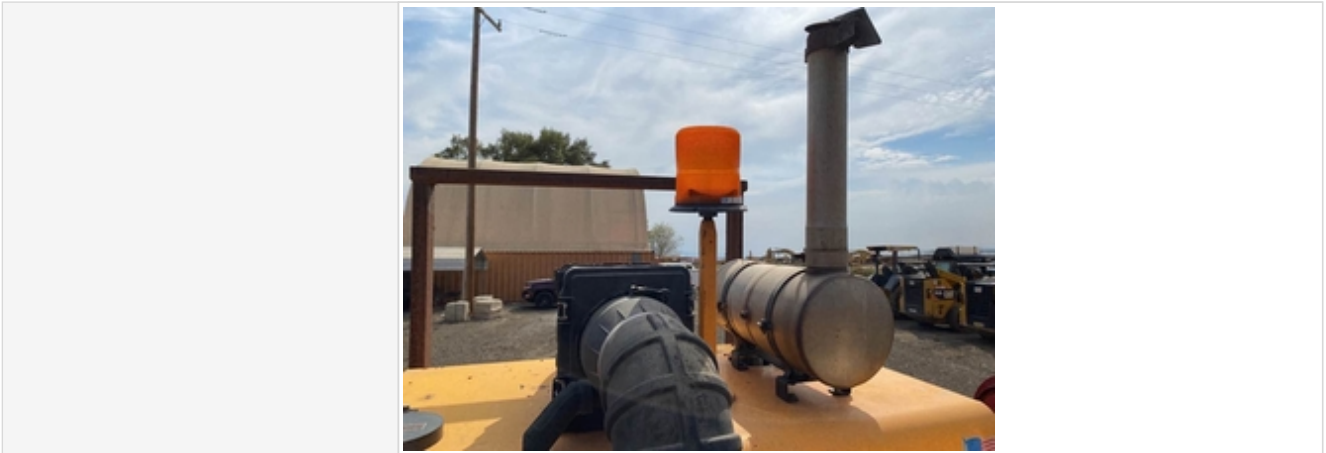
Glass Condition	0	
Mirrors	0	
Lighting System	3 - Normal Wear & Tear	
Lighting System Condition	One or more exterior lights are non-operational, Other (see comments)	
Comments	Beacon inoperable and right side light halfway working	
Lighting System Photos

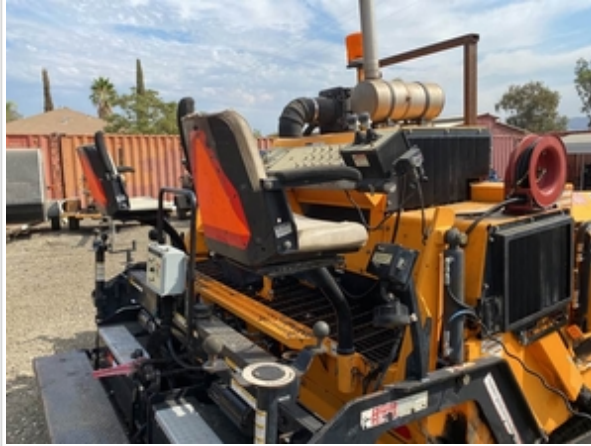
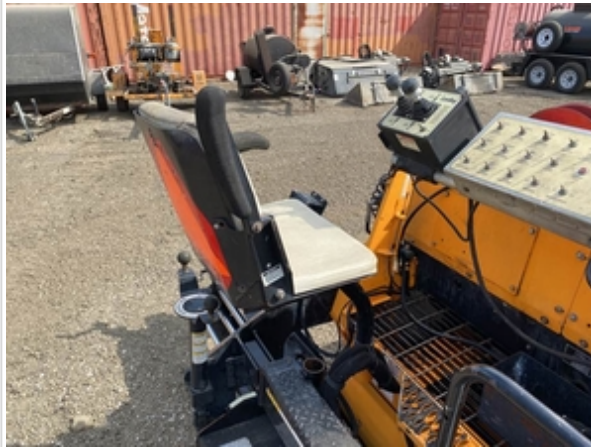
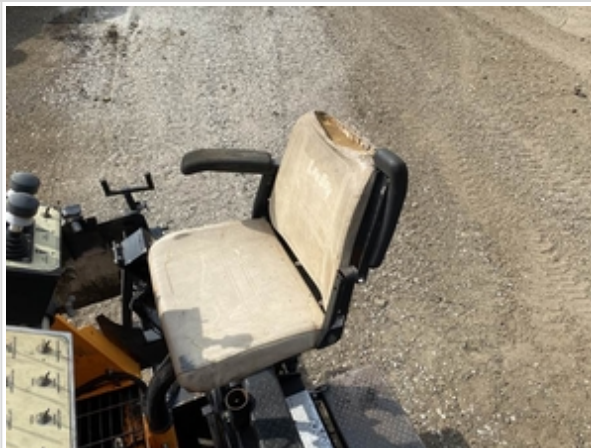
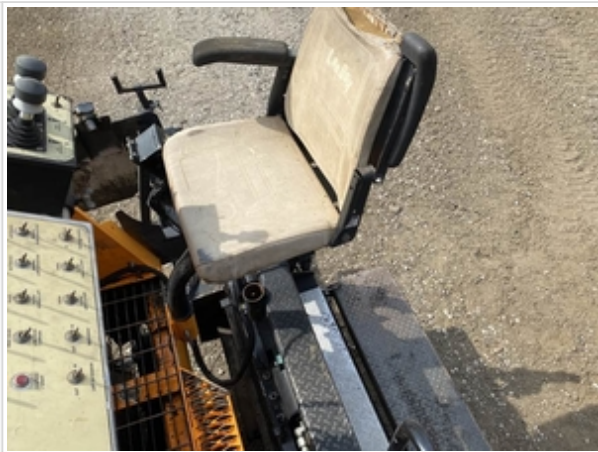
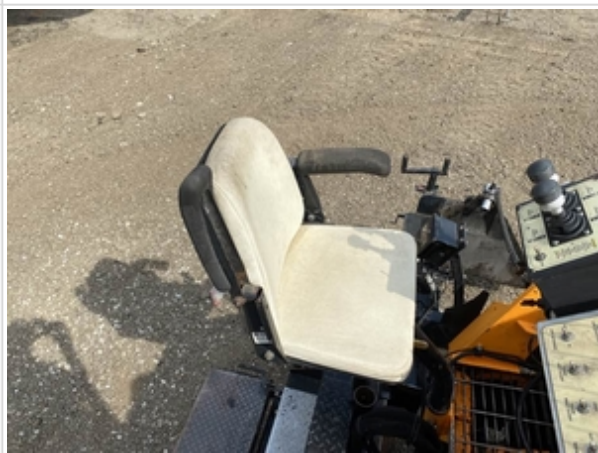
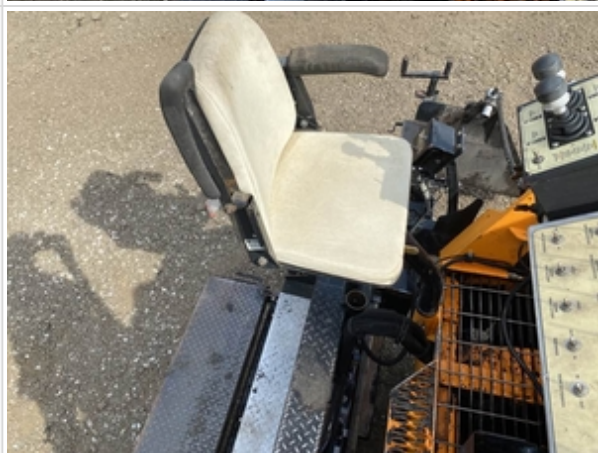
Operator's Seat & Arm Rests
Photos

Operator's Seat & Arm Rests	3 - Normal Wear & Tear
Operator's Seat & Arm Rests Condition	Seat(s) have minor surface staining or small tears, Other (see comments)
Comments	Left side seat okay right side torn cushion

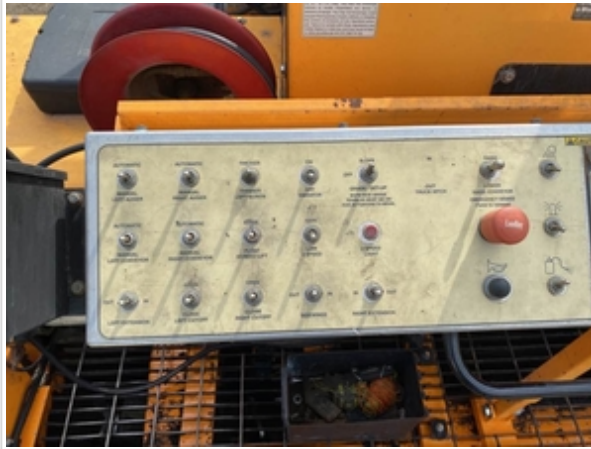
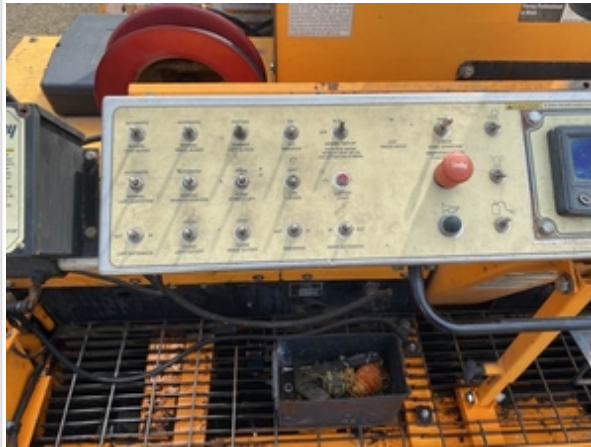
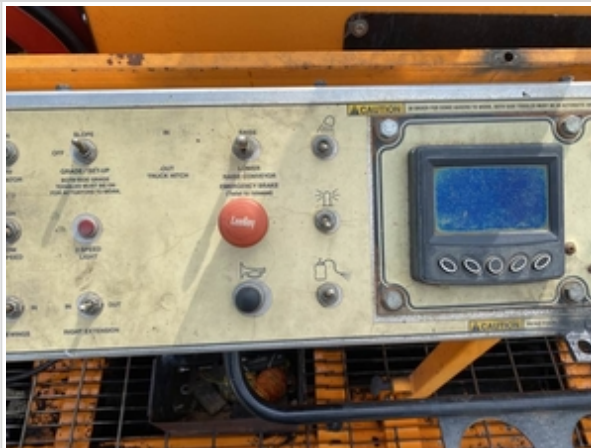
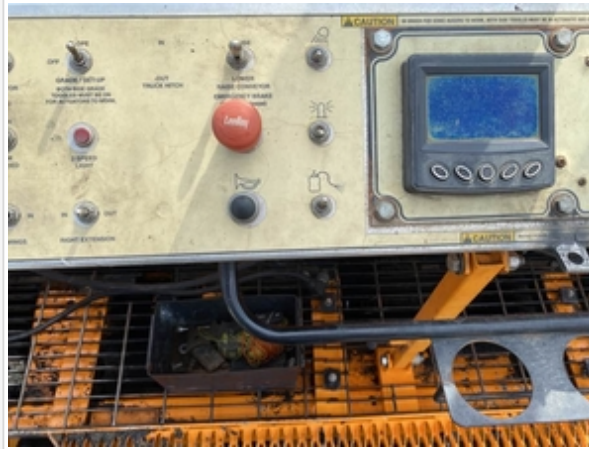
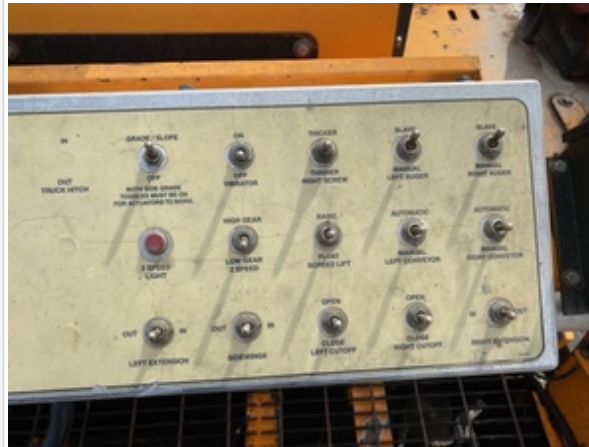
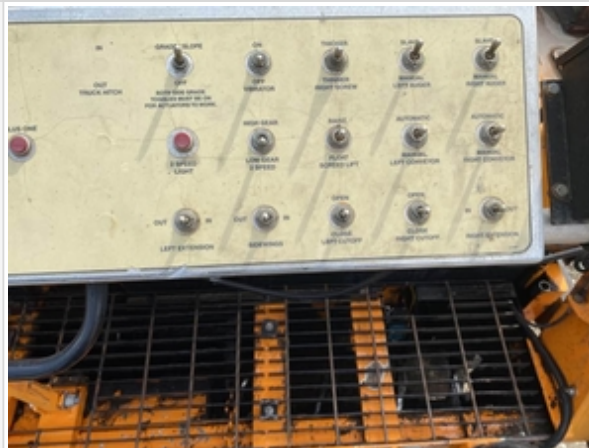
<p>Controls & Switches</p>	<p>3 - Normal Wear & Tear</p>
<p>Controls & Switches Condition</p>	<p>All switches are installed and functional</p>
<p>Controls & Switches Photos</p>

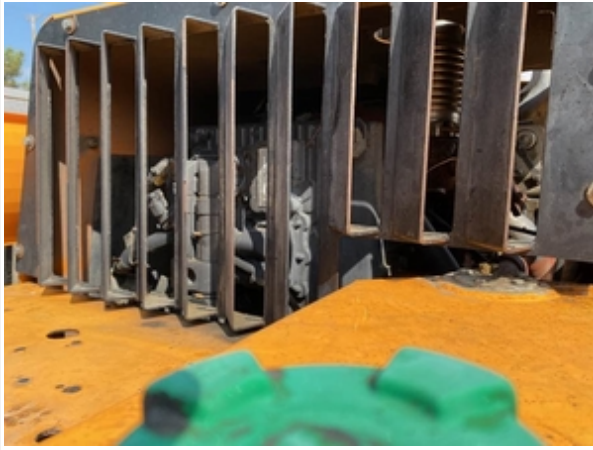
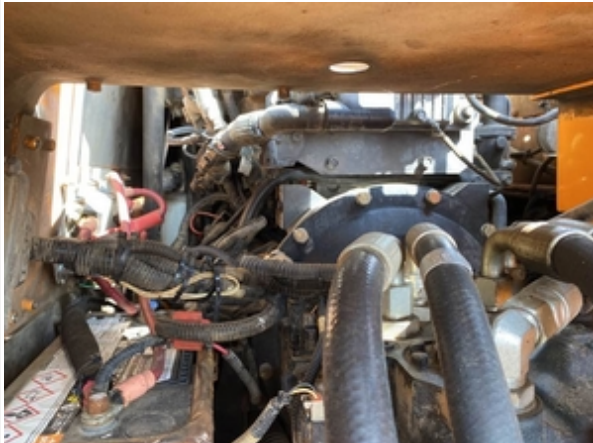
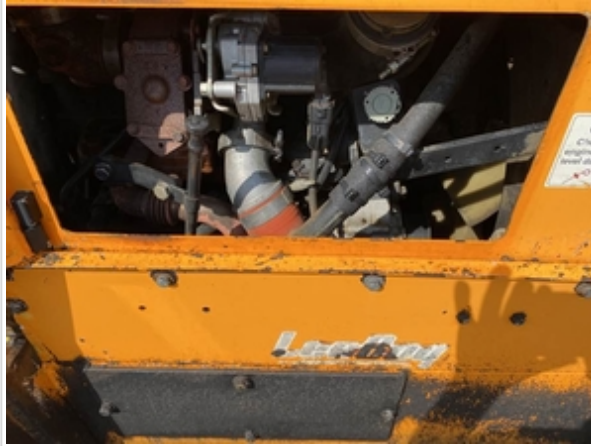
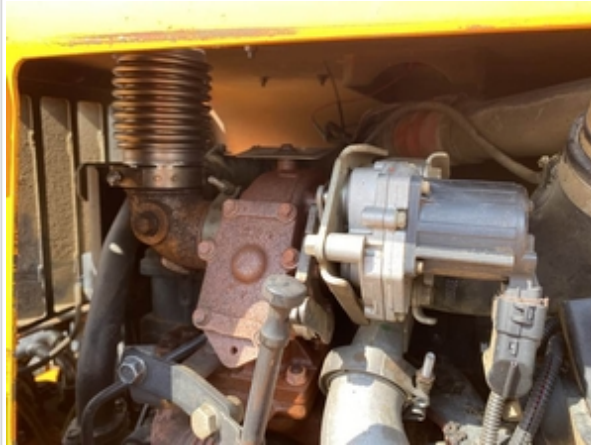
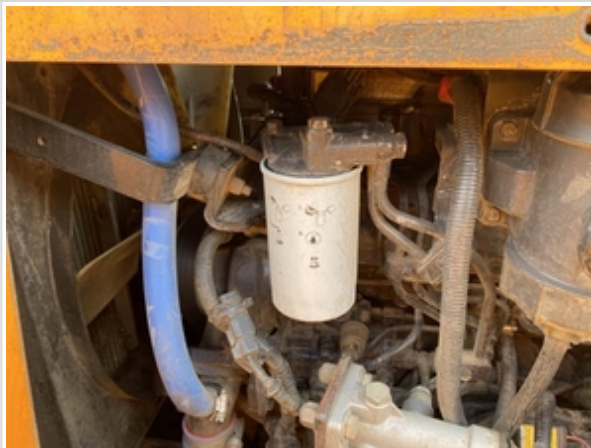
Engine Type (Make, Model, Cylinders, Hp)	Kubota V3800 - 4cyl. - 74 HP - 3.8L
Emissions Tier	Tier 4F
Engine Serial Number	68616855
Engine Fuel Type	Diesel
Engine Photos

Blow-by (Visual Observation Check)	No
Unusual Noises (Upon Start-up, Idle, Shutdown)	No
Unusual Noise Notes	Other (see comments)
Comments	Slight misfire at idle, above idle engine sounds normal
Engine Smoke (Upon Start-up, Idle, Shutdown)	No
Engine Smoke Notes	No engine smoke issues observed

Equipped with DPF (Diesel Particulate Filter)	No
Requires DEF (Diesel Exhaust Fluid)	No
Overall Engine Appearance	Dusty & dry
Overall Engine Comments	Slight misfire at idle when cold. Once engine warms up misfire goes away and engine sounds healthy at all engine rpm's. No active leaks found.

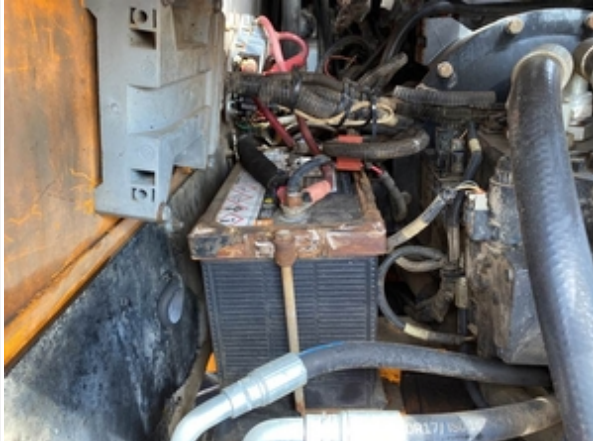
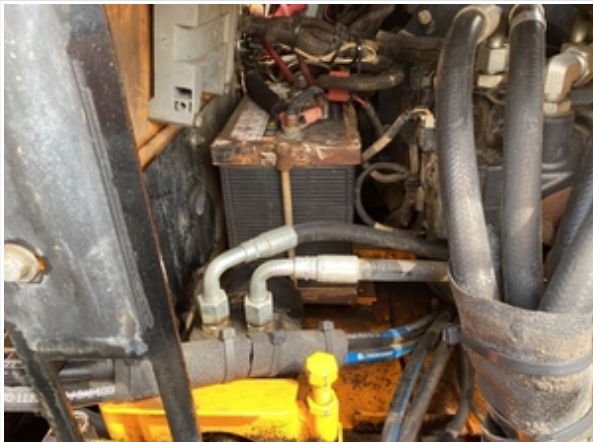
Engine Exhaust Color	Clear
Battery	3 - Normal Wear & Tear
Battery Condition	Clean & dry appearance, tight connections
Battery Condition Photos

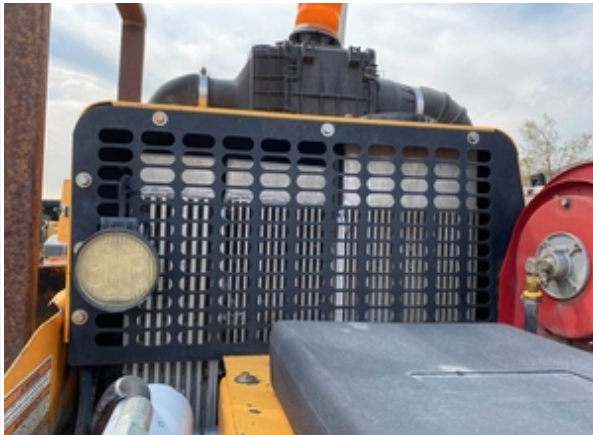
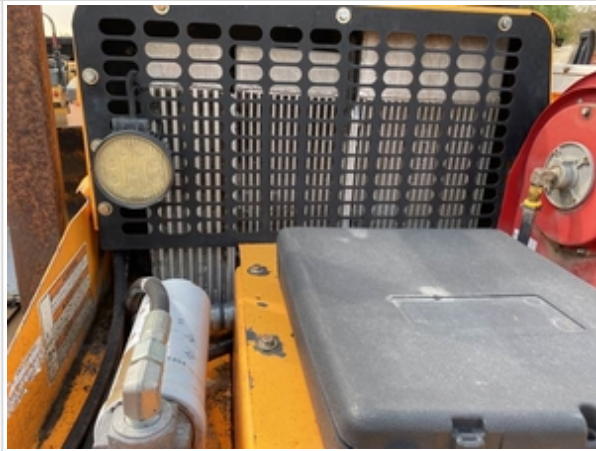
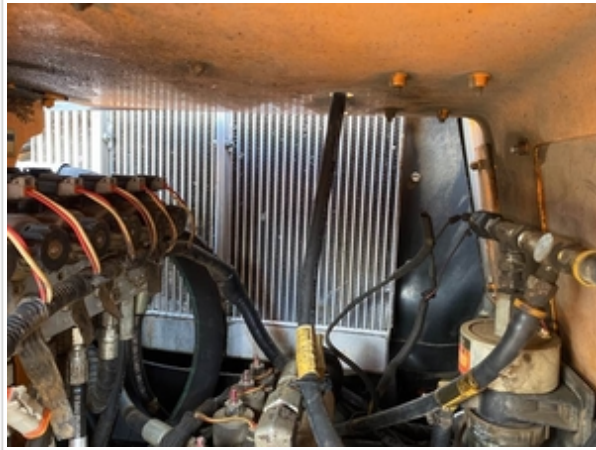
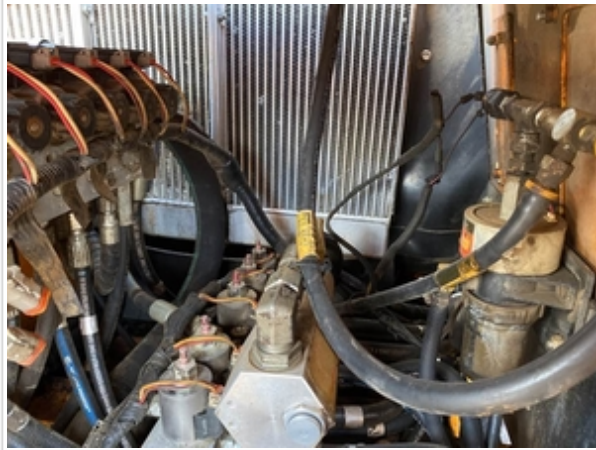
Radiator	3 - Normal Wear & Tear
Radiator Condition	Radiator fins & components appear to be in good working order, no signs of damage or leaks
Radiator Photos

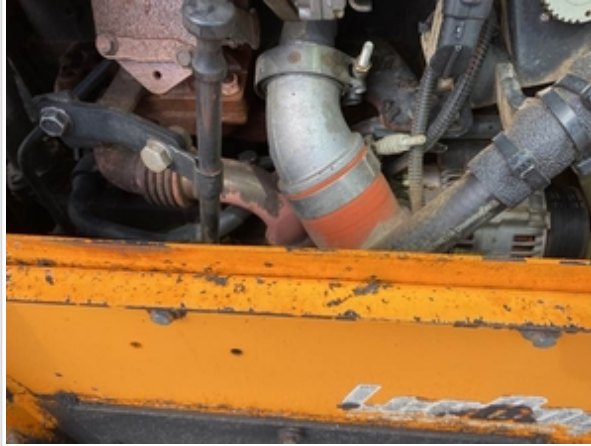
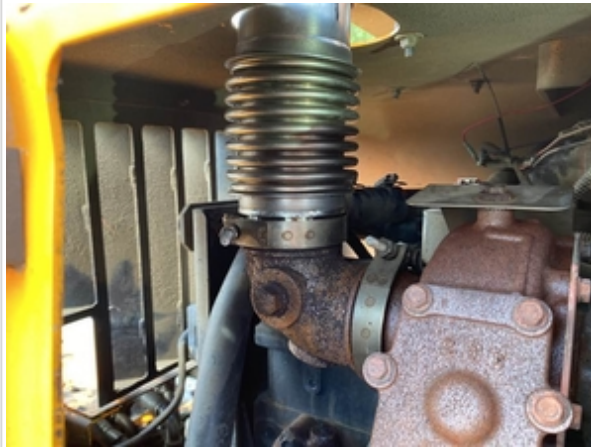
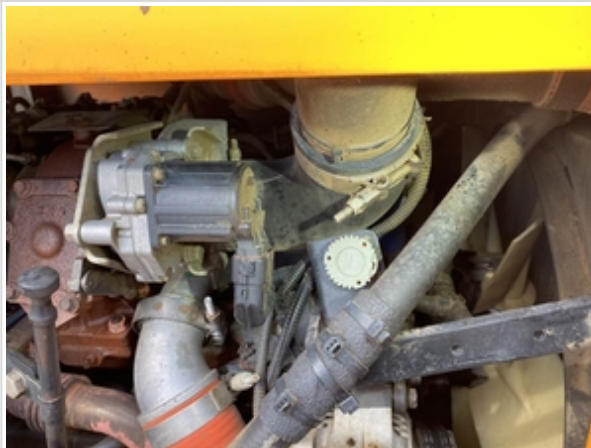
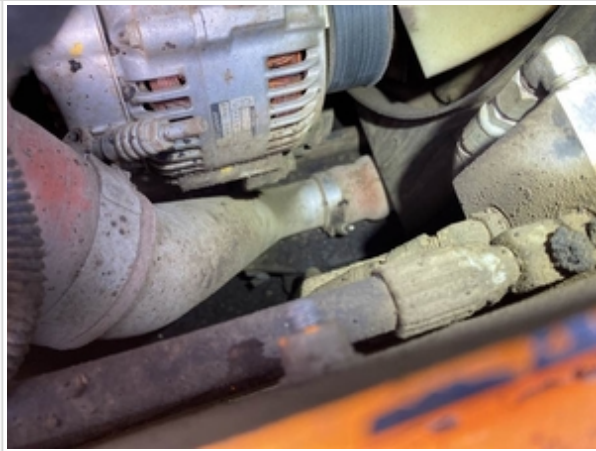
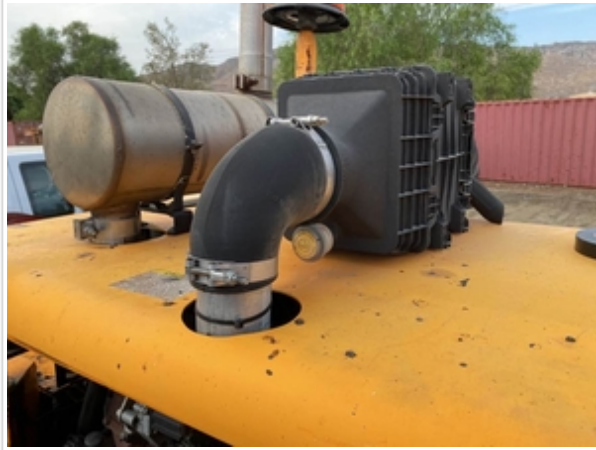
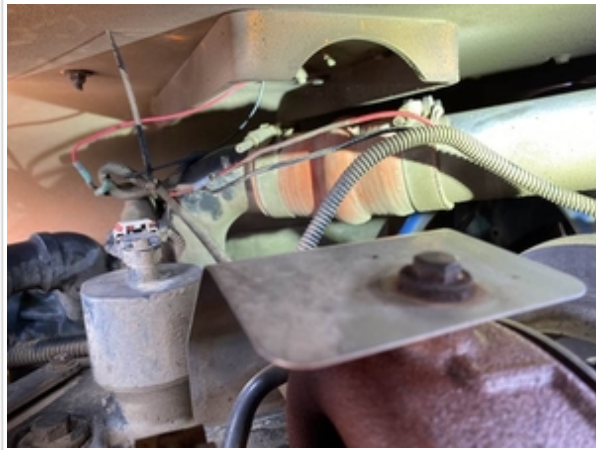
Hose Photos

<p>Hoses</p>	<p>3 - Normal Wear & Tear</p>
<p>Hose Condition</p>	<p>Firm, pliant hoses with no signs of wear or leaks</p>

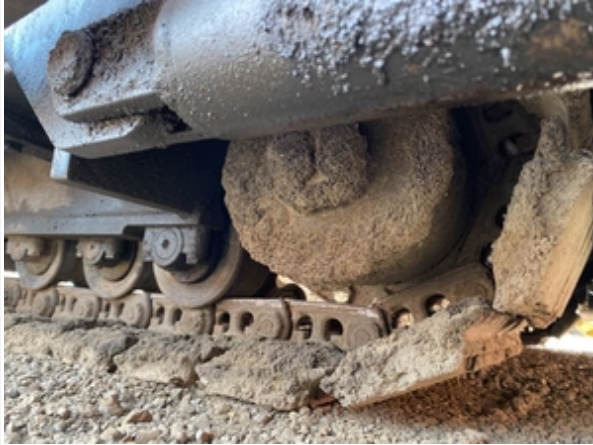
Transmission Info	Hydrostatic, propel motor driven
Clutch	0
Transmission	3 - Normal Wear & Tear
Left Drive Motor	3 - Normal Wear & Tear
Comments	Surface area covered in asphalt, no unusual noise heard
Left Final Drive	3 - Normal Wear & Tear
Comments	Surfaces covered in asphalt, no unusual noise heard
Left Final Drive Photos

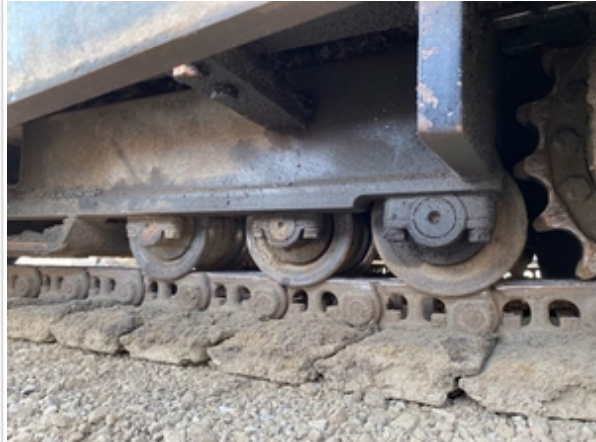
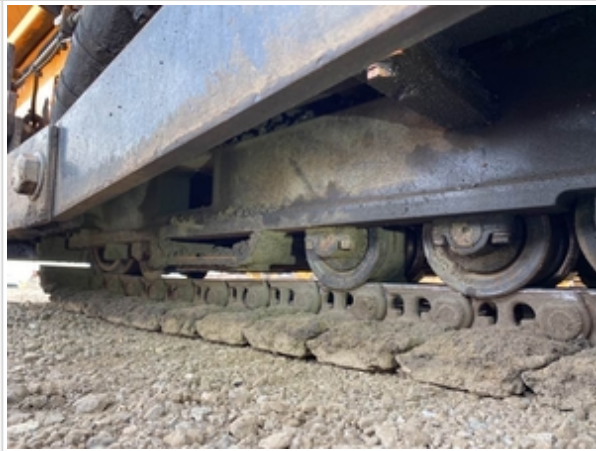
Instructions	<p>Evaluate the following on a 4 point scale (leave comments where an explanation is appropriate):</p> <p>4 = Like New, Recently Replaced 3 = Normal Wear & Tear 2 = Above Average Wear 1 = Service Required</p>
Roller Frames	3 - Normal Wear & Tear
Roller Frames Photos

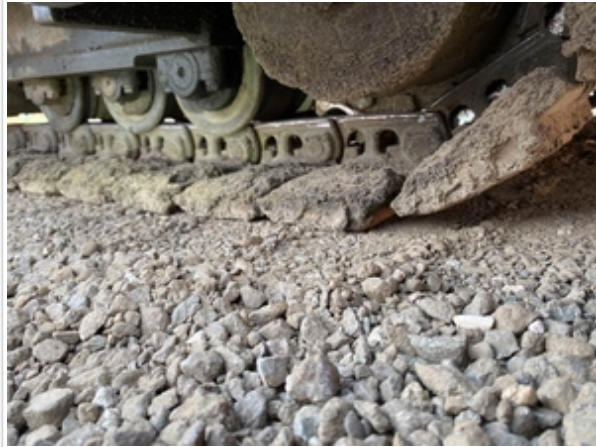
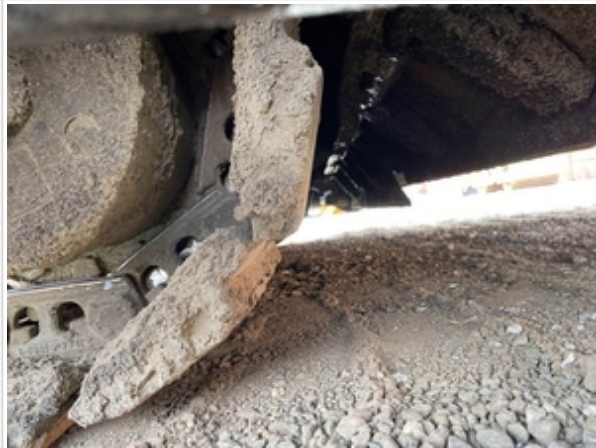
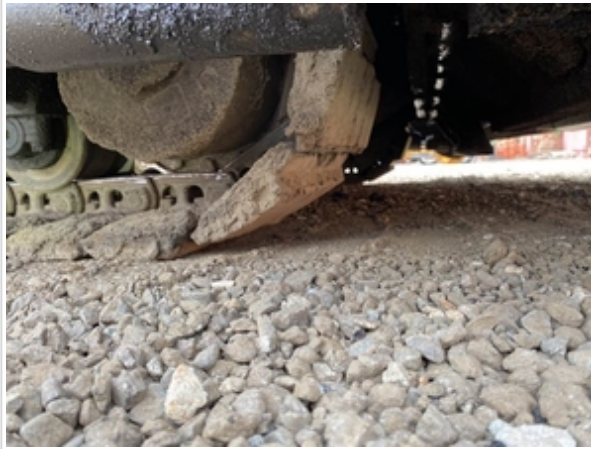
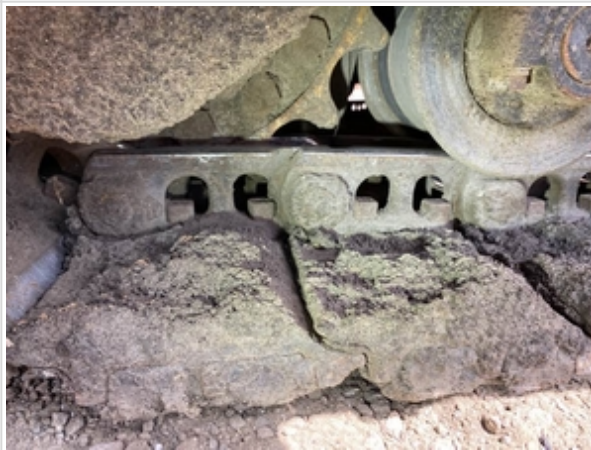
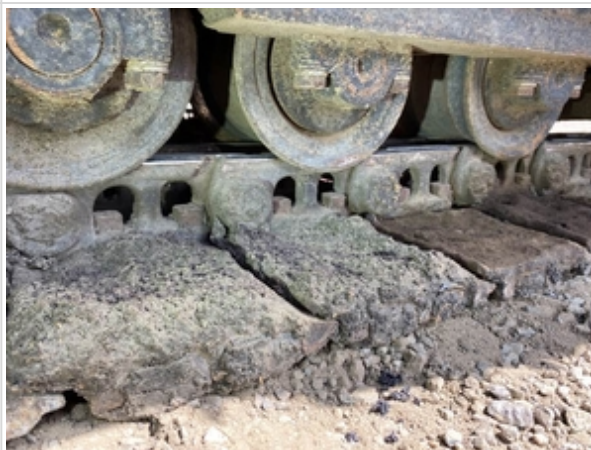
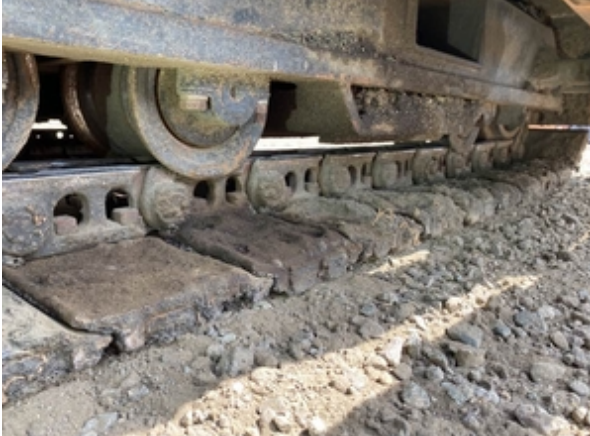
Track Belt	3 - Normal Wear & Tear	
Comments	Normal wear	
Track Belt Photos
