Inspection Report (Asphalt Paver)

Year	2016
Make	Leeboy
Model	8515C
Serial Number	134860
Hour Meter Reading	1,927 hours
Previous Application (e.g., earth moving, mining, demolition, etc)	Asphalt Paving Construction

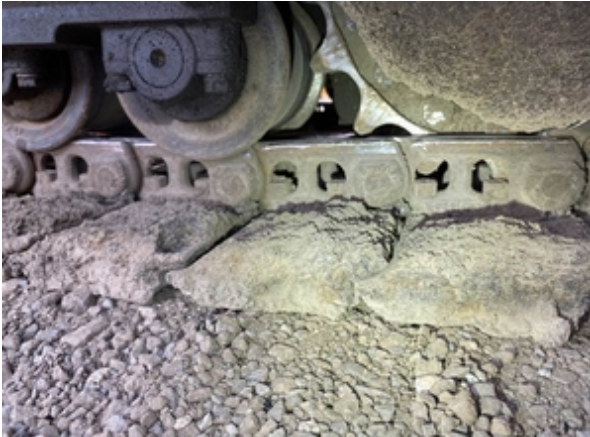
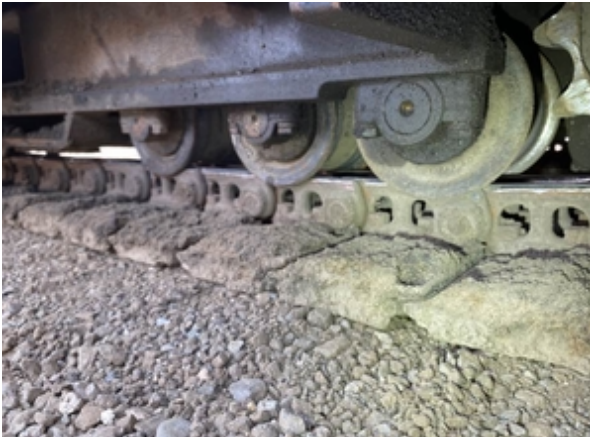
Rubber Belt Drive Lugs	3 - Normal Wear & Tear	
Comments	Normal wear	
Rubber Belt Drive Lugs Photos

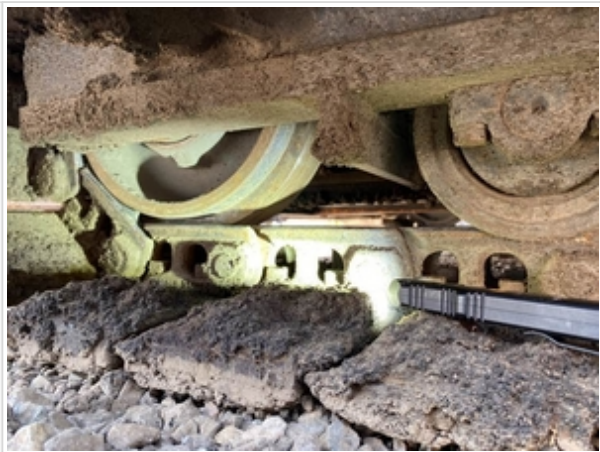
Front Idlers Photos

Track Tensioners	3 - Normal Wear & Tear	
Front Idlers	3 - Normal Wear & Tear

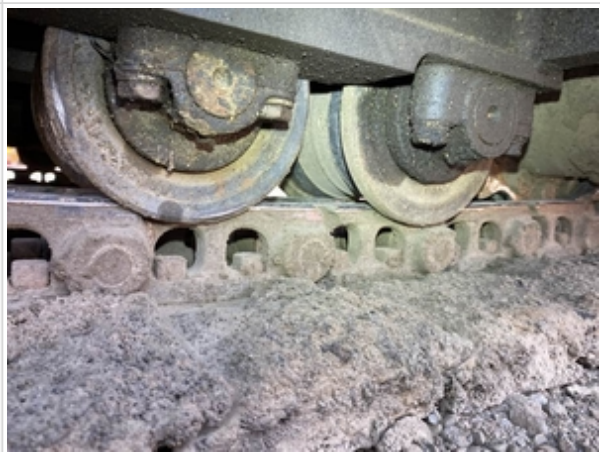
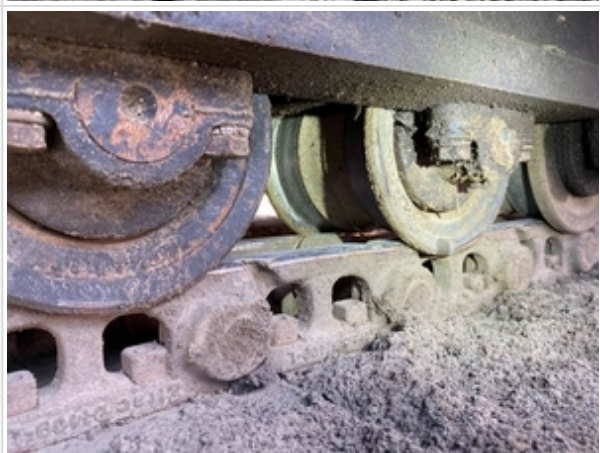
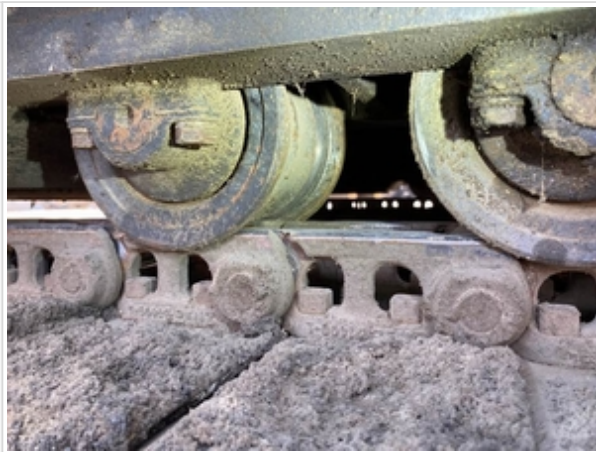
Rear Idlers	3 - Normal Wear & Tear	
Rear Idlers Photos

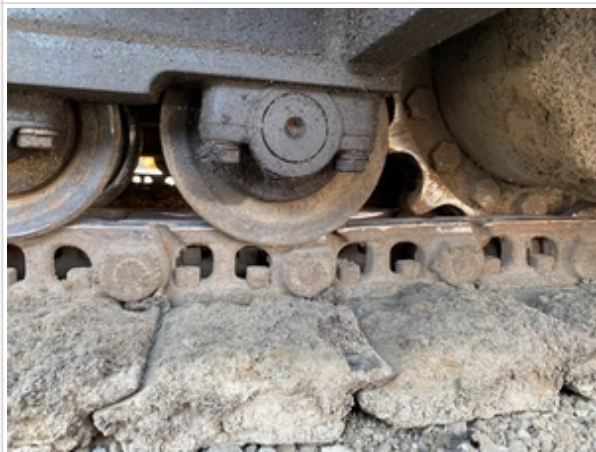
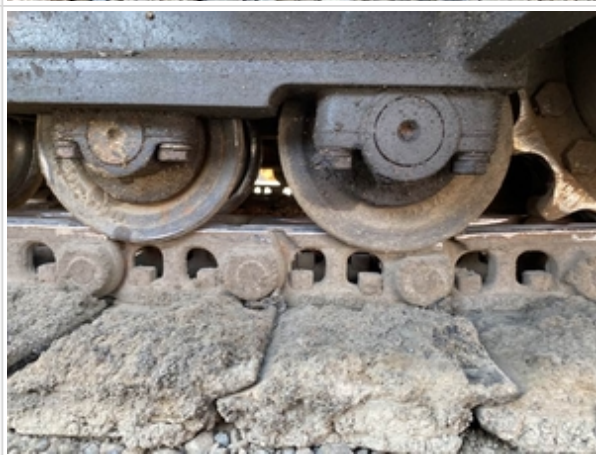
<p>Track Rollers</p>	<p>3 - Normal Wear & Tear</p>	
<p>Track Rollers Photos</p>

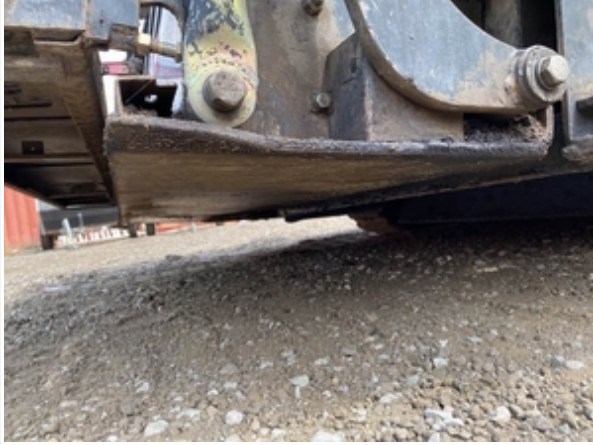
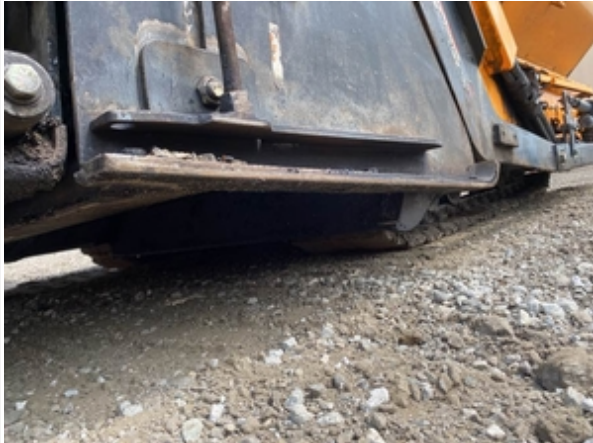
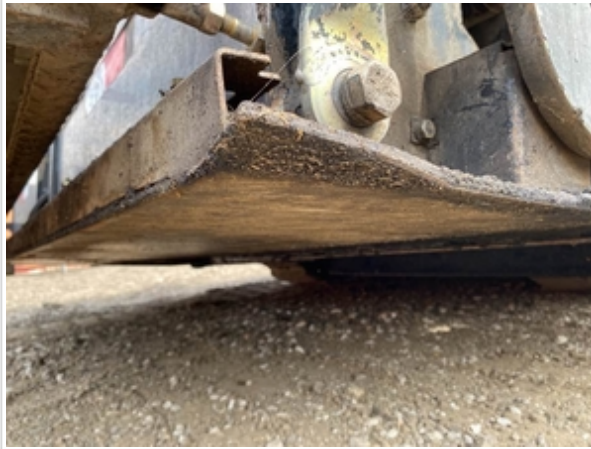
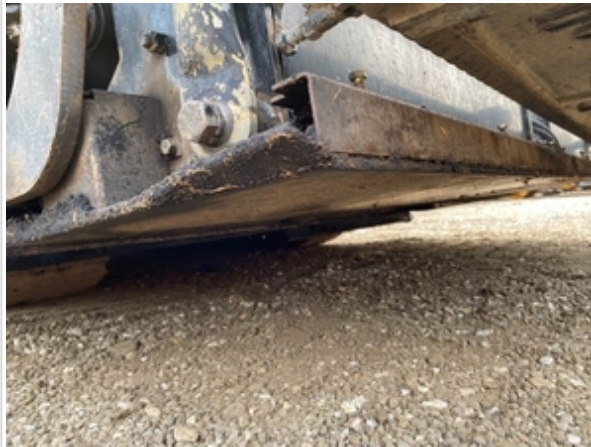
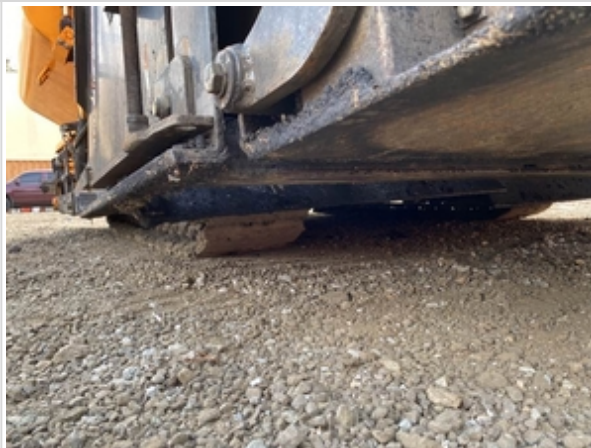
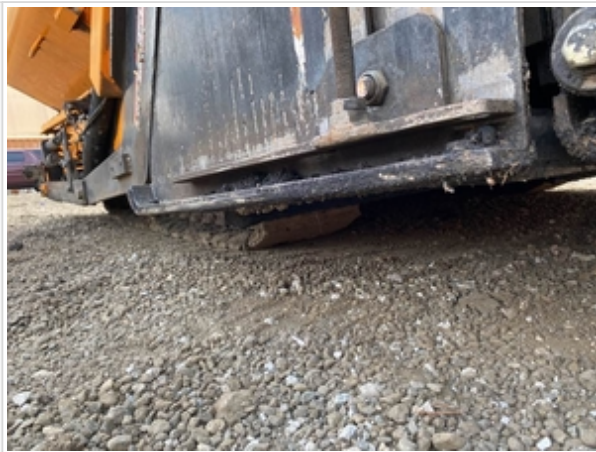
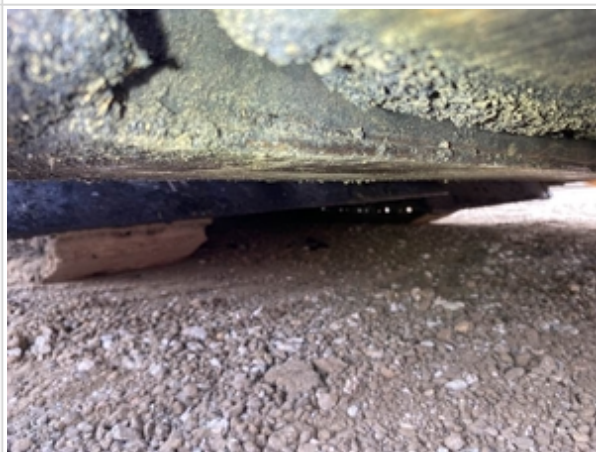
Screed Plates/Adjusters	3 - Normal Wear & Tear
Screed Plates/Adjusters Photos

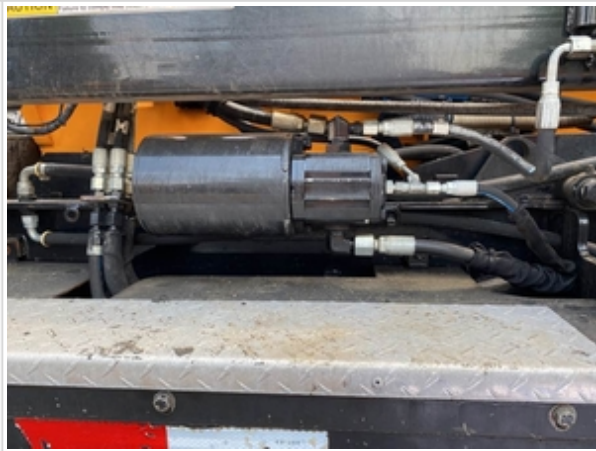
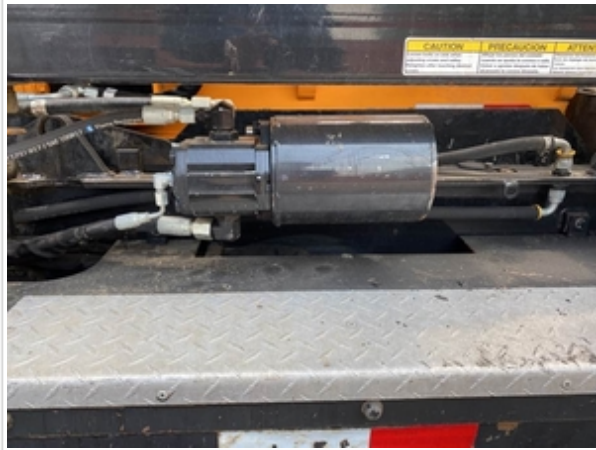
<p>Screed Vibrate Shaft Bearings & U Joints</p>	<p>3 - Normal Wear & Tear</p>	
<p>Screed Vibrate Shaft Bearings & U Joints Photos</p>

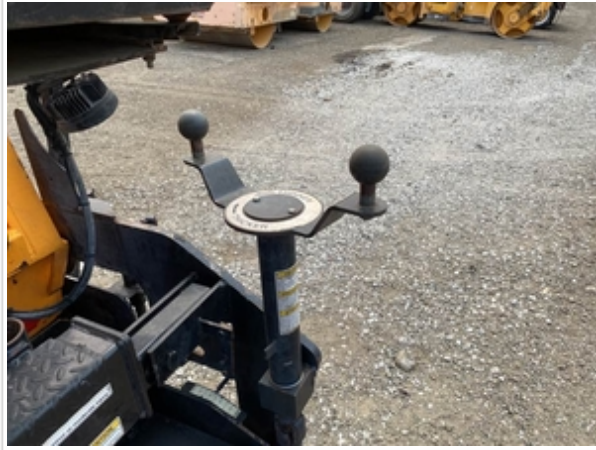
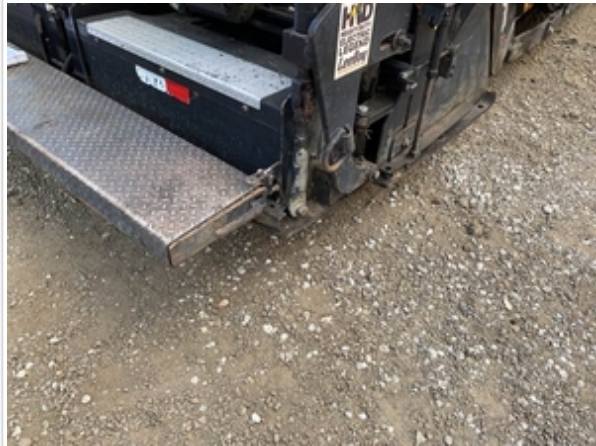
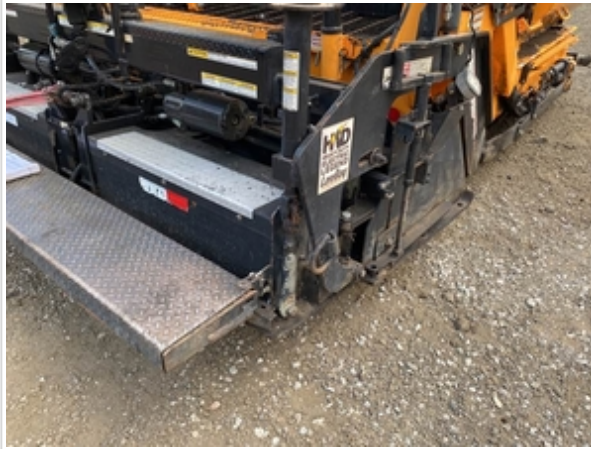
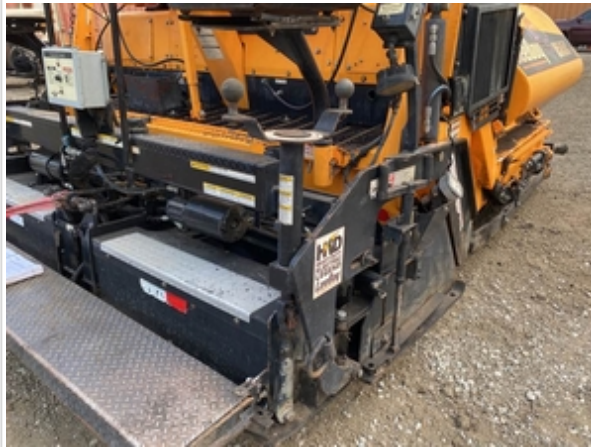
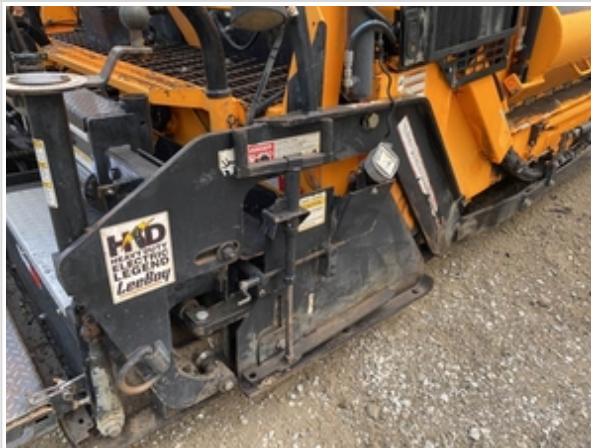
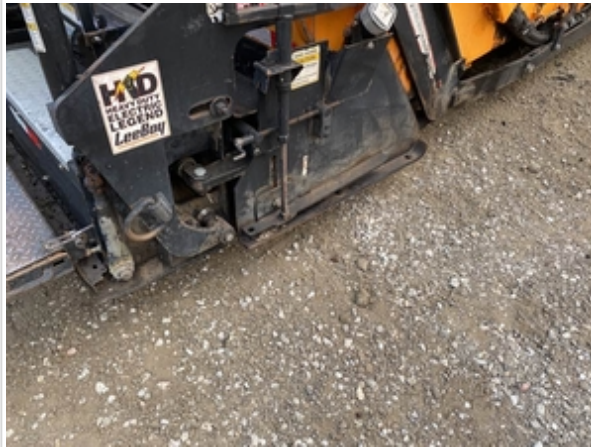
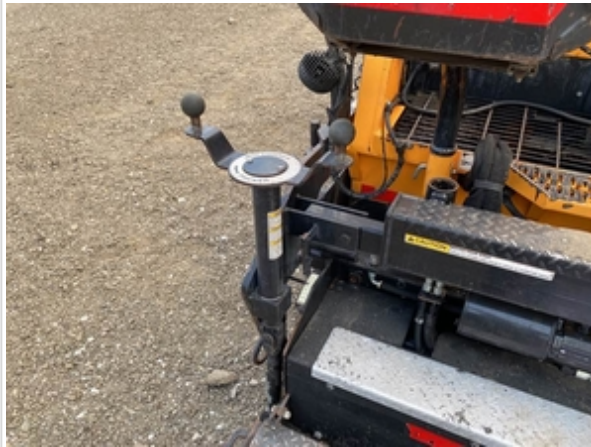
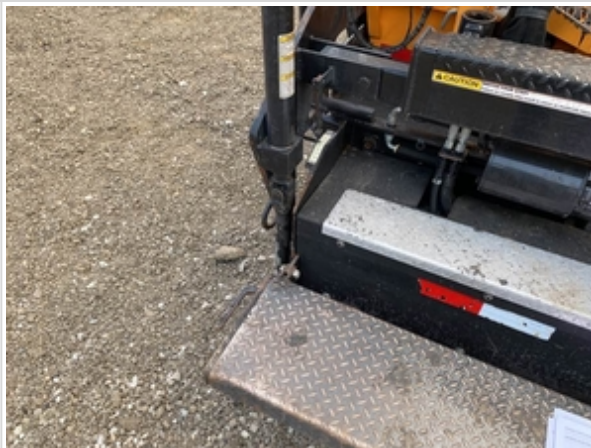
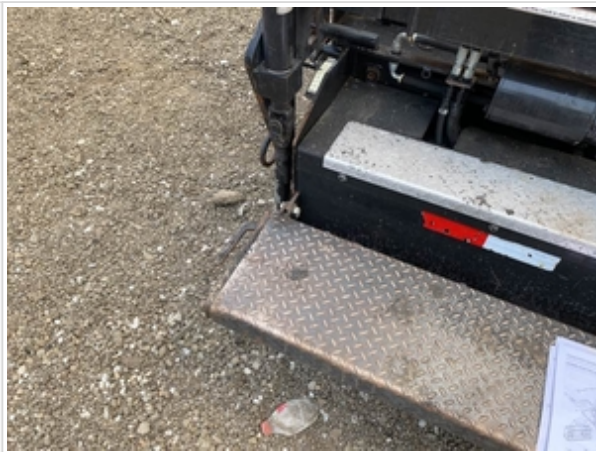
<p>Screed Depth Crank/Bearings/Shafts/Sleeves</p>	<p>3 - Normal Wear & Tear</p>	
<p>Screed Depth Crank/Bearings/Shafts/Sleeves Photos</p>

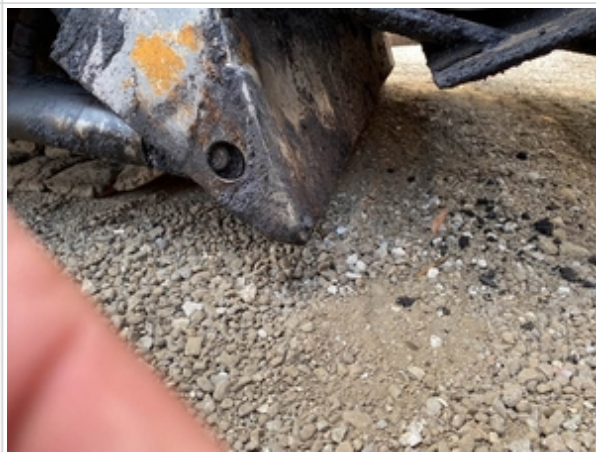
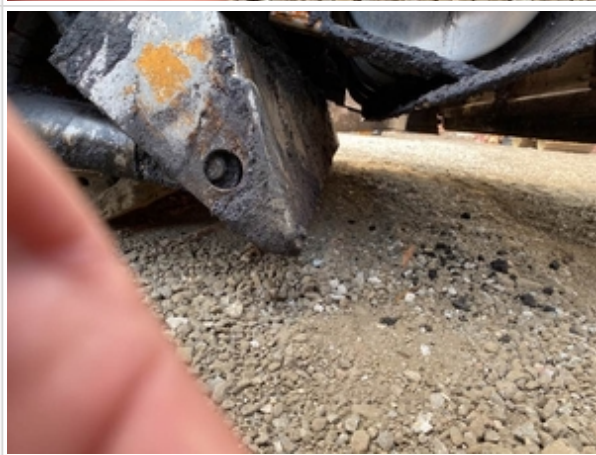
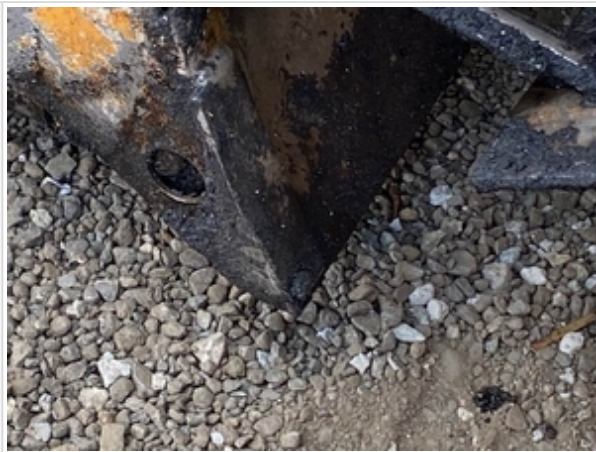
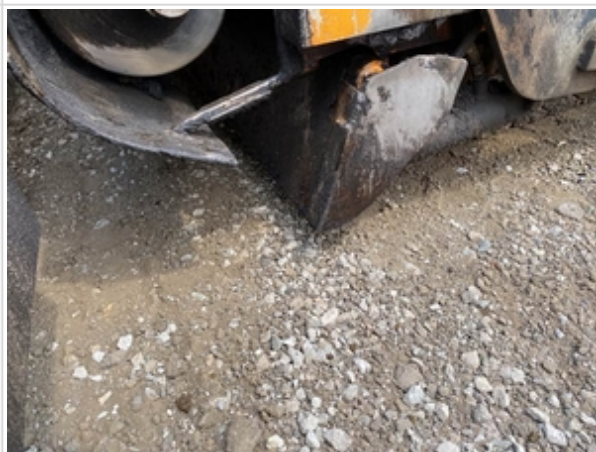
<p>Screed Pre-Strikeoff Plate</p>	<p>3 - Normal Wear & Tear</p>	
<p>Screed Pre-Strikeoff Plate Photos</p>

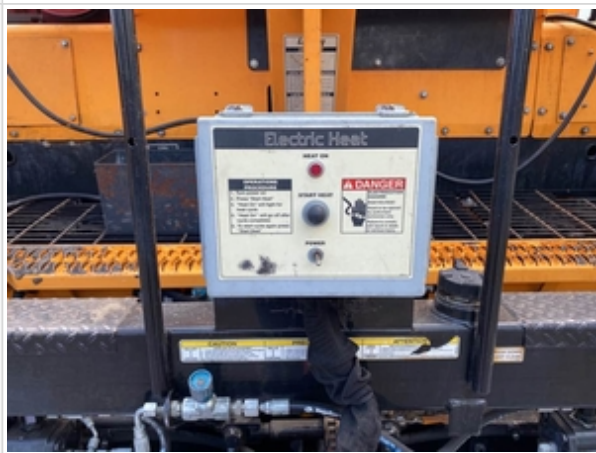
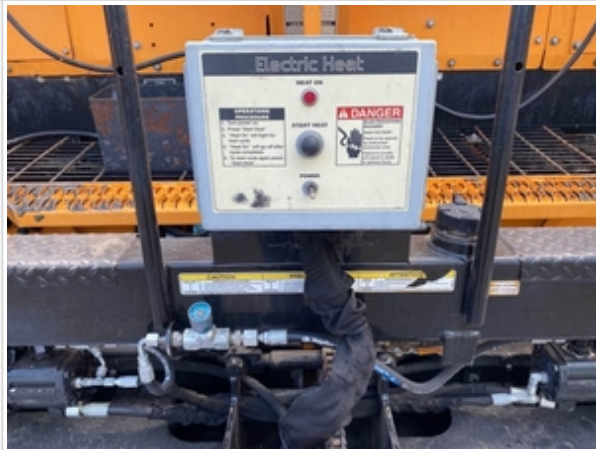
<p>Screed Heating Elements</p>	<p>3 - Normal Wear & Tear</p>
<p>Screed Heating Elements Photos</p>

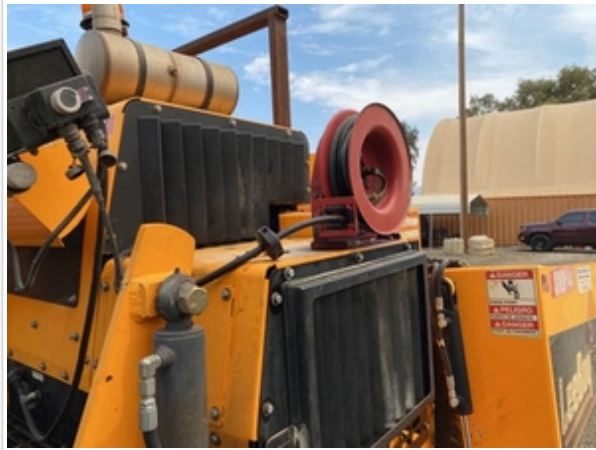
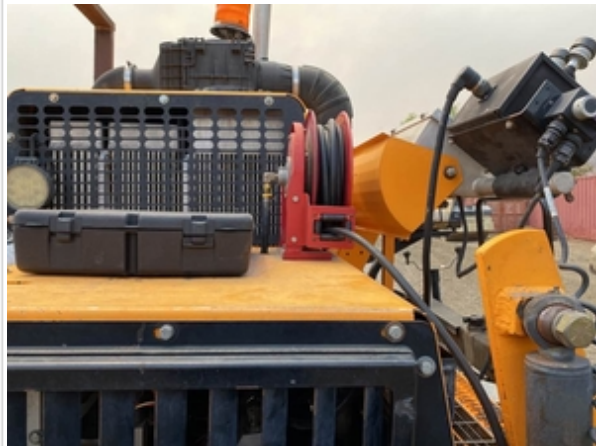
Screed Diesel Burner Assemblies	3 - Normal Wear & Tear	
Screed Diesel Burner Assemblies Photos

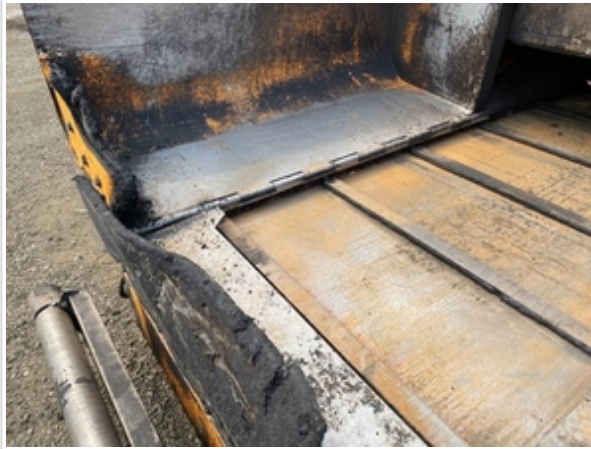
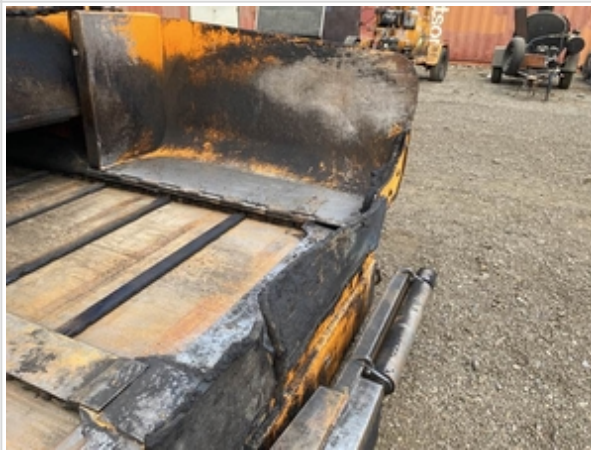
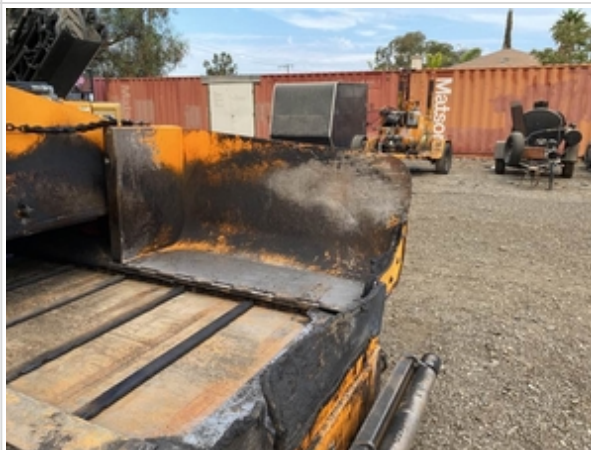
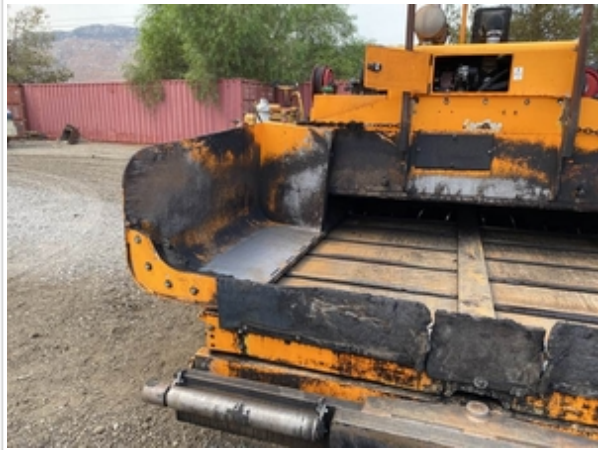
Hopper/Hopper Hinge/Flashing
Photos

Hopper/Hopper Hinge/Flashing	3
-------------------------------------	---

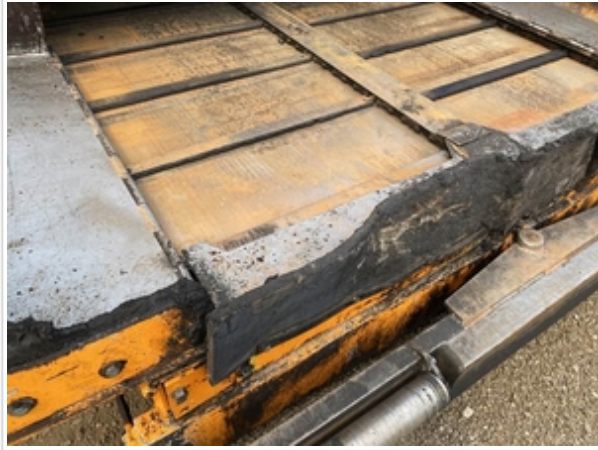
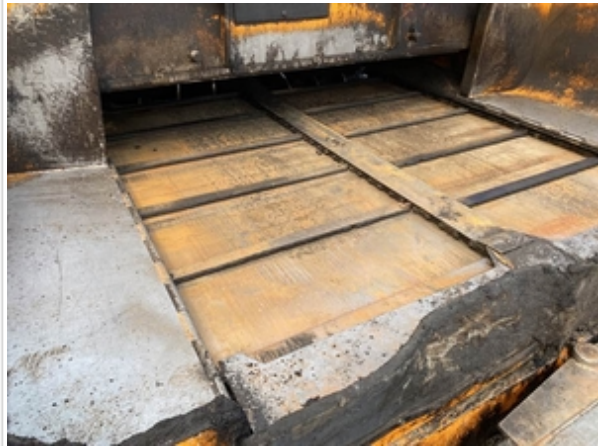
<p>Drag Conveyor/Chain/Bars/Floor Plates/Guards</p>	<p>3</p>	
<p>Drag Conveyor/Chain/Bars/Floor Plates/Guards Photos</p>

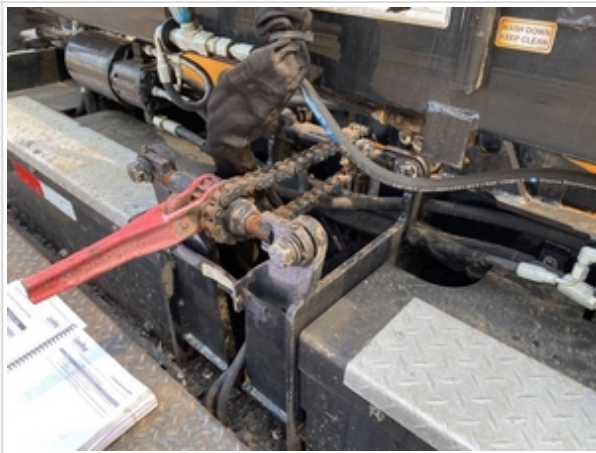
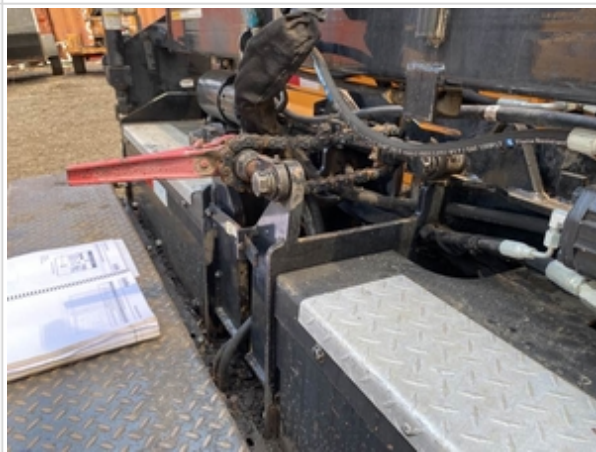
<p>Drag Conveyor Adjustor Photos</p>

Drag Conveyor Adjustor	3

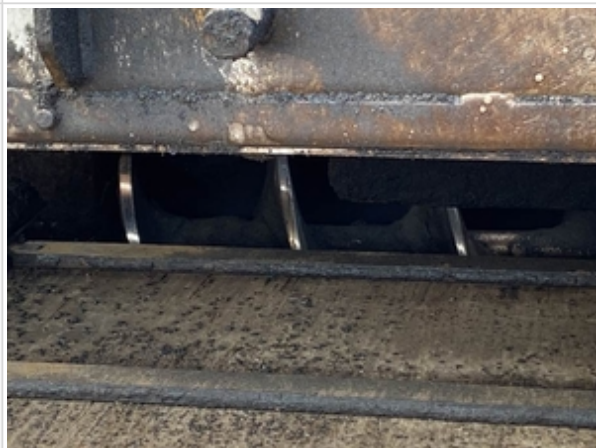
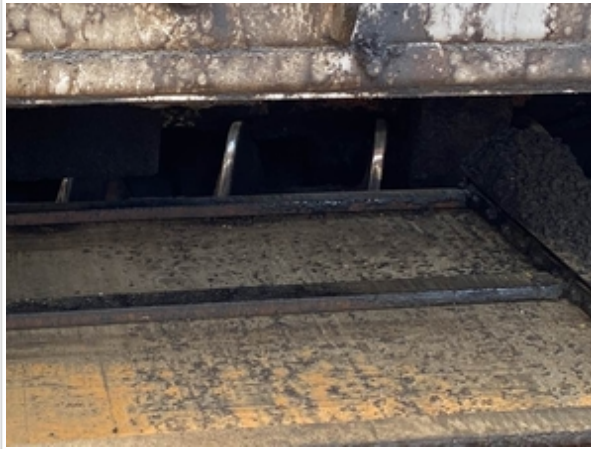
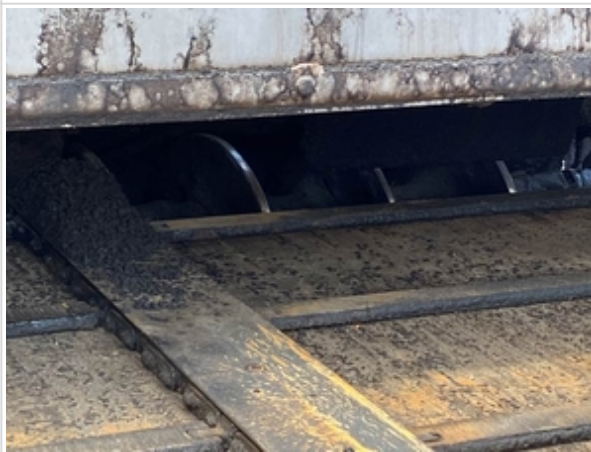
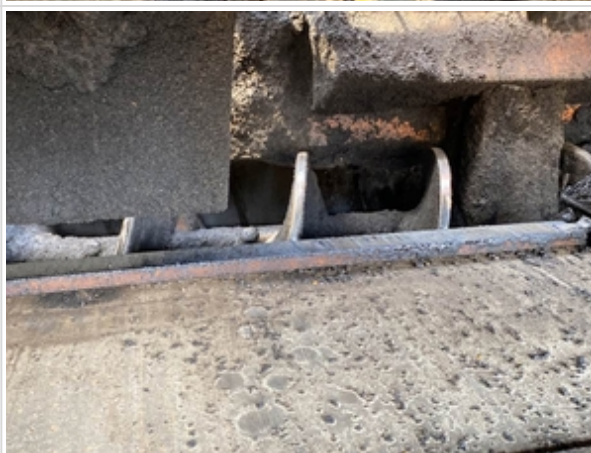
<p>Feeder Drive Shafts/Bearings/Sprockets/Idlers</p>	<p>3</p>	
<p>Auger/Flights/Shfts/Bearings</p>	<p>3</p>	
<p>Auger/Flights/Shfts/Bearings Photos</p>

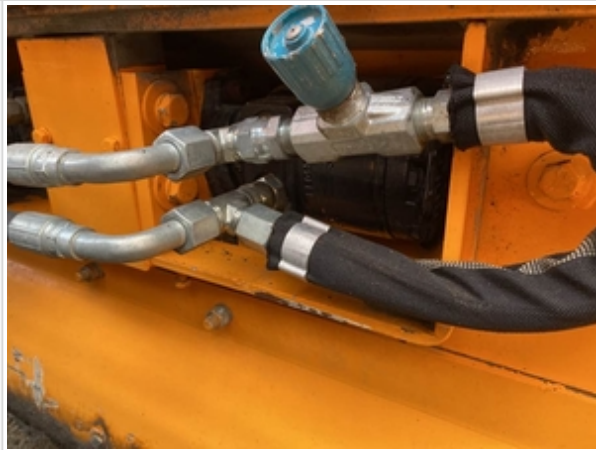
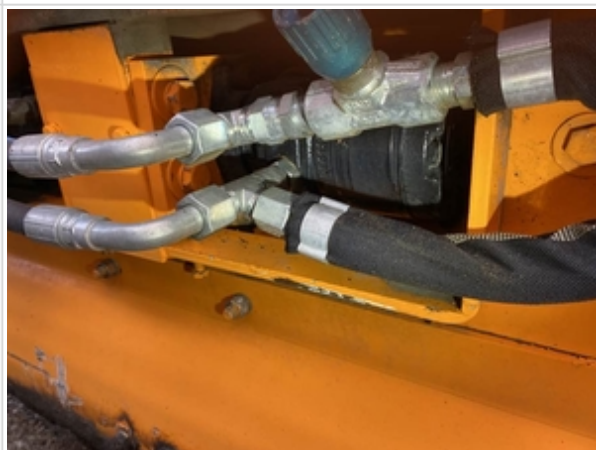
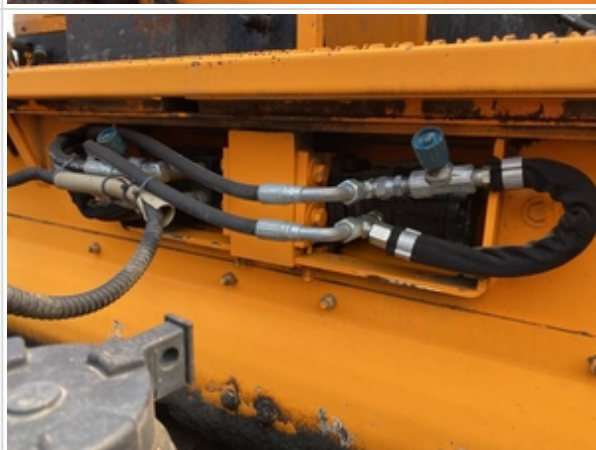
<p>Conveyor & Auger Drives/Chains/Sprockets Photos</p>

<p>Conveyor & Auger Drives/Chains/Sprockets</p>	<p>3</p>

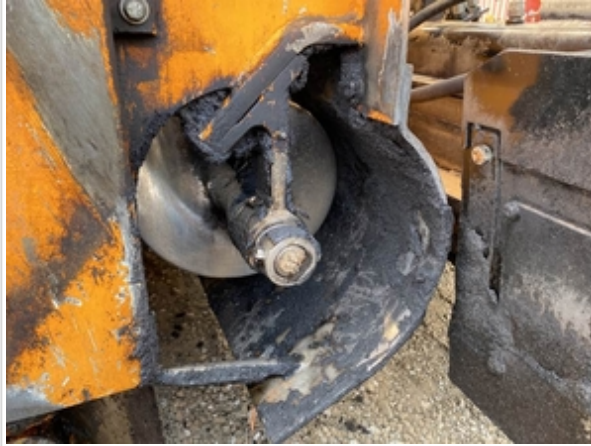
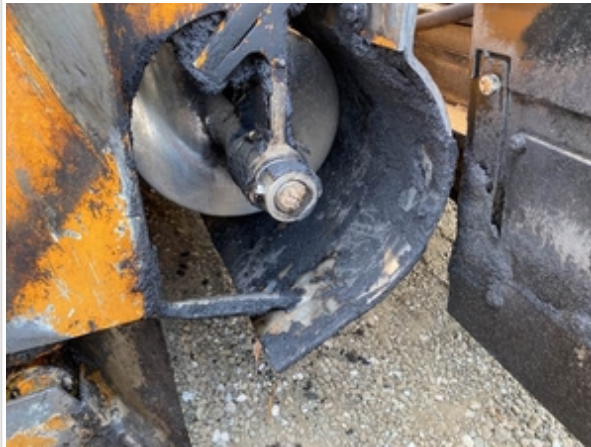
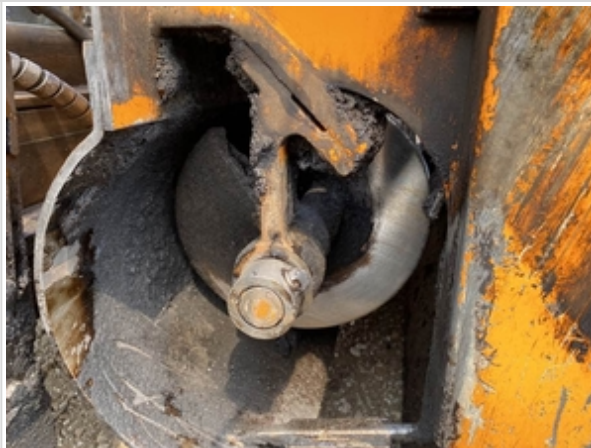
Conveyor & Auger Bearing
Remote Lube Lines Photos

<p>Conveyor & Auger Bearing Remote Lube Lines</p>	<p>3</p>

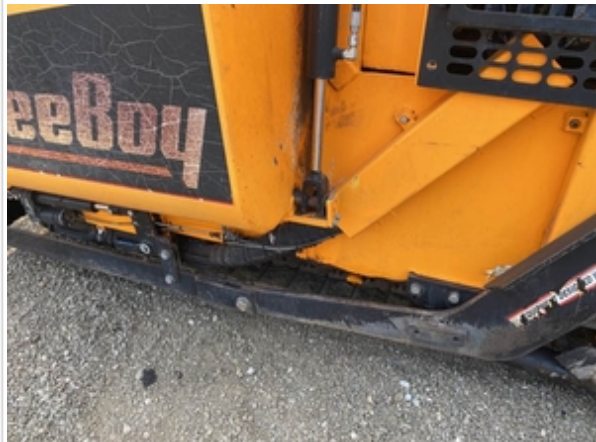
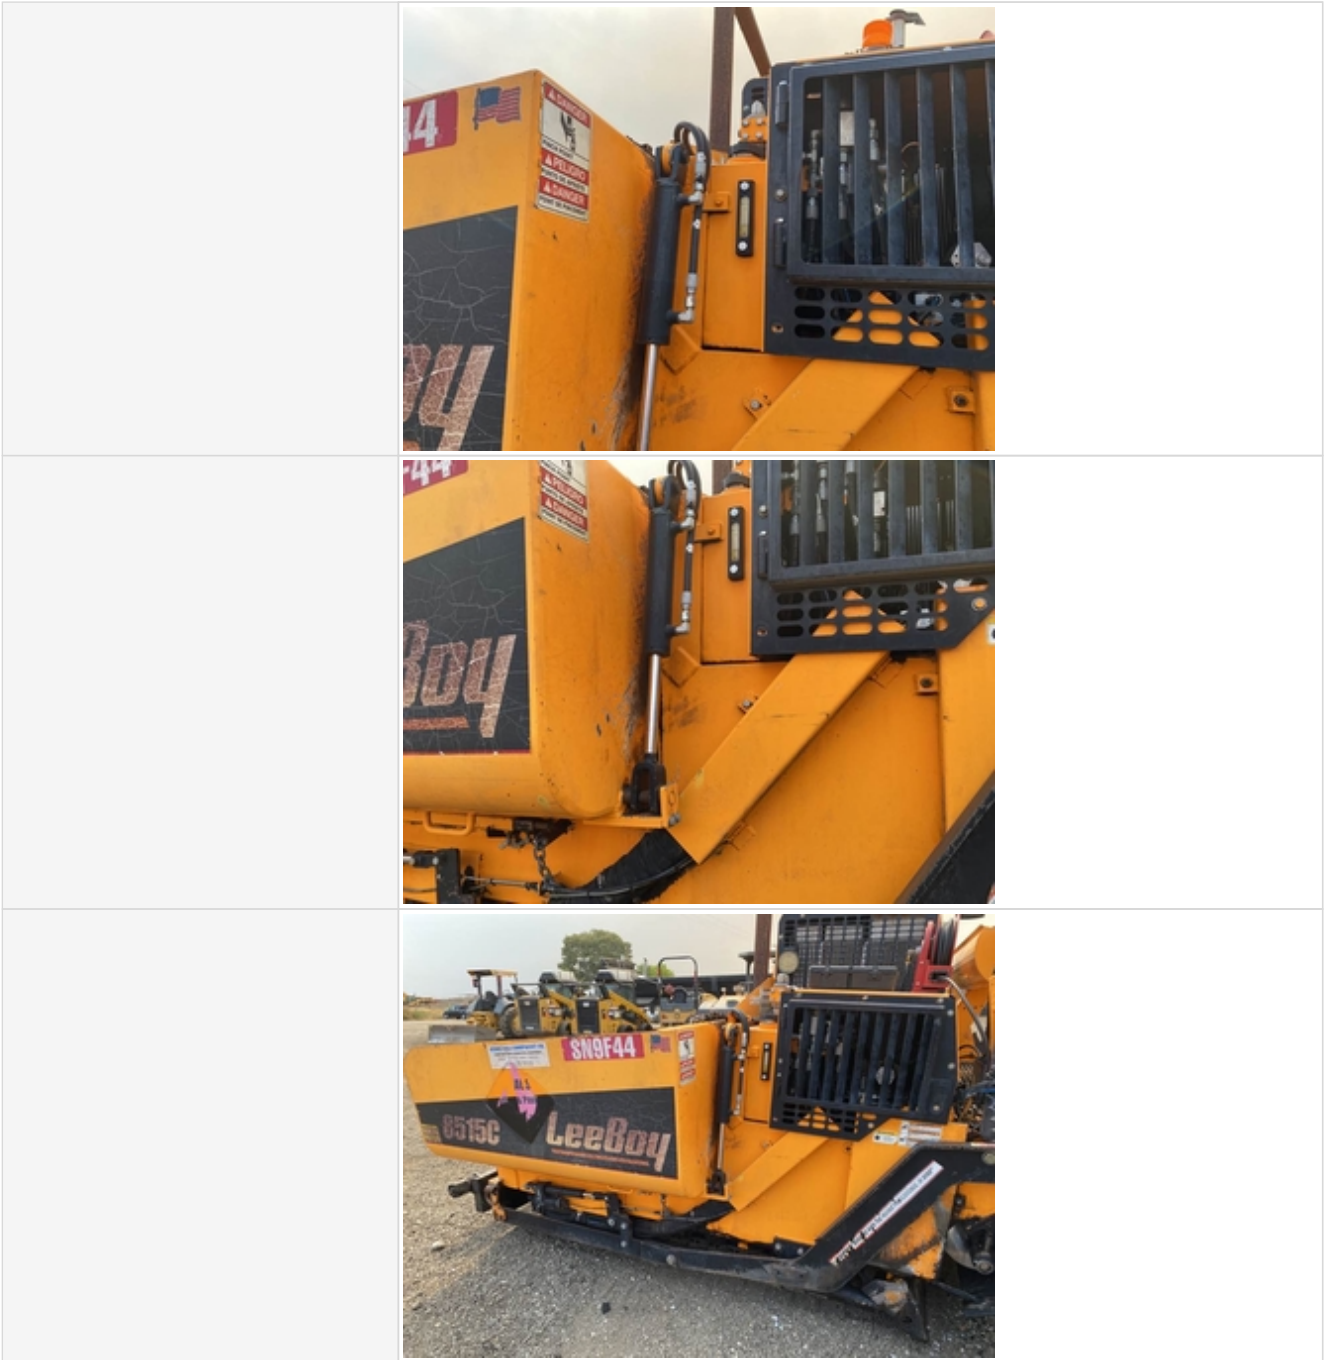
Hopper Wing Cylinders: Mounting Pin	3
Hopper Wing Cylinders: Oil Leaks	No
Hopper Wing Cylinders Photos

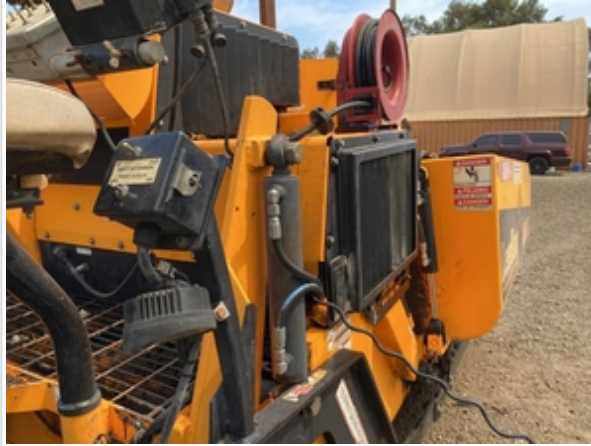
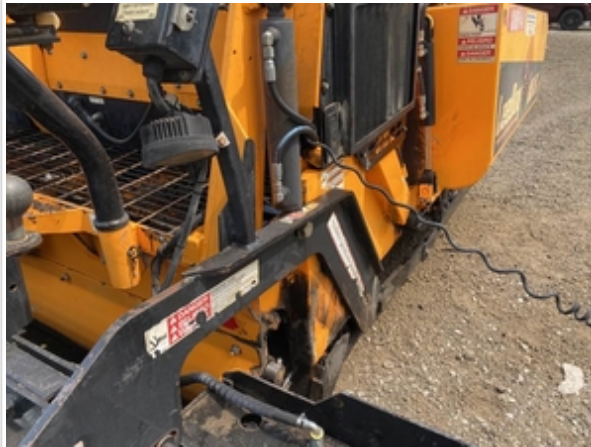
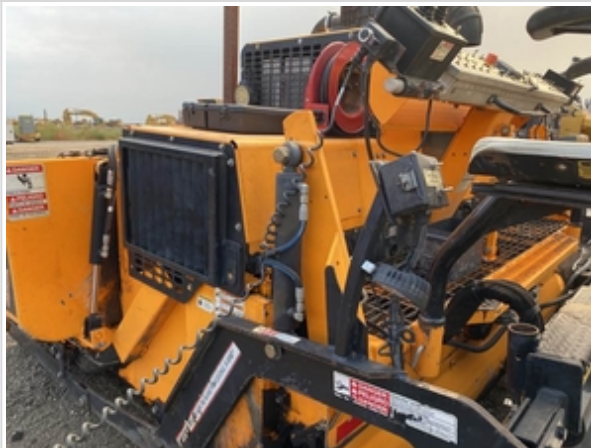
Screed Lift Cylinders Photos

<p>Screed Lift Cylinders: Mounting Pin</p>	<p>3</p>
<p>Screed Lift Cylinders: Oil Leaks</p>	<p>No</p>
