Inspection Report (Telehandler)

Year	2016
Make	JCB
Model	512 - 56 Telehandler
Serial Number	JCB5CH2GC02433899
Hour Meter Reading	3,334 hours
Previous Application (e.g., earth moving, mining, demolition, etc)	General Concrete Construction

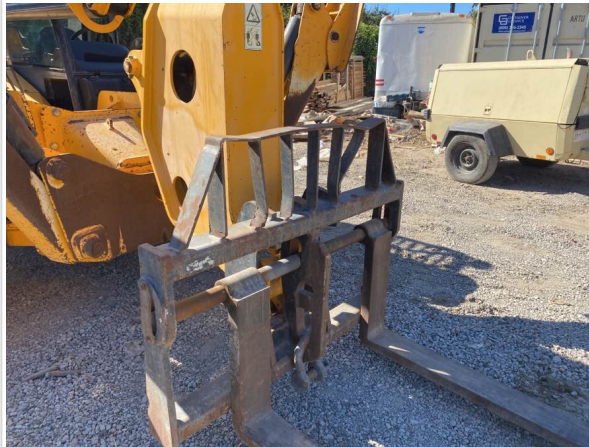
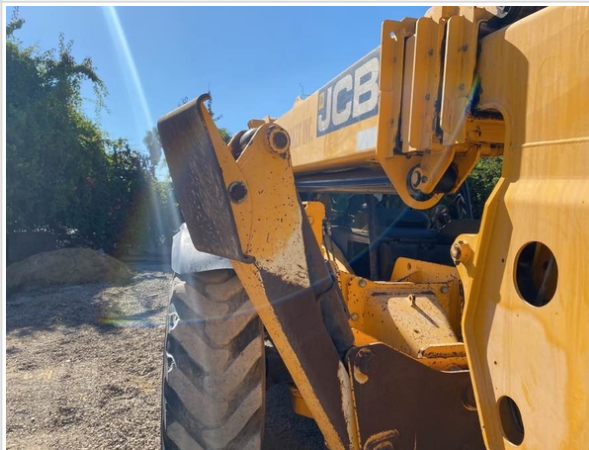
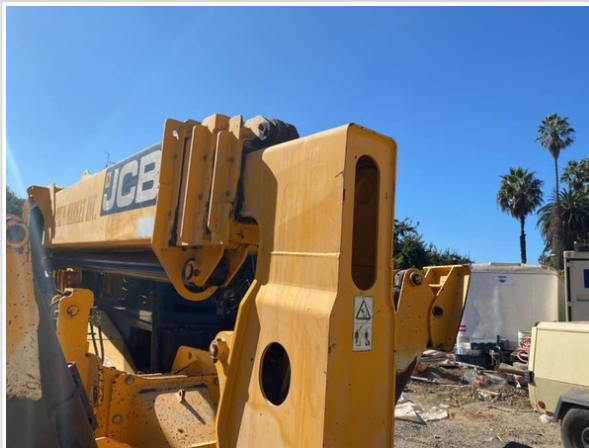
Front Photos

Front	3 - Normal Wear & Tear
Front Condition	Other (see comments)
Comments	Fork carriage backrest top section has a a dent and 1 broken support bar

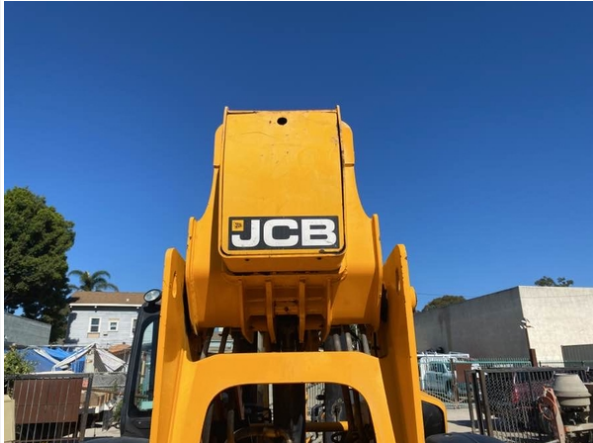
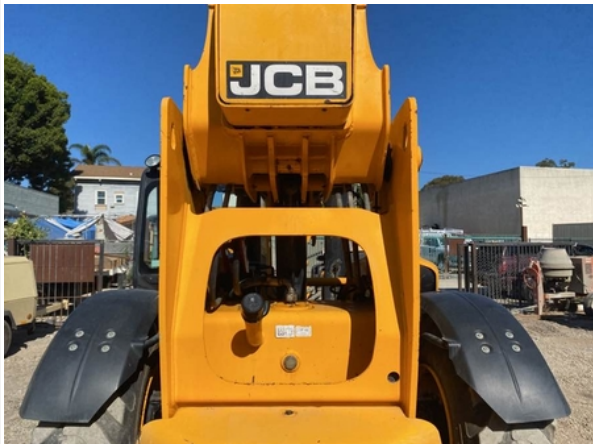
Rear	3 - Normal Wear & Tear	
Rear Condition	No visible damage, Other (see comments)	
Comments	Normal wear and tear scuff marks on counterweight	
Rear Photos

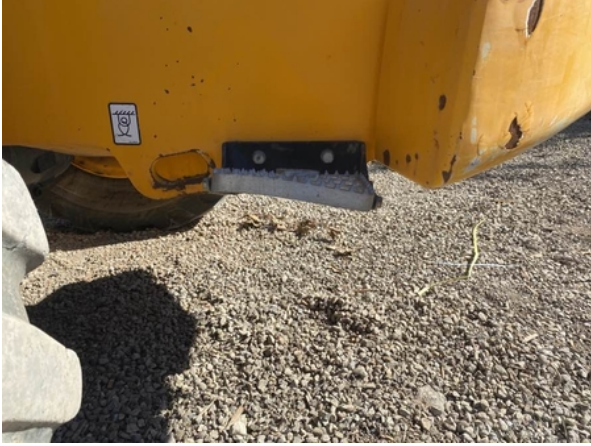
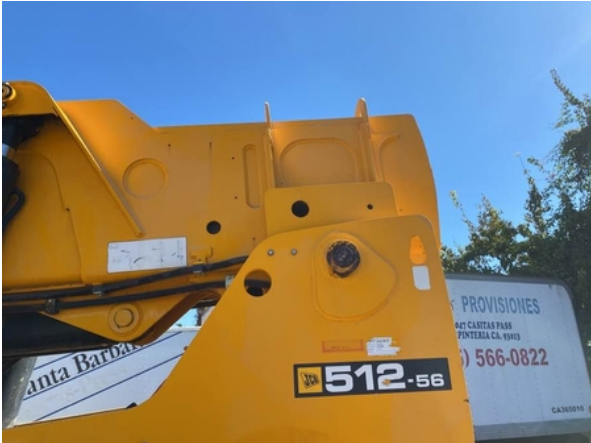
Left	3 - Normal Wear & Tear	
Left Condition	No visible damage, Other (see comments)	
Comments	Left side in good shape, rear step slightly bent upwards	
Left Photos

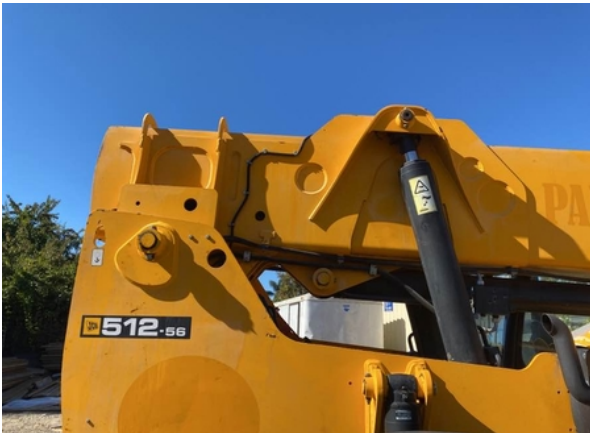
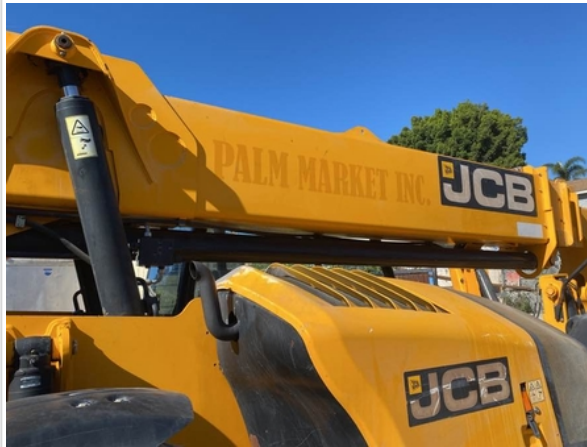
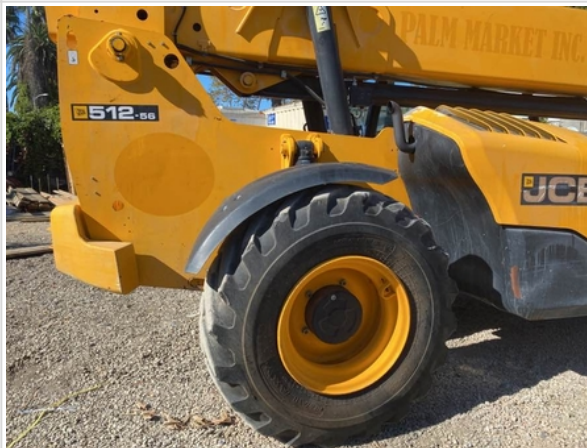
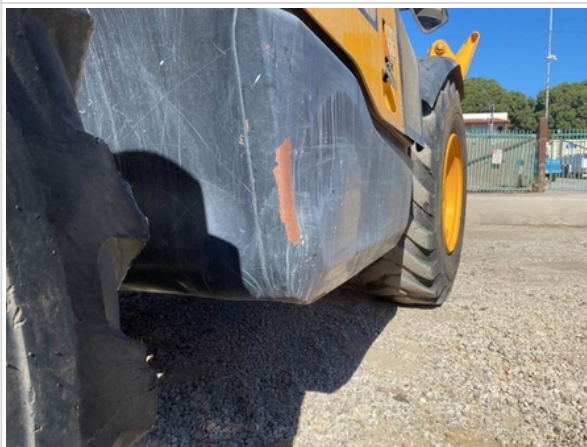
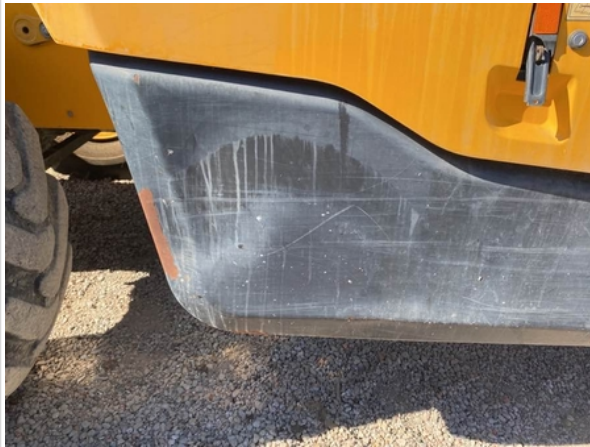
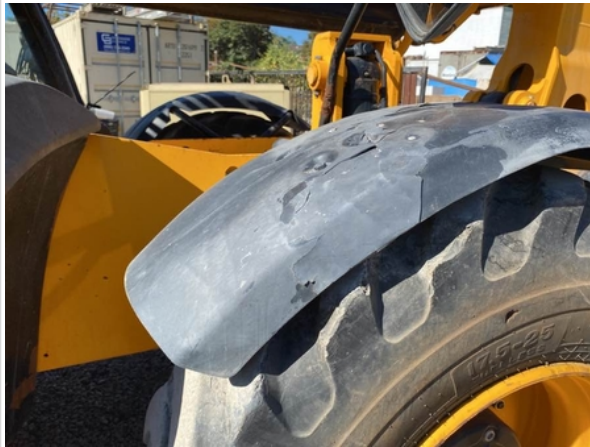
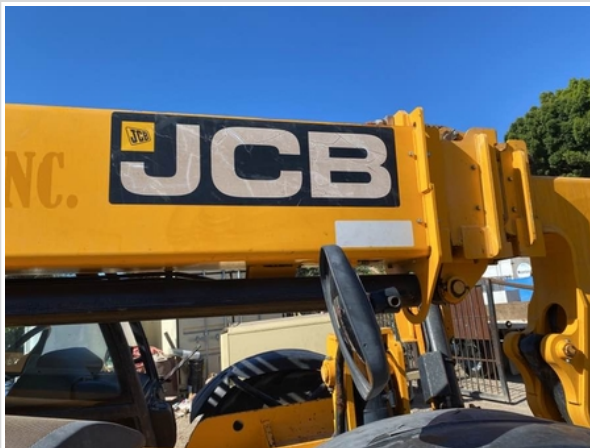
Right	3 - Normal Wear & Tear	
Right Condition	Other (see comments)	
Comments	Right side bottom of engine compartment exterior has a small dent and other areas on engine compartment exterior have scuff marks. Front fender has cracks in it	
Right Photos

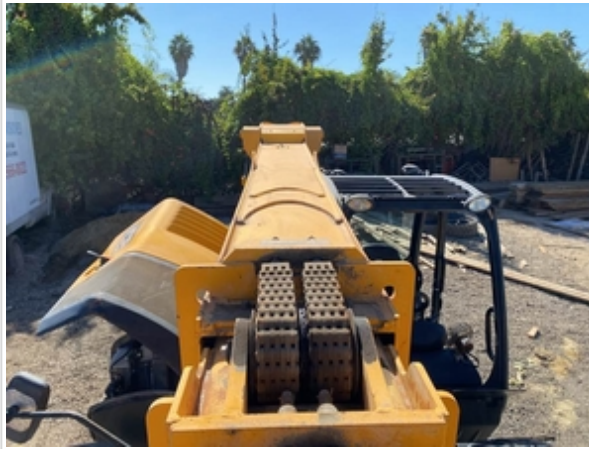
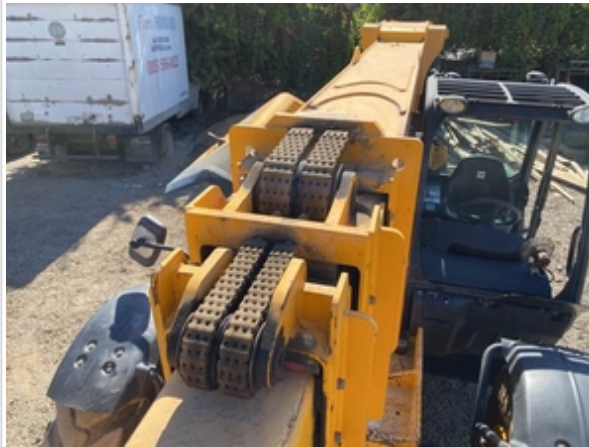
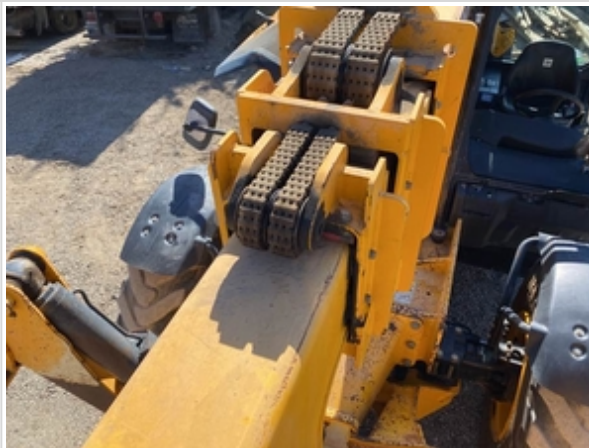
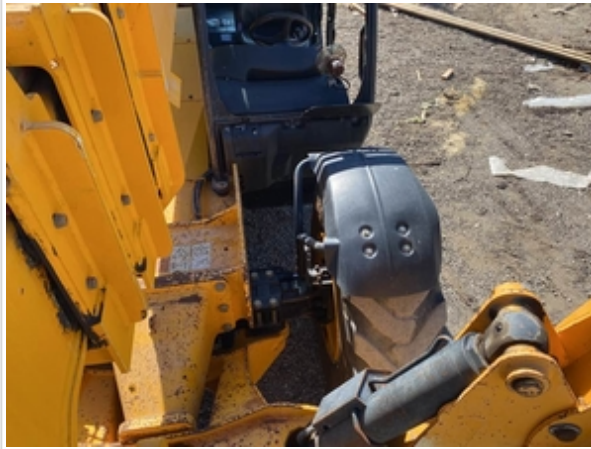
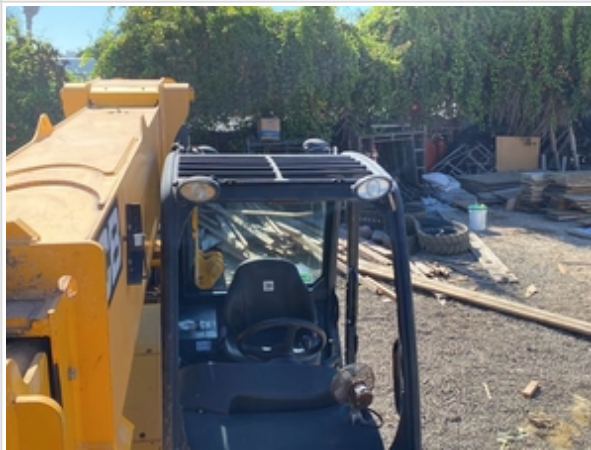
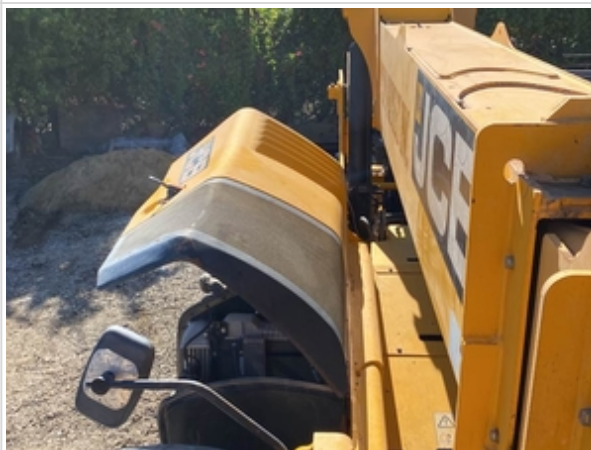
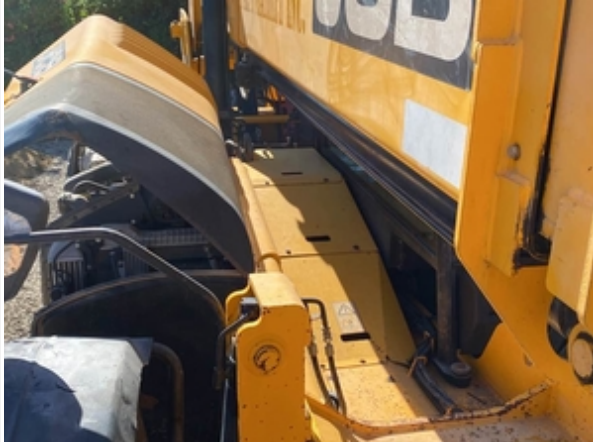
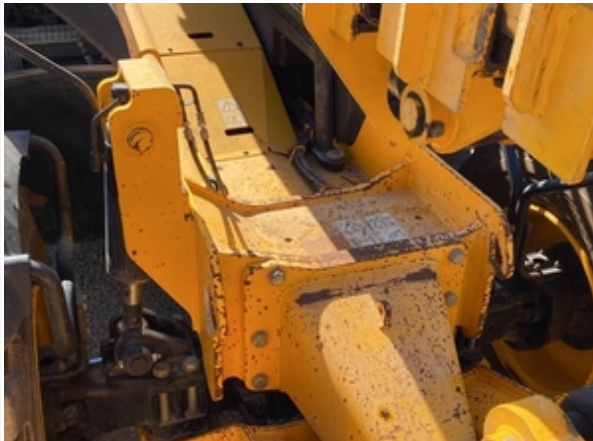
Upper	3 - Normal Wear & Tear	
Upper Condition	No visible damage

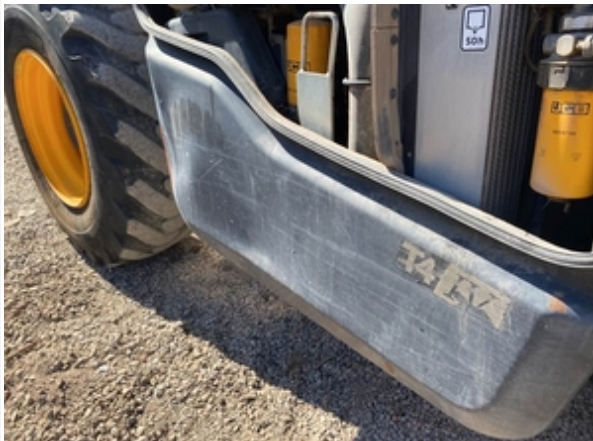
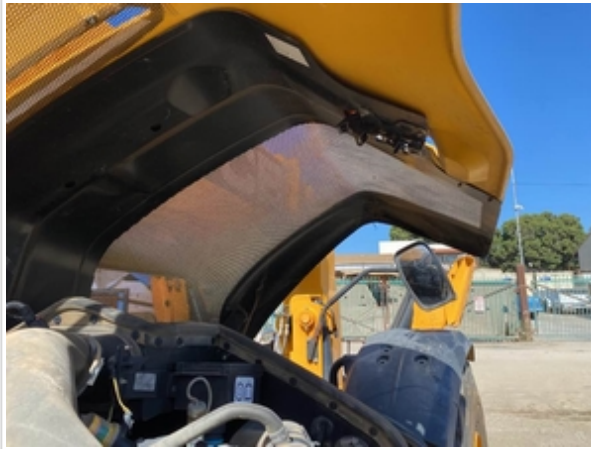
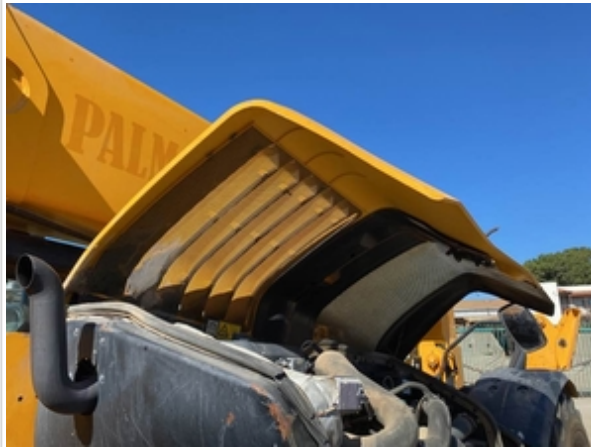
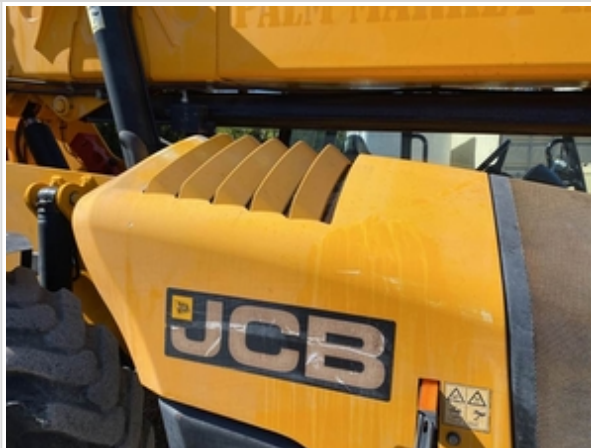
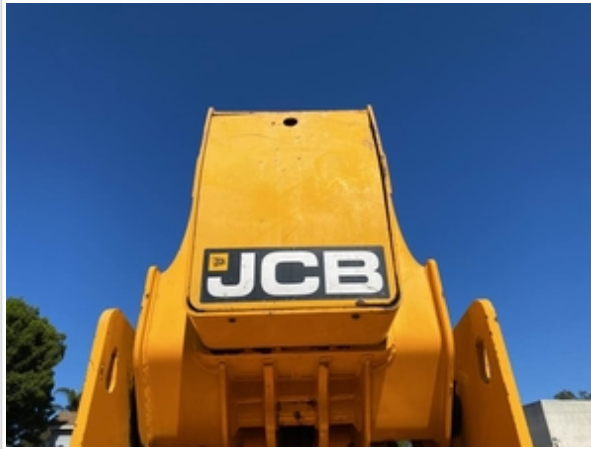
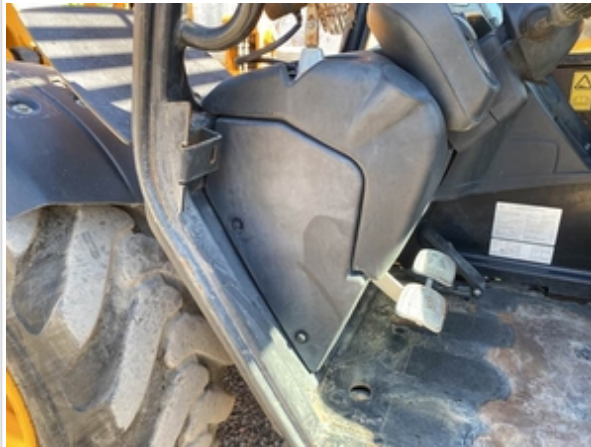
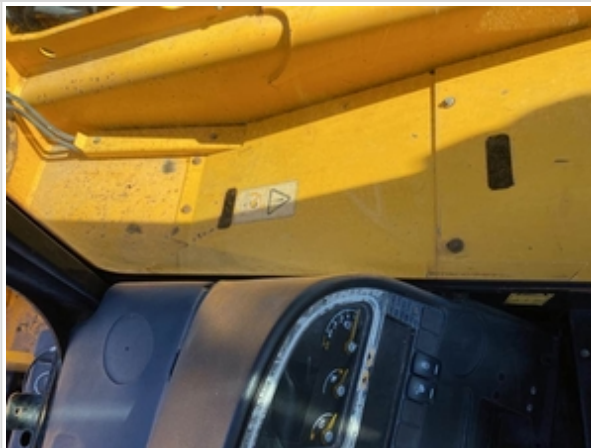
Body Panels (Any Rust Damage?)	3 - Normal Wear & Tear
Body Panel Condition	No visible damage, good paint condition and panel fitment, Other (see comments)
Comments	Dent on bottom side of engine compartment
Body Panels Photos

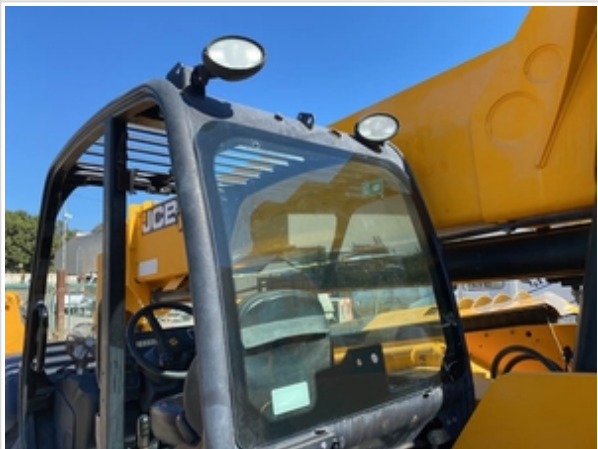
Glass Condition	3 - Normal Wear & Tear	
Glass Condition Notes	Glass intact, no visible damage	
Glass Condition Photos

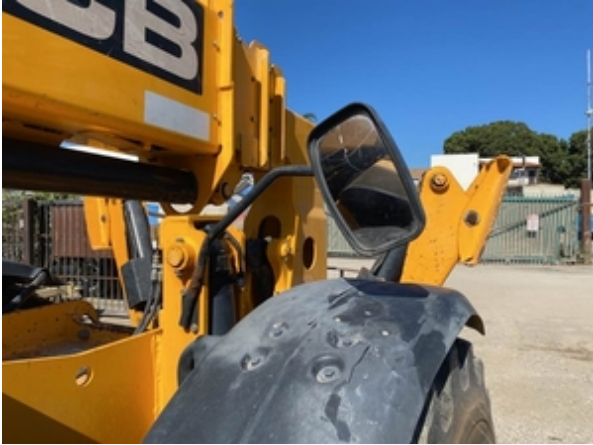
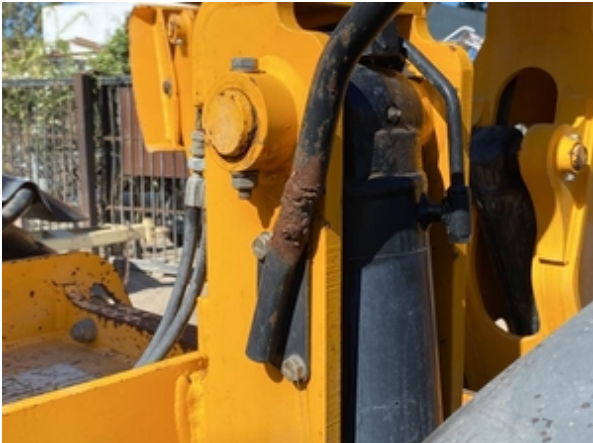
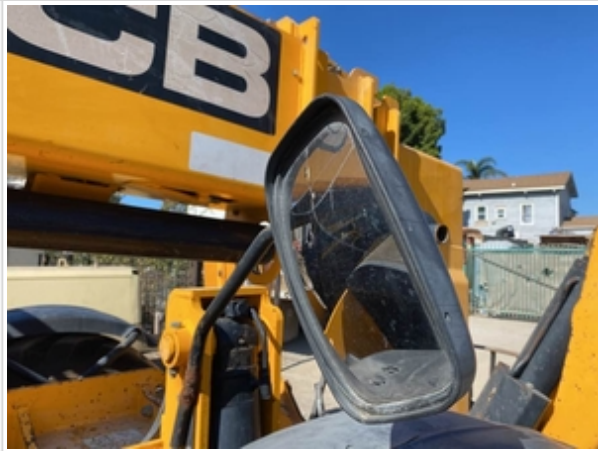
Mirrors	3 - Normal Wear & Tear	
Mirror Condition Notes	Minor chips or cracks observed	
Mirrors Photos

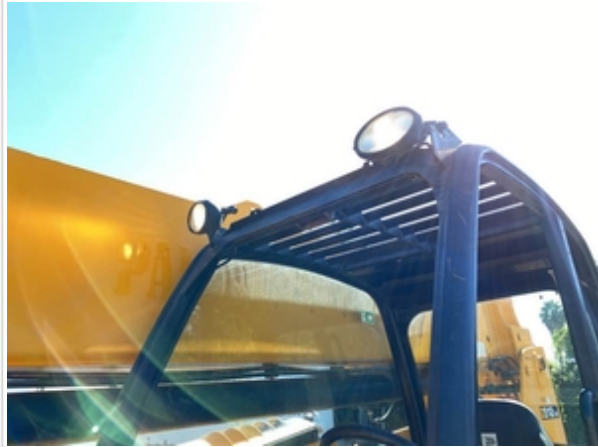
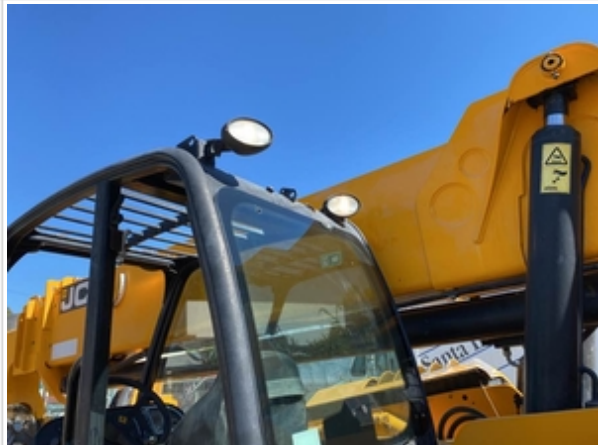
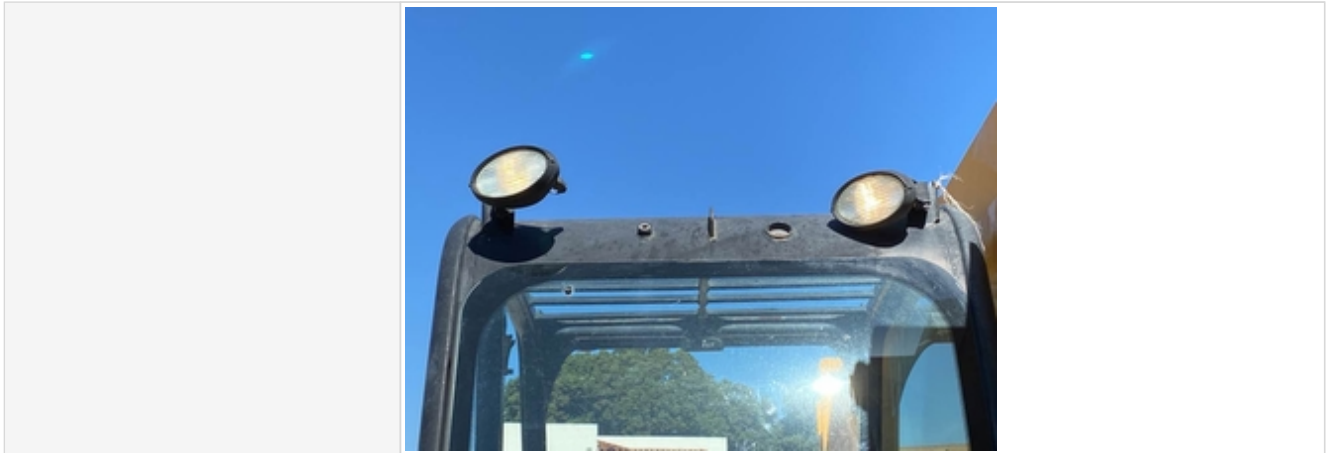
Lighting System	3 - Normal Wear & Tear	
Lighting System Condition	No visible damage, lighting system is operational	
Lighting System Photos

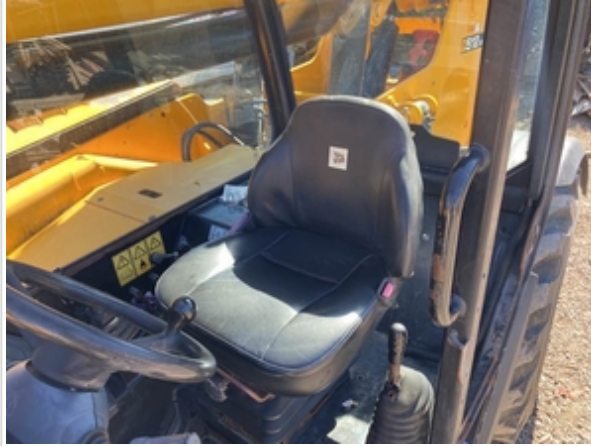
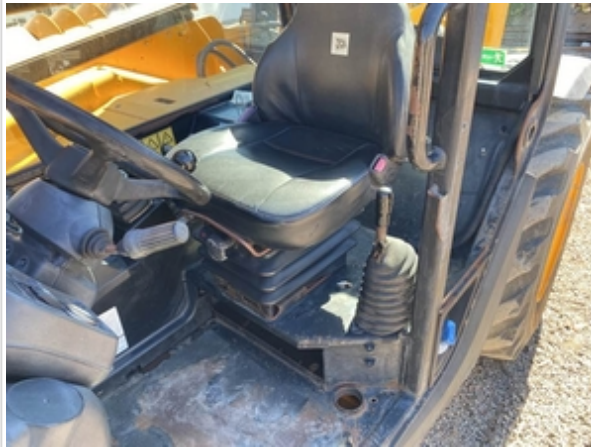
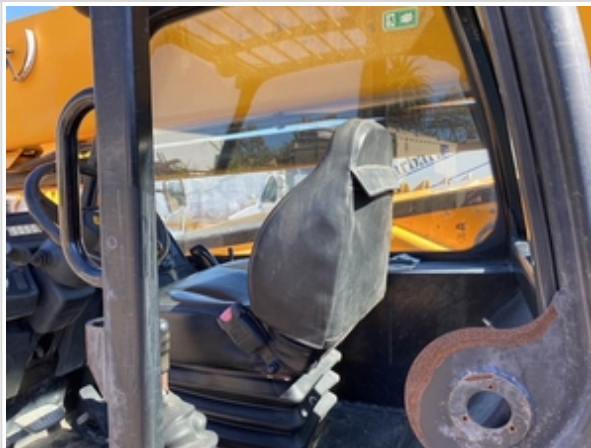
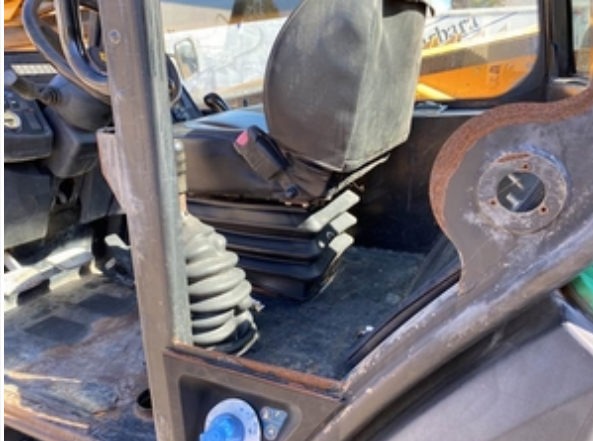
Operator's Seat & Arm Rests	3 - Normal Wear & Tear
Operator's Seat & Arm Rests Condition	Seat(s) in good condition, no stains or tears in upholstery

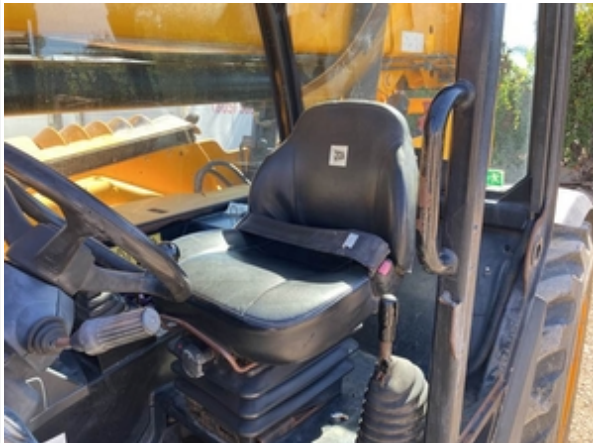
Seat Belt	3 - Normal Wear & Tear
Seat Belt Condition	Seat belt secures properly. Belt is intact and in good condition
Seat Belt Photos

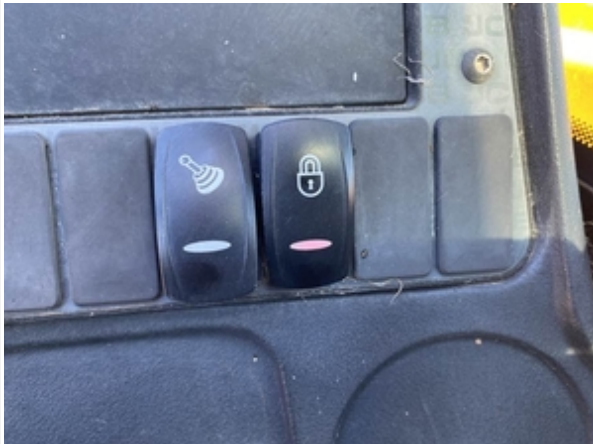
Cabin Lights	0
Safety Lock Out / Stop	3 - Normal Wear & Tear
Safety Lock Out / Stop Condition	Other (see comments), Safety lock out device is present, in good condition, and functional
Comments	Lockout functions properly (for outriggers only)
Safety Lock Out / Stop Photos

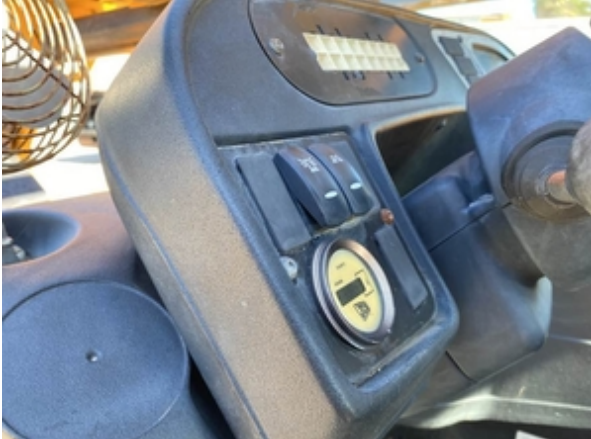
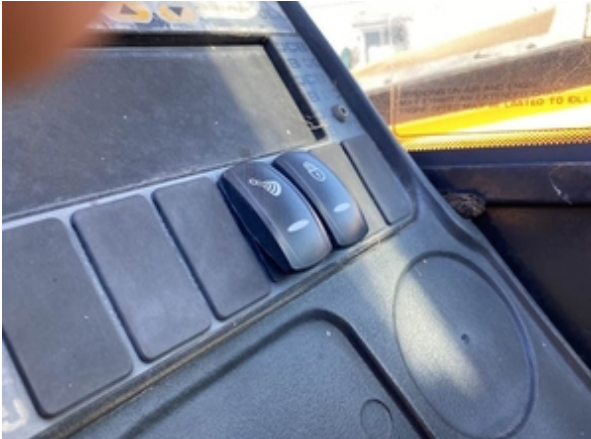
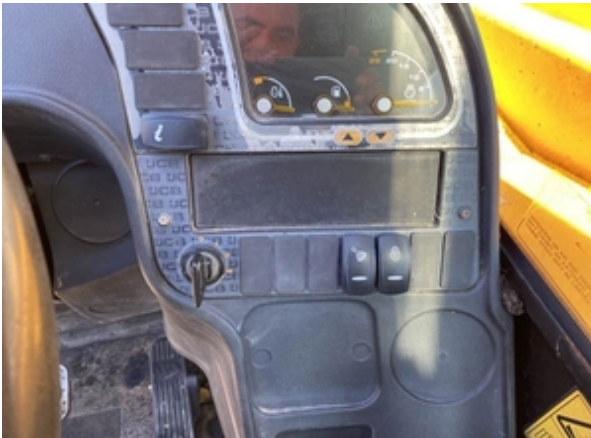
Controls & Switches Condition	All switches are installed and functional
Controls & Switches Photos

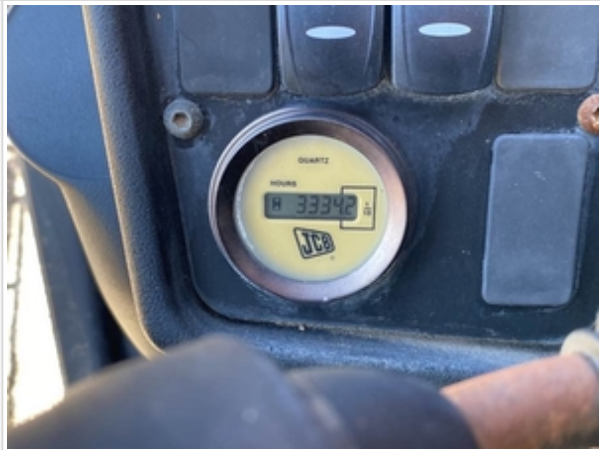
Hour Meter Activity	3 - Normal Wear & Tear
Hour Meter Condition	Hour meter is functional and in good condition

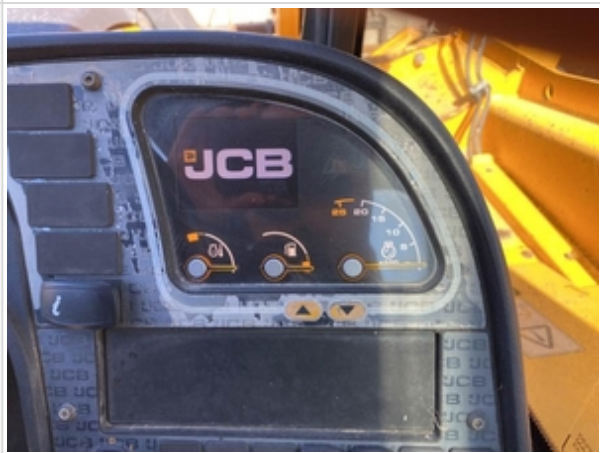
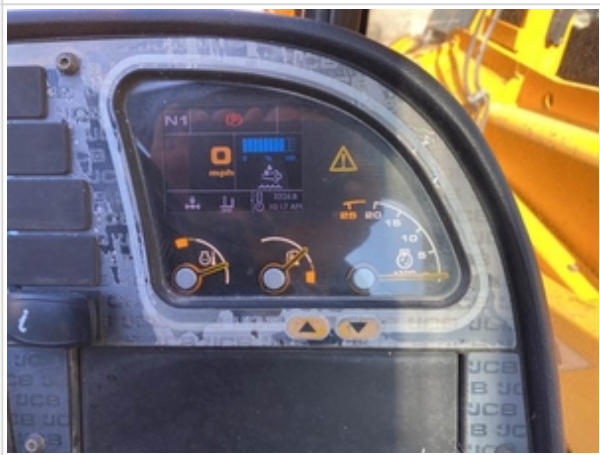
Other Gauge Activity	3 - Normal Wear & Tear	
Other Gauge Condition	All cockpit gauges are functional and in good condition	
Other Gauge Activity Photos

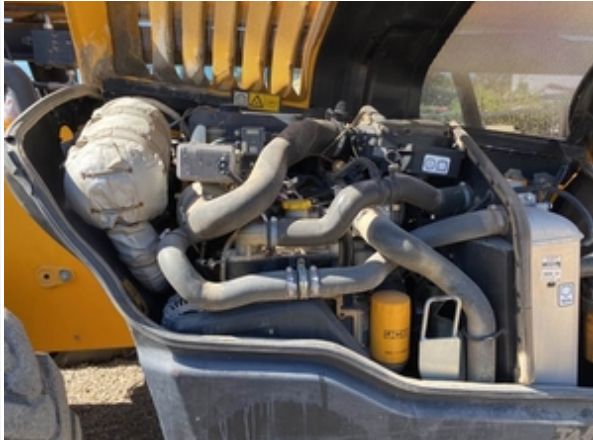
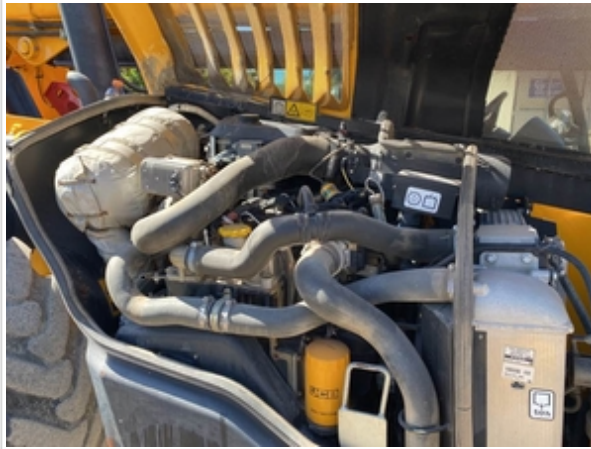
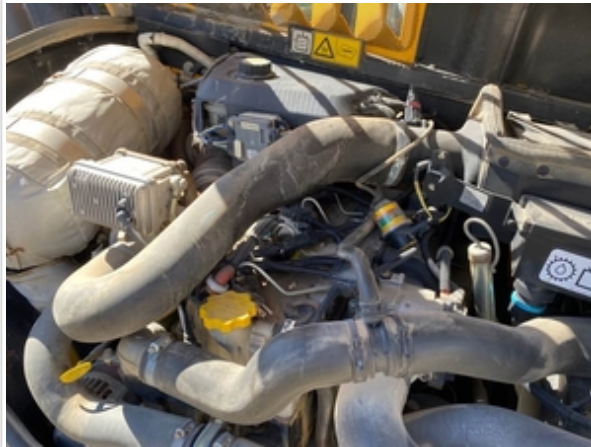
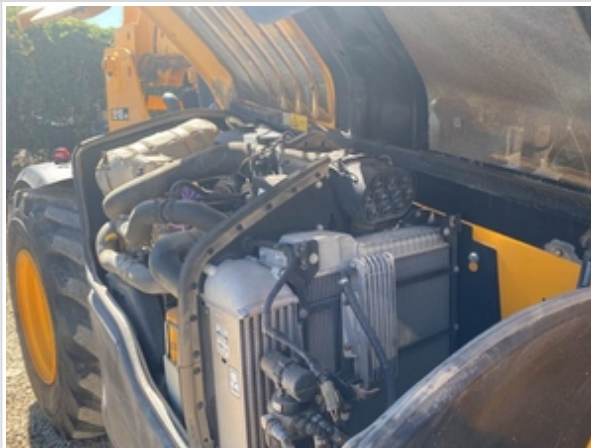
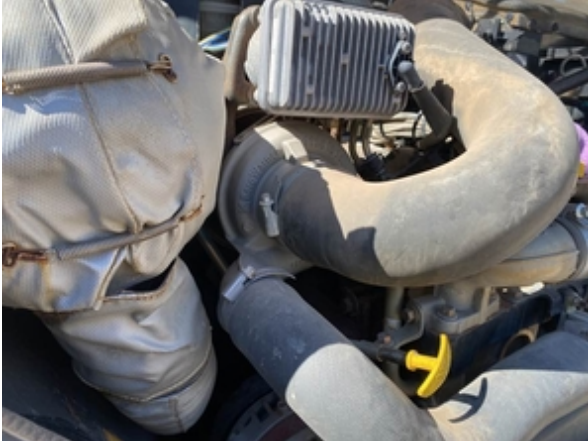
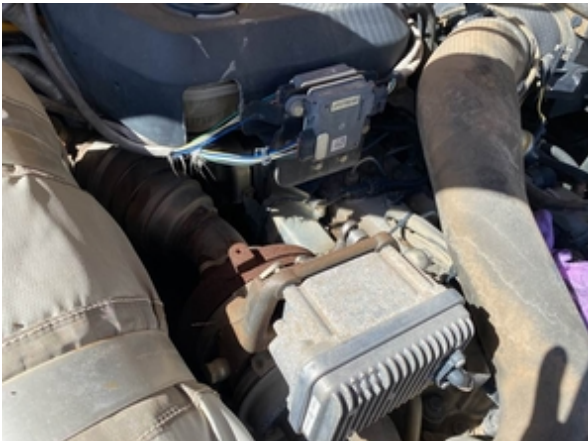
Engine Type (Make, Model, Cylinders, Hp)	JCB 4 Cyl. - 4.4L - 108 HP
Engine Serial Number	8J320/40919U0725315
Engine Fuel Type	Diesel
Engine Photos

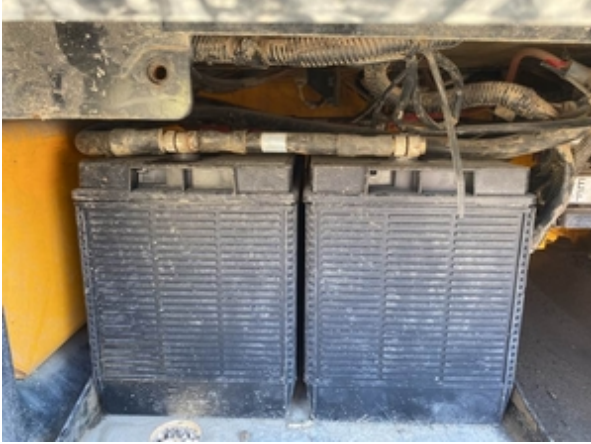
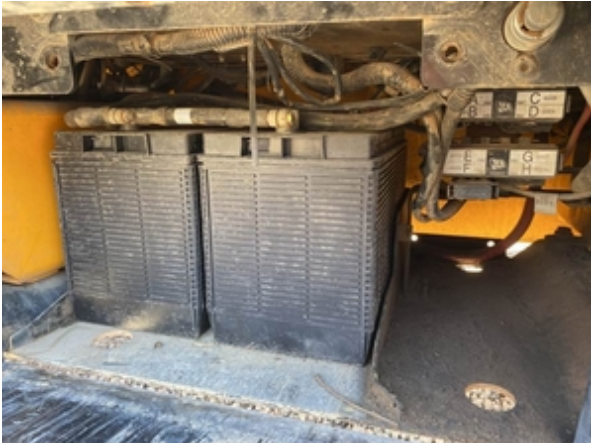
Battery Condition Photos

Blow-by (Visual Observation Check)	No	
Unusual Noises (Upon Start-up, Idle, Shutdown)	No	
Unusual Noise Notes	No unusual noises heard	
Engine Smoke (Upon Start-up, Idle, Shutdown)	No	
Engine Smoke Notes	No engine smoke issues observed	
Engine Exhaust Color	Clear	
Battery	3 - Normal Wear & Tear	
Battery Condition	Like new, recently replaced, Clean & dry appearance, tight connections, Other (see comments)	
Comments	Missing battery hold down hardware

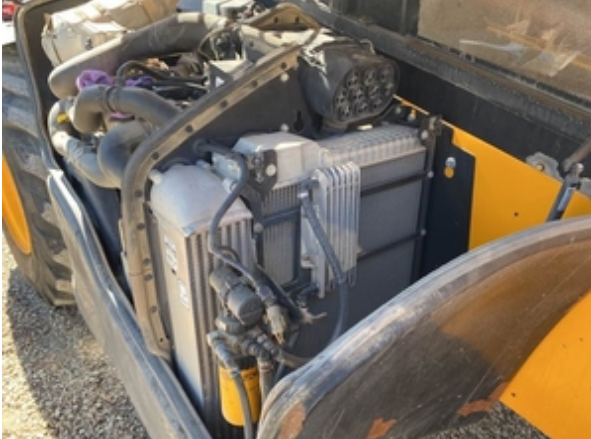
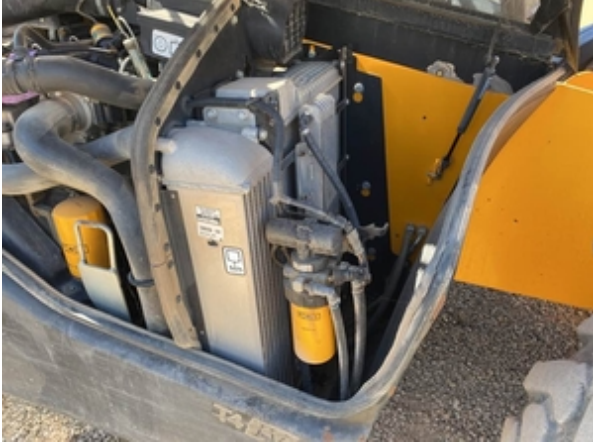
Radiator	3 - Normal Wear & Tear
Radiator Condition	Radiator fins & components appear to be in good working order, no signs of damage or leaks
Radiator Photos

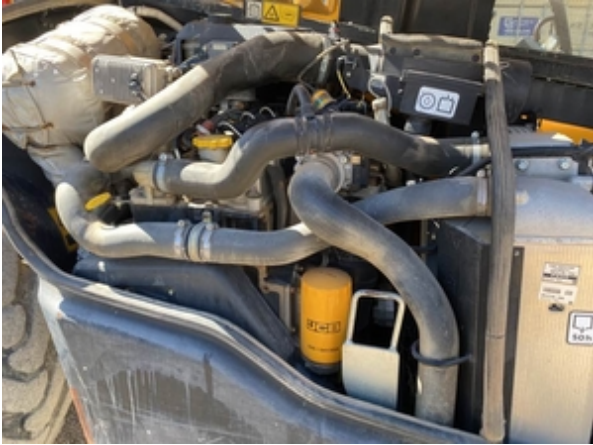
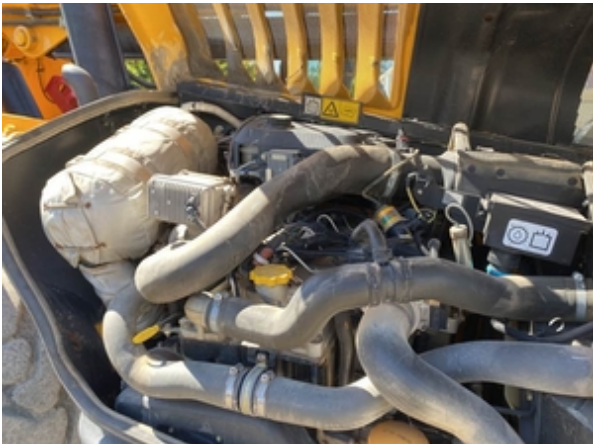
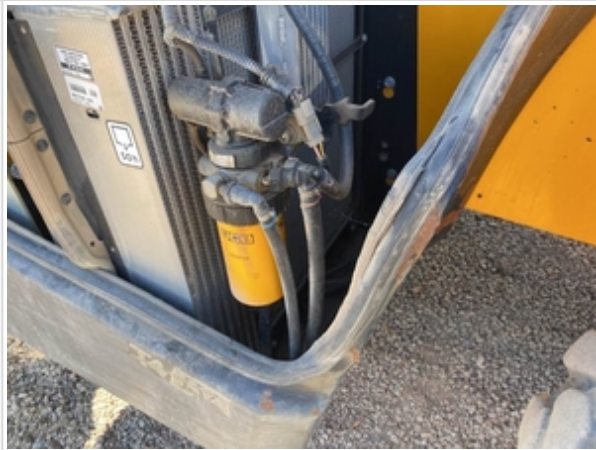
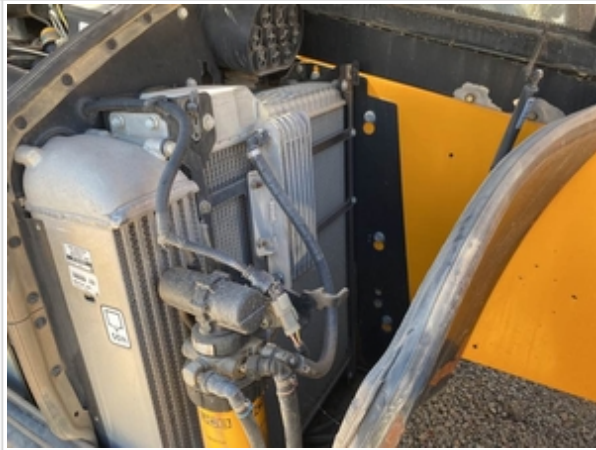
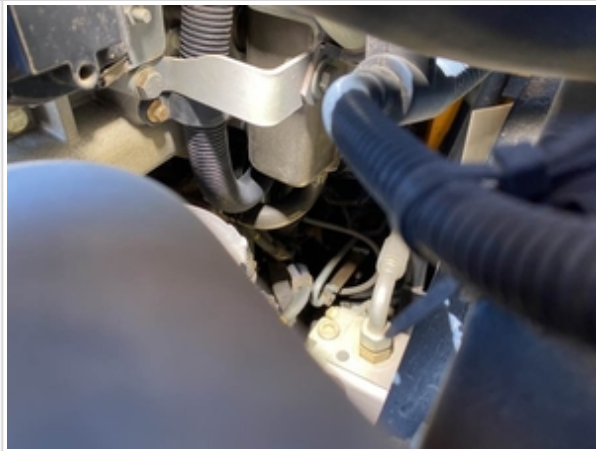
Belts	3 - Normal Wear & Tear	
Belt Condition	Belts appear in good condition & alignment with proper tension	
Hoses	3 - Normal Wear & Tear	
Hose Condition	Firm, pliant hoses with no signs of wear or leaks	
Hose Photos

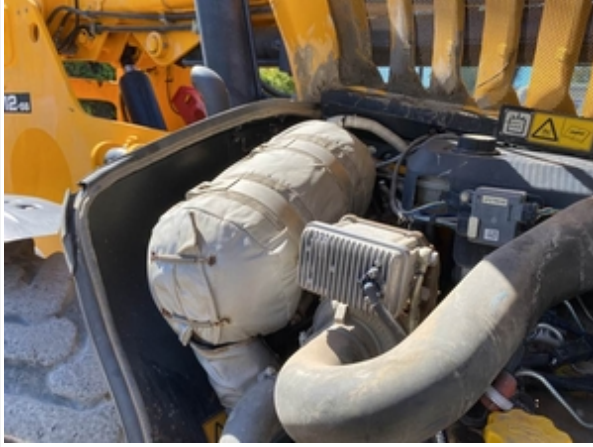
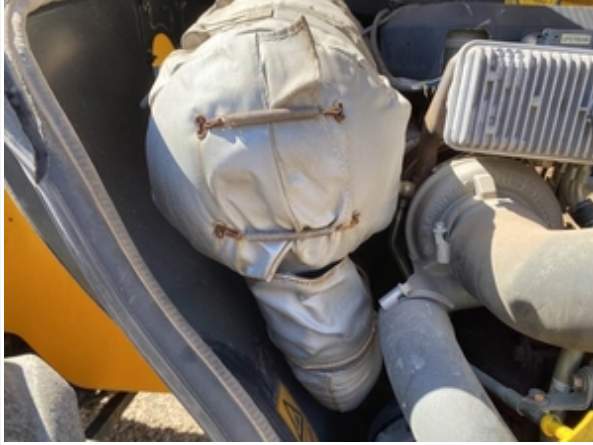
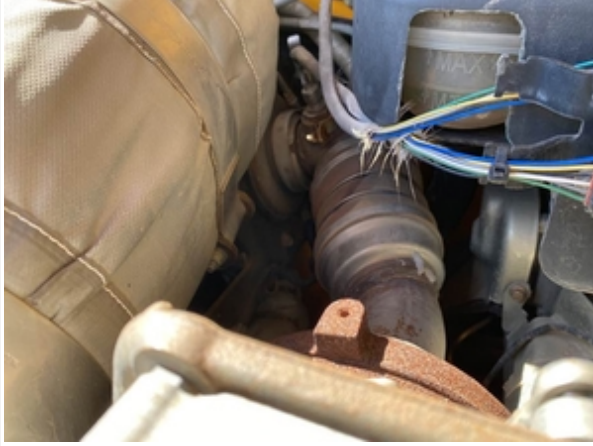
Oil Color / Appearance Notes	Clean oil appearance, no signs of cross contamination, Appropriate oil level
Fuel Leaks	No
Equipped with DPF (Diesel Particulate Filter)	Yes
DPF Condition	3 - Normal Wear & Tear
DPF Condition Notes	Filter housing is intact with no signs of damage or malfunction, DPF indicator is not illuminated
DPF Photos

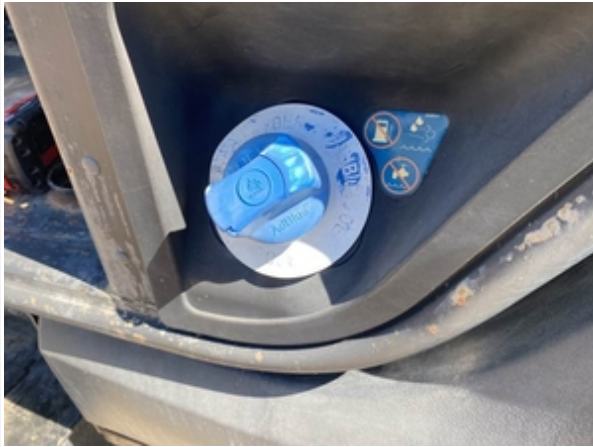
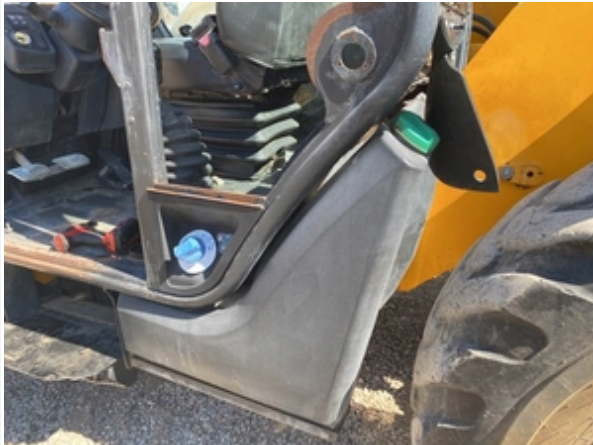
DEF Tank	3 - Normal Wear & Tear
DEF Tank Condition	Area around DEF tank cap is clean, fluid is clear & appears free of contaminants, Other (see comments)
Comments	DEF tank hidden behind diesel tank
DEF Tank Photos

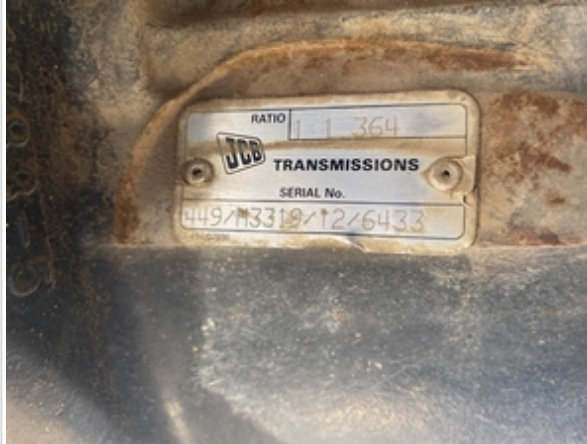
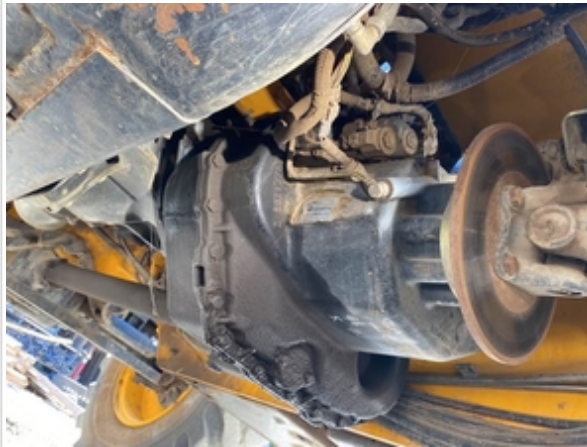
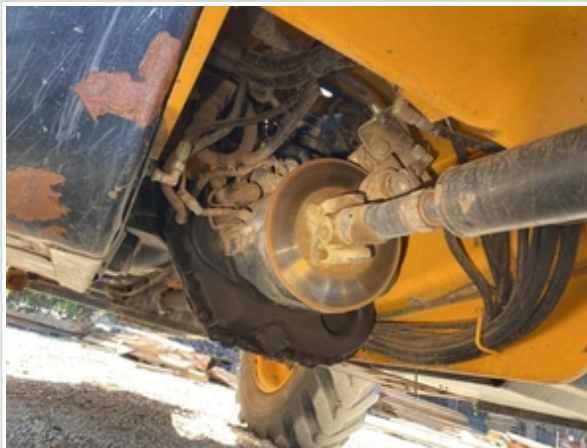
Transmission Photos

Drivetrain	
Transmission Info	Power shift 4 speed transmission
Transmission	3 - Normal Wear & Tear
Transmission Condition	No unusual noises or vibrations, Leaking transmission fluid observed, Other (see comments)
Comments	Minor

Overall Drivetrain Comments	Overall transmission operates great in all gears. Minor leak at bottom of trans. may just be o-ring for screen inspection cover.

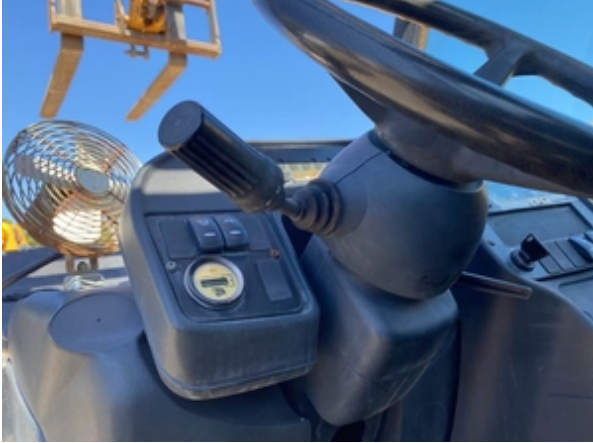
Shift Level Photos

Clutch	0	
Shift Lever	3 - Normal Wear & Tear	
Shift Lever Condition	Good forward and reverse function

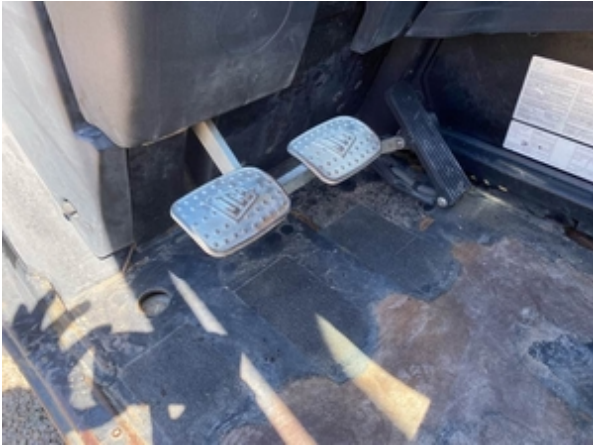
Foot Brake	3 - Normal Wear & Tear	
Foot Brake Condition	Good brake function	
Foot Brake Photos

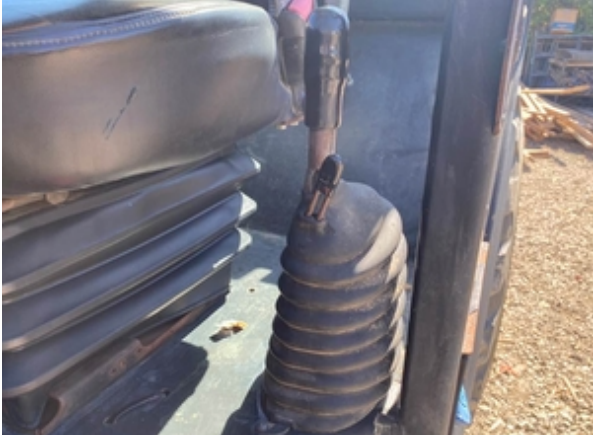
Inching Brake	0	
Parking Brake	3 - Normal Wear & Tear	
Parking Brake Condition	Good brake function	
Parking Brake Photos

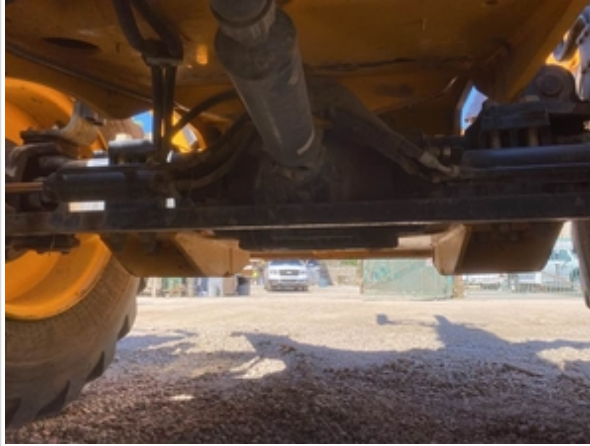
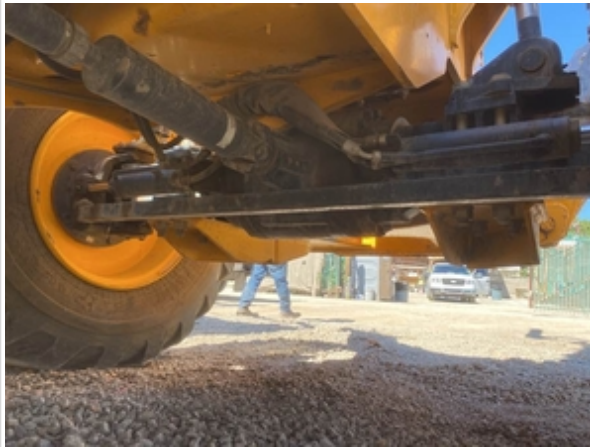
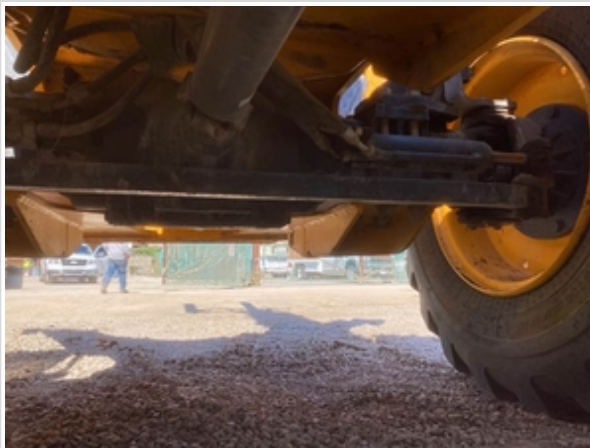
Front Axle Appearance Photos

Front Axle Appearance	3 - Normal Wear & Tear

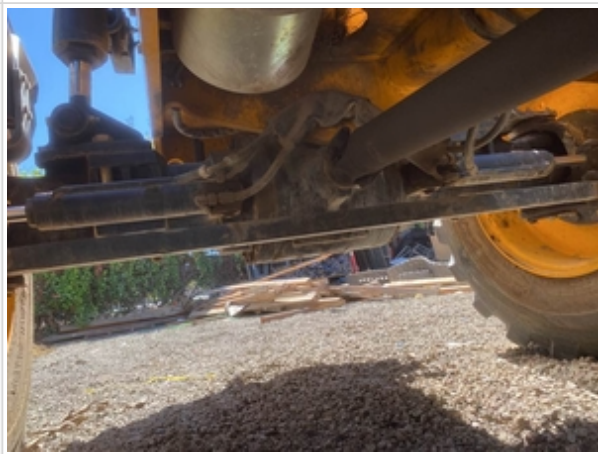
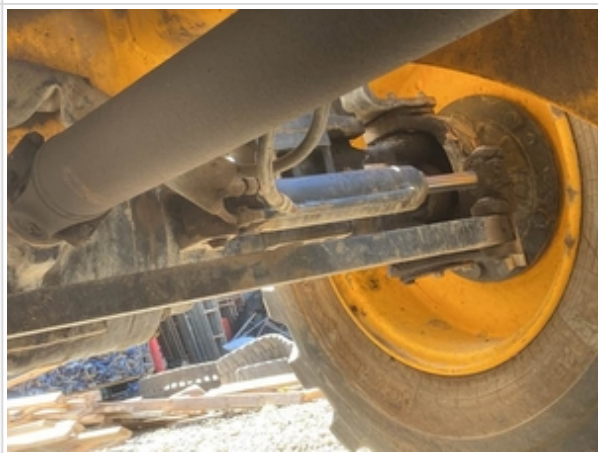
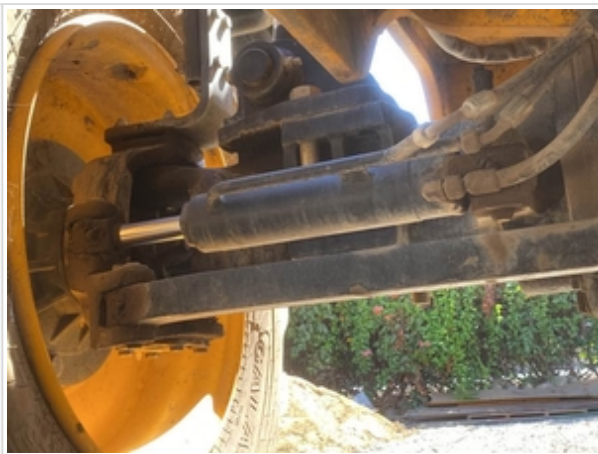
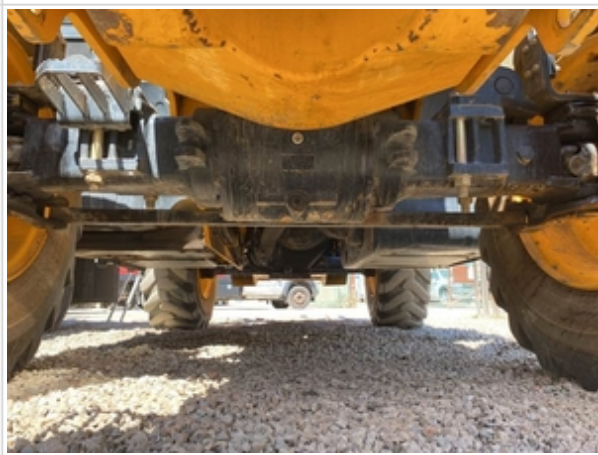
<p>Rear Axle Appearance</p>	<p>3 - Normal Wear & Tear</p>	
<p>Rear Axle Appearance Photos</p>
