Inspection Report (Telehandler)

Year	2016
Make	JCB
Model	512 - 56 Telehandler
Serial Number	JCB5CH2GC02433899
Hour Meter Reading	3,334 hours
Previous Application (e.g., earth moving, mining, demolition, etc)	General Concrete Construction

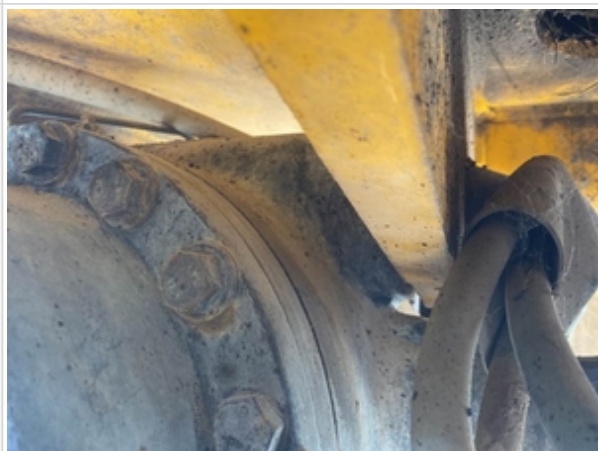
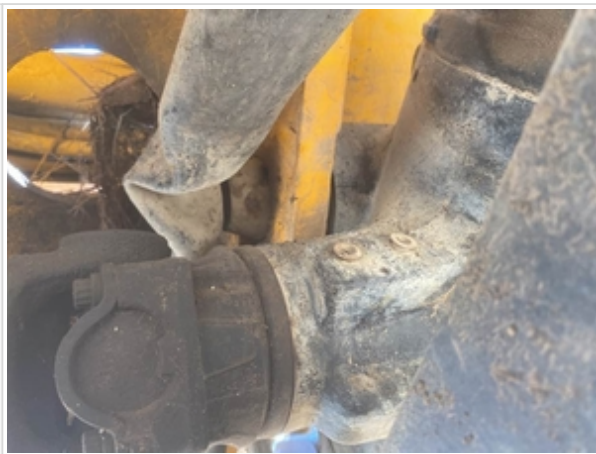
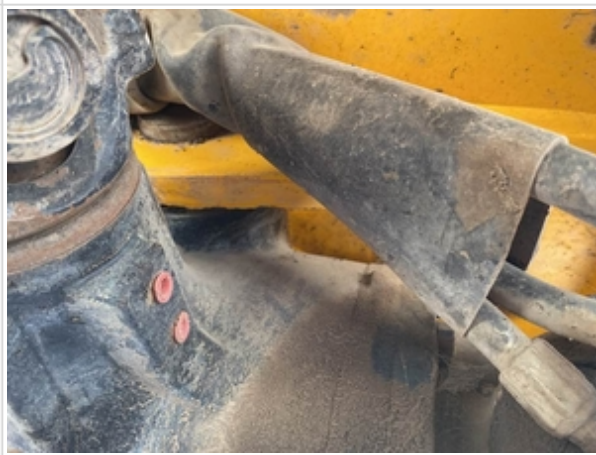
<p>Oscillating Pin Appearance</p>	<p>3 - Normal Wear & Tear</p>	
<p>Oscillating Pin Appearance Photos</p>

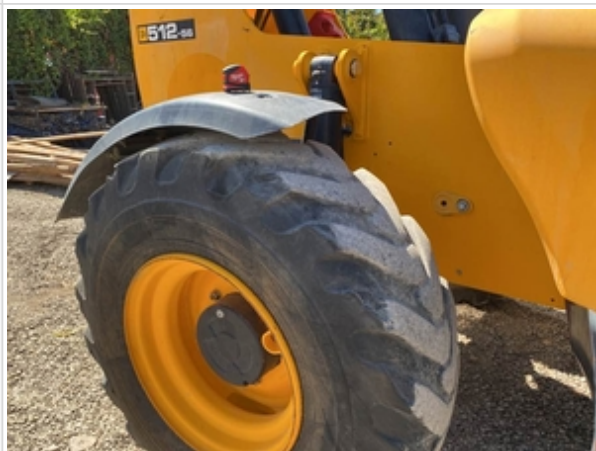
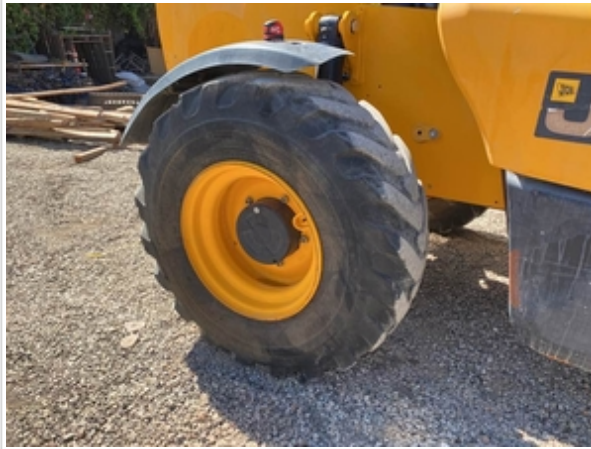
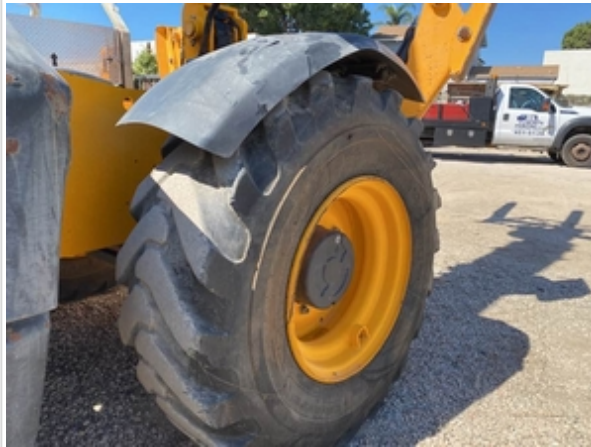
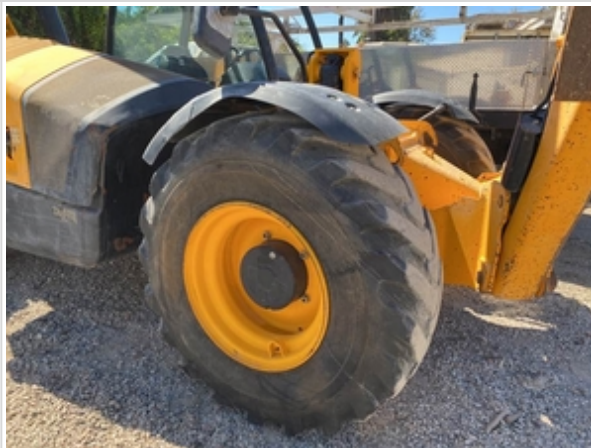
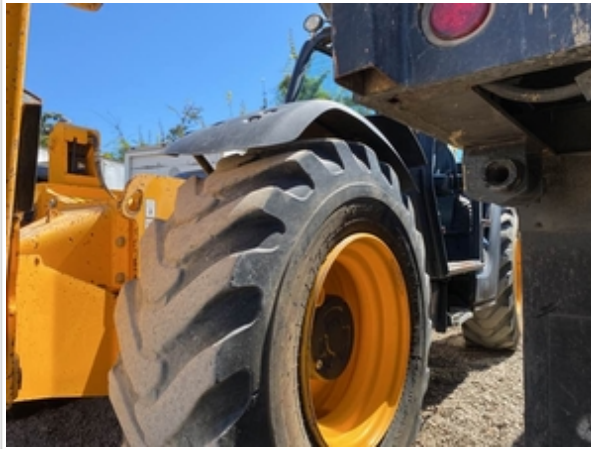
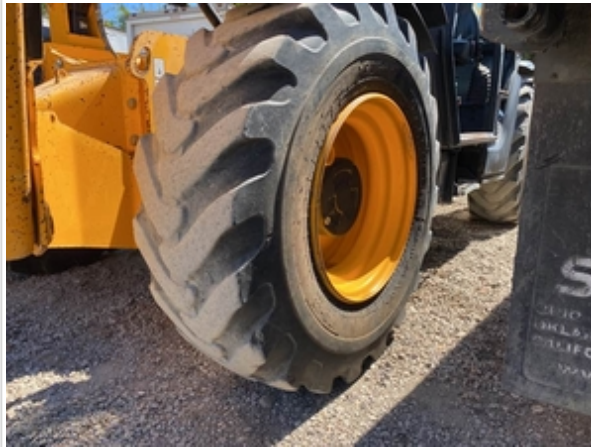
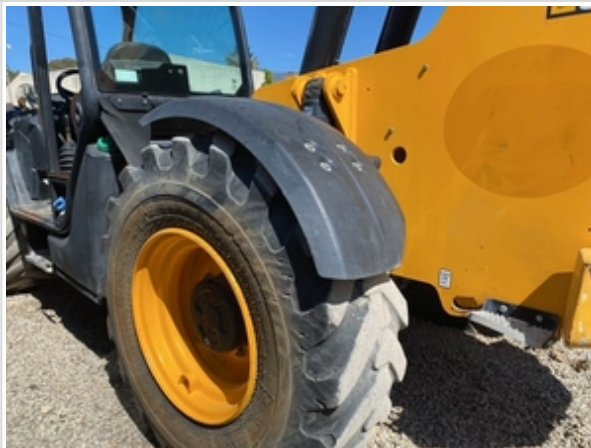
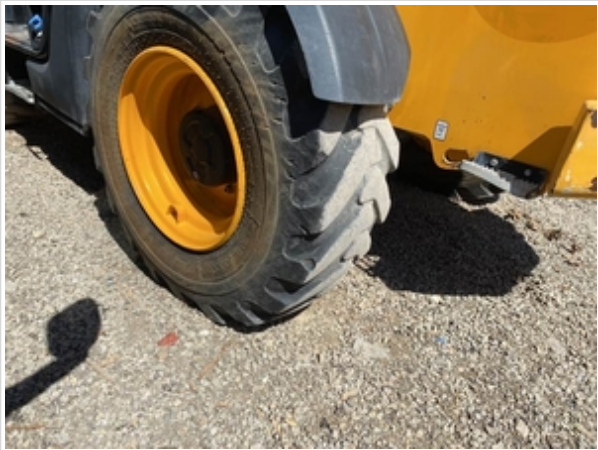
<p>Wheels & Tires</p>	<p>3 - Normal Wear & Tear</p>
<p>Wheels & Tires Photos</p>

Tire Brand	Galaxy	
Tire Size	17.5 - 25	
Front Left Tire - Ratio Remaining	30%	
Rear Left Tire - Ratio Remaining	30%	
Front Right Tire - Ratio Remaining	30%	
Rear Right Tire - Ratio Remaining	30%	
Boom Condition	3 - Normal Wear & Tear	
Boom Condition Photos

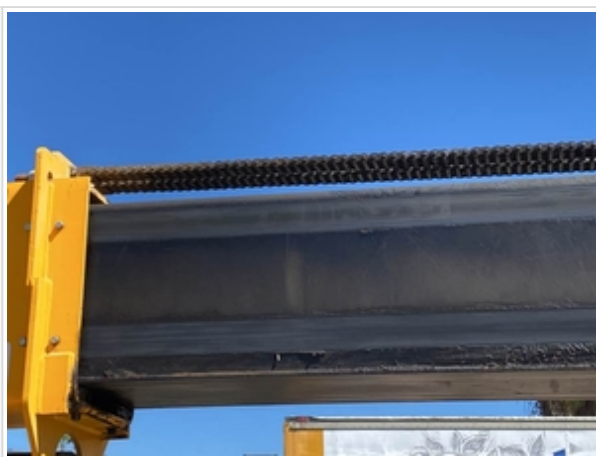
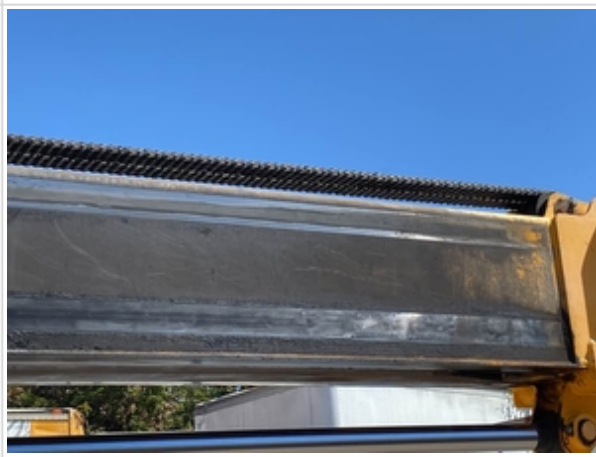
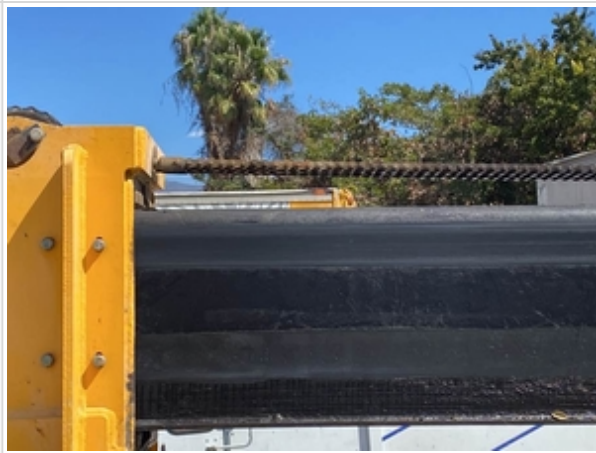
Chain / Tensioners

3 - Normal Wear & Tear

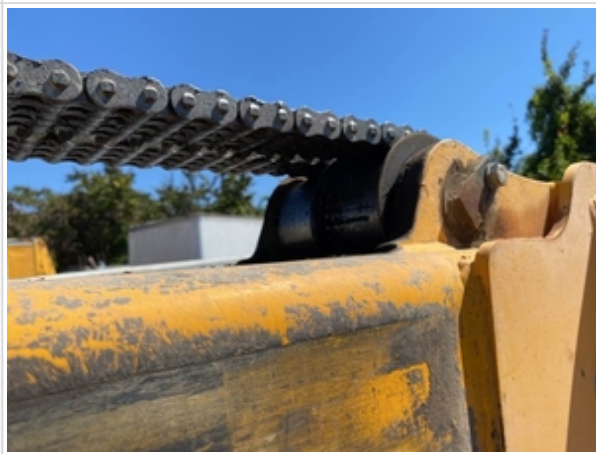
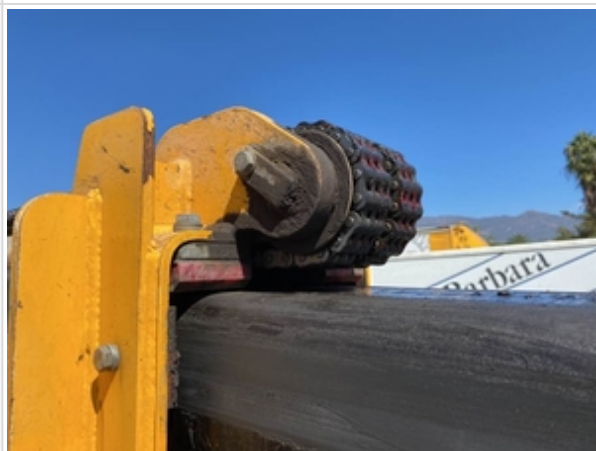
<p>Rollers & Guides</p>	<p>3 - Normal Wear & Tear</p>	
<p>Rollers & Guides Photos</p>

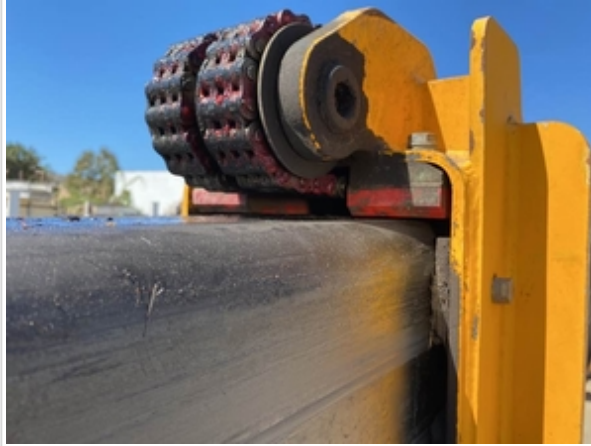
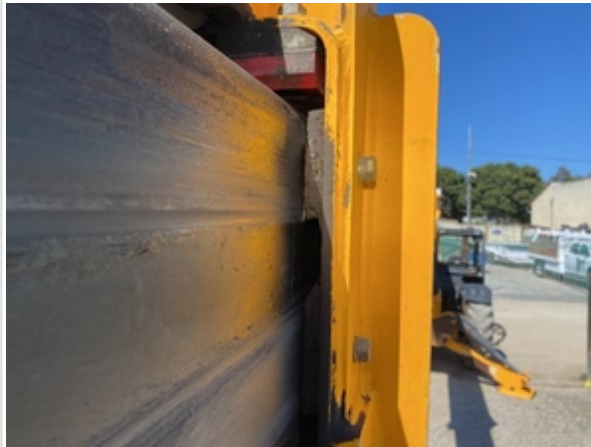
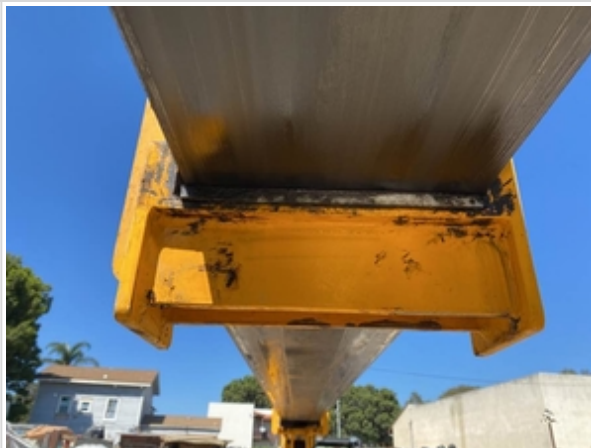
Boom Wear Guides Photos

Boom Wear Guides

3 - Normal Wear & Tear

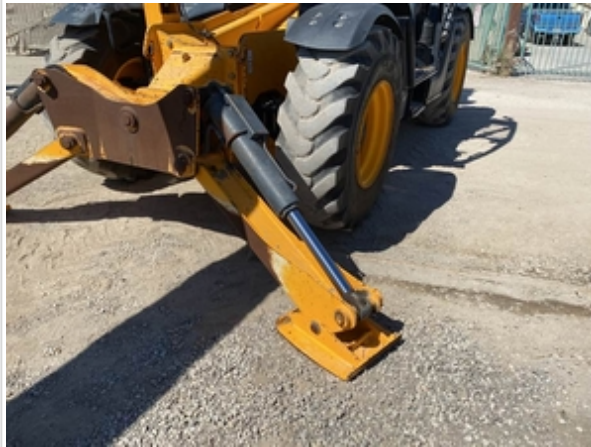
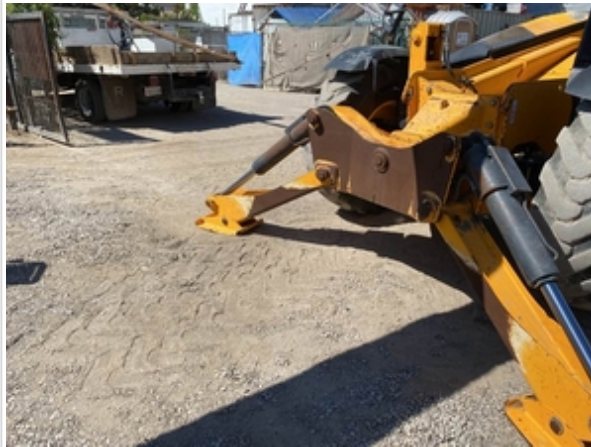
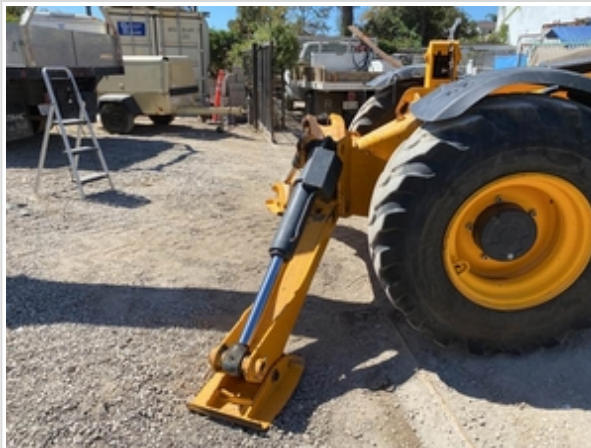
Outriggers Photos

Outriggers

3 - Normal Wear & Tear

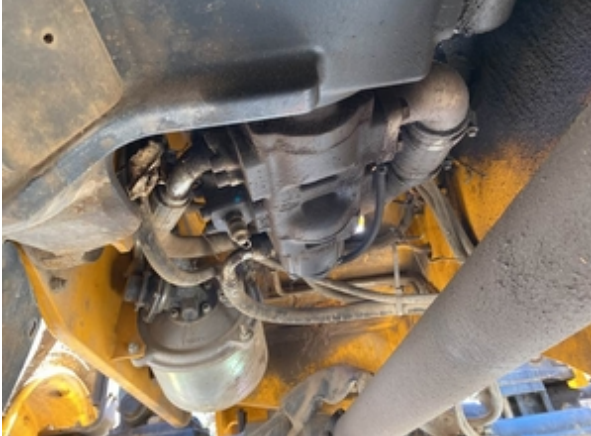
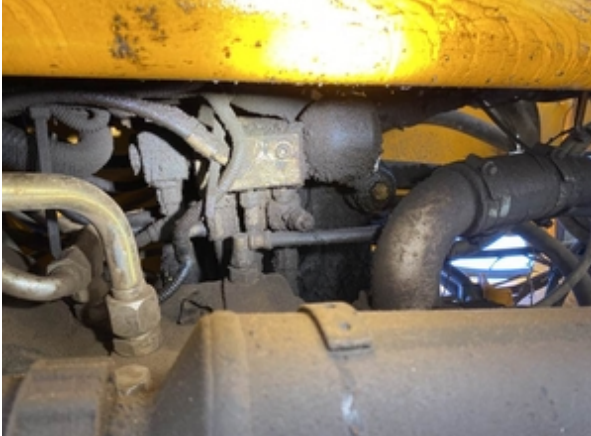
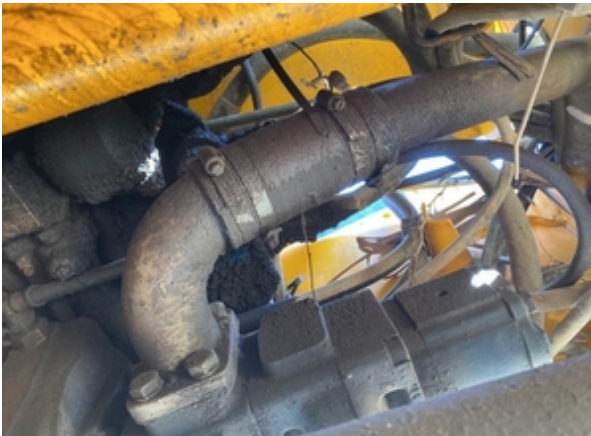
Hydraulic Lines / Fittings Condition	Hydraulic lines & fittings are clean and in good condition, Other (see comments), Active leaks in hoses or fittings observed
Comments	Small seepage leaks around main control valve accumulator and some lines
Appearance of Hydraulic Lines / Fittings Photos

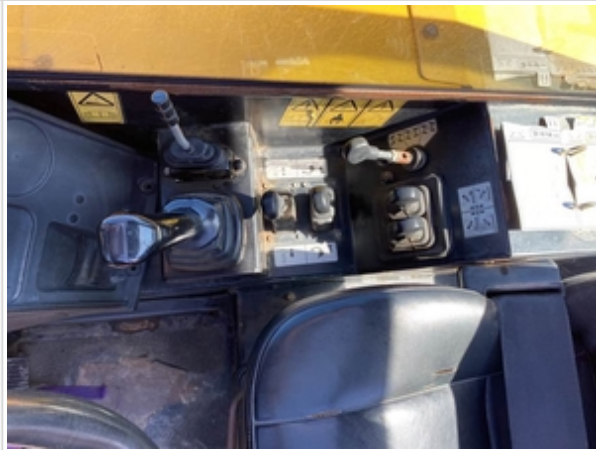
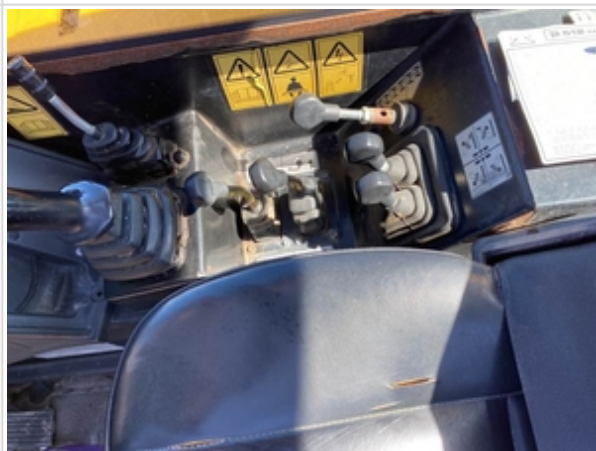
External Controls / Levers Photos

Unusual Noises (Hydraulic Pump)	No
Hydraulic Pump Notes	No unusual noises heard during operation
External Controls / Levers	3
External Controls / Levers Condition	Good function & condition of hydraulic controls

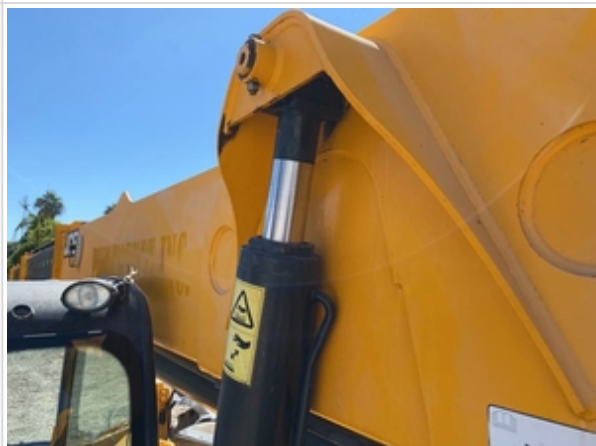
Boom Lift Cylinders	Check the boom lift cylinders. Note any wear, pitting, discoloration, etc. Take photos.
Boom Lift Cylinders: Mounting Pin	3
Boom Lift Cylinders: Oil Leaks	No
Boom Lift Cylinders Photos

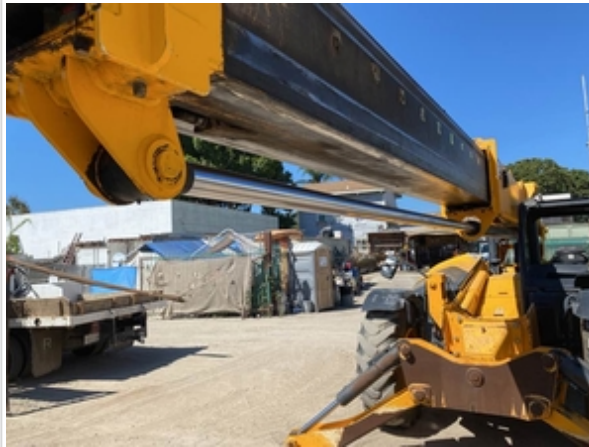
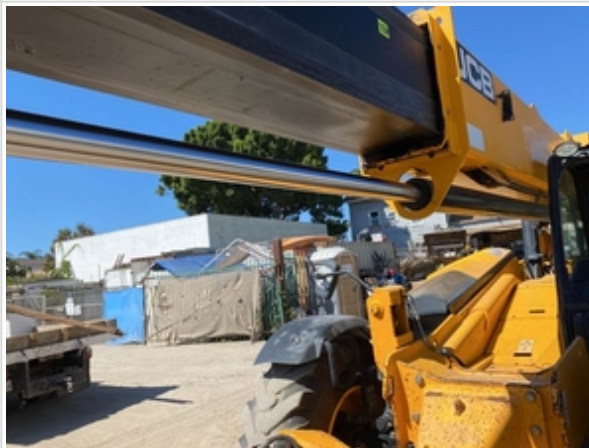
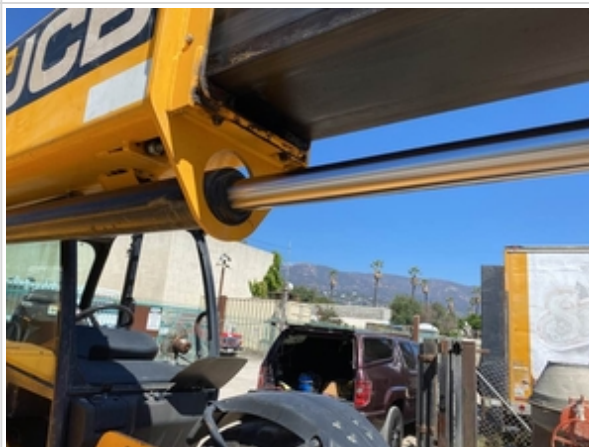
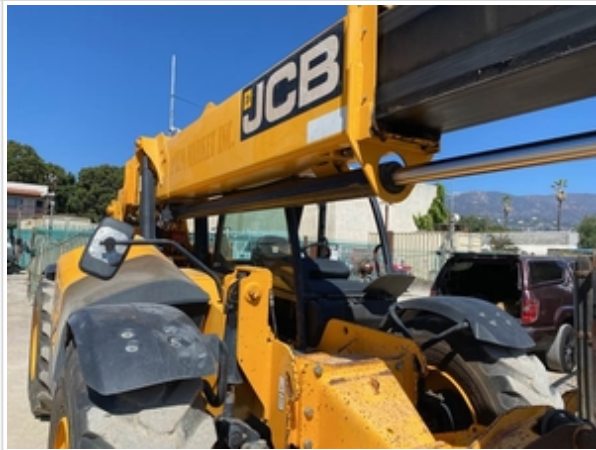
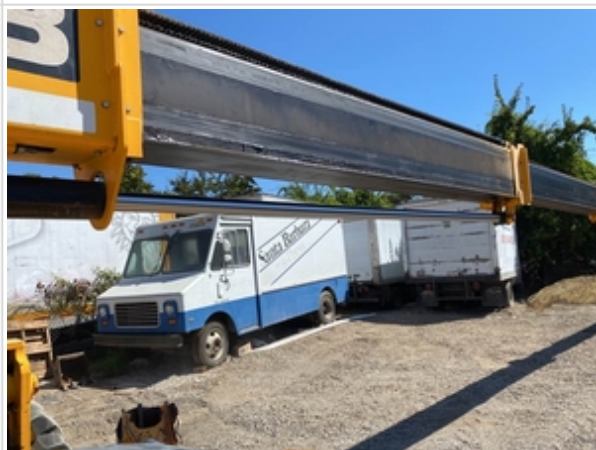
Telescopic Boom Cylinders
Photos

Telescopic Boom Cylinders	Check the telescopic boom cylinders. Note any wear, pitting, discoloration, etc. Take photos.	
Telescopic Boom Cylinders: Mounting Pin	3	
Telescopic Boom Cylinders: Oil Leaks	No

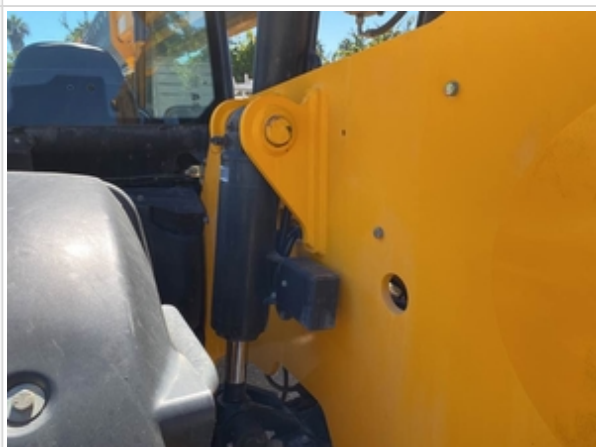
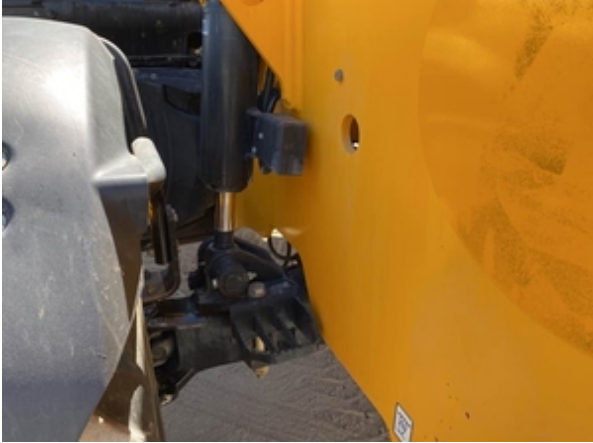
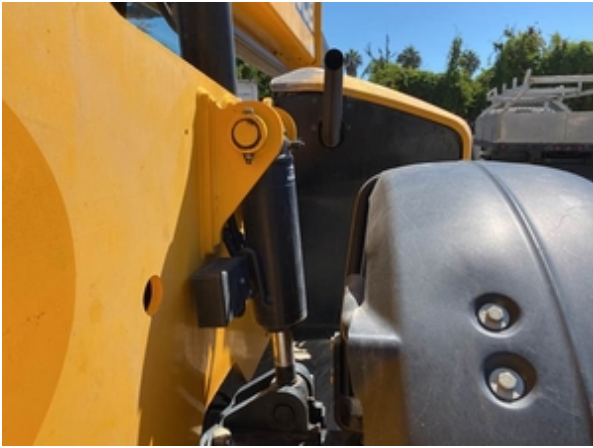
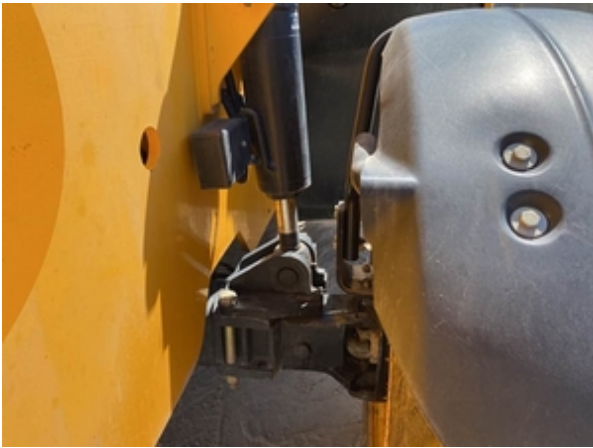
Frame Leveling Cylinders	Check the frame leveling cylinders. Note any wear, pitting, discoloration, etc. Take photos.	
Frame Leveling Cylinders: Mounting Pin	3	
Frame Leveling Cylinders: Oil Leaks	No	
Frame Leveling Cylinders Photos

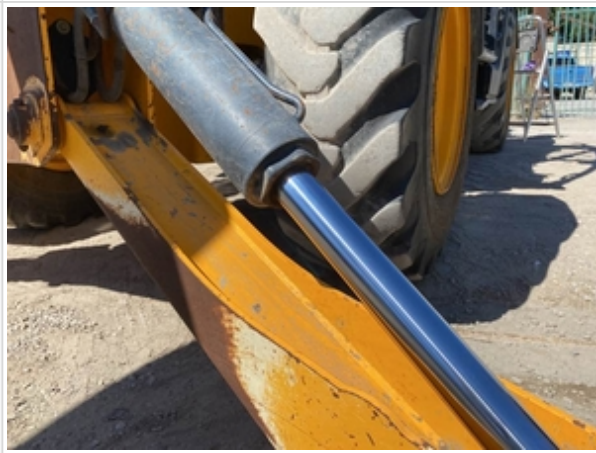
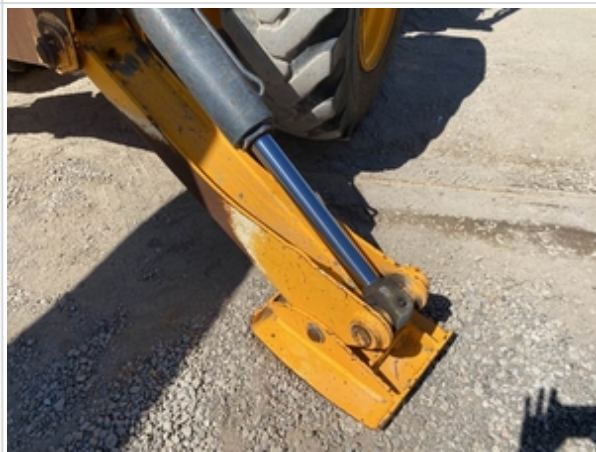
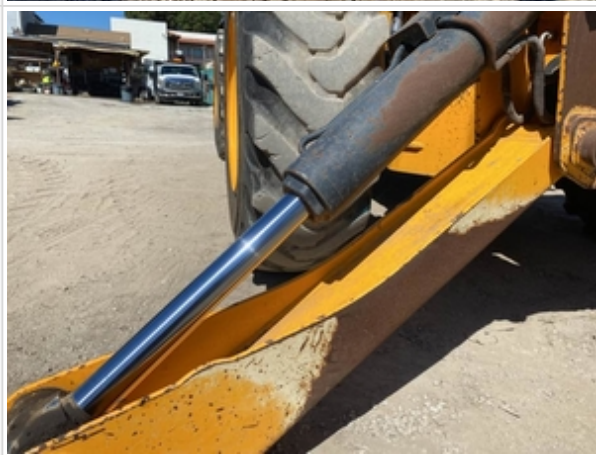
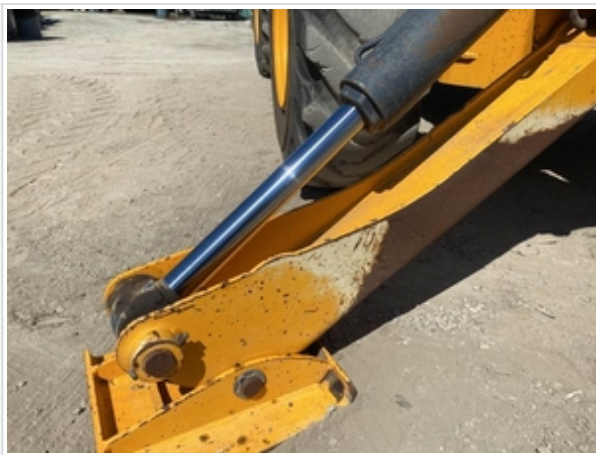
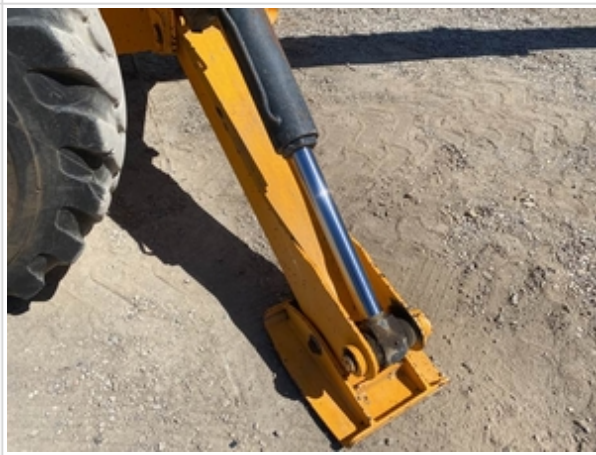
Outrigger Cylinders: Oil Leaks	No
Outrigger Cylinders Photos

Carriage Tilt Cylinder	Check the carriage tilt cylinders. Note any wear, pitting, discoloration, etc. Take photos.	
Carriage Tilt Cylinder: Mounting Pin	0	
Carriage Tilt Cylinder: Oil Leaks	No	
Side Shift Cylinder	Check the side shift cylinder. Note any wear, pitting, discoloration, etc. Take photos.	
Outrigger Cylinders	Check the outrigger cylinders. Note any wear, pitting, discoloration, etc. Take photos.	
Outrigger Cylinders: Mounting Pin	3

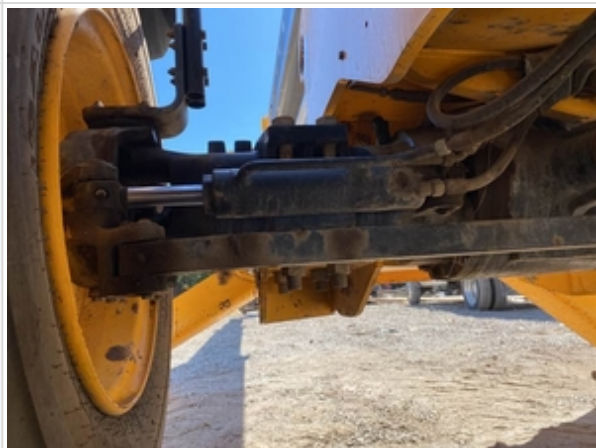
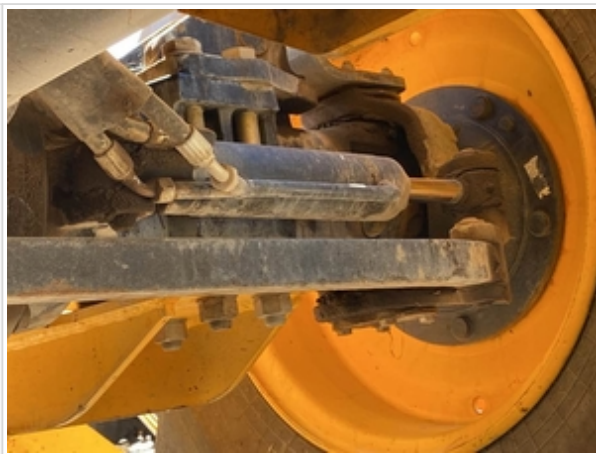
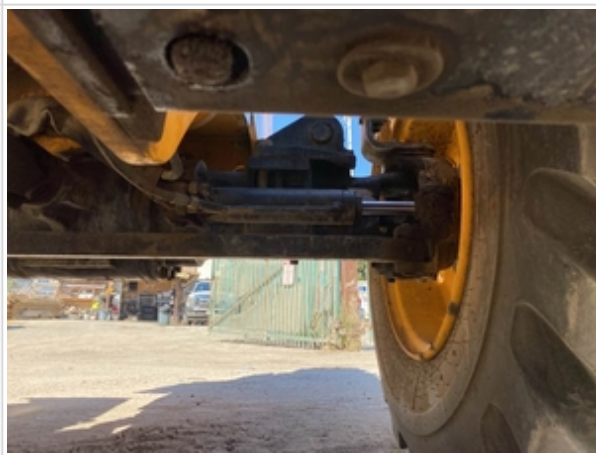
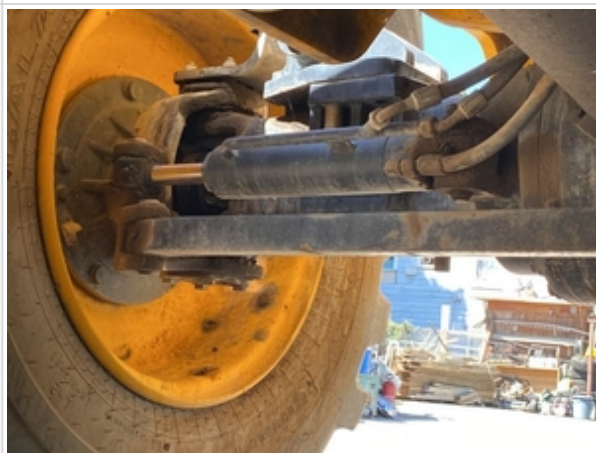
Steering Cylinders	Check the steering cylinders. Note any wear, pitting, discoloration, etc. Take photos.	
Steering Cylinders: Mounting Pin	3	
Steering Cylinders: Oil Leaks	No	
Steering Cylinders Photos

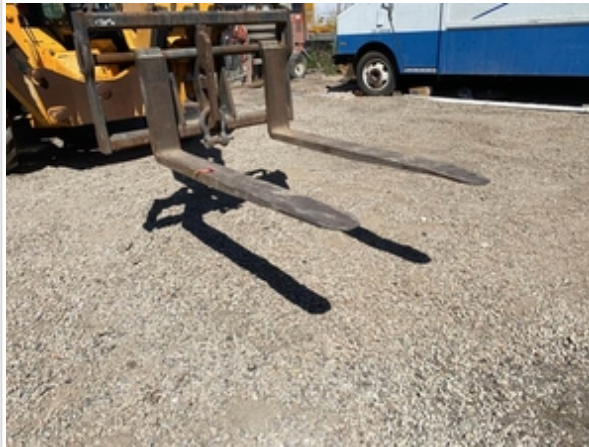
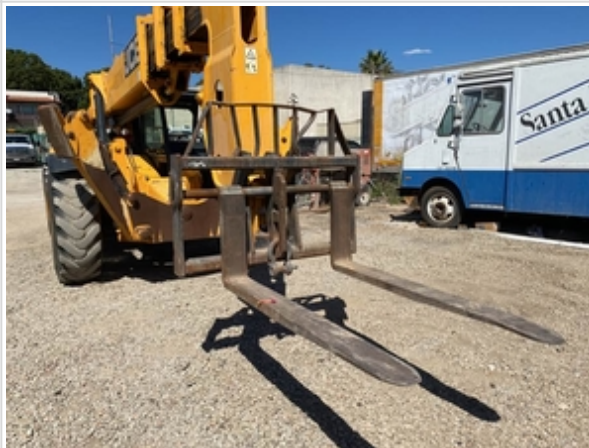
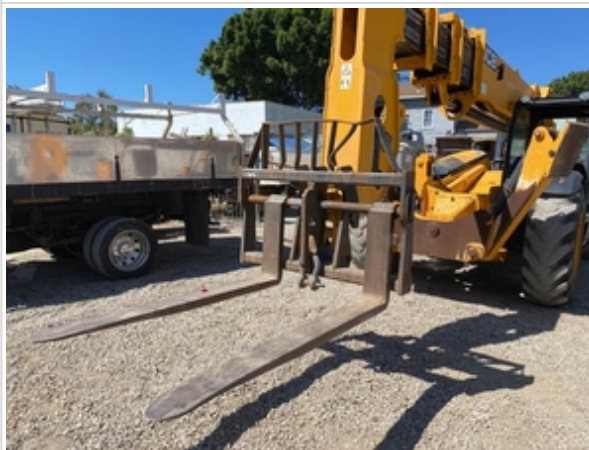
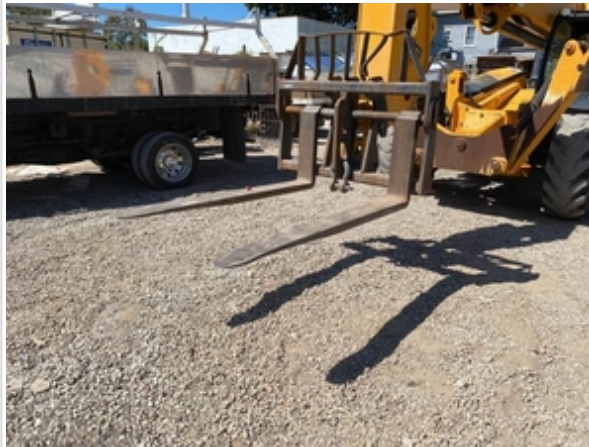
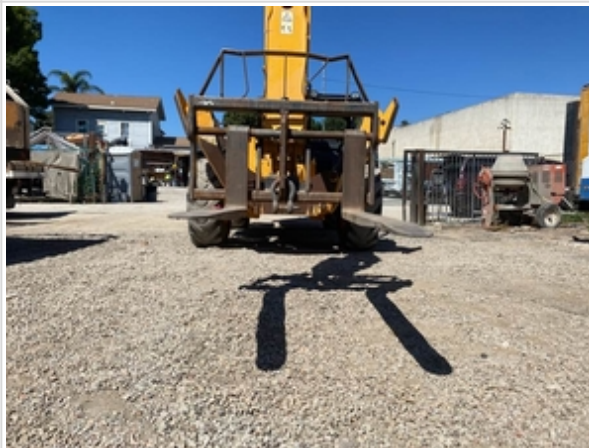
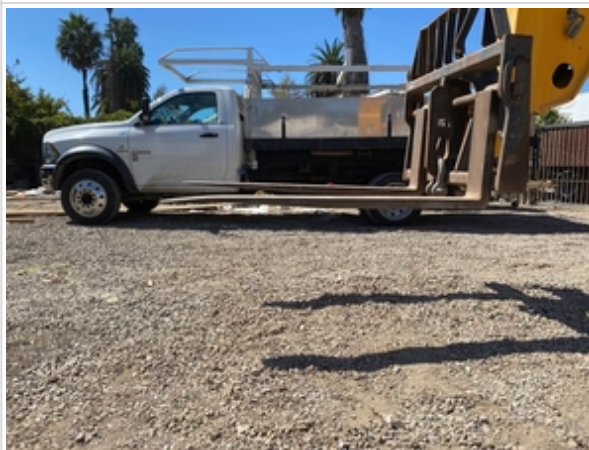
Forks / Work Tool Photos

Instructions	Evaluate the following on a 4 point scale (leave comments where an explanation is appropriate): 4 = Like New, Recently Replaced 3 = Normal Wear & Tear 2 = Above Average Wear 1 = Service Required
Forks / Work Tool Condition	3 - Normal Wear & Tear
Comments	6 inches wide 2 inches thick 5 ' long , l/s fork bent downwards
