Inspection Report (Wheel Loader)

Year	2011
Make	CAT
Model	966H
Serial Number	A6J01857
Hour Meter Reading	11,024
Previous Application (e.g., earth moving, mining, demolition, etc)	Excavating, Trenching, Mass Grading

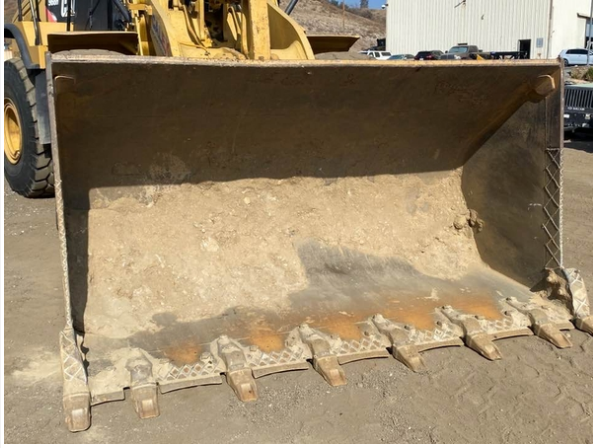
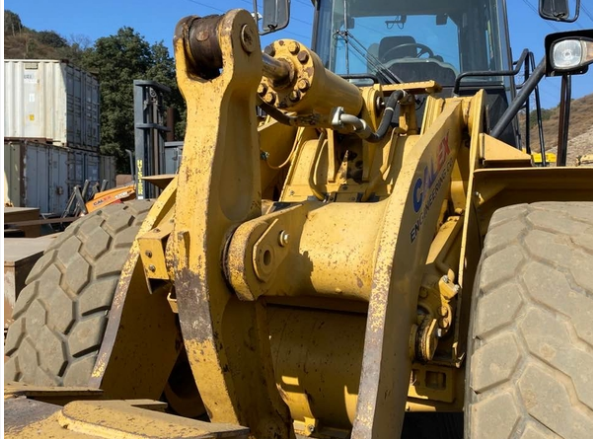
Front	3 - Normal Wear & Tear
Front Condition	No visible damage, Other (see comments)
Comments	Normal wear and tear
Front Photos

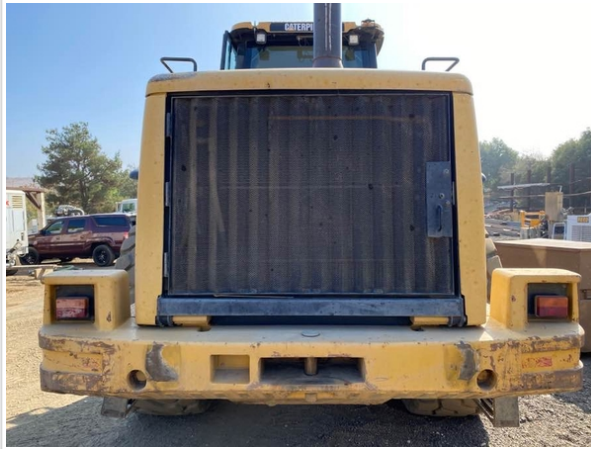
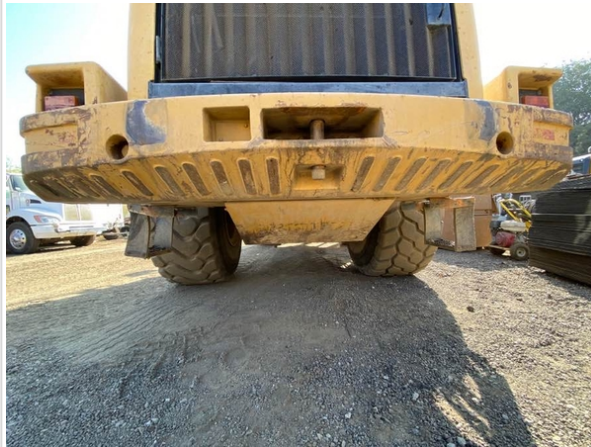
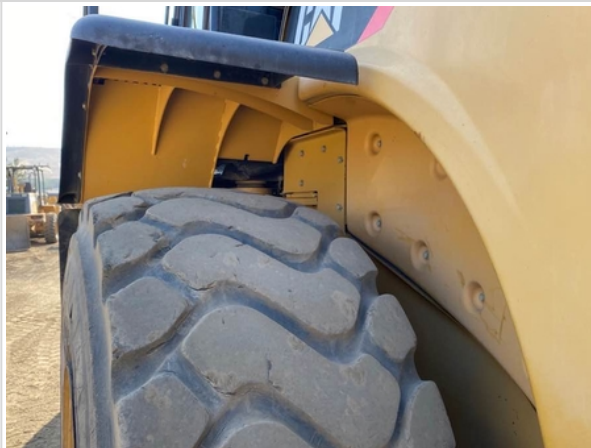
Rear Photos

Rear	3 - Normal Wear & Tear
Rear Condition	No visible damage, Other (see comments)
Comments	Normal wear and tear

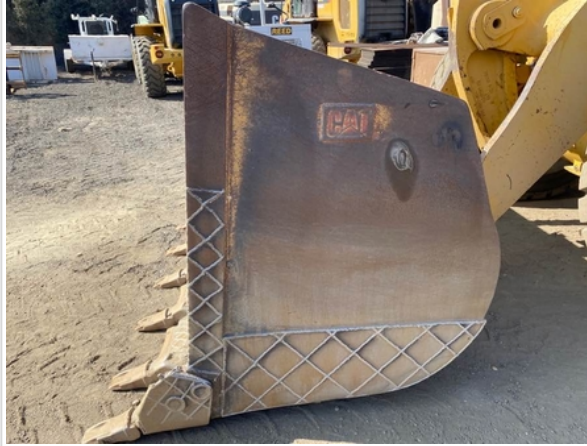
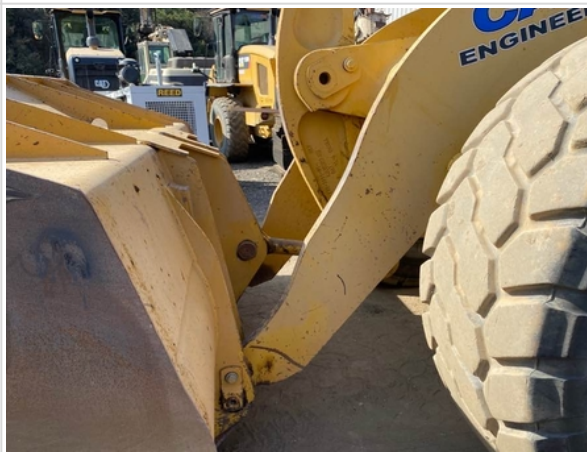
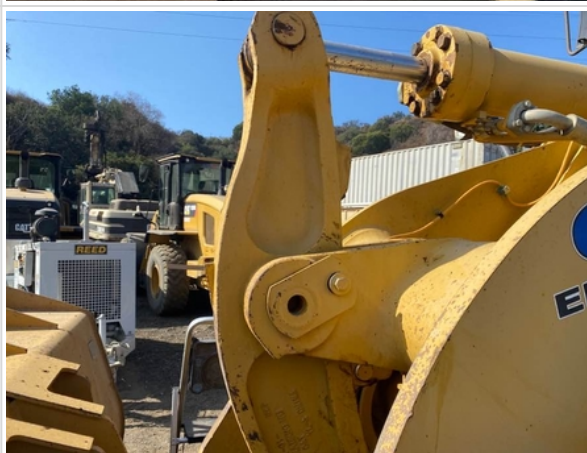
Left Photos

Left	3 - Normal Wear & Tear	
Left Condition	Other (see comments), No visible damage	
Comments	Normal wear, left side rear step bent

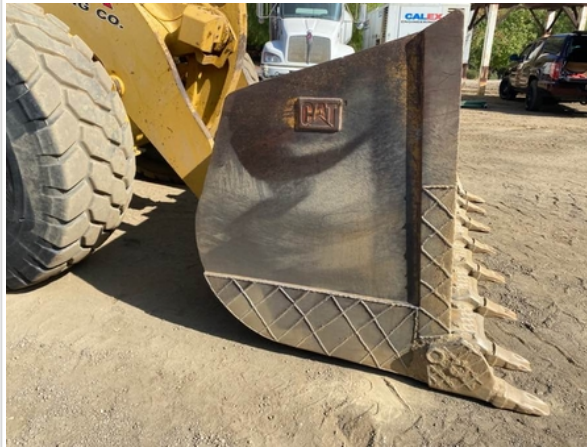
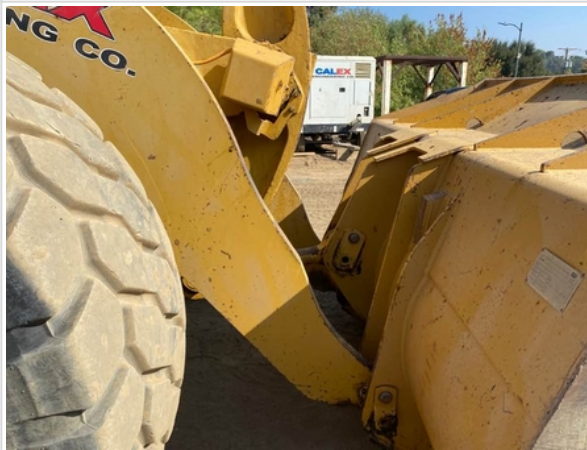
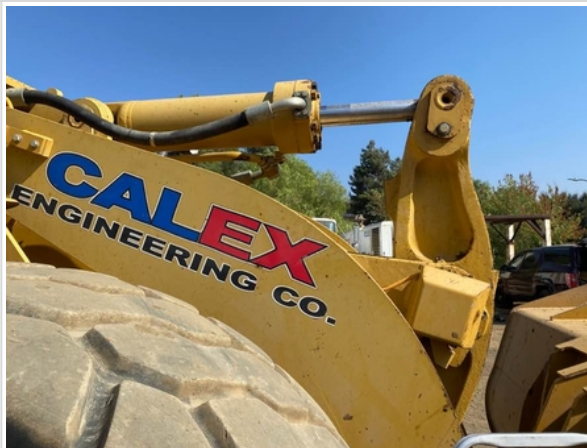
Right Photos

Right	3 - Normal Wear & Tear
Right Condition	Other (see comments)
Comments	Normal wear, scuff marks on rear counterweight, r/s fender bottom corner minor damage & mudflap slightly torn

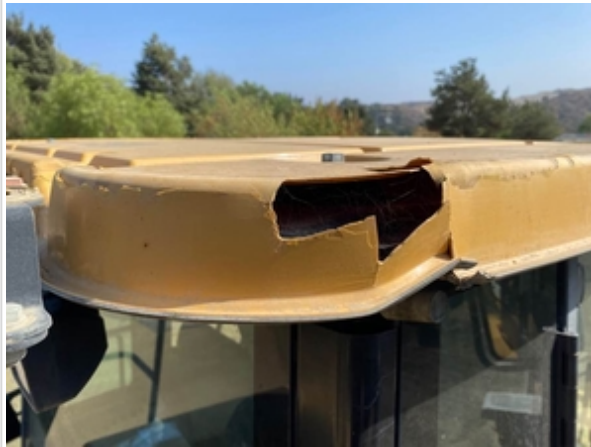
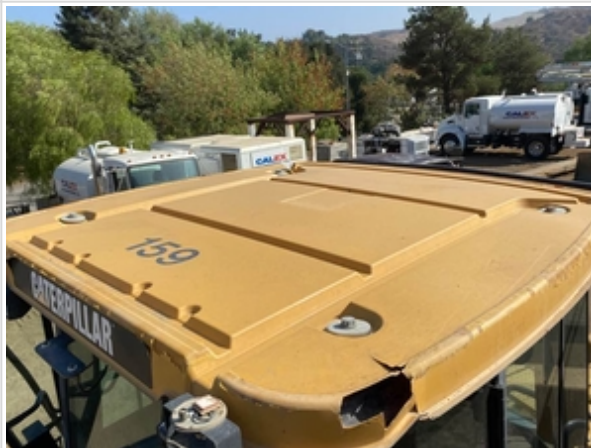
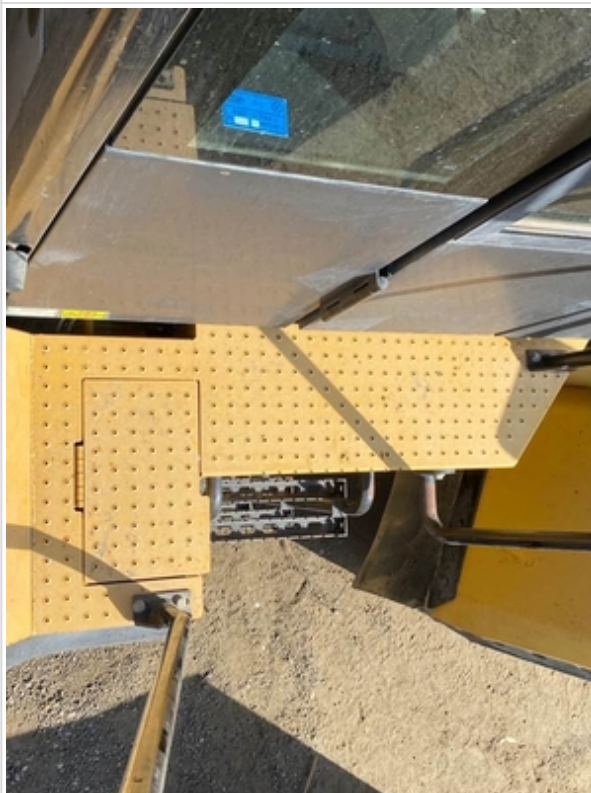
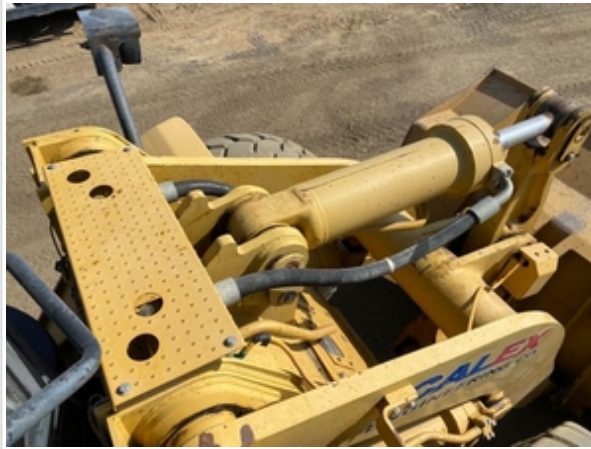
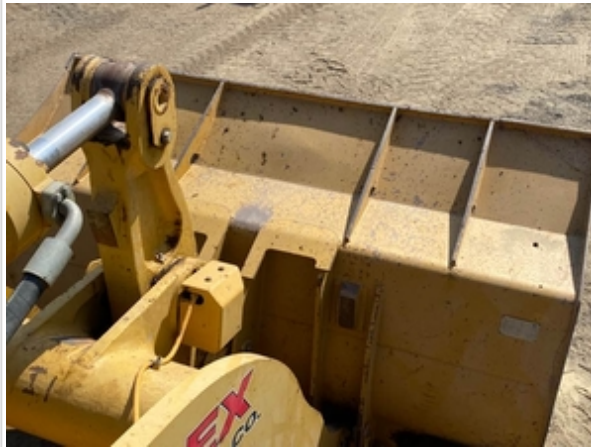
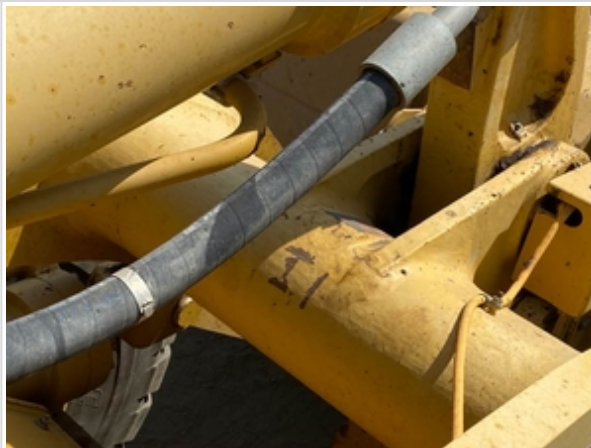
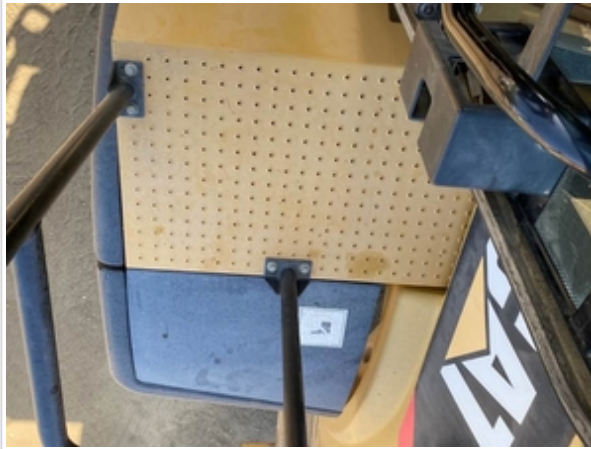
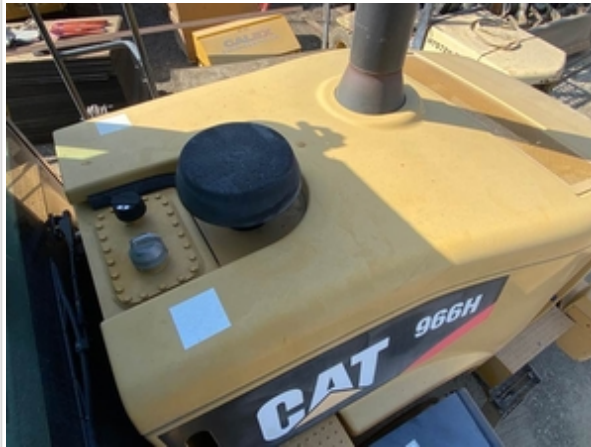
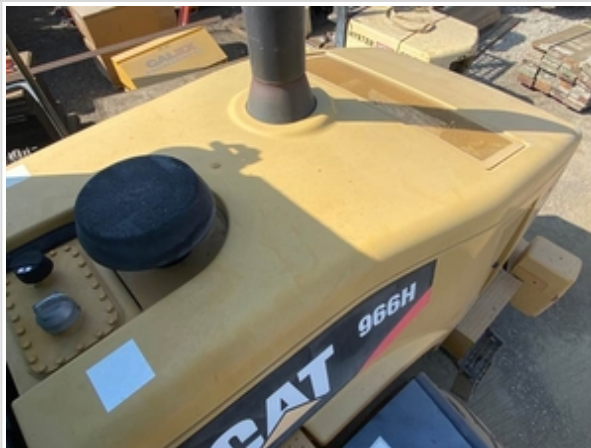
Upper	3 - Normal Wear & Tear
Upper Condition	No visible damage, Other (see comments)
Comments	R.O.P.S. Top Plastic cover corner cracked

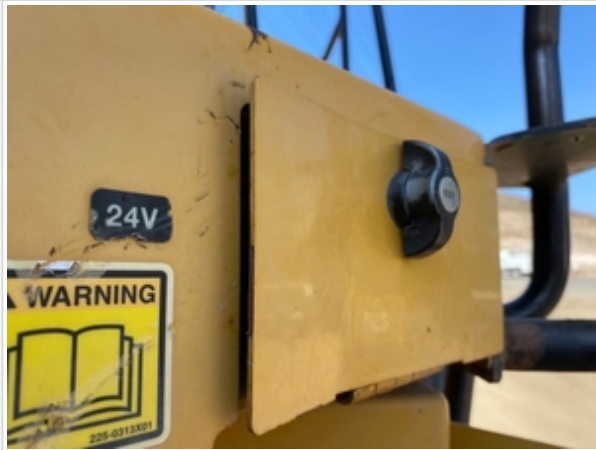
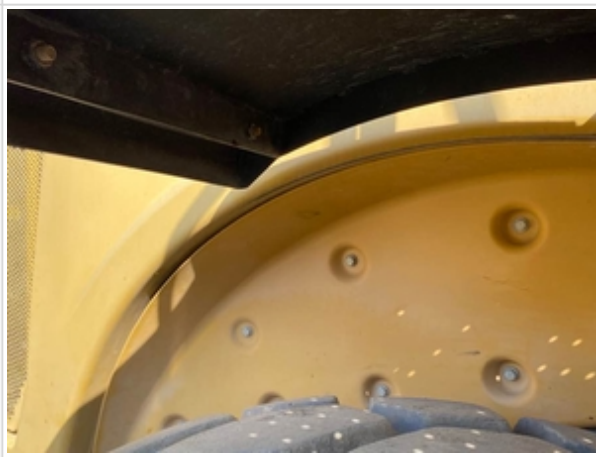
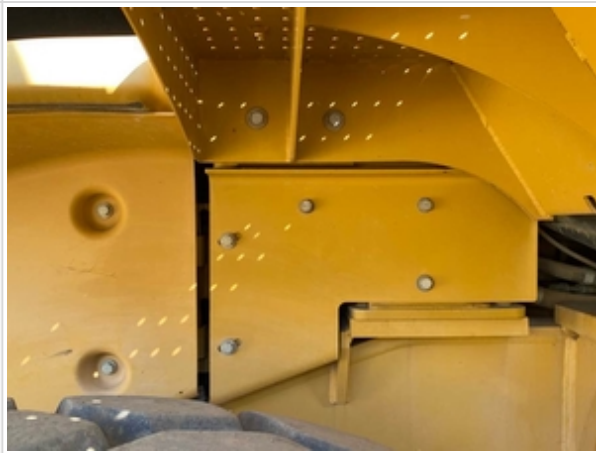
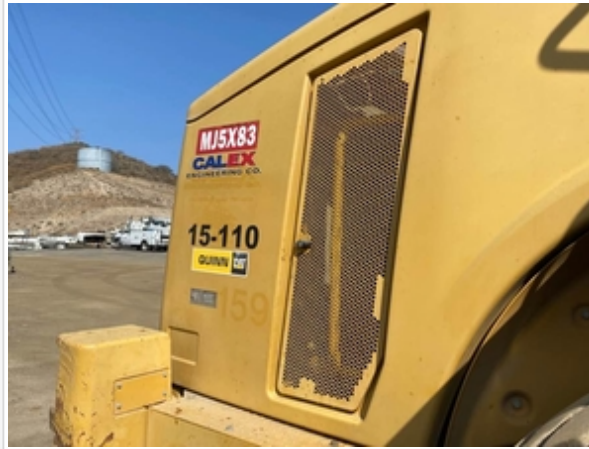
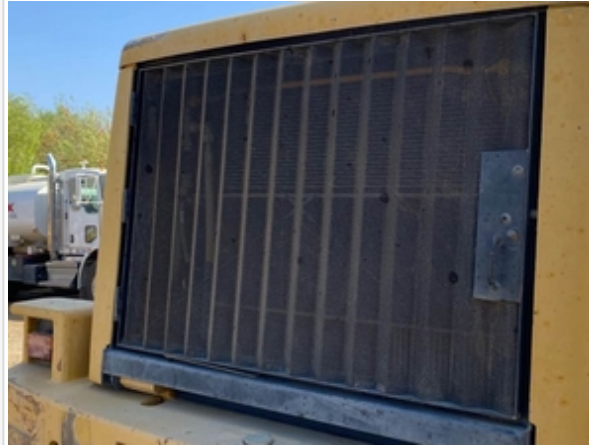
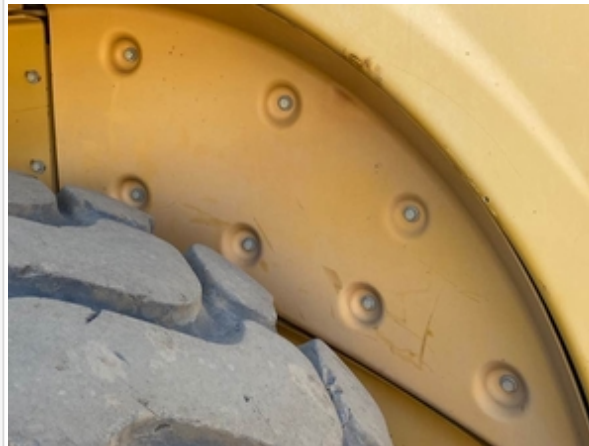
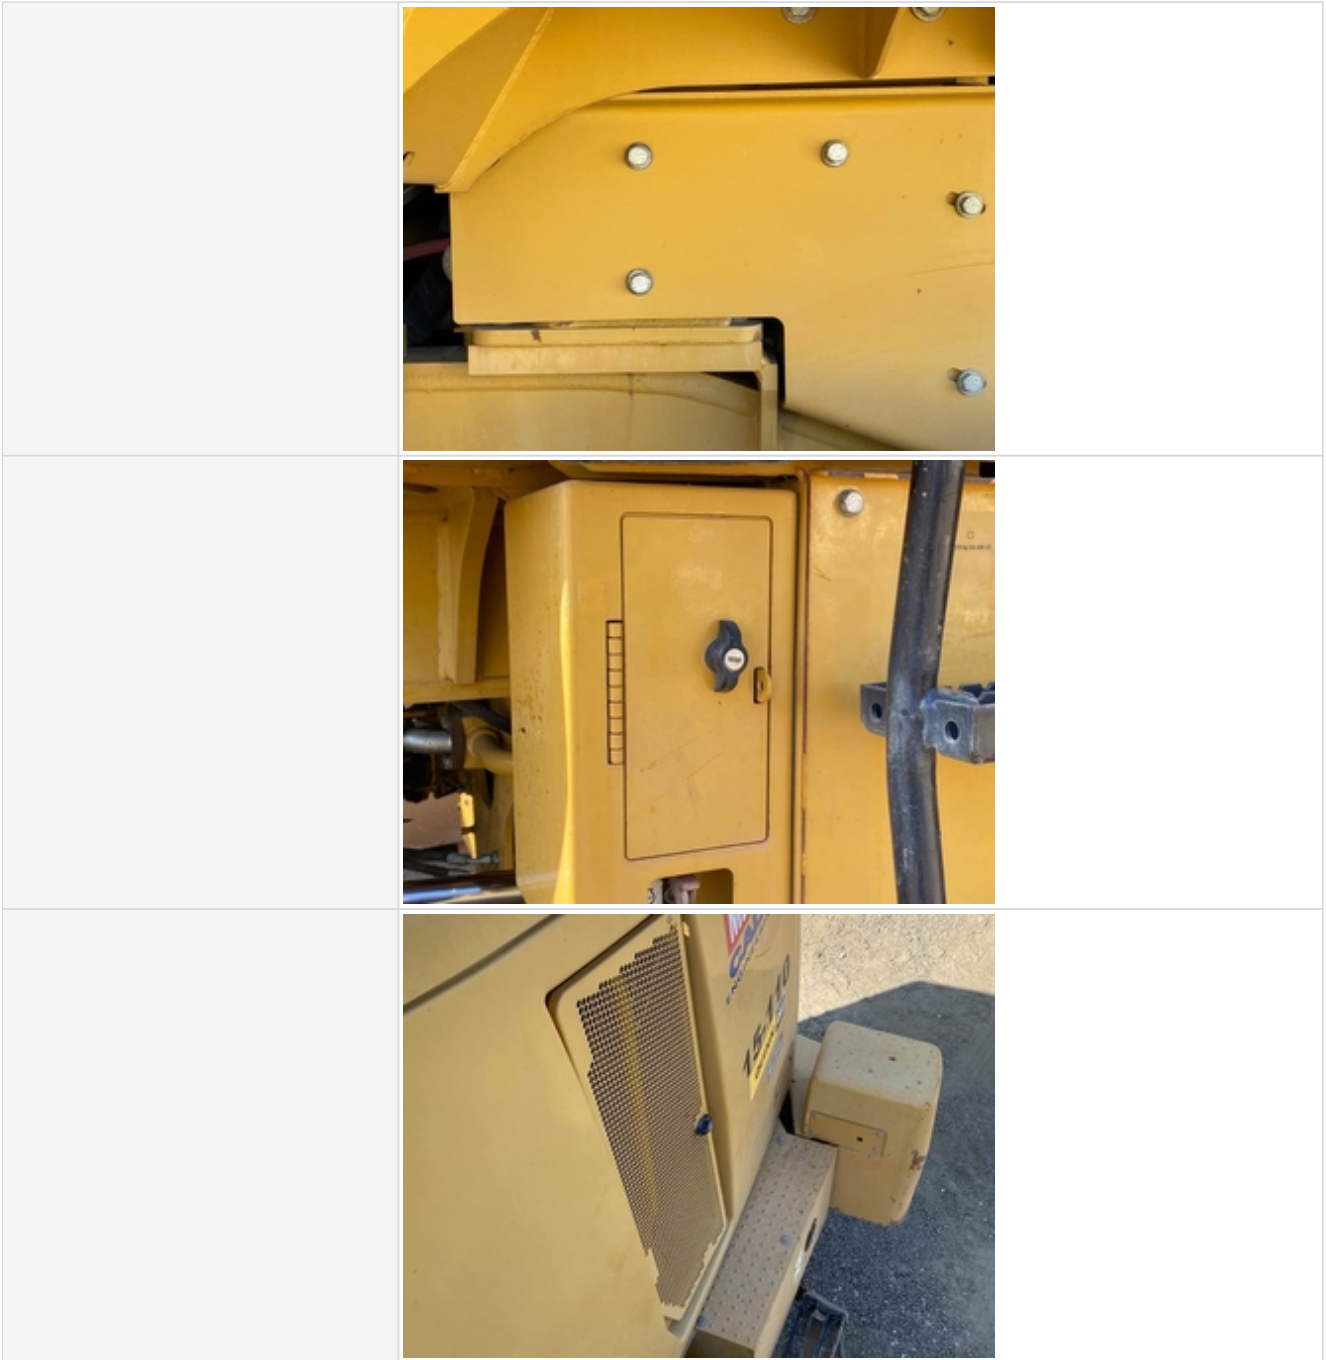
<p>Body Panels Photos</p>

Body Panels (Any Rust Damage?)	3 - Normal Wear & Tear
Body Panel Condition	No visible damage, good paint condition and panel fitment, Other (see comments)
Comments	L/S hood switch access panel bent

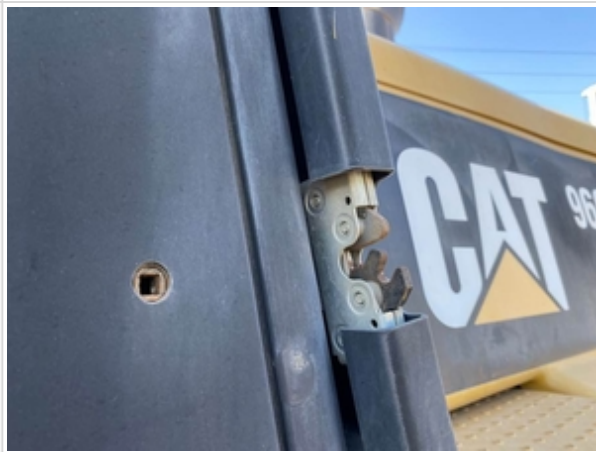
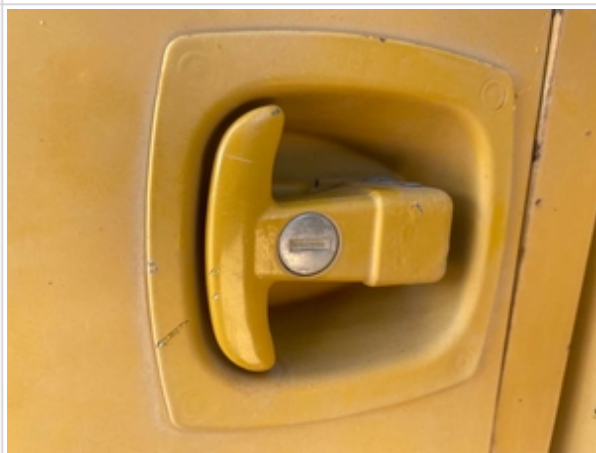
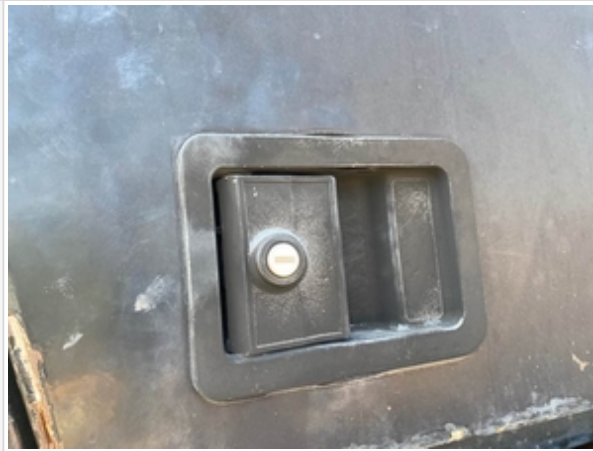
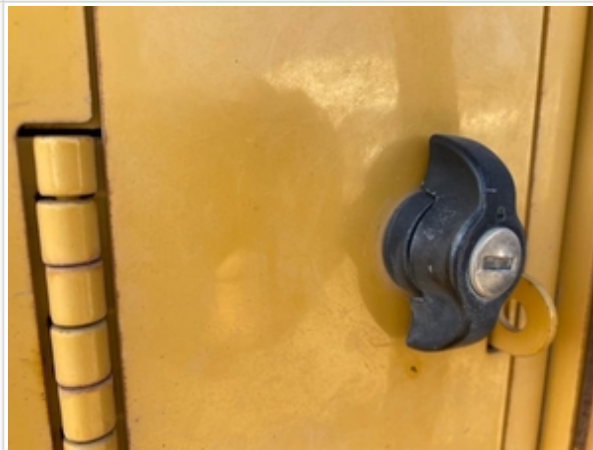
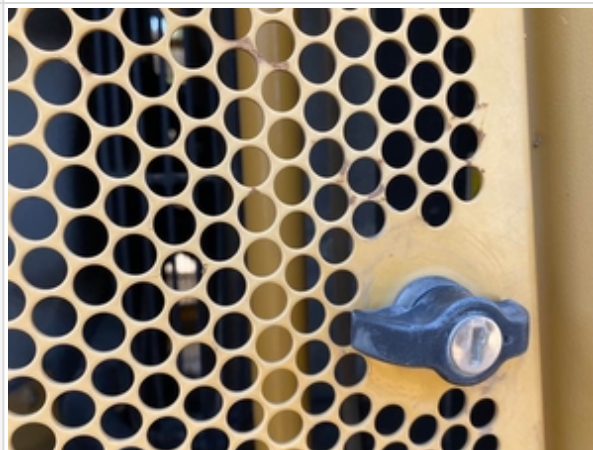
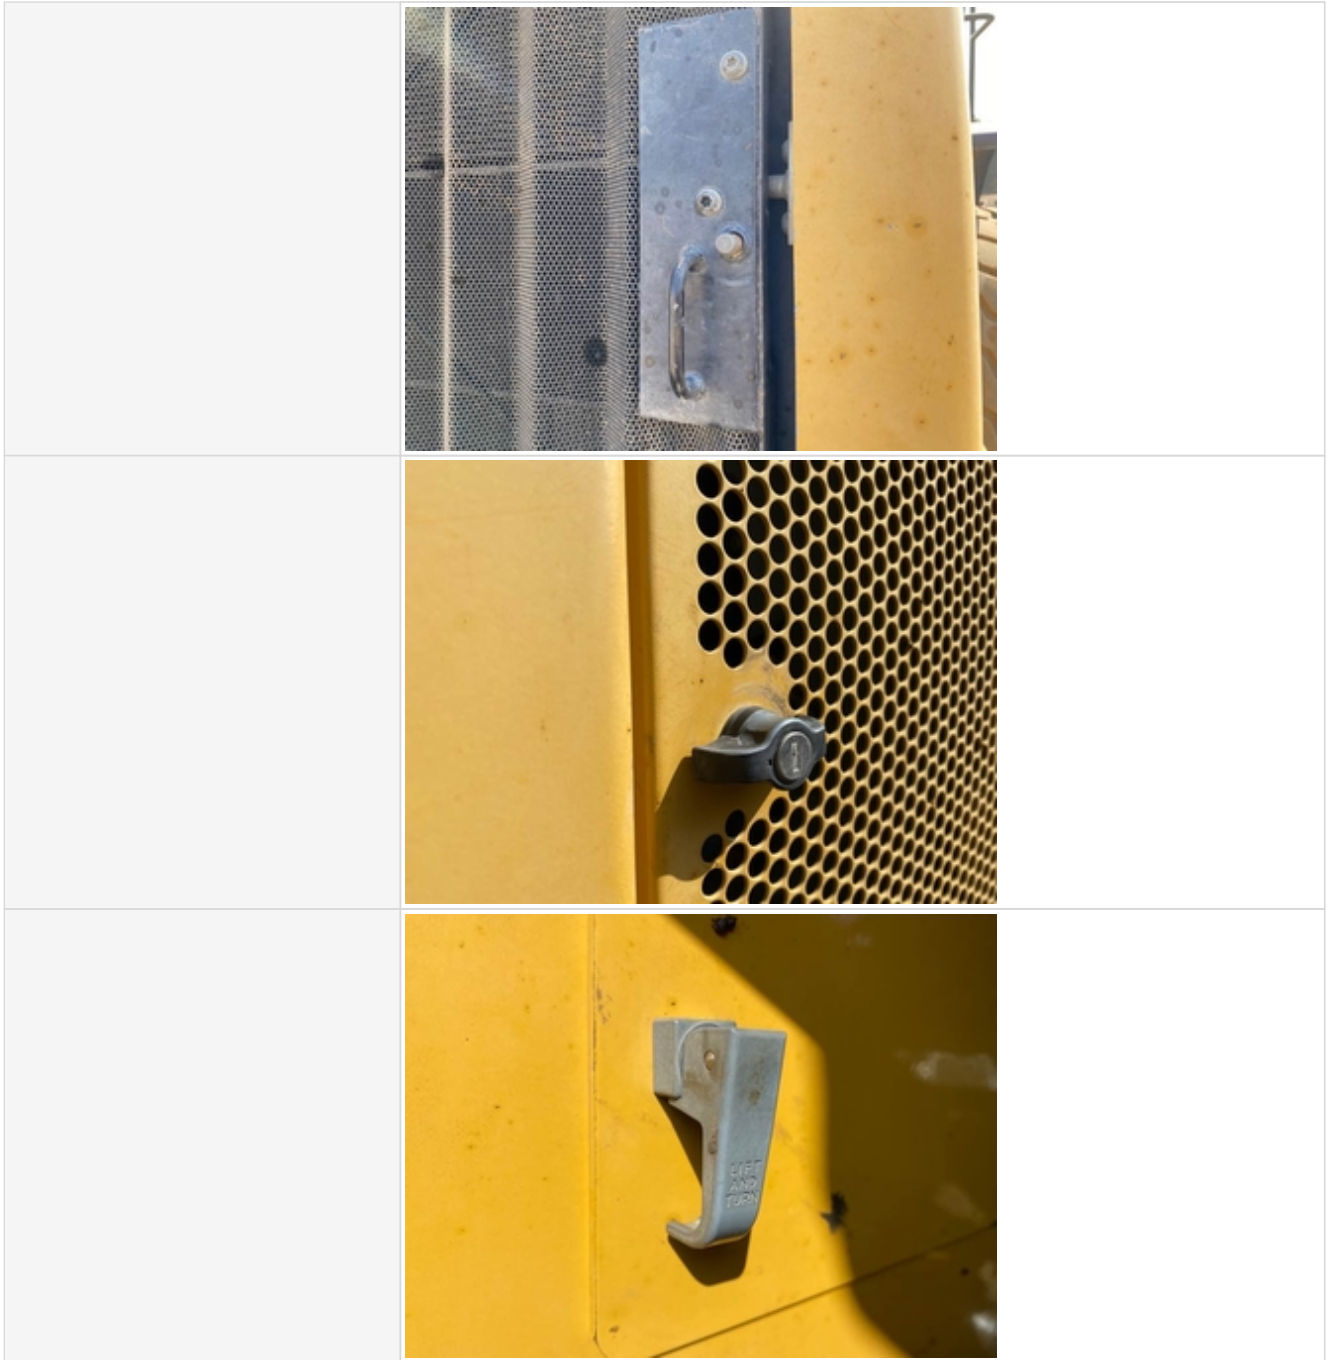
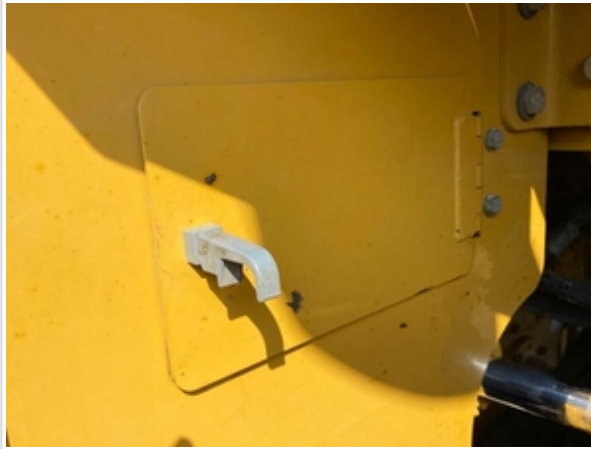
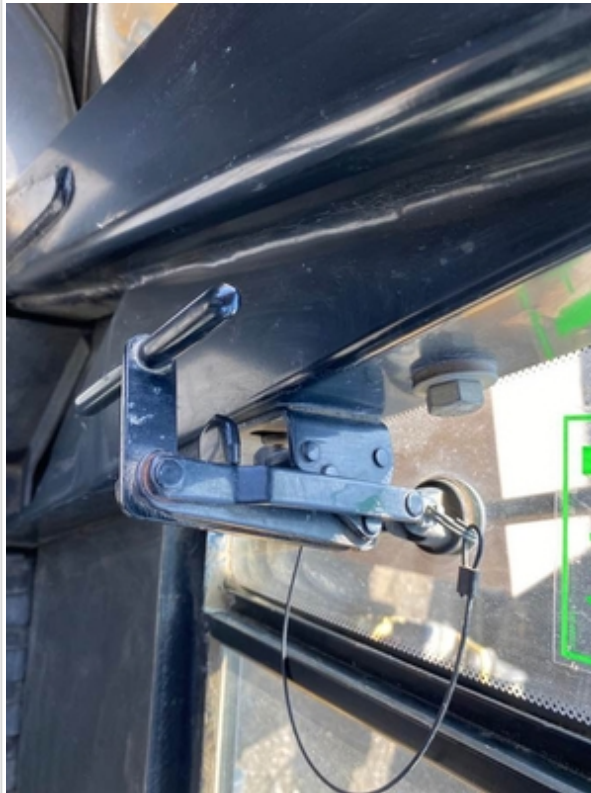
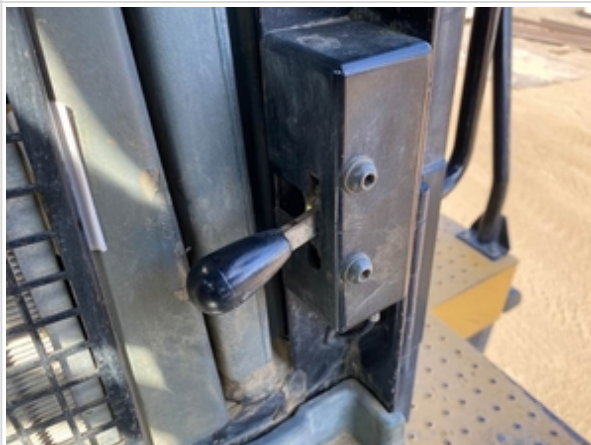
Doors / Canopy Latches	3 - Normal Wear & Tear
Doors / Canopy Latches Condition	No visible damage
Doors / Canopy Latches Photos

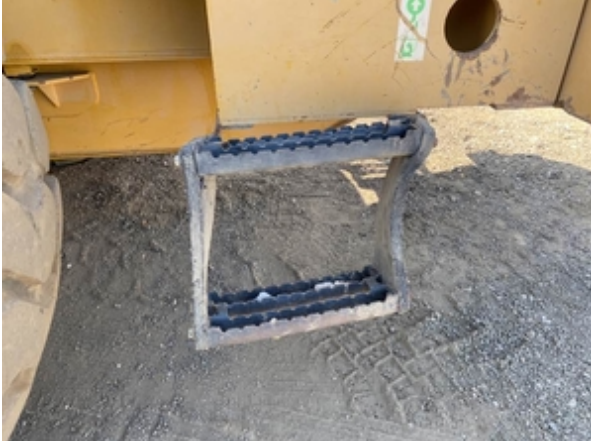
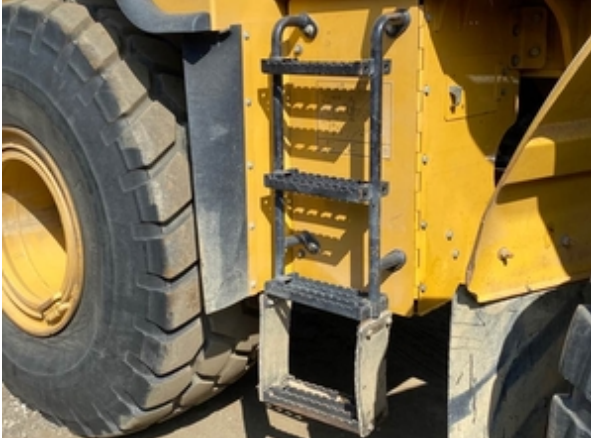
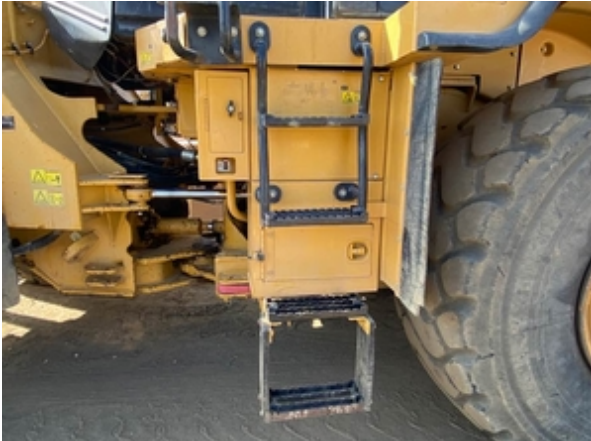
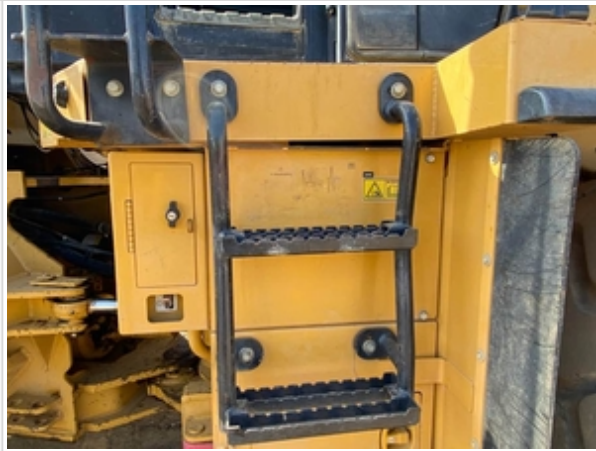
Steps / Ladders	3 - Normal Wear & Tear
Steps / Ladders Condition	Steps/ladders are fully intact and appear structurally sound, Bent or broken steps or rungs
Steps / Ladders Photos

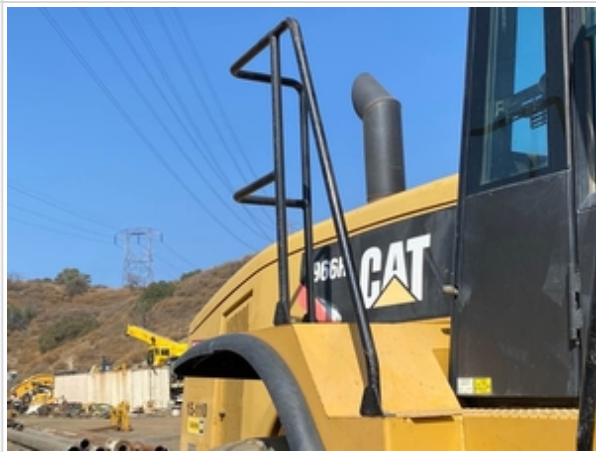
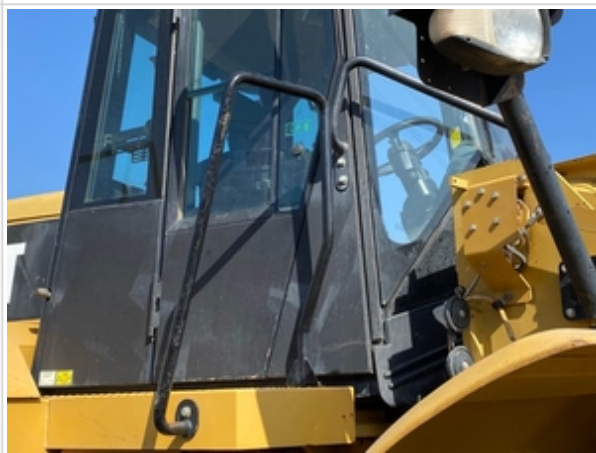
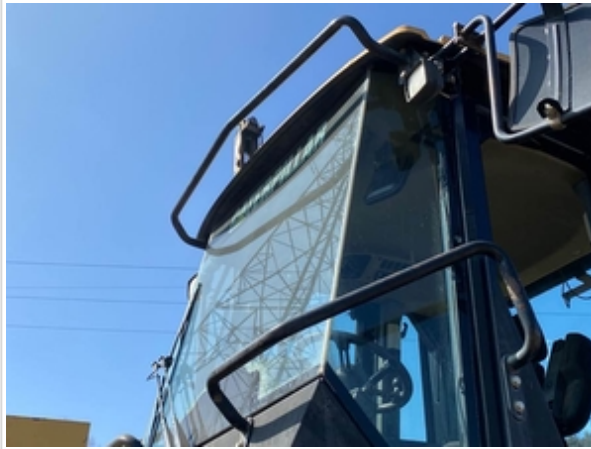
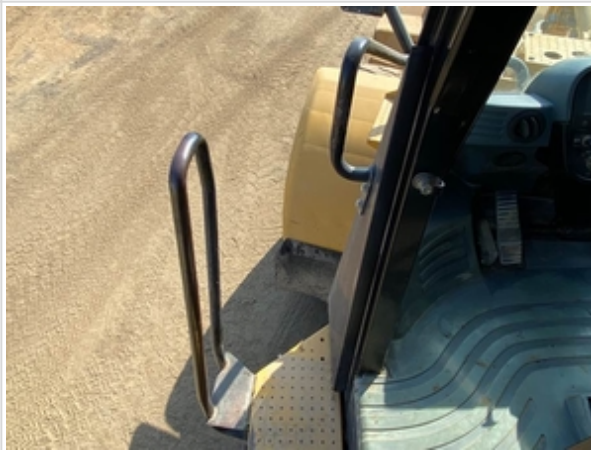
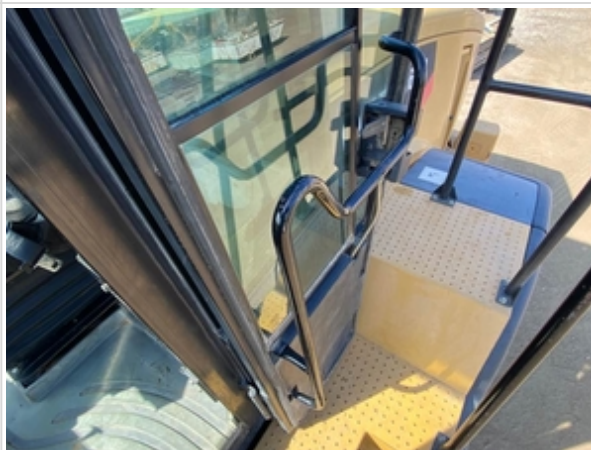
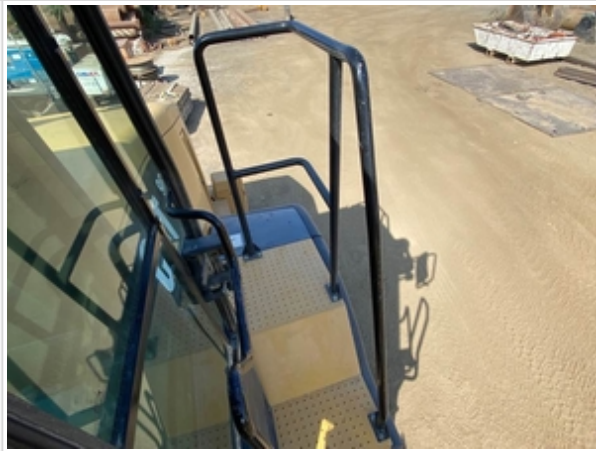
<p>Handrails</p>	<p>3 - Normal Wear & Tear</p>	
<p>Handrails Condition</p>	<p>Handrails are fully intact and appear structurally sound</p>	
<p>Handrail Photos</p>

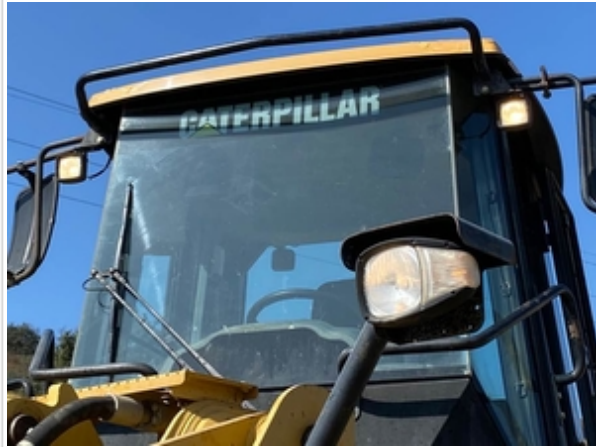
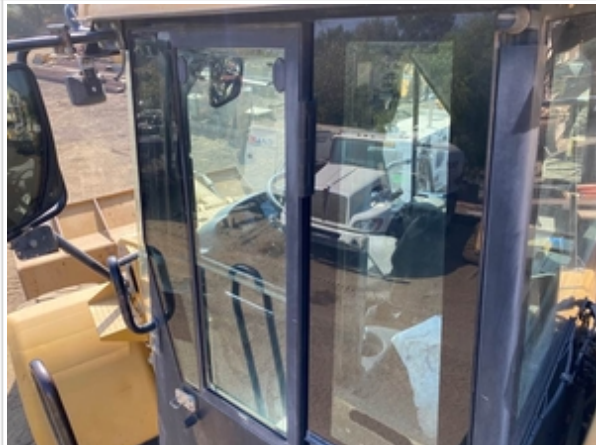
Glass Condition	3 - Normal Wear & Tear
Glass Condition Notes	Glass intact, no visible damage
Glass Condition Photos

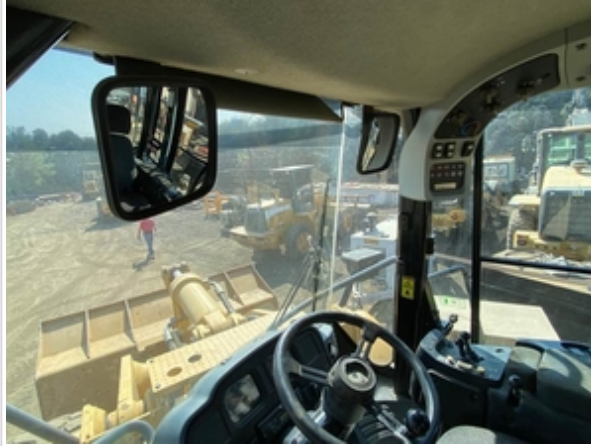
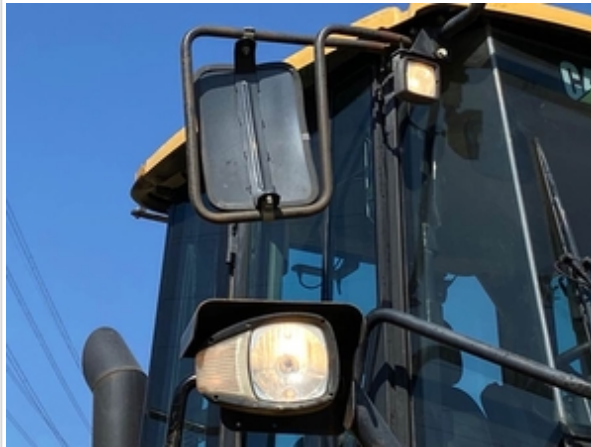
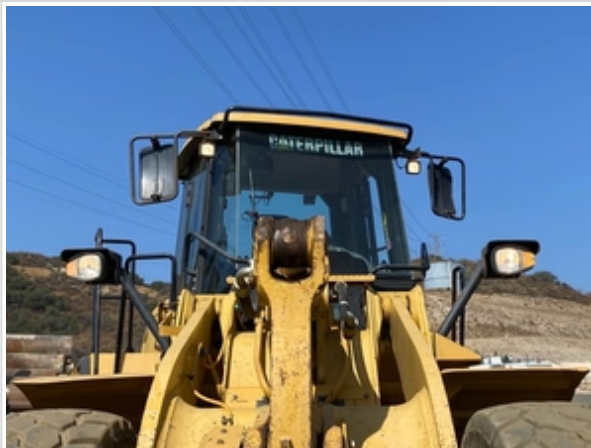
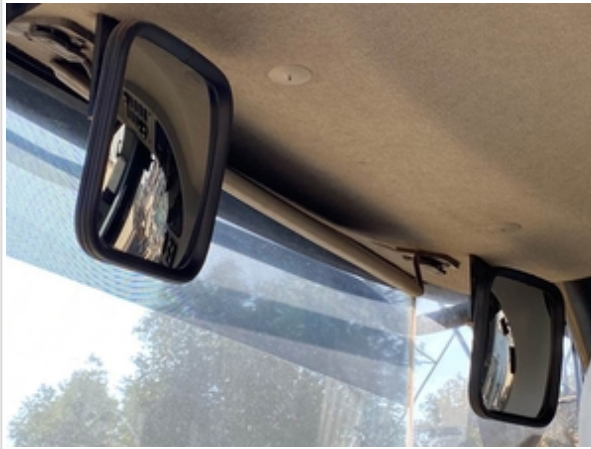
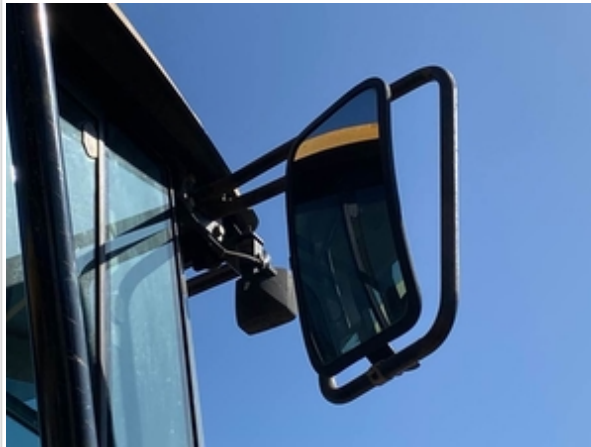
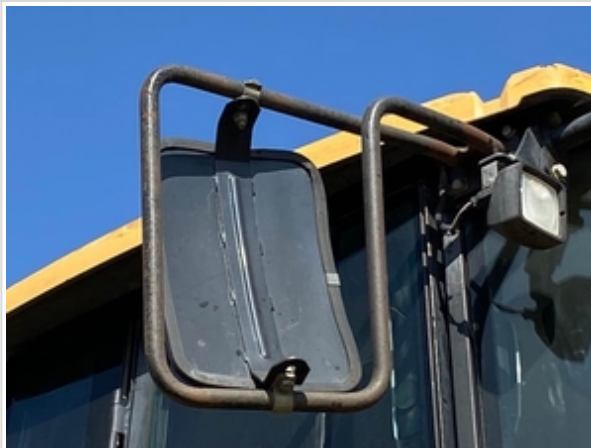
Mirrors Photos

Mirrors	3 - Normal Wear & Tear
Mirror Condition Notes	Mirrors present and intact, no visible damage

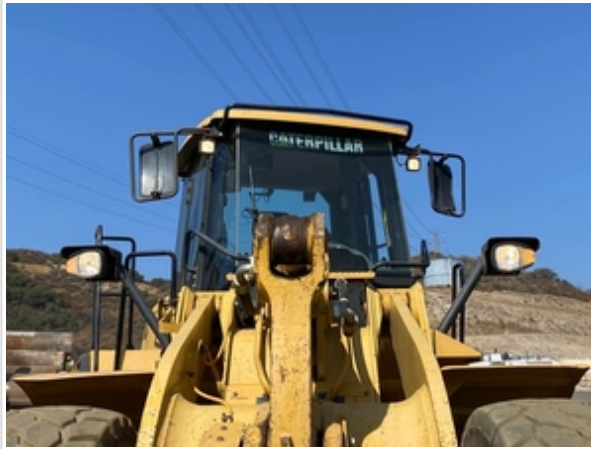
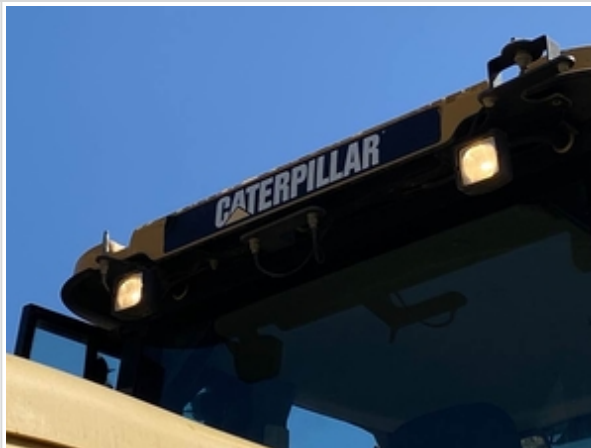
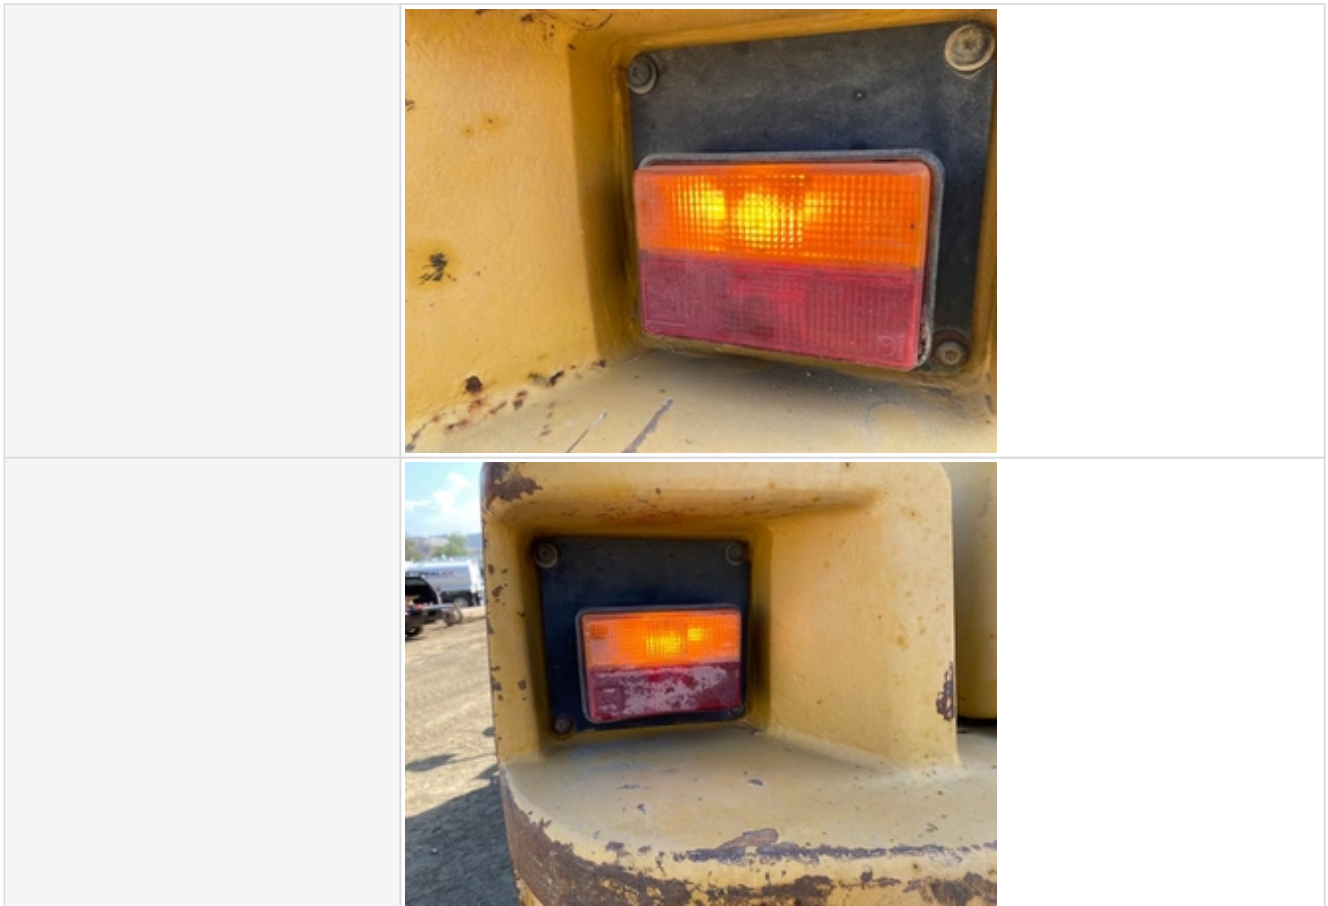
Lighting System	3 - Normal Wear & Tear	
Lighting System Condition	No visible damage, lighting system is operational	
Lighting System Photos

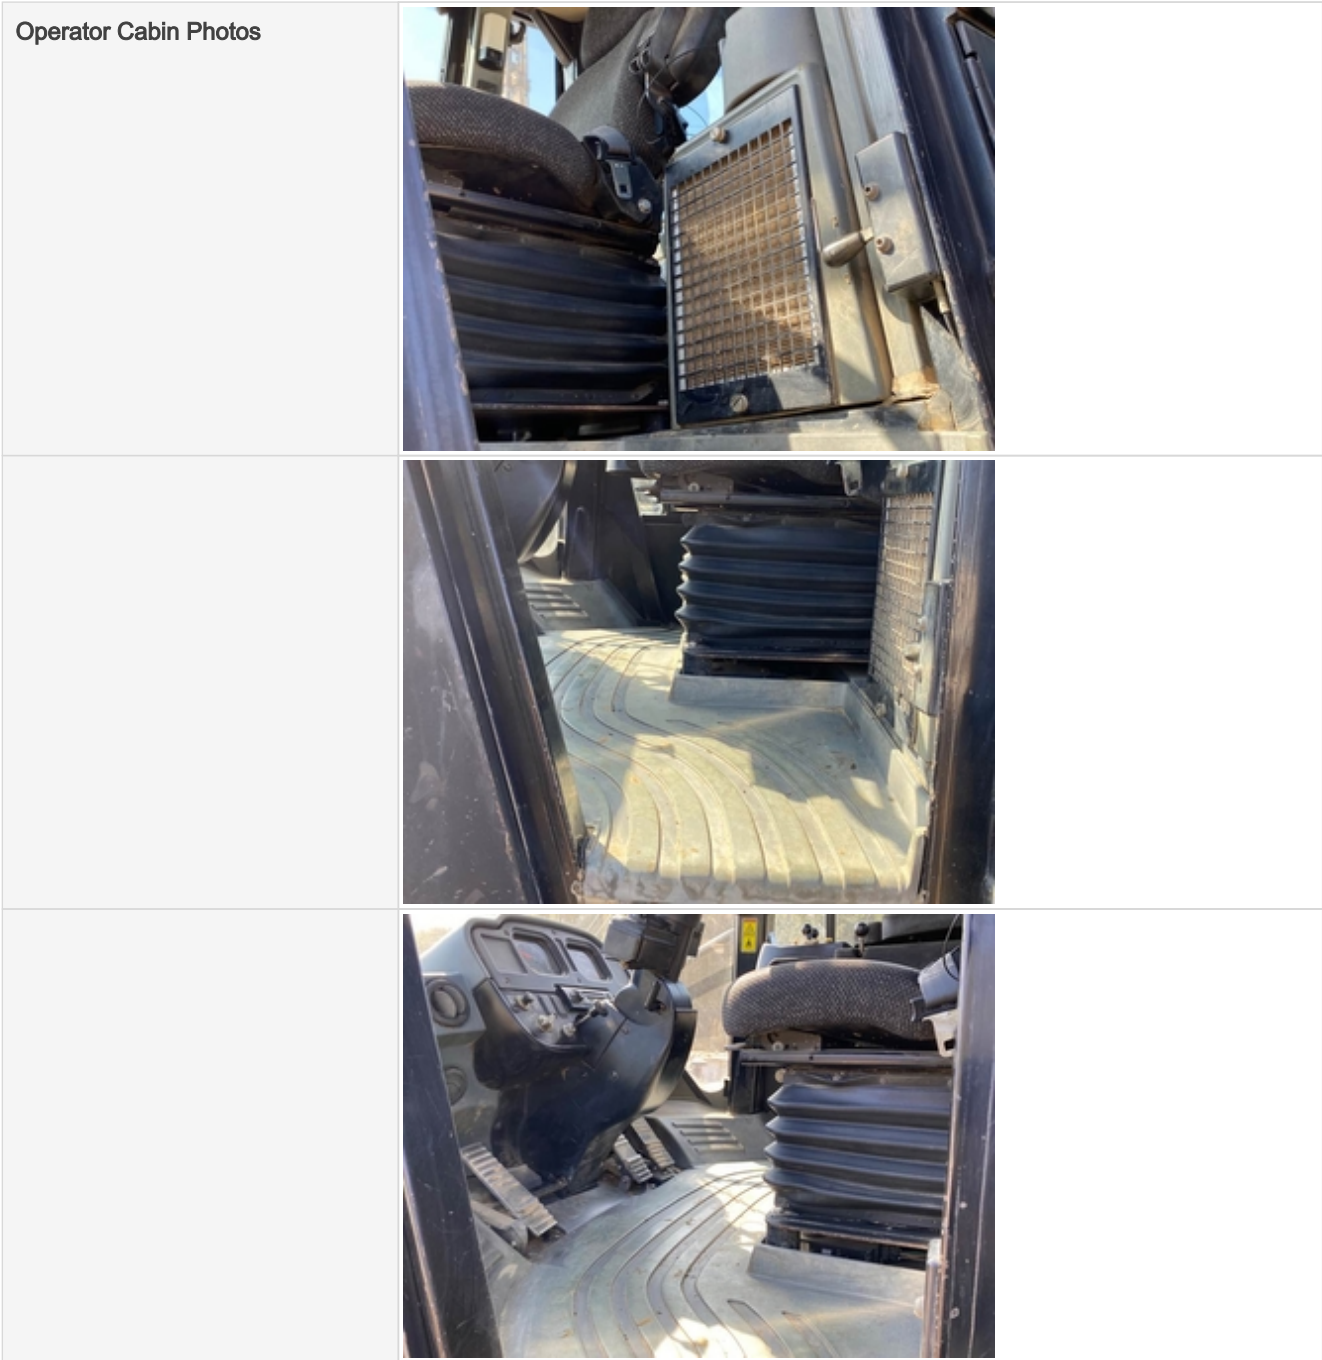
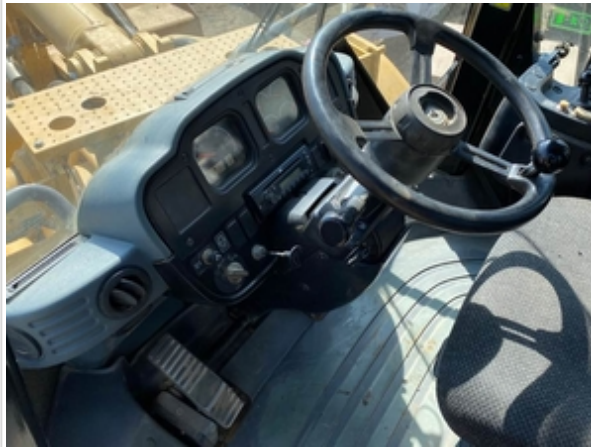
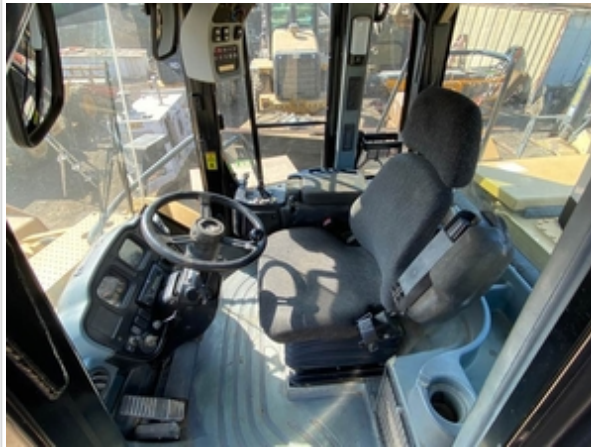
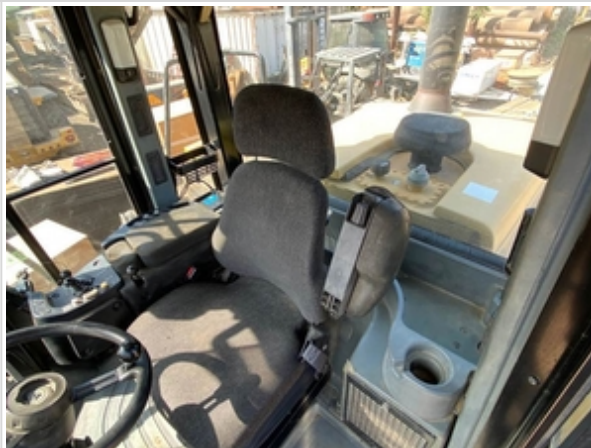
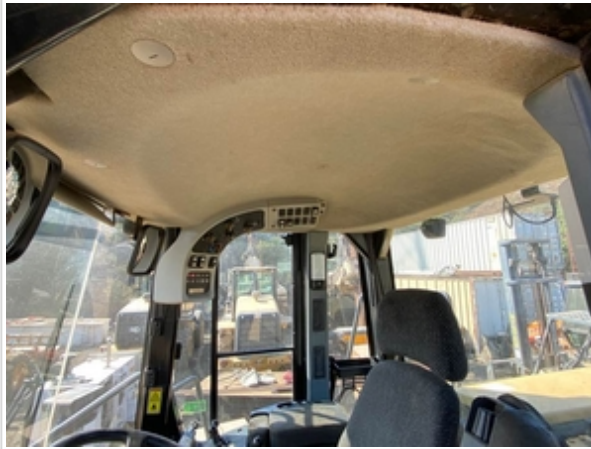
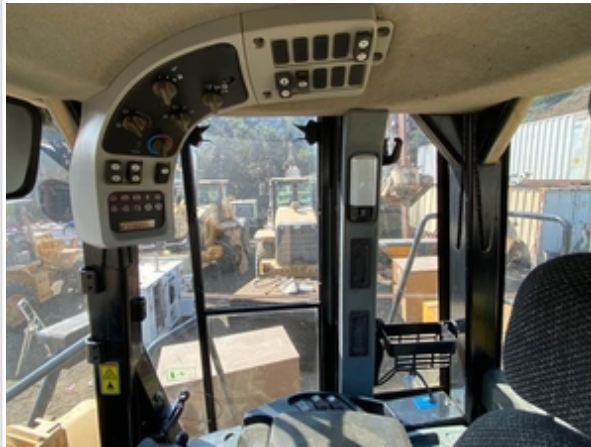
<p>Serial Number Plate Photo</p>	 
<p>Operator Cabin Overall</p>	<p>3 - Normal Wear & Tear</p>
<p>Operator Cabin Overall Condition</p>	<p>Good cabin appearance, solid floors, panels, and ceiling</p>
