Inspection Report (Wheel Loader)

Year	2011
Make	CAT
Model	966H
Serial Number	A6J01857
Hour Meter Reading	11,024
Previous Application (e.g., earth moving, mining, demolition, etc)	Excavating, Trenching, Mass Grading

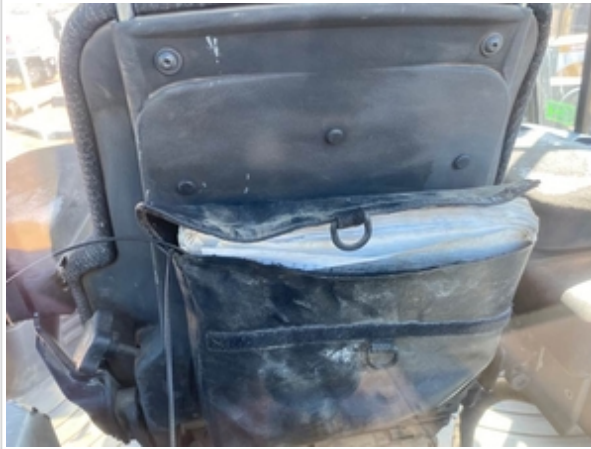
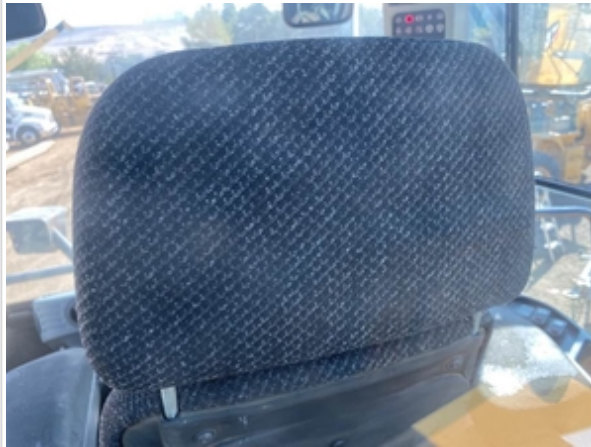
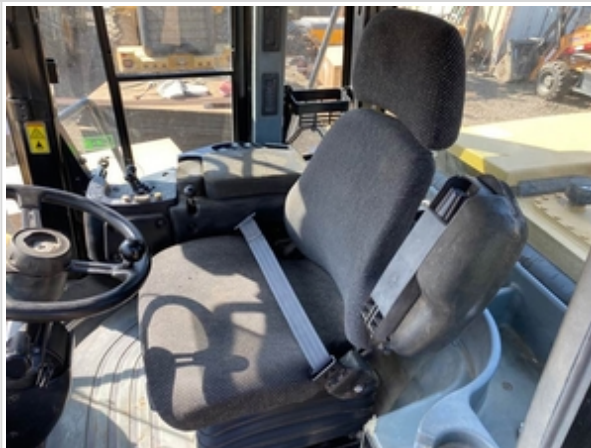
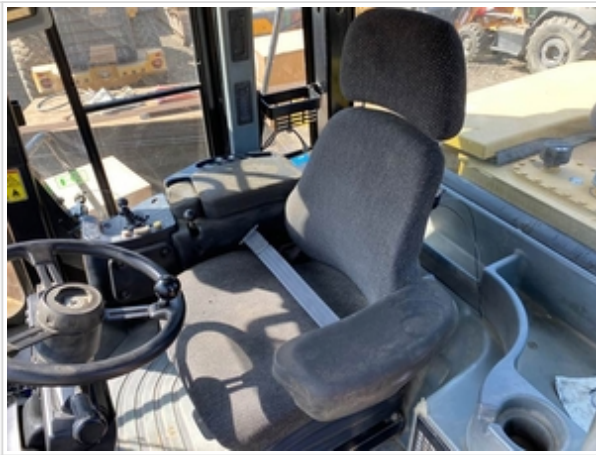
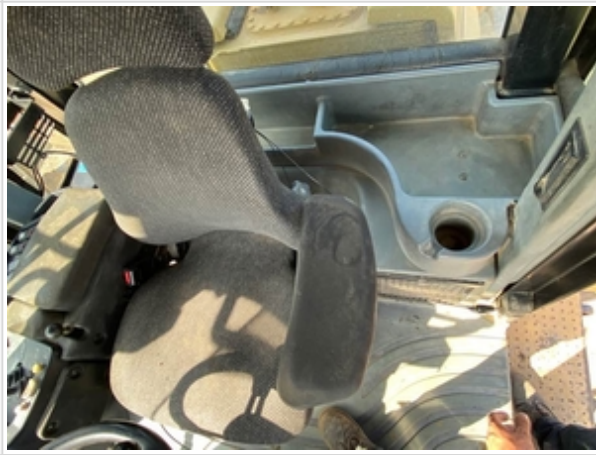
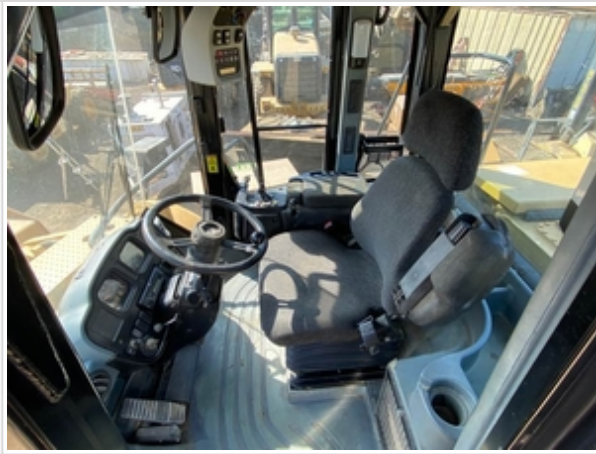
Operator's Seat & Arm Rests
Photos

<p>Operator's Seat & Arm Rests</p>	<p>3 - Normal Wear & Tear</p>	
<p>Operator's Seat & Arm Rests Condition</p>	<p>Seat(s) in good condition, no stains or tears in upholstery, Seat(s) have minor surface staining or small tears</p>

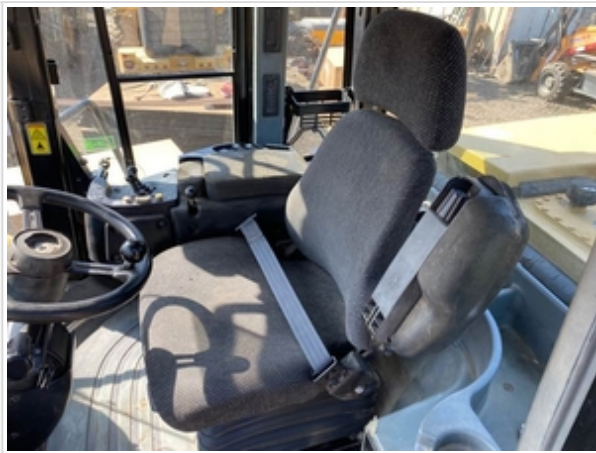
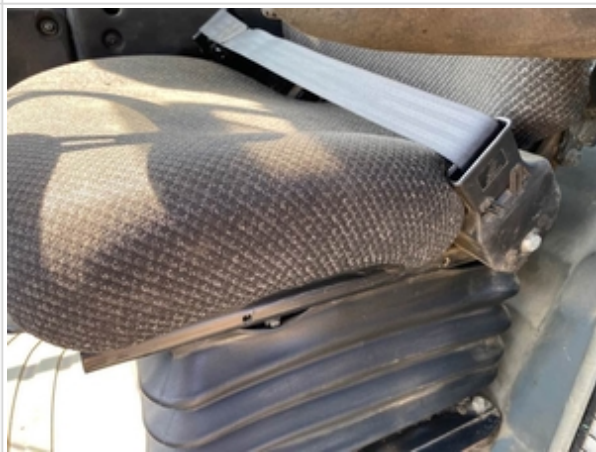
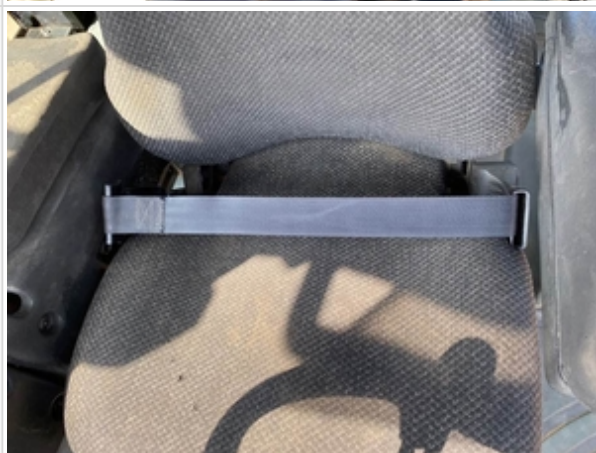
<p>Seat Belt Photos</p>

Seat Belt	3 - Normal Wear & Tear
Seat Belt Condition	Seat belt secures properly. Belt is intact and in good condition

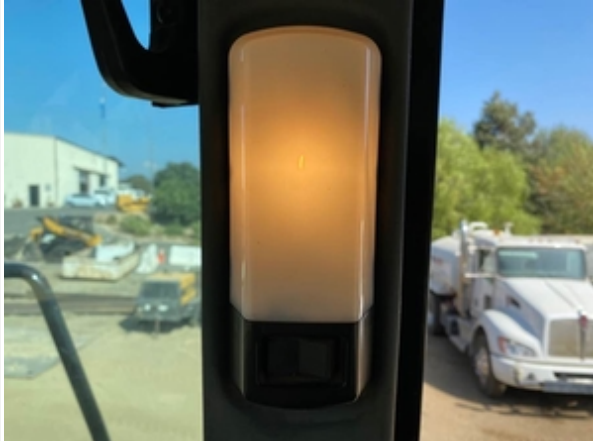
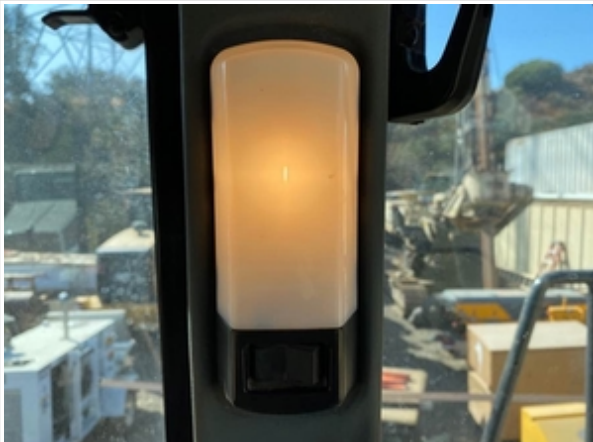
Cabin Lights Photos

<p>Cabin Lights</p>	<p>3 - Normal Wear & Tear</p>
<p>Cabin Lights Condition</p>	<p>Cabin lights are installed with all light covers in place, bulbs are installed and working properly</p>

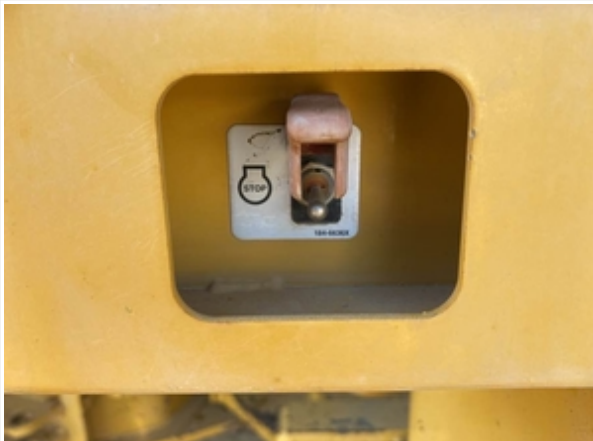
Safety Lock Out / Stop	3 - Normal Wear & Tear
Safety Lock Out / Stop Condition	Safety lock out device is present, in good condition, and functional
Safety Lock Out / Stop Photos

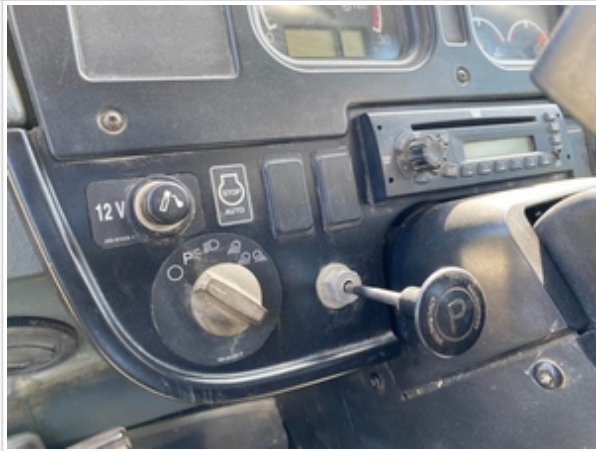
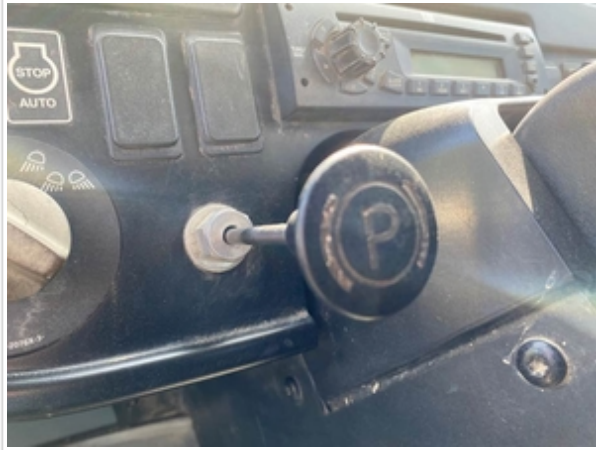
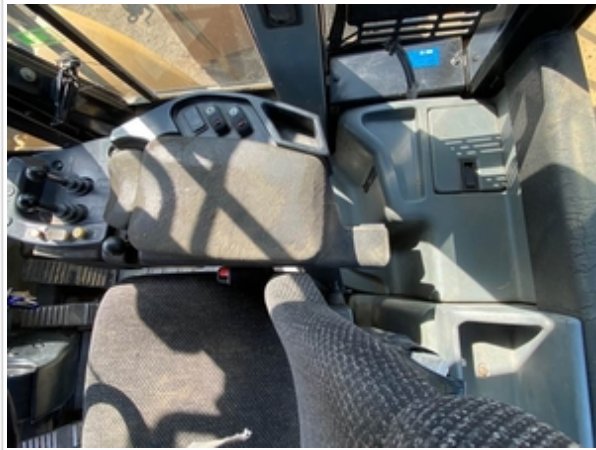
<p>Controls & Switches Photos</p>

Controls & Switches	3 - Normal Wear & Tear
Controls & Switches Condition	All switches are installed and functional

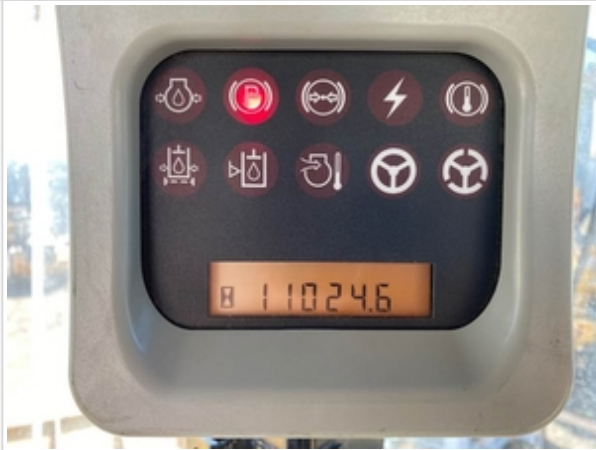
Hour Meter Activity Photos

Hour Meter Activity	3 - Normal Wear & Tear
Hour Meter Condition	Hour meter is functional and in good condition

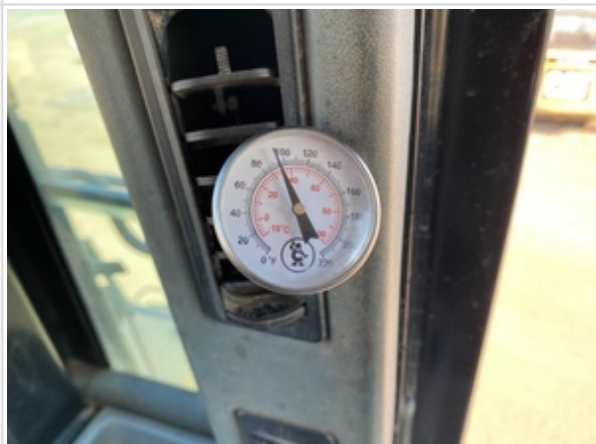
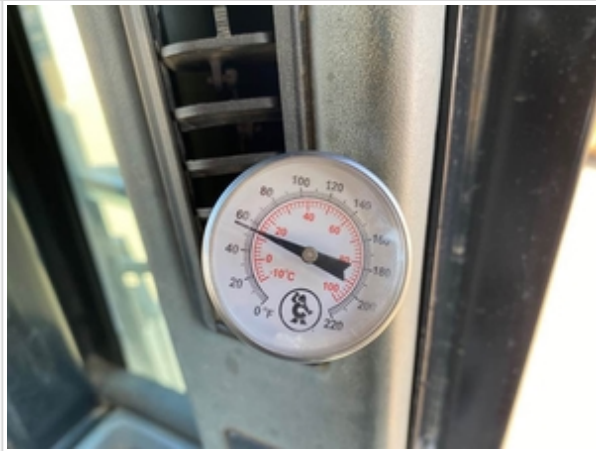
Heater & A/C	3 - Normal Wear & Tear
Heater & A/C Condition	Heater and A/C work and transition through full temperature range
Heater & A/C Photos

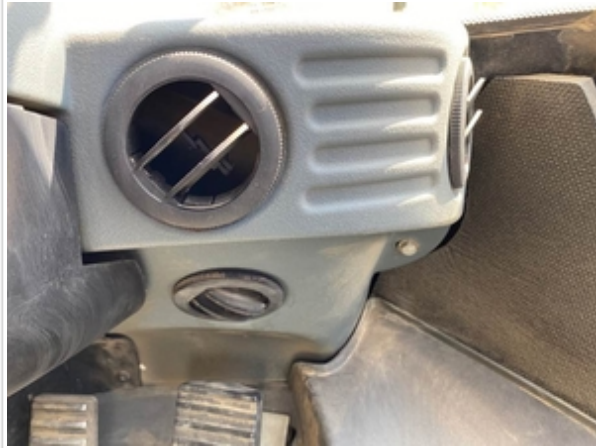
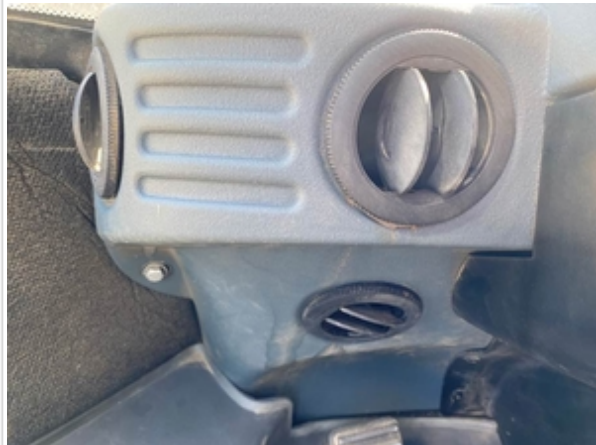
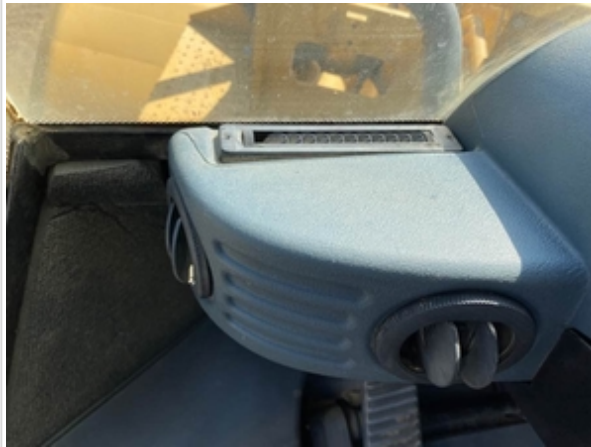
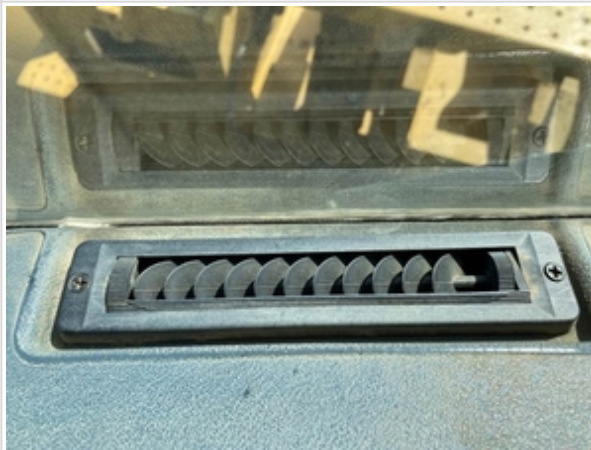
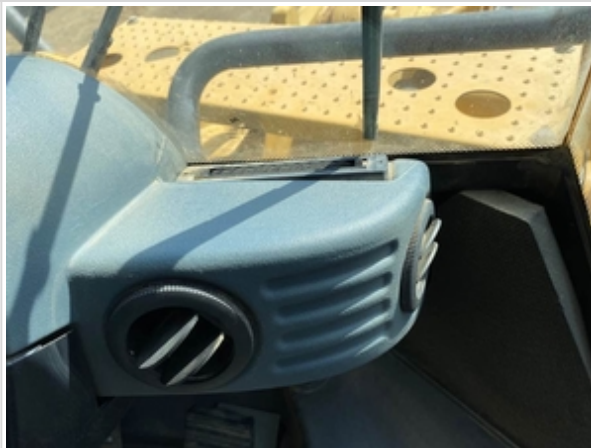
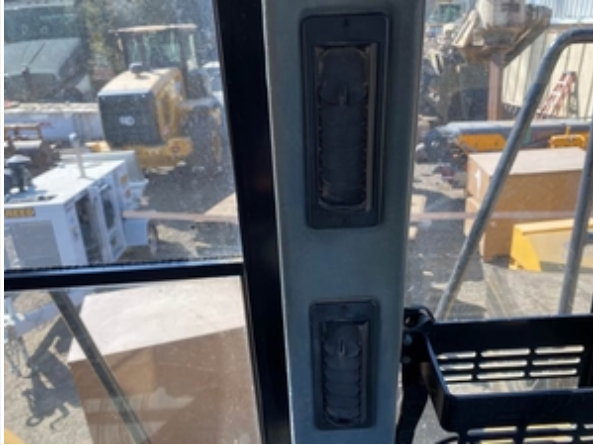
Fans / Vents	3 - Normal Wear & Tear
Fans / Vents Condition	Fan vents are functional, in good condition, and move through a full adjustable range of motion
Fans / Vents Photos

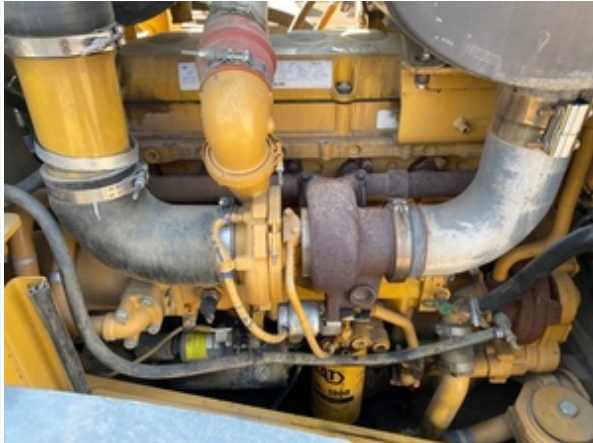
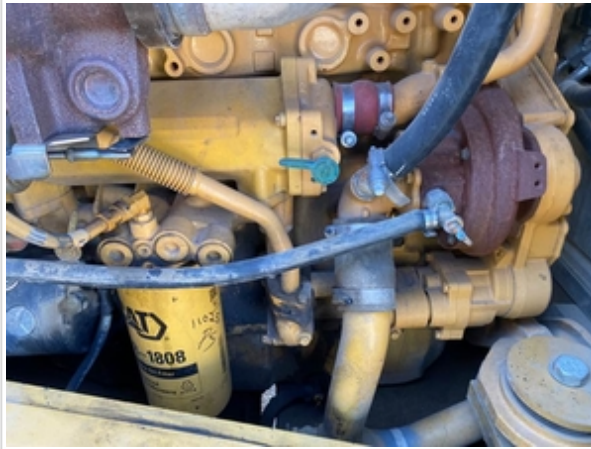
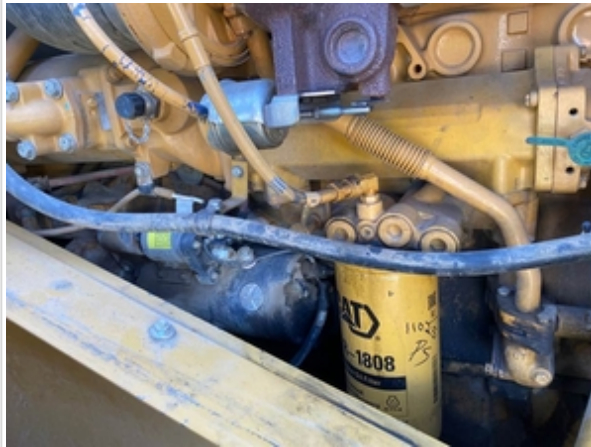
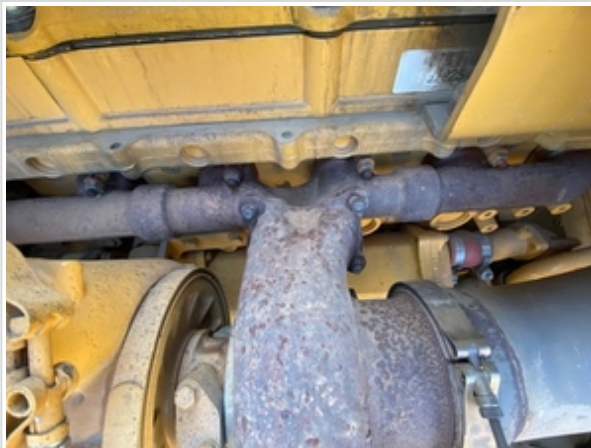
Engine	
Engine Type (Make, Model, Cylinders, Hp)	CAT C11 ACERT - 11.1L - 6Cyl. - 287HP
Emissions Tier	Tier 3
Engine Serial Number	N/A at this time
Engine Fuel Type	Diesel
Engine Photos

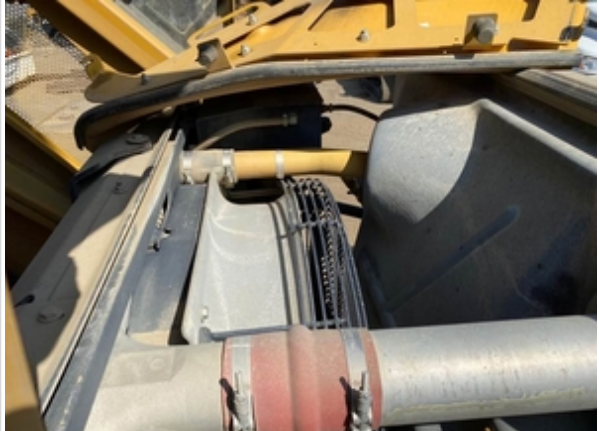
Blow-by (Visual Observation Check)	Yes	
Comments	Normal blowby out of hose	
Unusual Noises (Upon Start-up, Idle, Shutdown)	No	
Unusual Noise Notes	No unusual noises heard	
Engine Smoke (Upon Start-up, Idle, Shutdown)	Yes	
Engine Smoke Notes	Continuous engine smoke observed during operation, Other (see comments)	
Comments	Minor black smoke under load (normal)	
Engine Exhaust Color	Clear, Black, Other (see comments)	
Comments	Clear at idle, minor black smoke under load	
Battery	3 - Normal Wear & Tear	
Battery Condition	Inaccessible, unable to determine condition	
Comments	Rated good per startup	
Radiator	3 - Normal Wear & Tear	
Radiator Condition	Radiator fins & components appear to be in good working order, no signs of damage or leaks	
Radiator Photos

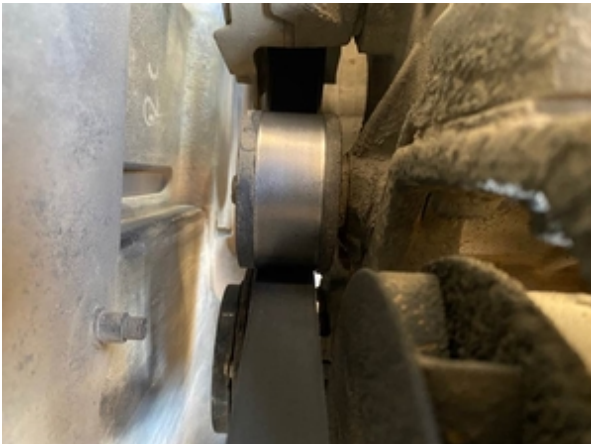
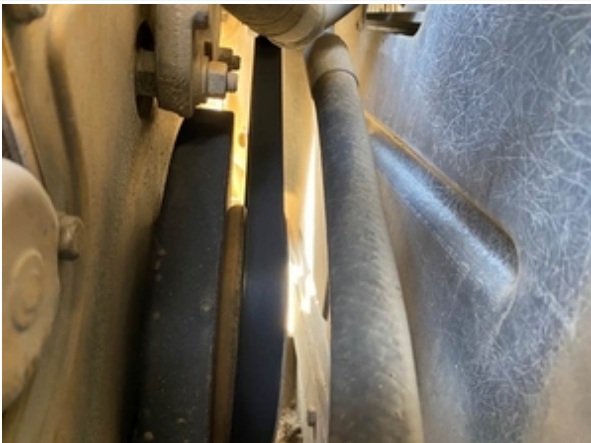
Belts	3 - Normal Wear & Tear
Belt Condition	Belts appear in good condition & alignment with proper tension
Belt Photos

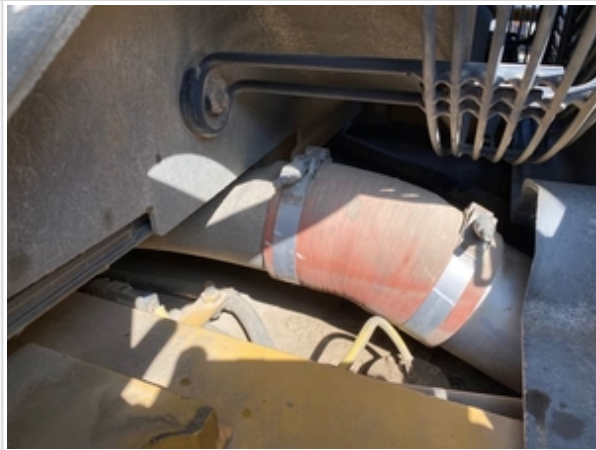
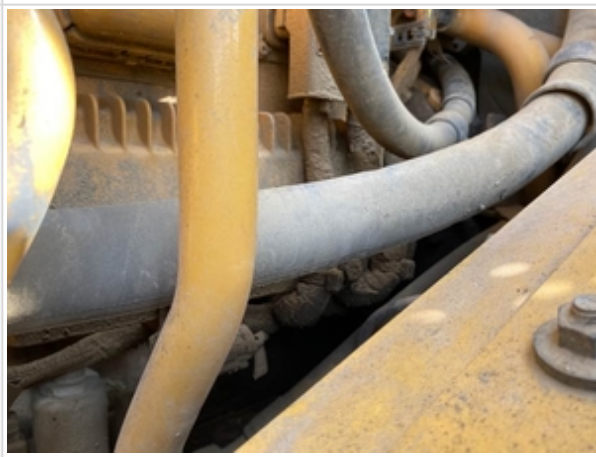
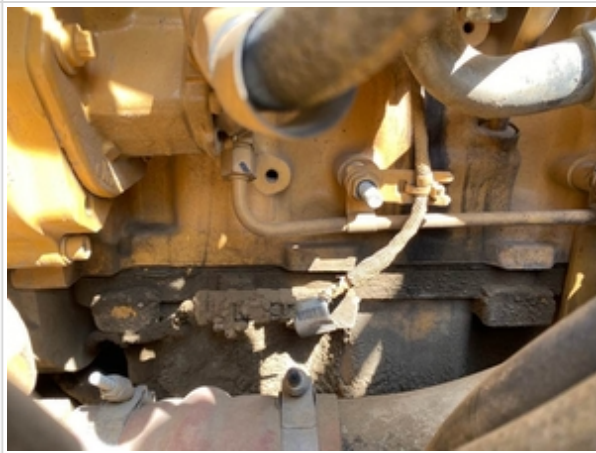
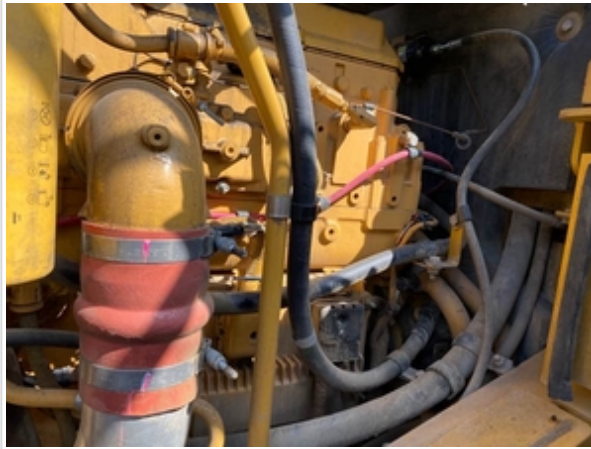
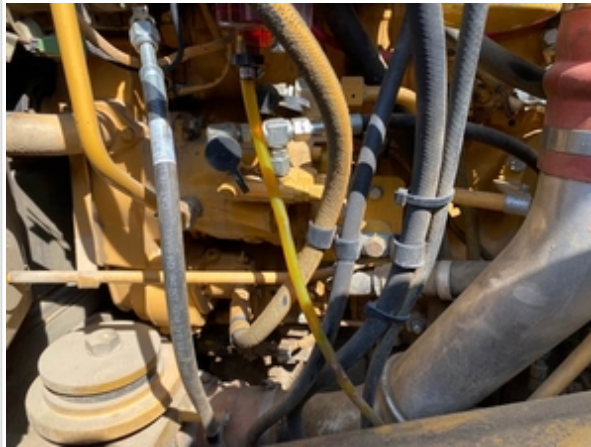
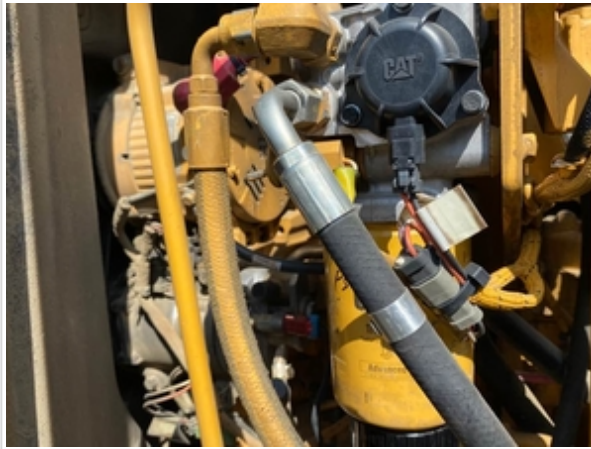
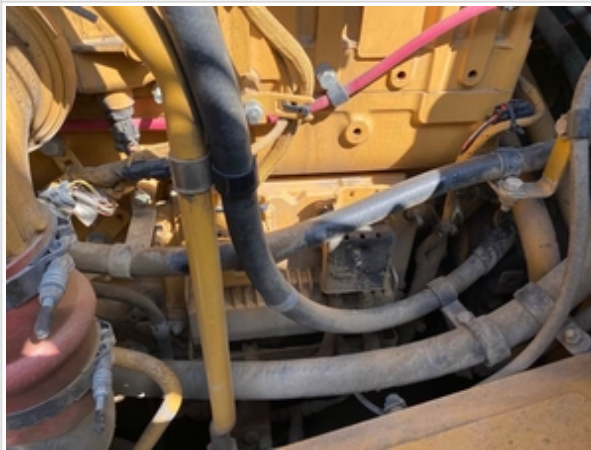
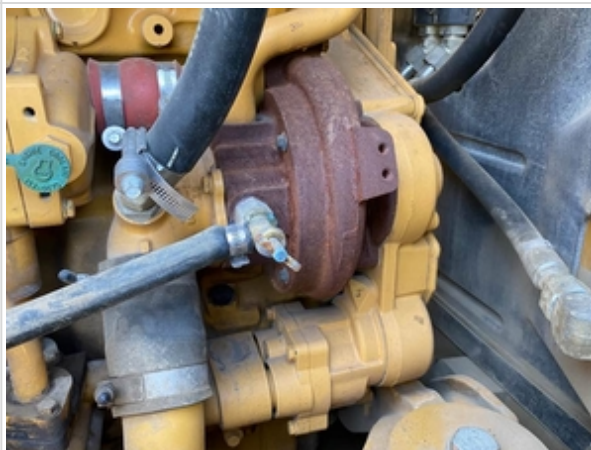
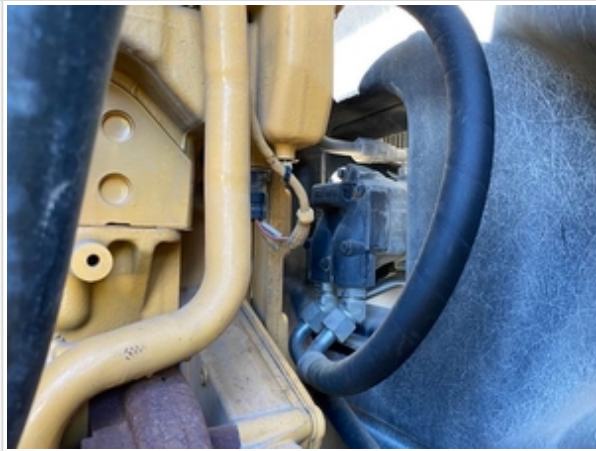
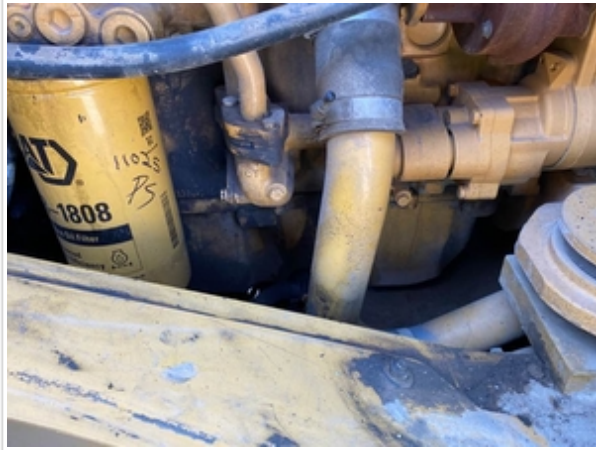
<p>Hose Photos</p>

Hoses	3 - Normal Wear & Tear
Hose Condition	Firm, pliant hoses with no signs of wear or leaks

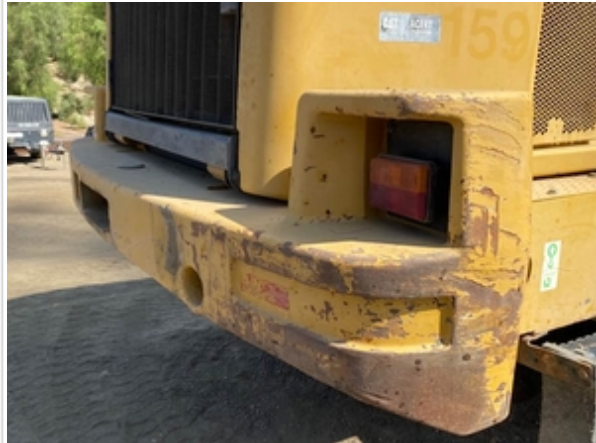
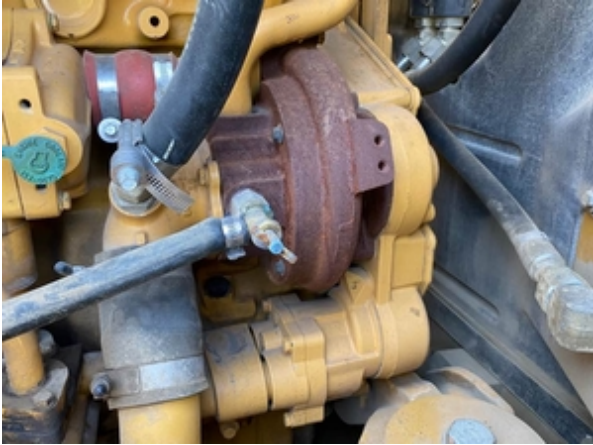
Water Pump	3 - Normal Wear & Tear
Water Pump Condition	No unusual pump noises heard
Water Pump Photos

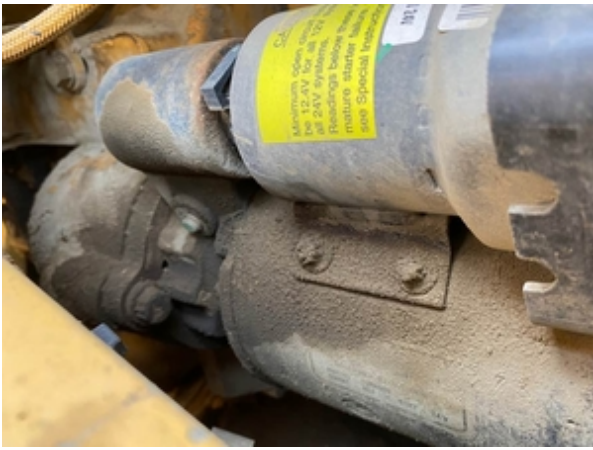
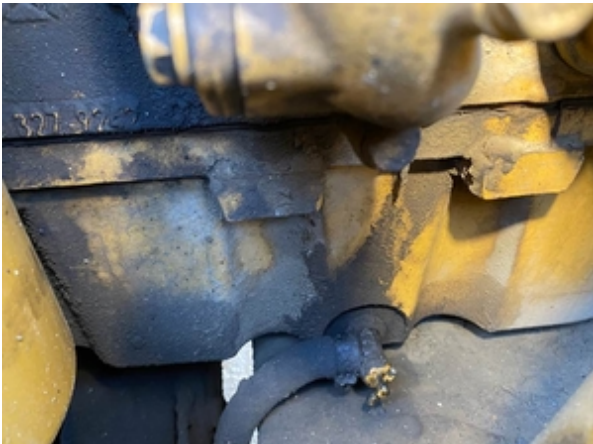
Cooling System Leaks	No	
Coolant Color / Appearance	3 - Normal Wear & Tear	
Coolant Color/Appearance Notes	Normal Translucent appearance, no visual signs of contamination	
Oil Leaks	Yes	
Oil Leak Notes	Dried oil seepages seen, Wetness & discoloration observed, Other (see comments)	
Comments	Minor oil leaks possibly from oil pan and or surrounding l/s lower engine area	
Oil Leak Photos

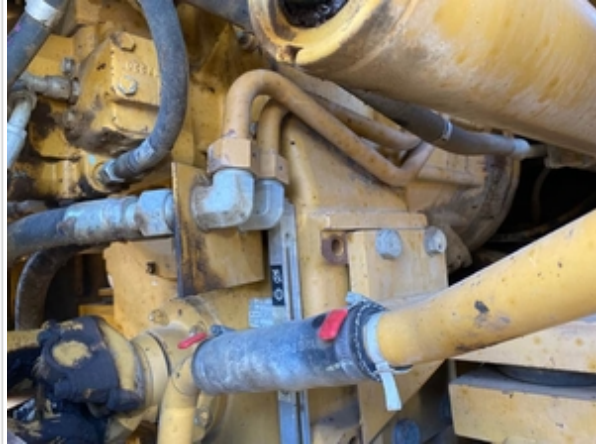
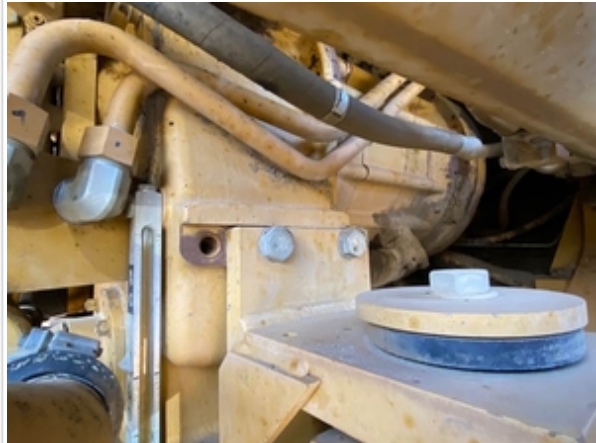
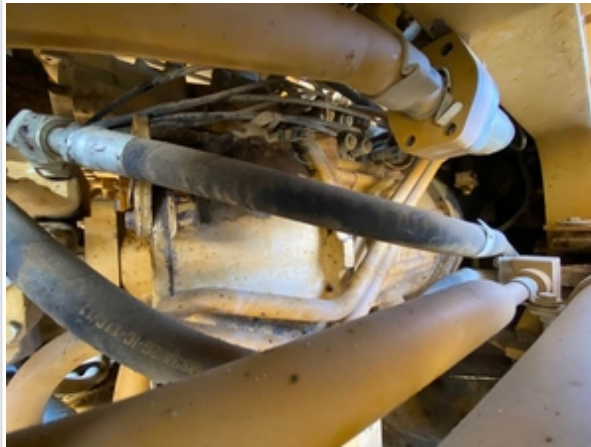
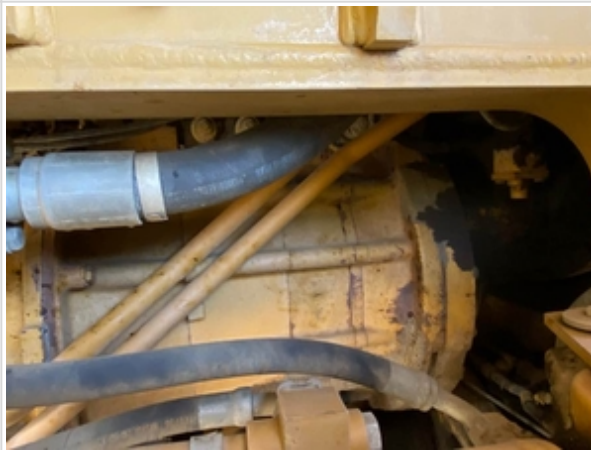
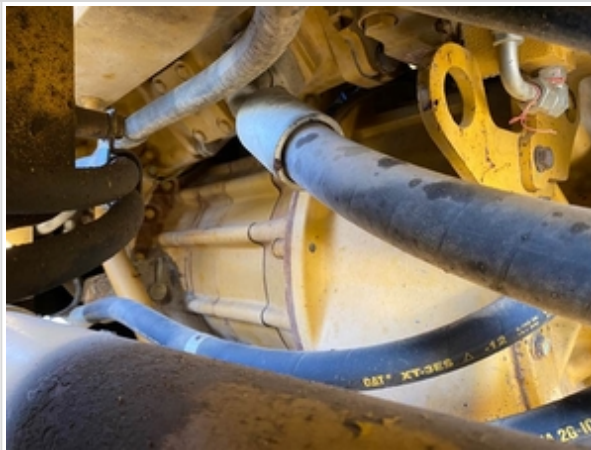
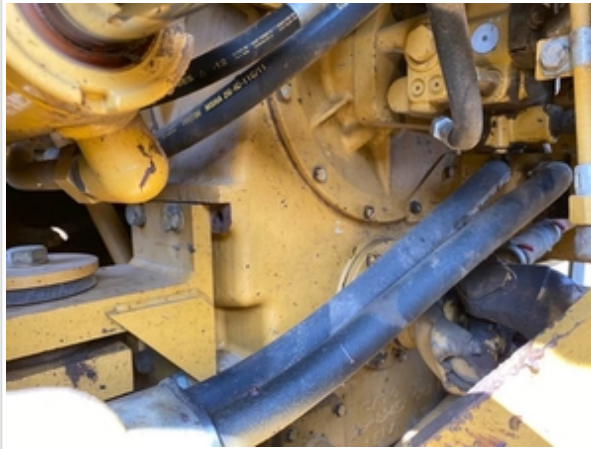
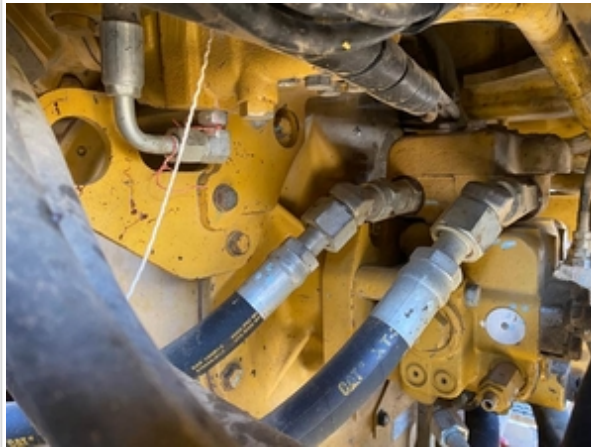
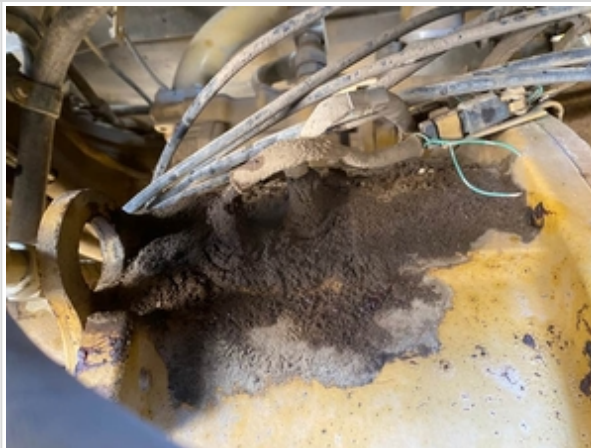
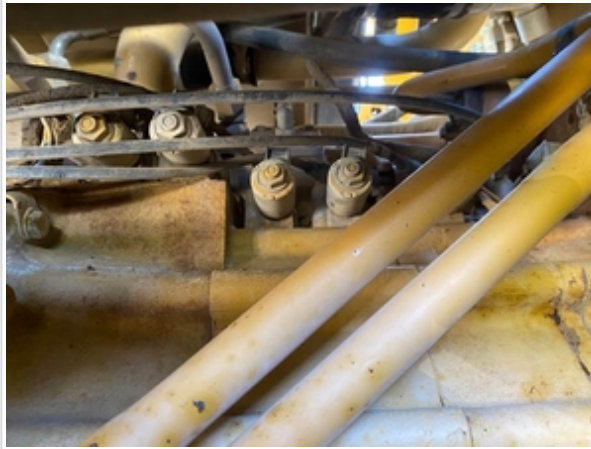
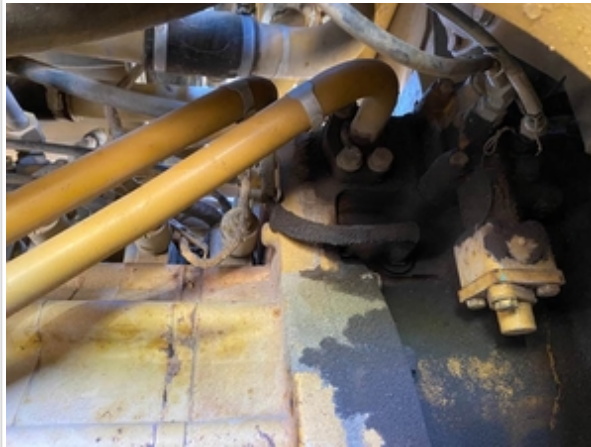
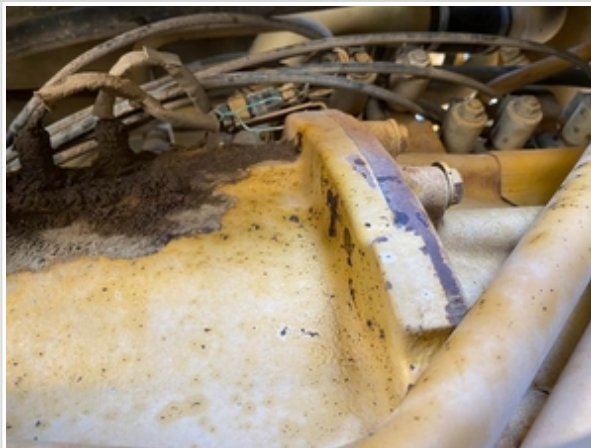
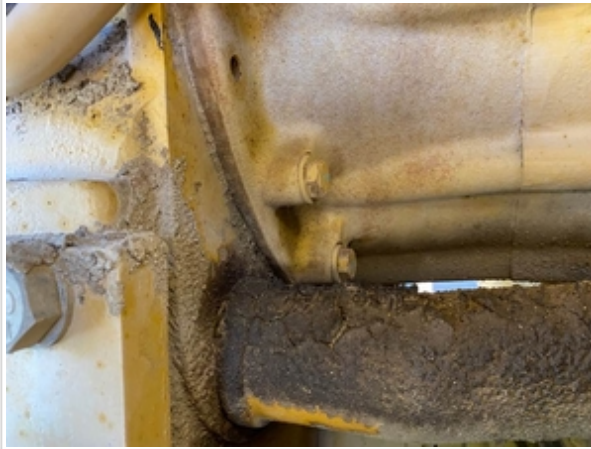
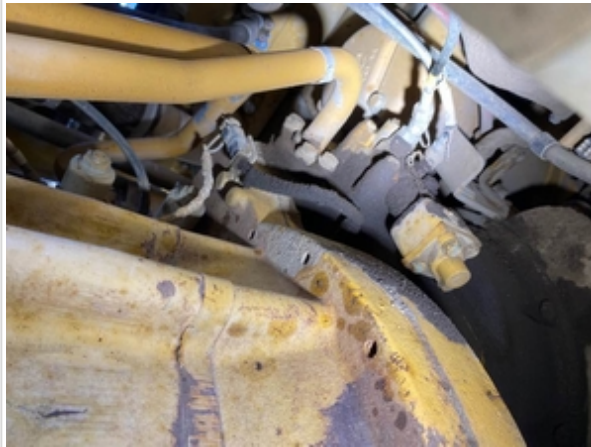
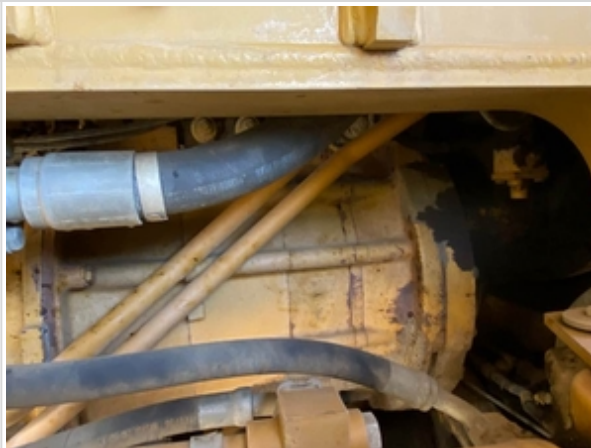
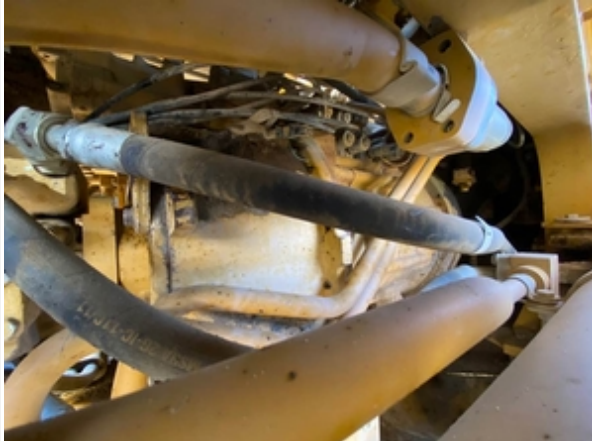
Drivetrain	
Hydrostatic Transmission?	No
Transmission Info (Make/Model/Speeds)	Powershift 4speed trans
Transmission	3 - Normal Wear & Tear
Transmission Condition	No unusual noises or vibrations, Leaking transmission fluid observed, Other (see comments)
Comments	Minor leak at torque converter mounted valve & minor seepages from transmission sensors
Transmission Photos

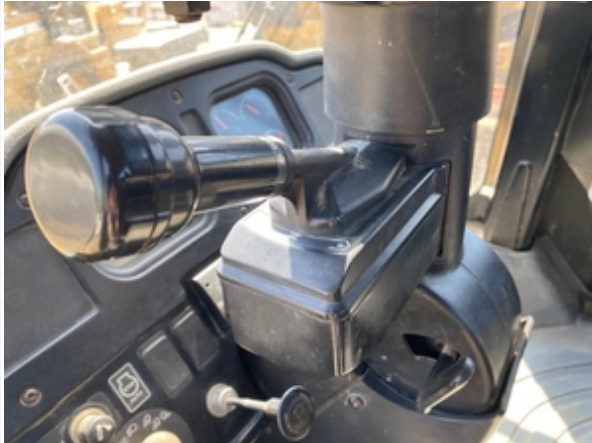
Clutch	0	
Shift Lever	3 - Normal Wear & Tear	
Shift Lever Condition	Good forward and reverse function	
Shift Level Photos

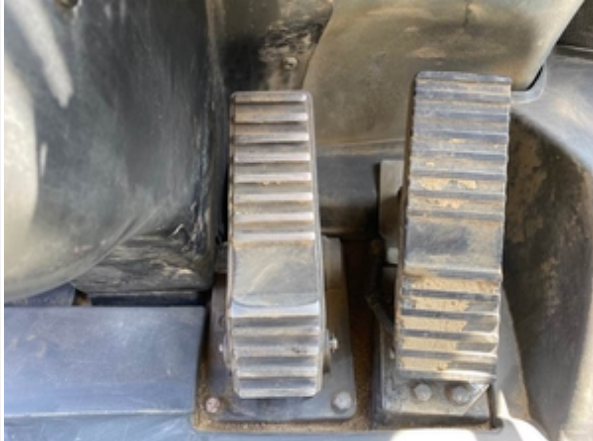
Foot Brake Photos

Foot Brake	3 - Normal Wear & Tear	
Foot Brake Condition	Good brake function

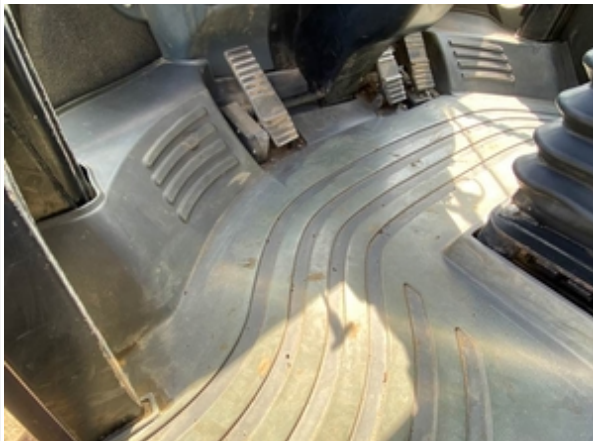
Inching Brake	3 - Normal Wear & Tear
Inching Brake Photos

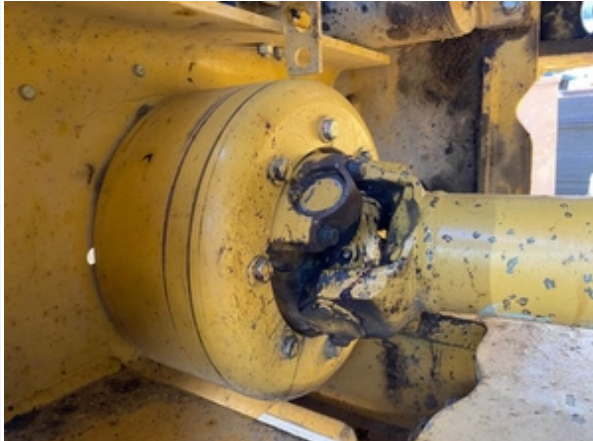
Parking Brake	3 - Normal Wear & Tear
Parking Brake Condition	Good brake function, Other (see comments)
Comments	Holds in 3rd and 2nd gear
Parking Brake Photos

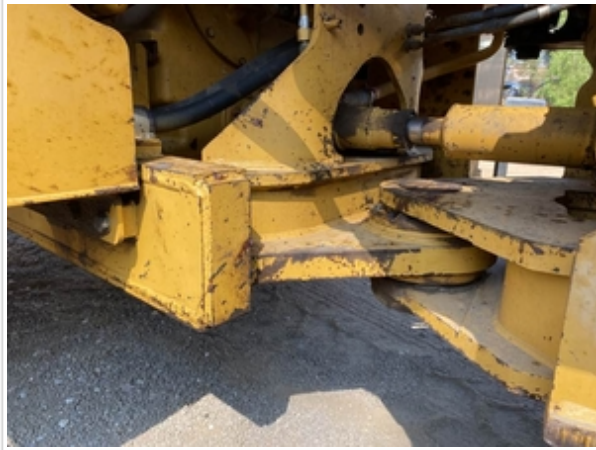
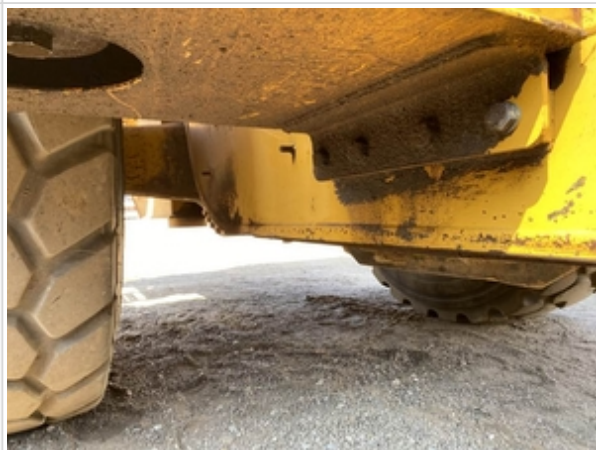
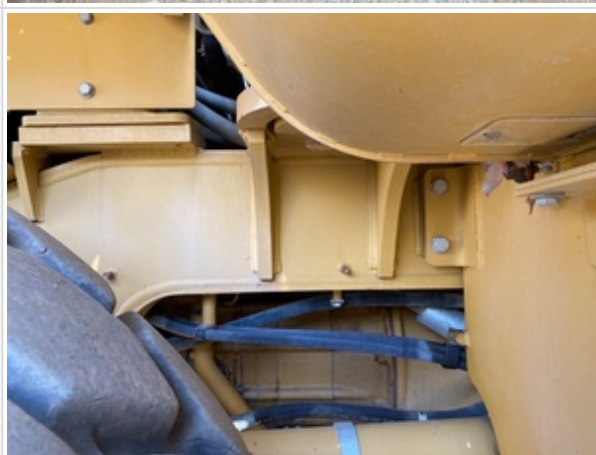
<p>Frame</p>	<p>3 - Normal Wear & Tear</p>
<p>Frame Photos</p>

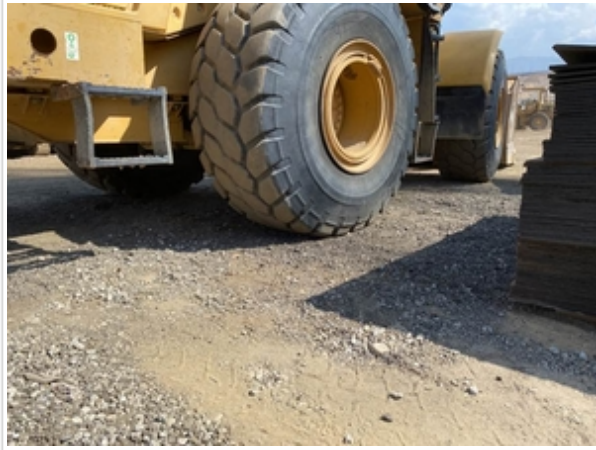
<p>Stance</p>	<p>3 - Normal Wear & Tear</p>
<p>Stance Photos</p>

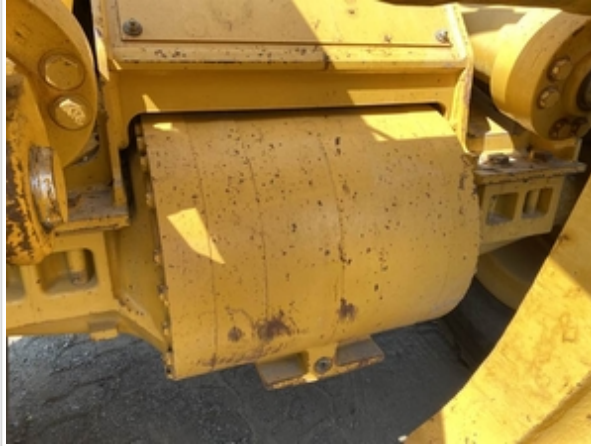
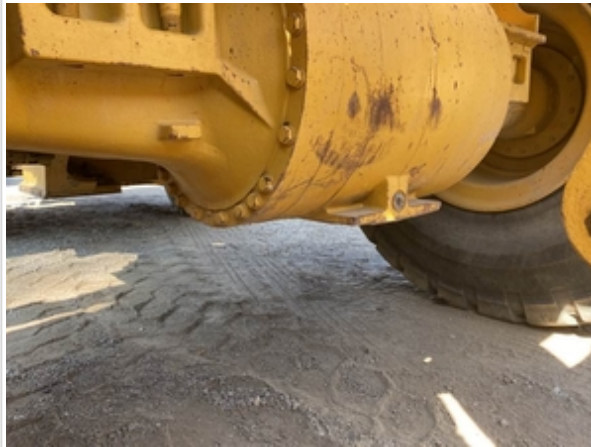
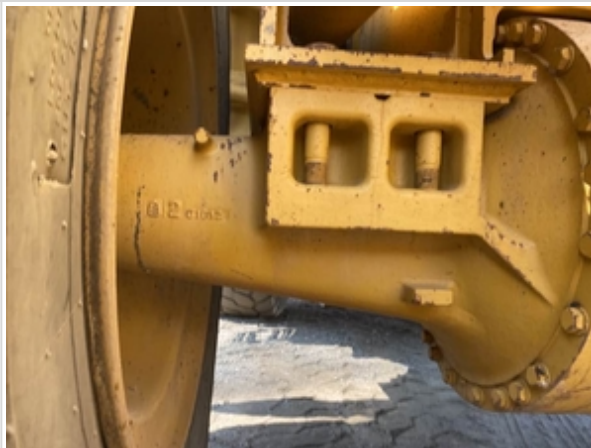
Front Axle Appearance Photos

<p>Front Axle Appearance</p>	<p>3 - Normal Wear & Tear</p>

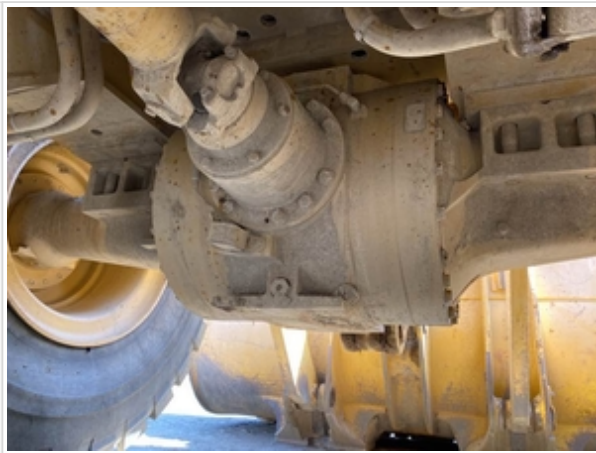
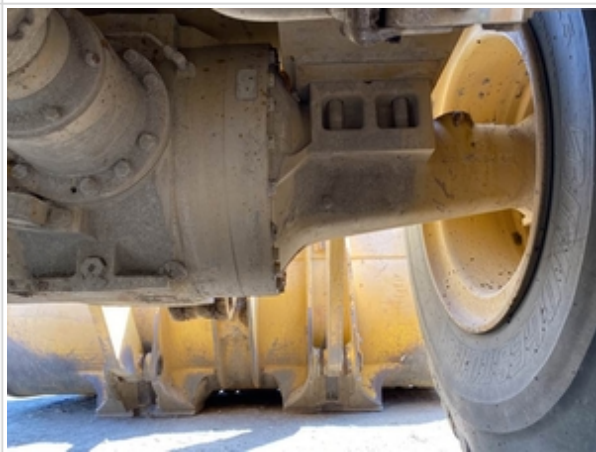
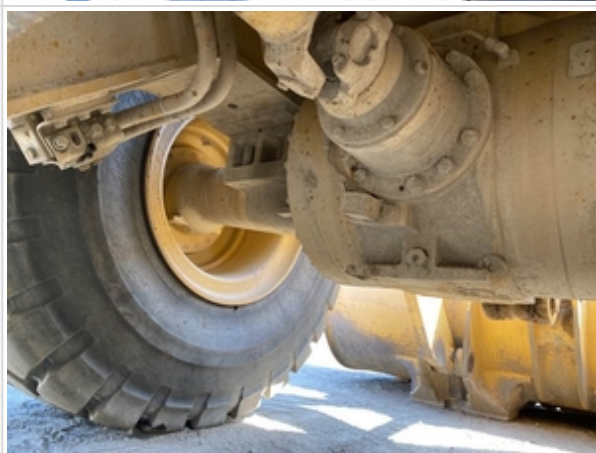
Rear Axle Appearance	3 - Normal Wear & Tear
Comments	Residual buildup on axle is excess grease from upper oscillation mount

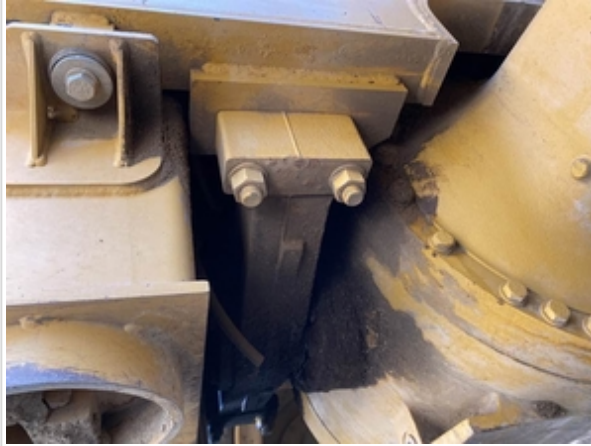
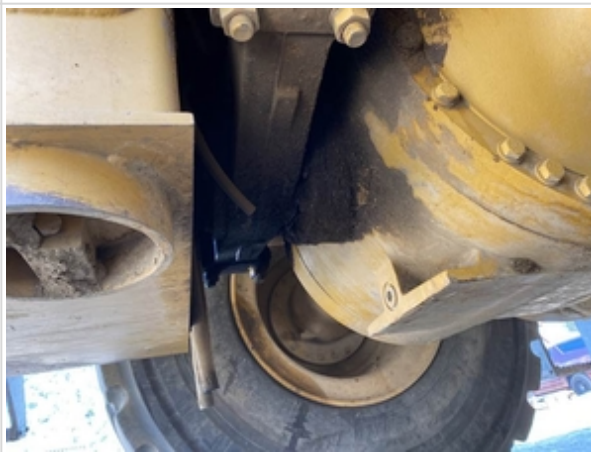
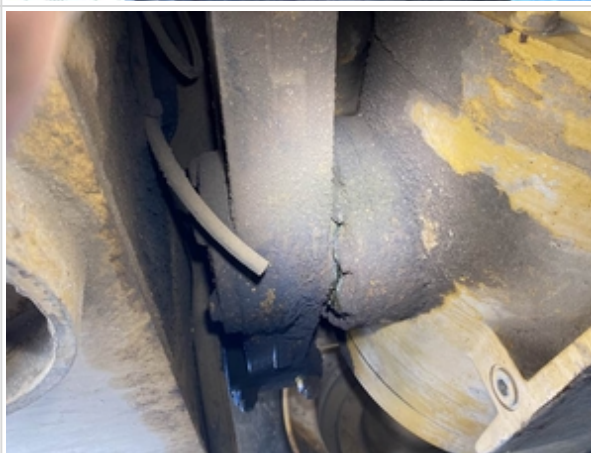
Articulating Center Pin
Appearance Photos

<p>Articulating Center Pin Appearance</p>	<p>3 - Normal Wear & Tear</p>

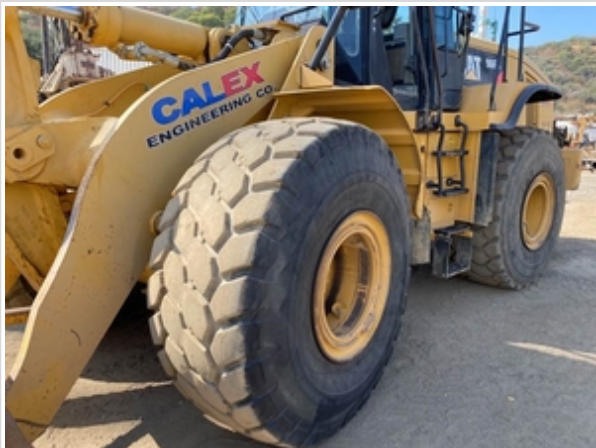
<p>Tire Brand</p>	<p>Bridgestone</p>	
<p>Tire Size</p>	<p>26.5R25</p>	
<p>Front Left Tire - Ratio Remaining</p>	<p>50%</p>	
<p>Front Left Tire Photos</p>

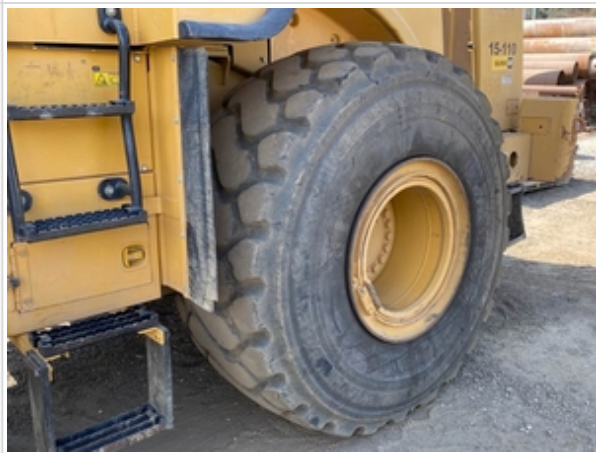
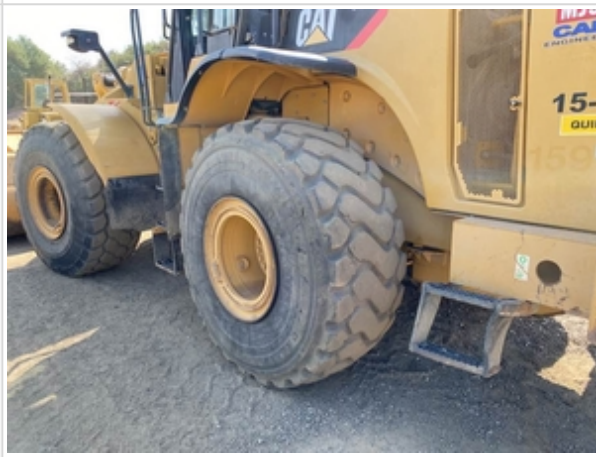
Rear Left Tire - Ratio Remaining	50%
Comments	Michelin
Rear Left Tire Photos

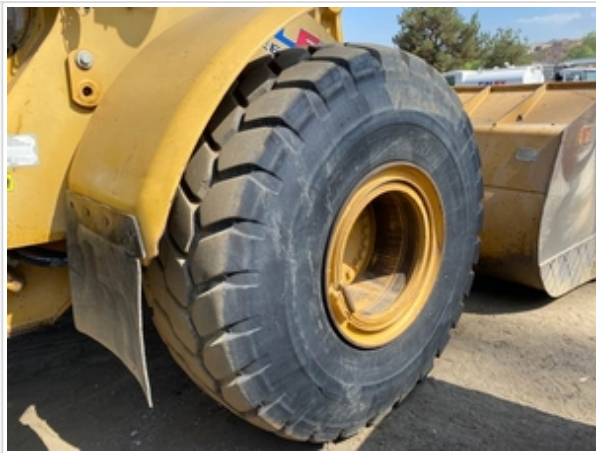
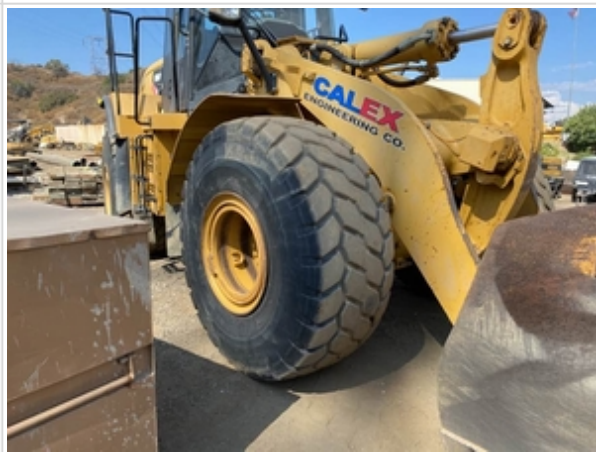
<p>Front Right Tire Photos</p>

Front Right Tire - Ratio Remaining	50%
Comments	Bridgestone
