Inspection Report (Wheel Loader)

Year	2011
Make	CAT
Model	966H
Serial Number	A6J01857
Hour Meter Reading	11,024
Previous Application (e.g., earth moving, mining, demolition, etc)	Excavating, Trenching, Mass Grading

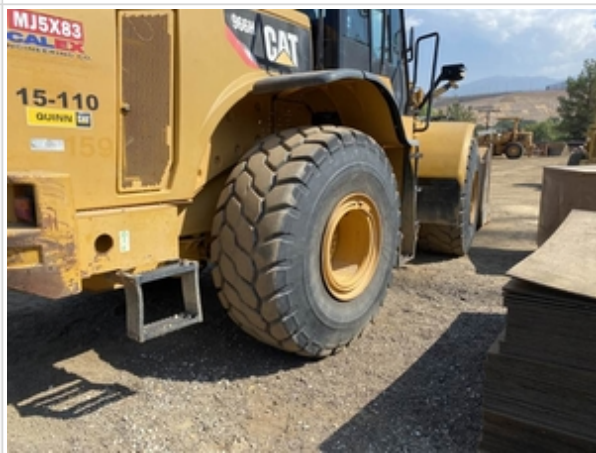
<p>Rear Right Tire - Ratio Remaining</p>	<p>50%</p>
<p>Comments</p>	<p>Bridgestone</p>
<p>Rear Right Tire Photos</p>

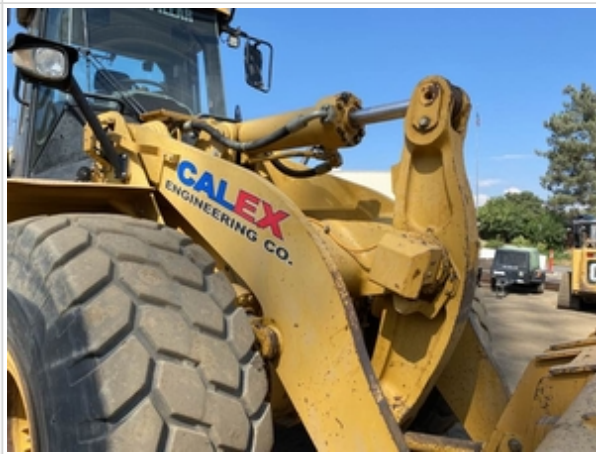
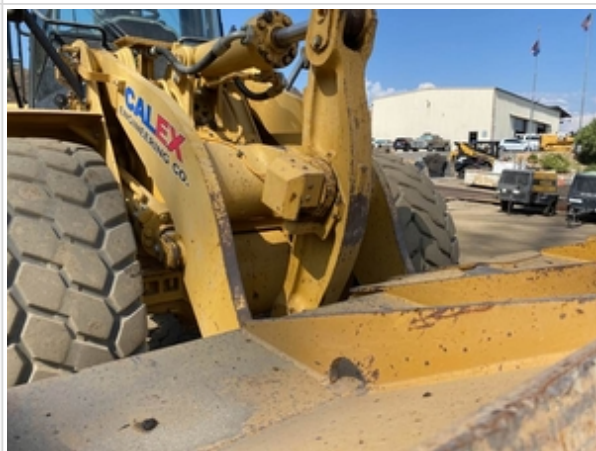
<p>Lift Arm</p>	<p>3 - Normal Wear & Tear</p>	
<p>Lift Arm Photos</p>

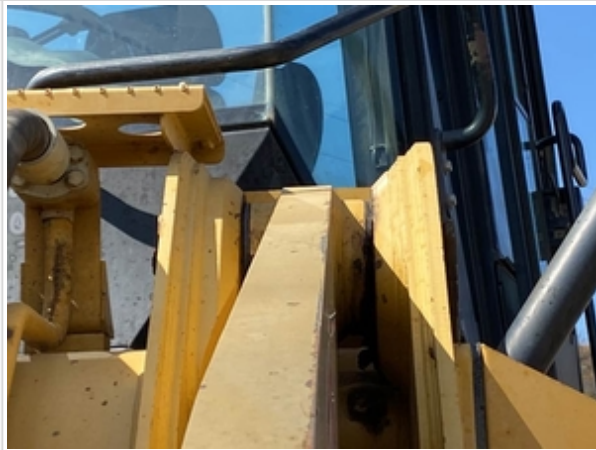
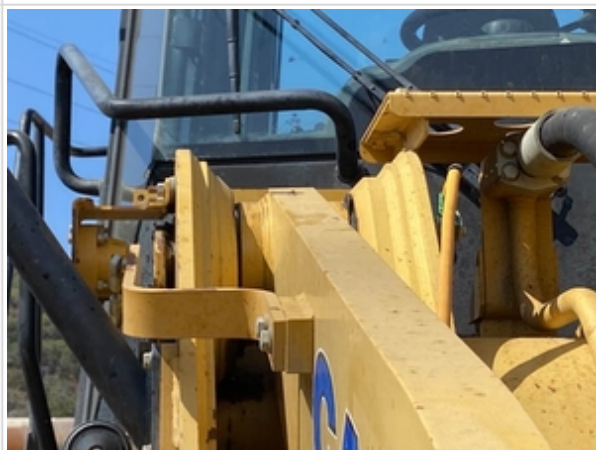
<p>Chassis to Arm Pins Photos</p>

<p>Chassis to Arm Pins</p>	<p>3 - Normal Wear & Tear</p>

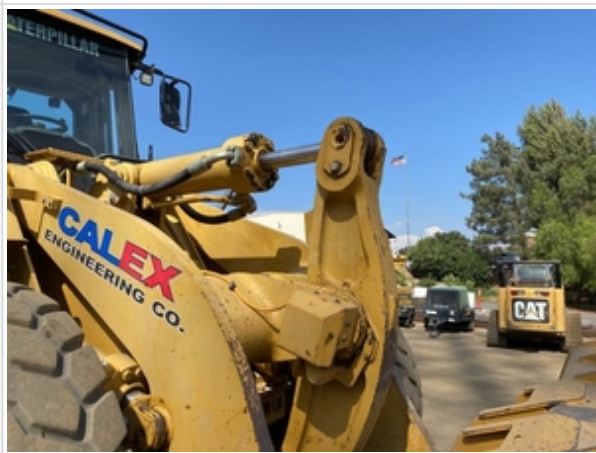
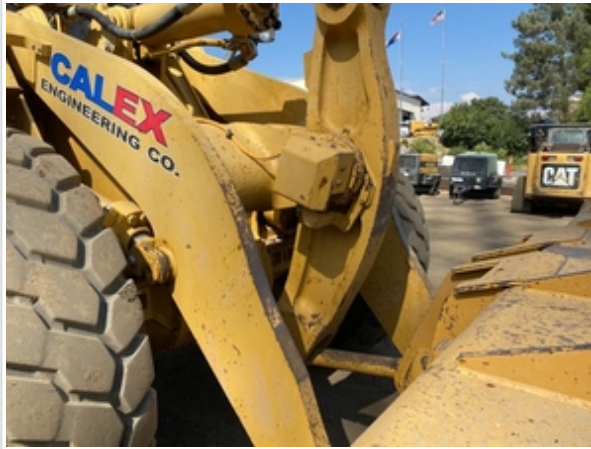
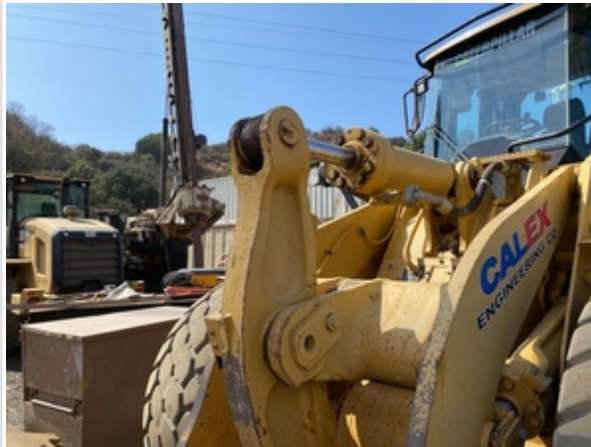
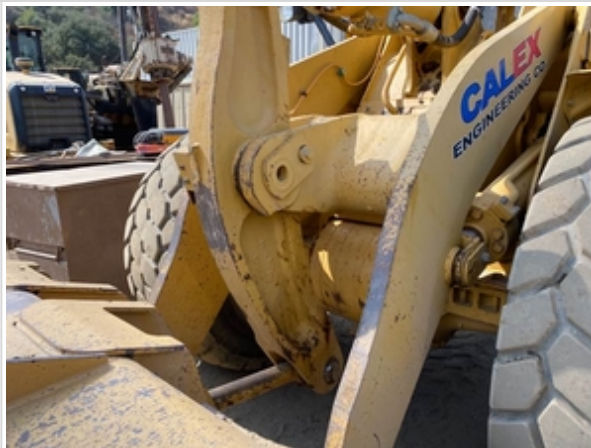
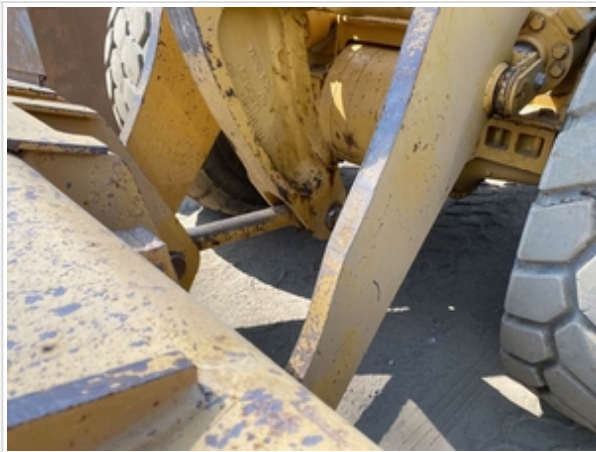
<p>Tilt Linkage</p>	<p>3 - Normal Wear & Tear</p>
<p>Tilt Linkage Photos</p>

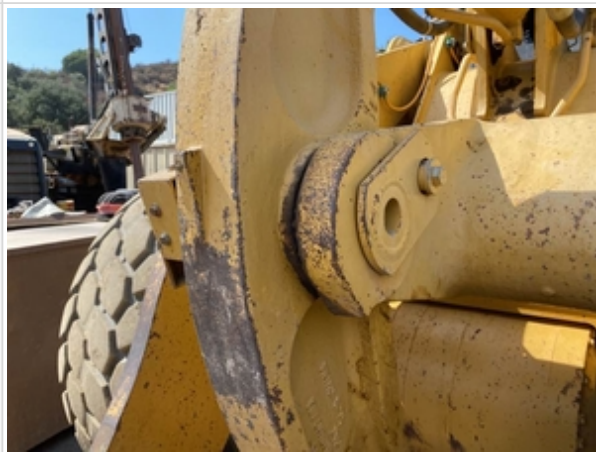
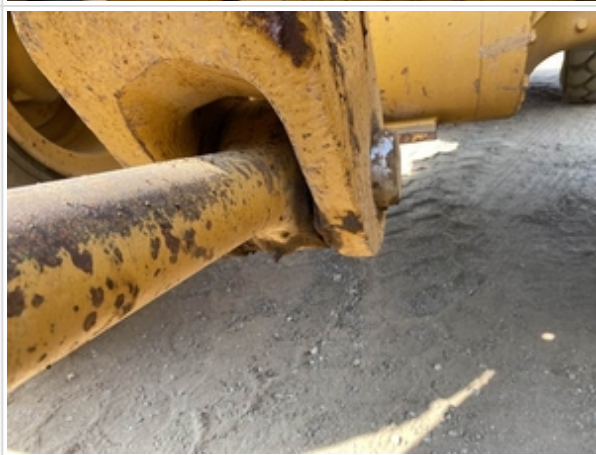
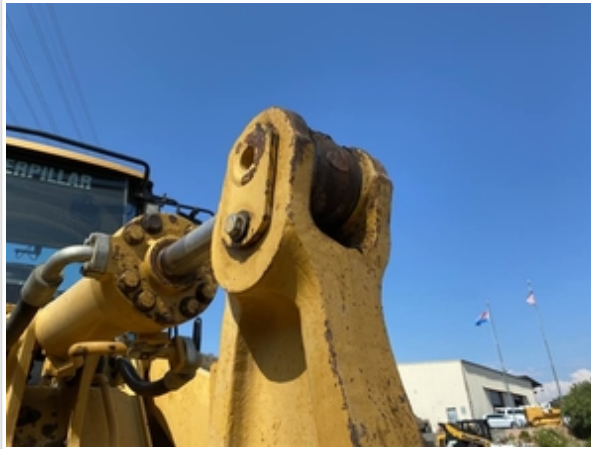
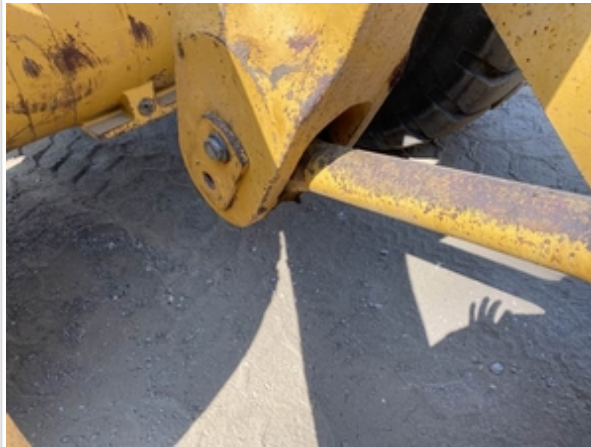
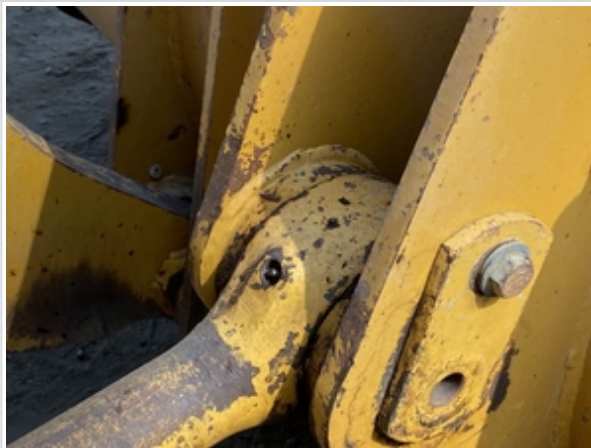
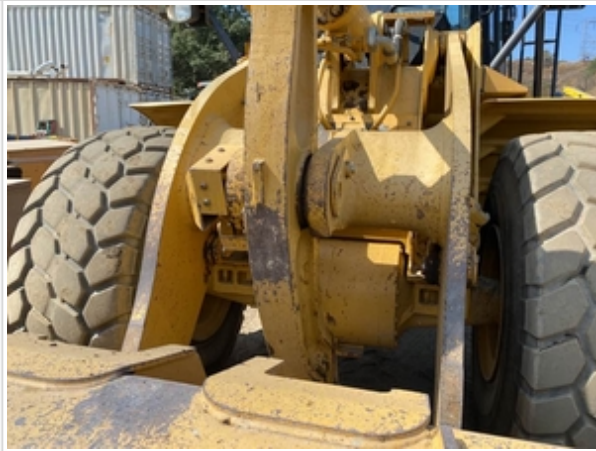
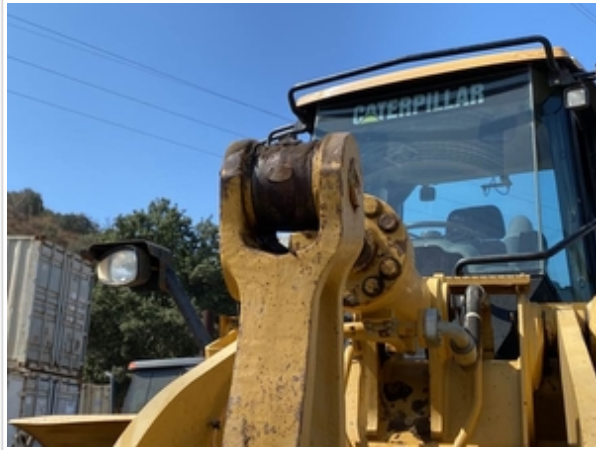
<p>Tilt Linkage Pins and Bushings</p>	<p>3 - Normal Wear & Tear</p>	
<p>Tilt Linkage Pins and Bushings Photos</p>

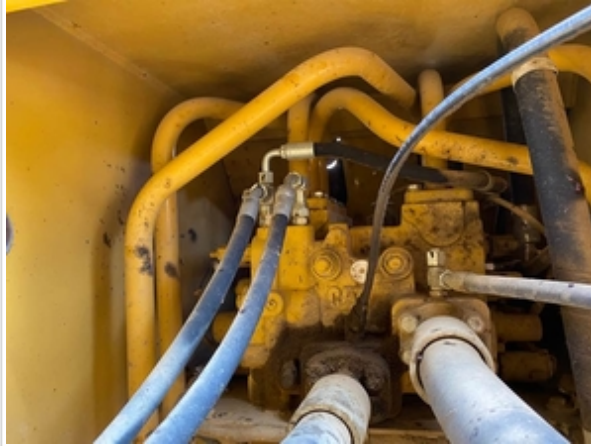
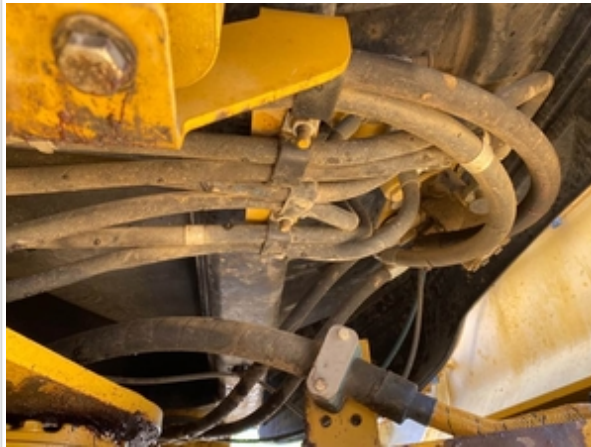
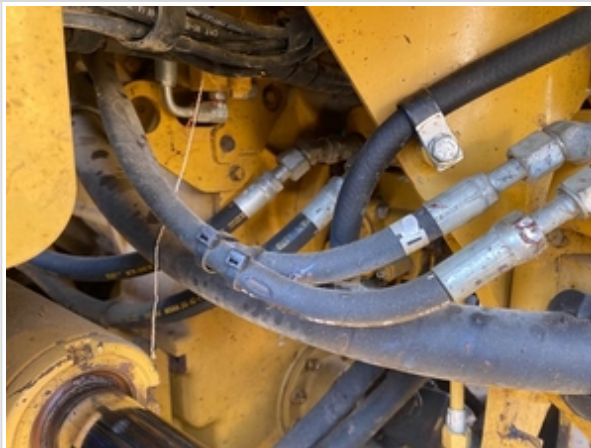
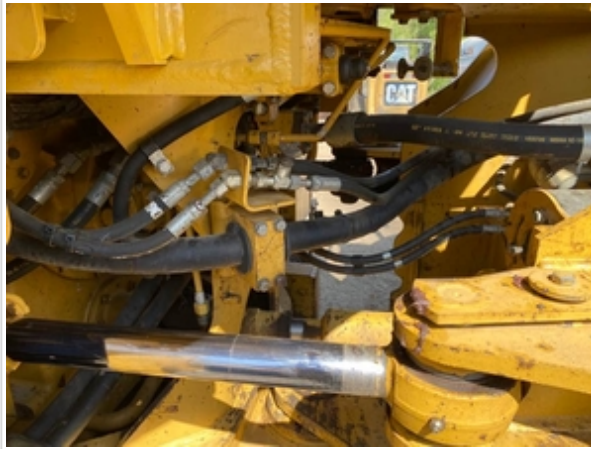
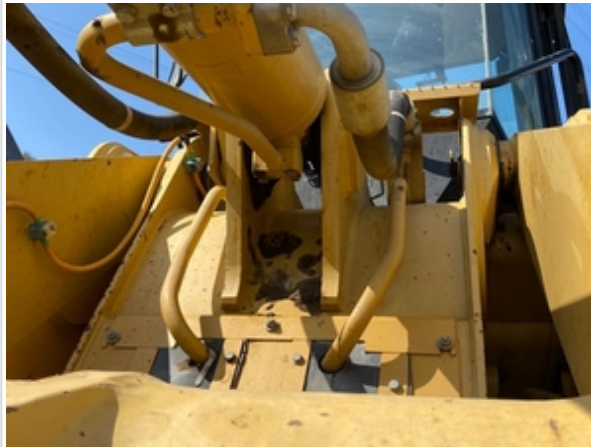
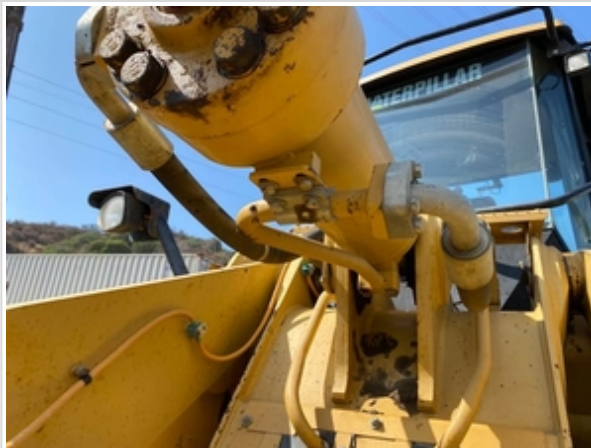
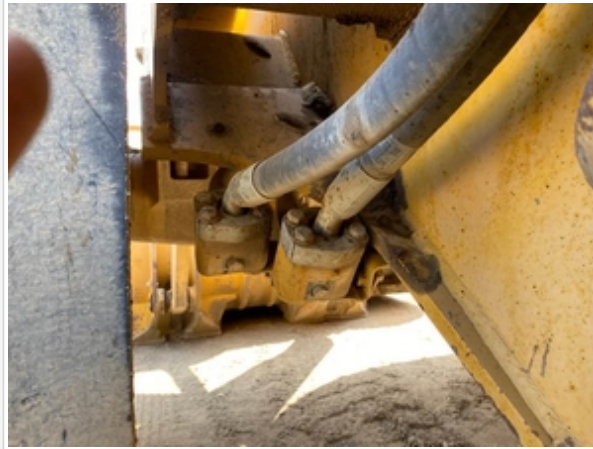
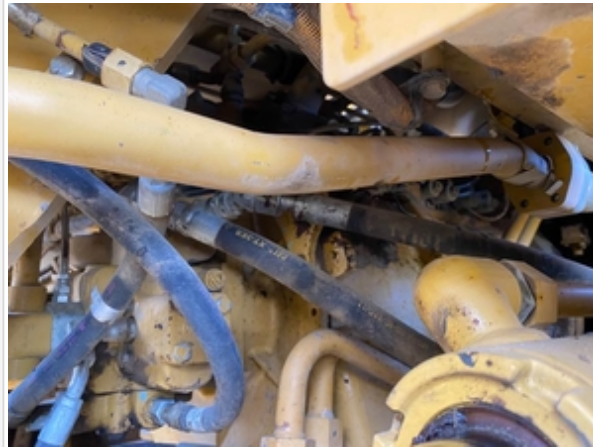
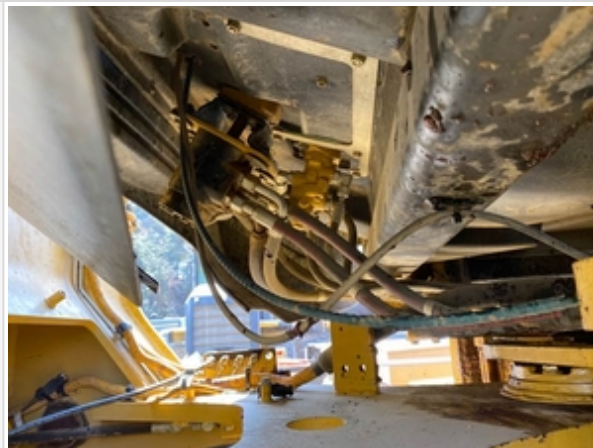
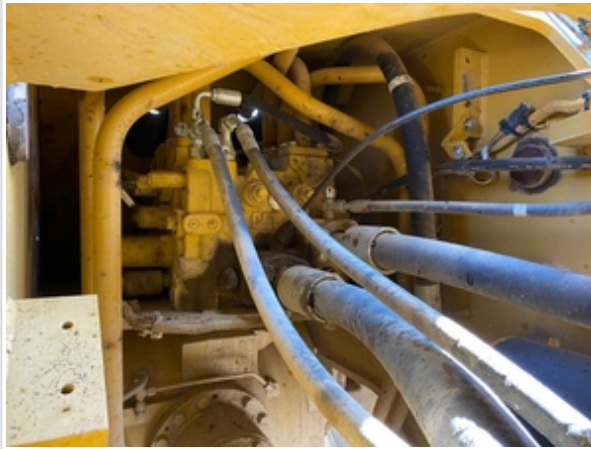
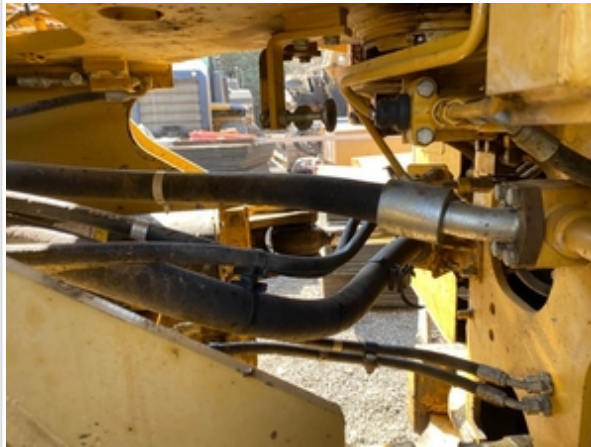
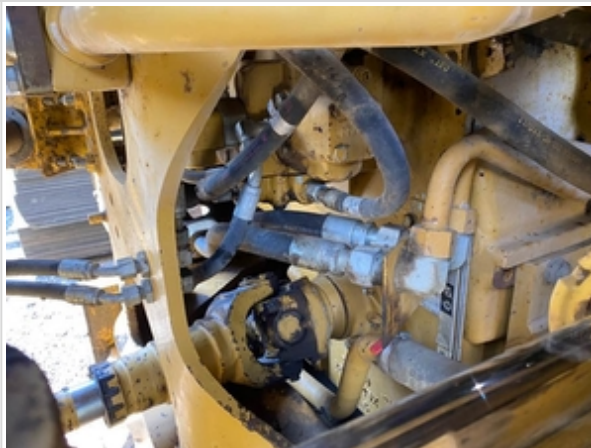
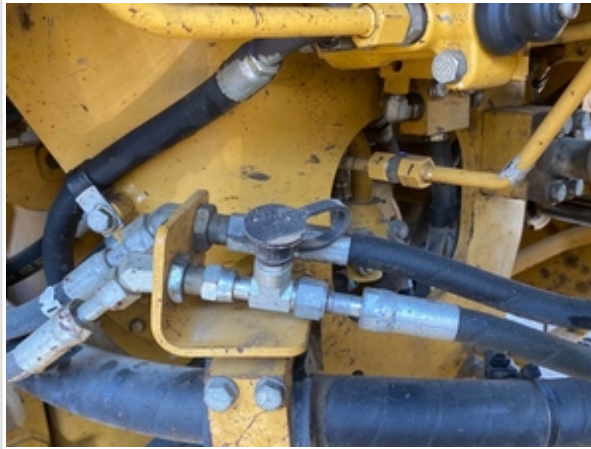
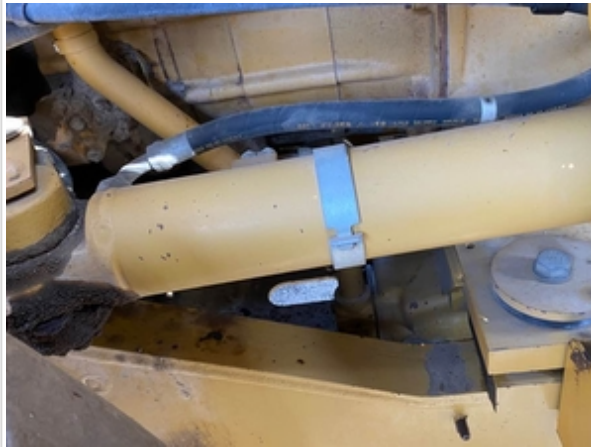
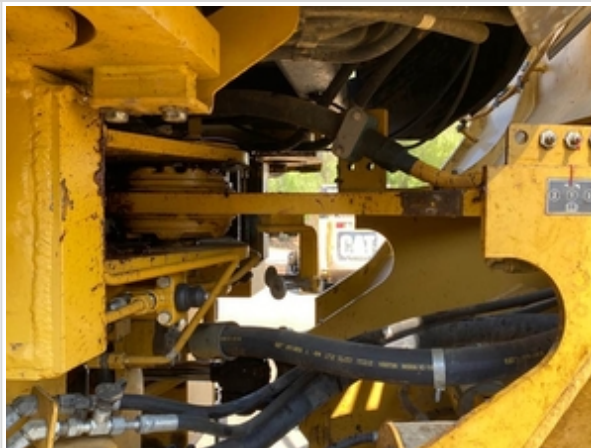
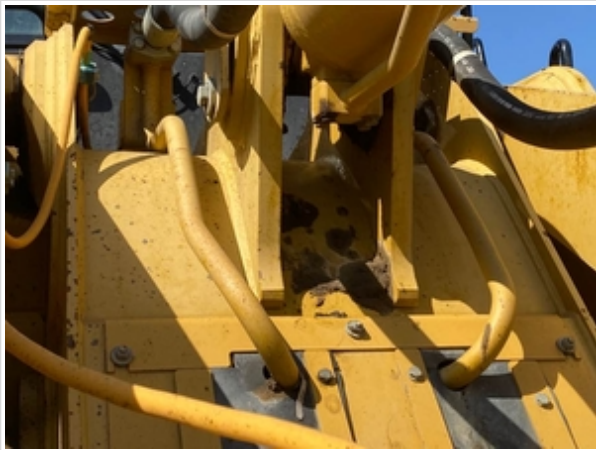
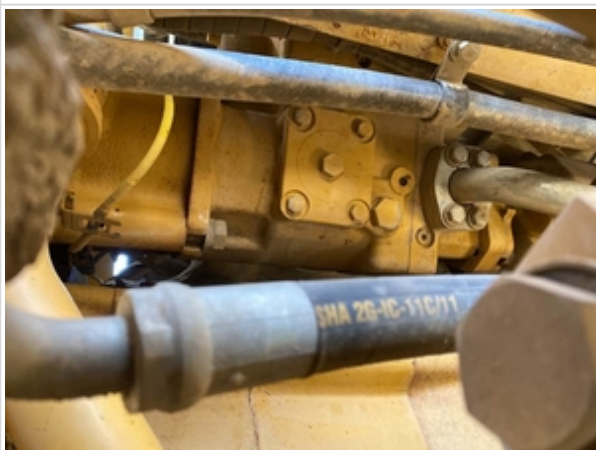
Appearance of Hydraulic Lines /
Fittings Photos

Wet or Damp Hydraulic Lines / Fittings	No
Appearance of Hydraulic Lines / Fittings	3
Hydraulic Lines / Fittings Condition	Hydraulic lines & fittings are clean and in good condition

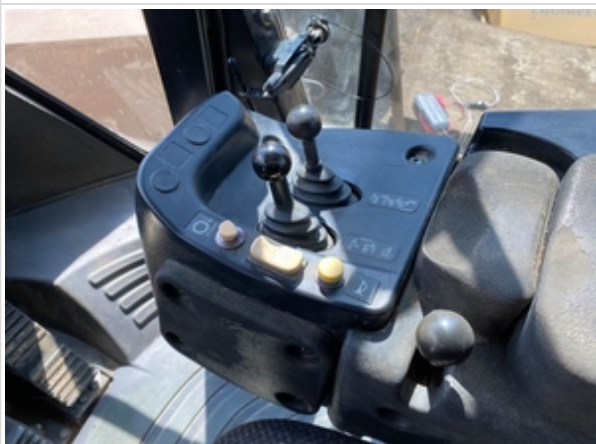
Unusual Noises (Hydraulic Pump)	No	
Hydraulic Pump Notes	No unusual noises heard during operation	
External Controls / Levers	3	
External Controls / Levers Condition	Good function & condition of hydraulic controls	
External Controls / Levers Photos

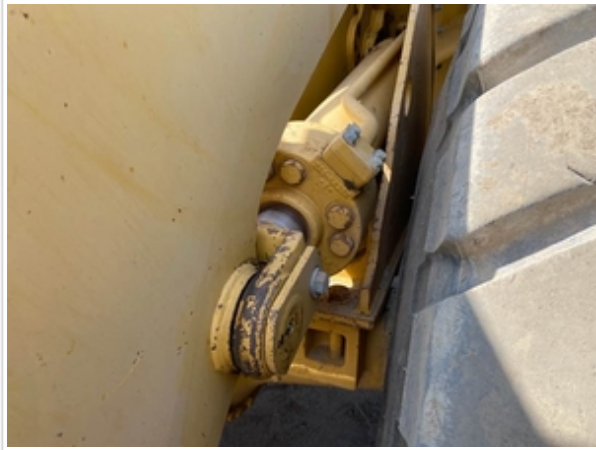
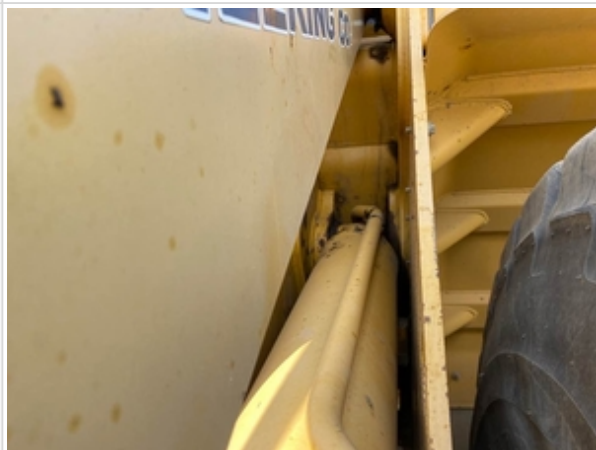
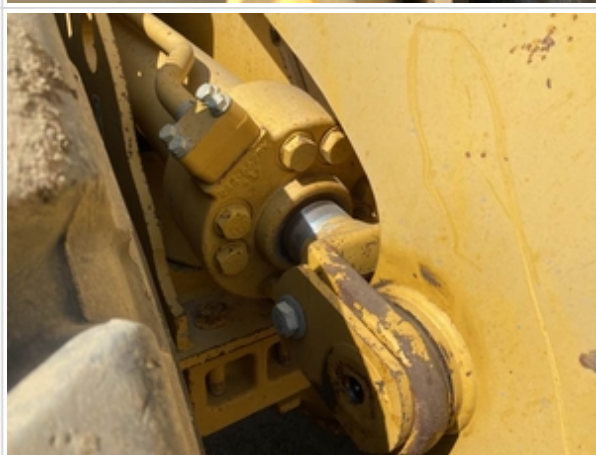
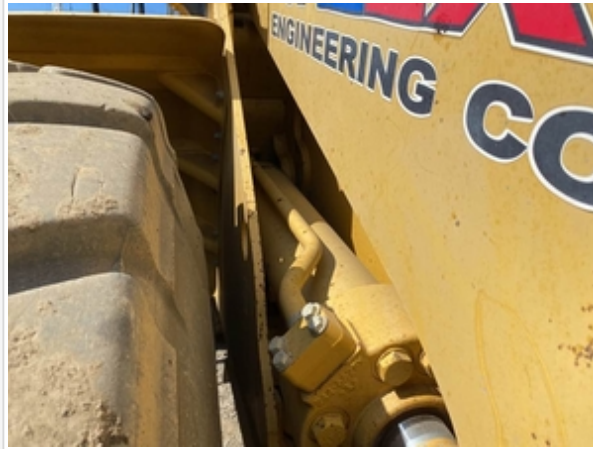
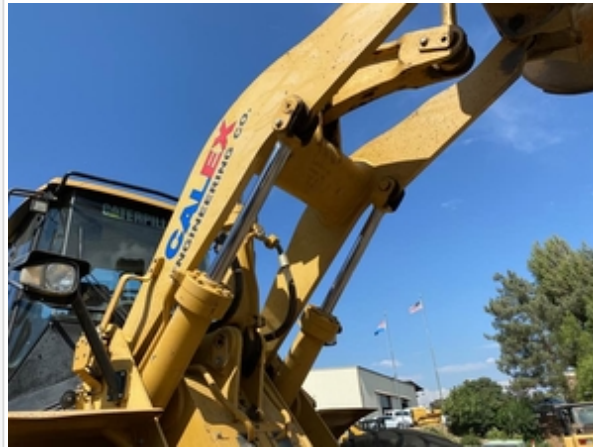
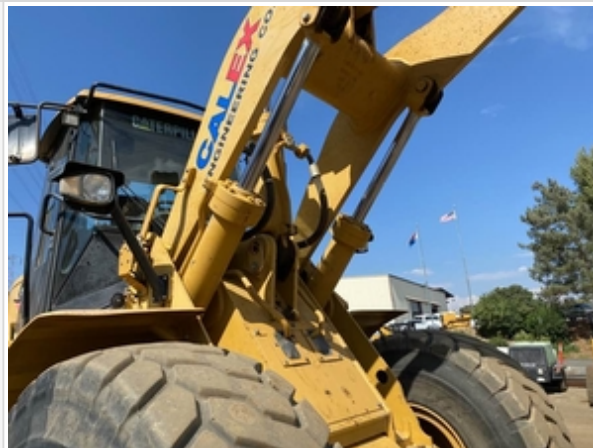
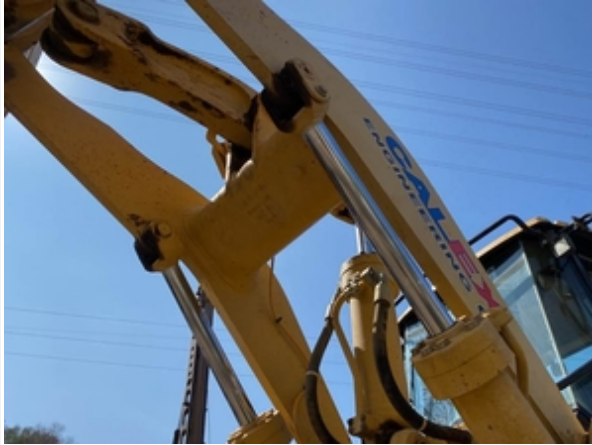
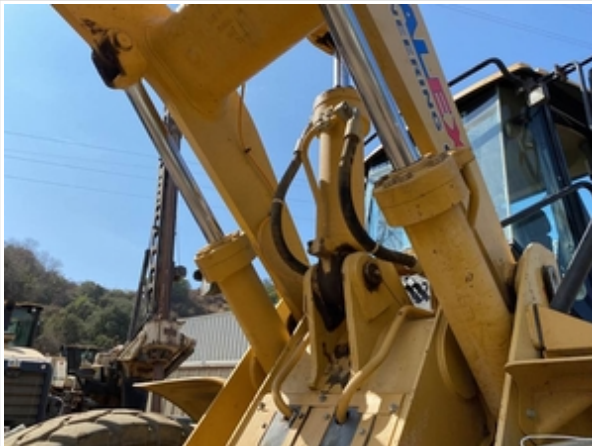
Lift Cylinder	Check the lift cylinder. Note any wear, pitting, discoloration, etc. Take photos.	
Lift Cylinder: Mounting Pin	3

Lift Cylinder: Oil Leaks	No
Lift Cylinder Photos

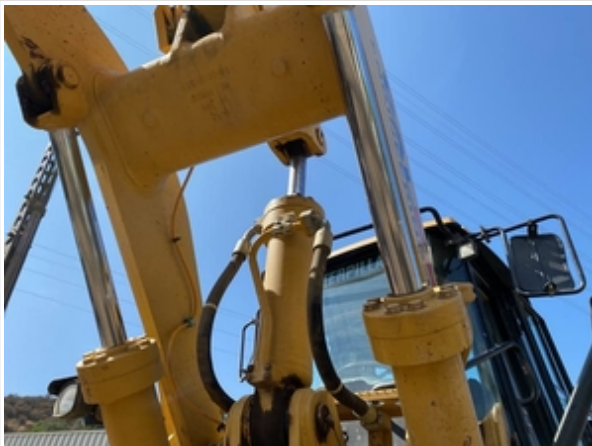
Bucket Cylinder	Check the bucket cylinder. Note any wear, pitting, discoloration, etc. Take photos.	
Bucket Cylinder: Mounting Pin	3	
Bucket Cylinder: Oil Leaks	No	
Comments	Cylinder rod in good shape. Chrome has grease splatter from power washing	
Bucket Cylinder Photos

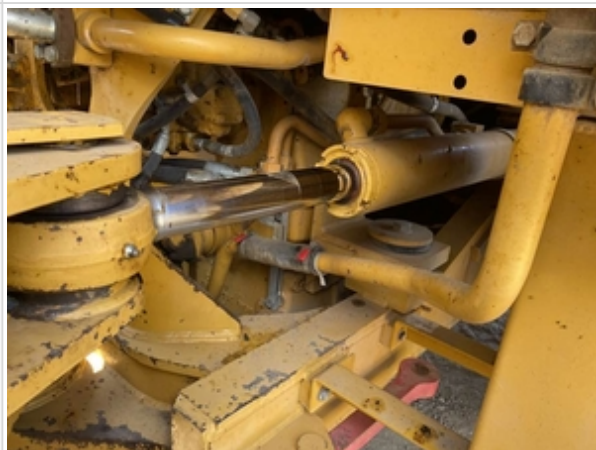
Steering Cylinder	Check the steering cylinder. Note any wear, pitting, discoloration, etc. Take photos.	
Steering Cylinder: Mounting Pin	3	
Steering Cylinder: Oil Leaks	No	
Steering Cylinder Photos

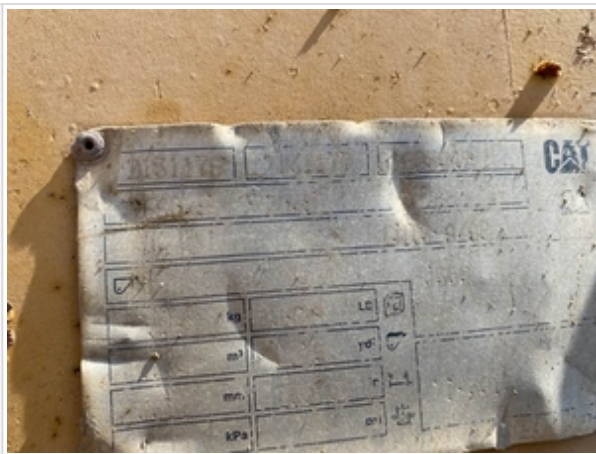
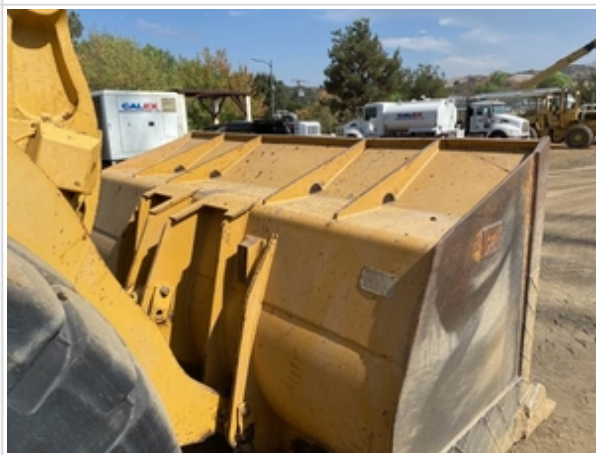
Bucket Photos

Bucket	3 - Normal Wear & Tear
--------	------------------------

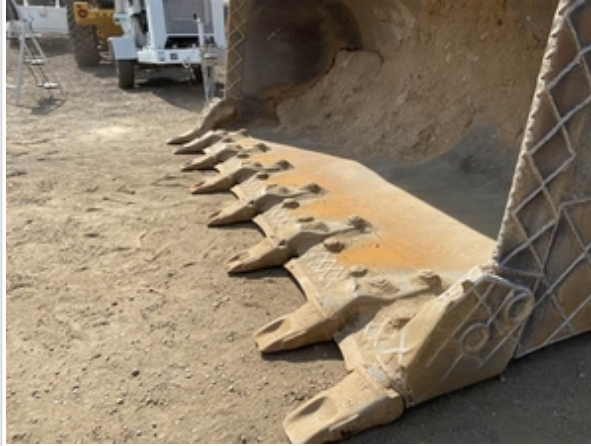
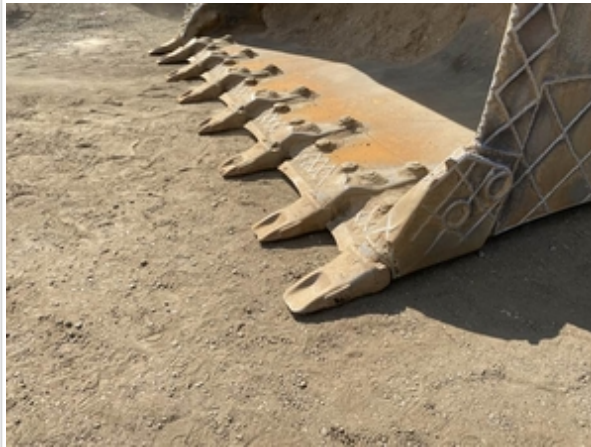
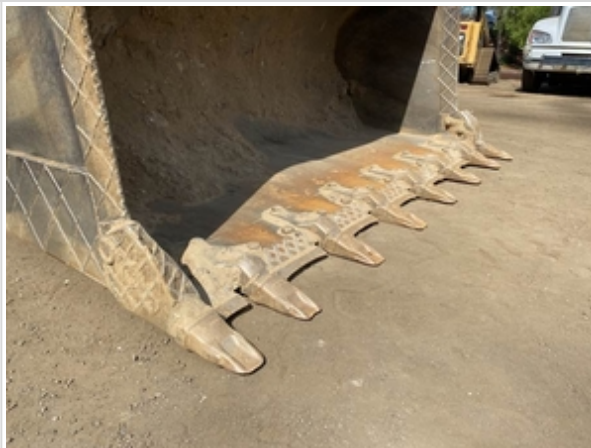
Bucket Edge/Shanks/Teeth
Photos

<p>Bucket Edge/Shanks/Teeth</p>	<p>3 - Normal Wear & Tear</p>
<p>Comments</p>	<p>Teeth in good shape segment edges look like they could be flipped to extend life.</p>
