Inspection Report (Wheel Loader)

Year	1996
Make	Kawasaki
Model	60z
Serial Number	60C1-0110
Hour Meter Reading	1220 + 1609
Previous Application (e.g., earth moving, mining, demolition, etc)	G

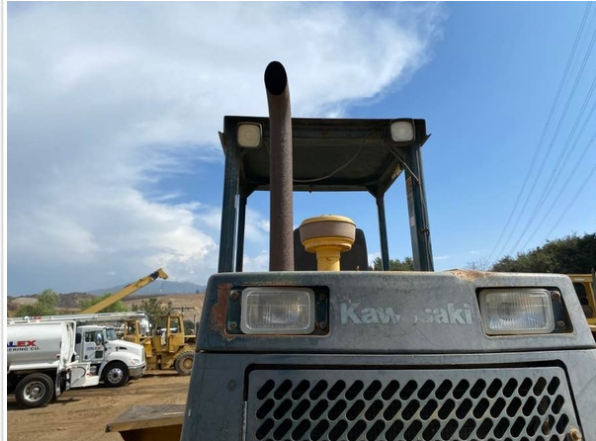
<p>Rear</p>	<p>3 - Normal Wear & Tear</p>
<p>Rear Condition</p>	<p>Other (see comments)</p>
<p>Comments</p>	<p>Normal wear and tear</p>
<p>Rear Photos</p>

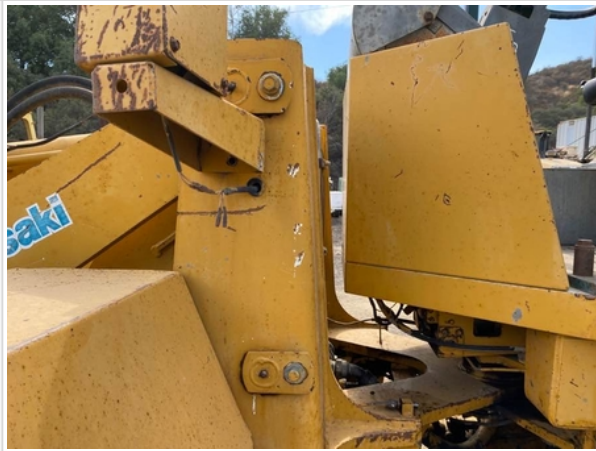
Left	3 - Normal Wear & Tear	
Left Condition	Other (see comments)	
Comments	Some damage to L/S fenders , normal wear	
Left Photos

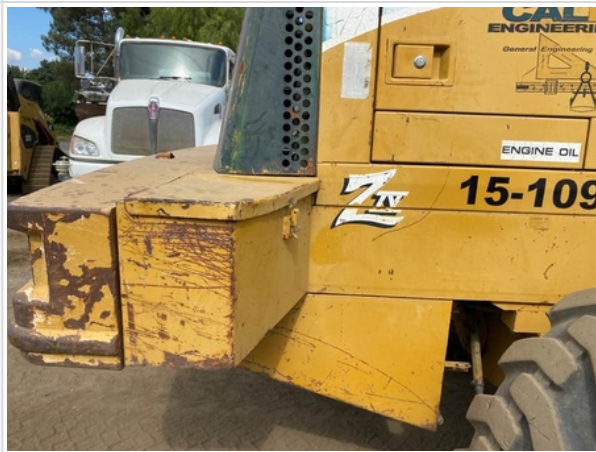
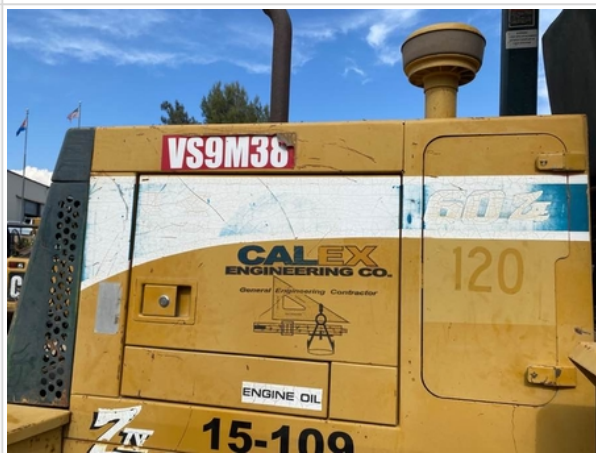
<p>Right</p>	<p>3 - Normal Wear & Tear</p>
<p>Right Condition</p>	<p>Other (see comments)</p>
<p>Right Photos</p>

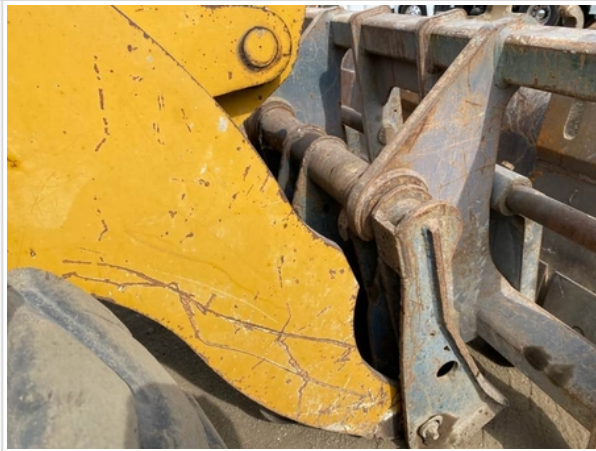
Upper	3 - Normal Wear & Tear	
Upper Condition	Other (see comments)	
Comments	Normal wear	
Upper Photos

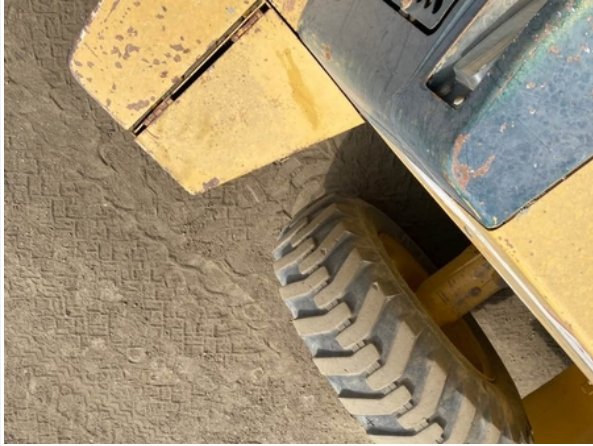
Body Panels (Any Rust Damage?)	3 - Normal Wear & Tear
Body Panel Condition	Other (see comments)
Comments	Fenders have some impact damage, compartment panels in good condition
Body Panels Photos

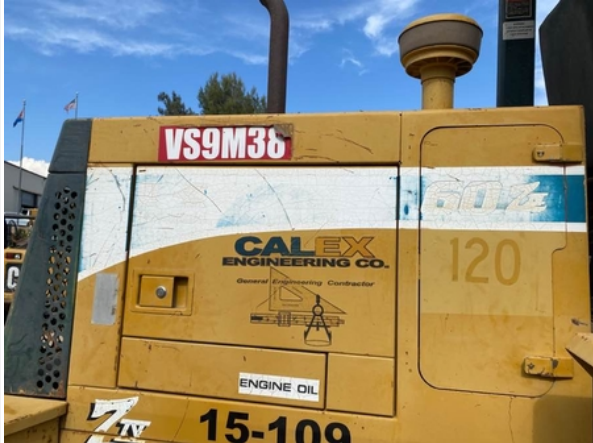
Doors / Canopy Latches	3 - Normal Wear & Tear
Doors / Canopy Latches Condition	No visible damage
Steps / Ladders	3 - Normal Wear & Tear
Steps / Ladders Condition	Steps/ladders are fully intact and appear structurally sound
Steps / Ladders Photos

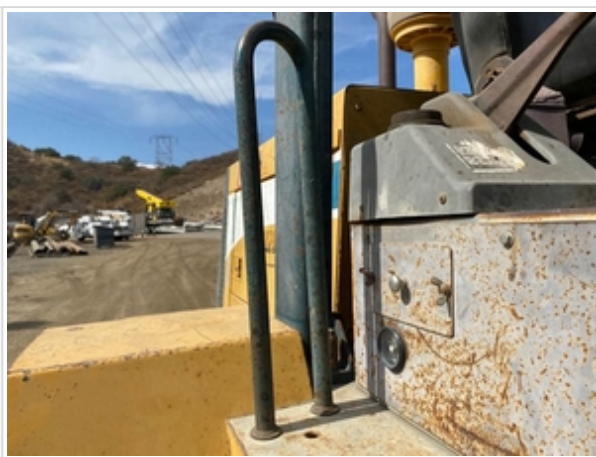
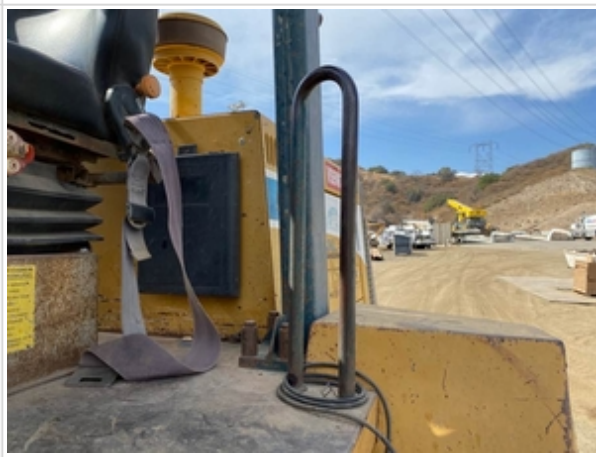
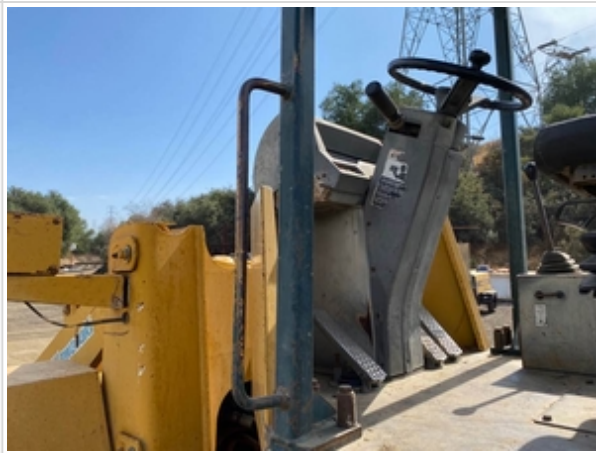
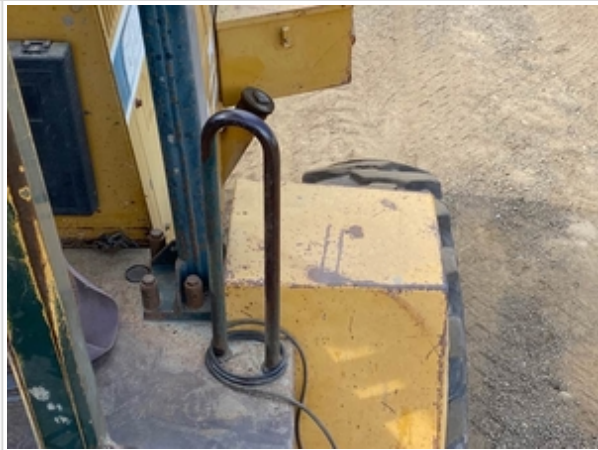
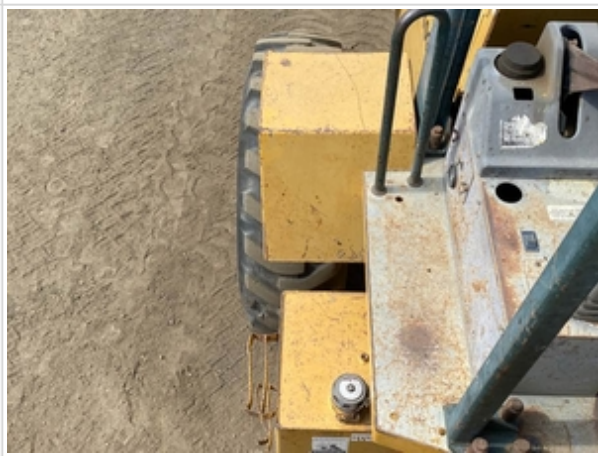
<p>Handrail Photos</p>

Handrails	3 - Normal Wear & Tear
Handrails Condition	Handrails are fully intact and appear structurally sound

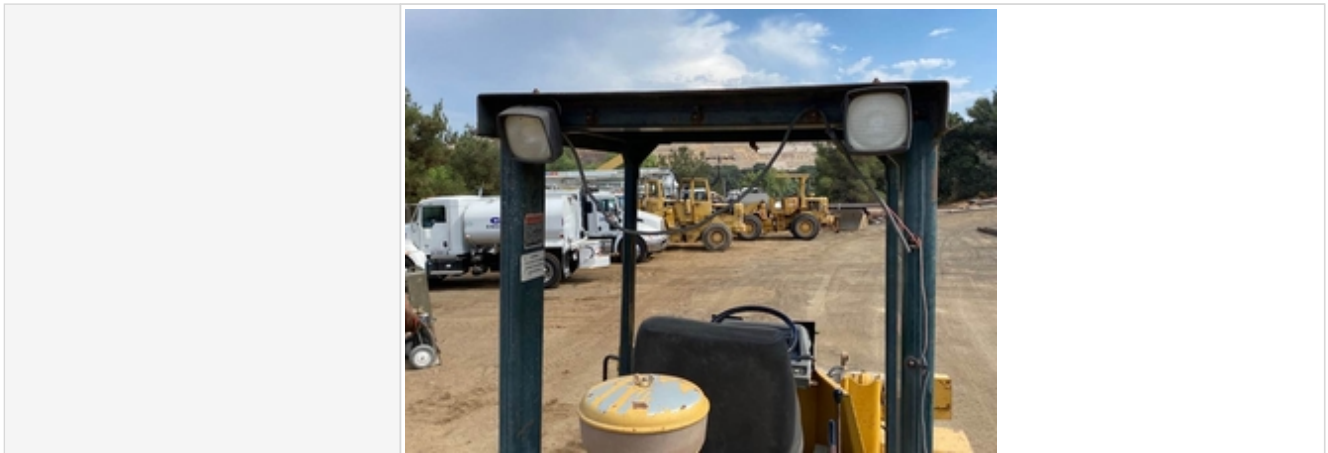
Glass Condition	0	
Mirrors	0	
Lighting System	2 - Above Average Wear	
Lighting System Condition	Overall lighting system is non-operational	
Lighting System Photos

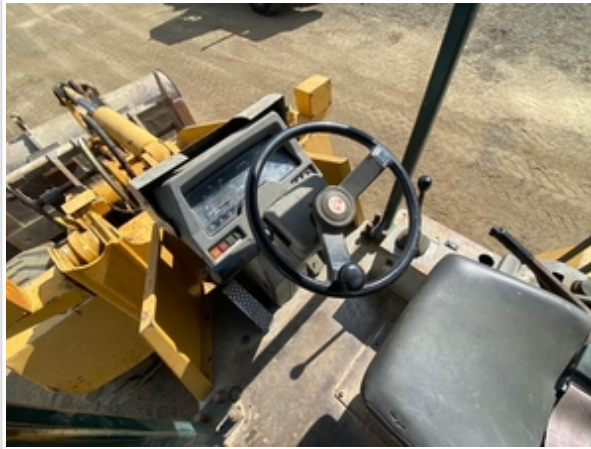
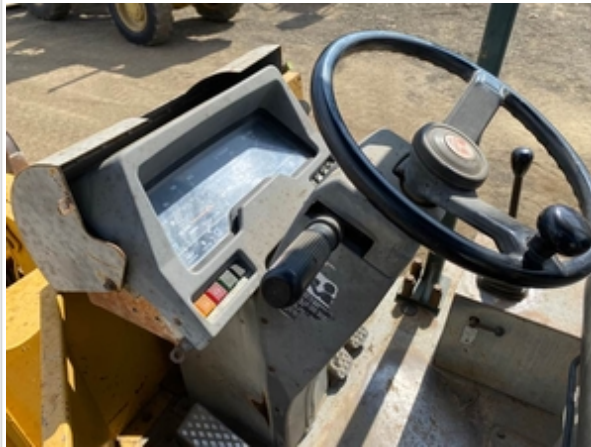
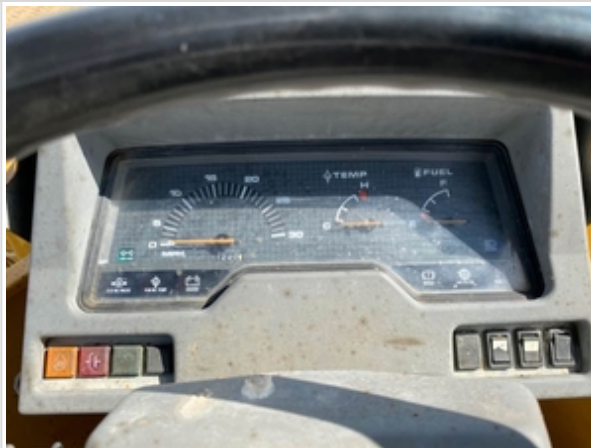
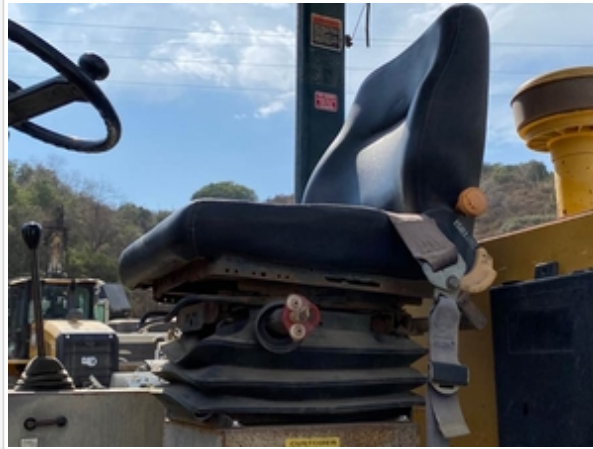
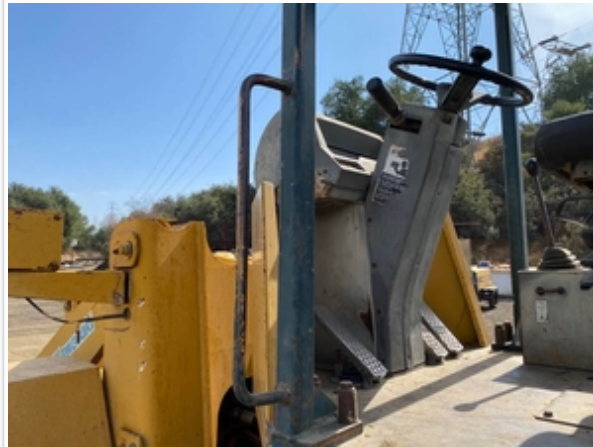
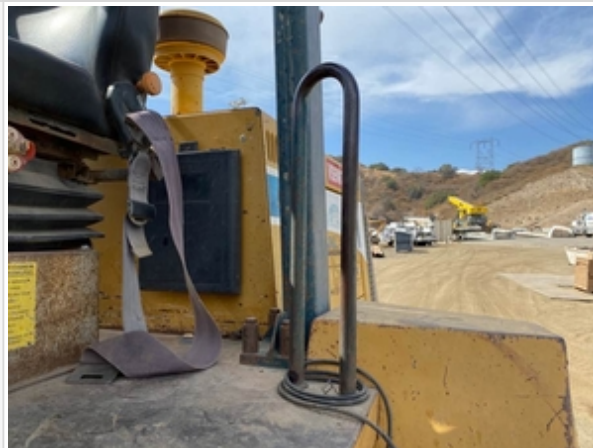
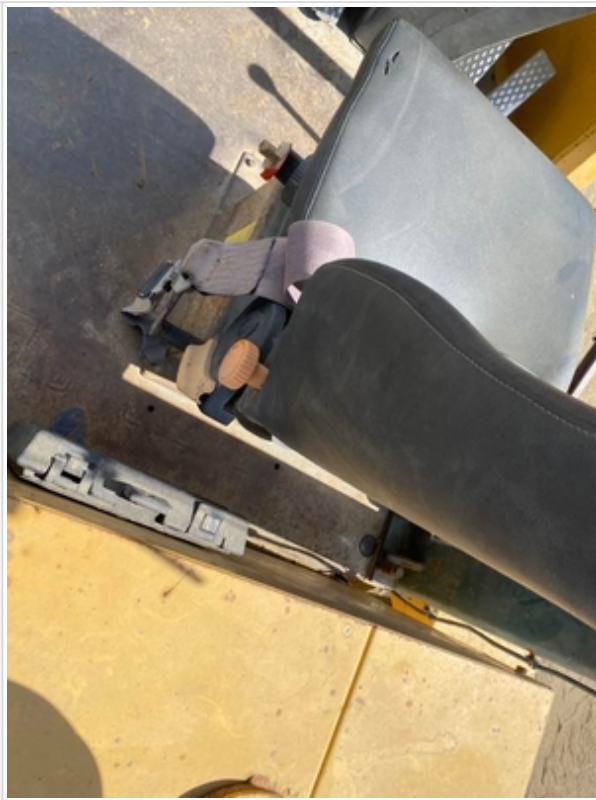
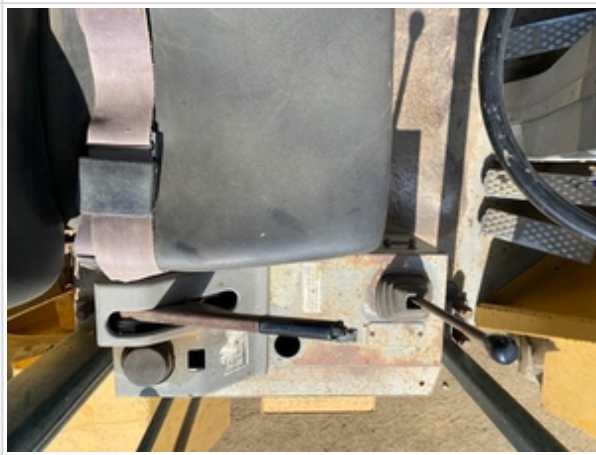
Operator Cabin Overall	3 - Normal Wear & Tear
Operator Cabin Overall Condition	Minor cosmetic wear to cabin surfaces, floors, panels, and ceiling
Operator Cabin Photos

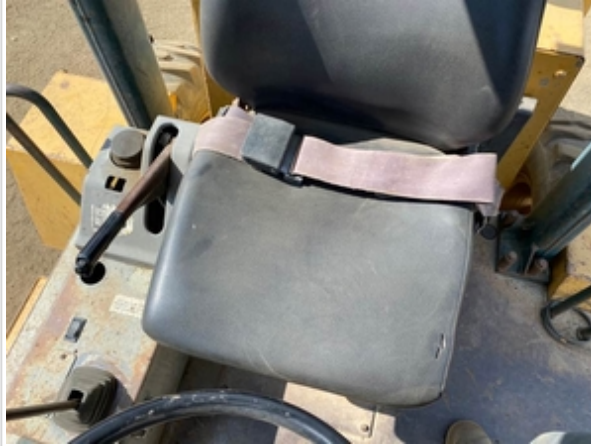
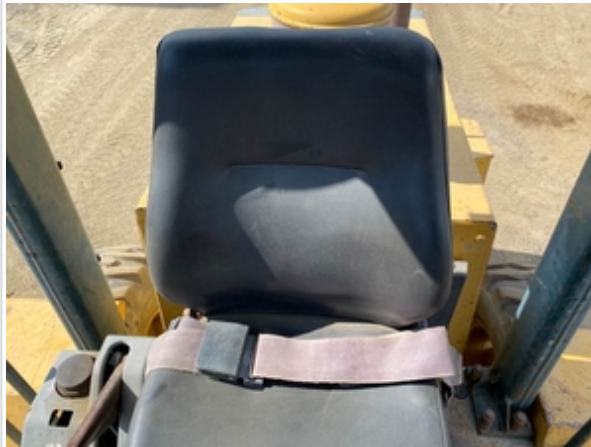
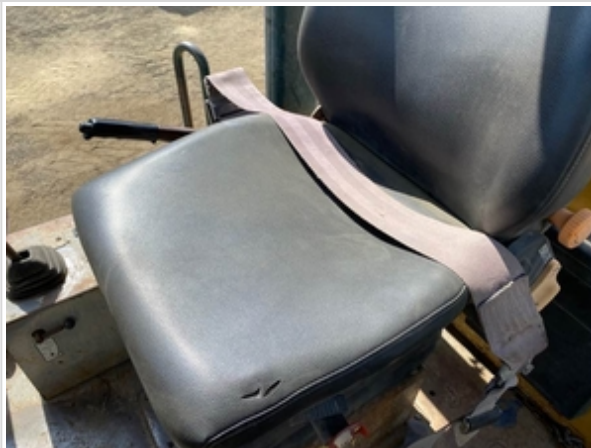
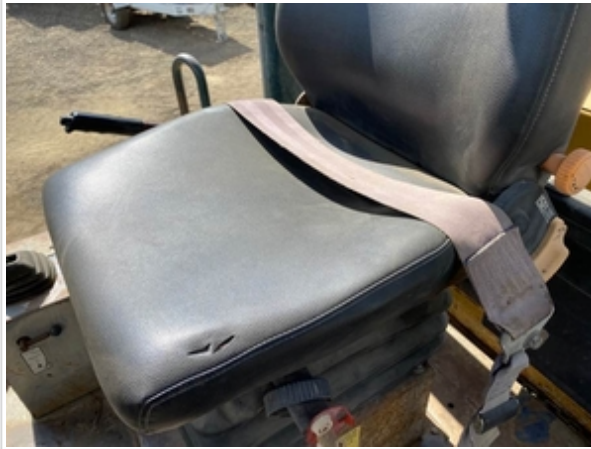
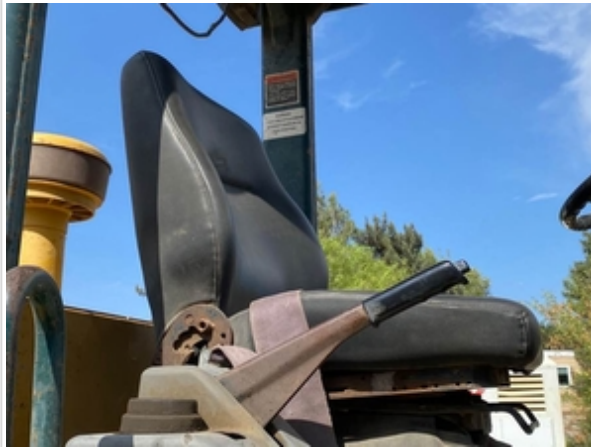
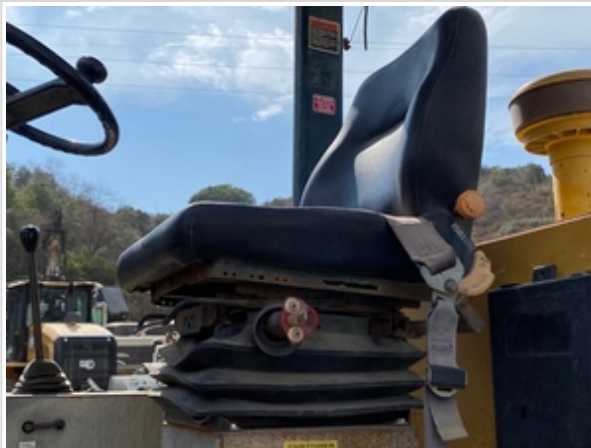
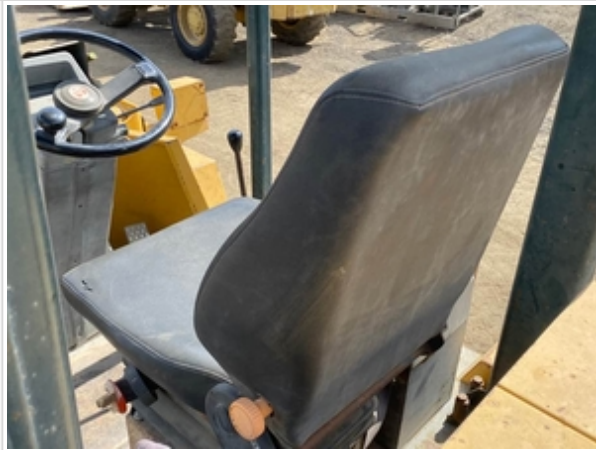
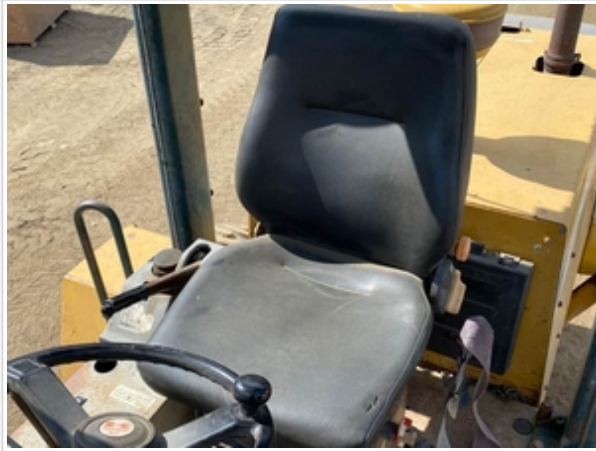
Operator's Seat & Arm Rests
Photos

Operator's Seat & Arm Rests	3 - Normal Wear & Tear
Operator's Seat & Arm Rests Condition	Seat(s) in good condition, no stains or tears in upholstery

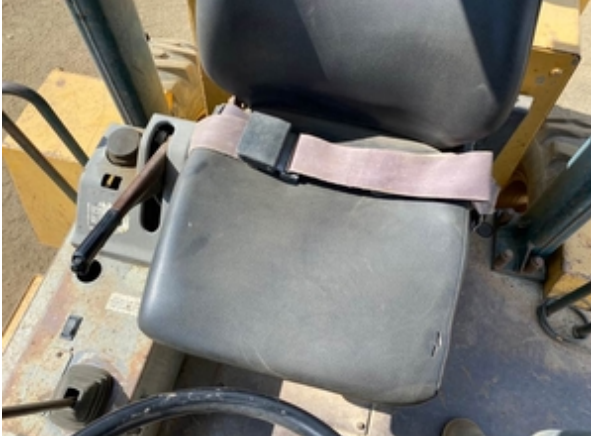
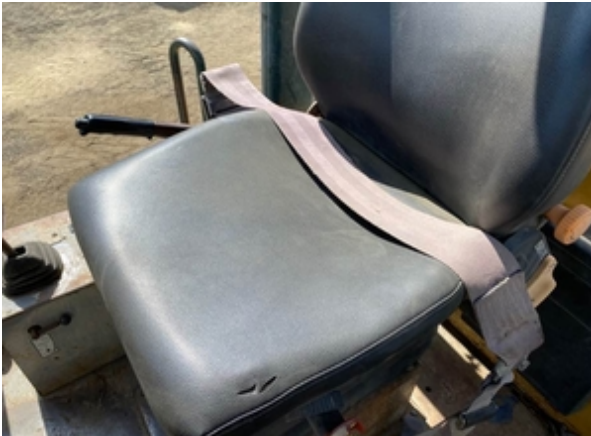
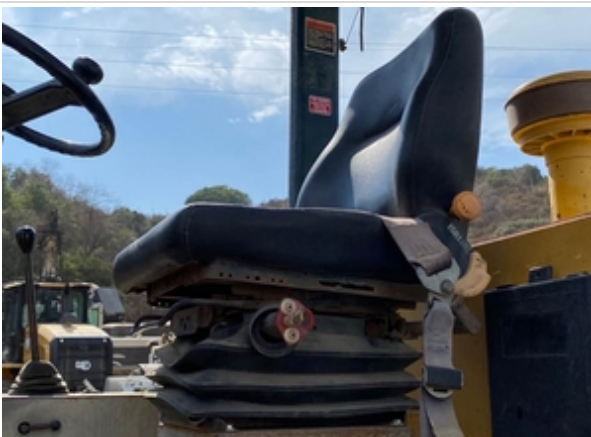
Seat Belt	3 - Normal Wear & Tear
Seat Belt Condition	Seat belt secures properly. Nicks, cuts, holes, or fraying observed on belt webbing, Other (see comments)
Comments	Seat belt works okay, just worn
Seat Belt Photos

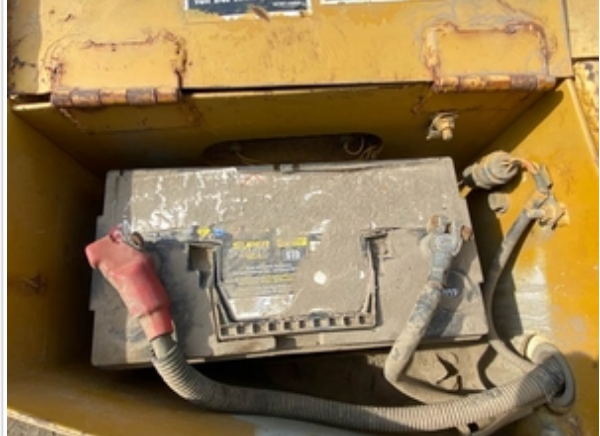
Blow-by (Visual Observation Check)	Yes	
Comments	Very little blow by (healthy engine)	
Unusual Noises (Upon Start-up, Idle, Shutdown)	No	
Unusual Noise Notes	No unusual noises heard	
Engine Smoke (Upon Start-up, Idle, Shutdown)	Yes	
Engine Smoke Notes	Engine smoke observed upon start up, Other (see comments)	
Comments	Black smoke at initial startup, okay under load	
Engine Exhaust Color	Clear, Black puffs observed under throttle, Other (see comments)	
Comments	Clear smoke at idle and under load, smokes only with initial throttle up	
Battery	3 - Normal Wear & Tear	
Battery Condition	Dusty & dirty appearance, Other (see comments)	
Comments	Work okay just dirty	
Battery Condition Photos

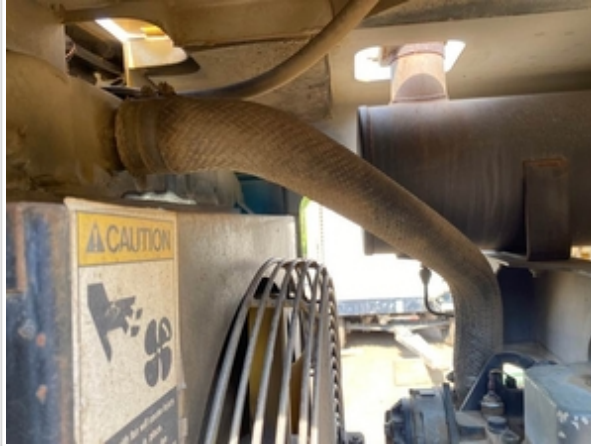
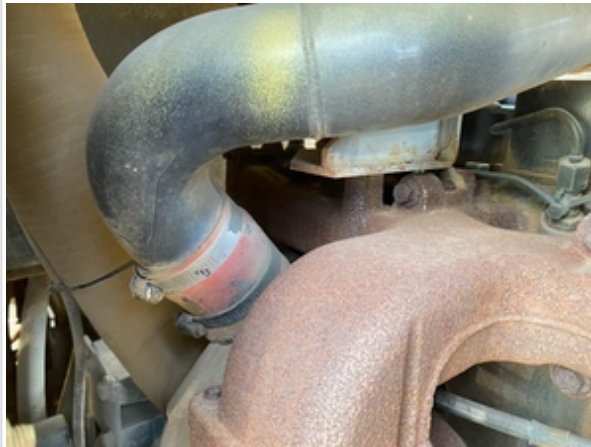
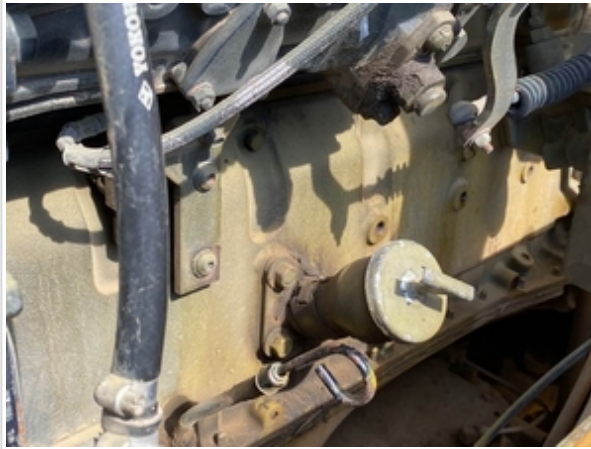
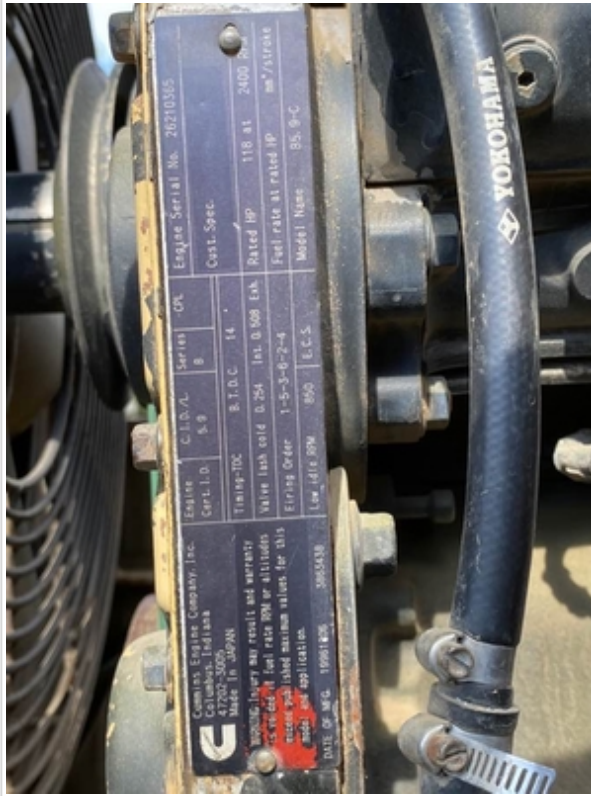
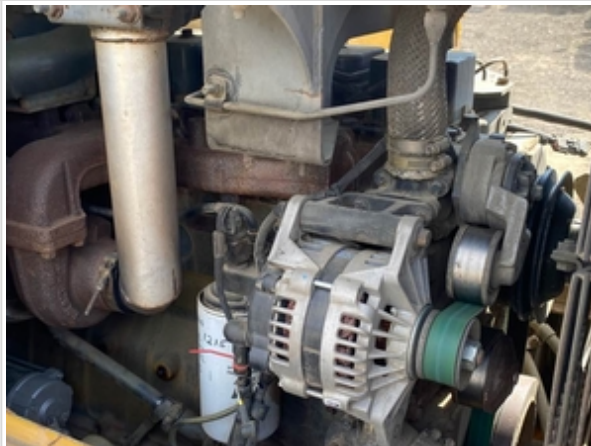
Hoses	3 - Normal Wear & Tear
Hose Condition	Firm, pliant hoses with no signs of wear or leaks

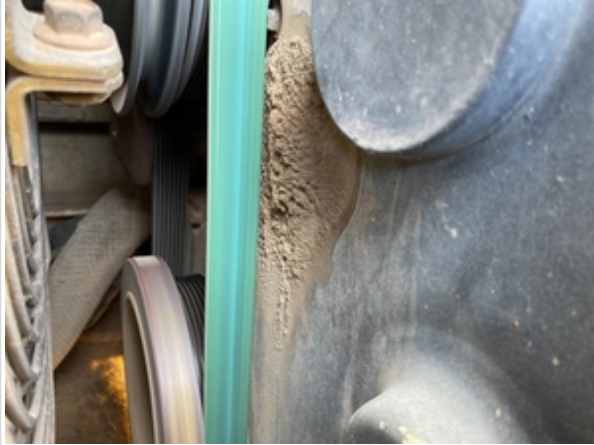
Water Pump	3 - Normal Wear & Tear
Water Pump Condition	No unusual pump noises heard
Cooling System Leaks	No
Coolant Color / Appearance	3 - Normal Wear & Tear
Oil Leaks	Yes
Oil Leak Notes	No oil leaks seen, Dried oil seepages seen
Comments	Front cover engine oil seepage buildup
Oil Leak Photos

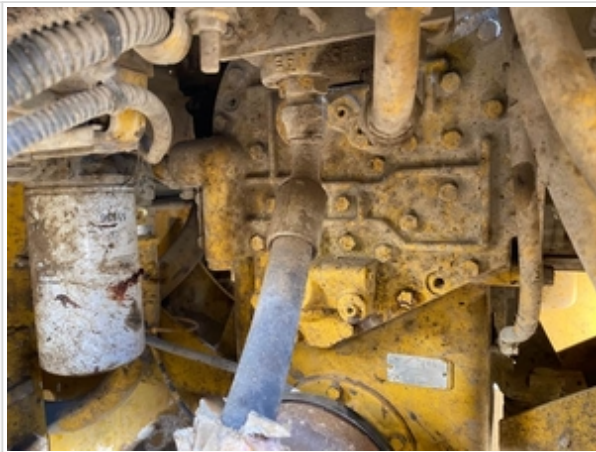
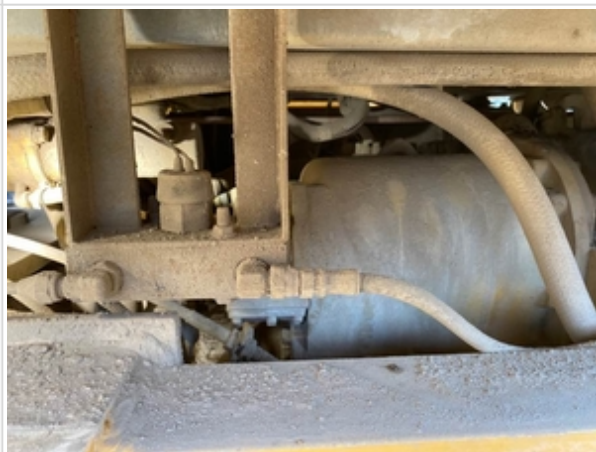
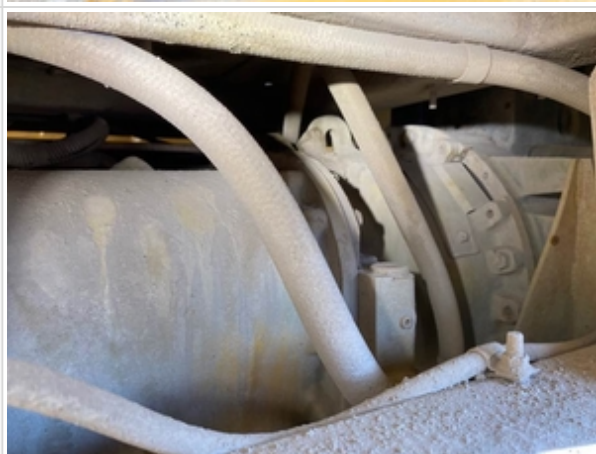
Hydrostatic Transmission?	No
Transmission Info (Make/Model/Speeds)	Powershift 3 speed trans AWD
Transmission	3 - Normal Wear & Tear
Transmission Condition	No unusual noises or vibrations

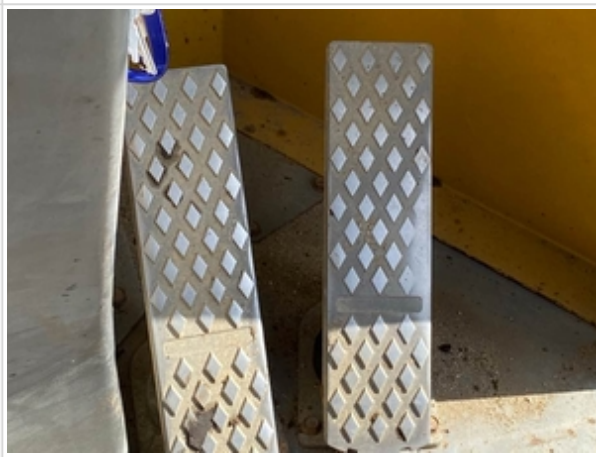
Foot Brake	3 - Normal Wear & Tear
Foot Brake Condition	Good brake function
Foot Brake Photos

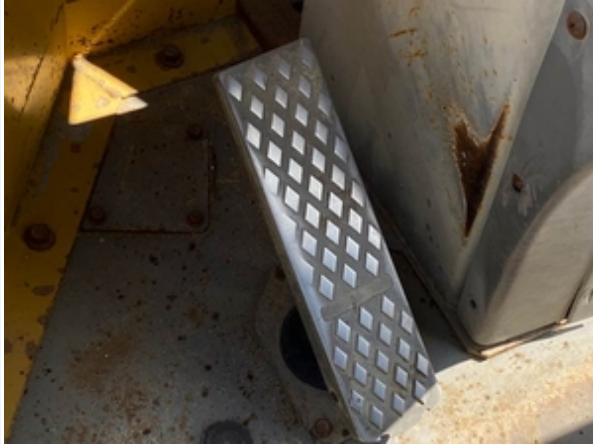
Inching Brake	3 - Normal Wear & Tear
Inching Brake Condition	Good brake function

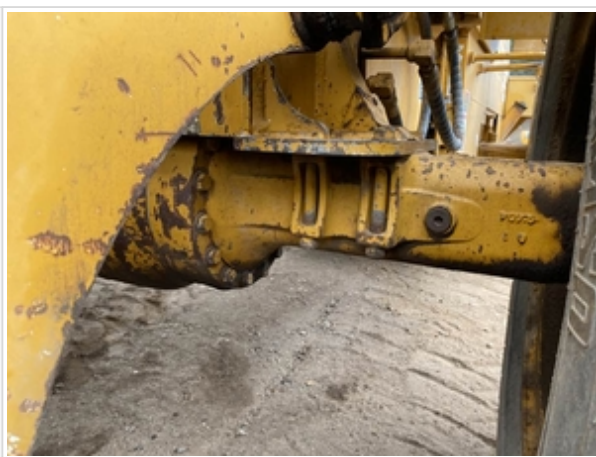
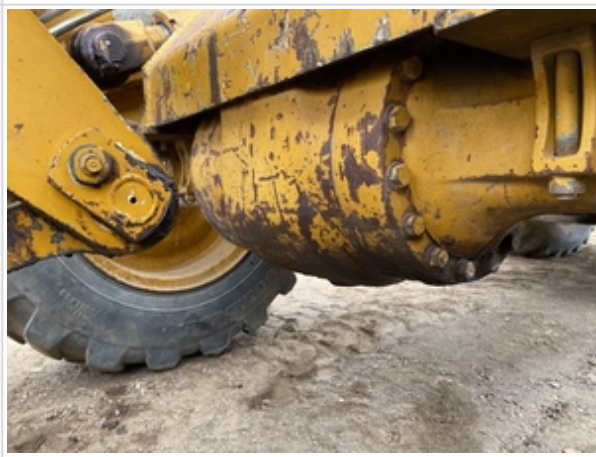
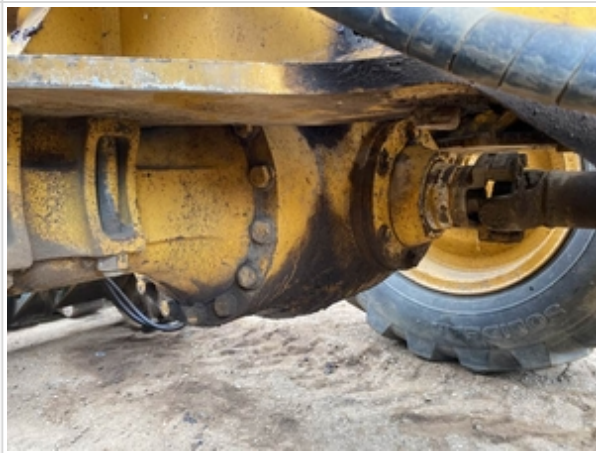
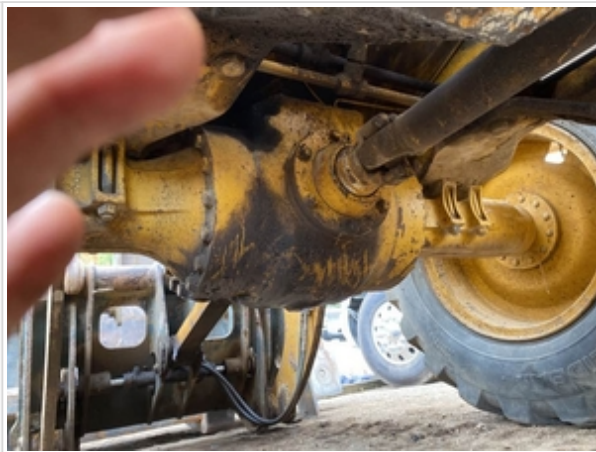
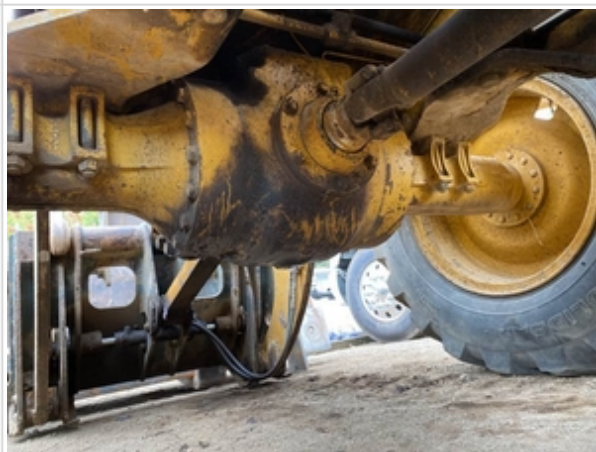
Front Axle Appearance	3 - Normal Wear & Tear
Comments	Signs of possible seepage from front axle no active leak found

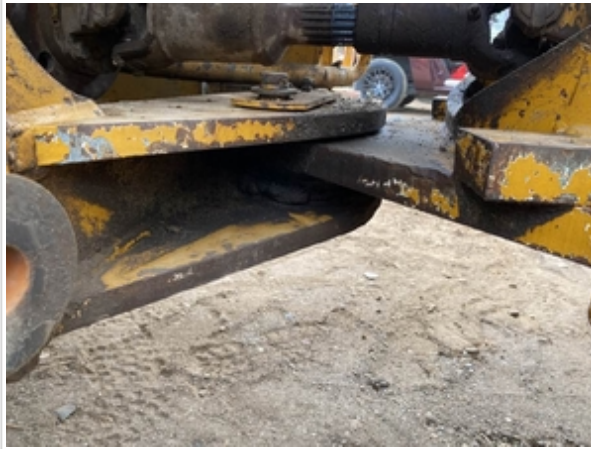
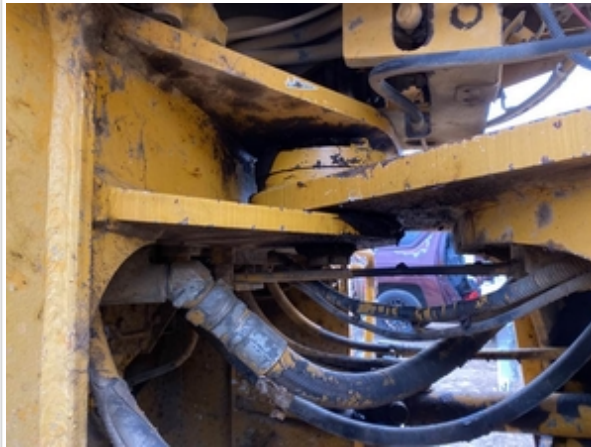
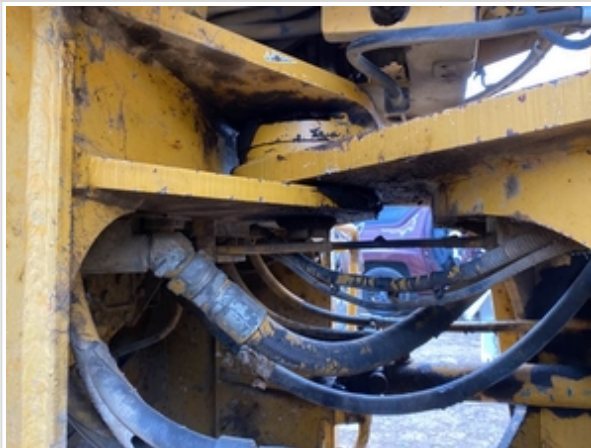
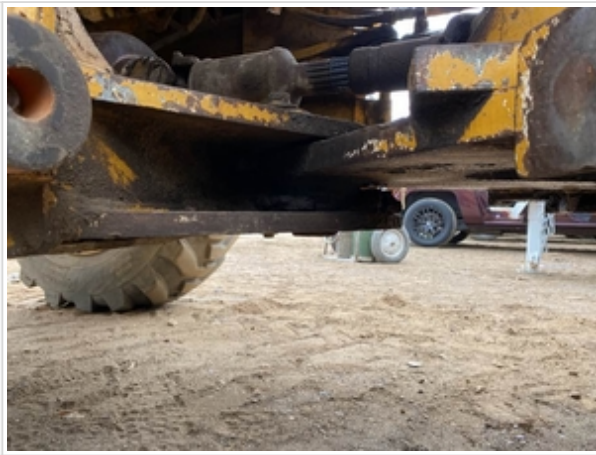
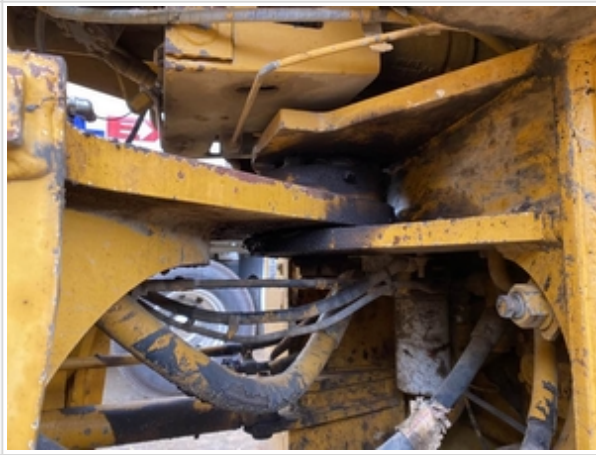
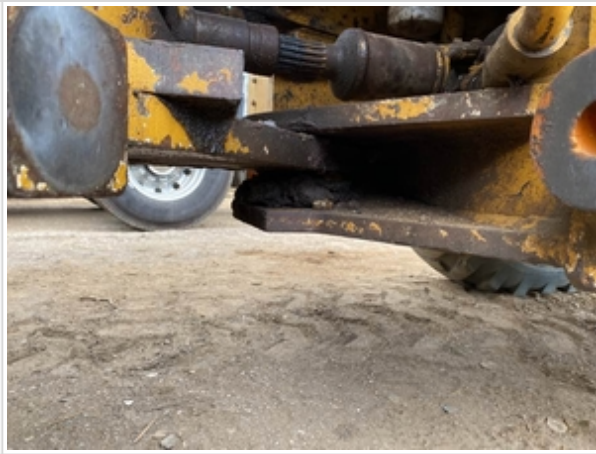
<p>Articulating Center Pin Appearance</p>	<p>3 - Normal Wear & Tear</p>	
<p>Articulating Center Pin Appearance Photos</p>

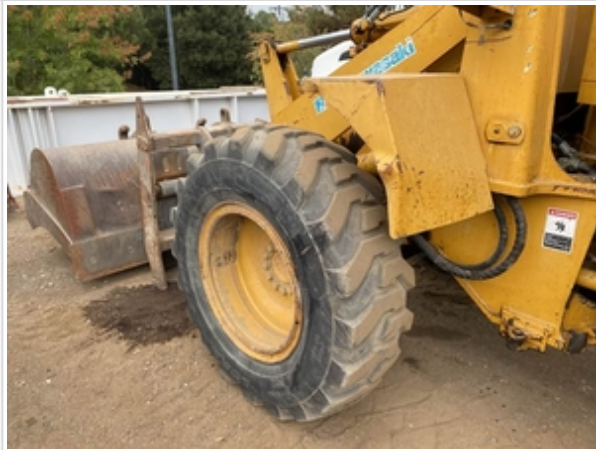
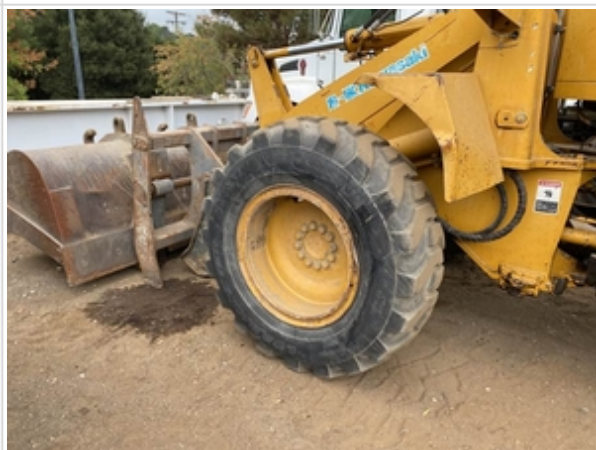
<p>Front Left Tire Photos</p>

Tire Brand	Camso
Tire Size	15.5 - 25
Front Left Tire - Ratio Remaining	50%

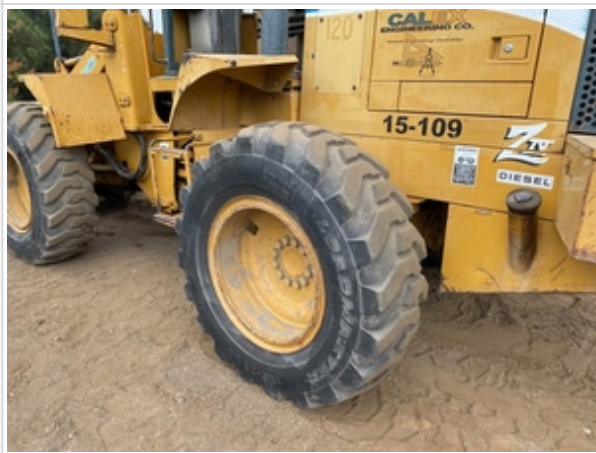
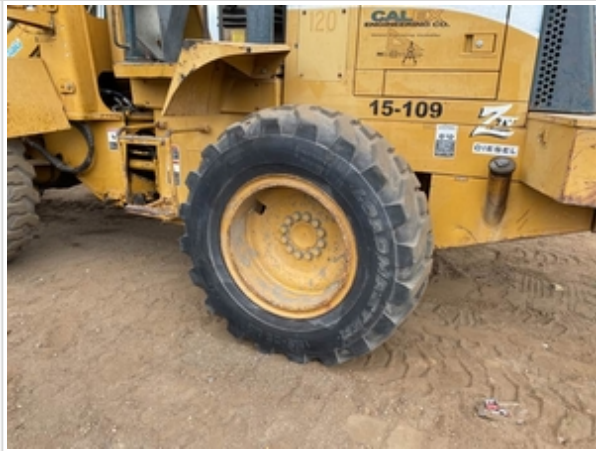
<p>Rear Left Tire - Ratio Remaining</p>	<p>50%</p>
<p>Rear Left Tire Photos</p>

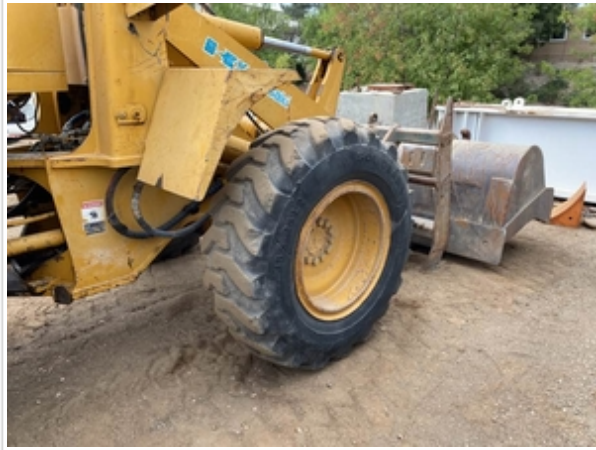
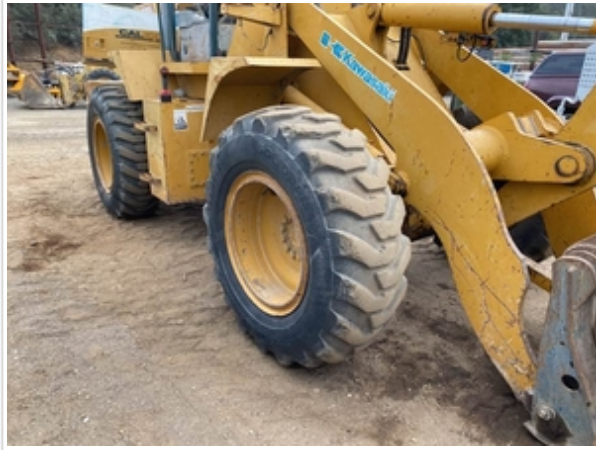
<p>Front Right Tire - Ratio Remaining</p>	<p>50%</p>	
<p>Front Right Tire Photos</p>

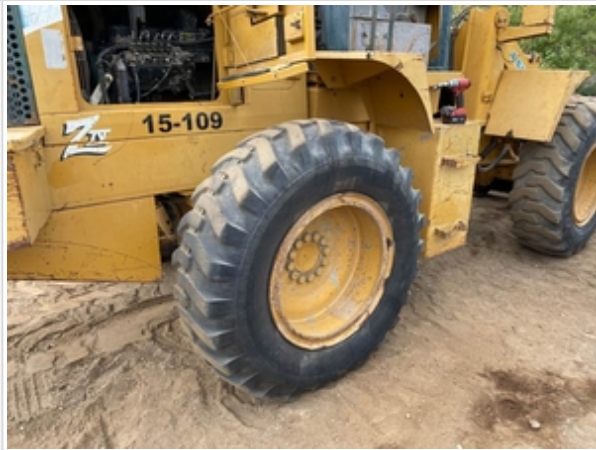
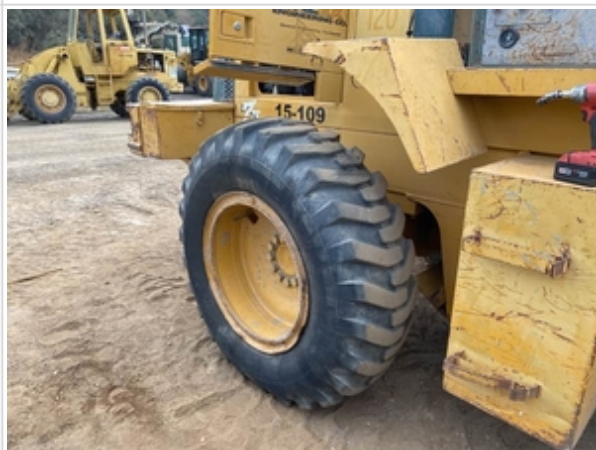
<p>Rear Right Tire Photos</p>

<p>Rear Right Tire - Ratio Remaining</p>	<p>50%</p>

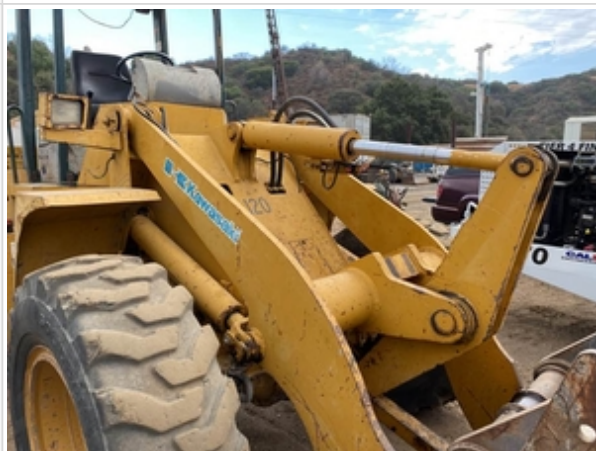
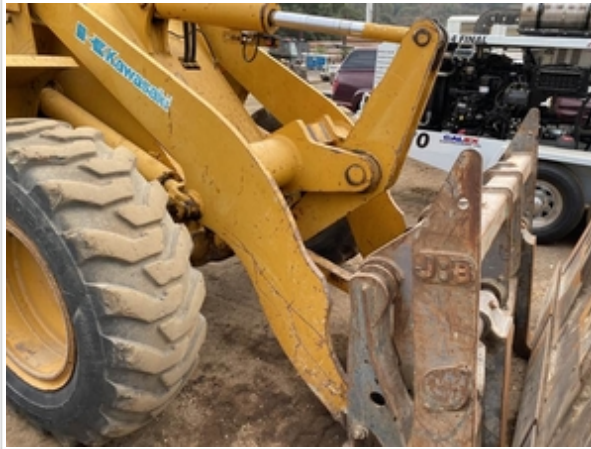
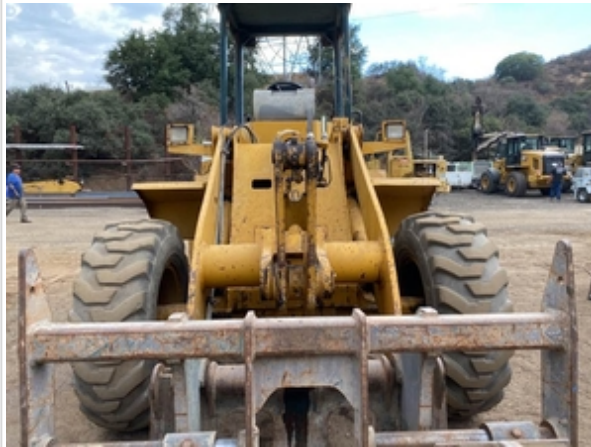
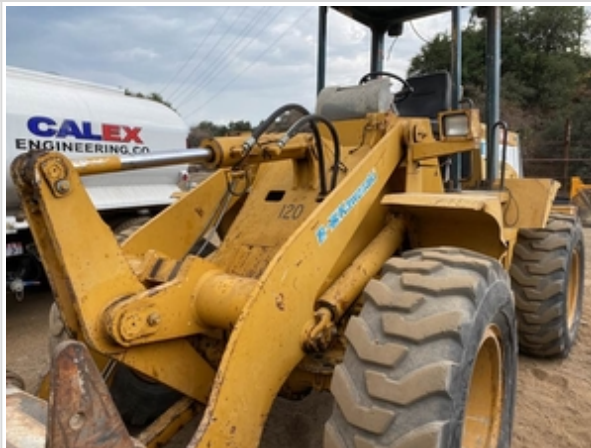
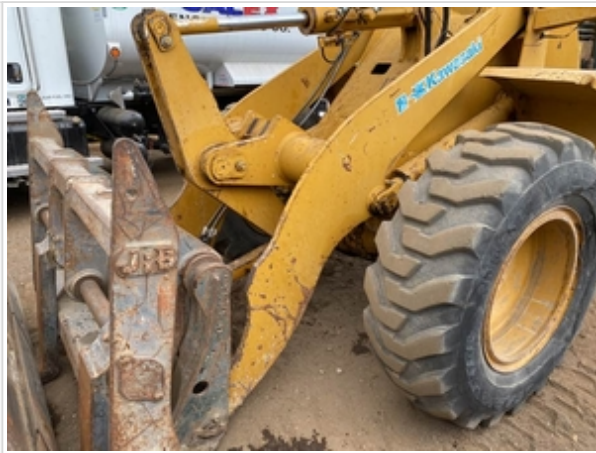
<p>Lift Arm</p>	<p>3 - Normal Wear & Tear</p>
<p>Lift Arm Photos</p>

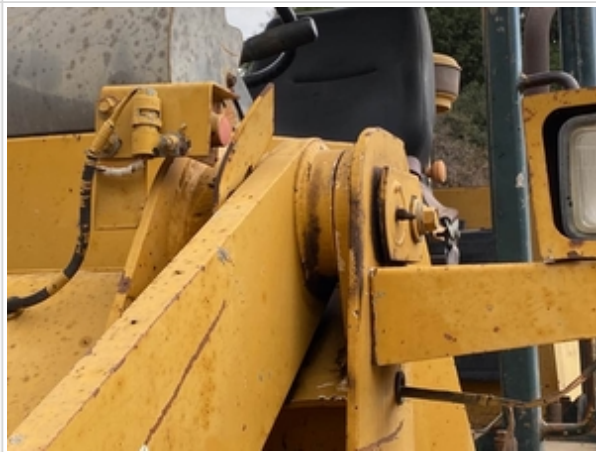
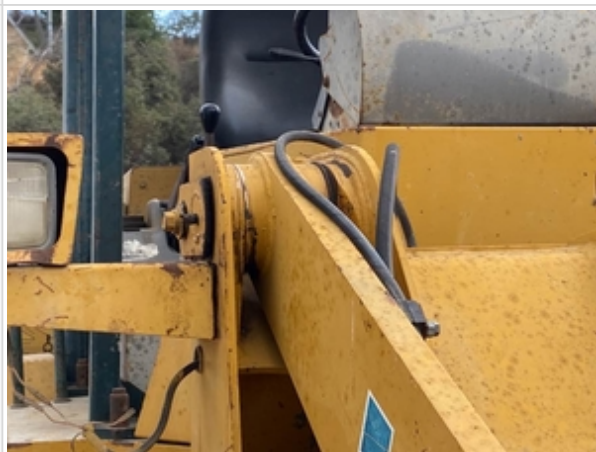
<p>Chassis to Arm Pins</p>	<p>3 - Normal Wear & Tear</p>
<p>Chassis to Arm Pins Photos</p>

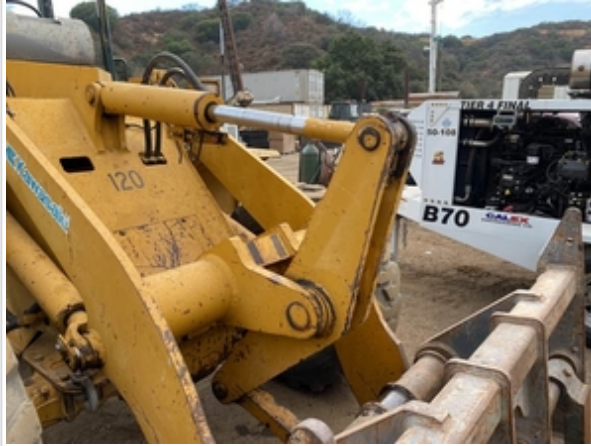
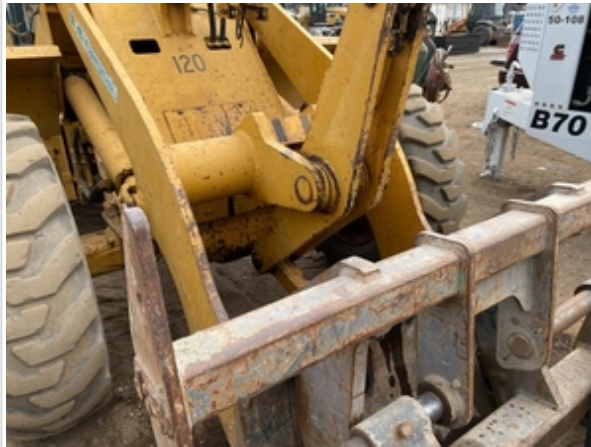
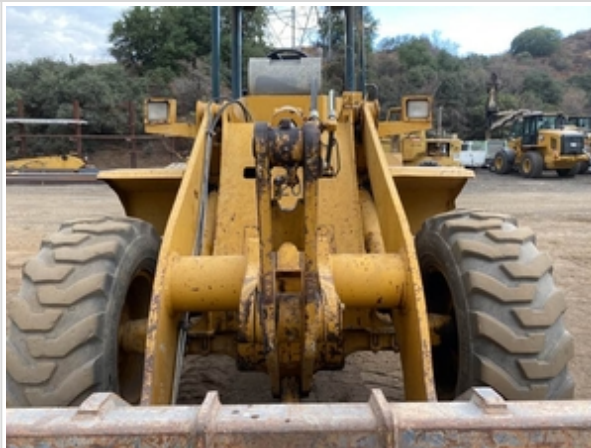
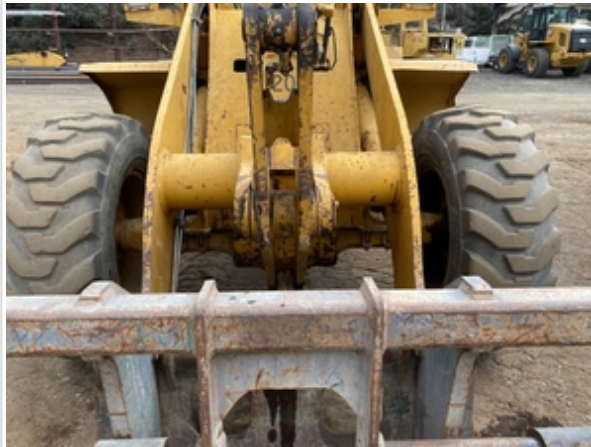
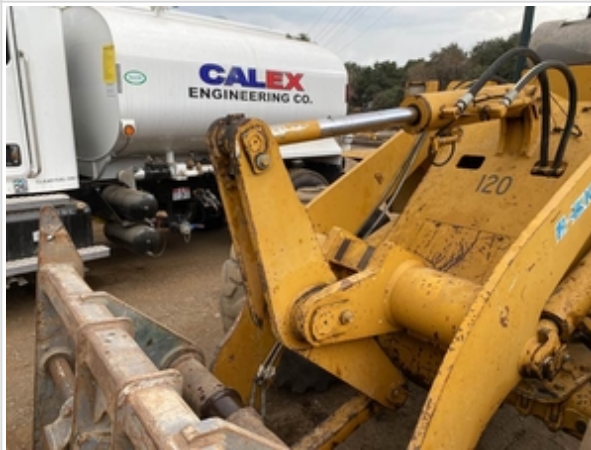
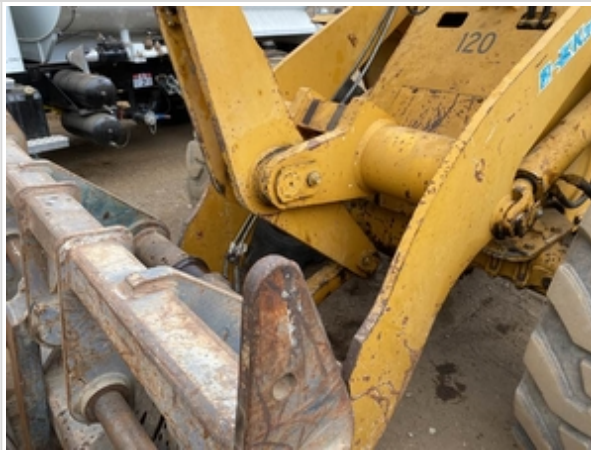
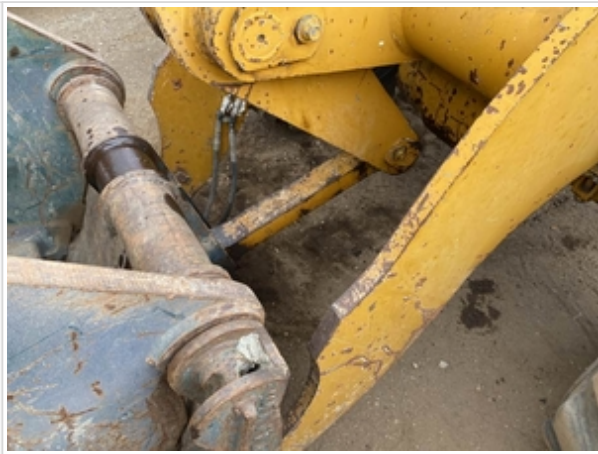
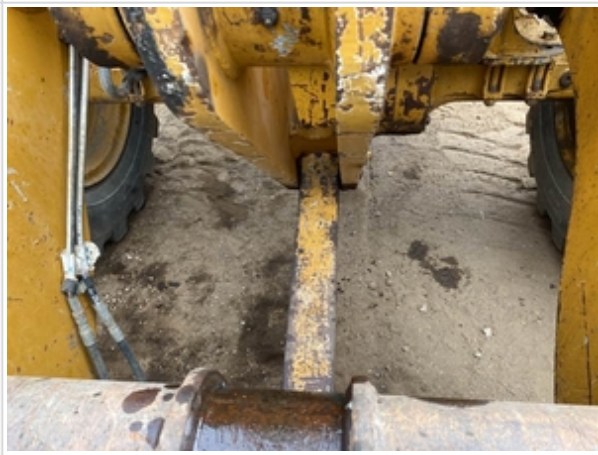
Tilt Linkage Photos

<p>Tilt Linkage</p>	<p>3 - Normal Wear & Tear</p>
