Inspection Report (Wheel Loader)

Year	1996
Make	Kawasaki
Model	60z
Serial Number	60C1-0110
Hour Meter Reading	1220 + 1609
Previous Application (e.g., earth moving, mining, demolition, etc)	G

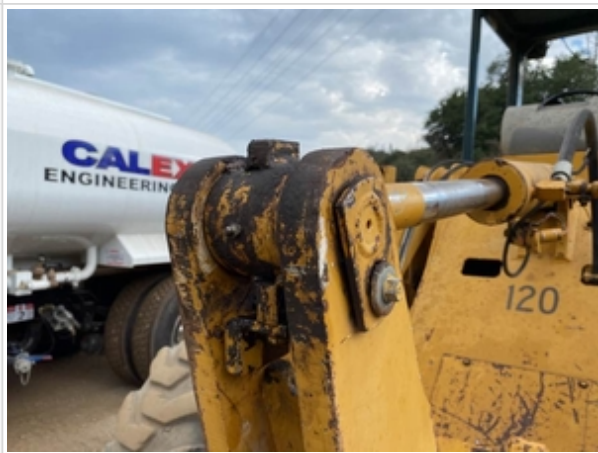
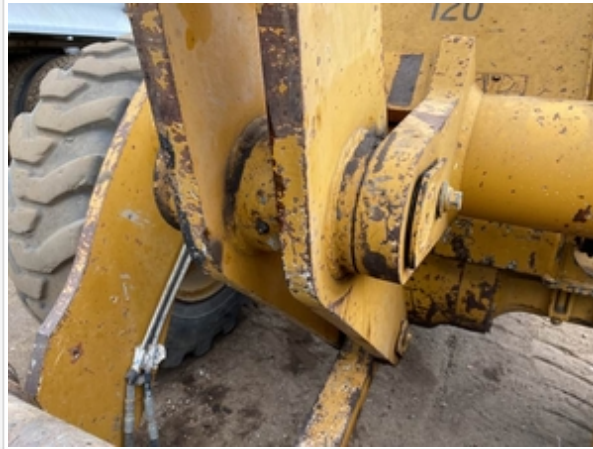
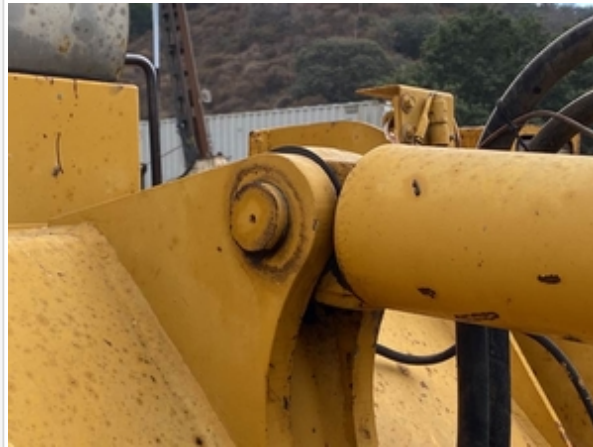
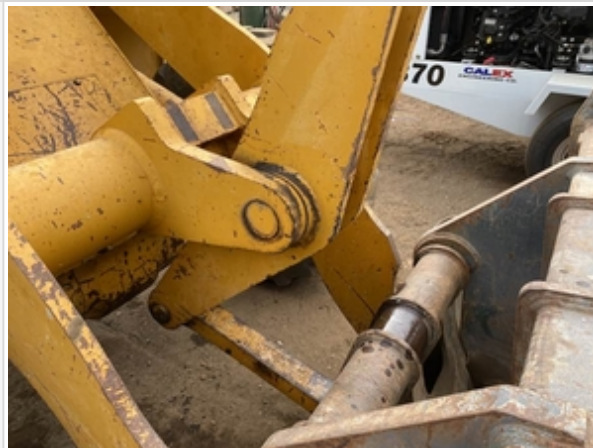
<p>Tilt Linkage Pins and Bushings</p>	<p>3 - Normal Wear & Tear</p>	
<p>Tilt Linkage Pins and Bushings Photos</p>

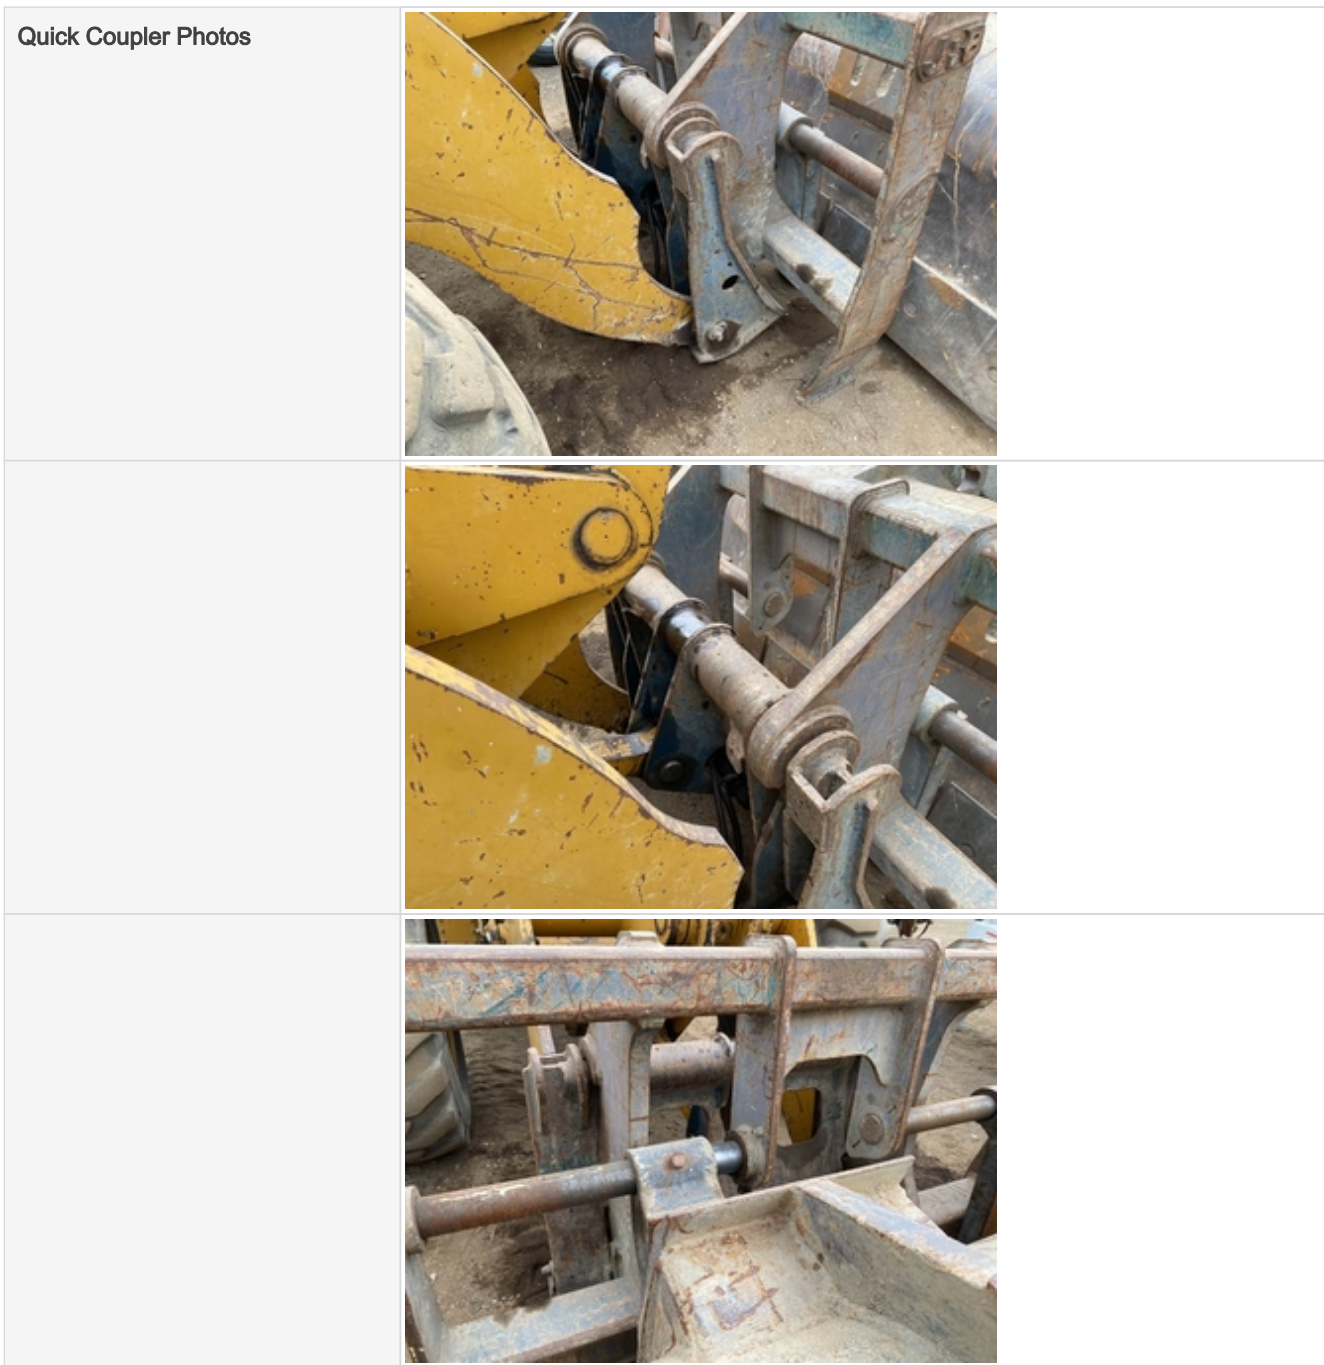
<p>Quick Coupler</p>	<p>2 - Above Average Wear</p>
<p>Comments</p>	<p>Lock cylinders need to be resealed</p>

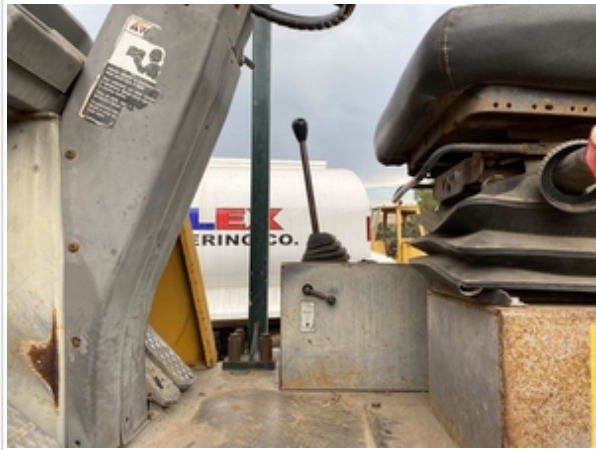
Unusual Noises (Hydraulic Pump)	No	
Hydraulic Pump Notes	No unusual noises heard during operation	
External Controls / Levers	3	
External Controls / Levers Condition	Good function & condition of hydraulic controls	
External Controls / Levers Photos

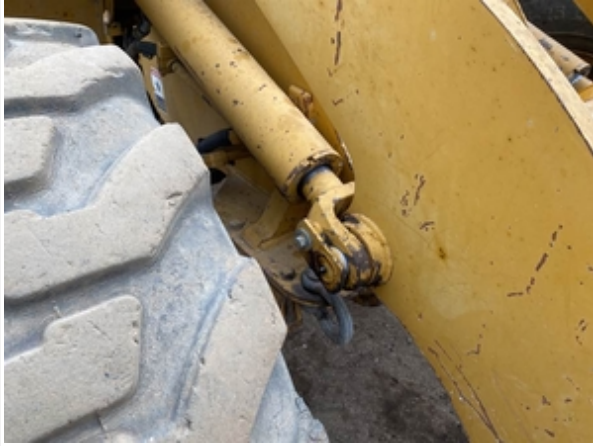
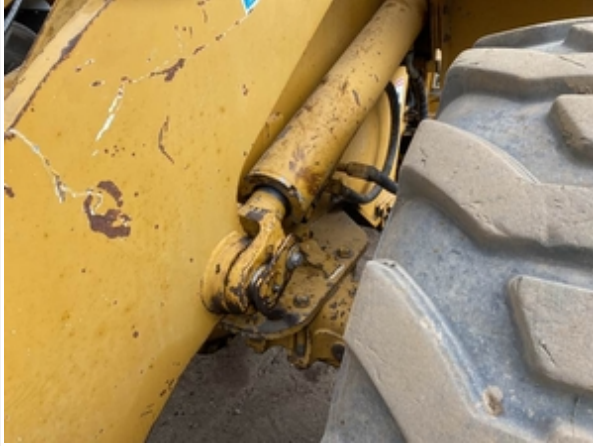
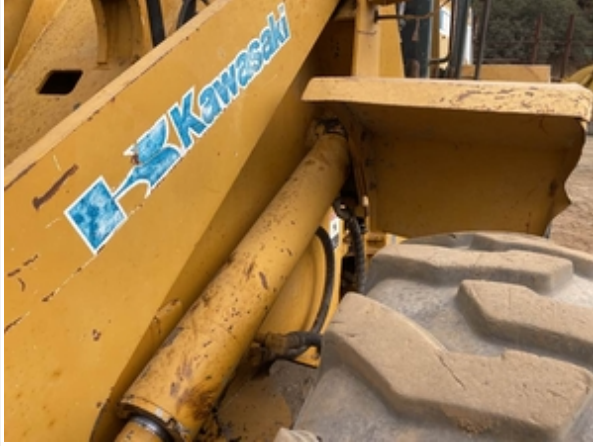
Lift Cylinder: Oil Leaks	No
Lift Cylinder Photos

Lift Cylinder	Check the lift cylinder. Note any wear, pitting, discoloration, etc. Take photos.
Lift Cylinder: Mounting Pin	3

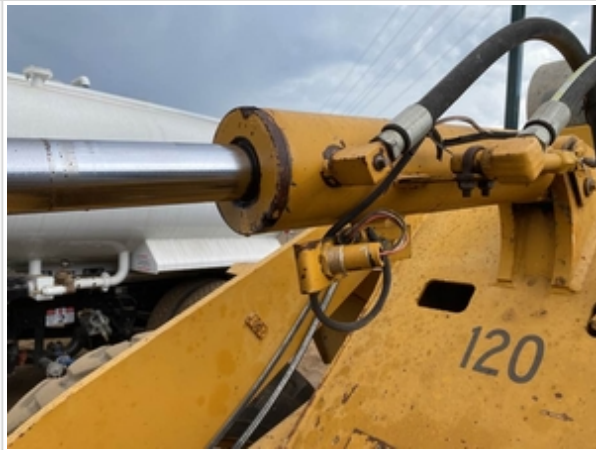
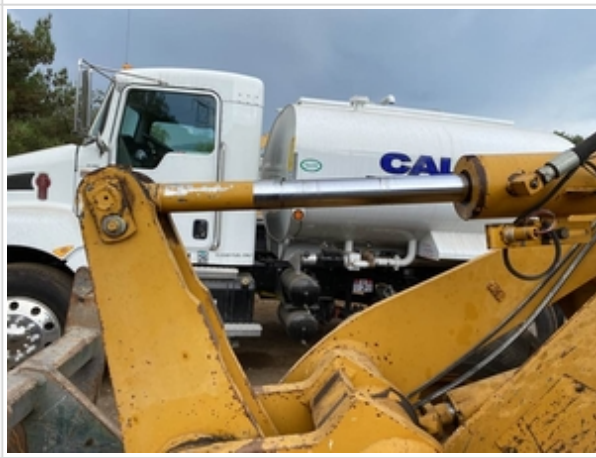
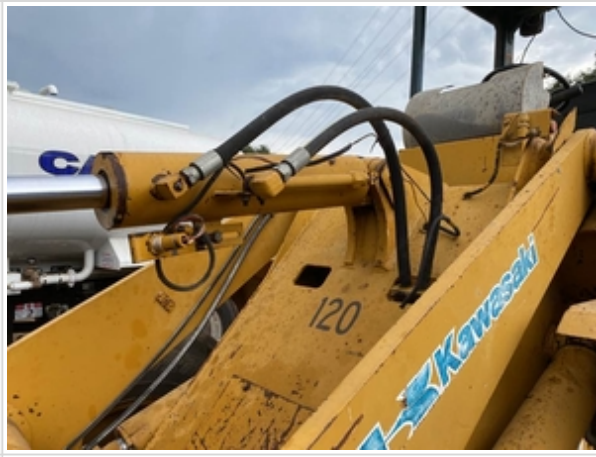
<p>Bucket Cylinder Photos</p>

Bucket Cylinder	Check the bucket cylinder. Note any wear, pitting, discoloration, etc. Take photos.
Bucket Cylinder: Mounting Pin	3
Bucket Cylinder: Oil Leaks	Yes

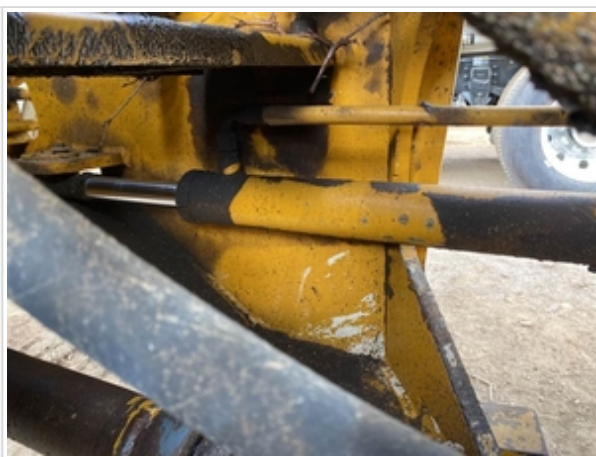
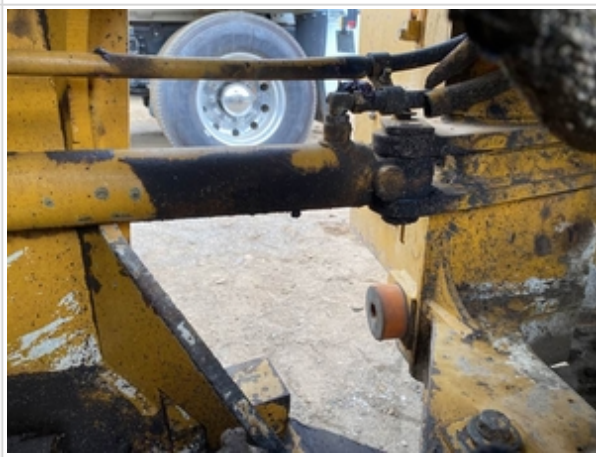
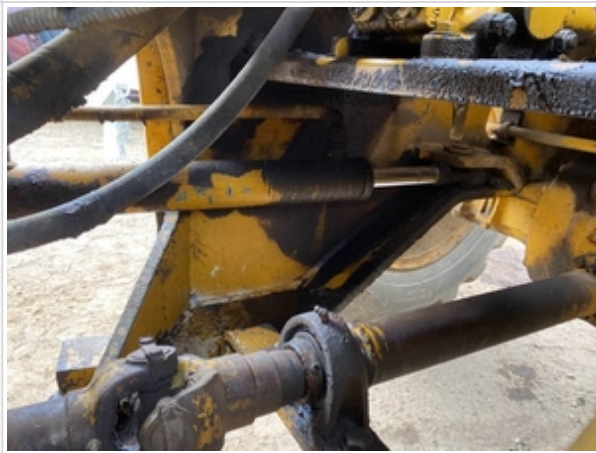
<p>Steering Cylinder Photos</p>

<p>Steering Cylinder</p>	<p>Check the steering cylinder. Note any wear, pitting, discoloration, etc. Take photos.</p>
<p>Steering Cylinder: Mounting Pin</p>	<p>3</p>
<p>Steering Cylinder: Oil Leaks</p>	<p>Yes</p>
<p>Comments</p>	<p>Residual buildup on cylinders may indicate seepage leak no active leaks found</p>

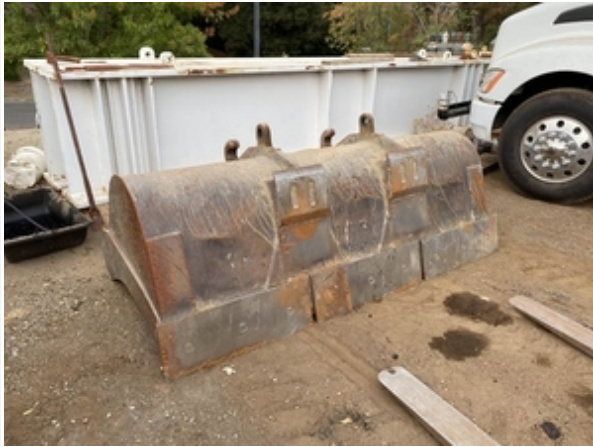
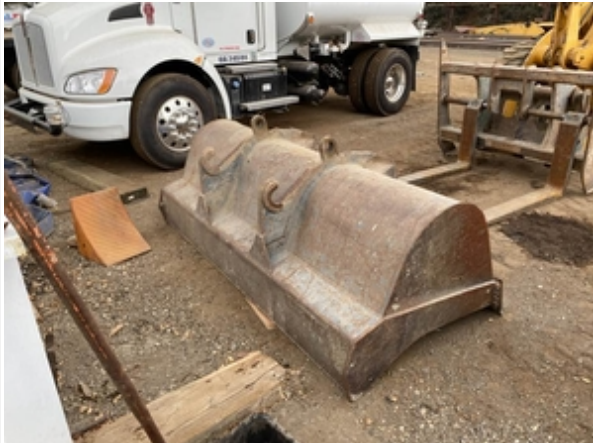
Bucket	3 - Normal Wear & Tear
Comments	8' wide 3'6" tall
Bucket Photos

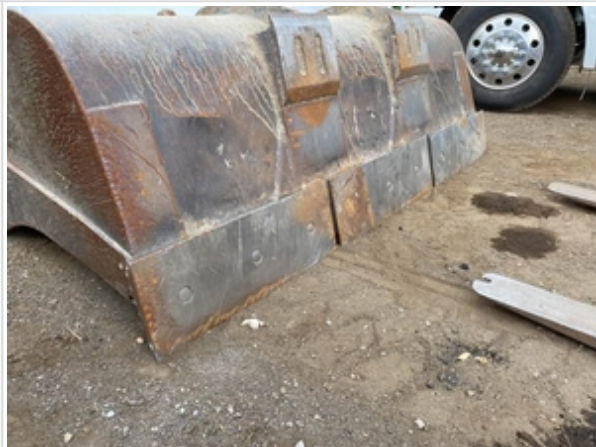
Bucket Edge/Shanks/Teeth	3 - Normal Wear & Tear	
Comments	Edge in good condition	
Bucket Edge/Shanks/Teeth Photos
