Inspection Report (Generator)

Year	1997
Make	Wacker
Model	G125
Serial Number	764001010
Hour Meter Reading	6,579
Previous Application (e.g., earth moving, mining, demolition, etc)	General Construction

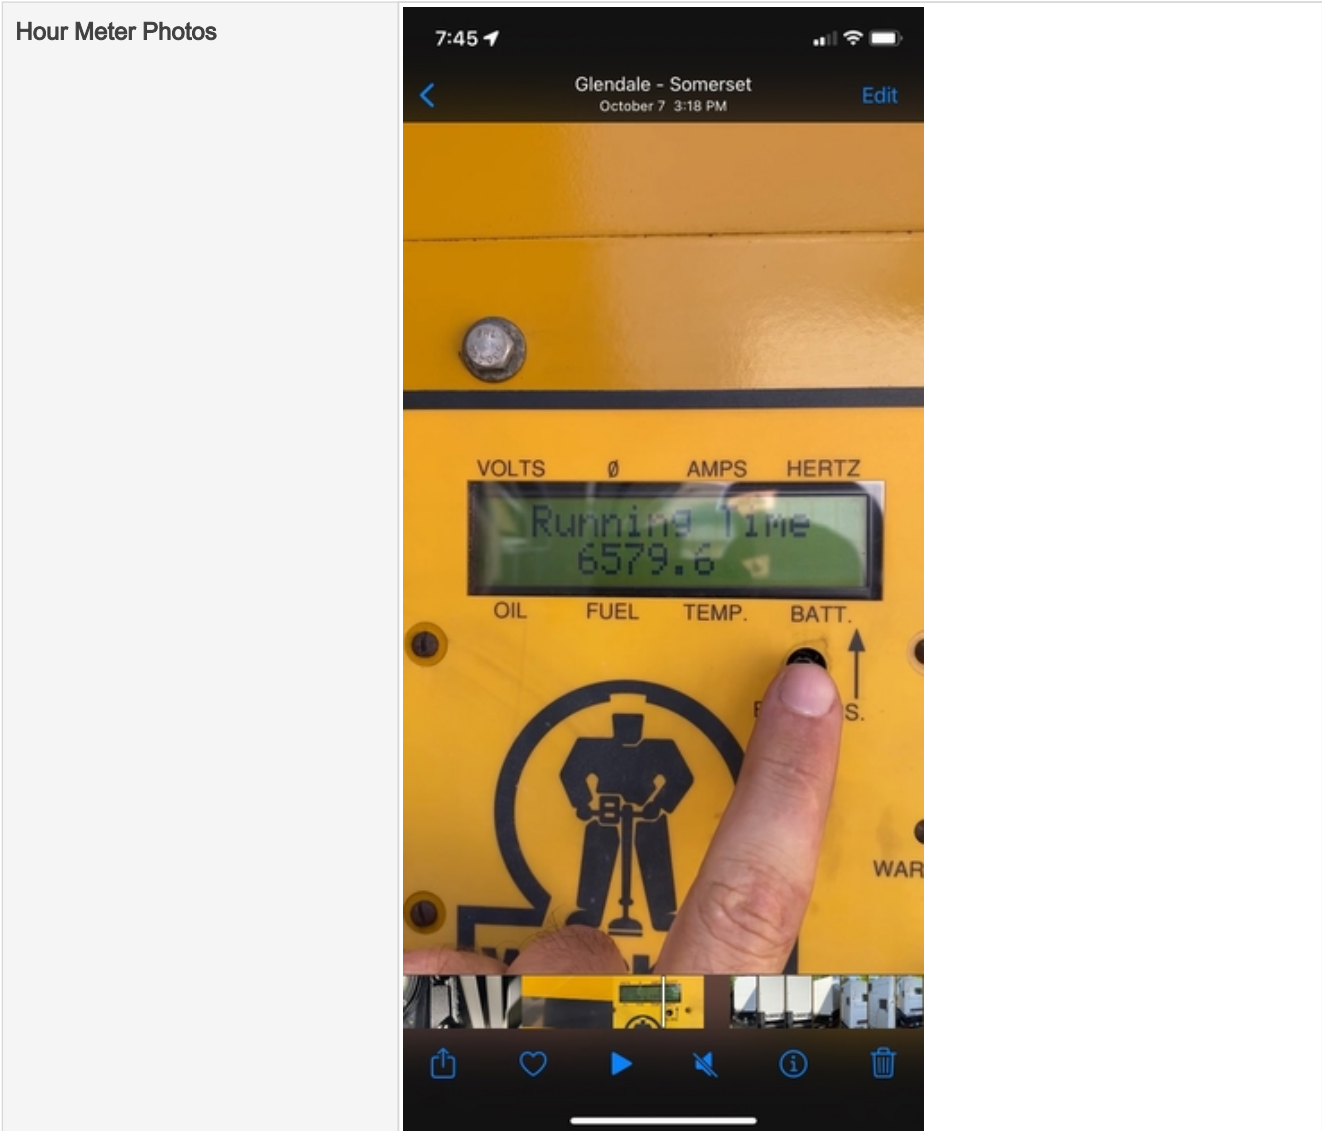
Hour Meter	3 - Normal Wear & Tear
------------	------------------------

RPM Display	3 - Normal Wear & Tear
Volt Display	3 - Normal Wear & Tear
Pressure Display	3 - Normal Wear & Tear
Menu Display	3 - Normal Wear & Tear
Display Screen Appearance	3 - Normal Wear & Tear

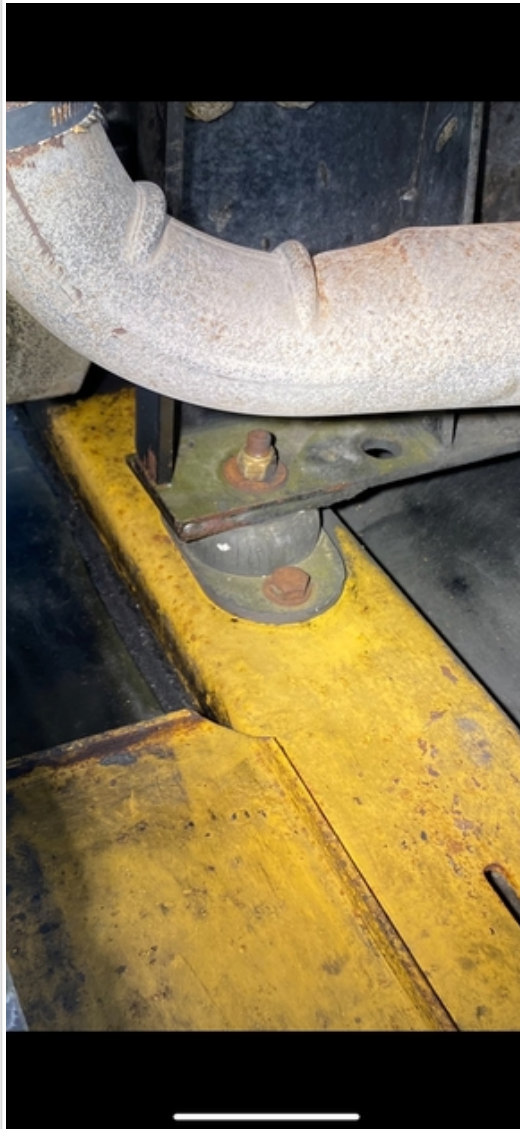
Mounting Plate Photos

Overall Mounting Plate Appearance	3 - Normal Wear & Tear
-----------------------------------	------------------------

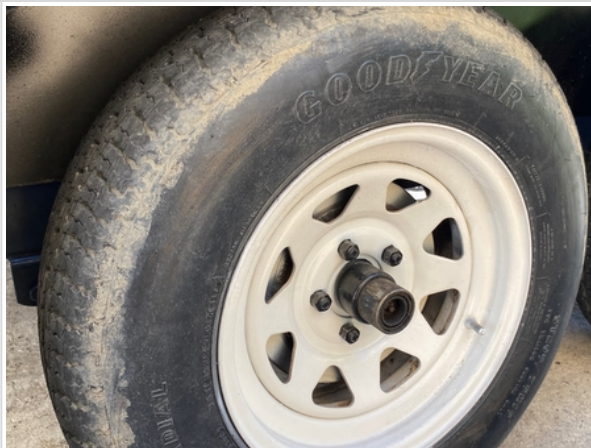
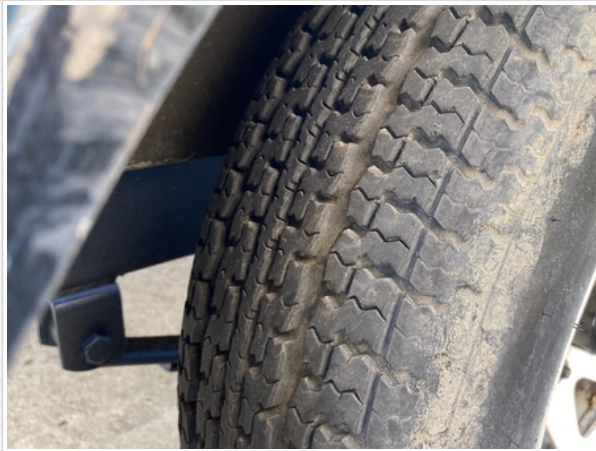
Loose Lugs	No
Tire Brand	Goodyear
Tire Size	ST205/75R/15
Front Left Tire - Ratio Remaining	50%
Front Right Tire - Ratio Remaining	50%
Rear Right Tire - Ratio Remaining	50%
Rear Left Tire - Ratio Remaining	50%
