Inspection Report (Wheel Loader)

Year	1981
Make	CAT
Model	930B - unit 15-101
Serial Number	41K10862
Hour Meter Reading	4,018
Previous Application (e.g., earth moving, mining, demolition, etc)	General Construction excavation

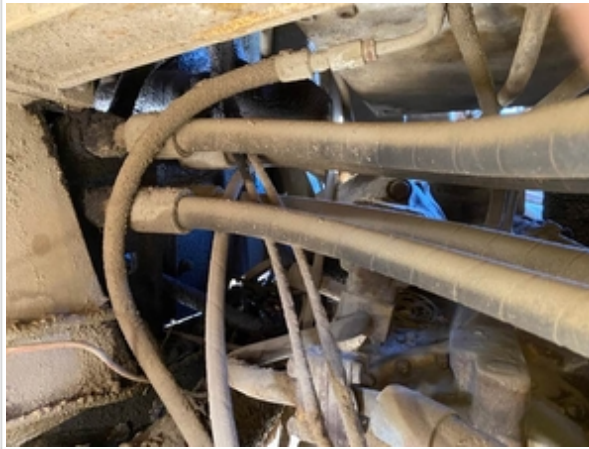
Appearance of Hydraulic Lines /
Fittings Photos

Hydraulics Overall	
Wet or Damp Hydraulic Lines / Fittings	Yes
Appearance of Hydraulic Lines / Fittings	3
Hydraulic Lines / Fittings Condition	Active leaks in hoses or fittings observed, Hydraulic lines & fittings are clean and in good condition, Other (see comments)
Comments	Some hoses showing signs of active leaks
