Inspection Report (Wheel Loader)

Year	2013
Make	CAT
Model	924K
Serial Number	PWR01937
Hour Meter Reading	17,642
Previous Application (e.g., earth moving, mining, demolition, etc)	General Construction

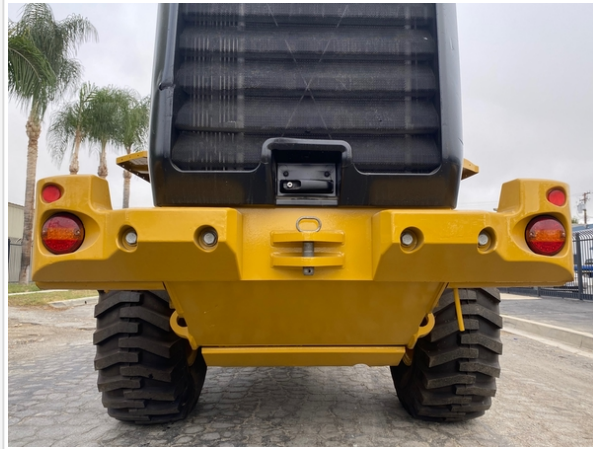
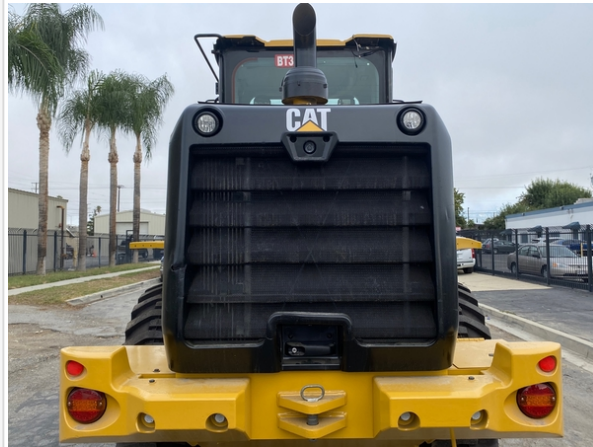
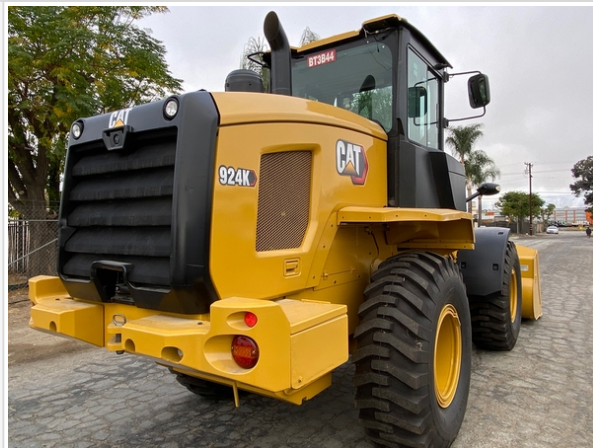
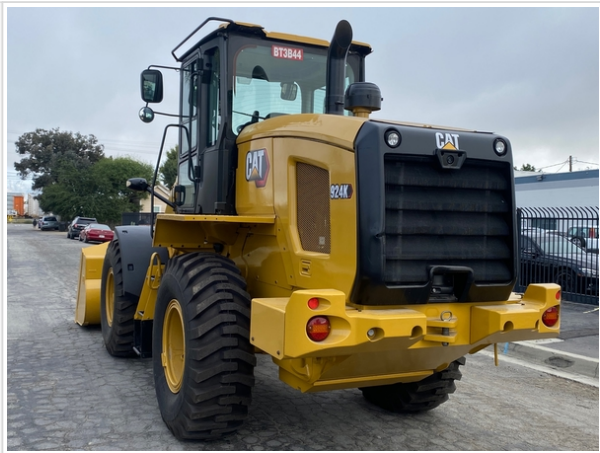
<p>Rear</p>	<p>4 - Like New, Recently Replaced</p>
<p>Rear Condition</p>	<p>No visible damage</p>
<p>Rear Photos</p>

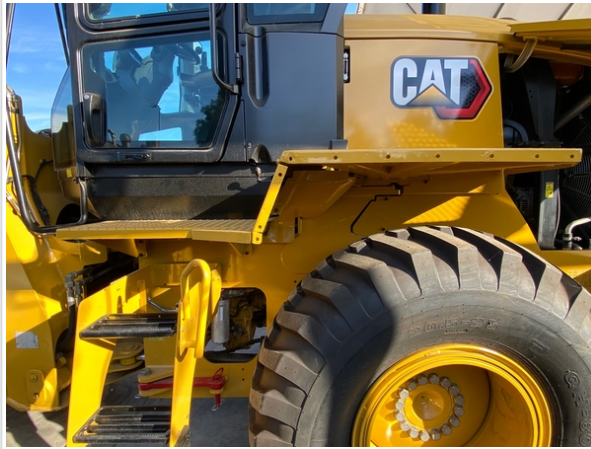
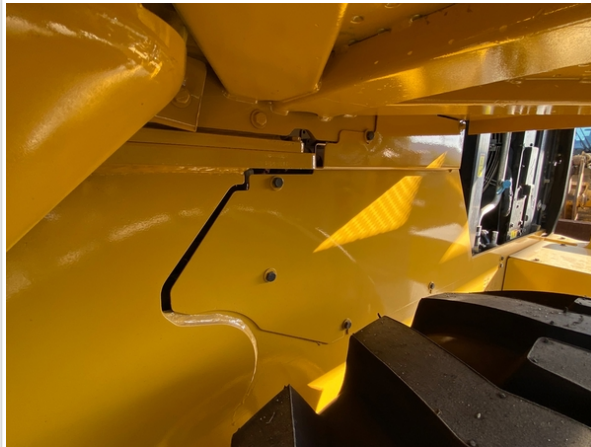
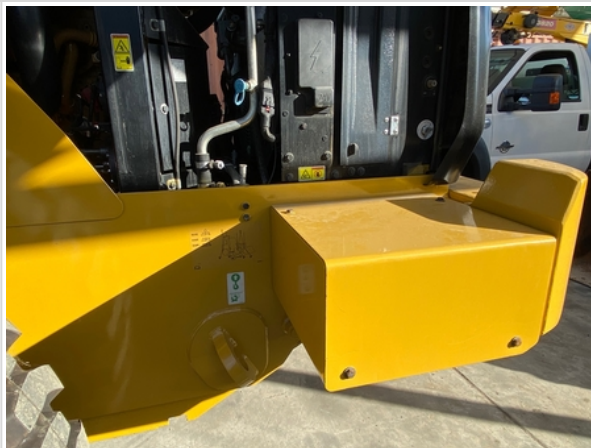
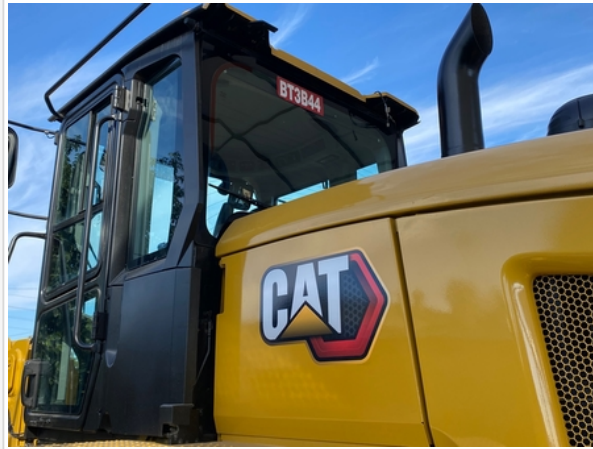
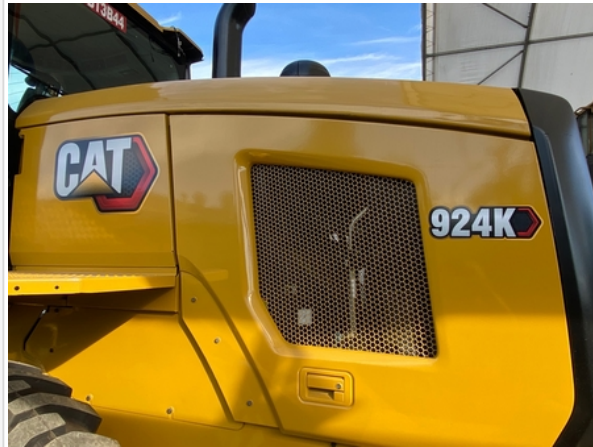
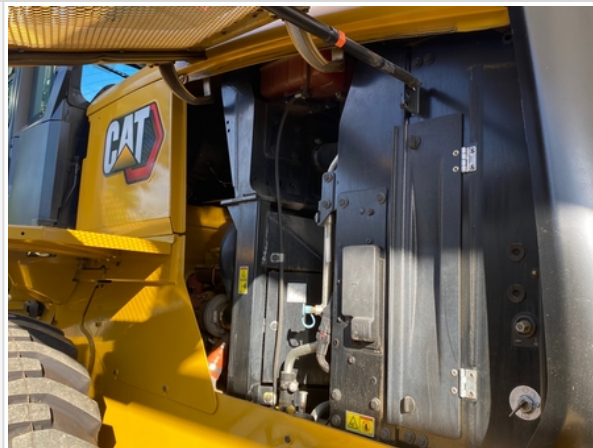
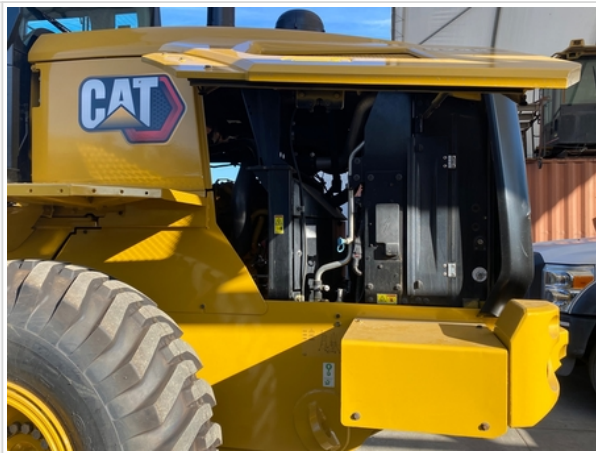
Left	4 - Like New, Recently Replaced	
Left Condition	No visible damage	
Left Photos

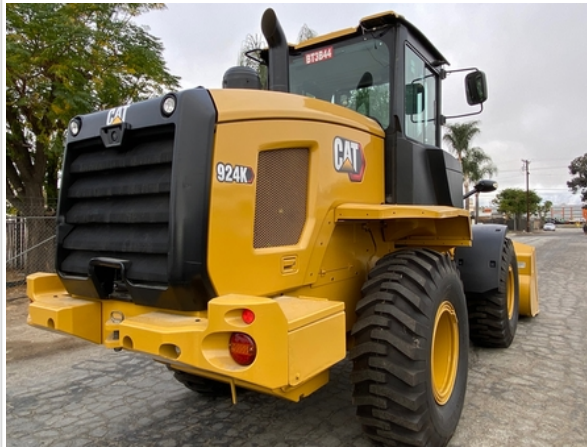
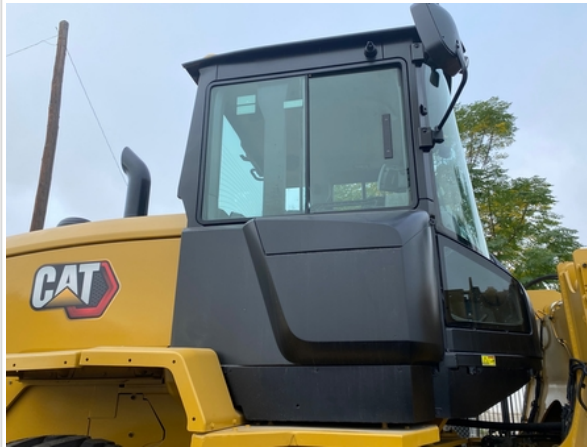
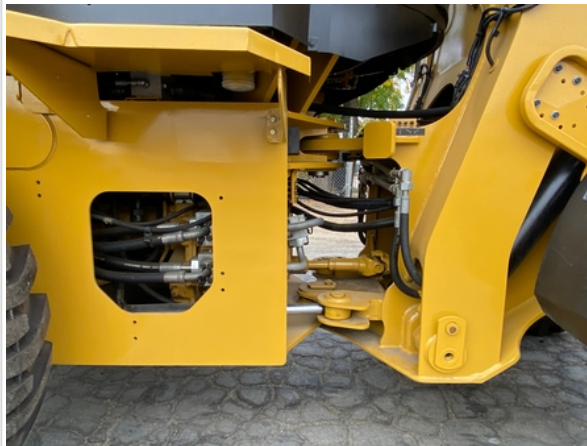
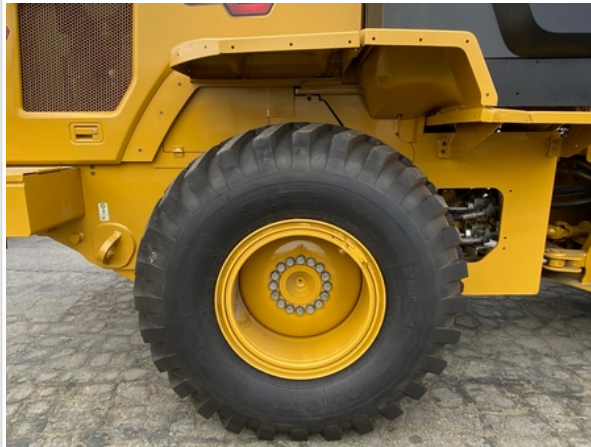
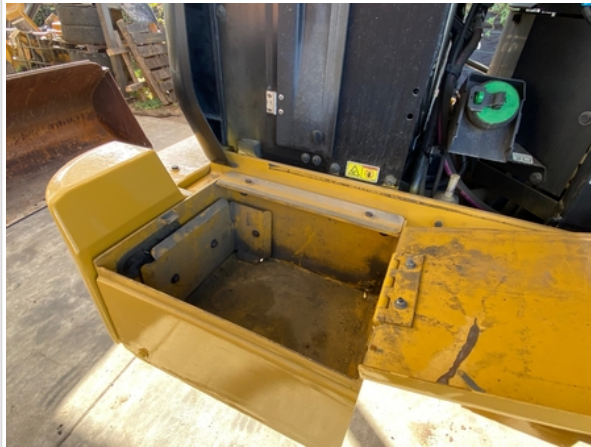
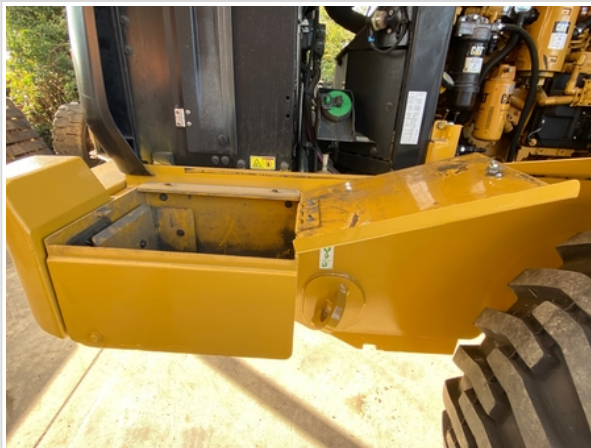
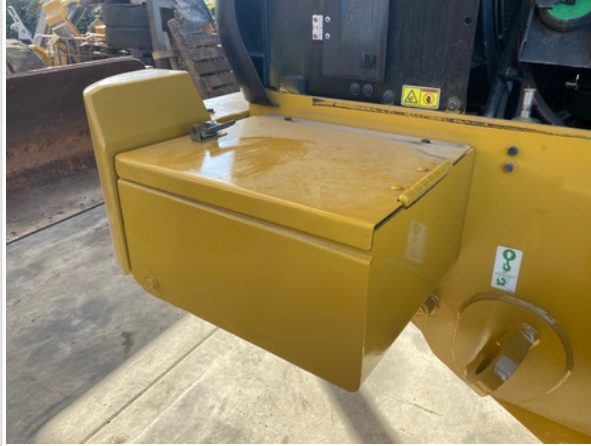
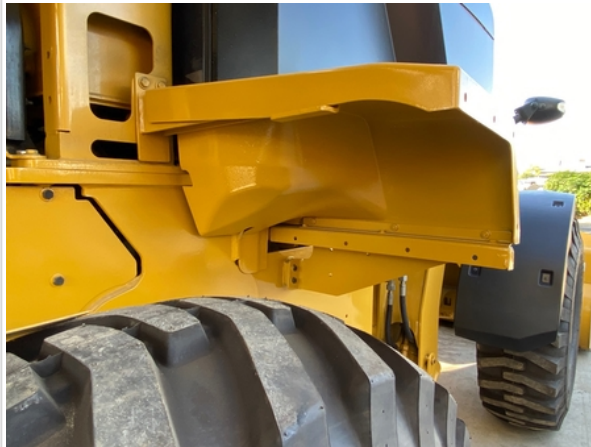
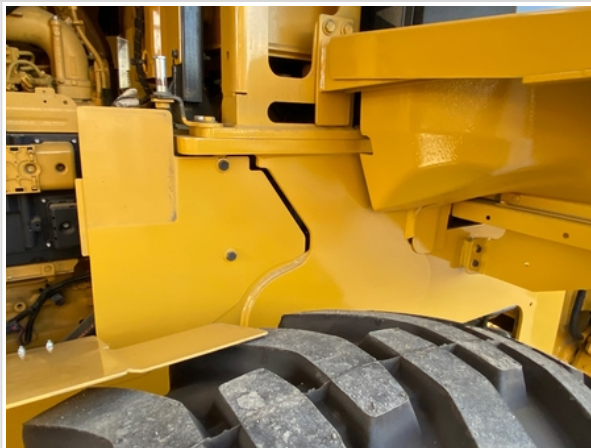
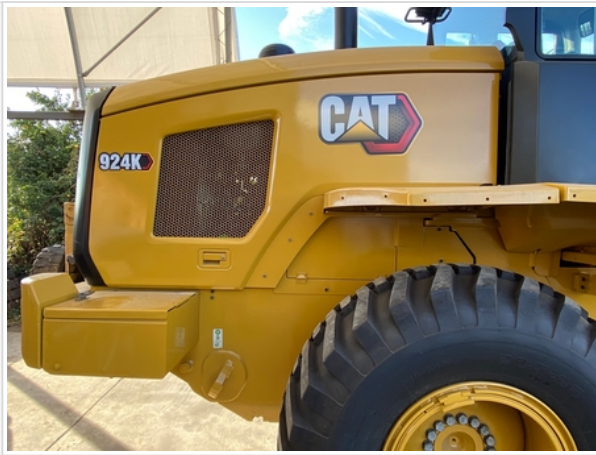
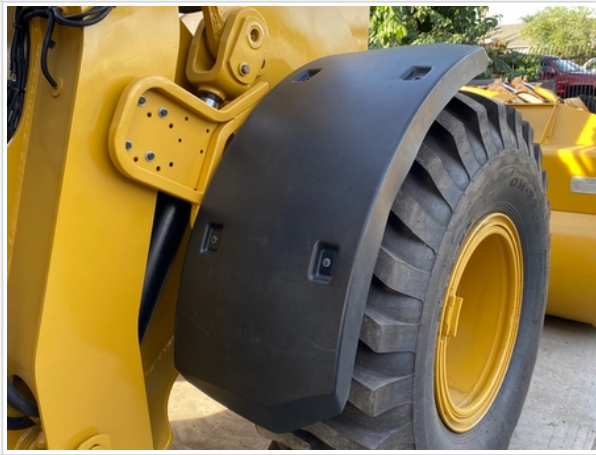
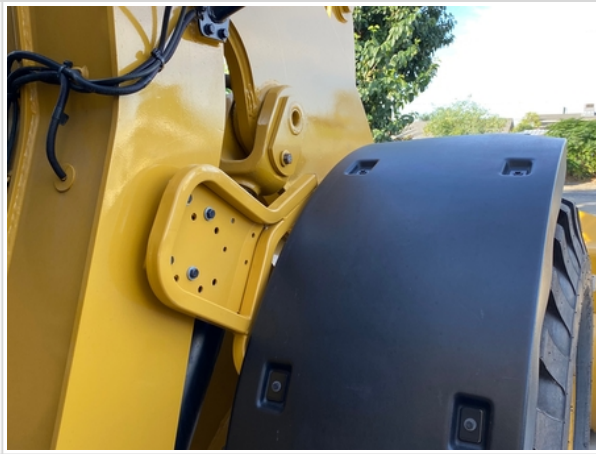
<p>Right</p>	<p>4 - Like New, Recently Replaced</p>	
<p>Right Condition</p>	<p>No visible damage</p>	
<p>Right Photos</p>

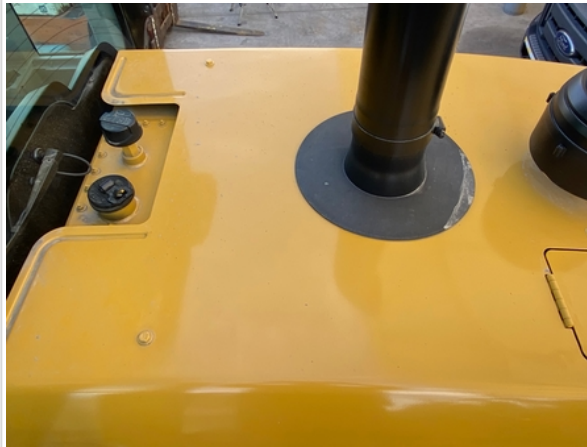
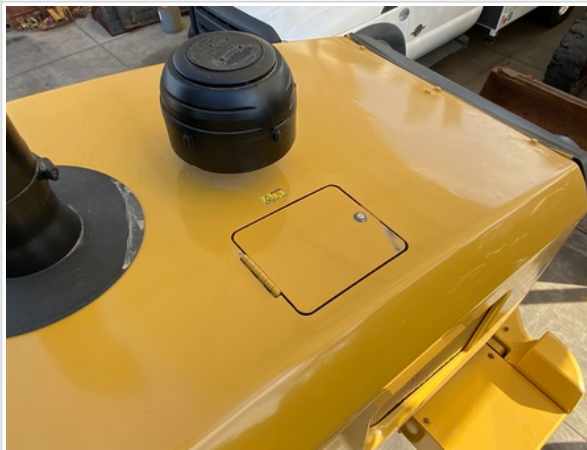
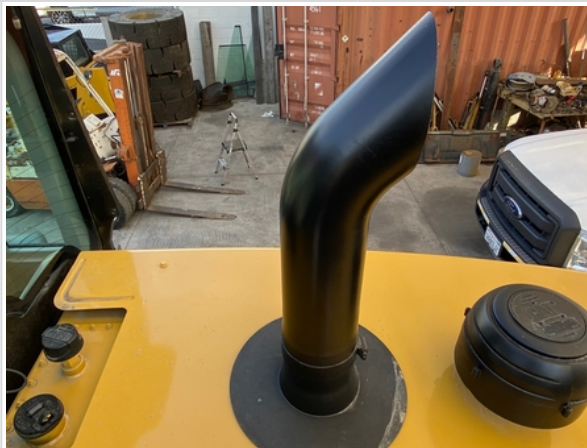
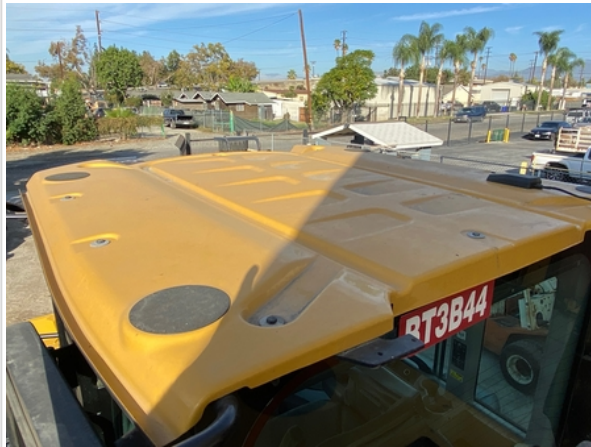
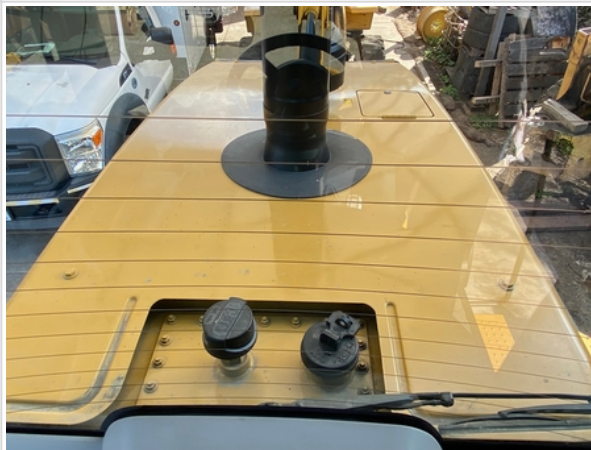
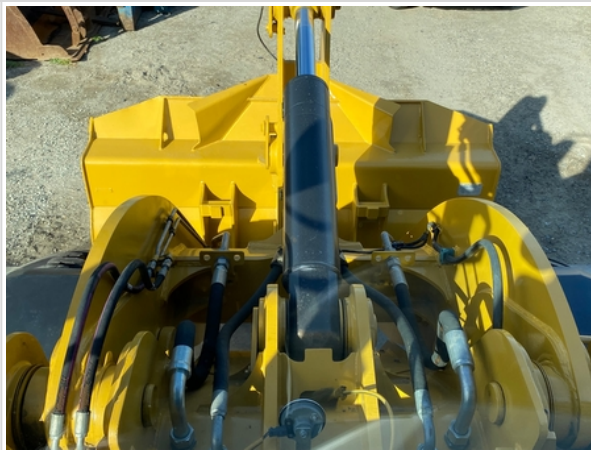
Upper Photos

<p>Upper</p>	<p>3 - Normal Wear & Tear</p>
<p>Upper Condition</p>	<p>No visible damage</p>

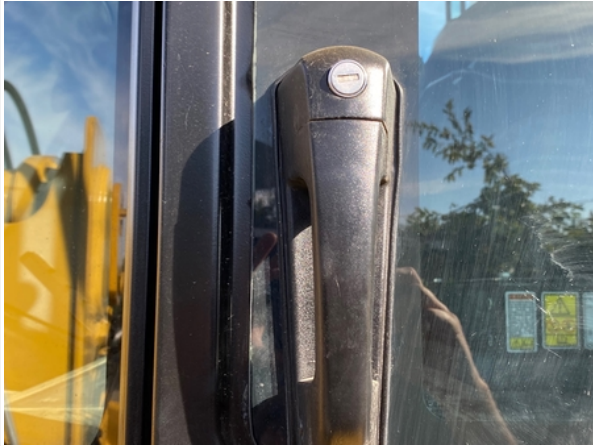
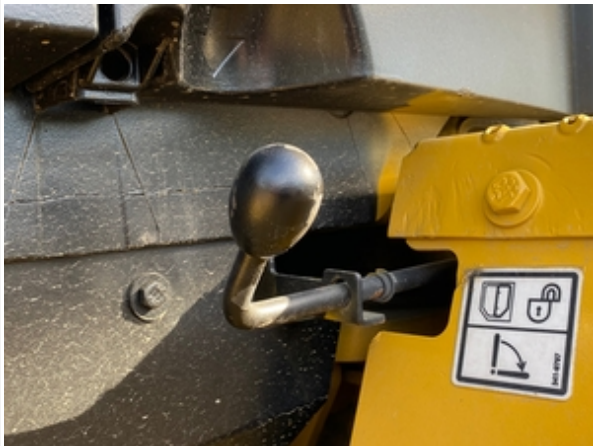
Body Panels (Any Rust Damage?)	3 - Normal Wear & Tear
Doors / Canopy Latches	3 - Normal Wear & Tear
Doors / Canopy Latches Condition	No visible damage
Doors / Canopy Latches Photos

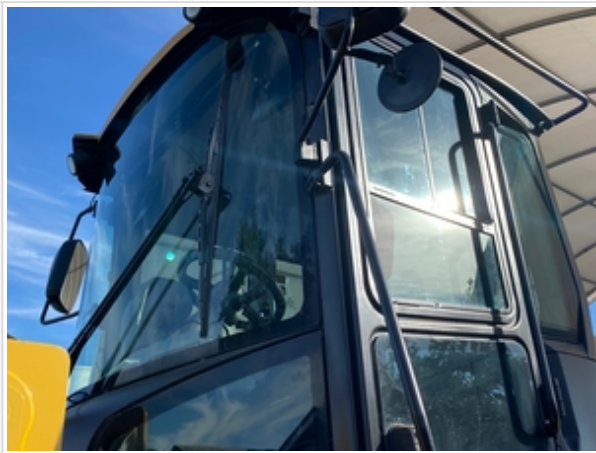
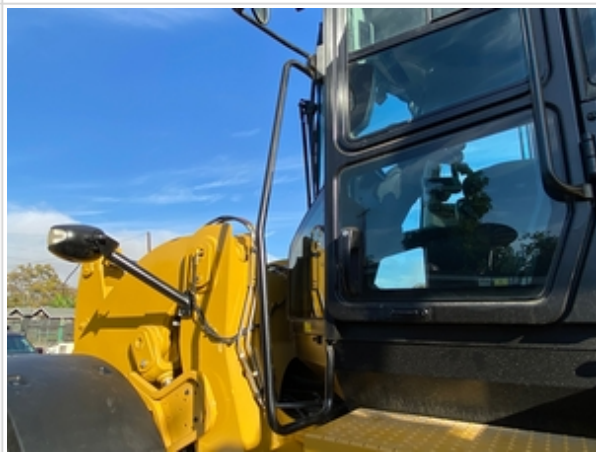
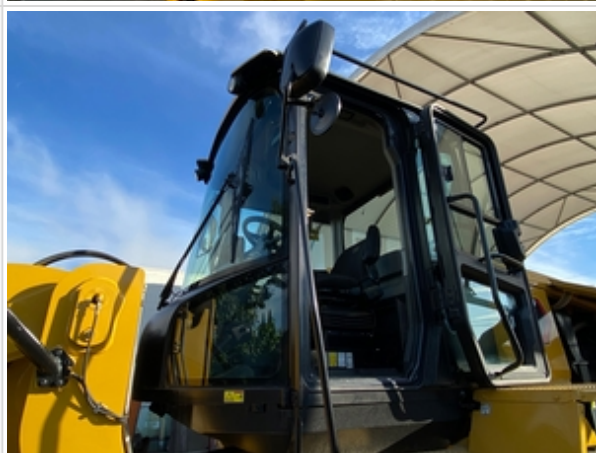
Glass Condition	3 - Normal Wear & Tear
Glass Condition Notes	Glass intact, no visible damage

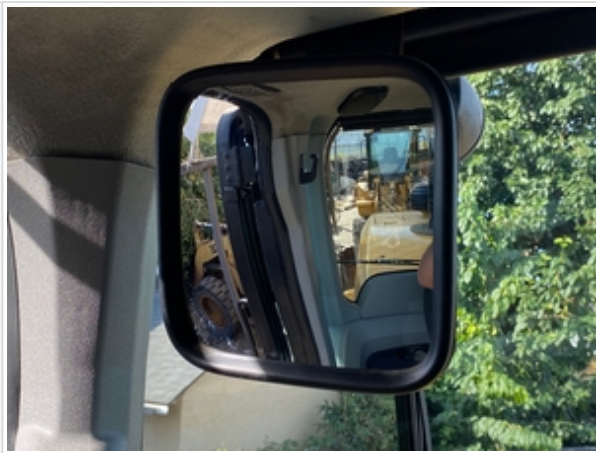
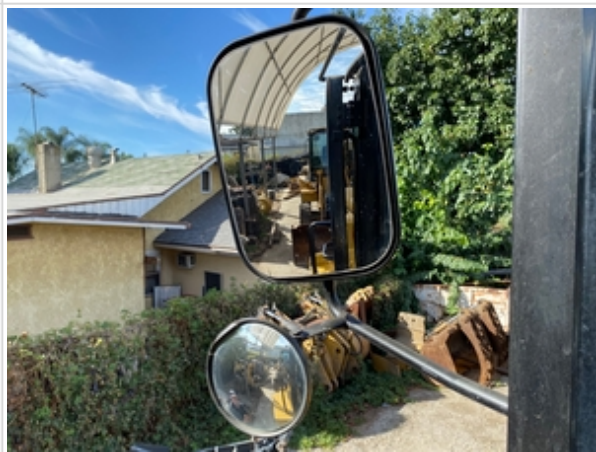
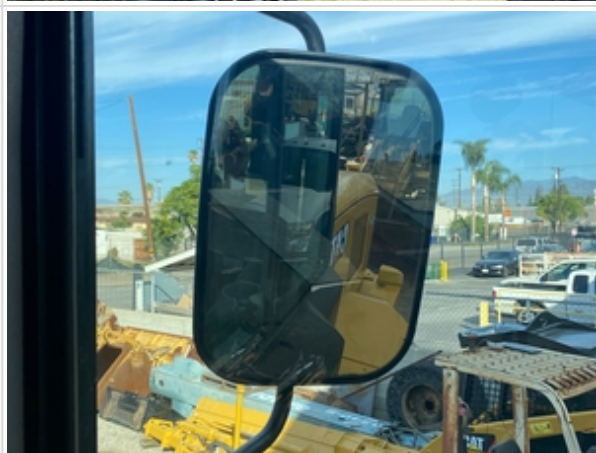
Mirrors	3 - Normal Wear & Tear	
Mirror Condition Notes	Mirrors present and intact, no visible damage	
Mirrors Photos

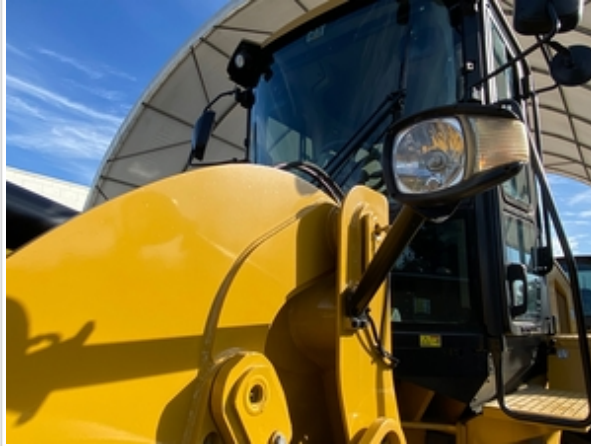
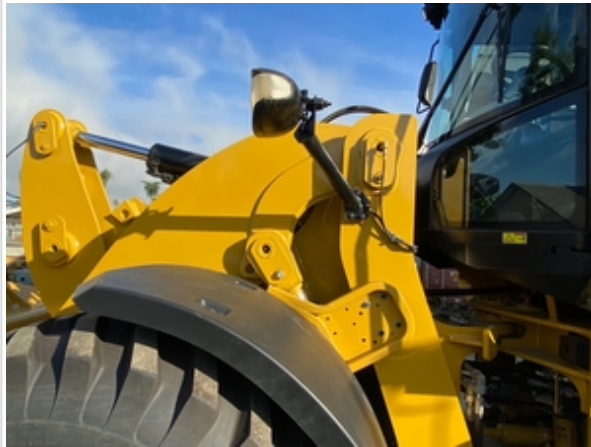
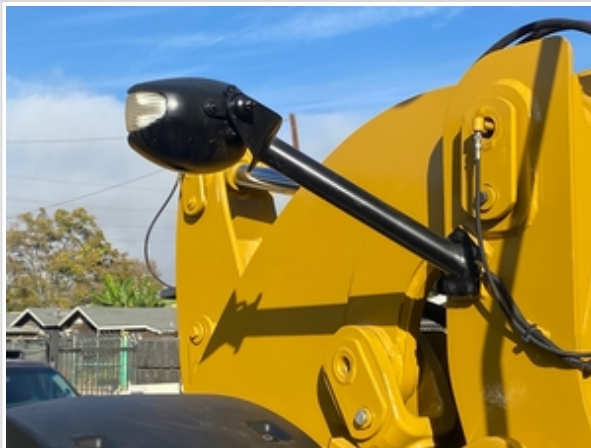
Lighting System Photos

Lighting System	3 - Normal Wear & Tear
Lighting System Condition	No visible damage, lighting system is operational

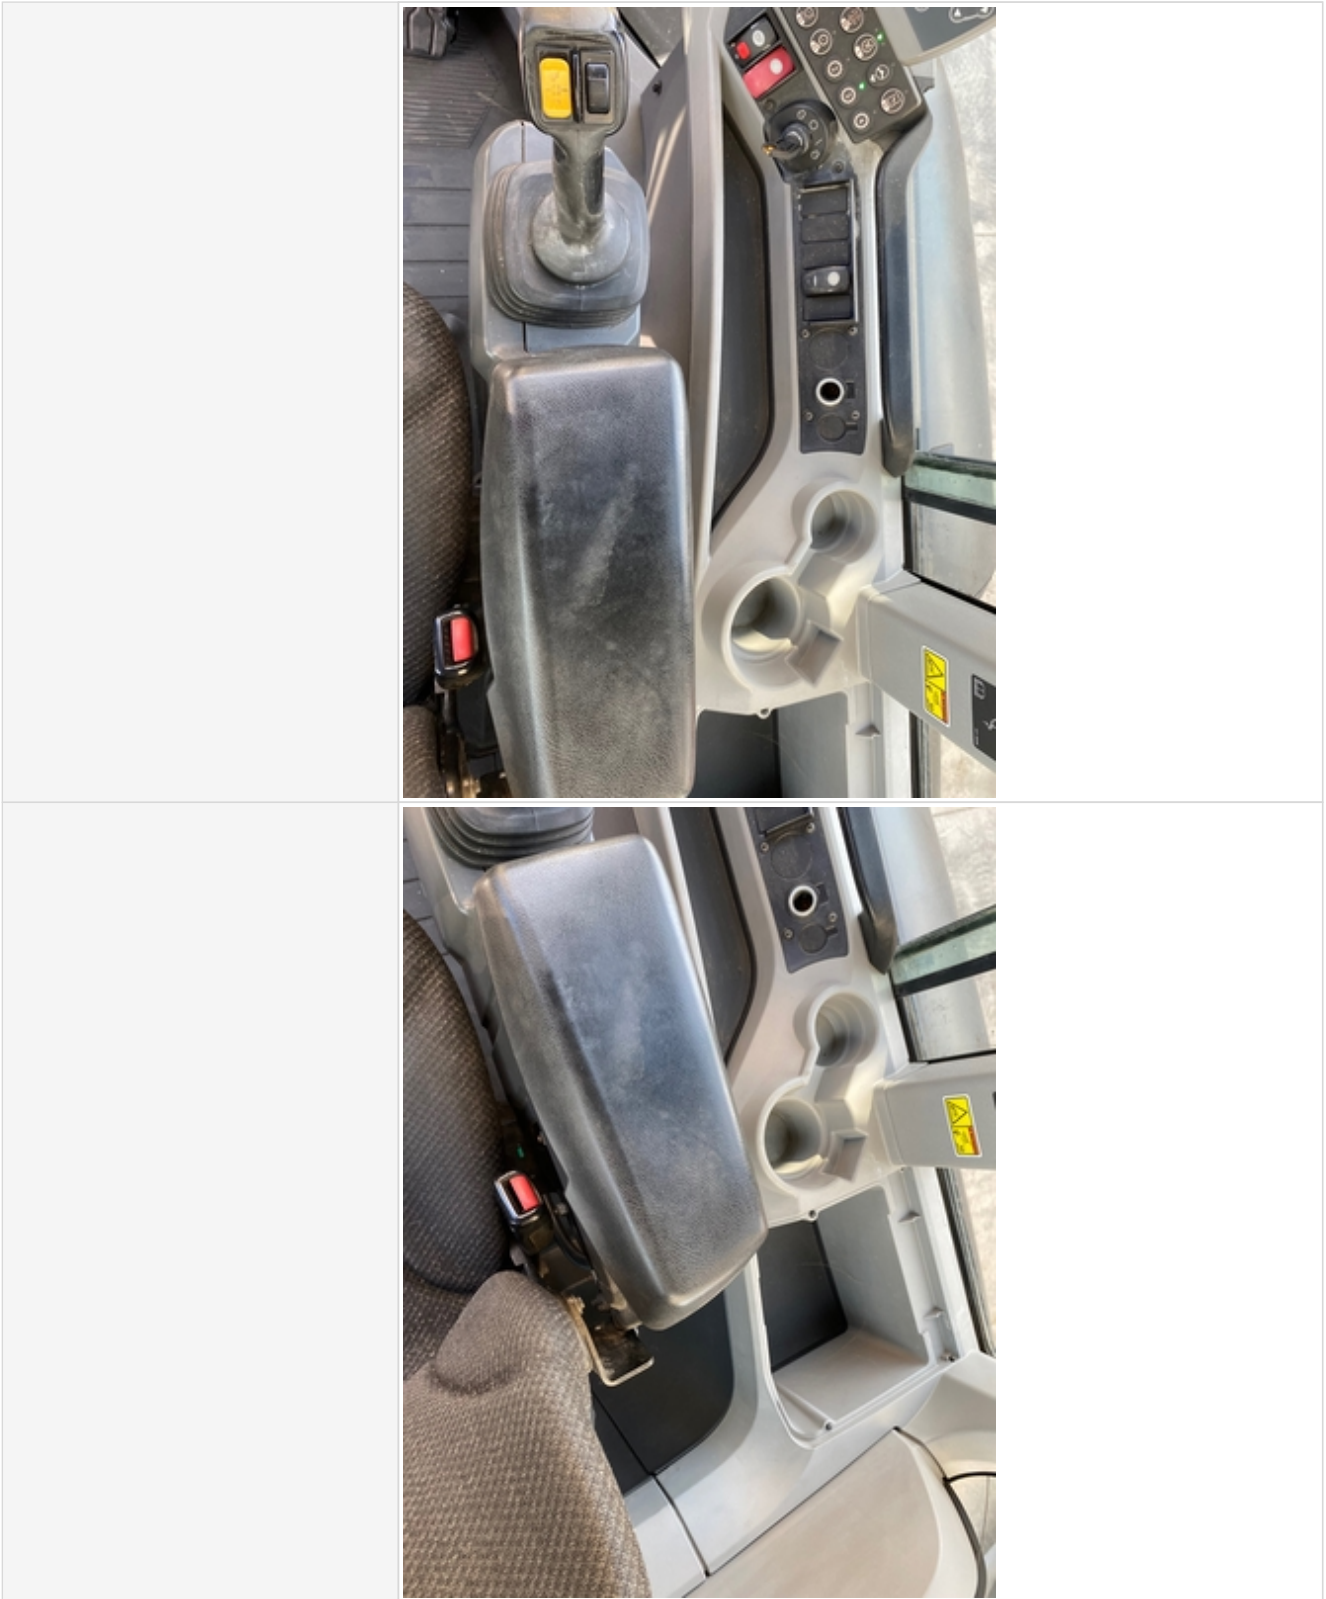
Operator Cabin Overall	3 - Normal Wear & Tear
Operator Cabin Overall Condition	Good cabin appearance, solid floors, panels, and ceiling
Operator Cabin Photos

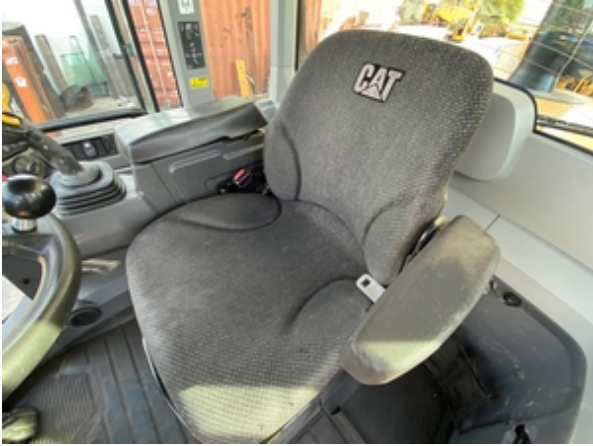
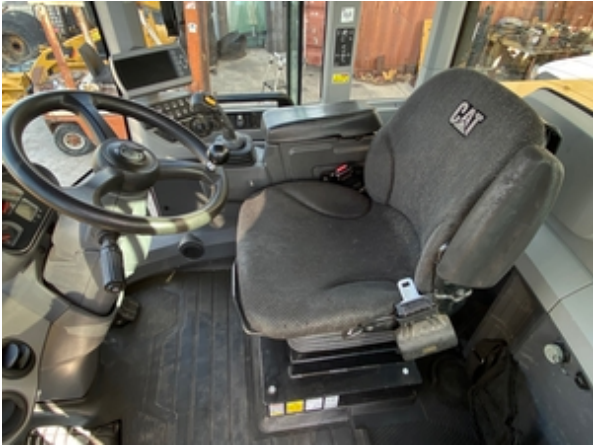
Operator's Seat & Arm Rests	3 - Normal Wear & Tear
Operator's Seat & Arm Rests Condition	Seat(s) in good condition, no stains or tears in upholstery
Operator's Seat & Arm Rests Photos

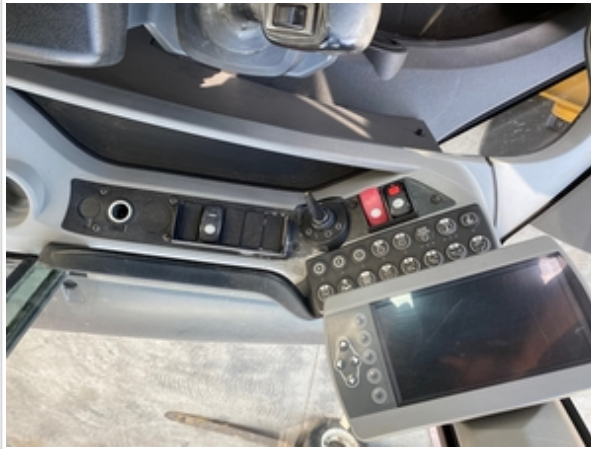
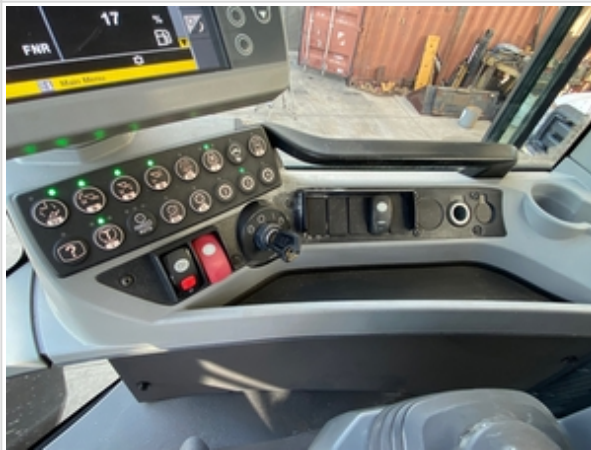
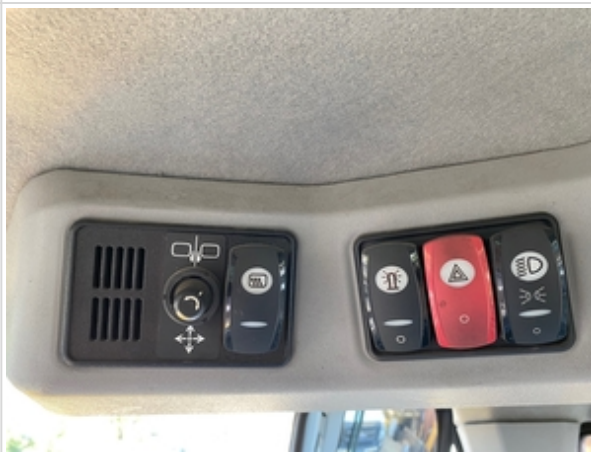
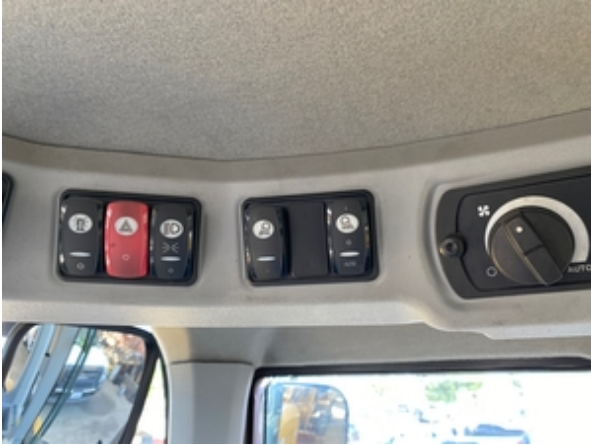
Seat Belt Photos	 
Cabin Lights	3 - Normal Wear & Tear
Cabin Lights Condition	Cabin lights are installed with all light covers in place, bulbs are installed and working properly
Cabin Lights Photos	 
Safety Lock Out / Stop	3 - Normal Wear & Tear
Safety Lock Out / Stop Condition	Safety lock out device is present, in good condition, and functional
Controls & Switches	3 - Normal Wear & Tear
Controls & Switches Condition	All switches are installed and functional
Controls & Switches Photos

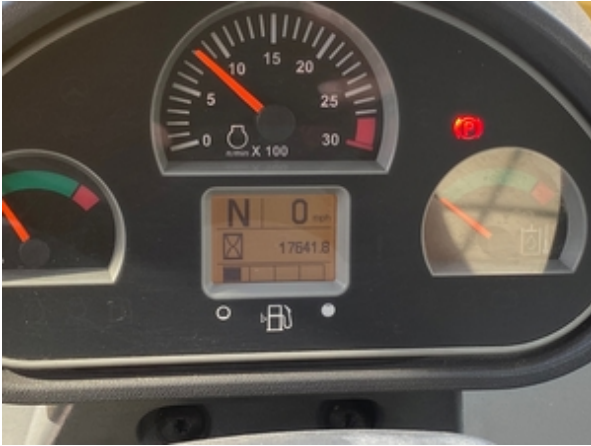
Hour Meter Activity	3 - Normal Wear & Tear
Hour Meter Condition	Hour meter is functional and in good condition
Hour Meter Activity Photos

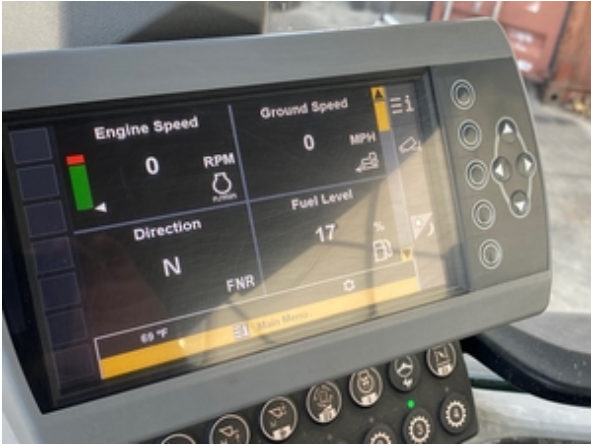
Other Gauge Activity	3 - Normal Wear & Tear
Other Gauge Condition	All cockpit gauges are functional and in good condition
Other Gauge Activity Photos

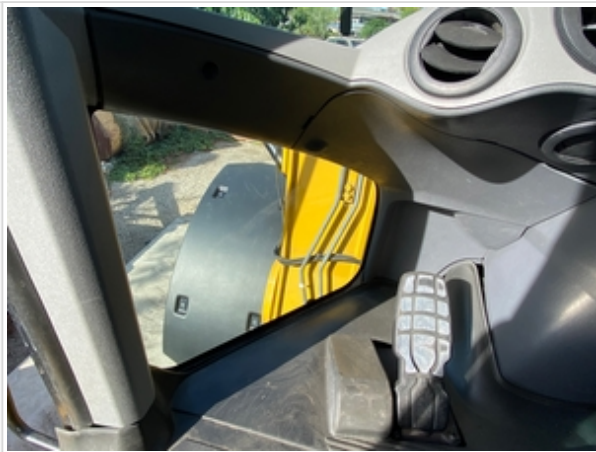
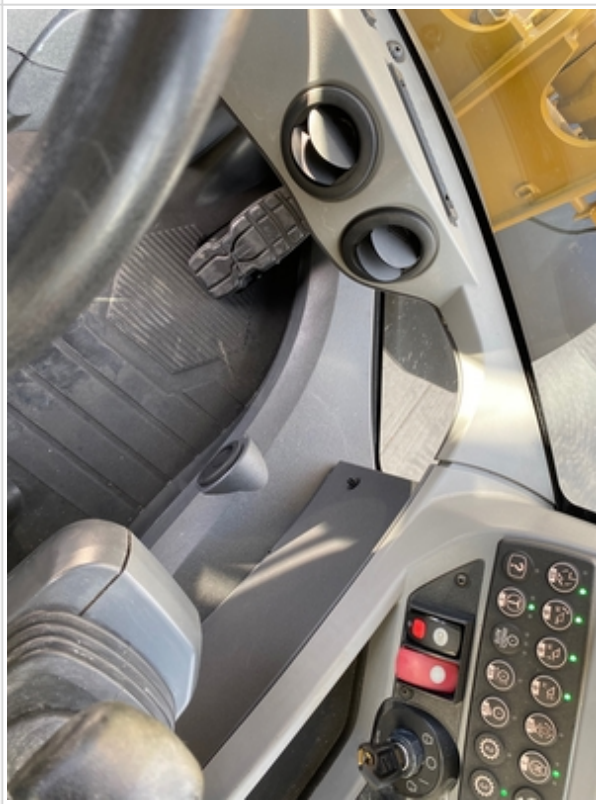
<p>Fans / Vents</p>	<p>3 - Normal Wear & Tear</p>	
<p>Fans / Vents Condition</p>	<p>Fan vents are functional, in good condition, and move through a full adjustable range of motion</p>	
<p>Fans / Vents Photos</p>

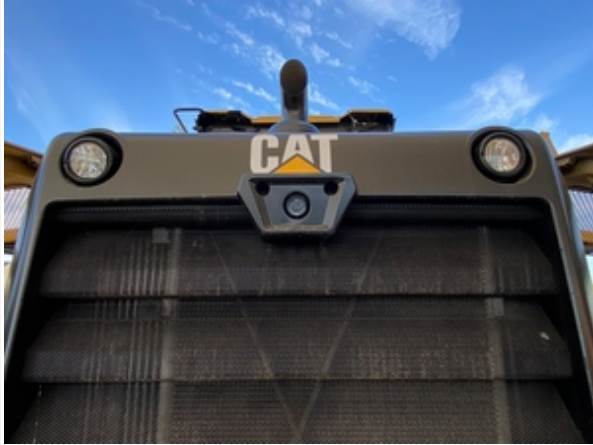
Backup Camera Photos

Travel Alarm	3 - Normal Wear & Tear
Travel Alarm Condition	Travel alarm is installed and functioning as expected
Horn	3 - Normal Wear & Tear
Horn Condition	Horn is installed and functioning as expected
Backup Camera	3 - Normal Wear & Tear
Backup Camera Condition	Back up camera is installed and functioning as expected

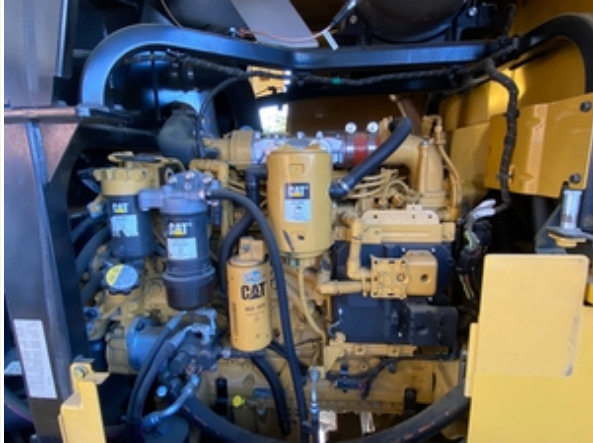
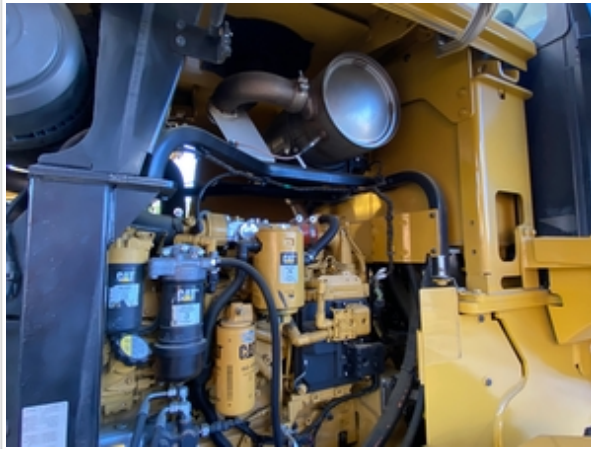
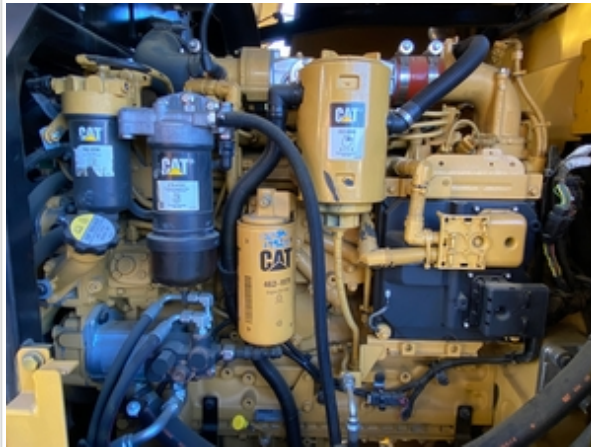
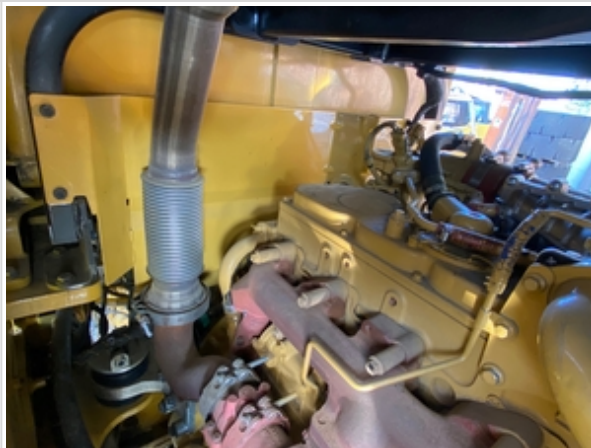
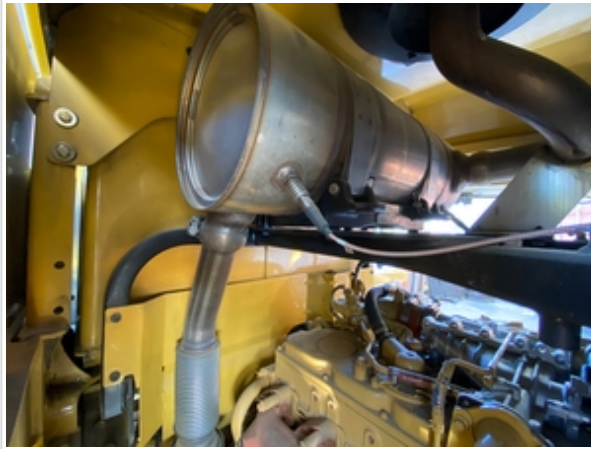
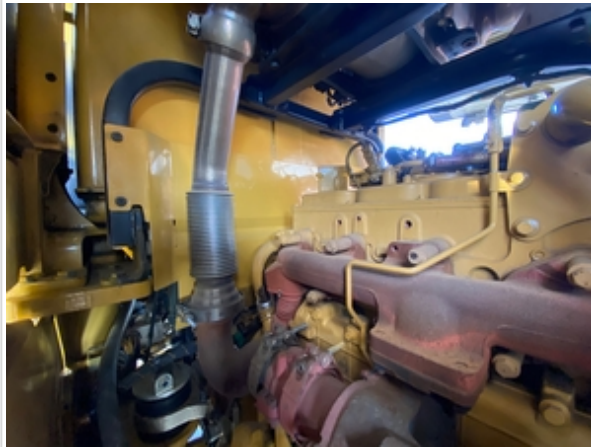
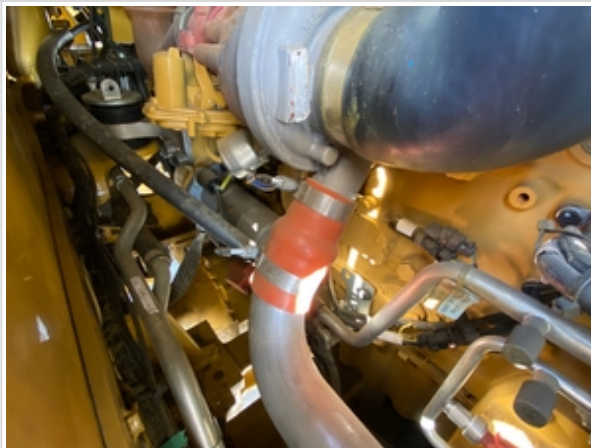
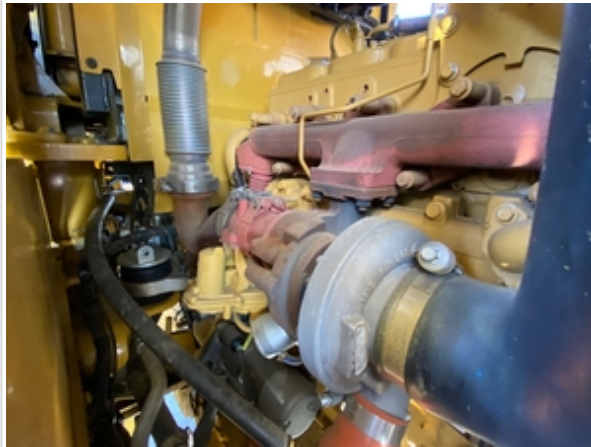
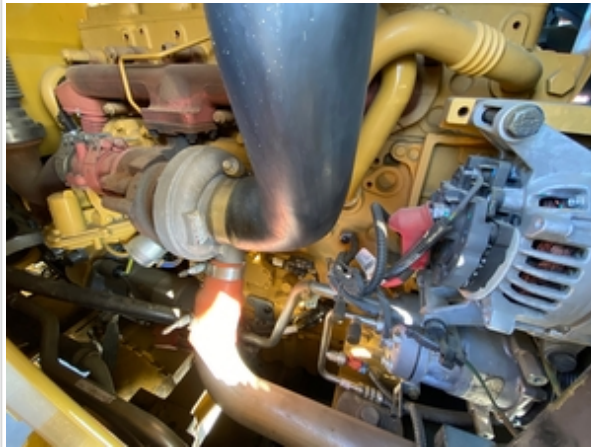
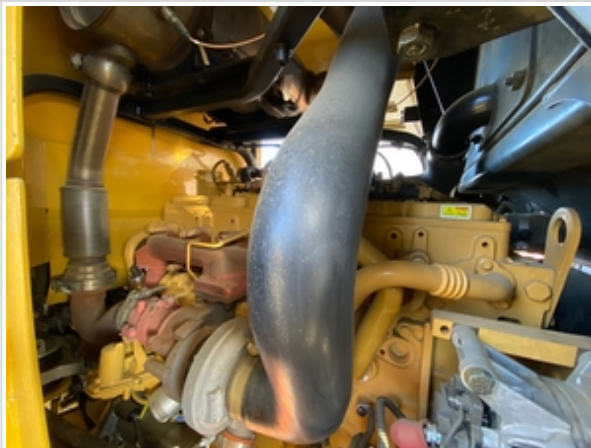
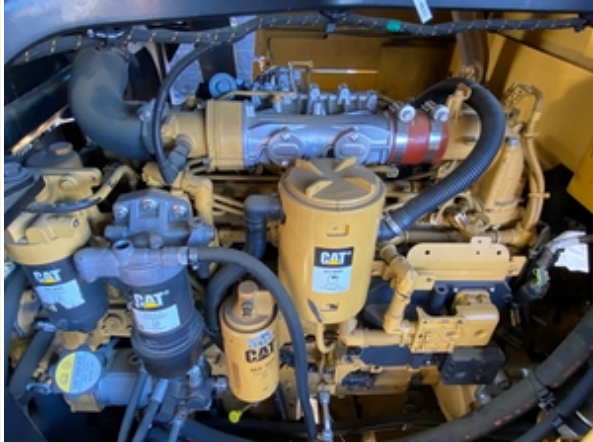
Requires DEF (Diesel Exhaust Fluid)	No
Overall Engine Appearance	Clean & dry
Overall Engine Comments	Overall engine in solid condition. Engine runs and sounds healthy. Super clean engine compartment and no active leaks found.

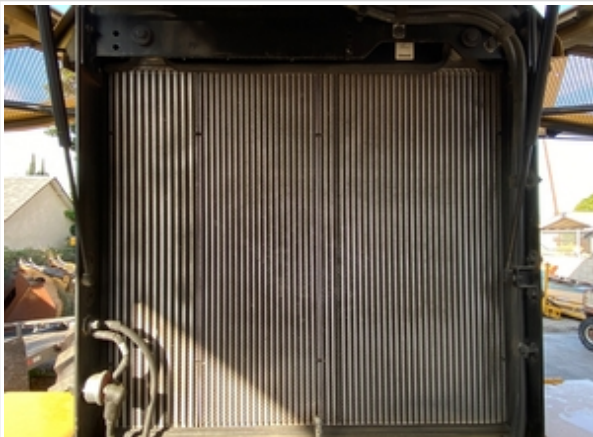
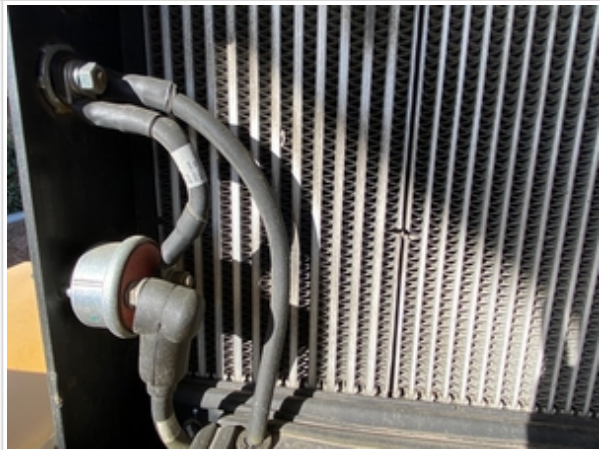
Blow-by (Visual Observation Check)	No	
Unusual Noises (Upon Start-up, Idle, Shutdown)	No	
Unusual Noise Notes	No unusual noises heard	
Engine Smoke (Upon Start-up, Idle, Shutdown)	No	
Engine Smoke Notes	No engine smoke issues observed	
Engine Exhaust Color	Clear	
Battery	3 - Normal Wear & Tear	
Battery Condition	Clean & dry appearance, tight connections	
Radiator	3 - Normal Wear & Tear	
Radiator Condition	Radiator fins & components appear to be in good working order, no signs of damage or leaks	
Radiator Photos

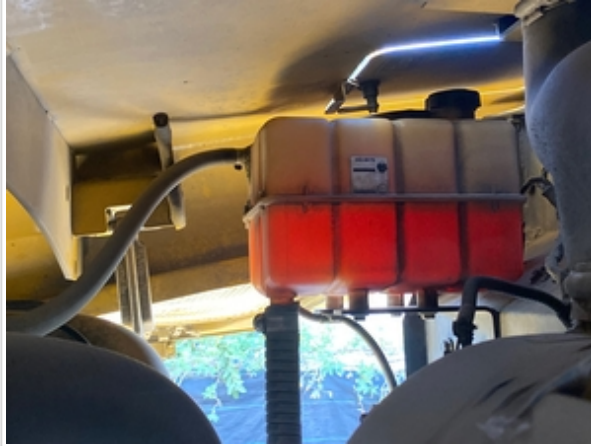
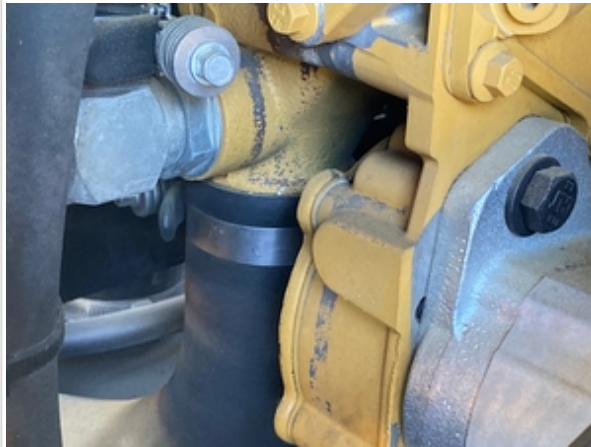
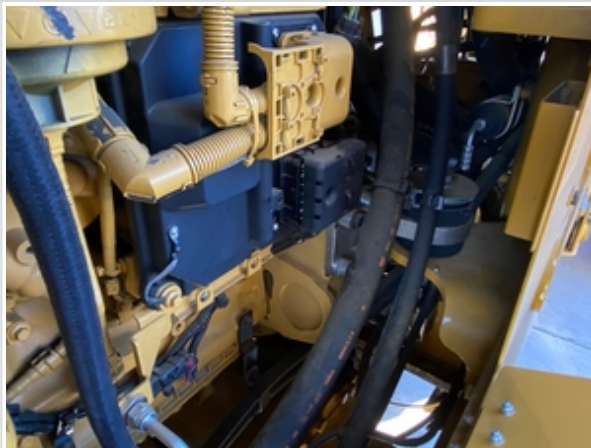
Belts	3 - Normal Wear & Tear	
Belt Condition	Belts appear in good condition & alignment with proper tension	
Hoses	3 - Normal Wear & Tear	
Hose Condition	Firm, pliant hoses with no signs of wear or leaks	
Hose Photos
