Inspection Report (Wheel Loader)

Year	2013
Make	CAT
Model	924K
Serial Number	PWR01937
Hour Meter Reading	17,642
Previous Application (e.g., earth moving, mining, demolition, etc)	General Construction

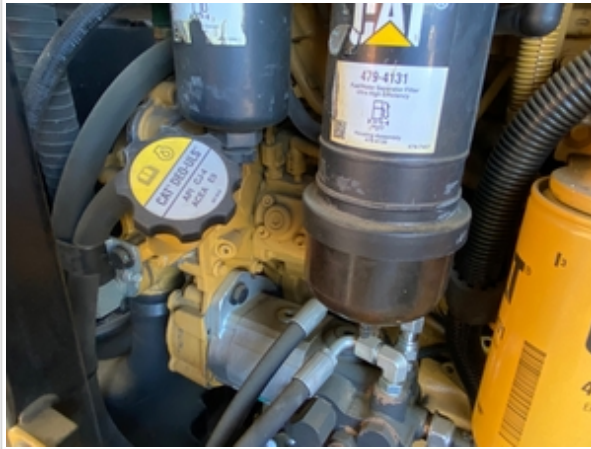
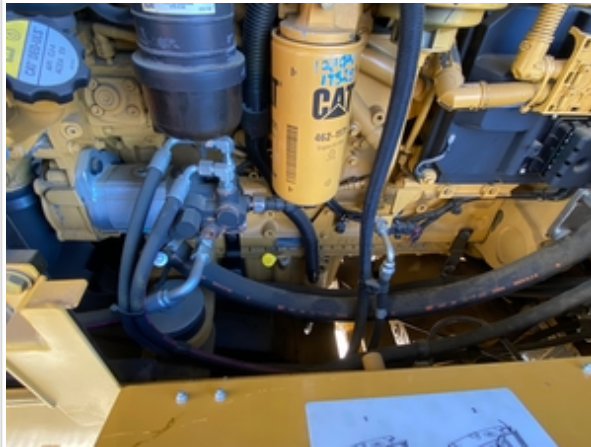
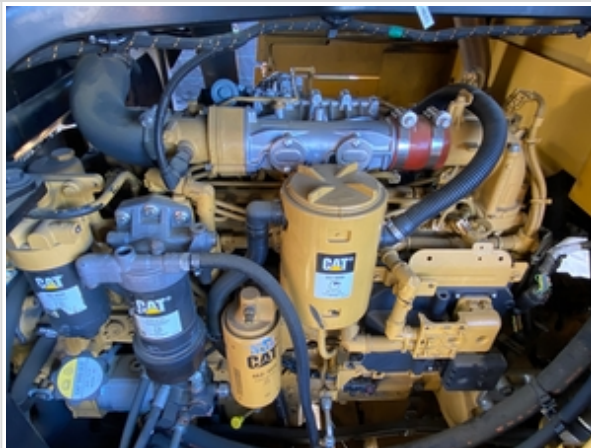
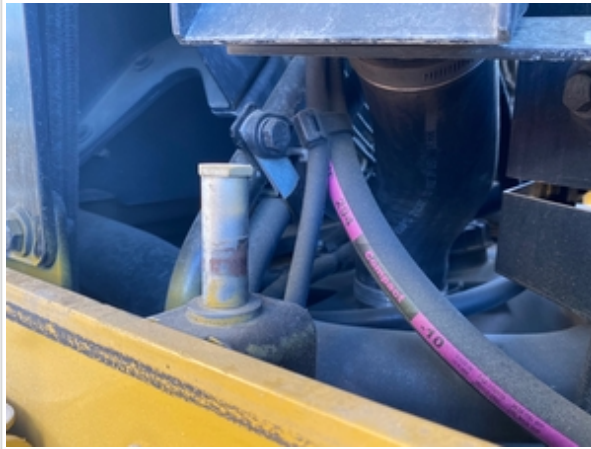
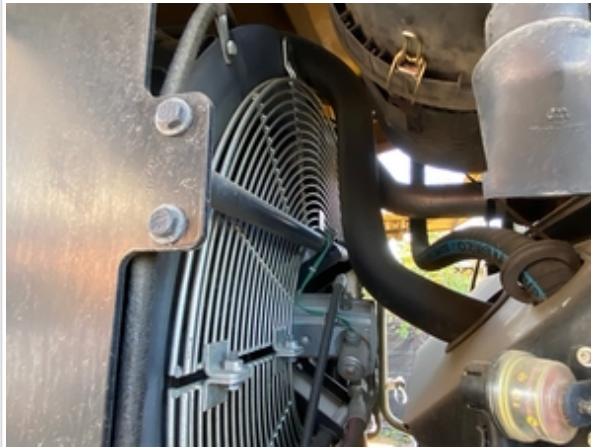
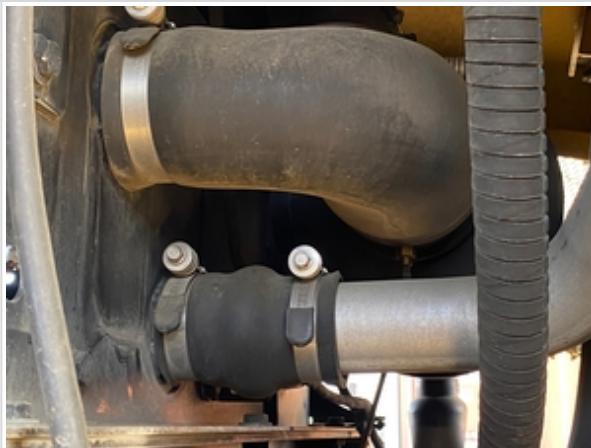
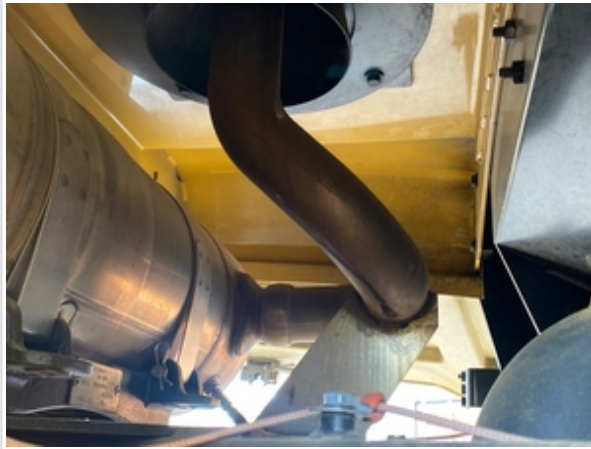
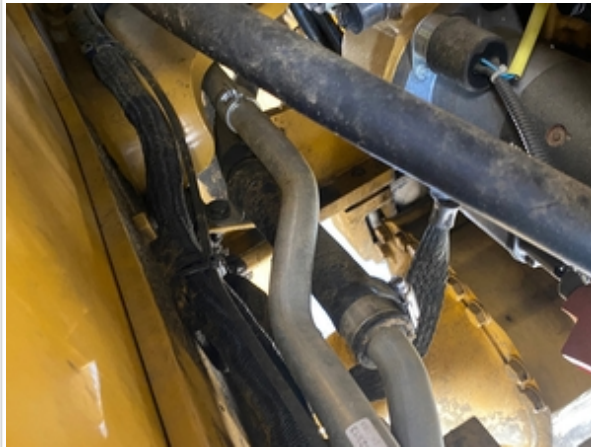
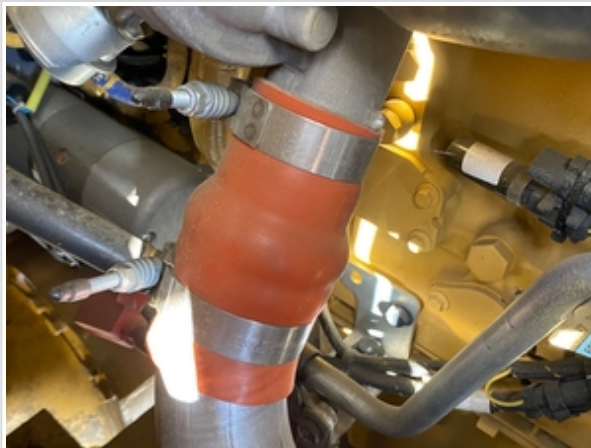
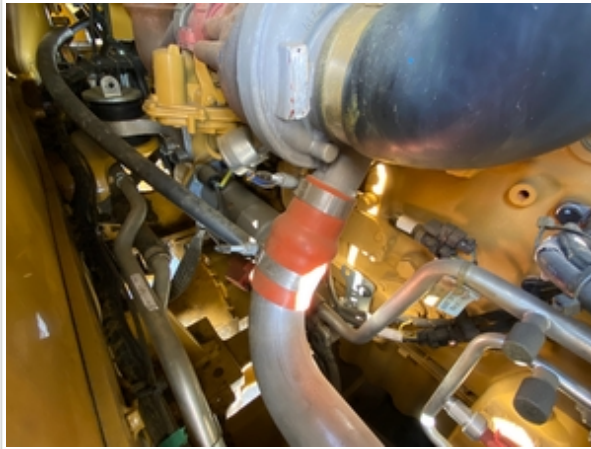
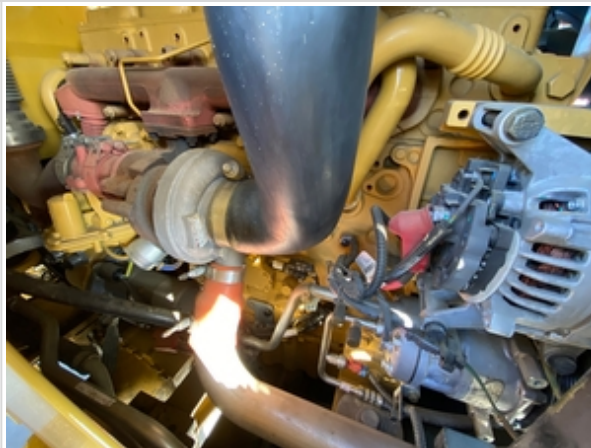
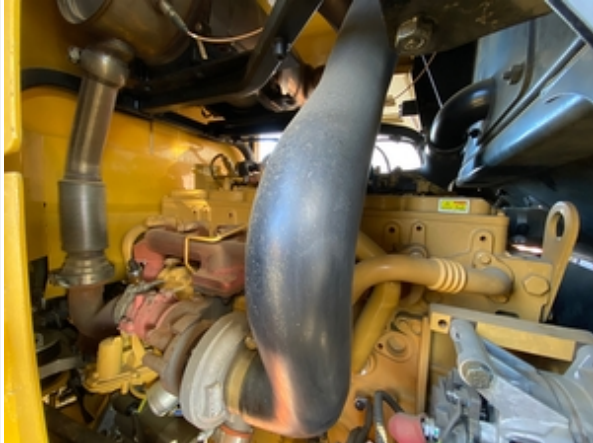
Belts	3 - Normal Wear & Tear	
Belt Condition	Belts appear in good condition & alignment with proper tension	
Hoses	3 - Normal Wear & Tear	
Hose Condition	Firm, pliant hoses with no signs of wear or leaks	
Hose Photos

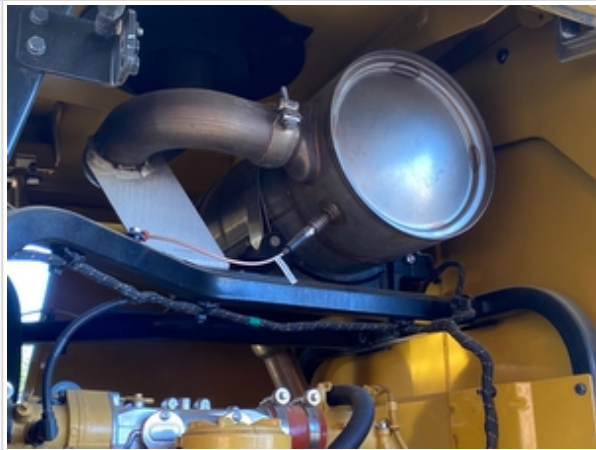
Water Pump	3 - Normal Wear & Tear	
Water Pump Condition	No unusual pump noises heard	
Cooling System Leaks	No	
Coolant Color / Appearance	3 - Normal Wear & Tear	
Coolant Color/Appearance Notes	Normal Translucent appearance, no visual signs of contamination	
Oil Leaks	No	
Oil Color / Appearance	3 - Normal Wear & Tear	
Oil Color / Appearance Notes	Clean oil appearance, no signs of cross contamination, Appropriate oil level	
Fuel Leaks	No	
Equipped with DPF (Diesel Particulate Filter)	Yes	
DPF Condition	3 - Normal Wear & Tear	
DPF Condition Notes	Filter housing is intact with no signs of damage or malfunction, DPF indicator is not illuminated	
DPF Photos

Requires DEF (Diesel Exhaust Fluid)	No
Overall Engine Appearance	Clean & dry
Overall Engine Comments	Overall engine in solid condition. Engine runs and sounds healthy. Super clean engine compartment and no active leaks found.

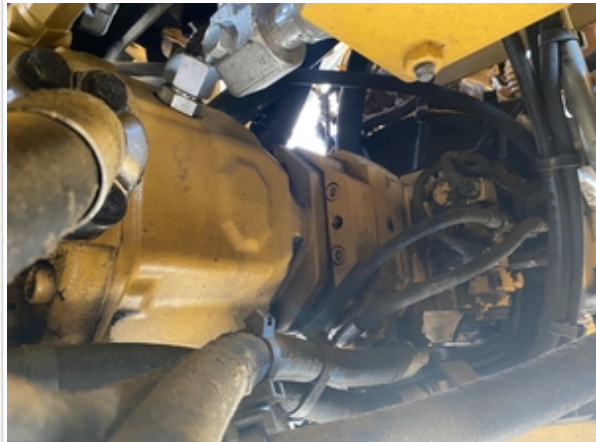
Hydrostatic Transmission?	Yes
2 Speed?	Yes
Hydrostatic Drive Configuration	Split Transmission
Drive Motors	2 - Above Average Wear
Comments	Speed ranges from 1 to 4
Drive Motor Photos

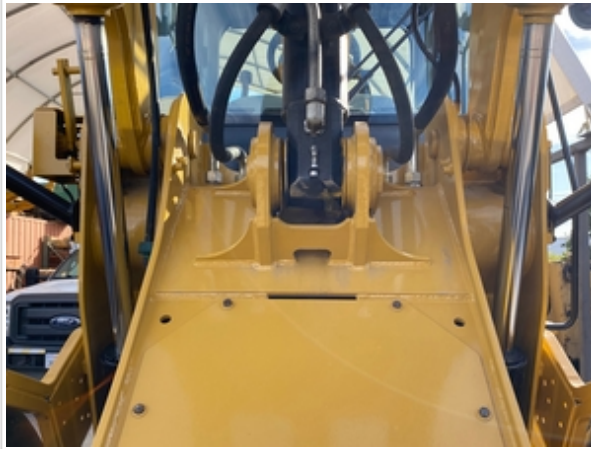
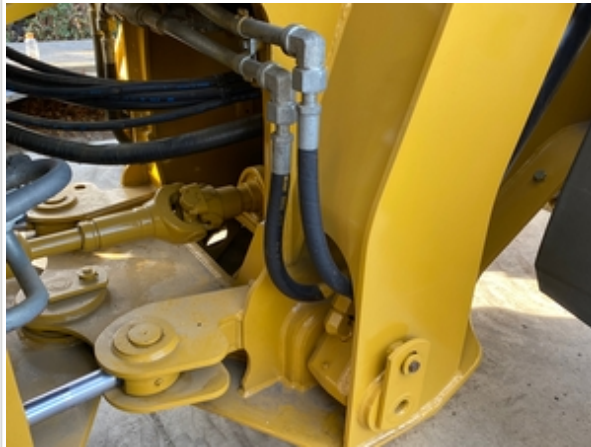
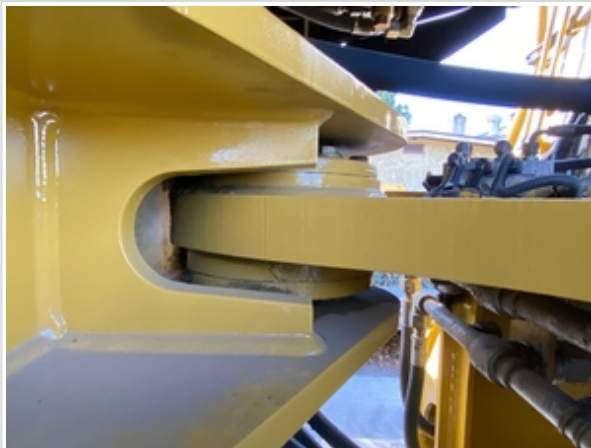
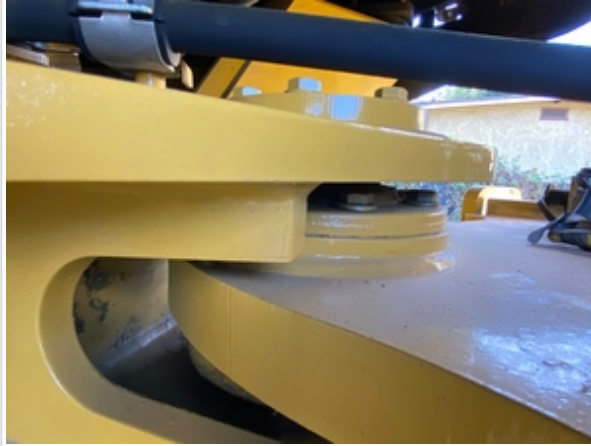
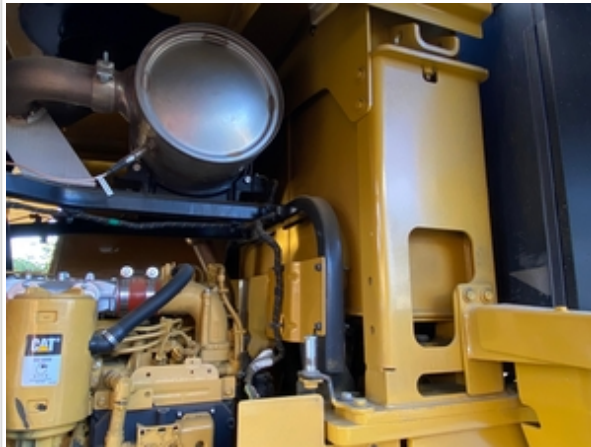
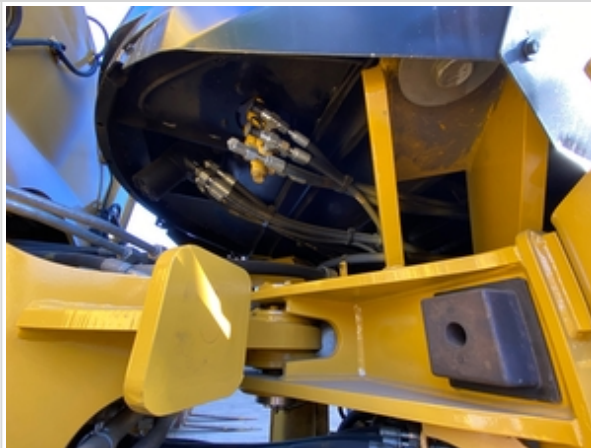
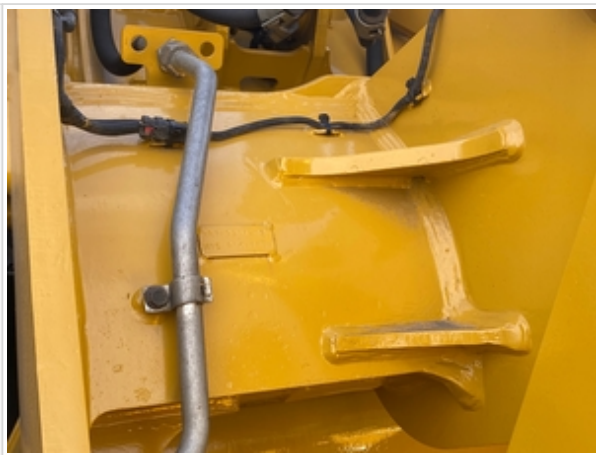
Frame	4 - Like New, Recently Replaced	
Frame Photos

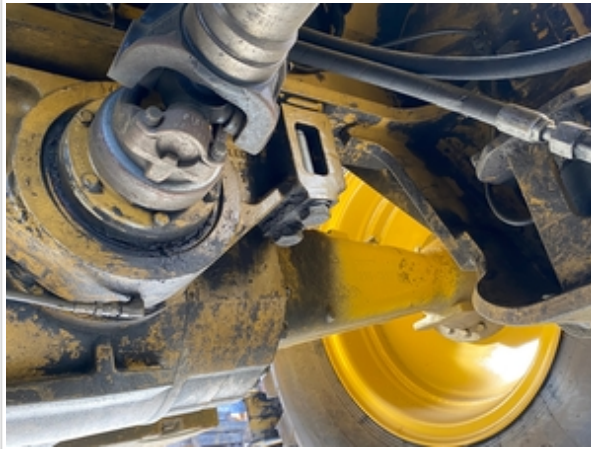
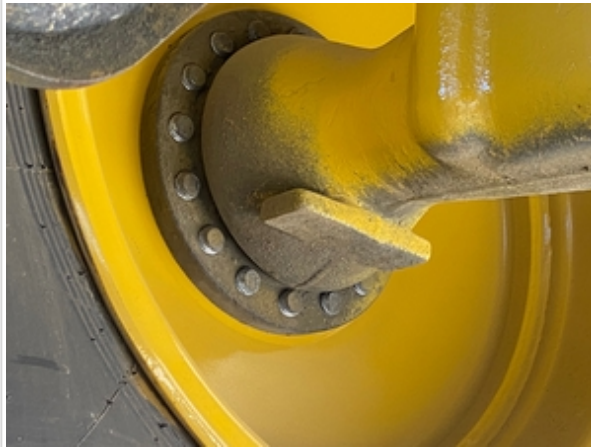
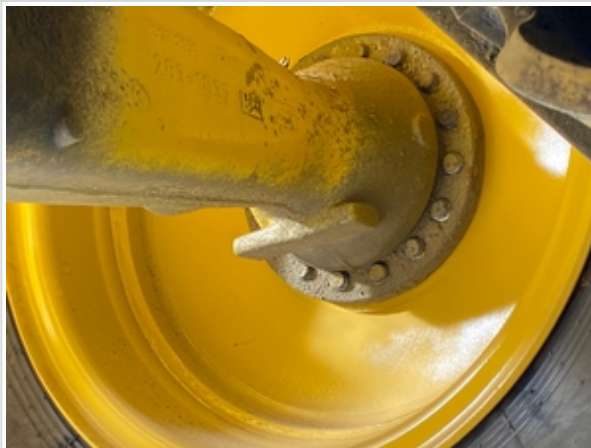
Rear Axle Appearance	3 - Normal Wear & Tear	
Rear Axle Appearance Photos

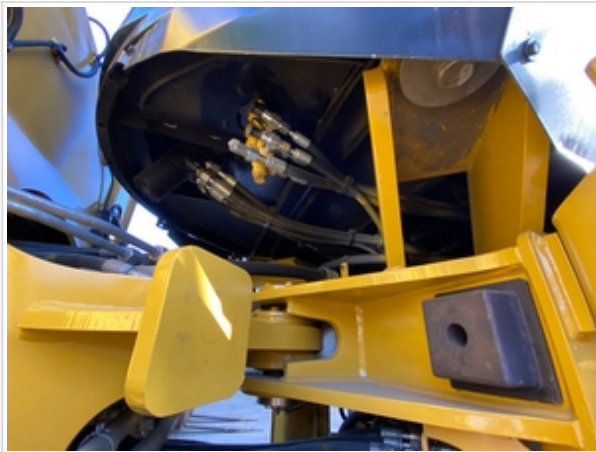
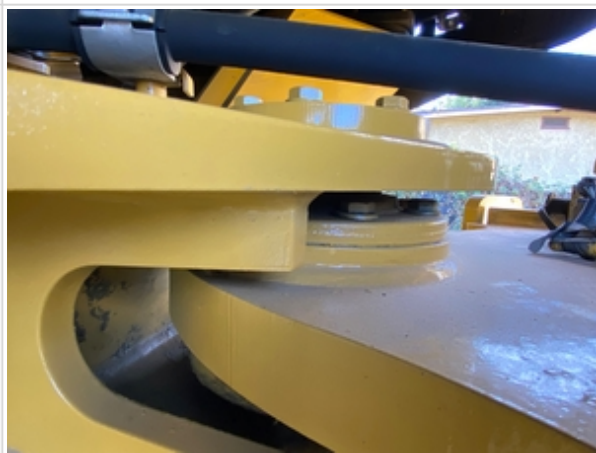
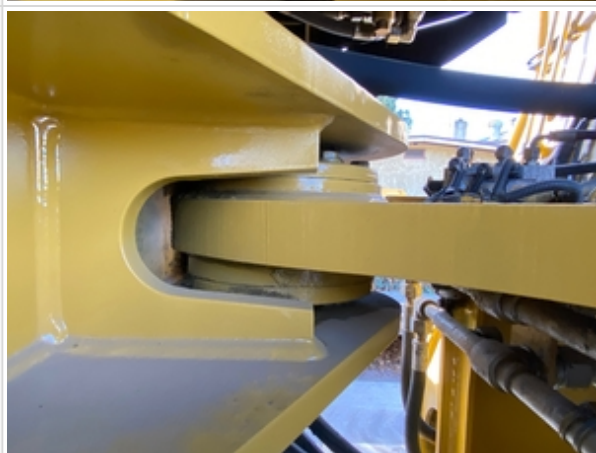
<p>Articulating Center Pin Appearance Photos</p>

**Articulating Center Pin
Appearance**

3 - Normal Wear & Tear

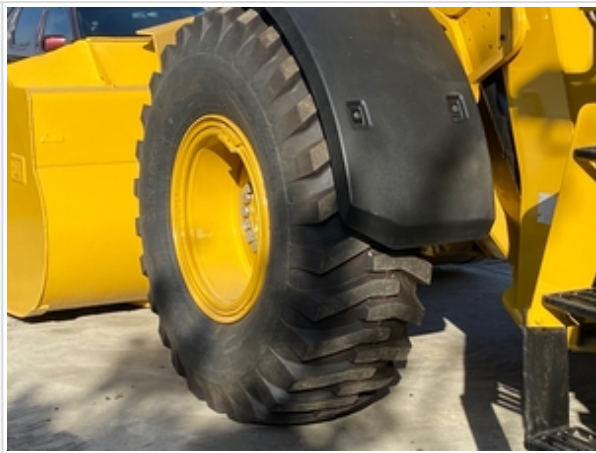
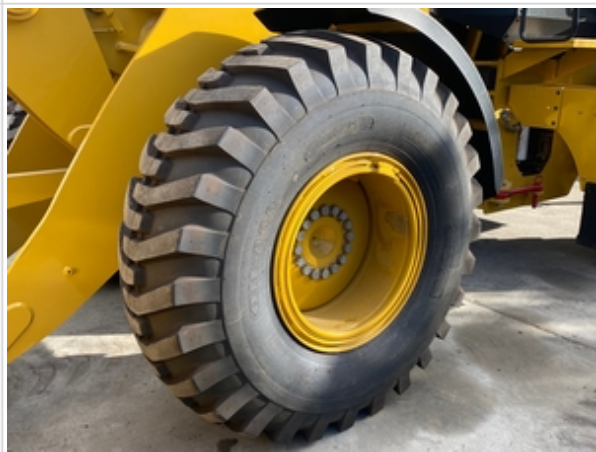
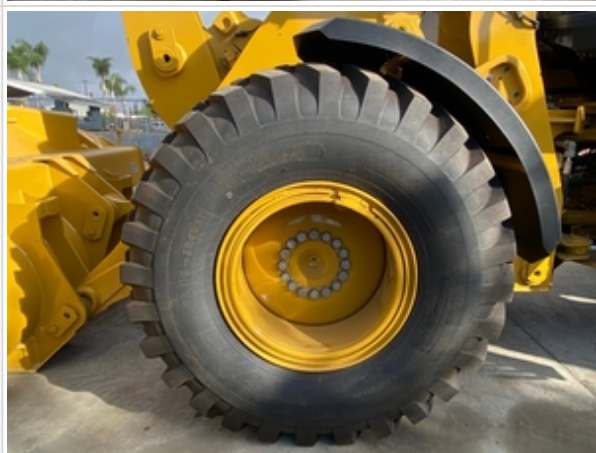
<p>Front Left Tire Photos</p>

<p>Tire Brand</p>	<p>Duramax</p>
<p>Tire Size</p>	<p>20.5 x 25</p>
<p>Front Left Tire - Ratio Remaining</p>	<p>90%</p>
<p>Comments</p>	<p>Tires above 90% brand new</p>

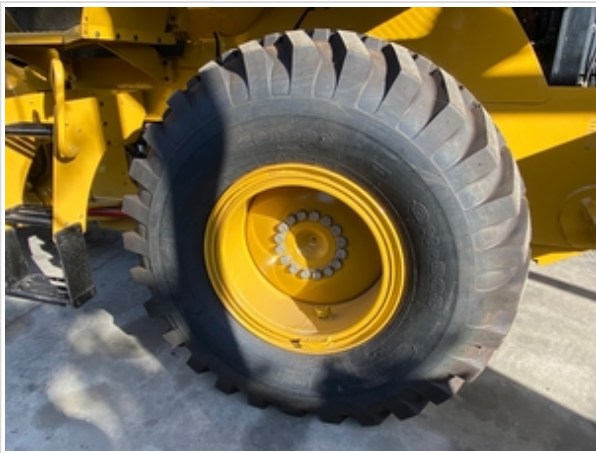
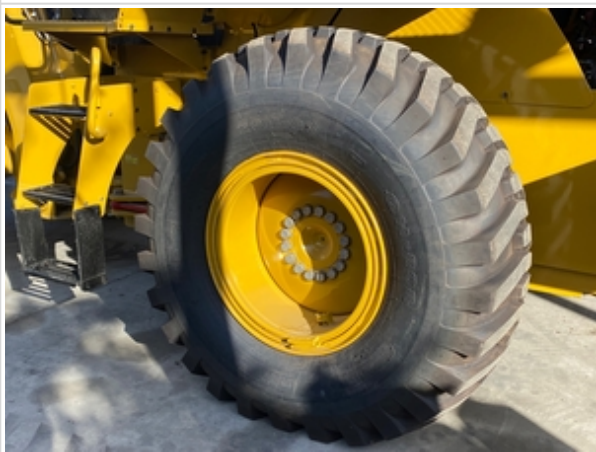
Rear Left Tire Photos

<p>Rear Left Tire - Ratio Remaining</p>	<p>90%</p>
<p>Comments</p>	<p>Tires above 90% brand new</p>

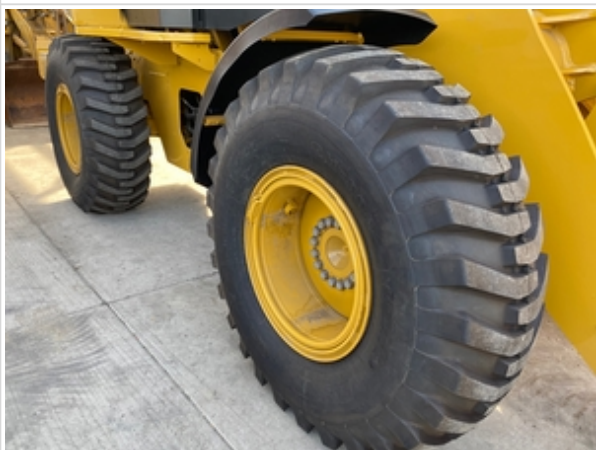
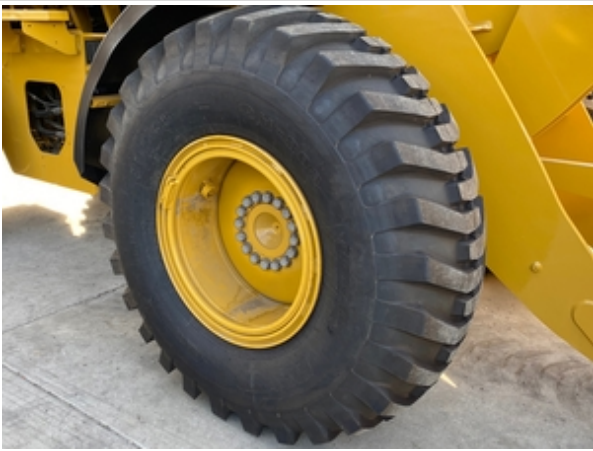
Front Right Tire - Ratio Remaining	90%	
Comments	Tires above 90% brand new	
Front Right Tire Photos

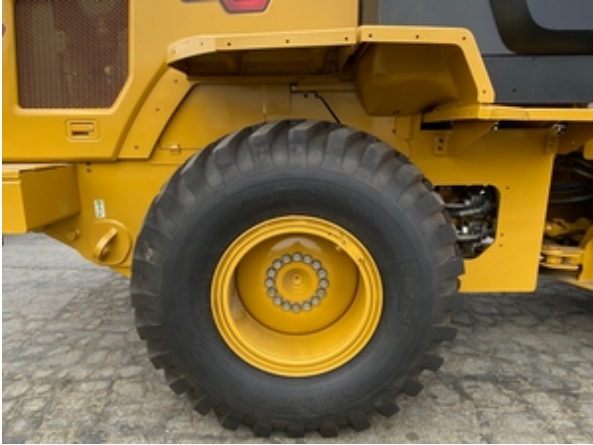
Rear Right Tire - Ratio Remaining	90%	
Comments	Tires above 90% brand new	
Rear Right Tire Photos

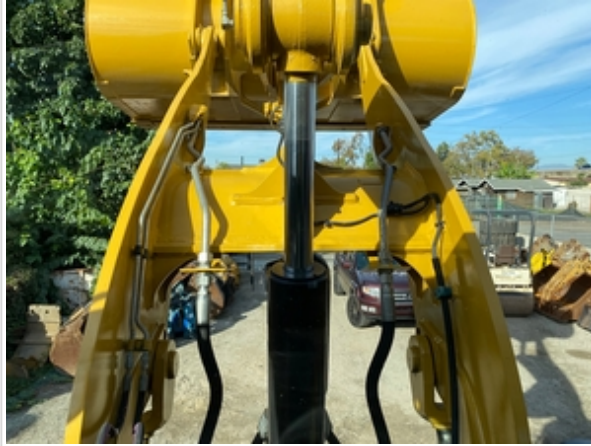
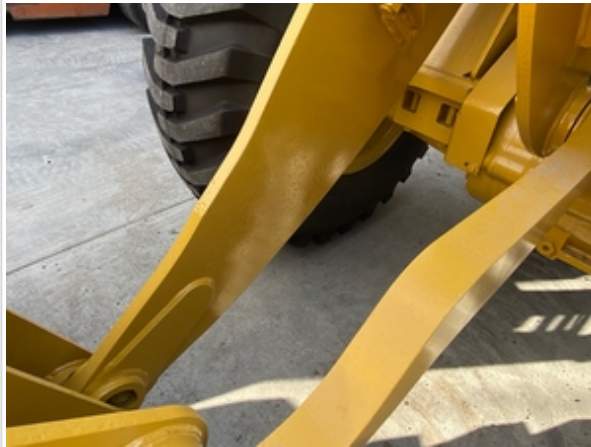
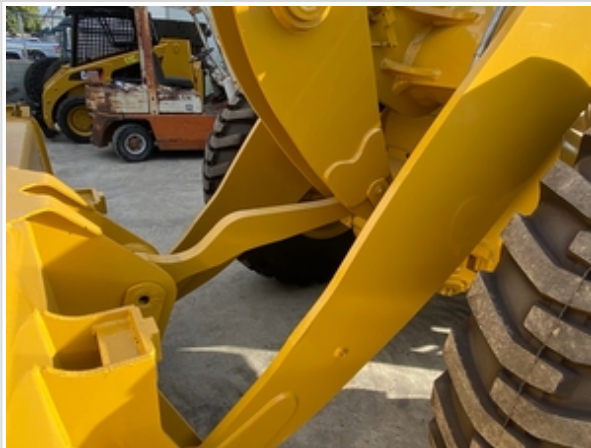
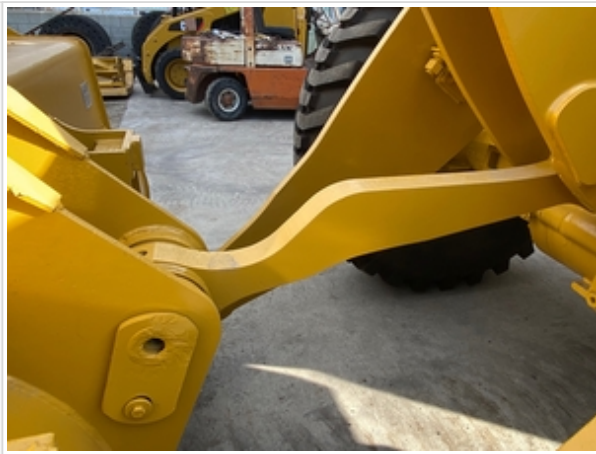
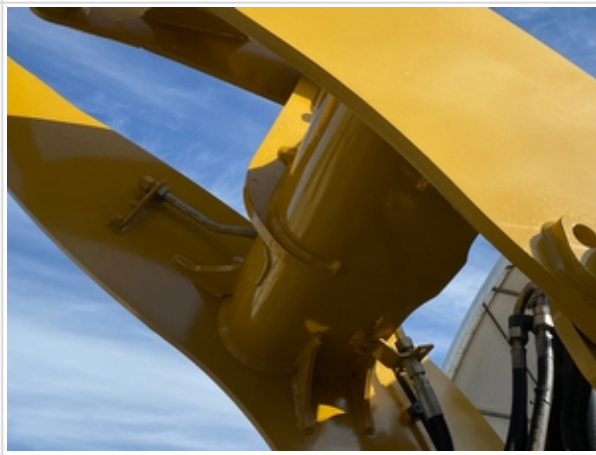
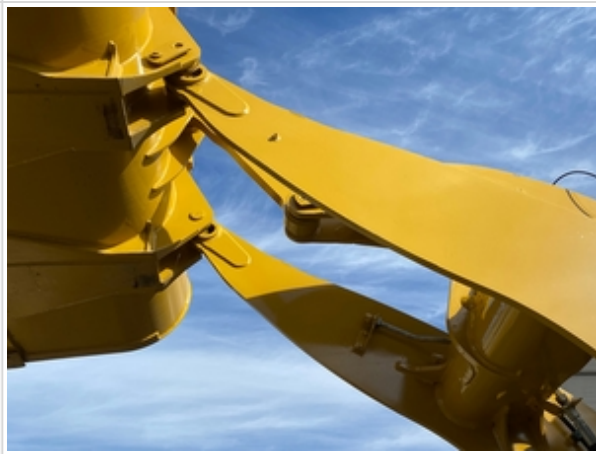
Lift Arm Photos

Lift Arm	3 - Normal Wear & Tear

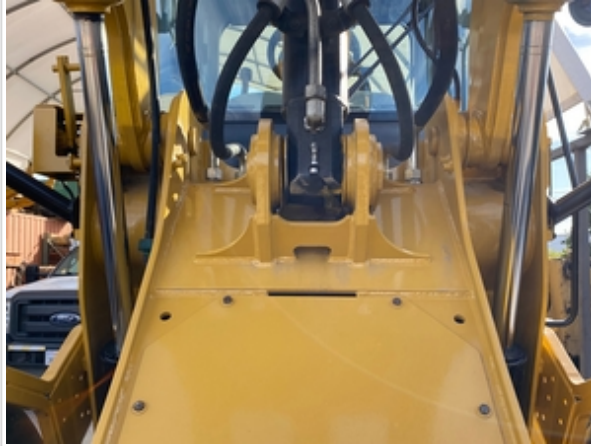
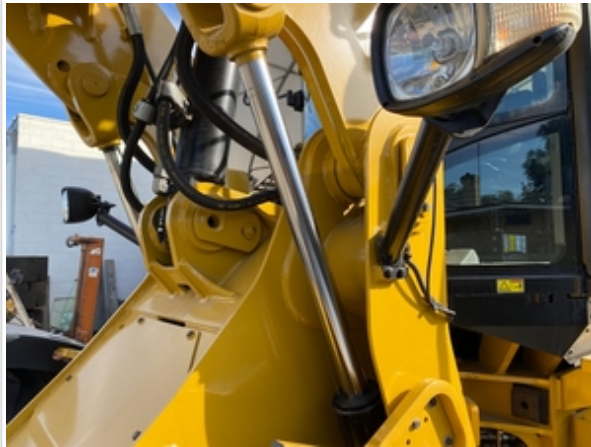
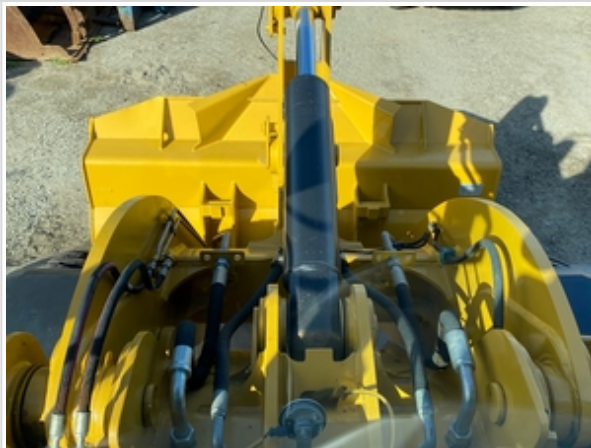
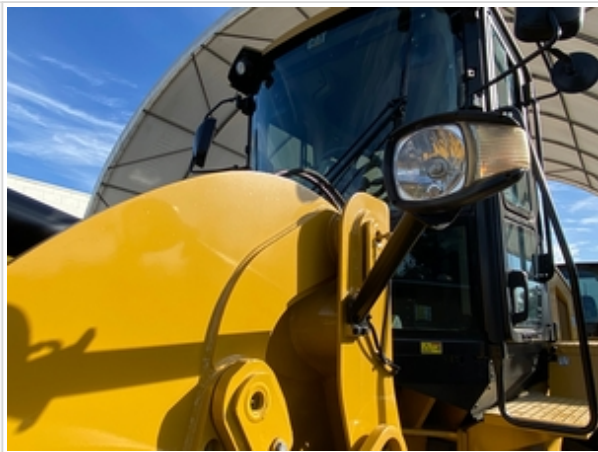
Chassis to Arm Pins Photos

<p>Chassis to Arm Pins</p>	<p>3 - Normal Wear & Tear</p>

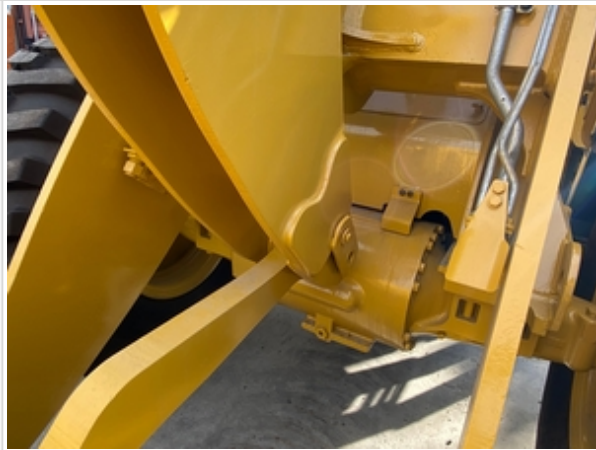
<p>Tilt Linkage</p>	<p>3 - Normal Wear & Tear</p>	
<p>Tilt Linkage Photos</p>

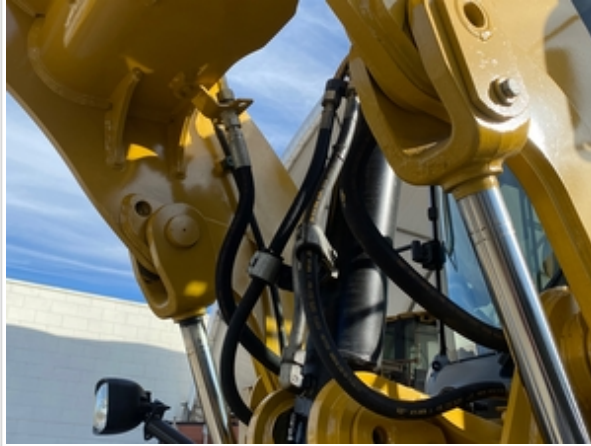
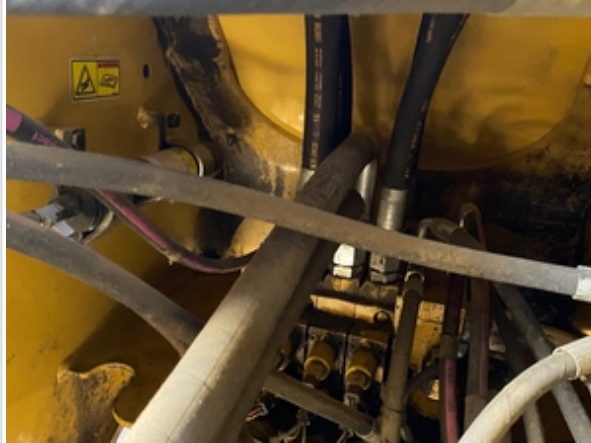
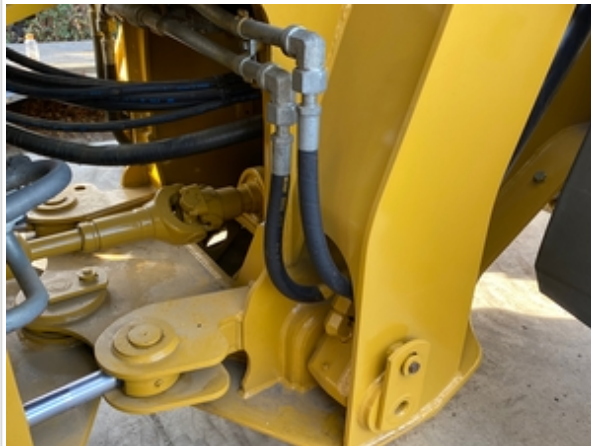
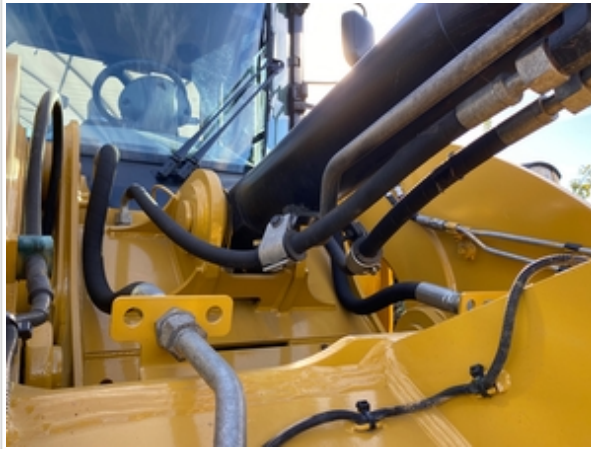
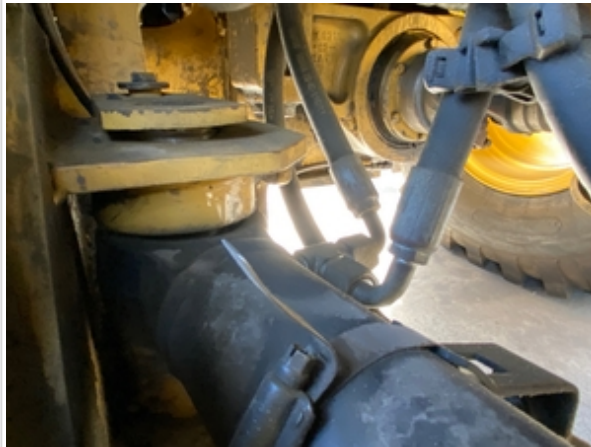
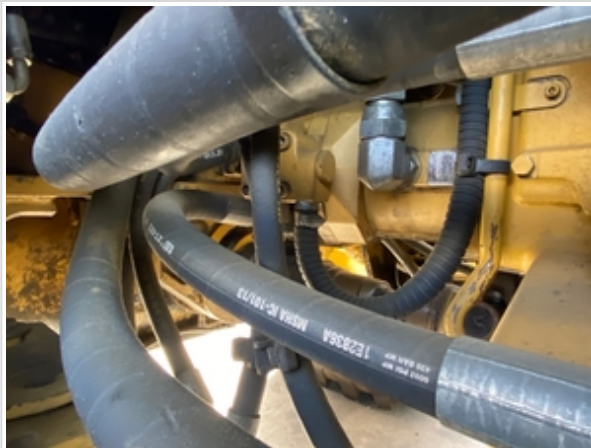
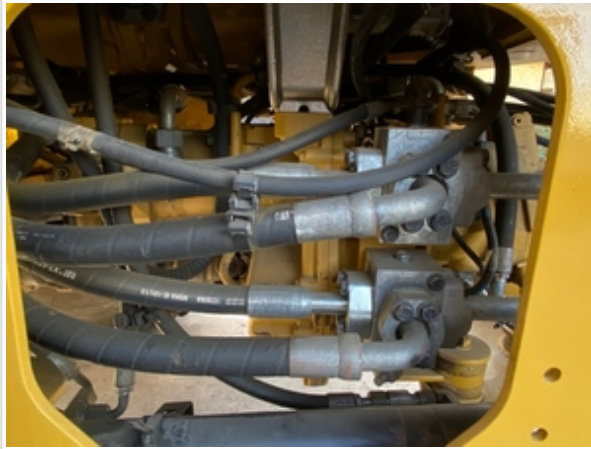
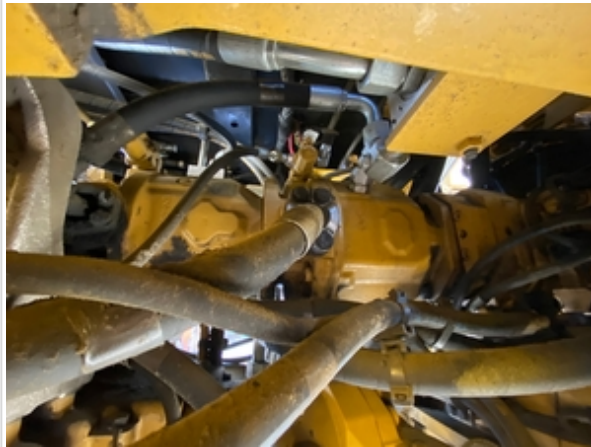
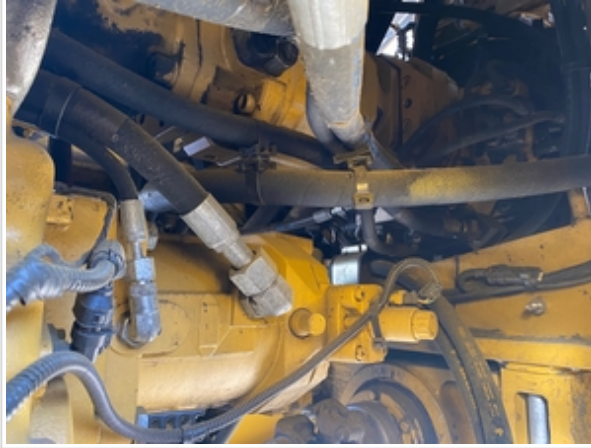
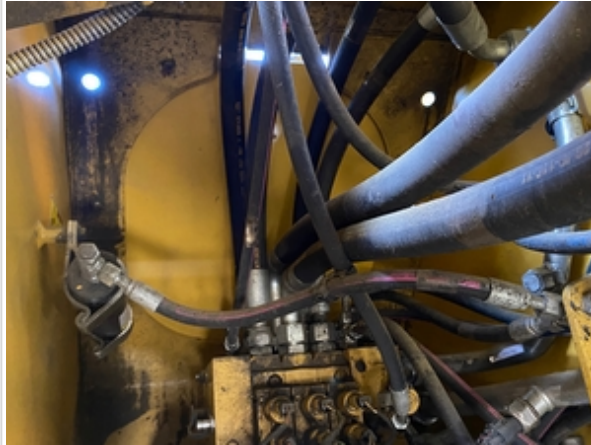
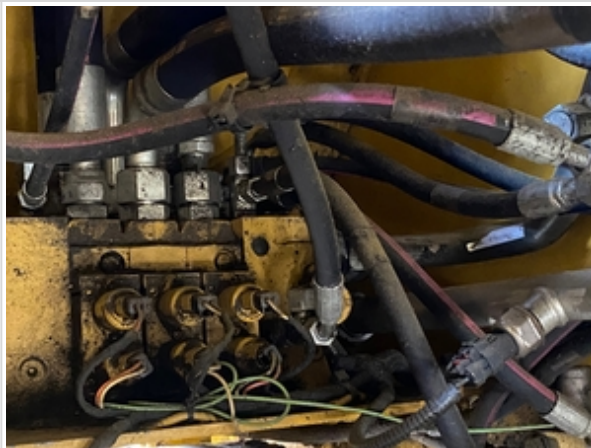
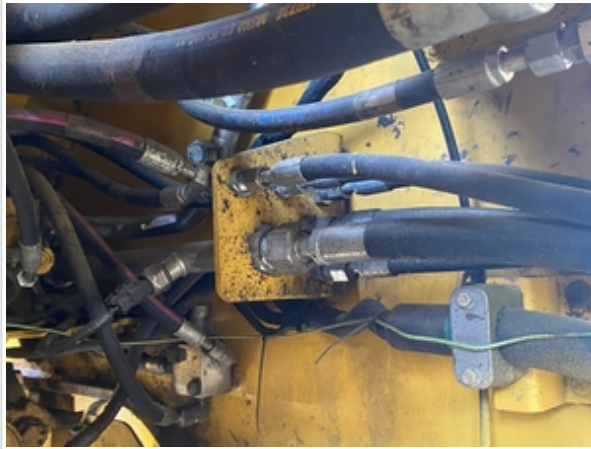
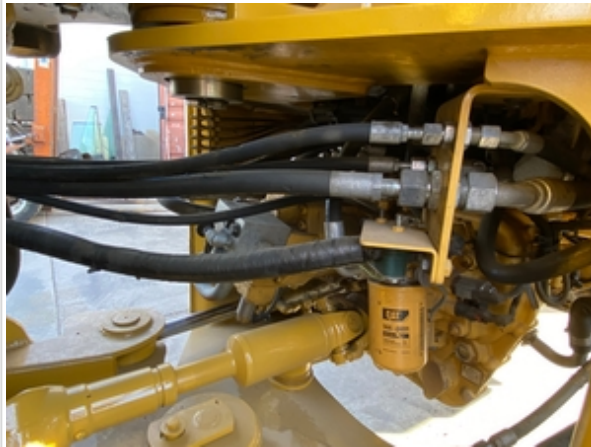
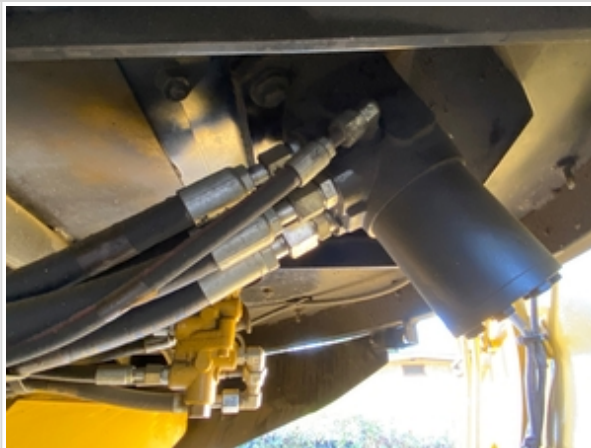
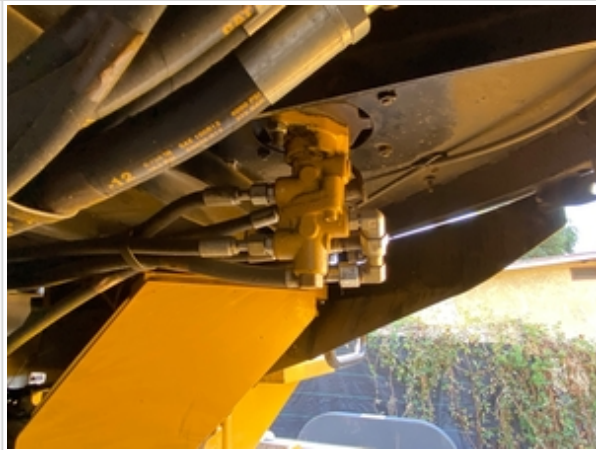
Appearance of Hydraulic Lines /
Fittings Photos

Wet or Damp Hydraulic Lines / Fittings	No
Appearance of Hydraulic Lines / Fittings	3
Hydraulic Lines / Fittings Condition	Hydraulic lines & fittings are clean and in good condition

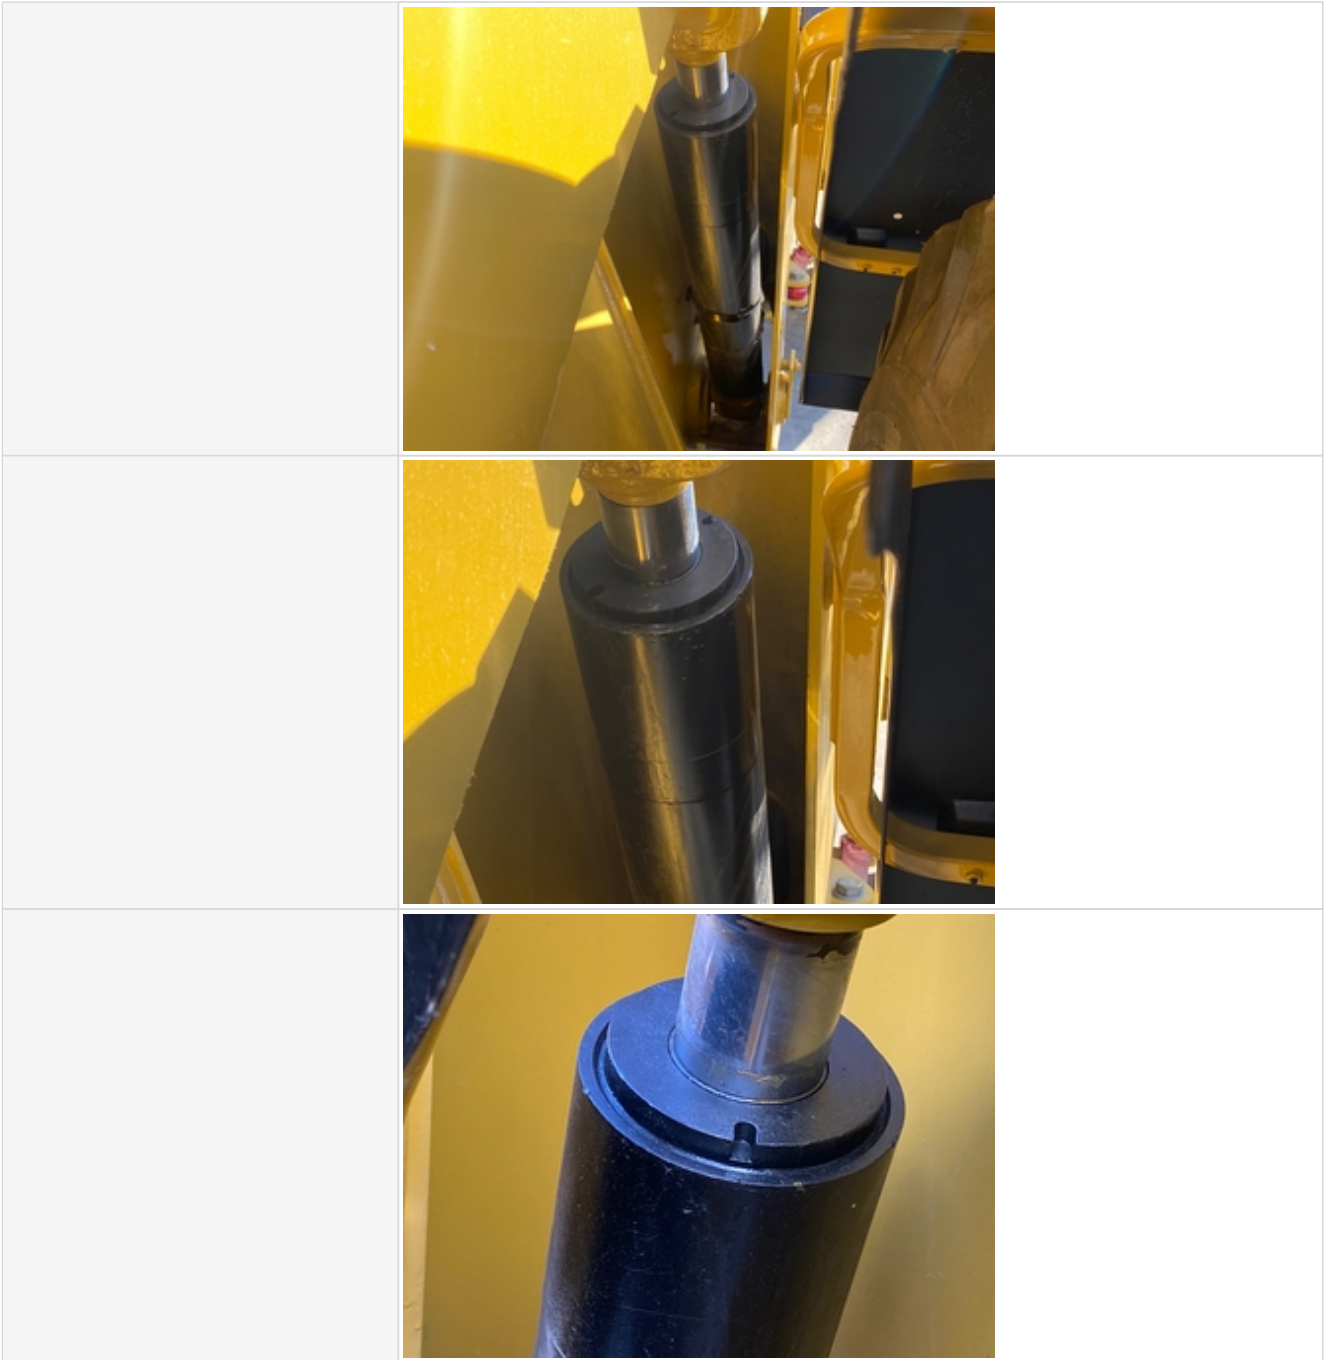
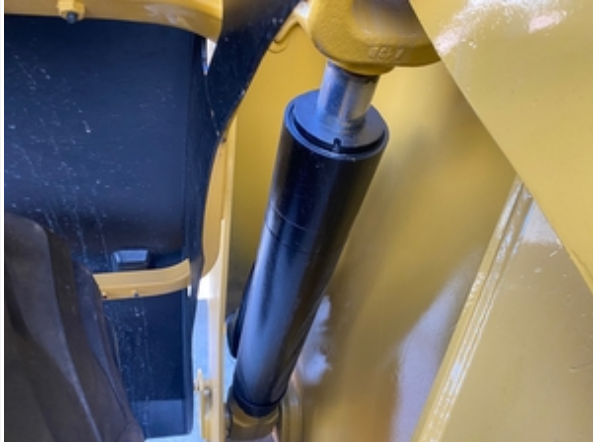
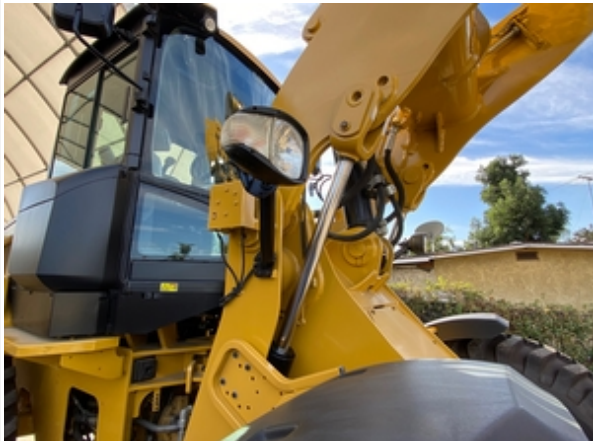
Lift Cylinder: Oil Leaks	No
Lift Cylinder Photos

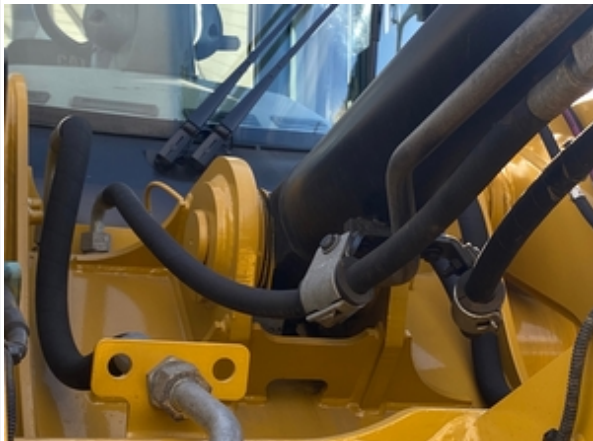
Bucket Cylinder	Check the bucket cylinder. Note any wear, pitting, discoloration, etc. Take photos.
Bucket Cylinder: Mounting Pin	3
Bucket Cylinder: Oil Leaks	No
Bucket Cylinder Photos

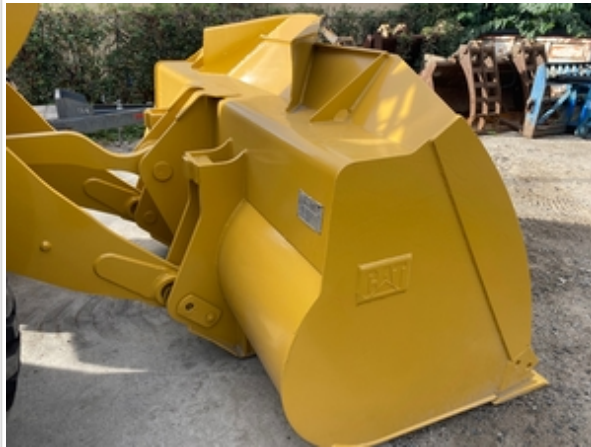
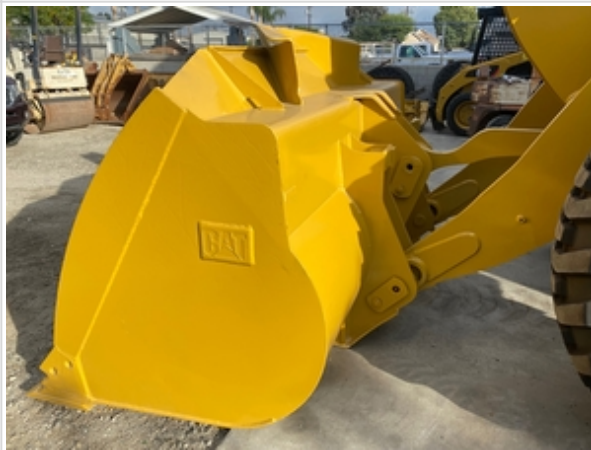
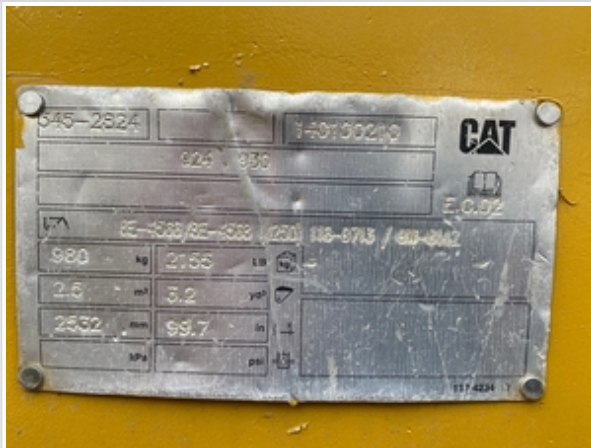
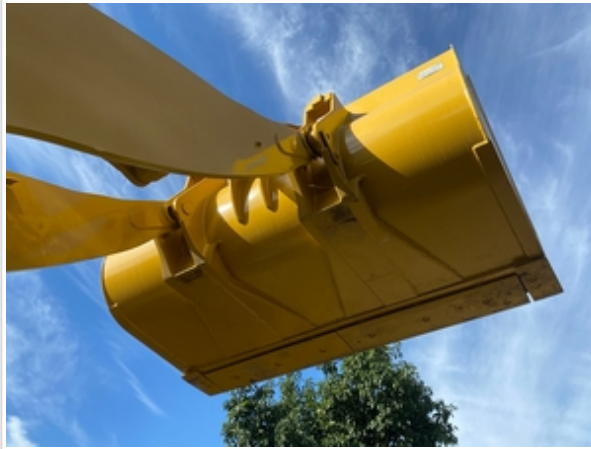
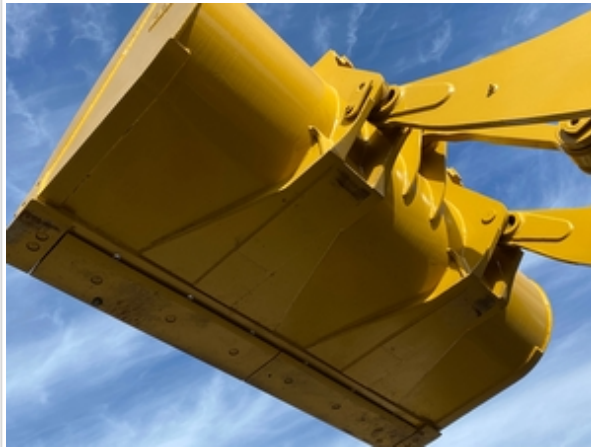
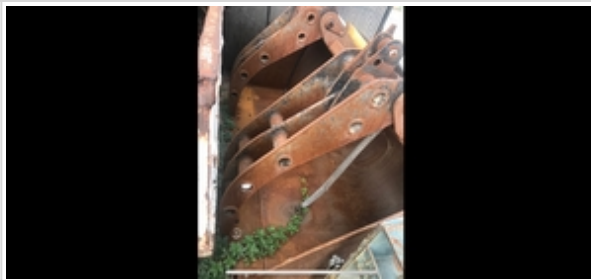
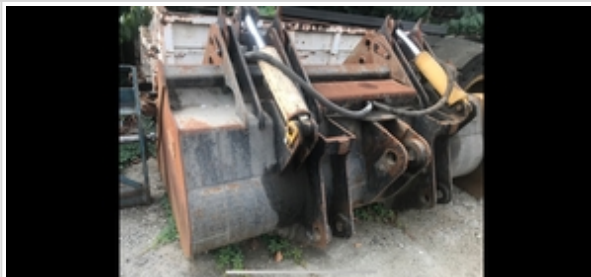
Bucket	4 - Like New, Recently Replaced
Bucket Photos

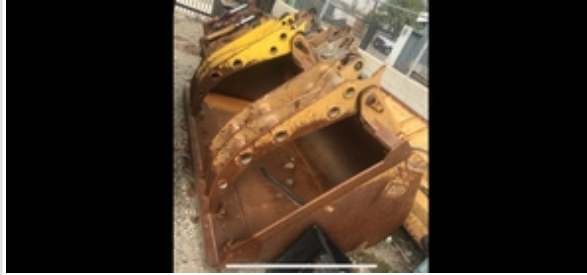
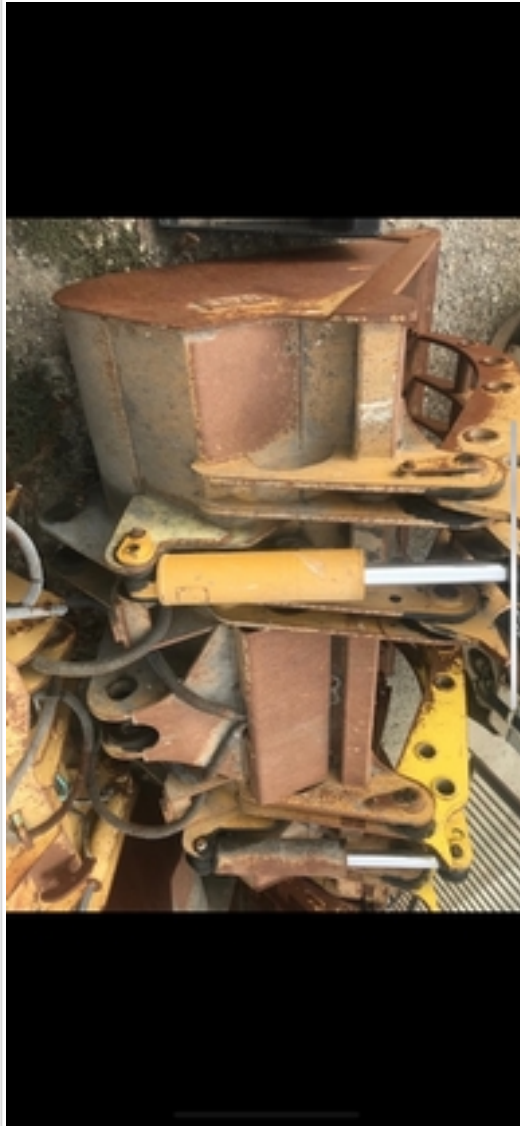
Bucket Edge/Shanks/Teeth

3 - Normal Wear & Tear
