## Inspection Report (On-Highway Dump Truck)

Year	2012
Make	Peterbilt
Model	388
Serial Number	1XP-WD49X-8-CD168910
Truck Odometer Reading	650,050
Current Inspection / State Cert / DOT	N/A
Previous Application (e.g., earth moving, mining, demolition, etc)	General Construction

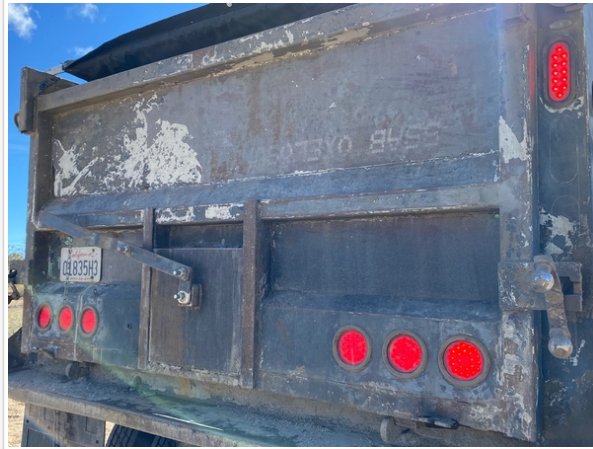
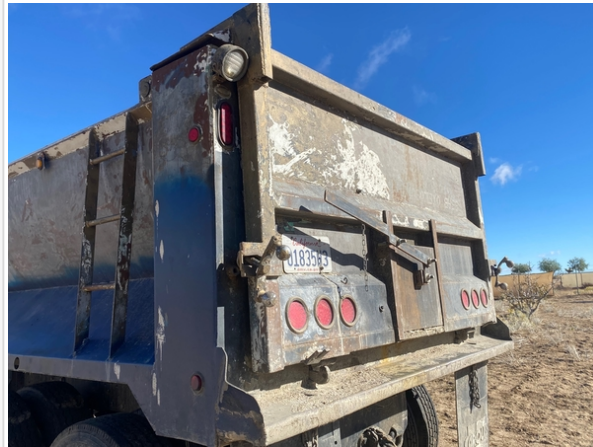
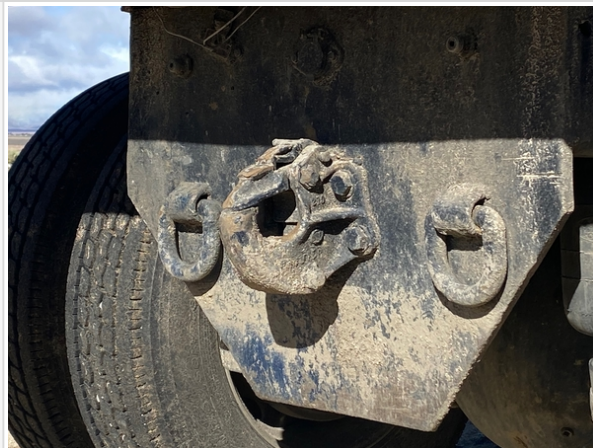
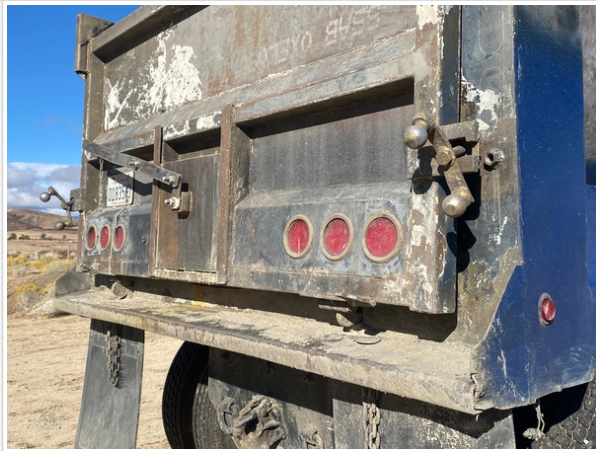
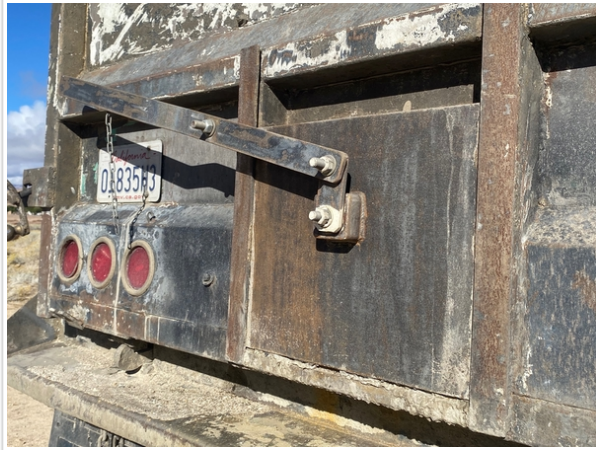
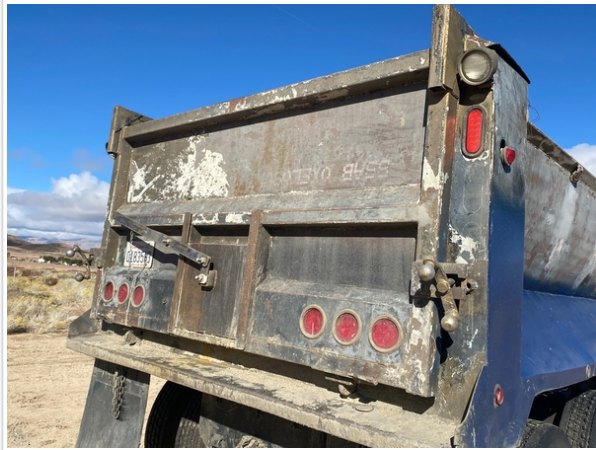
<b>Rear</b>	3 - Normal Wear & Tear
<b>Rear Condition</b>	No visible damage
<b>Rear Photos</b>

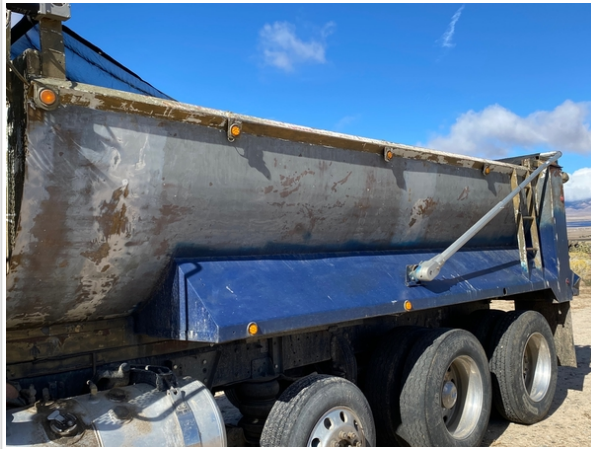
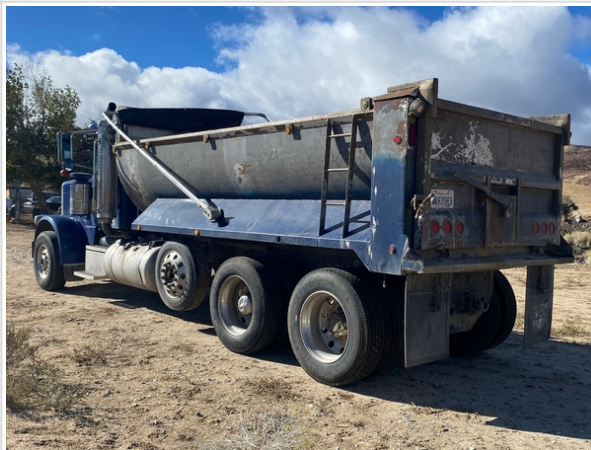
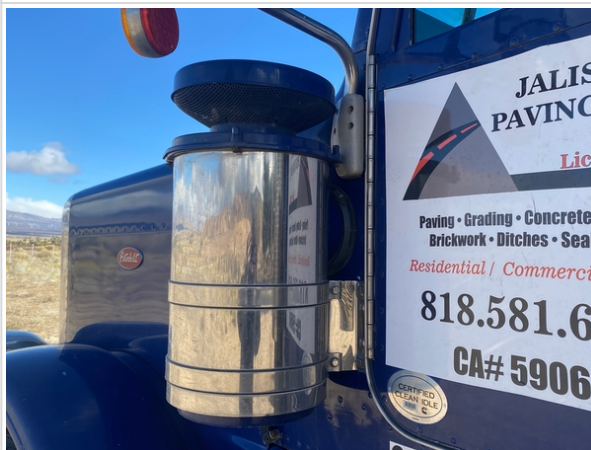
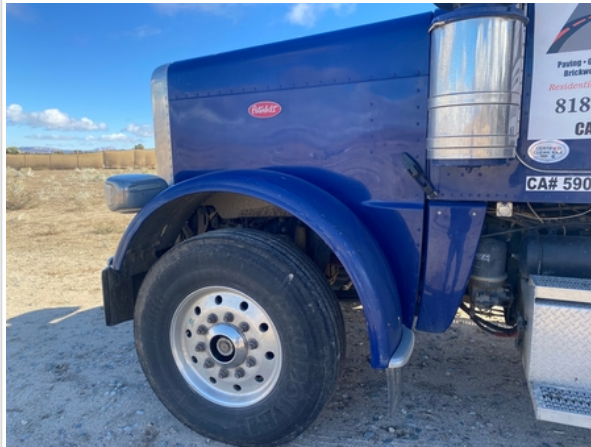
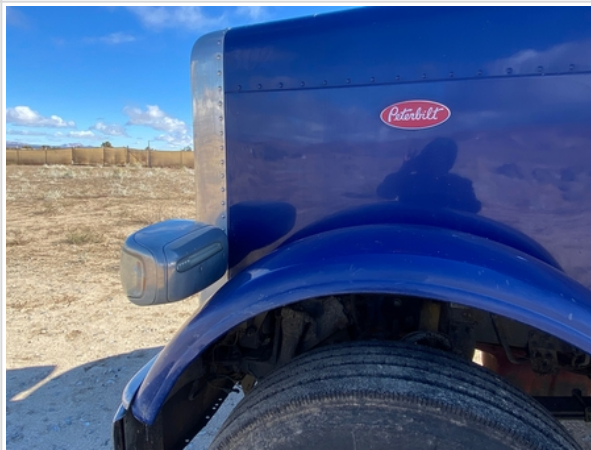
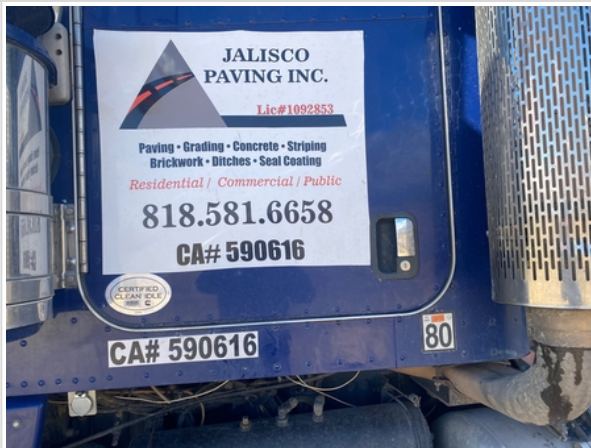
Left Photos

<b>Left</b>	3 - Normal Wear & Tear
<b>Left Condition</b>	No visible damage

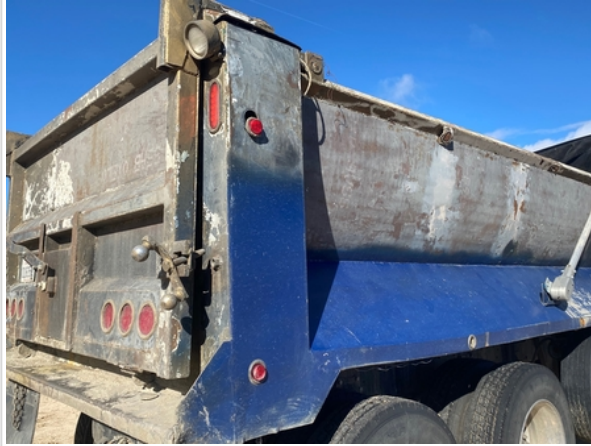
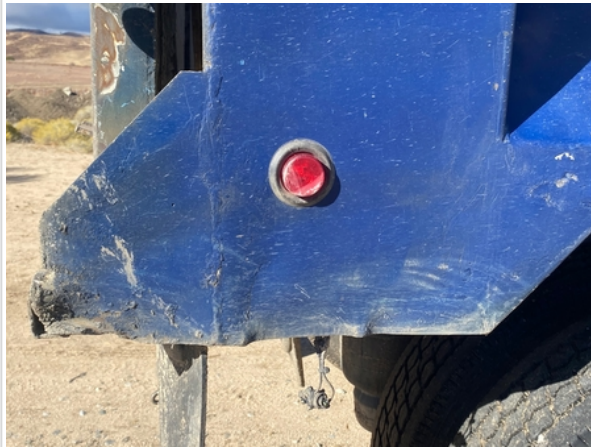
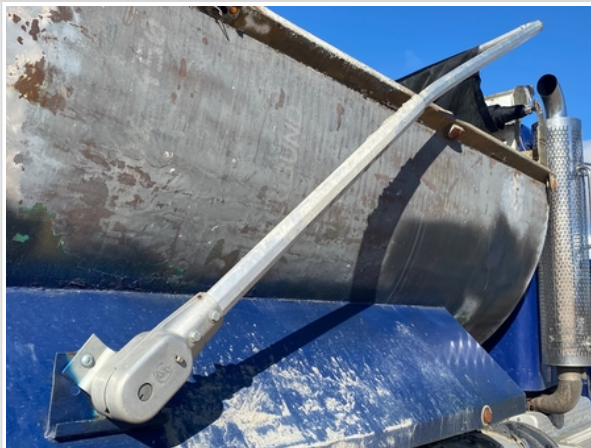
Right Photos

<b>Right</b>	3 - Normal Wear & Tear
<b>Right Condition</b>	No visible damage

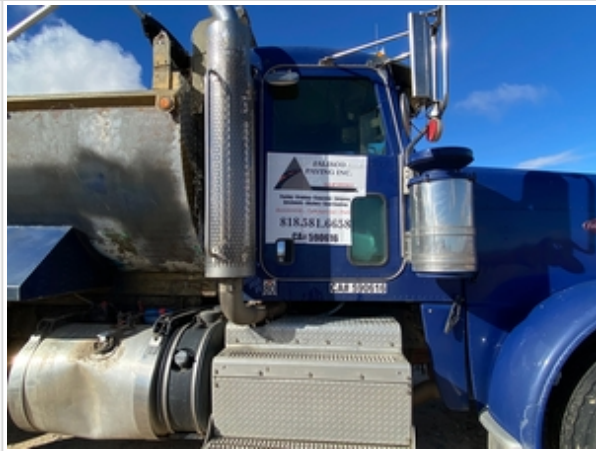
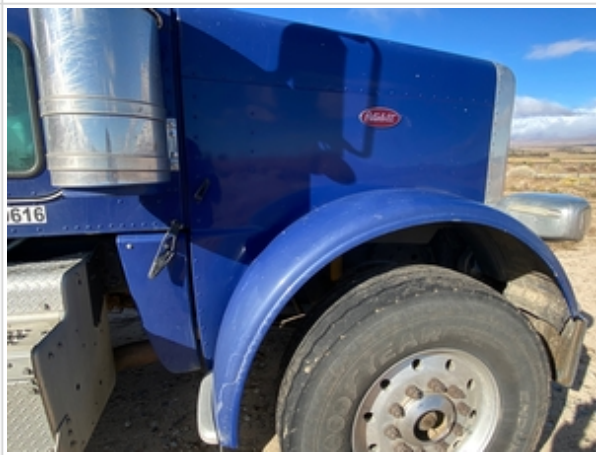
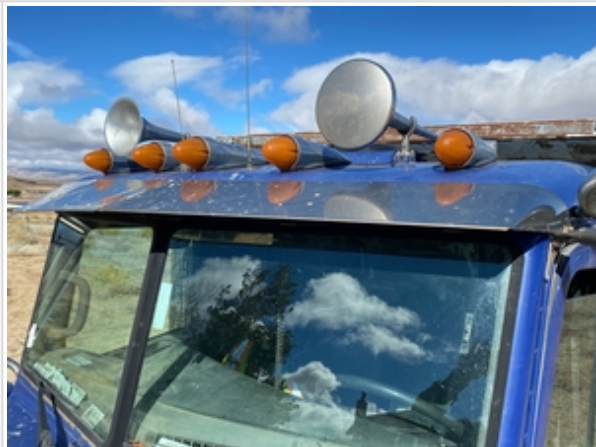
<p><b>Upper</b></p>	<p>3 - Normal Wear &amp; Tear</p>	
<p><b>Upper Condition</b></p>	<p>No visible damage</p>	
<p><b>Upper Photos</b></p>

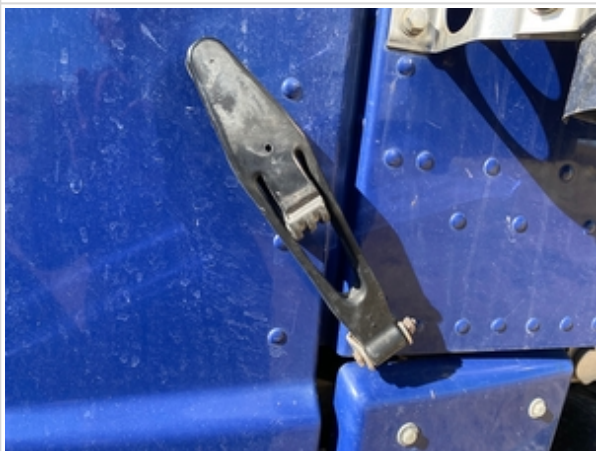
<b>Body Panels (Any Rust Damage?)</b>	2 - Above Average Wear	
<b>Body Panel Condition</b>	Other (see comments)	
<b>Comments</b>	Rear dump body has surface rust in some areas	
<b>Doors / Canopy Latches</b>	3 - Normal Wear & Tear	
<b>Doors / Canopy Latches Condition</b>	No visible damage	
<b>Doors / Canopy Latches Photos</b>

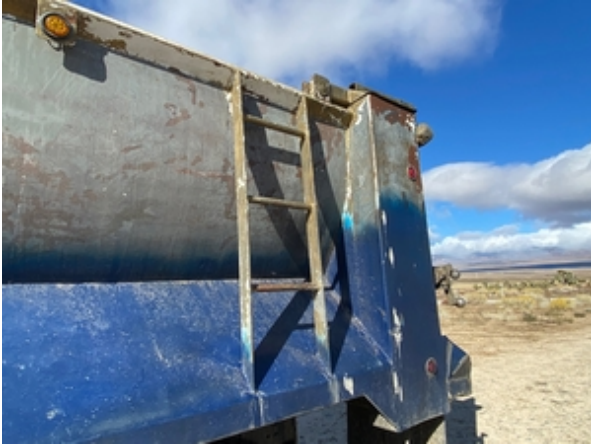
Steps / Ladders Photos

<b>Steps / Ladders</b>	3 - Normal Wear & Tear	
<b>Steps / Ladders Condition</b>	Steps/ladders are fully intact and appear structurally sound

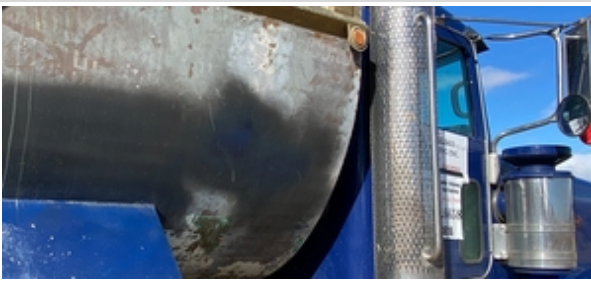
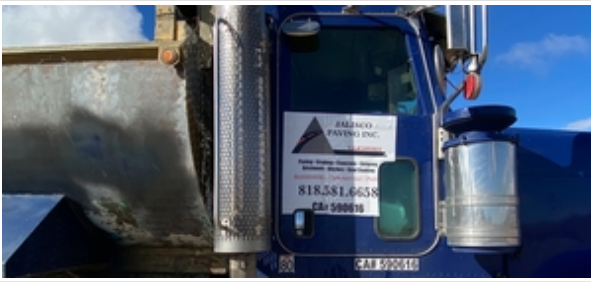
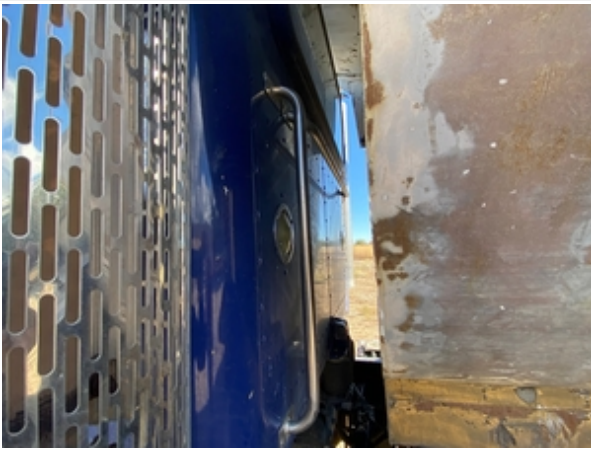
Handrails	3 - Normal Wear & Tear
Handrails Condition	Handrails are fully intact and appear structurally sound
Handrail Photos

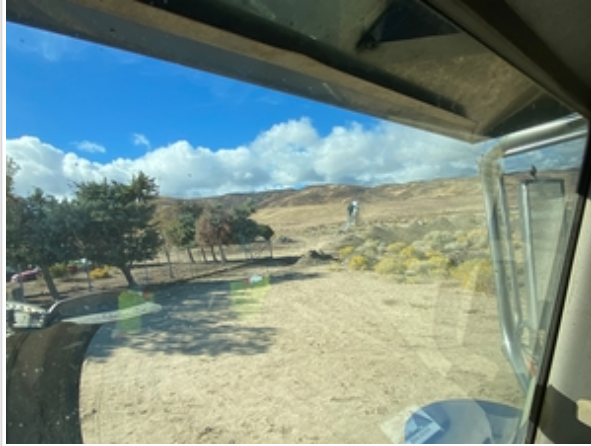
Glass Condition Photos

Glass Condition	3 - Normal Wear & Tear
Glass Condition Notes	Glass intact, no visible damage, Minor chips or cracks observed
Comments	Some cracked chips in front windshield

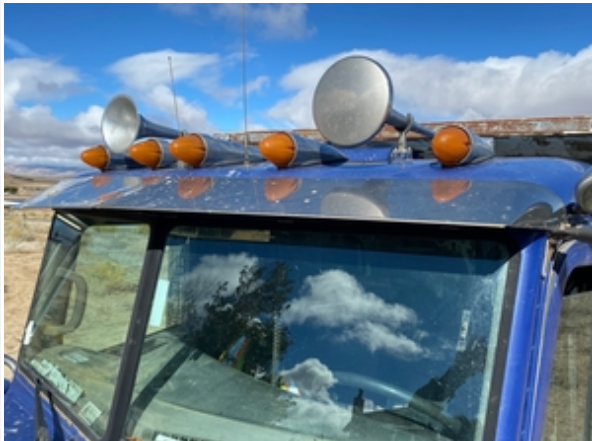
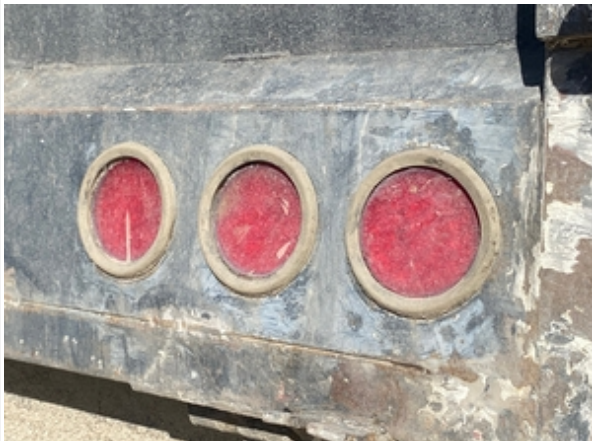
<b>Lighting System</b>	2 - Above Average Wear	
<b>Lighting System Condition</b>	One or more exterior lights are non-operational, Other (see comments)	
<b>Comments</b>	Most lights work, aftermarket lights installed, some marker lamps inoperable	
<b>Lighting System Photos</b>

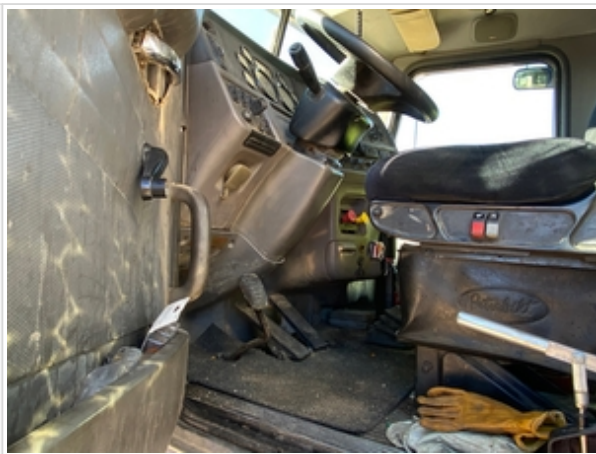
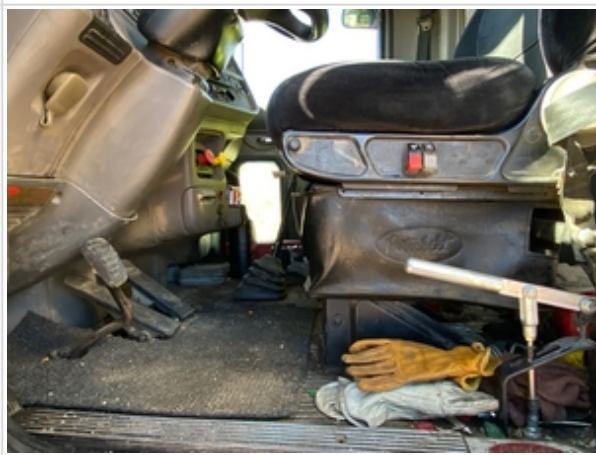
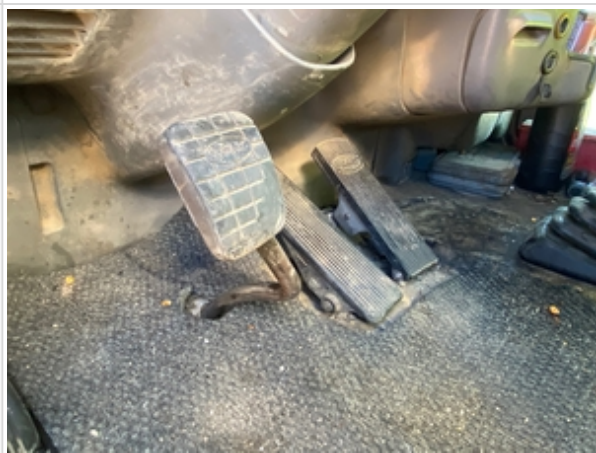
<p>Operator Cabin Photos</p>

<p>Serial Number Plate Photo</p>	 	
<p>Operator Cabin</p>	<p>3 - Normal Wear &amp; Tear</p>

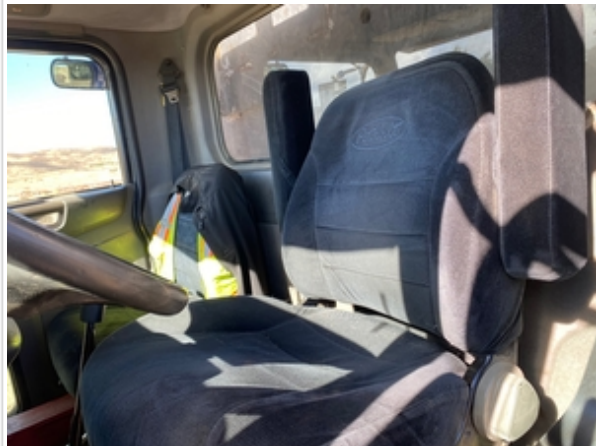
<p><b>Operator's Seat &amp; Arm Rests</b></p>	<p>3 - Normal Wear &amp; Tear</p>
<p><b>Operator's Seat &amp; Arm Rests Photos</b></p>

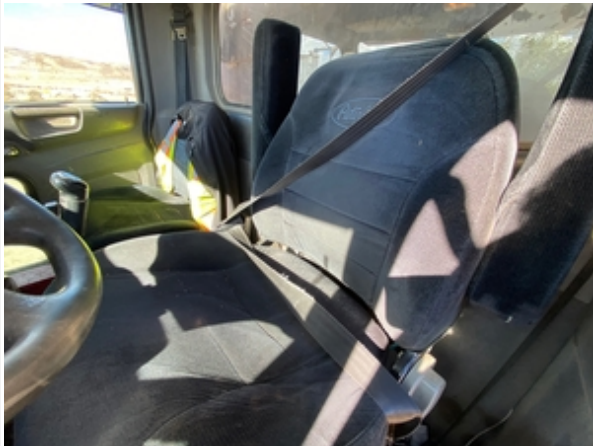
<b>Seat Belt</b>	3 - Normal Wear & Tear
<b>Seat Belt Photos</b>

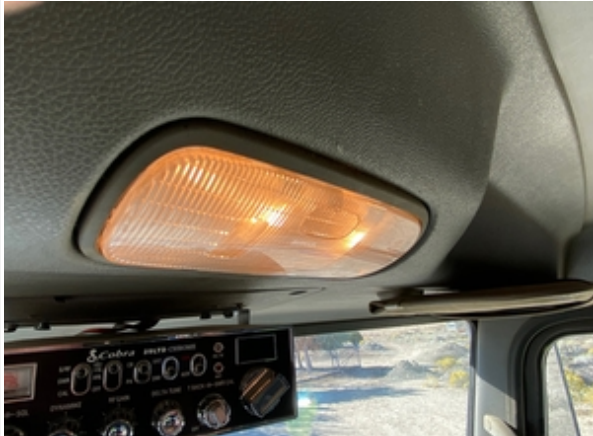
<b>Cabin Lights</b>	3 - Normal Wear & Tear
<b>Comments</b>	Passenger side bulb out (inop.)
<b>Cabin Lights Photos</b>

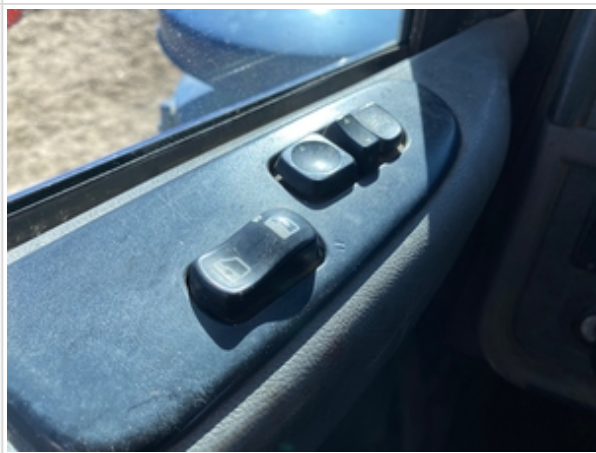
<p><b>Controls &amp; Switches</b></p>	<p>3 - Normal Wear &amp; Tear</p>	
<p><b>Controls &amp; Switches Photos</b></p>

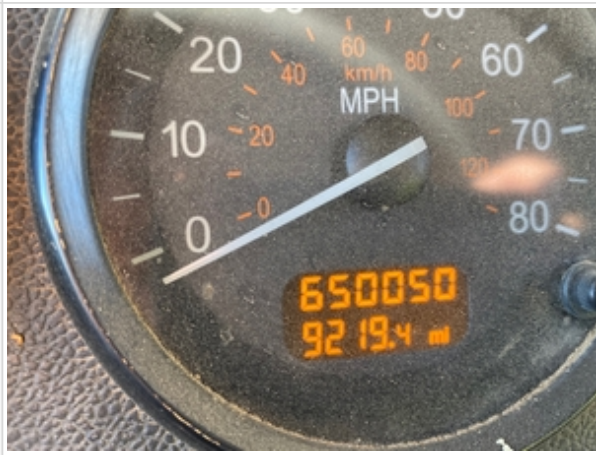
<b>Odometer Activity</b>	3 - Normal Wear & Tear
<b>Odometer Activity Photos</b>

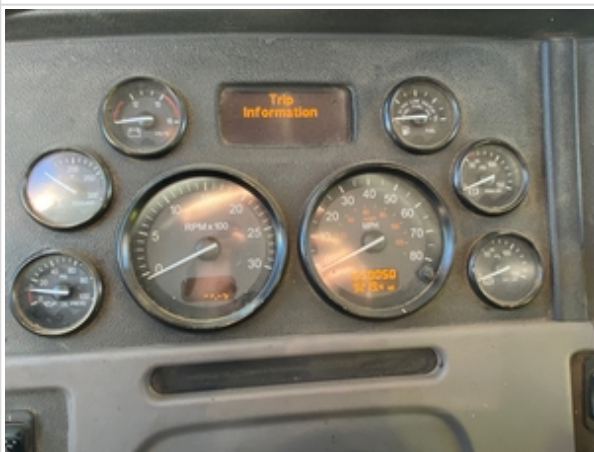
<b>Other Gauge Activity</b>	3 - Normal Wear & Tear

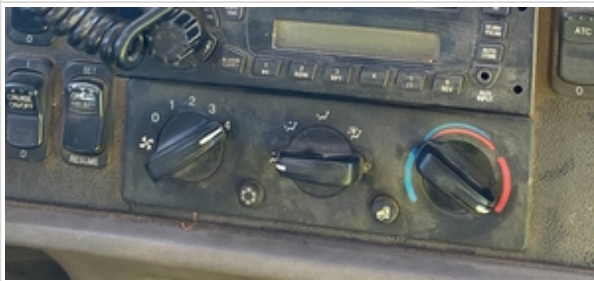
<p>Heater &amp; A/C</p>	<p>3 - Normal Wear &amp; Tear</p>
<p>Heater &amp; A/C Photos</p>

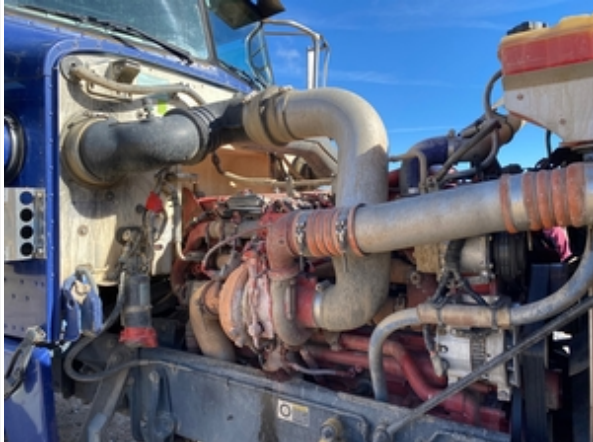
Engine Type (Make, Model, Cylinders, Hp)	Cummins - ISX15 - 6 Cyl - 485 HP
Emissions Tier	Tier 4F
Engine Serial Number	79531255
Engine Fuel Type	Diesel
Engine Photos

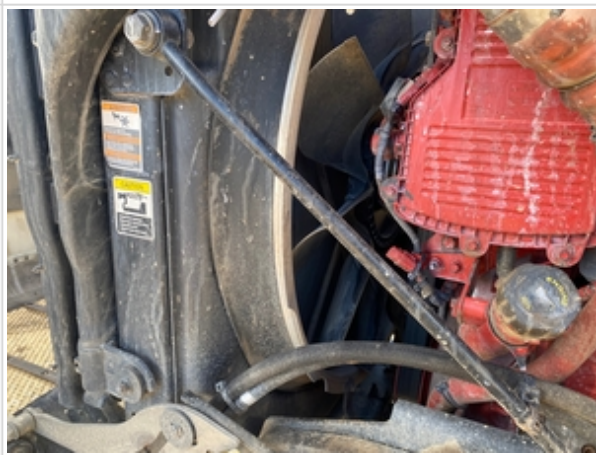
<p>Radiator Photos</p>

<b>Blow-by (Visual Observation Check)</b>	No
<b>Unusual Noises (Upon Start-up, Idle, Shutdown)</b>	No
<b>Unusual Noise Notes</b>	No unusual noises heard
<b>Engine Smoke (Upon Start-up, Idle, Shutdown)</b>	No
<b>Engine Smoke Notes</b>	No engine smoke issues observed
<b>Engine Exhaust Color</b>	Clear
<b>Battery</b>	3 - Normal Wear & Tear
<b>Battery Condition</b>	Other (see comments), Like new, recently replaced
<b>Comments</b>	(Per customer) recently replaced
<b>Radiator</b>	3 - Normal Wear & Tear
<b>Radiator Condition</b>	Radiator fins & components appear to be in good working order, no signs of damage or leaks

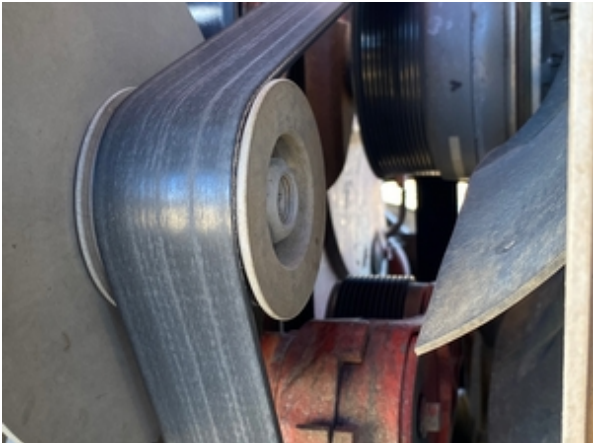
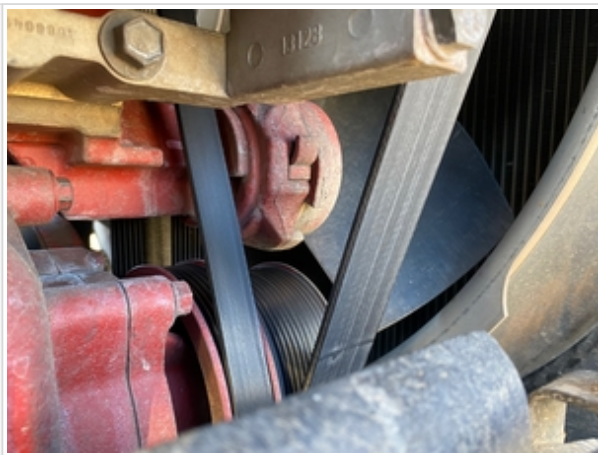
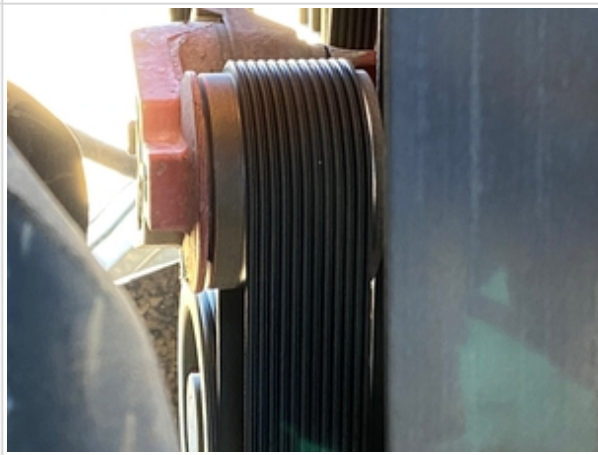
<b>Belts</b>	3 - Normal Wear & Tear	
<b>Belt Condition</b>	Belts appear in good condition & alignment with proper tension	
<b>Belt Photos</b>

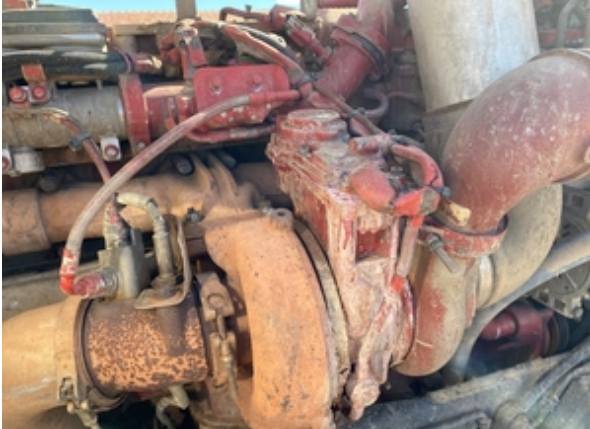
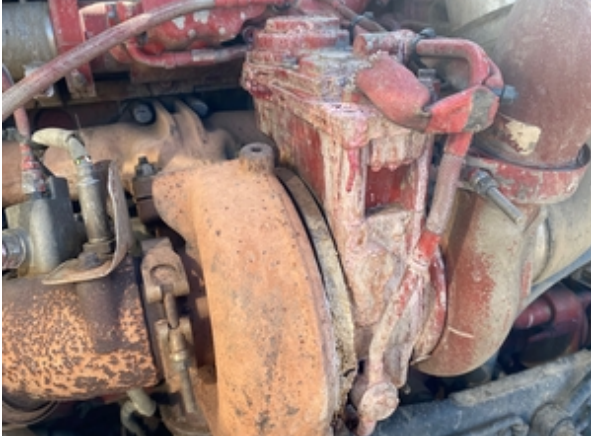
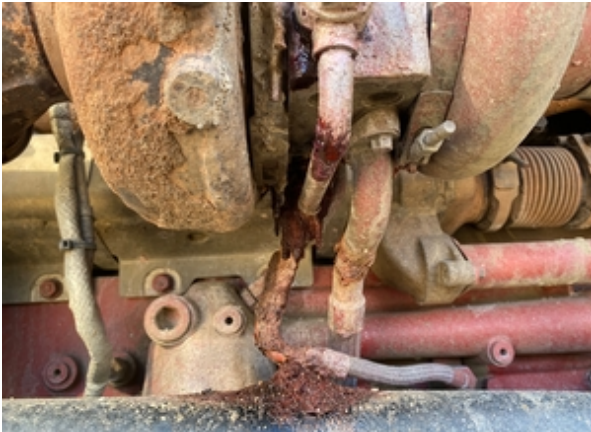
<b>Water Pump</b>	3 - Normal Wear & Tear	
<b>Water Pump Condition</b>	No unusual pump noises heard	
<b>Cooling System Leaks</b>	Yes	
<b>Cooling System Condition</b>	Wetness observed on cooling system hoses, Other (see comments)	
<b>Comments</b>	Residual Coolant leak buildup seen underneath turbo at hoses and fittings and actuator	
<b>Cooling System Leaks Photos</b>

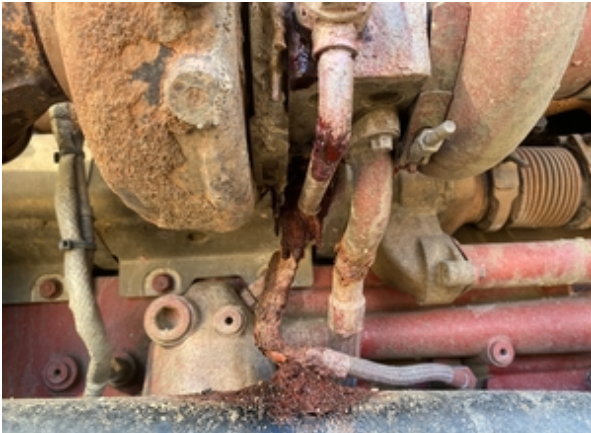
<b>Coolant Color / Appearance</b>	3 - Normal Wear & Tear
<b>Coolant Color/Appearance Notes</b>	Normal Translucent appearance, no visual signs of contamination
<b>Oil Leaks</b>	Yes
<b>Oil Leak Notes</b>	Wetness & discoloration observed, Other (see comments)
<b>Comments</b>	Oil leaks seen around turbo lines
<b>Oil Leak Photos</b>

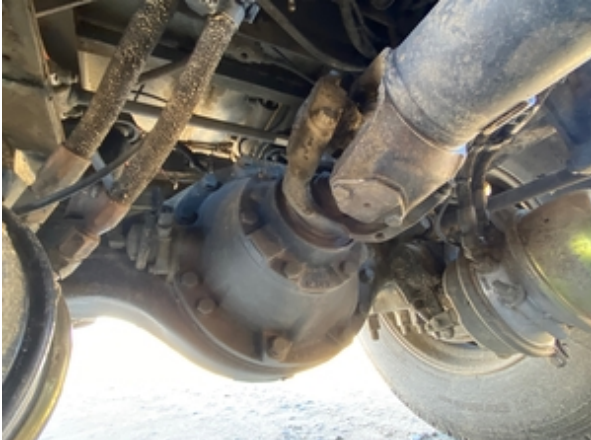
<b>Differential</b>	Check condition of the differential(s). Take photos and notes as relevant.
<b>Rear Differential</b>	3 - Normal Wear & Tear
<b>Rear Differential Condition</b>	Dry housing appearance, no unusual noises heard during operation
<b>Rear Differential Photos</b>

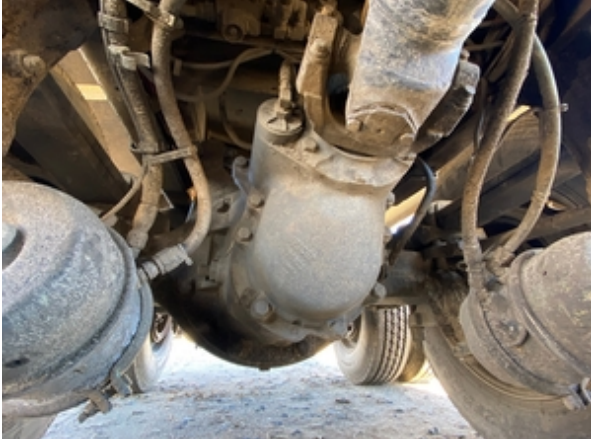
<b>Front Differential</b>	3 - Normal Wear & Tear
<b>Front Differential Condition</b>	Dry housing appearance, no unusual noises heard during operation
<b>Front Differential Photos</b>

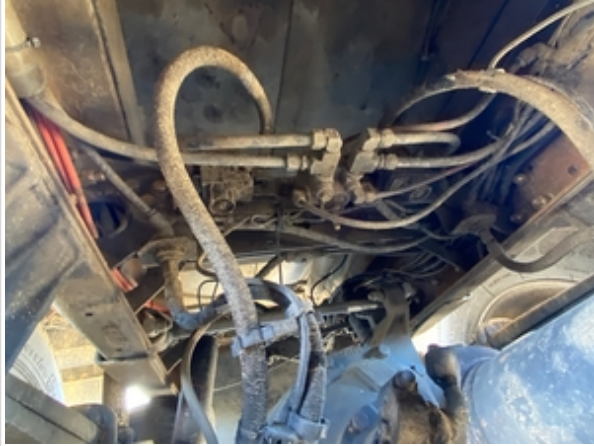
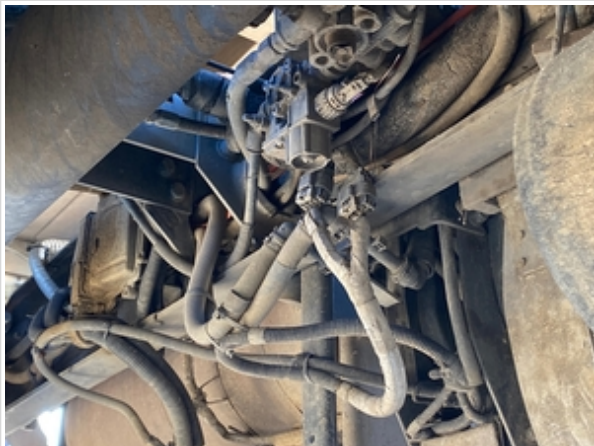
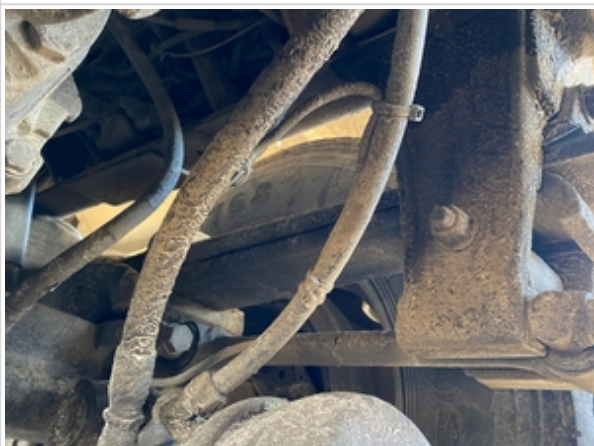
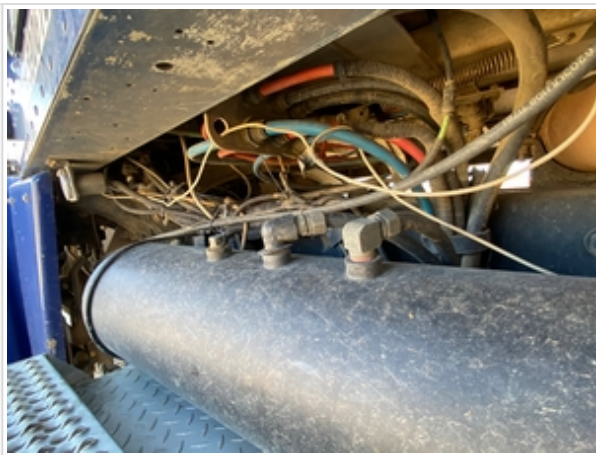
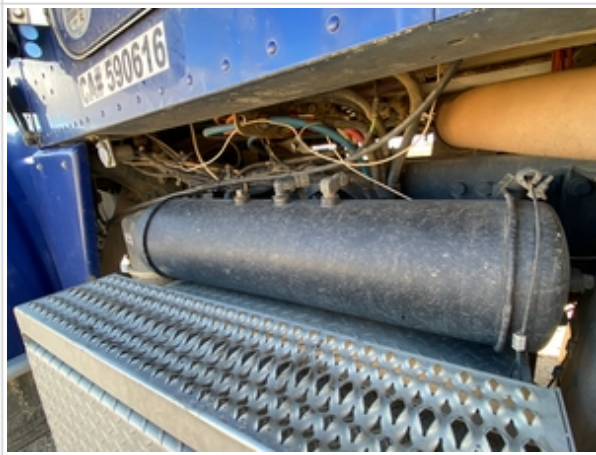
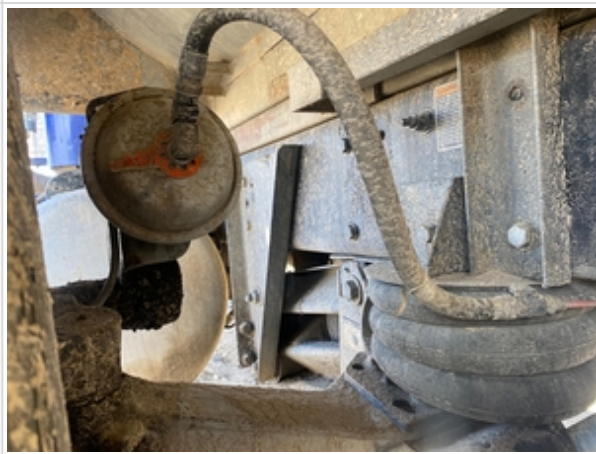
Air Brake System Leaks	No
Air Brake Hose Condition	3 - Normal Wear & Tear
Air Brake System Photos

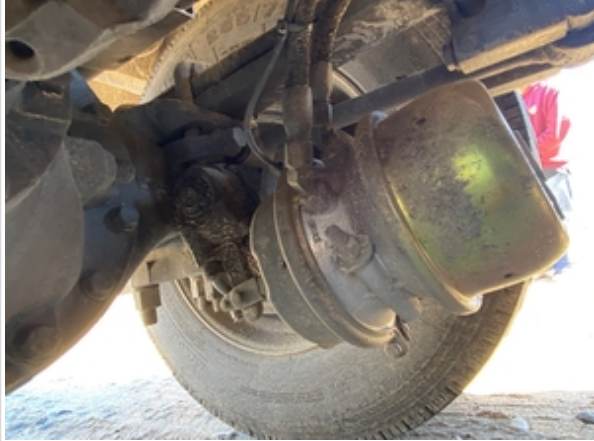
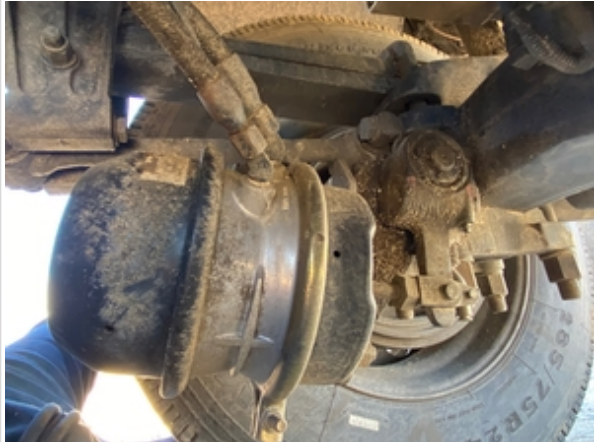
Engine Brake Configuration	2 Position
Engine Brake	3 - Normal Wear & Tear
Parking Brake	3 - Normal Wear & Tear
Parking Brake Condition	Good brake function
Parking Brake Photos

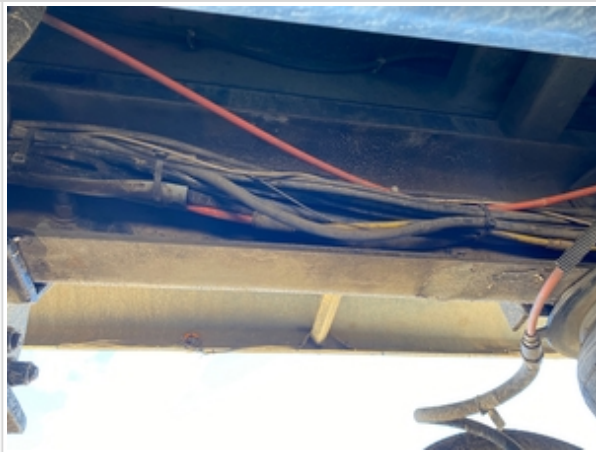
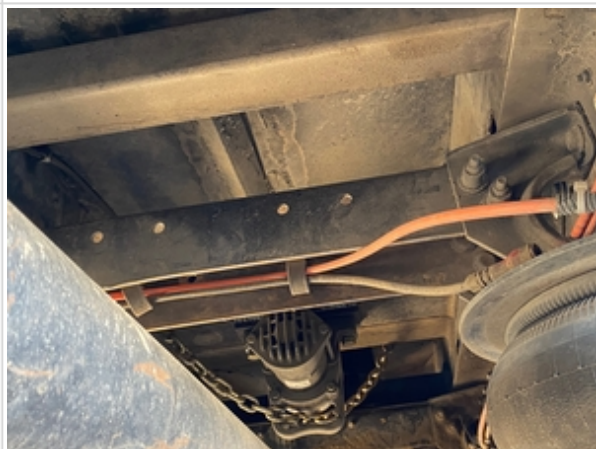
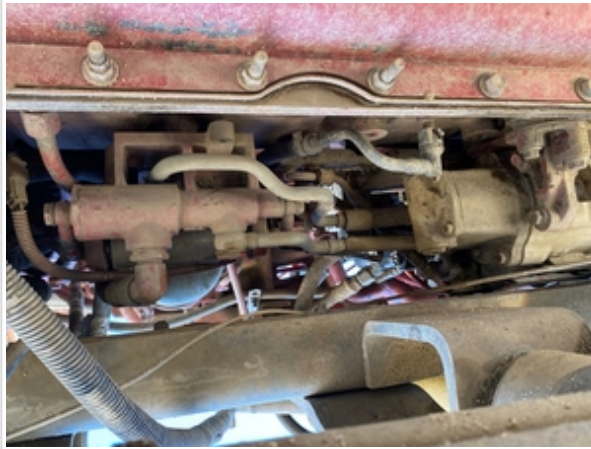
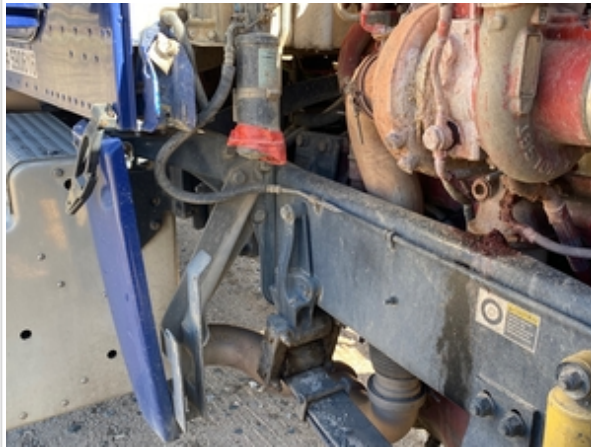
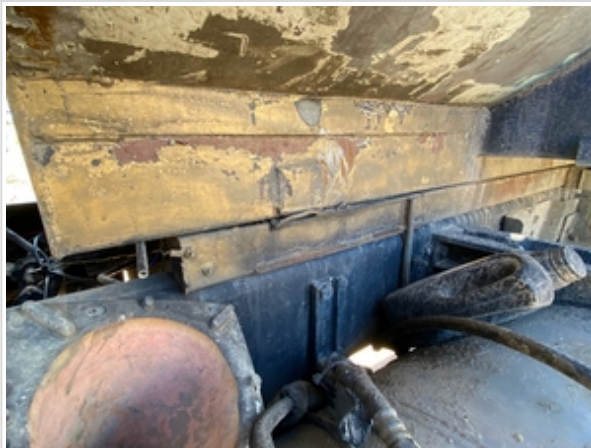
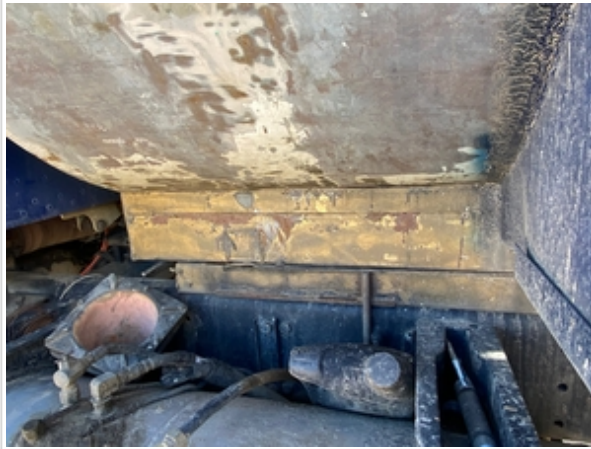
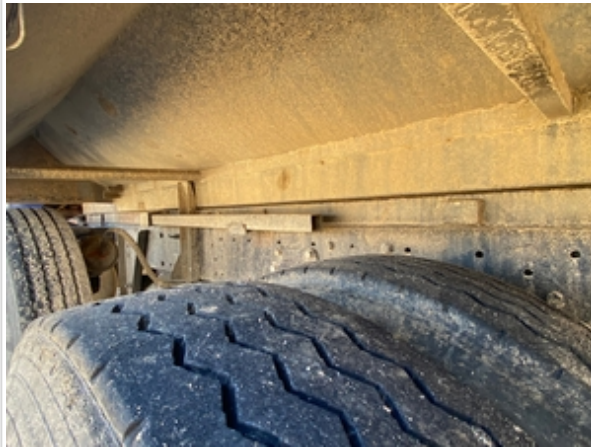
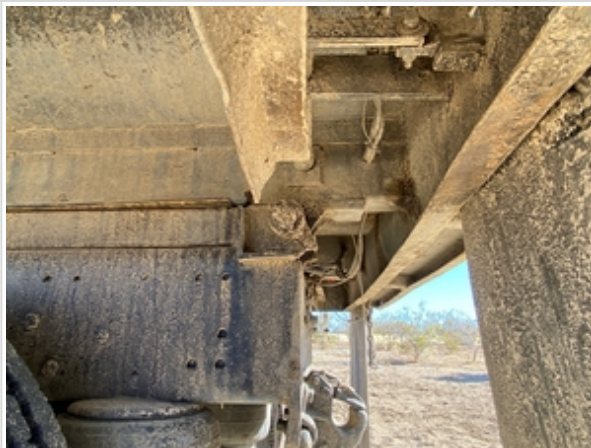
<b>Frame Condition</b>	3	
<b>Frame Photos</b>

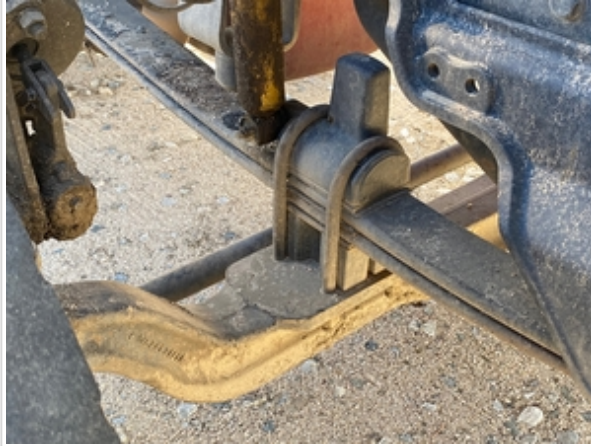
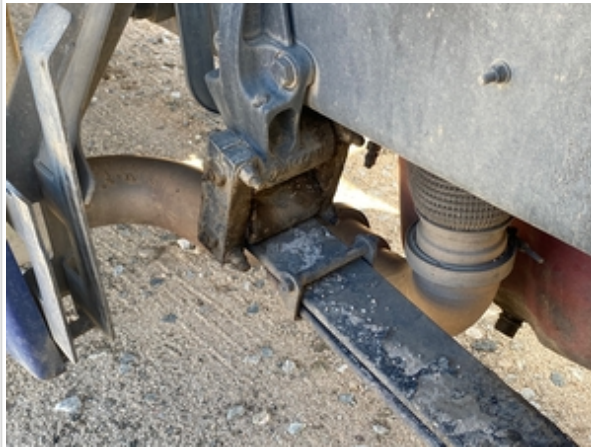
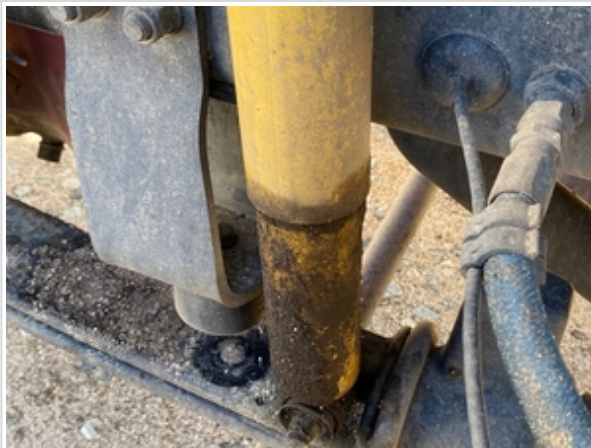
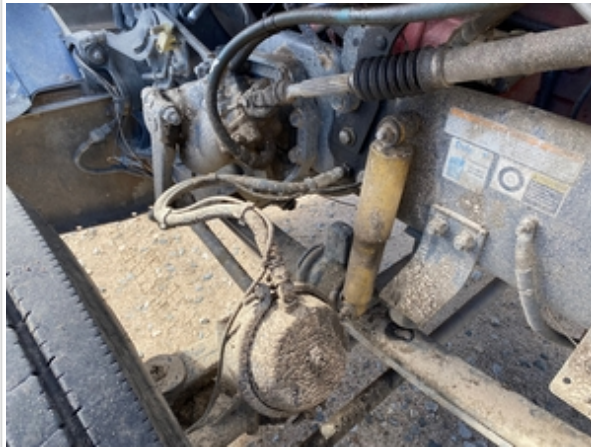
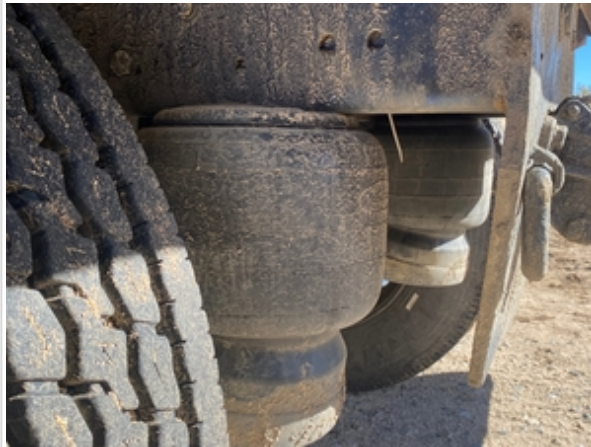
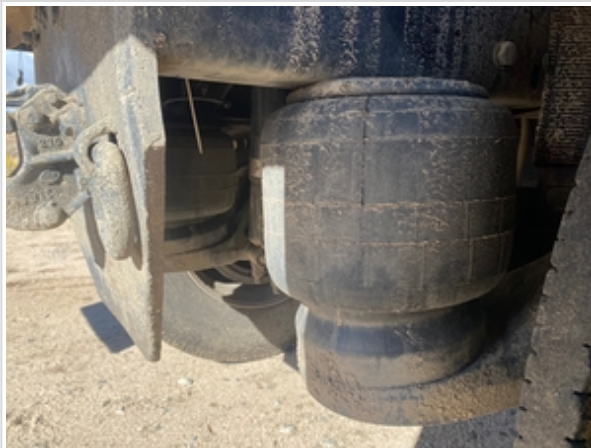
Suspension Photos

Suspension	3
Comments	Front shocks worn, leaking

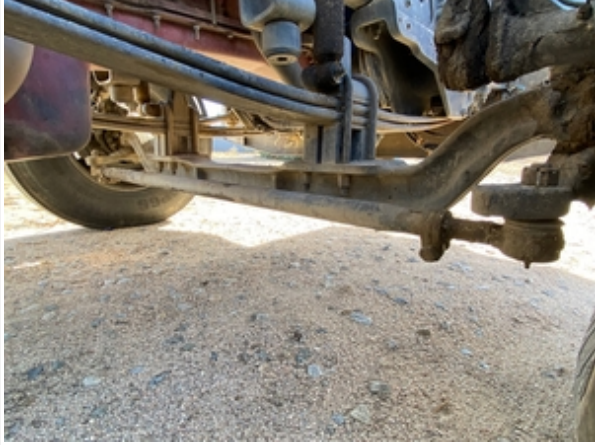
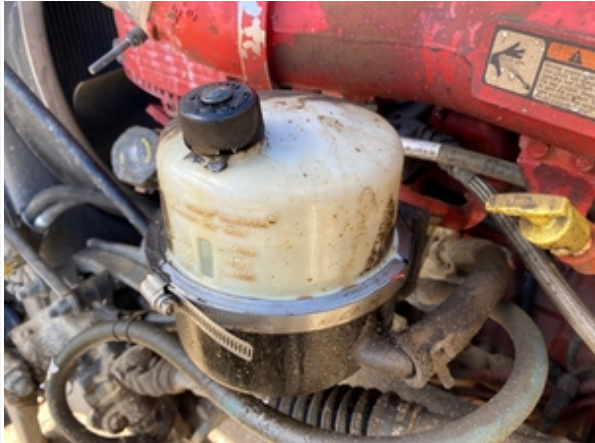
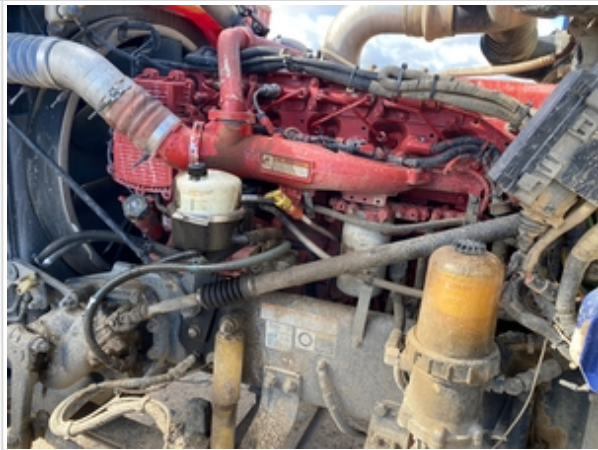
Steering Components	3
Steering Components Photos

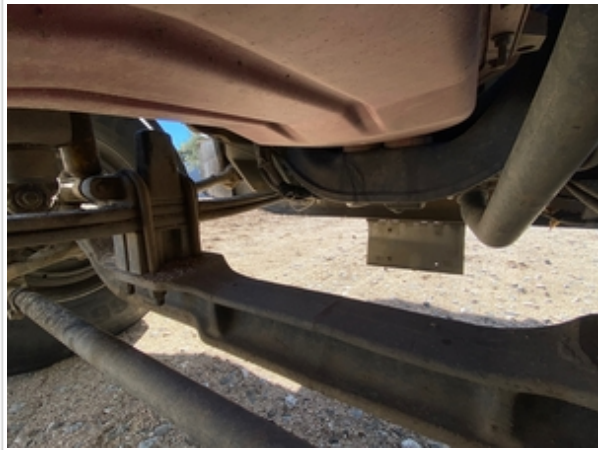
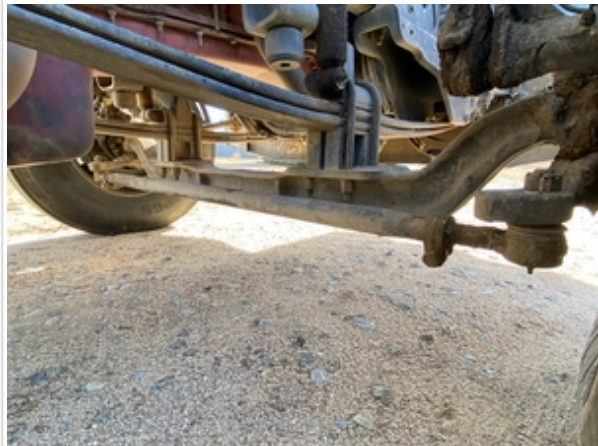
<b>Steer Axle Condition</b>	3	
<b>Steer Axle Photos</b>

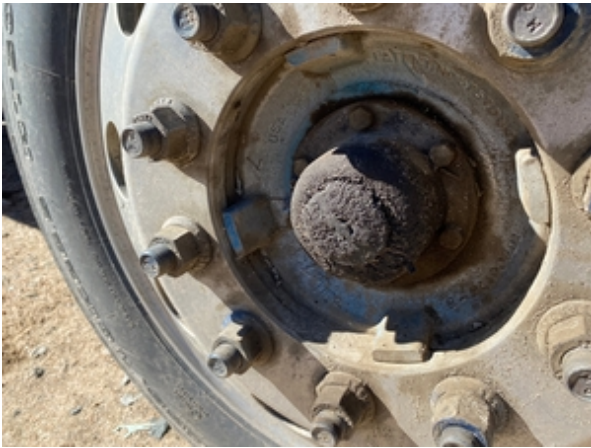
Wheels & Hub Photos

<b>Wheels &amp; Hub Condition</b>	3	
-----------------------------------	---	--

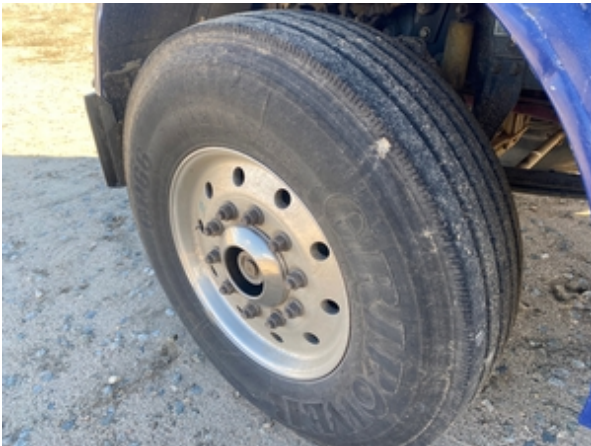
Wheel Seal Leaks	No
Tire Brand	Goodyear & Gripower
Tire Size	315/80R/22.5 & 285/75/24.5
Front Left Tire - Ratio Remaining	70%
Front Left Tire Photos

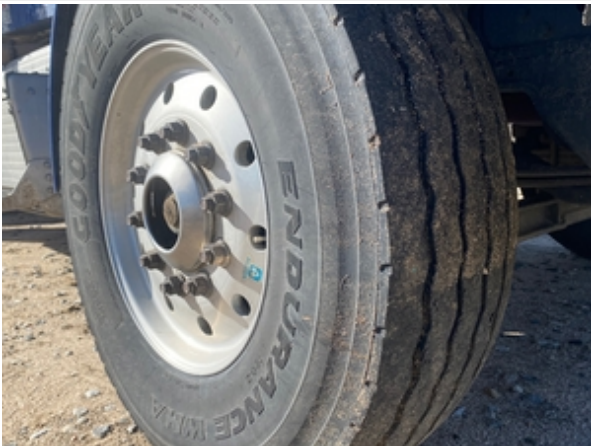
Front Right Tire - Ratio Remaining	70%
Front Right Tire Photos

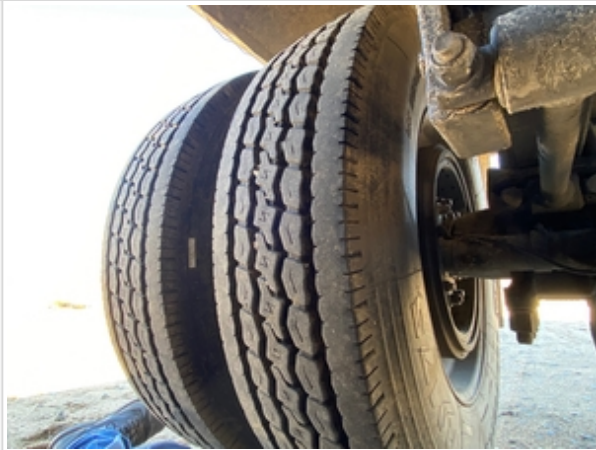
Rear Right Tire Photos

Rear Right Tire - Ratio Remaining	70%

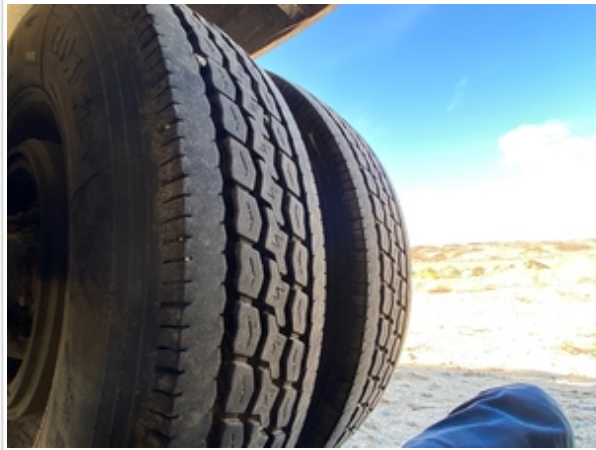
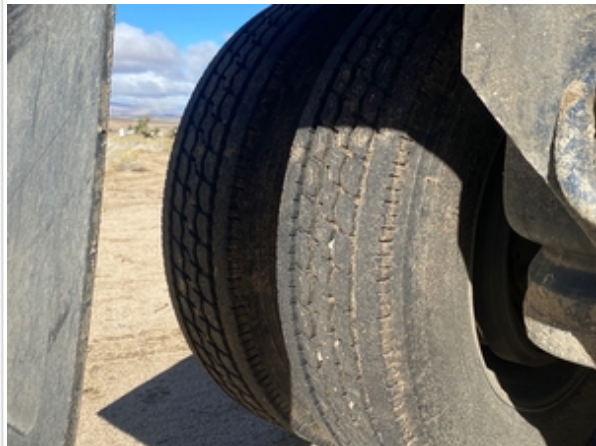
Rear Left Tire - Ratio Remaining	70%
Rear Left Tire Photos
