## Inspection Report (On-Highway Dump Truck)

Year	2012
Make	Peterbilt
Model	388
Serial Number	1XP-WD49X-8-CD168910
Truck Odometer Reading	650,050
Current Inspection / State Cert / DOT	N/A
Previous Application (e.g., earth moving, mining, demolition, etc)	General Construction

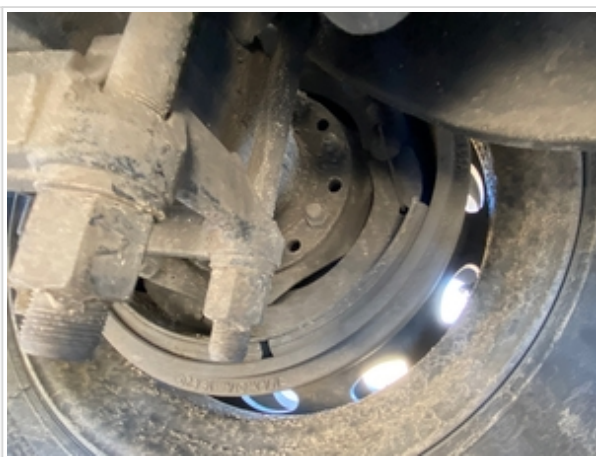
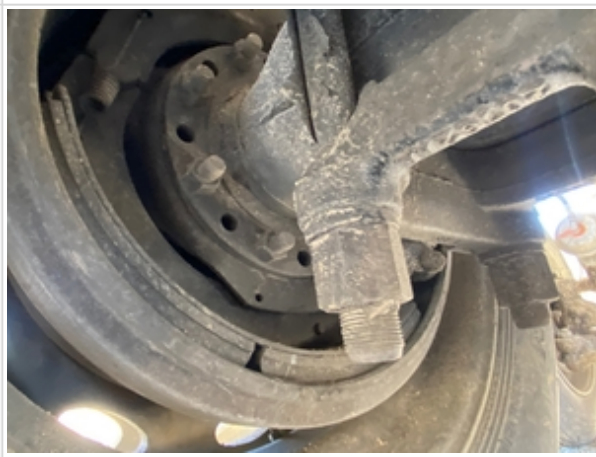
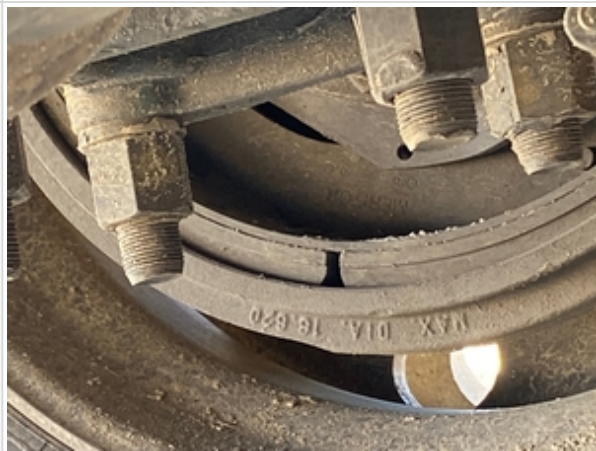
<p>Brake Shoe Photos</p>

Brake Shoe Thickness	50%
Comments	Front brake shoes low, rears around 50 to 70%

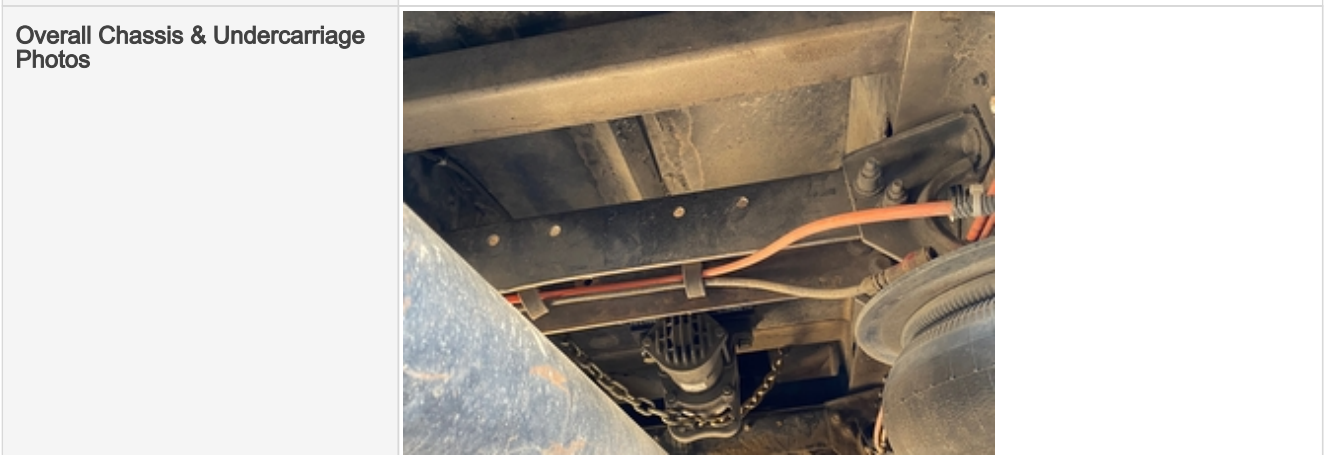
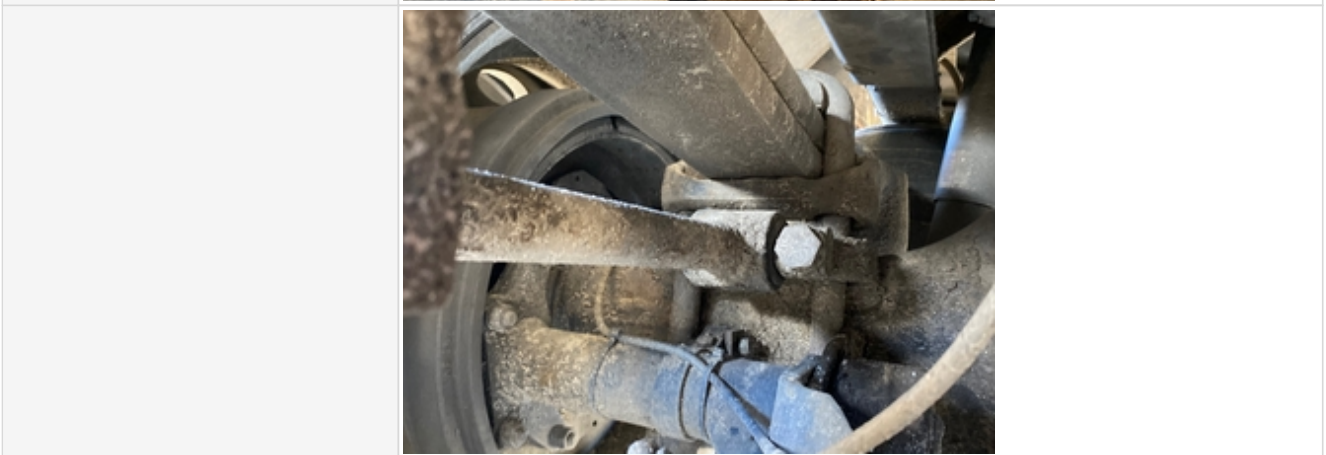
Overall Chassis	3
Overall Chassis Comments	Overall chassis in good condition. Components all intact and no major issues observed.

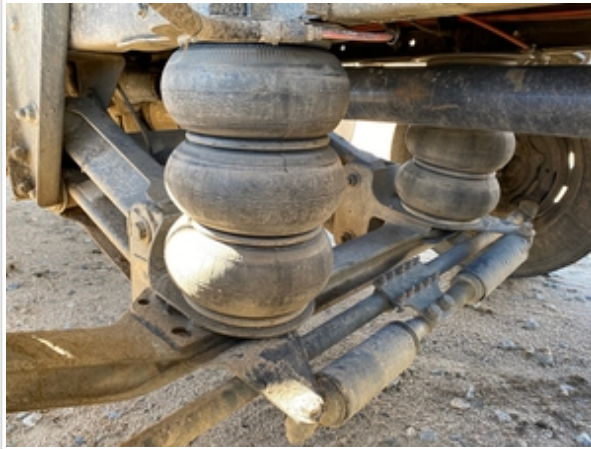
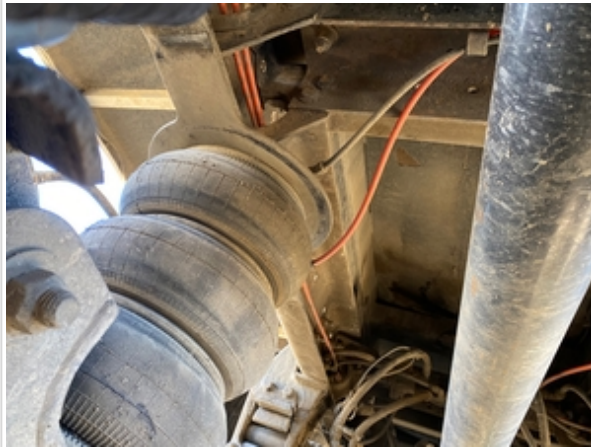
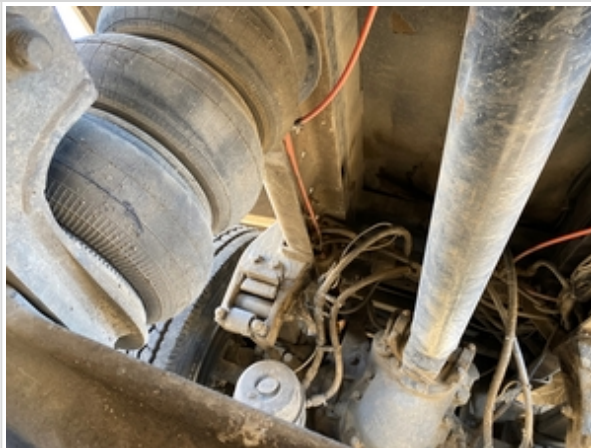
<b>Instructions</b>	Check the condition of additional axle(s), wheels & tires. Note any damage or wear. Take photos.	
<b>Axle Description &amp; Position</b>	Drop down axle	
<b>Steerable?</b>	No	
<b>Drop Axle?</b>	Yes	
<b>Super Dump?</b>	Yes	
<b>Axle Condition</b>	3 - Normal Wear & Tear	
<b>Axle Condition Photos</b>

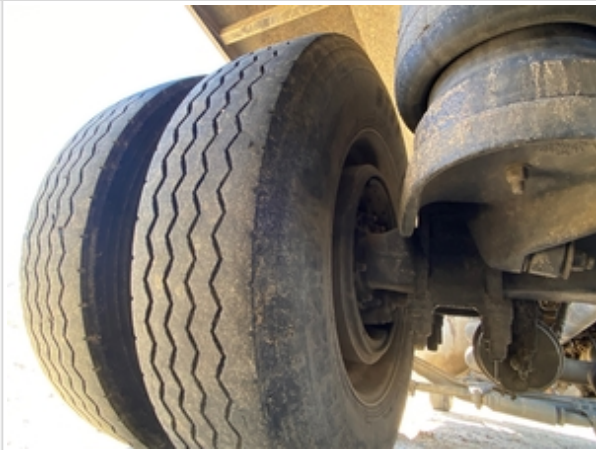
Wheels & Tires Photos

**Wheels & Tires**

2 - Above Average Wear

Tire Brand	Generic Recaps
Tire Size	285/75/24.5
Left Tire(s) Ratio Remaining	50%
Right Tire(s) Ratio Remaining	50%

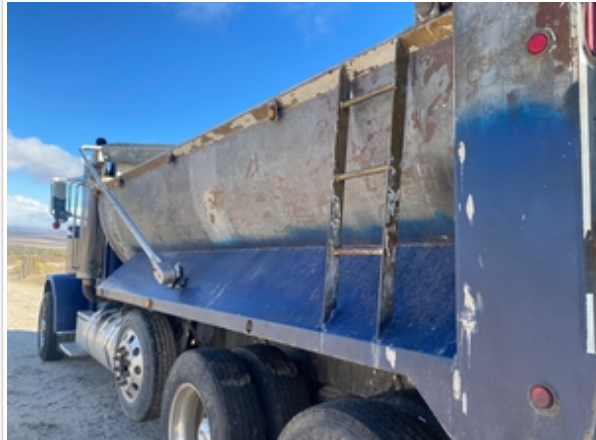
Dump Body Make & Material	N/A
Dump Body Length (ft and inches)	N/A
Dump Body Height (ft and inches)	N/A
Bed Body	3 - Normal Wear & Tear
Bed Body Photos
