Inspection Report (Telehandler)

Year	2012
Make	JLG Skytrak
Model	8042
Serial Number	0160048079
Hour Meter Reading	2,994
Previous Application (e.g., earth moving, mining, demolition, etc)	Equipment Rental

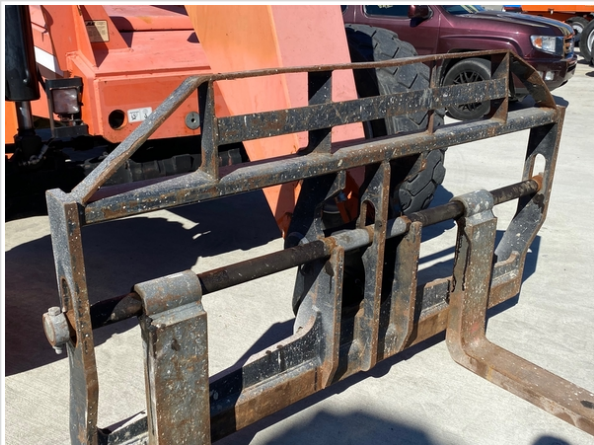
Front	3 - Normal Wear & Tear
Front Condition	No visible damage
Front Photos

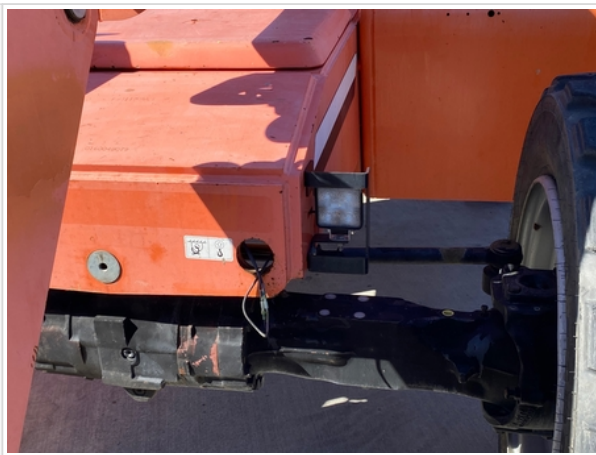
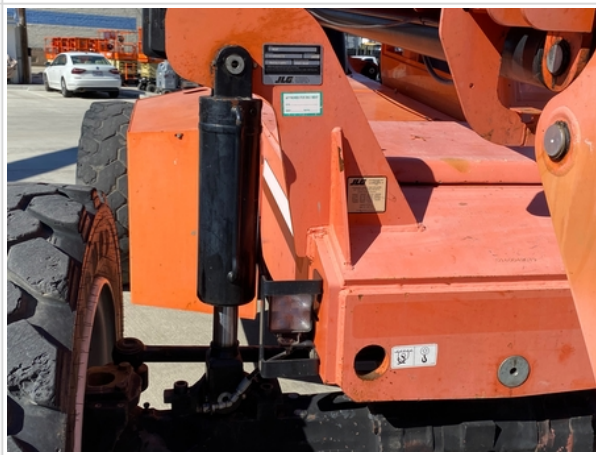
Rear	3 - Normal Wear & Tear
Rear Condition	No visible damage
Rear Photos

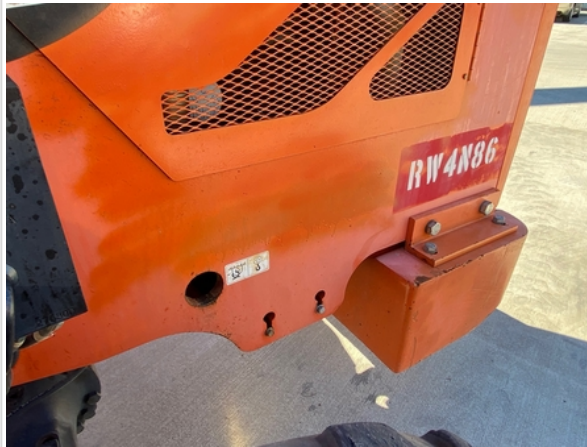
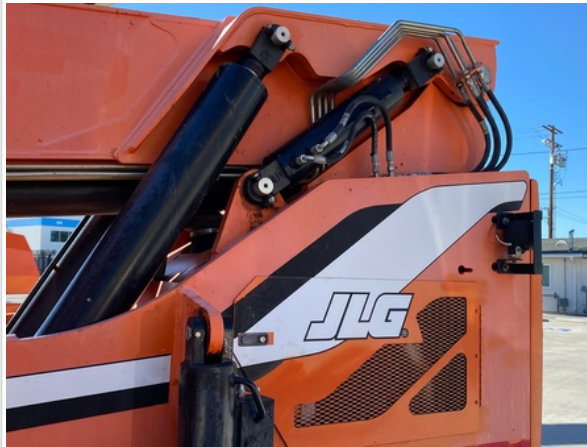
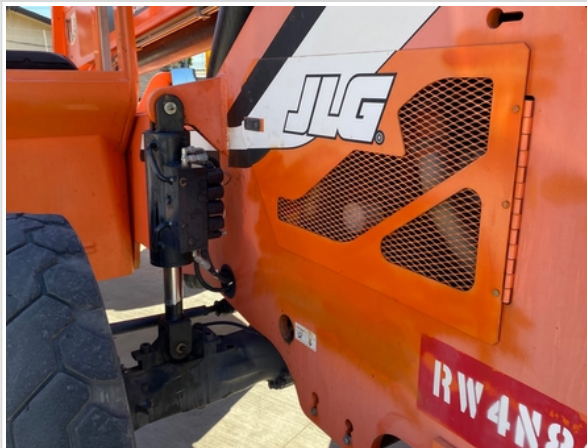
Left Photos

Left	3 - Normal Wear & Tear
Left Condition	No visible damage

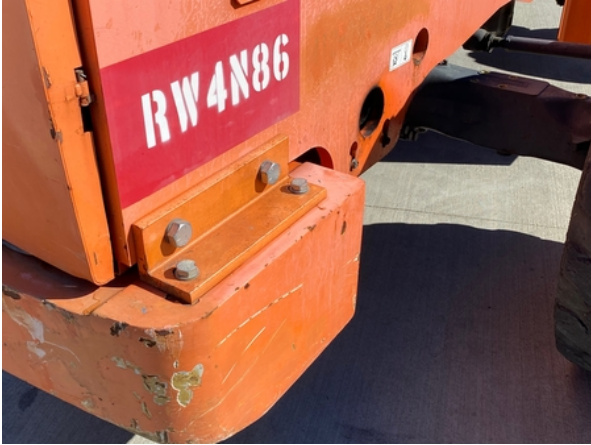
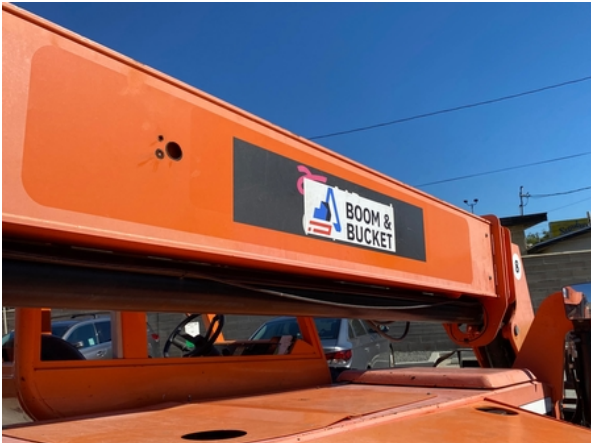
Right	3 - Normal Wear & Tear	
Right Condition	No visible damage	
Right Photos

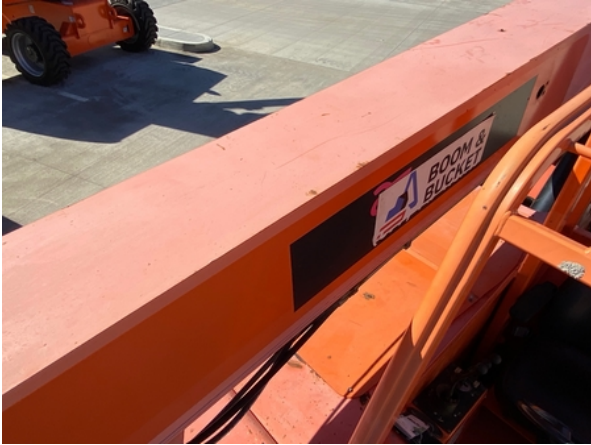
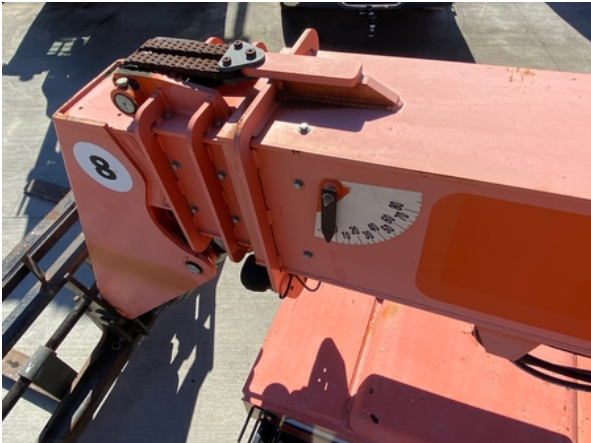
Upper	3 - Normal Wear & Tear	
Upper Condition	No visible damage	
Upper Photos

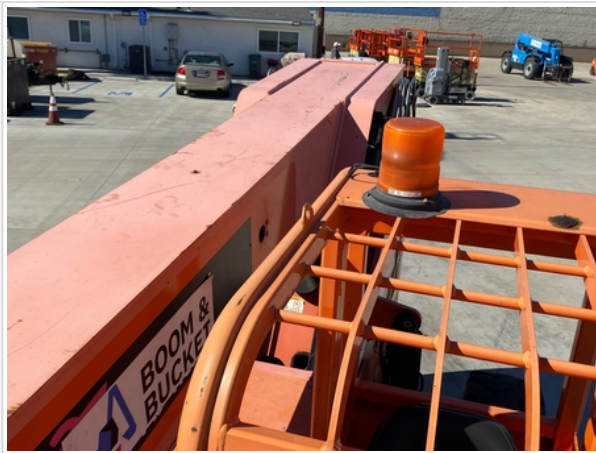
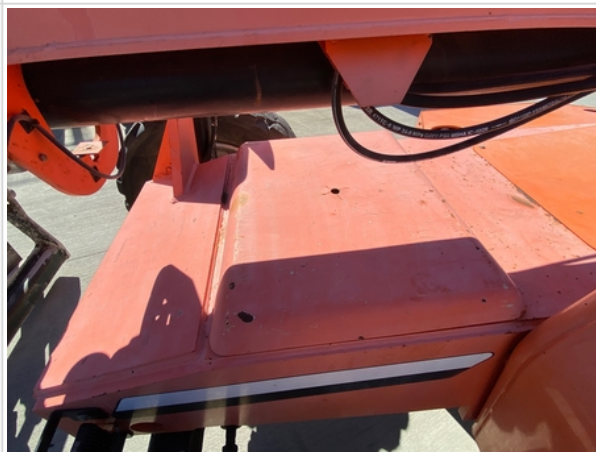
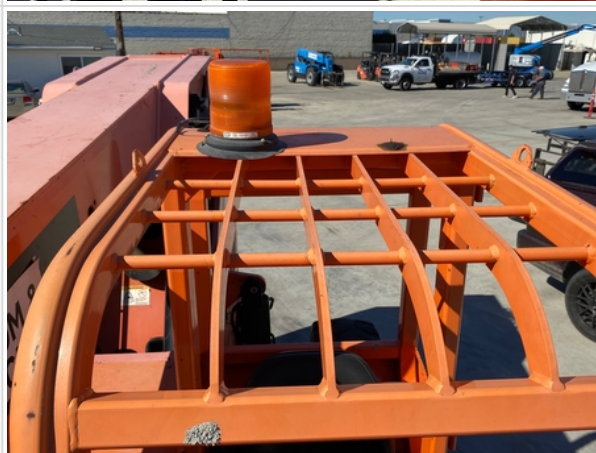
Body Panels (Any Rust Damage?)	3 - Normal Wear & Tear
Body Panel Condition	No visible damage, good paint condition and panel fitment

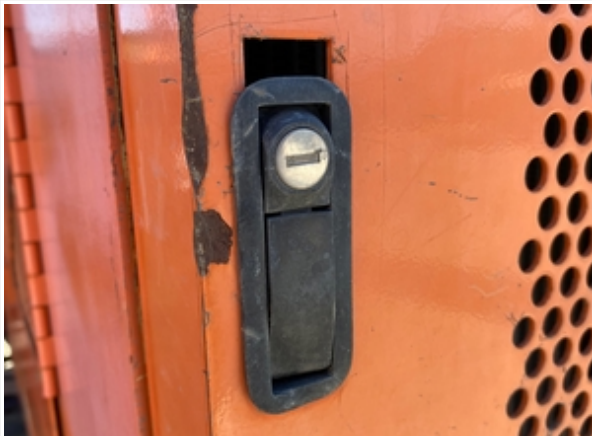
Doors / Canopy Latches	3 - Normal Wear & Tear	
Doors / Canopy Latches Condition	No visible damage	
Doors / Canopy Latches Photos

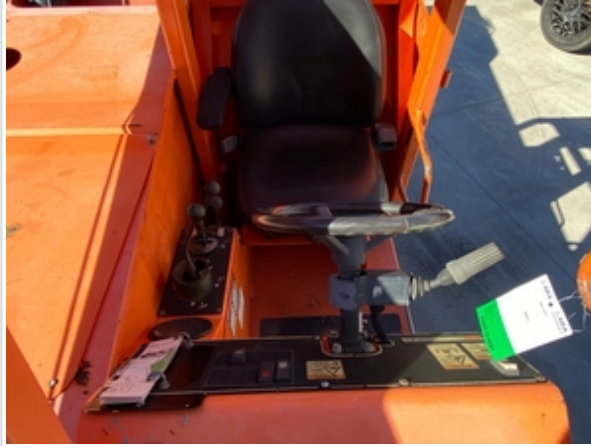
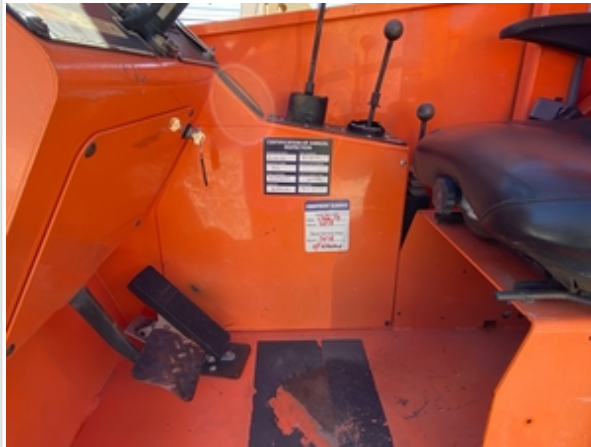
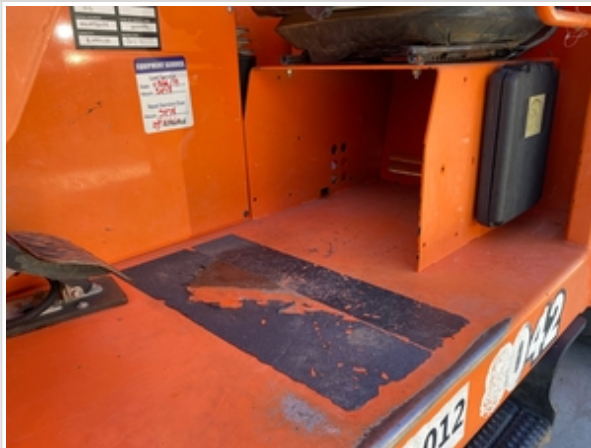
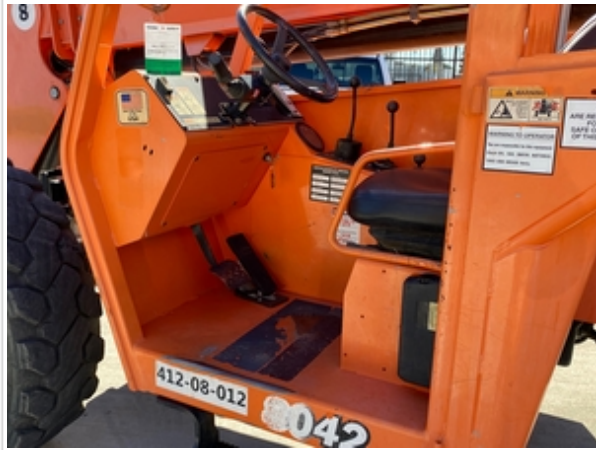
Operator Cabin Photos

Serial Number Plate Photo	 
Operator Cabin Overall	3 - Normal Wear & Tear
Operator Cabin Overall Condition	Good cabin appearance, solid floors, panels, and ceiling

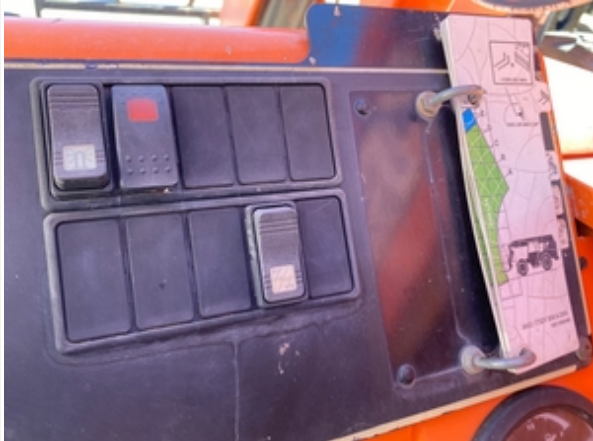
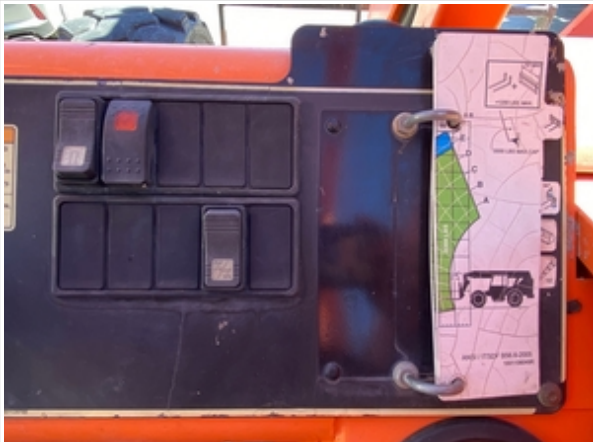
Seat Belt	3 - Normal Wear & Tear
Seat Belt Condition	Seat belt secures properly. Belt is intact and in good condition
Cabin Lights	0
Safety Lock Out / Stop	0
Controls & Switches	3 - Normal Wear & Tear
Controls & Switches Condition	All switches are installed and functional
Controls & Switches Photos

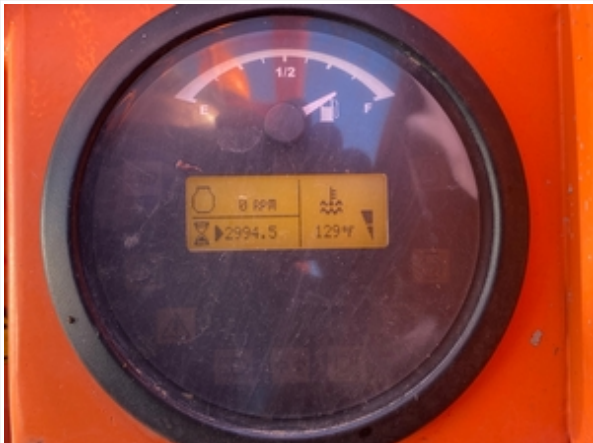
Hour Meter Activity	3 - Normal Wear & Tear
Hour Meter Condition	Hour meter is functional and in good condition
Hour Meter Activity Photos

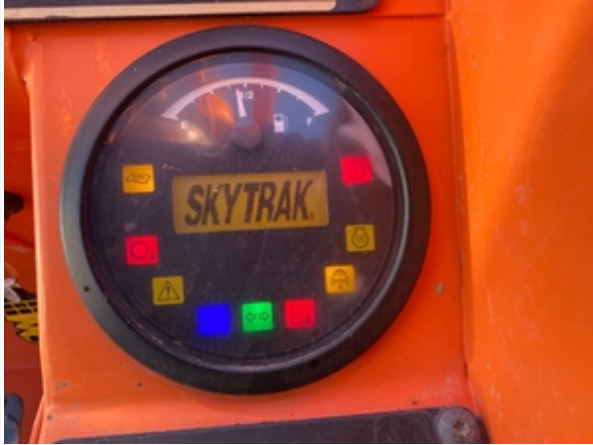
Other Gauge Activity Photos

Other Gauge Activity	3 - Normal Wear & Tear
Other Gauge Condition	All cockpit gauges are functional and in good condition

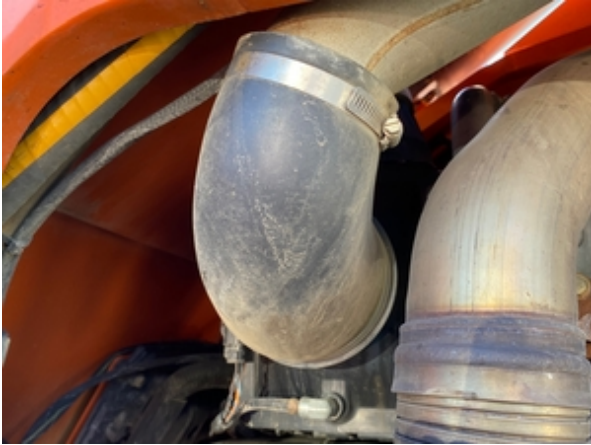
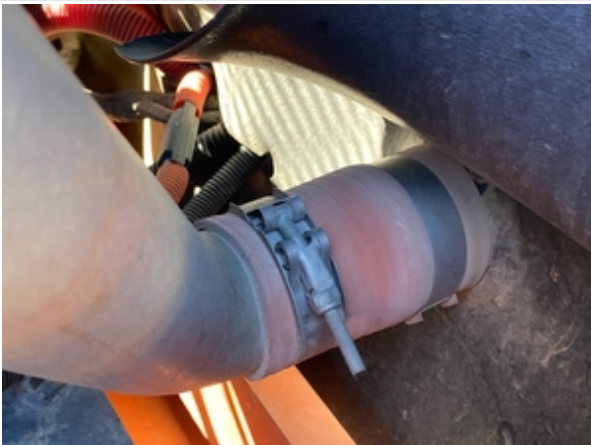
Hoses	3 - Normal Wear & Tear
Hose Condition	Firm, pliant hoses with no signs of wear or leaks
Hose Photos

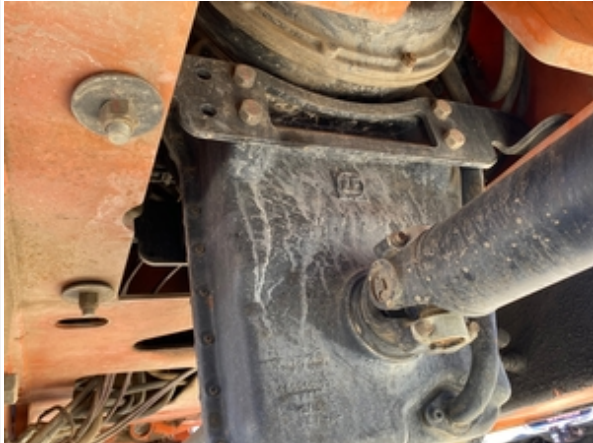
Hydrostatic Transmission?	No
Transmission Info (Make/Model/Speeds)	Powershift Transmission
Transmission	3 - Normal Wear & Tear
Transmission Condition	No unusual noises or vibrations
Transmission Photos

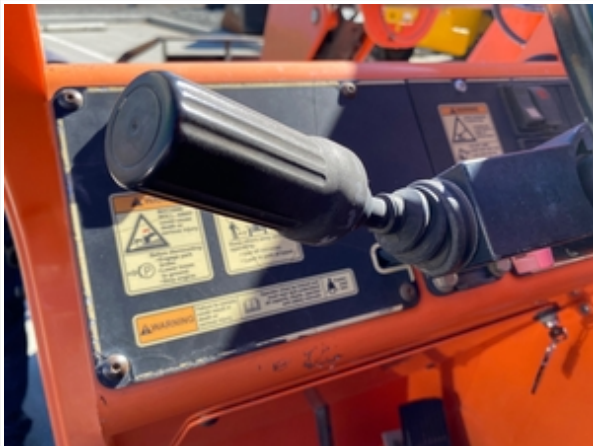
Clutch	0
Shift Lever	3 - Normal Wear & Tear
Shift Lever Condition	Good forward and reverse function
Shift Level Photos

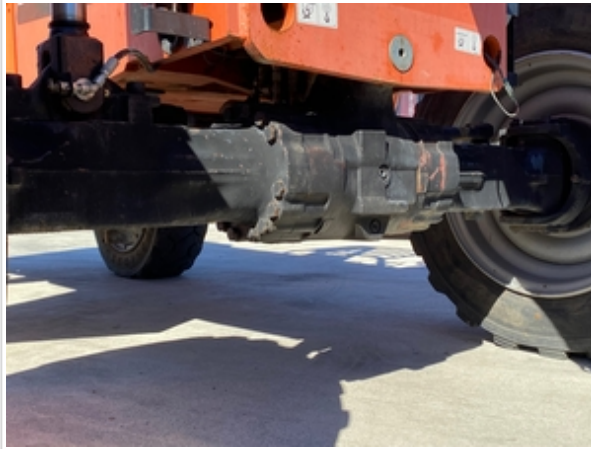
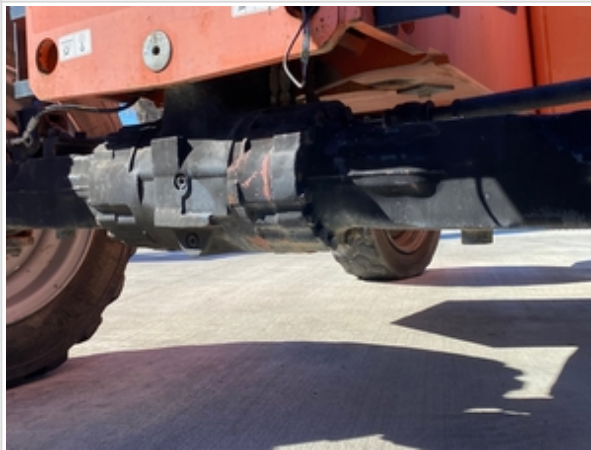
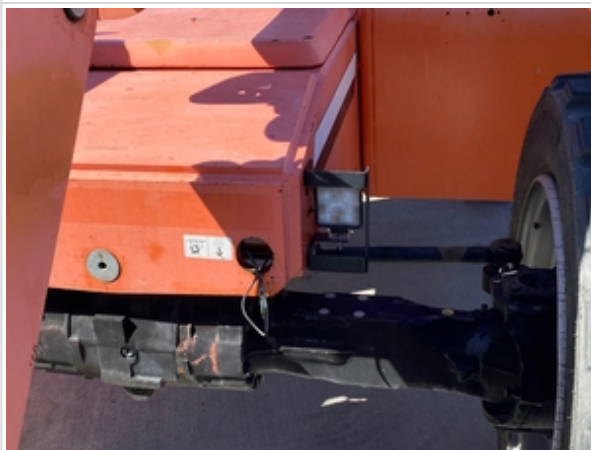
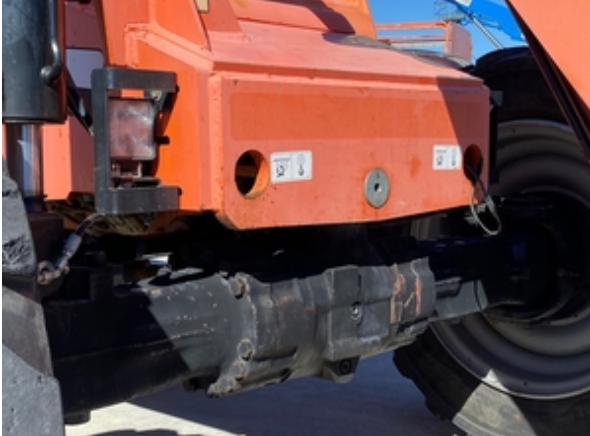
Front Axle Appearance Photos

<p>Front Axle Appearance</p>	<p>3 - Normal Wear & Tear</p>

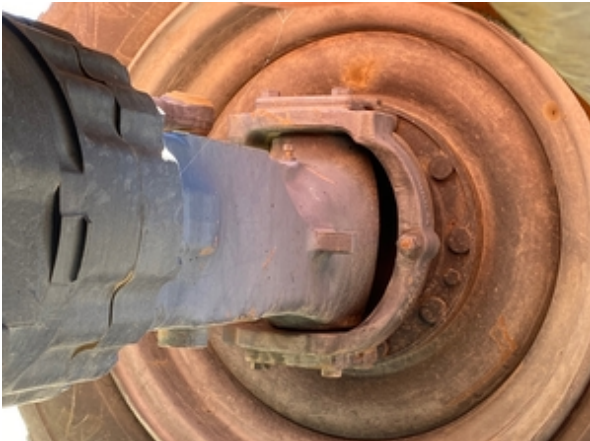
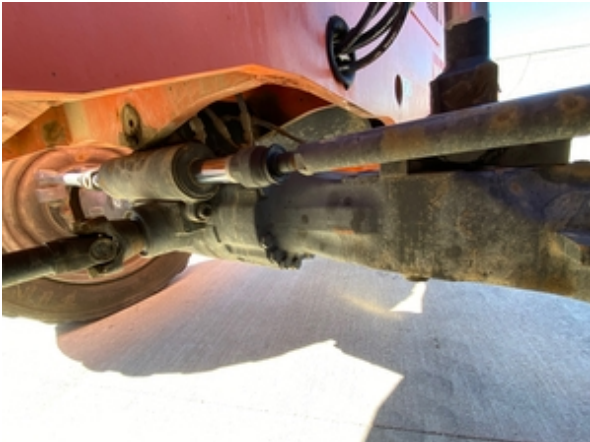
<p>Rear Axle Appearance</p>	<p>3 - Normal Wear & Tear</p>	
<p>Rear Axle Appearance Photos</p>

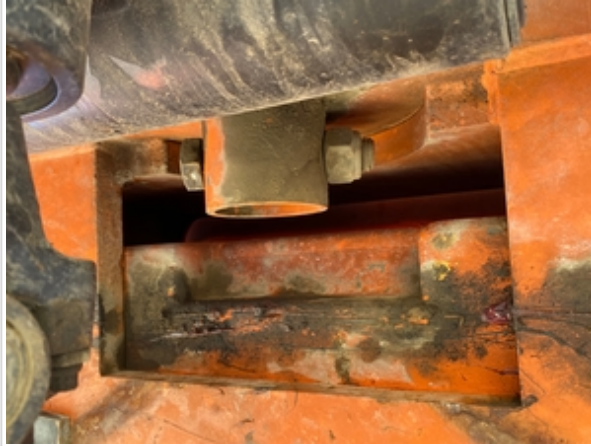
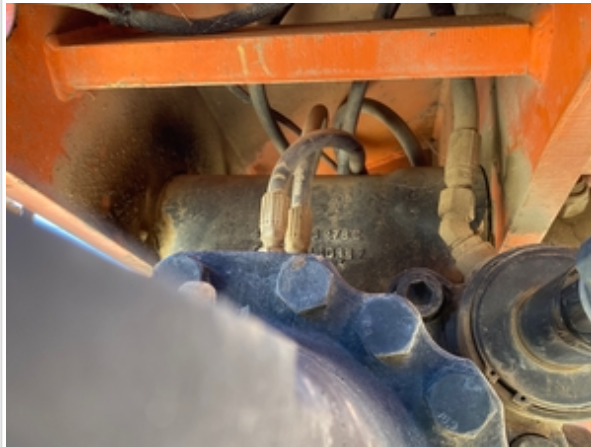
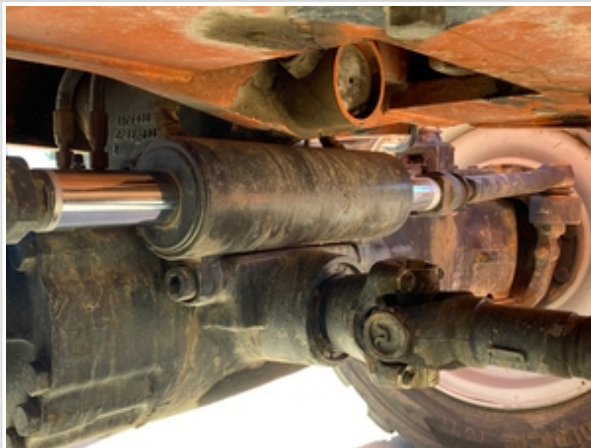
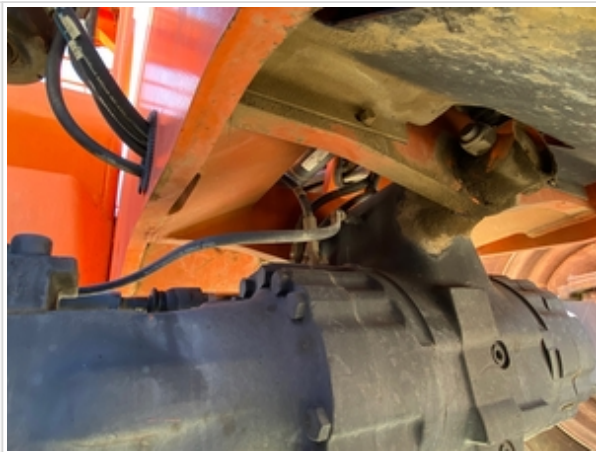
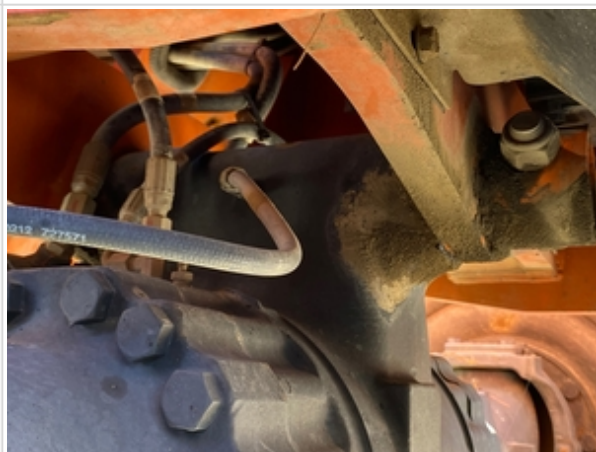
Oscillating Pin Appearance Photos

<p>Oscillating Pin Appearance</p>	<p>3 - Normal Wear & Tear</p>

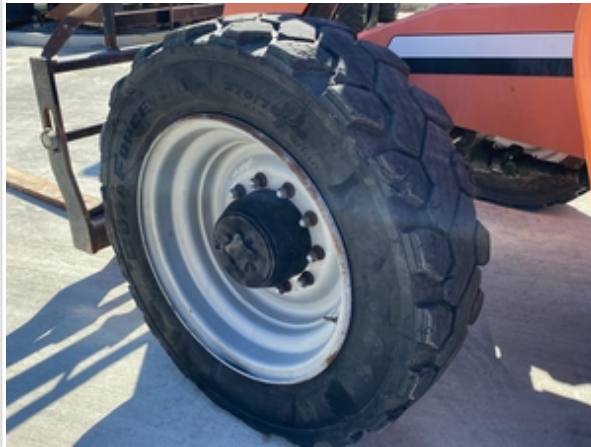
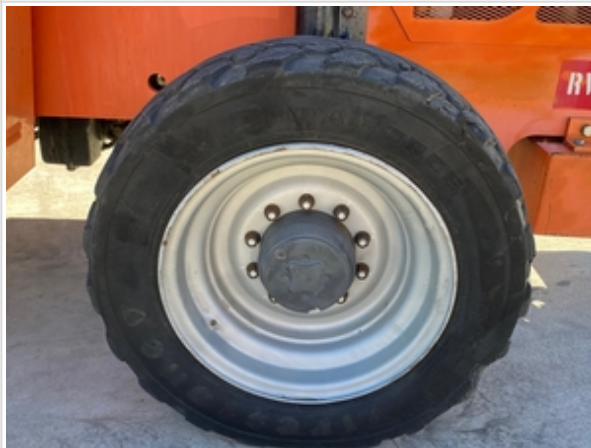
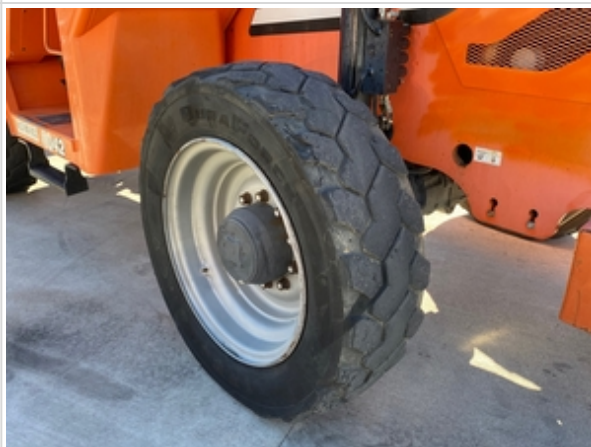
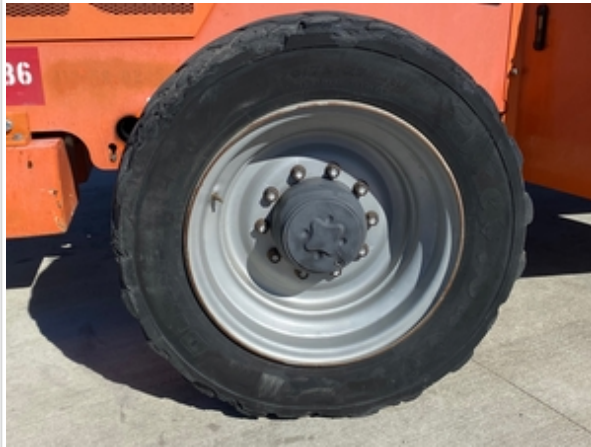
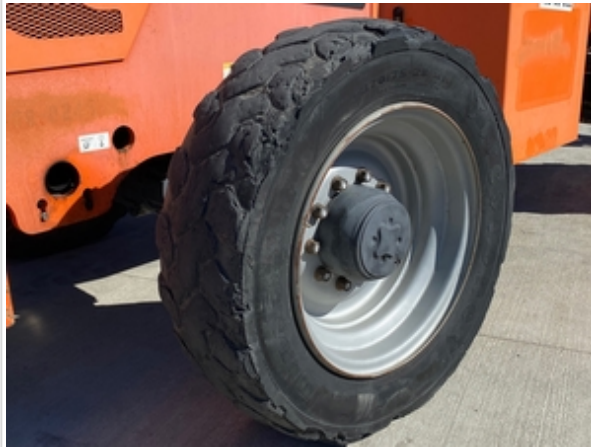
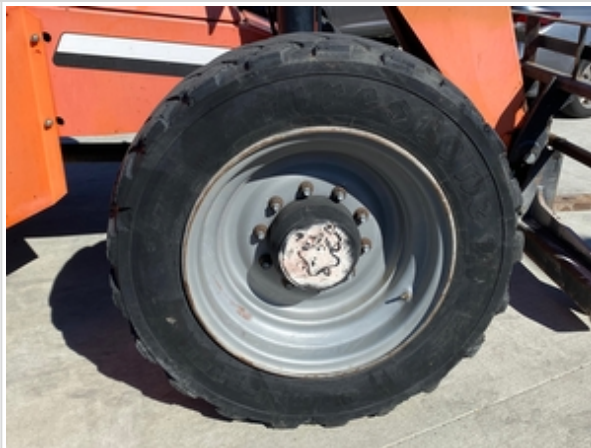
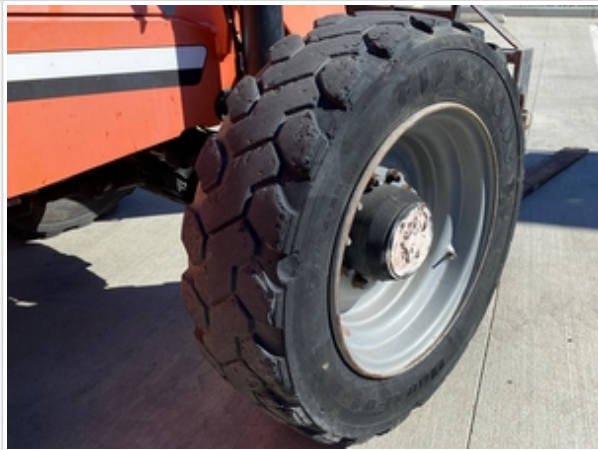
<p>Wheels & Tires</p>	<p>3 - Normal Wear & Tear</p>	
<p>Wheels & Tires Photos</p>

Tire Brand	Firestone	
Tire Size	360/75-28	
Front Left Tire - Ratio Remaining	30%	
Rear Left Tire - Ratio Remaining	30%	
Front Right Tire - Ratio Remaining	10%	
Rear Right Tire - Ratio Remaining	30%	
Boom Condition	3 - Normal Wear & Tear	
Boom Condition Photos

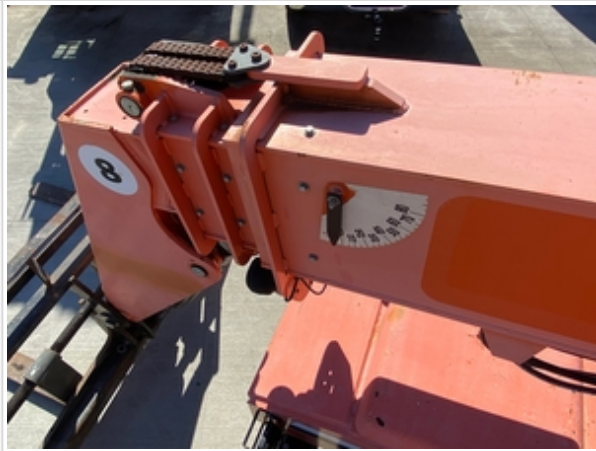
<p>Chain / Tensioners</p>	<p>3 - Normal Wear & Tear</p>	
<p>Chain / Tensioners Photos</p>

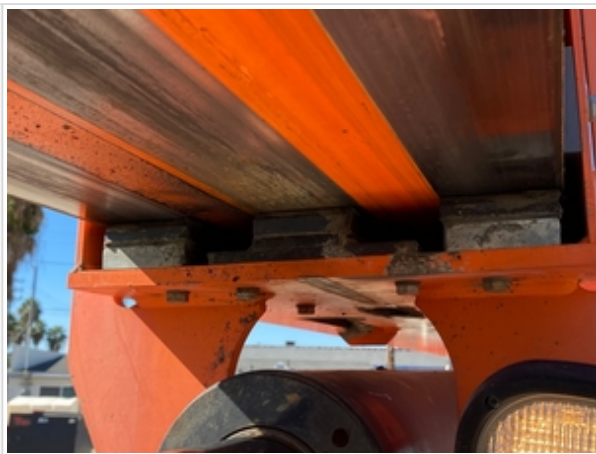
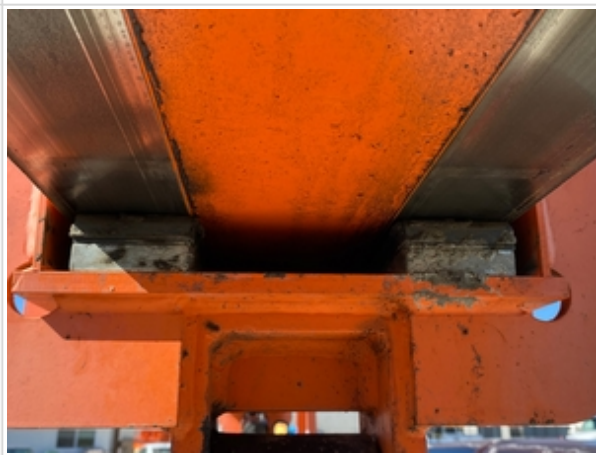
Rollers & Guides	3 - Normal Wear & Tear	
Boom Wear Guides	3 - Normal Wear & Tear	
Boom Wear Guides Photos

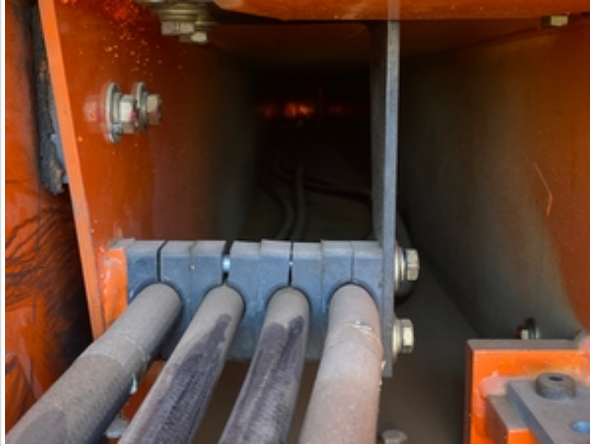
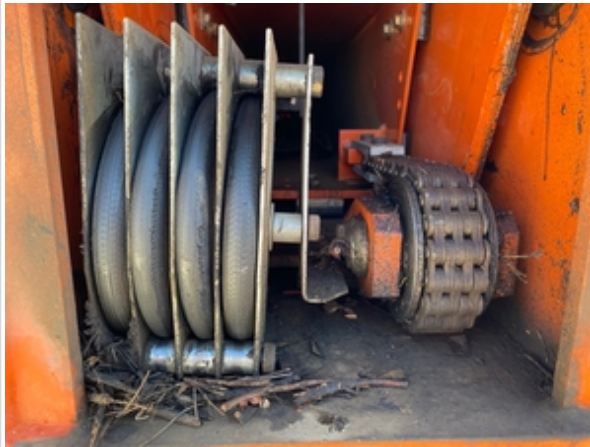
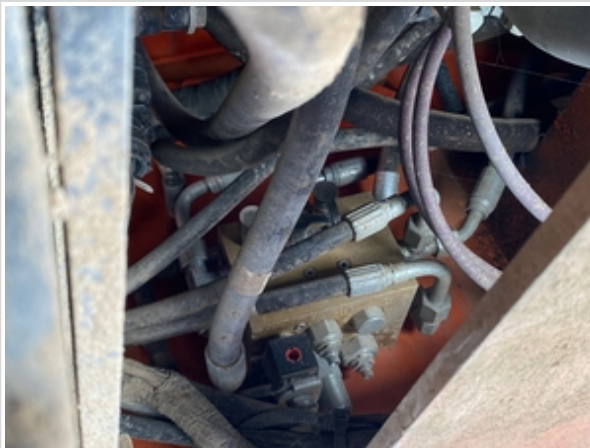
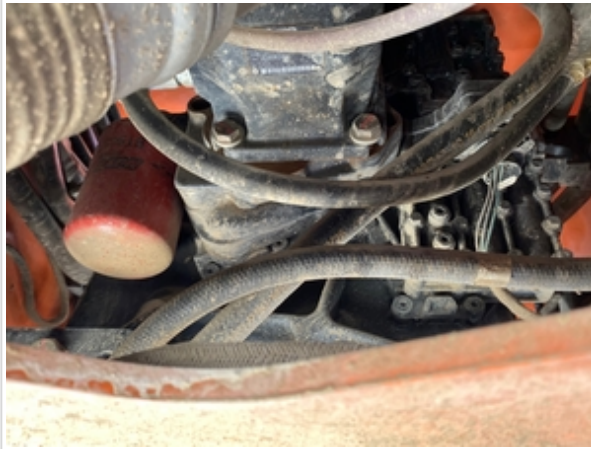
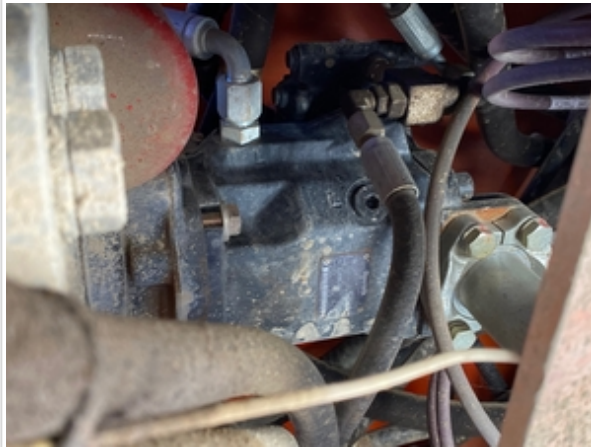
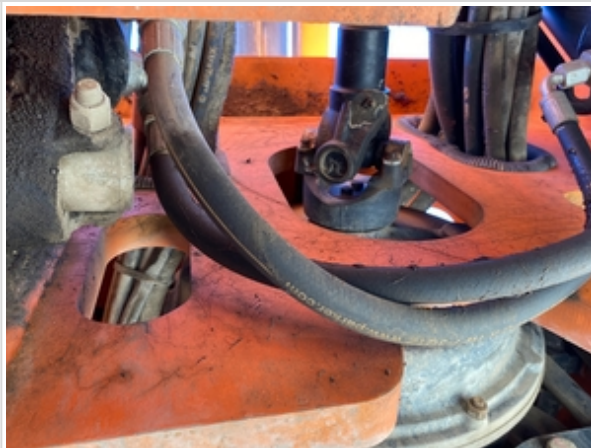
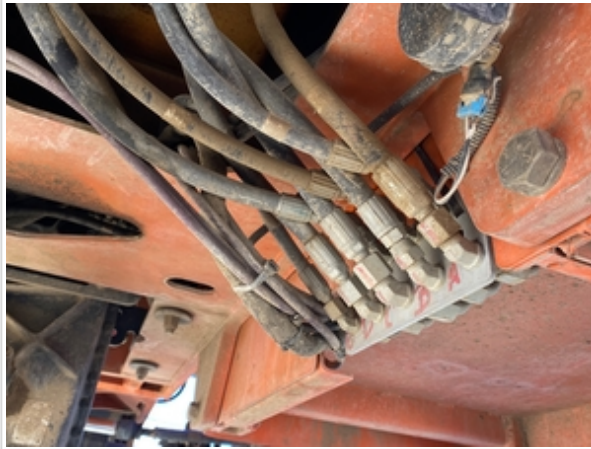
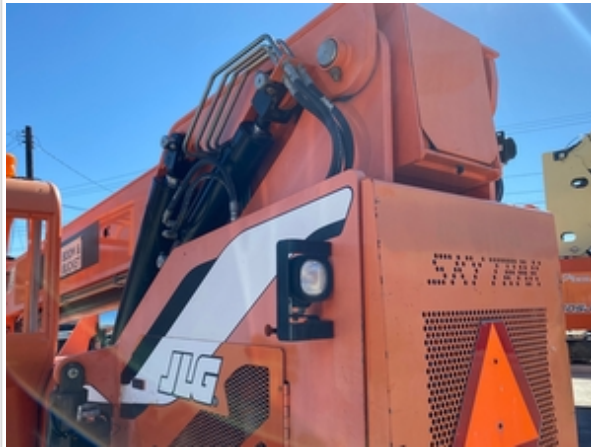
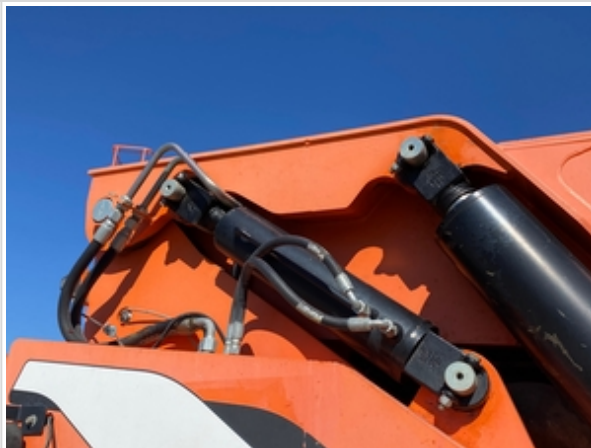
Appearance of Hydraulic Lines /
Fittings Photos

Wet or Damp Hydraulic Lines / Fittings	No	
Appearance of Hydraulic Lines / Fittings	3	
Hydraulic Lines / Fittings Condition	Hydraulic lines & fittings are clean and in good condition

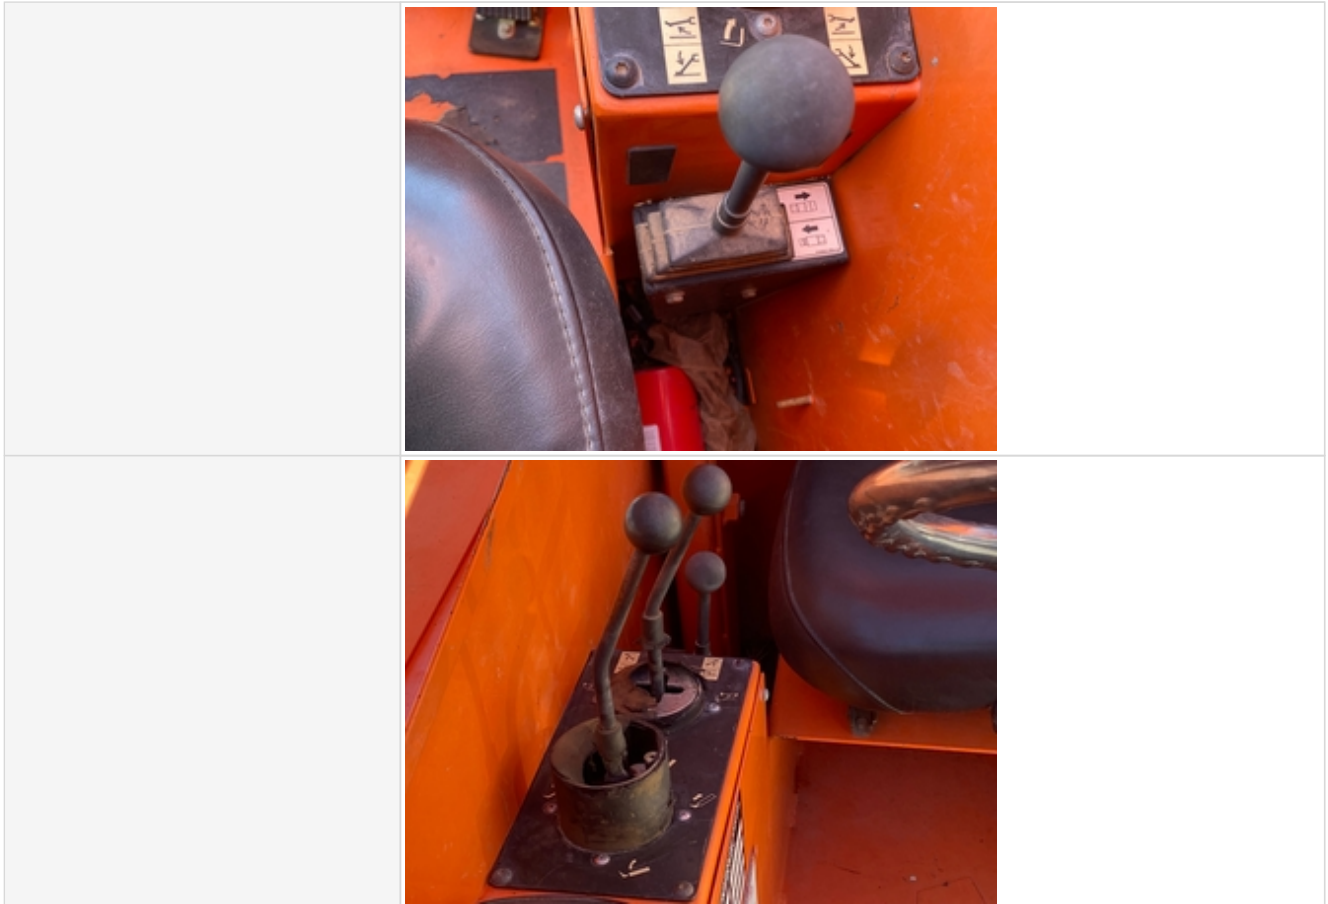
Unusual Noises (Hydraulic Pump)	No	
Hydraulic Pump Notes	No unusual noises heard during operation	
External Controls / Levers	3	
External Controls / Levers Condition	Good function & condition of hydraulic controls	
External Controls / Levers Photos

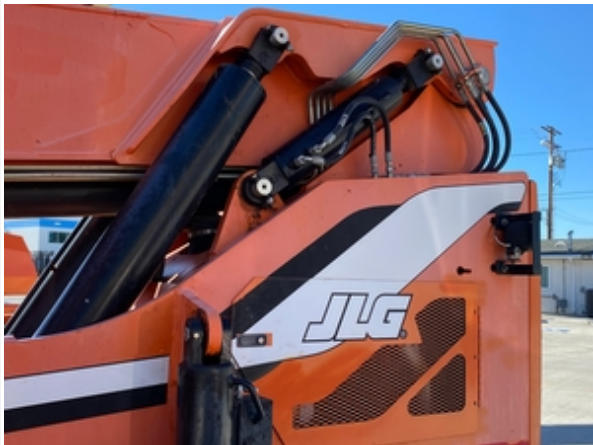
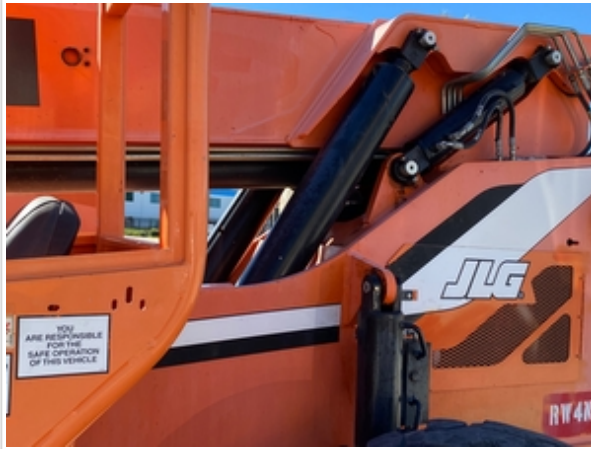
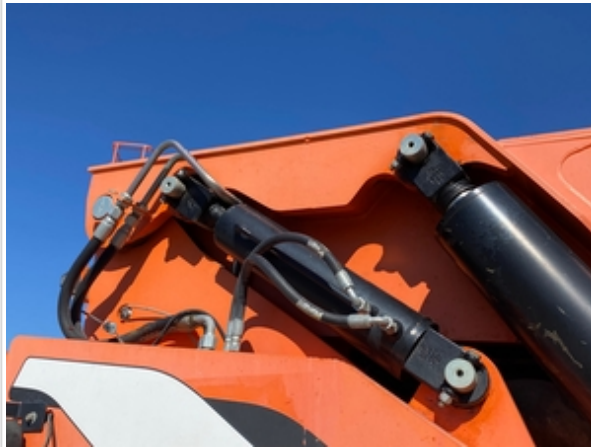
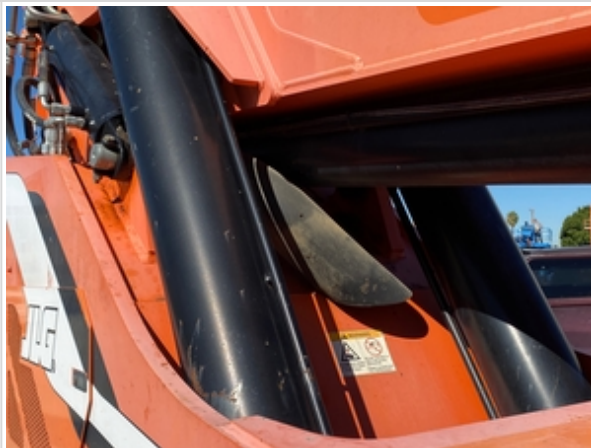
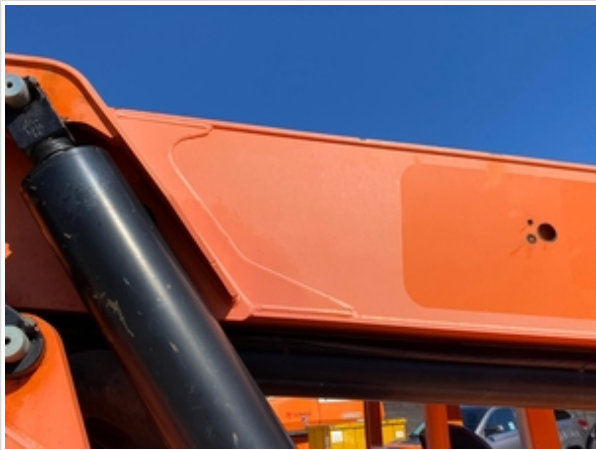
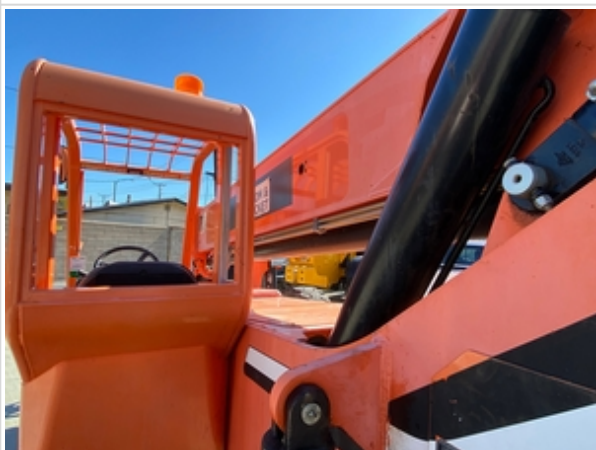
Boom Lift Cylinders	Check the boom lift cylinders. Note any wear, pitting, discoloration, etc. Take photos.
Boom Lift Cylinders: Mounting Pin	3
Boom Lift Cylinders: Oil Leaks	No
Boom Lift Cylinders Photos

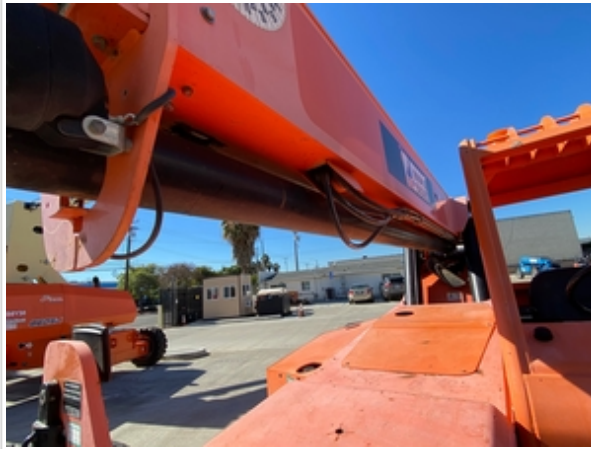
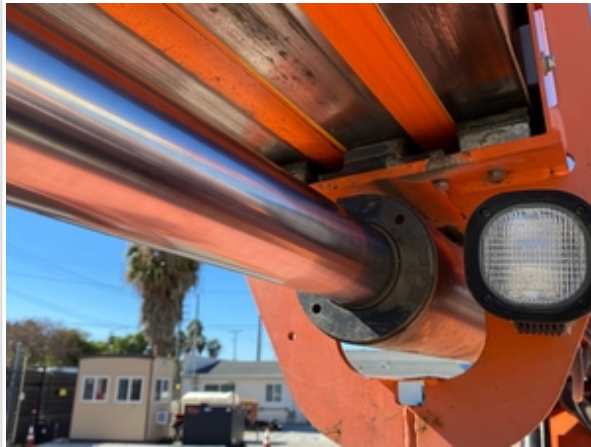
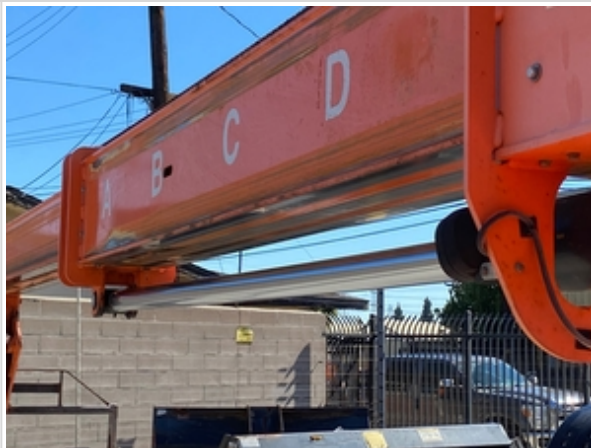
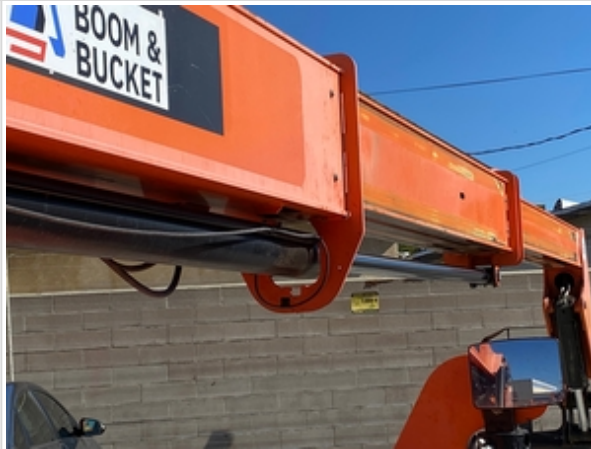
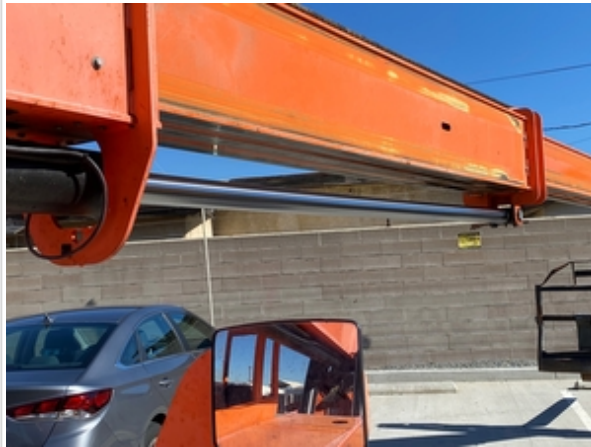
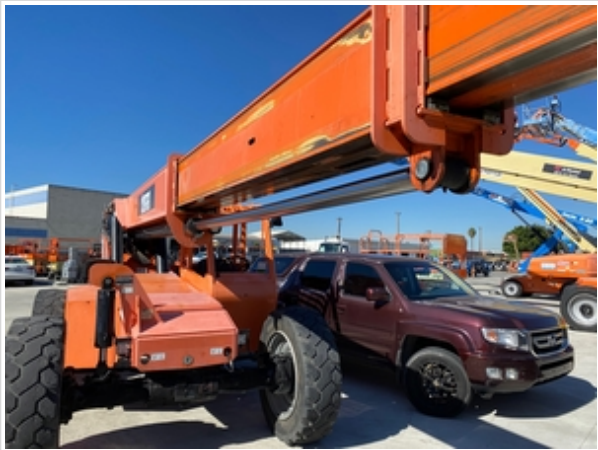
Telescopic Boom Cylinders	Check the telescopic boom cylinders. Note any wear, pitting, discoloration, etc. Take photos.	
Telescopic Boom Cylinders: Mounting Pin	3	
Telescopic Boom Cylinders: Oil Leaks	No	
Telescopic Boom Cylinders Photos

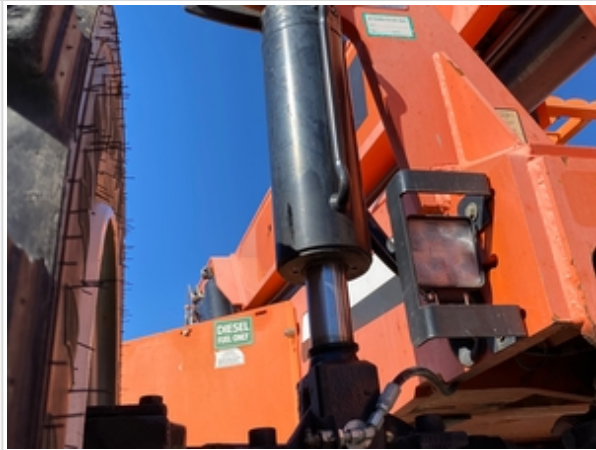
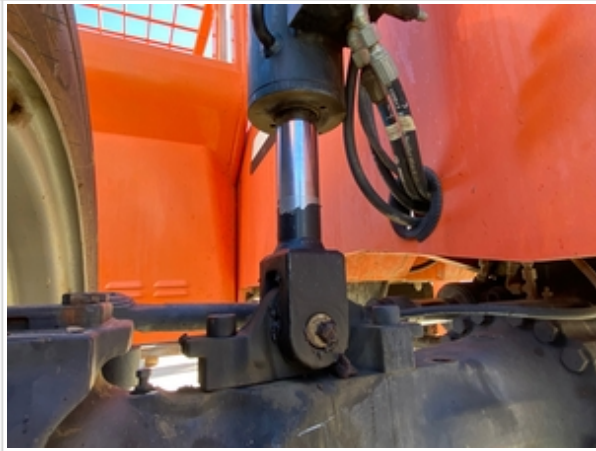
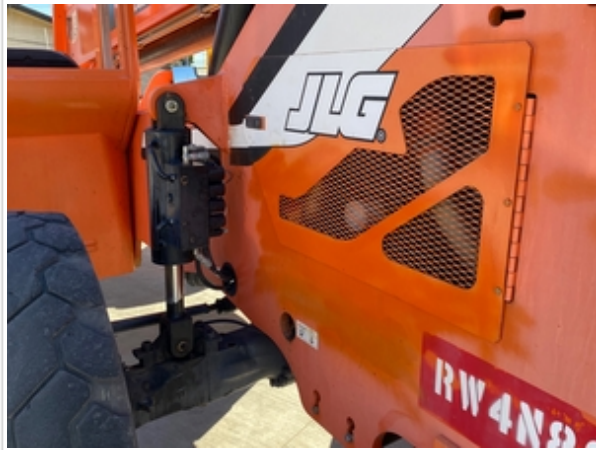
Frame Leveling Cylinders	Check the frame leveling cylinders. Note any wear, pitting, discoloration, etc. Take photos.	
Frame Leveling Cylinders: Mounting Pin	3	
Frame Leveling Cylinders: Oil Leaks	No	
Frame Leveling Cylinders Photos

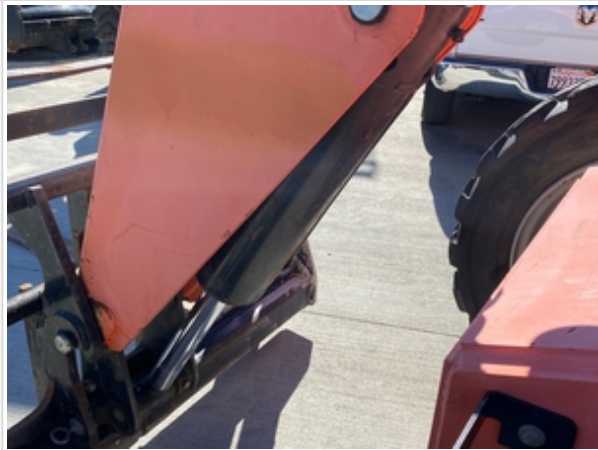
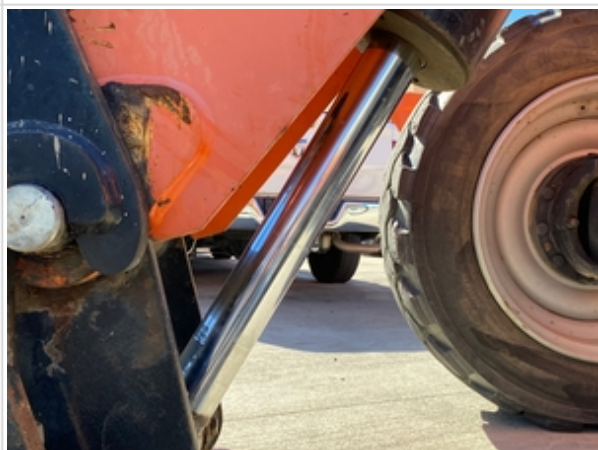
Carriage Tilt Cylinder Photos

Carriage Tilt Cylinder	Check the carriage tilt cylinders. Note any wear, pitting, discoloration, etc. Take photos.
Carriage Tilt Cylinder: Mounting Pin	3
Carriage Tilt Cylinder: Oil Leaks	No

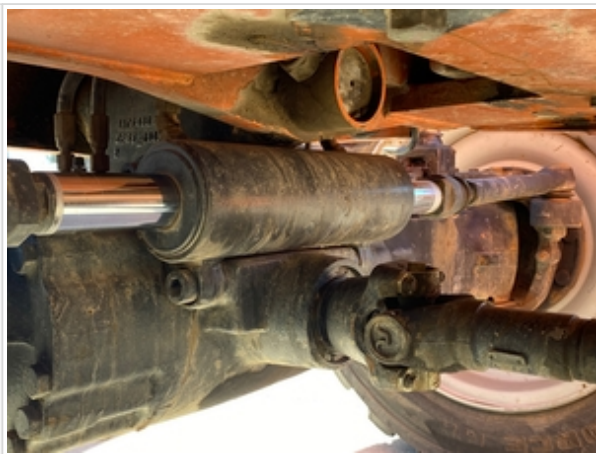
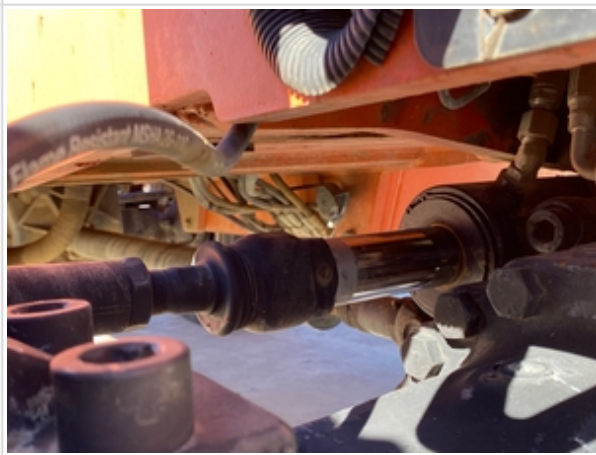
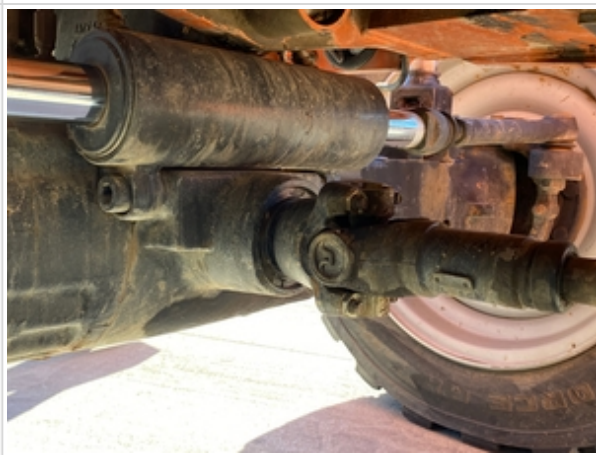
Side Shift Cylinder	Check the side shift cylinder. Note any wear, pitting, discoloration, etc. Take photos.	
Outrigger Cylinders	Check the outrigger cylinders. Note any wear, pitting, discoloration, etc. Take photos.	
Steering Cylinders	Check the steering cylinders. Note any wear, pitting, discoloration, etc. Take photos.	
Steering Cylinders: Mounting Pin	3	
Steering Cylinders: Oil Leaks	No	
Steering Cylinders Photos
