Inspection Report (Skid Steer)

Year	2006
Make	Bobcat
Model	S250
Serial Number	526018752
Hour Meter Reading	3,059
Previous Application (e.g., earth moving, mining, demolition, etc)	Demo Construction

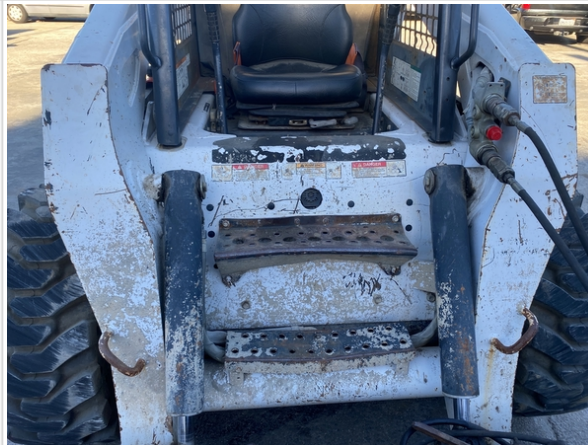
Front	3 - Normal Wear & Tear
Front Condition	Visible chipped paint or dents, Other (see comments)
Comments	Bent step
Front Photos

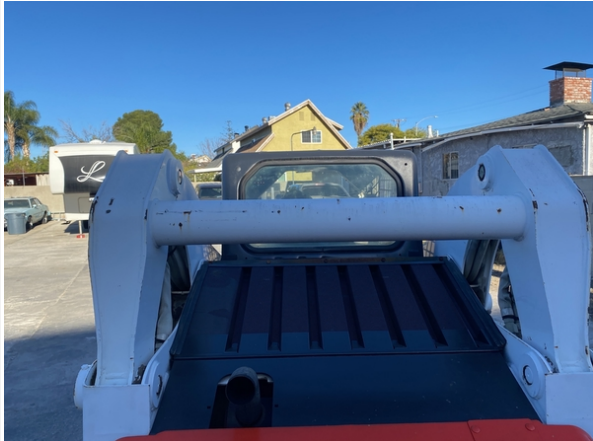
Rear	3 - Normal Wear & Tear	
Rear Condition	No visible damage, Other (see comments)	
Comments	Rear l/s light missing	
Rear Photos

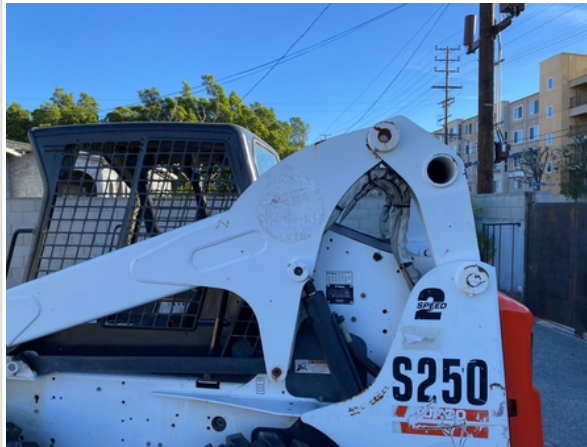
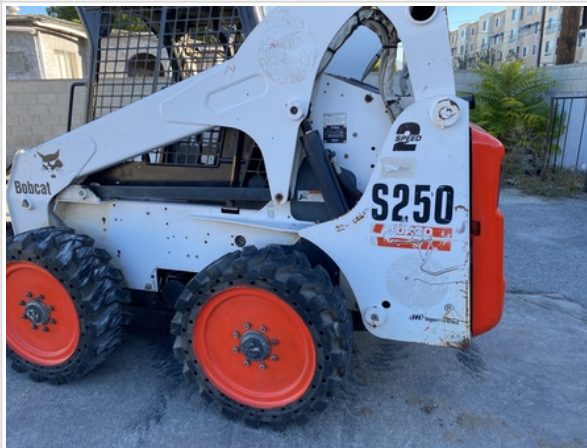
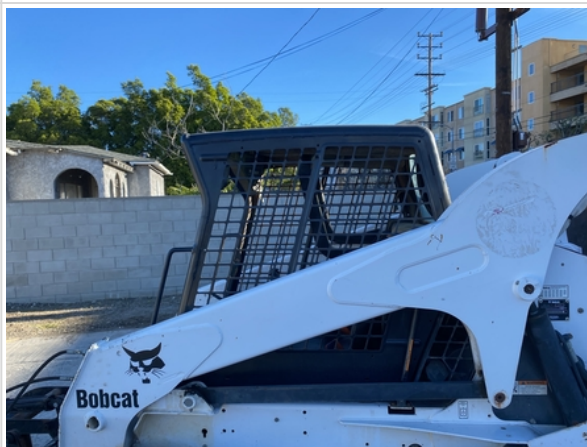
Left Photos

Left	3 - Normal Wear & Tear	
Left Condition	No visible damage, Other (see comments)	
Comments	L/S Drive Motor Cover Missing

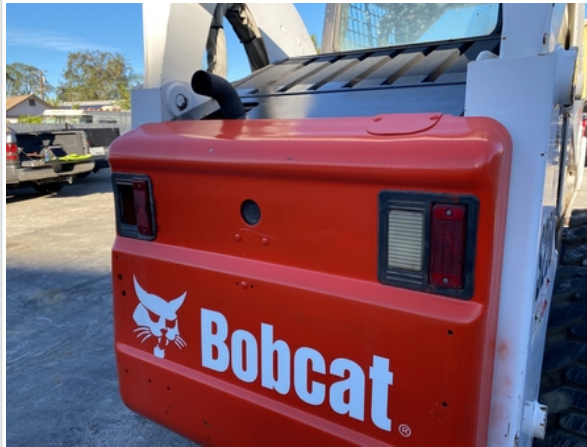
Mirrors	0
Lighting System	2 - Above Average Wear
Lighting System Condition	One or more exterior lights are non-operational
Comments	Rear light inop. & L/S light fixture missing
Lighting System Photos

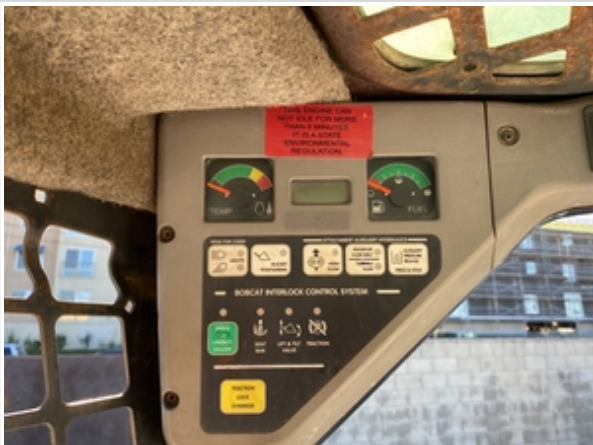
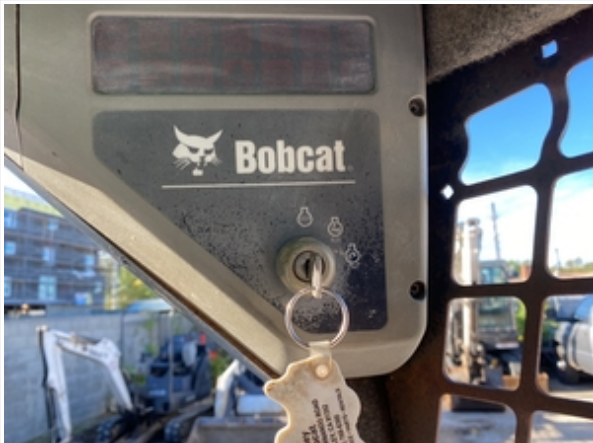
Controls & Switches	3 - Normal Wear & Tear
Controls & Switches Condition	All switches are installed and functional
Controls & Switches Photos

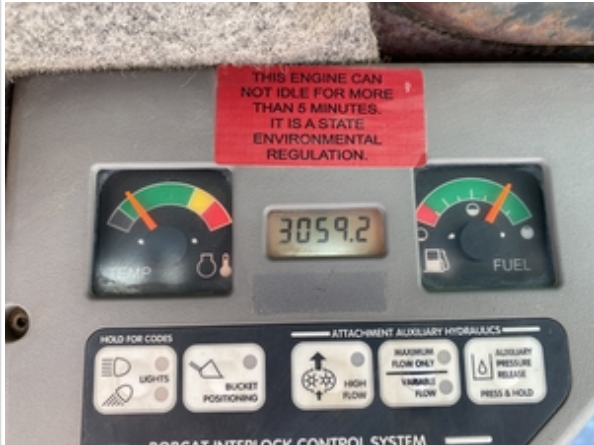
Hour Meter Activity	3 - Normal Wear & Tear
Hour Meter Condition	Hour meter is functional and in good condition

Hour Meter Activity Photos	 
Other Gauge Activity	3 - Normal Wear & Tear
Other Gauge Condition	All cockpit gauges are functional and in good condition
Other Gauge Activity Photos

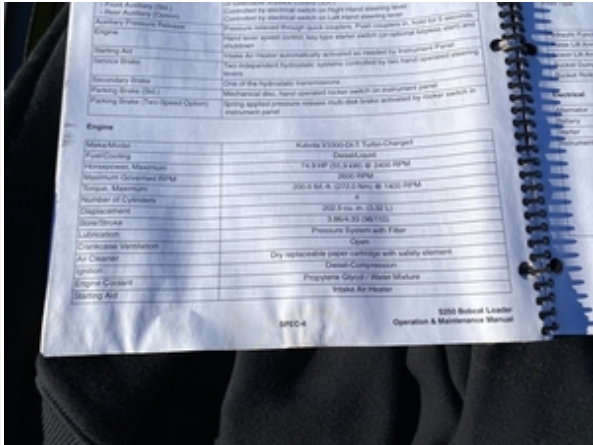
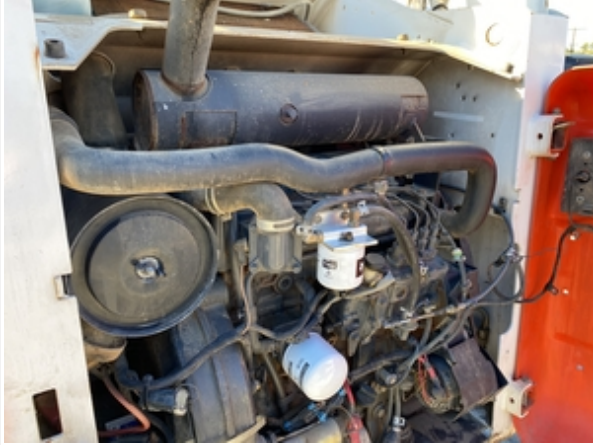
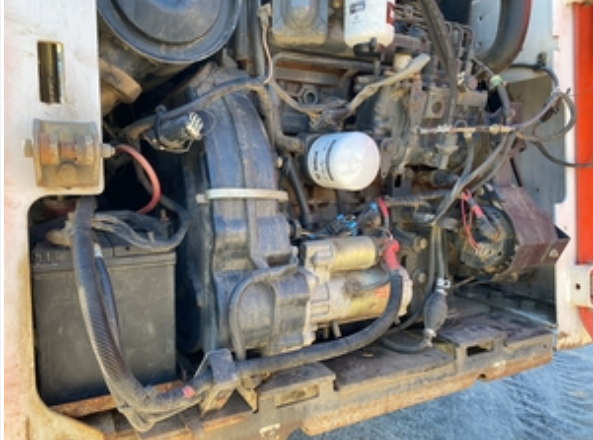
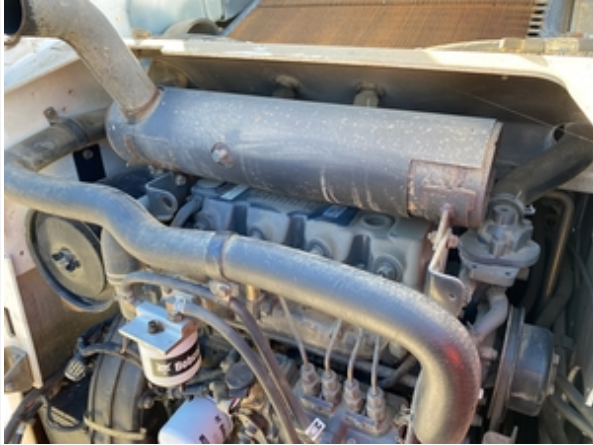
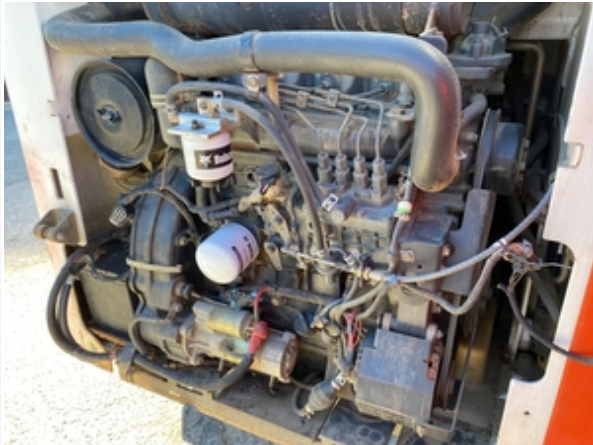
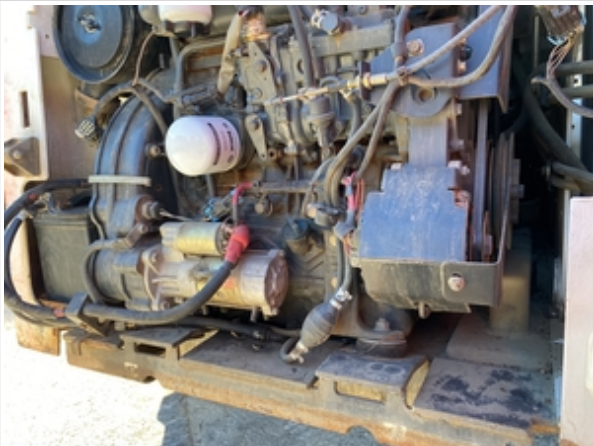
Engine Fuel Type	Diesel
Engine Photos

Blow-by (Visual Observation Check)	No	
Unusual Noises (Upon Start-up, Idle, Shutdown)	No	
Unusual Noise Notes	No unusual noises heard	
Engine Smoke (Upon Start-up, Idle, Shutdown)	No	
Engine Smoke Notes	No engine smoke issues observed	
Engine Exhaust Color	Clear

Cooling System Leaks	No
Coolant Color / Appearance	3 - Normal Wear & Tear
Coolant Color/Appearance Notes	Normal Translucent appearance, no visual signs of contamination
Oil Leaks	No
Oil Color / Appearance	3 - Normal Wear & Tear
Oil Color / Appearance Notes	Clean oil appearance, no signs of cross contamination, Appropriate oil level
Fuel Leaks	No
Equipped with DPF (Diesel Particulate Filter)	No
Requires DEF (Diesel Exhaust Fluid)	No
Overall Engine Appearance	Dusty & dry
Overall Engine Comments	Overall engine in well maintained condition. No active leaks seen.

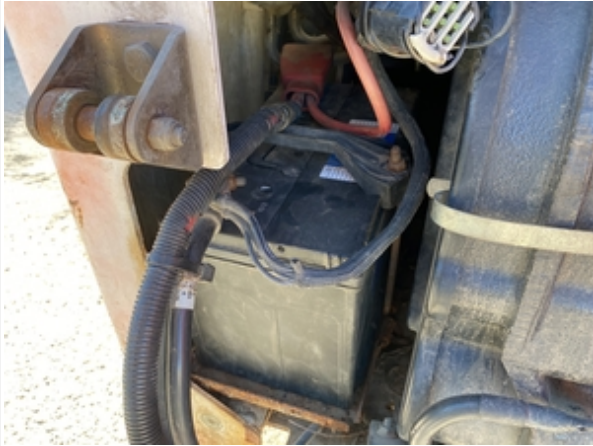
Battery	3 - Normal Wear & Tear
Battery Condition	Clean & dry appearance, tight connections
Battery Condition Photos

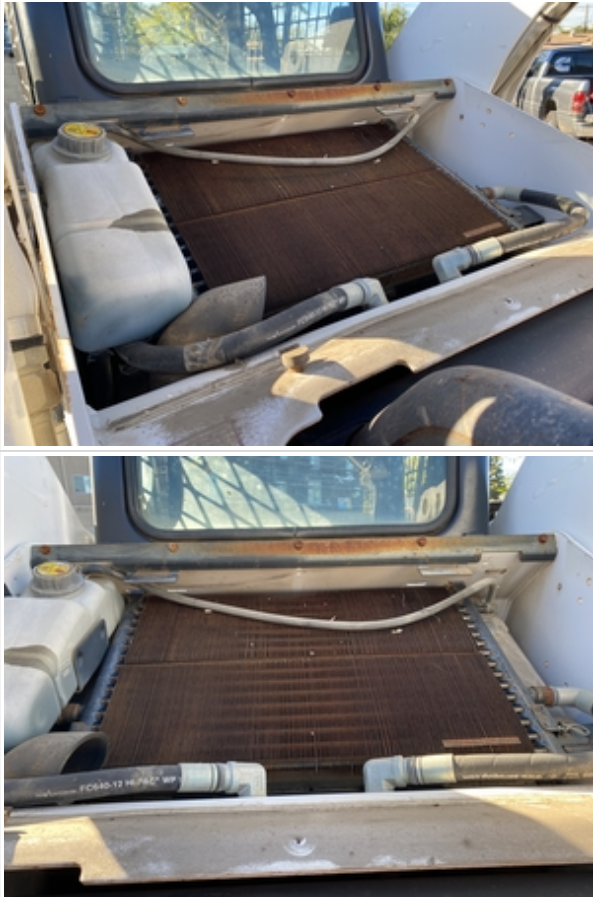
Radiator	3 - Normal Wear & Tear
Radiator Condition	Radiator fins & components appear to be in good working order, no signs of damage or leaks
Radiator Photos

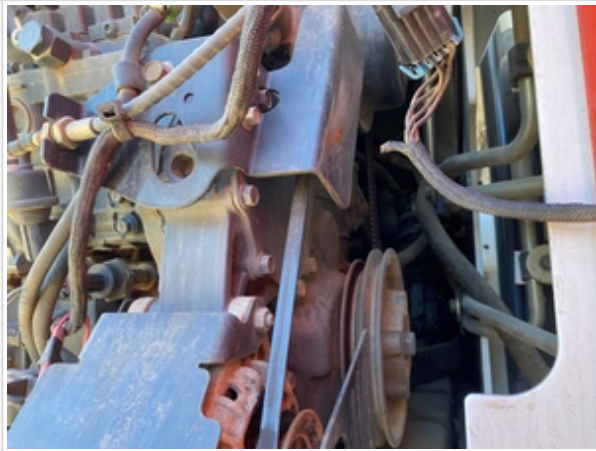
Belt Photos

Belts	3 - Normal Wear & Tear
Belt Condition	Belts appear in good condition & alignment with proper tension

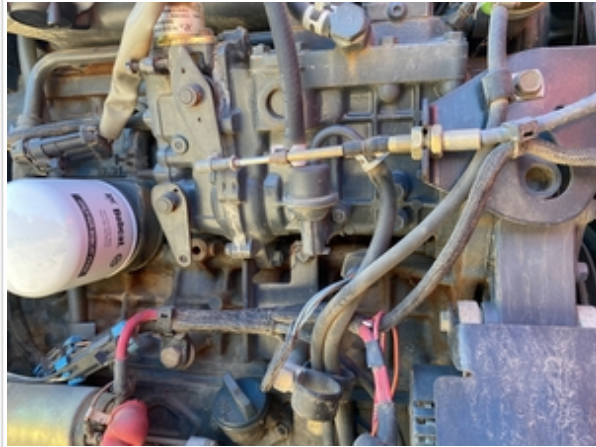
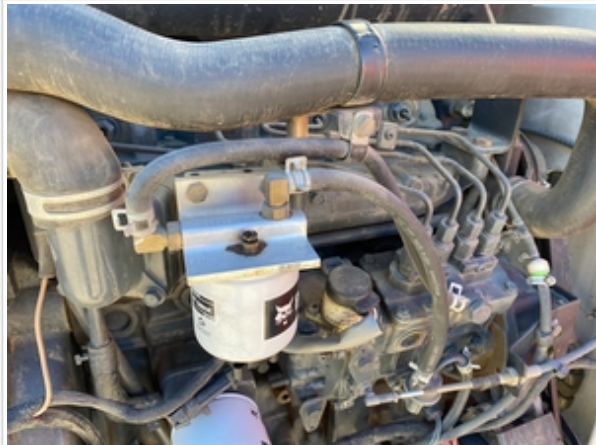
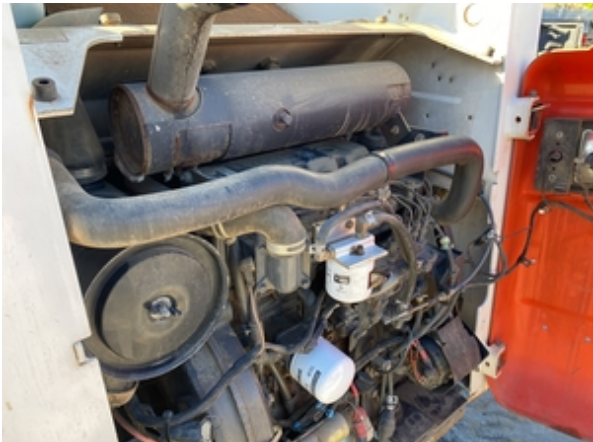
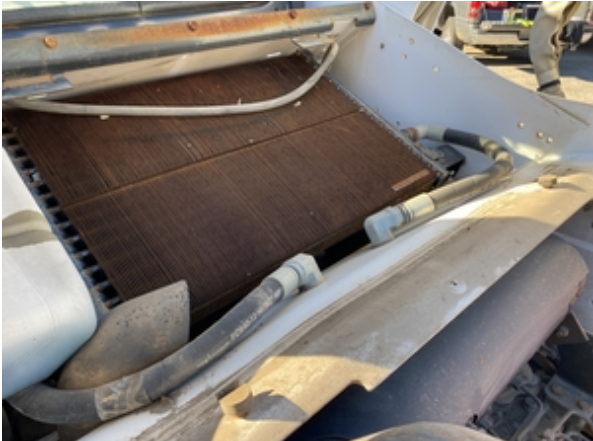
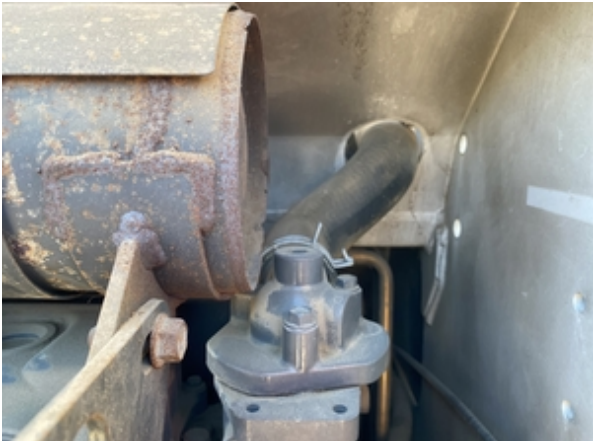
Hoses	3 - Normal Wear & Tear
Hose Condition	Firm, pliant hoses with no signs of wear or leaks
Hose Photos

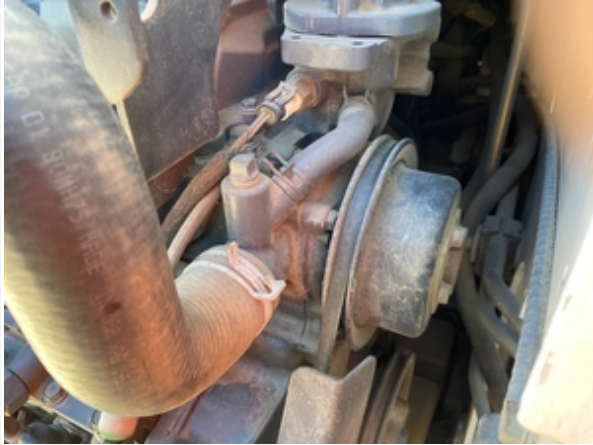
Water Pump Photos

Water Pump	3 - Normal Wear & Tear
Water Pump Condition	No unusual pump noises heard

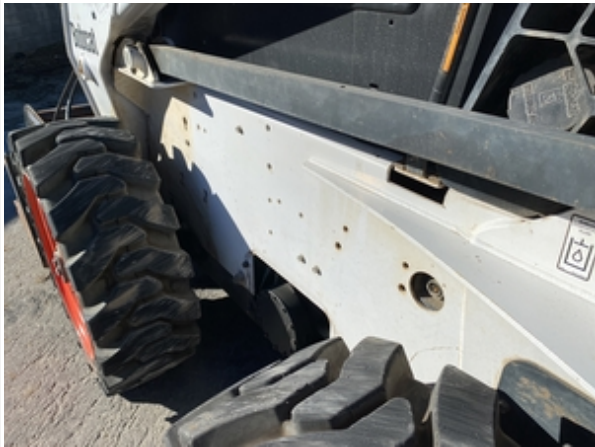
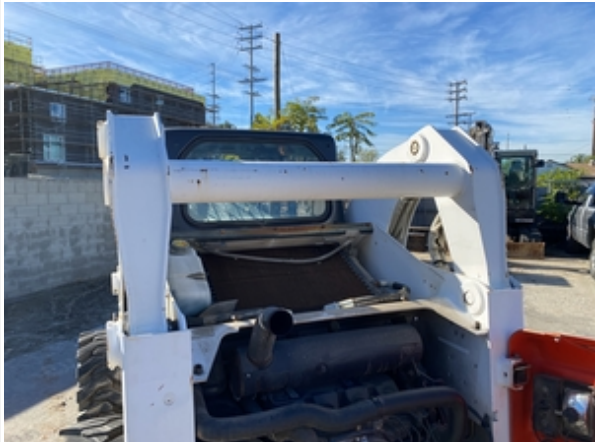
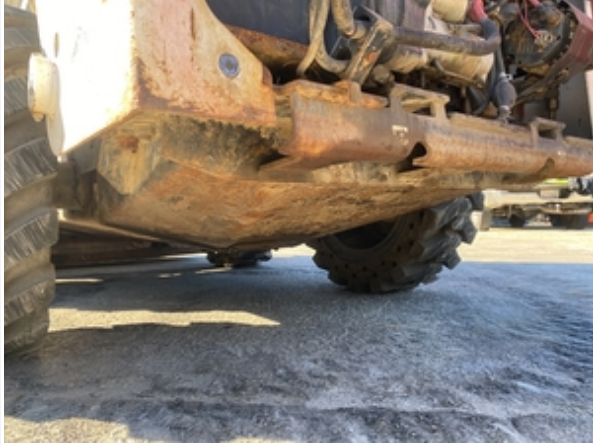
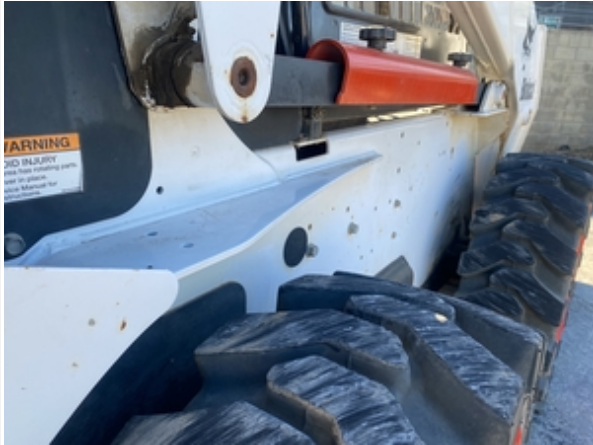
Frame	3 - Normal Wear & Tear
Frame Photos

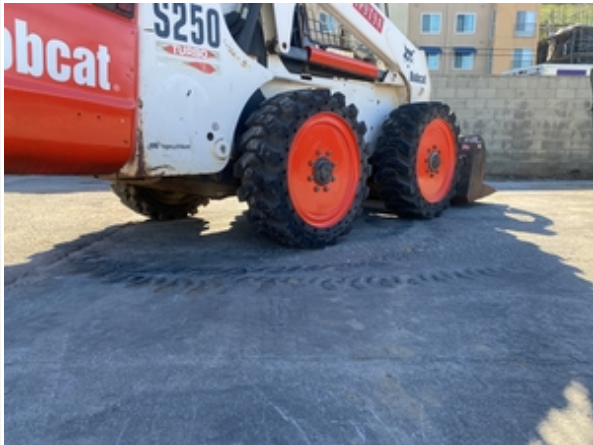
Stance	3 - Normal Wear & Tear	
Stance Photos

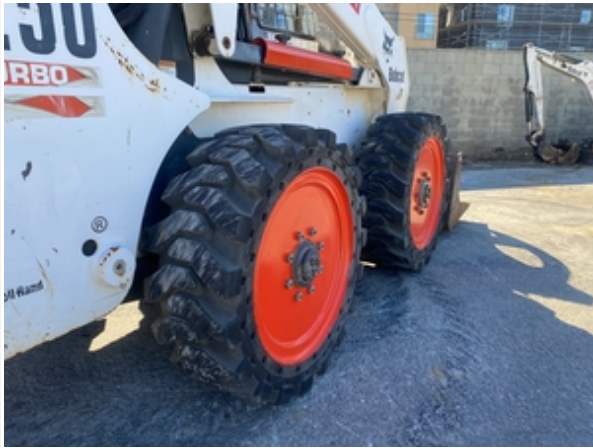
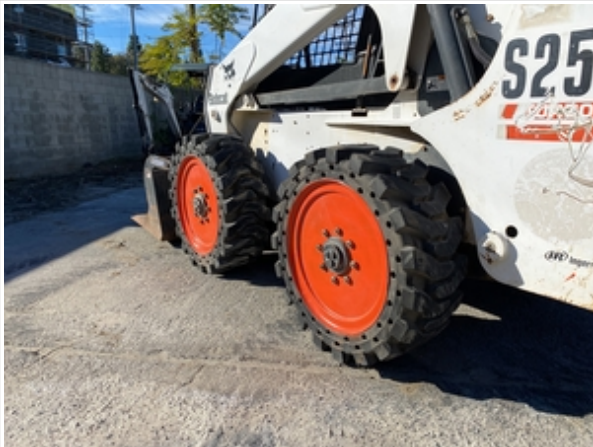
Wheels & Tires Photos

Wheels & Tires	3 - Normal Wear & Tear

Tire Brand	Kolossus
Tire Size	33 x 12 -20
Front Left Tire - Ratio Remaining	90%
Rear Left Tire - Ratio Remaining	90%
Front Right Tire - Ratio Remaining	90%
Rear Right Tire - Ratio Remaining	90%
Lift Arm	3 - Normal Wear & Tear
Lift Arm Photos

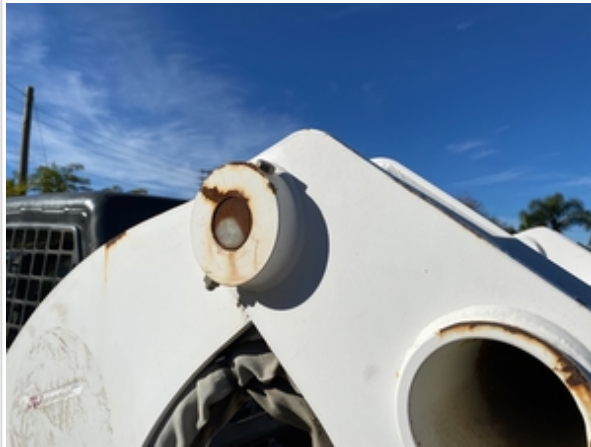
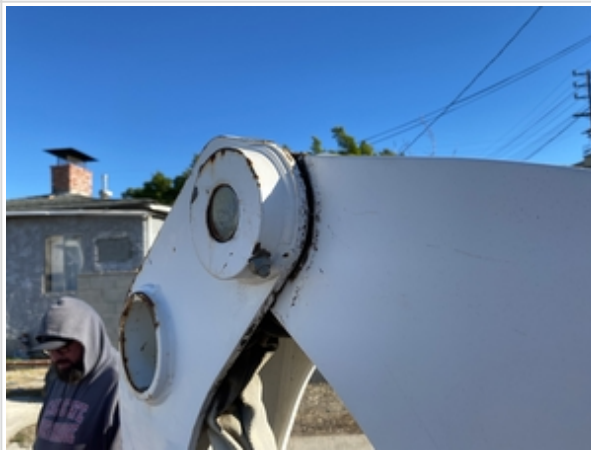
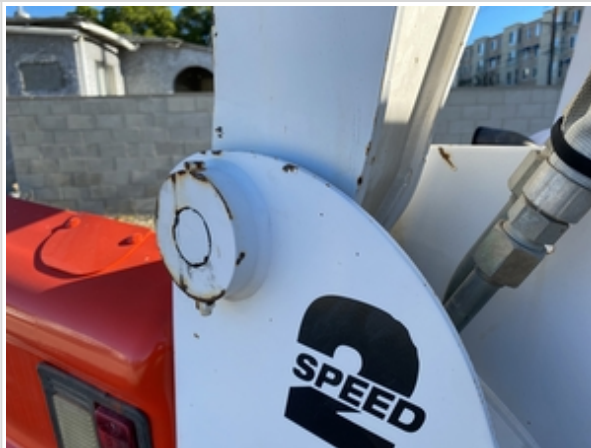
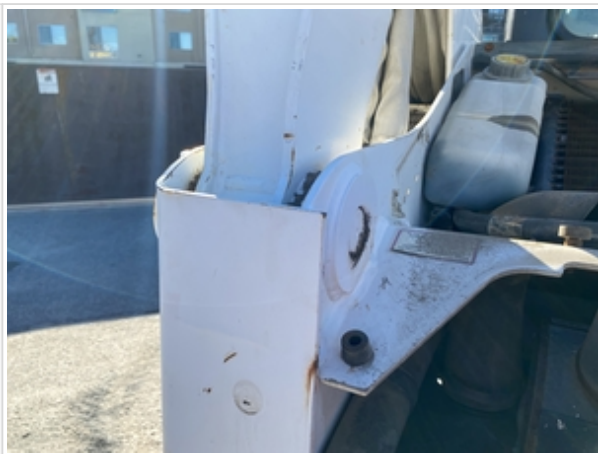
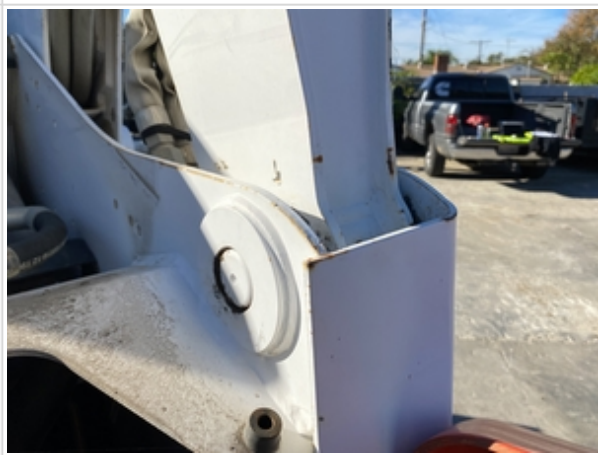
Chassis to Arm Pins Photos

3 - Normal Wear & Tear

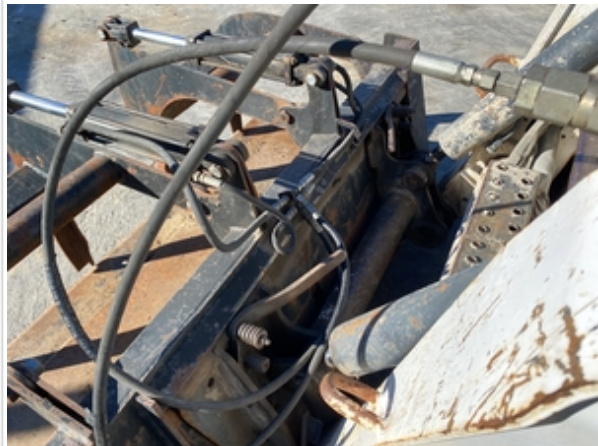
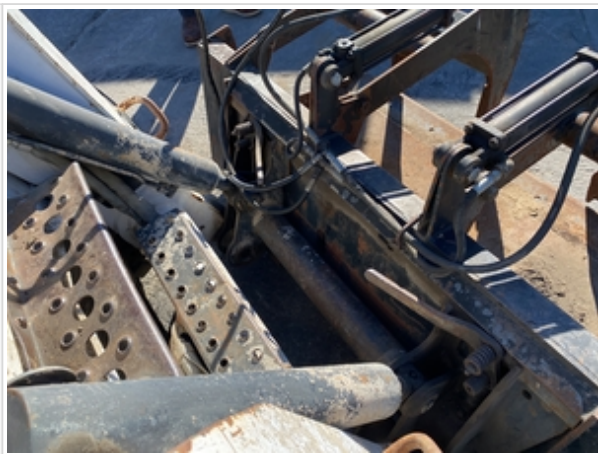
Quick Coupler	3 - Normal Wear & Tear	
Quick Coupler Photos

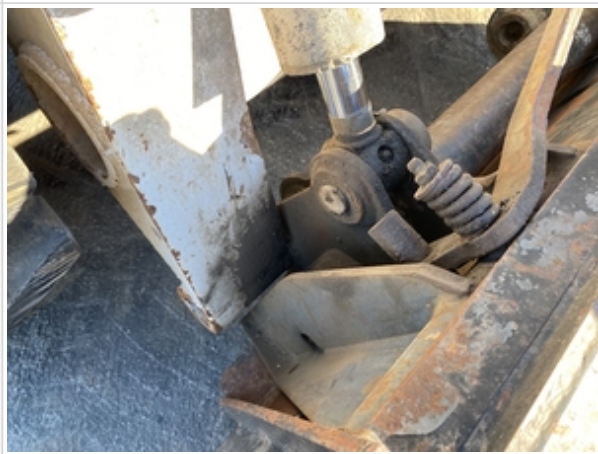
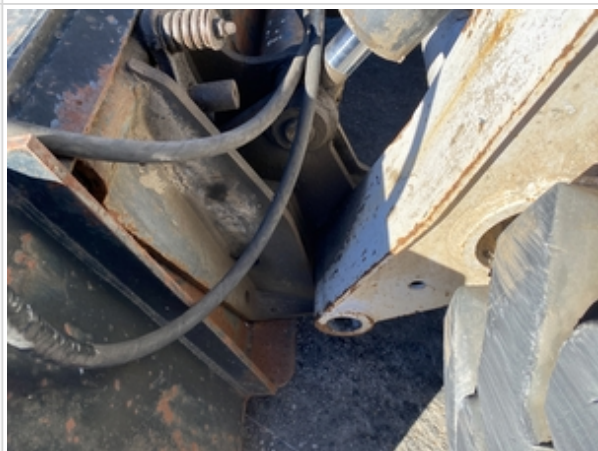
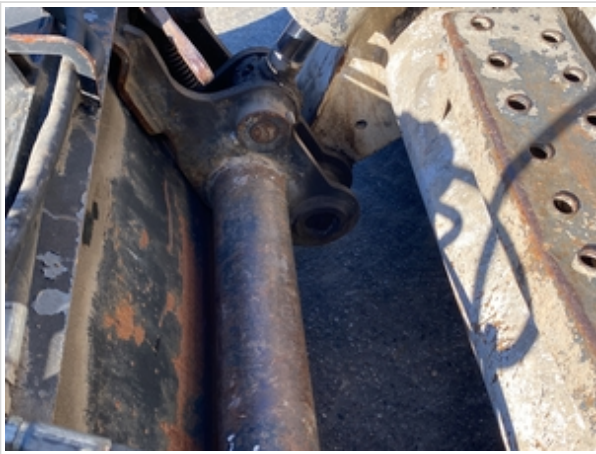
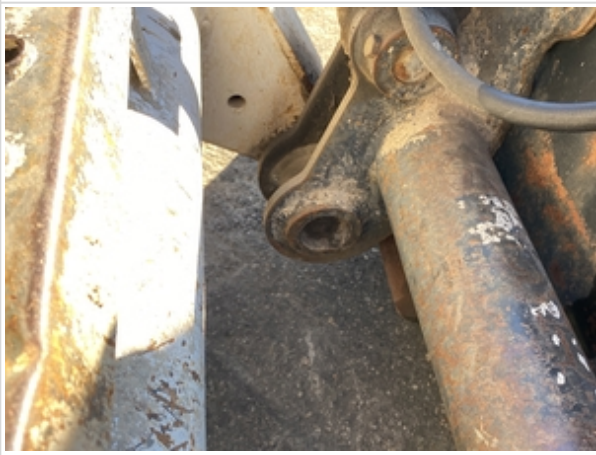
Quick Coupler to Arms Pins	3 - Normal Wear & Tear	
Quick Coupler to Arms Pins Photos

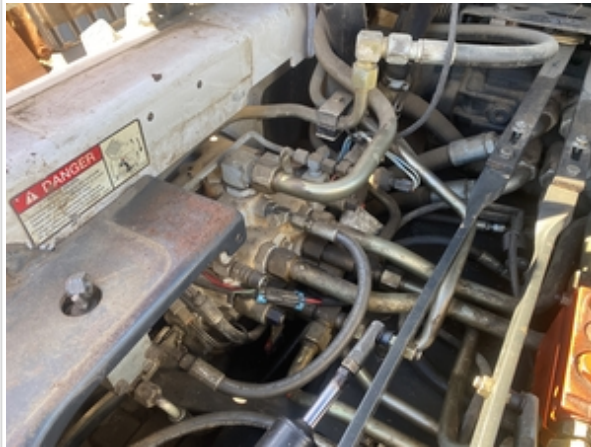
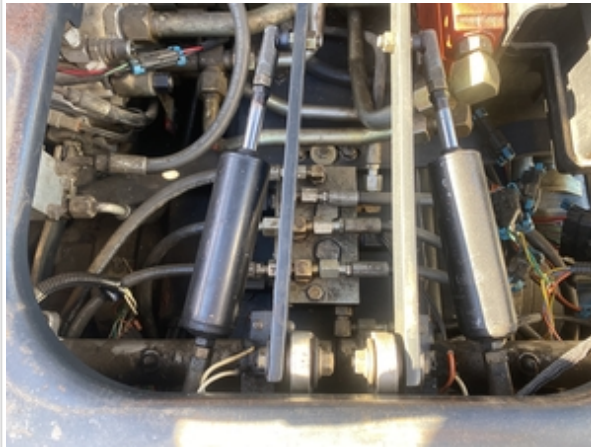
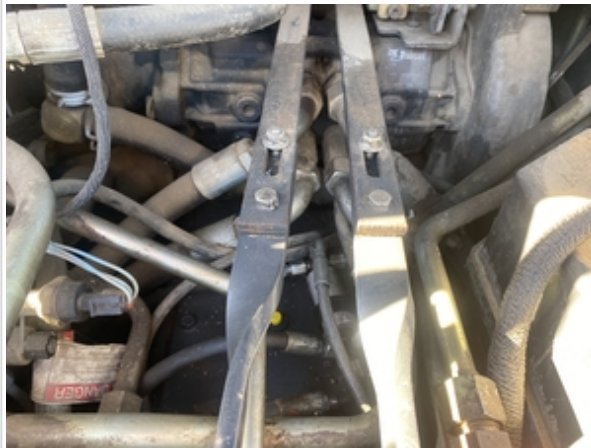
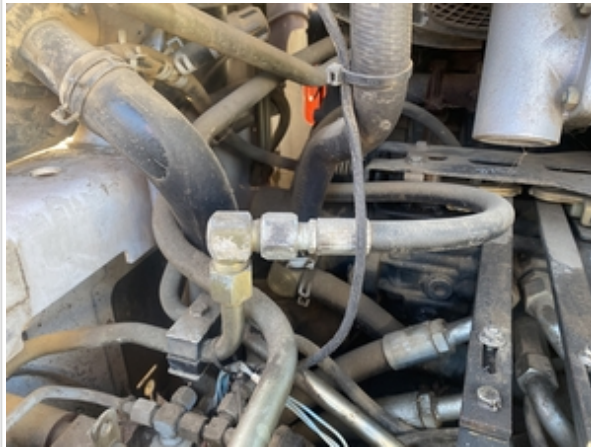
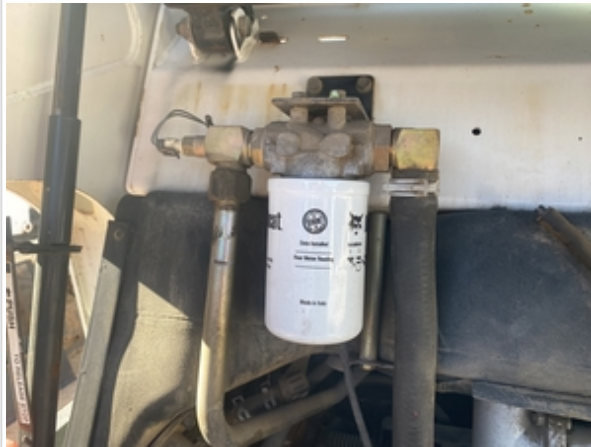
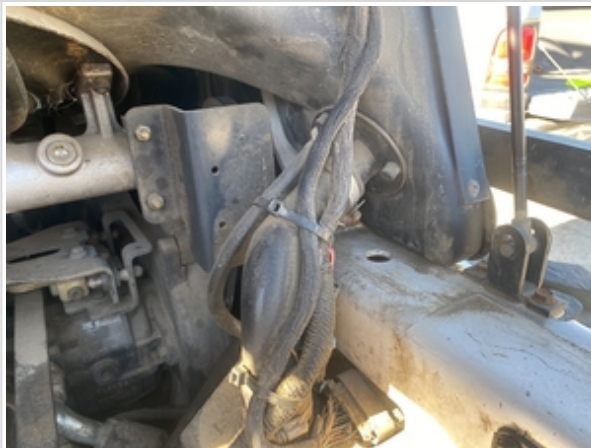
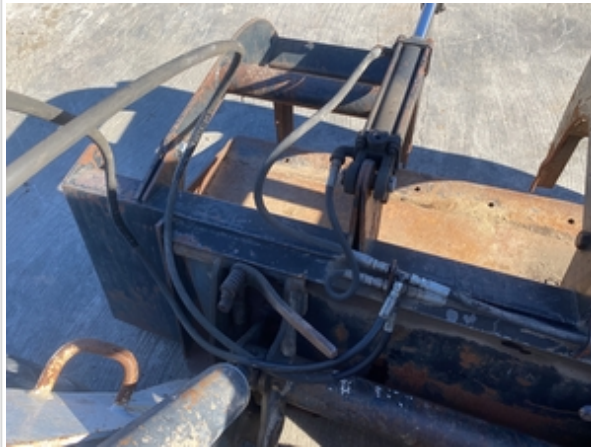
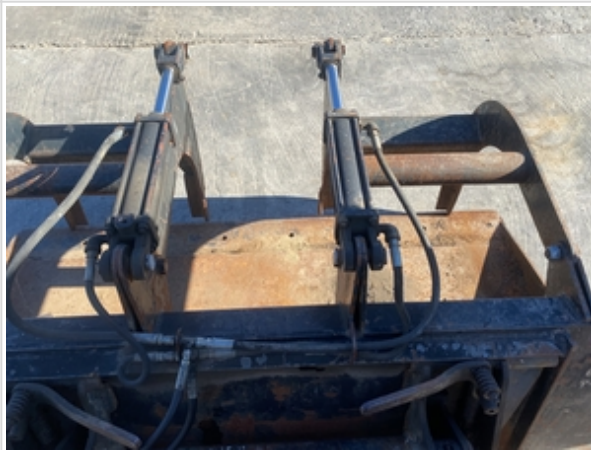
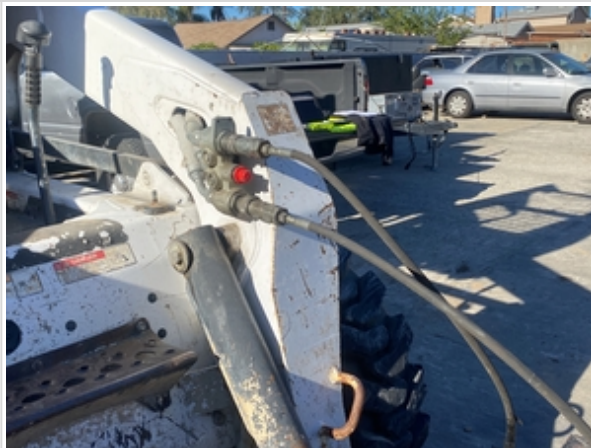
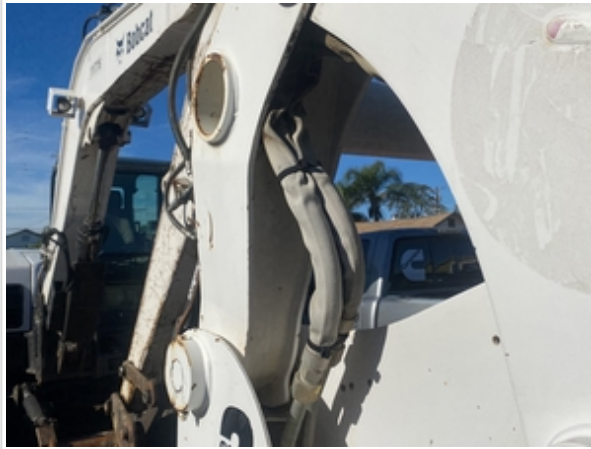
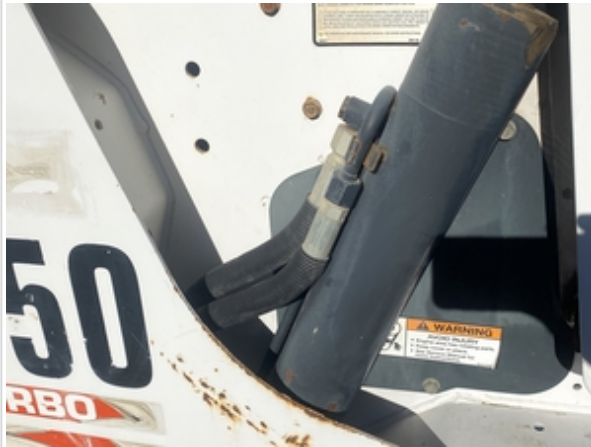
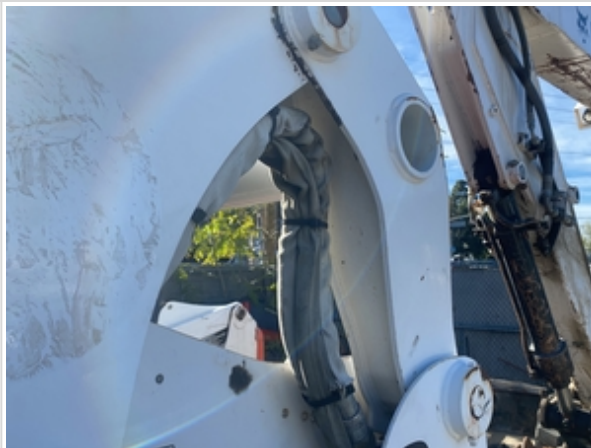
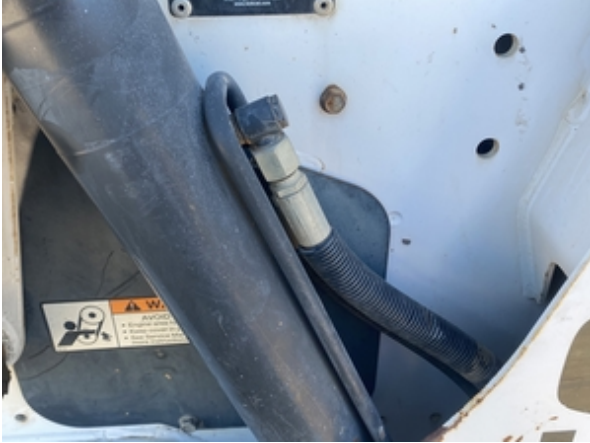
Appearance of Hydraulic Lines /
Fittings Photos

Wet or Damp Hydraulic Lines / Fittings	Yes
Appearance of Hydraulic Lines / Fittings	3
Hydraulic Lines / Fittings Condition	Hydraulic lines & fittings are clean and in good condition, Active leaks in hoses or fittings observed, Other (see comments)
Comments	Hydraulic leak observed from L/S drive motor compartment, Top of R/S pump

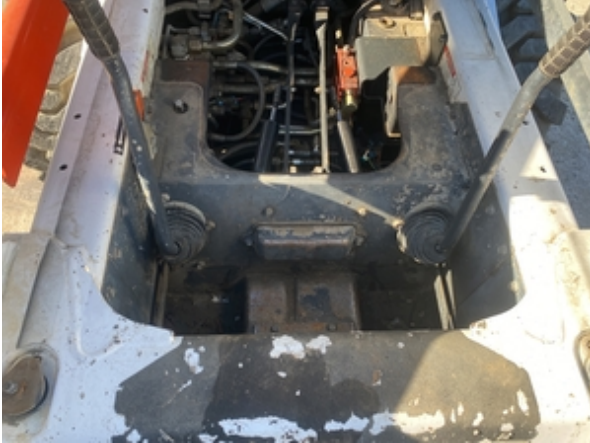
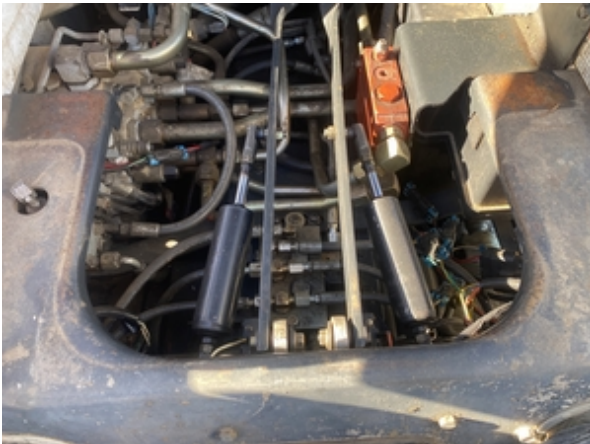
Unusual Noises (Hydraulic Pump)	No	
Hydraulic Pump Notes	No unusual noises heard during operation, Other unusual sounds (see comments)	
Comments	Minor seepage r/s of hydraulic pump	
External Controls / Levers	3	
External Controls / Levers Condition	Good function & condition of hydraulic controls	
External Controls / Levers Photos

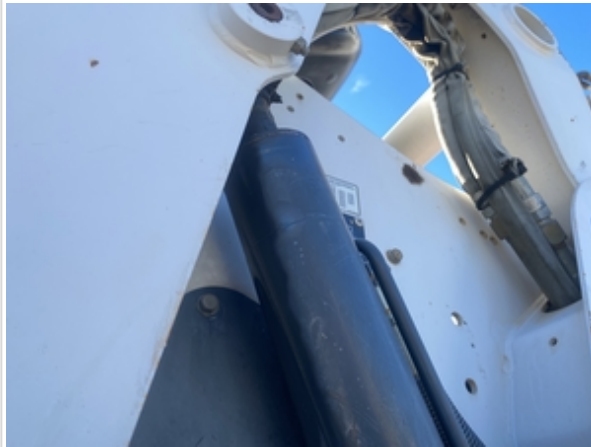
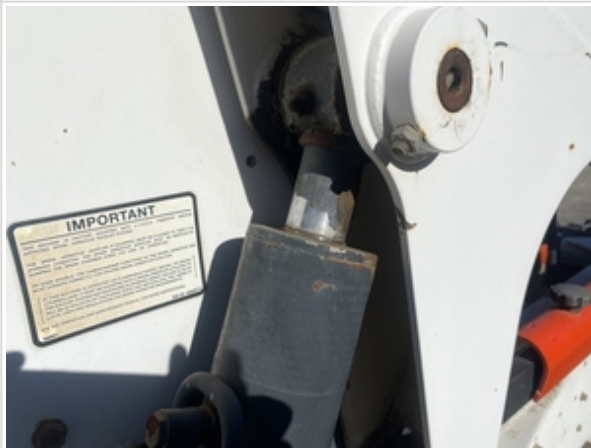
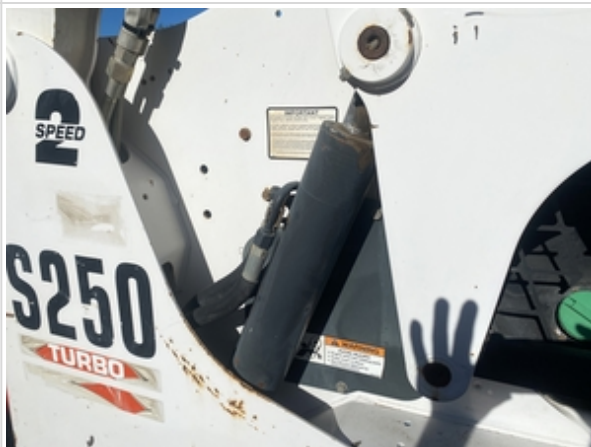
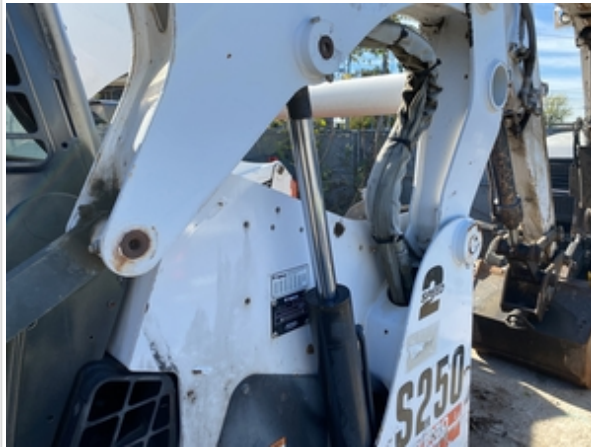
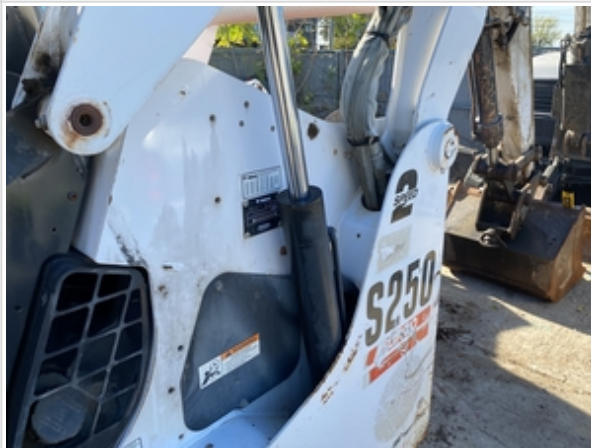
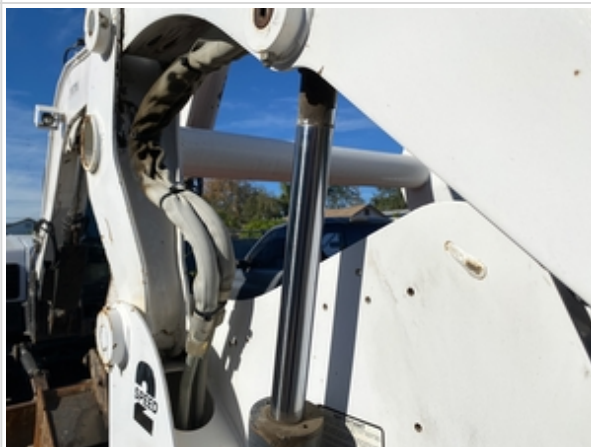
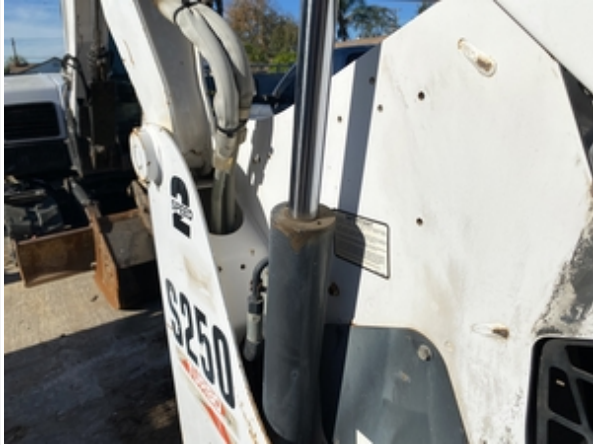
Lift Cylinder	Check the lift cylinder. Note any wear, pitting, discoloration, etc. Take photos.
Lift Cylinder: Mounting Pin	3
Lift Cylinder: Oil Leaks	Yes
Comments	L/S lift cylinder leaking minor amount of oil
Lift Cylinder Photos

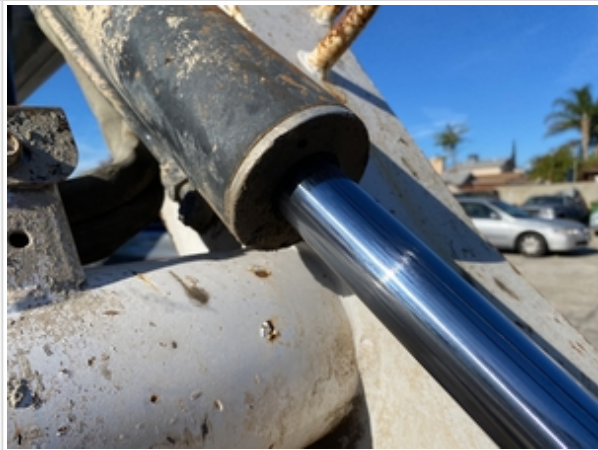
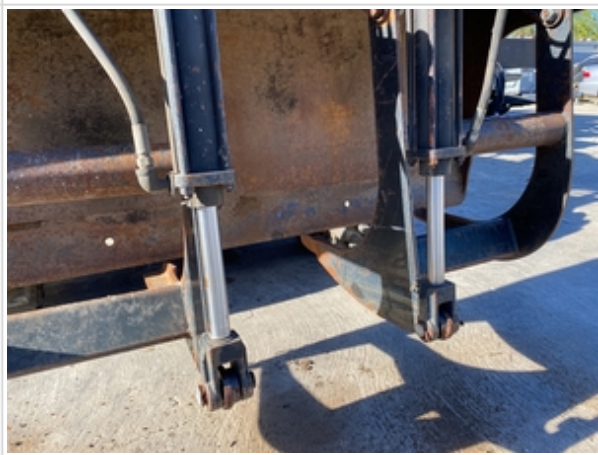
Bucket Cylinder	Check the bucket cylinder. Note any wear, pitting, discoloration, etc. Take photos.	
Bucket Cylinder: Mounting Pin	3	
Bucket Cylinder: Oil Leaks	No	
Comments	Minor scores on both bucket cylinders	
Bucket Cylinder Photos

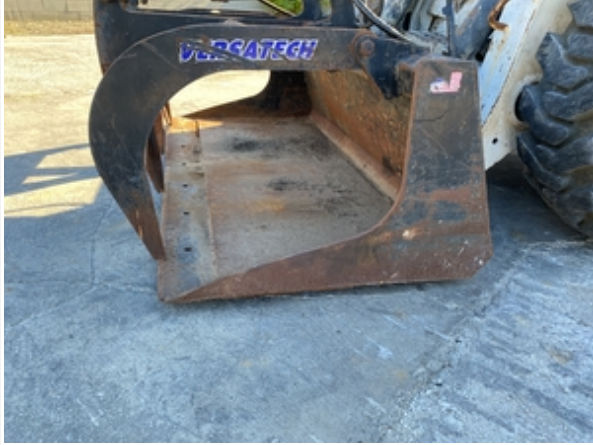
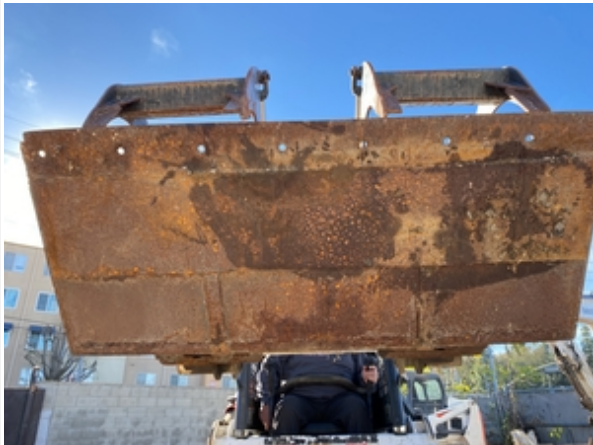
Bucket Condition	3 - Normal Wear & Tear	
Bucket Photos
