Inspection Report (Mini Excavator)

Year	2014
Make	Bobcat
Model	E85 M
Serial Number	B34T11776
Hour Meter Reading	2,232
Previous Application (e.g., earth moving, mining, demolition, etc)	General Construction

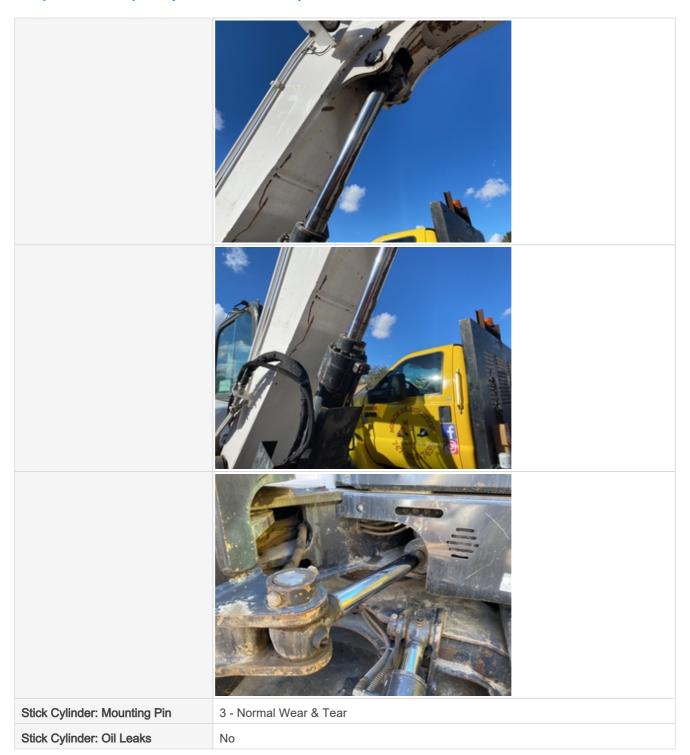
Hydraulics Cylinders Insp	pection Points
Boom Cylinder: Mounting Pin	3 - Normal Wear & Tear
Boom Cylinder: Oil Leaks	No
Boom Cylinder Photos
