#### **Inspection Report (Vibratory Compactor)**

Year	2012
Make	Bomag
Model	BMP 8500
Serial Number	101 720 11 2686
Hour Meter Reading	562 Hours
Previous Application (e.g., earth moving, mining, demolition, etc)	General Construction

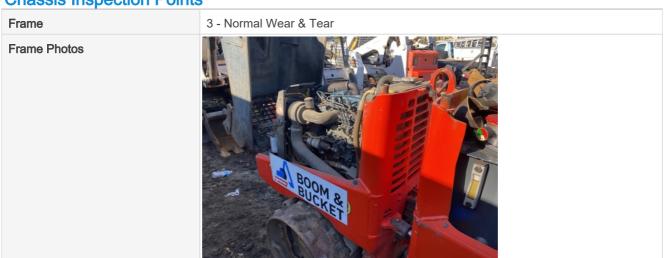
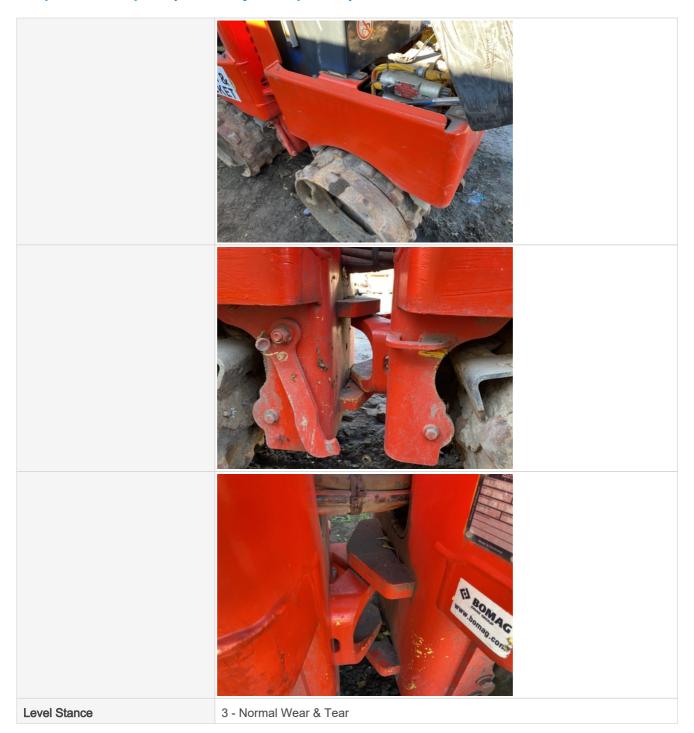
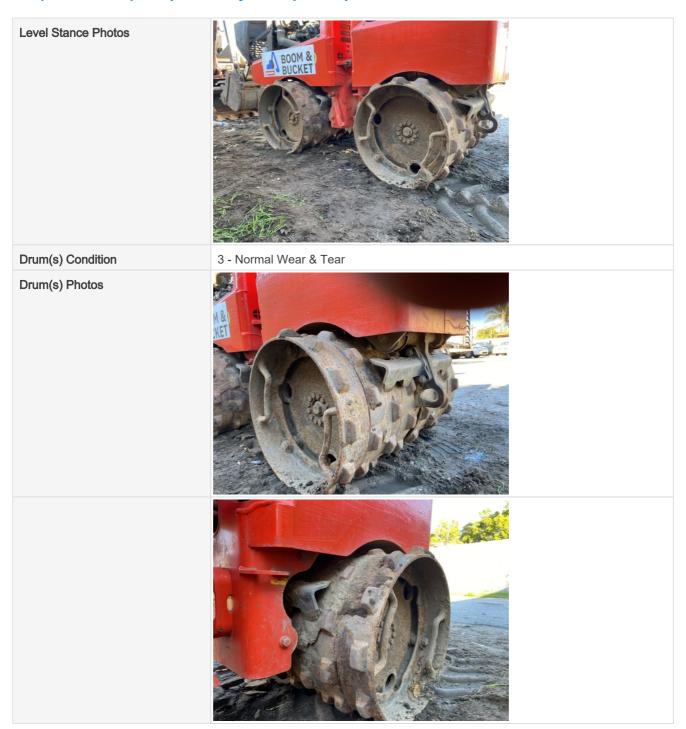
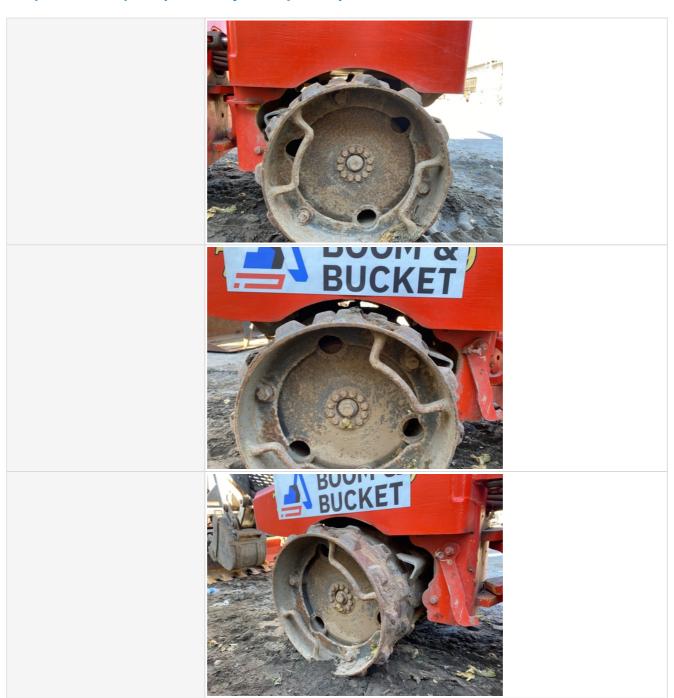
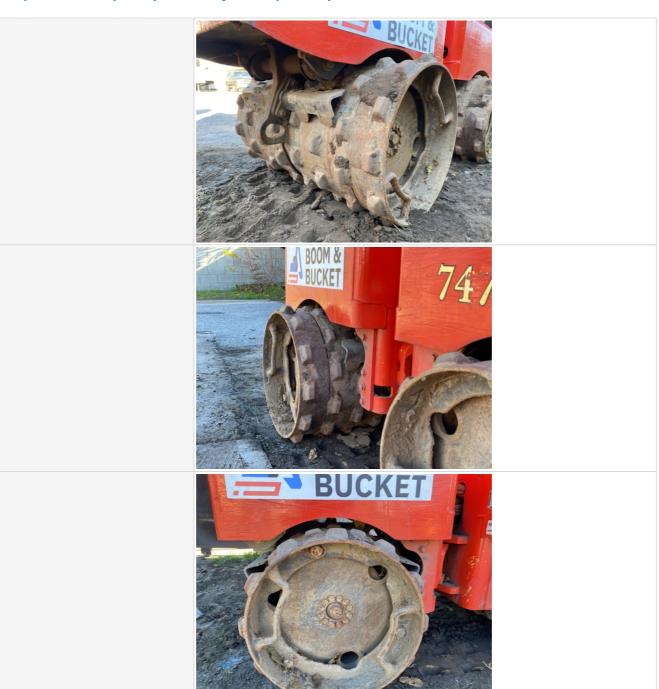
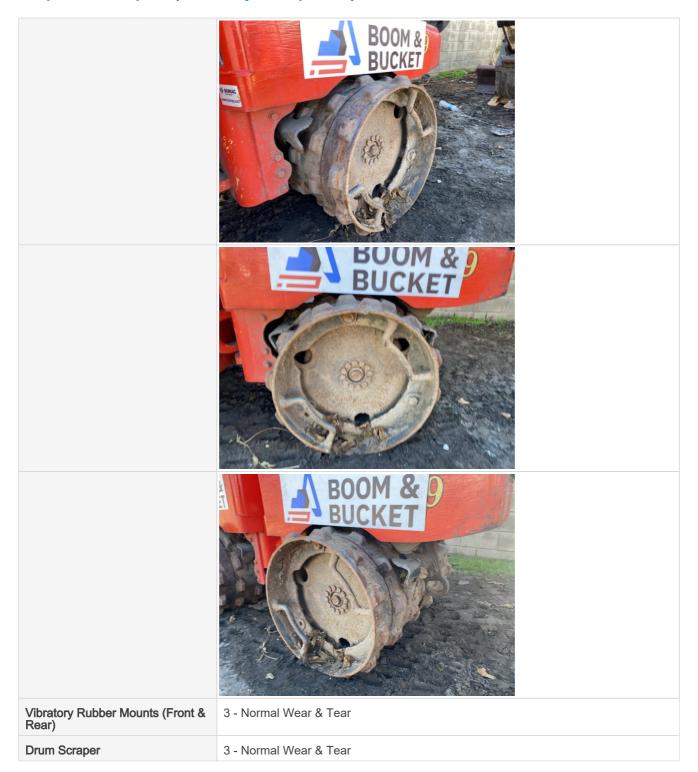
#### **Chassis Inspection Points**

# **Drum Scraper Photos Padfoot Feet Condition** 3 - Normal Wear & Tear **Padfoot Fitment** 3 - Normal Wear & Tear 0 **Padfoot Hardware Overall Chassis** 3 - Normal Wear & Tear Overall chassis in great condition. Chassis holding together well and no issues **Overall Chassis Comments**

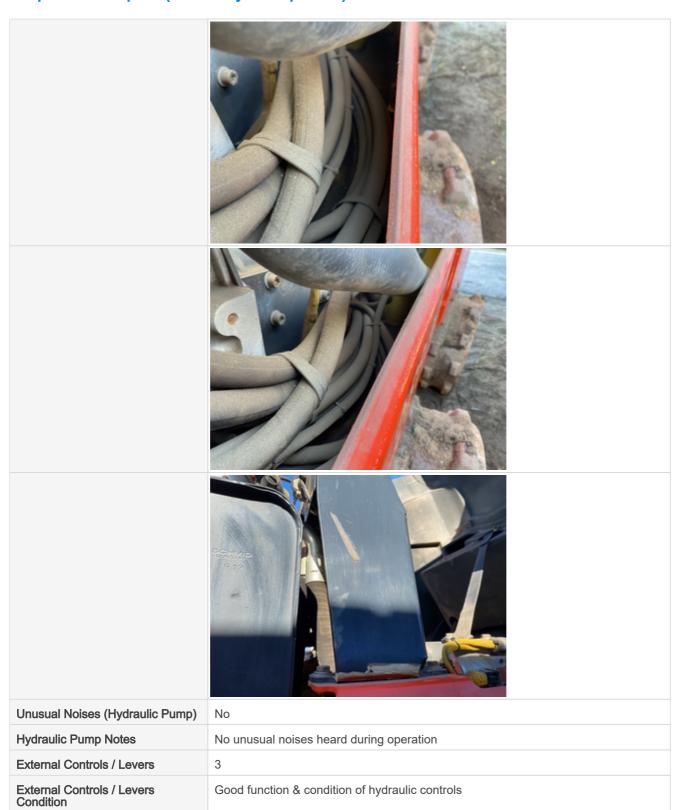
Appearance of Hydraulic Lines / Fittings Photos

Hydraulics Overall	
Wet or Damp Hydraulic Lines / Fittings	No
Appearance of Hydraulic Lines / Fittings	3
Hydraulic Lines / Fittings Condition	Hydraulic lines & fittings are clean and in good condition
