Inspection Report (On-Highway Dump Truck)

Year	2007
Make	Western Star
Model	4900
Serial Number	5KKHAECV87PY54268
Truck Odometer Reading	299,830
Current Inspection / State Cert / DOT	N/A
Previous Application (e.g., earth moving, mining, demolition, etc)	Pipeline Construction

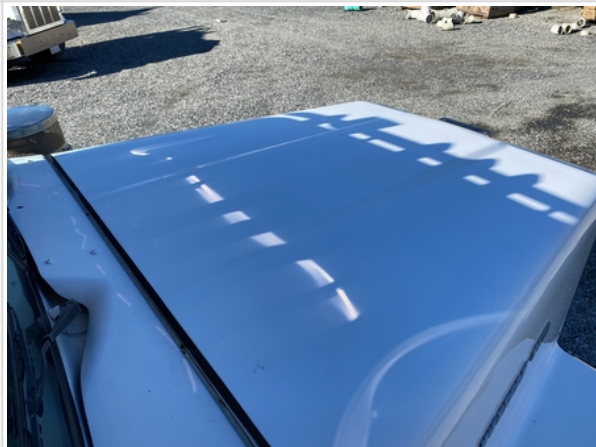
Upper	3 - Normal Wear & Tear	
Upper Condition	No visible damage	
Upper Photos

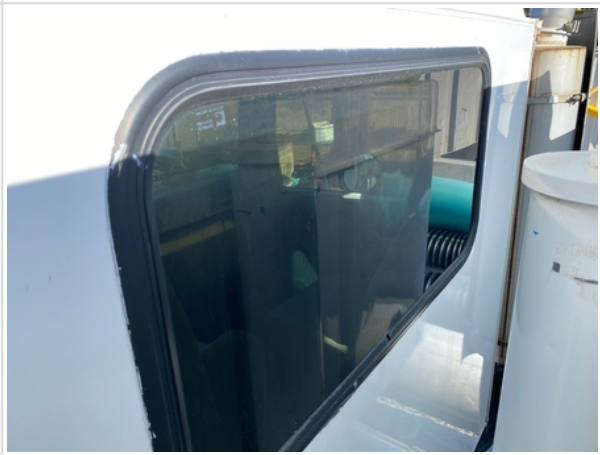
Body Panels (Any Rust Damage?)	3 - Normal Wear & Tear	
Body Panel Condition	No visible damage, good paint condition and panel fitment	
Doors / Canopy Latches	3 - Normal Wear & Tear	
Doors / Canopy Latches Condition	No visible damage	
Steps / Ladders	3 - Normal Wear & Tear	
Steps / Ladders Condition	Steps/ladders are fully intact and appear structurally sound	
Handrails	3 - Normal Wear & Tear	
Handrails Condition	Handrails are fully intact and appear structurally sound	
Glass Condition	3 - Normal Wear & Tear	
Glass Condition Notes	Glass intact, no visible damage	
Glass Condition Photos

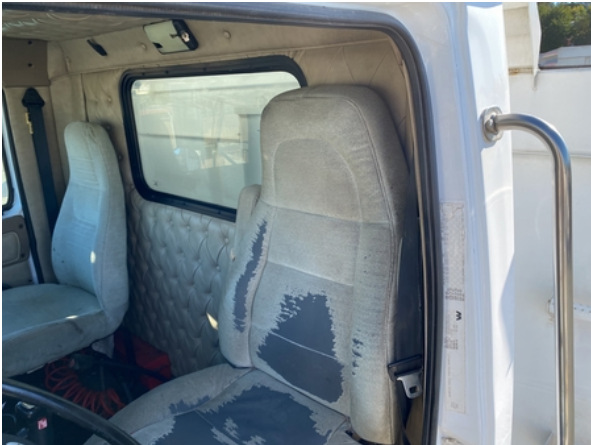
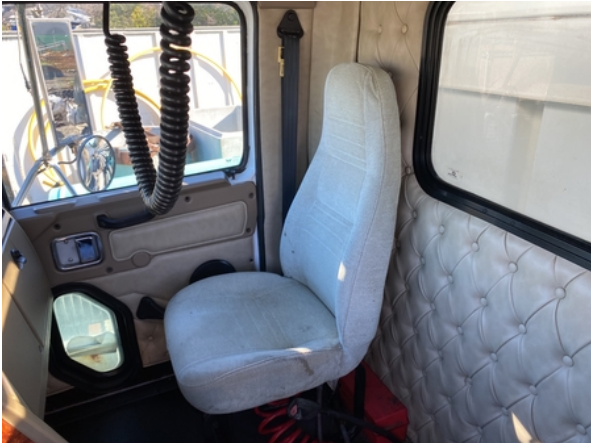
Operator's Seat & Arm Rests	3 - Normal Wear & Tear
Operator's Seat & Arm Rests Photos

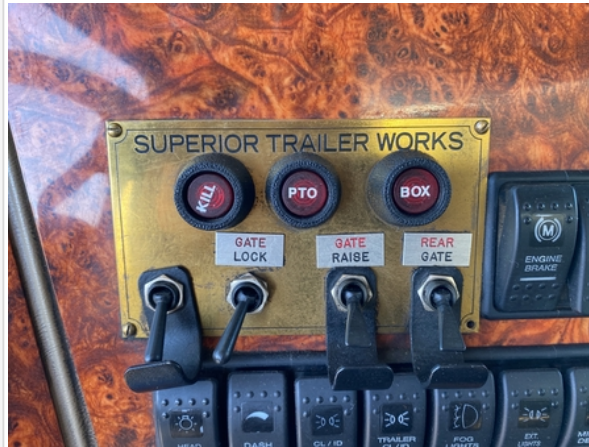
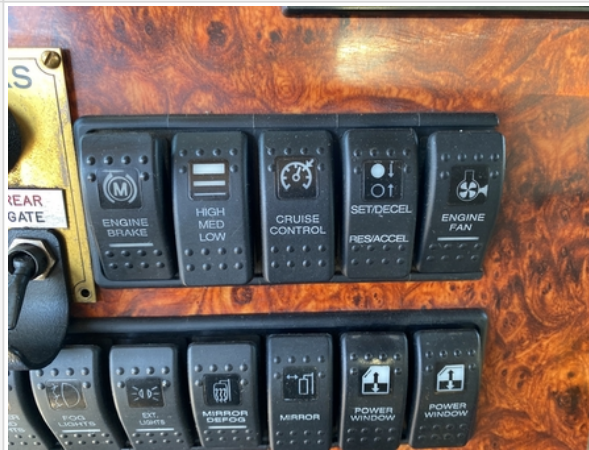
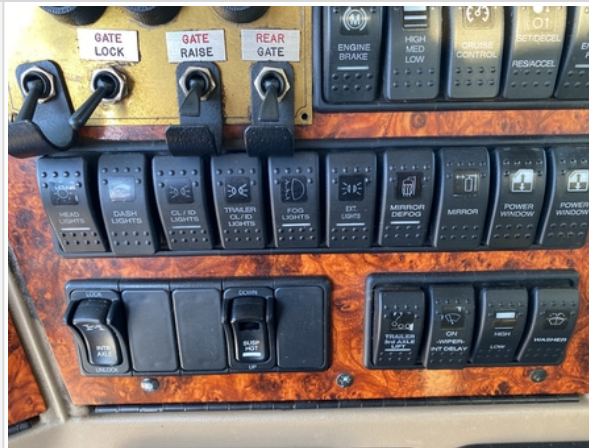
Controls & Switches Photos

Seat Belt	3 - Normal Wear & Tear
Cabin Lights	3 - Normal Wear & Tear
Controls & Switches	3 - Normal Wear & Tear

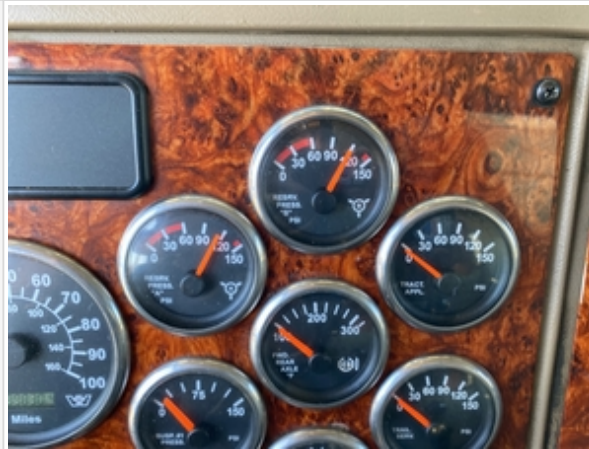
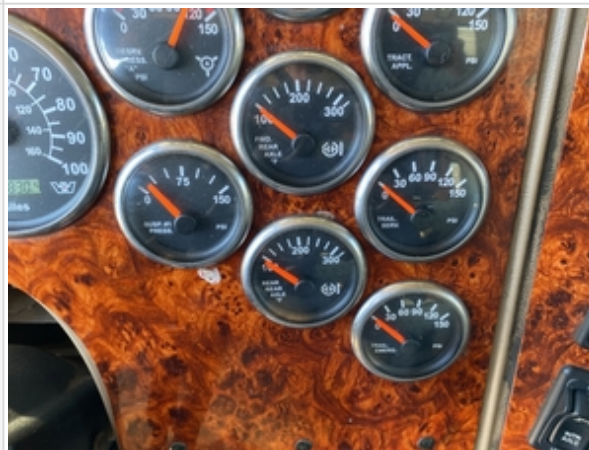
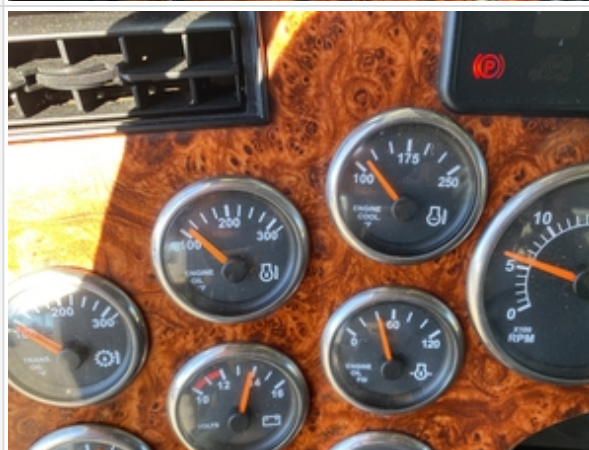
Other Gauge Activity Photos

Odometer Activity	3 - Normal Wear & Tear
Odometer Activity Photos	 
Other Gauge Activity	3 - Normal Wear & Tear

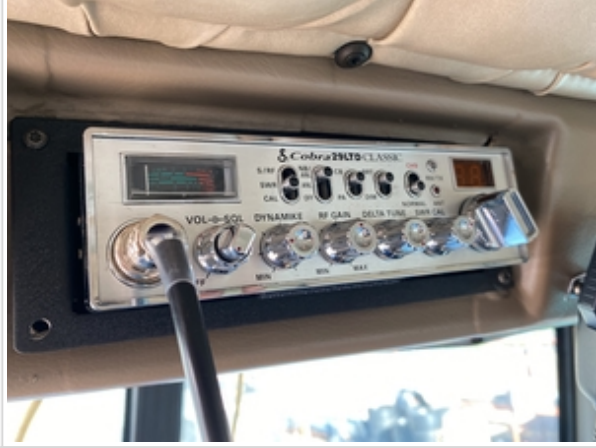
Heater & A/C	3 - Normal Wear & Tear
Fans / Vents	3 - Normal Wear & Tear
Horn	3 - Normal Wear & Tear
Reverse Alarm / Backup Signal	3 - Normal Wear & Tear
Backup Camera	0
Other Electronic Devices	3 - Normal Wear & Tear
Other Electronic Device Photos

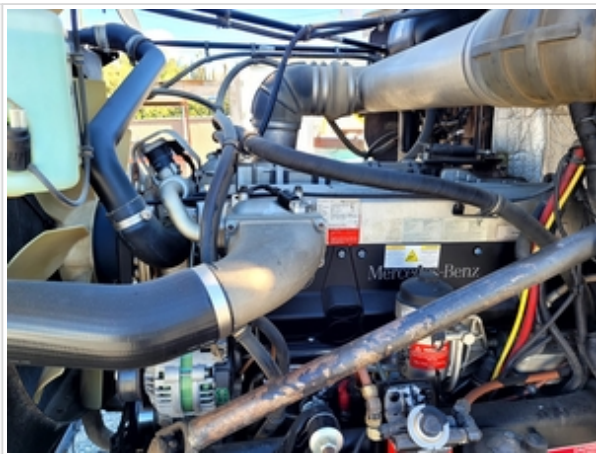
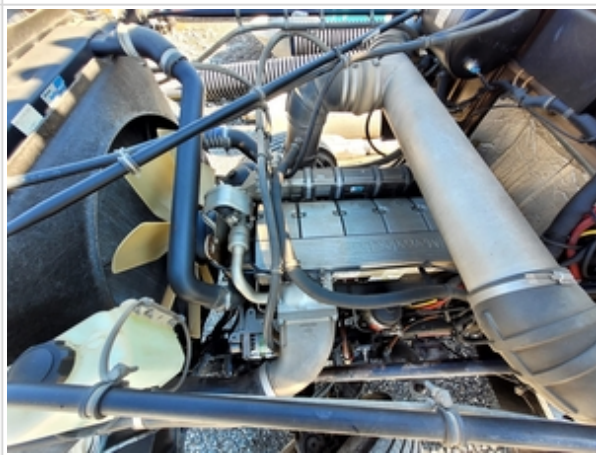
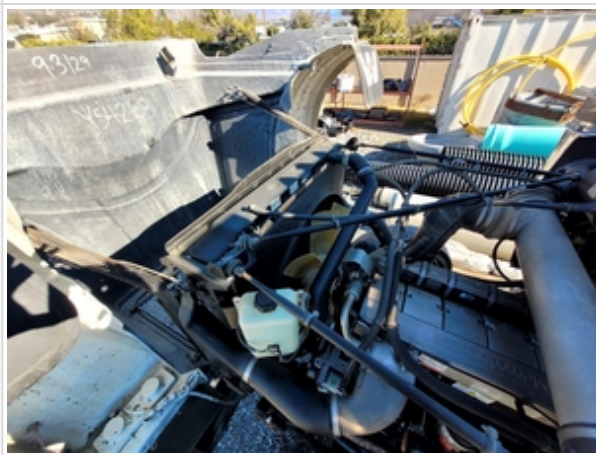
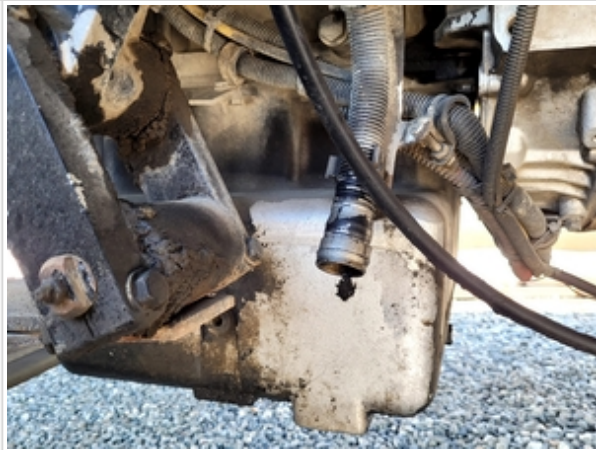
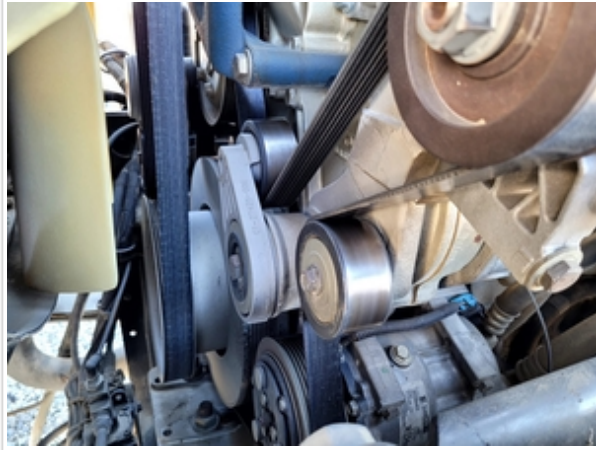
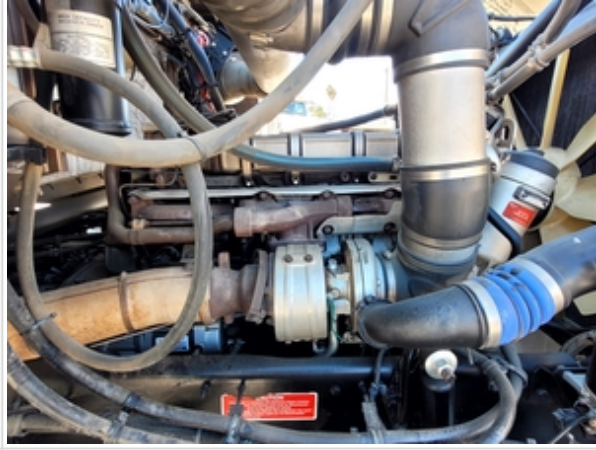
Engine Photos

Blow-by (Visual Observation Check)	No
Unusual Noises (Upon Start-up, Idle, Shutdown)	No
Unusual Noise Notes	No unusual noises heard
Engine Smoke (Upon Start-up, Idle, Shutdown)	No
Engine Smoke Notes	No engine smoke issues observed
Engine Exhaust Color	Clear

Requires DEF (Diesel Exhaust Fluid)	No
Overall Engine Appearance	Clean & dry
Overall Engine Comments	Overall, engine looks well maintained. A few, dried, residual oil leaks observed at bottom of left side of engine. No major active leaks observed.

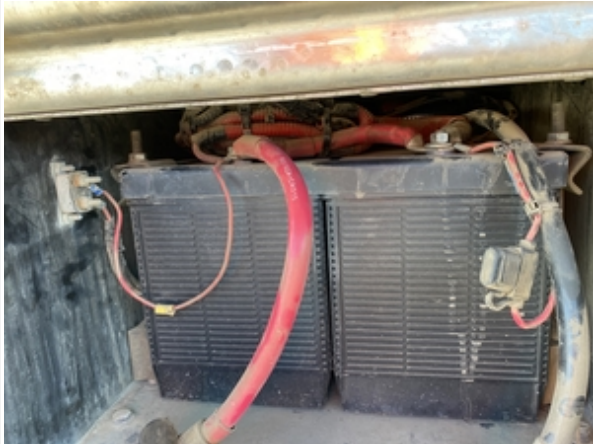
Battery	3 - Normal Wear & Tear
Battery Condition	Clean & dry appearance, tight connections
Battery Condition Photos

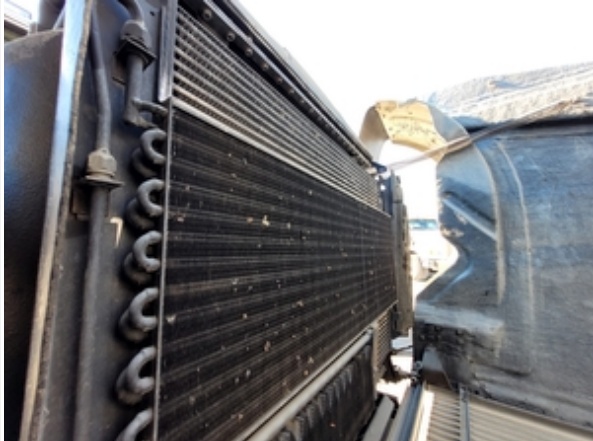
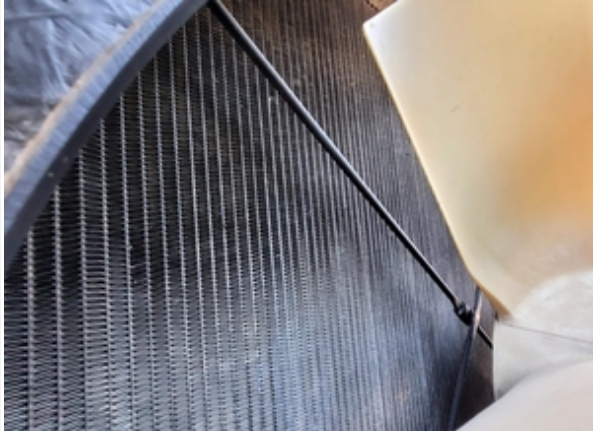
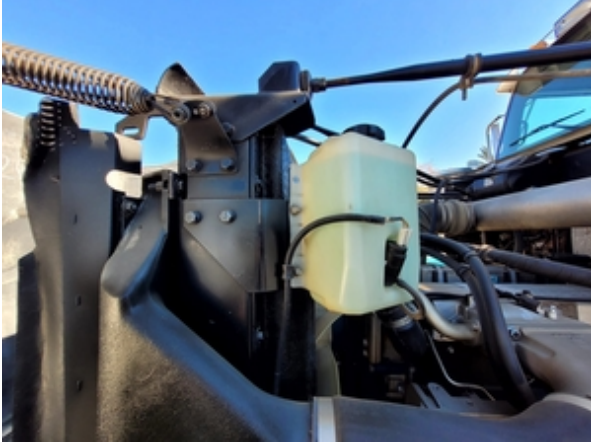
Radiator	3 - Normal Wear & Tear
Radiator Condition	Radiator fins & components appear to be in good working order, no signs of damage or leaks
Radiator Photos

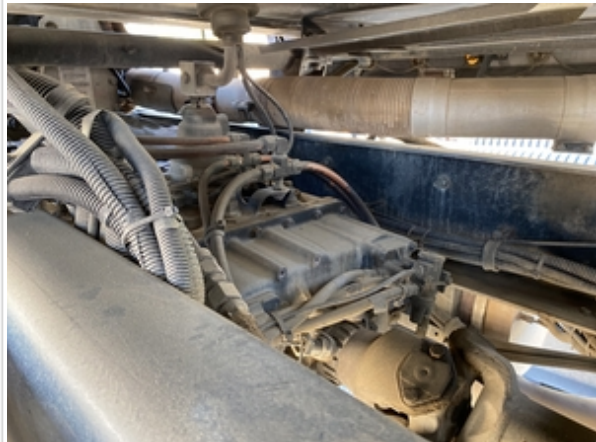
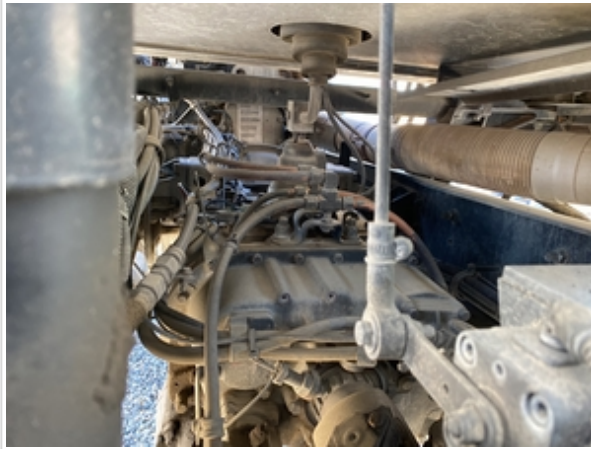
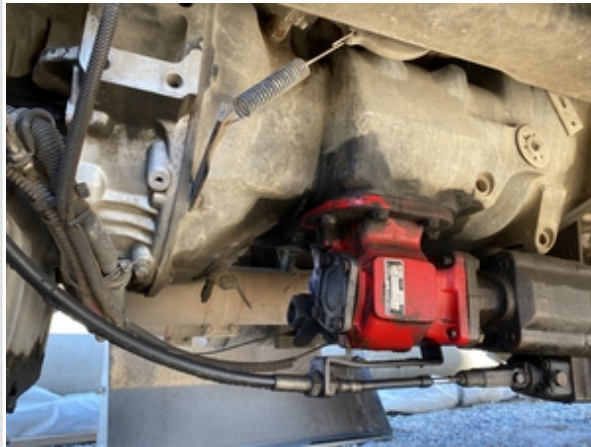
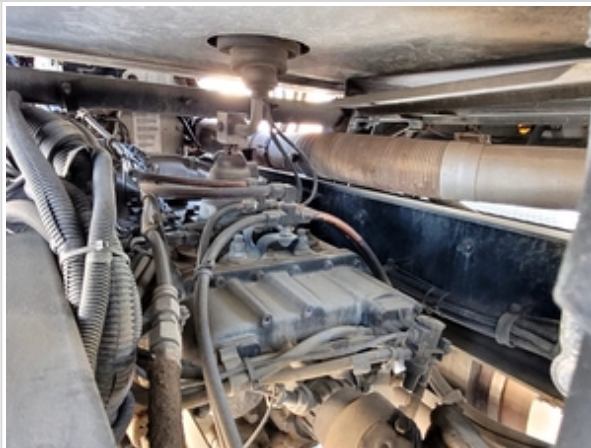
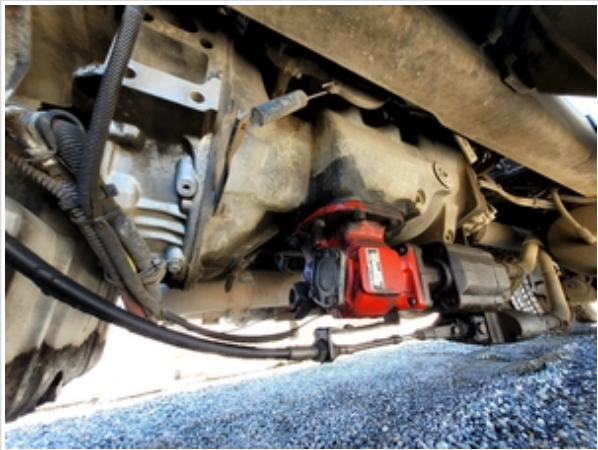
Transmission Info (Make/Model)	Eaton Fuller 10 speed Manual
Drive Type	4X6
Overdrive	N/A
Transmission	3 - Normal Wear & Tear
Transmission Condition	No unusual noises or vibrations
Transmission Condition Photos

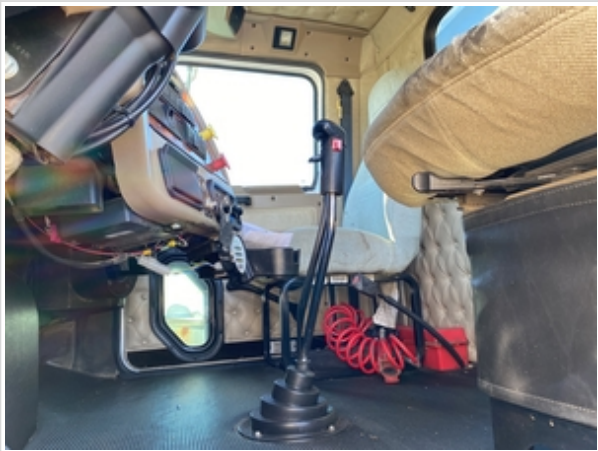
Clutch	3 - Normal Wear & Tear	
Clutch Condition	Clutch is functioning as expected	
Shift Lever	3 - Normal Wear & Tear	
Shift Lever Condition	Good forward and reverse function	
Shift Lever Photos

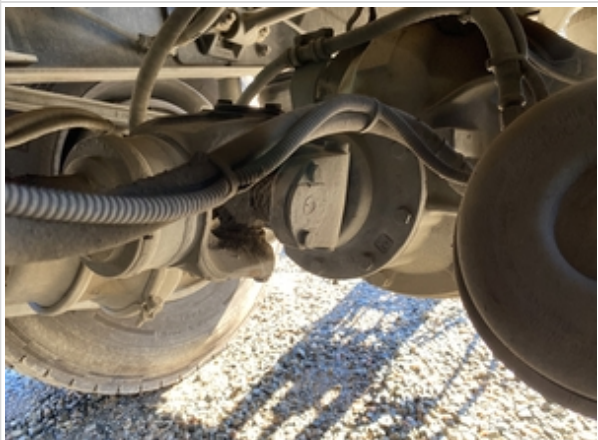
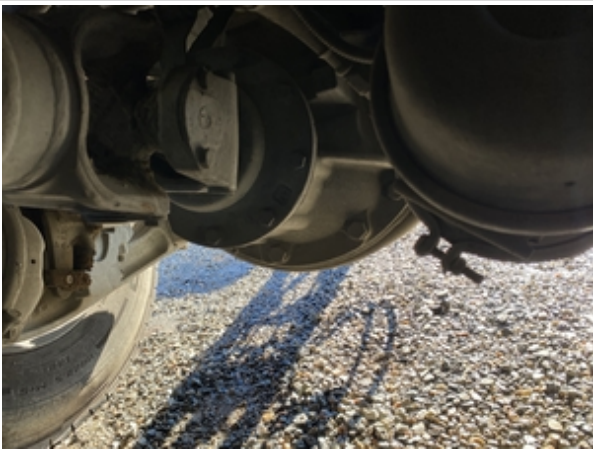
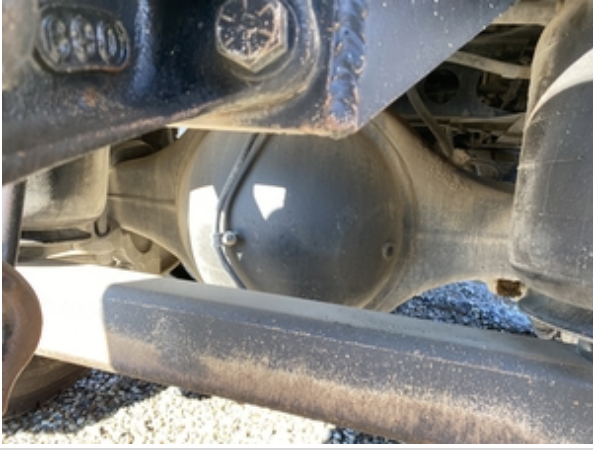
Differential	Check condition of the differential(s). Take photos and notes as relevant.	
Rear Differential	3 - Normal Wear & Tear	
Rear Differential Condition	Dry housing appearance, no unusual noises heard during operation	
Rear Differential Photos

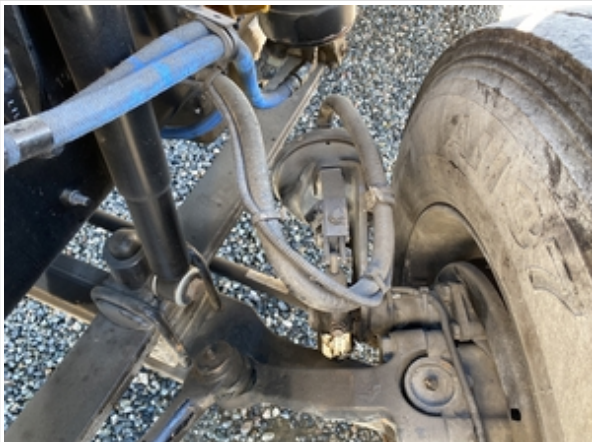
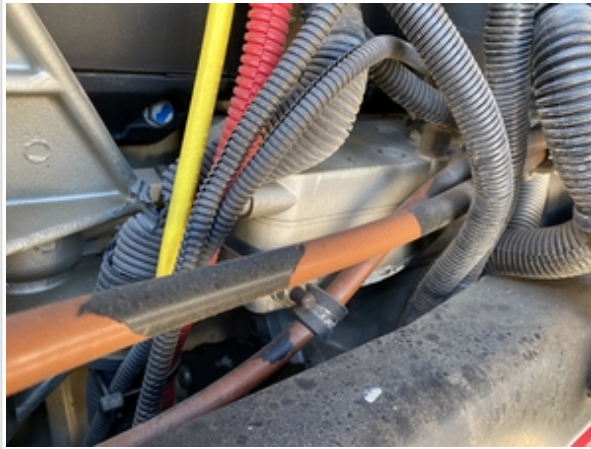
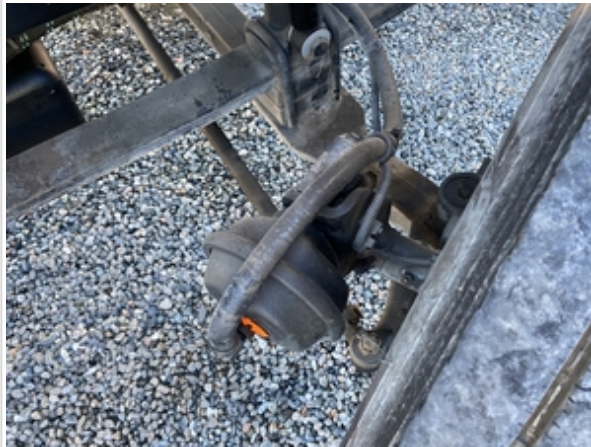
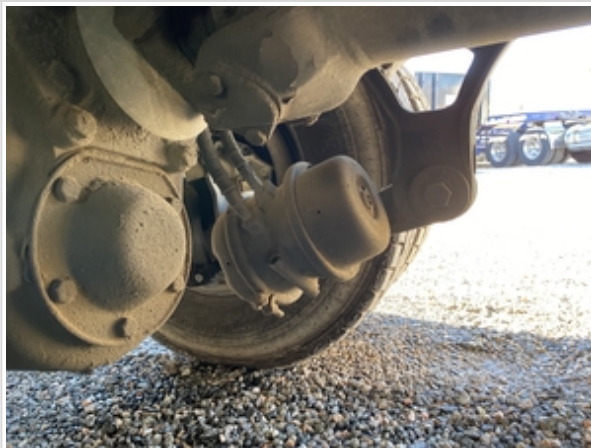
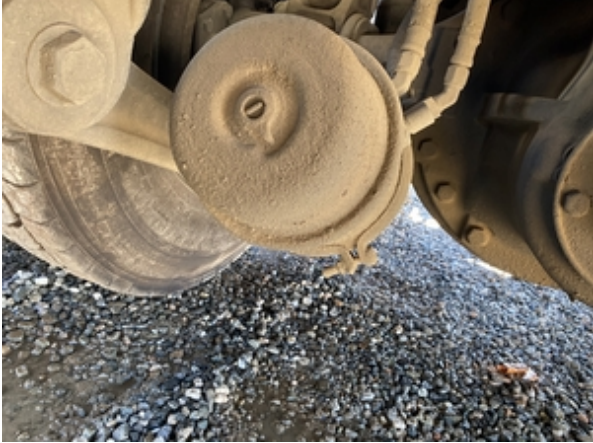
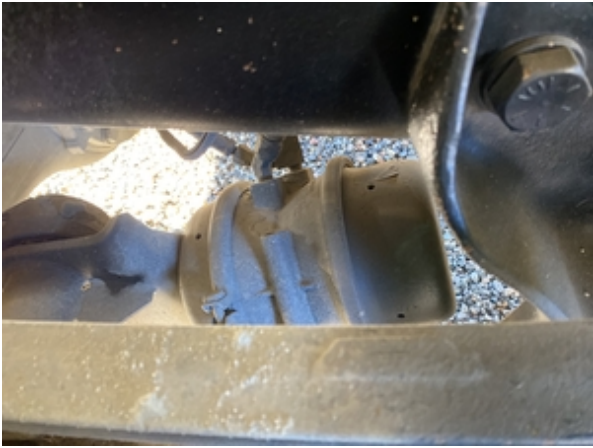
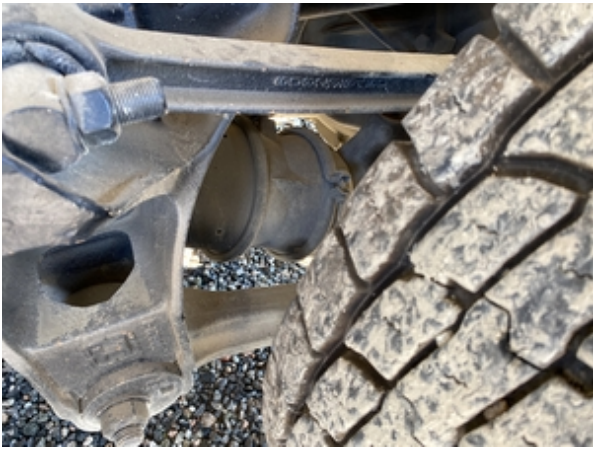
Brake System Type	Air Brakes	
Air Brakes Build Correct Pressure	Yes	
Air Brake System Leaks	No	
Air Brake Hose Condition	3 - Normal Wear & Tear	
Air Brake System Photos

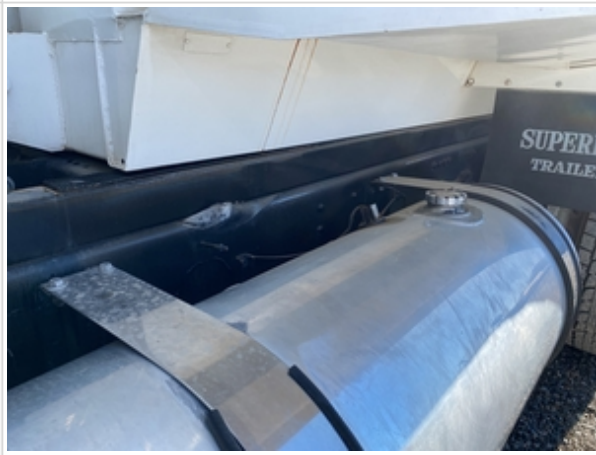
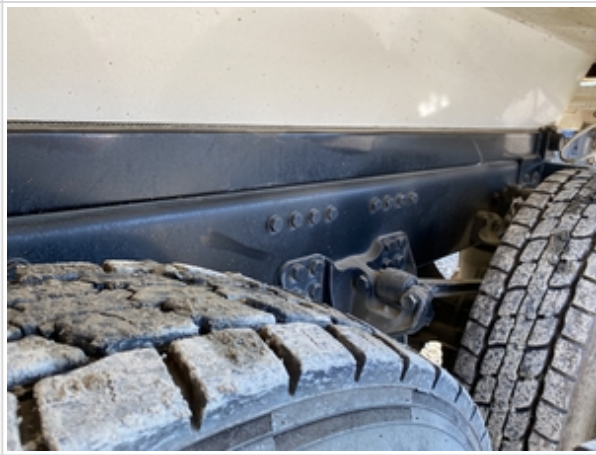
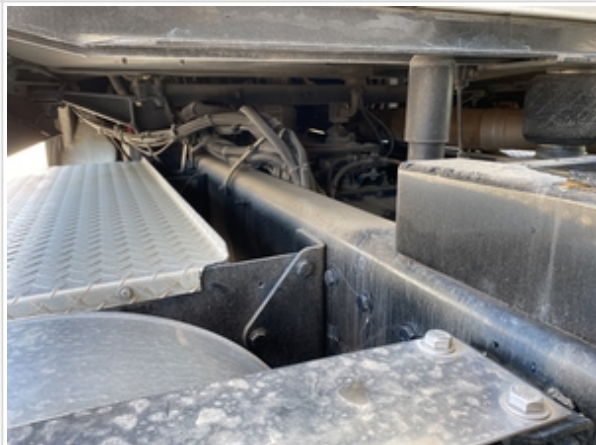
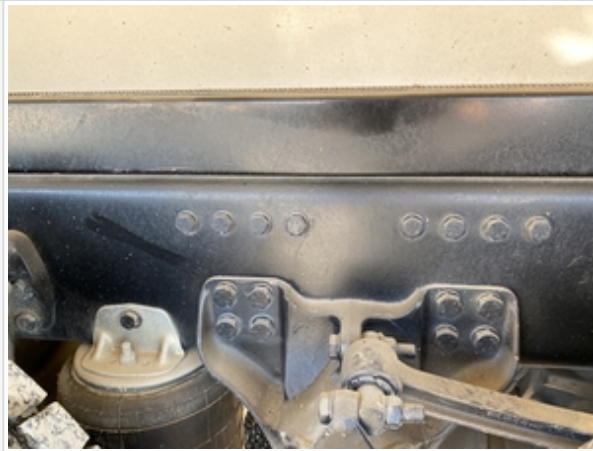
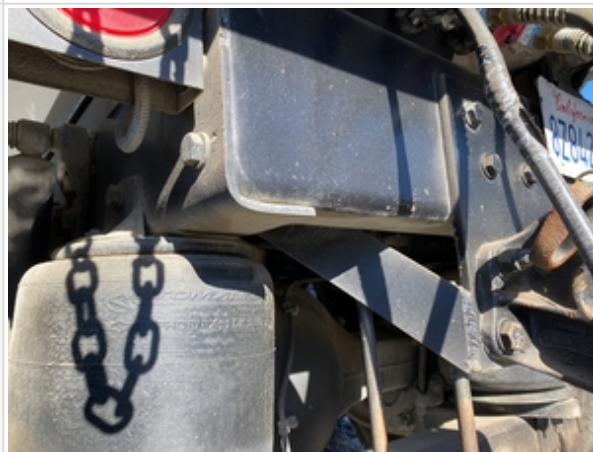
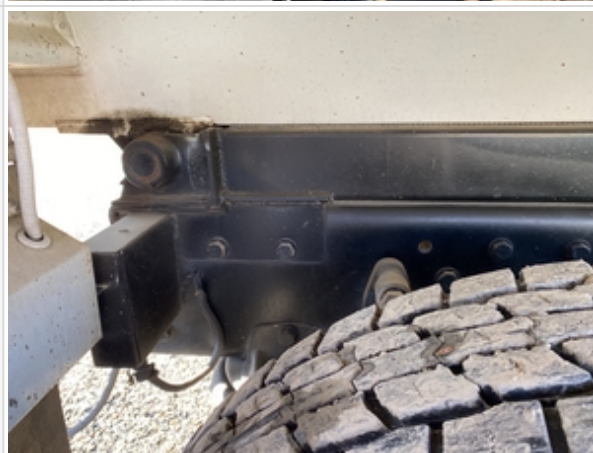
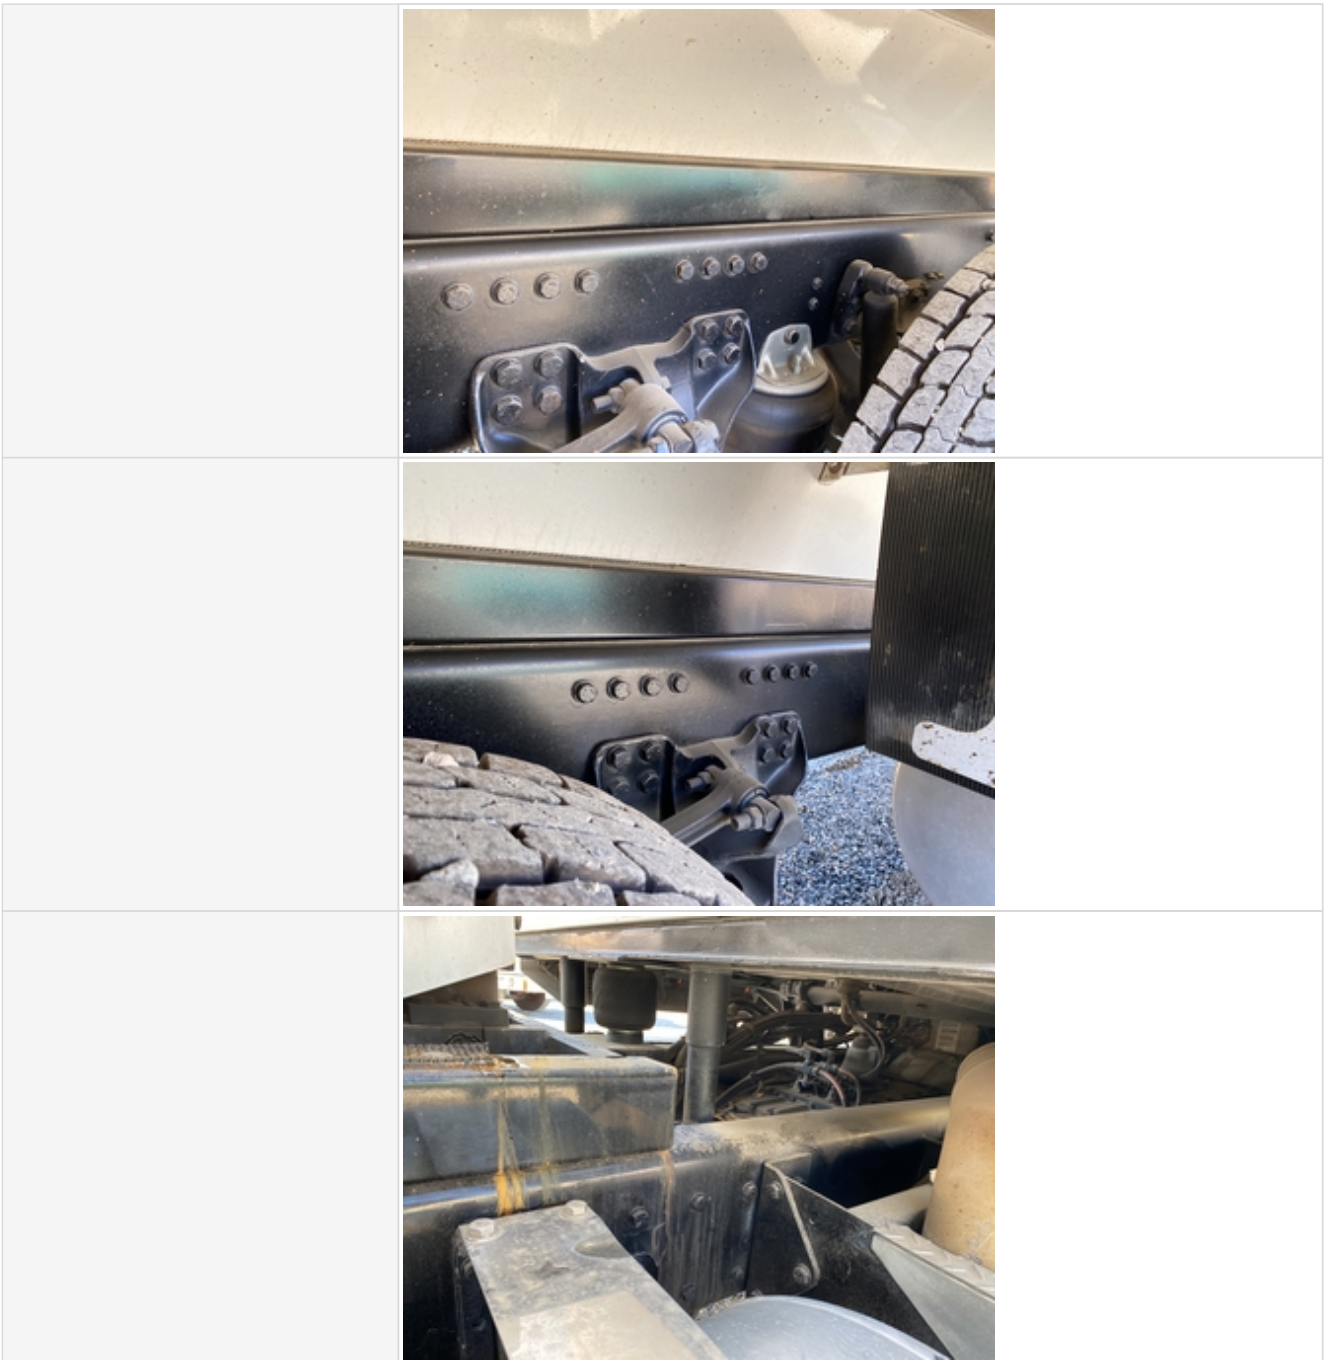
Frame Condition	3
Frame Photos

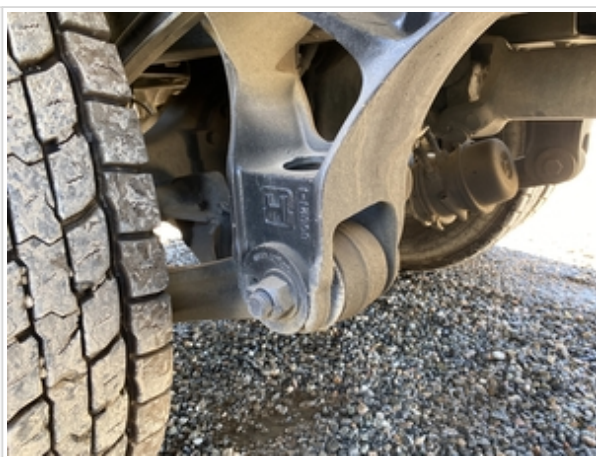
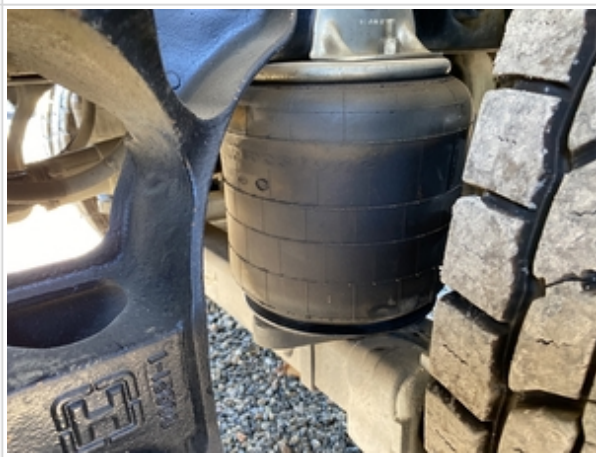
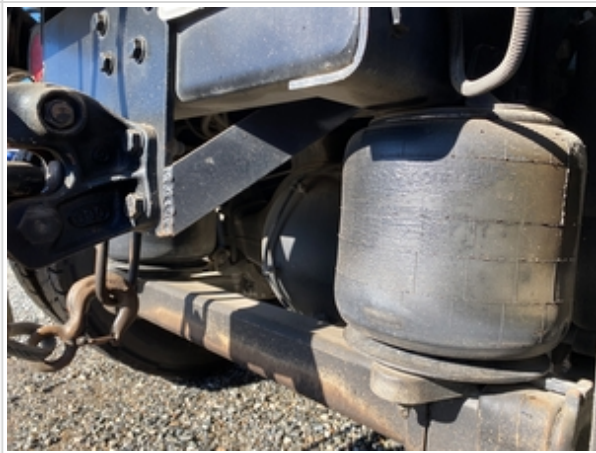
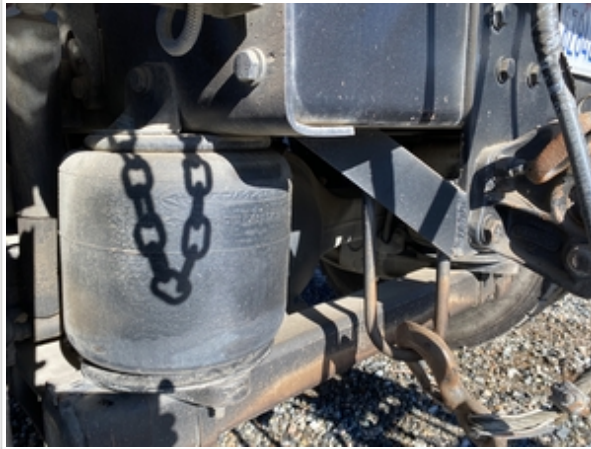
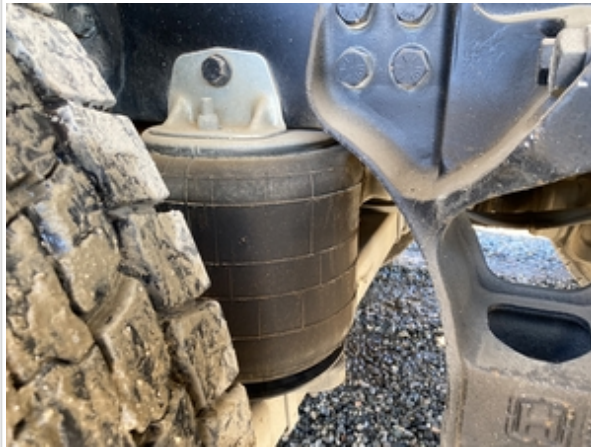
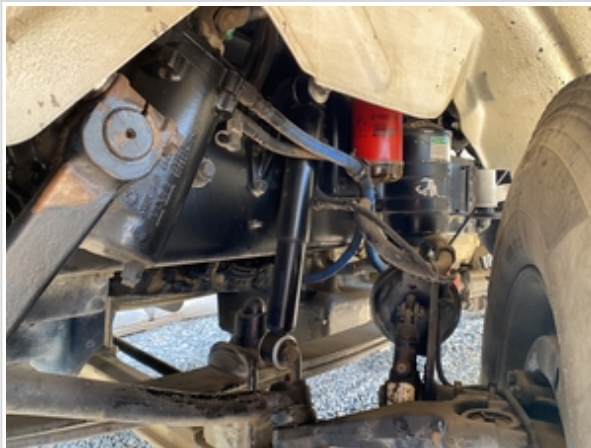
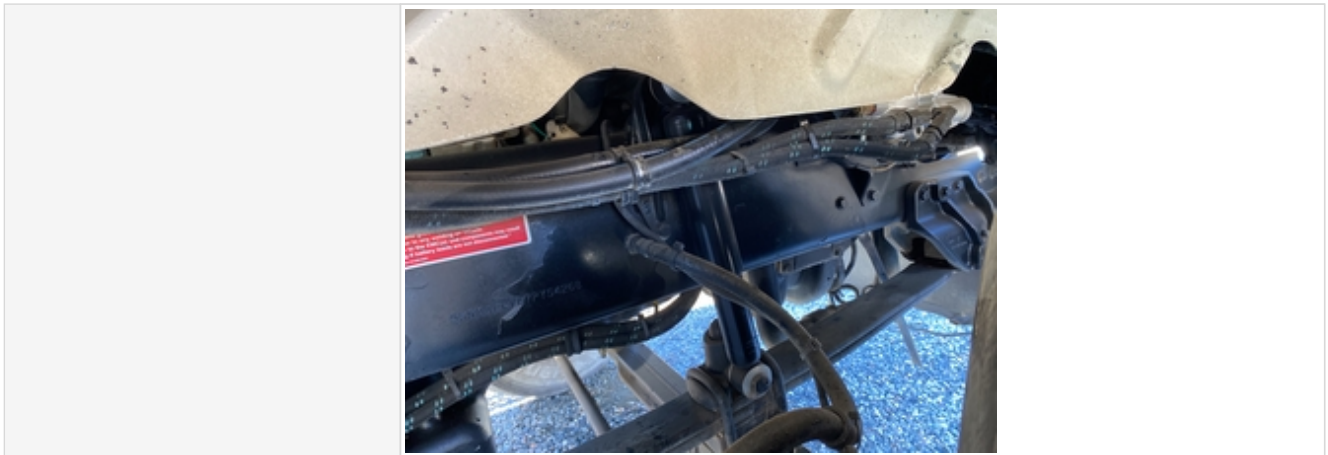
<p>Suspension Photos</p>

Suspension	3
------------	---

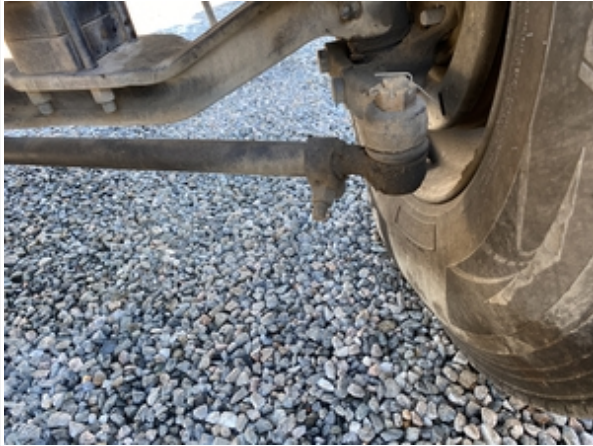
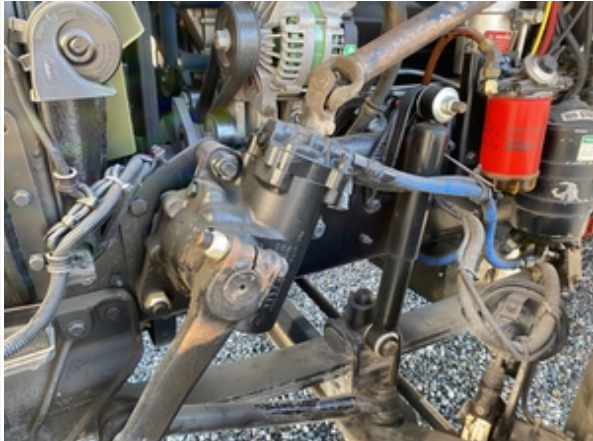
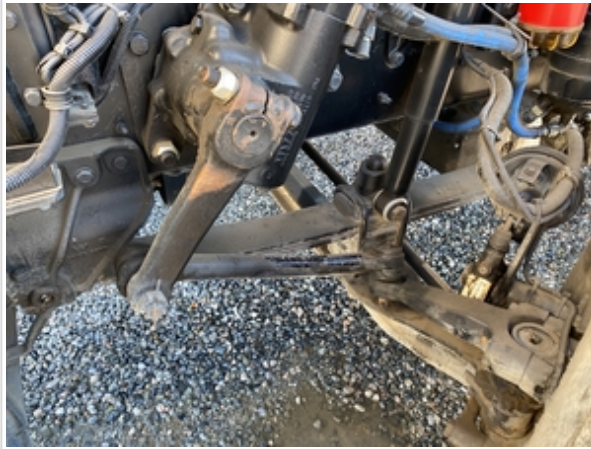
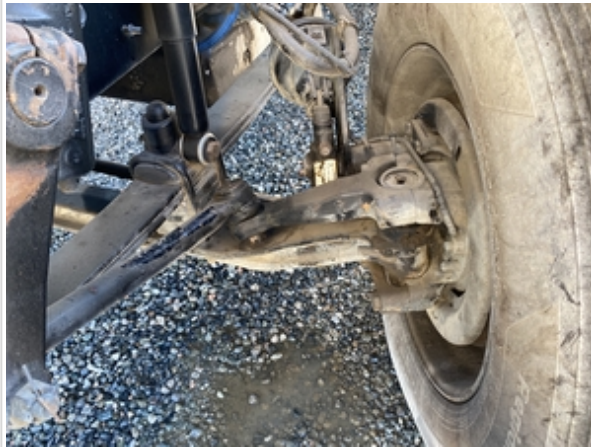
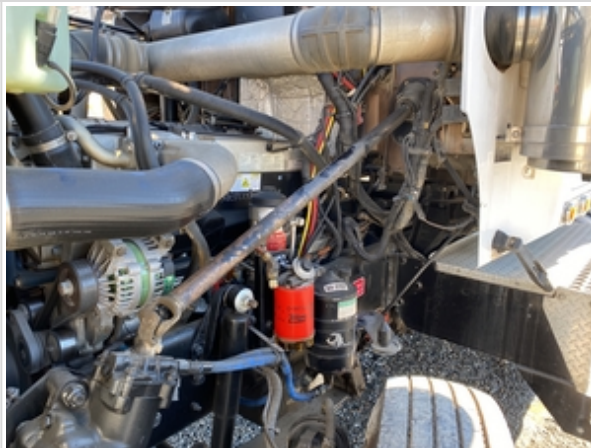
Steering Components	3
Steering Components Photos

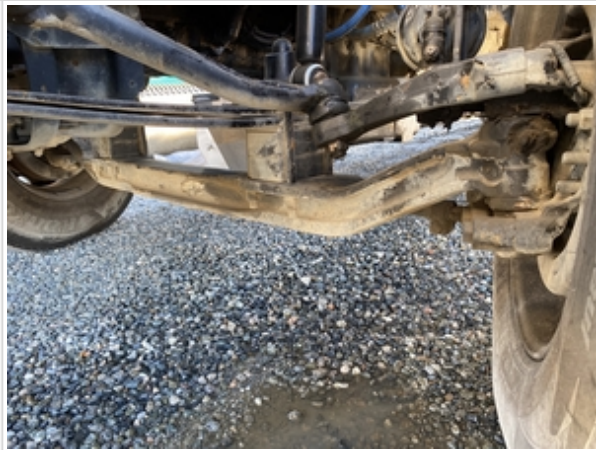
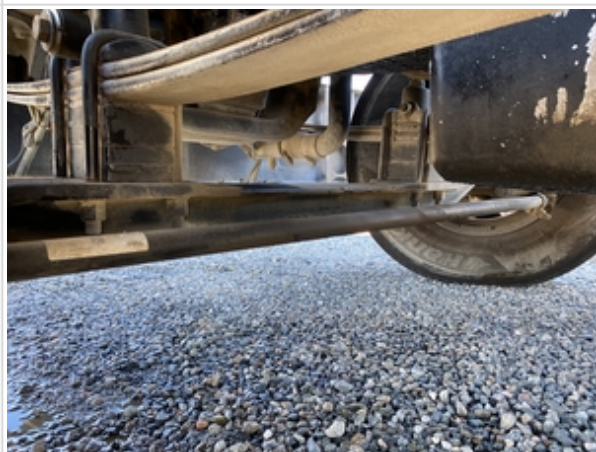
Steer Axle Photos

Steer Axle Condition

3

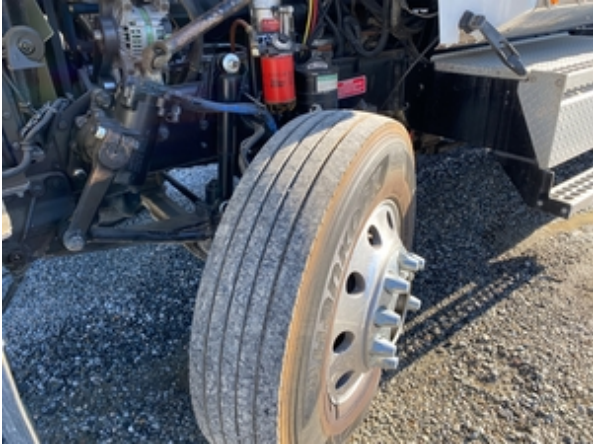
Wheel Seal Leaks	No
Tire Brand	Hankook - Front Cooper - Rear
Tire Size	11R22.5 (all around)
Front Left Tire - Ratio Remaining	30%
Front Left Tire Photos

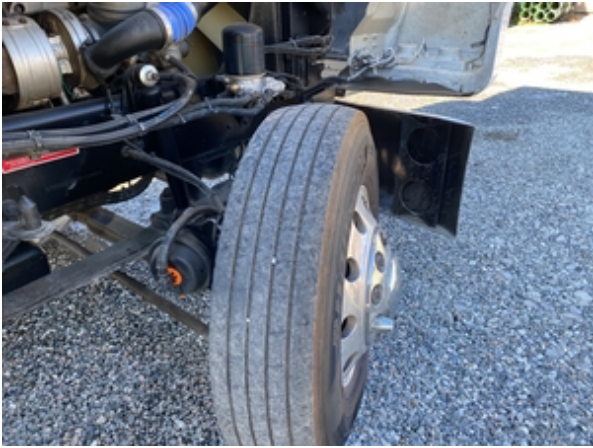
Front Right Tire - Ratio Remaining	30%
Front Right Tire Photos

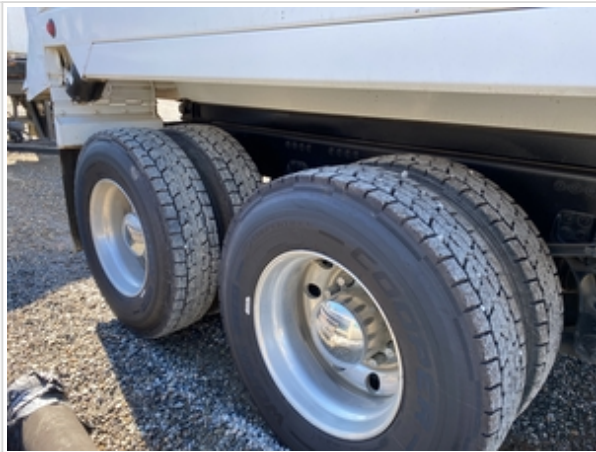
Rear Right Tire Photos

Rear Right Tire - Ratio Remaining	90%

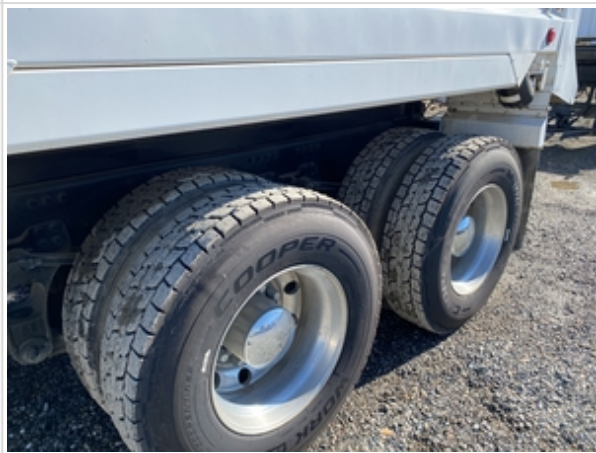
Rear Left Tire - Ratio Remaining	90%
Rear Left Tire Photos

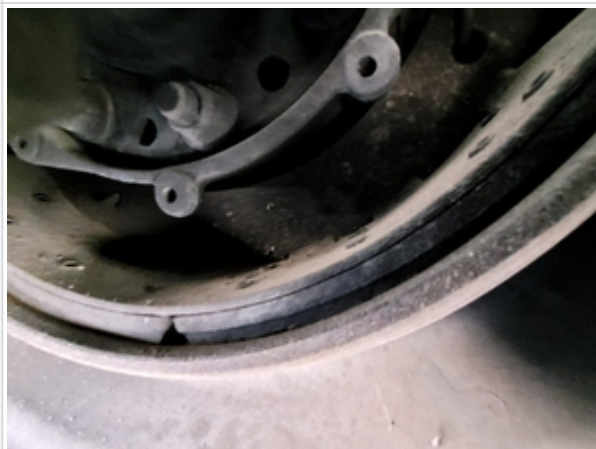
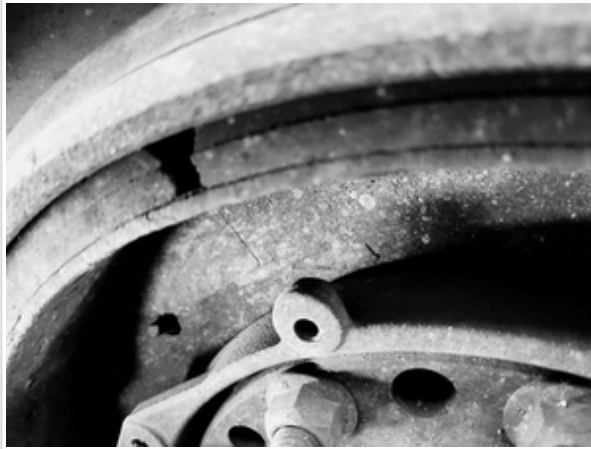
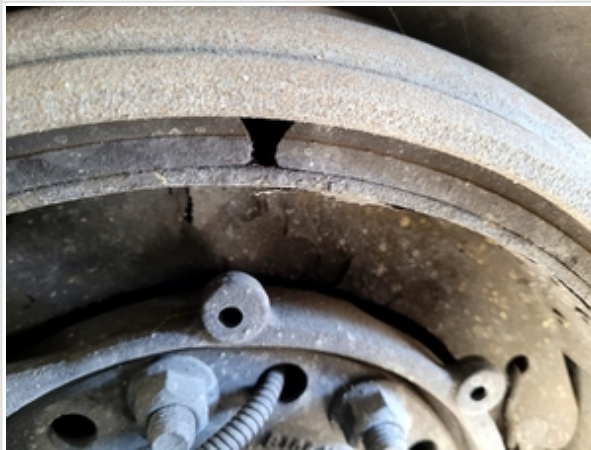
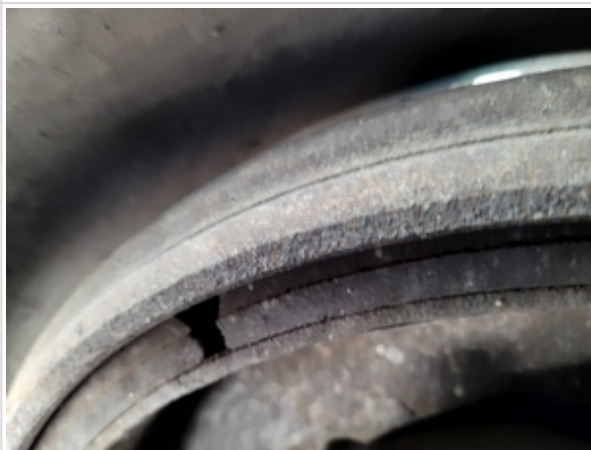
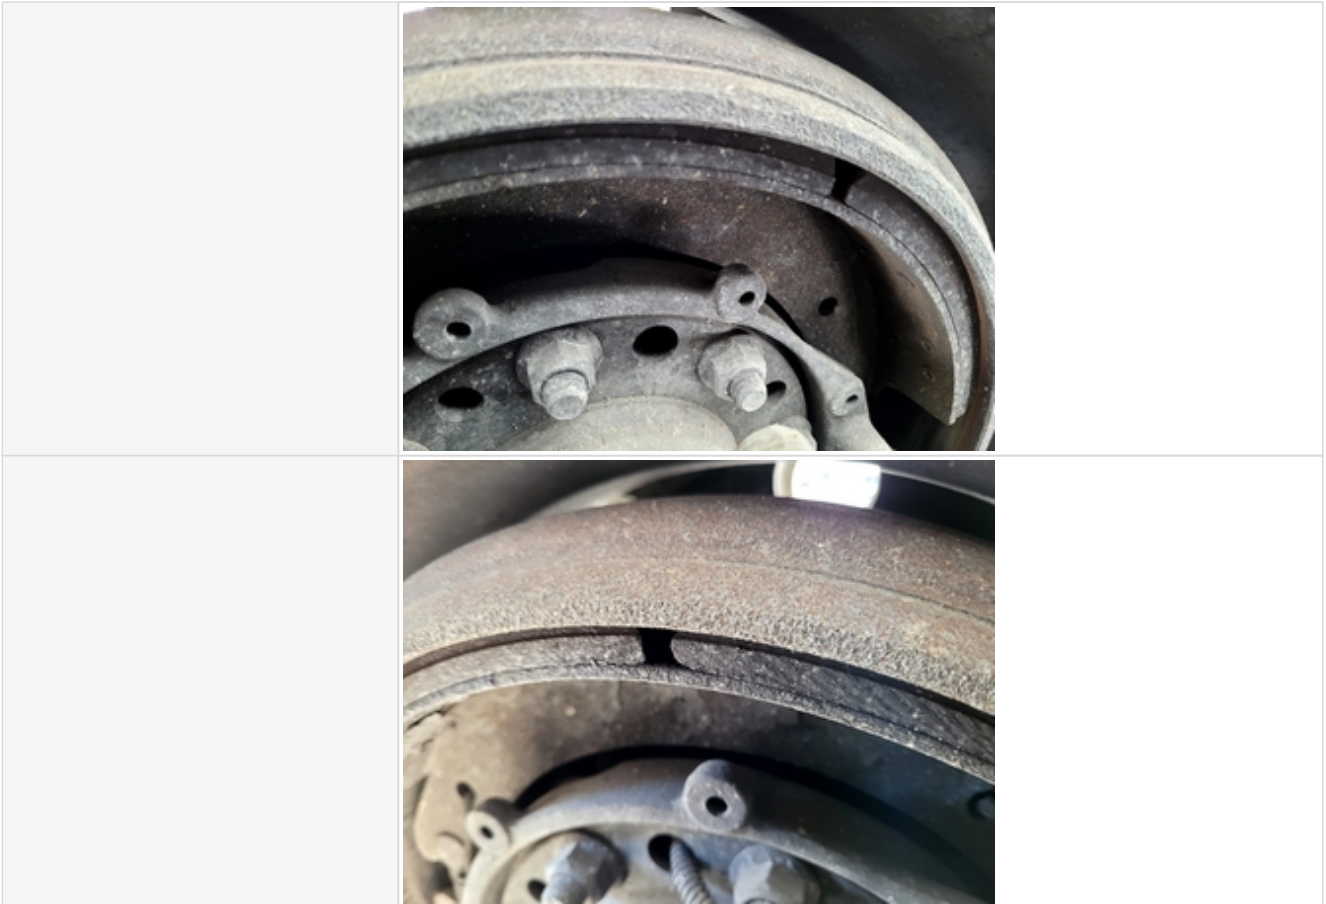
Brake Shoe Thickness	50%
Comments	Most brake shoes above 50%. A few brake shoes just under 50%
Brake Shoe Photos

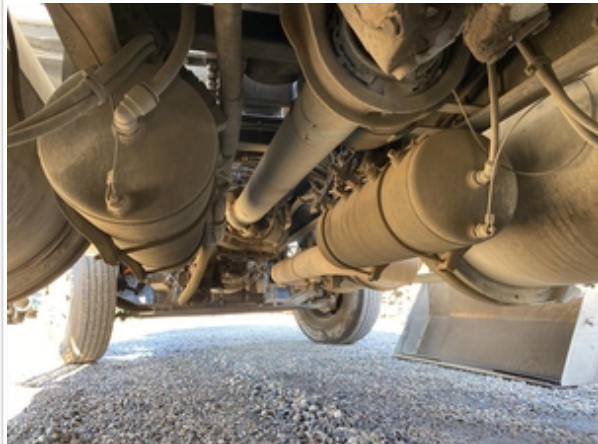
Overall Chassis	3
Overall Chassis Comments	Overall chassis in good condition. No obvious major issues seen.
Overall Chassis & Undercarriage Photos
