Inspection Report (On-Highway Dump Truck)

Year	2007
Make	Western Star
Model	4900
Serial Number	5KKHAECV87PY54268
Truck Odometer Reading	299,830
Current Inspection / State Cert / DOT	N/A
Previous Application (e.g., earth moving, mining, demolition, etc)	Pipeline Construction

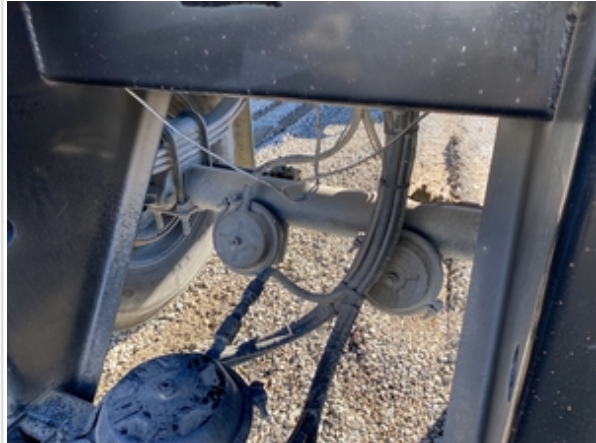
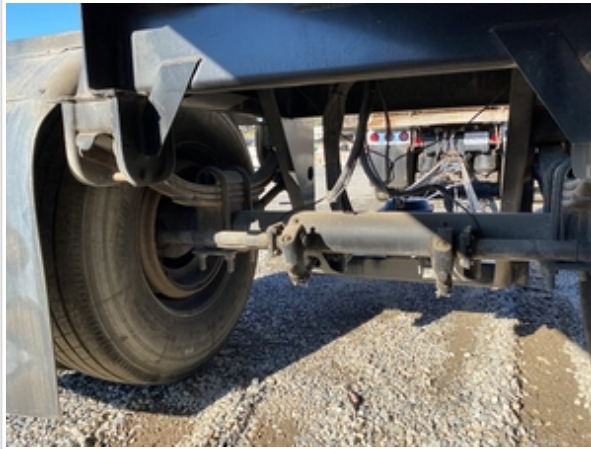
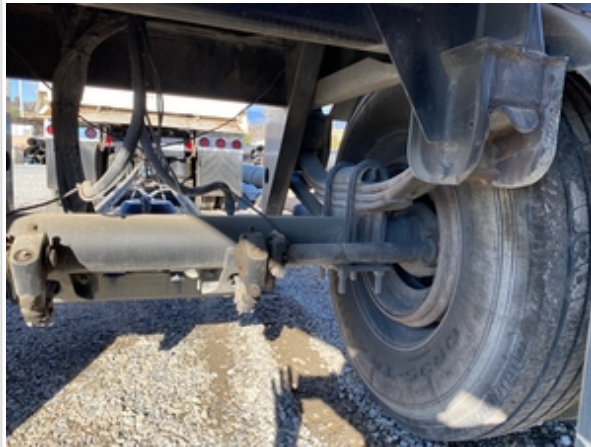
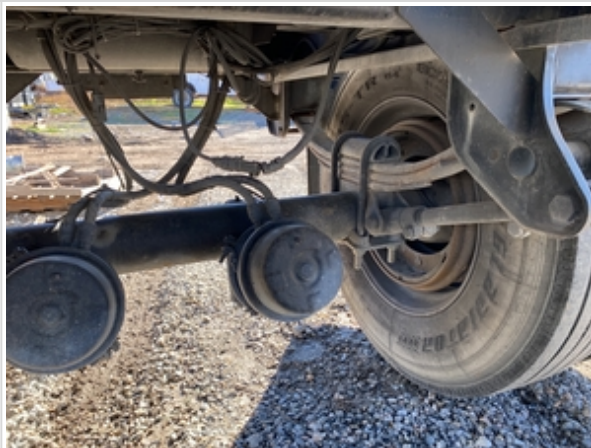
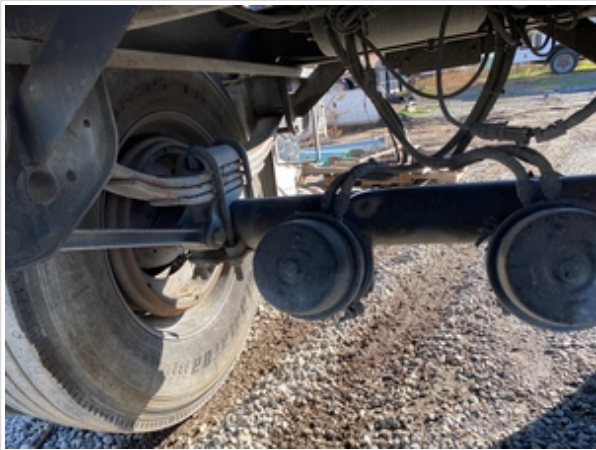
Instructions	Check the condition of additional axle(s), wheels & tires. Note any damage or wear. Take photos.	
Steerable?	No	
Drop Axle?	No	
Super Dump?	No	
Axle Condition	3 - Normal Wear & Tear	
Axle Condition Photos

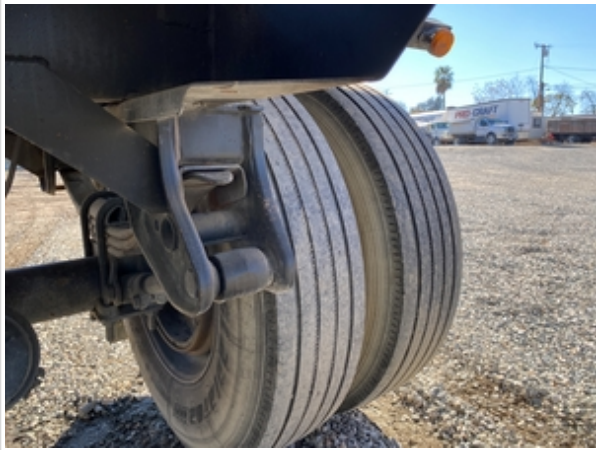
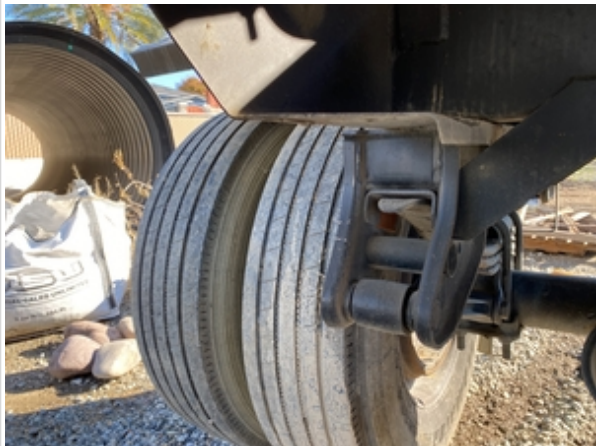
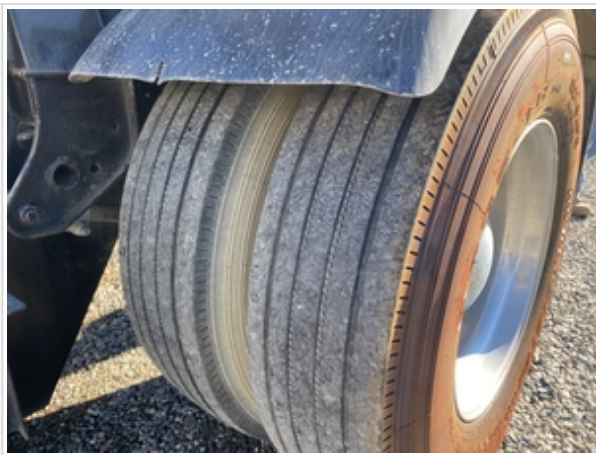
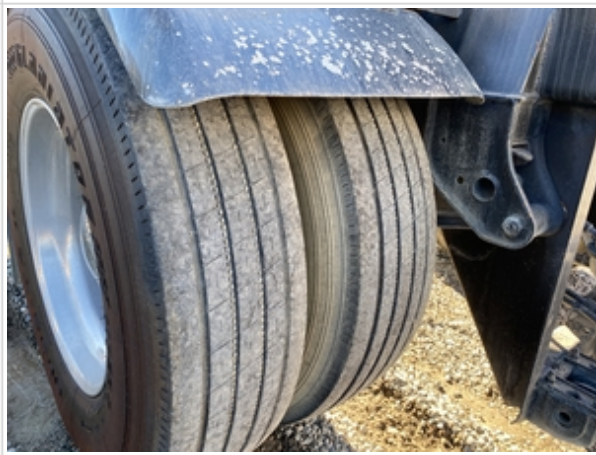
<p>Wheels & Tires</p>	<p>3 - Normal Wear & Tear</p>	
<p>Wheels & Tires Photos</p>

Tire Brand	Gladiator
Tire Size	11r22.5
Left Tire(s) Ratio Remaining	30%
Right Tire(s) Ratio Remaining	30%

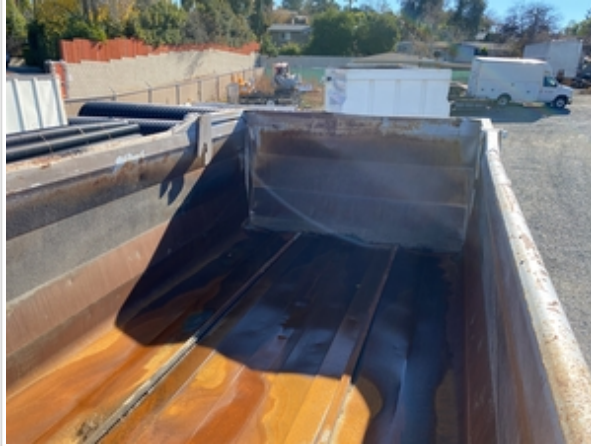
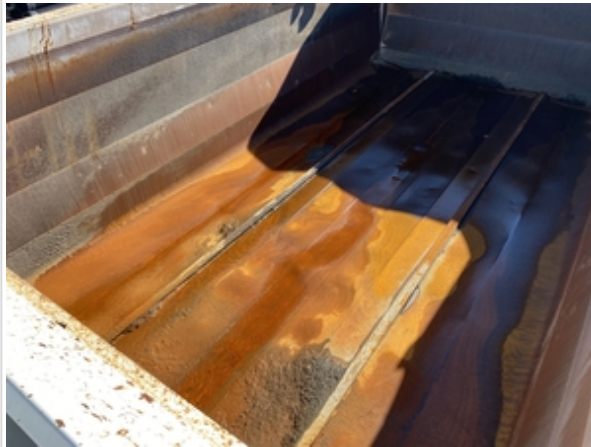
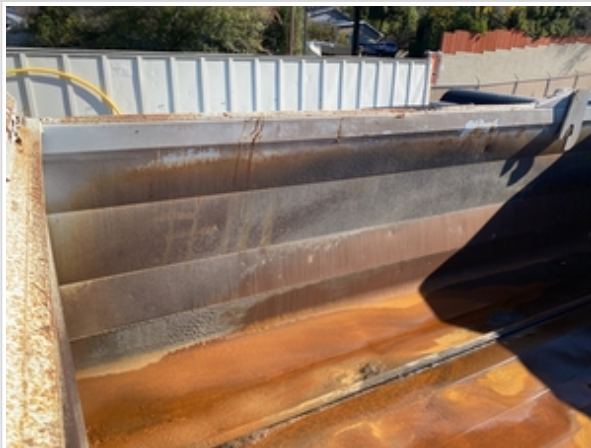
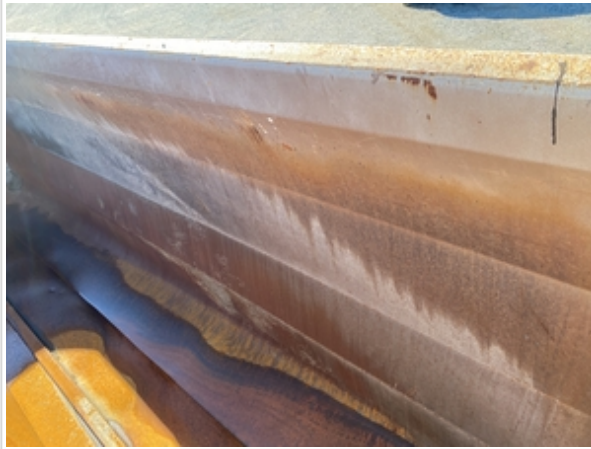
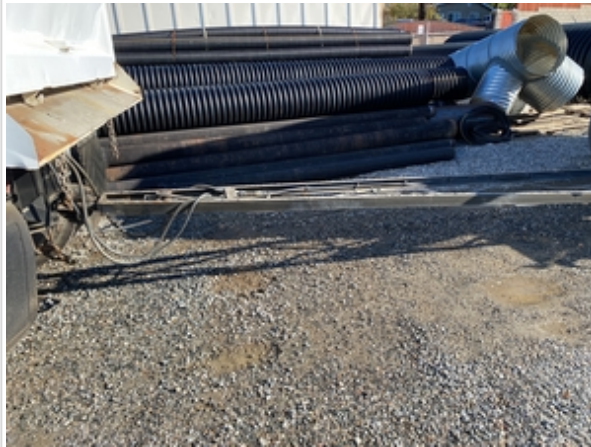
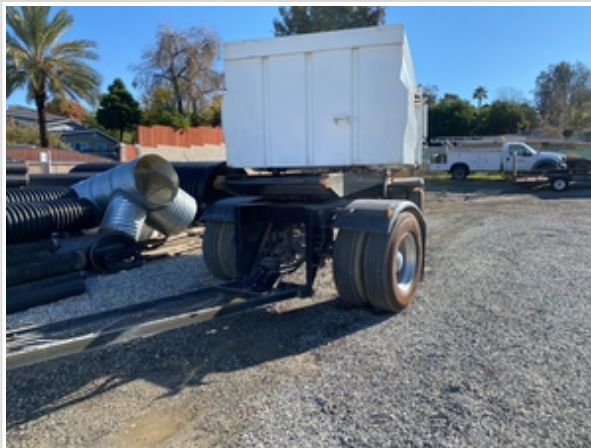
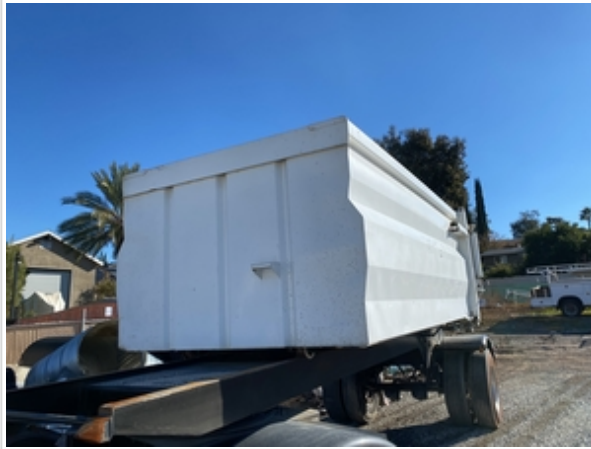
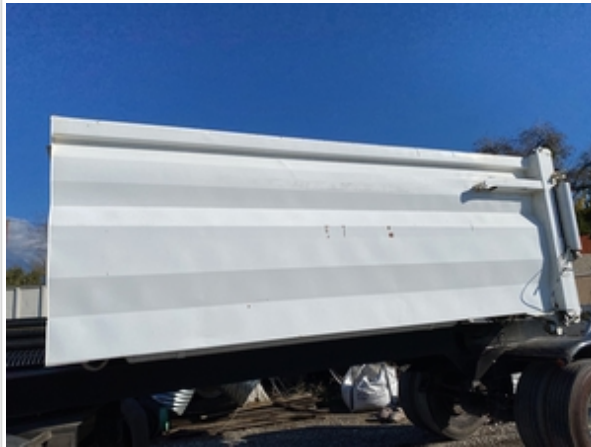
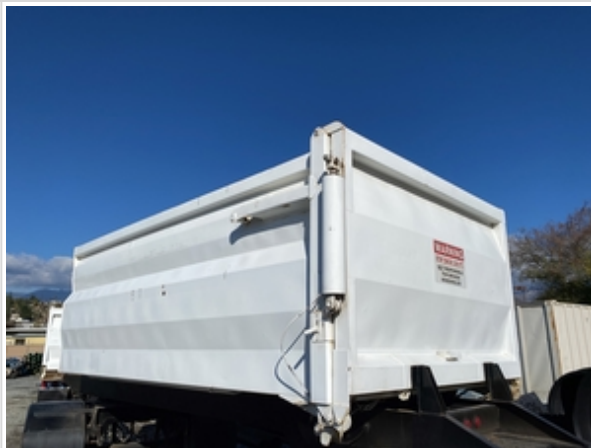
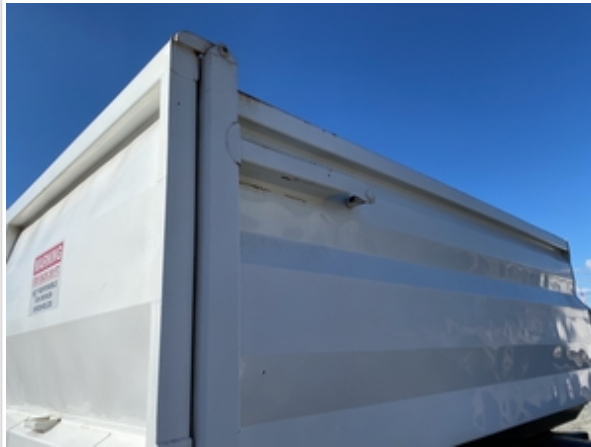
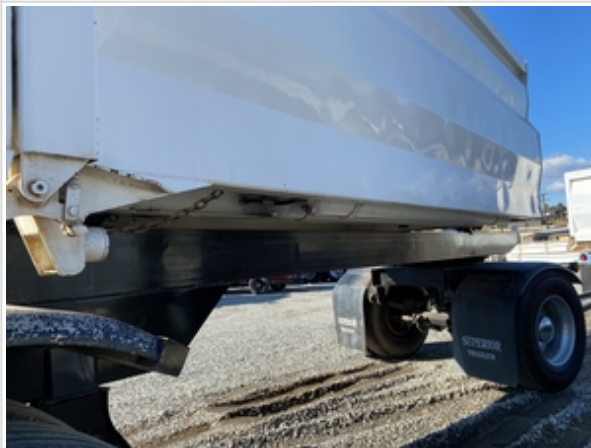
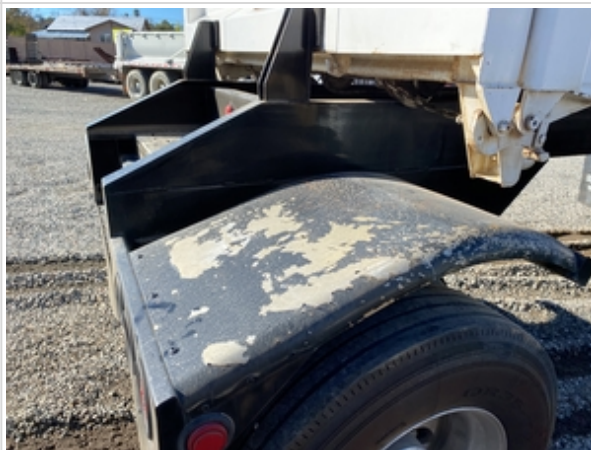
Bed Body Photos

Dump Body Make & Material	Superior Truck Body
Dump Body Length (ft and inches)	Both are 14' dump bodies
Dump Body Height (ft and inches)	8'6"
Bed Body	3 - Normal Wear & Tear
Comments	Pictures show both dump body bed floors

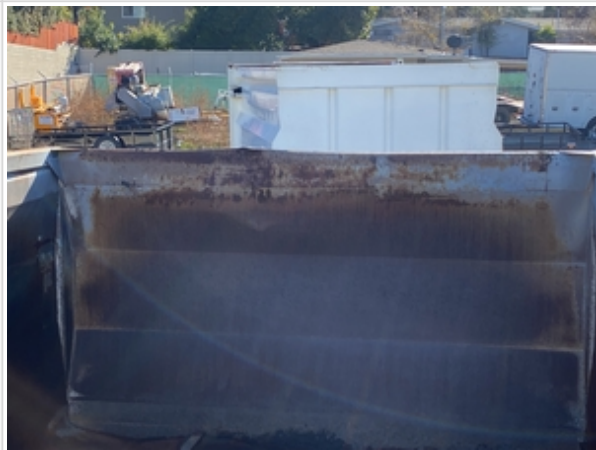
Tailgate	3 - Normal Wear & Tear
Comments	Air controlled lift gate
Tailgate Photos
