## Inspection Report (On-Highway Truck Cab + Chassis)

| Make | Kenworth |
| Model | T800 |
| Serial Number | 1XKDDP9X9EJ387099 |

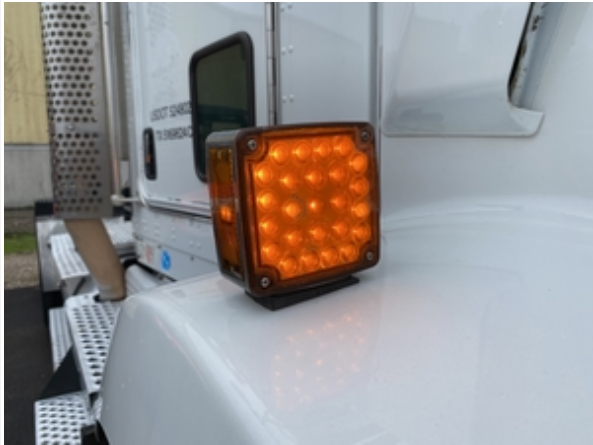
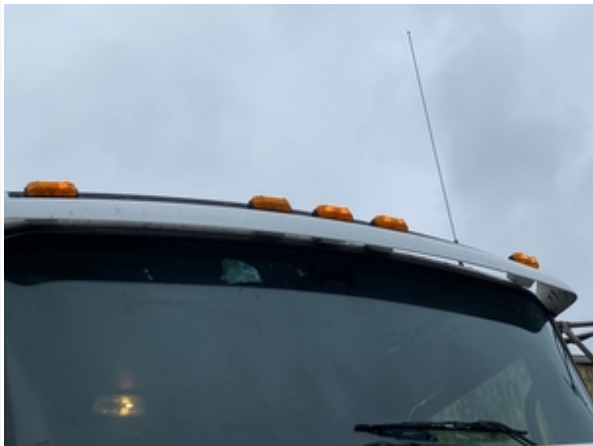
| Exterior Lights Photos | |

| Exterior Lights | 3 - Normal Wear & Tear |
| Exterior Lights Condition | No visible damage, lighting system is operational, Other (see comments) |
| Comments | A few small, roof mounted running lights, inoperable, rear right signal light inoperable |

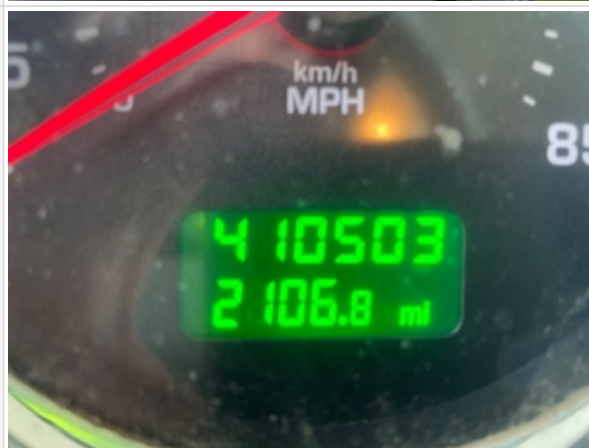
Odometer Photo

| Odometer Activity | 3 - Normal Wear & Tear | |
| Odometer Condition | Odometer is working and in good condition | |

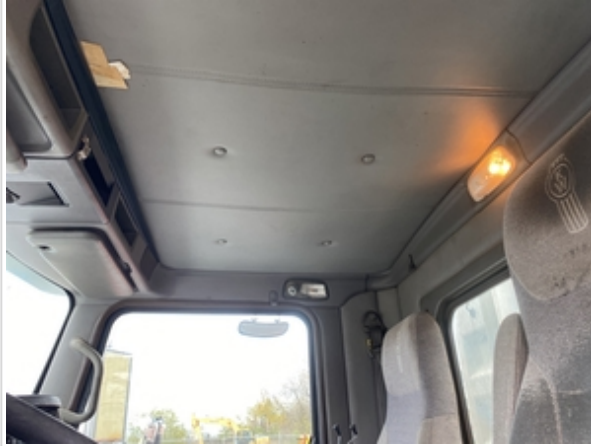
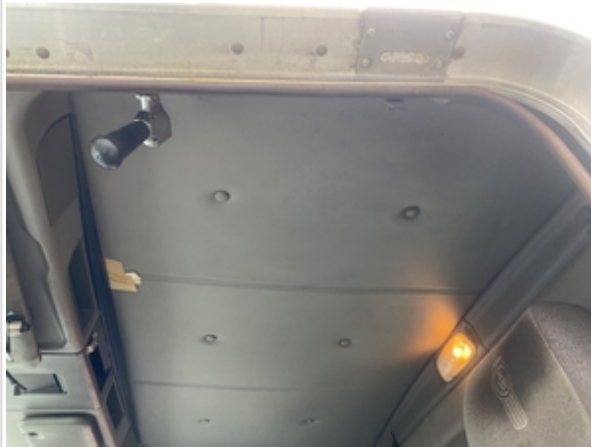
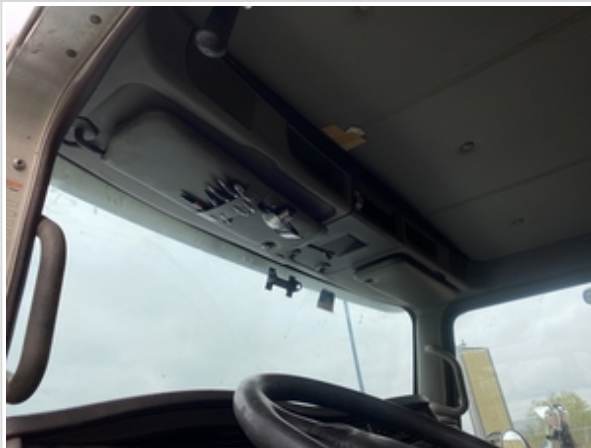
Cab Interior Photos

| Seats/Seat Belt Condition | Seat(s) has major surface staining or tears |
| Cab Interior Overall Rating | 2 - Above Average Wear |
| Comments | Rated two only because Both seats have large stains ,broken switches and air brake knob's worn |

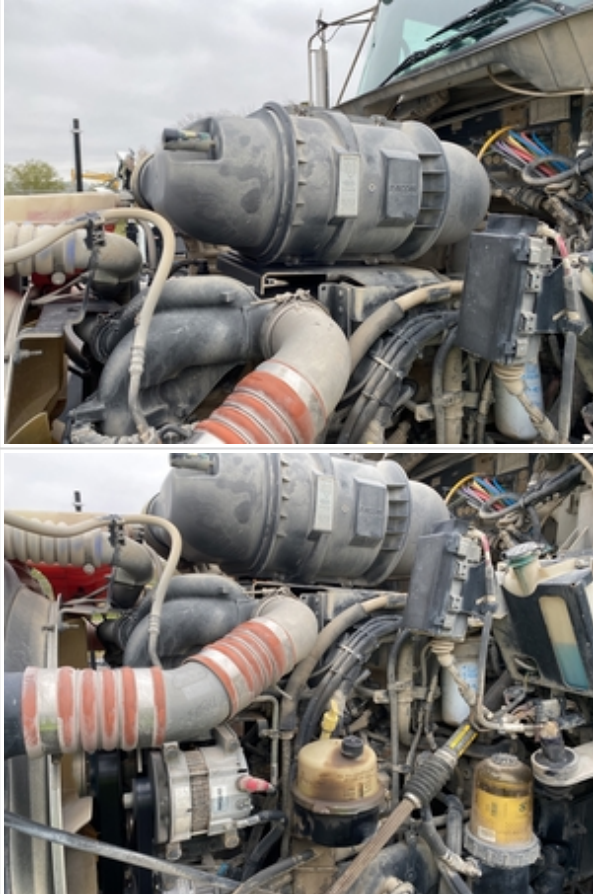
| Engine Photos | |

| Overall Engine Comments | Overall engine well maintained, minor seepage at valve cover breather. |

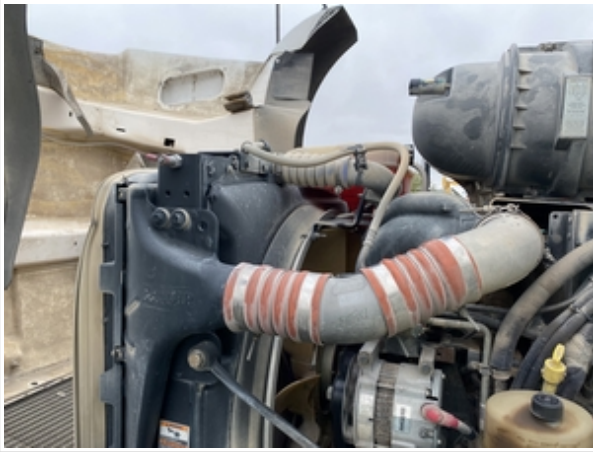
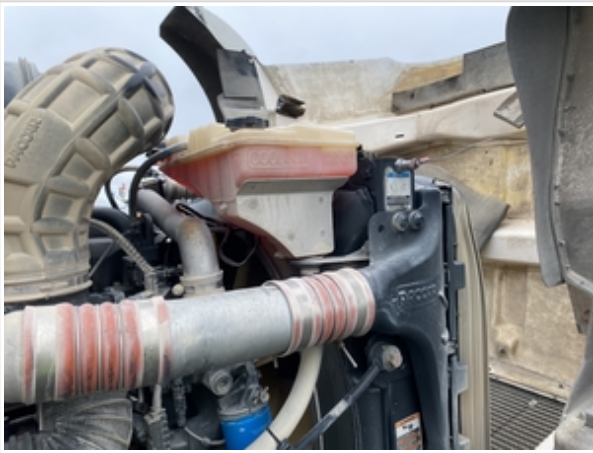
| Radiator Photos | |

| Radiator | 3 - Normal Wear & Tear |
| Radiator Condition | Radiator fins & components appear to be in good working order, no signs of damage or leaks |

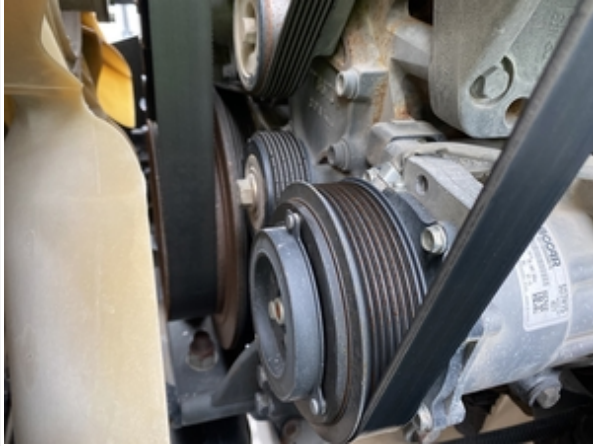
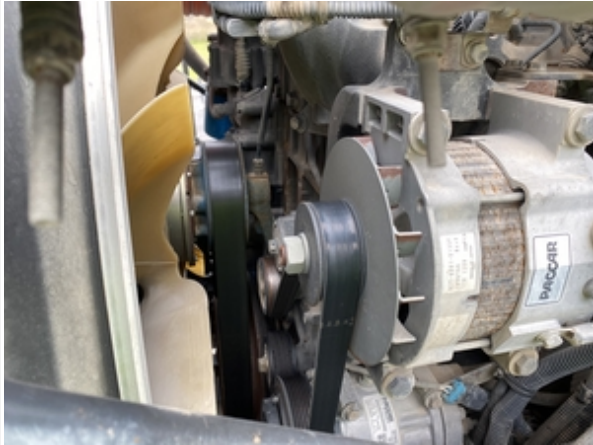
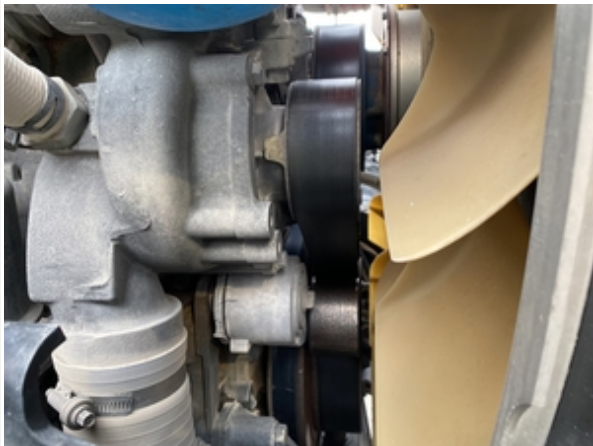
| Belt Photos | |

| Belts | 3 - Normal Wear & Tear |
| Belt Condition | Belts appear in good condition & alignment with proper tension |

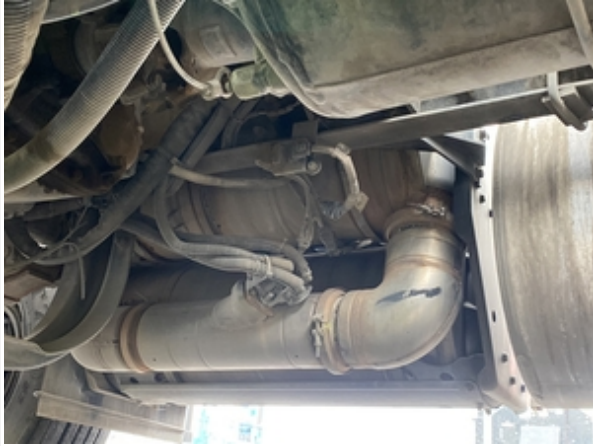
| DPF Photos | |

| DPF Condition | 3 - Normal Wear & Tear |

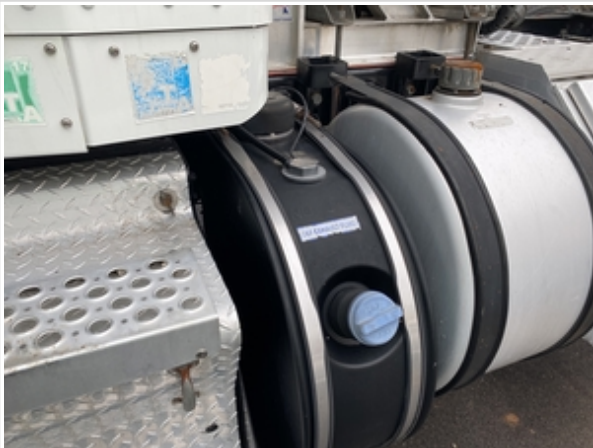
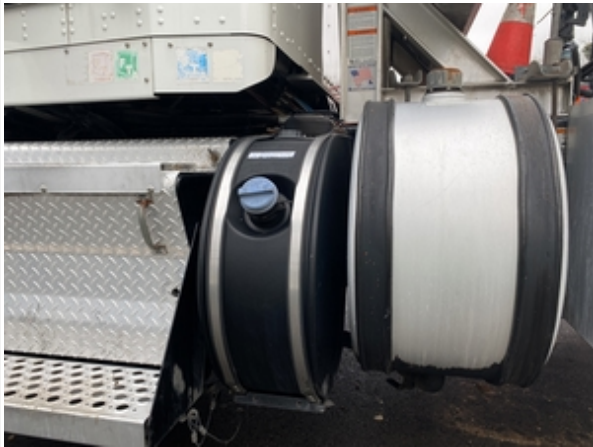
| DEF Tank Photos | |

| DEF Tank | 3 - Normal Wear & Tear |
| DEF Tank Condition | Area around DEF tank cap is clean, fluid is clear & appears free of contaminants |

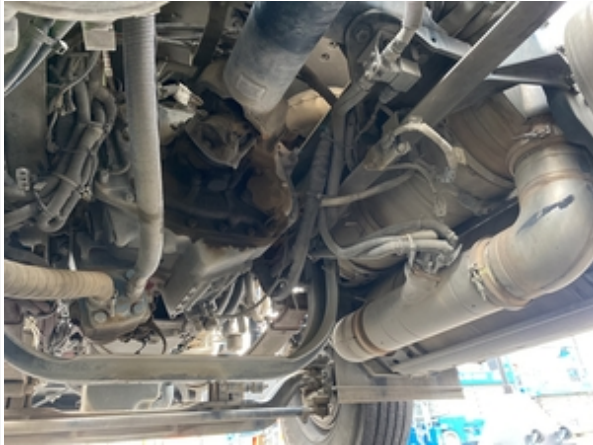
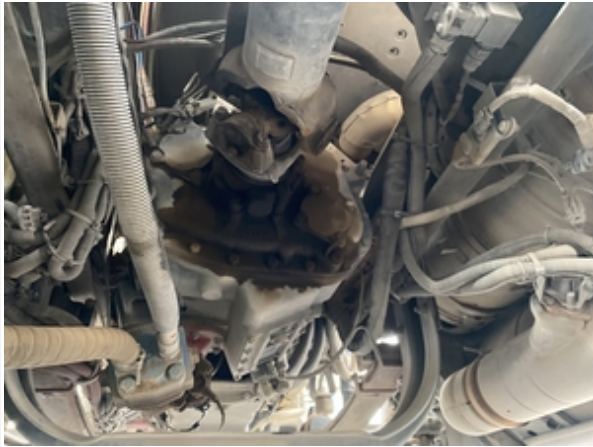
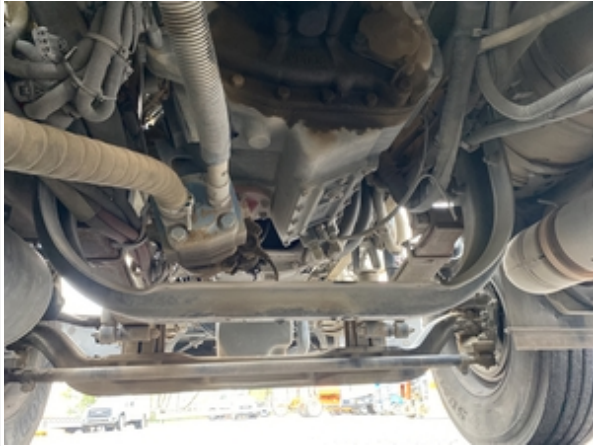
| Transmission Condition Photos | |

| Transmission | 3 - Normal Wear & Tear |
| Transmission Condition | No unusual noises or vibrations |

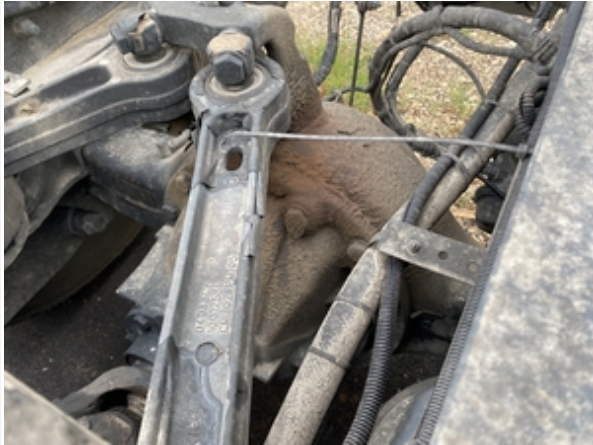
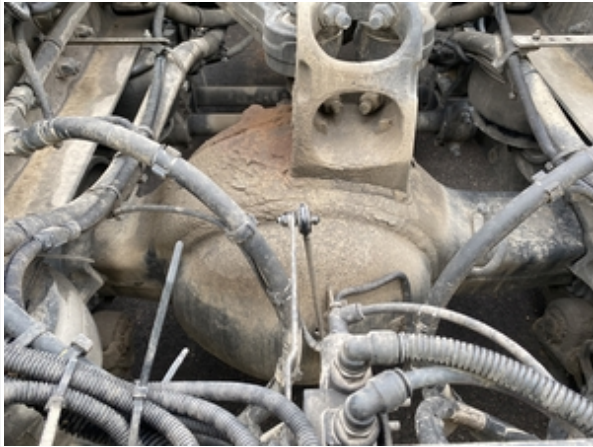
| Rear Differential Photos | |

| Rear Differential | 3 - Normal Wear & Tear |
| Rear Differential Condition | Dry housing appearance, no unusual noises heard during operation |

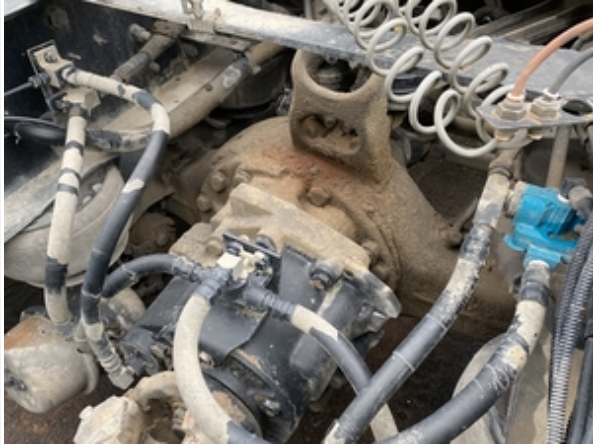
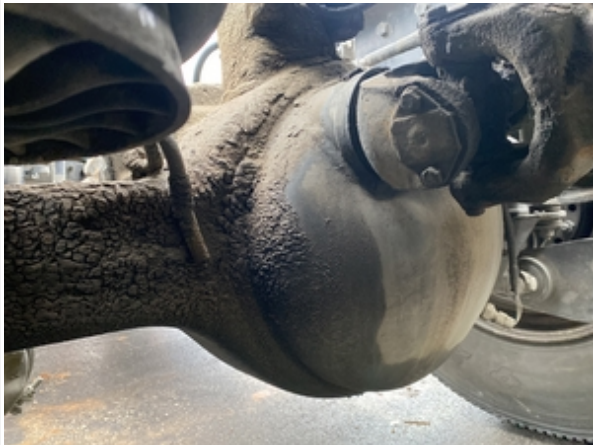
| Front Differential | 3 - Normal Wear & Tear |
| Front Differential Condition | Dried seepages seen on differential housing cover, Other (see comments) |

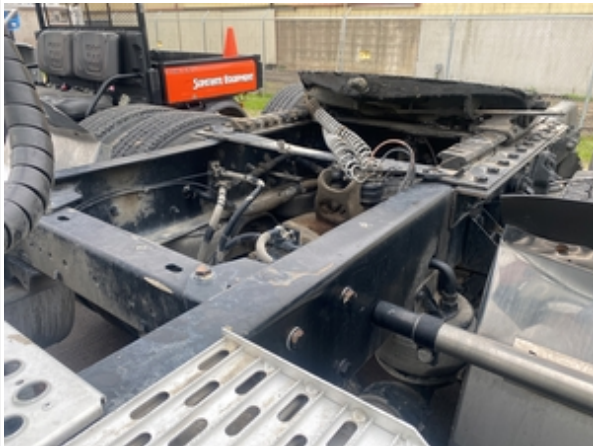
| Frame Photos | |

| Frame Condition | 3 |

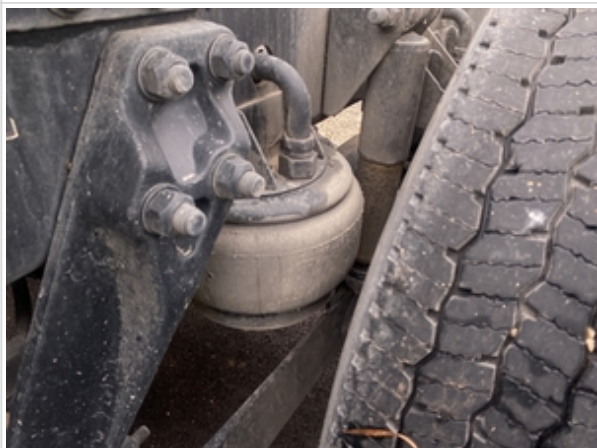
| Suspension Photos | |

| Suspension | 3 |

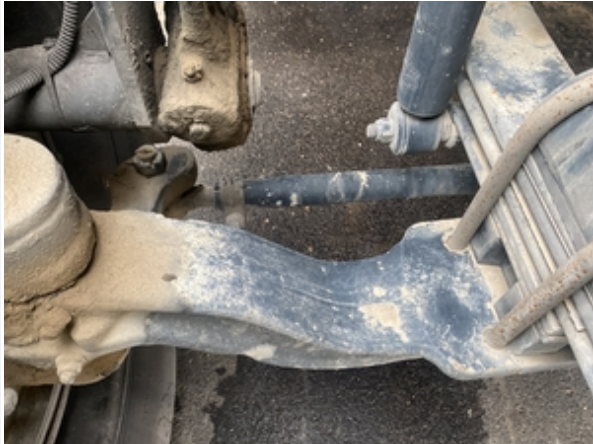
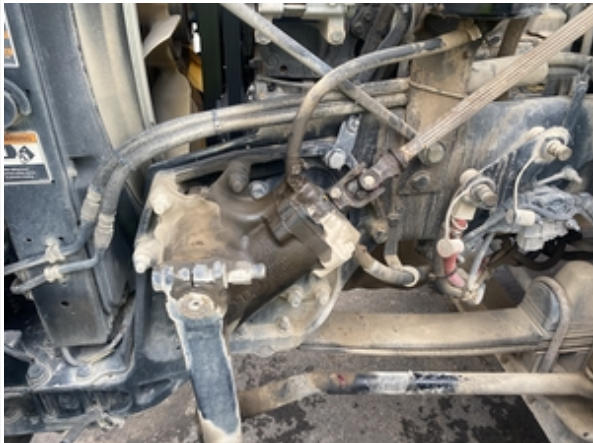
| Steering Components Photos | |

| Steering Components | 3 |

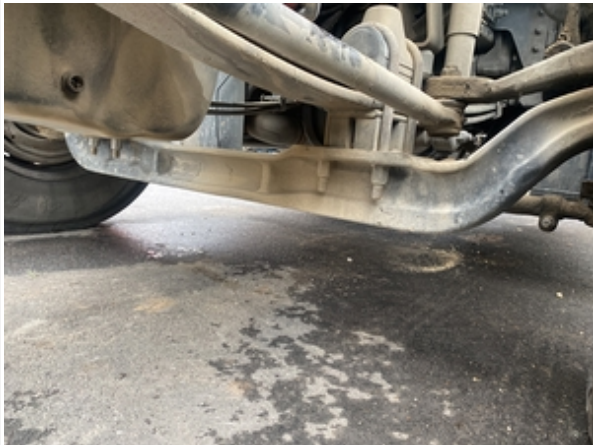
| Steer Axle Photos | | |

| Steer Axle Condition | 3 | |

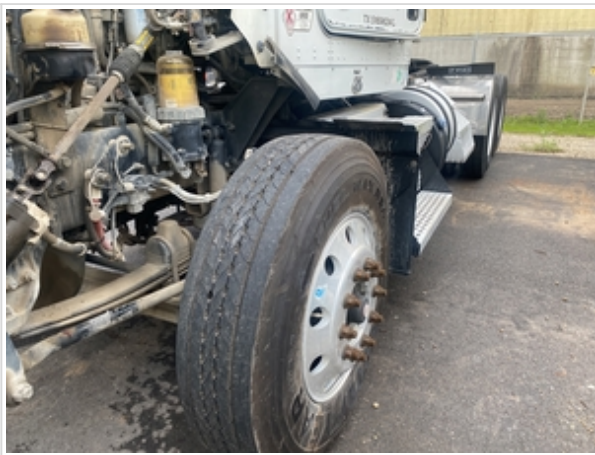
| Front Left Tire Photos | |

| Front Left Tire - Ratio Remaining | 90% |

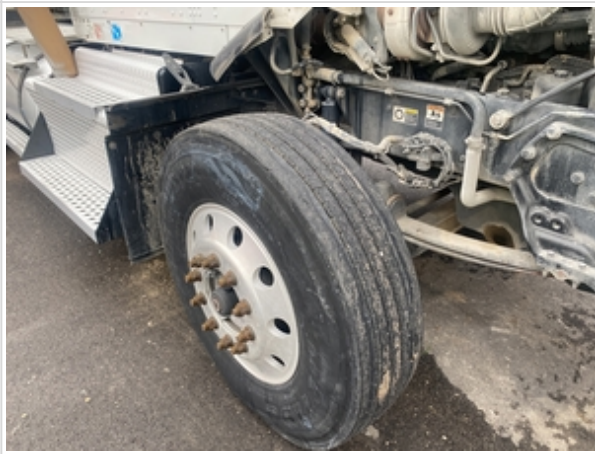
| Front Right Tire Photos | |

| Front Right Tire - Ratio Remaining | 50% |

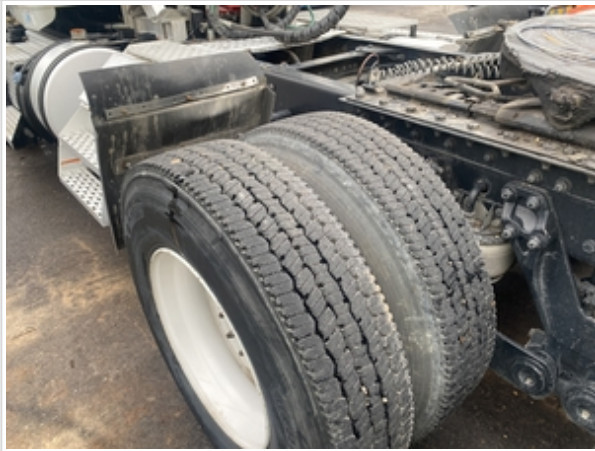
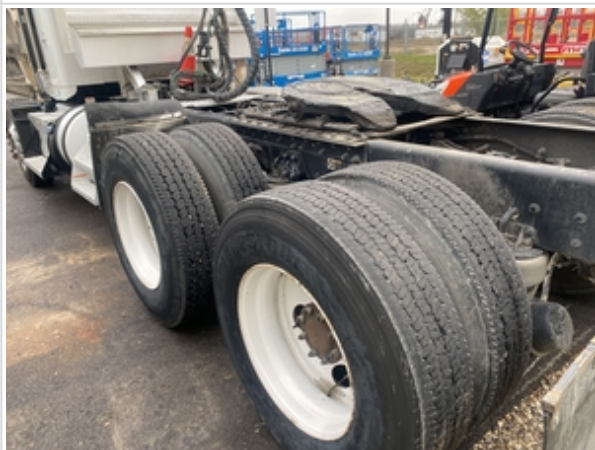
| Rear Left Tire Photos | | |

| Rear Left Tire - Ratio Remaining | 50% |

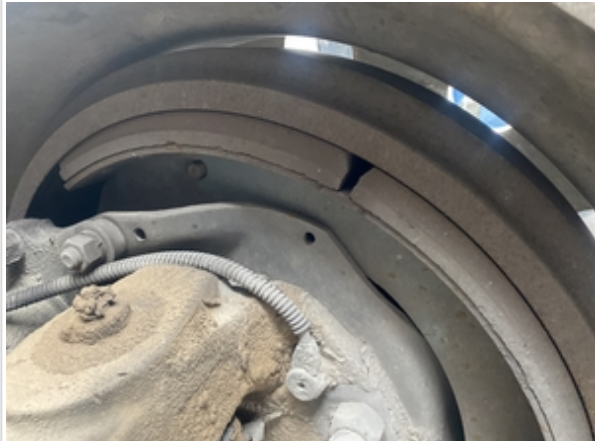
| Brake Shoe Photos | |

| Brake Shoe Thickness | 90% |
| Comments | All brake shoes above 80% |

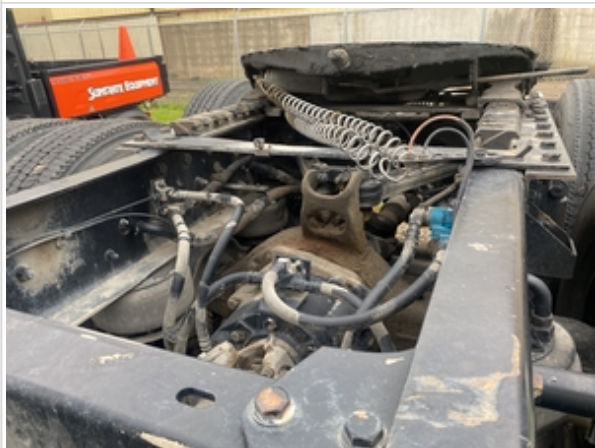
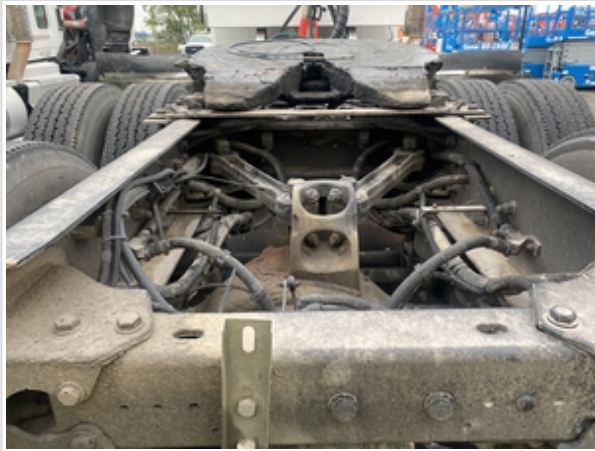
| Overall Chassis & Undercarriage Photos | |

| Overall Chassis | 3 |
