## Inspection Report (On-Highway Flatbed Truck)

Year	2015
Make	Ford
Model	F750XLT
Serial Number	3FRXF7FE0FV662351
Truck Odometer Reading	193,992
Current Inspection / State Cert / DOT	Last performed 6/2020
Previous Application (e.g., earth moving, mining, demolition, etc)	Compact Rentals Equipment Tow/Hauler

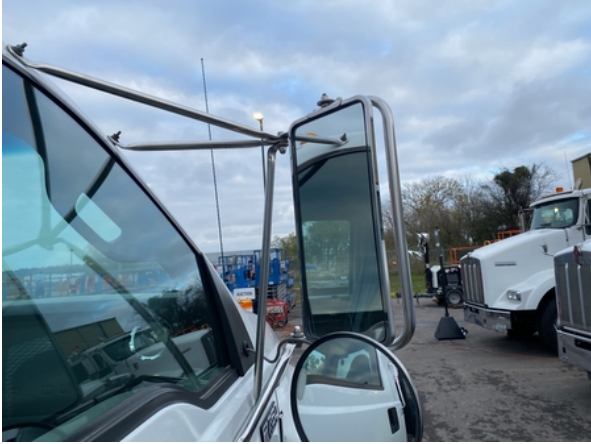
<b>Body Panels</b>	3 - Normal Wear & Tear	
<b>Body Panel Condition</b>	No visible damage, good paint condition and panel fitment, Other (see comments)	
<b>Comments</b>	Minor fiberglass damage to front left side of hood, small dent center of front bumper	
<b>Body Panels Photos</b>

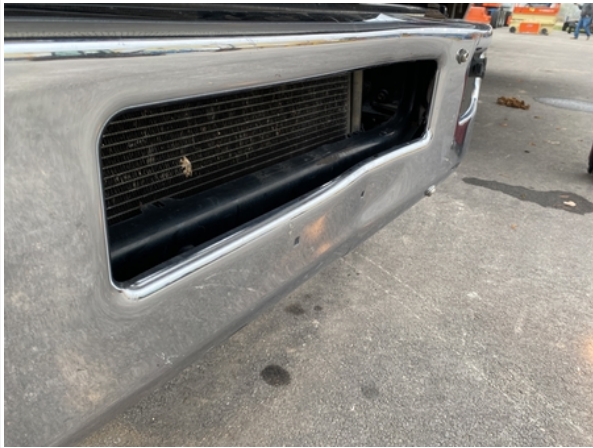
Doors / Canopy Latches	3 - Normal Wear & Tear
Doors / Canopy Latches Condition	No visible damage
Steps / Ladders	3 - Normal Wear & Tear
Steps / Ladders Condition	Steps/ladders are fully intact and appear structurally sound
Handrails	3 - Normal Wear & Tear
Handrails Condition	Handrails are fully intact and appear structurally sound
Glass	3 - Normal Wear & Tear
Glass Condition	Glass intact, no visible damage
Mirrors	3 - Normal Wear & Tear
Mirror Condition	Mirrors present and intact, no visible damage
Exterior Lights	3 - Normal Wear & Tear
Exterior Lights Condition	No visible damage, lighting system is operational

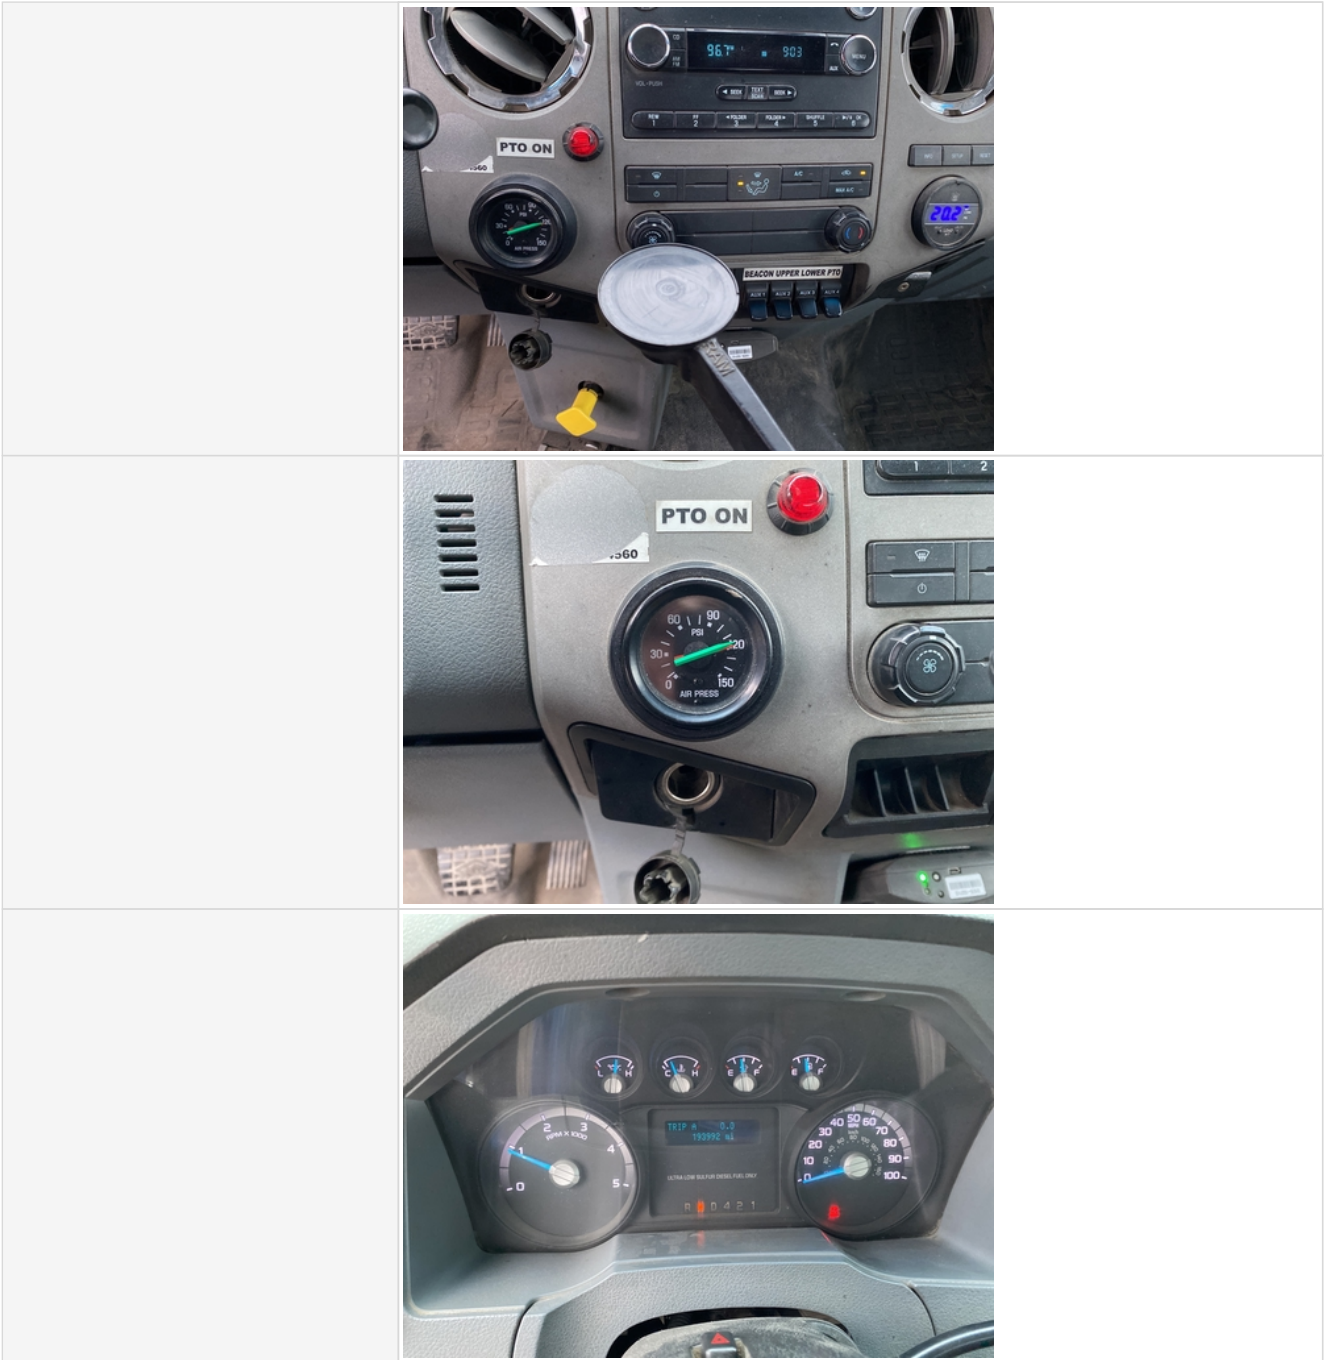
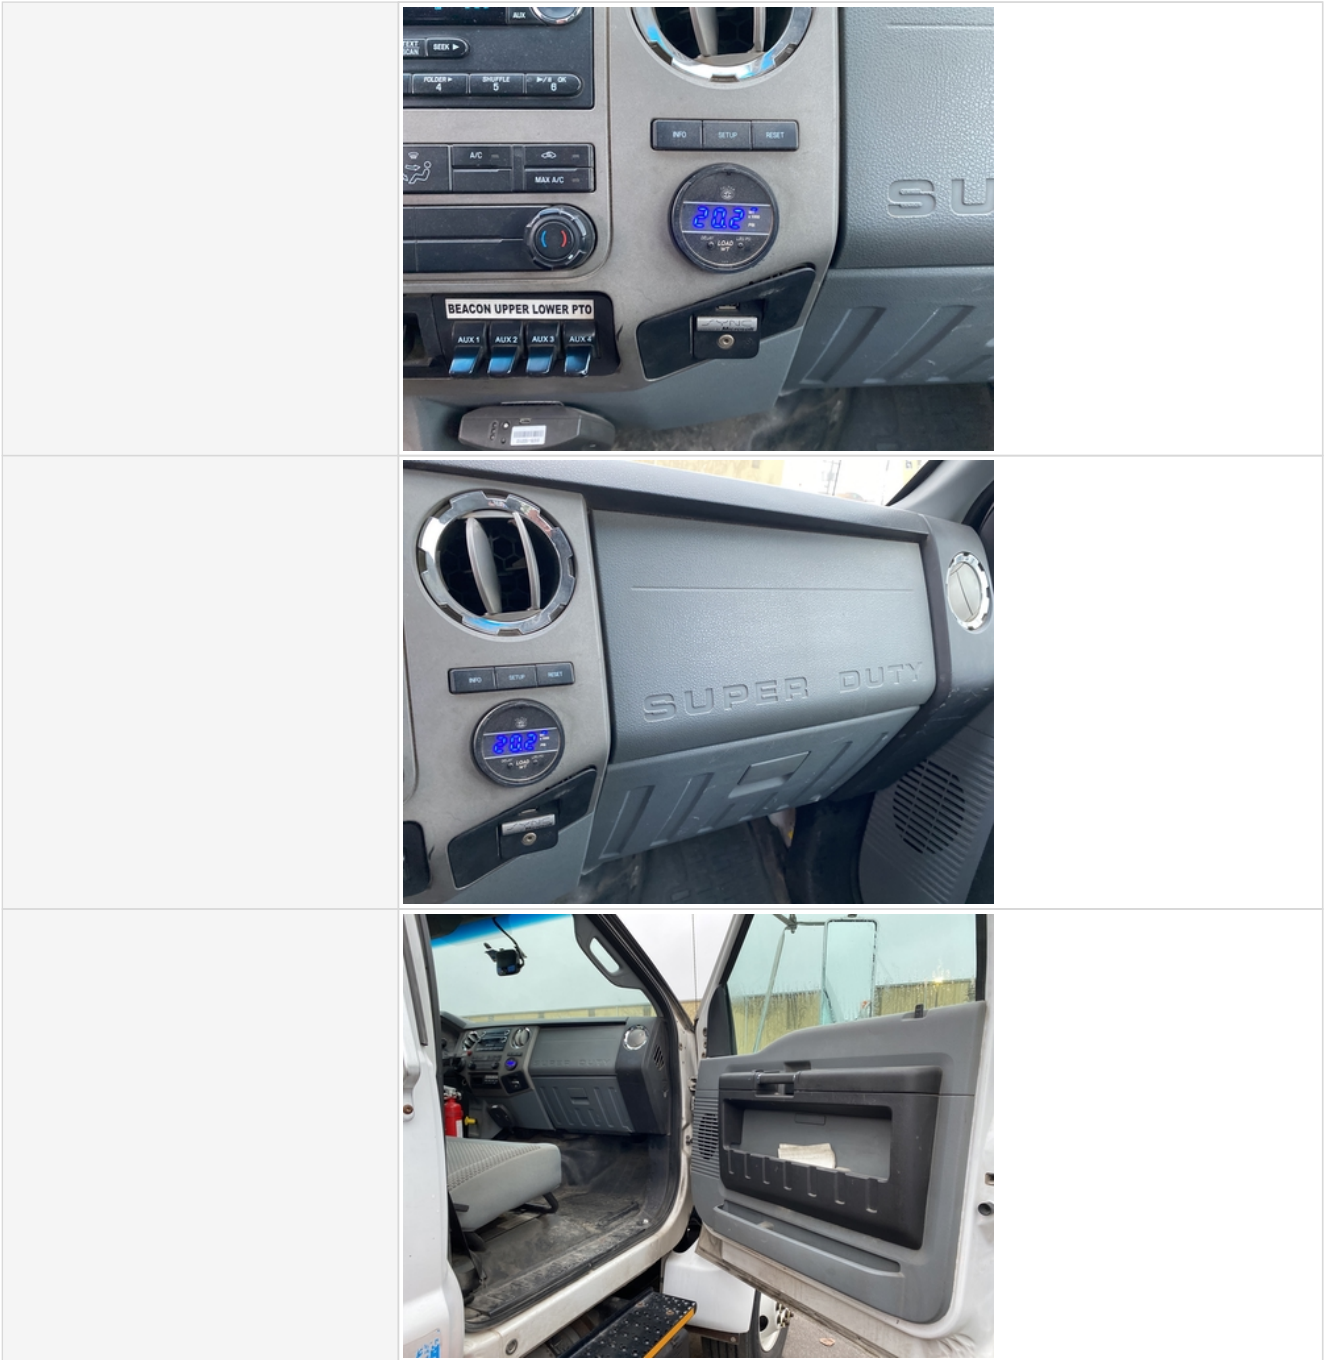
<b>Odometer Activity</b>	3 - Normal Wear & Tear
<b>Odometer Condition</b>	Odometer is working and in good condition
<b>Controls/Switches/Gauges</b>	3 - Normal Wear & Tear
<b>Controls/Switches/Gauges Condition</b>	All switches/gauges are in good condition and functioning
<b>Horn</b>	3 - Normal Wear & Tear
<b>Horn Condition</b>	Horn is functioning as expected
<b>Reverse Alarm / Backup Camera</b>	3 - Normal Wear & Tear
<b>Reverse Alarm / Backup Camera Condition</b>	Reverse alarm working as expected
<b>Heater &amp; A/C</b>	3 - Normal Wear & Tear
<b>Heat &amp; A/C Condition</b>	Heater and A/C work as expected
<b>Interior Lights</b>	3 - Normal Wear & Tear
<b>Interior Lights Condition</b>	All interior lights are installed and functioning
<b>Seats/Seat Belts</b>	3 - Normal Wear & Tear
<b>Seats/Seat Belt Condition</b>	Seat(s) in good condition, no stains or tears in upholstery
<b>Cab Interior Overall Rating</b>	3 - Normal Wear & Tear

Comments	Cabin in good condition just recommend a detail wash
----------	--

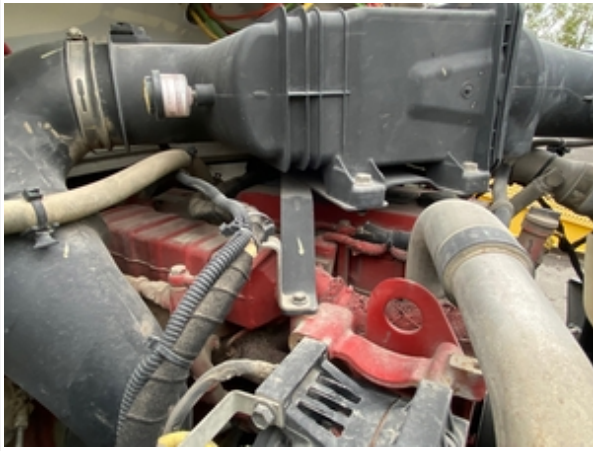
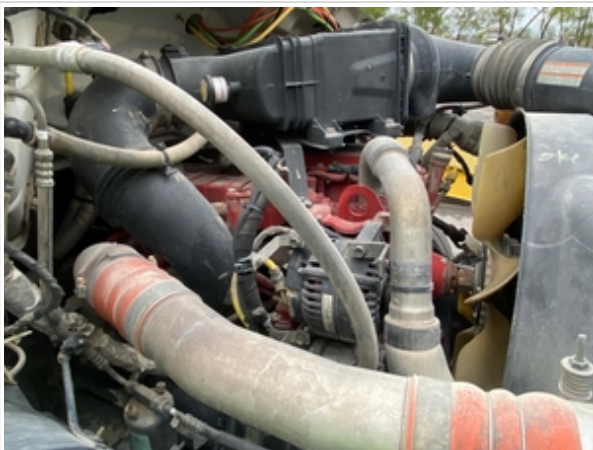
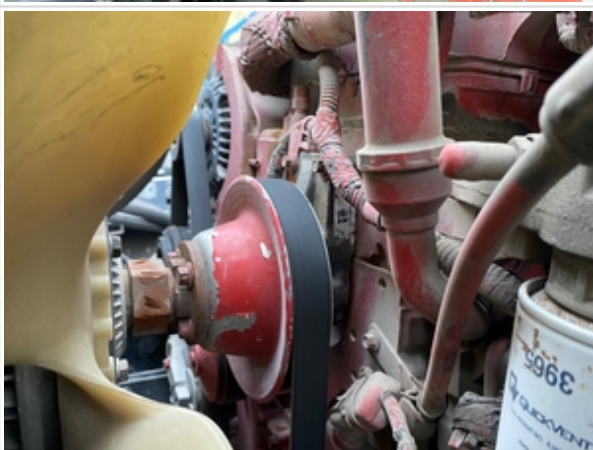
Engine Type (Make, Model, Cylinders, Hp)	Cummins - ISB 6.7L - 6CYL. - 280HP
Emissions Tier	Tier 4i
Engine Serial Number	73689724
Engine Fuel Type	Diesel
Engine Photos

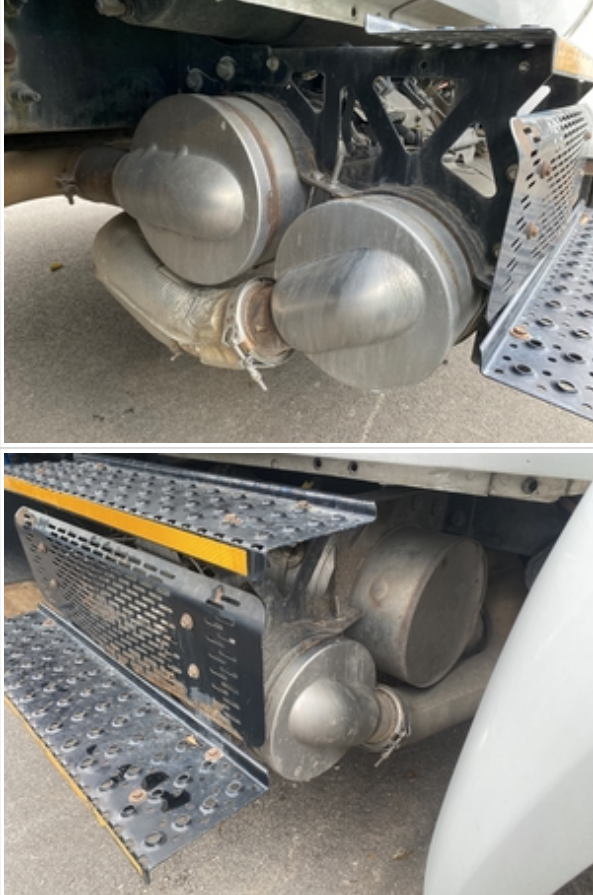
Coolant Color / Appearance	3 - Normal Wear & Tear
Coolant Color/Appearance Notes	Normal Translucent appearance, no visual signs of contamination
Oil Leaks	No
Oil Color / Appearance	3 - Normal Wear & Tear
Oil Color / Appearance Notes	Clean oil appearance, no signs of cross contamination, Appropriate oil level
Fuel Leaks	No
Equipped with DPF (Diesel Particulate Filter)	Yes
DPF Condition	3 - Normal Wear & Tear
DPF Condition Notes	Filter housing is intact with no signs of damage or malfunction, DPF indicator is not illuminated
DPF Photos

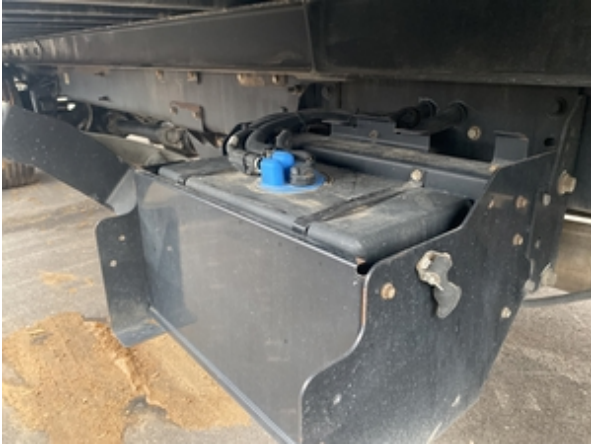
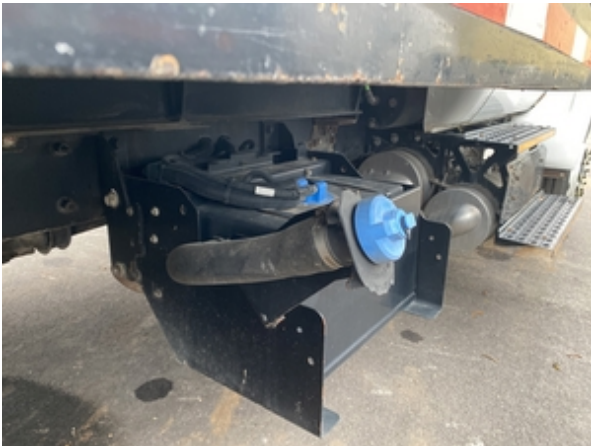
<b>Requires DEF (Diesel Exhaust Fluid)</b>	Yes
<b>DEF Tank</b>	3 - Normal Wear & Tear
<b>DEF Tank Condition</b>	Area around DEF tank cap is clean, fluid is clear & appears free of contaminants
<b>DEF Tank Photos</b>

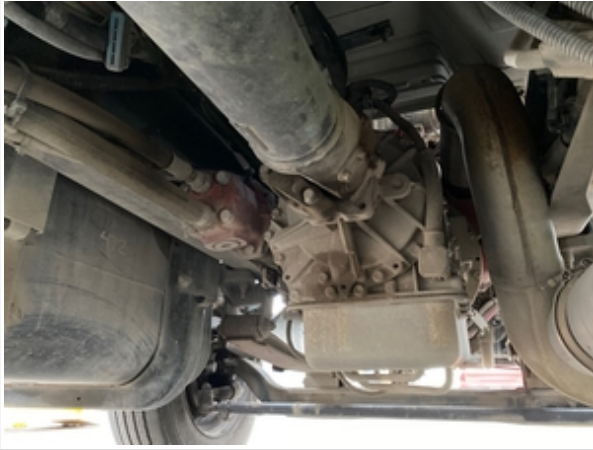
Transmission Info (Make/Model)	Ford 5Speed Automatic
Drive Type	4X2
Overdrive	N/A
Transmission	3 - Normal Wear & Tear
Transmission Condition	No unusual noises or vibrations
Transmission Condition Photos

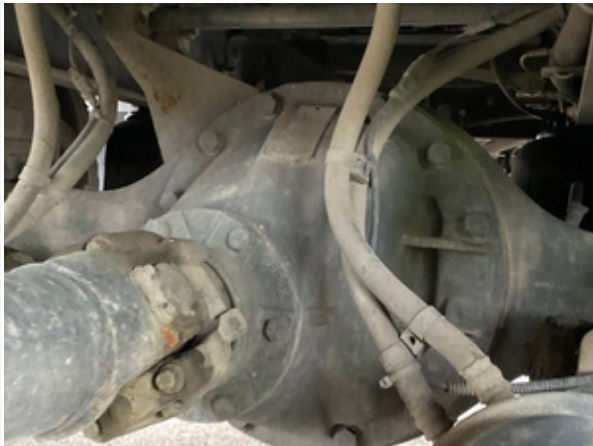
Clutch	0
Shift Lever	3 - Normal Wear & Tear
Shift Lever Condition	Good forward and reverse function
Differential	Check condition of the differential(s). Take photos and notes as relevant.
Rear Differential	3 - Normal Wear & Tear
Rear Differential Condition	Dry housing appearance, no unusual noises heard during operation
Rear Differential Photos

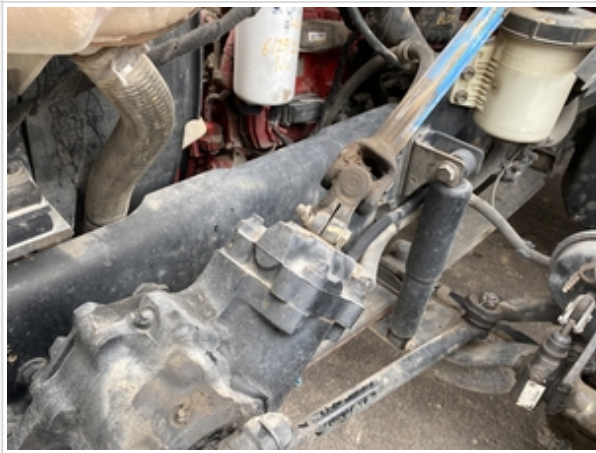
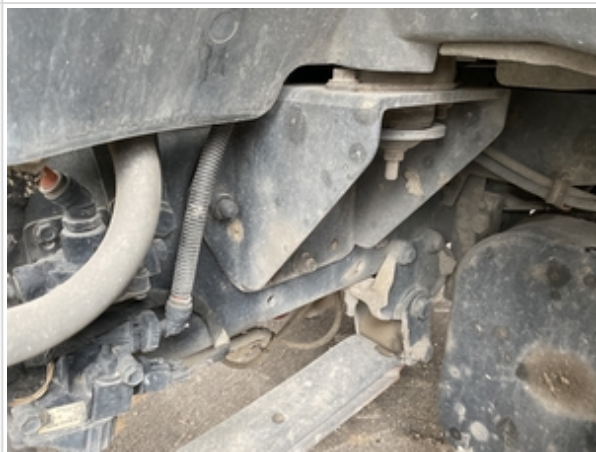
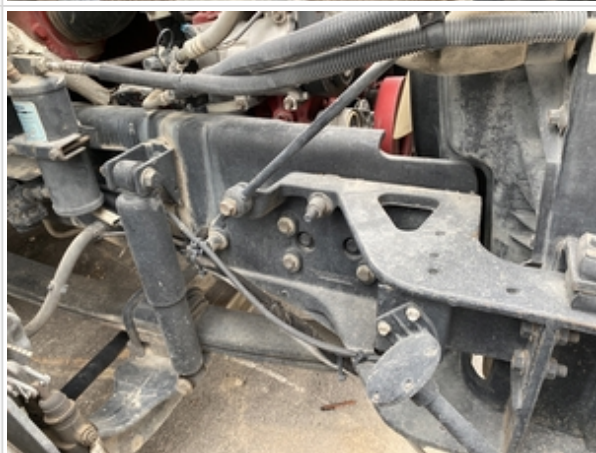
Frame Condition	3
Frame Photos

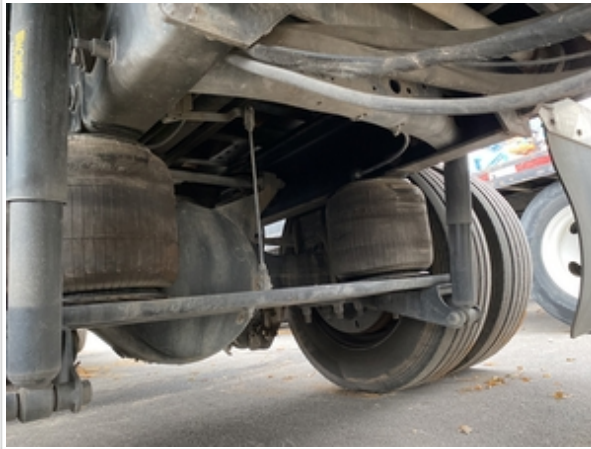
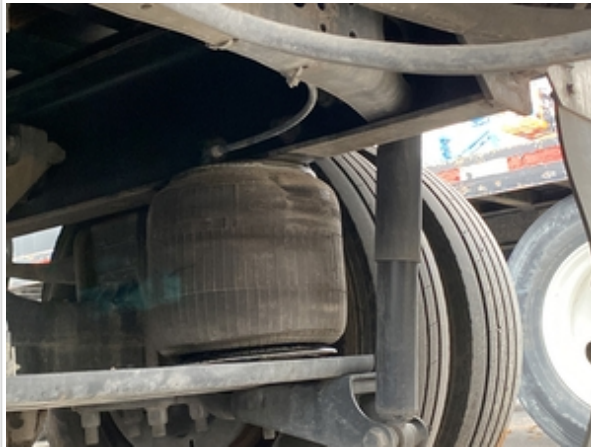
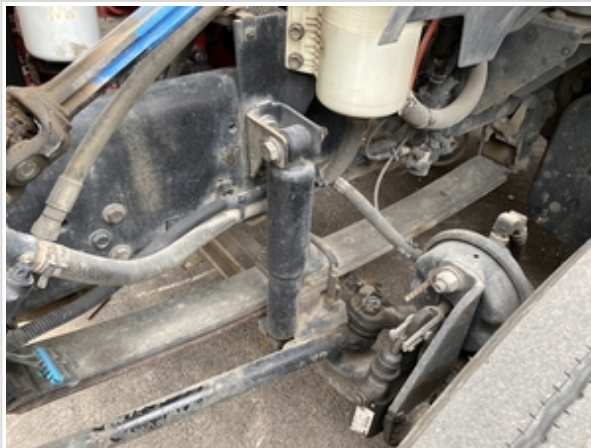
Suspension	3
Suspension Photos

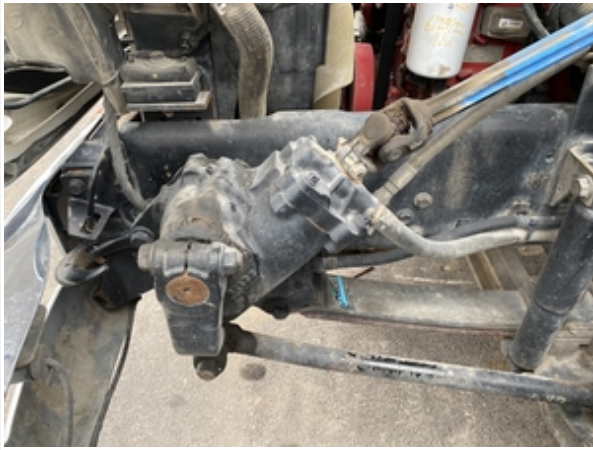
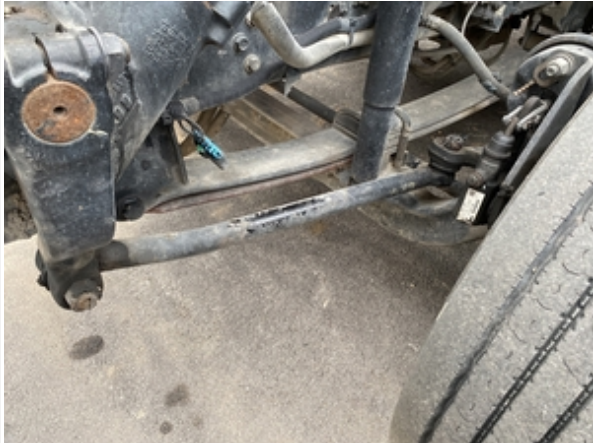
Steering Components	3
Steering Components Photos

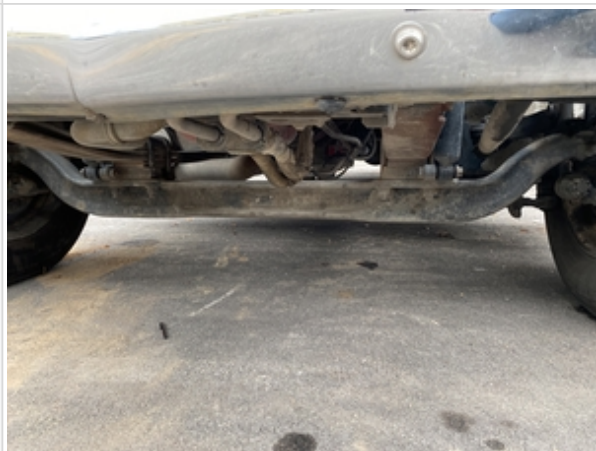
<b>Steer Axle Condition</b>	3	
<b>Steer Axle Photos</b>

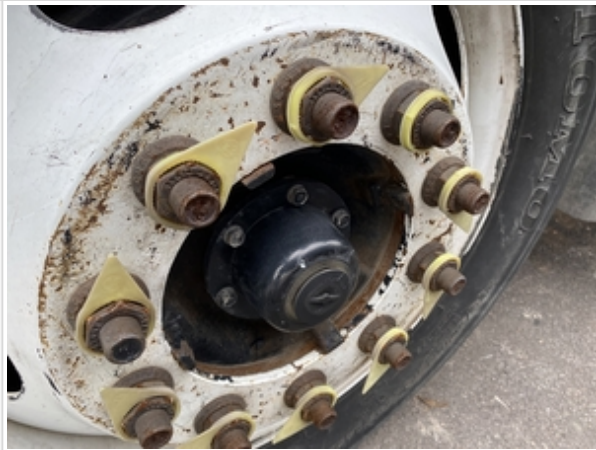
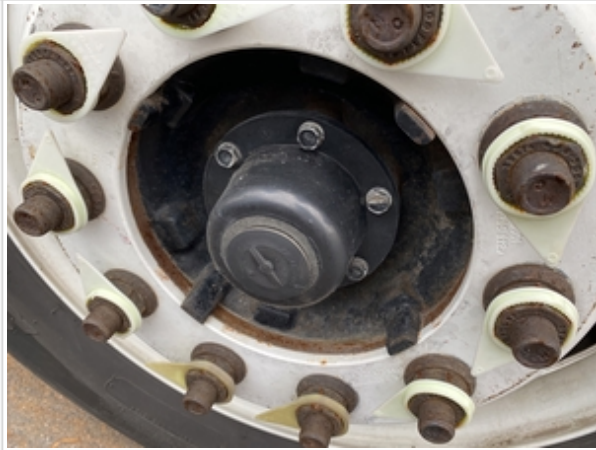
<b>Wheels &amp; Hub Condition</b>	3	
-----------------------------------	---	--

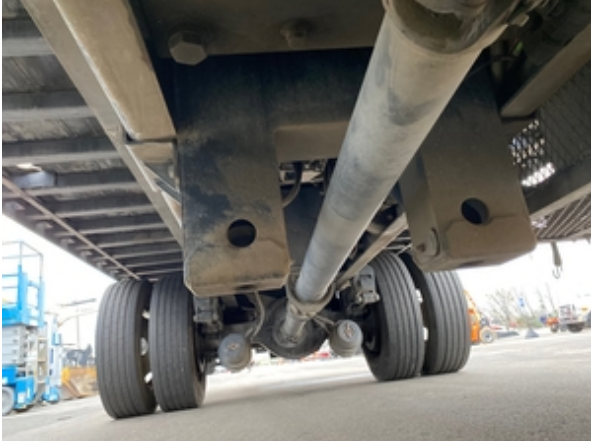
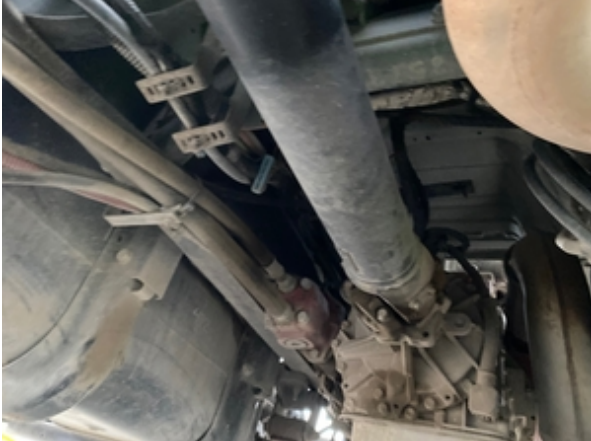
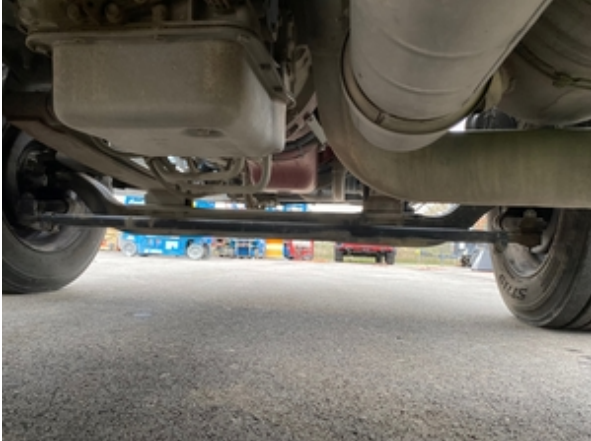
Overall Chassis Comments	Overall chassis in good condition
Overall Chassis & Undercarriage Photos

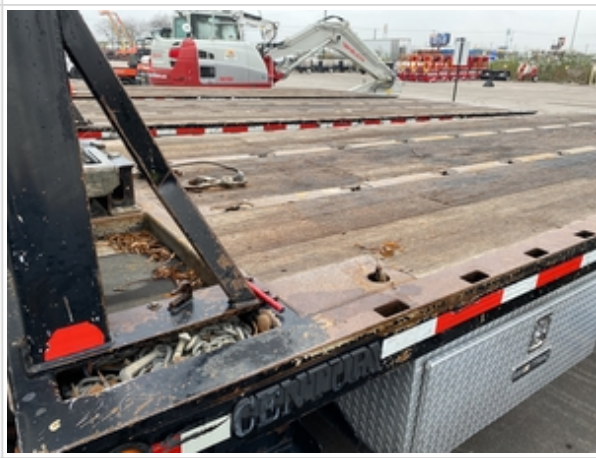
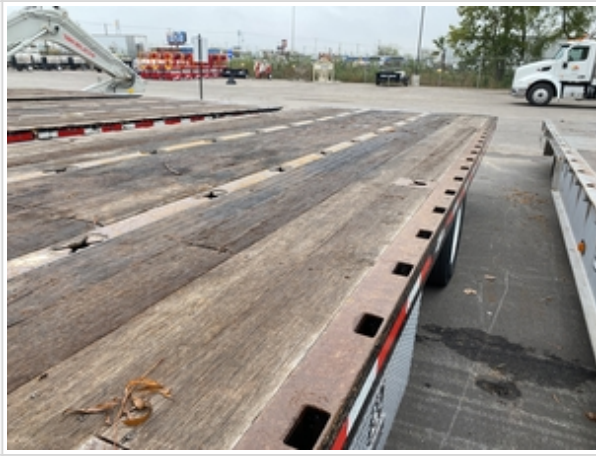
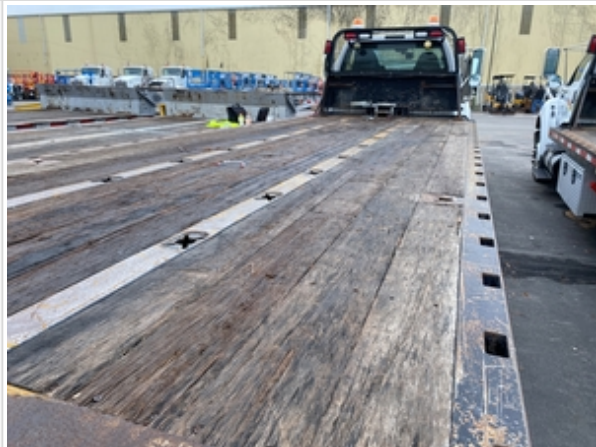
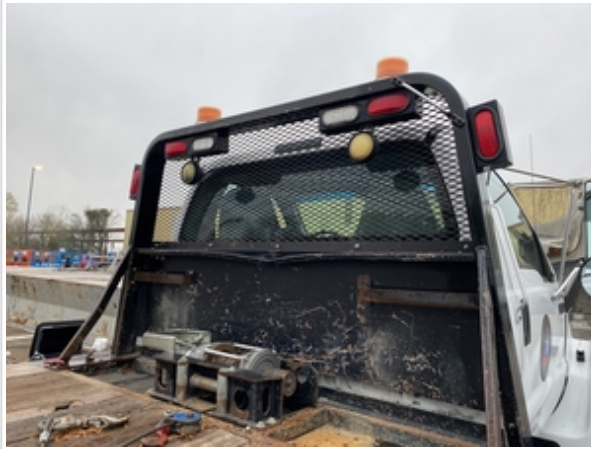
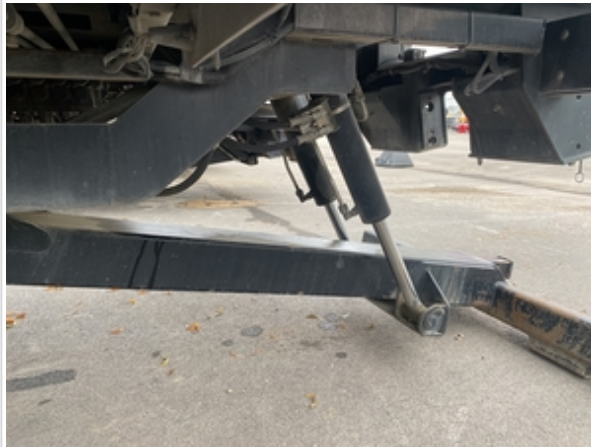
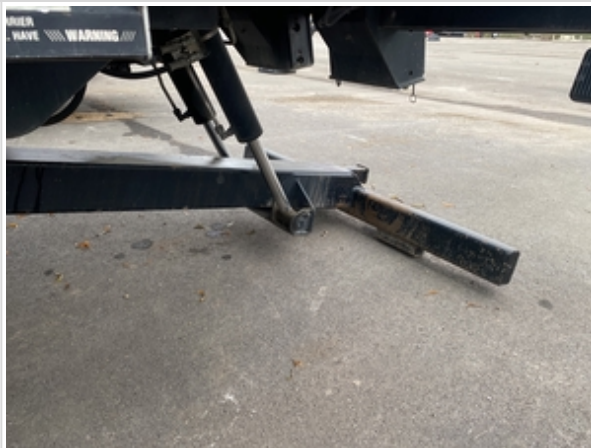
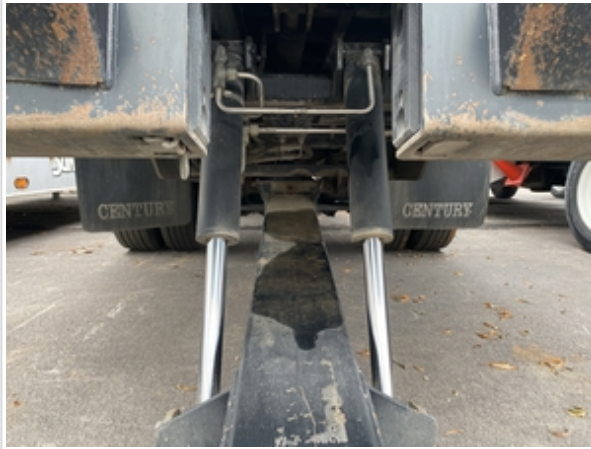
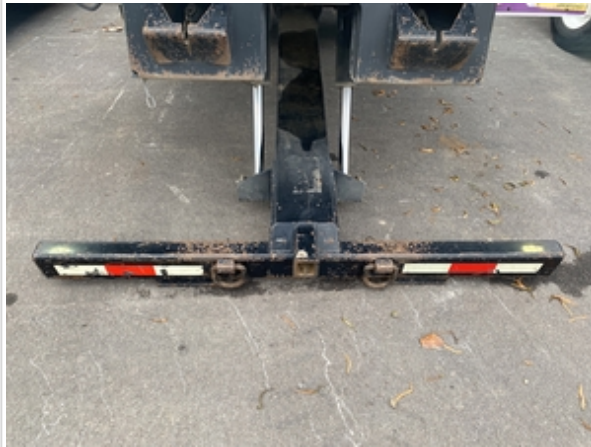
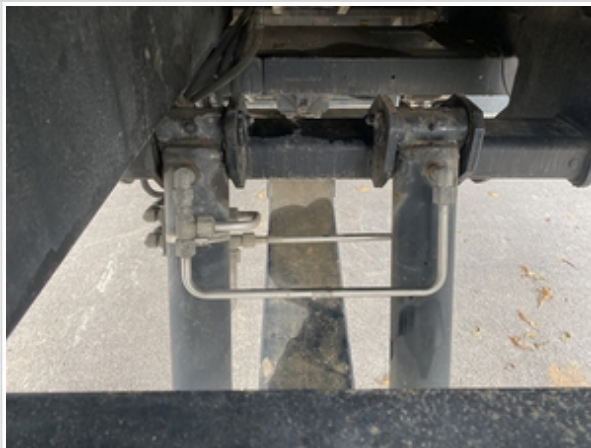
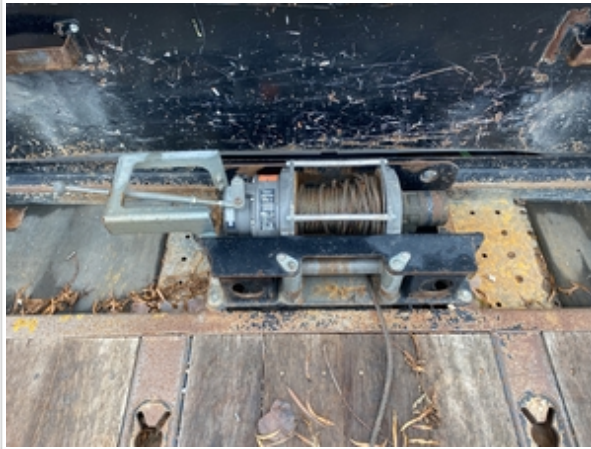
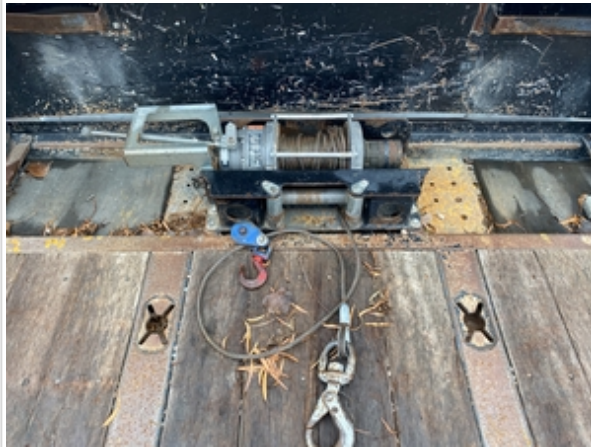
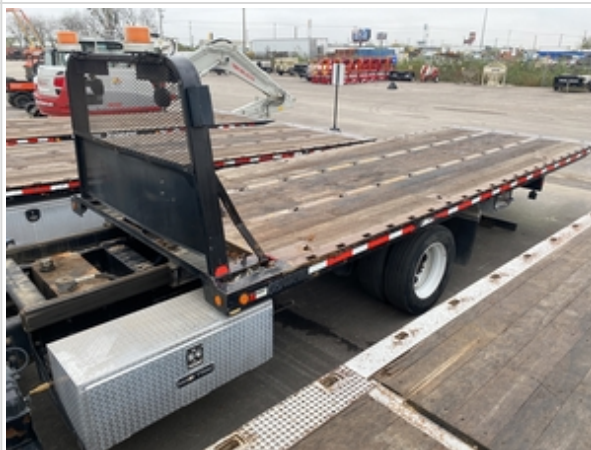
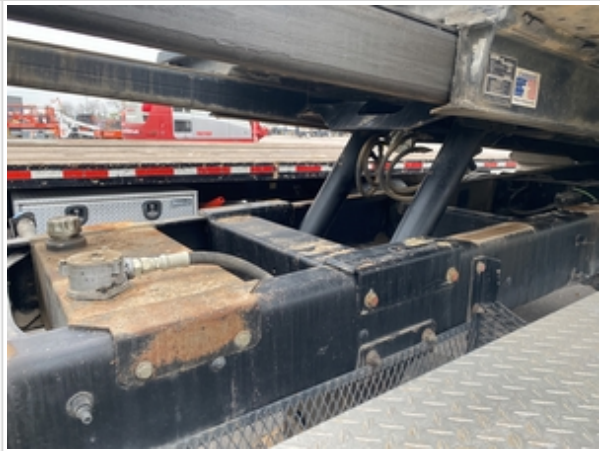
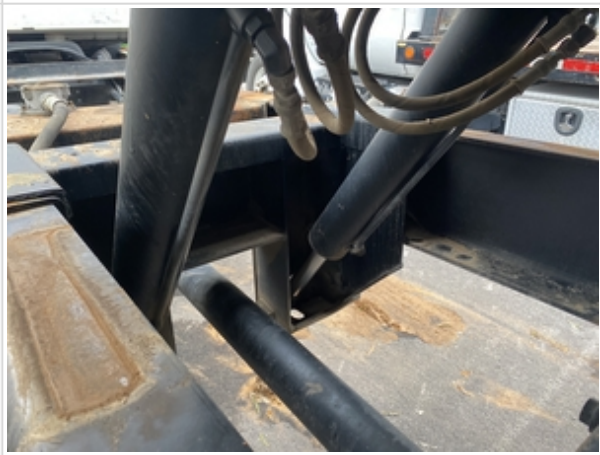
<b>Bed Details (Deck Type, Additional Features)</b>	Century 16,000LBs. (Capacity)
<b>Flatbed Length (ft and inches)</b>	24'
<b>Flatbed Width (ft and inches)</b>	8'6"
<b>Flatbed Body</b>	3
<b>Flatbed Body Photos</b>

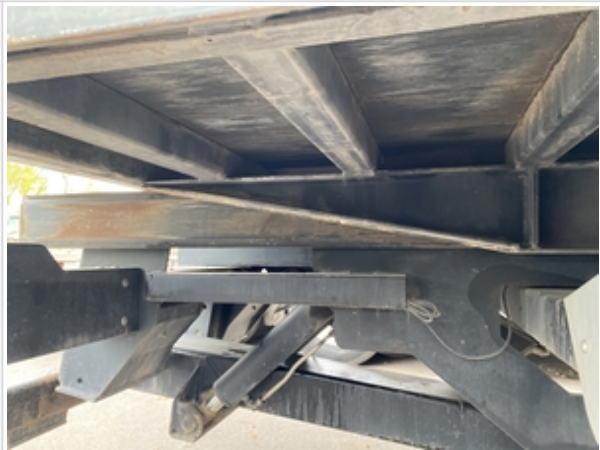
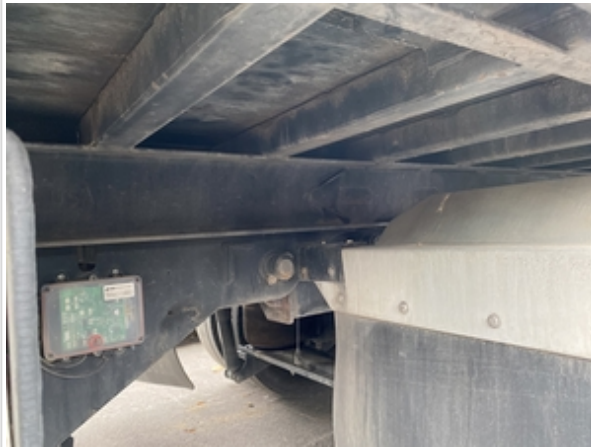
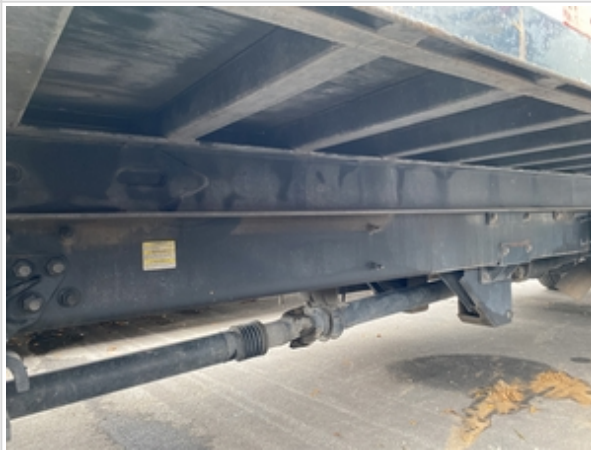
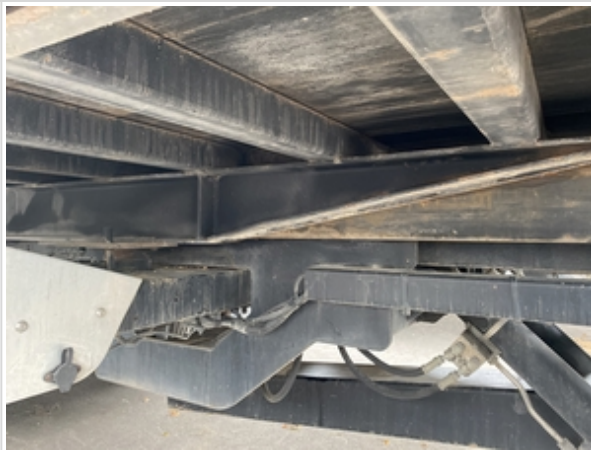
<b>Tailgate Latch</b>	0	
<b>Support Frame</b>	3	
<b>Support Frame Photos</b>
