Inspection Report (On-Highway Flatbed Truck)

Year	Sunstate Heavy Haul Trailer
Make	2016 Trailking
Model	TK80HT
Serial Number	ID - 144681 - VIN# - 1TKA04824GM067858
Truck Odometer Reading	N/A
Current Inspection / State Cert / DOT	N/A
Previous Application (e.g., earth moving, mining, demolition, etc)	Equipment Rental Hauler

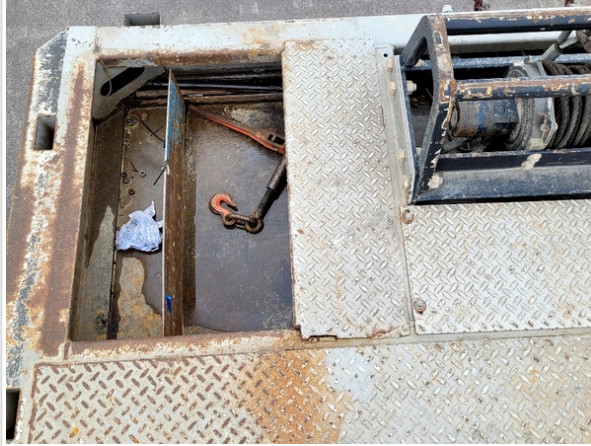
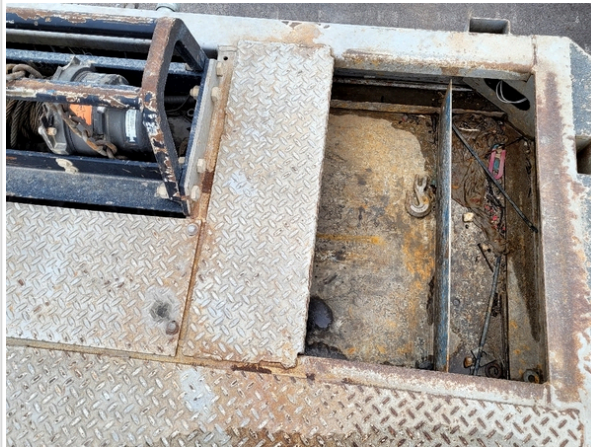
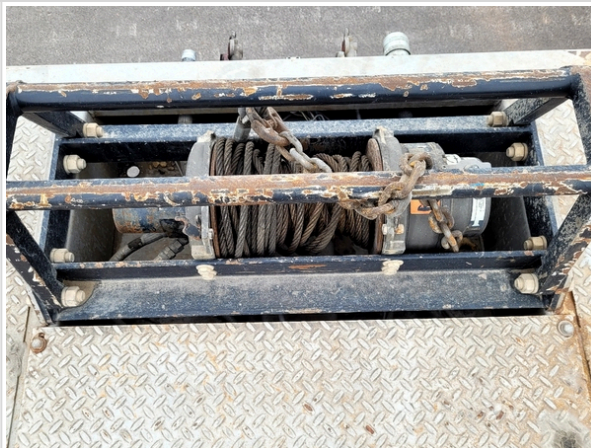
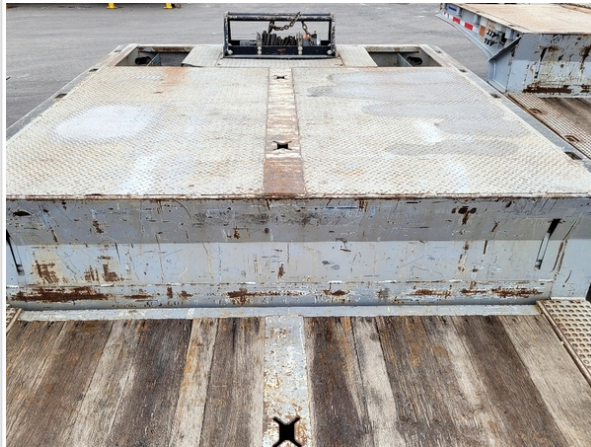
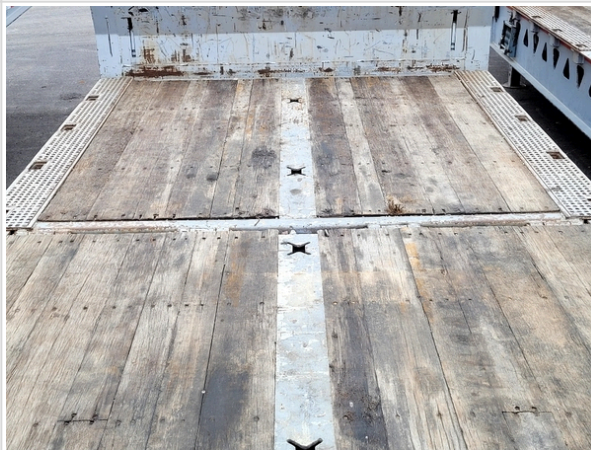
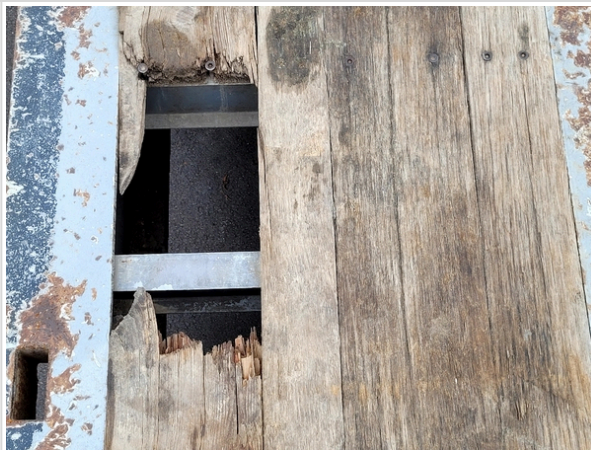
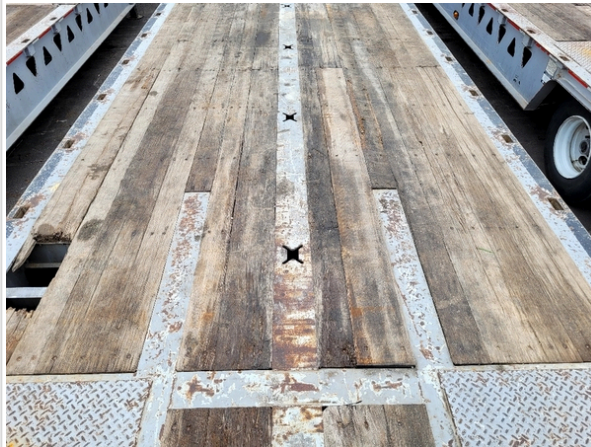
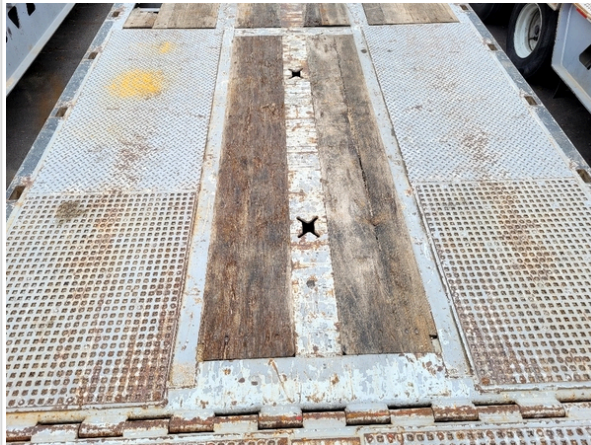
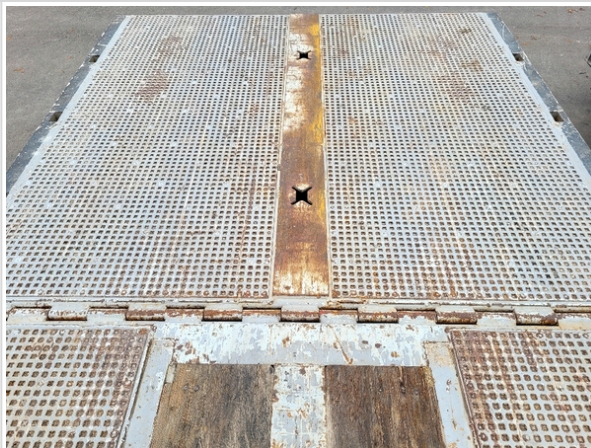
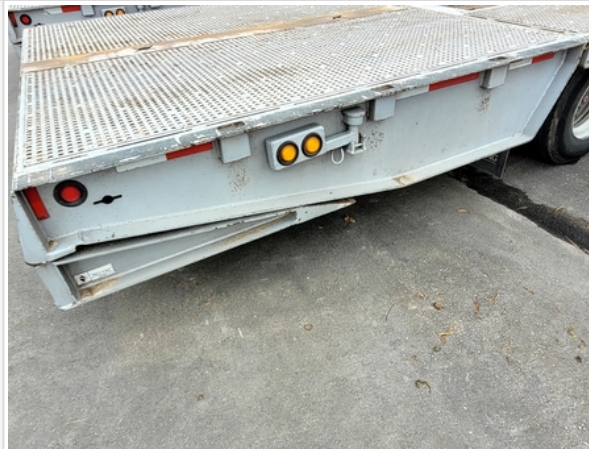
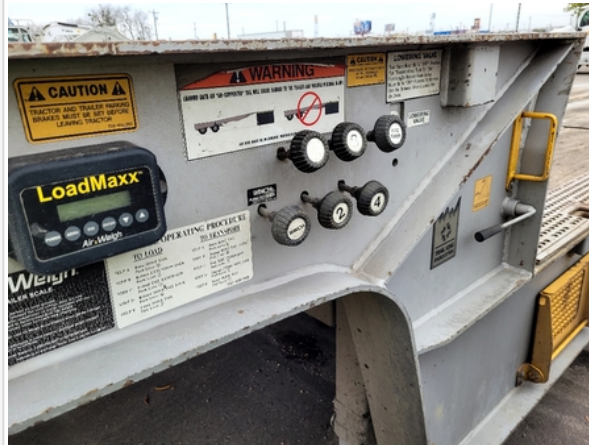
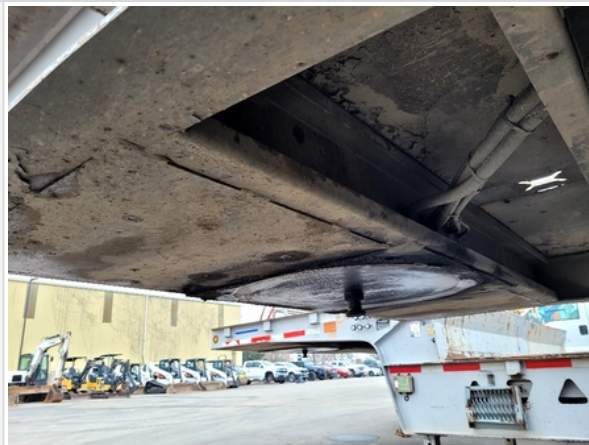
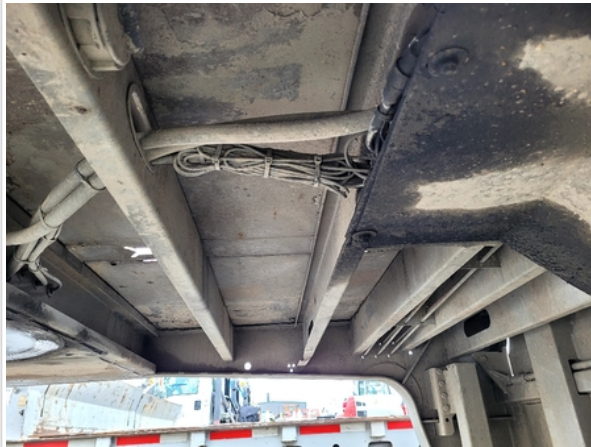
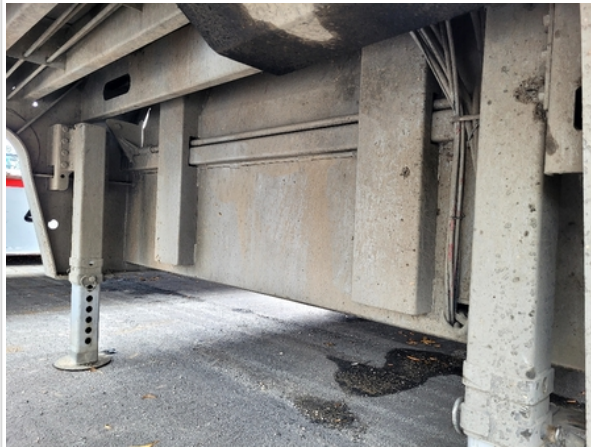
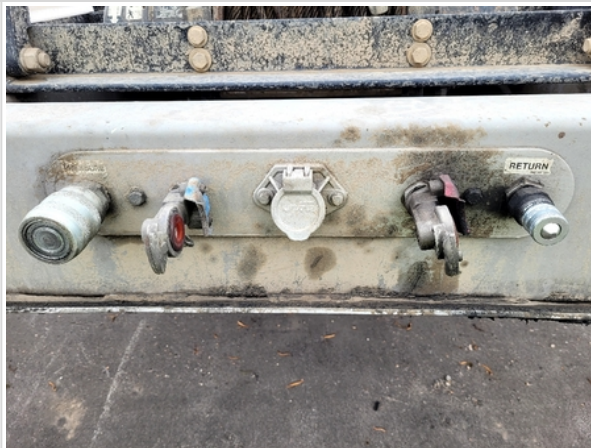
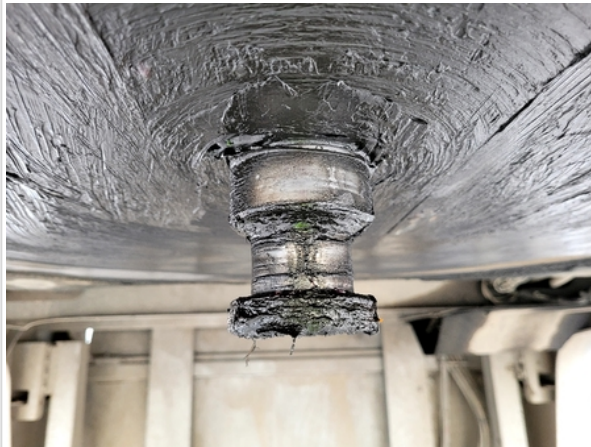
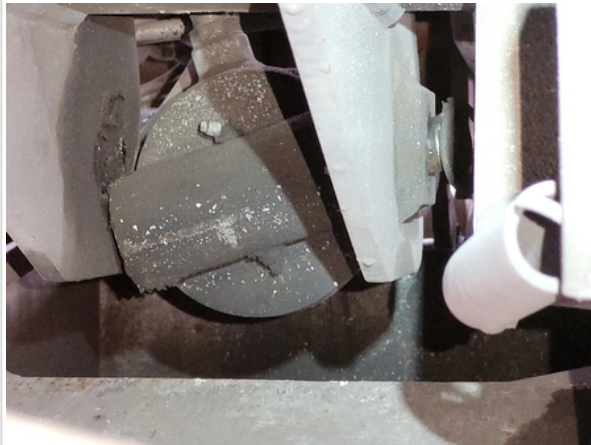
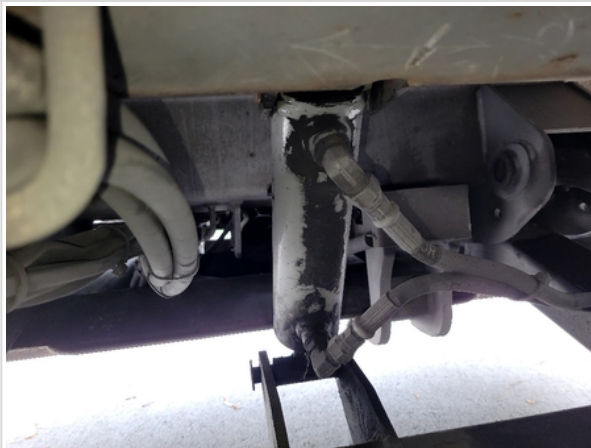
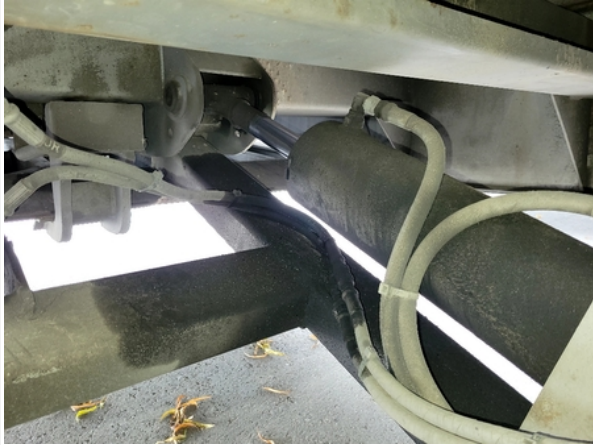
Close-up Exterior Photos

Body Panels	3 - Normal Wear & Tear
Body Panel Condition	Other (see comments)
Comments	Some underneath cover panels missing. Top deck compartment panels missing.
Doors / Canopy Latches	0
Steps / Ladders	0
Handrails	0
Glass	0
Mirrors	0
Exterior Lights	3 - Normal Wear & Tear
Exterior Lights Condition	No visible damage, lighting system is operational, Other (see comments)
Comments	Not tested with tractor hooked up but visually light fixtures in good condition
