Year	1980
Make	Grove
Model	RT980 -80
Serial Number	45308
Hour Meter Reading	2,612 (hours not accurate)
Previous Application (e.g., earth moving, mining, demolition, etc)	Boring Equipment Industry

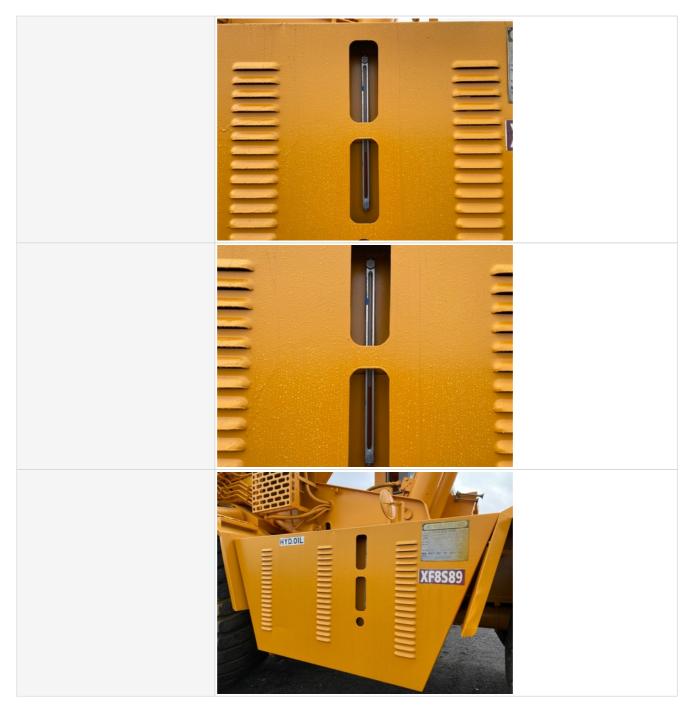
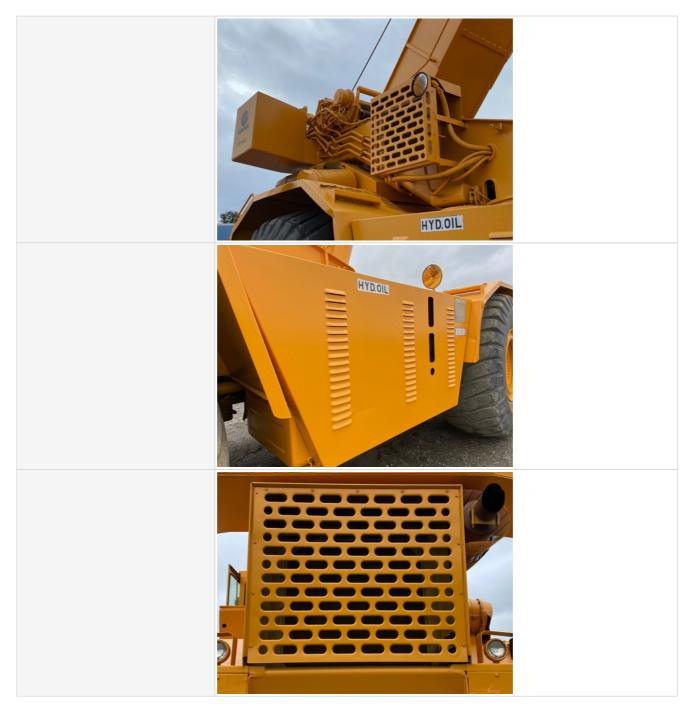
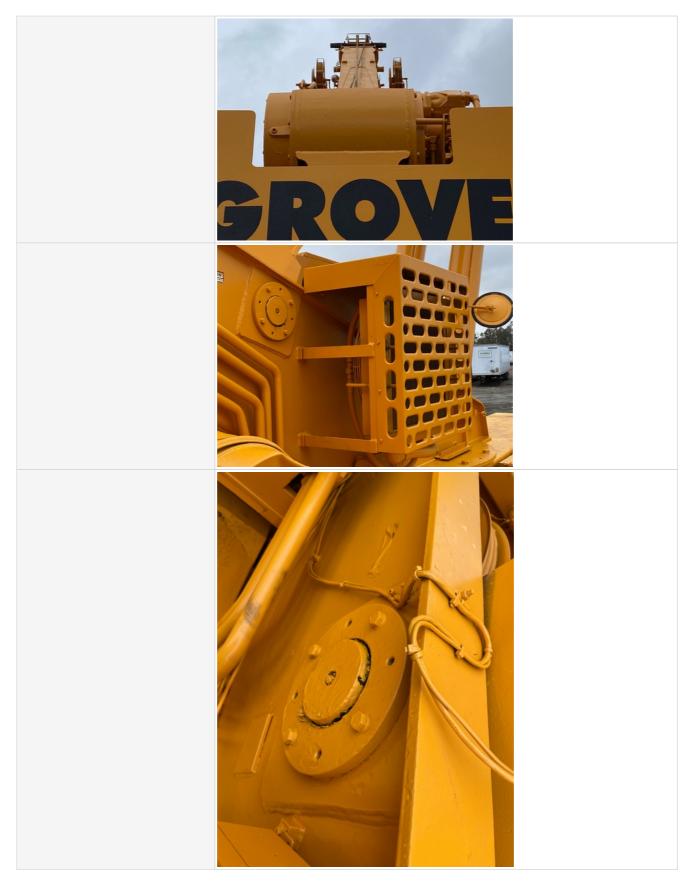
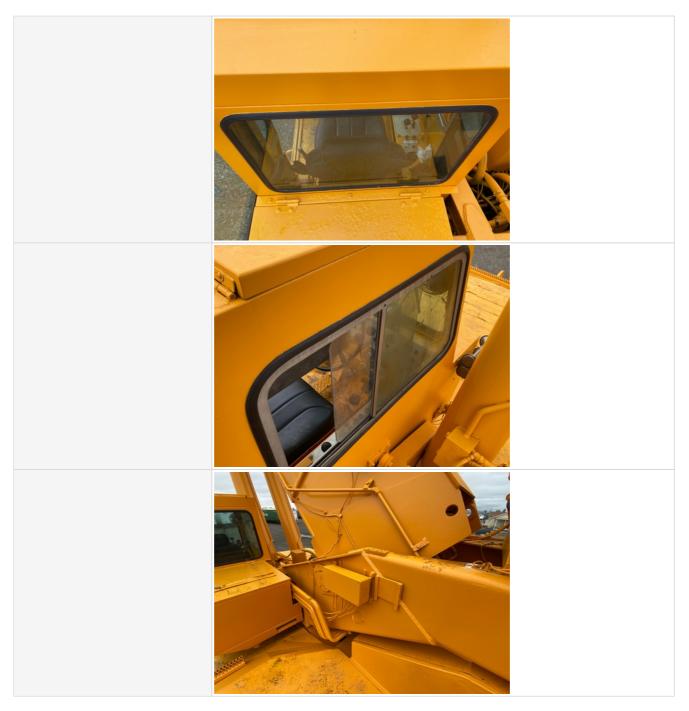
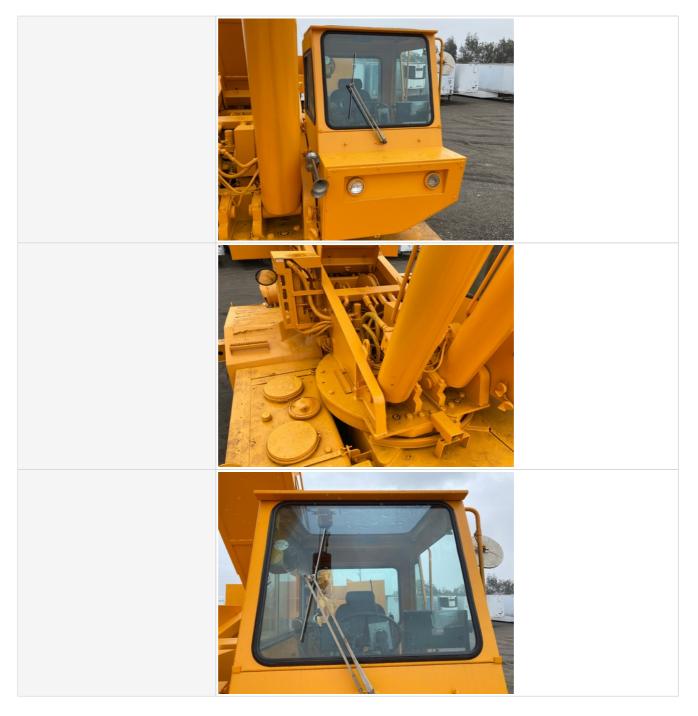
General Appearance	
Front	3 - Normal Wear & Tear
Front Condition	No visible damage
Front Photos

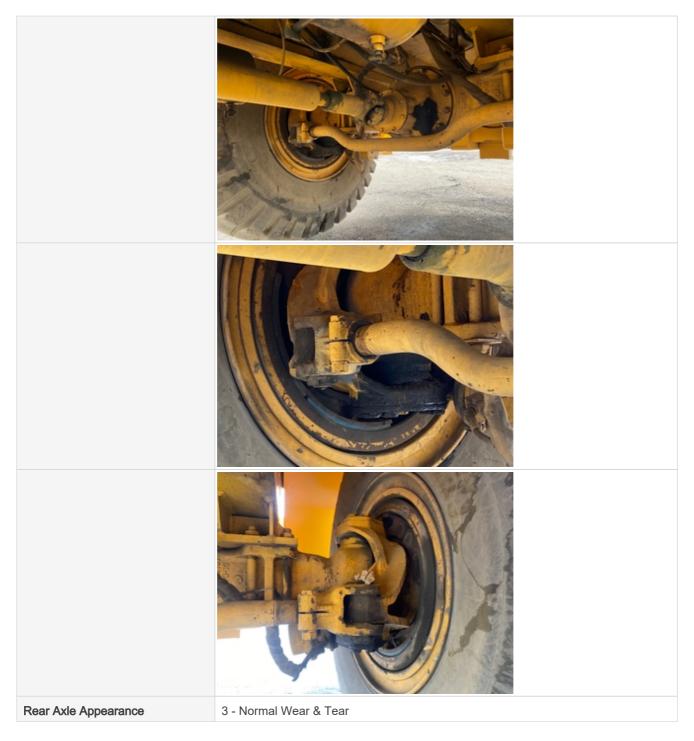
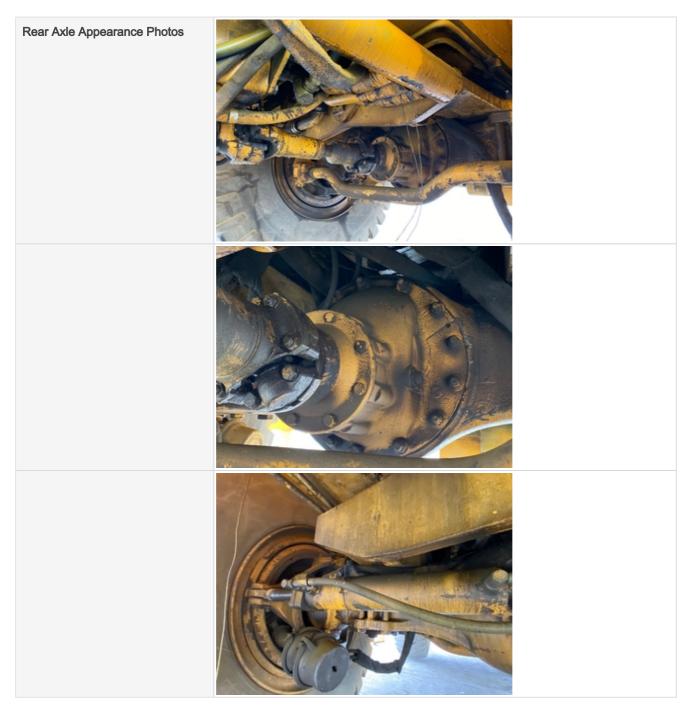
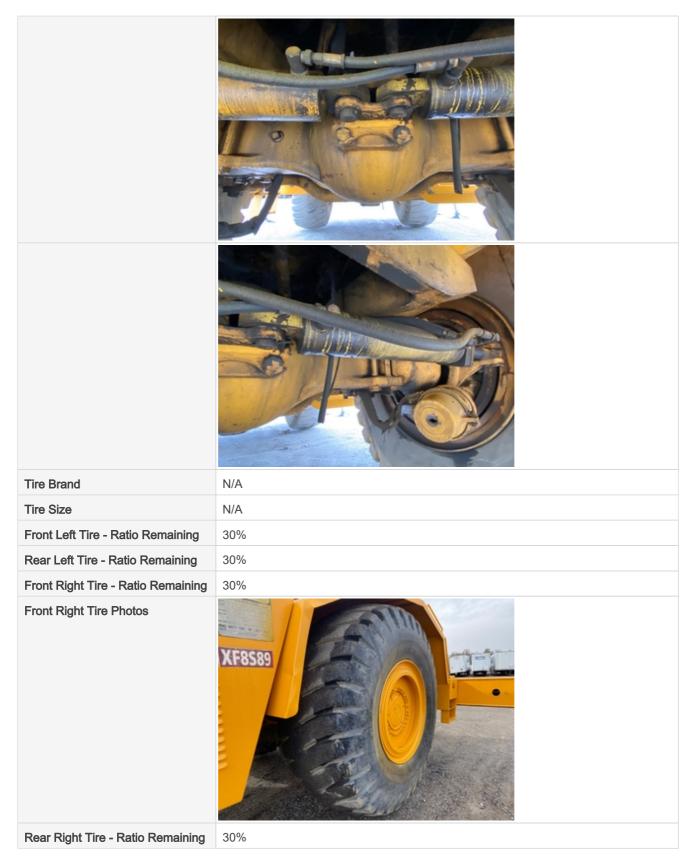
Stance	3 - Normal Wear & Tear
Turntable Bearing	3 - Normal Wear & Tear
Front Axle Appearance	3 - Normal Wear & Tear
Front Axle Appearance Photos

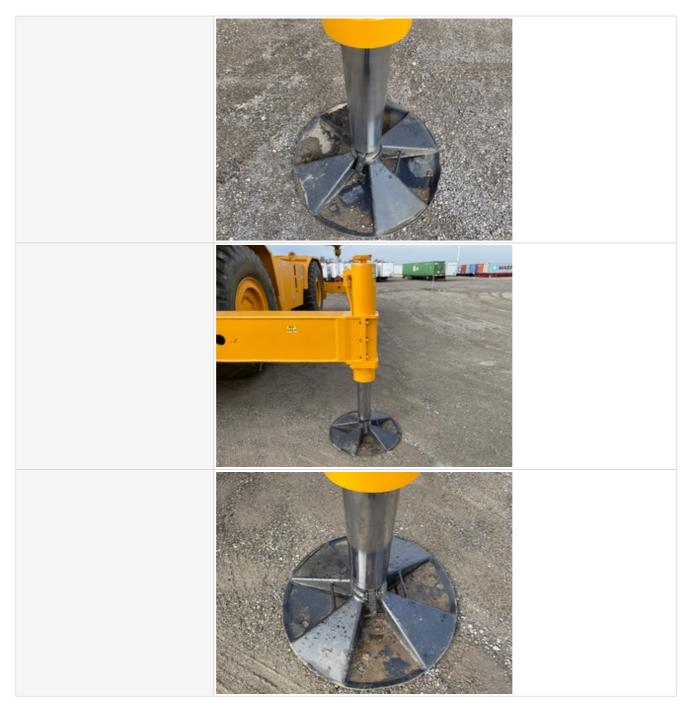
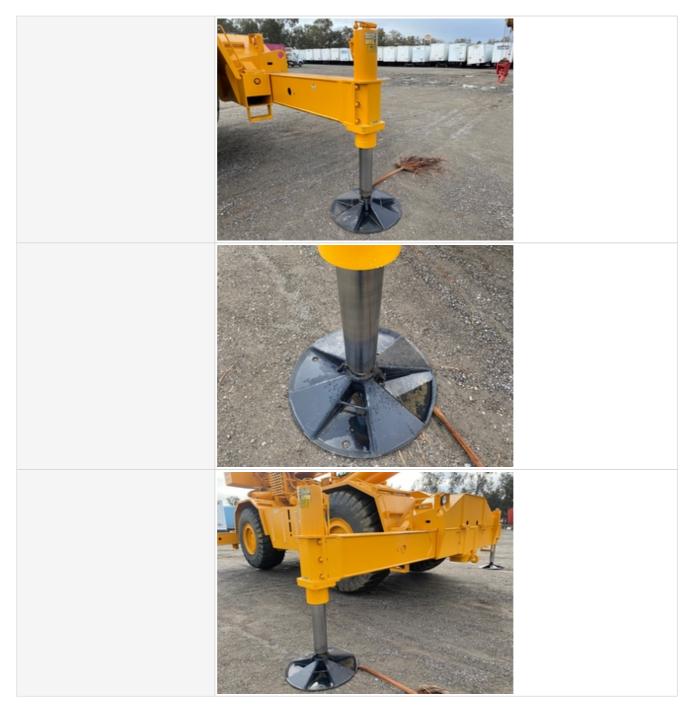
Rear Right Tire Photos	
Outrigger Condition	3 - Normal Wear & Tear
Outrigger Photos

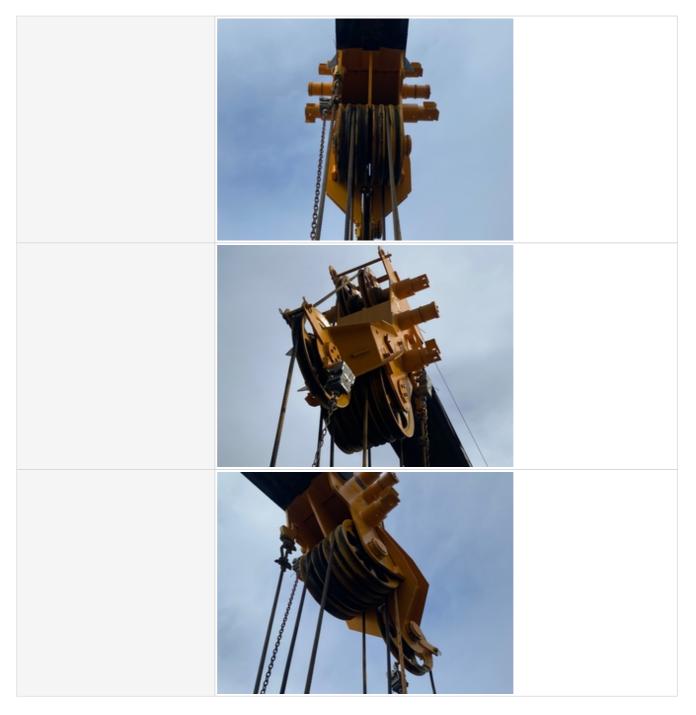
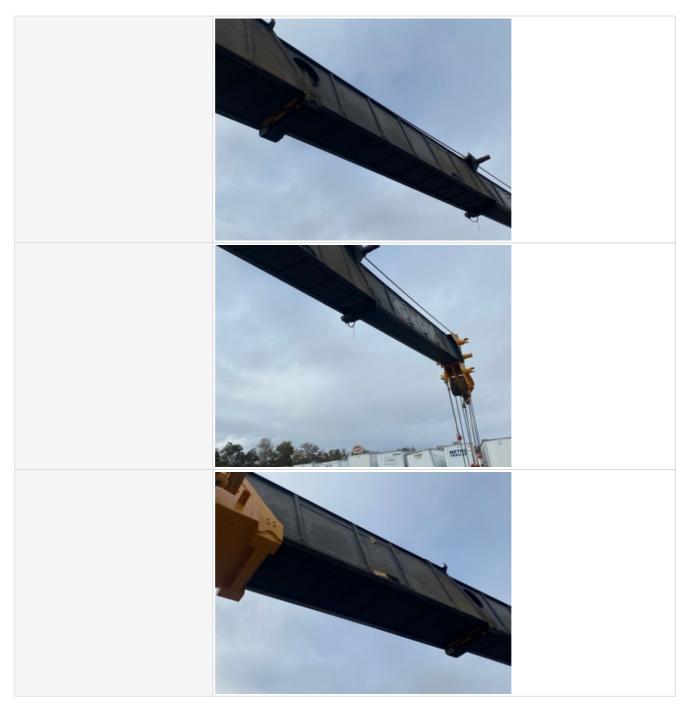
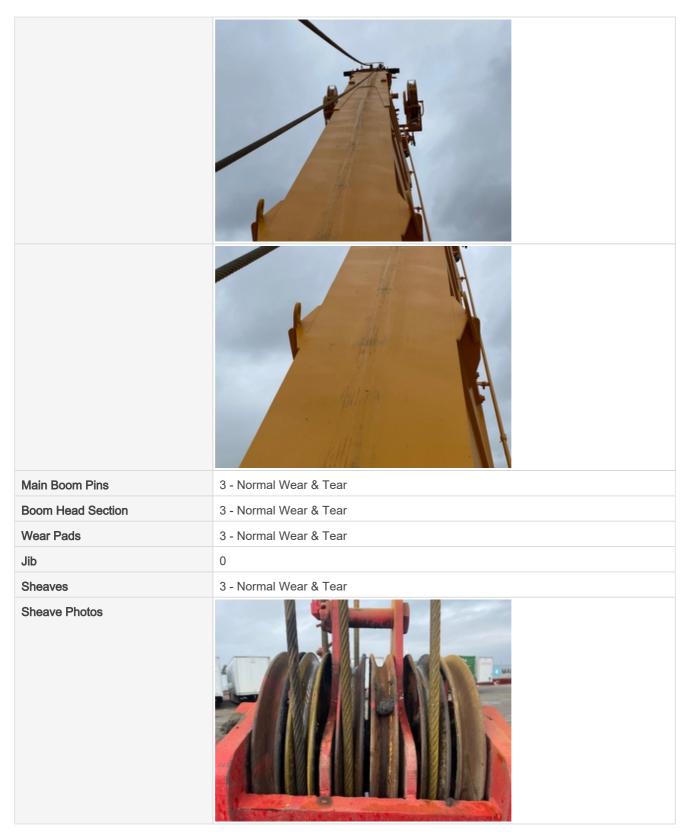
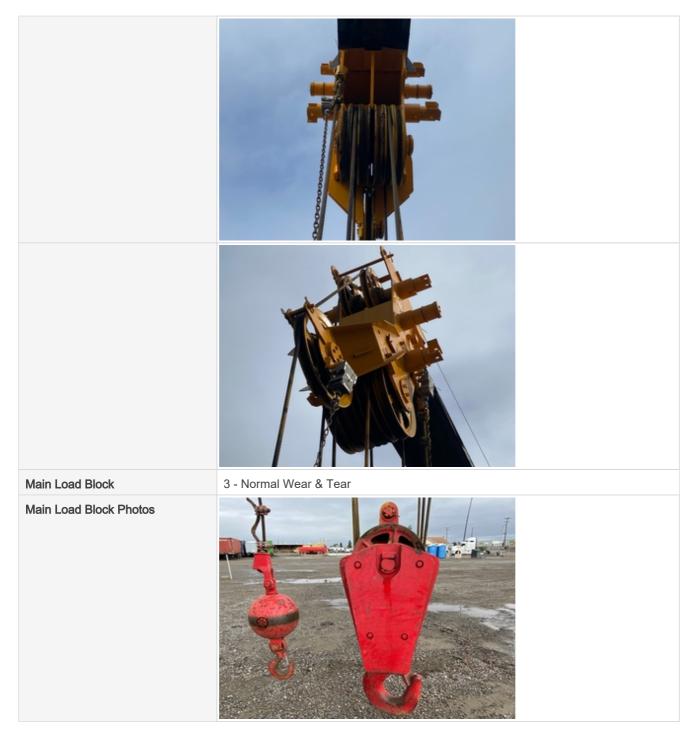
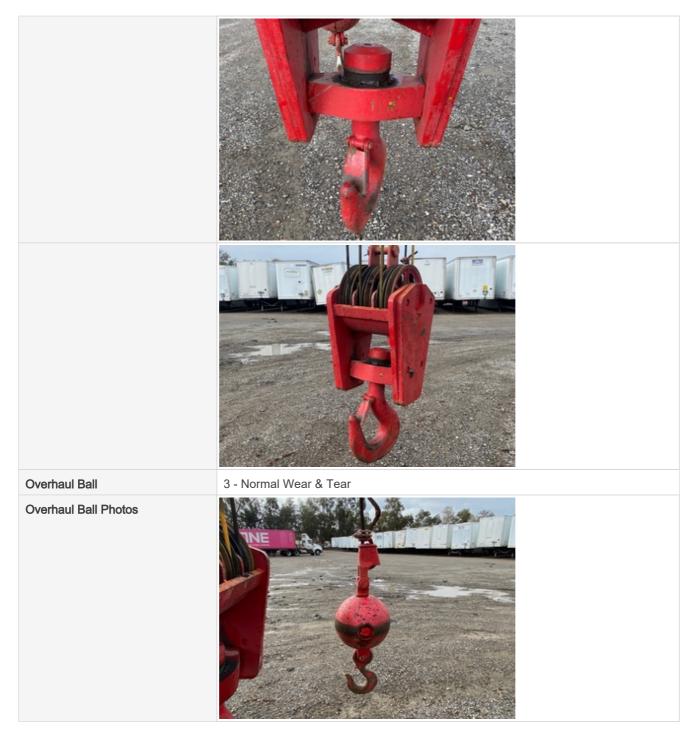
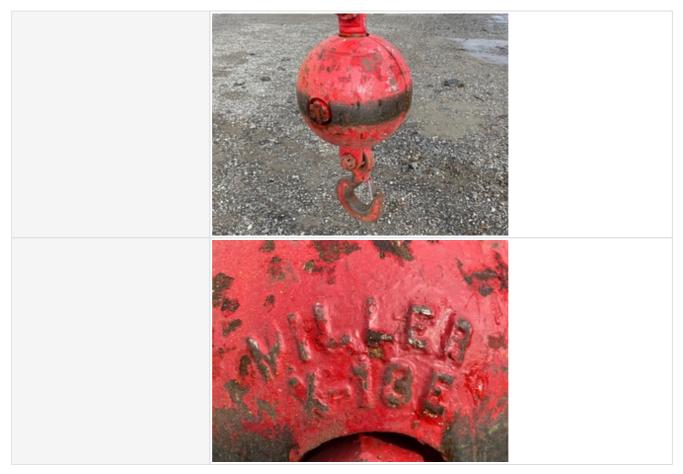
Outrigger Cylinders: Oil Leaks	No
Crane Specific	
Counterweight	3 - Normal Wear & Tear
Boom Angle Indicator	3 - Normal Wear & Tear
Comments	Electronic unit installed in cab
Main Boom Sections	3 - Normal Wear & Tear
Main Boom Photos
