Inspection Report (Compact Track Loader)

Year	2017
Make	Bobcat
Model	T740
Serial Number	B3CA12473
Hour Meter Reading	2,654
Previous Application (e.g., earth moving, mining, demolition, etc)	Asphalt Paving Construction

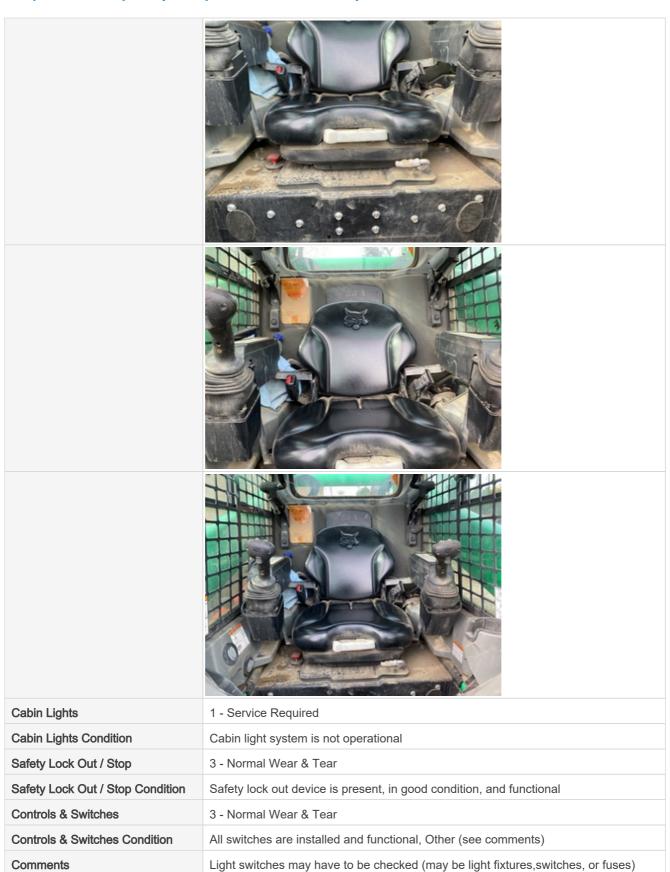
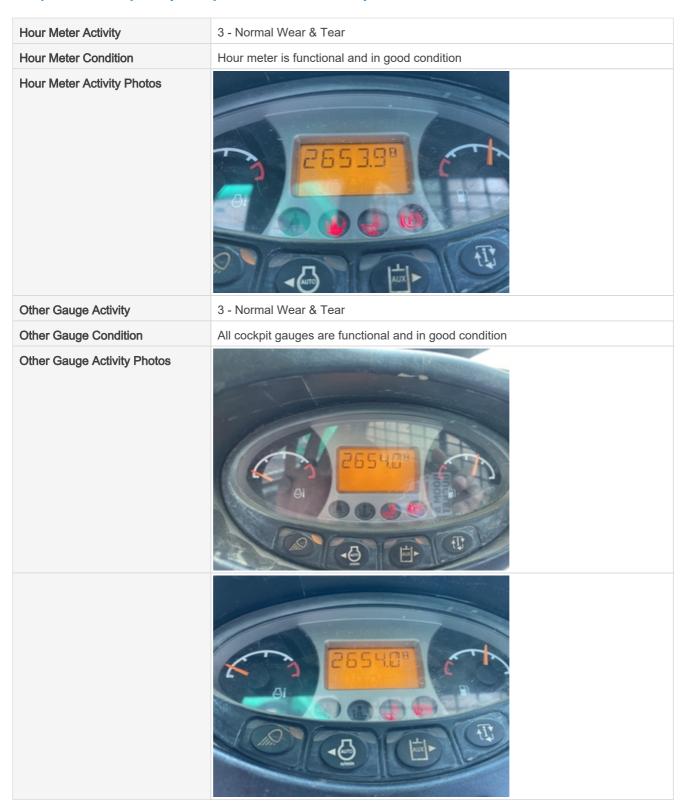
Operator Cabin Overall	3 - Normal Wear & Tear
Operator Cabin Overall Condition	Minor cosmetic wear to cabin surfaces, floors, panels, and ceiling
Operator Seat	3 - Normal Wear & Tear
Operator Seat Condition	Seat(s) in good condition, no stains or tears in upholstery
Operator Seat Photos

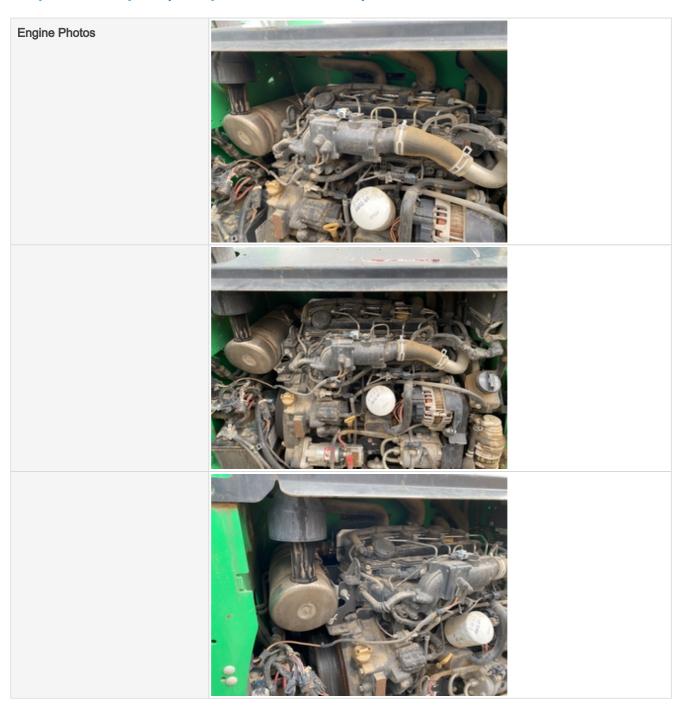
Engine	
Engine Type (Make, Model, Cylinders, Hp)	Bobcat - 4CYL 3.4L - 74HP
Emissions Tier	Tier 4F
Engine Serial Number	N/A
Engine Fuel Type	Diesel

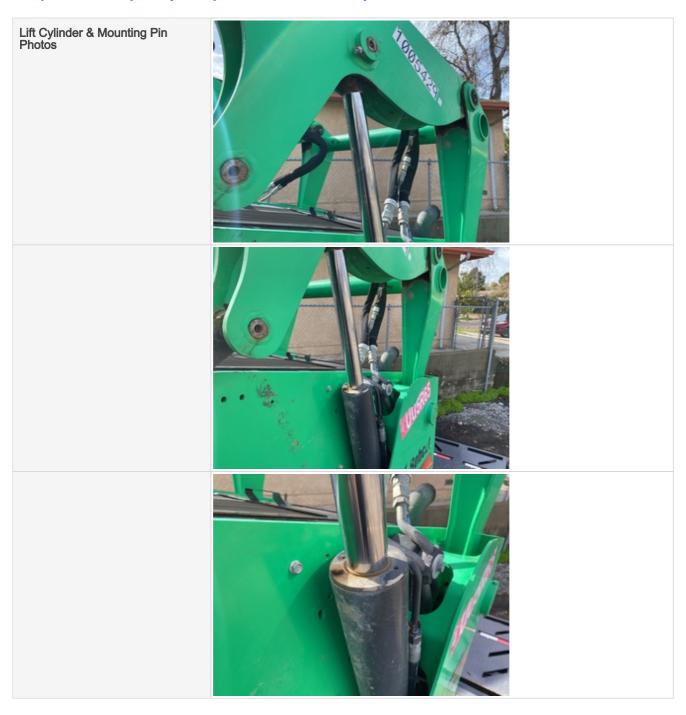
Lift Cylinder	Check the lift cylinder. Note any wear, pitting, discoloration, etc. Take photos.
Lift Cylinder & Mounting Pin	3
Lift Cylinder: Oil Leaks	No
