## Inspection Report (Vibratory Compactor)

Year	2015
Make	Bomag
Model	BW 213 PDH-4i
Serial Number	101585321054
Hour Meter Reading	2,437 Hrs.
Previous Application (e.g., earth moving, mining, demolition, etc)	Finish Grading General Construction

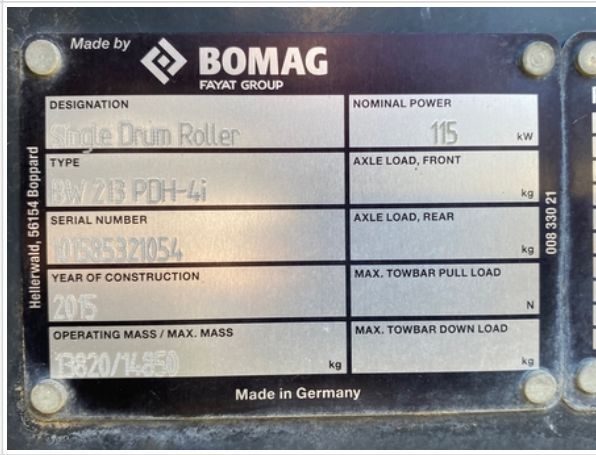
<b>Control Station</b>	Take close-up photos of operator control station or cab including the floors, panels, headliner, seat, controls & displays, gauges & meters, and interior lights. Note any damage or wear.										
<b>Serial Number Plate Photo</b>

<p>Made in Germany</p> <p>Hellerwald, 56154 Boppard 0009 330 21</p>	DESIGNATION Single Drum Roller	NOMINAL POWER 115 kW	TYPE PW 213 PDH-4i	AXLE LOAD, FRONT kg	SERIAL NUMBER 01685321054	AXLE LOAD, REAR kg	YEAR OF CONSTRUCTION 2015	MAX. TOWBAR PULL LOAD N	OPERATING MASS / MAX. MASS 13820/14850 kg	MAX. TOWBAR DOWN LOAD kg
DESIGNATION Single Drum Roller	NOMINAL POWER 115 kW										
TYPE PW 213 PDH-4i	AXLE LOAD, FRONT kg										
SERIAL NUMBER 01685321054	AXLE LOAD, REAR kg										
YEAR OF CONSTRUCTION 2015	MAX. TOWBAR PULL LOAD N										
OPERATING MASS / MAX. MASS 13820/14850 kg	MAX. TOWBAR DOWN LOAD kg										
<b>Operator Cabin Photos</b>

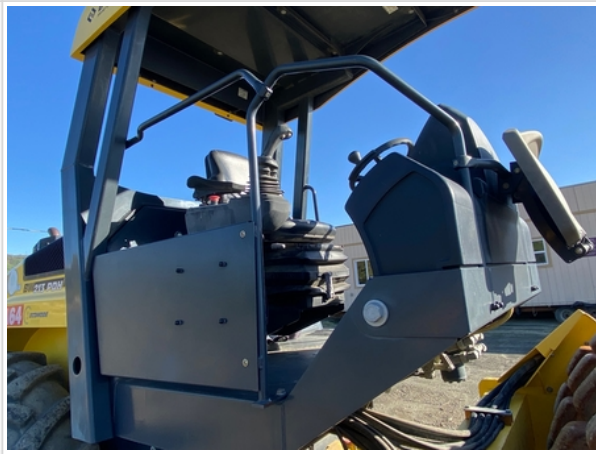
Operator Cabin Overall	3 - Normal Wear & Tear
Operator Cabin Overall Condition	Good cabin appearance, solid floors, panels, and ceiling, Minor cosmetic wear to cabin surfaces, floors, panels, and ceiling
Operator Seat	3 - Normal Wear & Tear
Operator Seat Condition	Seat(s) have minor surface staining or small tears
Cabin Lights	0
Safety Lock Out / Stop	3 - Normal Wear & Tear
Safety Lock Out / Stop Condition	Safety lock out device is present, in good condition, and functional
Controls & Switches	3 - Normal Wear & Tear
Controls & Switches Condition	All switches are installed and functional
Hour Meter Activity	3 - Normal Wear & Tear
Hour Meter Condition	Hour meter is functional and in good condition
Hour Meter Activity Photos	 
Other Gauge Activity	3 - Normal Wear & Tear
Other Gauge Condition	All cockpit gauges are functional and in good condition
Heater & A/C	0
Travel Alarm	3 - Normal Wear & Tear
Travel Alarm Condition	System is configured but not operating correctly, Other (see comments)

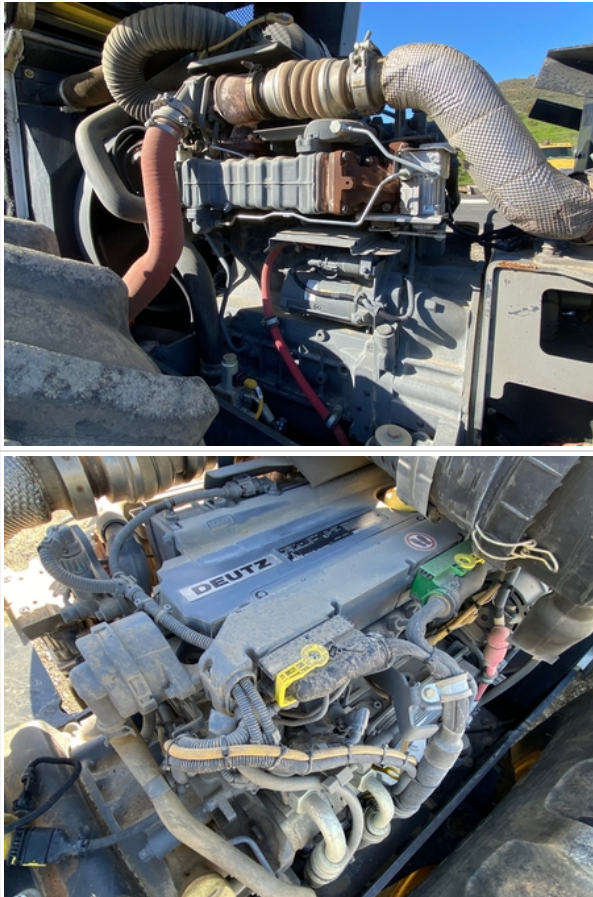
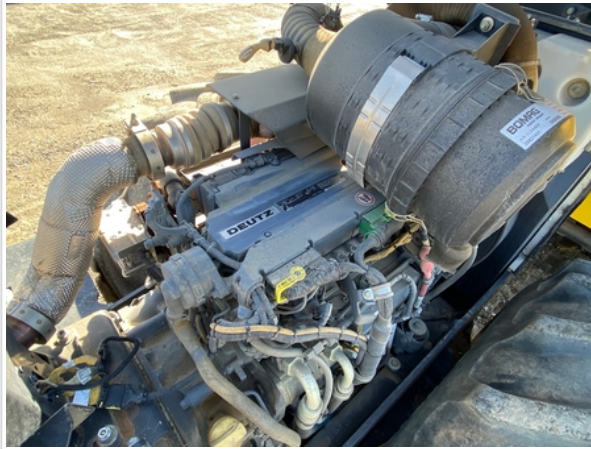
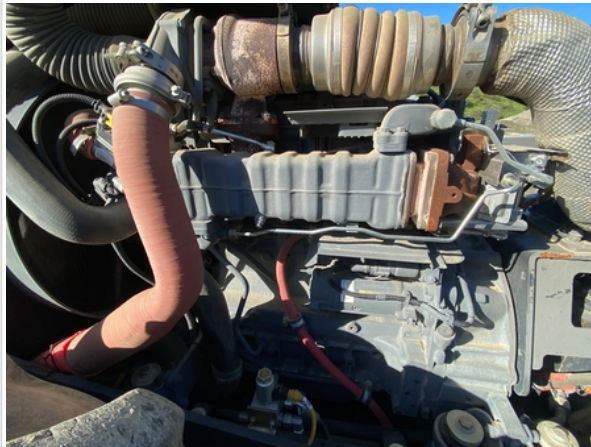
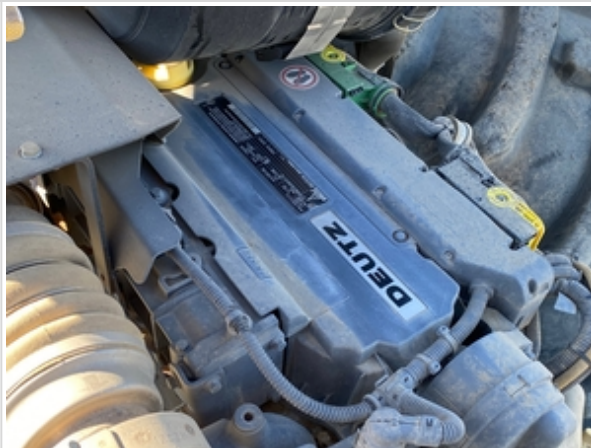
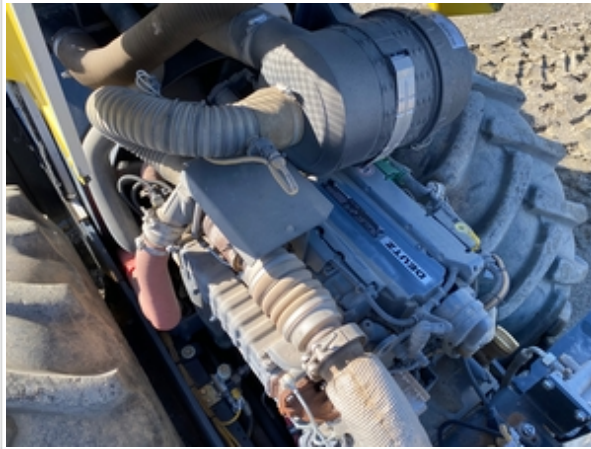
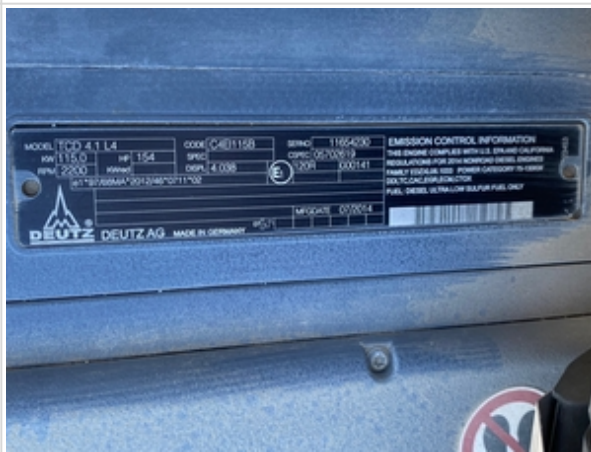
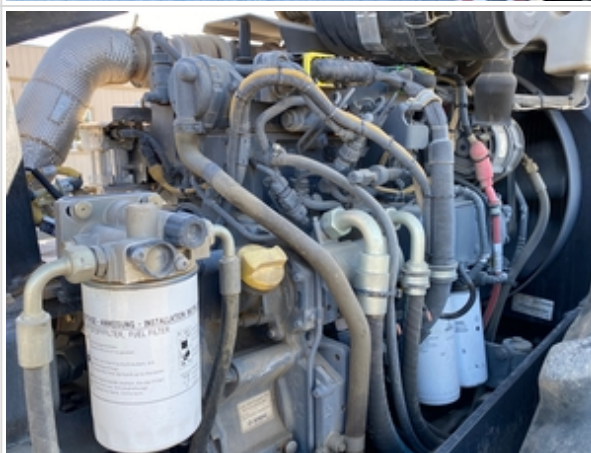
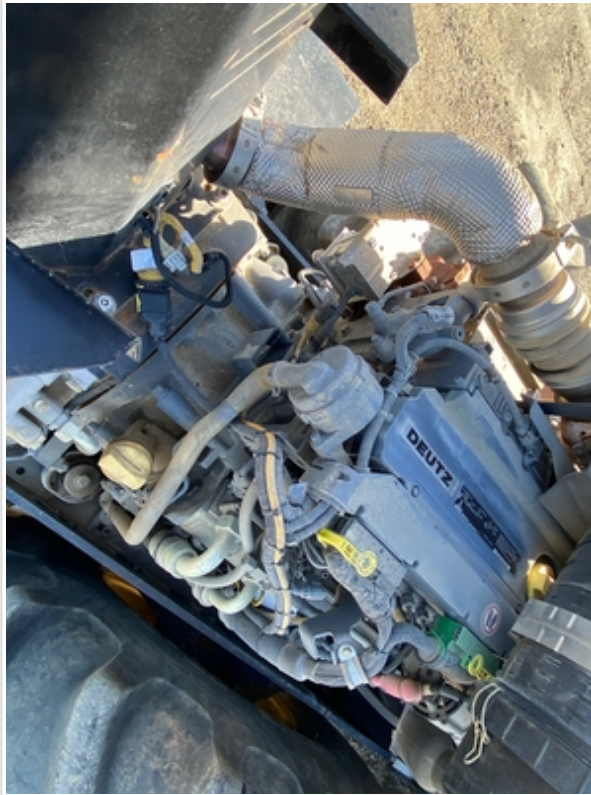
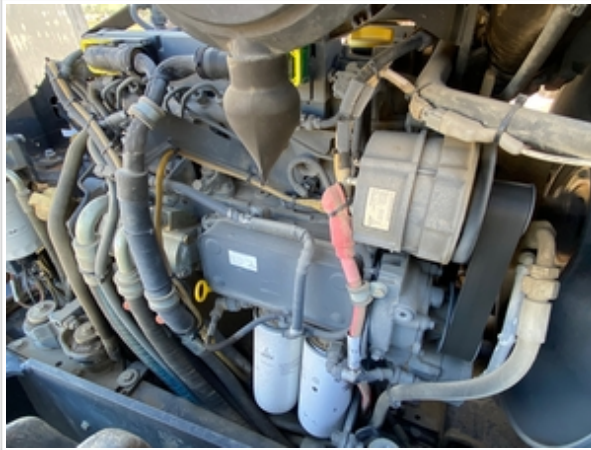
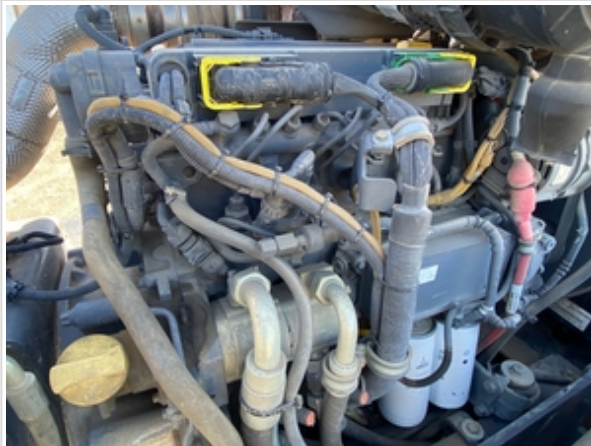
Engine Type (Make, Model, Cylinders, Hp)	Deutz - TCD4.1L4 - 6CYL. - 154HP - 4.1L
Emissions Tier	Tier 4i
Engine Serial Number	11654230
Engine Fuel Type	Diesel
Engine Photos

<b>Requires DEF (Diesel Exhaust Fluid)</b>	No
<b>Overall Engine Appearance</b>	Clean & dry
<b>Overall Engine Comments</b>	Overall engine runs well and no active leaks or seepages observed. Engine is in excellent maintained condition. Aftertreatment has been updated per dealership and has very low runtime on it.

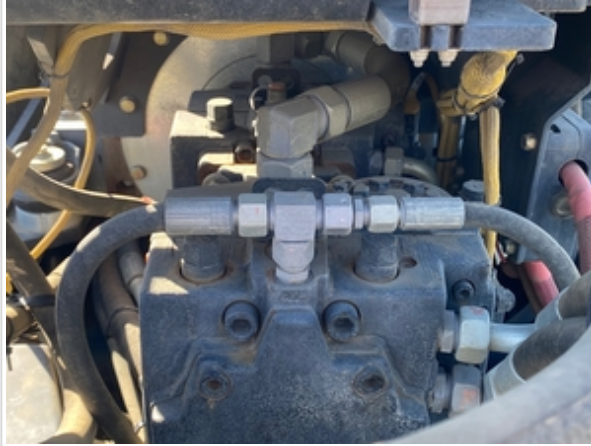
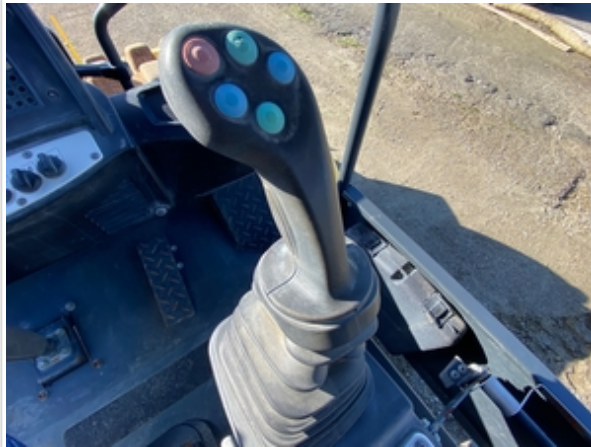
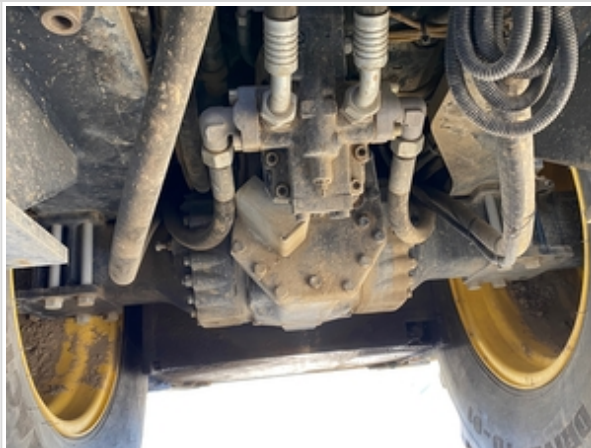
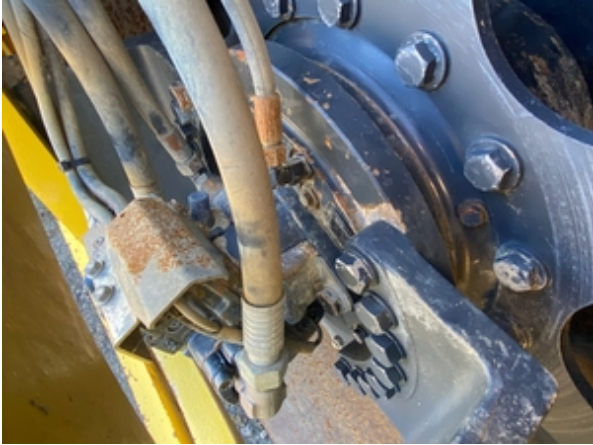
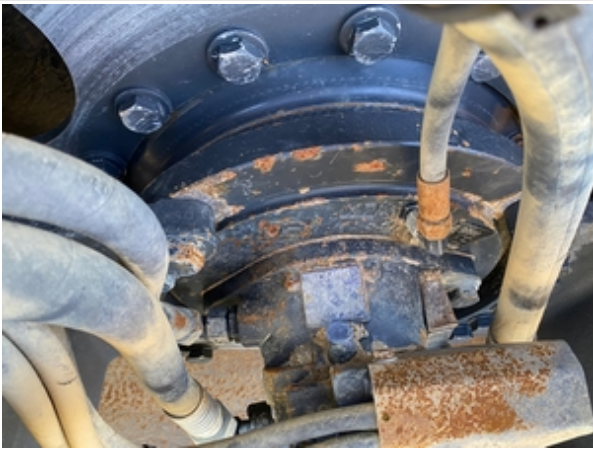
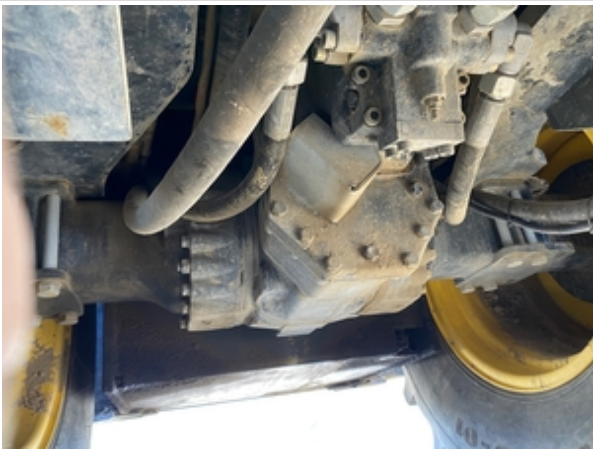
Drivetrain Photos

<b>Hydrostatic Transmission?</b>	Yes	
<b>2 Speed?</b>	Yes	
<b>Hydrostatic Drive Configuration</b>	Split Transmission	
<b>Drive Motors</b>	2 - Above Average Wear	
<b>Comments</b>	Drive motor directly mounted to rear axle and front drum	
<b>Hydrostatic Parking Brake</b>	3 - Normal Wear & Tear	
<b>Hydrostatic Parking Brake Condition</b>	Good brake function

Overall Drivetrain Comments	Overall drivetrain in solid condition with no abnormalities observed during the inspection. Machine travels well in forward and reverse in low and high speeds.
-----------------------------	---

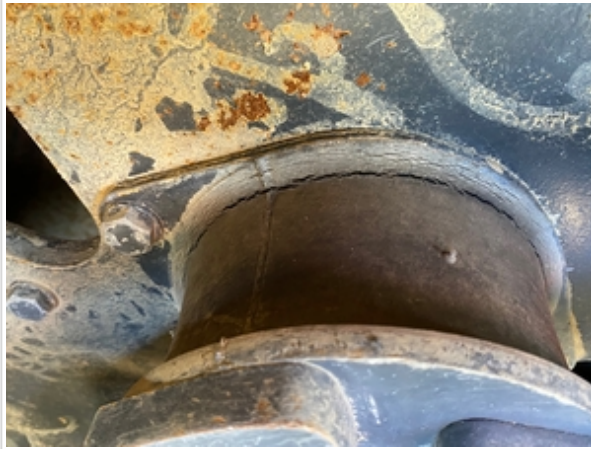
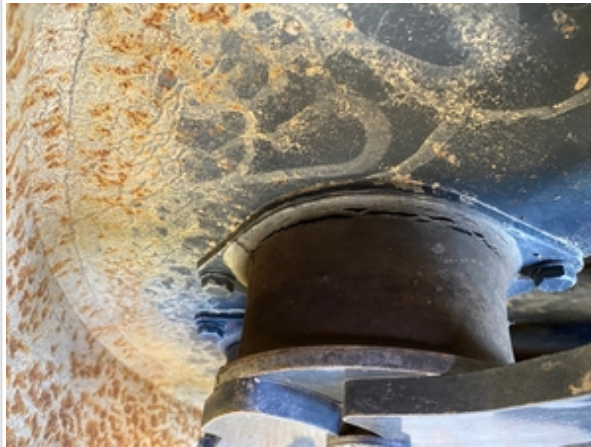
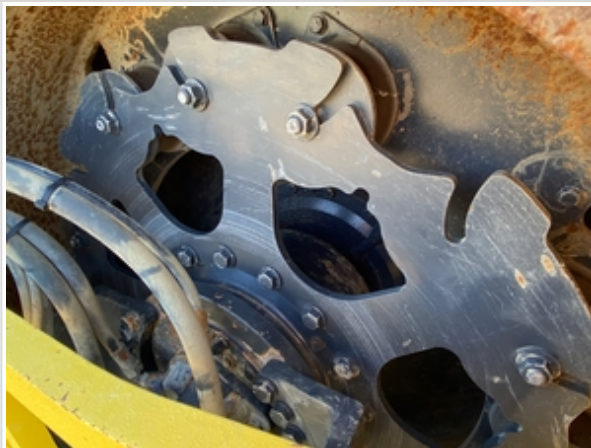
Vibratory Rubber Mounts (Front & Rear) Photos

Frame	4 - Like New, Recently Replaced
Level Stance	4 - Like New, Recently Replaced
Drum(s) Condition	3 - Normal Wear & Tear
Vibratory Rubber Mounts (Front & Rear)	3 - Normal Wear & Tear
Comments	Some isolator rubber mounts showing surface cracks

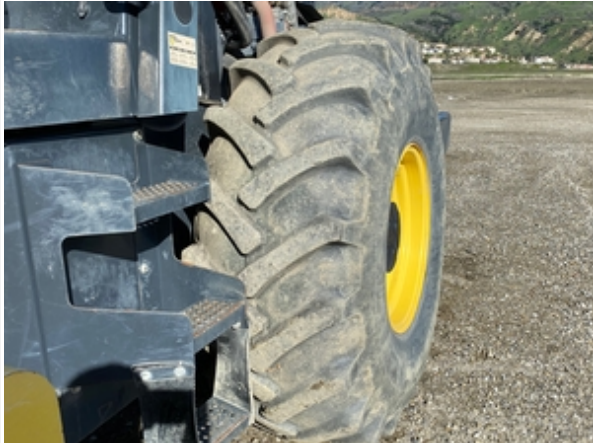
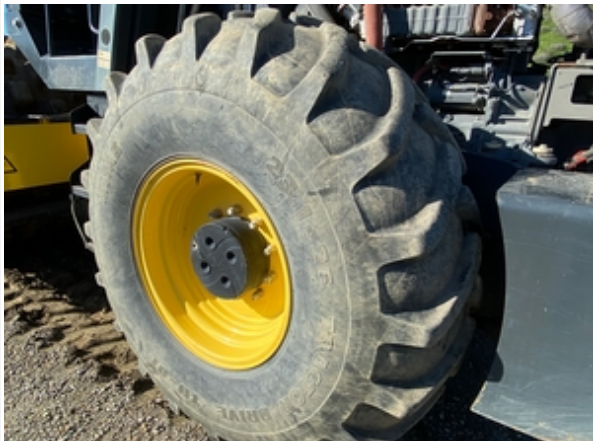
Tire Brand	MITAS	
Tire Size	23.1-26	
Left Tire - Ratio Remaining	70%	
Left Tire Photos

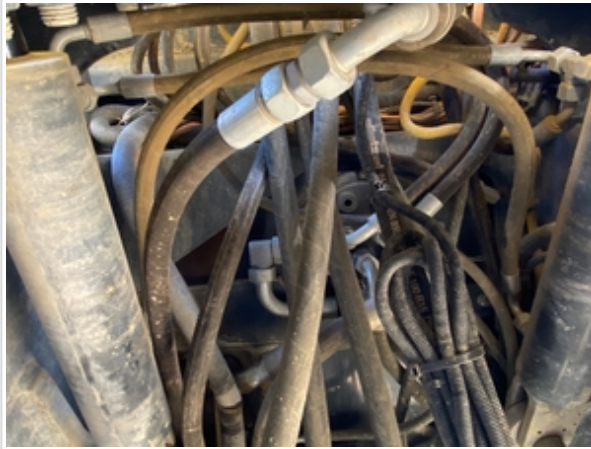
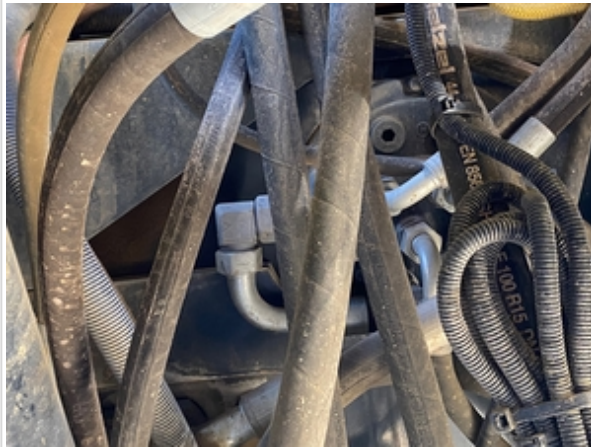
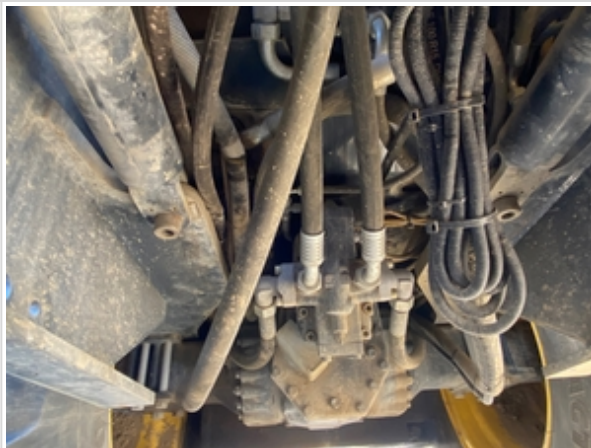
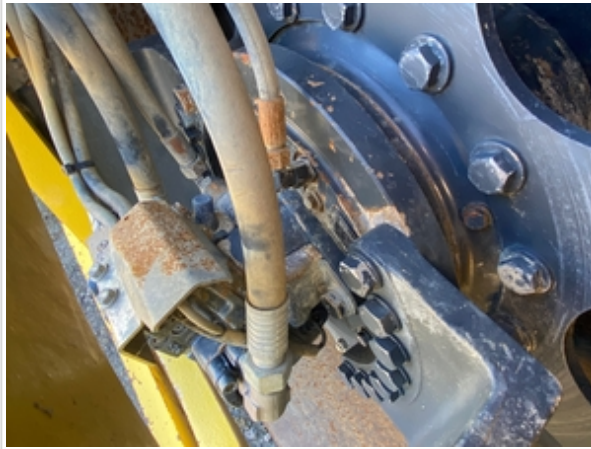
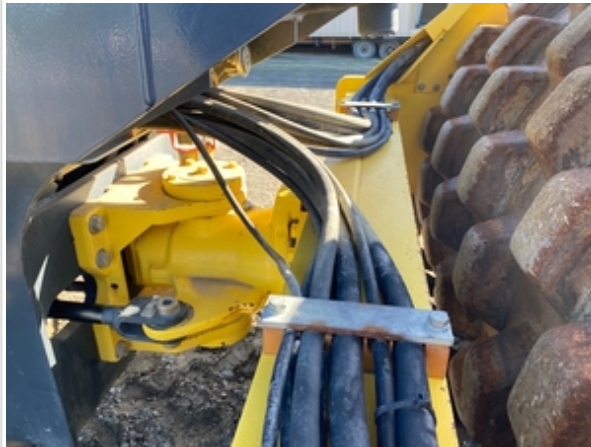
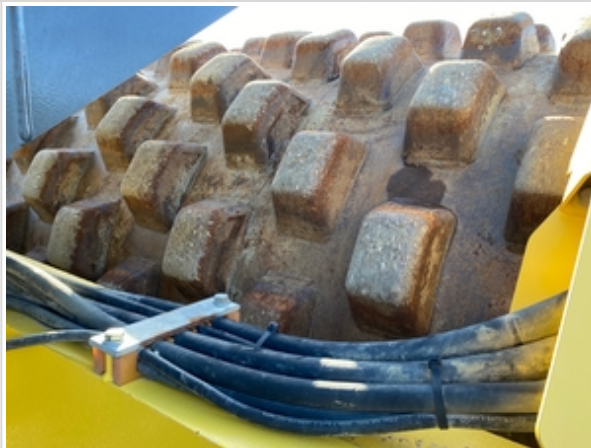
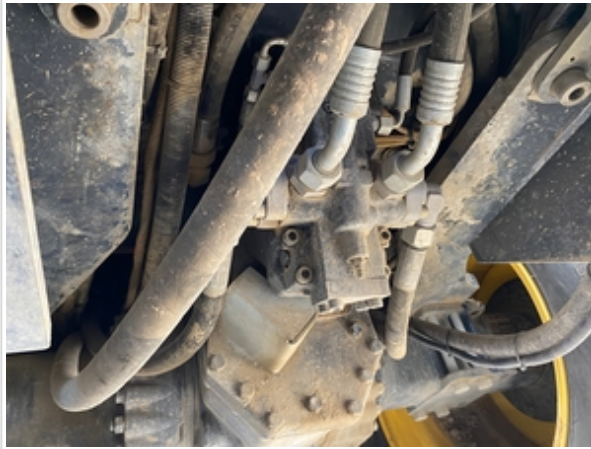
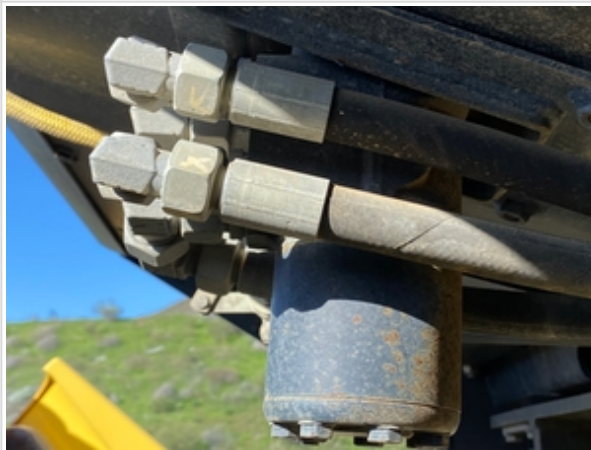
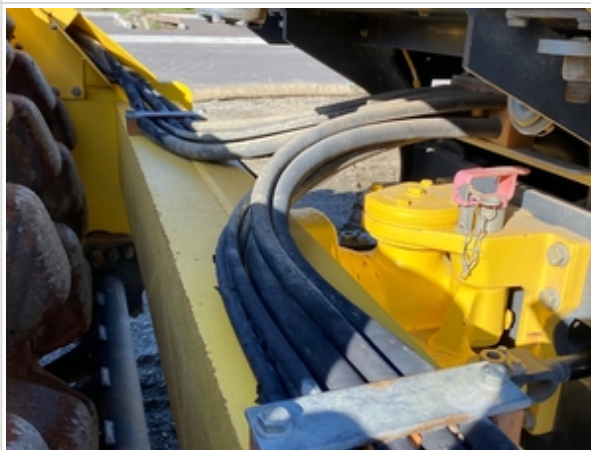
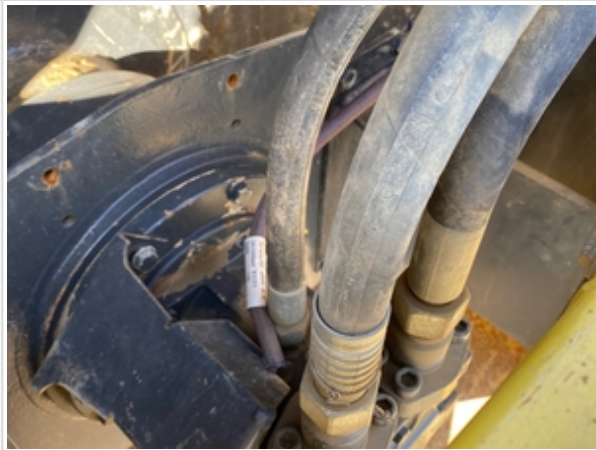
<b>Wet or Damp Hydraulic Lines / Fittings</b>	No	
<b>Appearance of Hydraulic Lines / Fittings</b>	3 - Normal Wear & Tear	
<b>Hydraulic Lines / Fittings Condition</b>	Hydraulic lines & fittings are clean and in good condition	
<b>Appearance of Hydraulic Lines / Fittings Photos</b>

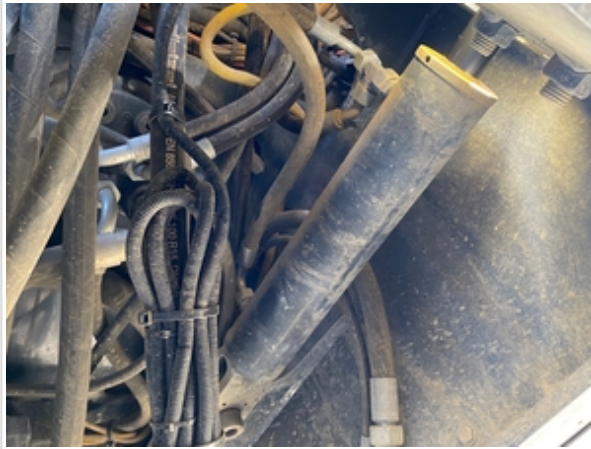
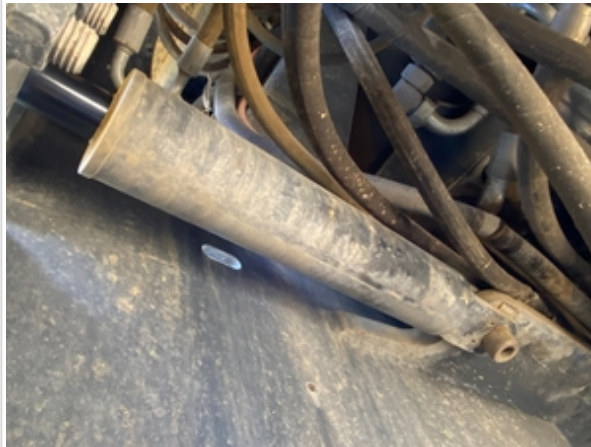
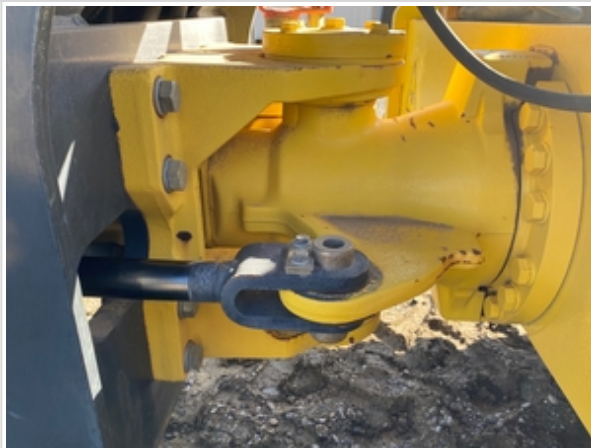
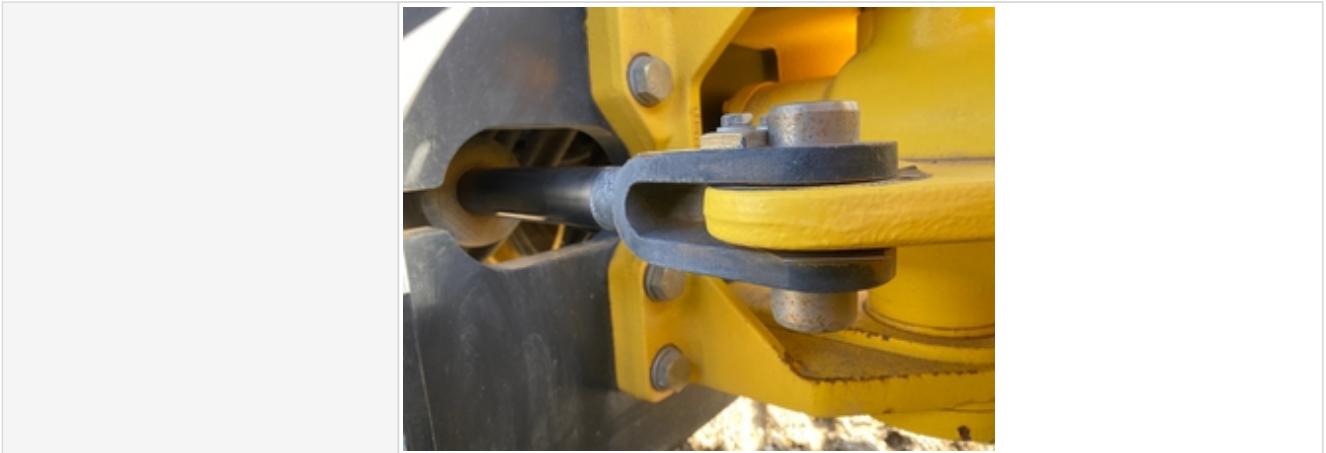
Steering Cylinders	Check the steering cylinder. Note any wear, pitting, discoloration, etc. Take photos.
Steering Cylinders: Mounting Pin	3
Steering Cylinders: Oil Leaks	No
Steering Cylinders Photos
