Inspection Report (On-Highway Dump Truck)

Year	2011
Make	Peterbilt
Model	367
Serial Number	1NPTLU0XXBD127979
Truck Odometer Reading	423,762
Previous Application (e.g., earth moving, mining, demolition, etc)	Asphalt Paving Construction

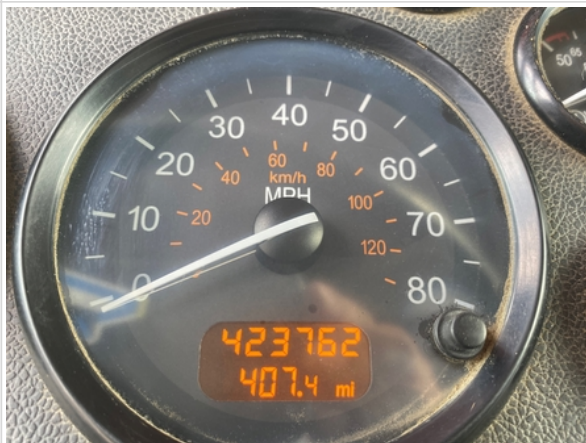
Odometer Photo

Odometer Activity	3 - Normal Wear & Tear
Odometer Condition	Odometer is working and in good condition
Controls/Switches/Gauges	3 - Normal Wear & Tear
Controls/Switches/Gauges Condition	All switches/gauges are in good condition and functioning
Brake System Type	Air Brakes
Air Brakes Build Correct Pressure	Yes
Clutch	3 - Normal Wear & Tear

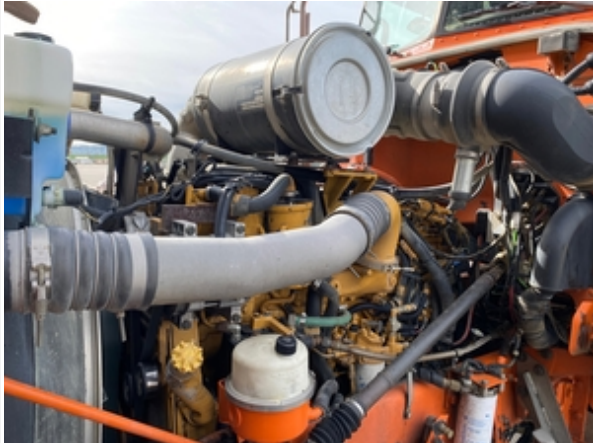
Engine	
Engine Type (Make, Model, Cylinders, Hp)	CAT - C13 - 6Cyl. - 12.5L - 470HP
Emissions Tier	Tier 4i
Engine Serial Number	LEE22411
Engine Fuel Type	Diesel
Engine Photos

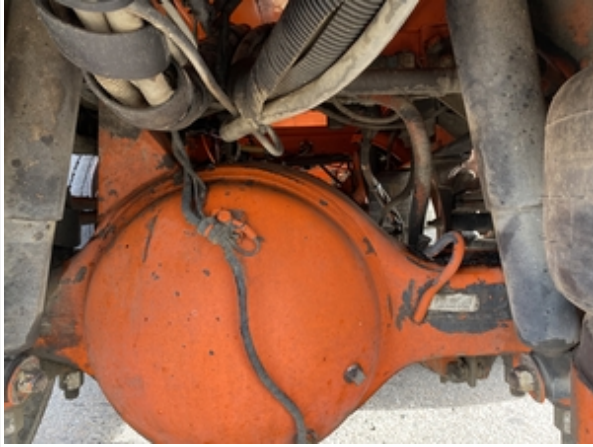
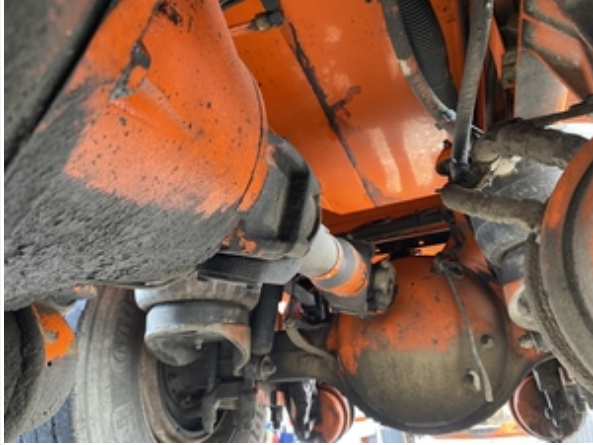
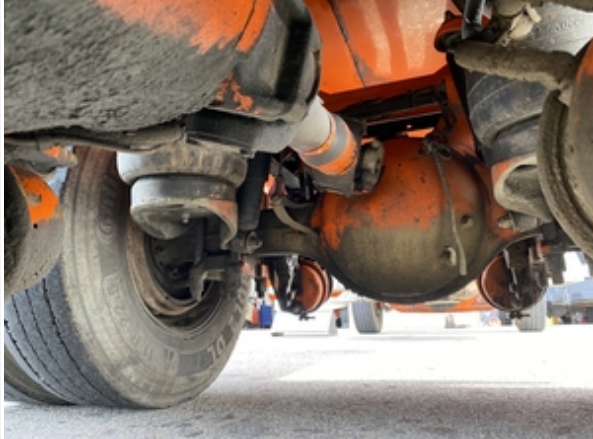
Chassis Inspection Points	Take photos of all undercarriage and chassis components including frame, suspension, axles, steering, and brake components. Note any damage or wear.	
Chassis & Undercarriage Photos

Overall Chassis Condition	3 - Normal Wear & Tear	
Overall Chassis Comments	Overall only found front right shock that needs to be replaced. The rear suspension looks to have been recently rebuilt and serviced.

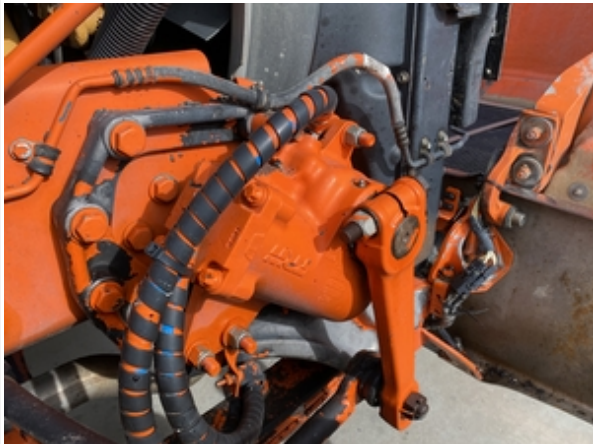
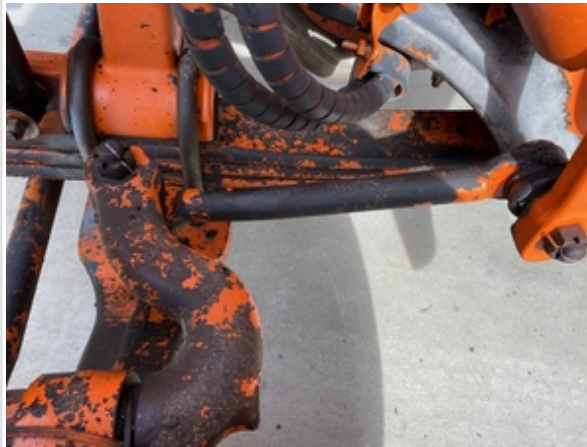
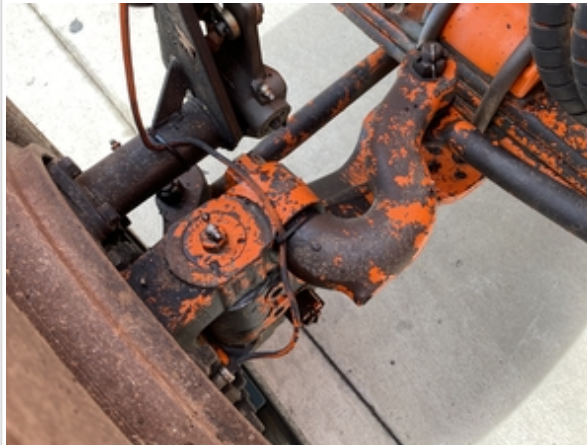
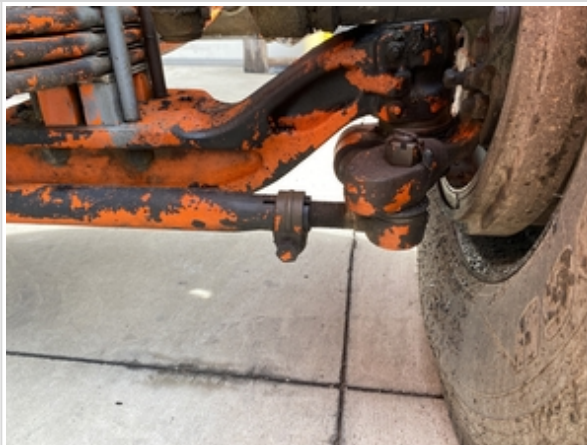
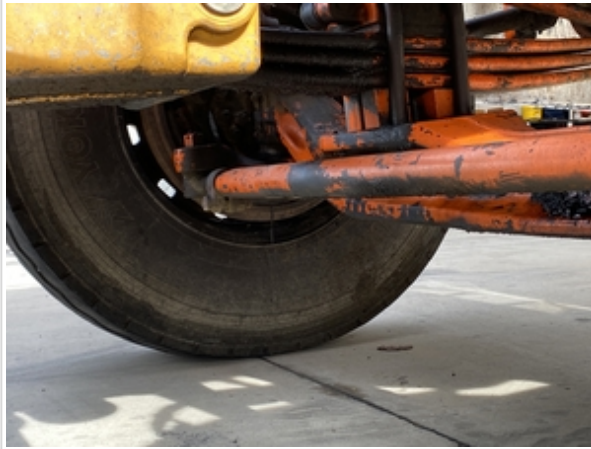
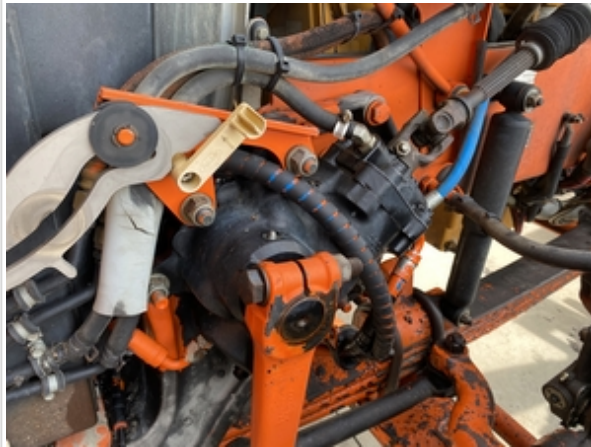
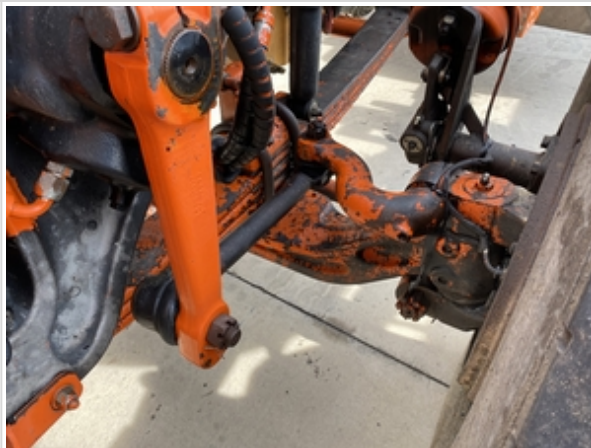
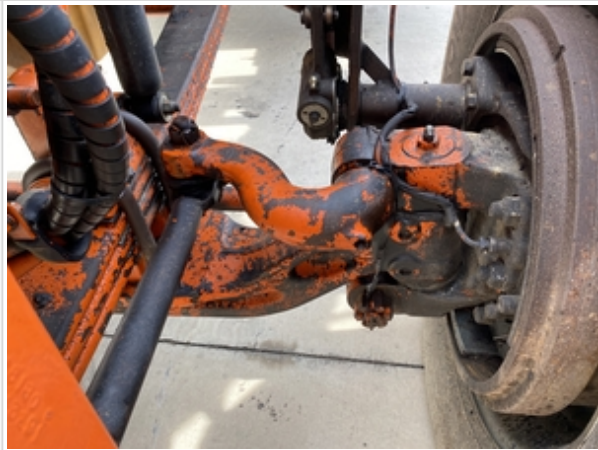
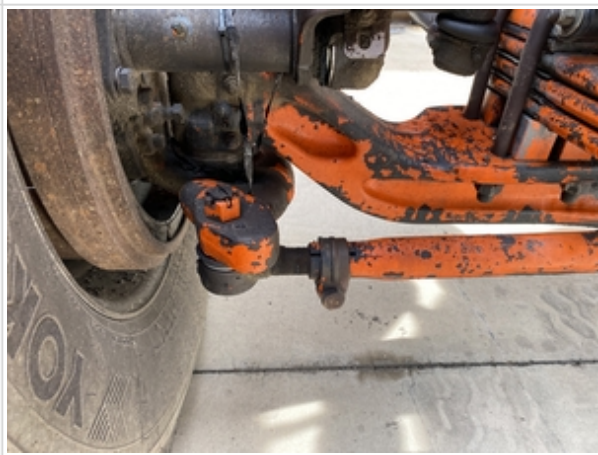
Frame	3 - Normal Wear & Tear	
Suspension	3 - Normal Wear & Tear	
Steer Axle Condition	3 - Normal Wear & Tear	
Steering Components	3 - Normal Wear & Tear	
Steering Component Photos

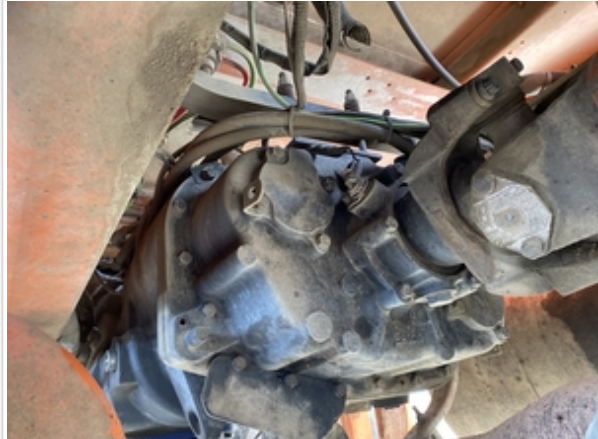
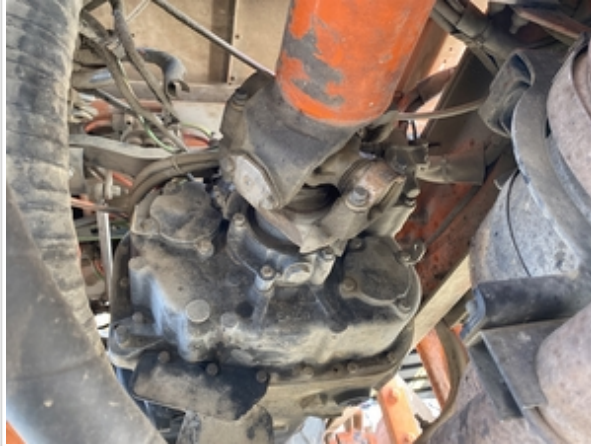
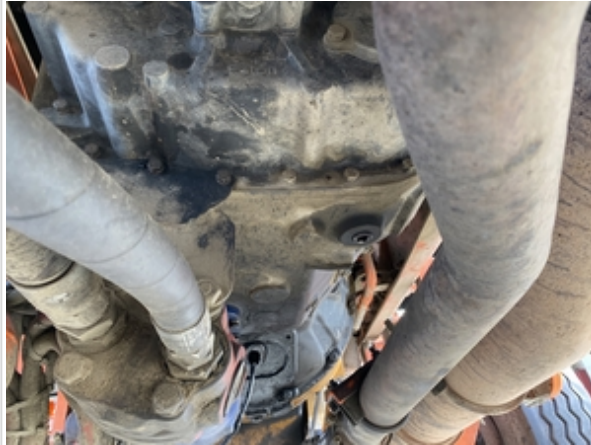
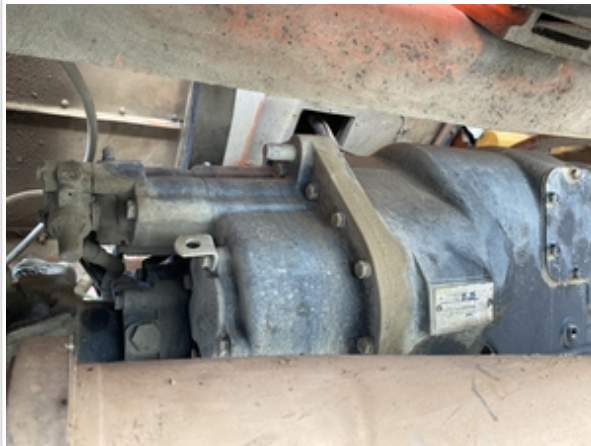
Transmission Info (Make/Model)	Eaton Fuller 10 Speed
Transmission	3 - Normal Wear & Tear
Transmission Condition	No unusual noises or vibrations
Transmission Condition Photos

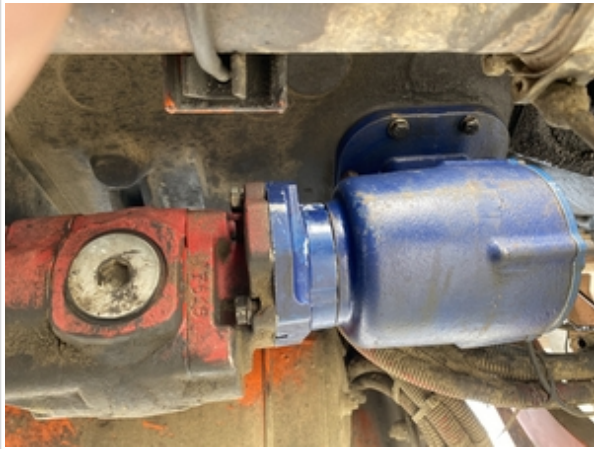
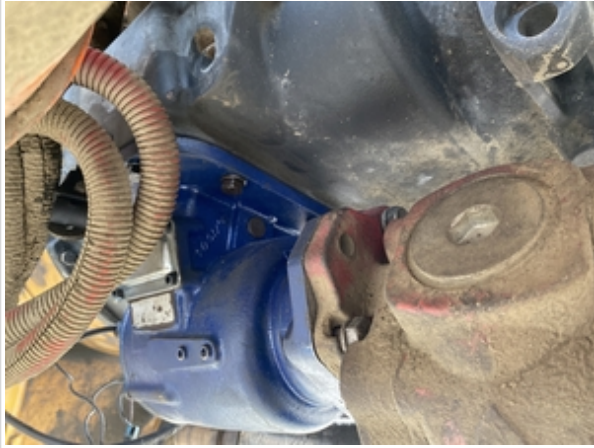
PTO Photos

PTO	3 - Normal Wear & Tear

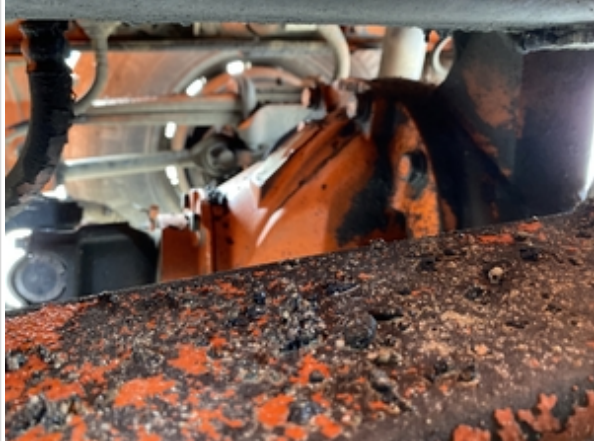
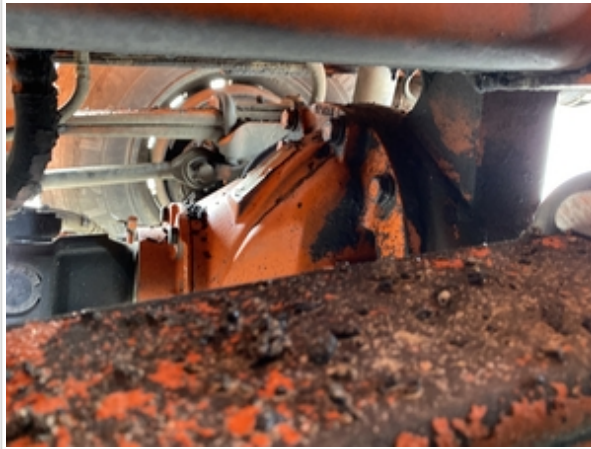
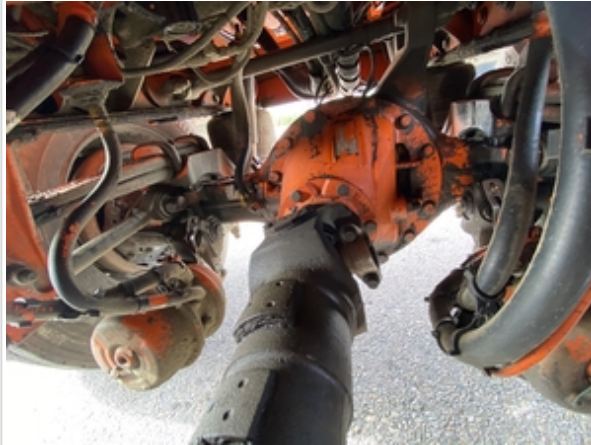
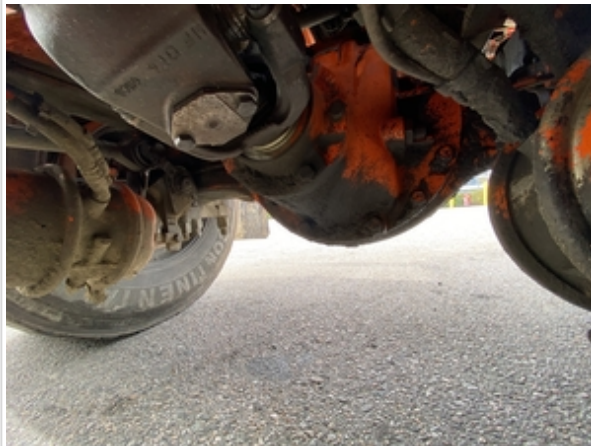
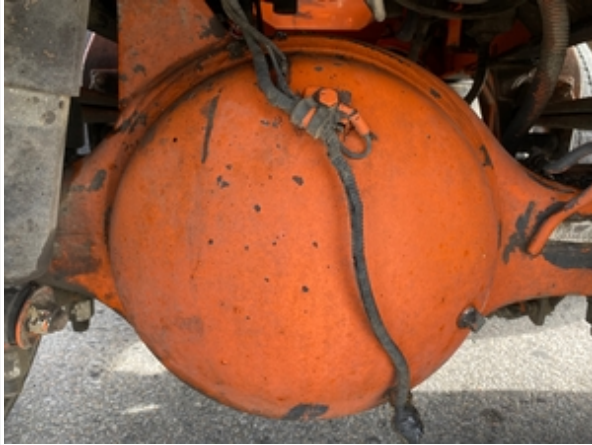
Differential	Check condition of the differential(s). Take photos and notes as relevant.
Rear Differential	3 - Normal Wear & Tear
Rear Differential Condition	Dry housing appearance, no unusual noises heard during operation
Rear Differential Photos

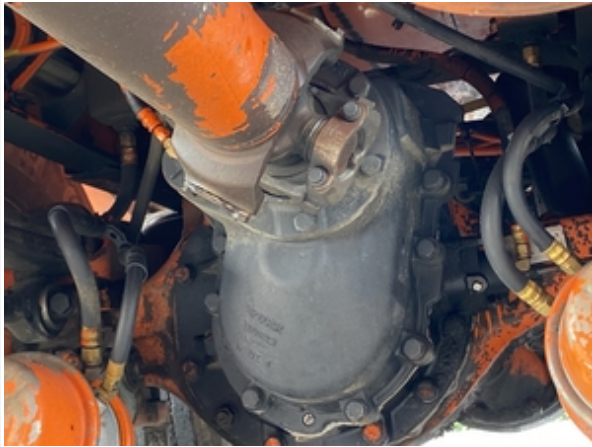
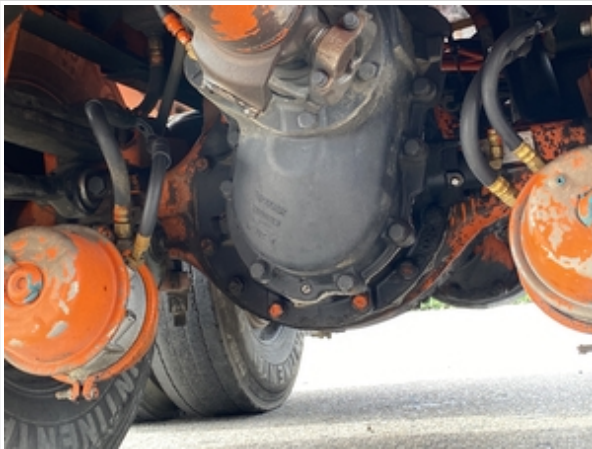
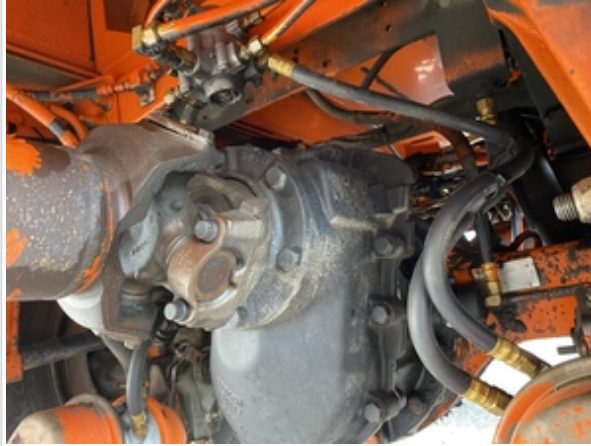
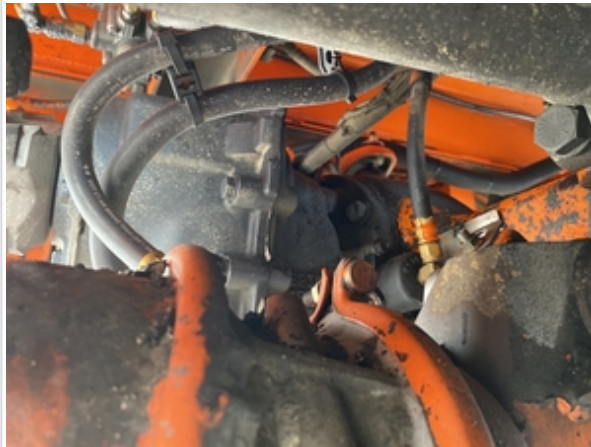
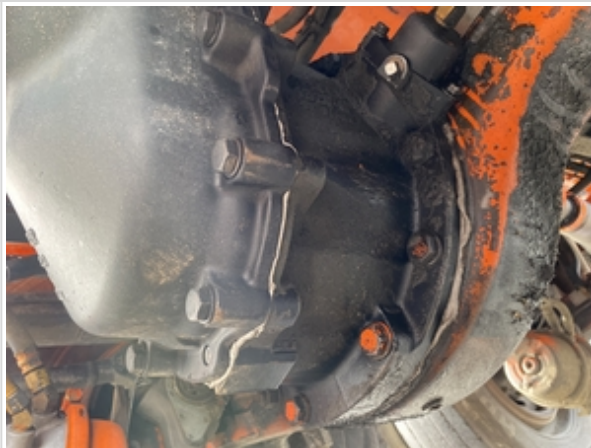
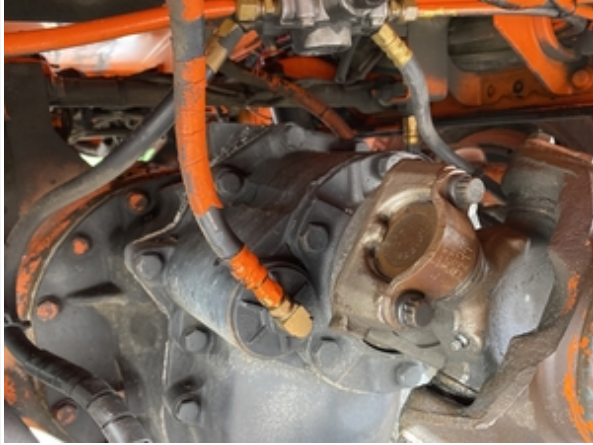
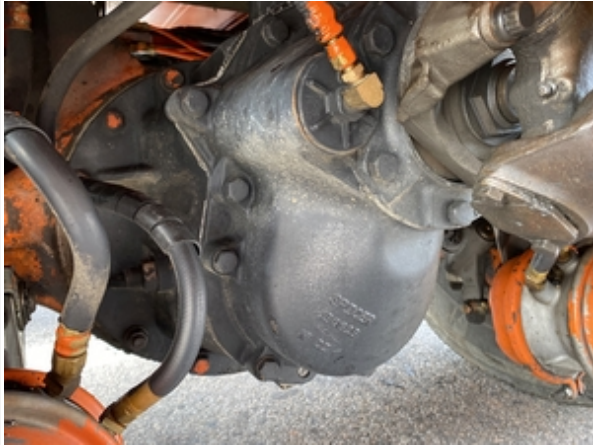
Front Differential	3 - Normal Wear & Tear	
Front Differential Condition	Dry housing appearance, no unusual noises heard during operation, Other (see comments)	
Comments	Looks to have been recently replaced	
Front Differential Photos

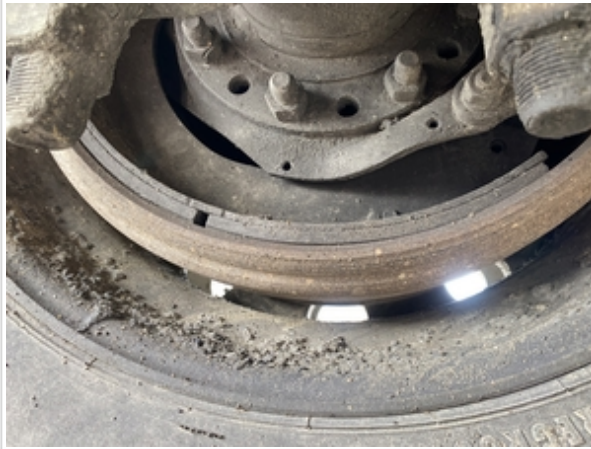
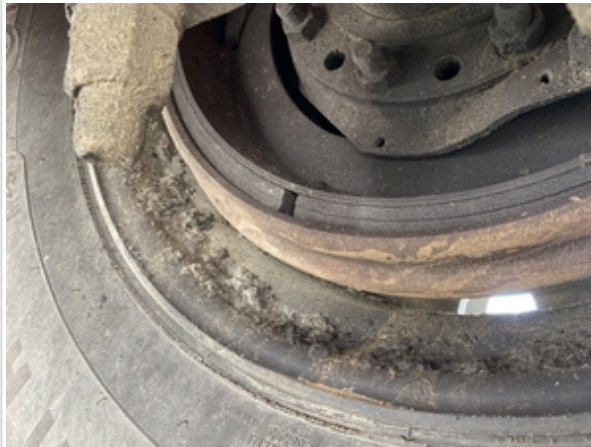
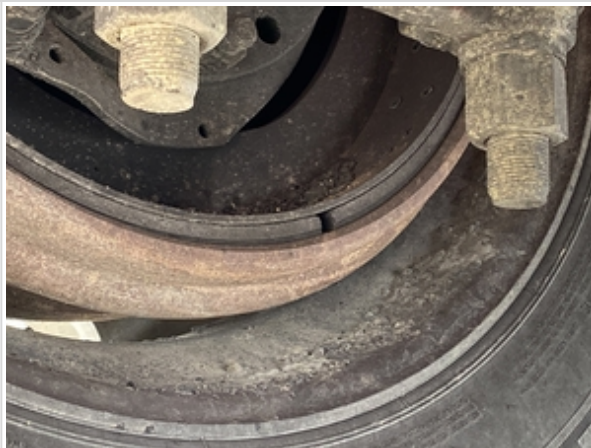
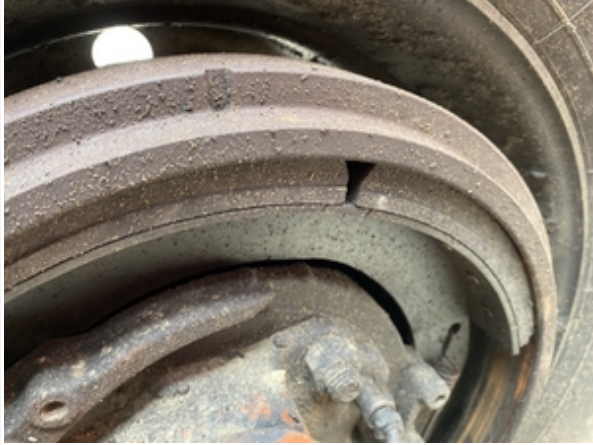
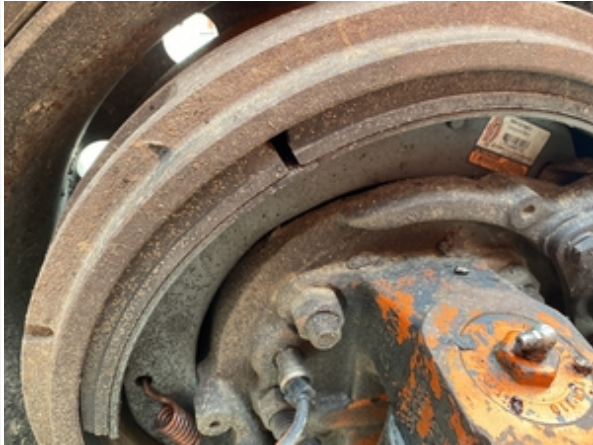
Brake Shoe Thickness	10%	
Comments	Rear brake shoes low and need to be replaced soon fronts above 90%	
Brake Shoe Photos

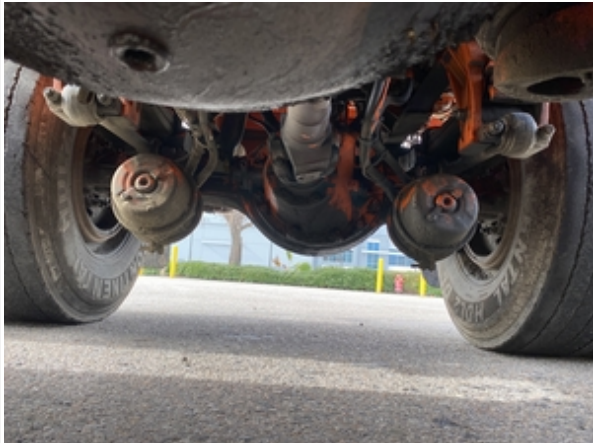
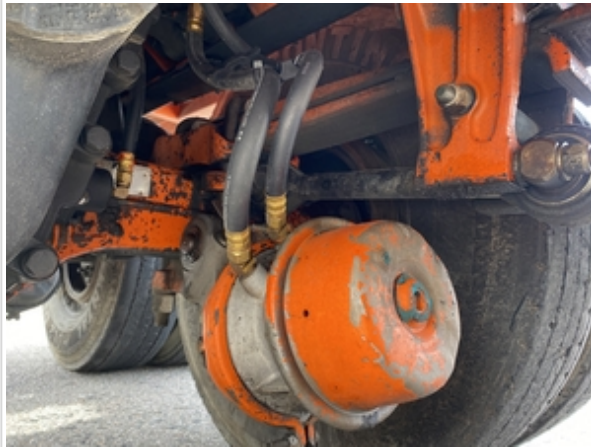
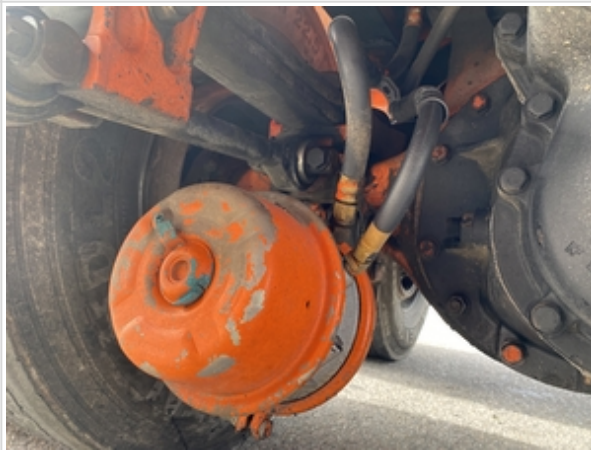
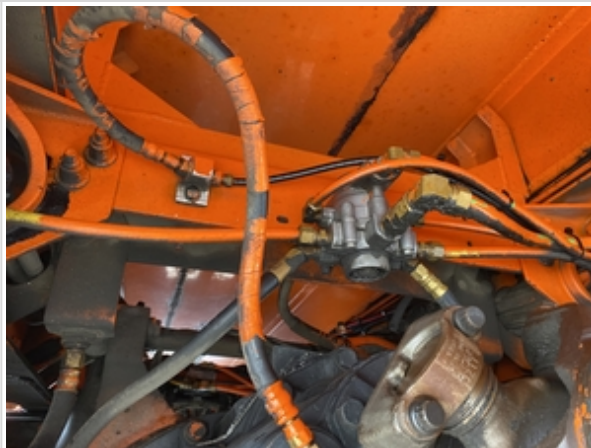
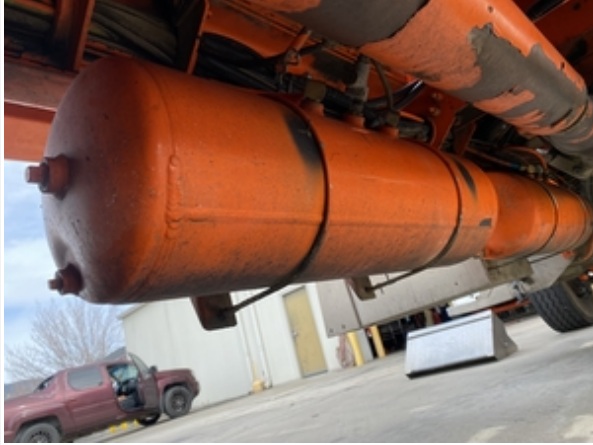
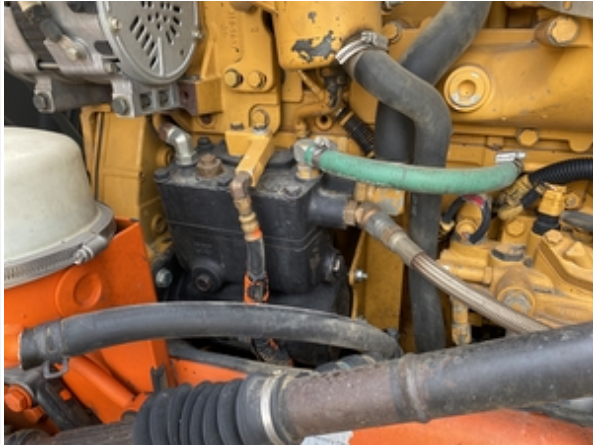
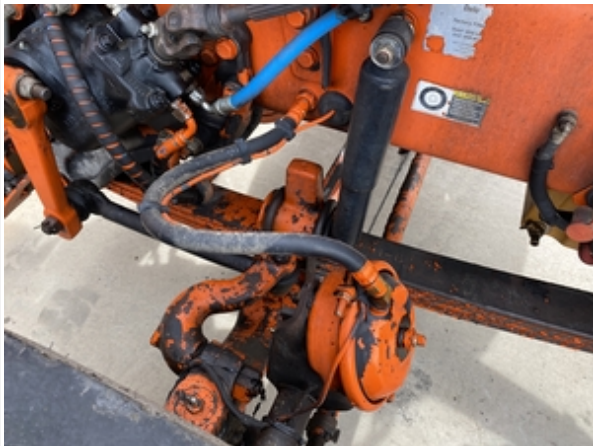
Air Brake System Leaks	No	
Air Brake Hose Condition	3 - Normal Wear & Tear	
Air Brake System Photos

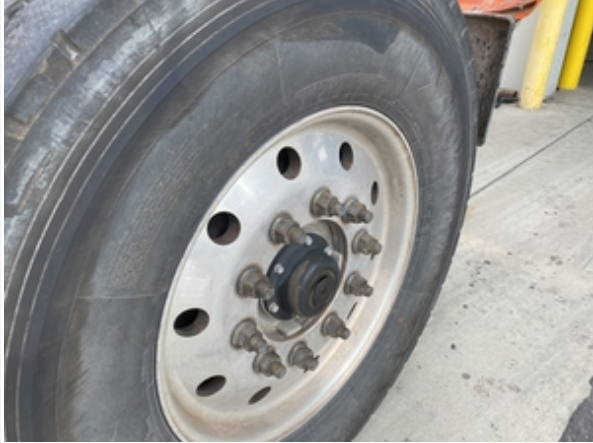
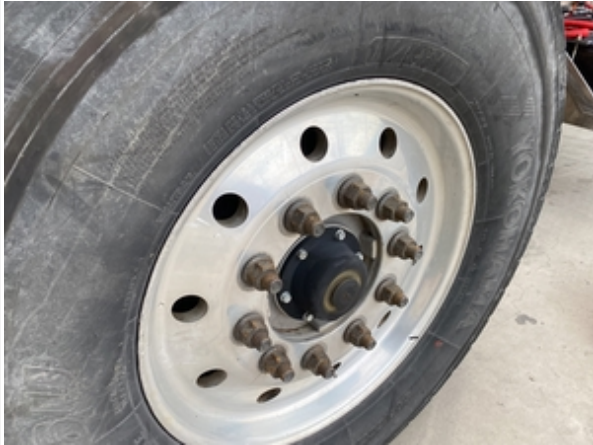
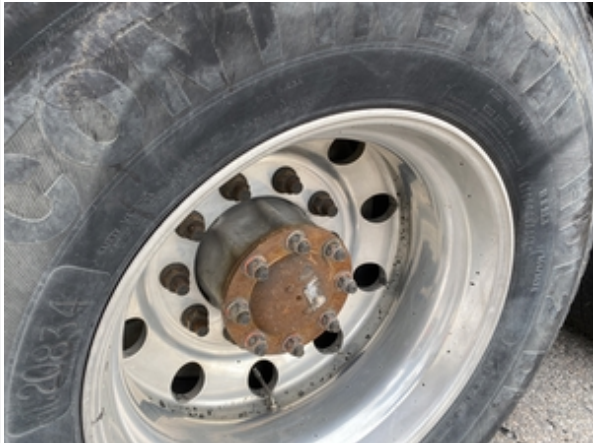
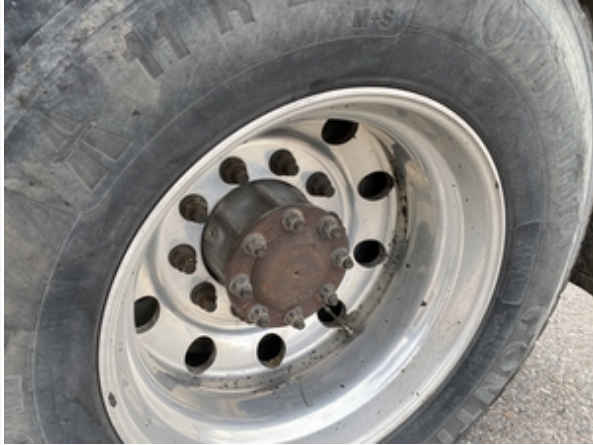
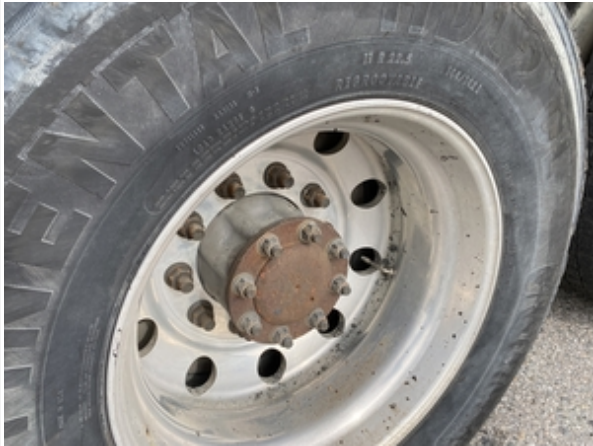
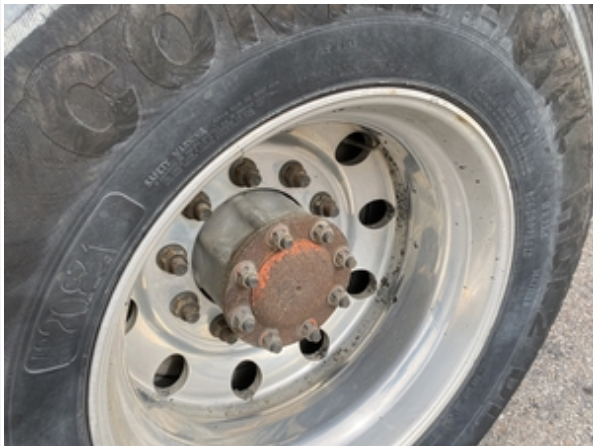
Wheels & Hub Condition	3
Wheels & Hub Photos

Wheel Seal Leaks	No	
Tire Brand	Rear - Continental Front - Yokohama	
Tire Size	Rear - 11R 22.5. Front - 315/80R/22.5	
Front Left Tire - Ratio Remaining	50%

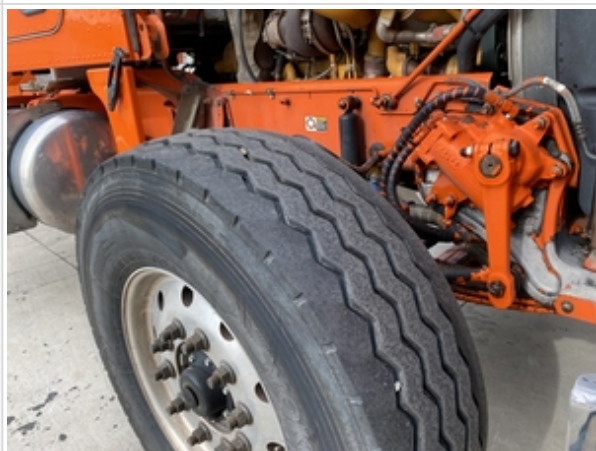
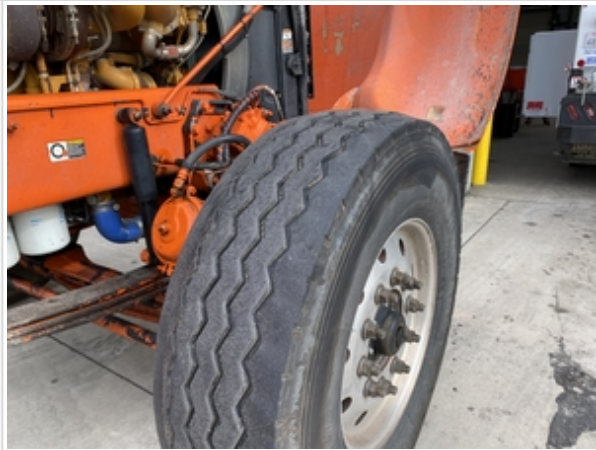
Front Right Tire - Ratio Remaining	50%
Front Right Tire Photos

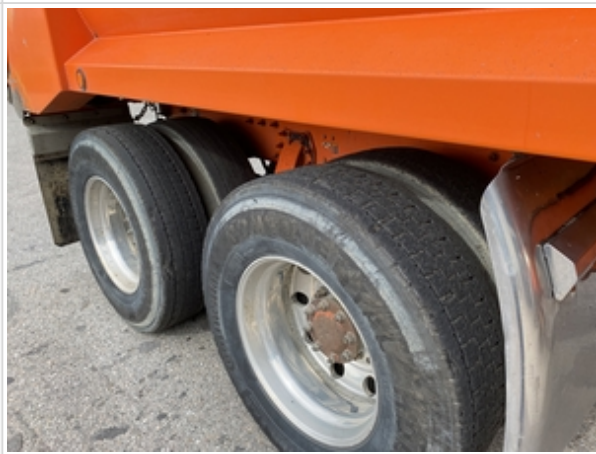
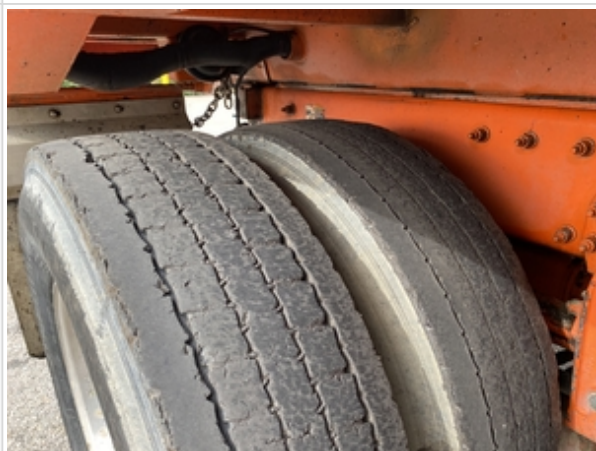
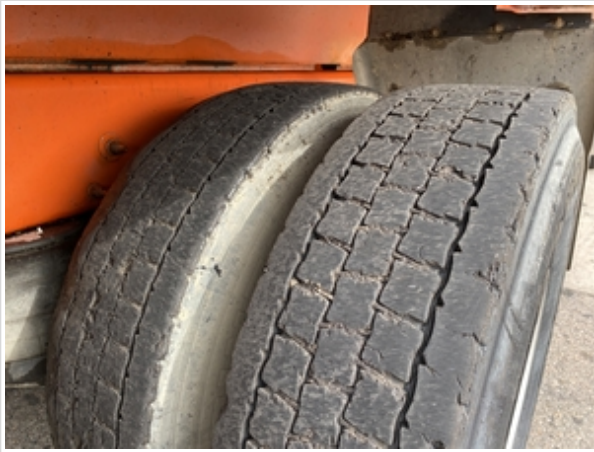
Rear Right Tire - Ratio Remaining	10%	
Rear Right Tire Photos

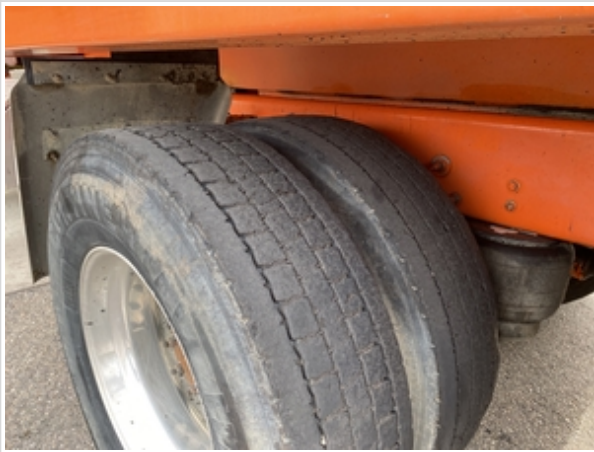
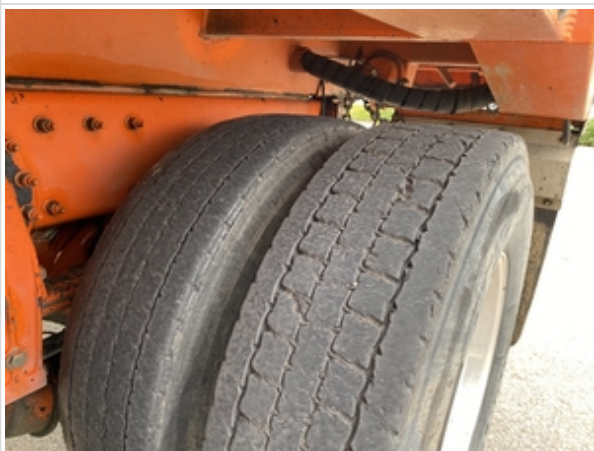
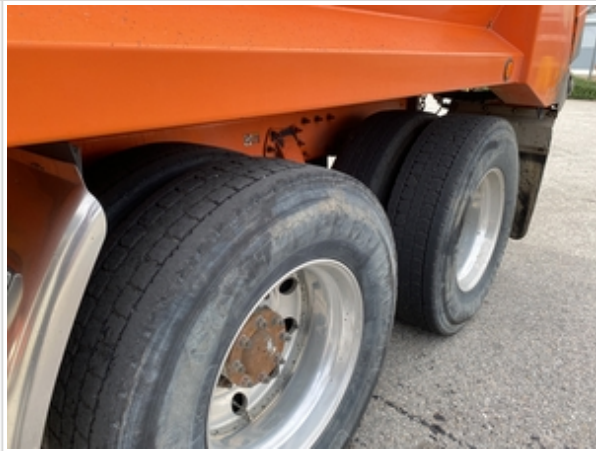
Rear Left Tire - Ratio Remaining	10%
Rear Left Tire Photos

What Needs Work	All rear tires and brake shoes will need to be replaced soon. Dump body drop down function, struggles and should be addressed for ease of functioning. Minor seepage seen from engine oil pan gasket and bell housing cover plate. Batteries may need to be replaced and/or charging system checked.
Date/Time	01-12-2023

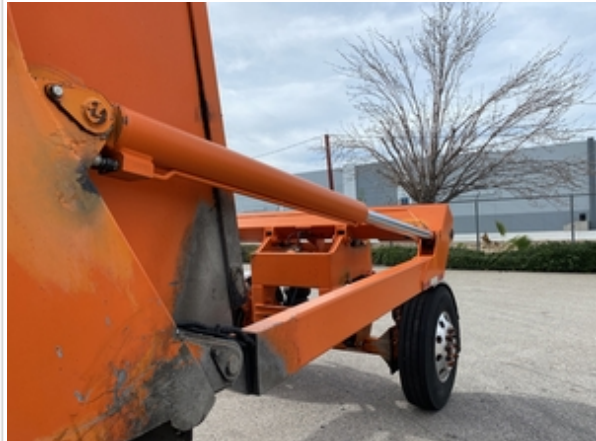
Instructions	Check the condition of additional axle(s), wheels & tires. Note any damage or wear. Take photos.
Axle Description & Position	Strong Arm Hydraulic Drop Down Axle
Steerable?	No
Drop Axle?	Yes
Super Dump?	Yes
Weight Rating	12,000Lbs.
Axle Condition	3 - Normal Wear & Tear
Axle Condition Photos

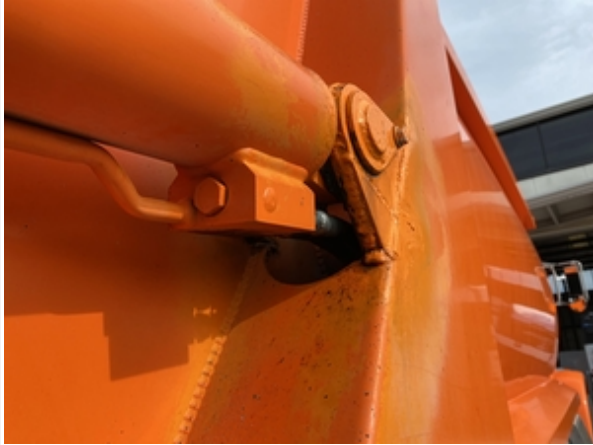
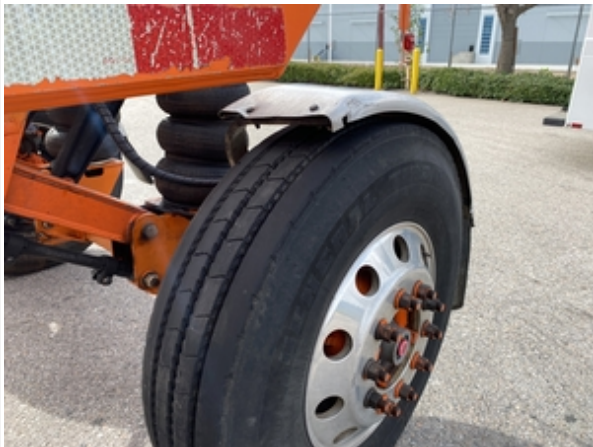
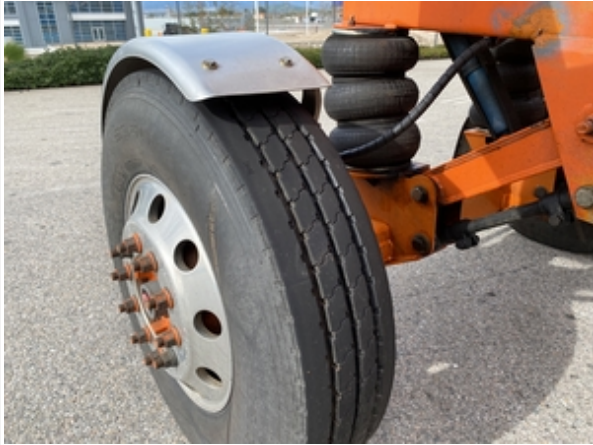
Wheels & Tires	3 - Normal Wear & Tear	
Wheels & Tires Photos

Tire Brand	AmeriSteel	
Tire Size	11R22.5	
Left Tire(s) Ratio Remaining	90%	
Right Tire(s) Ratio Remaining	90%
