Inspection Report (On-Highway Dump Truck)

Year	2011
Make	Peterbilt
Model	367
Serial Number	1NPTLU0XXBD127979
Truck Odometer Reading	423,762
Previous Application (e.g., earth moving, mining, demolition, etc)	Asphalt Paving Construction

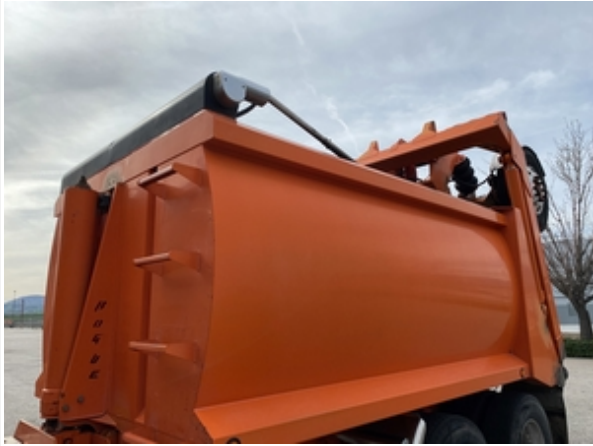
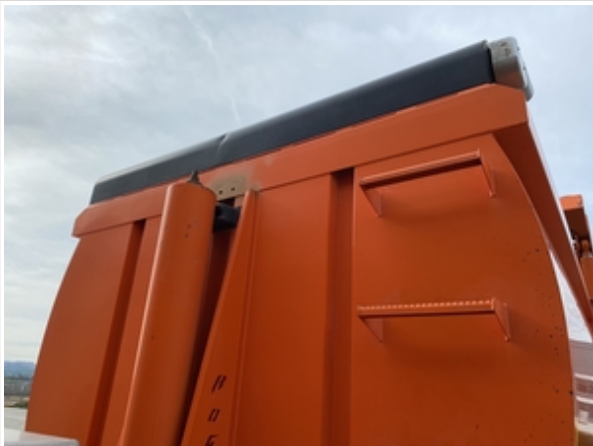
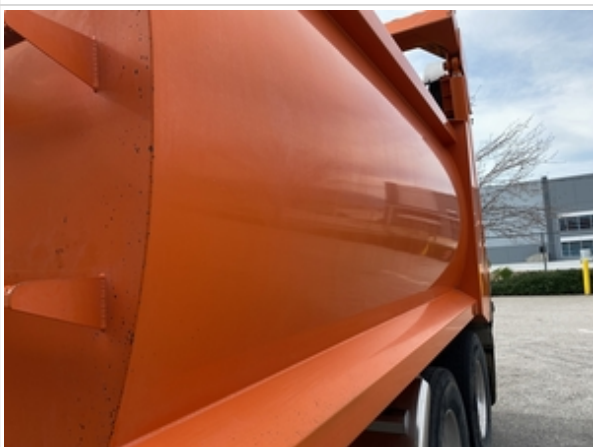
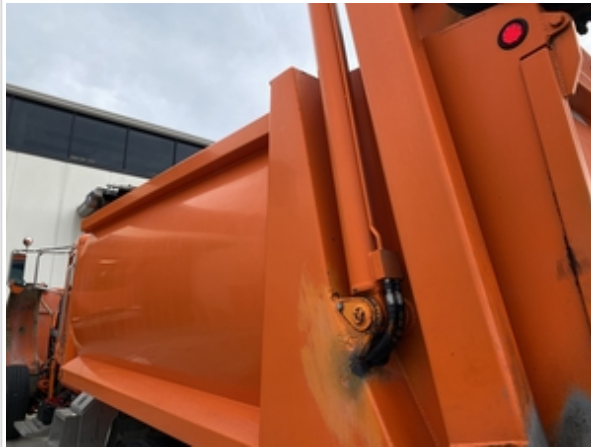
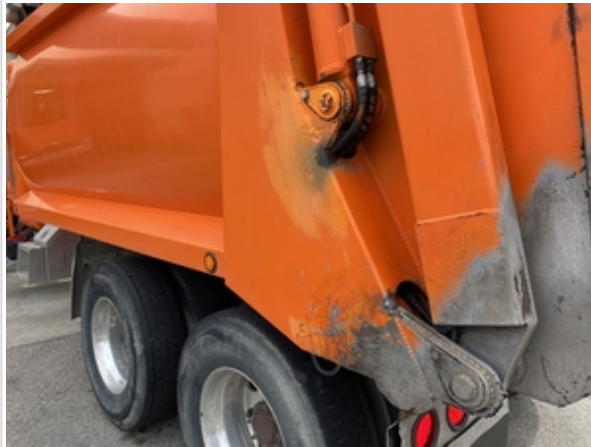
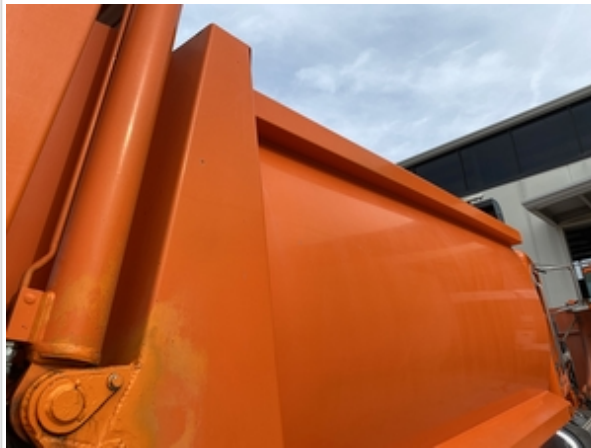
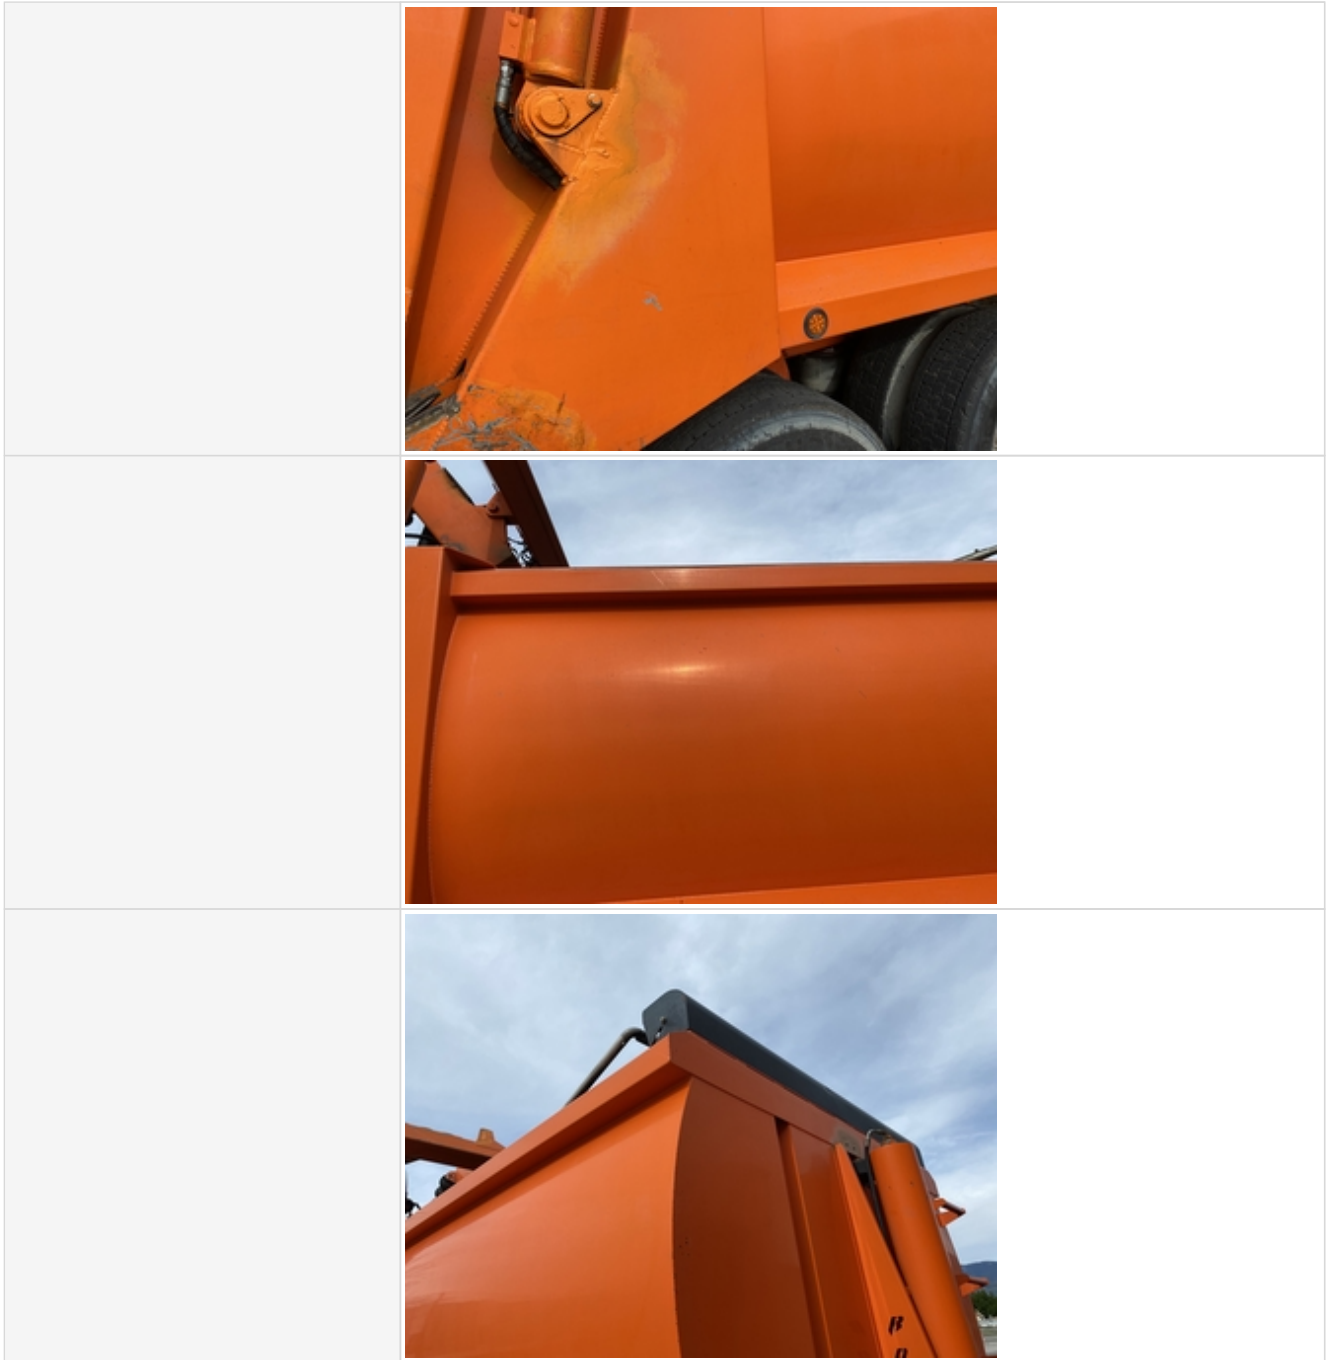
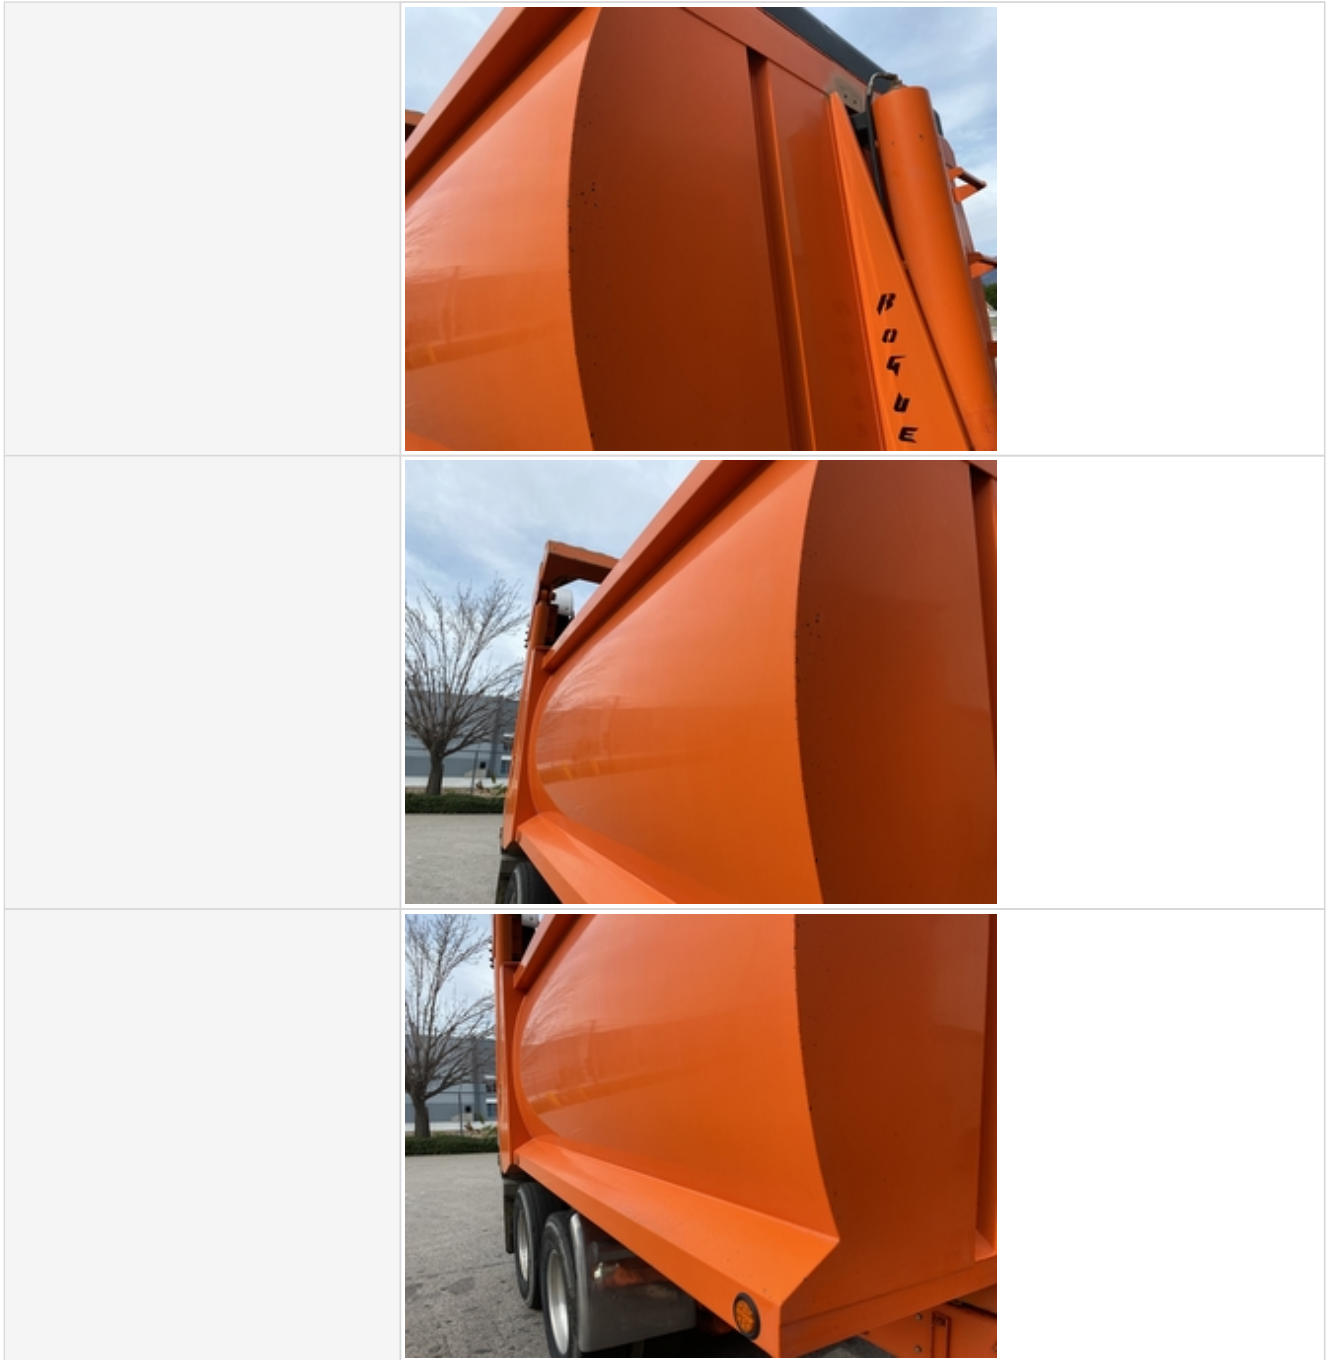
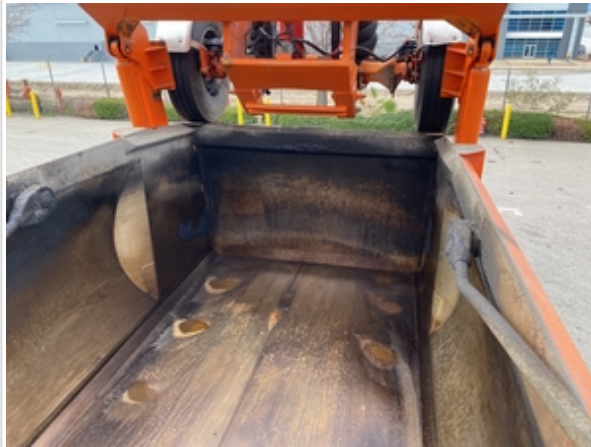
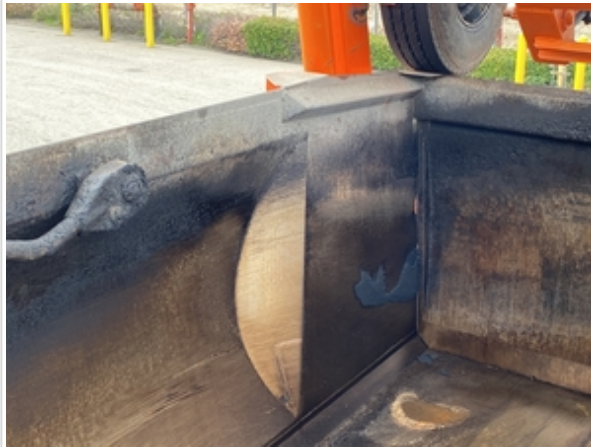
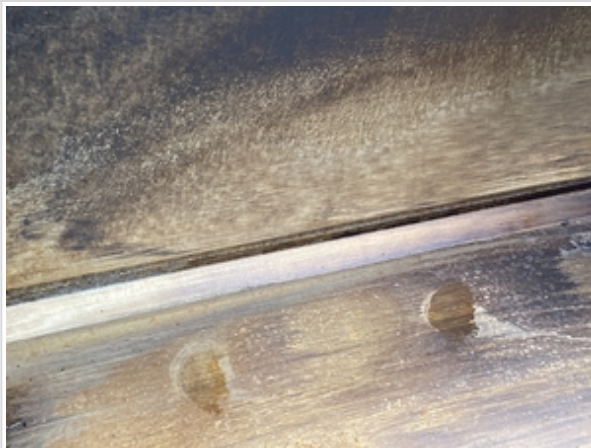
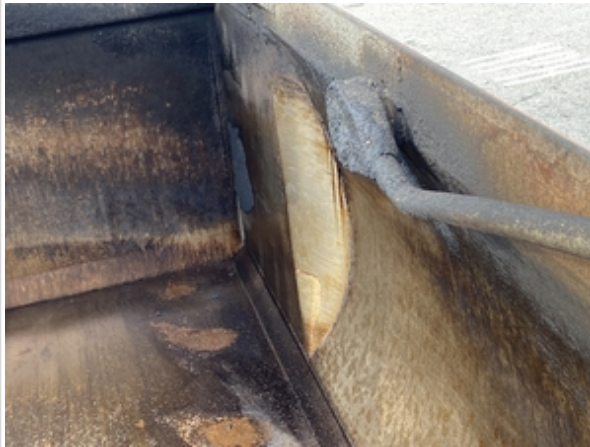
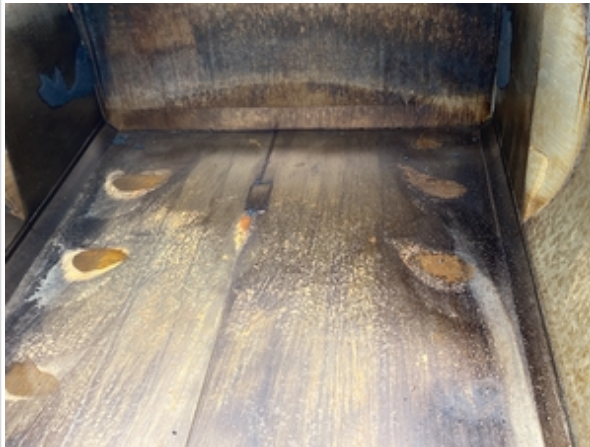
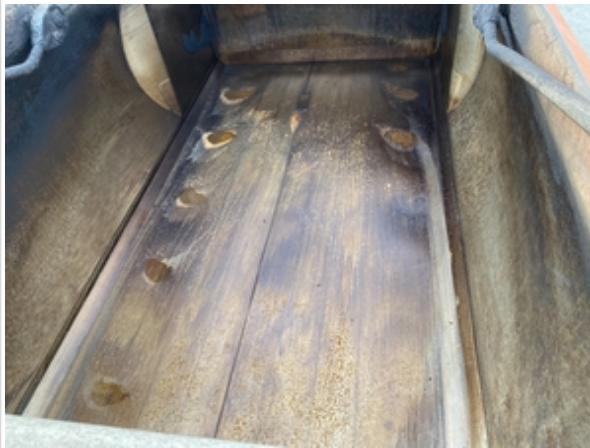
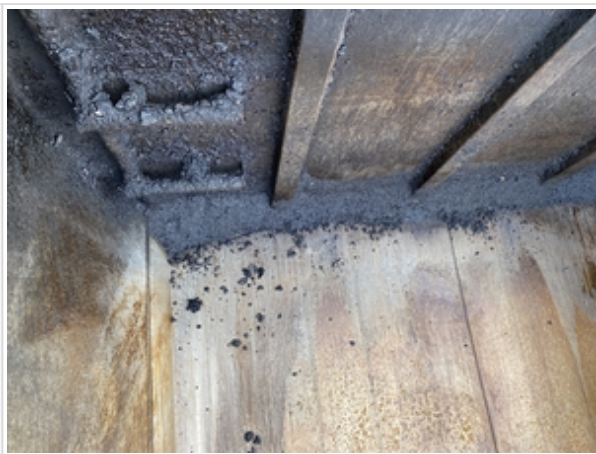
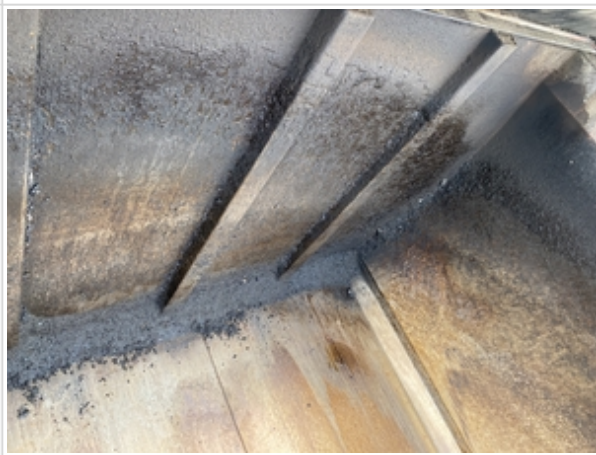
Dump Body Make & Material	Rogue
Dump Body Length (ft and inches)	14'
Dump Body Height (ft and inches)	5'
Bed Body	3 - Normal Wear & Tear
Bed Body Photos

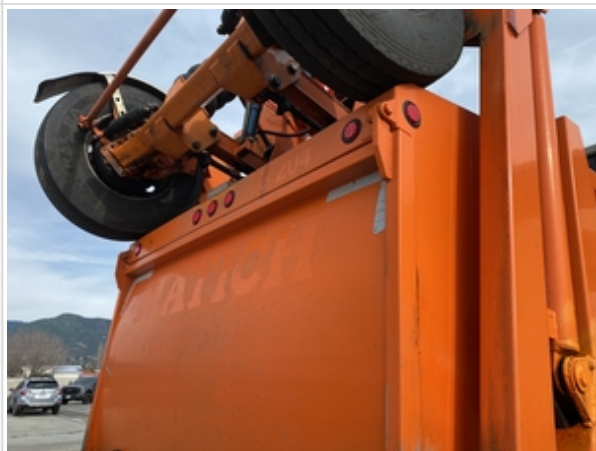
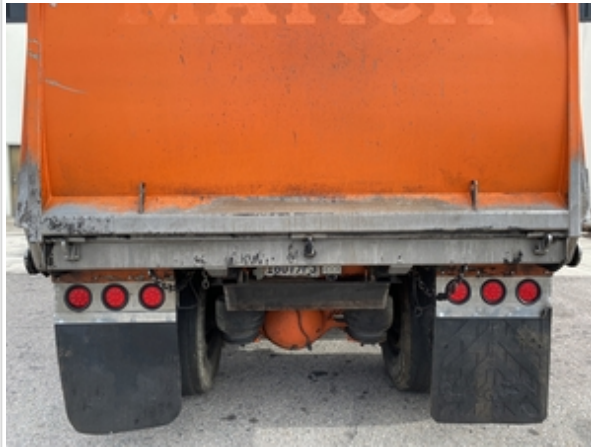
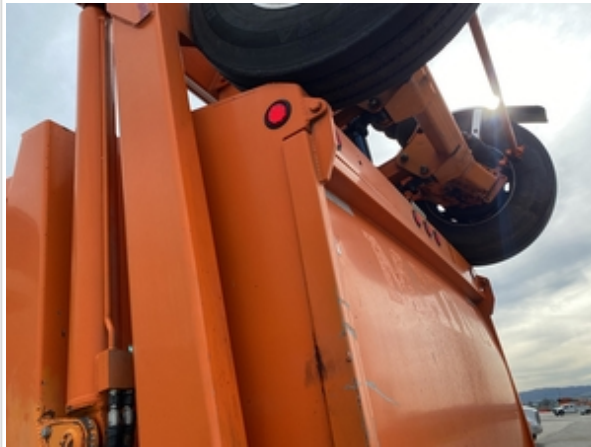
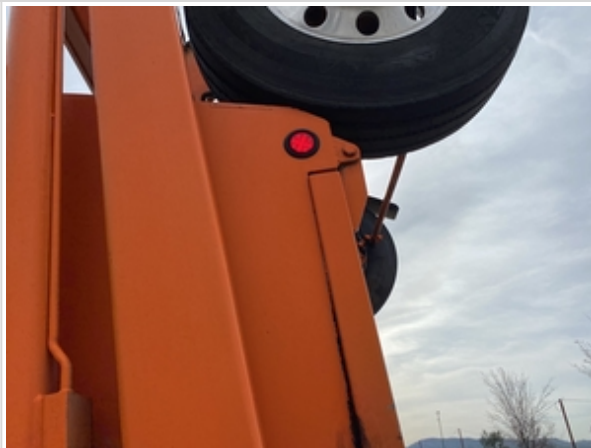
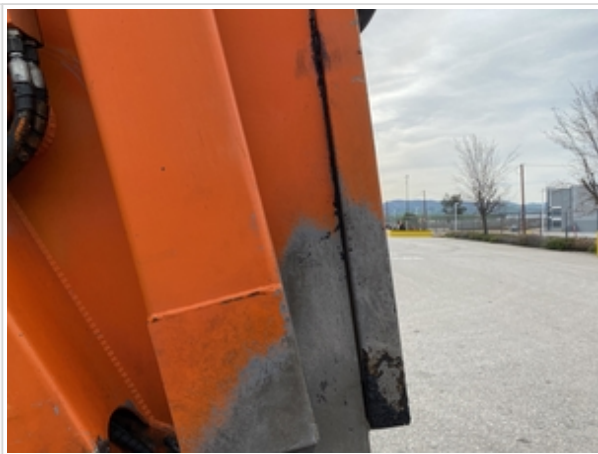
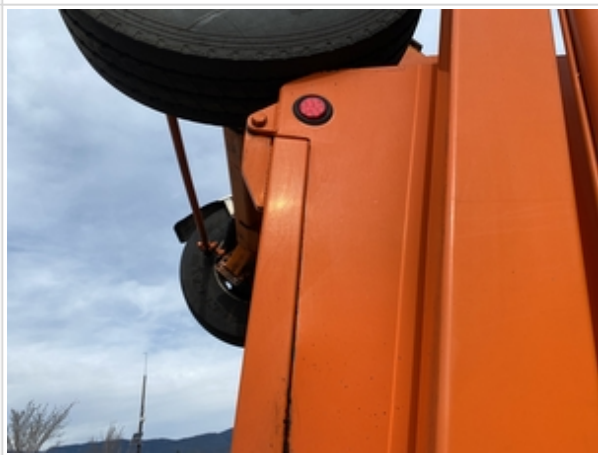
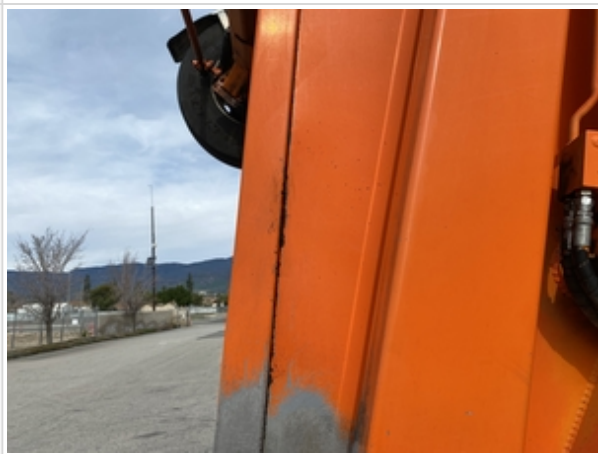
Tailgate	3 - Normal Wear & Tear	
Tailgate Photos

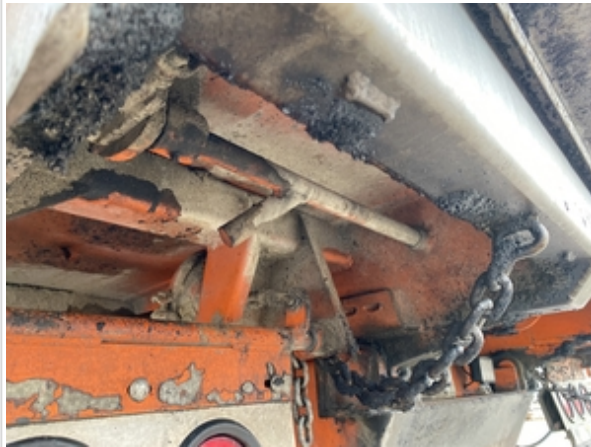
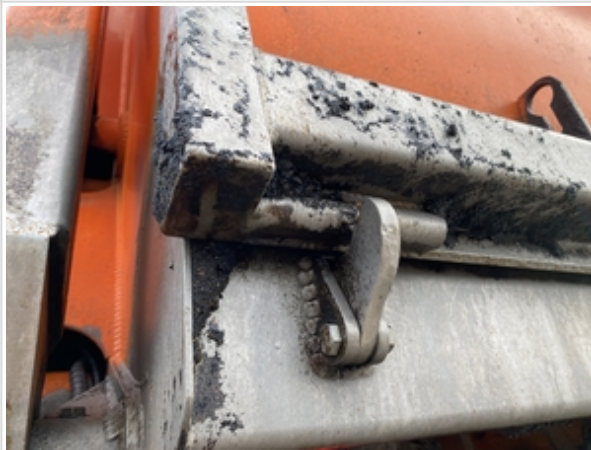
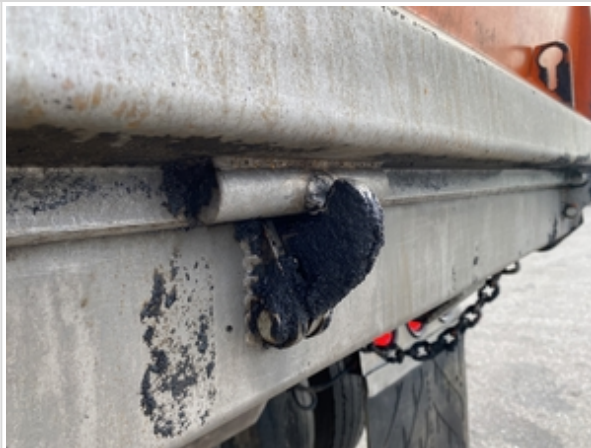
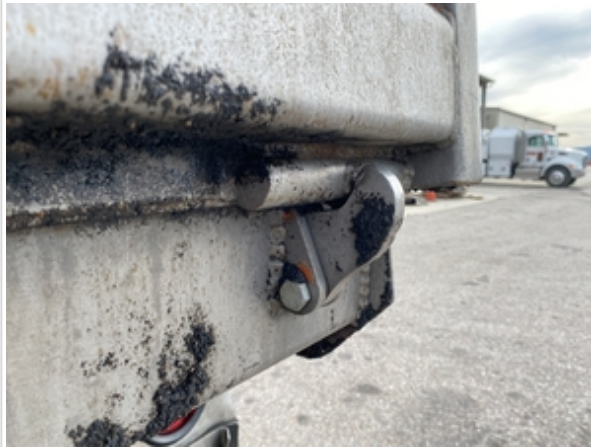
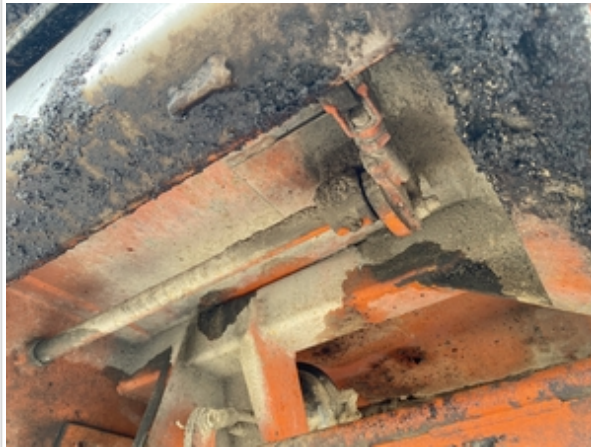
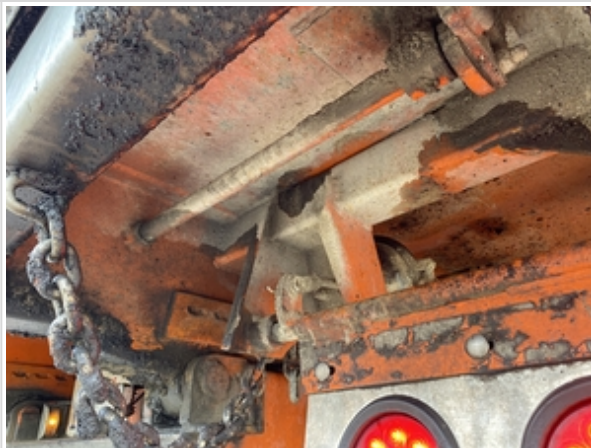
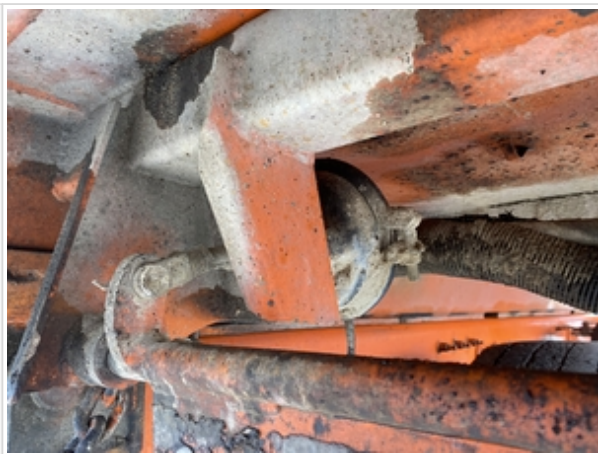
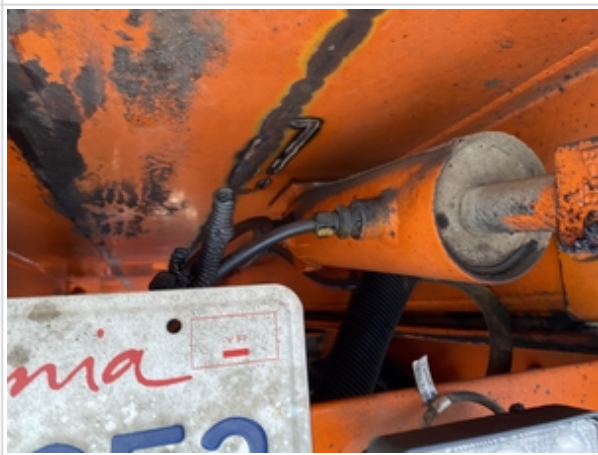
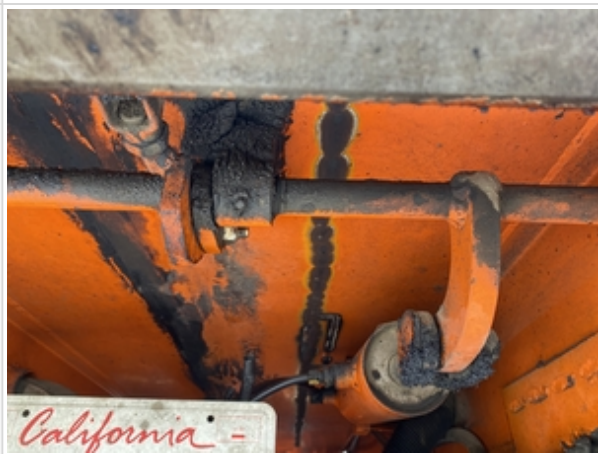
Tailgate Latch Photos

Tailgate Latch	3 - Normal Wear & Tear

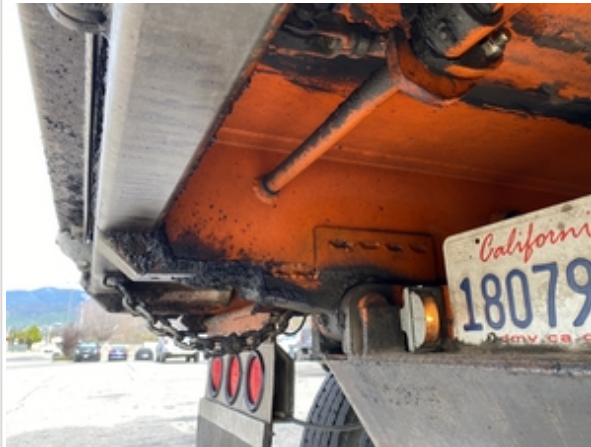
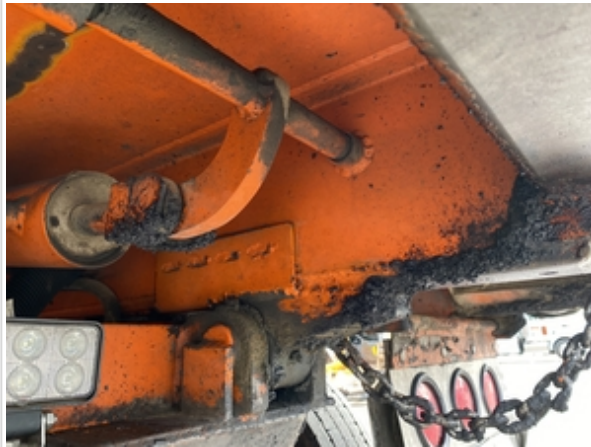
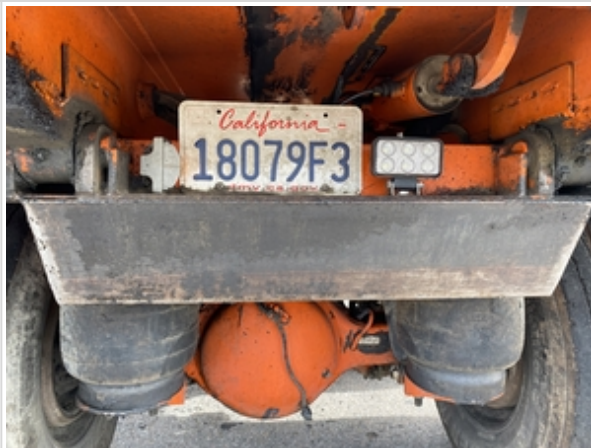
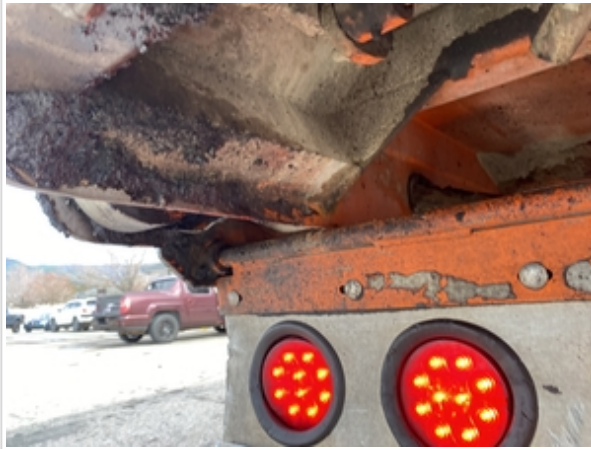
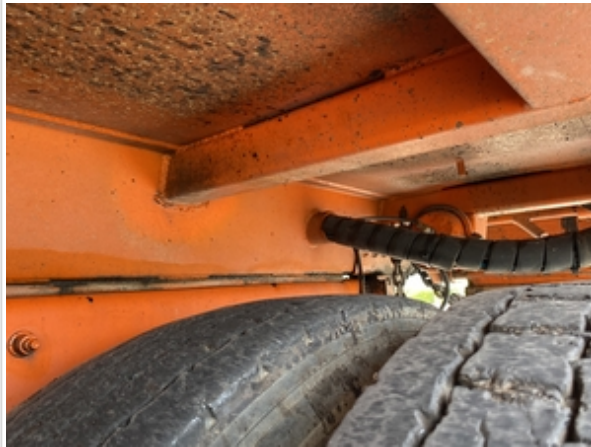
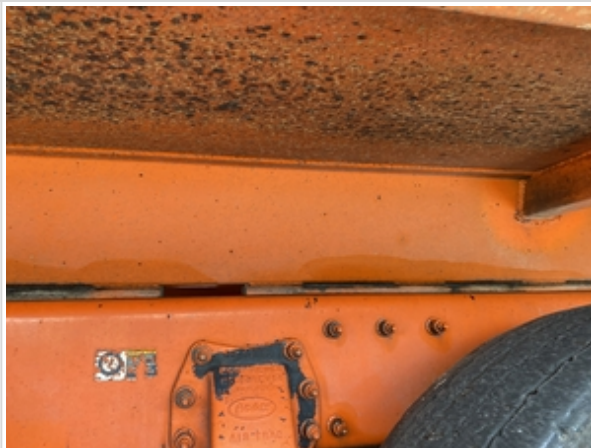
Support Frame Photos

Support Frame	3 - Normal Wear & Tear

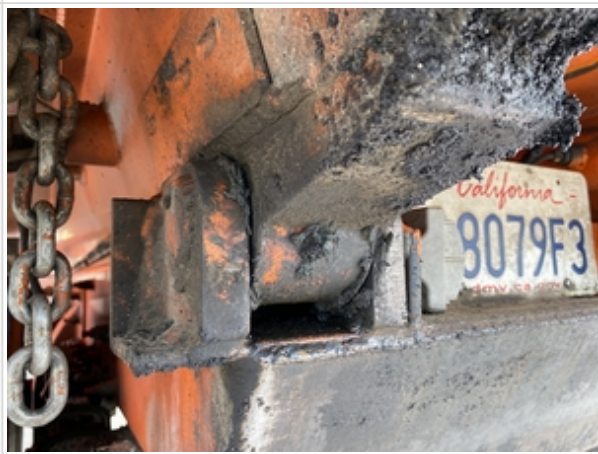
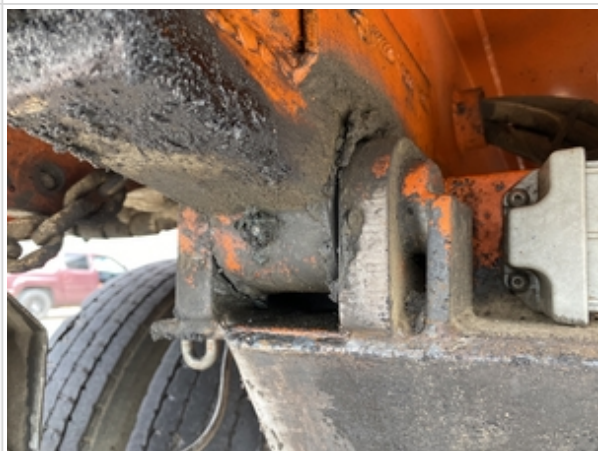
Hinge Points	3 - Normal Wear & Tear	
Hinge Point Photos

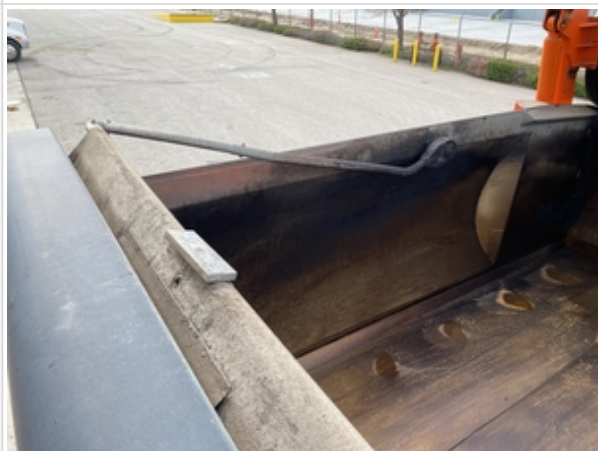
Tarp	3 - Normal Wear & Tear	
Tarp Photos

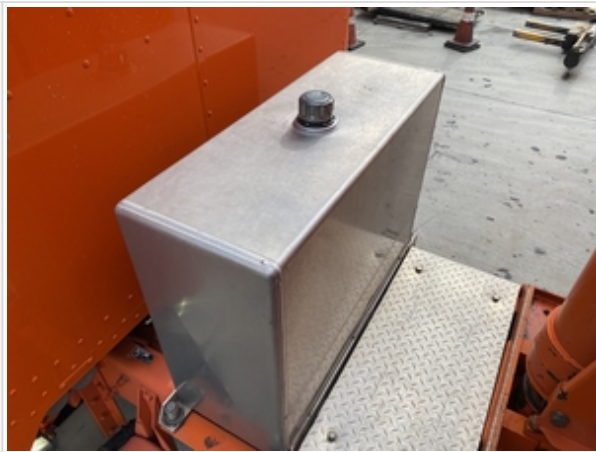
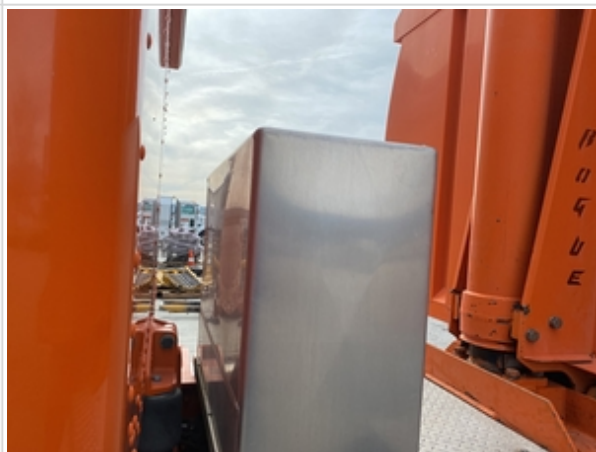
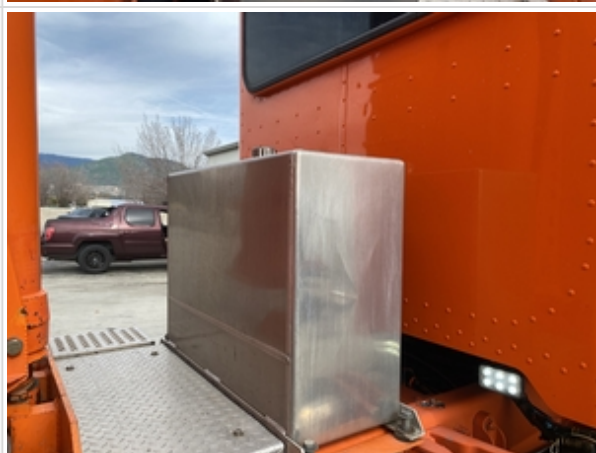
Hydraulic Tank Photos

Hydraulics	Check the condition of the hydraulics. Check lines, hoses, fittings, leaks, function, etc. Note any damage or wear. Take photos.
Hydraulic Tank	3 - Normal Wear & Tear

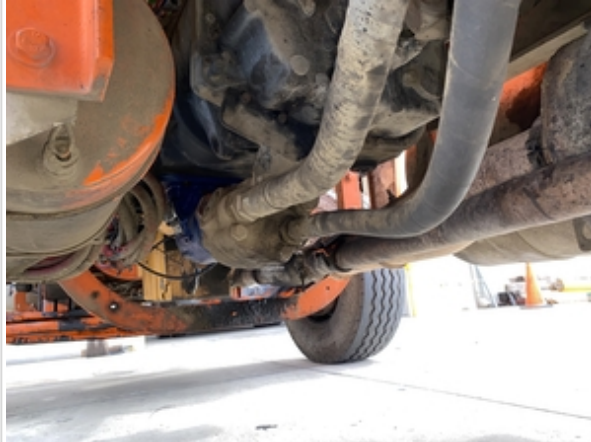
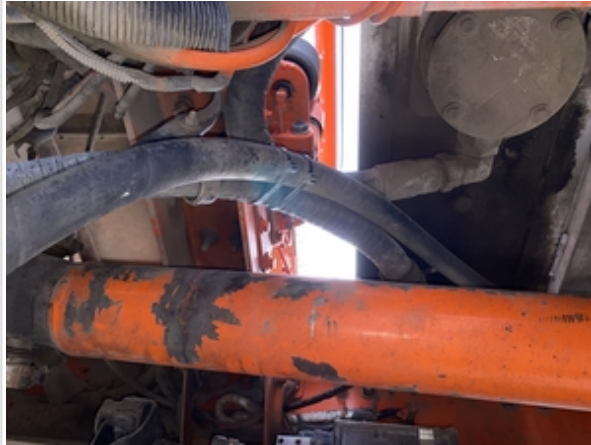
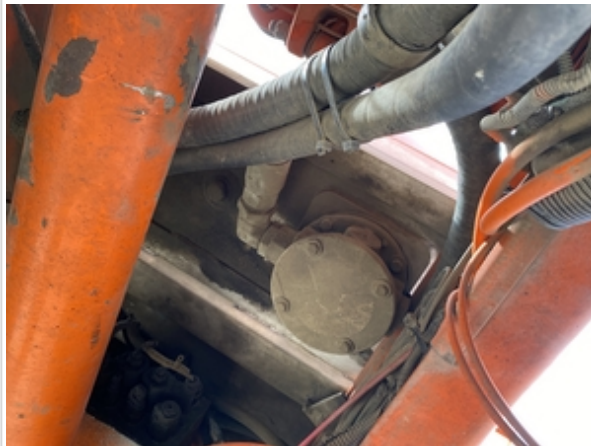
Hose Photos

Hoses	3 - Normal Wear & Tear

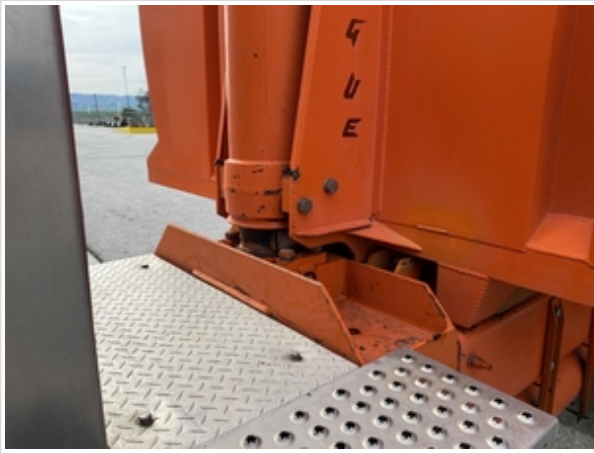
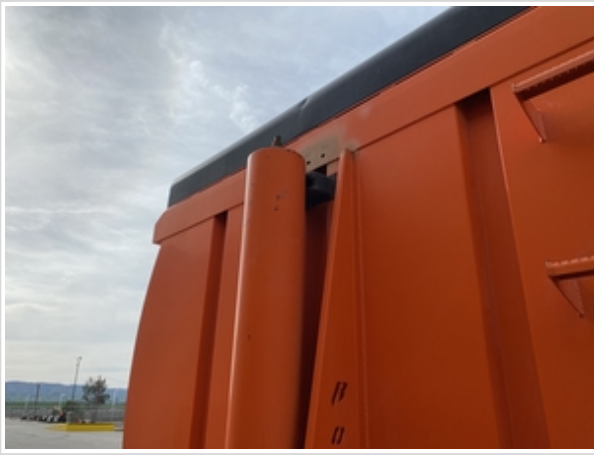
Hydraulic Cylinders	3 - Normal Wear & Tear
Hydraulic Cylinder Photos

Hydraulic Function	3 - Normal Wear & Tear
Comments	Dump body lift cylinder works well when raised. When dump body cylinder telescopes in, it struggles a bit and requires the strong arm drop axles assistance for quicker response .

What Needs Work	All rear tires and brake shoes will need to be replaced soon. Dump body drop down function, struggles and should be addressed for ease of functioning. Minor seepage seen from engine oil pan gasket and bell housing cover plate. Batteries may need to be replaced and/or charging system checked.
Date/Time	01-12-2023
