Inspection Report (On-Highway Flatbed Truck)

Year	2014
Make	Trailking
Model	TK80HT-482
Serial Number	1TKA04825EM013367
Truck Odometer Reading	N/A
Current Inspection / State Cert / DOT	Inspected 9/2022 per 49 CFR, Part 396, FMCSR
Previous Application (e.g., earth moving, mining, demolition, etc)	EQUIPMENT RENTAL HAULER

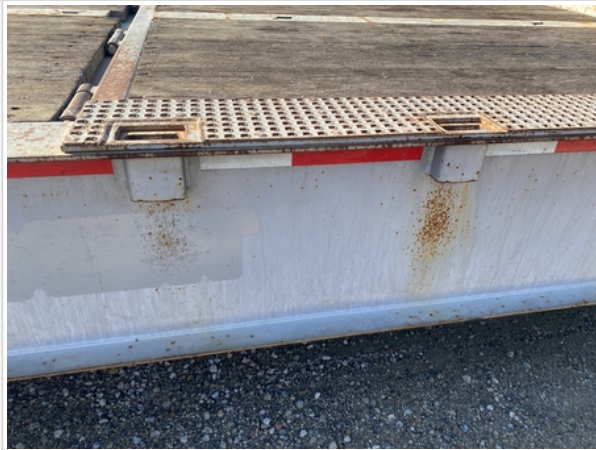
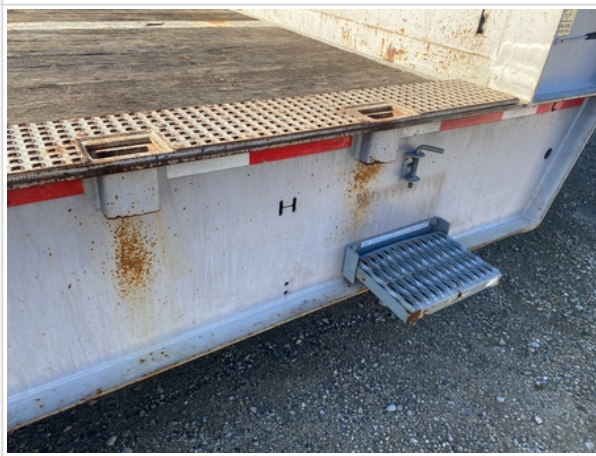
Body Panels	3 - Normal Wear & Tear
Body Panel Condition	No visible damage, good paint condition and panel fitment, Other (see comments)
Comments	Front, top deck, storage lids slightly bent
Doors / Canopy Latches	3 - Normal Wear & Tear
Doors / Canopy Latches Condition	No visible damage
Steps / Ladders	3 - Normal Wear & Tear
Steps / Ladders Condition	Steps/ladders are fully intact and appear structurally sound
Handrails	0
Glass	0
Mirrors	0
Exterior Lights	3 - Normal Wear & Tear
Exterior Lights Condition	No visible damage, lighting system is operational, Other (see comments)
Comments	Unable to test lighting system with tractor connected

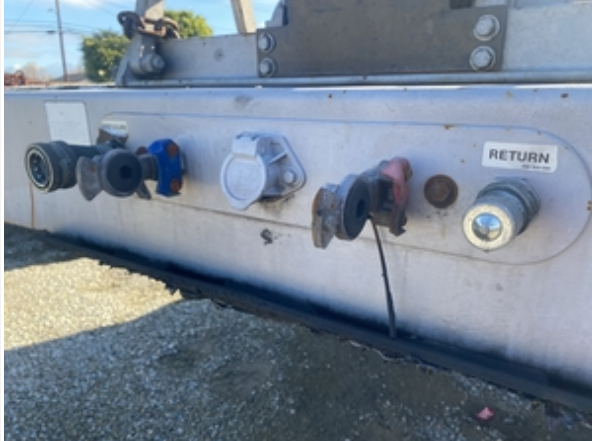
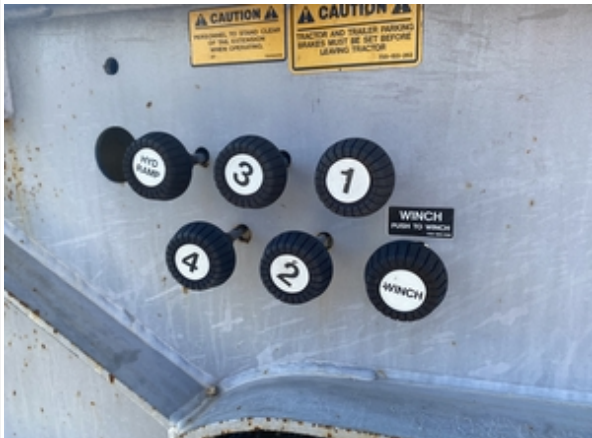
Odometer Activity	0	
Controls/Switches/Gauges	3 - Normal Wear & Tear	
Controls/Switches/Gauges Condition	Other (see comments)	
Comments	All control levers look to be in good functioning condition unable to test with tractor and PTO connected	
Controls/Switches/Gauges Photos

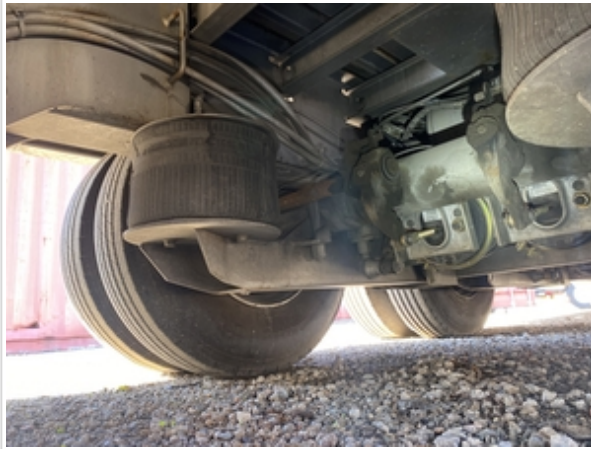
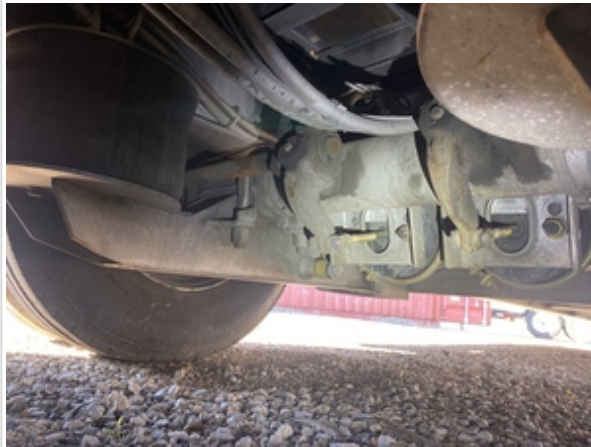
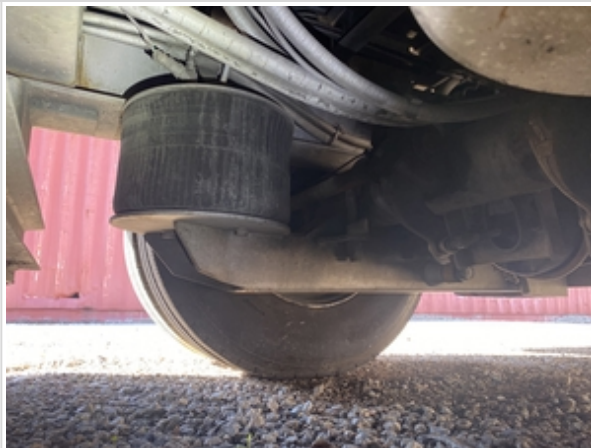
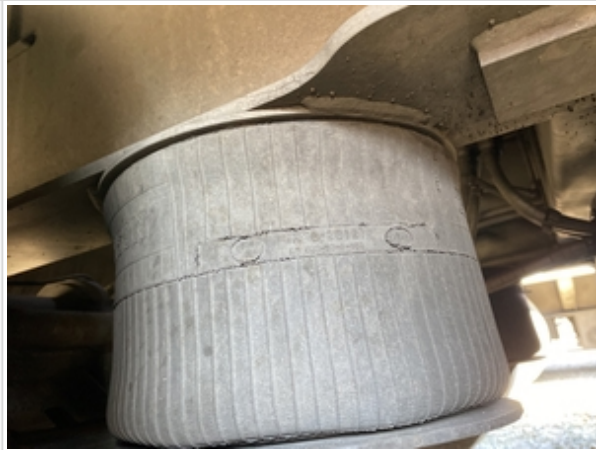
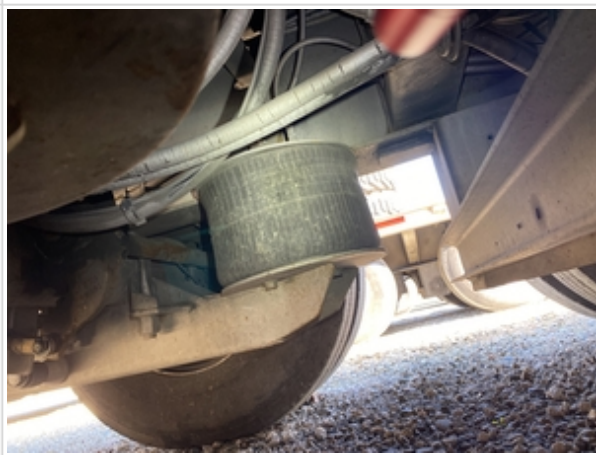
Frame	3 - Normal Wear & Tear	
Suspension	3 - Normal Wear & Tear	
Steer Axle Condition	3 - Normal Wear & Tear	
Comments	*Rear drive axles	
Steering Components	0	
Overall Chassis Condition	3 - Normal Wear & Tear	
Overall Chassis Comments	Trailer chassis has good appearance with no obvious issues observed during the inspection.

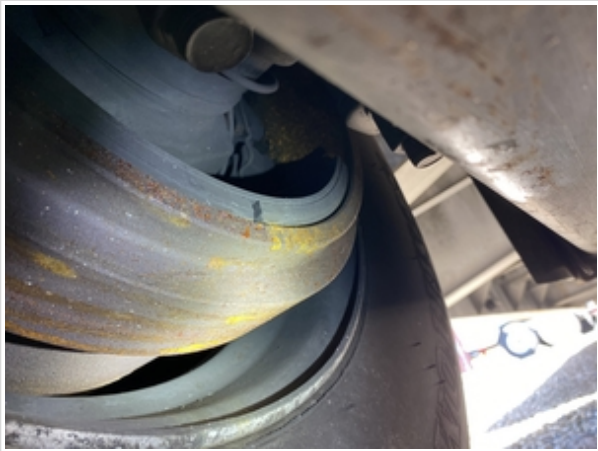
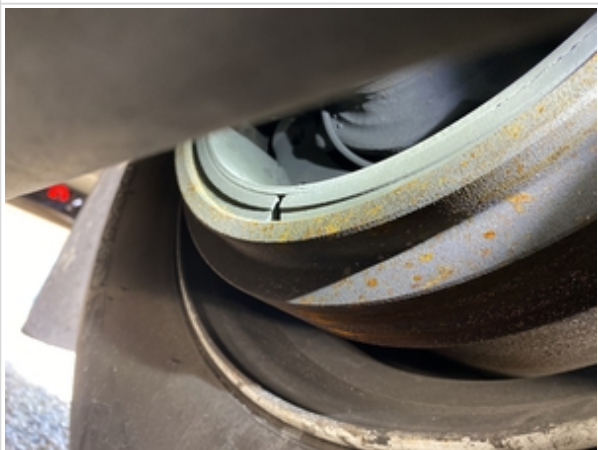
Differential	Check condition of the differential(s). Take photos and notes as relevant.	
Rear Differential	0	
Front Differential	0	
Brake Shoe Thickness	50%	
Comments	Front @40-50% Rear @80%	
Brake Shoe Photos

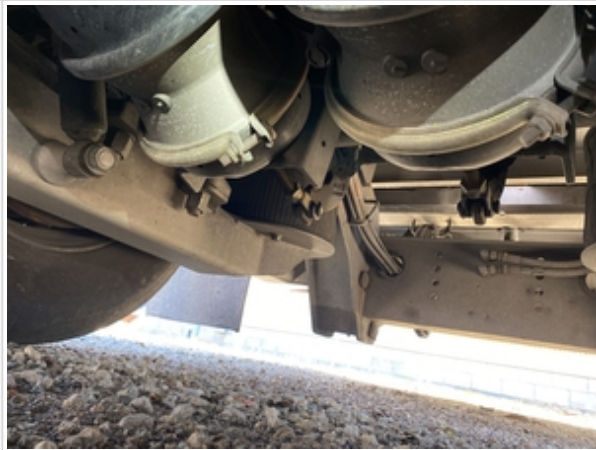
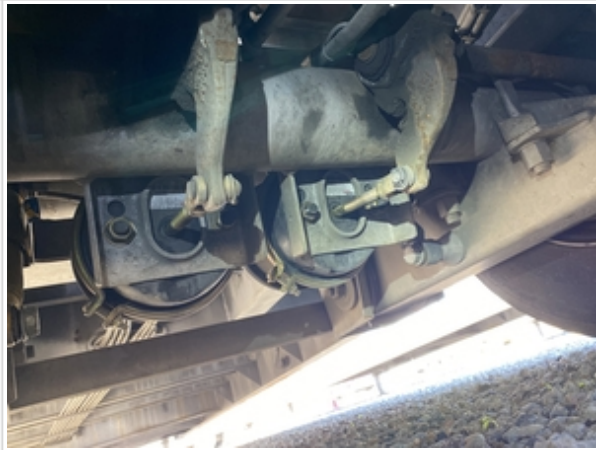
Air Brake System Leaks	N/A	
Air Brake Hose Condition	3 - Normal Wear & Tear	
Comments	Unable to test air system	
Air Brake System Photos

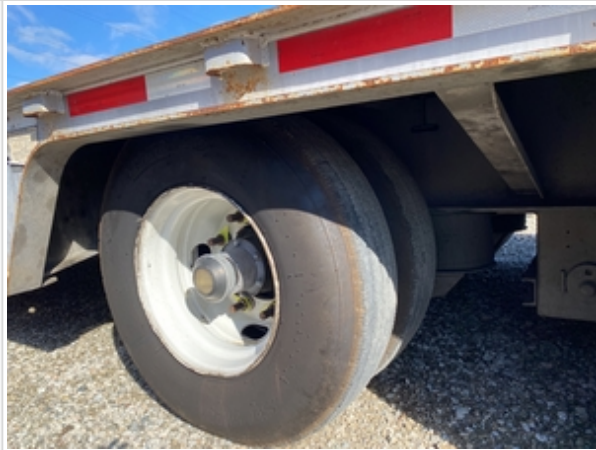
Wheel Seal Leaks	No	
Tire Brand	Sumitomo ST 727	
Tire Size	10R/17.5	
Front Left Tire - Ratio Remaining	70%	
Front Left Tire Photos

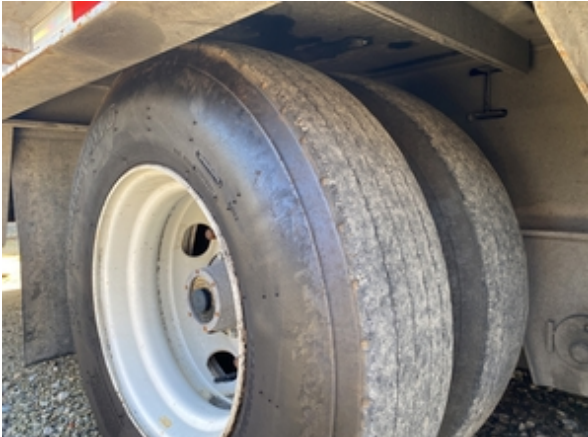
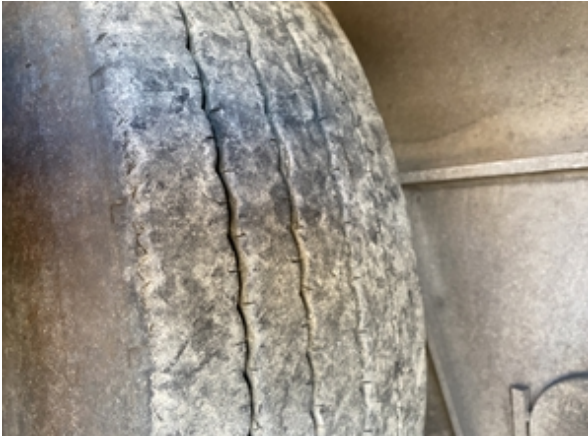
Rear Right Tire - Ratio Remaining	10%	
Rear Right Tire Photos
