Inspection Report (Telehandler)

Year	2013
Make	SKYTRAK
Model	10054
Serial Number	0160055292
Hour Meter Reading	4,211 Hours
Previous Application (e.g., earth moving, mining, demolition, etc)	Equipment Rentals

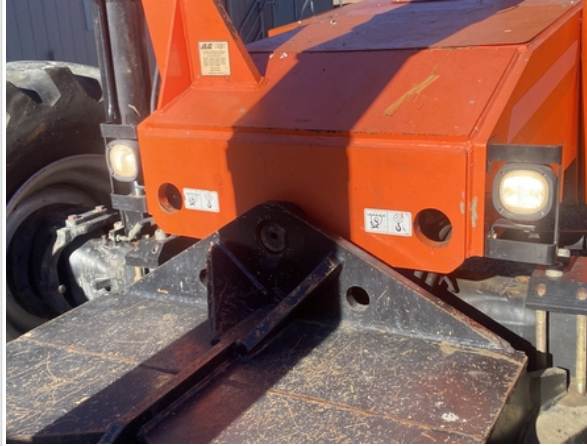
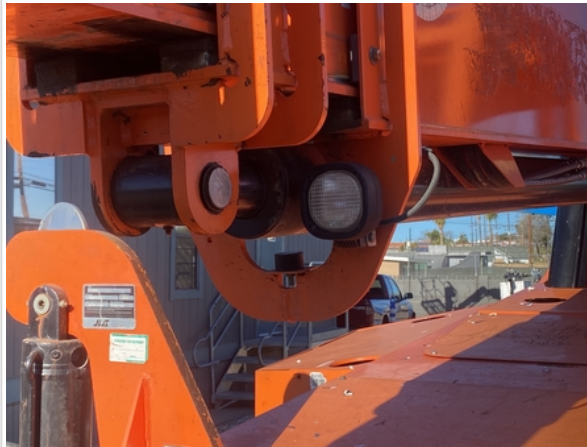
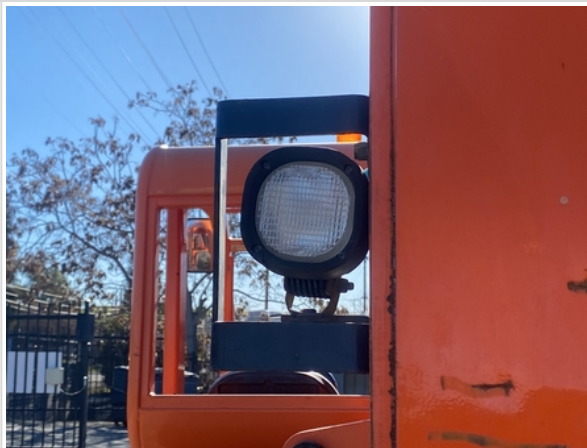
Exterior Lights Photos

Body Panels	3 - Normal Wear & Tear
Body Panel Condition	No visible damage, good paint condition and panel fitment, Other (see comments)
Comments	Minor scuff marks all the way around, minor damage to rear door grill
Doors / Canopy Latches	3 - Normal Wear & Tear
Doors / Canopy Latches Condition	Other (see comments)
Comments	Rear door latch sticking (still locks closed, have to use small screwdriver to assist unlatching)
Steps / Ladders	3 - Normal Wear & Tear
Steps / Ladders Condition	Steps/ladders are fully intact and appear structurally sound
Handrails	3 - Normal Wear & Tear
Handrails Condition	Handrails are fully intact and appear structurally sound
Glass	0
Mirrors	3 - Normal Wear & Tear
Mirror Condition	Mirrors present and intact, no visible damage
Exterior Lights	3 - Normal Wear & Tear
Exterior Lights Condition	Other (see comments)
Comments	Bottom 2 front lights okay, other lights inoperable

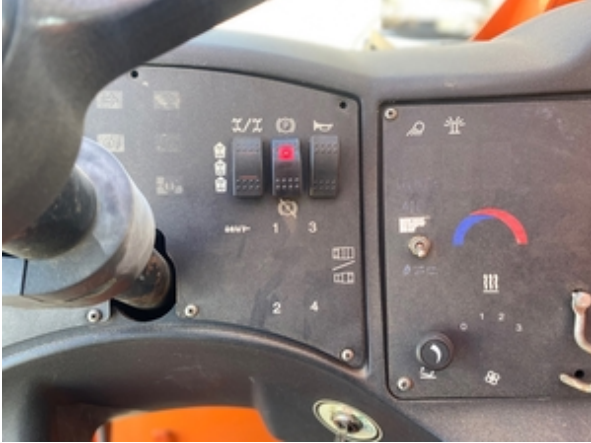
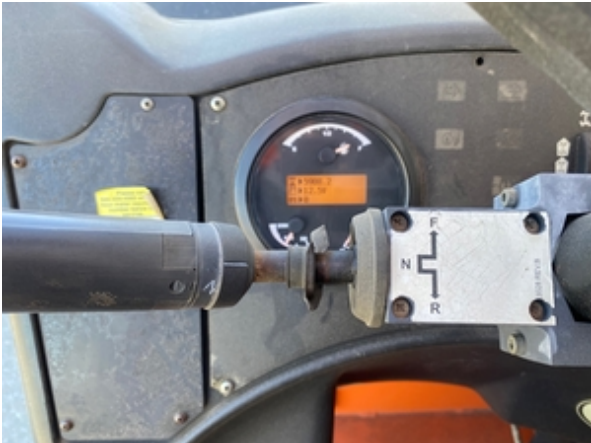
Controls & Switches Photos

Operator Cabin Overall	3 - Normal Wear & Tear
Operator Cabin Overall Condition	Minor cosmetic wear to cabin surfaces, floors, panels, and ceiling, Good cabin appearance, solid floors, panels, and ceiling
Operator Seat	3 - Normal Wear & Tear
Operator Seat Condition	Seat(s) in good condition, no stains or tears in upholstery
Cabin Lights	0
Safety Lock Out / Stop	3 - Normal Wear & Tear
Safety Lock Out / Stop Condition	Safety lock out device is present, in good condition, and functional
Controls & Switches	3 - Normal Wear & Tear
Controls & Switches Condition	All switches are installed and functional

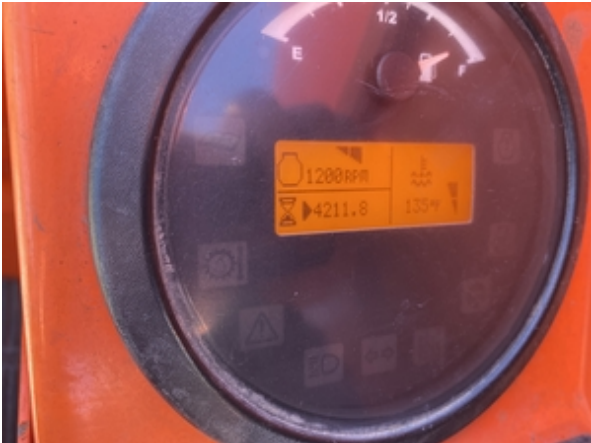
Hour Meter Activity	3 - Normal Wear & Tear
Hour Meter Condition	Hour meter is functional and in good condition
Hour Meter Activity Photos

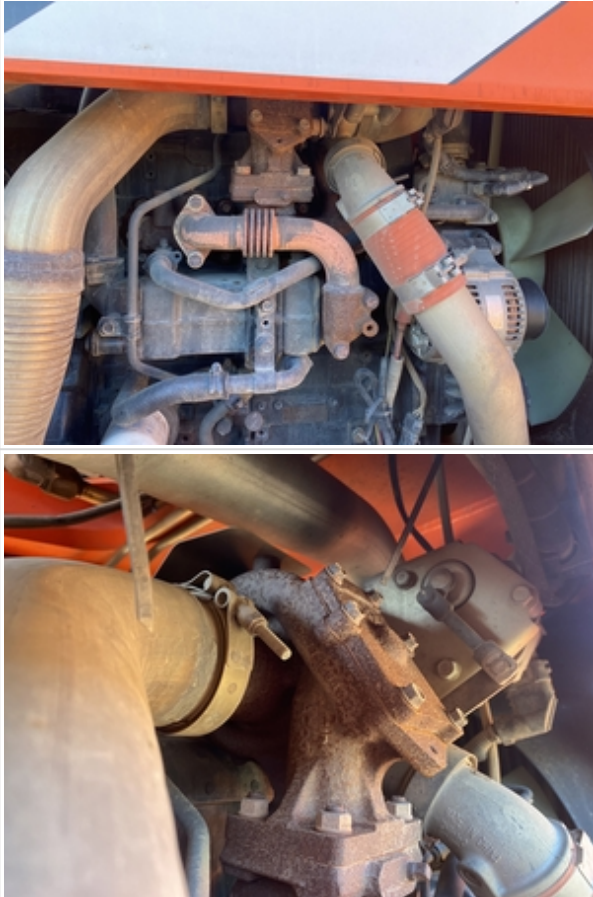
Engine Type (Make, Model, Cylinders, Hp)	Cummins - QSB 3.3 - 4Cyl. - 100HP
Emissions Tier	Tier 3
Engine Serial Number	68607267
Engine Fuel Type	Diesel
Engine Photos

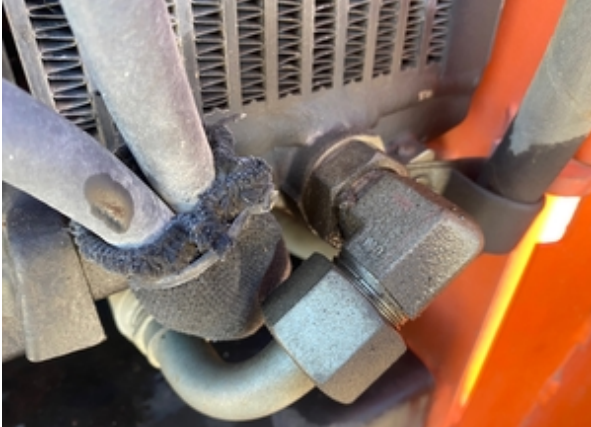
Radiator	2 - Above Average Wear
Radiator Condition	Radiator fins & components appear to be in good working order, no signs of damage or leaks, Other (see comments)
Comments	Possible leakage seen from fittings at radiator
Radiator Photos

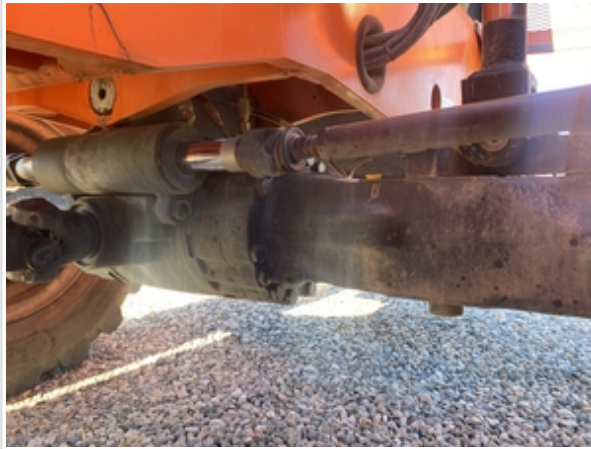
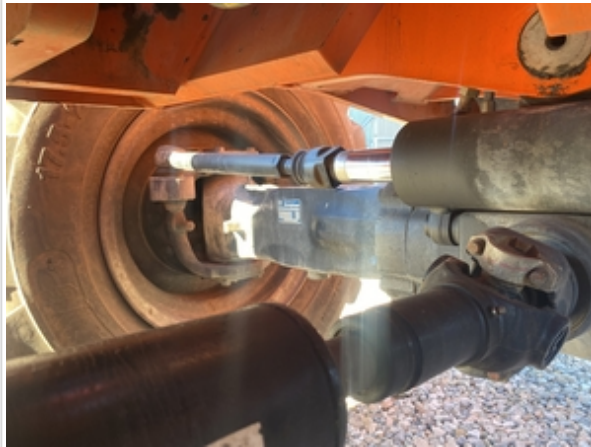
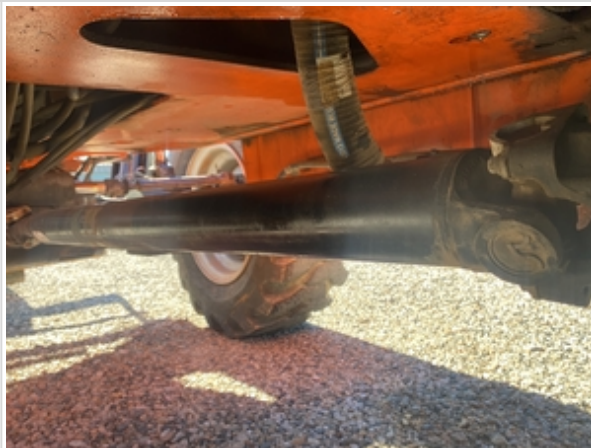
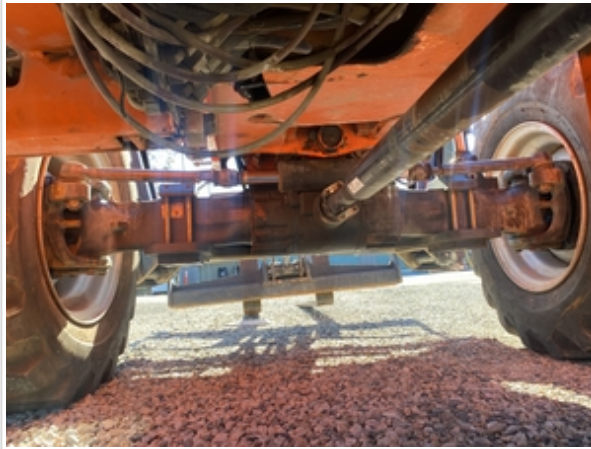
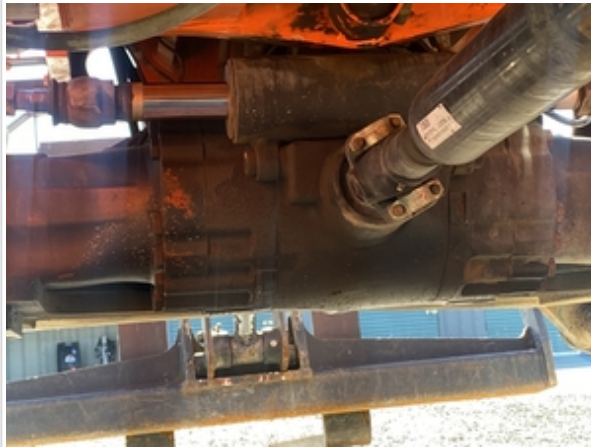
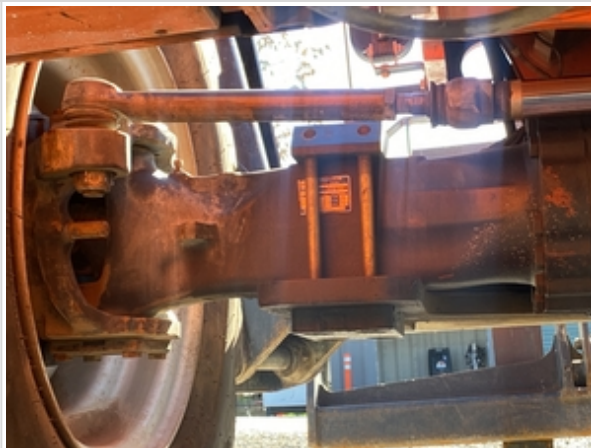
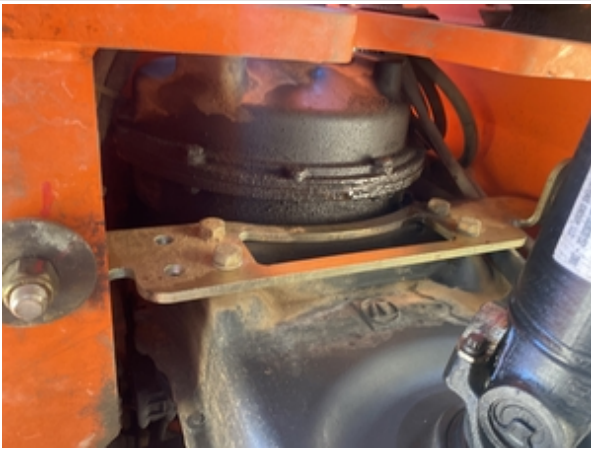
Hydrostatic Transmission?	No
Transmission Info (Make/Model/Speeds)	Powershift 4 Speed Forward 3 Speed Reverse
Transmission	3 - Normal Wear & Tear
Transmission Condition	Other (see comments), No unusual noises or vibrations
Comments	Residual oil buildup seen around Top Side of Transmission

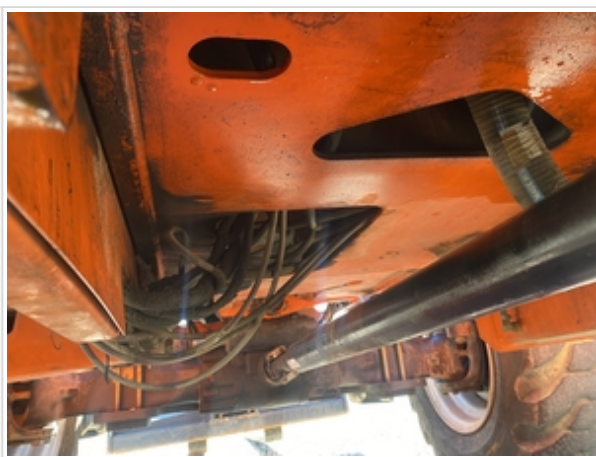
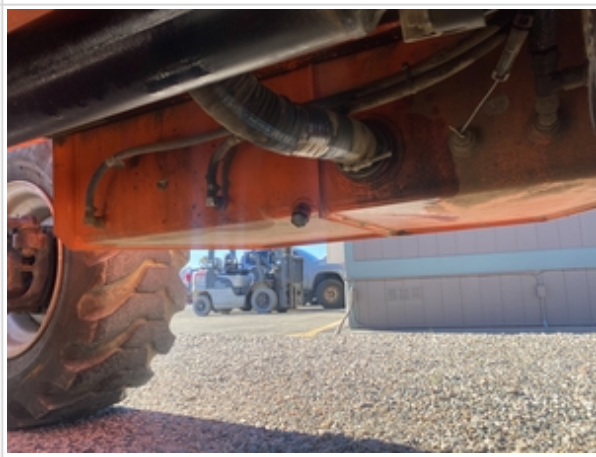
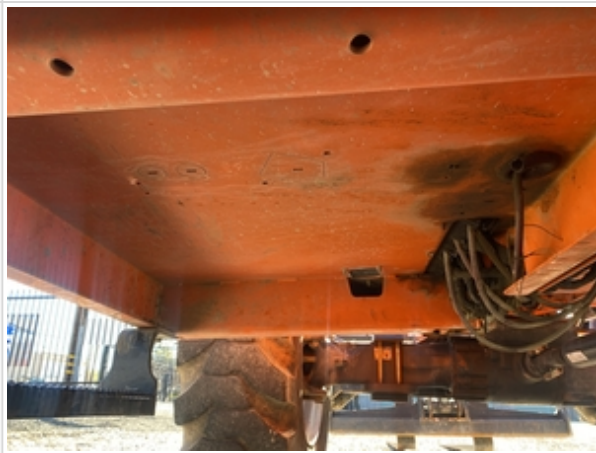
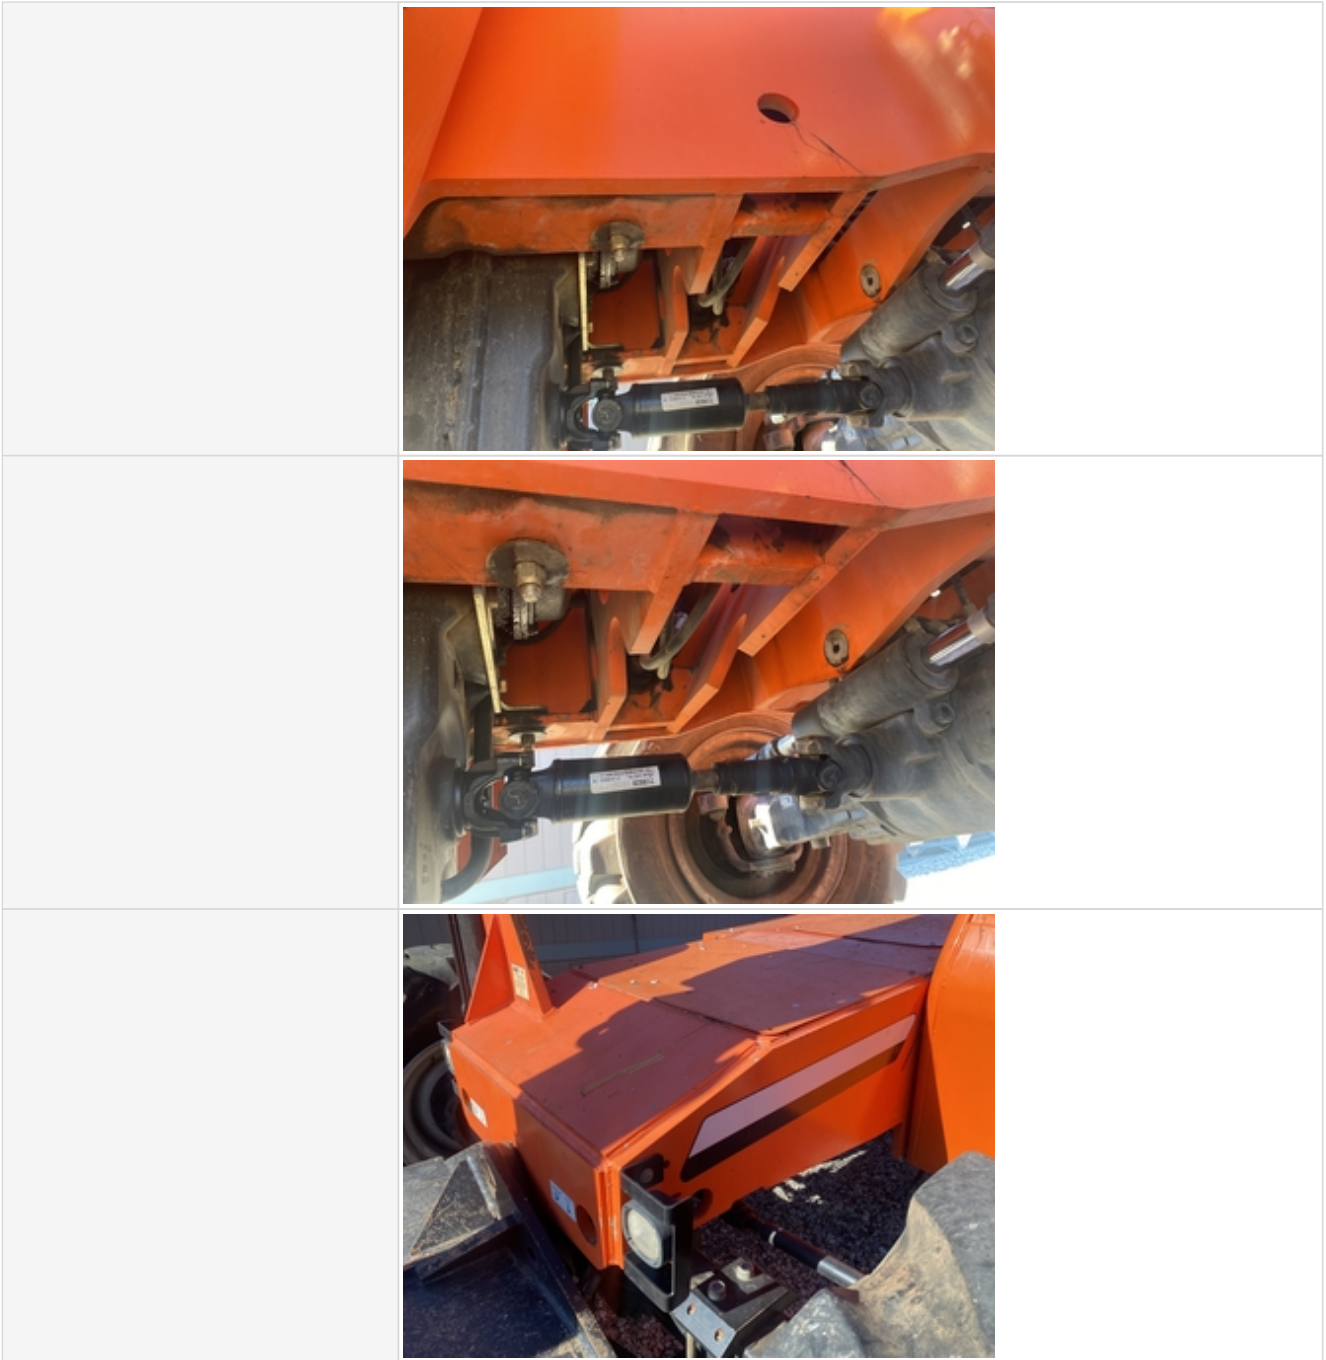
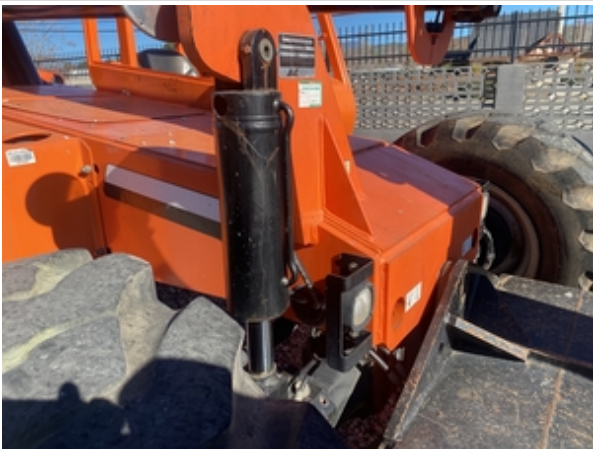
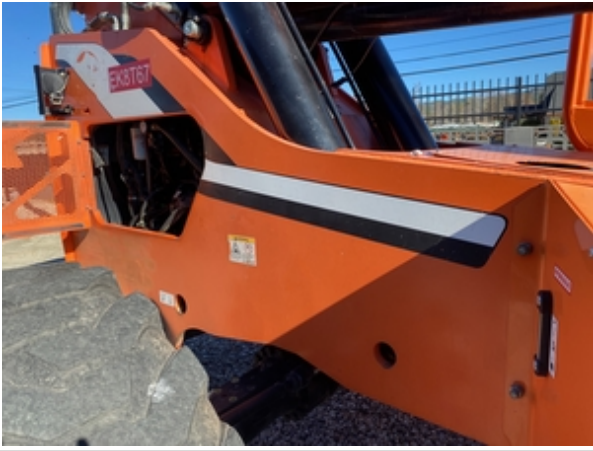
<p>Frame Photos</p>

Frame	3 - Normal Wear & Tear
-------	------------------------

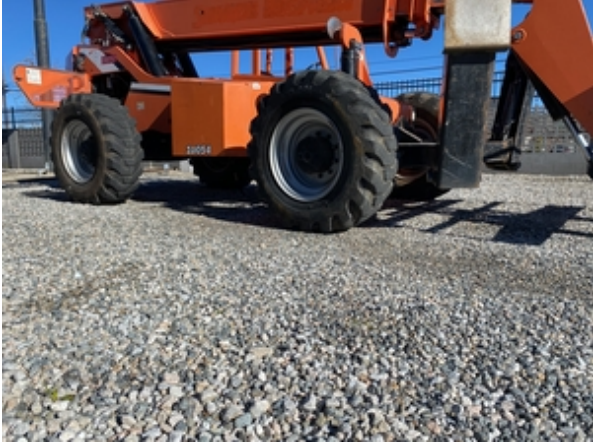
Stance	3 - Normal Wear & Tear	
Stance Photos

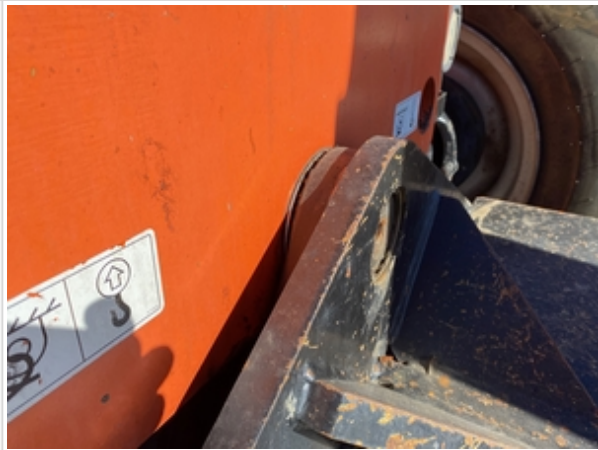
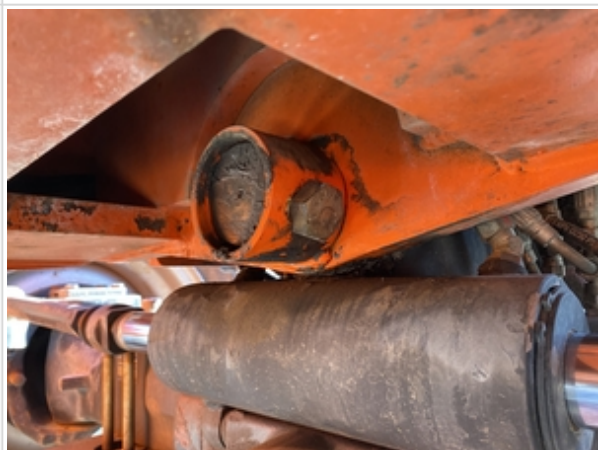
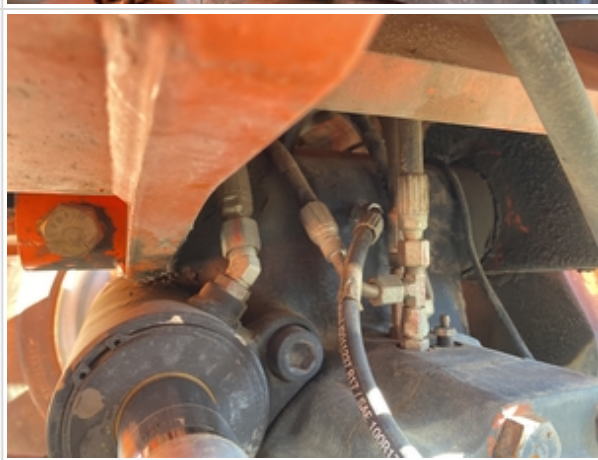
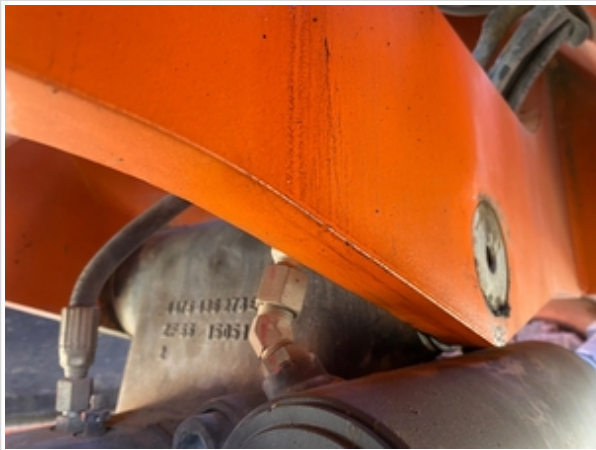
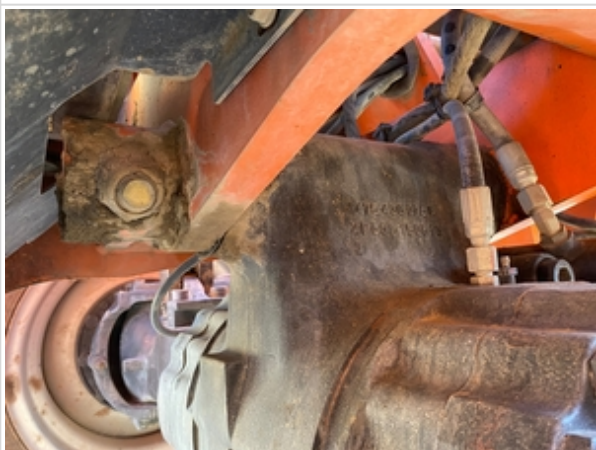
<p>Oscillating Pin Appearance Photos</p>

Front Axle Appearance	3 - Normal Wear & Tear	
Rear Axle Appearance	3 - Normal Wear & Tear	
Oscillating Pin Appearance	3 - Normal Wear & Tear

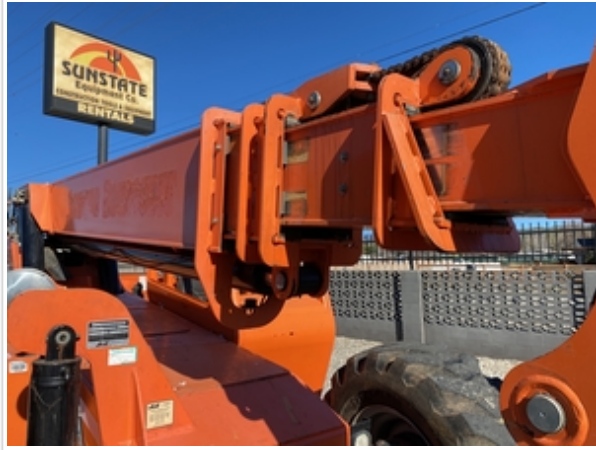
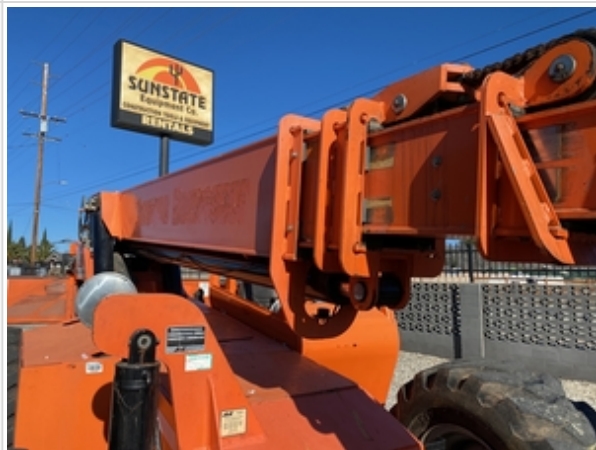
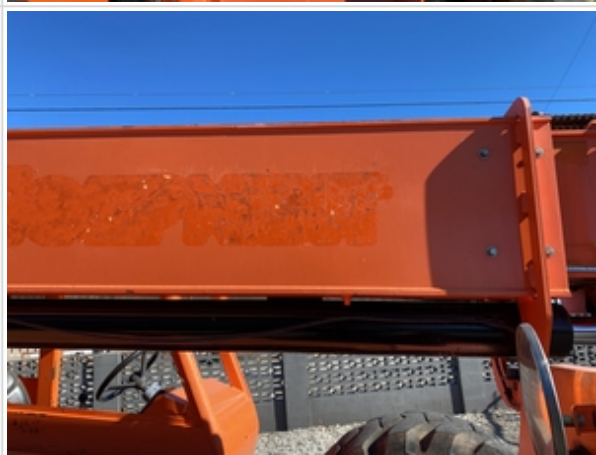
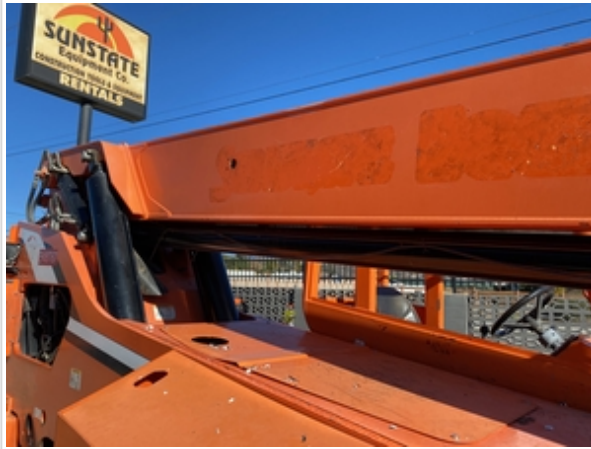
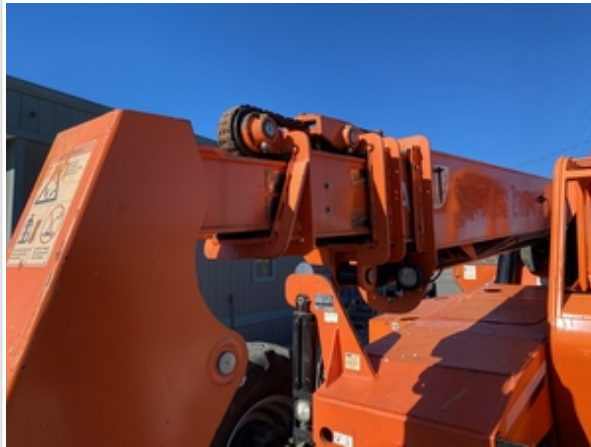
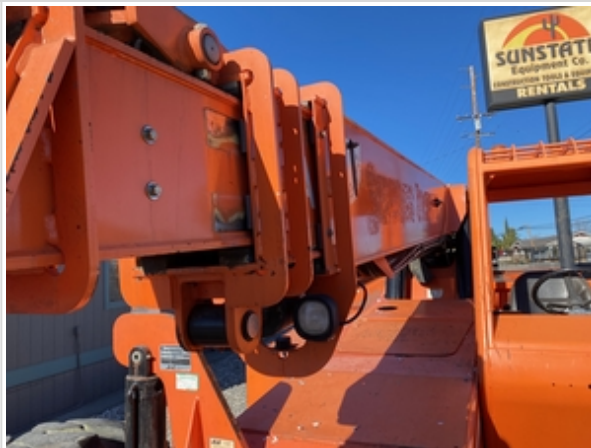
Rear Right Tire - Ratio Remaining	10%
Boom Condition	3 - Normal Wear & Tear
Boom Condition Photos

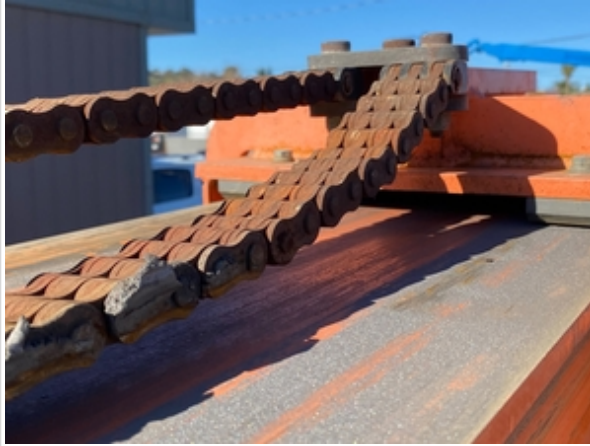
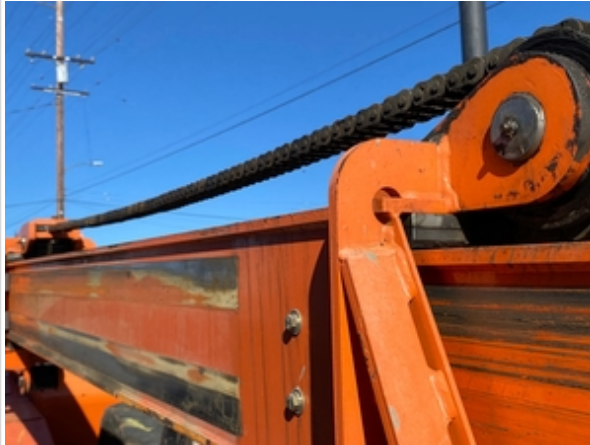
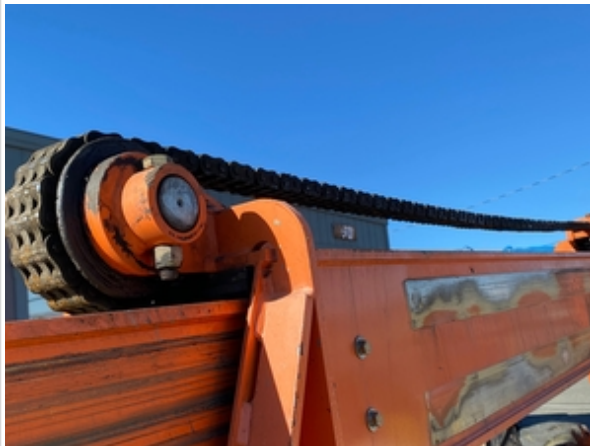
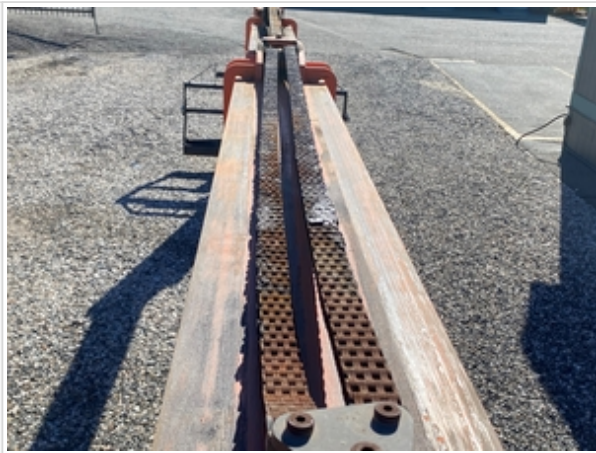
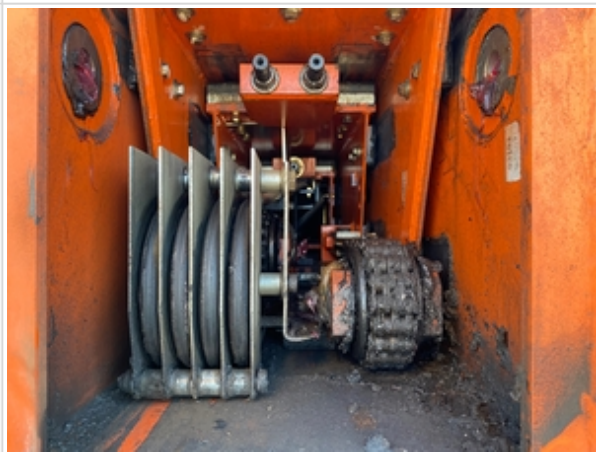
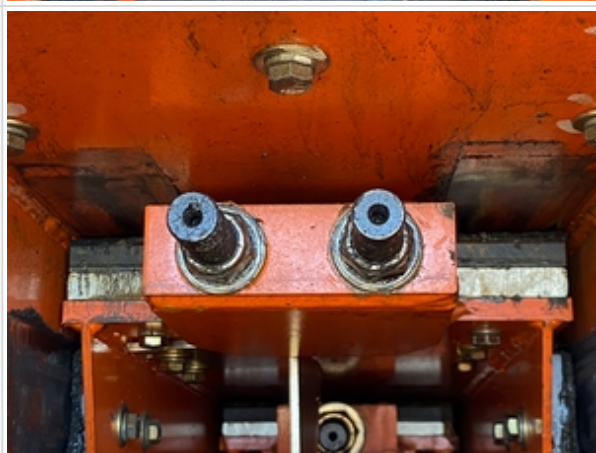
Chain / Tensioners Photos

<p>Chain / Tensioners</p>	<p>3 - Normal Wear & Tear</p>

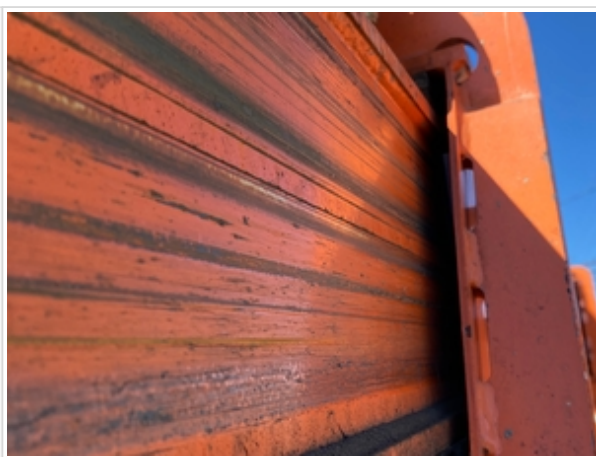
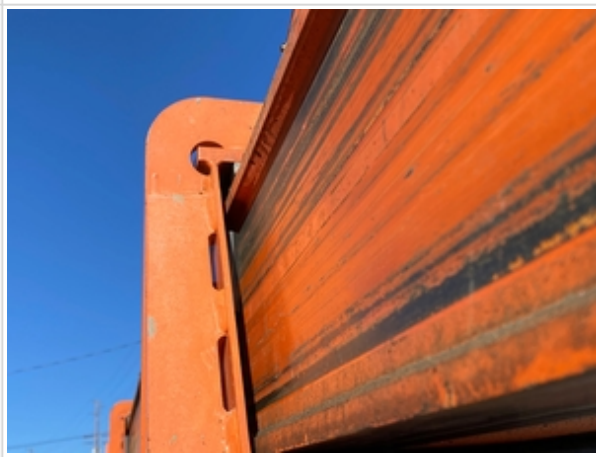
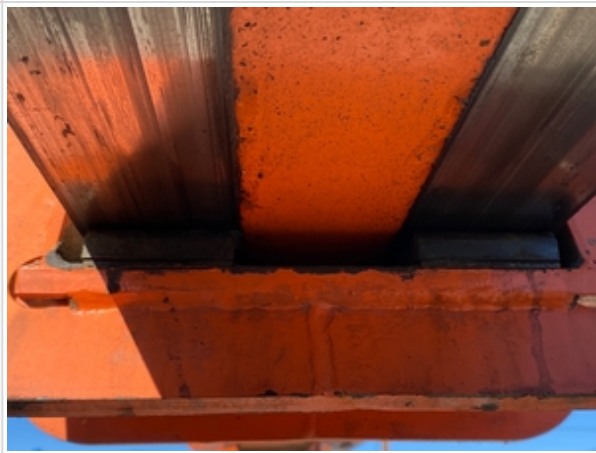
<p>Boom Wear Guides Photos</p>

Rollers & Guides	3 - Normal Wear & Tear
Boom Wear Guides	3 - Normal Wear & Tear

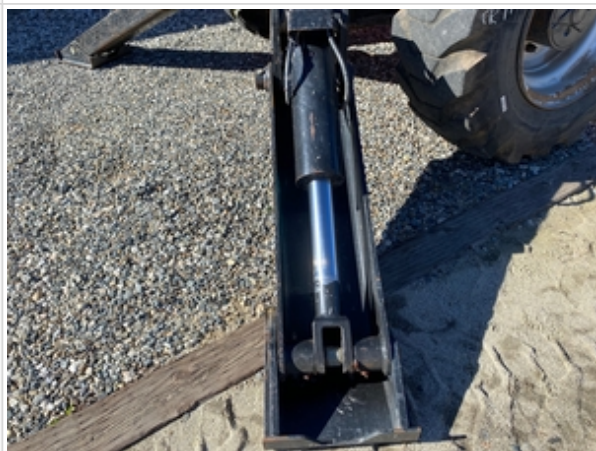
<p>Outriggers</p>	<p>3 - Normal Wear & Tear</p>	
<p>Outriggers Photos</p>

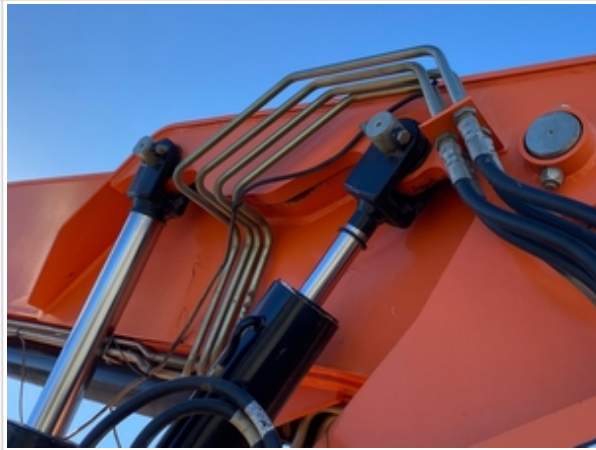
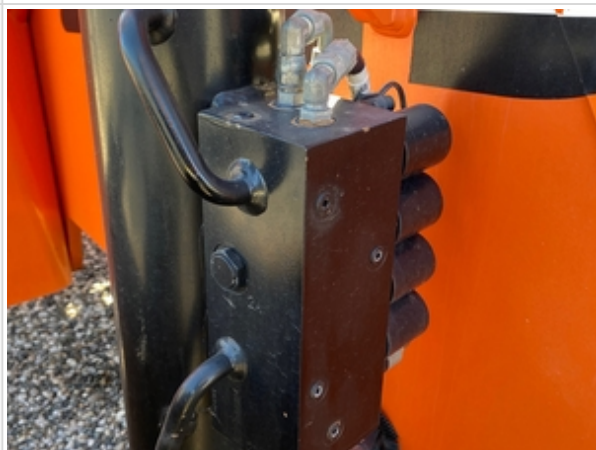
Hydraulic System	Take close-up photos of the hydraulic components including the pump, lines, fittings, controls, and levers. Note any damage, wear, or leaks.
Hydraulic System Photos

Wet or Damp Hydraulic Lines / Fittings	Yes

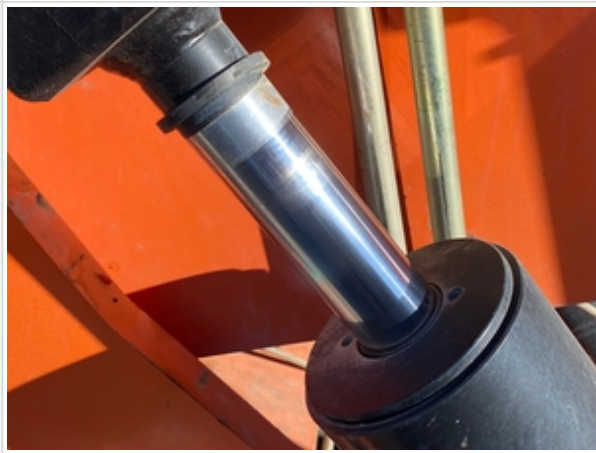
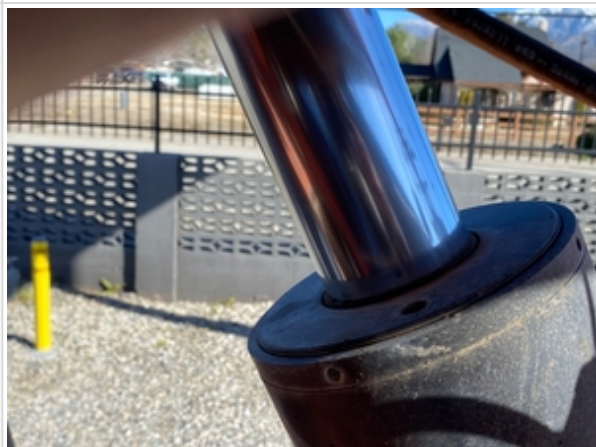
Boom Lift Cylinders	Check the boom lift cylinders. Note any wear, pitting, discoloration, etc. Take photos.
Boom Lift Cylinders: Mounting Pin	3 - Normal Wear & Tear
Boom Lift Cylinders: Oil Leaks	No
Boom Lift Cylinders Photos

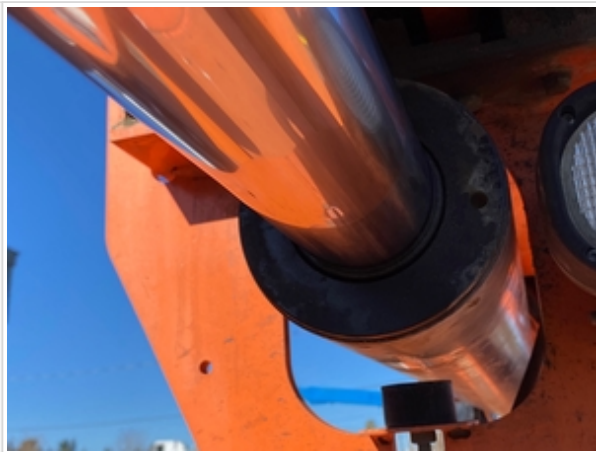
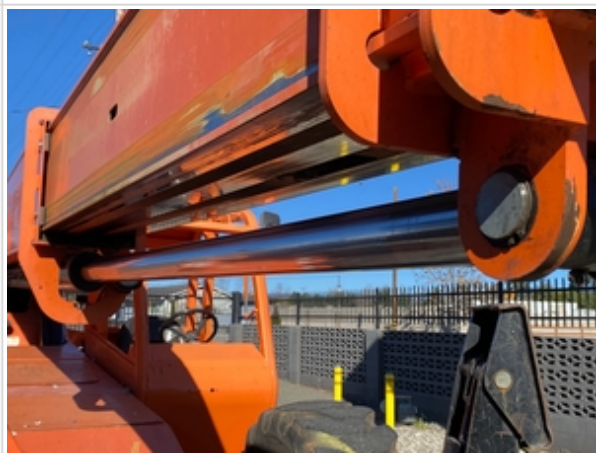
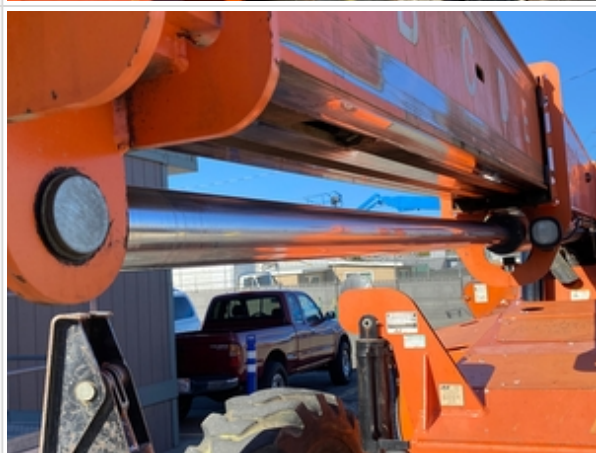
Telescopic Boom Cylinders Photos

Telescopic Boom Cylinders	Check the telescopic boom cylinders. Note any wear, pitting, discoloration, etc. Take photos.	
Telescopic Boom Cylinders: Mounting Pin	3 - Normal Wear & Tear	
Telescopic Boom Cylinders: Oil Leaks	No

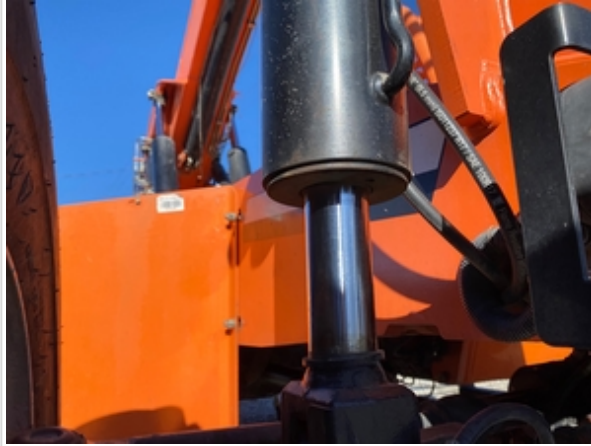
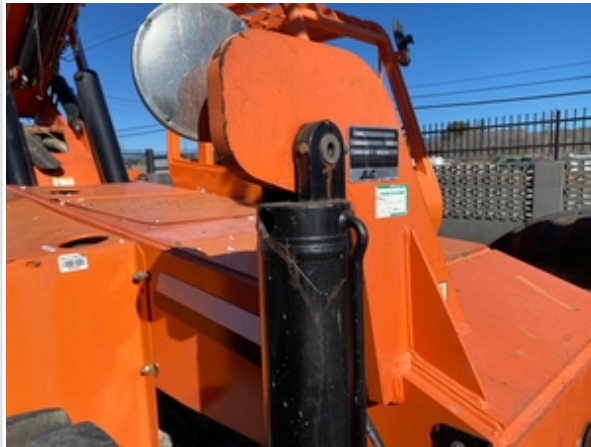
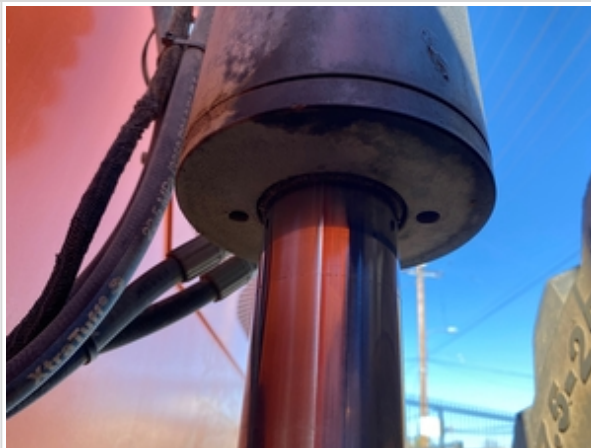
Frame Leveling Cylinders Photos

Frame Leveling Cylinders	Check the frame leveling cylinders. Note any wear, pitting, discoloration, etc. Take photos.
Frame Leveling Cylinders: Mounting Pin	3 - Normal Wear & Tear
Frame Leveling Cylinders: Oil Leaks	No

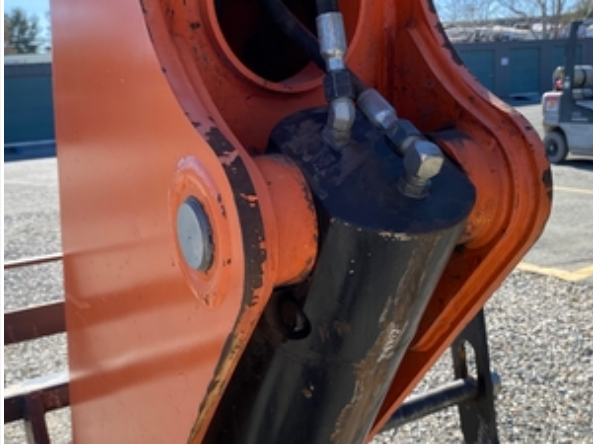
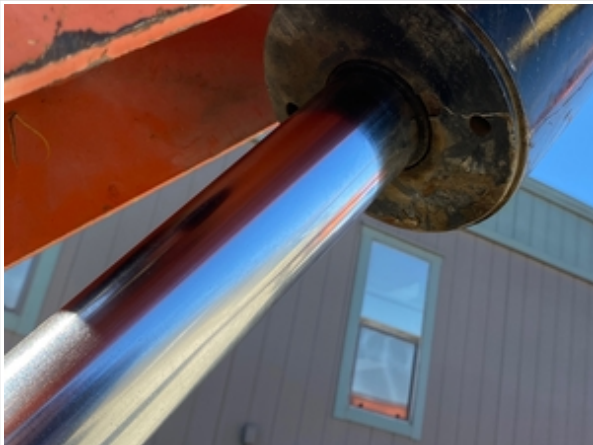
Carriage Tilt Cylinder Photos

Carriage Tilt Cylinder	Check the carriage tilt cylinders. Note any wear, pitting, discoloration, etc. Take photos.	
Carriage Tilt Cylinder: Mounting Pin	3 - Normal Wear & Tear	
Carriage Tilt Cylinder: Oil Leaks	No

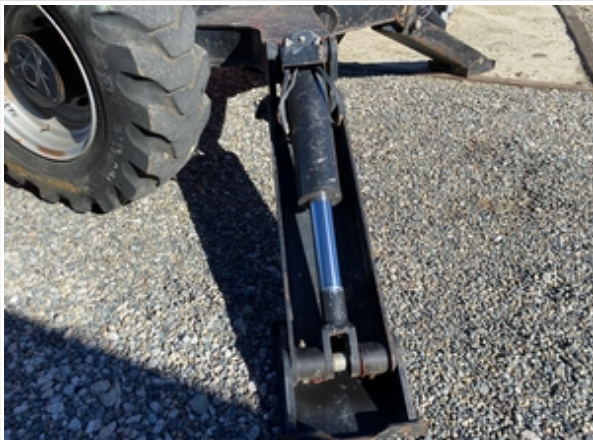
Side Shift Cylinder	Check the side shift cylinder. Note any wear, pitting, discoloration, etc. Take photos.
Outrigger Cylinders	Check the outrigger cylinders. Note any wear, pitting, discoloration, etc. Take photos.
Outrigger Cylinders: Mounting Pin	3 - Normal Wear & Tear
Outrigger Cylinders: Oil Leaks	No
Outrigger Cylinders Photos

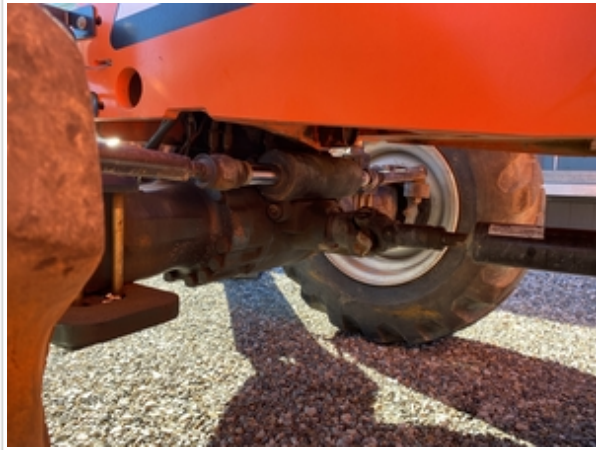
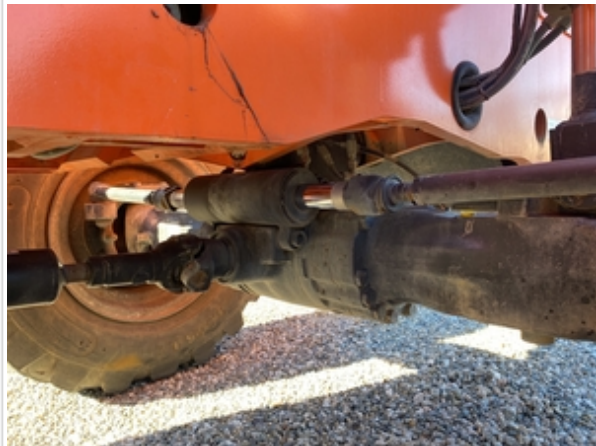
Steering Cylinders	Check the steering cylinders. Note any wear, pitting, discoloration, etc. Take photos.
Steering Cylinders: Mounting Pin	3 - Normal Wear & Tear
Steering Cylinders: Oil Leaks	No
Steering Cylinders Photos

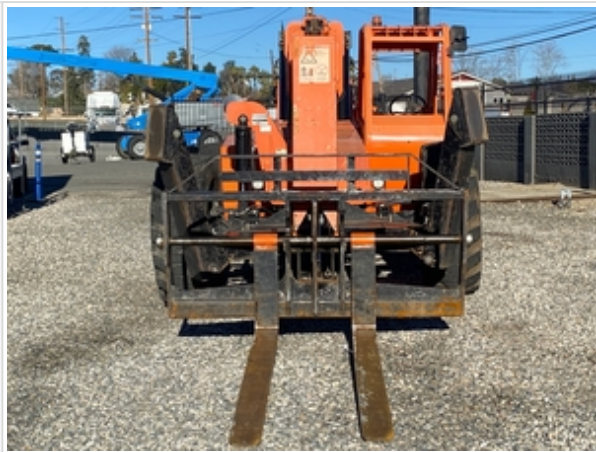
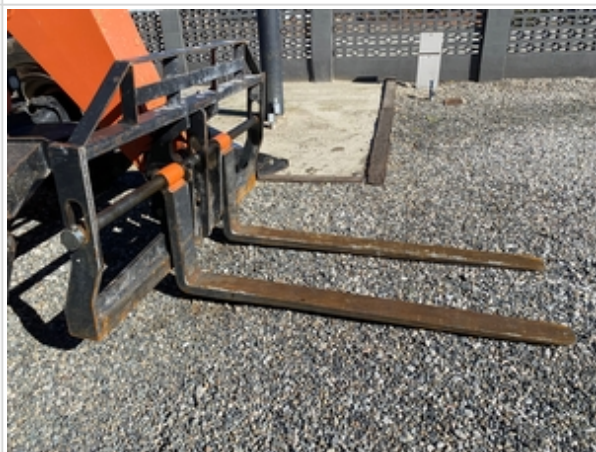
<p>Forks / Work Tool Photos</p>

Forks / Work Tool Condition	3 - Normal Wear & Tear
------------------------------------	------------------------

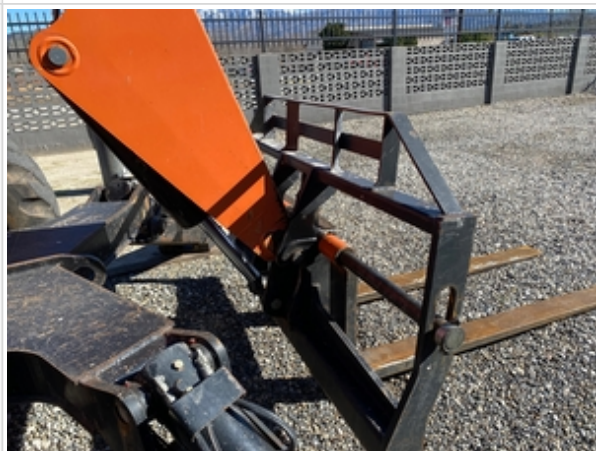
<p>Back Rest Condition</p>	<p>3 - Normal Wear & Tear</p>
<p>Back Rest Photos</p>
