Inspection Report (On-Highway Flatbed Truck)

Year	2015
Make	Ford
Model	F-750
Serial Number	3FRXF7FE5FV005710
Truck Odometer Reading	168,613 Miles
Current Inspection / State Cert / DOT	Last Performed 04/2022
Previous Application (e.g., earth moving, mining, demolition, etc)	Compact Rental Equipment Hauler

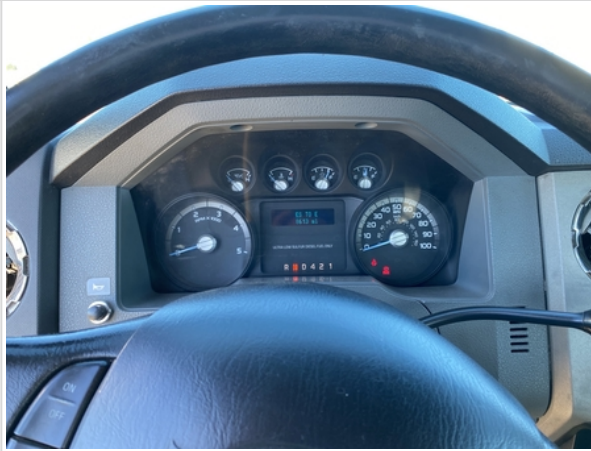
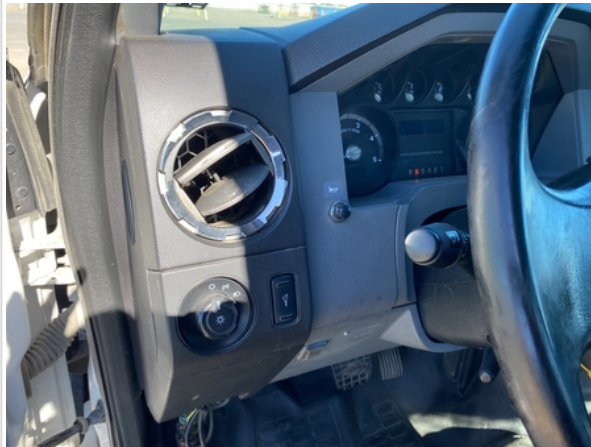
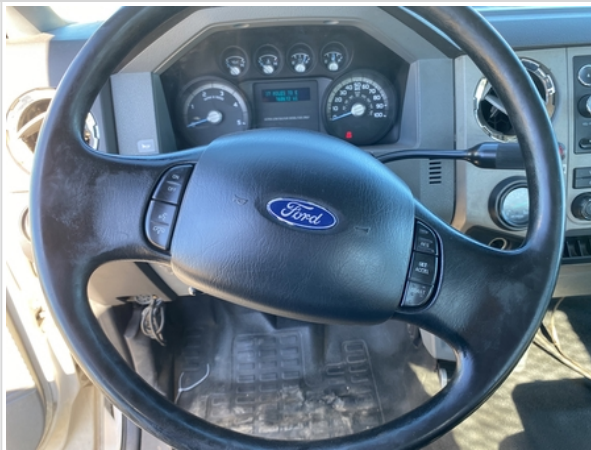
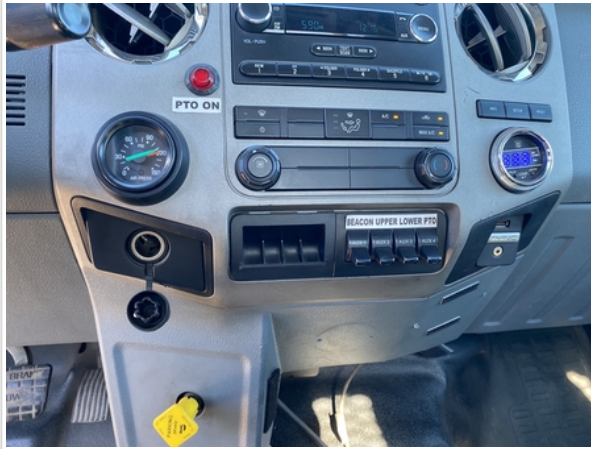
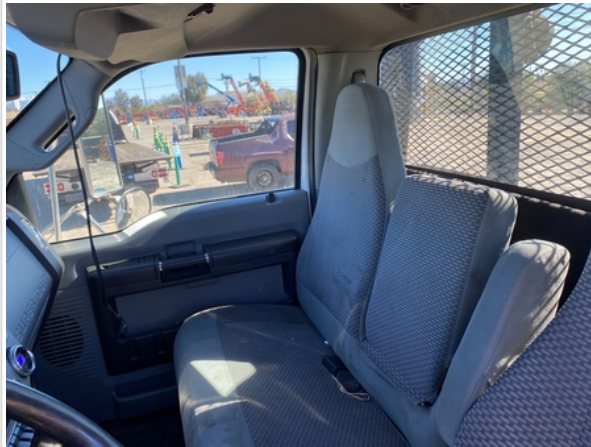
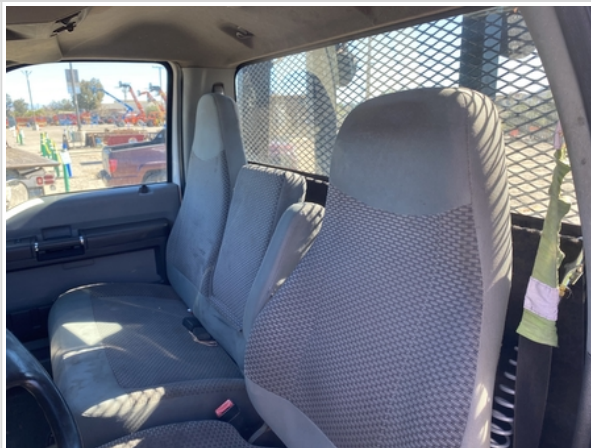
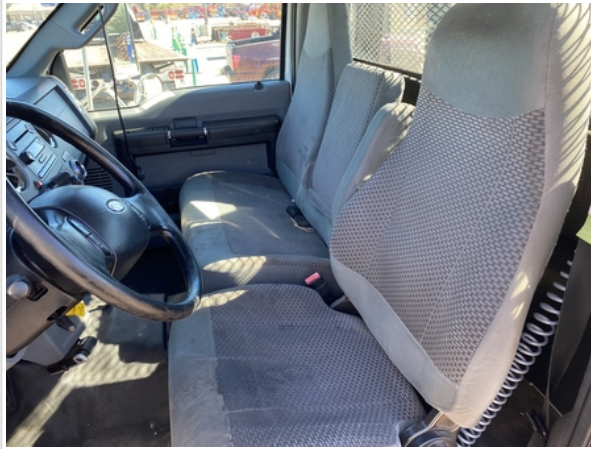
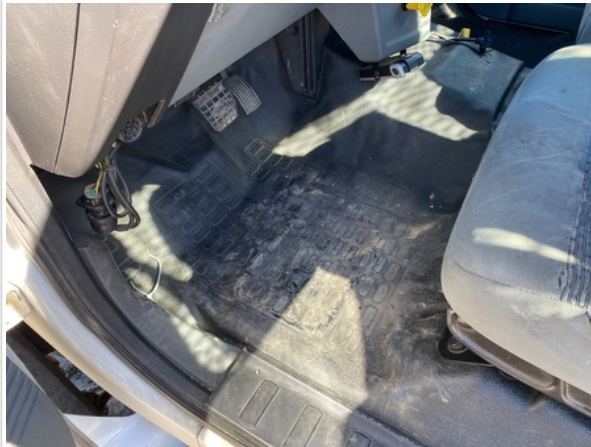
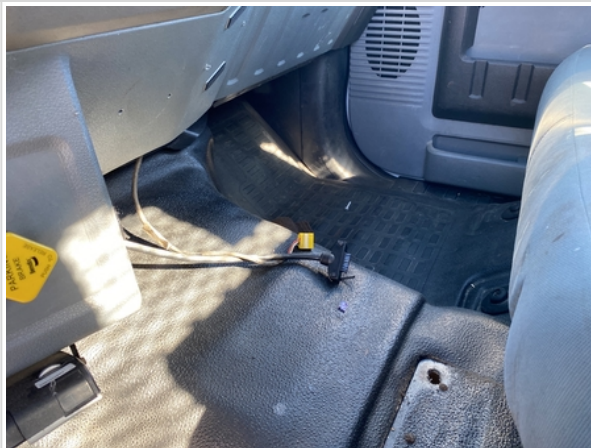
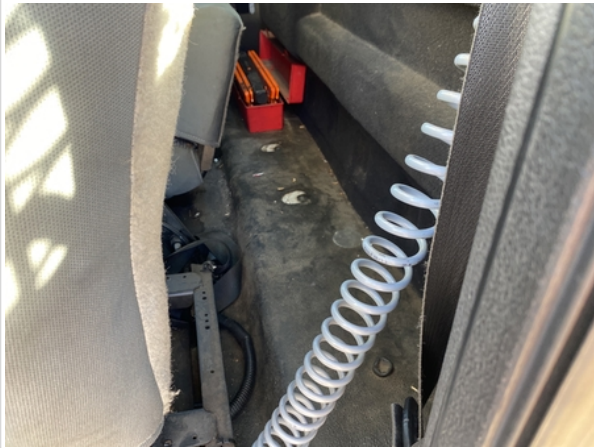
Odometer Activity	3 - Normal Wear & Tear
Odometer Condition	Odometer is working and in good condition
Controls/Switches/Gauges	3 - Normal Wear & Tear
Controls/Switches/Gauges Condition	All switches/gauges are in good condition and functioning
Brake System Type	Air Brakes
Air Brakes Build Correct Pressure	Yes
Clutch	0
Horn	3 - Normal Wear & Tear
Horn Condition	Horn is functioning as expected
Reverse Alarm / Backup Camera	3 - Normal Wear & Tear
Reverse Alarm / Backup Camera Condition	Other (see comments)
Comments	Back up camera installed and rear view mirror works as the monitor. (Did not observe monitor display turn on during inspection)
Heater & A/C	3 - Normal Wear & Tear
Heat & A/C Condition	Heater and A/C work as expected
Interior Lights	3 - Normal Wear & Tear
Interior Lights Condition	All interior lights are installed and functioning
Seats/Seat Belts	3 - Normal Wear & Tear
Seats/Seat Belt Condition	Seat(s) in good condition, no stains or tears in upholstery

Cab Interior Overall Rating	3 - Normal Wear & Tear
Comments	Overall cab In good shape. Normal wear and tear

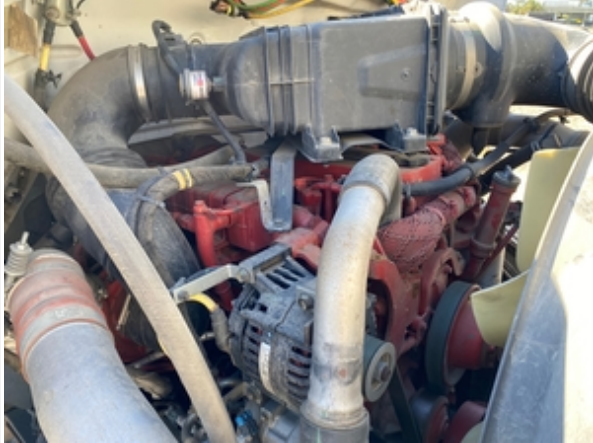
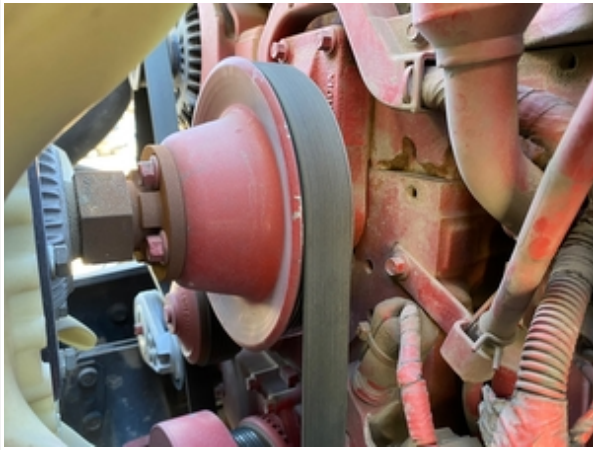
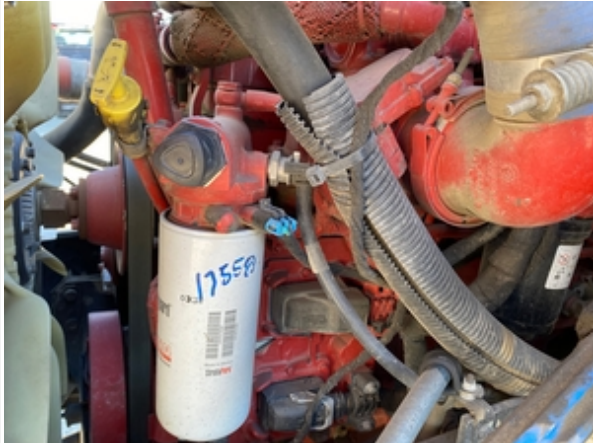
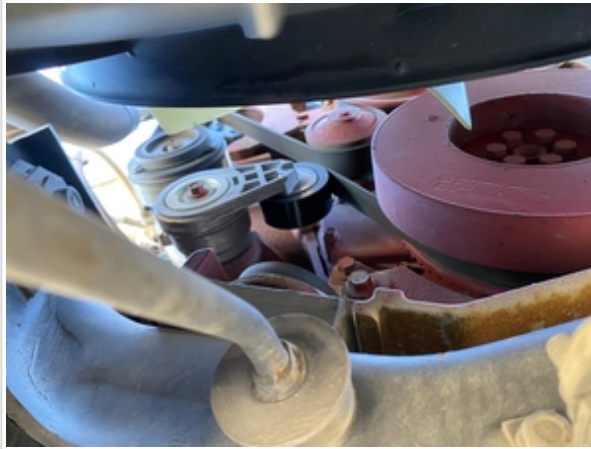
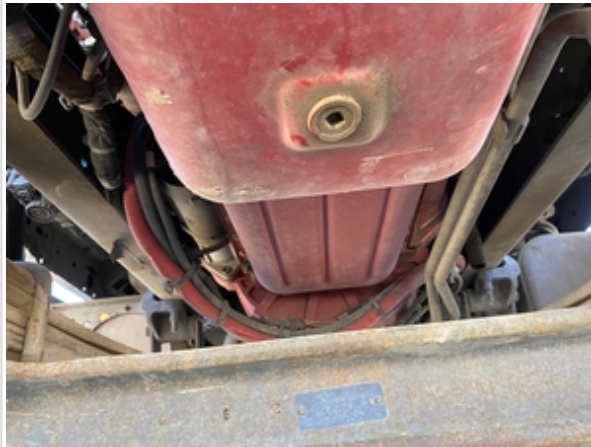
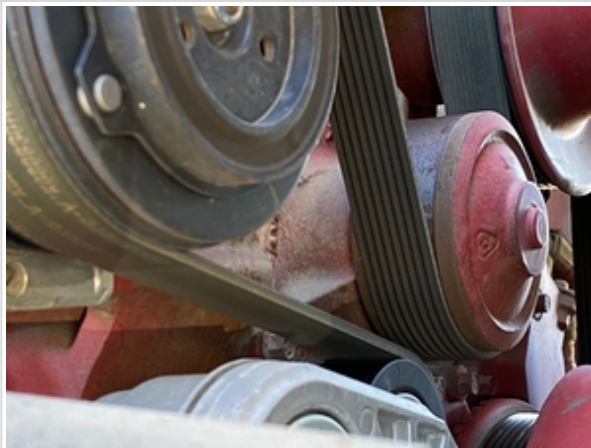
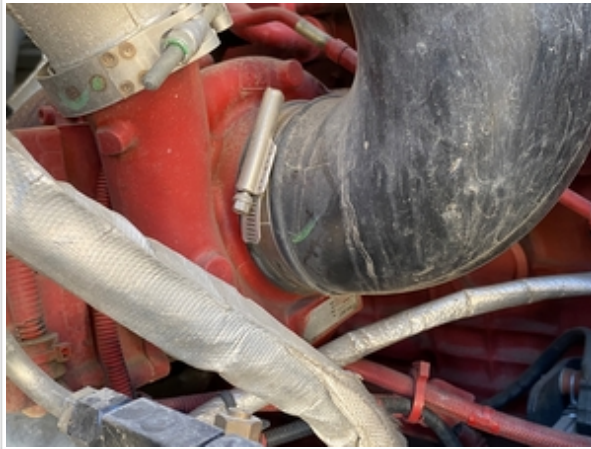
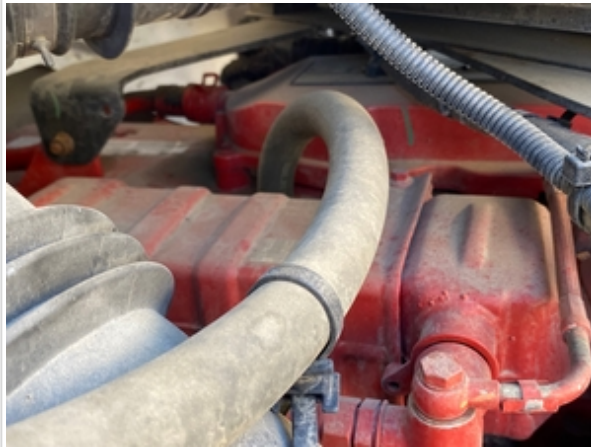
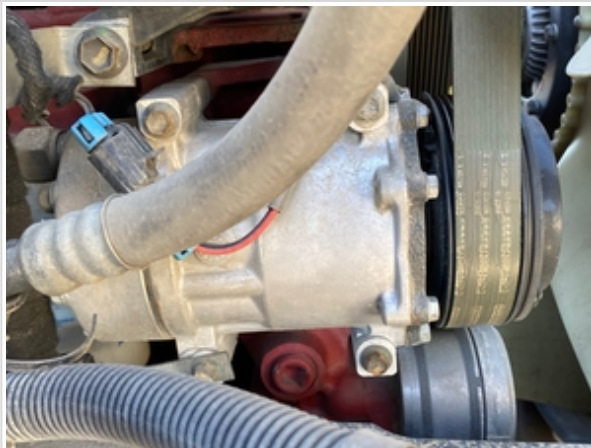
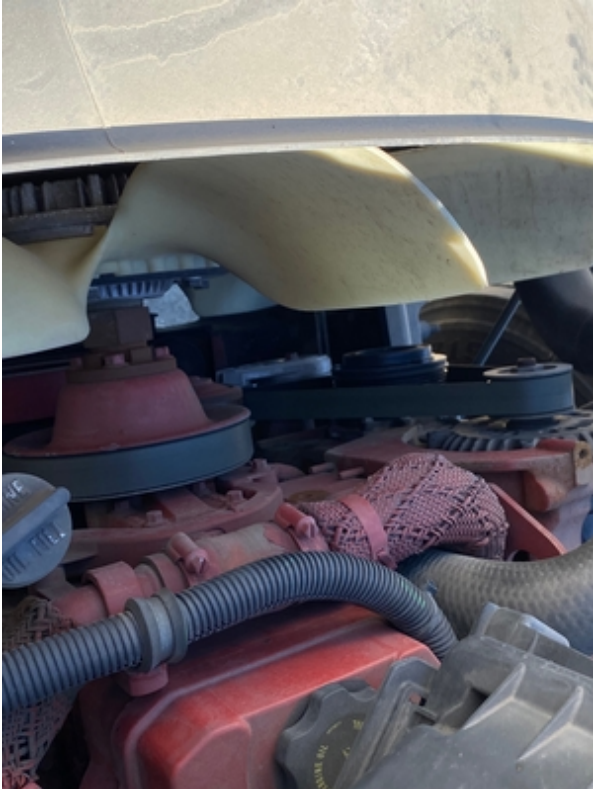
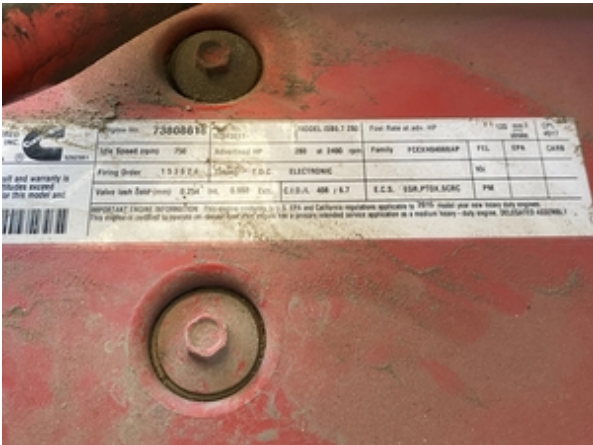
Emissions Tier	Tier 4F
Engine Serial Number	73808678
Engine Fuel Type	Diesel
Engine Photos

Blow-by (Visual Observation Check)	No
Unusual Noises (Upon Start-up, Idle, Shutdown)	No
Unusual Noise Notes	No unusual noises heard
Engine Smoke (Upon Start-up, Idle, Shutdown)	No
Engine Smoke Notes	No engine smoke issues observed
Engine Exhaust Color	Clear
Battery	3 - Normal Wear & Tear
Battery Condition	Clean & dry appearance, tight connections

Overall Engine Appearance	Clean & dry
Overall Engine Comments	Overall engine is in excellent well maintained condition with no active leaks or obvious issues observed.

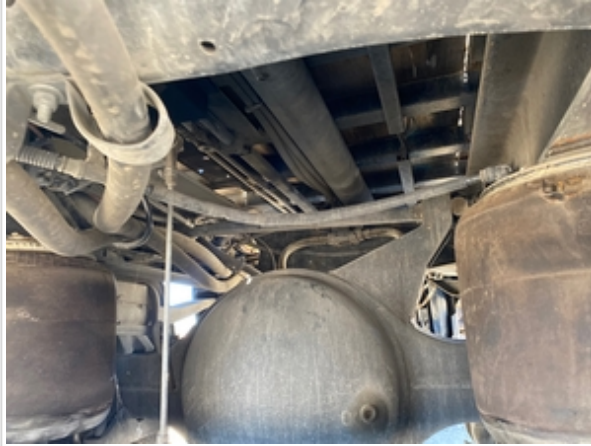
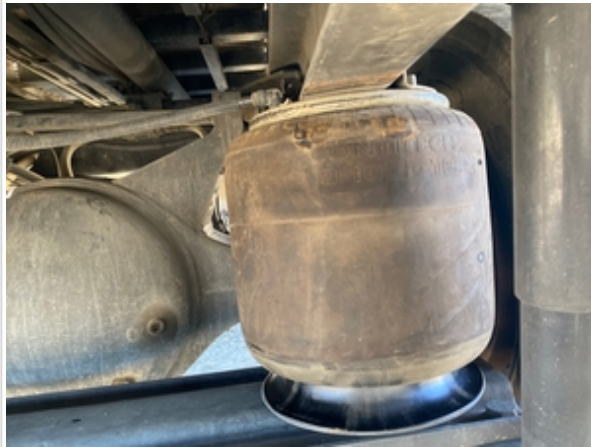
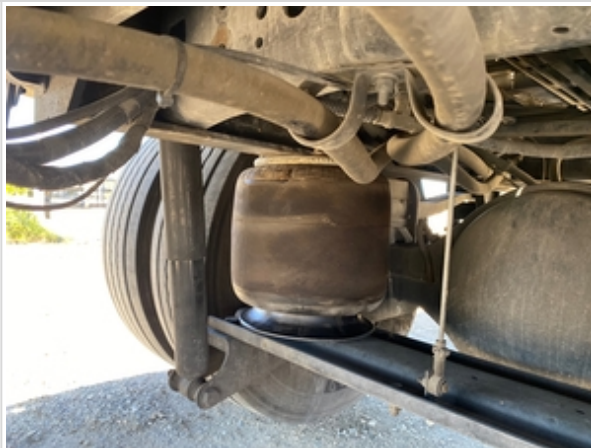
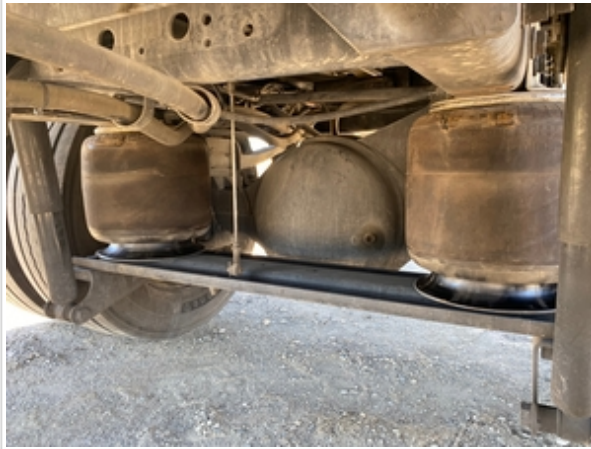
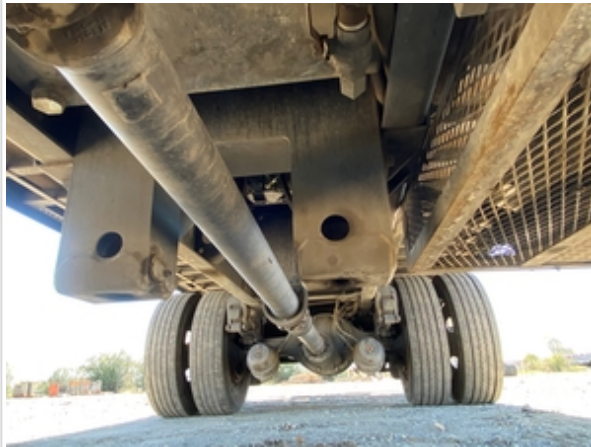
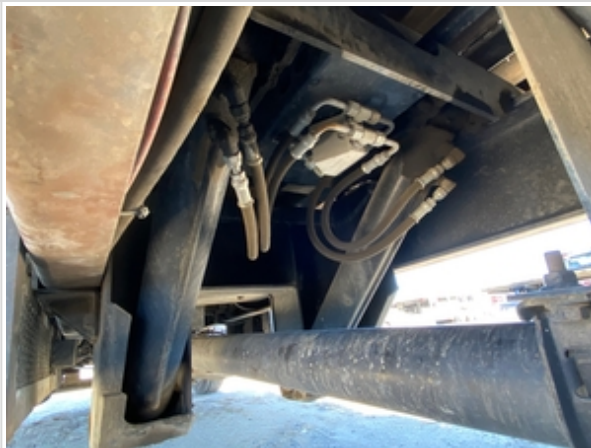
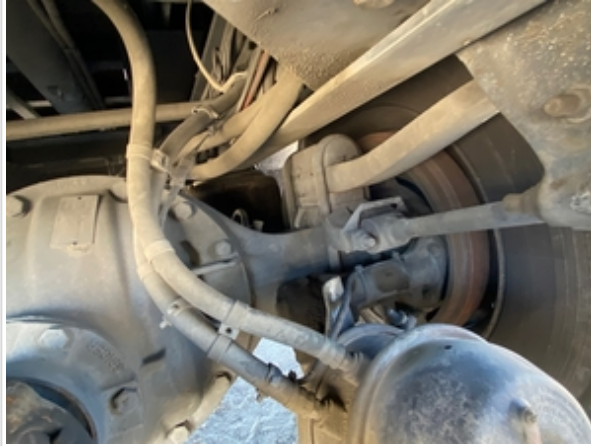
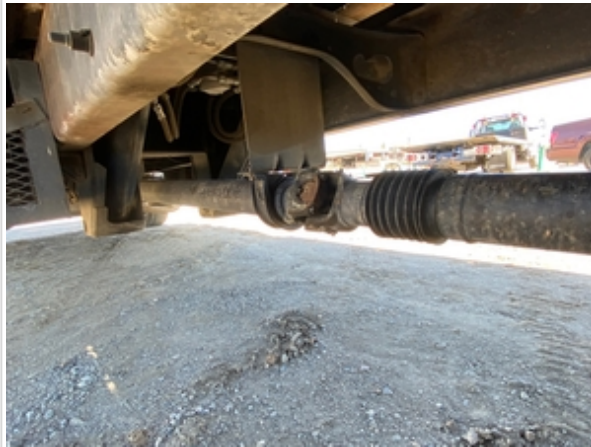
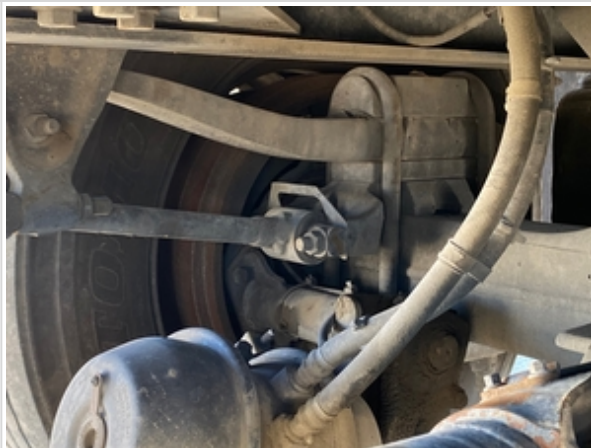
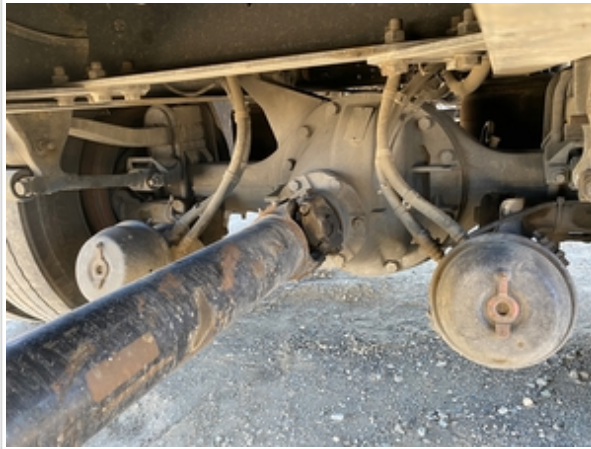
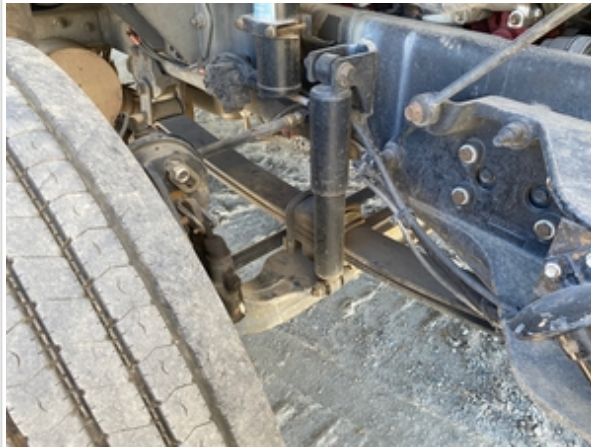
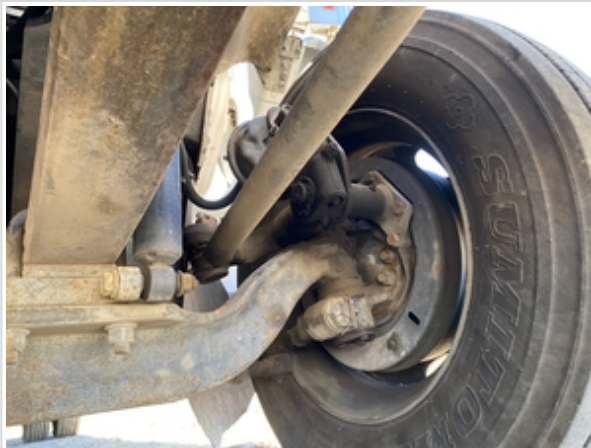
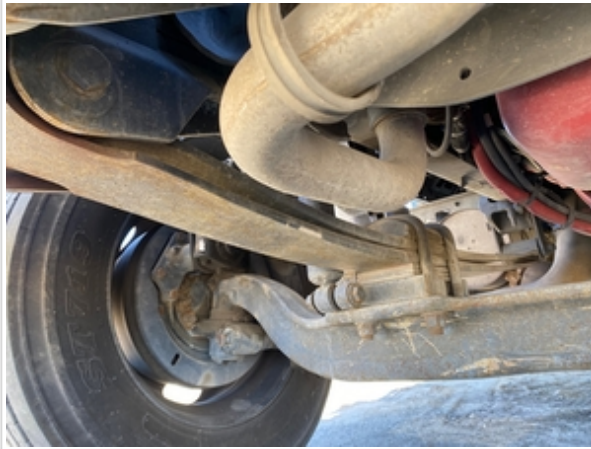
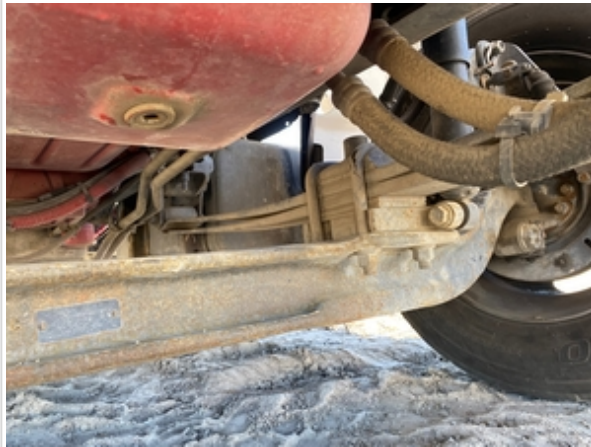
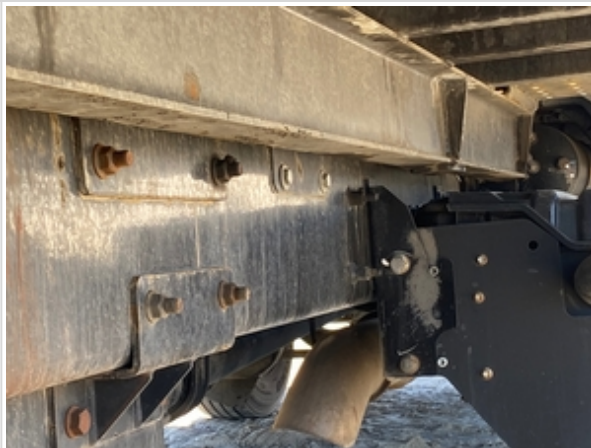
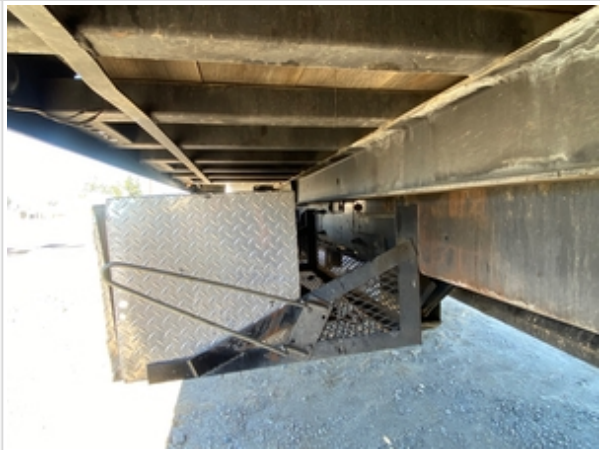
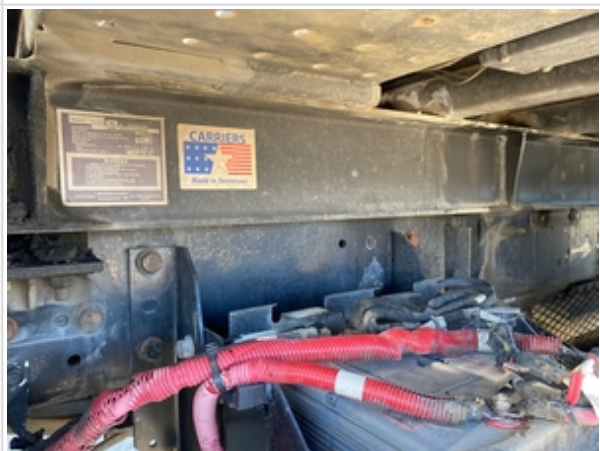
Chassis & Undercarriage Photos

Frame	3 - Normal Wear & Tear	
Suspension	3 - Normal Wear & Tear	
Steer Axle Condition	3 - Normal Wear & Tear	
Steering Components	3 - Normal Wear & Tear	
Steering Component Photos

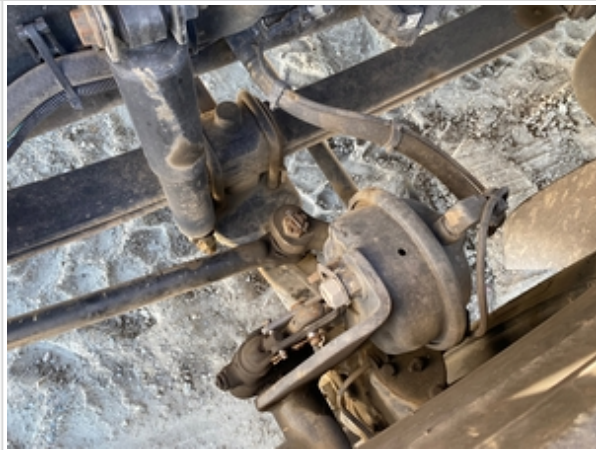
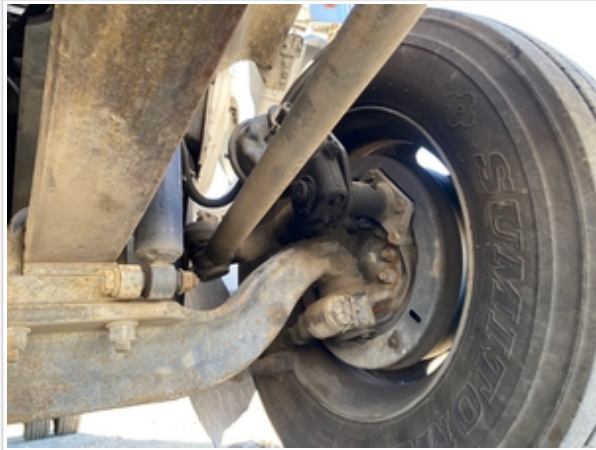
Overall Chassis Condition	3 - Normal Wear & Tear
Overall Chassis Comments	Overall chassis in good condition.

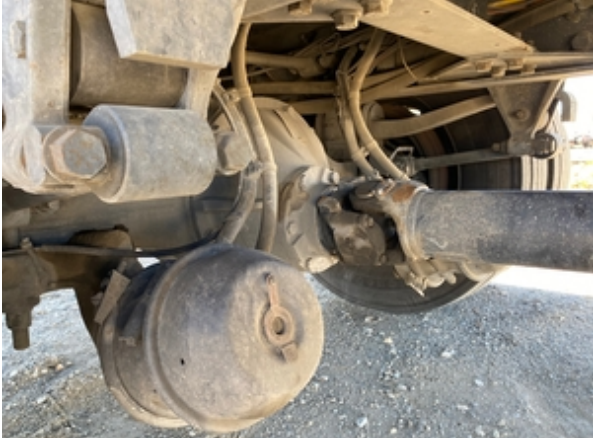
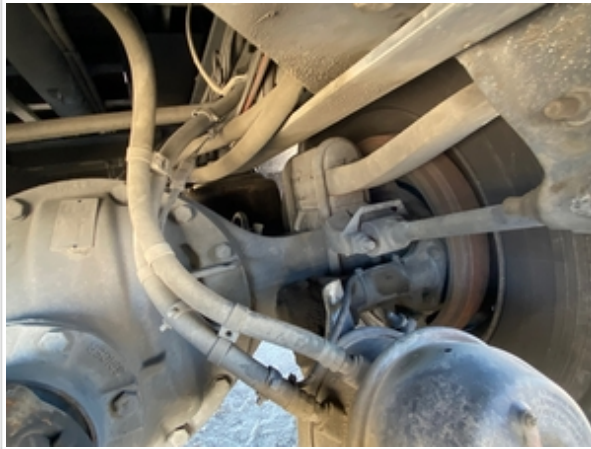
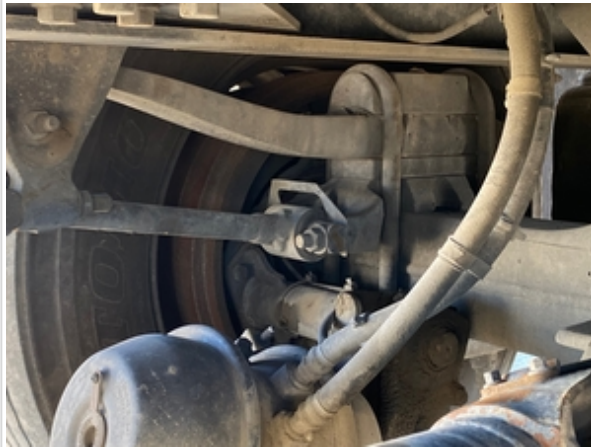
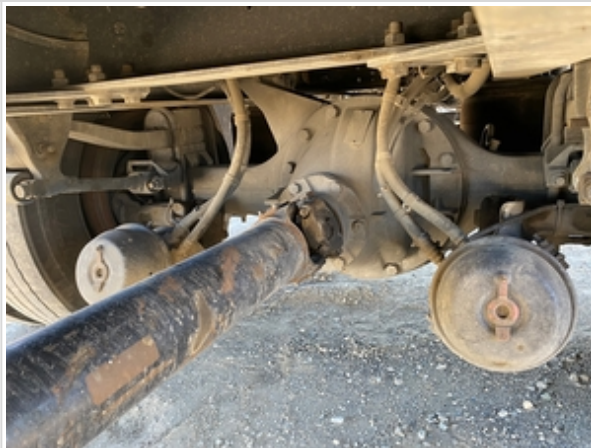
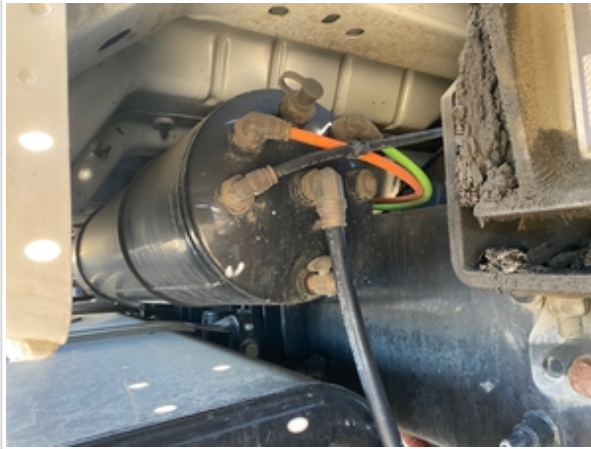
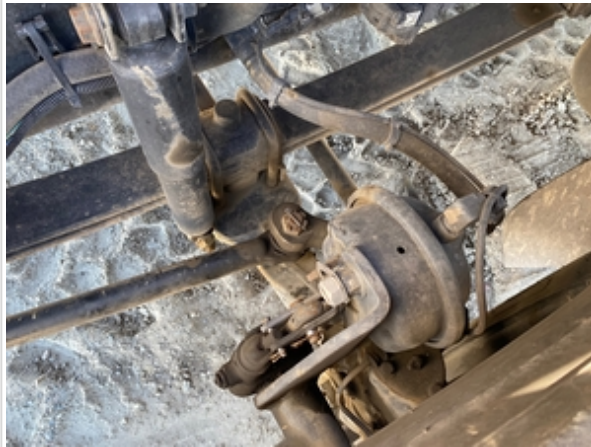
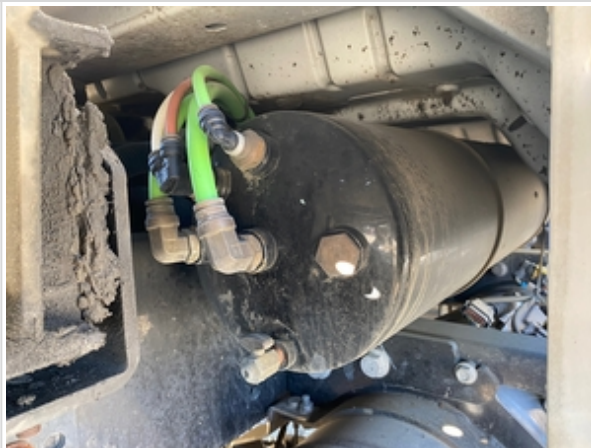
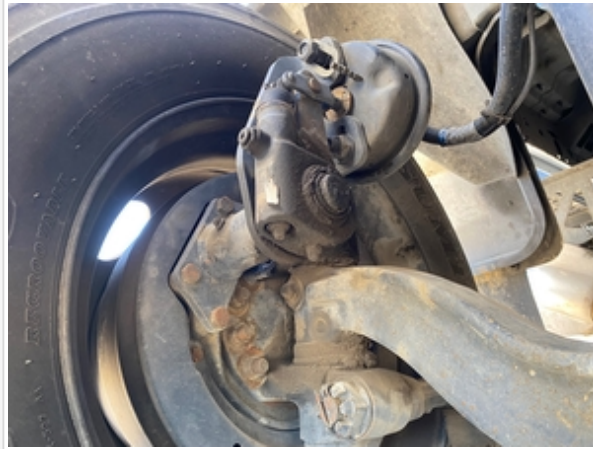
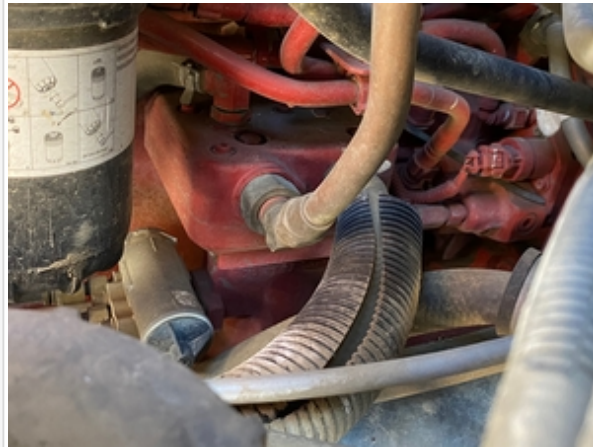
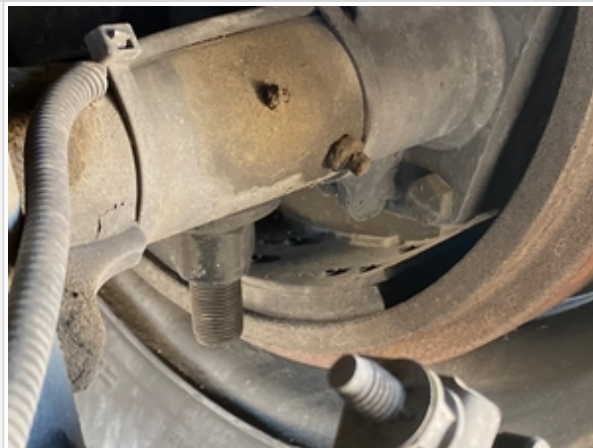
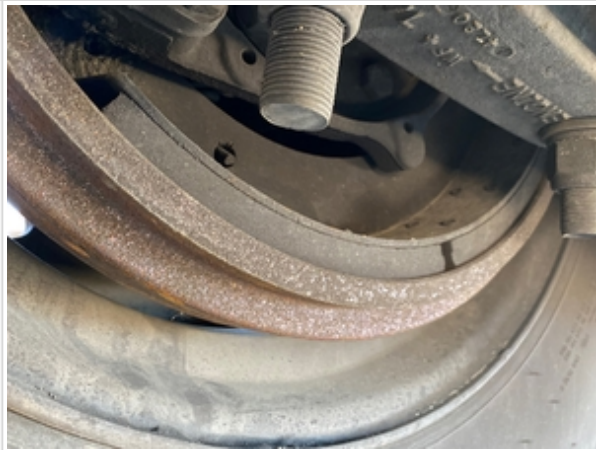
Differential	Check condition of the differential(s). Take photos and notes as relevant.
Rear Differential	3 - Normal Wear & Tear
Rear Differential Condition	Dry housing appearance, no unusual noises heard during operation
Front Differential	0
Brake Shoe Thickness	70%
Comments	Rear brakes shoes around 70% or higher, Front brakes unknown due to brake covers in place
Air Brake System Leaks	No
Air Brake Hose Condition	3 - Normal Wear & Tear
Air Brake System Photos

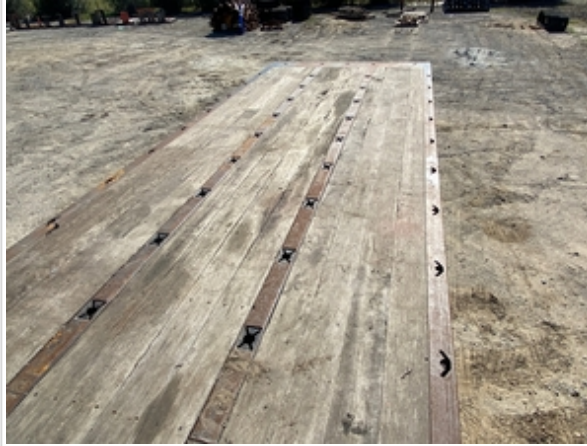
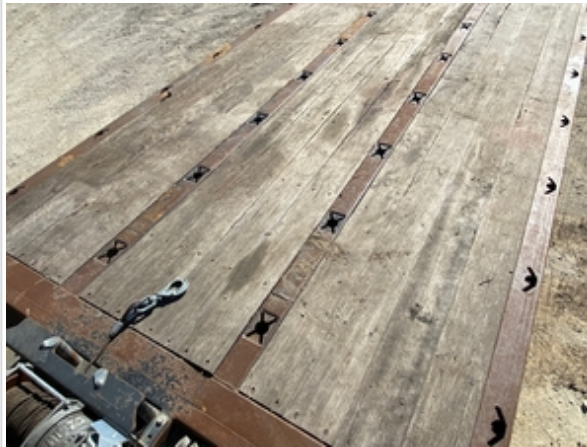
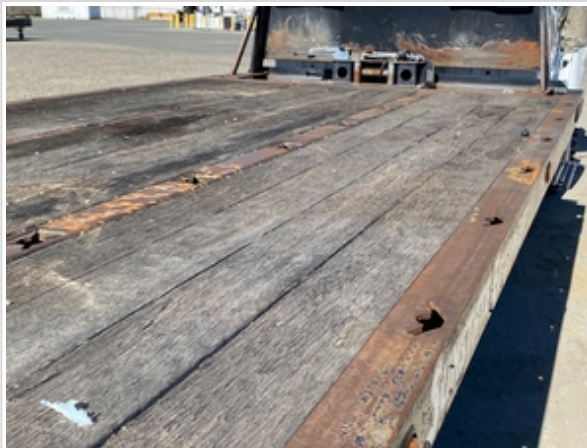
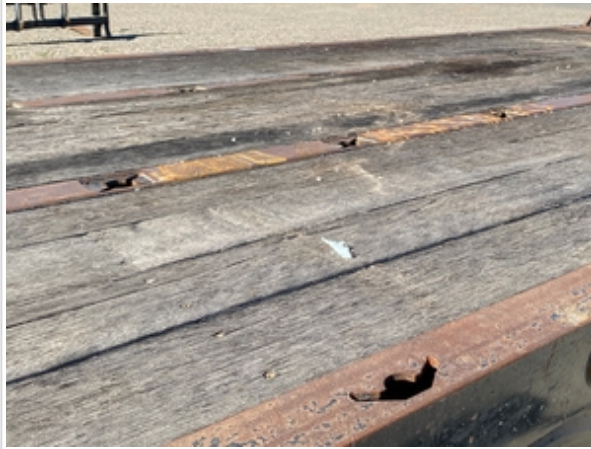
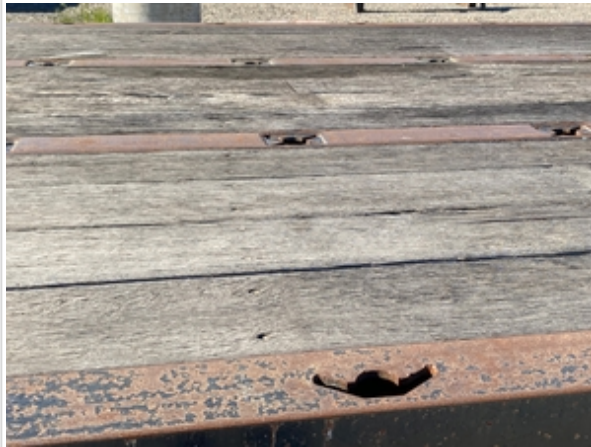
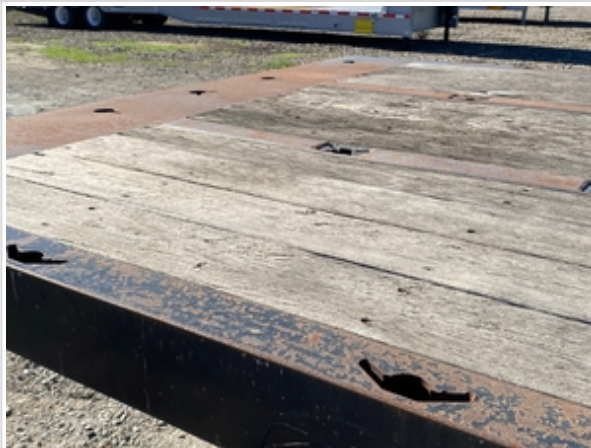
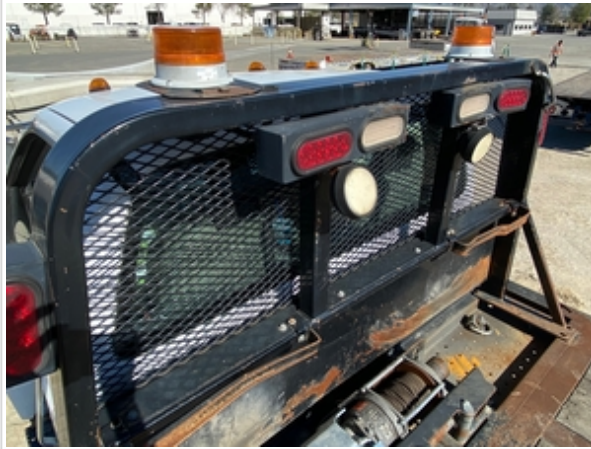
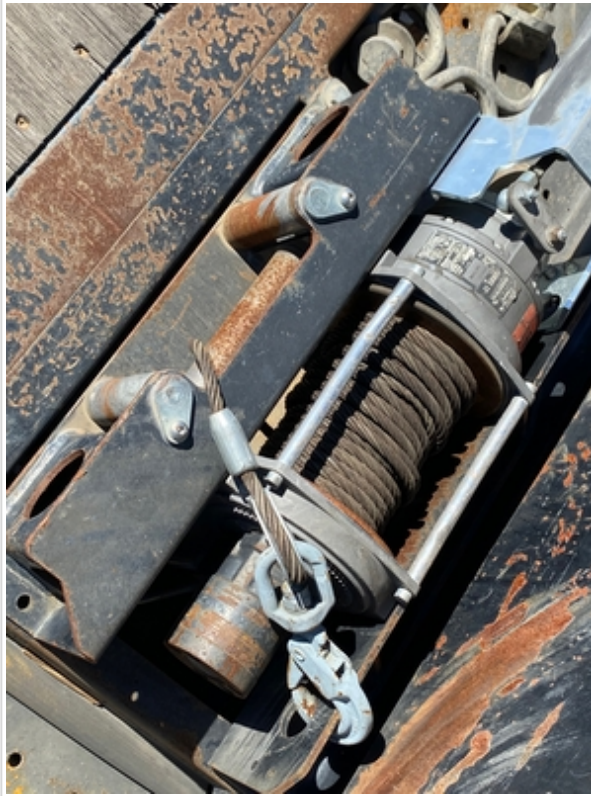
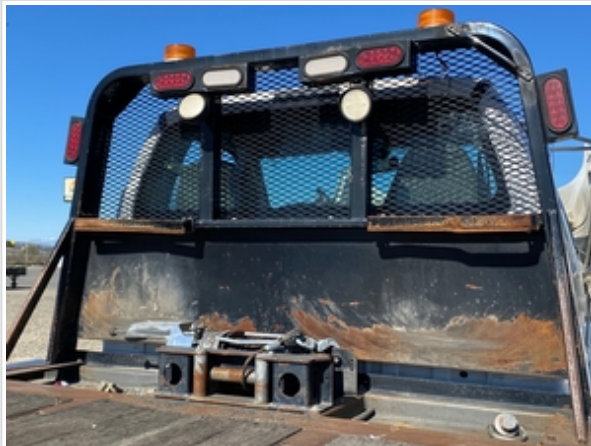
Flatbed Body Photos

Flatbed Body	Check the condition of the flat bed body. Note any damage or wear. Take photos.
Bed Details (Deck Type, Additional Features)	Century 16,000 Lbs. (Capacity)
Flatbed Length (ft and inches)	24'
Flatbed Width (ft and inches)	8'6"
Flatbed Body	3

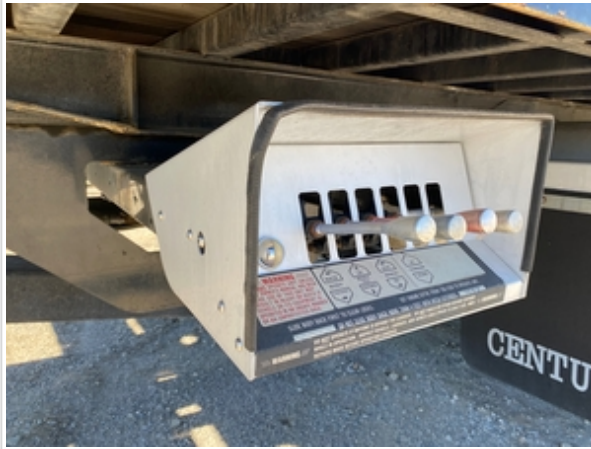
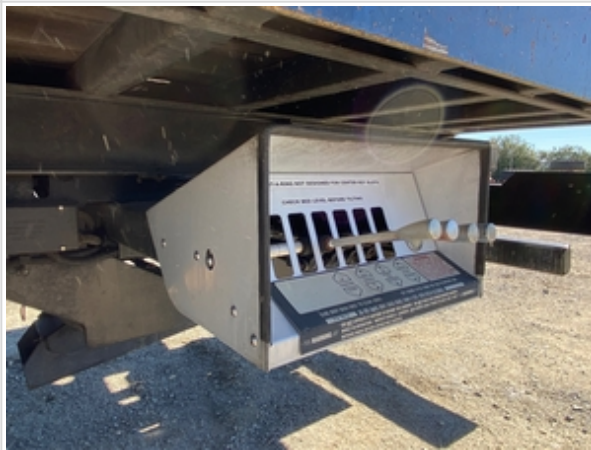
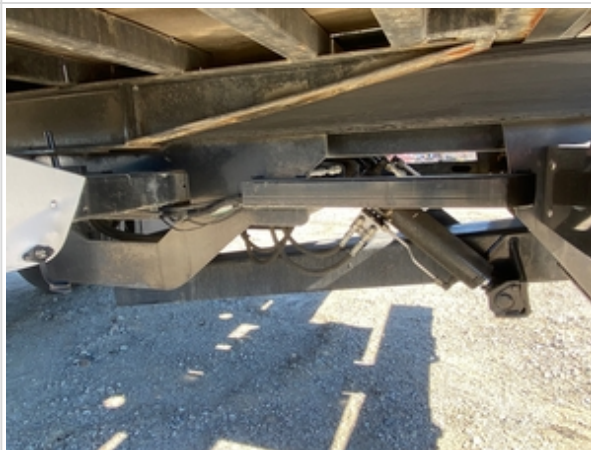
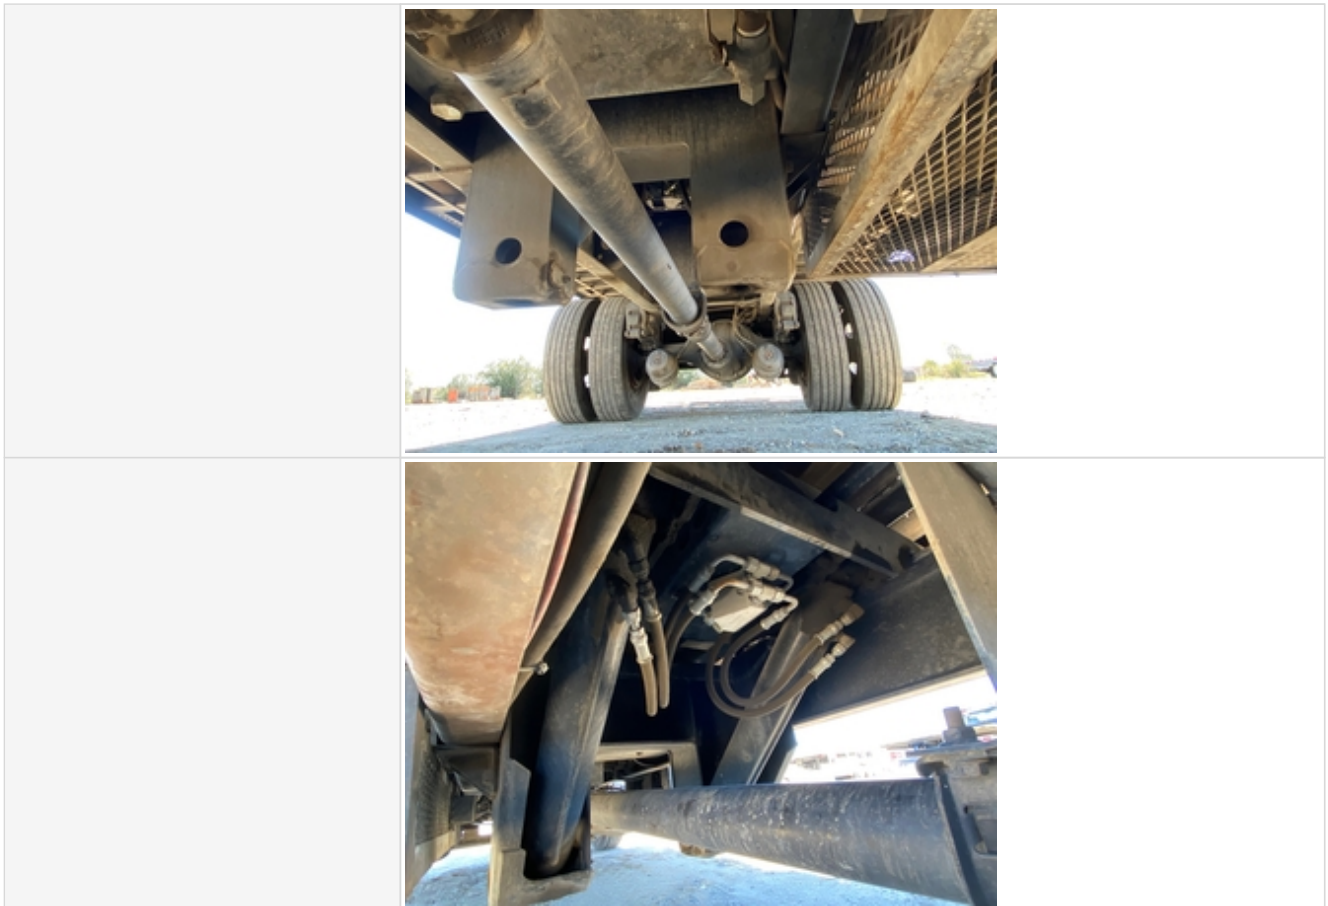
Tailgate Latch	0
Support Frame	3
Support Frame Photos
