Inspection Report (Telehandler)

| Make | SKYTRAK |
| Model | 10054 |
| Serial Number | 17806 |

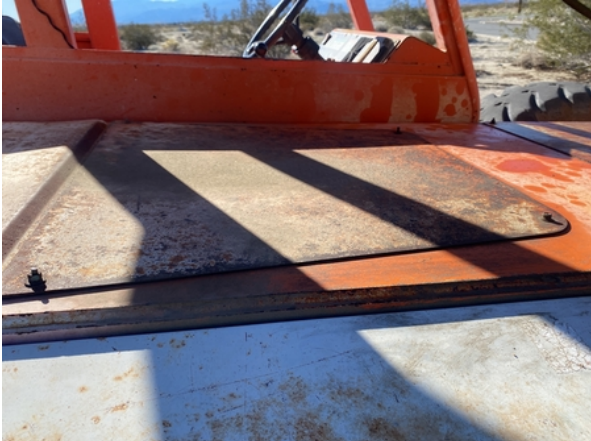
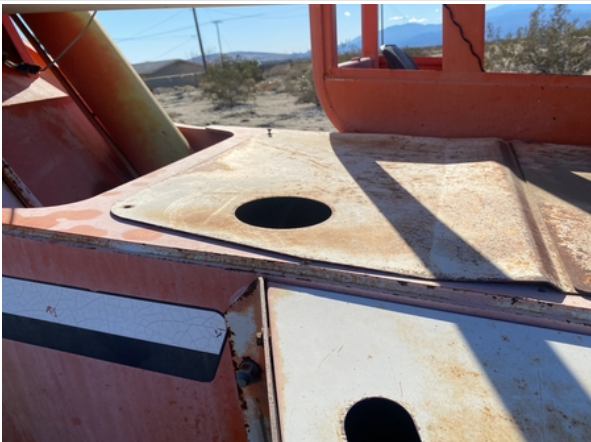
| Body Panels | 3 - Normal Wear & Tear |
| Body Panel Condition | No visible damage, good paint condition and panel fitment |
| Steps / Ladders | 2 - Above Average Wear |
| Steps / Ladders Condition | Bent or broken steps or rungs |
| Exterior Lights | 2 - Above Average Wear |
| Exterior Lights Condition | Overall lighting system is non-operational |

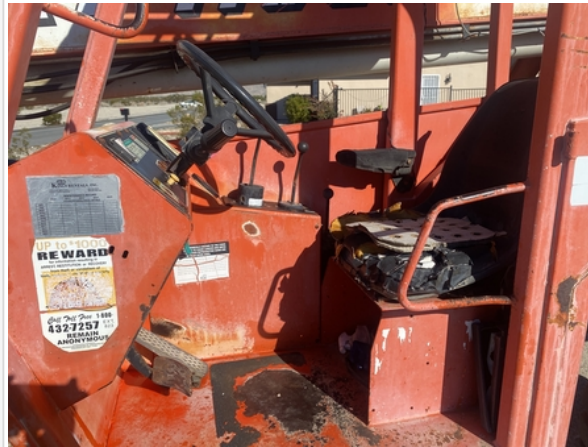
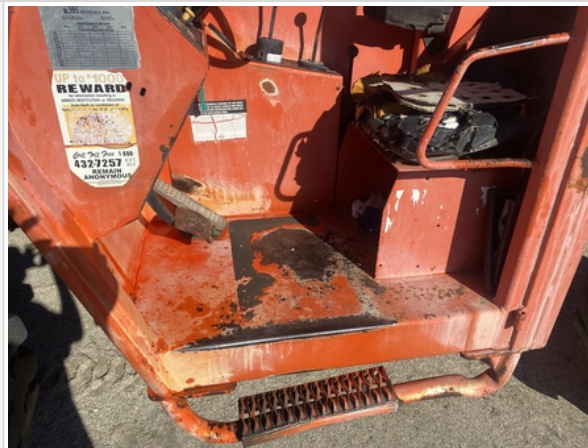
Operator Cabin Photos

| Operator Cabin Overall | 2 - Above Average Wear |
| Operator Cabin Overall Condition | Minor cosmetic wear to cabin surfaces, floors, panels, and ceiling. Other (see comments) |
| Operator Seat Condition | Seat(s) has major surface staining or tears |

| Controls & Switches Condition | Switches have good functionality, minor cosmetic damage observed, Other (see comments) |
| Comments | Decals worn on switches |

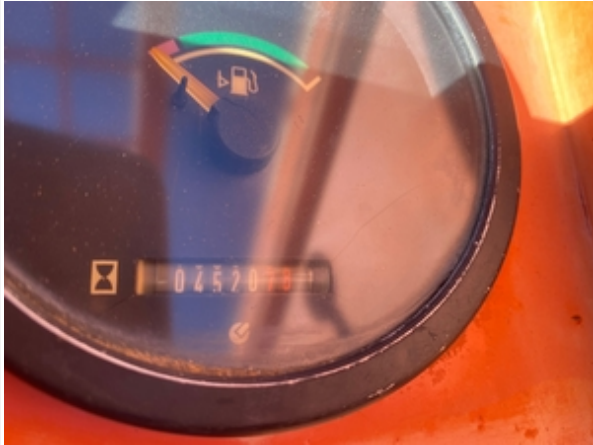
| Hour Meter Activity Photos | |

| Hour Meter Activity | 3 - Normal Wear & Tear |
| Hour Meter Condition | Hour meter is functional and in good condition |

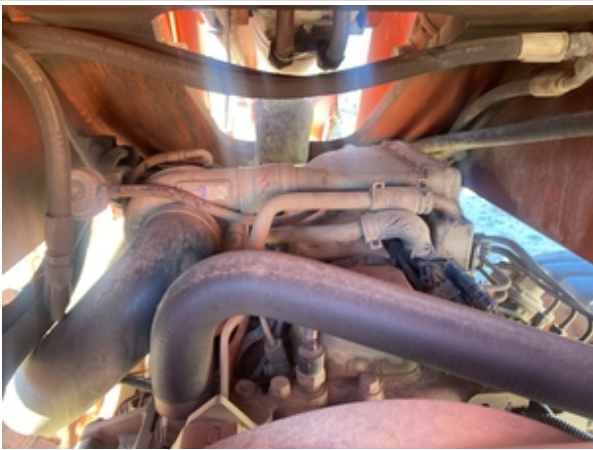
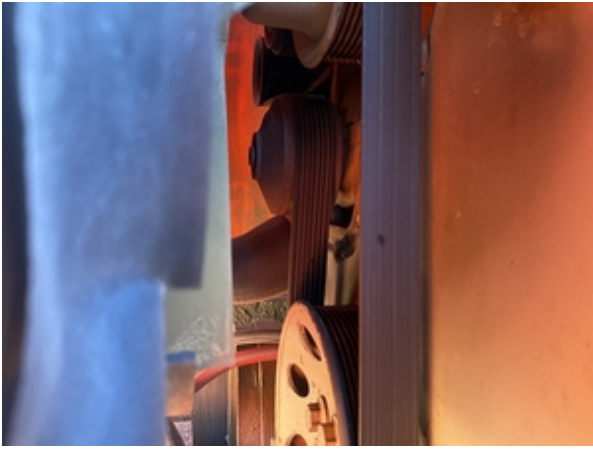
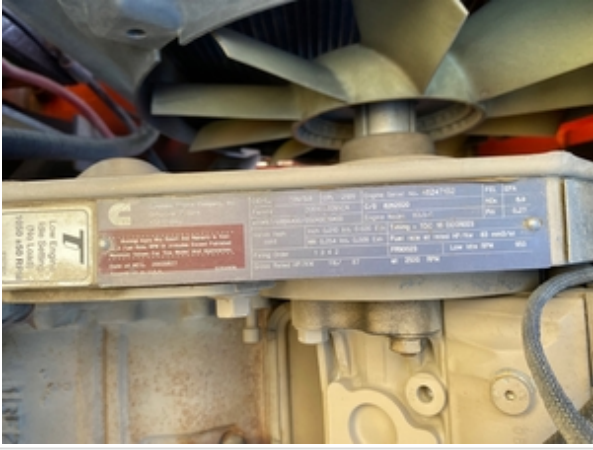
| Blow-by (Visual Observation Check) | Yes | |
| Comments | Minor blowby observed at breather hose | |
| Comments | Negative Cable loose at Battery (causing intermittent no start) | |

| Battery | 2 - Above Average Wear |
| Battery Condition | Other (see comments) |
| Comments | Negative cable loose hold down not installed |

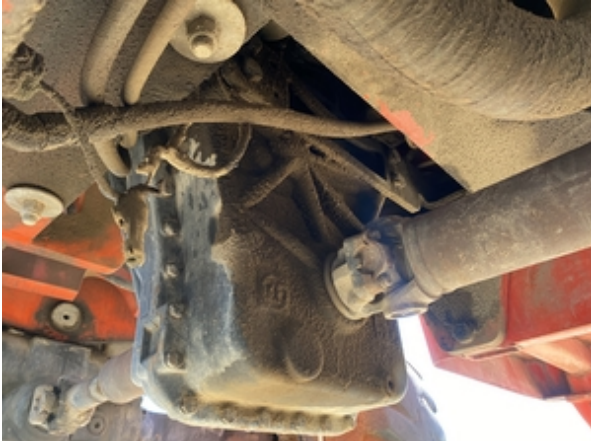
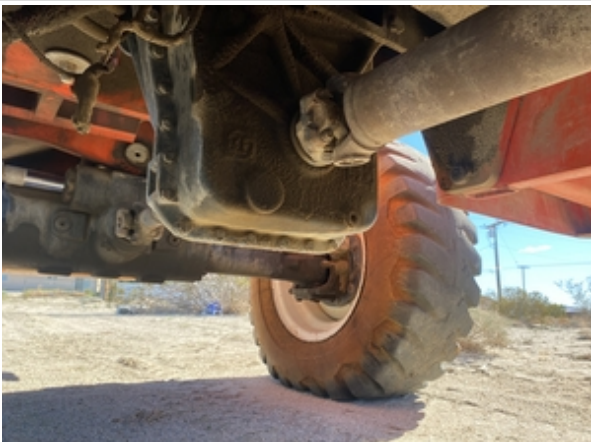
| Transmission Photos | | |

| Transmission | 3 - Normal Wear & Tear | |
| Transmission Condition | No unusual noises or vibrations | |

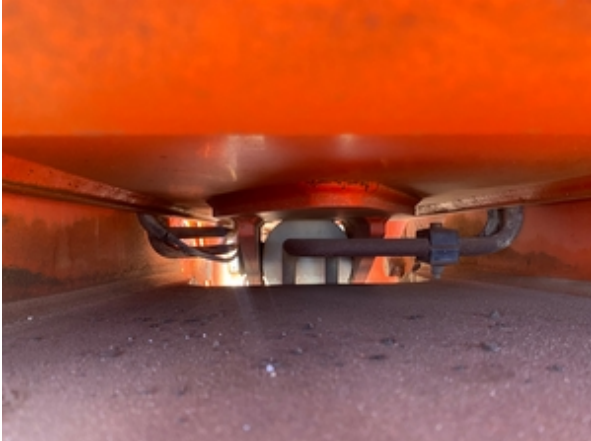
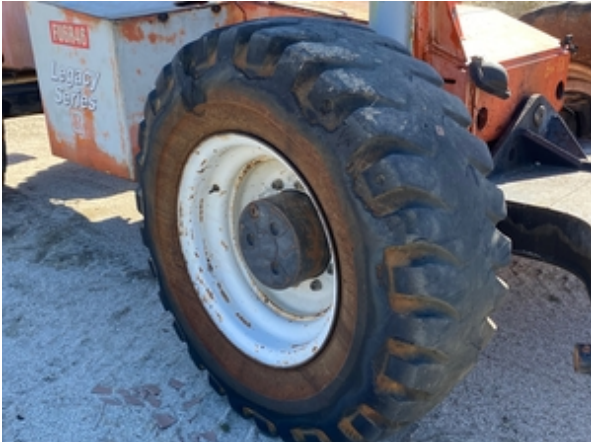
| Wheels & Tires | 2 - Above Average Wear | |
| Comments | Tires are Foam Filled | |

| What Needs Work | Cosmetically, machine could use a paint job. Some hydraulic hoses showing signs of surface cracks and may need to be replaced soon. Tires may need to be replaced soon. Battery needs to be properly mounted. Minor active leak at main control valve. Hydraulic leak at front tilt cylinder hose fitting. Horn, Backup alarm And lights inoperable. |

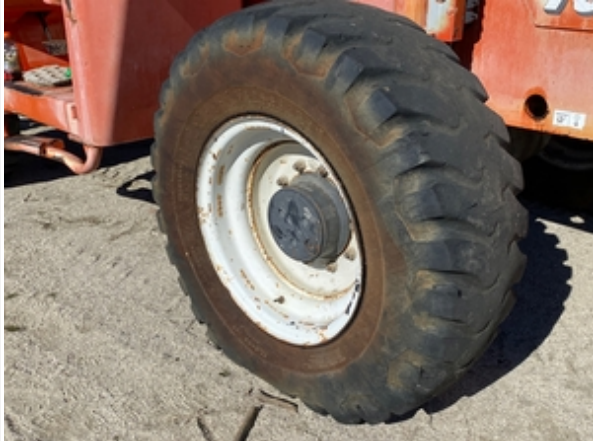
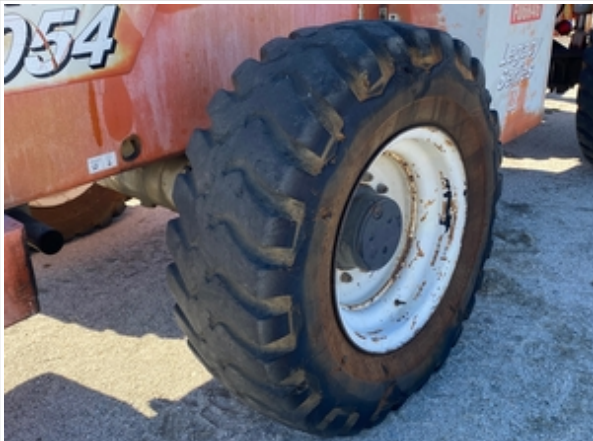
| Tire Brand | Firestone |
| Tire Size | 17.5 - 25 |
| Rear Right Tire - Ratio Remaining | 10% |

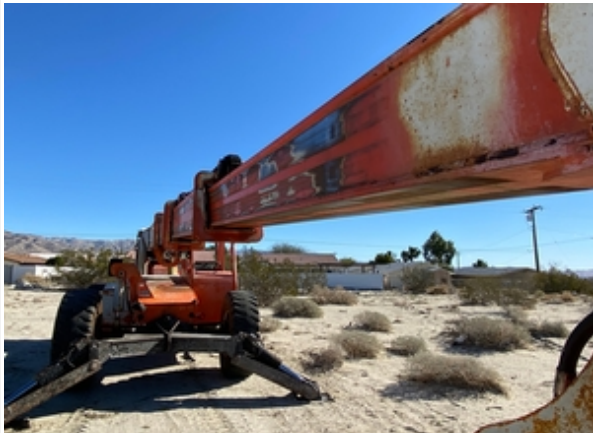
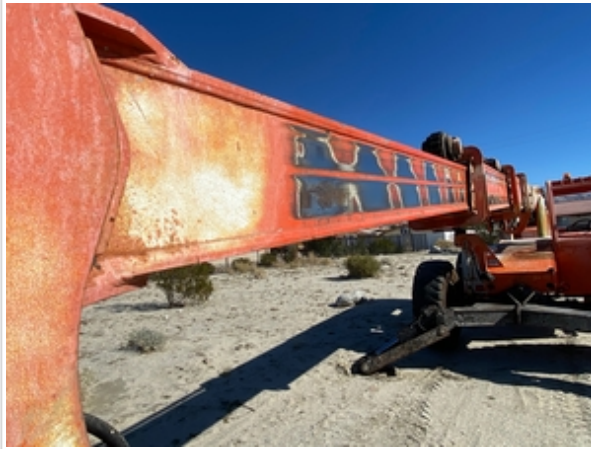
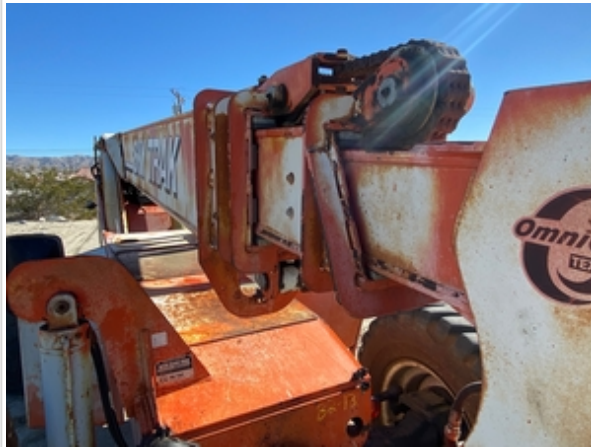
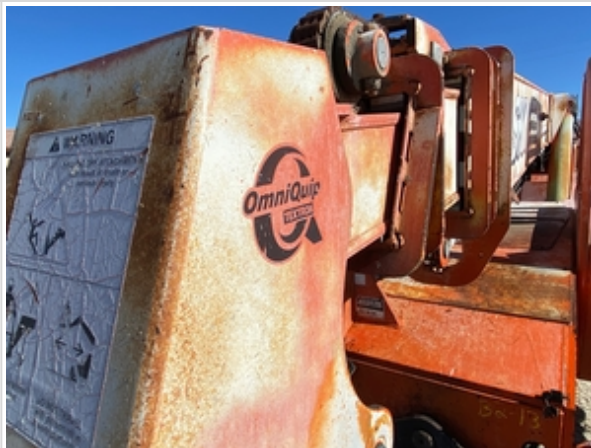
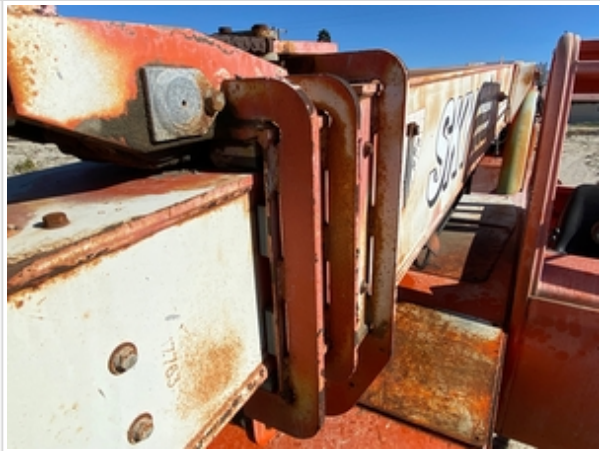
| Boom Condition Photos | |

| Boom Condition | 3 - Normal Wear & Tear |

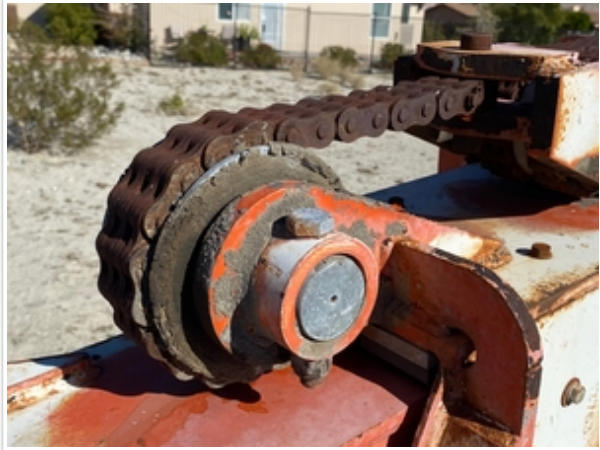
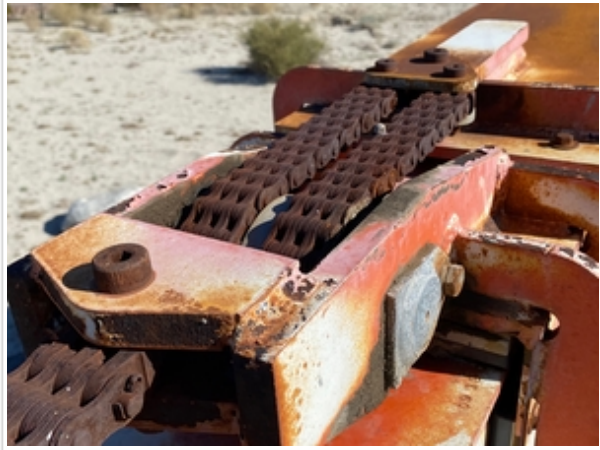
| Chain / Tensioners Photos | | |

| Chain / Tensioners | 3 - Normal Wear & Tear | |

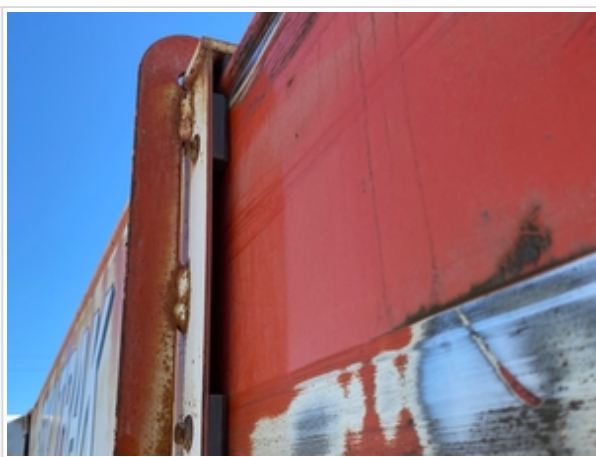
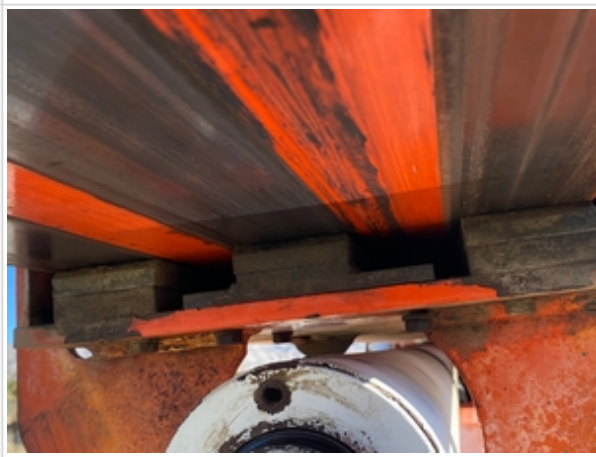
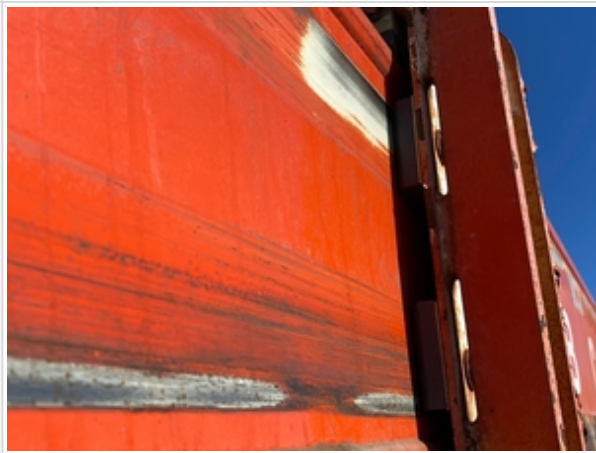
| <p>Boom Wear Guides Photos</p> | | |

| Boom Wear Guides | 3 - Normal Wear & Tear | |

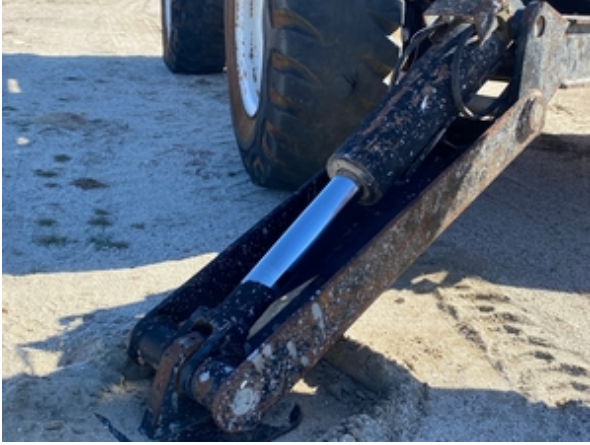
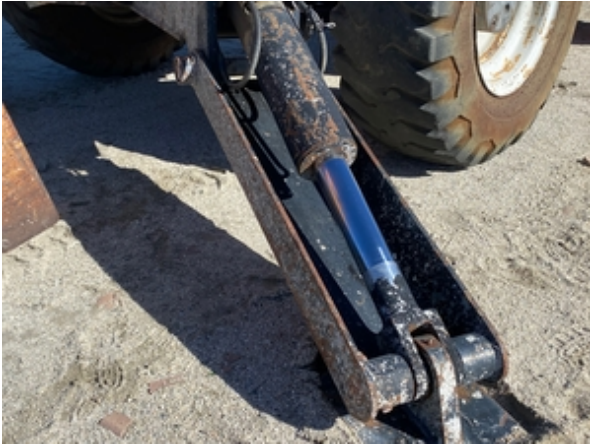
| Outriggers Photos | | |

| Outriggers | 3 - Normal Wear & Tear | |

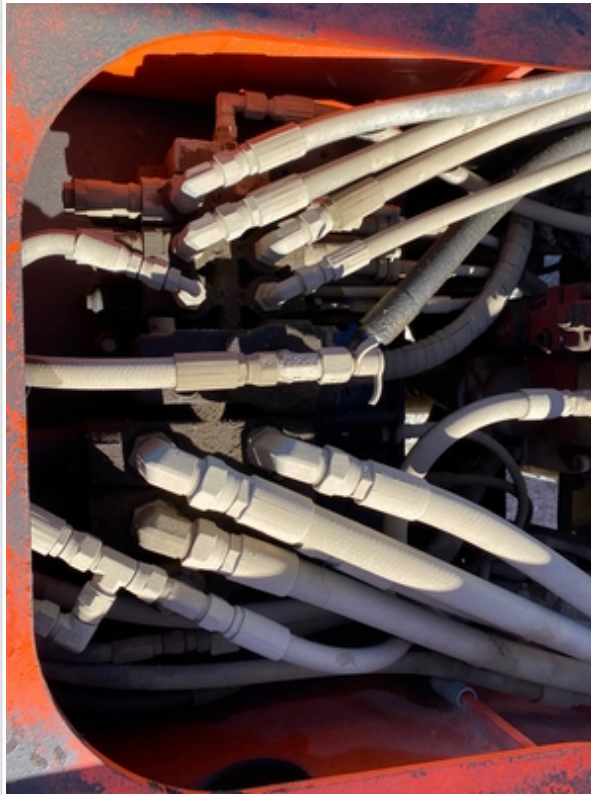
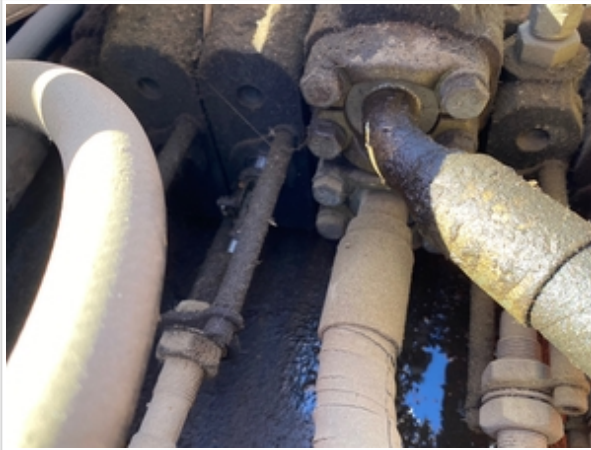
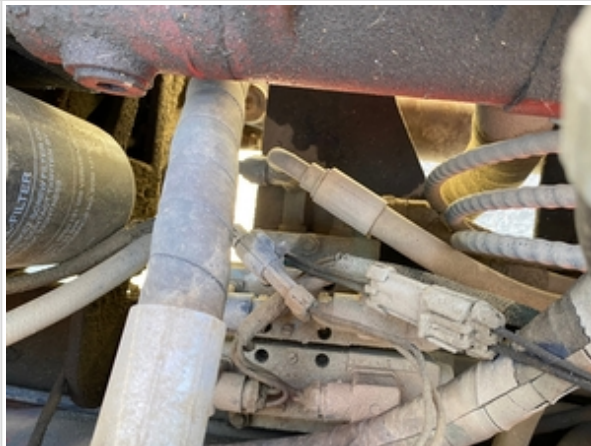
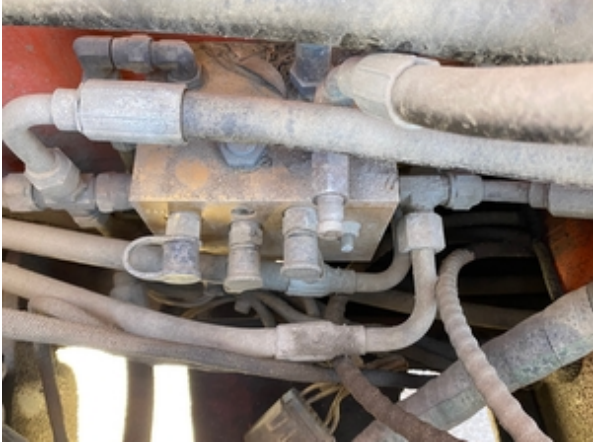
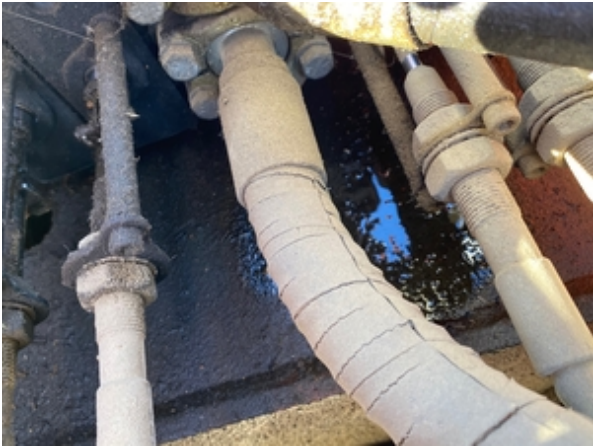
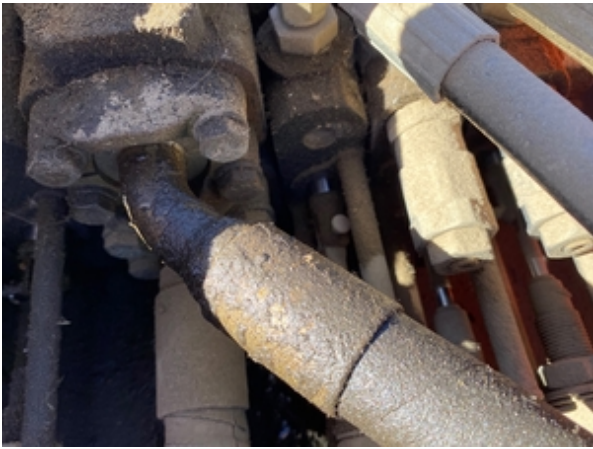
Hydraulic System Photos

| Wet or Damp Hydraulic Lines / Fittings | Yes | |
| Hydraulic Lines / Fittings Condition | Hydraulic lines & fittings are clean and in good condition, Other (see comments) | |
| Comments | Most hydraulic hoses in good condition. Some showing signs of normal aged surface cracks | |

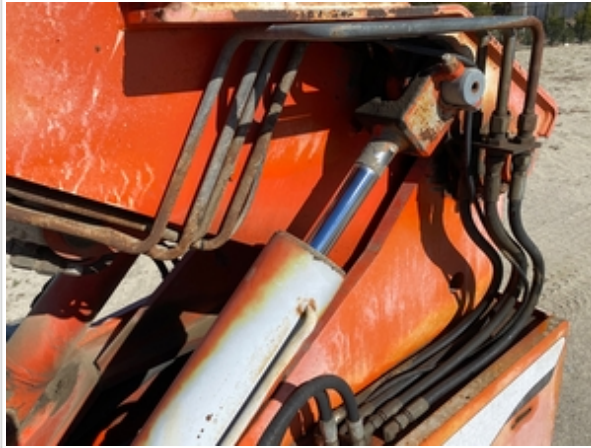
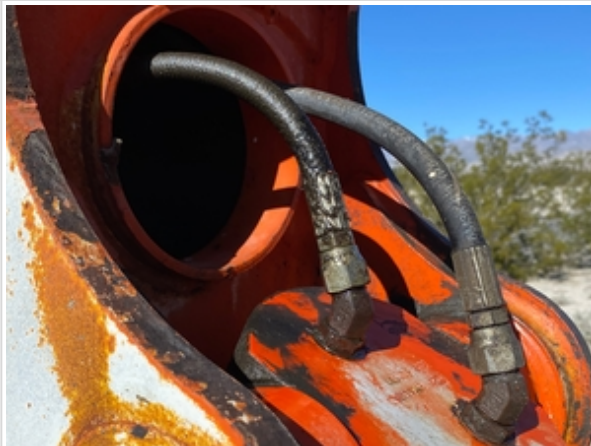
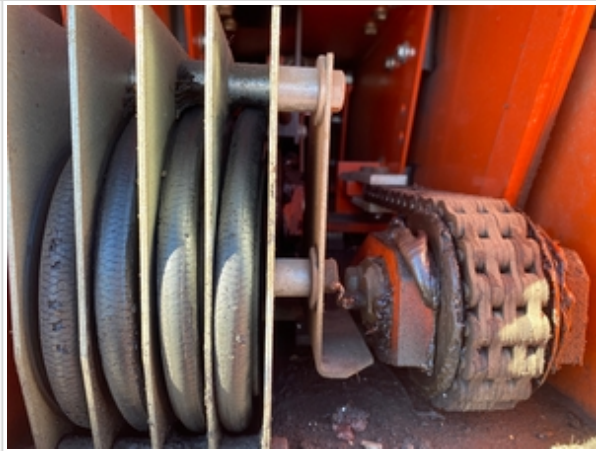
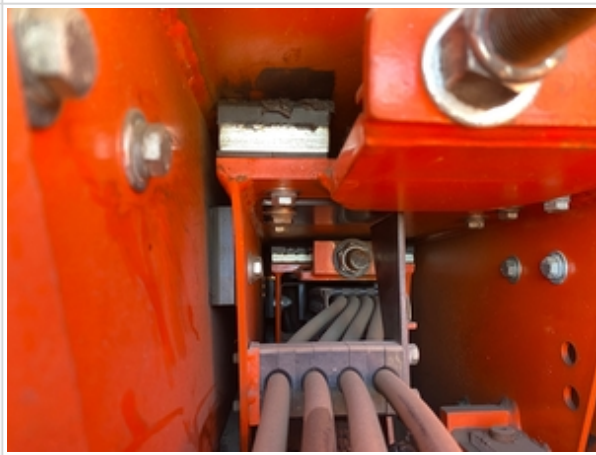
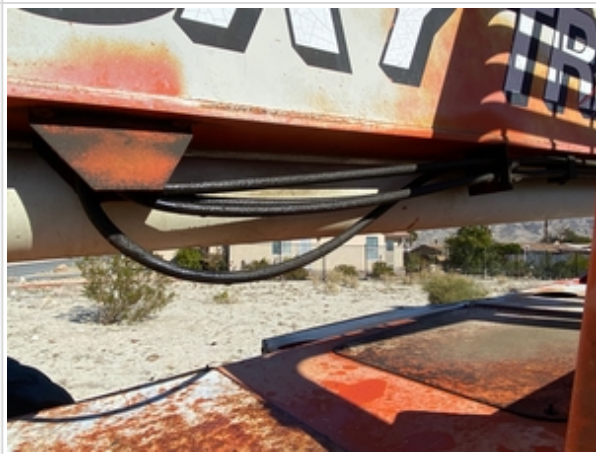
Appearance of Hydraulic Lines /
Fittings Photos

| Appearance of Hydraulic Lines / Fittings | 3 - Normal Wear & Tear | |

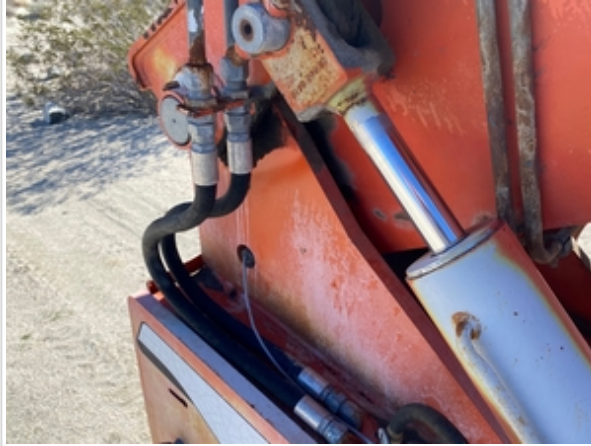
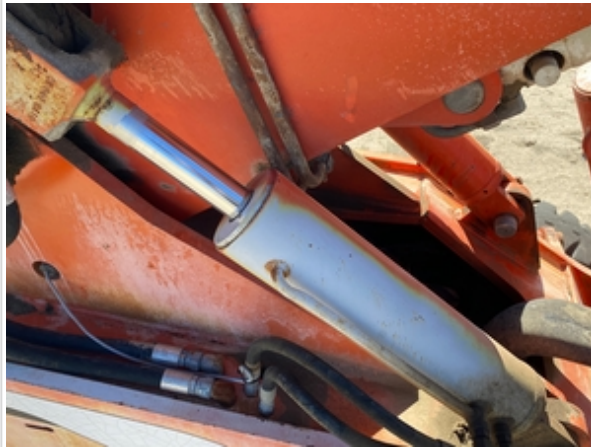
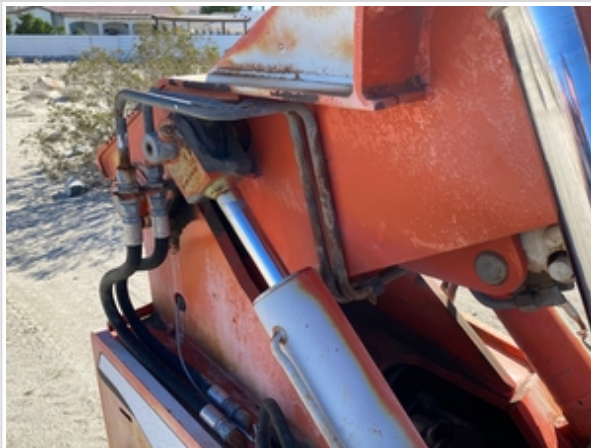
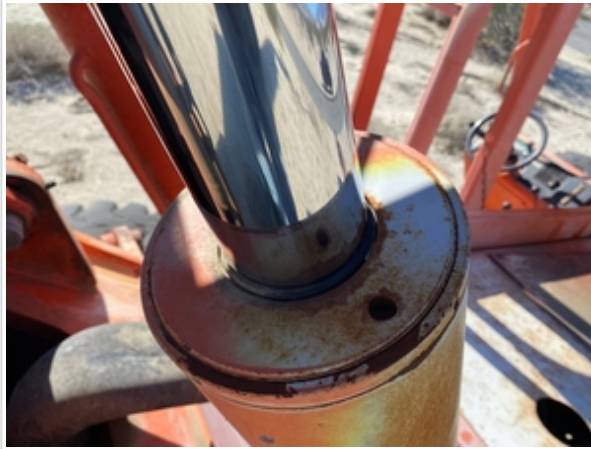
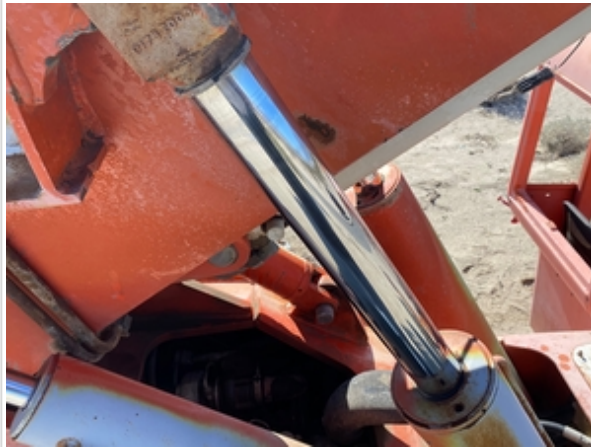
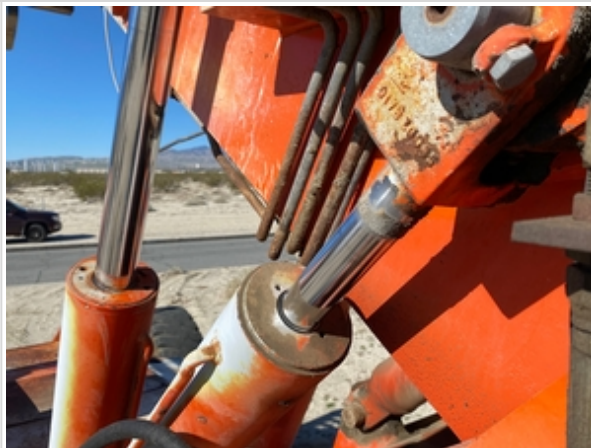
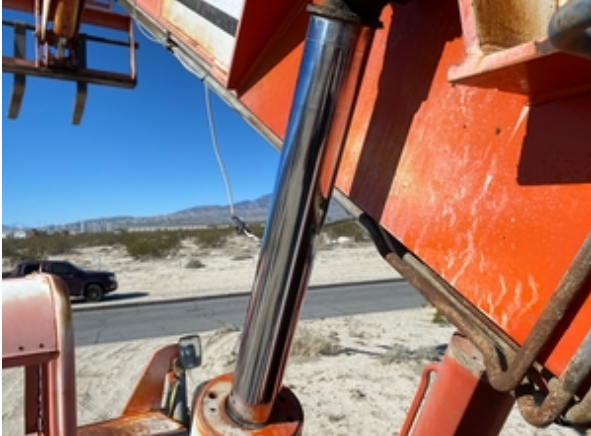
Boom Lift Cylinders Photos

| Boom Lift Cylinders: Mounting Pin | 3 - Normal Wear & Tear |
| Boom Lift Cylinders: Oil Leaks | No |

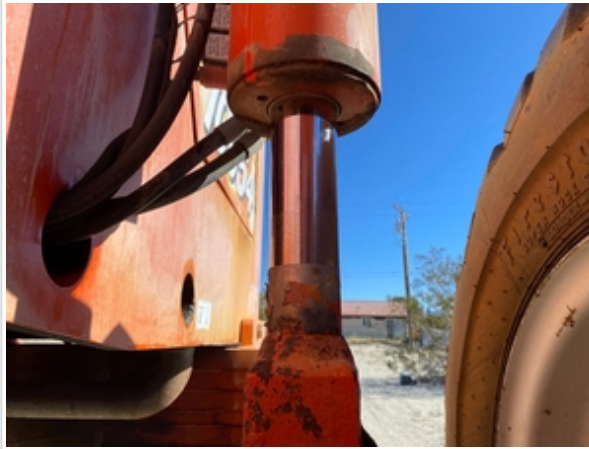
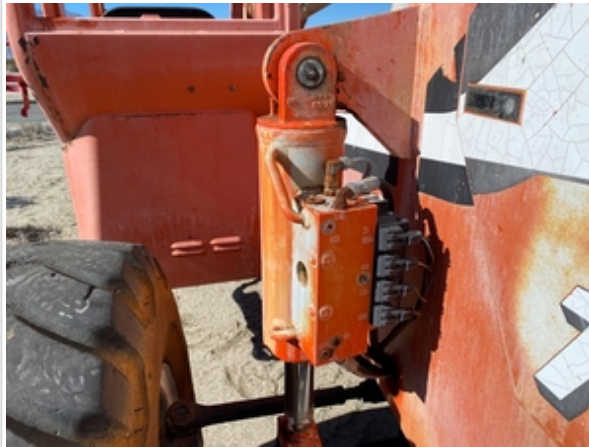
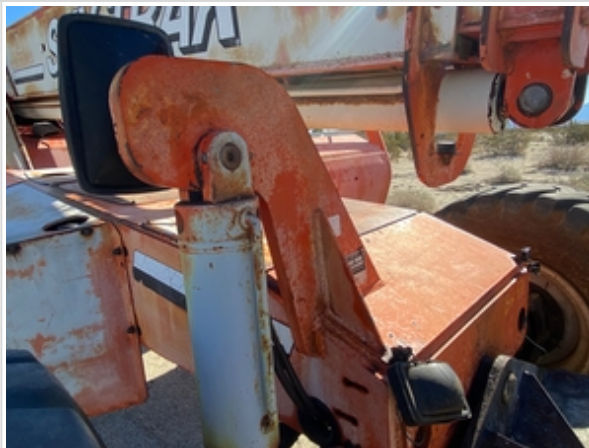
Frame Leveling Cylinders Photos

| Frame Leveling Cylinders: Mounting Pin | 3 - Normal Wear & Tear |
| Frame Leveling Cylinders: Oil Leaks | No |

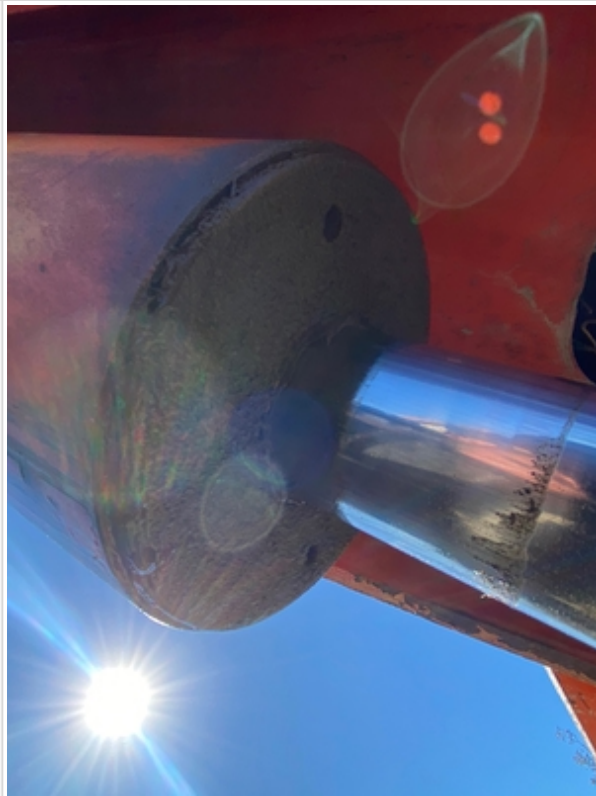
| Carriage Tilt Cylinder Photos | |

| Carriage Tilt Cylinder: Mounting Pin | 3 - Normal Wear & Tear | |
| Carriage Tilt Cylinder: Oil Leaks | No | |

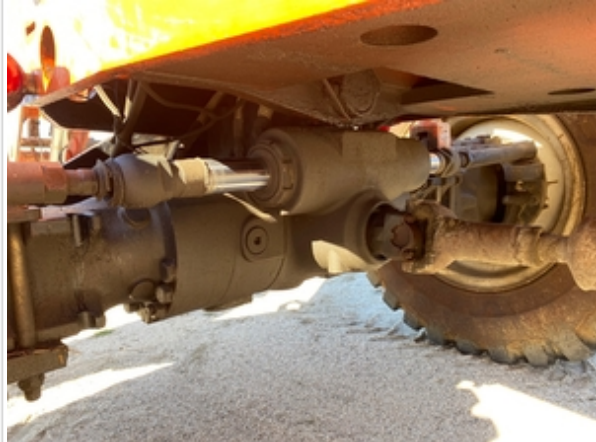
| Steering Cylinders Photos | |

| Steering Cylinders: Mounting Pin | 3 - Normal Wear & Tear |
| Steering Cylinders: Oil Leaks | No |

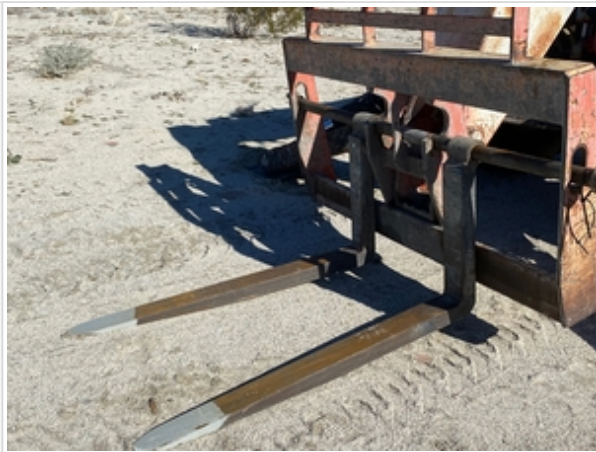
| <p>Forks / Work Tool Photos</p> | |

| Forks / Work Tool Condition | 3 - Normal Wear & Tear |

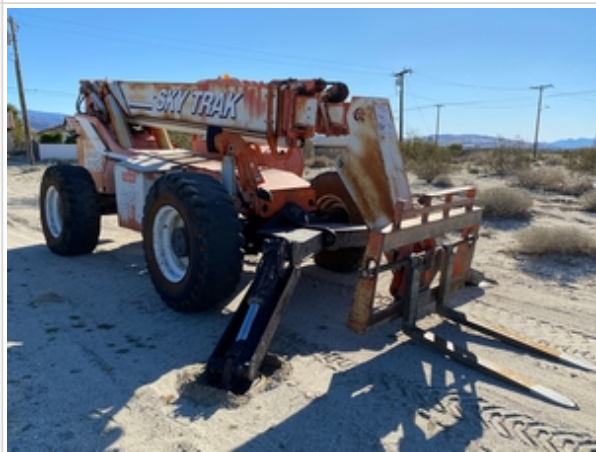
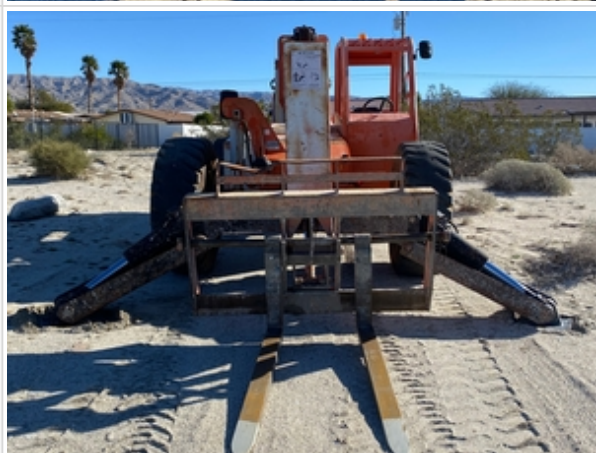
| <p>Back Rest Photos</p> | |

| <p>Back Rest Condition</p> | <p>3 - Normal Wear & Tear</p> |
