Inspection Report (Compact Track Loader)

| Make | CAT |
| Model | 287C |
| Serial Number | MAS00561 |

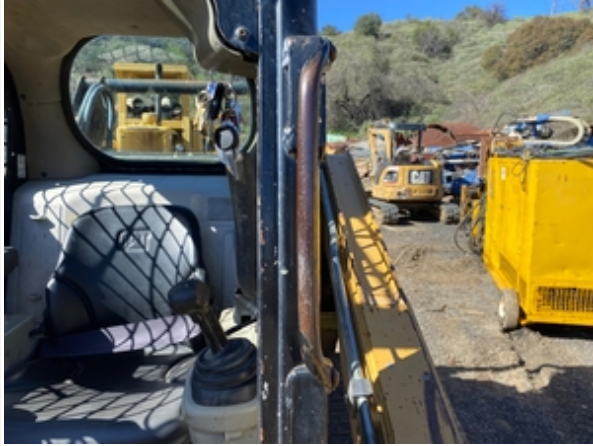
| Glass | 3 - Normal Wear & Tear | |
| Glass Condition | Glass intact, no visible damage | |

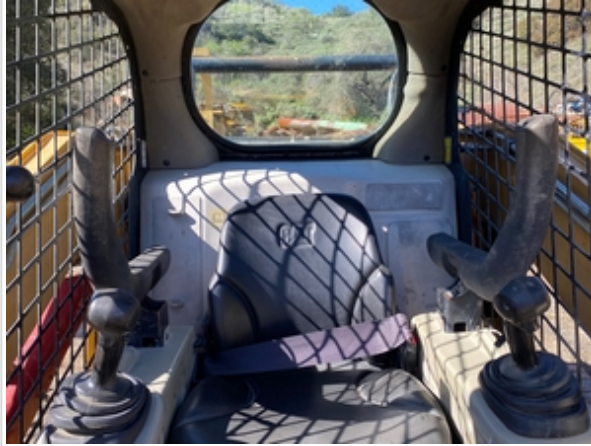
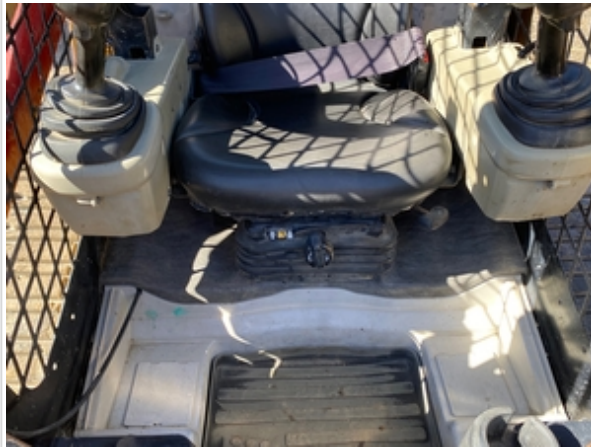
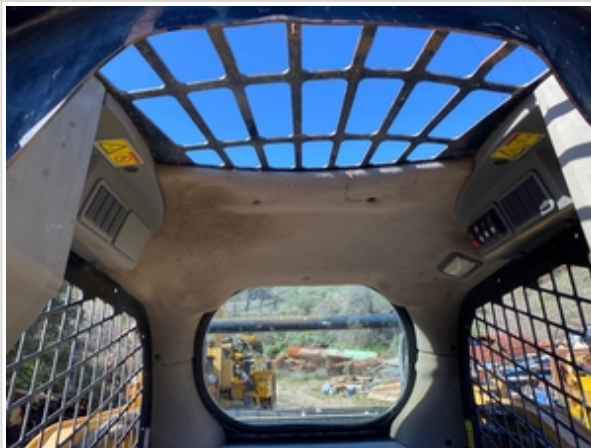
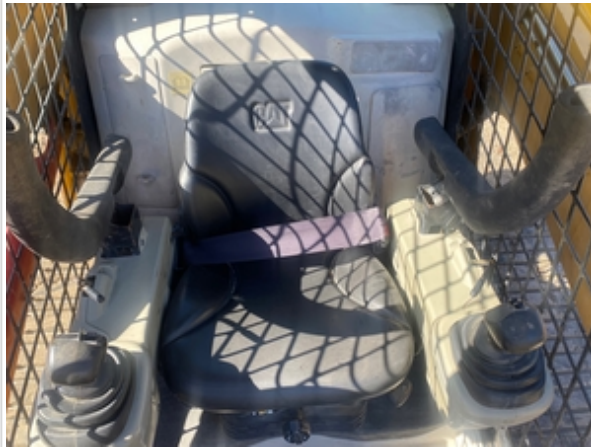
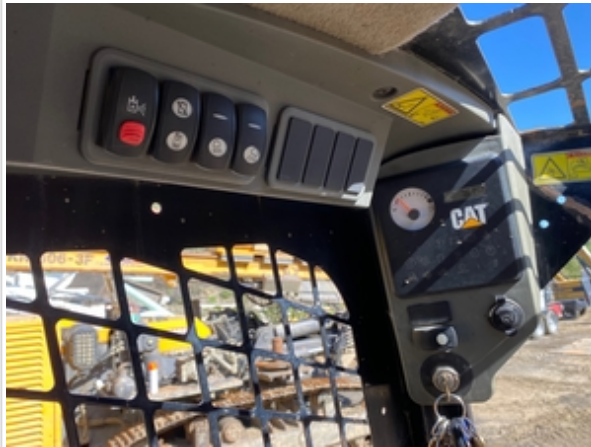
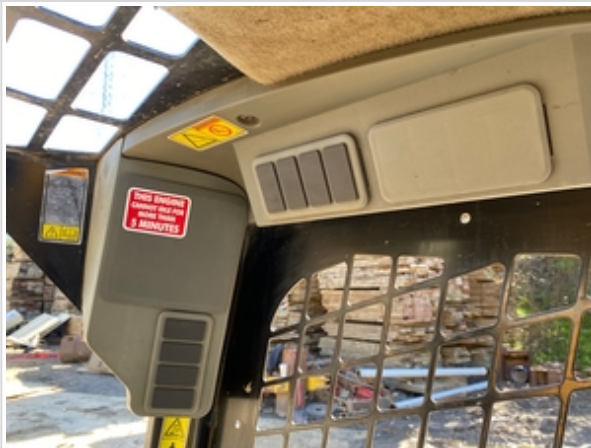
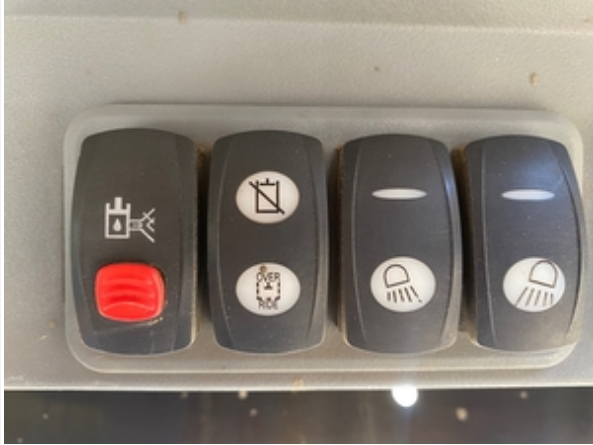
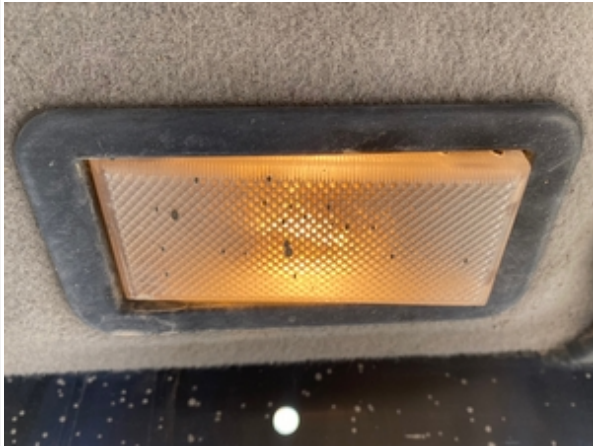
Operator Cabin Photos

| Operator Cabin Overall | 3 - Normal Wear & Tear | |
| Operator Cabin Overall Condition | Good cabin appearance, solid floors, panels, and ceiling, Minor cosmetic wear to cabin surfaces, floors, panels, and ceiling | |

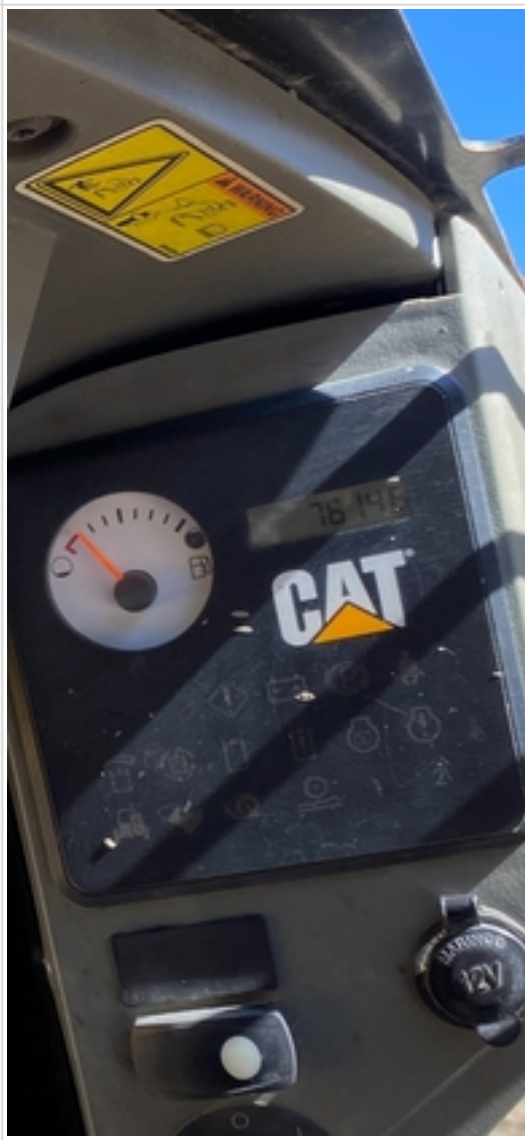
| Hour Meter Activity | 3 - Normal Wear & Tear | |
| Hour Meter Condition | Hour meter is functional and in good condition | |

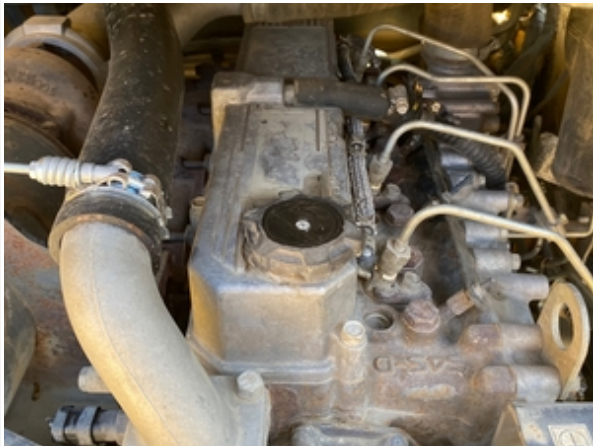
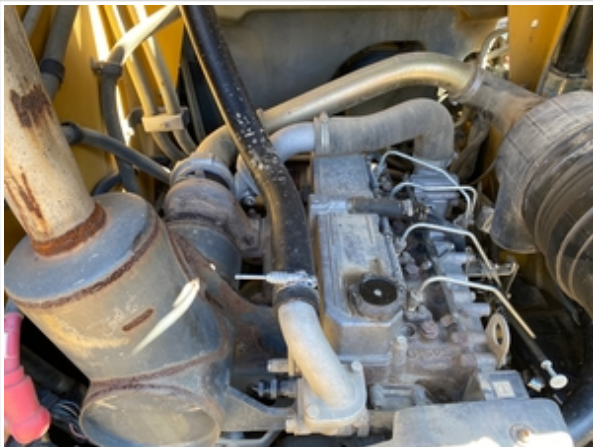
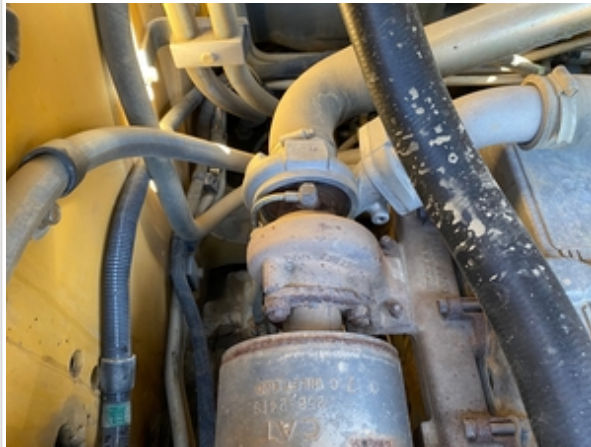
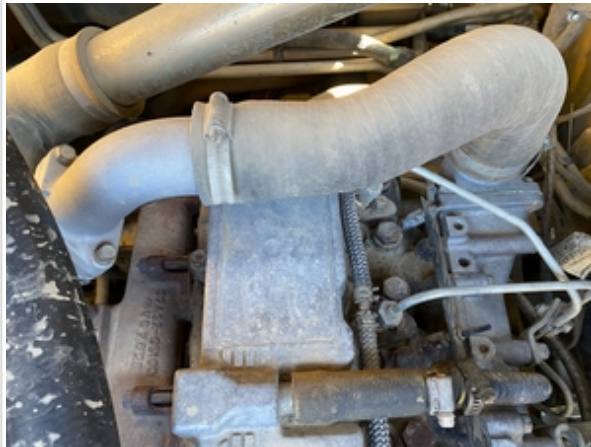
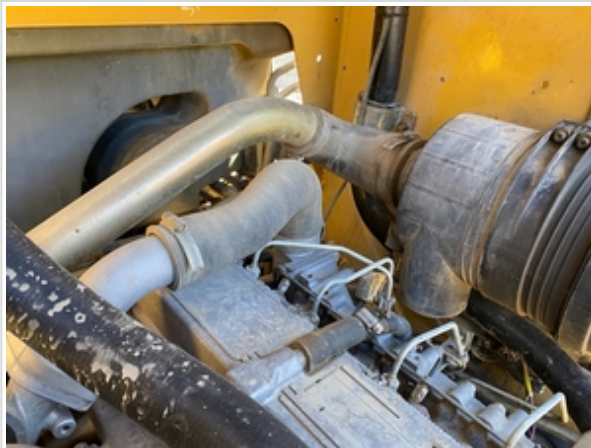
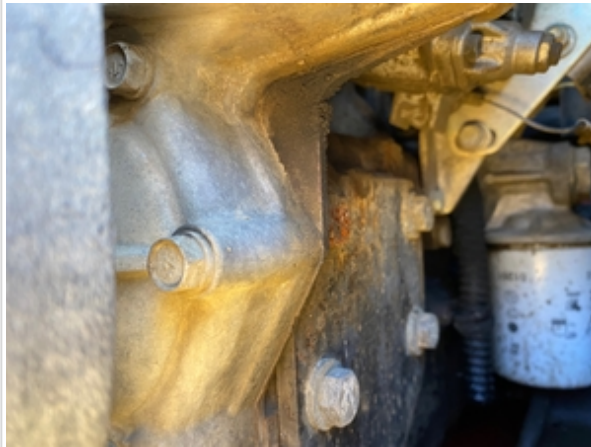
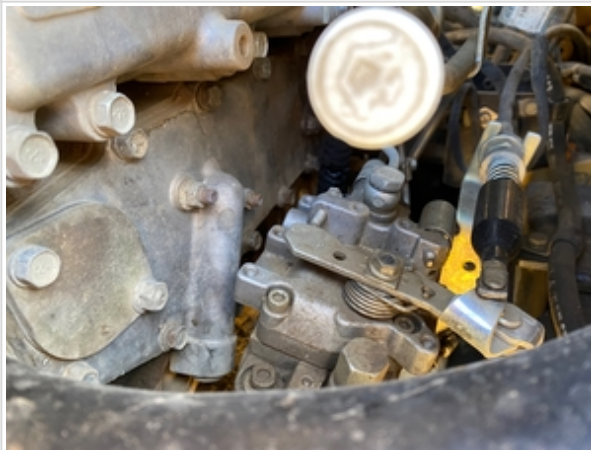
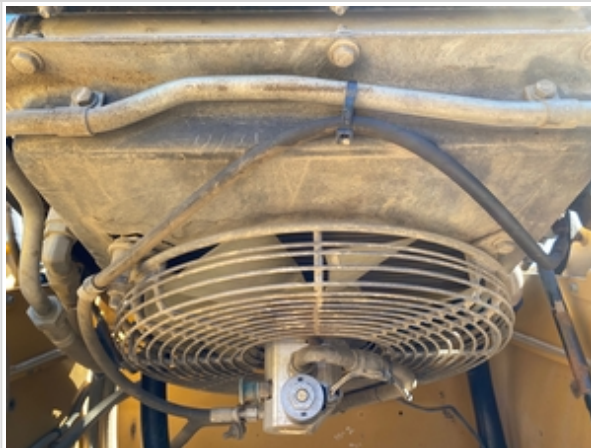
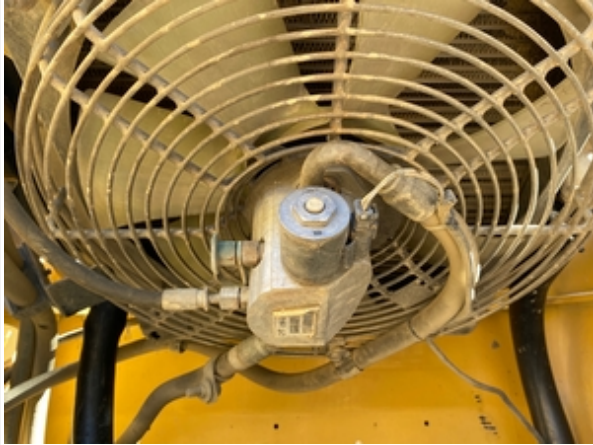
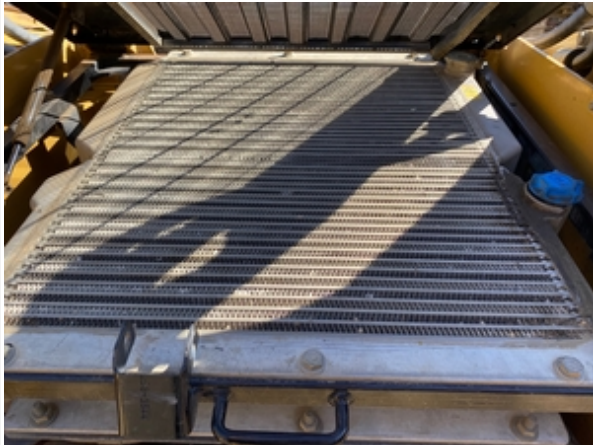
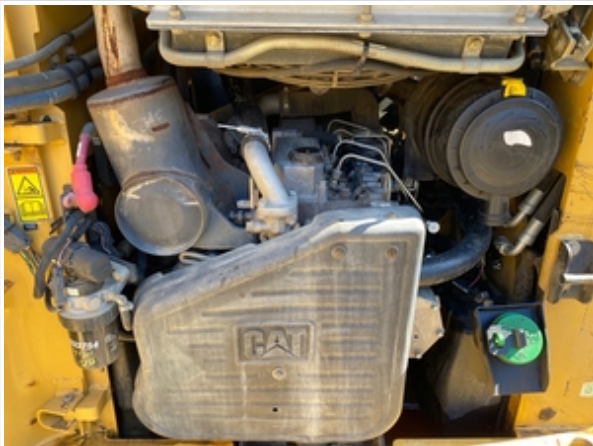
| Engine Photos | |

| Overall Engine Comments | Overall engine in well maintained condition |

| Comments | Engine service recommended |

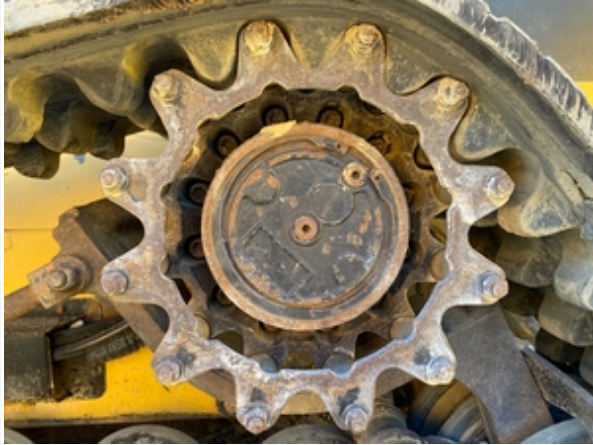
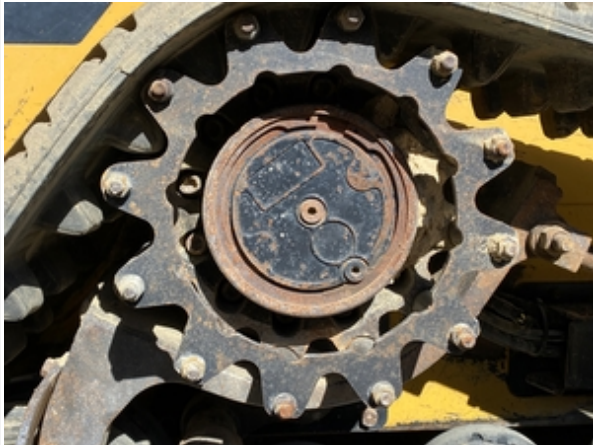
| Drivetrain Photos | | |

| Drive Motors | 2 - Above Average Wear | |
| Overall Drivetrain Comments | Drivetrain works well in all directions. No abnormalities observed with hydrostatics during inspection. | |

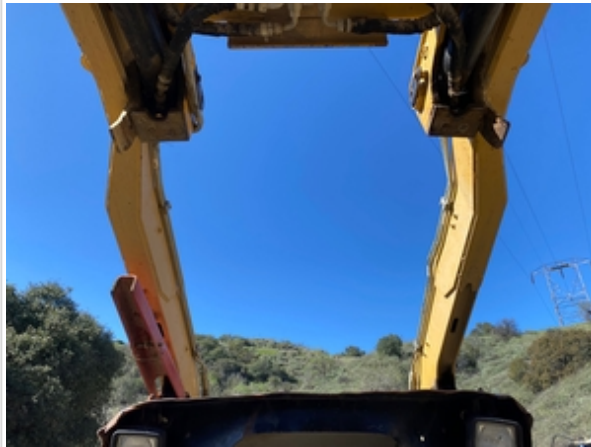
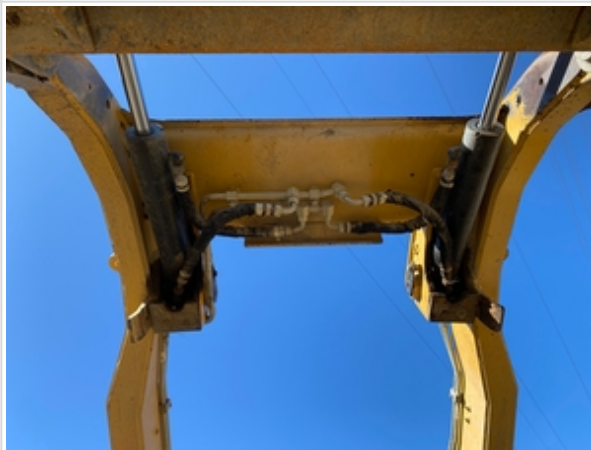
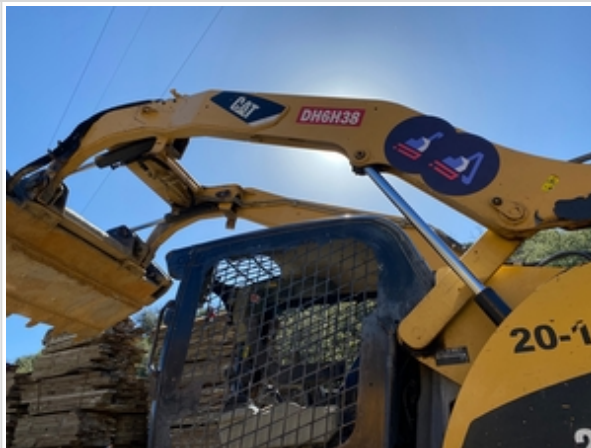
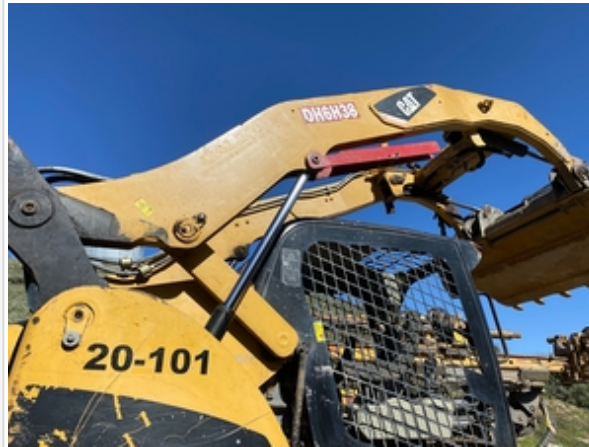
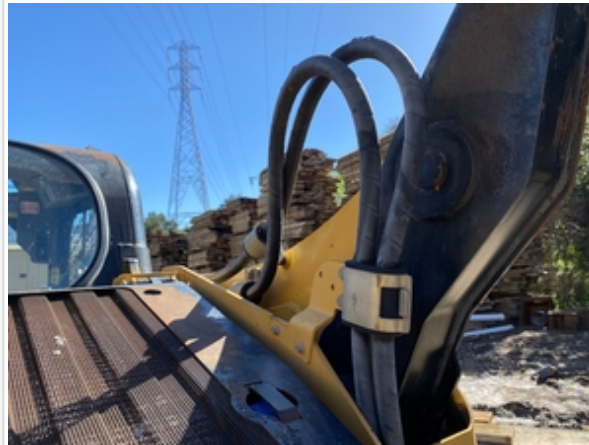
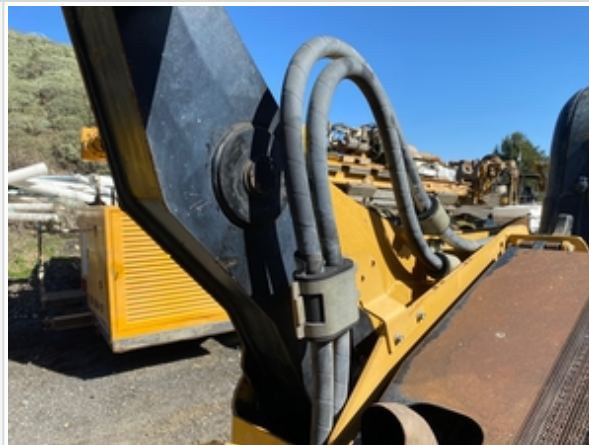
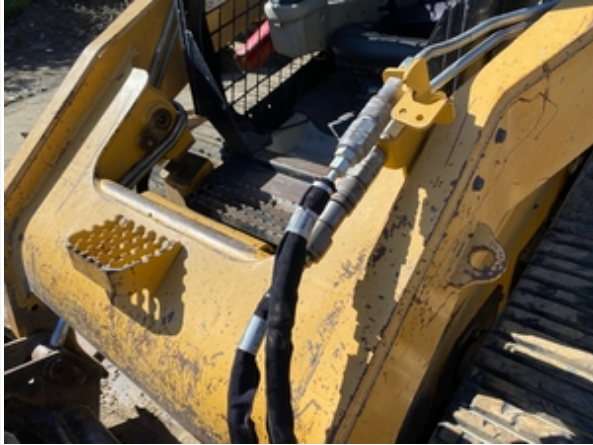
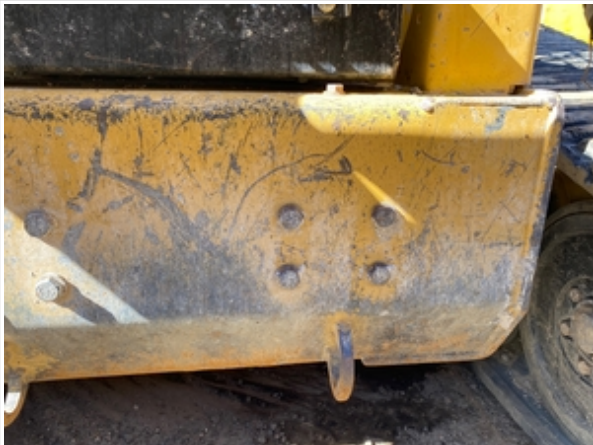
Chassis Photos

| Overall Chassis Comments | Overall chassis in solid condition. Implements and frame in good working condition. |

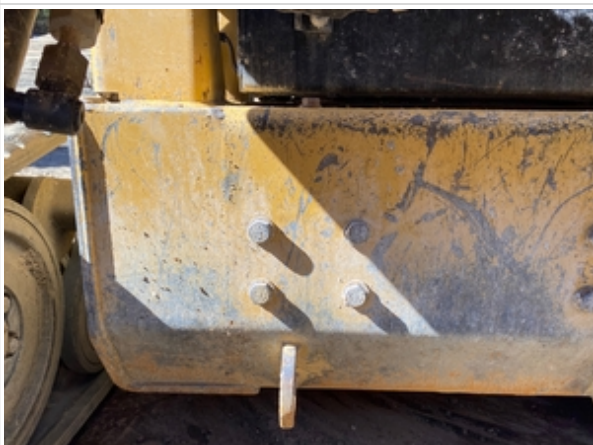
| Frame | 3 - Normal Wear & Tear | |
| Stance | 3 - Normal Wear & Tear | |
| Lift Arm | 3 - Normal Wear & Tear | |
| Chassis to Arm Pins | 3 - Normal Wear & Tear | |
| Quick Coupler | 3 - Normal Wear & Tear | |
| Quick Coupler to Arms Pins | 3 - Normal Wear & Tear | |
| Overall Chassis | 3 - Normal Wear & Tear | |

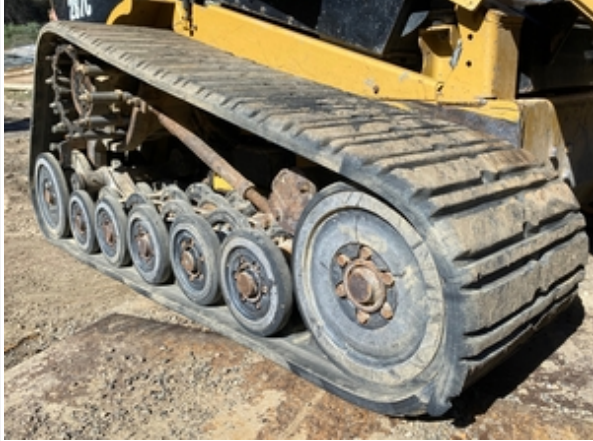
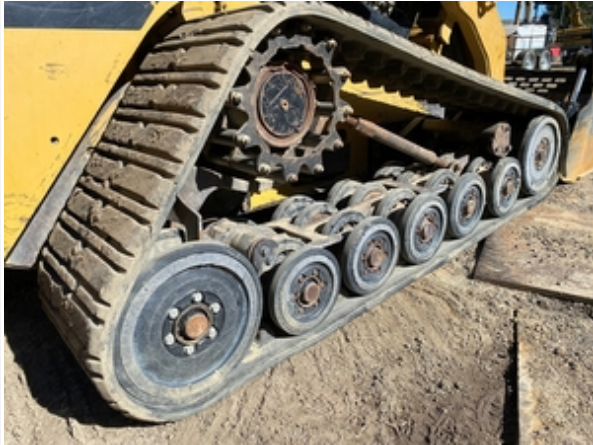
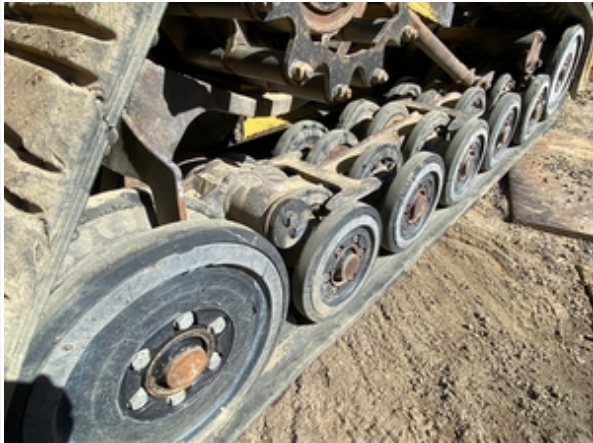
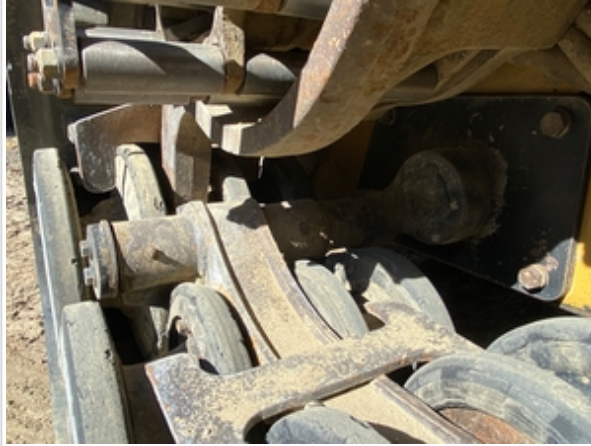
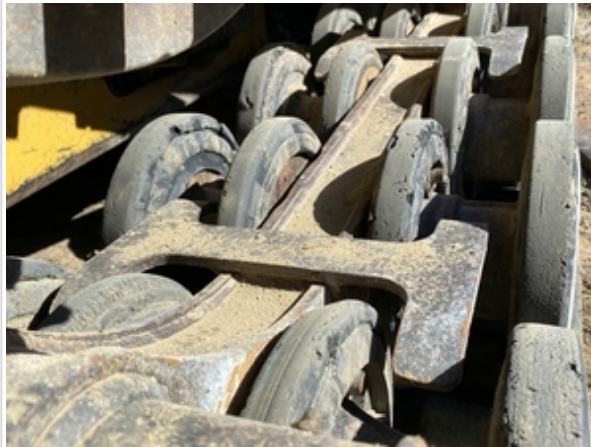
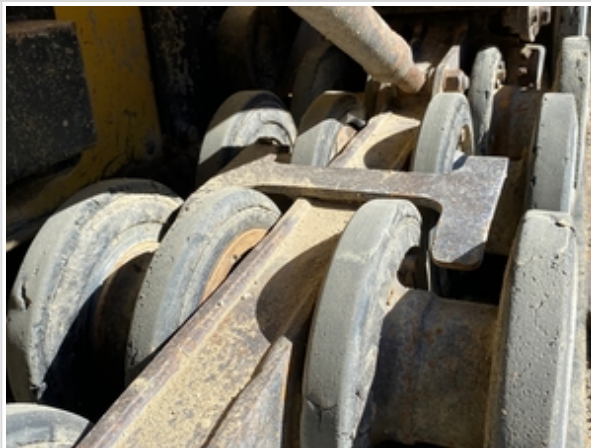
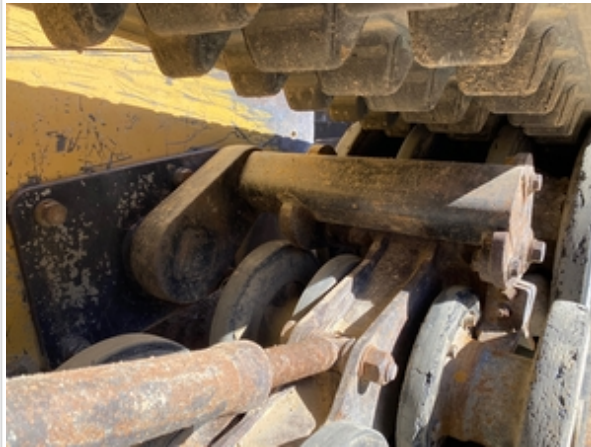
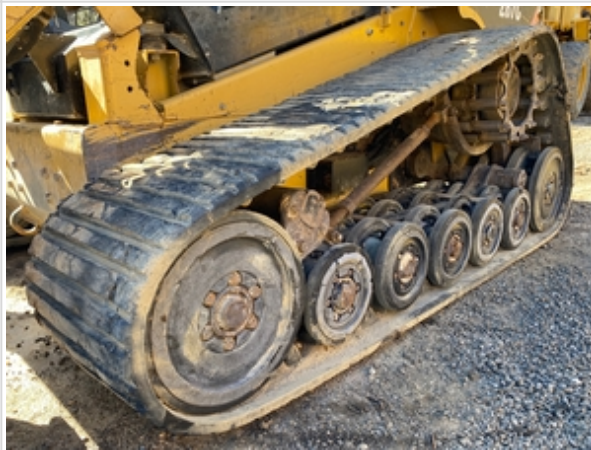
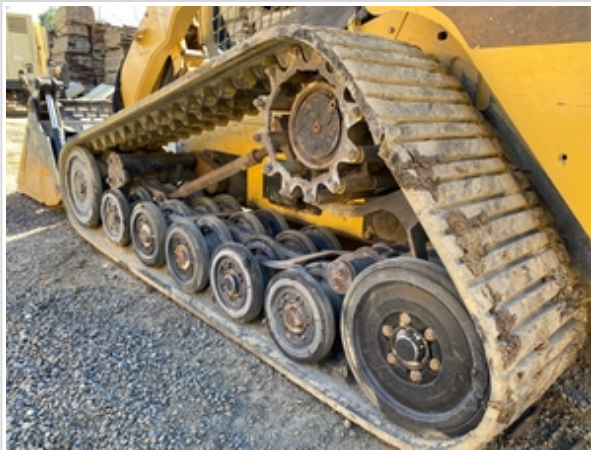
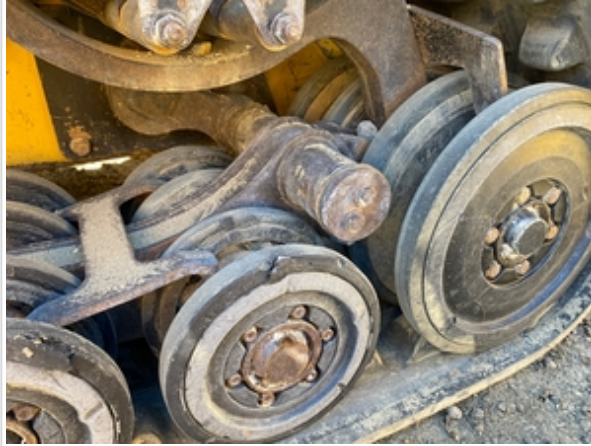
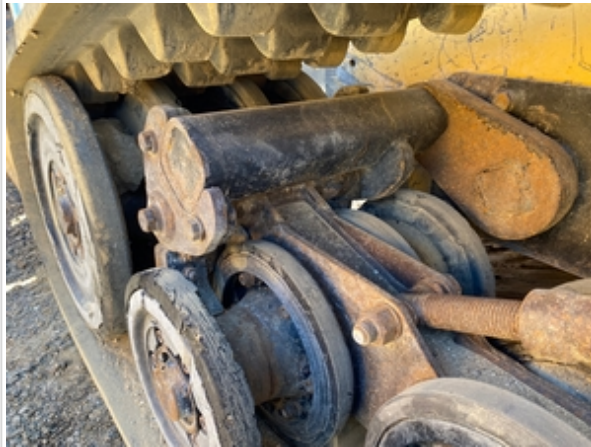
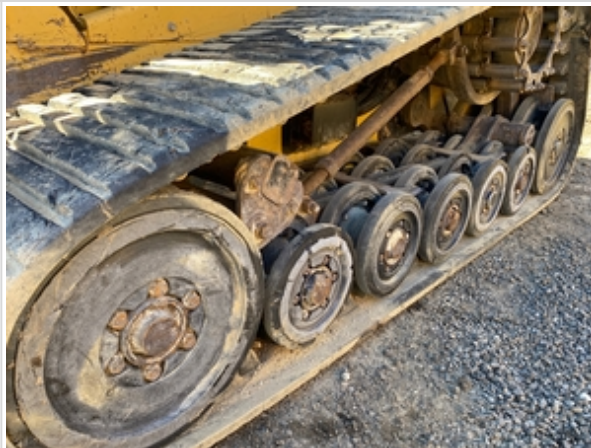
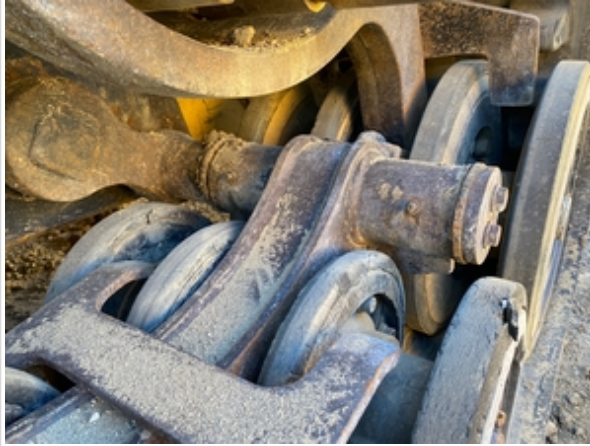
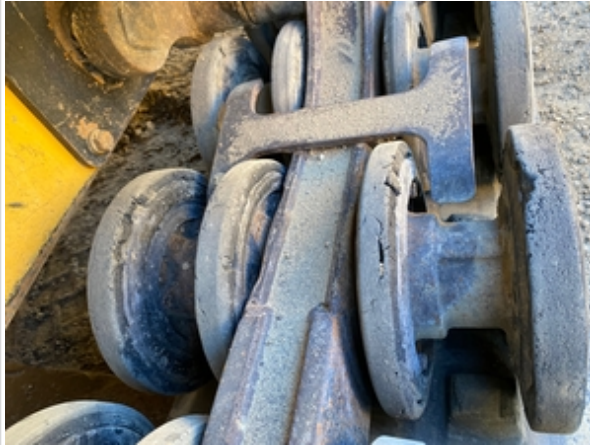
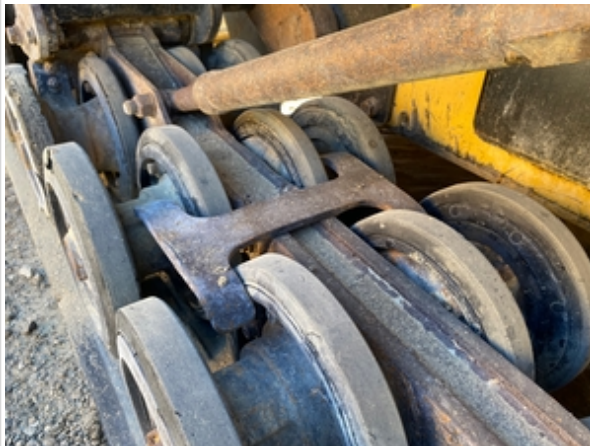
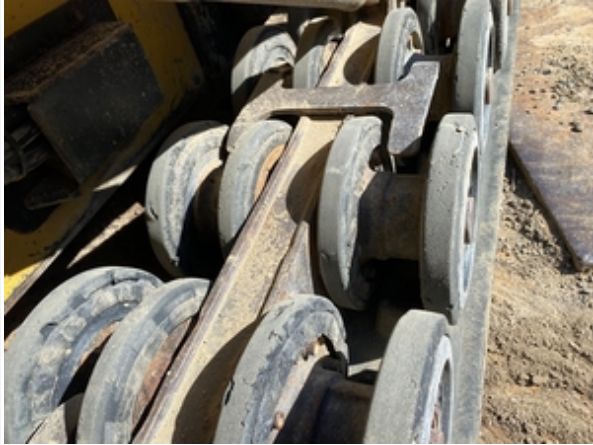
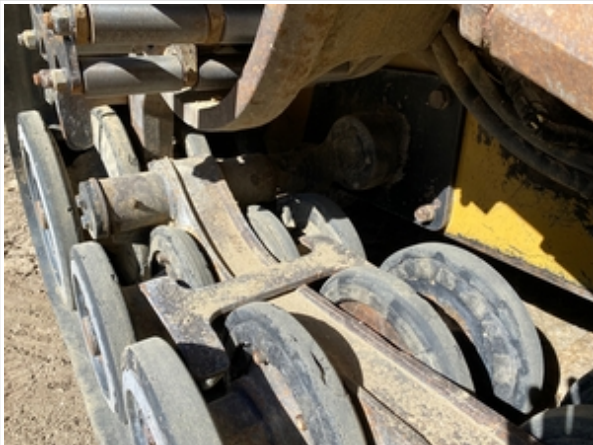
| Undercarriage Photos | | |

| Roller Frames | 3 - Normal Wear & Tear | |
| Track Belt | 3 - Normal Wear & Tear | |
| Rubber Belt Drive Lugs | 3 - Normal Wear & Tear | |
| Track Tensioners | 3 - Normal Wear & Tear | |
| Front Idlers | 3 - Normal Wear & Tear | |
| Rear Idlers | 3 - Normal Wear & Tear | |
| Track Rollers | 3 - Normal Wear & Tear | |
| Sprockets | 3 - Normal Wear & Tear | |

| What Needs Work | Some Undercarriage idlers and bogies may need to be replaced soon. Cosmetic scuff marks and some dents observed. Front cab handrail bent in and travel alarm inoperable. Both lift cylinders leaking a bit and should be resealed. |

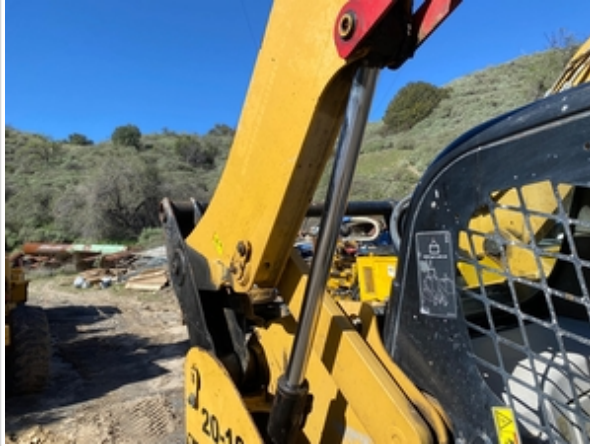
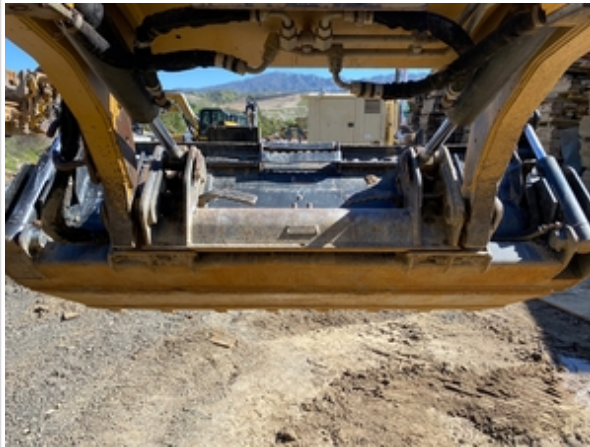
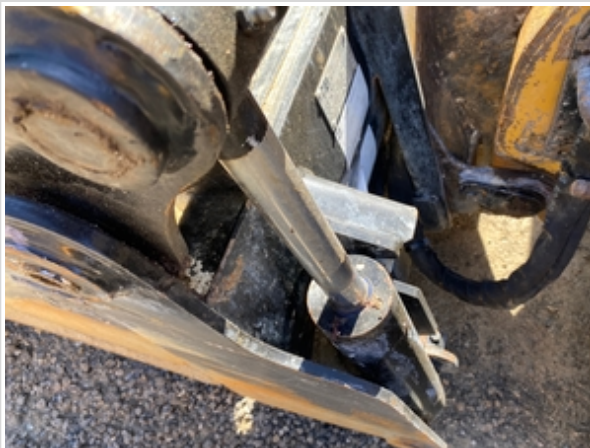
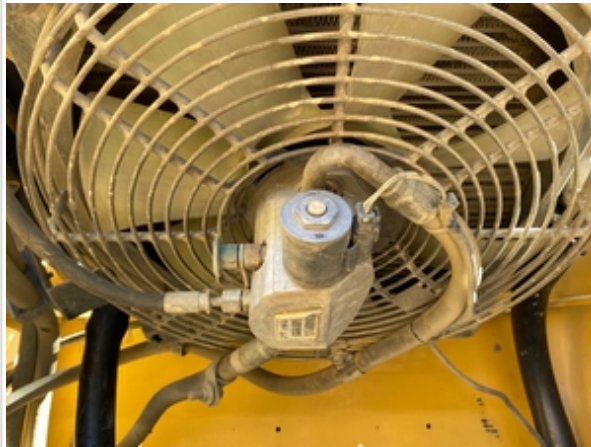
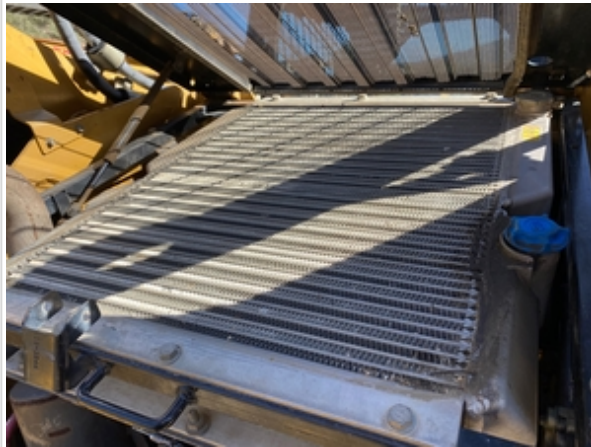
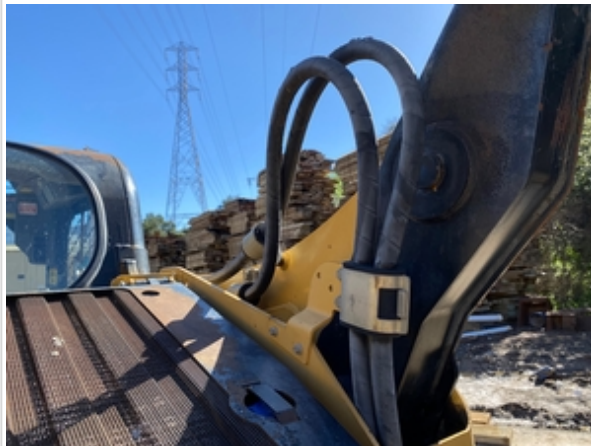
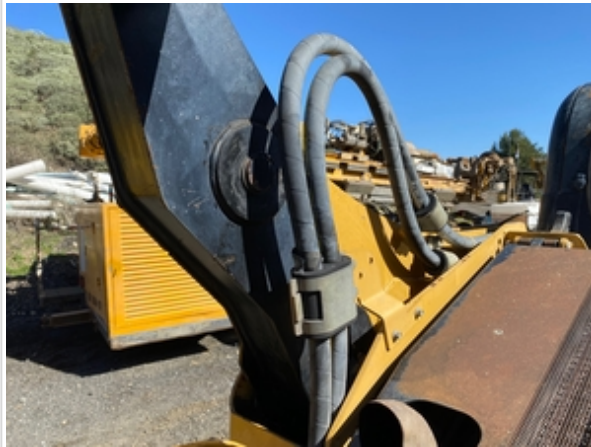
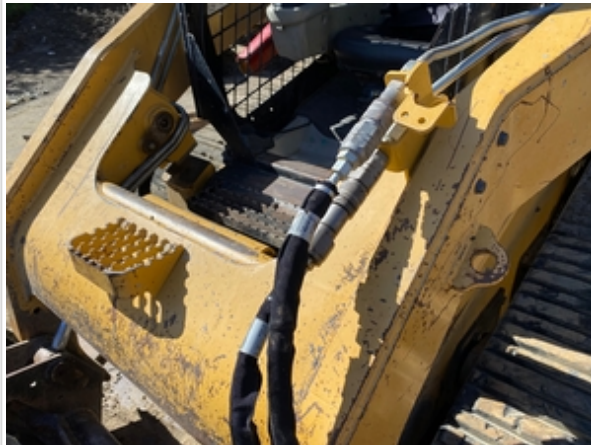
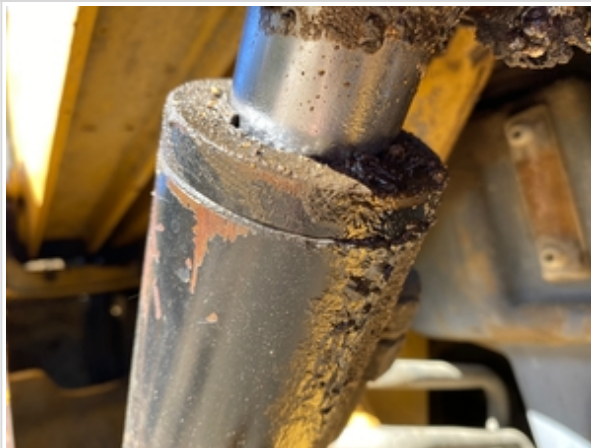
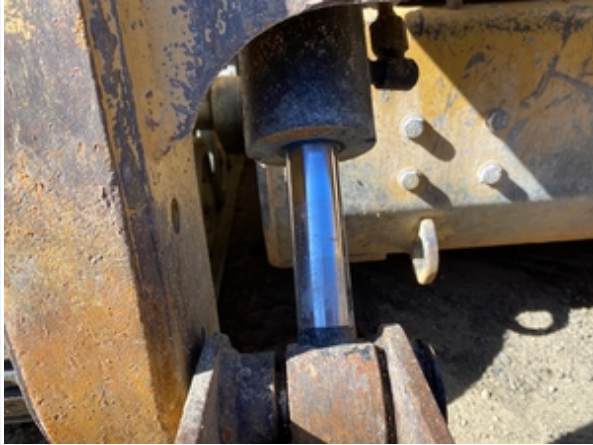
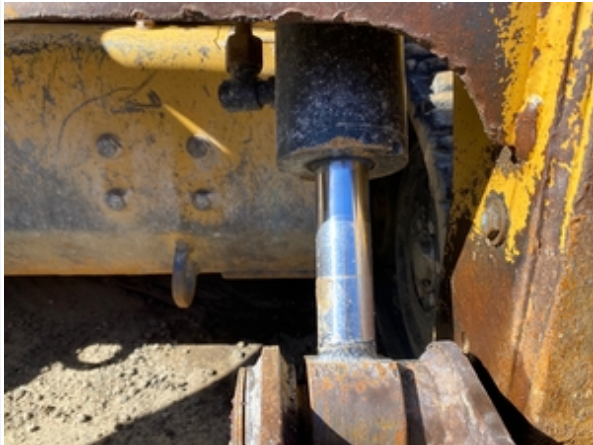
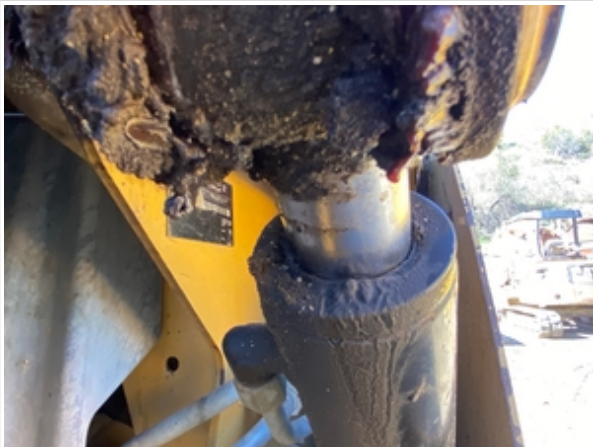
Hydraulic System Photos

| Wet or Damp Hydraulic Lines / Fittings | No | |
| Appearance of Hydraulic Lines / Fittings | 3 - Normal Wear & Tear | |
| Hydraulic Lines / Fittings Condition | Hydraulic lines & fittings are clean and in good condition | |

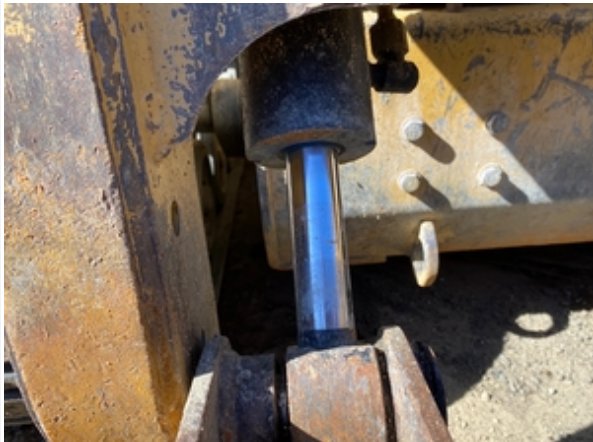
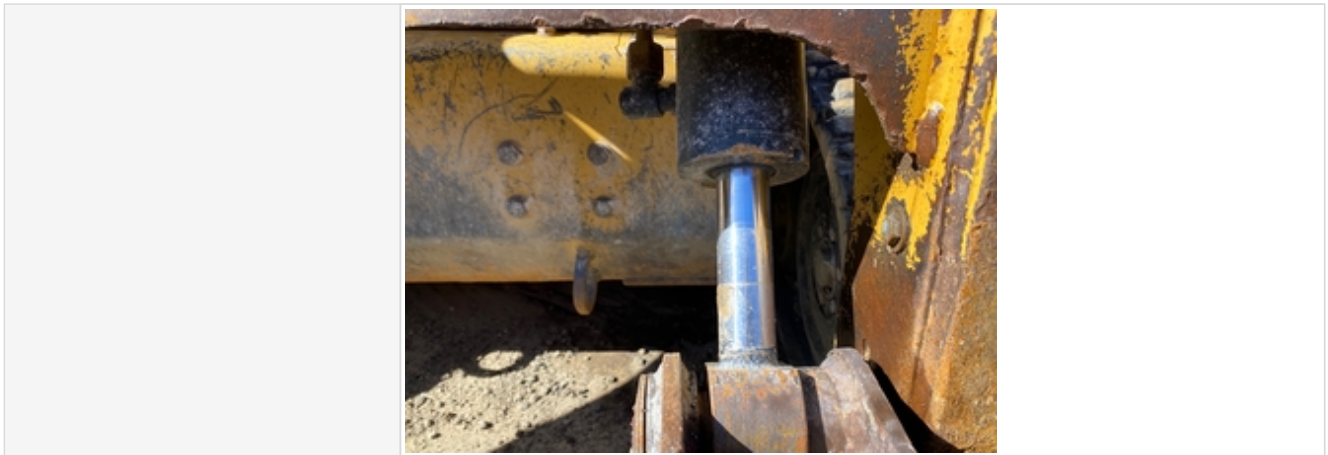
| Bucket Cylinder & Mounting Pin Photos | |

| Bucket Cylinder & Mounting Pin | 3 |
| Bucket Cylinder: Oil Leaks | No |

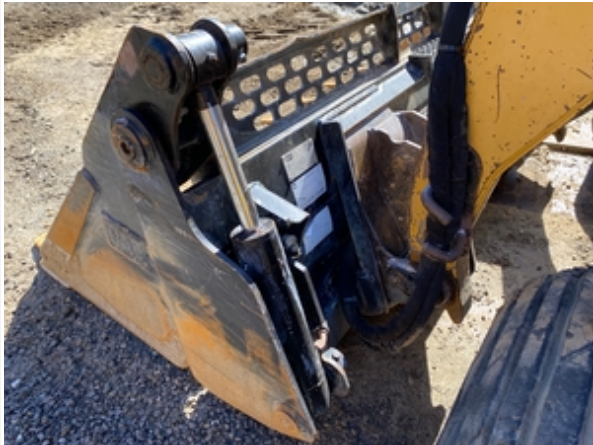
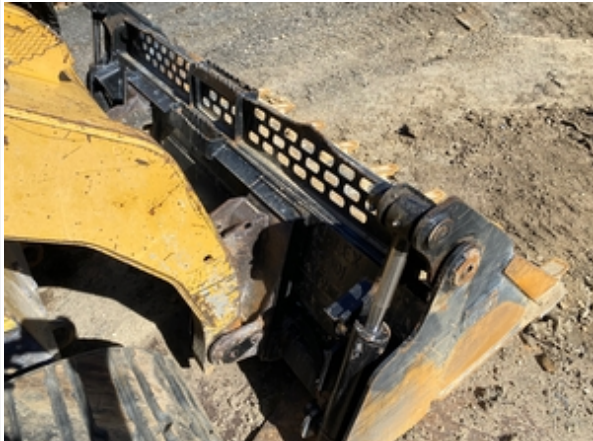
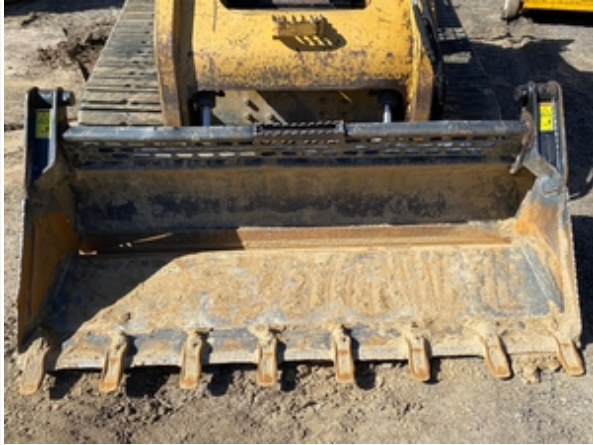
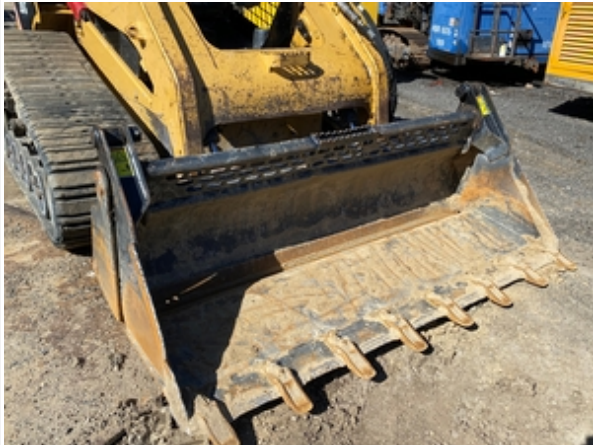
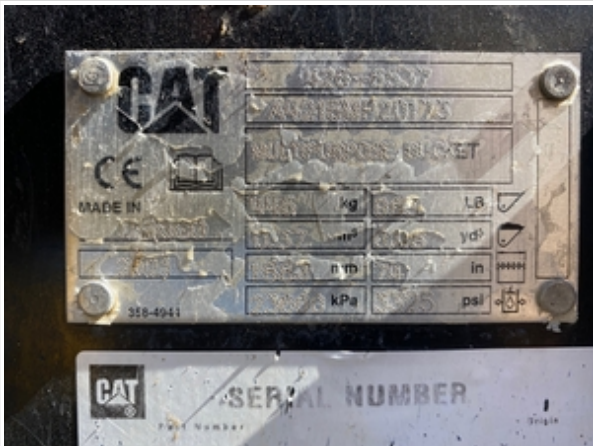
| Bucket Photos | |

| Bucket | 3 - Normal Wear & Tear |
| Comments | 74" 4&1 Multipurpose CAT Bucket |

| Bucket Edge / Deflectors | 3 - Normal Wear & Tear | |
