Inspection Report (Telehandler)

Year	2006
Make	Genie
Model	GTH-5519
Serial Number	14977
Hour Meter Reading	2,708
Previous Application (e.g., earth moving, mining, demolition, etc)	General Construction

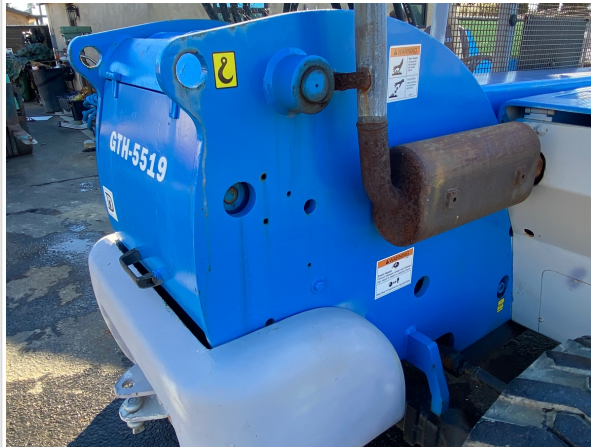
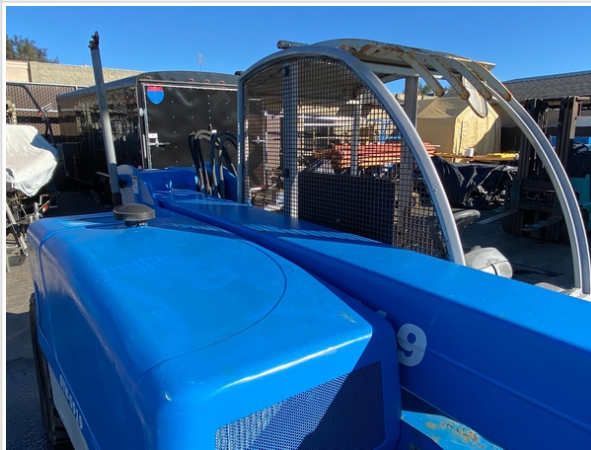
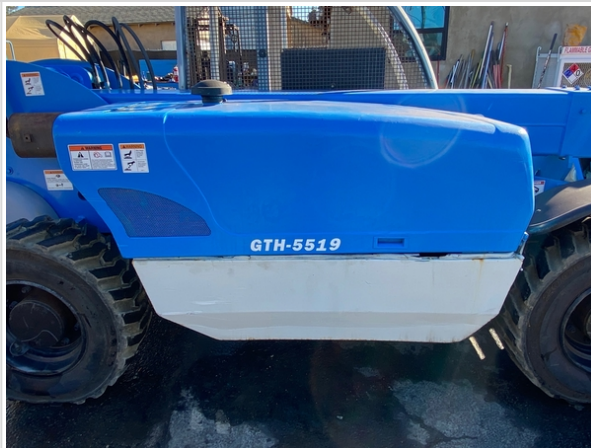
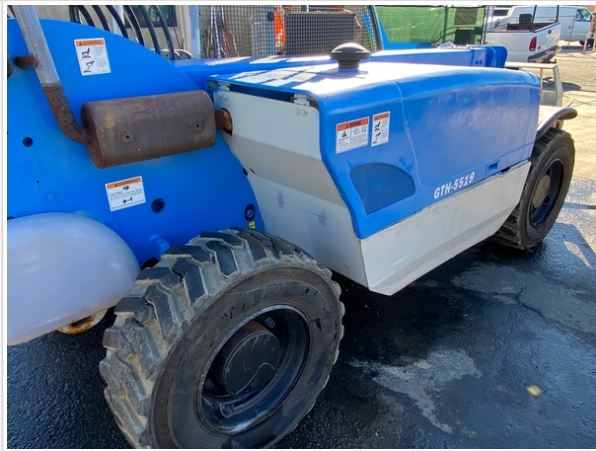
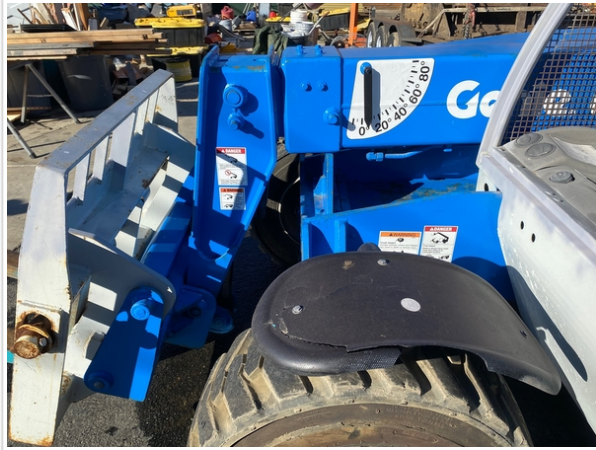
Close-up Exterior Photos

Body Panels	3 - Normal Wear & Tear
Body Panel Condition	No visible damage, good paint condition and panel fitment
Doors / Canopy Latches	3 - Normal Wear & Tear
Doors / Canopy Latches Condition	No visible damage
Steps / Ladders	3 - Normal Wear & Tear
Steps / Ladders Condition	Steps/ladders are fully intact and appear structurally sound
Handrails	3 - Normal Wear & Tear
Handrails Condition	Handrails are fully intact and appear structurally sound
Glass	0
Mirrors	3 - Normal Wear & Tear
Mirror Condition	Mirrors present and intact, no visible damage
Exterior Lights	0

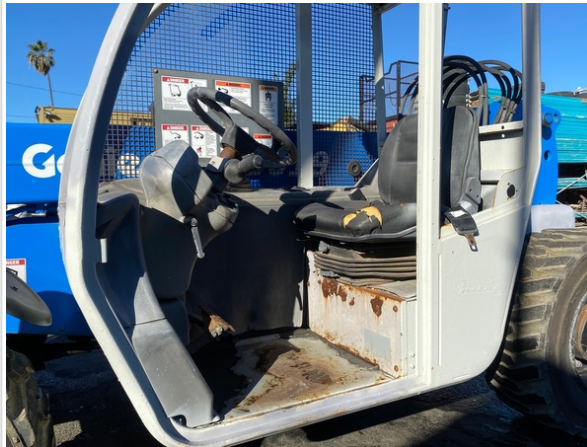
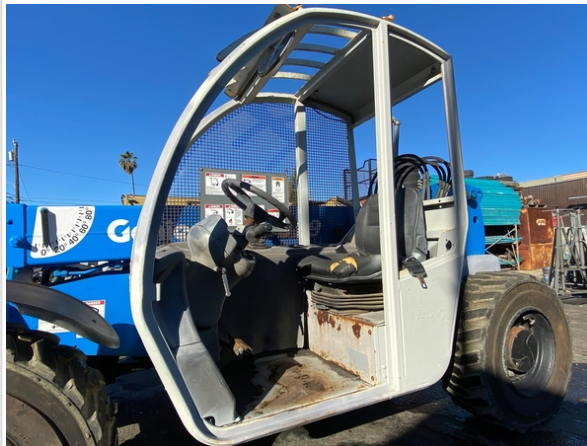
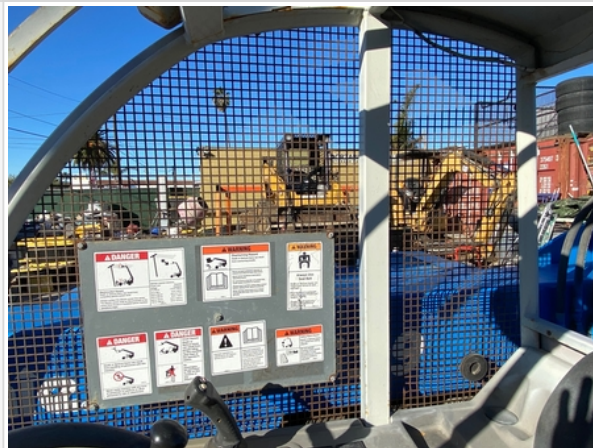
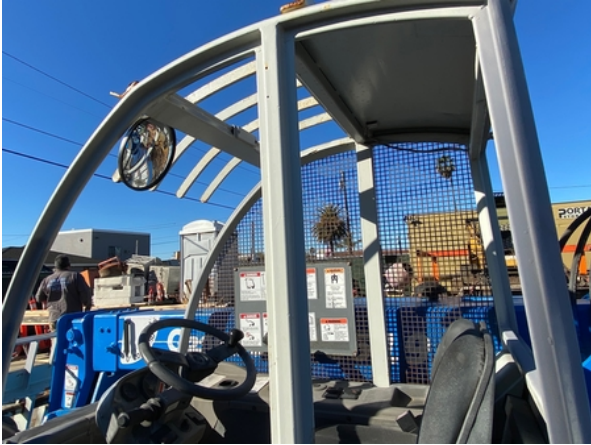
Operator Cabin Photos

Operator Cabin Overall	3 - Normal Wear & Tear
Operator Cabin Overall Condition	Good cabin appearance, solid floors, panels, and ceiling, Minor cosmetic wear to cabin surfaces, floors, panels, and ceiling
Operator Seat	2 - Above Average Wear
Operator Seat Condition	Seat(s) in good condition, no stains or tears in upholstery, Seat(s) have minor surface staining or small tears
Cabin Lights	0
Safety Lock Out / Stop	3 - Normal Wear & Tear
Safety Lock Out / Stop Condition	Safety lock out device is present, in good condition, and functional
Controls & Switches	3 - Normal Wear & Tear
Controls & Switches Condition	All switches are installed and functional
Hour Meter Activity	3 - Normal Wear & Tear
Hour Meter Condition	Hour meter is functional and in good condition
Hour Meter Activity Photos

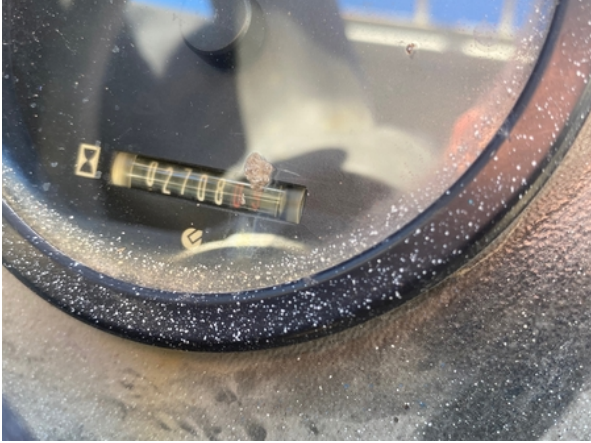
Other Gauge Activity	3 - Normal Wear & Tear
Other Gauge Condition	All cockpit gauges are functional and in good condition

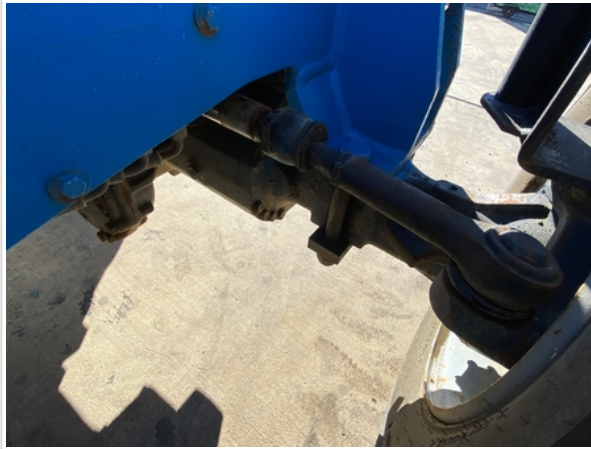
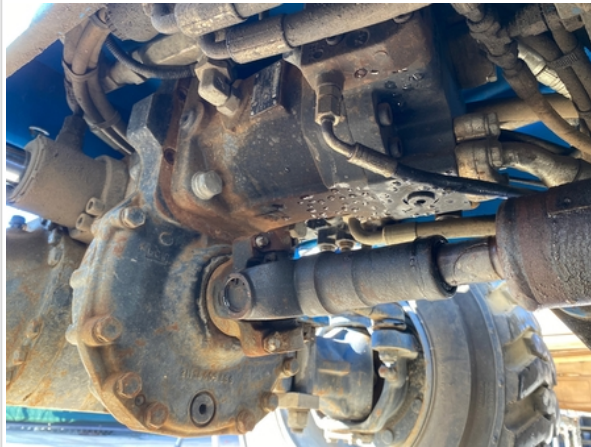
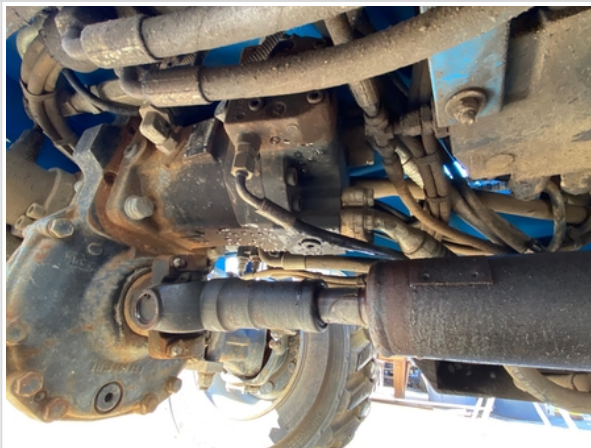
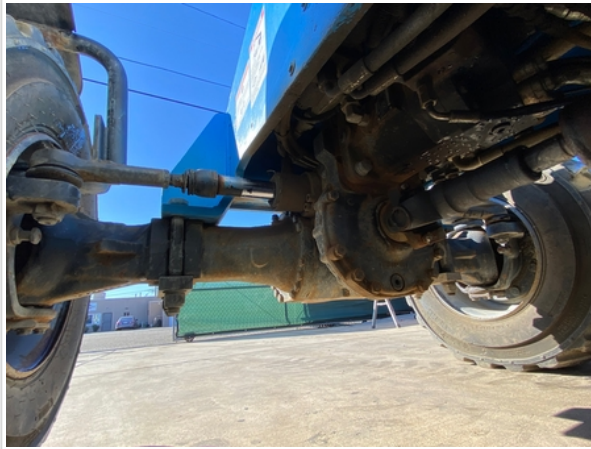
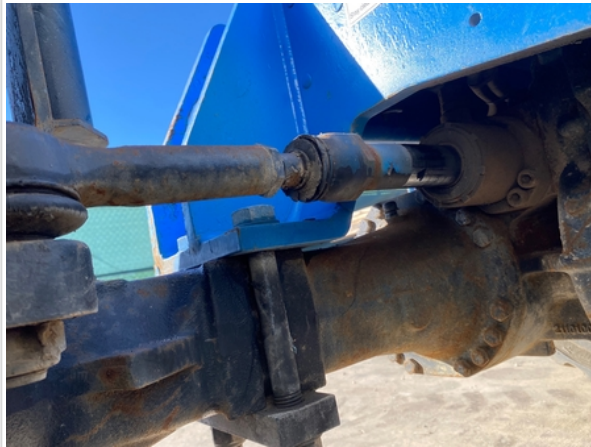
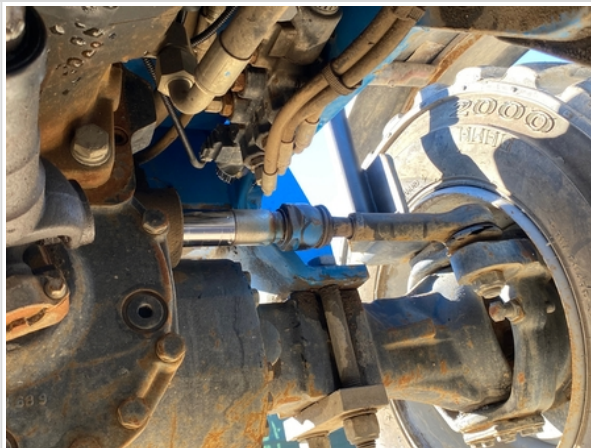
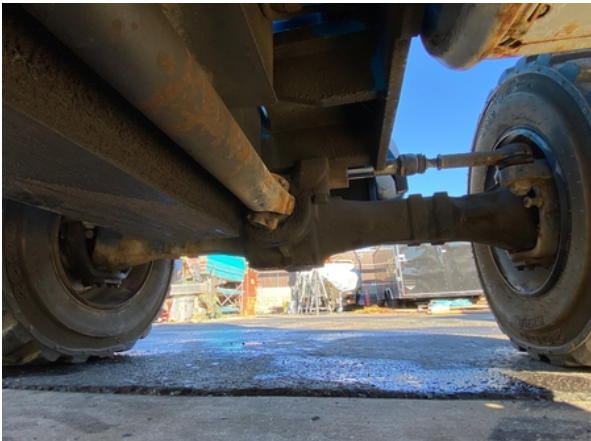
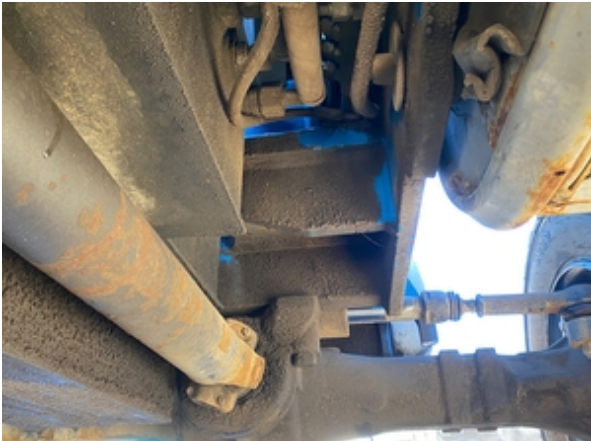
Hydrostatic Transmission?	Yes
2 Speed?	No
Hydrostatic Drive Configuration	Other (see comments)
Comments	Hydraulic Drive to 4x4 Transfer Case, 2 Axle Configuration
Drive Motors	0
Hydrostatic Parking Brake	3 - Normal Wear & Tear
Hydrostatic Parking Brake Condition	Good brake function
Overall Drivetrain Comments	Drivetrain in good looking condition with no active leaks observed during inspection.

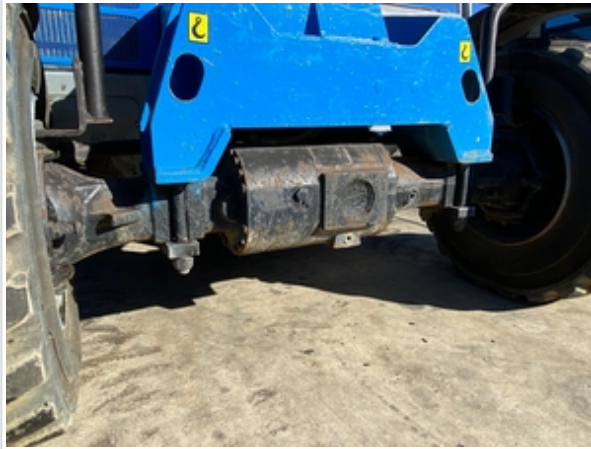
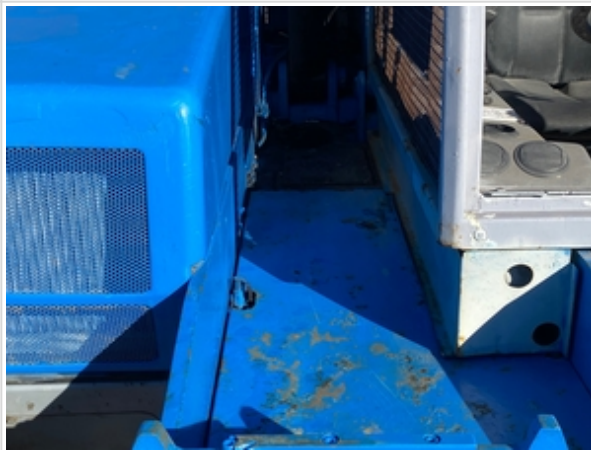
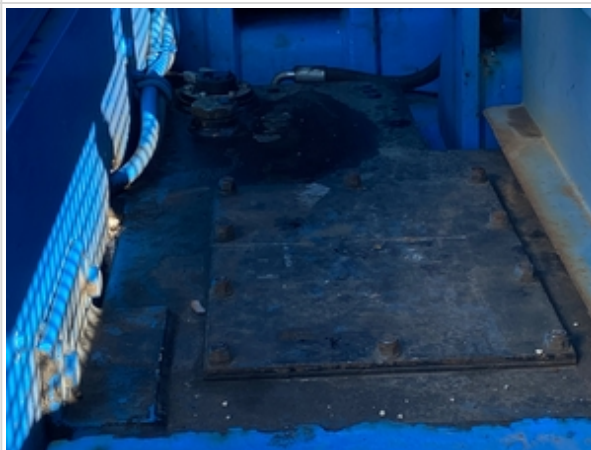
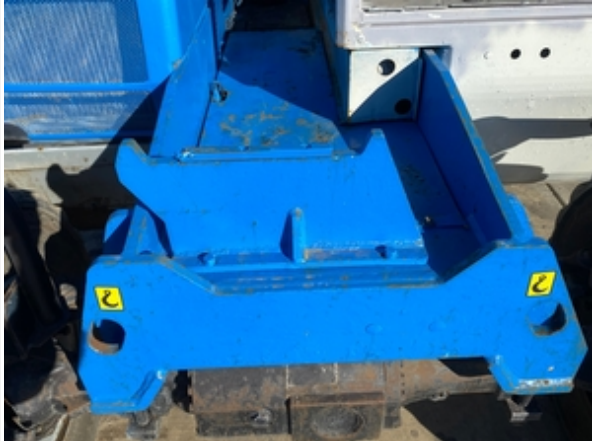
Frame Photos

Stance	3 - Normal Wear & Tear	
Front Axle Appearance	3 - Normal Wear & Tear	
Rear Axle Appearance	3 - Normal Wear & Tear	
Oscillating Pin Appearance	3 - Normal Wear & Tear	
Wheels & Tires	3 - Normal Wear & Tear	
Comments	Foam Filled	
Wheels & Tires Photos

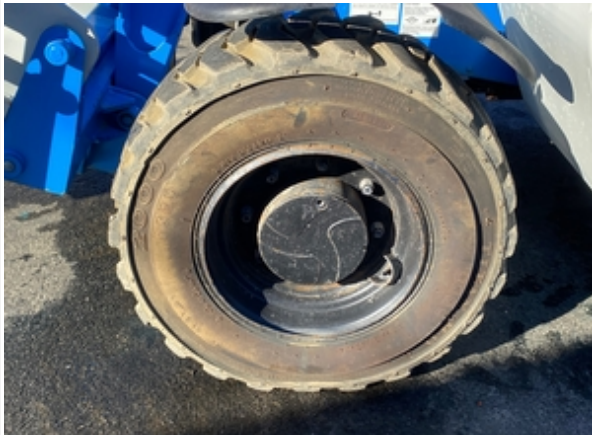
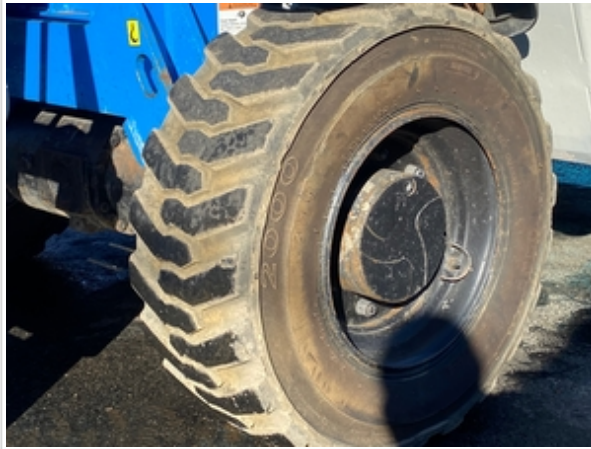
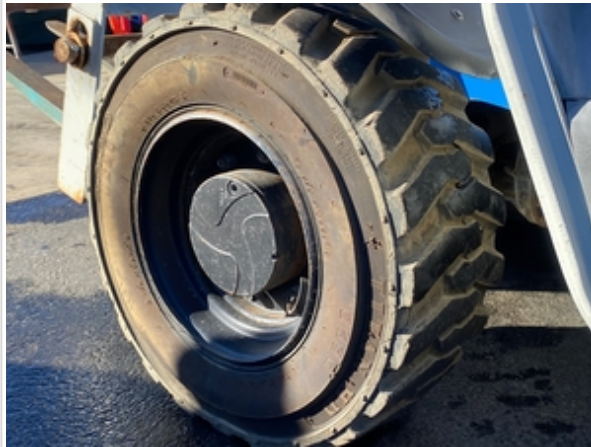
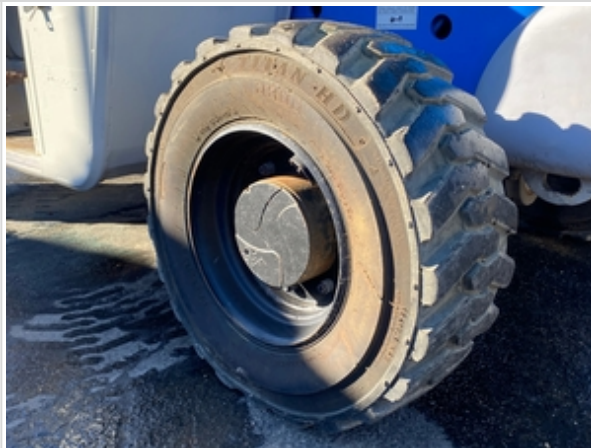
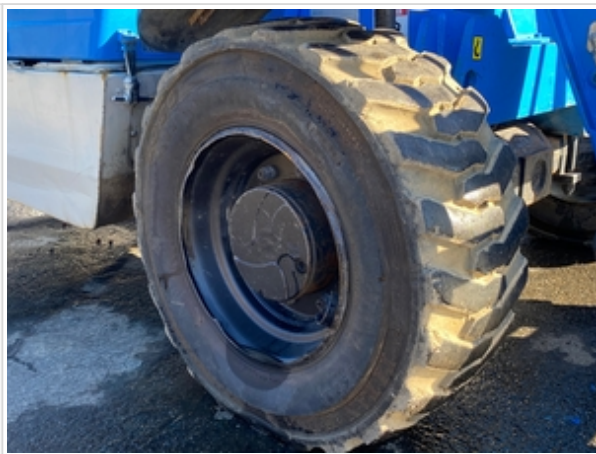
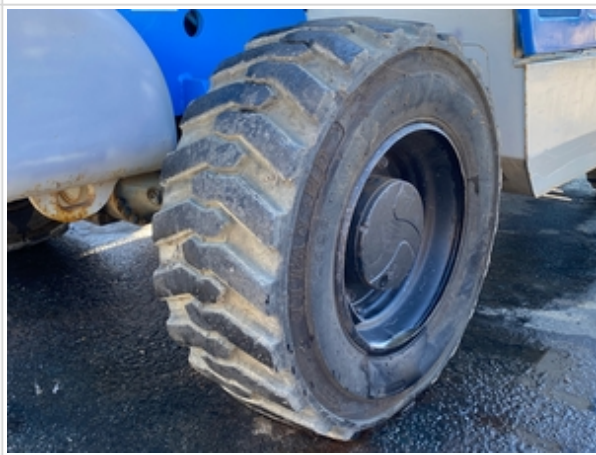
Tire Brand	Titan HF	
Tire Size	N/A	
Front Left Tire - Ratio Remaining	50%	
Rear Left Tire - Ratio Remaining	50%	
Front Right Tire - Ratio Remaining	50%	
Rear Right Tire - Ratio Remaining	50%	
Boom Condition	3 - Normal Wear & Tear	
Boom Condition Photos

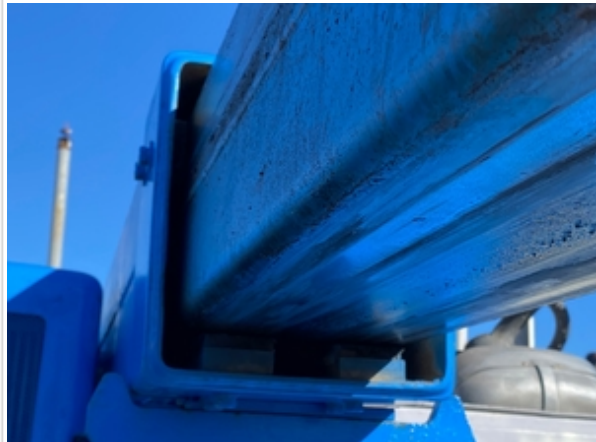
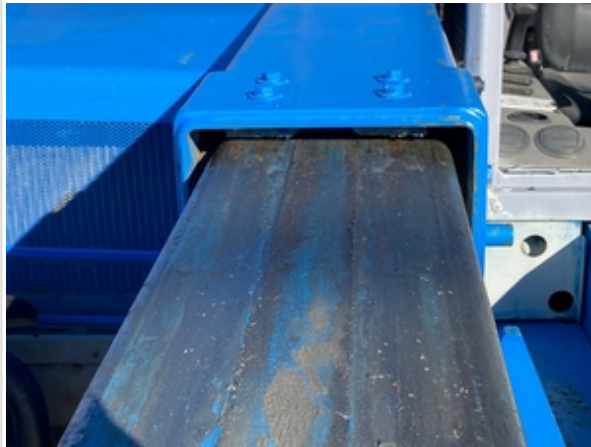
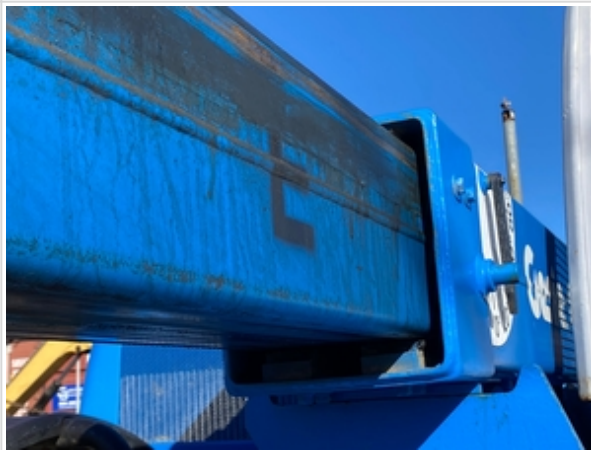
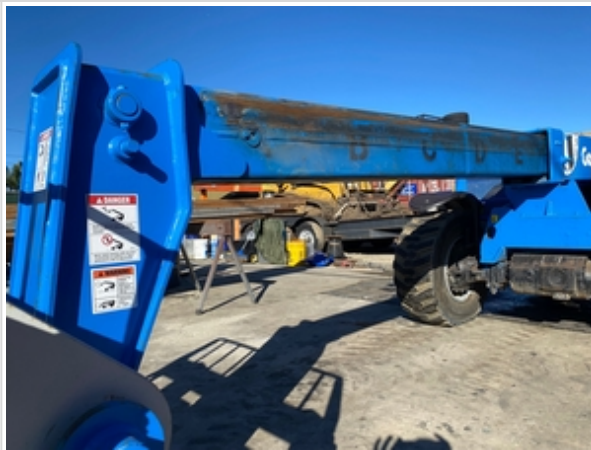
Chain / Tensioners	3 - Normal Wear & Tear	
Rollers & Guides	3 - Normal Wear & Tear	
Boom Wear Guides	2 - Above Average Wear	
Comments	Minor uneven wear at rear r/s of boom wear pads	
Boom Wear Guides Photos

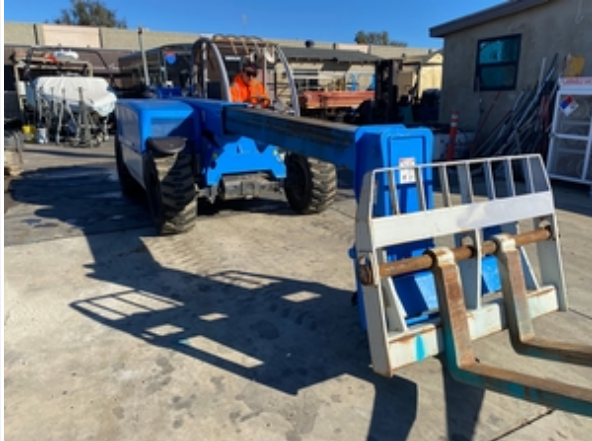
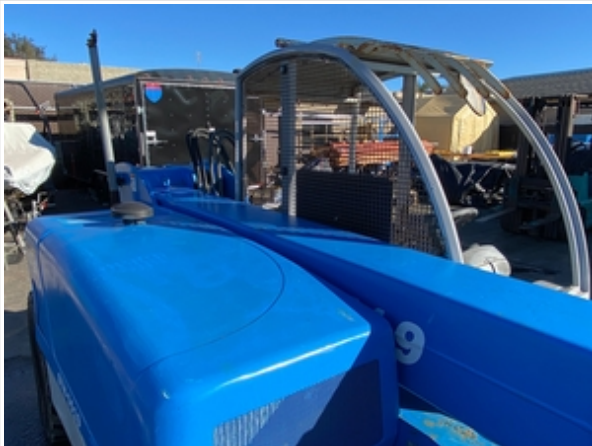
Overall Chassis	3 - Normal Wear & Tear
Overall Chassis Comments	Chassis in good condition with only wear at rear pads observed as a minor wear item.
