Inspection Report (Wheel Loader)

Year	2011
Make	CAT
Model	938H
Serial Number	MJC01729
Hour Meter Reading	7,826
Previous Application (e.g., earth moving, mining, demolition, etc)	Erosion Control Construction

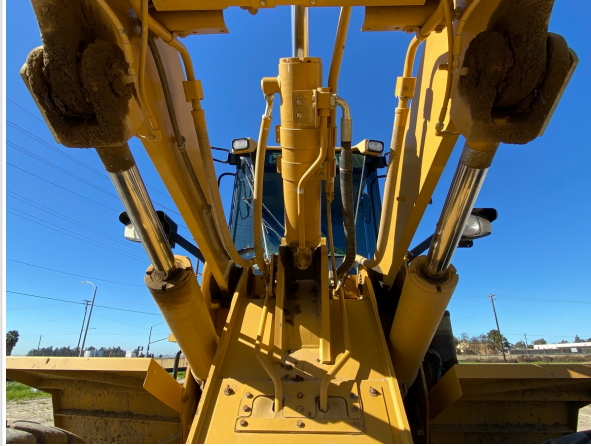
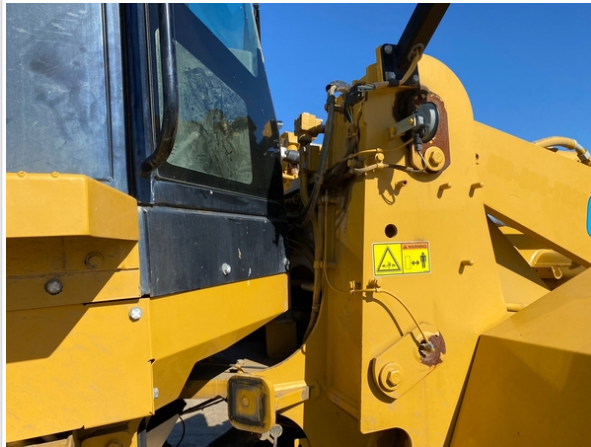
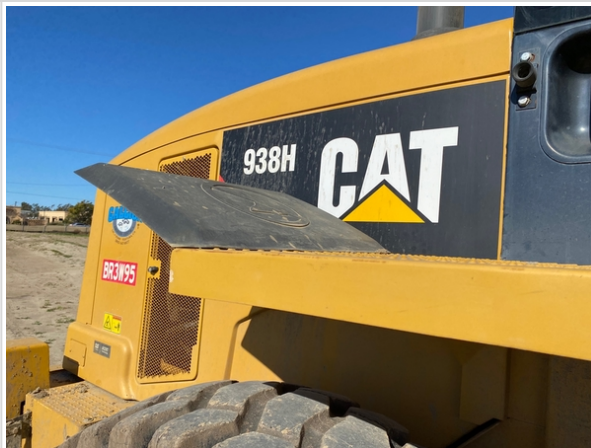
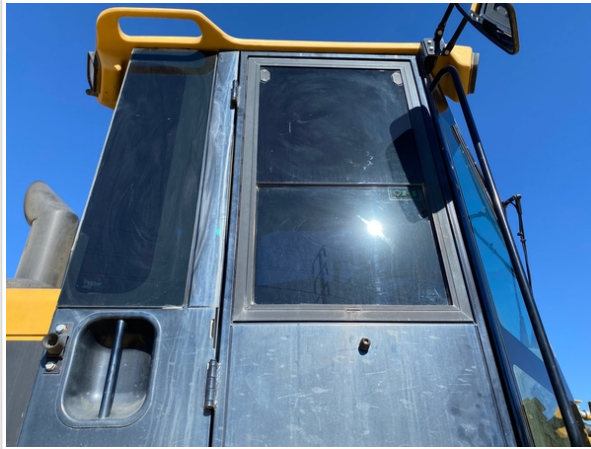
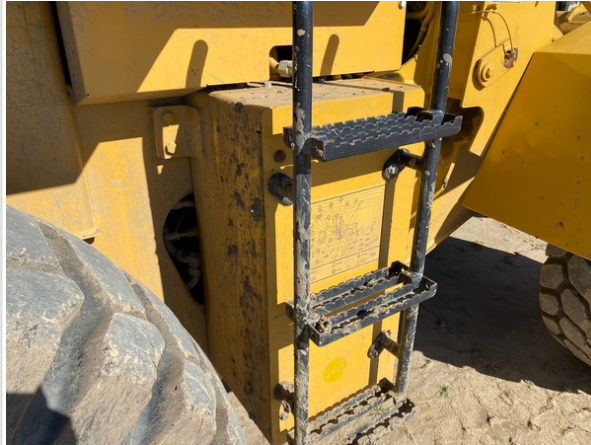
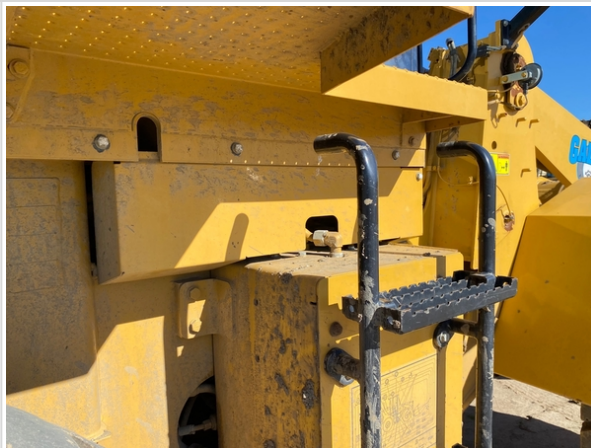
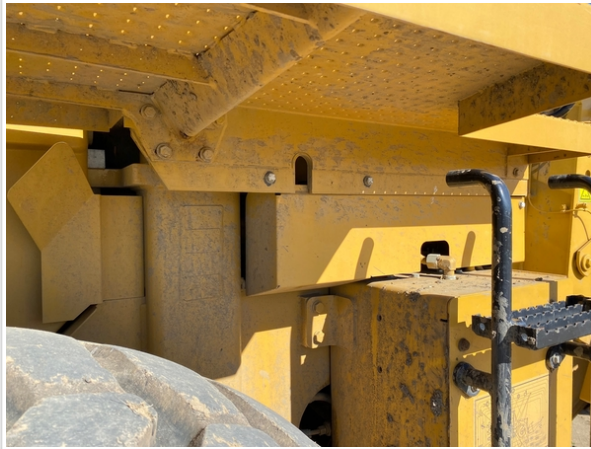
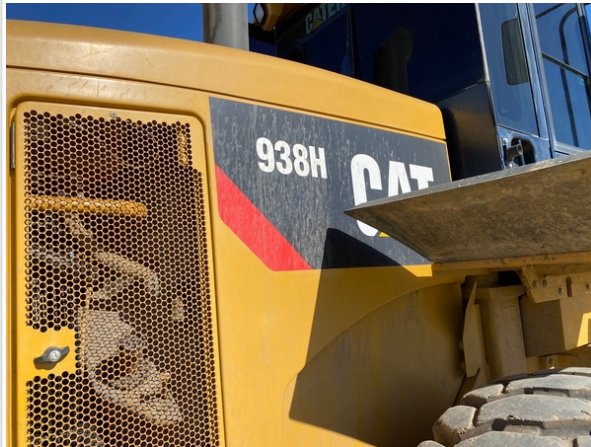
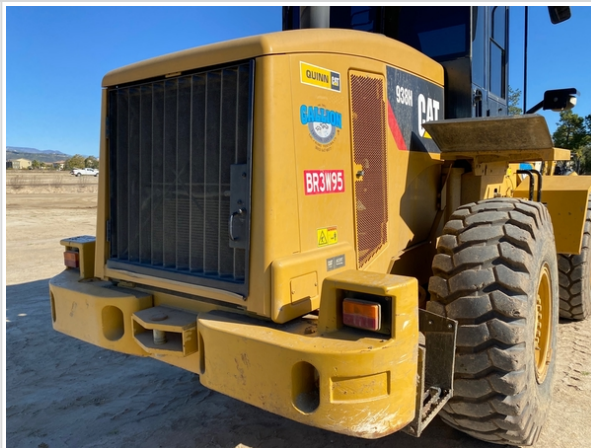
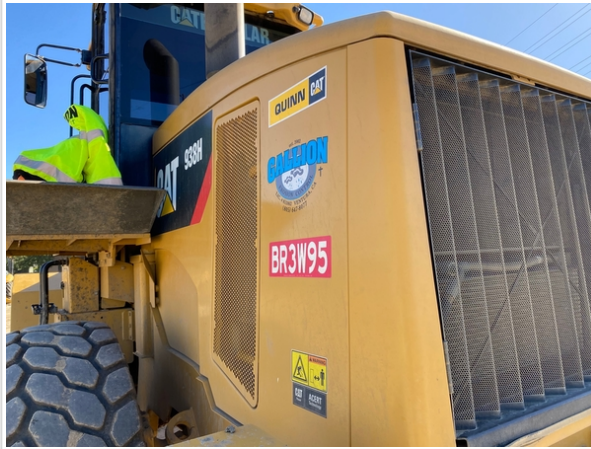
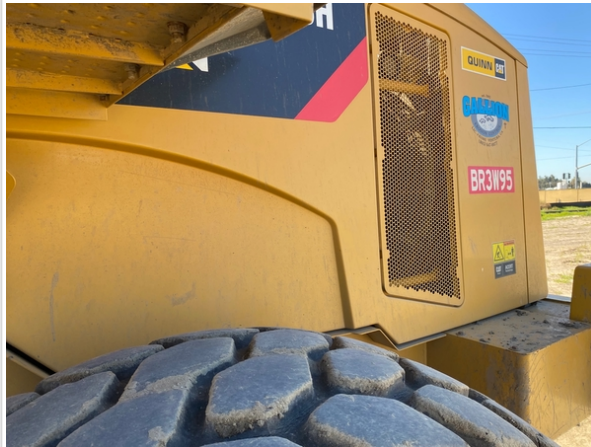
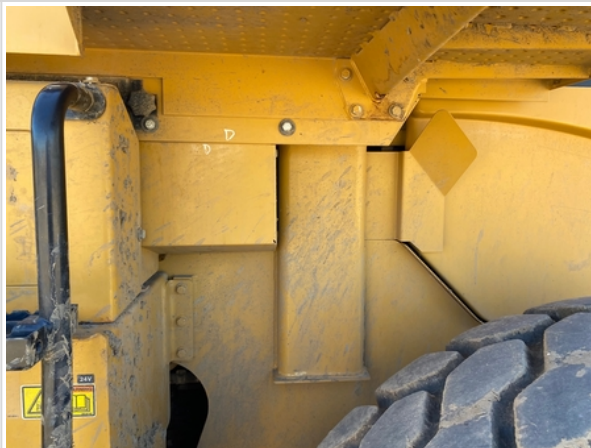
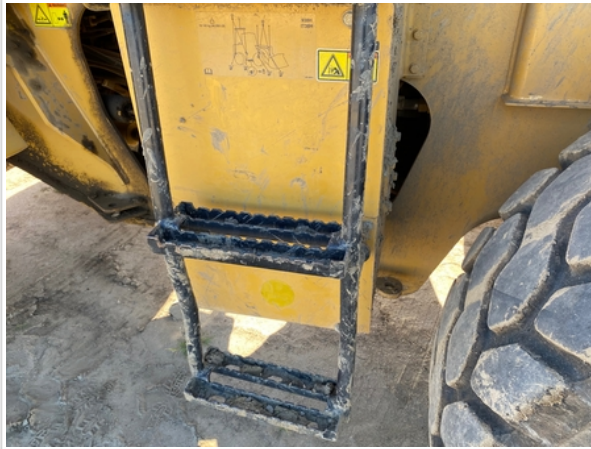
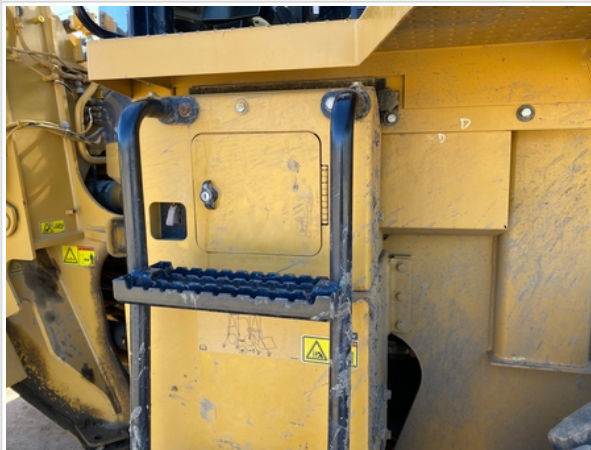
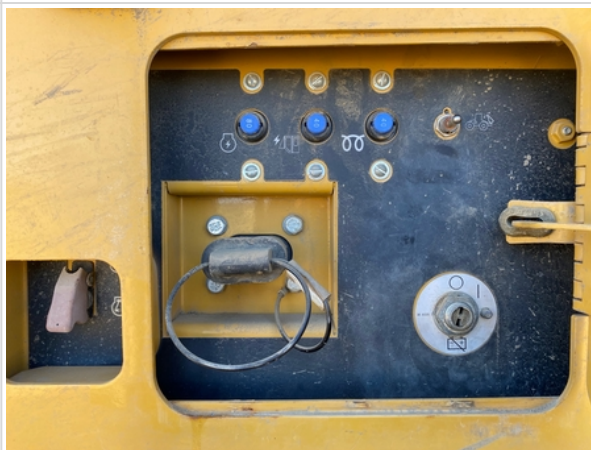
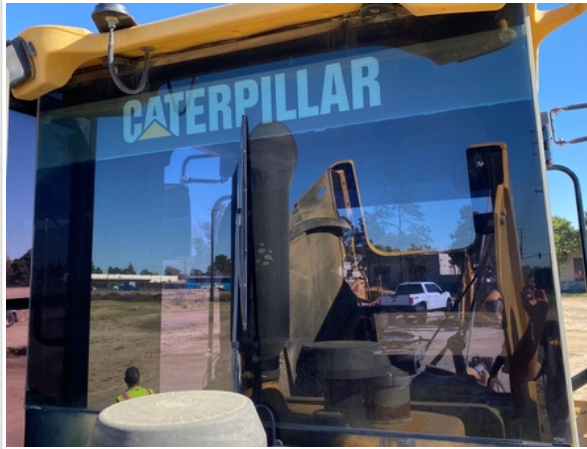
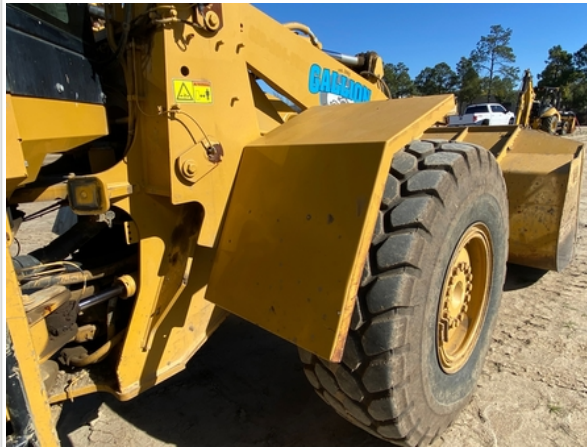
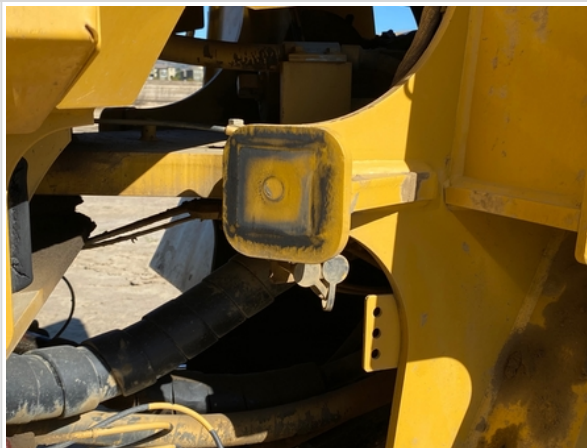
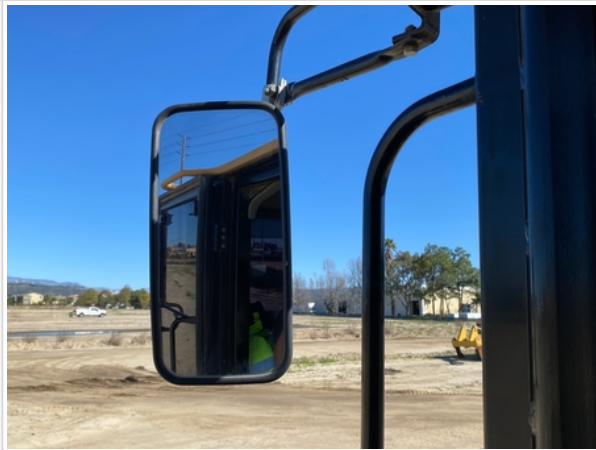
Close-up Exterior Photos

Body Panels	3 - Normal Wear & Tear
Body Panel Condition	No visible damage, good paint condition and panel fitment
Doors / Canopy Latches	3 - Normal Wear & Tear
Doors / Canopy Latches Condition	No visible damage
Steps / Ladders	3 - Normal Wear & Tear
Steps / Ladders Condition	Steps/ladders are fully intact and appear structurally sound
Handrails	3 - Normal Wear & Tear
Handrails Condition	Handrails are fully intact and appear structurally sound
Glass	3 - Normal Wear & Tear
Glass Condition	Glass intact, no visible damage
Mirrors	3 - Normal Wear & Tear
Mirror Condition	Mirrors present and intact, no visible damage
Exterior Lights	3 - Normal Wear & Tear
Exterior Lights Condition	One or more exterior lights are non-operational

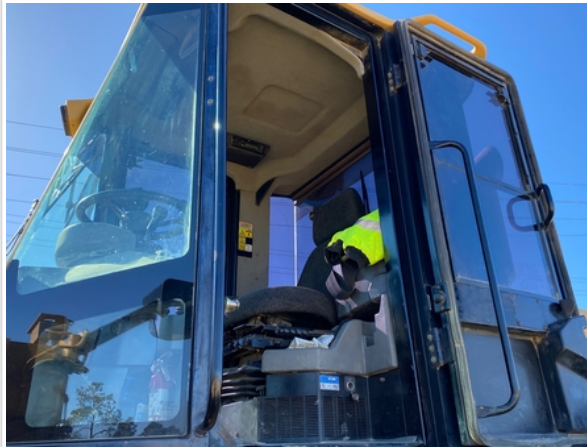
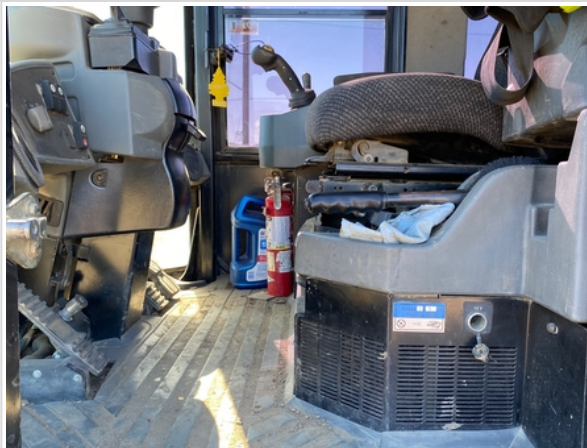
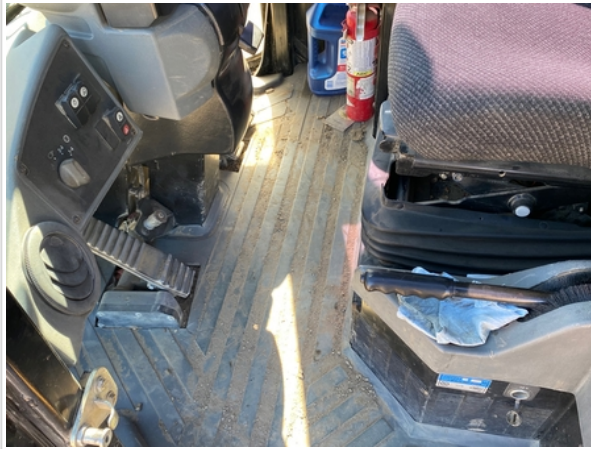
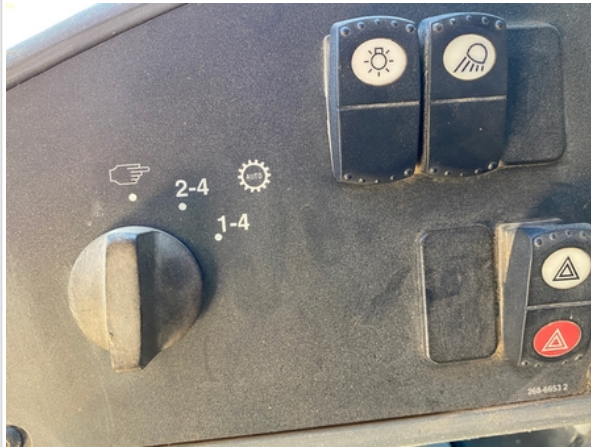
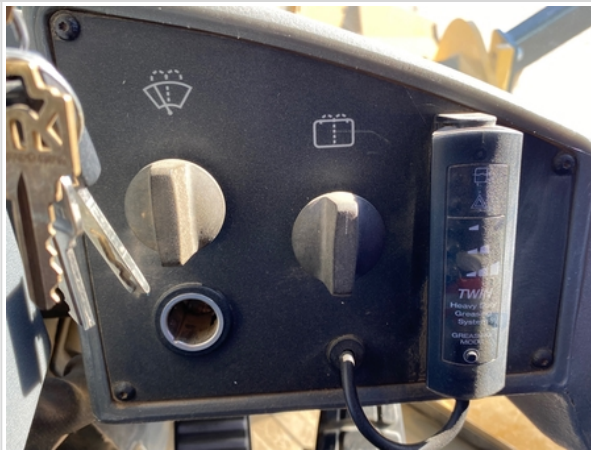
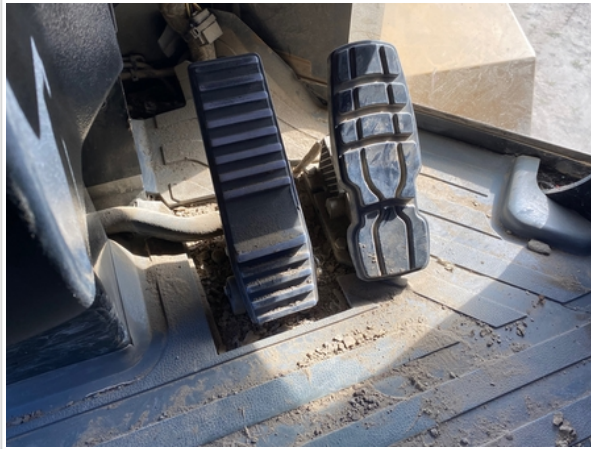
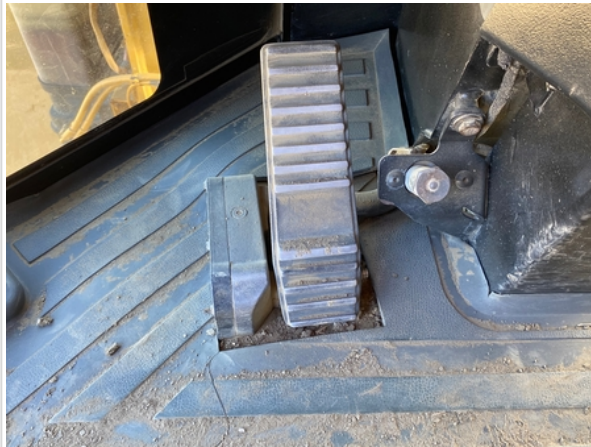
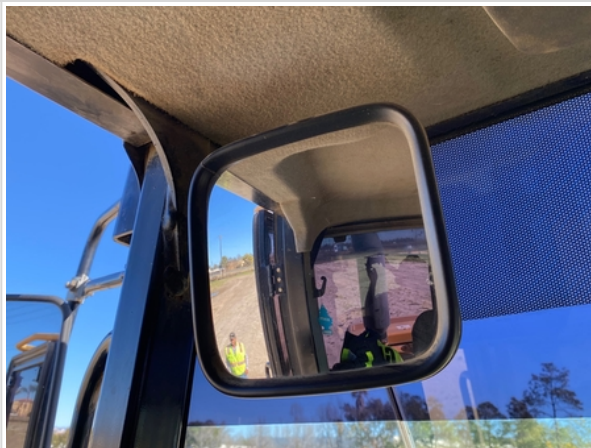
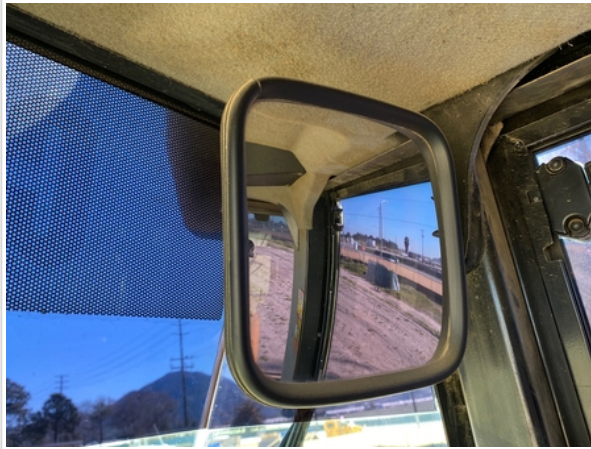
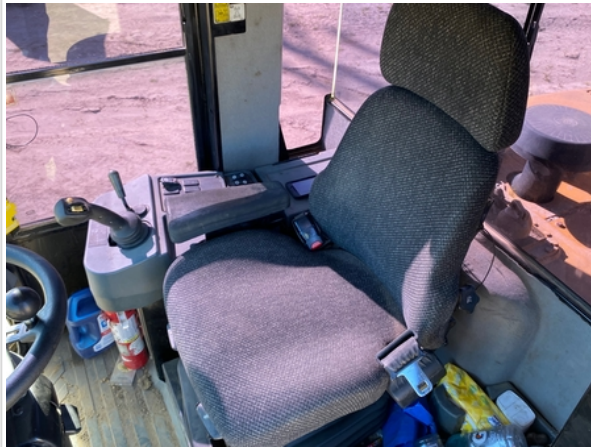
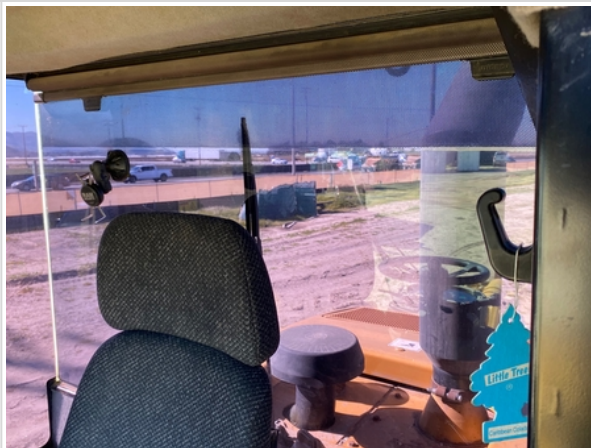
Operator Cabin Photos

Operator Cabin Overall	3 - Normal Wear & Tear
Operator Cabin Overall Condition	Good cabin appearance, solid floors, panels, and ceiling
Operator Seat	3 - Normal Wear & Tear
Operator Seat Condition	Seat(s) in good condition, no stains or tears in upholstery
Cabin Lights	3 - Normal Wear & Tear
Cabin Lights Condition	Cabin lights are installed with all light covers in place, bulbs are installed and working properly
Safety Lock Out / Stop	3 - Normal Wear & Tear
Safety Lock Out / Stop Condition	Safety lock out device is present, in good condition, and functional
Controls & Switches	3 - Normal Wear & Tear
Controls & Switches Condition	All switches are installed and functional
Hour Meter Activity	3 - Normal Wear & Tear
Hour Meter Condition	Hour meter is functional and in good condition

Other Gauge Activity	3 - Normal Wear & Tear
Other Gauge Condition	All cockpit gauges are functional and in good condition
Heater & A/C	3 - Normal Wear & Tear
Heater & A/C Condition	Heater and A/C work as expected
Travel Alarm	3 - Normal Wear & Tear
Travel Alarm Condition	Travel alarm is installed and functioning as expected
Horn	3 - Normal Wear & Tear
Horn Condition	Horn is installed and functioning as expected
Backup Camera	0

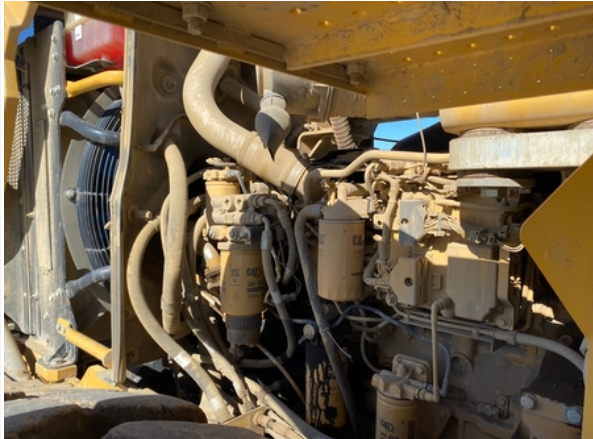
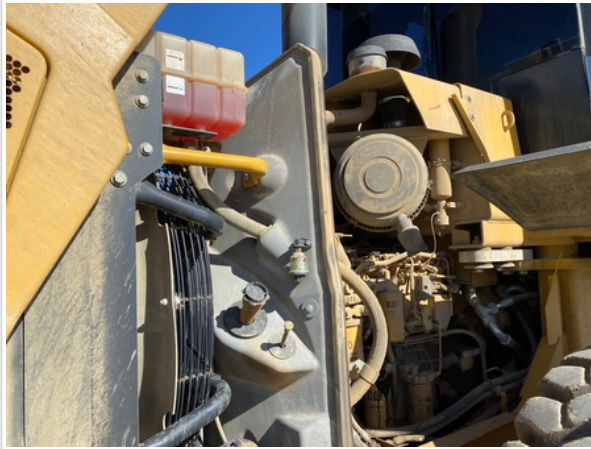
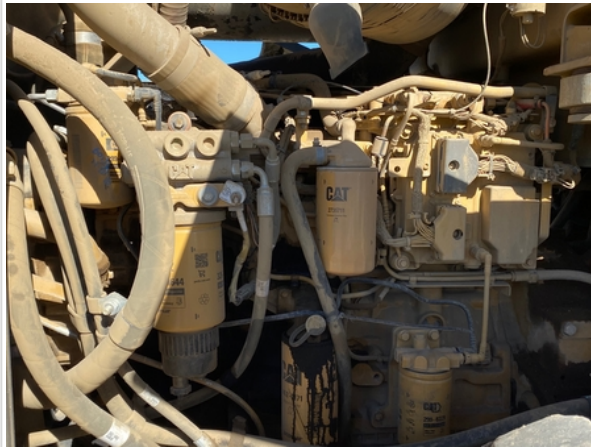
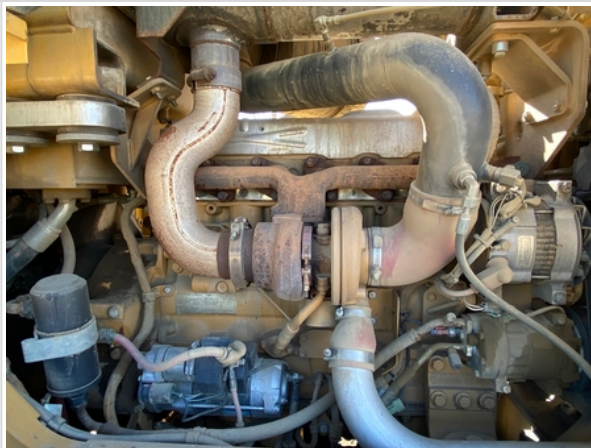
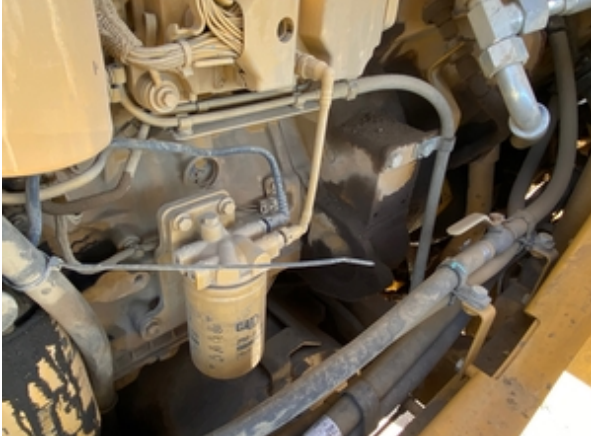
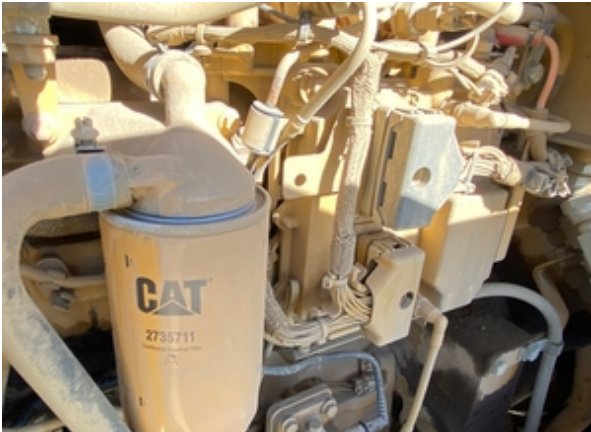
Blow-by (Visual Observation Check)	No
Unusual Noises (Upon Start-up, Idle, Shutdown)	No
Unusual Noise Notes	No unusual noises heard
Engine Smoke (Upon Start-up, Idle, Shutdown)	No
Engine Smoke Notes	No engine smoke issues observed
Engine Exhaust Color	Clear
Battery	3 - Normal Wear & Tear
Battery Condition	Other (see comments), Inaccessible, unable to determine condition
Radiator	3 - Normal Wear & Tear
Radiator Condition	Radiator fins & components appear to be in good working order, no signs of damage or leaks
Belts	3 - Normal Wear & Tear
Belt Condition	Belts appear in good condition & alignment with proper tension
Hoses	3 - Normal Wear & Tear
Hose Condition	Firm, pliant hoses with no signs of wear or leaks

Oil Color / Appearance	3 - Normal Wear & Tear
Oil Color / Appearance Notes	Clean oil appearance, no signs of cross contamination, Appropriate oil level
Fuel Leaks	No
Requires DEF (Diesel Exhaust Fluid)	No
Overall Engine Appearance	Dusty & dry
Overall Engine Comments	Overall engine operated well under load and at idle. A few active leaks observed.

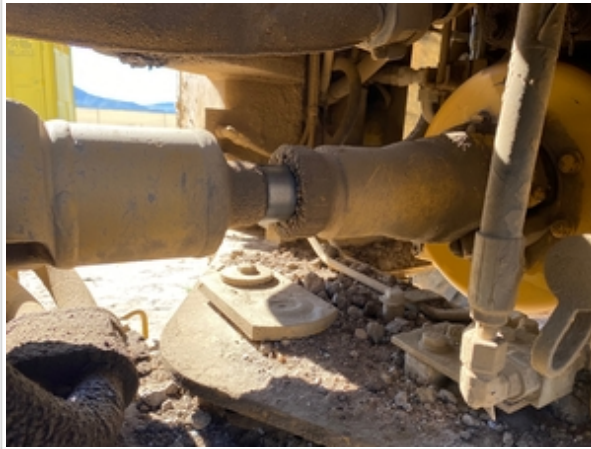
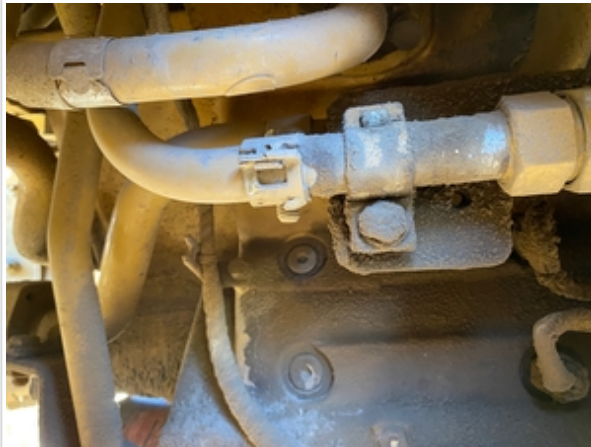
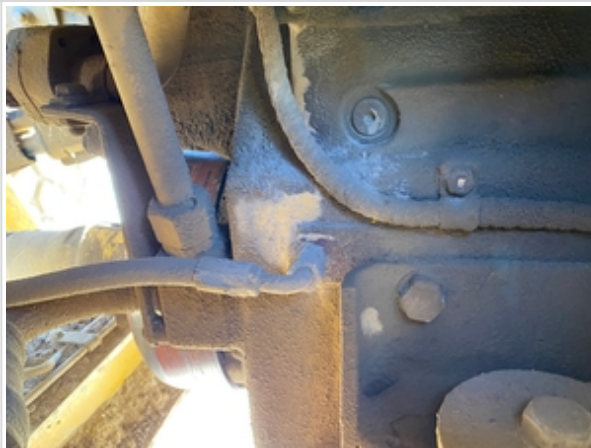
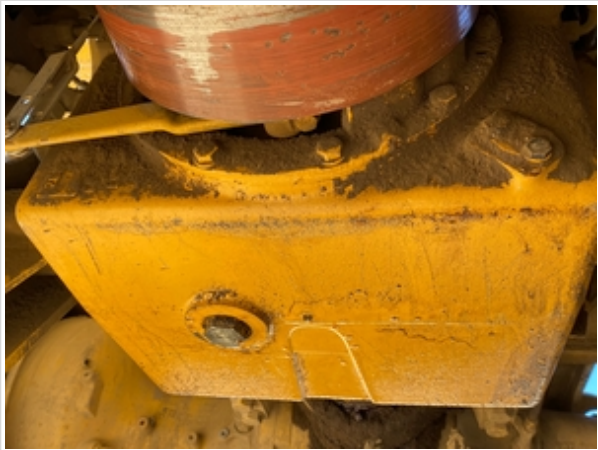
<p>Drivetrain Photos</p>

Hydrostatic Transmission?	No	
Transmission Info (Make/Model/Speeds)	Powershift 4 Speed	
Transmission	2 - Above Average Wear	
Transmission Condition	No unusual noises or vibrations, Other (see comments)	
Comments	Minor active leaks observed around transmission	
Clutch	0	
Shift Lever	3 - Normal Wear & Tear	
Shift Lever Condition	Good forward and reverse function	
Foot Brake	3 - Normal Wear & Tear	
Foot Brake Condition	Good brake function	
Inching Brake	3 - Normal Wear & Tear	
Inching Brake Condition	Good brake function	
Parking Brake	3 - Normal Wear & Tear	
Parking Brake Condition	Good brake function	
Overall Drivetrain Comments	Overall Drivetrain has good working appearance. Minor leaks observed at transmission. Operator worked machine through forward and reverse gears onsite and no abnormalities observed during the inspection.

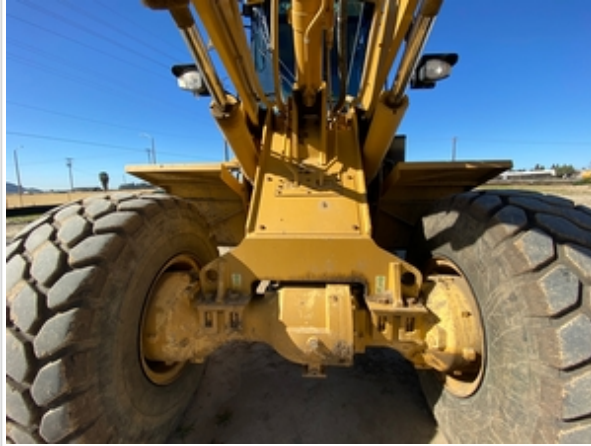
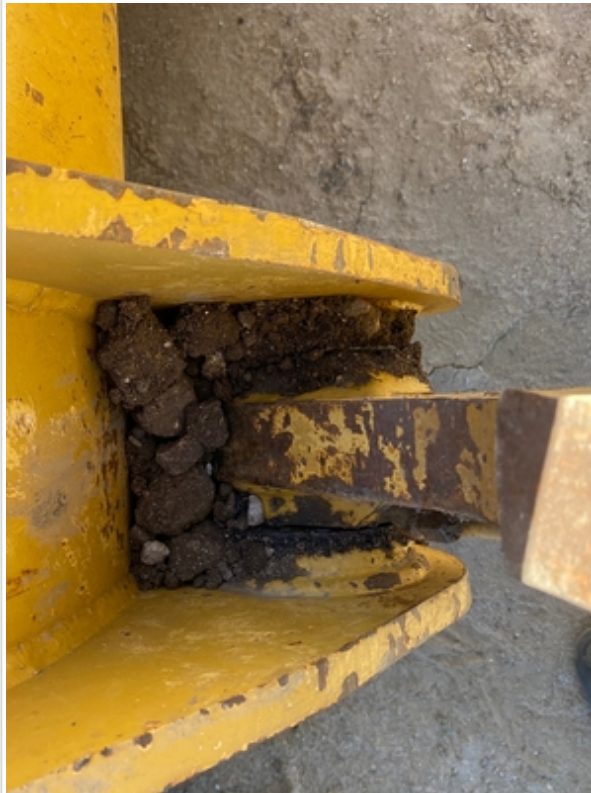
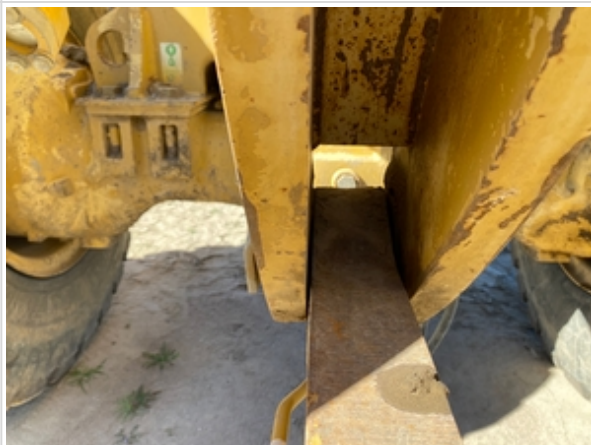
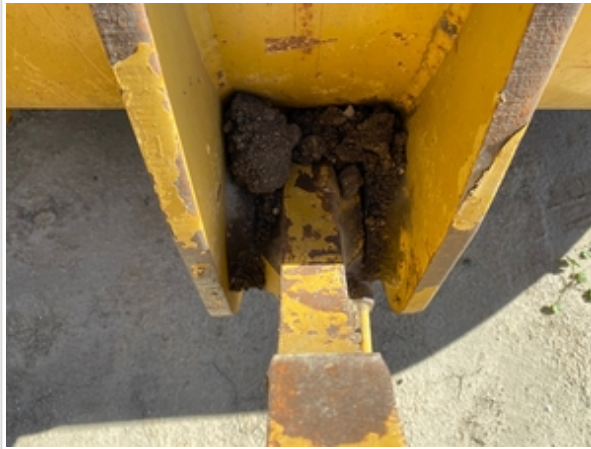
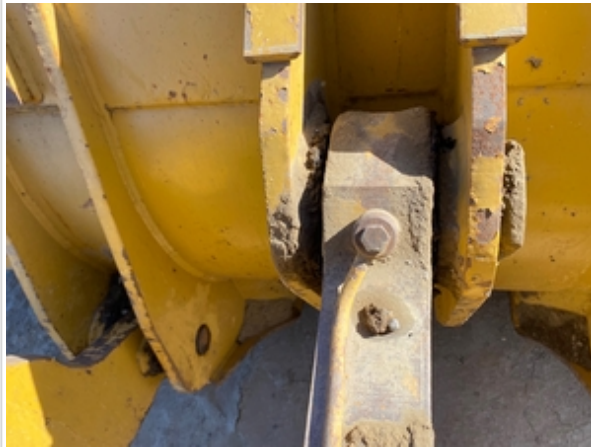
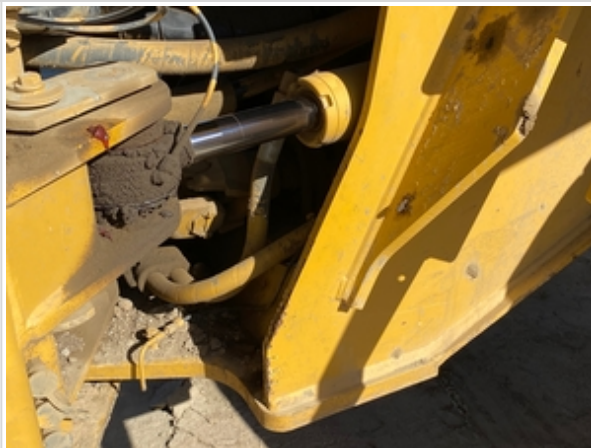
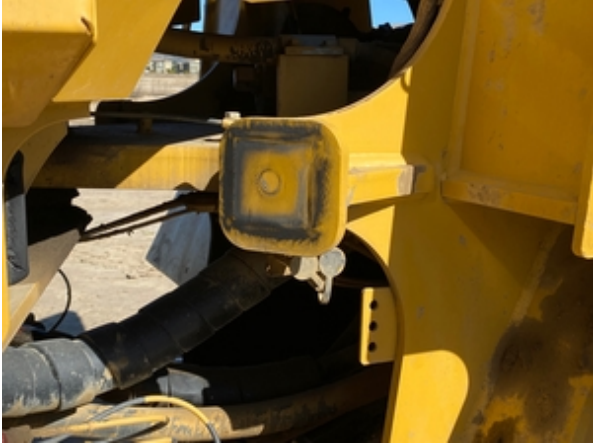
Frame Photos

Frame	3 - Normal Wear & Tear
--------------	------------------------

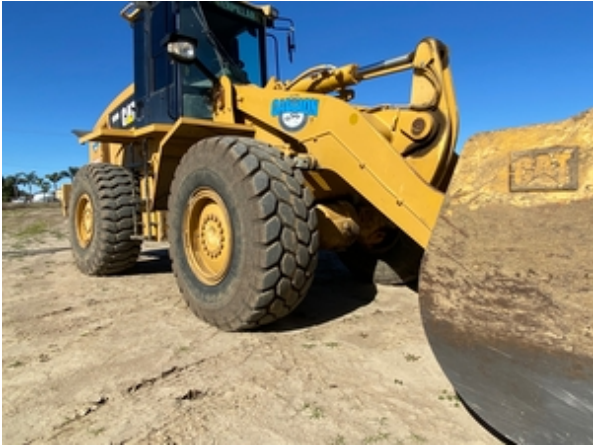
Stance	3 - Normal Wear & Tear	
Stance Photos

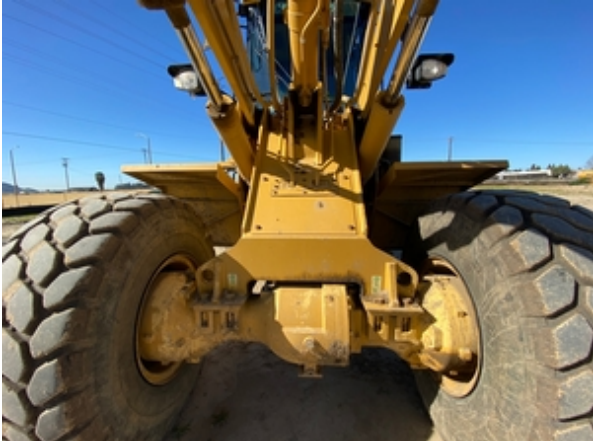
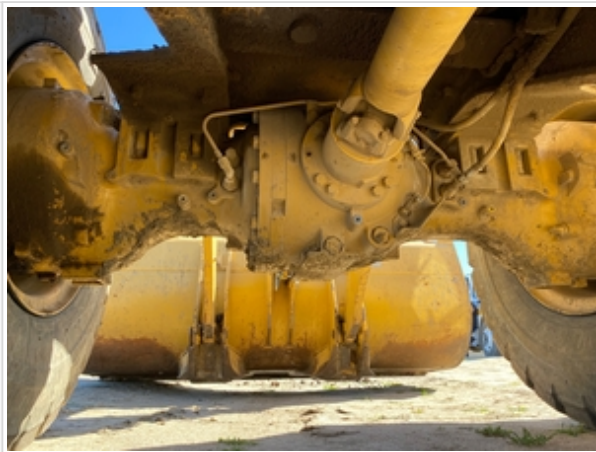
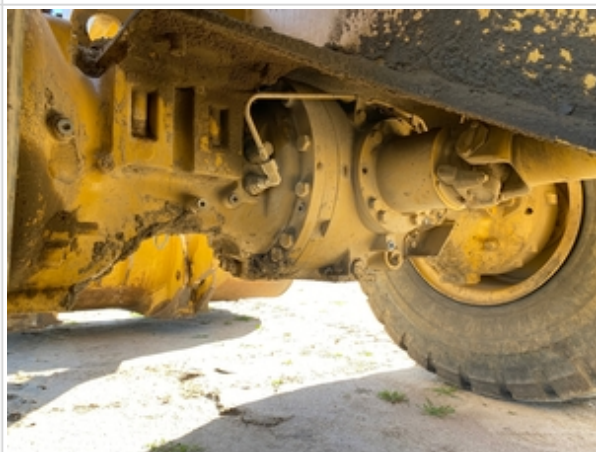
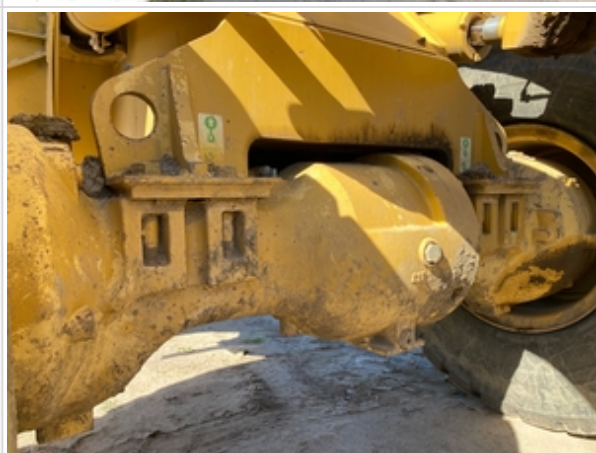
Front Axle Appearance	3 - Normal Wear & Tear	
Front Axle Appearance Photos

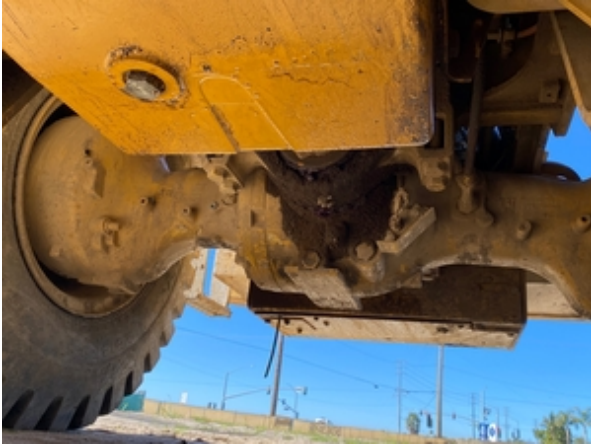
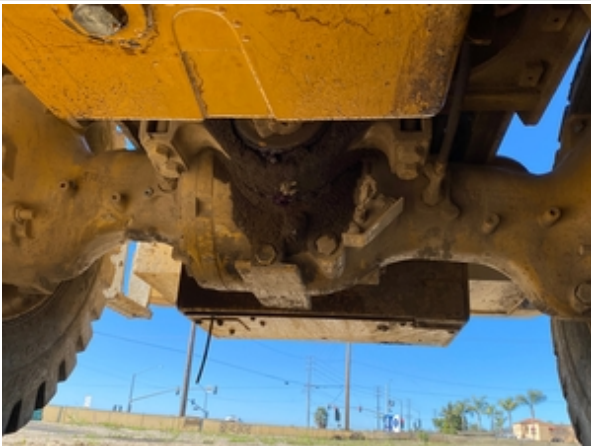
Rear Axle Appearance Photos

<p>Rear Axle Appearance</p>	<p>3 - Normal Wear & Tear</p>

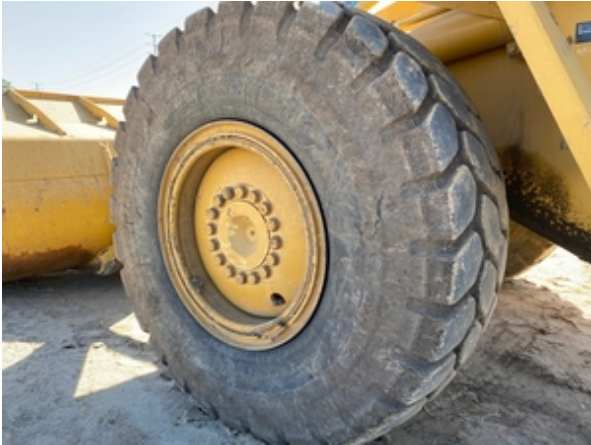
Tire Brand	Galaxy	
Tire Size	20.5 - 25	
Front Left Tire - Ratio Remaining	30%	
Front Left Tire Photos

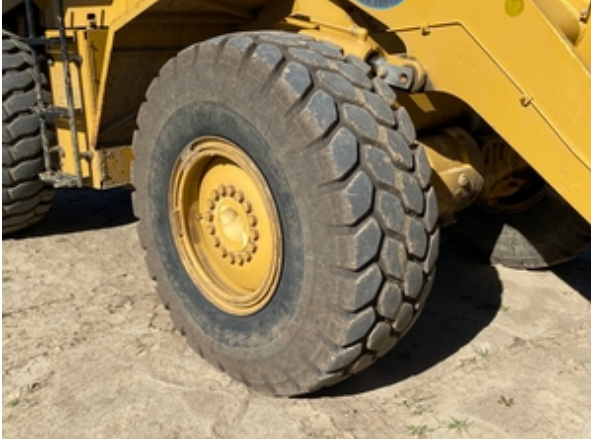
Rear Left Tire Photos

Rear Left Tire - Ratio Remaining	30%

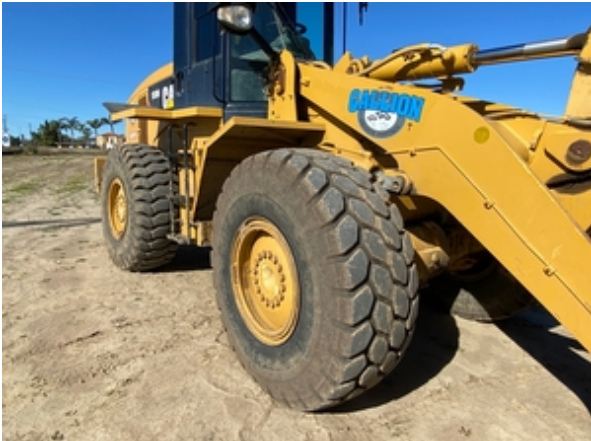
Front Right Tire - Ratio Remaining	30%
Front Right Tire Photos

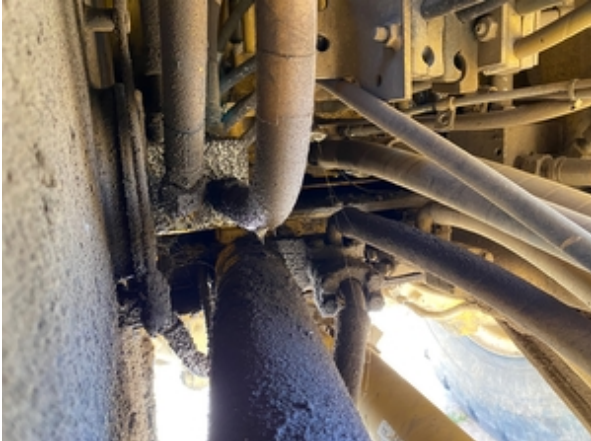
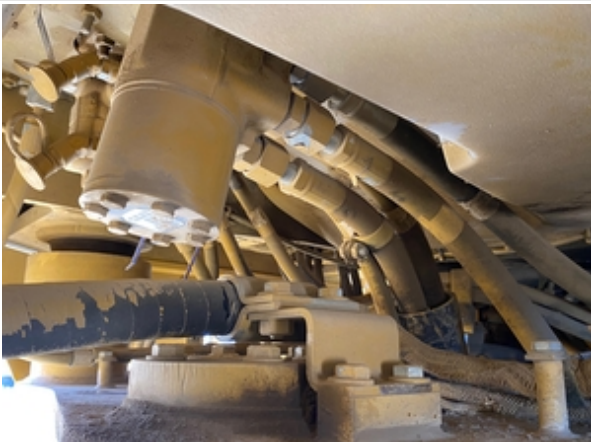
Wet or Damp Hydraulic Lines / Fittings	Yes
Appearance of Hydraulic Lines / Fittings	3 - Normal Wear & Tear
Hydraulic Lines / Fittings Condition	Hydraulic lines & fittings are clean and in good condition
Unusual Noises (Hydraulic Pump)	No
Hydraulic Pump Notes	No unusual noises heard during operation

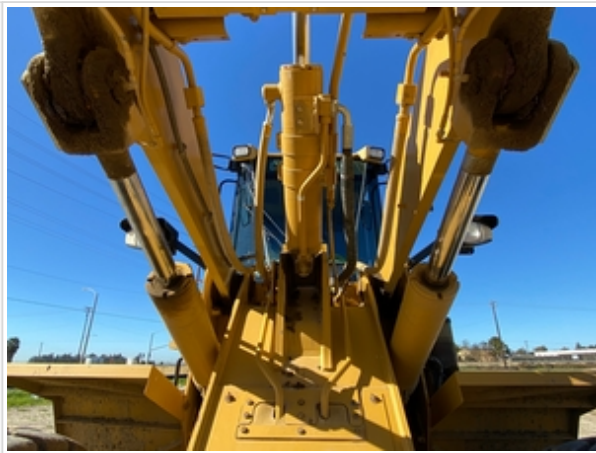
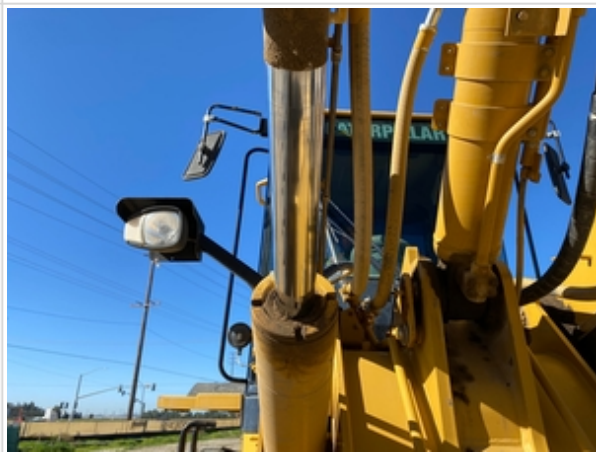
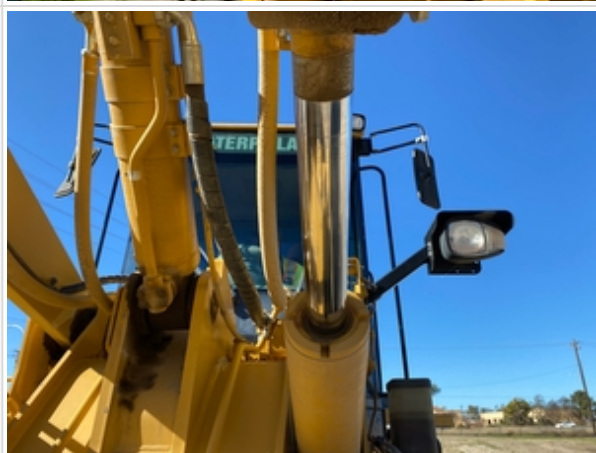
Lift Cylinder Photos

Lift Cylinder	Check the lift cylinder. Note any wear, pitting, discoloration, etc. Take photos.
Lift Cylinder: Mounting Pin	3
Lift Cylinder: Oil Leaks	No

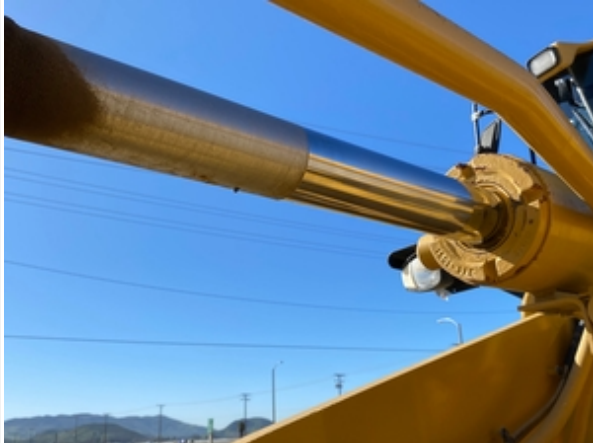
Bucket Cylinder Photos

Bucket Cylinder	Check the bucket cylinder. Note any wear, pitting, discoloration, etc. Take photos.
Bucket Cylinder: Mounting Pin	3
Bucket Cylinder: Oil Leaks	No

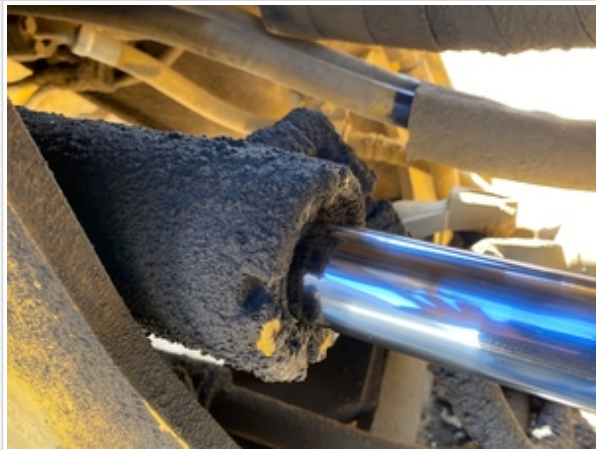
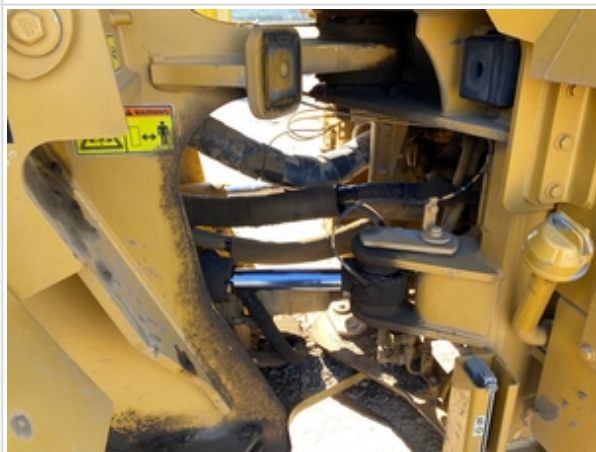
Steering Cylinder	Check the steering cylinder. Note any wear, pitting, discoloration, etc. Take photos.	
Steering Cylinder: Mounting Pin	3	
Steering Cylinder: Oil Leaks	Yes	
Comments	Minor seepage at left side steer rod seal	
Steering Cylinder Photos

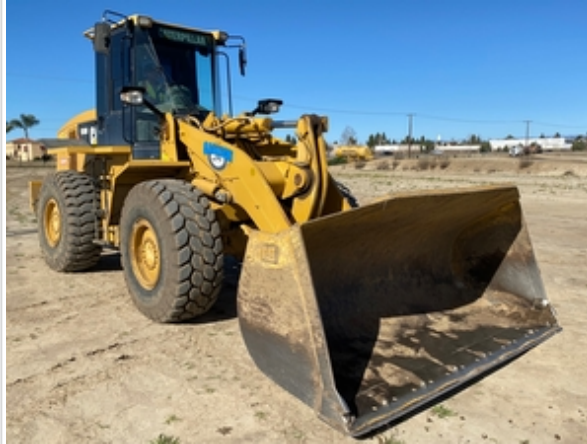
<p>Bucket</p>	<p>3 - Normal Wear & Tear</p>
<p>Bucket Photos</p>

Bucket Edge/Shanks/Teeth	3 - Normal Wear & Tear
--------------------------	------------------------
