Inspection Report (Compact Track Loader)

Year	2015
Make	Bobcat
Model	T740
Serial Number	B3CA11018
Hour Meter Reading	2,281
Previous Application (e.g., earth moving, mining, demolition, etc)	Masonry General Construction

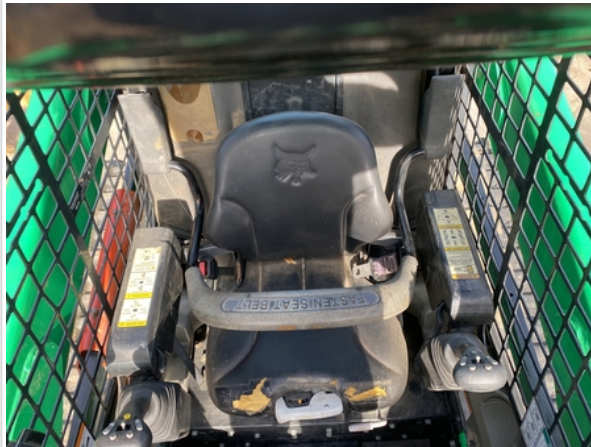
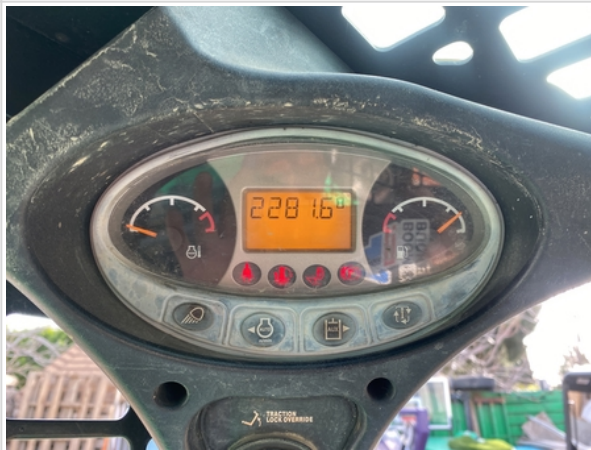
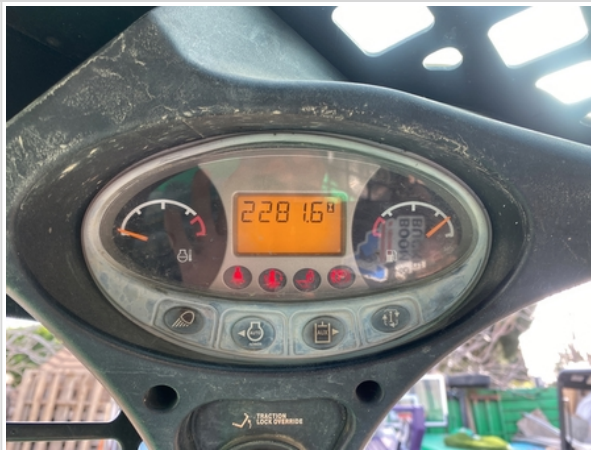
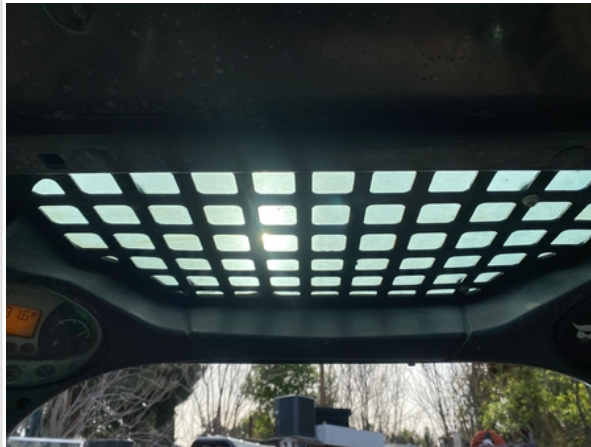
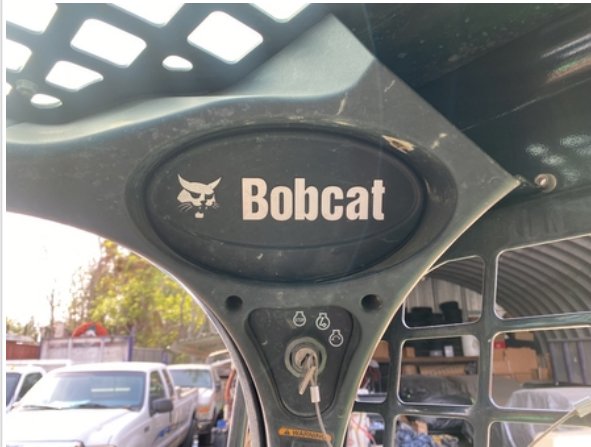
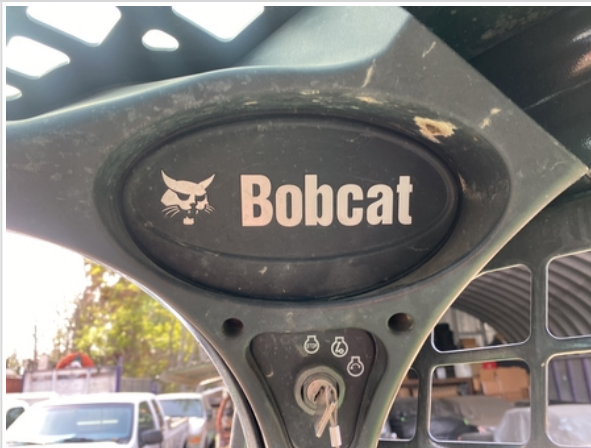
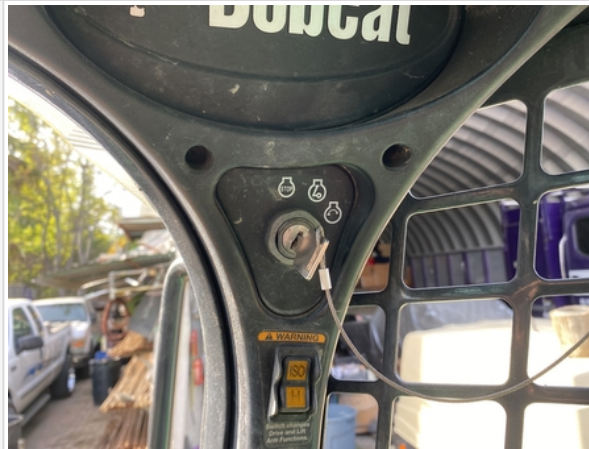
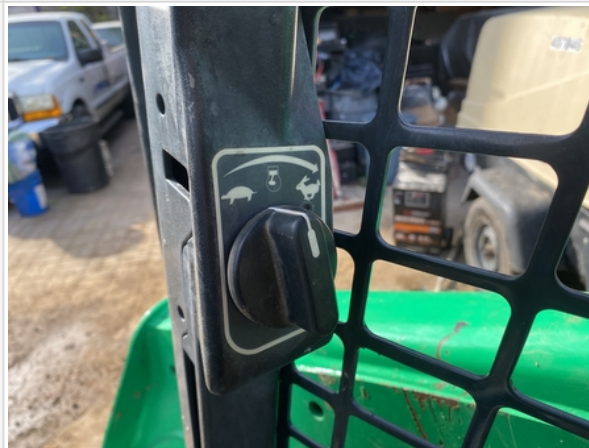
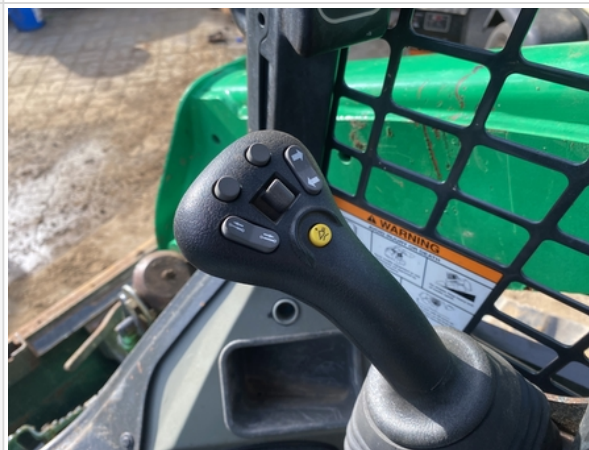
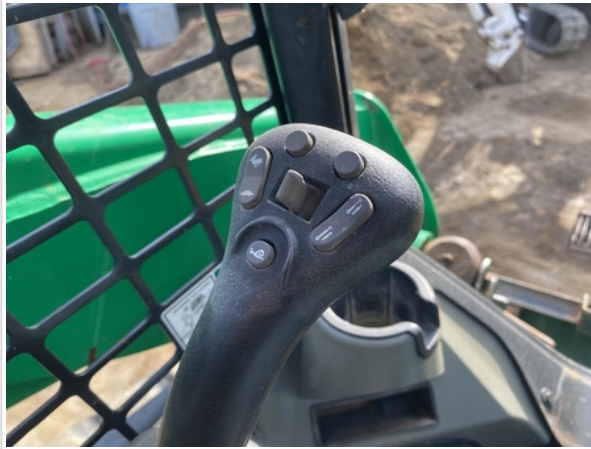
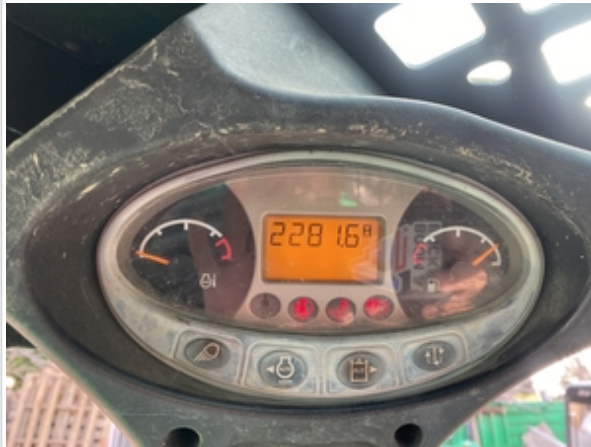
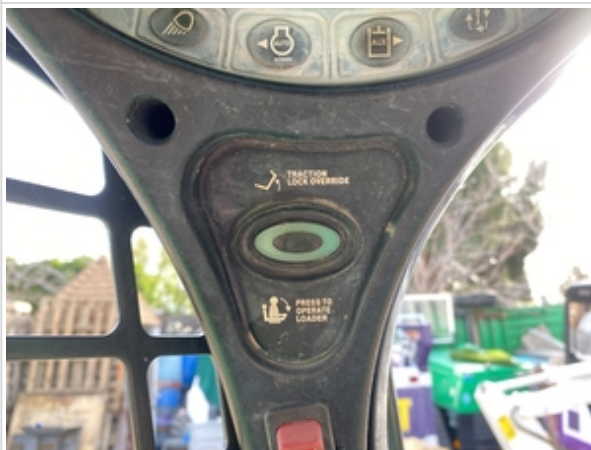
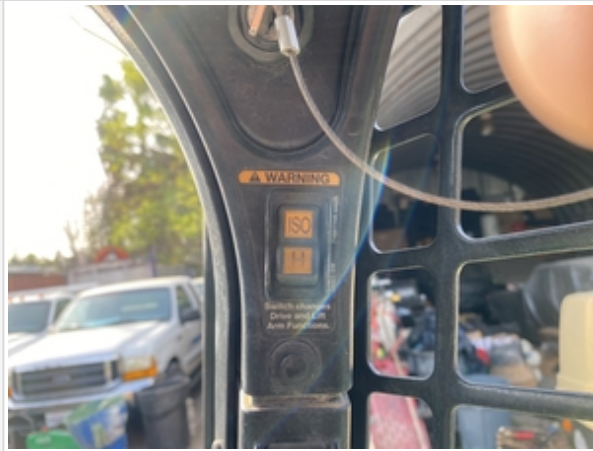
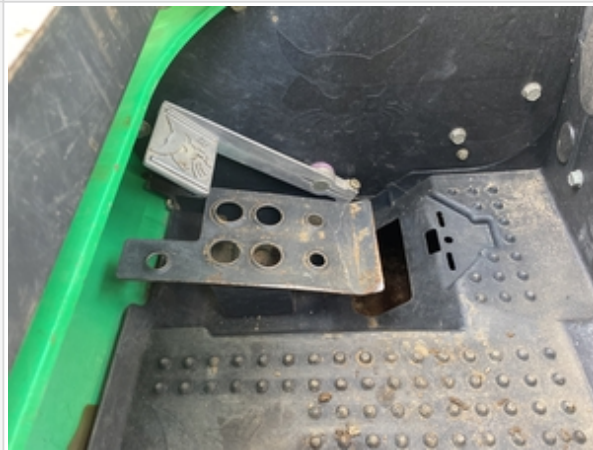
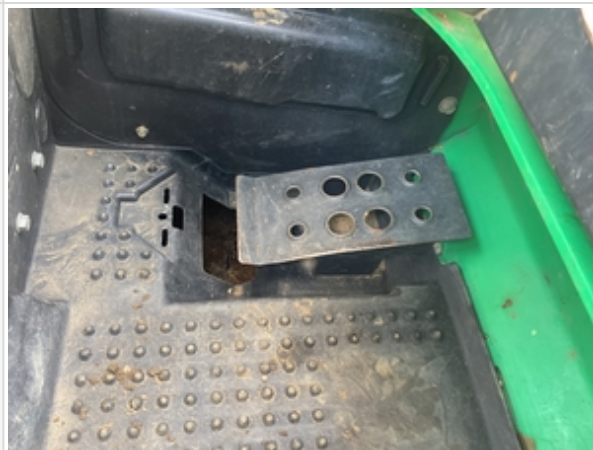
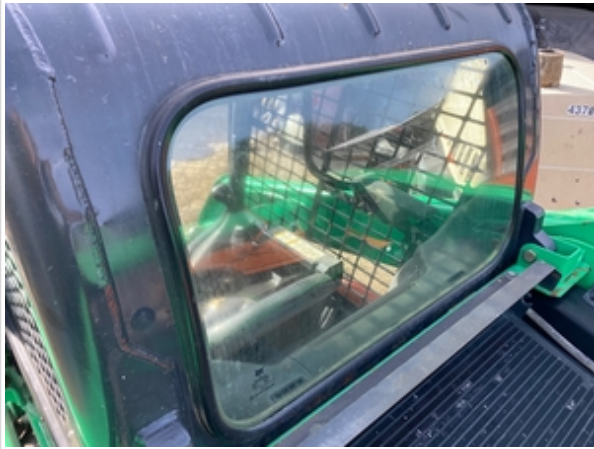
Operator Cabin Overall	3 - Normal Wear & Tear
Operator Cabin Overall Condition	Minor cosmetic wear to cabin surfaces, floors, panels, and ceiling
Operator Seat	3 - Normal Wear & Tear
Operator Seat Condition	Seat(s) have minor surface staining or small tears
Cabin Lights	0
Safety Lock Out / Stop	3 - Normal Wear & Tear
Safety Lock Out / Stop Condition	Safety lock out device is present, in good condition, and functional
Controls & Switches	3 - Normal Wear & Tear
Controls & Switches Condition	All switches are installed and functional
Hour Meter Activity	3 - Normal Wear & Tear
Hour Meter Condition	Hour meter is functional and in good condition
Other Gauge Activity	3 - Normal Wear & Tear
Other Gauge Condition	All cockpit gauges are functional and in good condition
Heater & A/C	0
Travel Alarm	2 - Above Average Wear
Travel Alarm Condition	System is configured but not operating correctly, Other (see comments)

Comments	Travel alarm on machine but not operating during inspection
Horn	3 - Normal Wear & Tear
Horn Condition	Horn is installed and functioning as expected
Backup Camera	0

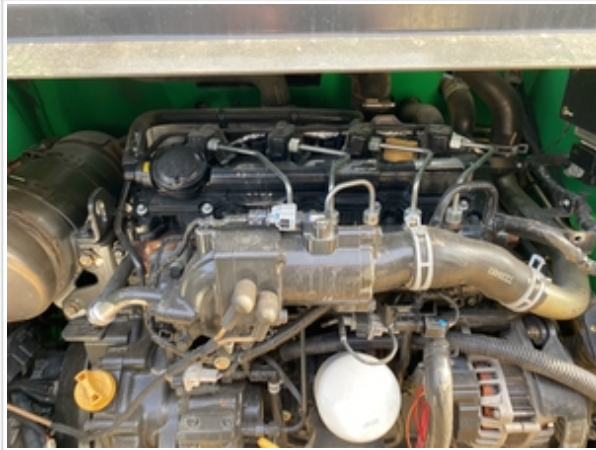
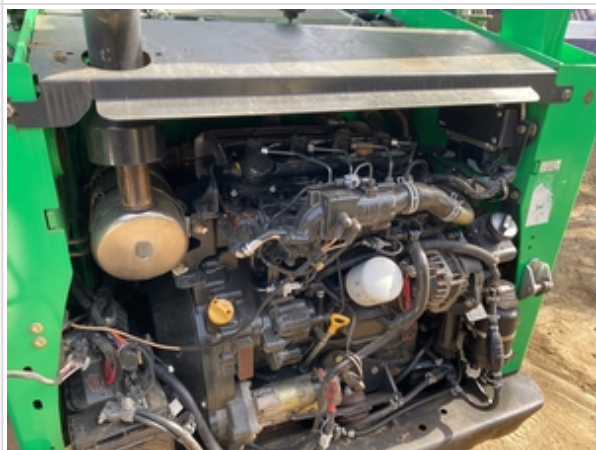
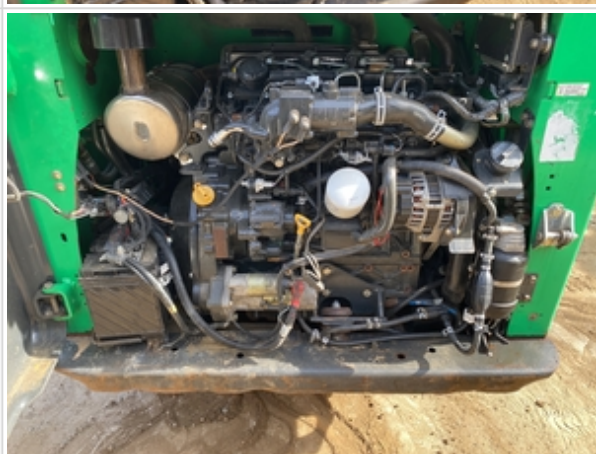
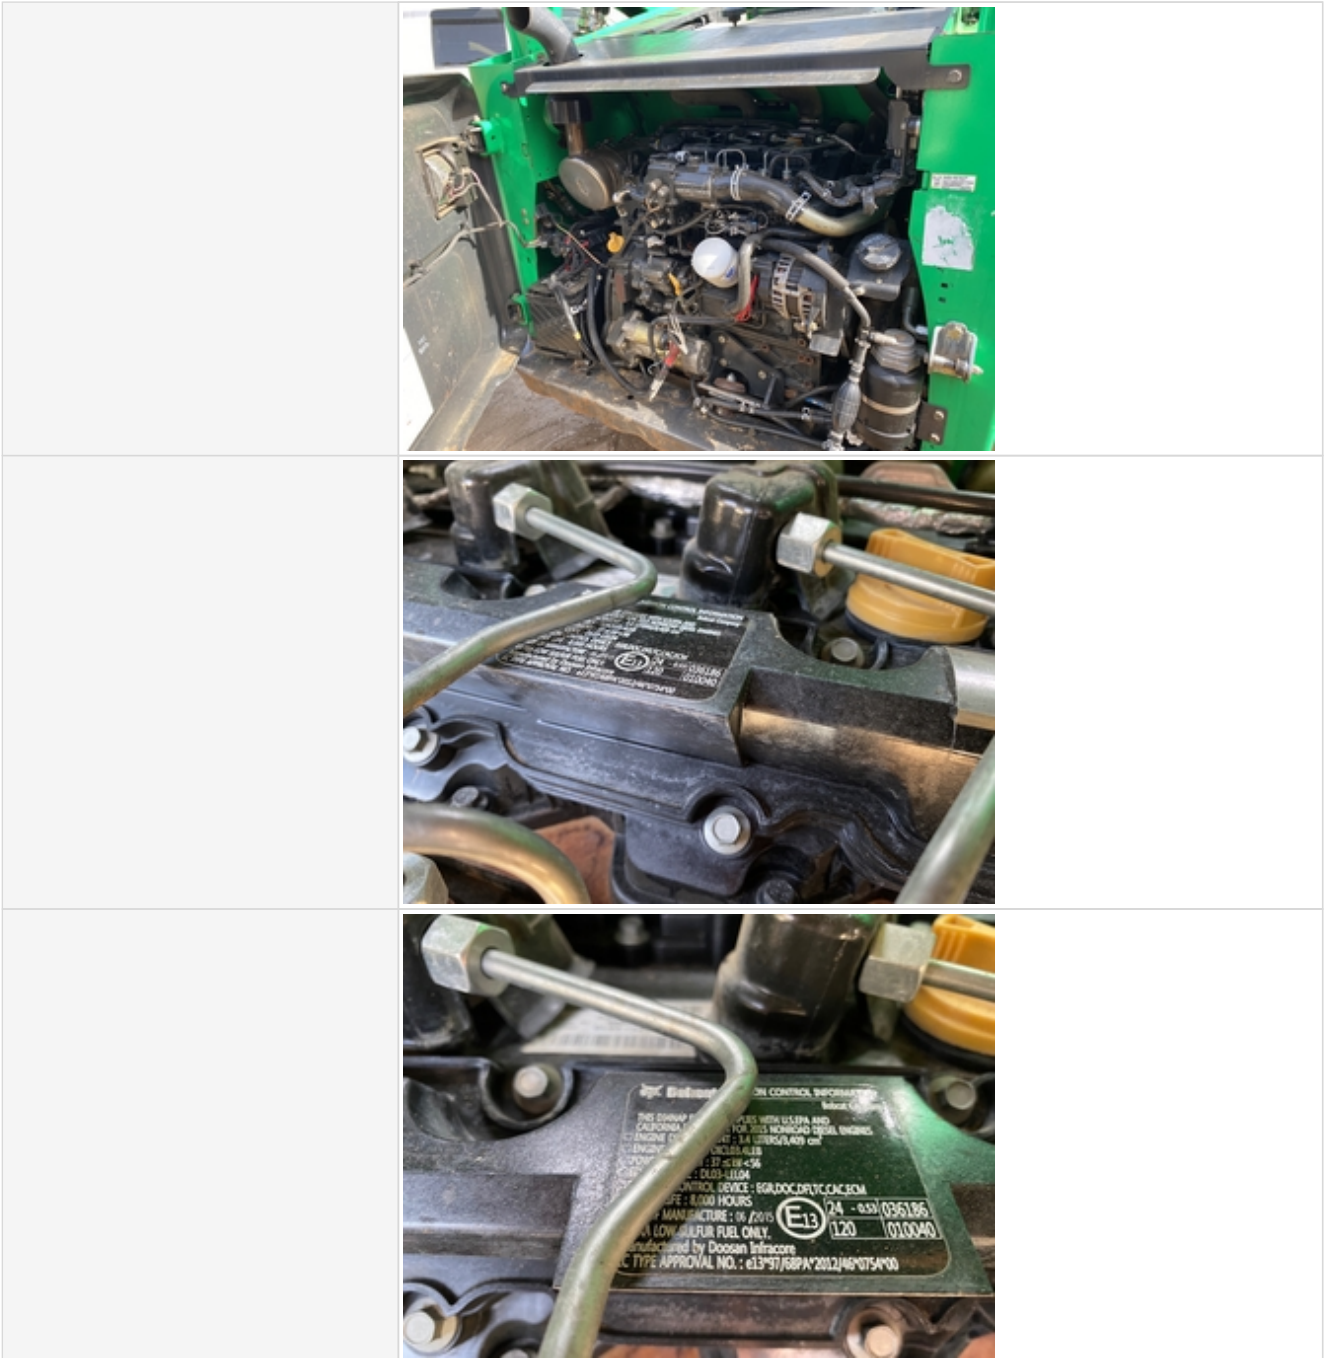
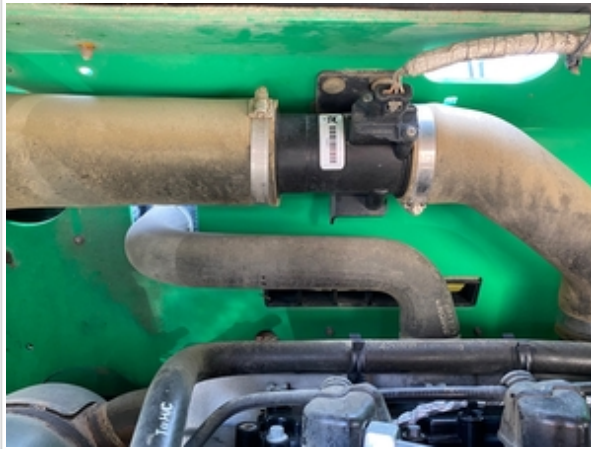
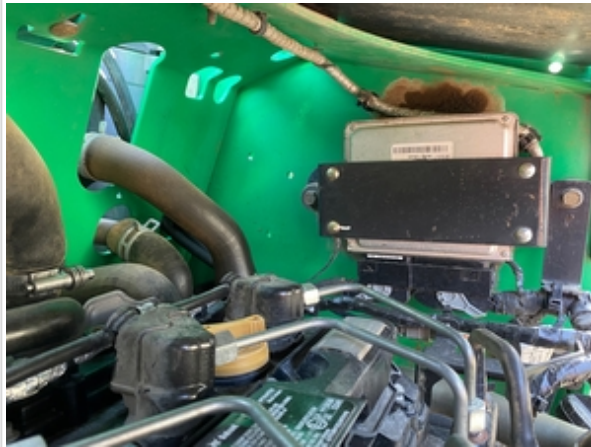
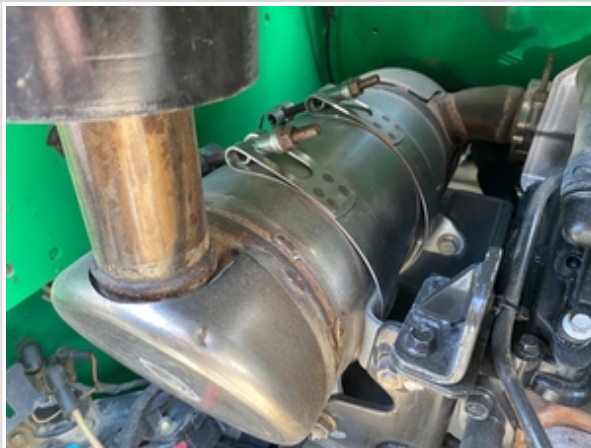
Engine Serial Number	5005627
Engine Fuel Type	Diesel
Engine Photos

Blow-by (Visual Observation Check)	No	
Unusual Noises (Upon Start-up, Idle, Shutdown)	Yes	
Unusual Noise Notes	No unusual noises heard, Other (see comments)	
Comments	Starter solenoid not engaging (intermittently) causing starter motor to spin and not turnover engine	
Engine Smoke (Upon Start-up, Idle, Shutdown)	No	
Engine Smoke Notes	No engine smoke issues observed	
Engine Exhaust Color	Clear	
Battery	3 - Normal Wear & Tear	
Battery Condition	Like new, recently replaced	
Radiator	3 - Normal Wear & Tear	
Radiator Condition	Radiator fins & components appear to be in good working order, no signs of damage or leaks	
Belts	3 - Normal Wear & Tear	
Belt Condition	Belts appear in good condition & alignment with proper tension	
Hoses	3 - Normal Wear & Tear

Hose Condition	Firm, pliant hoses with no signs of wear or leaks
Water Pump	3 - Normal Wear & Tear
Water Pump Condition	No unusual pump noises heard
Cooling System Leaks	No
Coolant Color / Appearance	3 - Normal Wear & Tear
Coolant Color/Appearance Notes	Normal Translucent appearance, no visual signs of contamination
Oil Leaks	No
Oil Color / Appearance	3 - Normal Wear & Tear
Oil Color / Appearance Notes	Clean oil appearance, no signs of cross contamination, Appropriate oil level
Fuel Leaks	No
Requires DEF (Diesel Exhaust Fluid)	No
Overall Engine Appearance	Clean & dry
Overall Engine Comments	Engine sounds healthy at idle and under load. No leaks observed and engine appearance in well maintained condition. Only small issue is starter starting to fail intermittently and will not engage to turn engine.

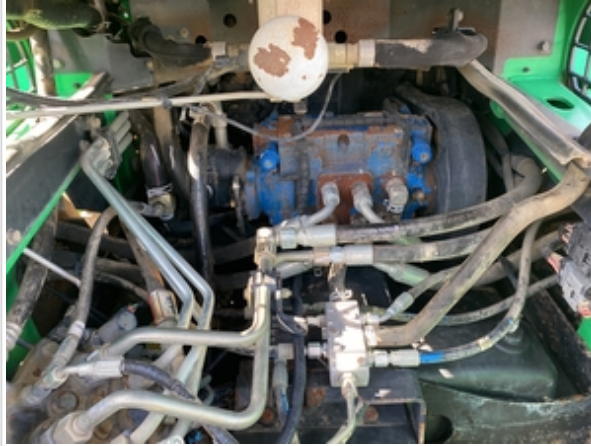
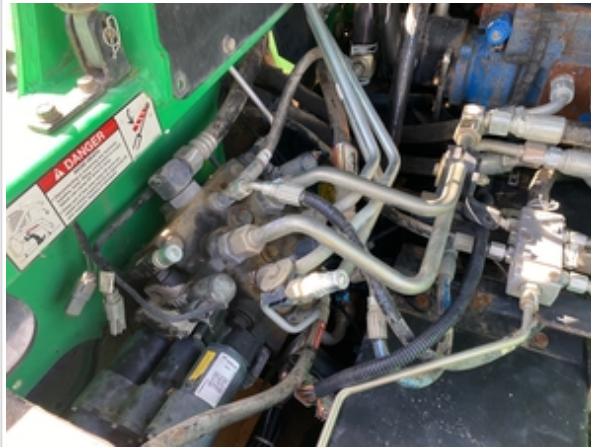
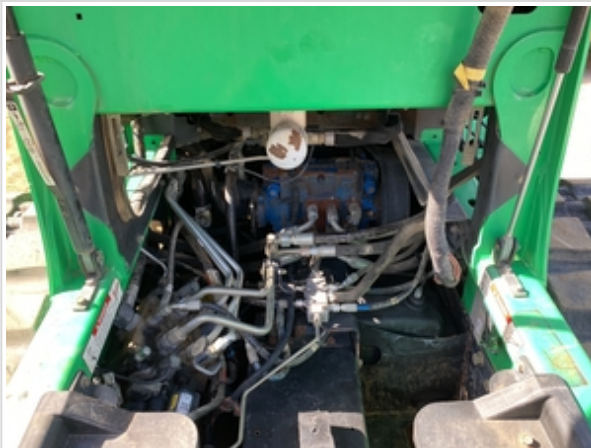
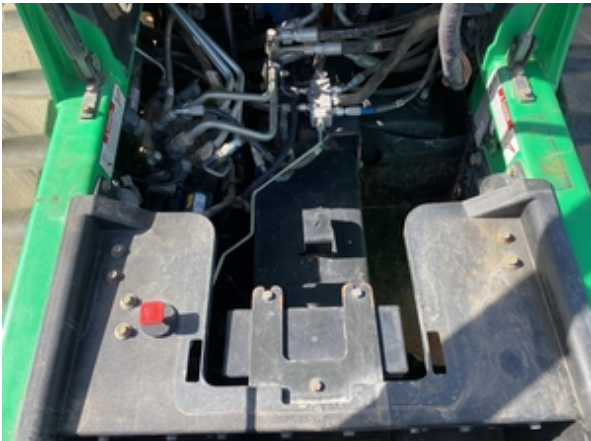
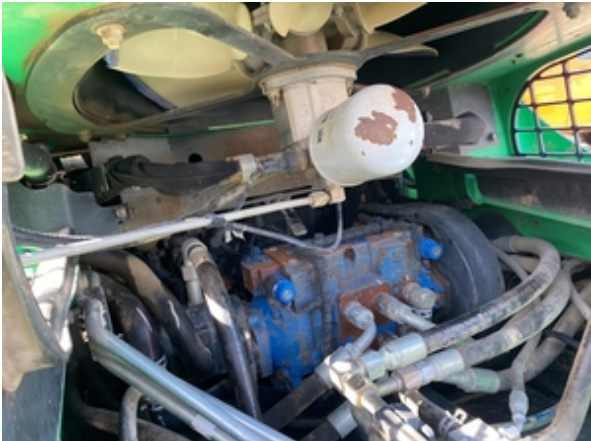
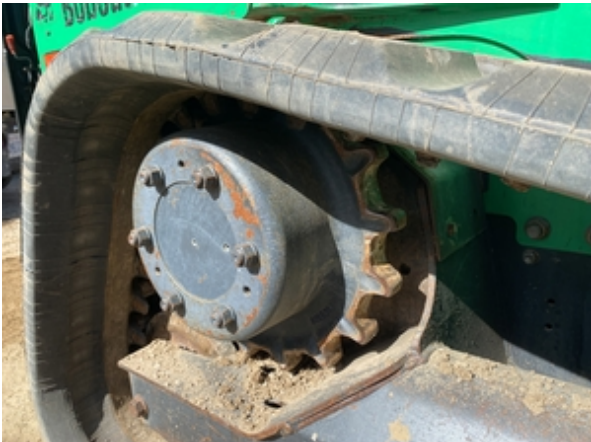
Drivetrain	Take close-up photos of the drivetrain components including transmission housing, drive shaft, drive motors, fittings, and hoses. Note any damage or wear.
Drivetrain Photos

Hydrostatic Transmission?	Yes
2 Speed?	Yes
Hydrostatic Drive Configuration	Split Transmission
Drive Motors	2 - Above Average Wear
Hydrostatic Parking Brake	3 - Normal Wear & Tear
Hydrostatic Parking Brake Condition	Good brake function

Overall Drivetrain Comments	Overall drivetrain in good working condition. No operational travel issues observed during its movements in all directions.
-----------------------------	---

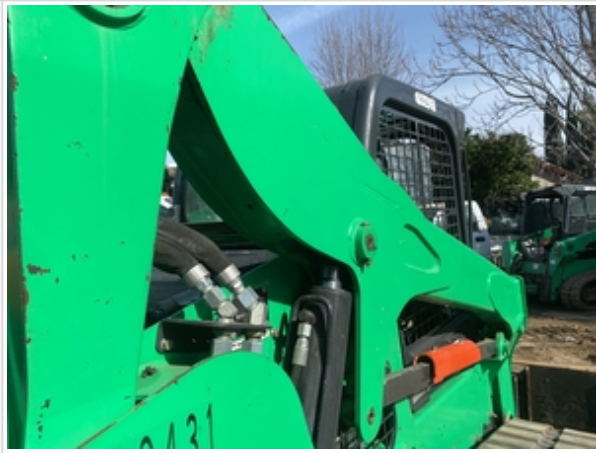
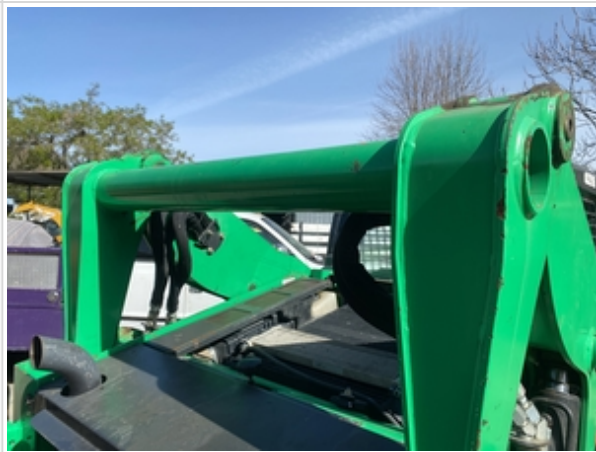
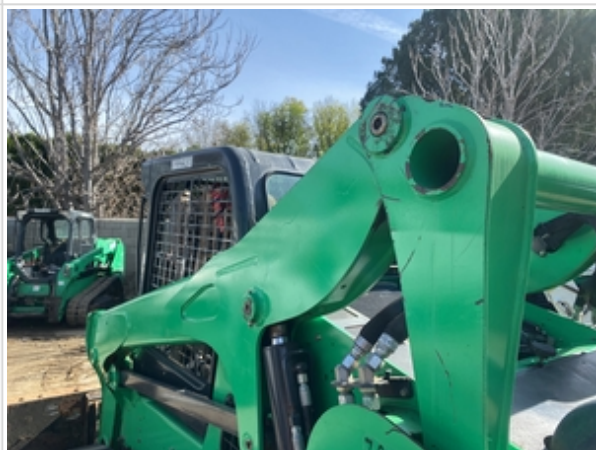
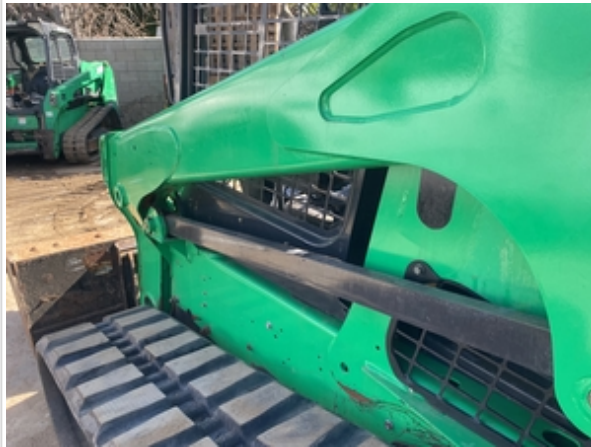
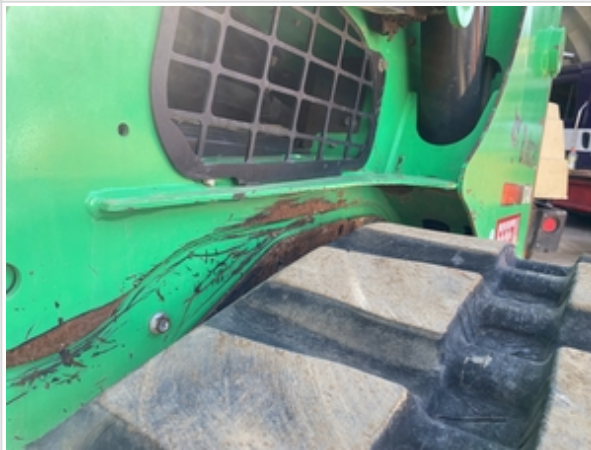
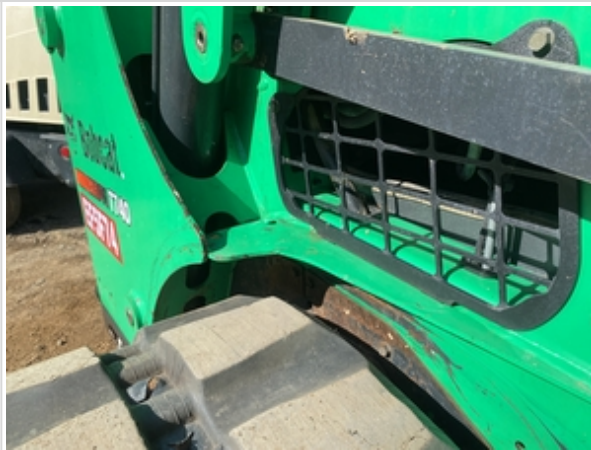
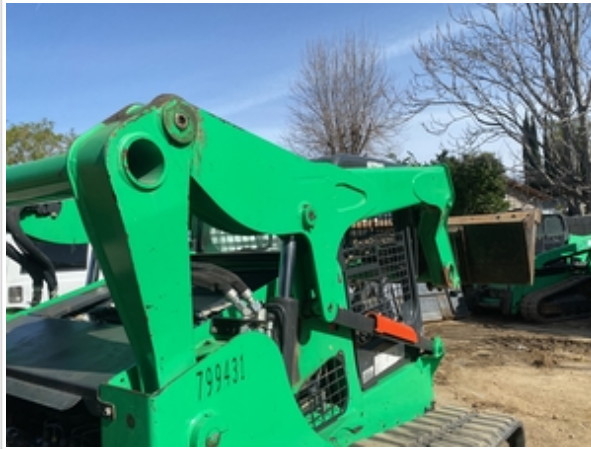
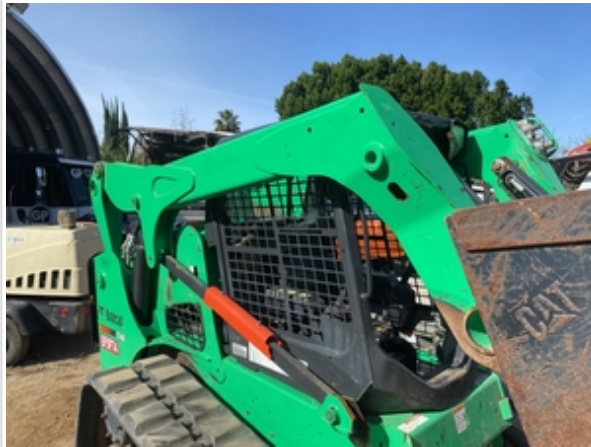
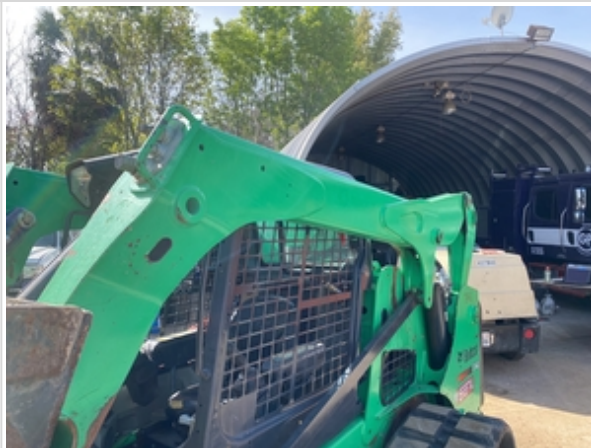
Chassis Photos

Frame	3 - Normal Wear & Tear
Stance	3 - Normal Wear & Tear
Lift Arm	3 - Normal Wear & Tear
Chassis to Arm Pins	3 - Normal Wear & Tear
Quick Coupler	3 - Normal Wear & Tear
Quick Coupler to Arms Pins	2 - Above Average Wear
Comments	Minor wear at bucket cylinder to quick coupler pin bores
Quick Coupler to Arms Pins Photos

Overall Chassis	3 - Normal Wear & Tear
Overall Chassis Comments	Overall chassis in good condition with Normal wear observed throughout the implements. Some excess play seen in front bucket coupler to cylinder pins.

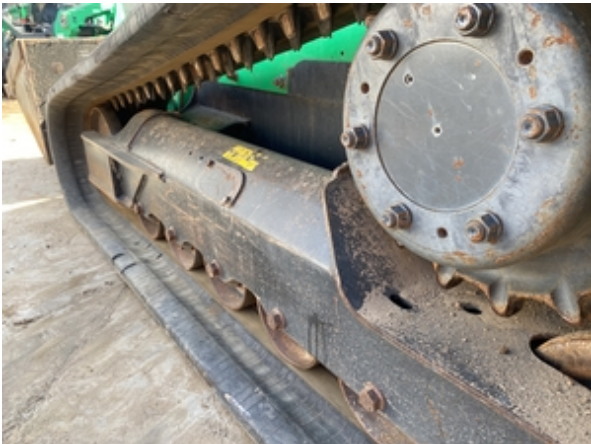
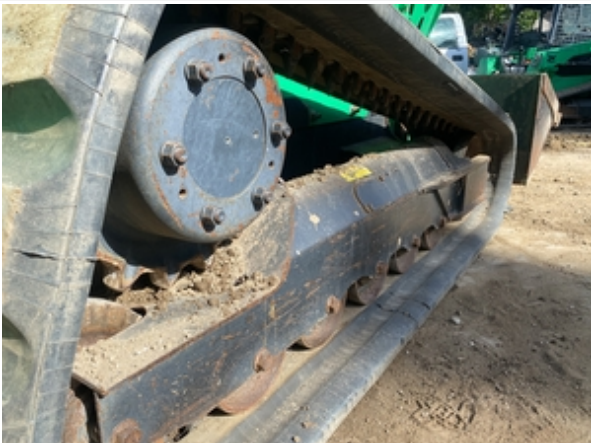
Track Width (inches)	17&1/2"
Roller Frames	3 - Normal Wear & Tear
Roller Frames Photos

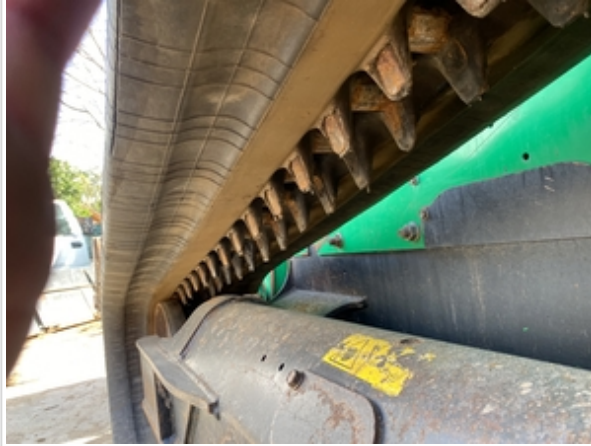
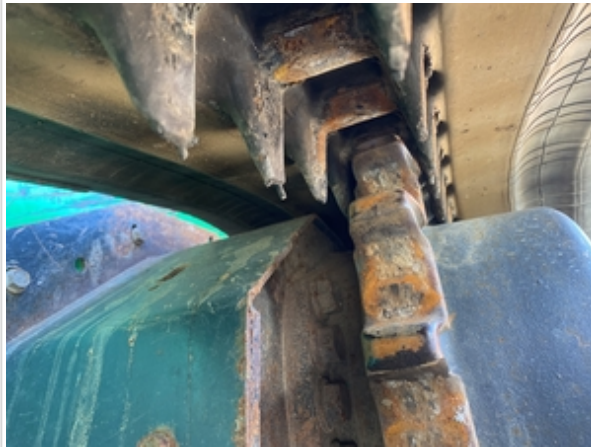
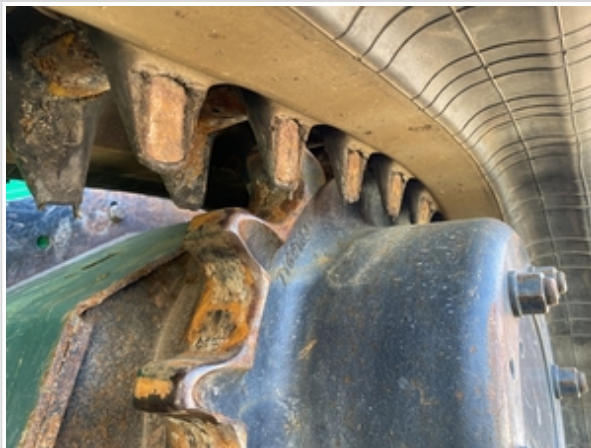
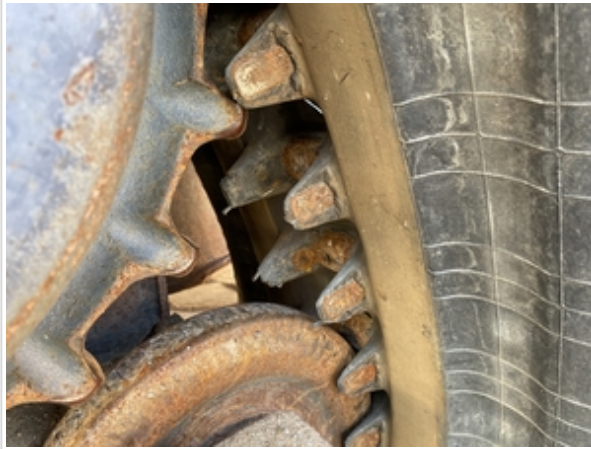
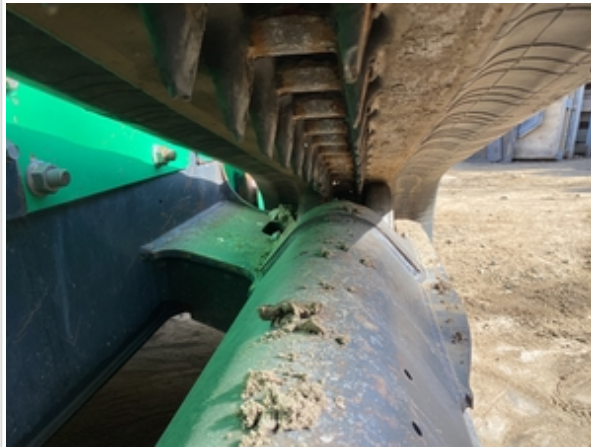
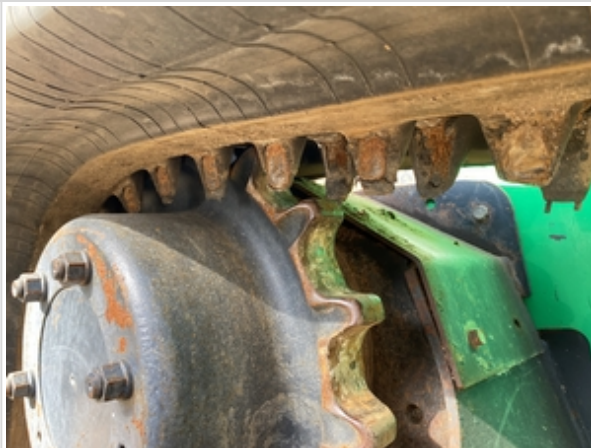
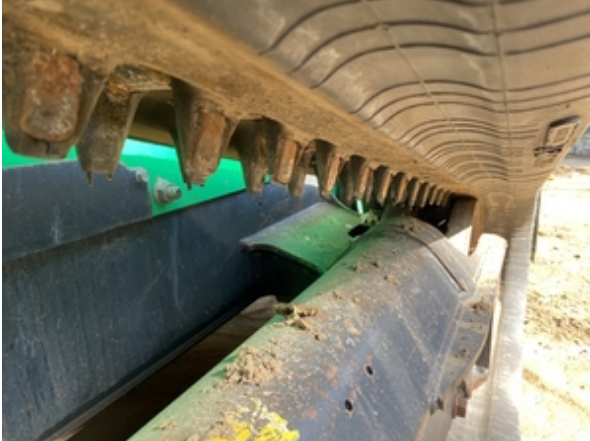
Rubber Belt Drive Lugs Photos

Track Belt	3 - Normal Wear & Tear
Rubber Belt Drive Lugs	3 - Normal Wear & Tear

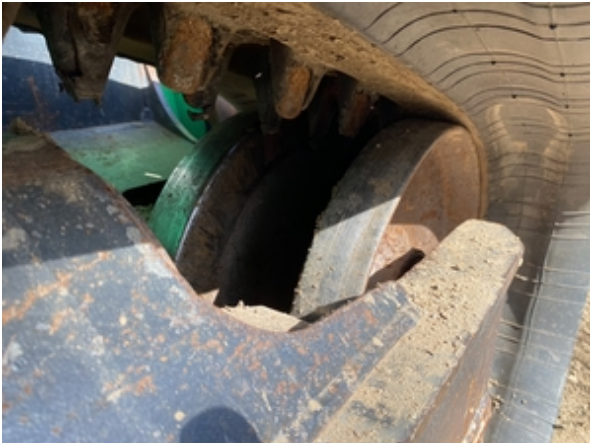
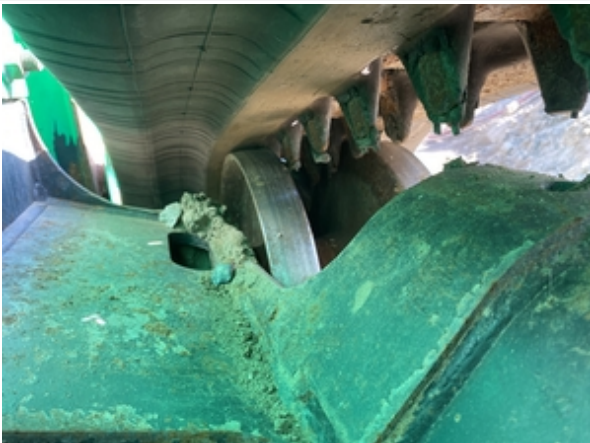
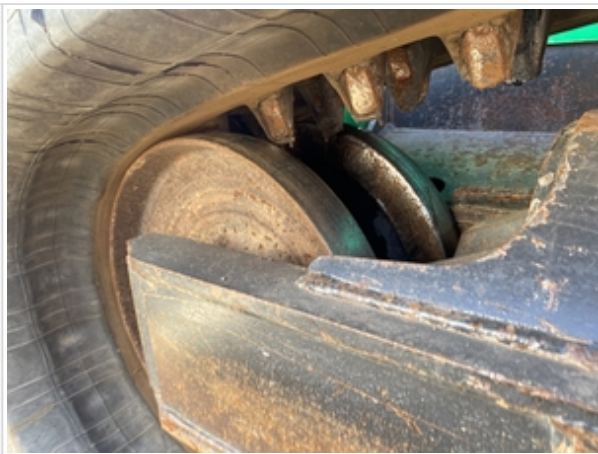
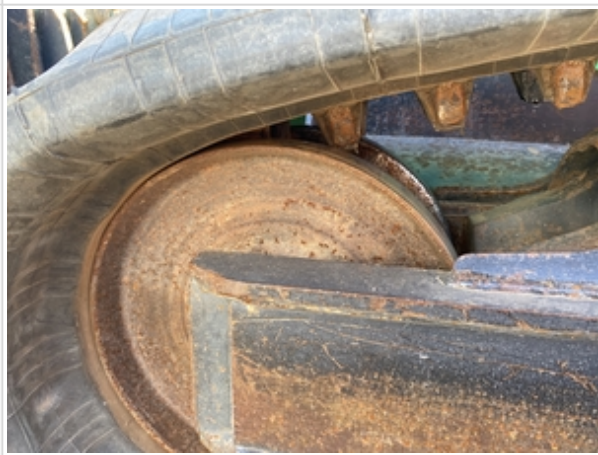
Track Tensioners	3 - Normal Wear & Tear	
Front Idlers	3 - Normal Wear & Tear	
Front Idlers Photos

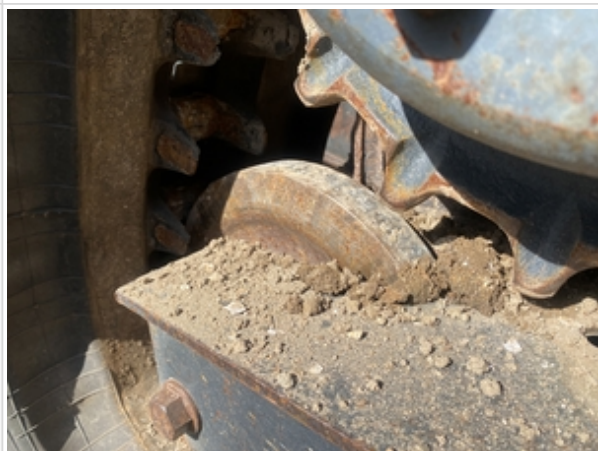
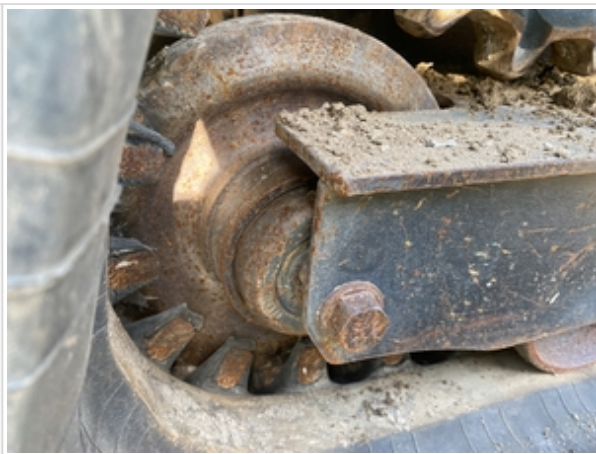
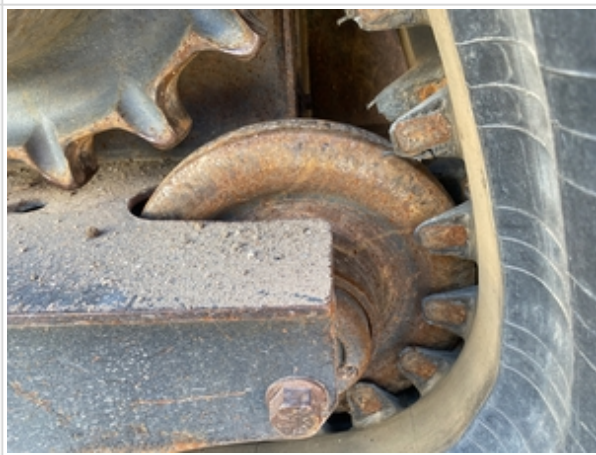
<p>Rear Idlers</p>	<p>3 - Normal Wear & Tear</p>	
<p>Rear Idlers Photos</p>

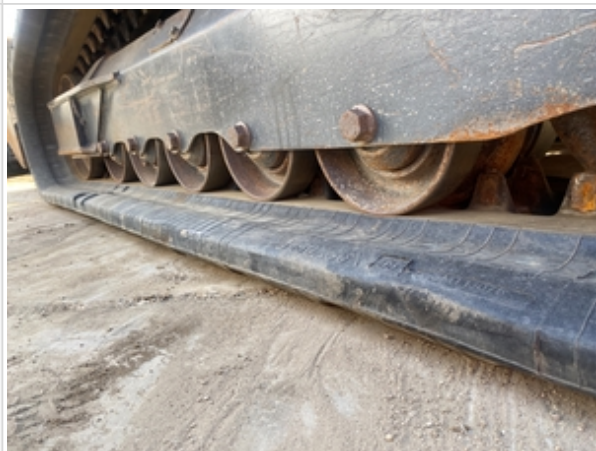
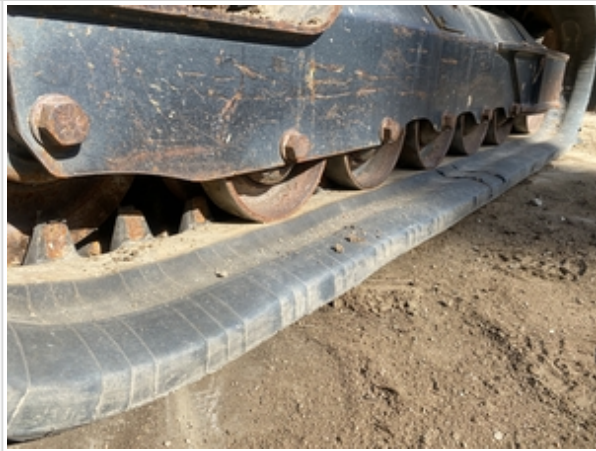
<p>Track Rollers</p>	<p>3 - Normal Wear & Tear</p>	
<p>Track Rollers Photos</p>

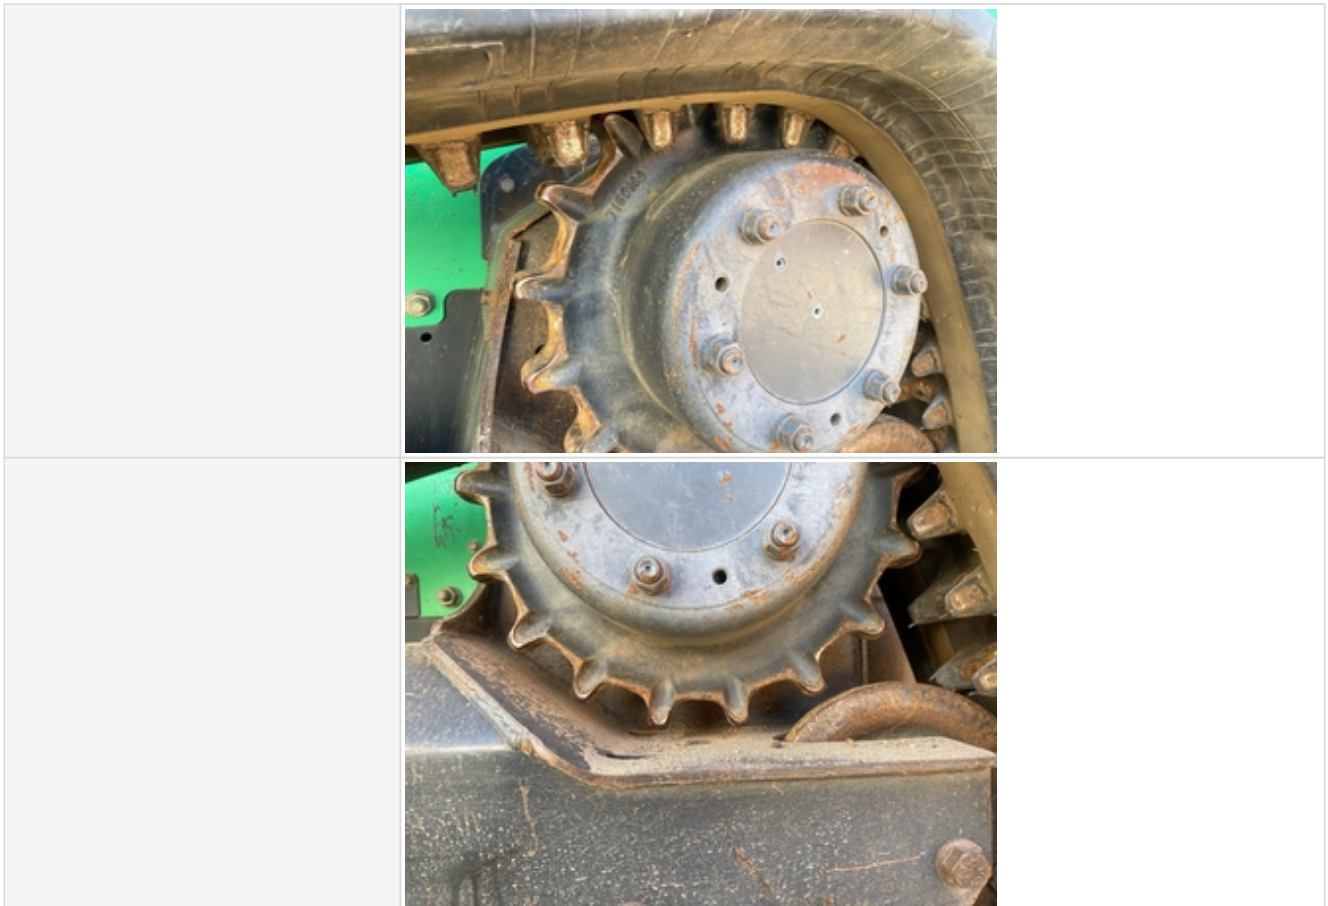
Sprockets	3 - Normal Wear & Tear	
Comments	Normal wear on sprocket for the hours	
Sprockets Photos

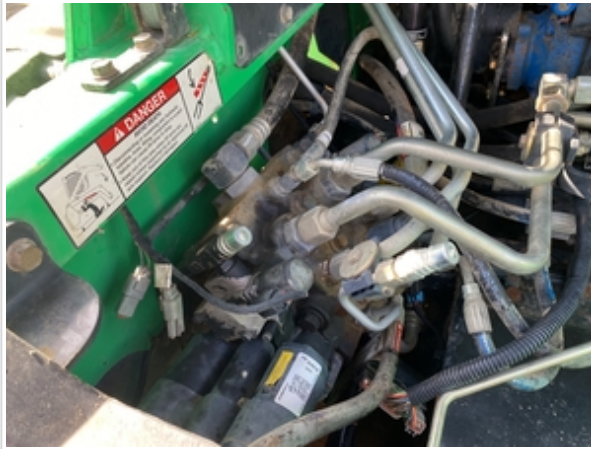
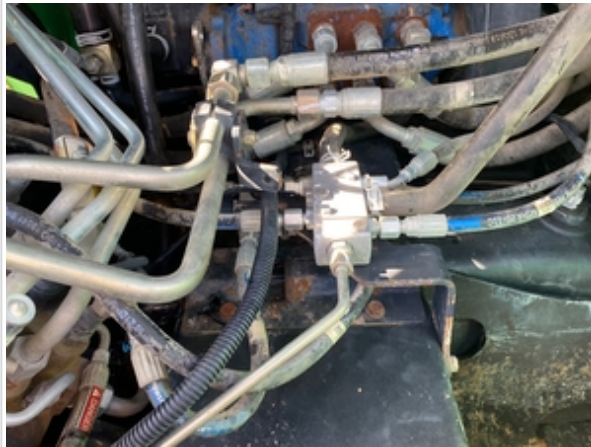
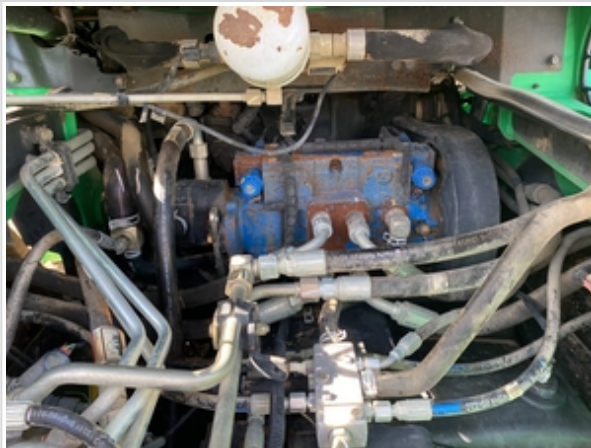
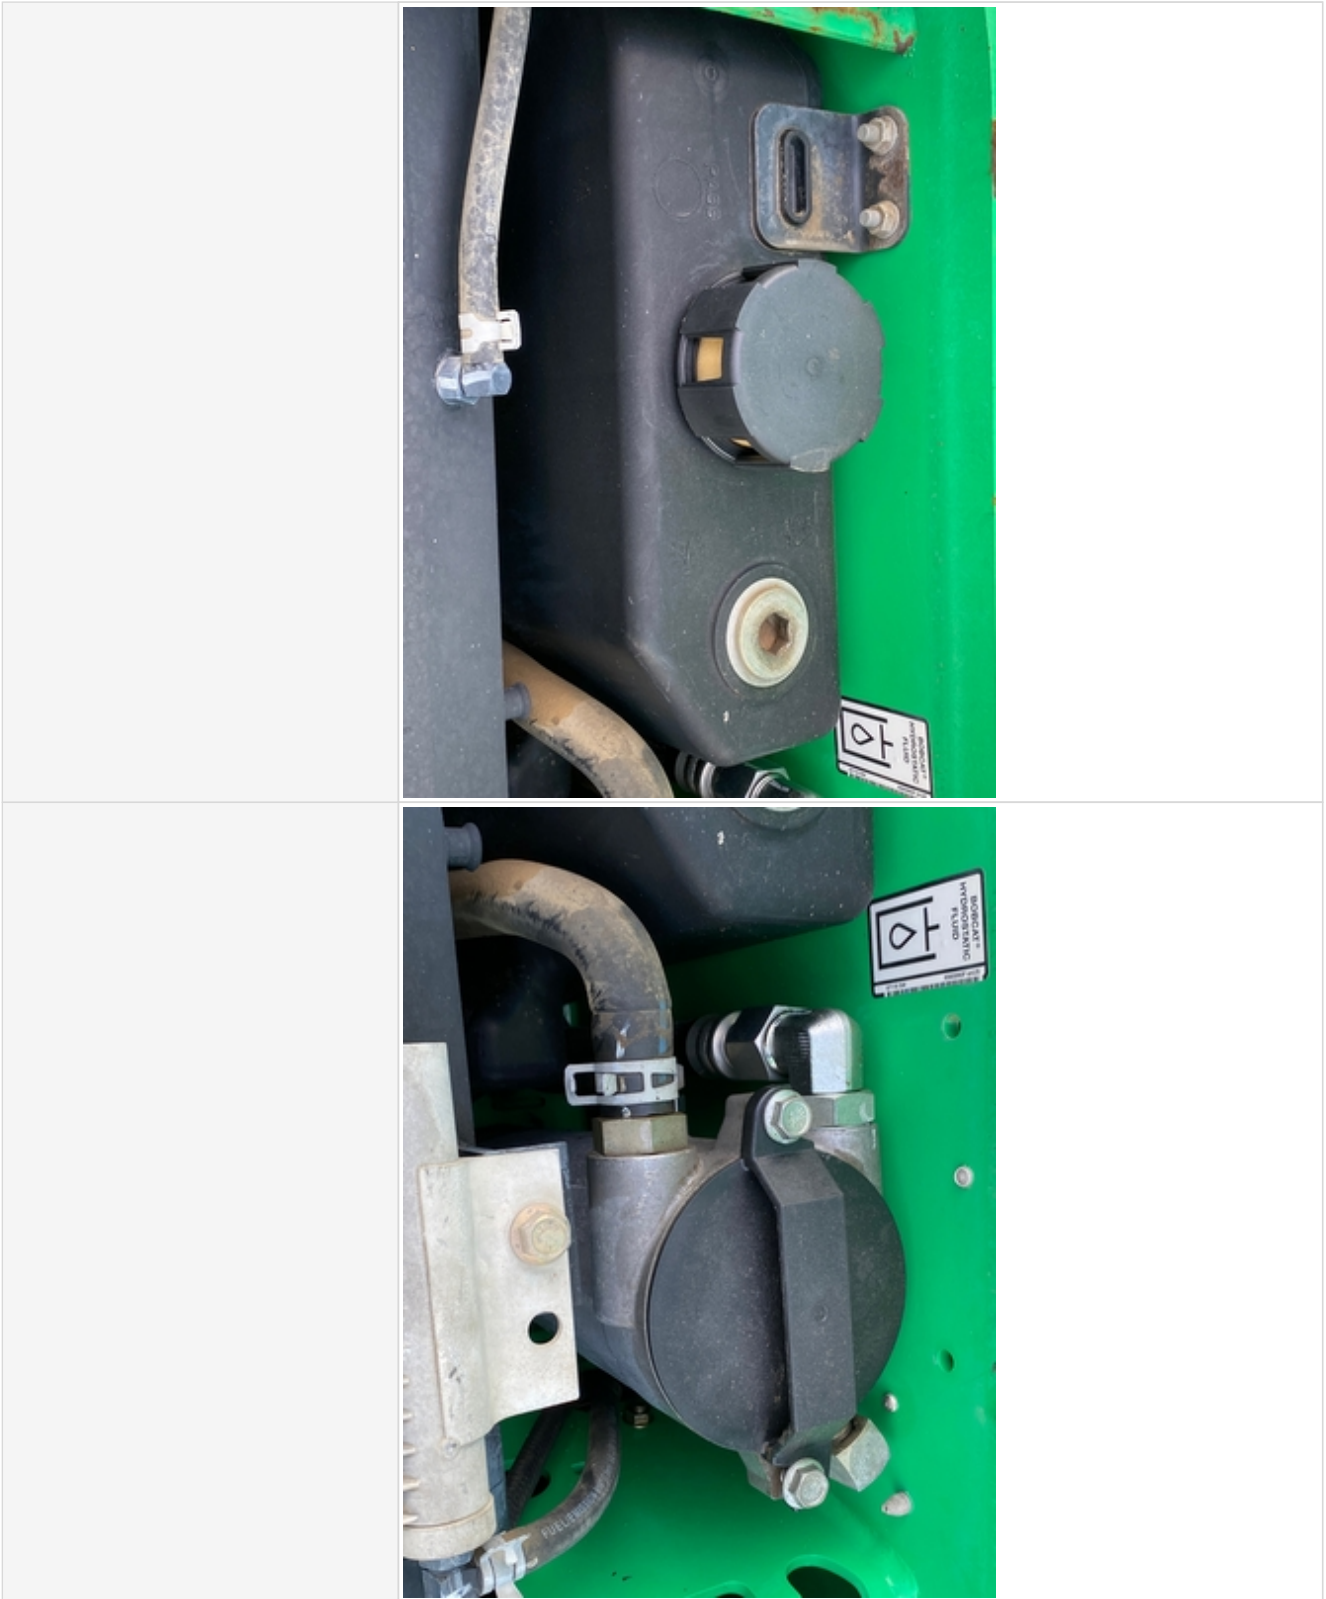
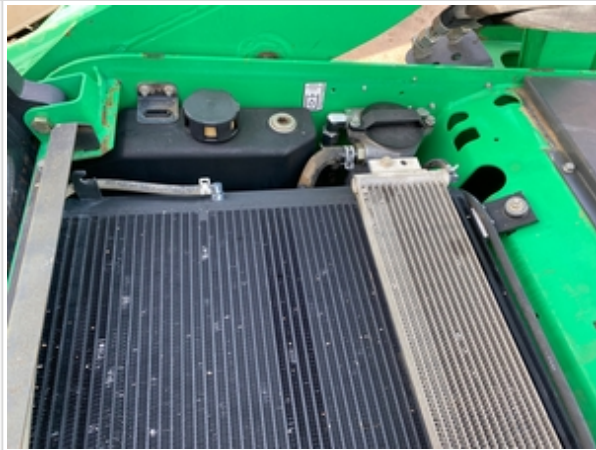
Hydraulic System	Take close-up photos of the hydraulic components including the pump, lines, fittings, controls, and levers. Note any damage, wear, or leaks.
Hydraulic System Photos

Wet or Damp Hydraulic Lines / Fittings	No
Appearance of Hydraulic Lines / Fittings	3 - Normal Wear & Tear
Hydraulic Lines / Fittings Condition	Hydraulic lines & fittings are clean and in good condition
Unusual Noises (Hydraulic Pump)	No
Hydraulic Pump Notes	No unusual noises heard during operation
