Inspection Report (Compact Track Loader)

Year	2015
Make	Bobcat
Model	T740
Serial Number	B3CA11018
Hour Meter Reading	2,281
Previous Application (e.g., earth moving, mining, demolition, etc)	Masonry General Construction

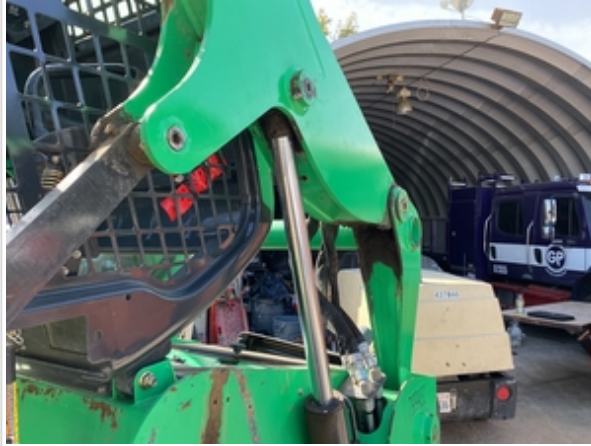
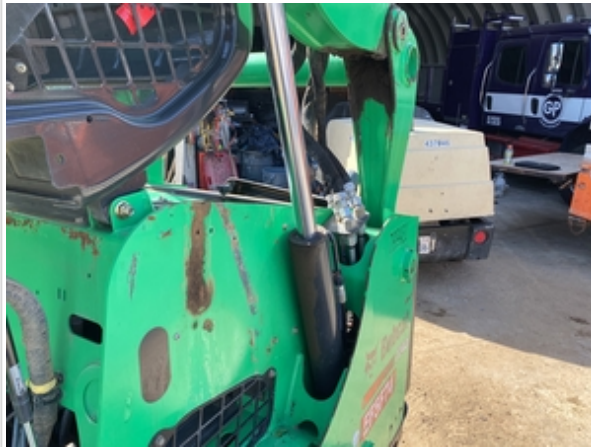
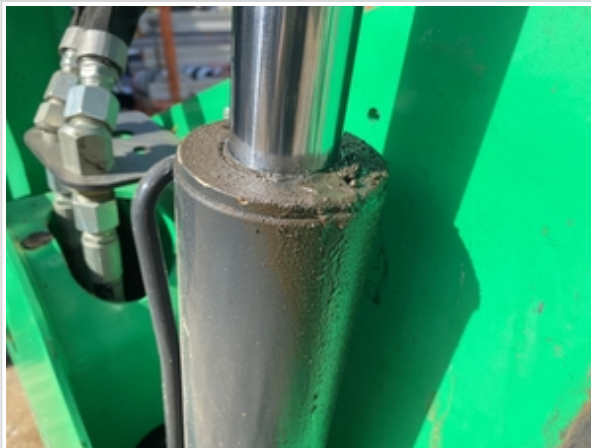
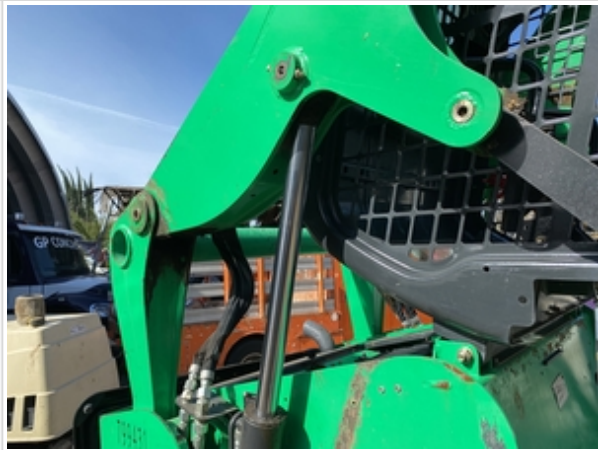
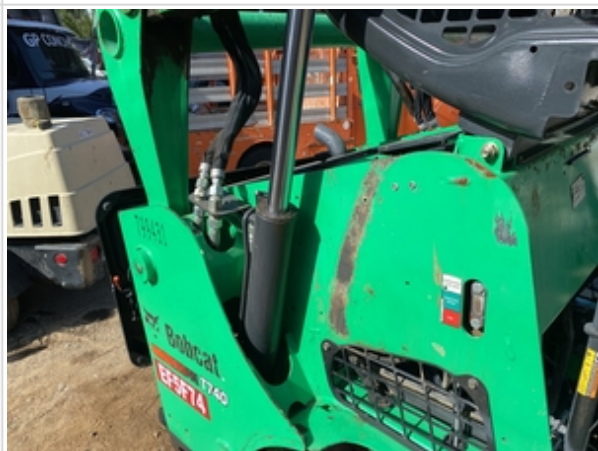
Lift Cylinder	Check the lift cylinder. Note any wear, pitting, discoloration, etc. Take photos.
Lift Cylinder & Mounting Pin	3
Lift Cylinder: Oil Leaks	Yes
Comments	Both lift cylinders showing signs of minor leakage at rod seals
Lift Cylinder & Mounting Pin Photos

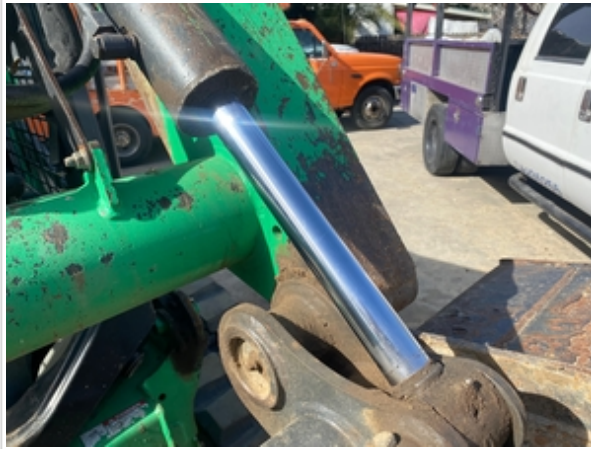
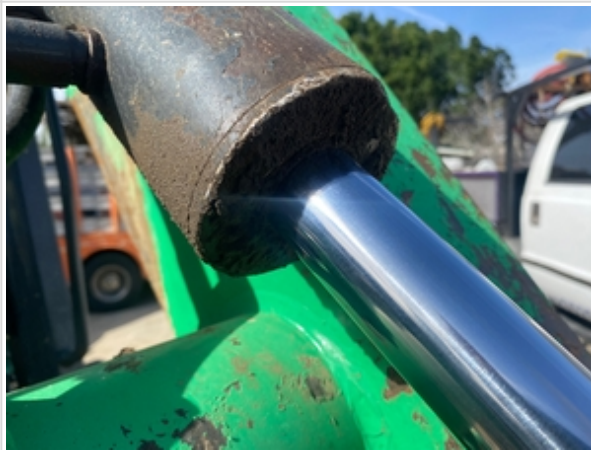
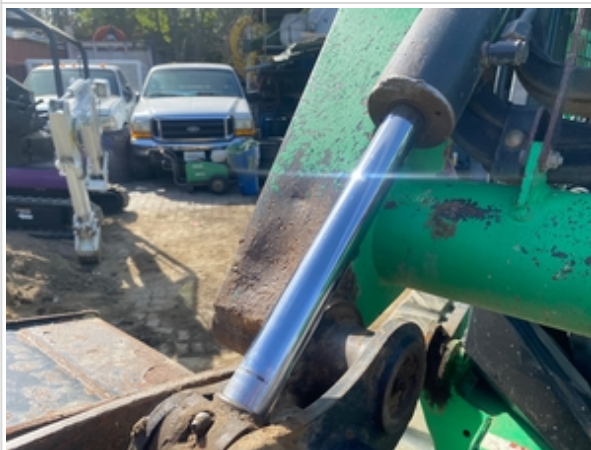
Bucket Cylinder	Check the bucket cylinder. Note any wear, pitting, discoloration, etc. Take photos.	
Bucket Cylinder & Mounting Pin	3	
Bucket Cylinder: Oil Leaks	No	
Comments	No active leaks observed, left side bucket cylinder has signs of seepage buildup	
Bucket Cylinder & Mounting Pin Photos
