Inspection Report (Compact Track Loader)

Year	2016
Make	Bobcat
Model	T550
Serial Number	AJZV15768
Hour Meter Reading	2,366
Previous Application (e.g., earth moving, mining, demolition, etc)	masonry general construction

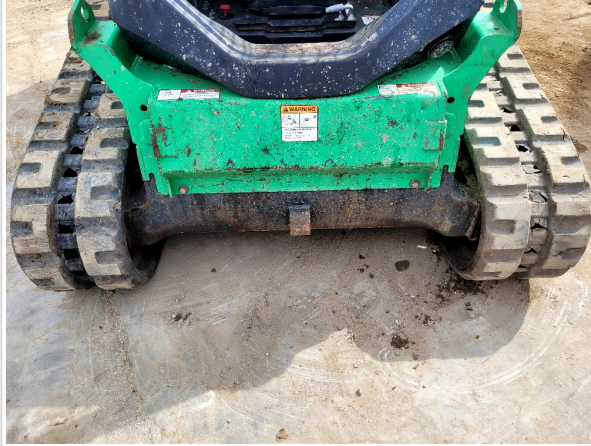
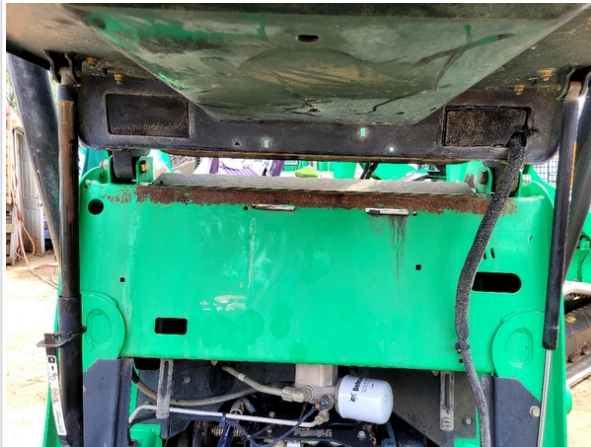
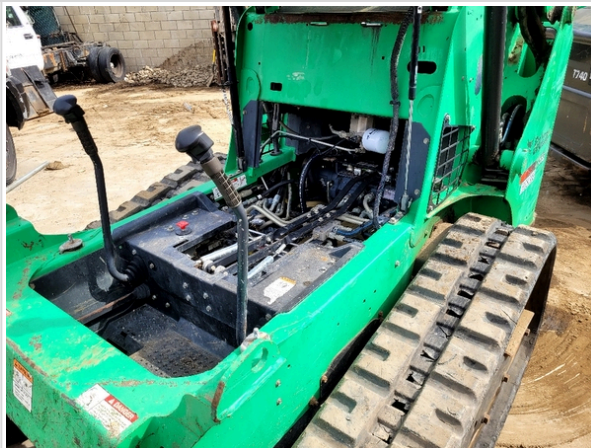
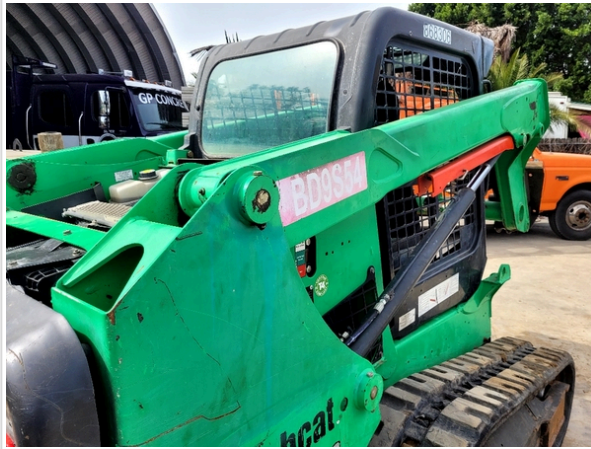
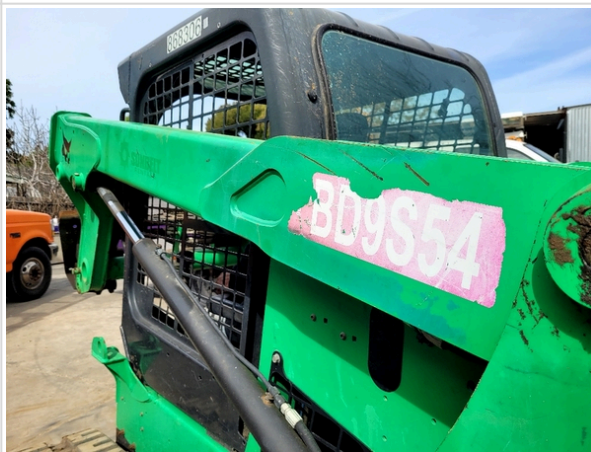
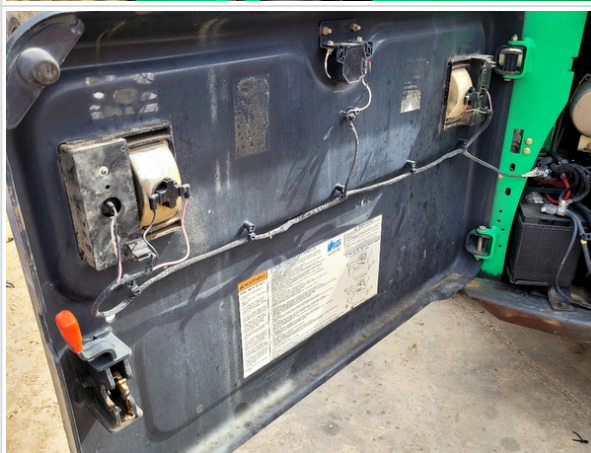
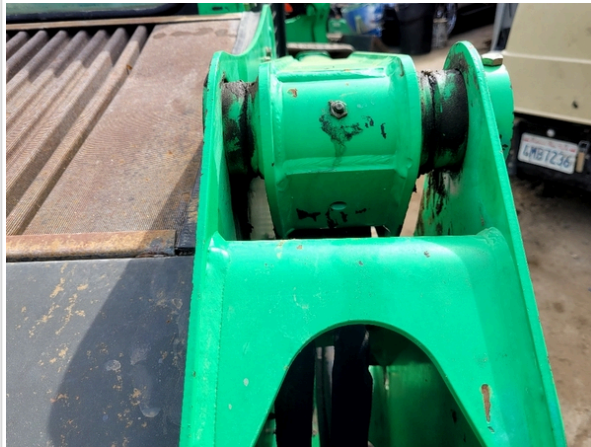
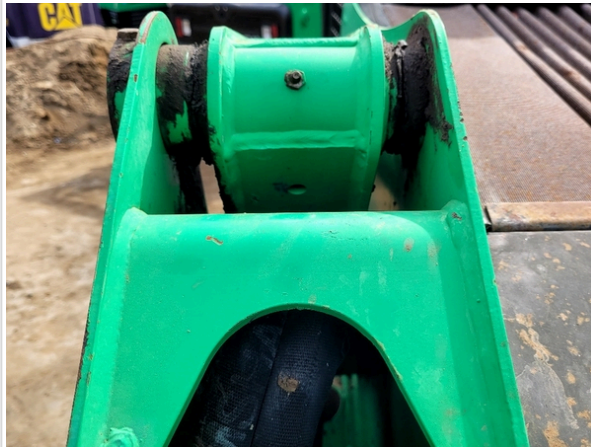
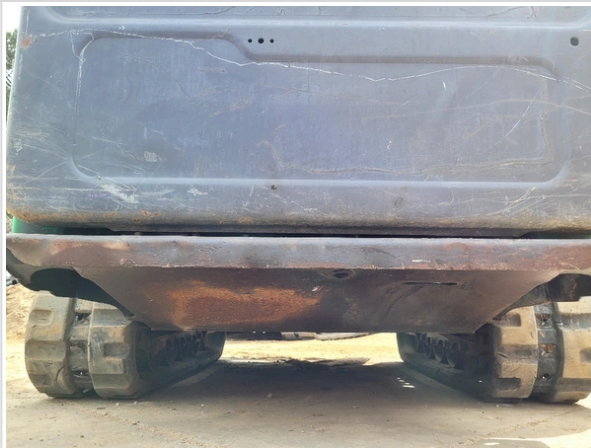
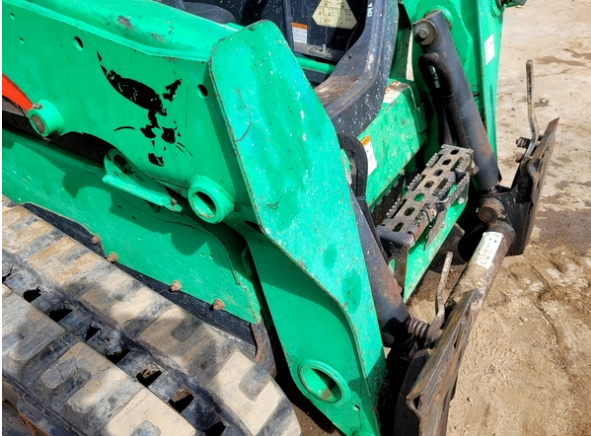
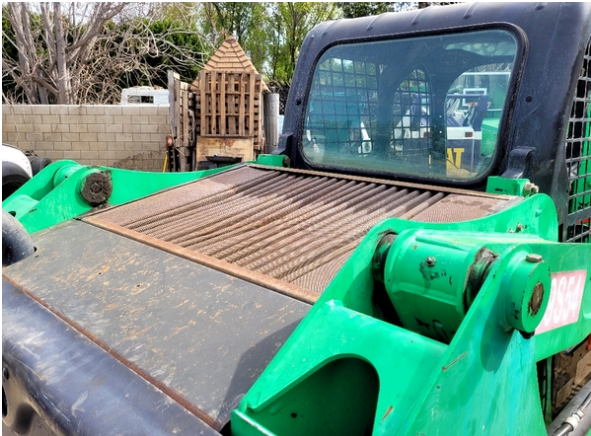
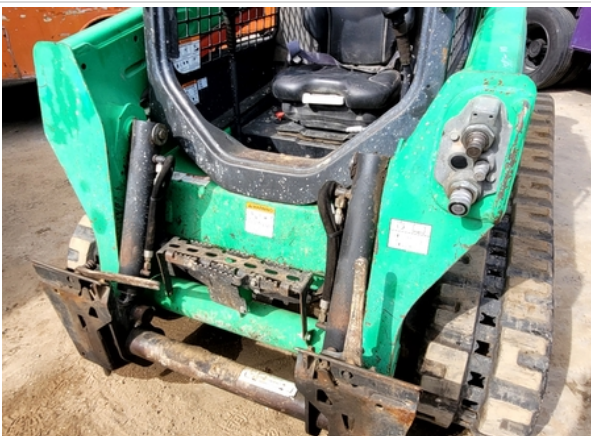
Close-up Exterior Photos

Body Panels	3 - Normal Wear & Tear
Body Panel Condition	No visible damage, good paint condition and panel fitment
Doors / Canopy Latches	3 - Normal Wear & Tear
Doors / Canopy Latches Condition	No visible damage
Steps / Ladders	3 - Normal Wear & Tear
Steps / Ladders Condition	Steps/ladders are fully intact and appear structurally sound
Handrails	3 - Normal Wear & Tear

Handrails Condition	Handrails are fully intact and appear structurally sound
Glass	3 - Normal Wear & Tear
Glass Condition	Glass intact, no visible damage
Mirrors	0
Exterior Lights	3 - Normal Wear & Tear
Exterior Lights Condition	No visible damage, lighting system is operational

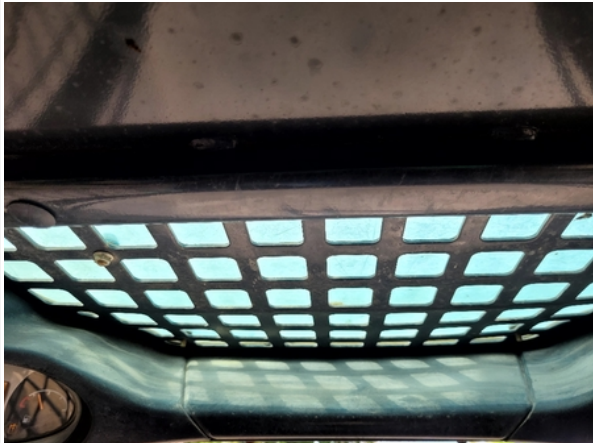
Operator Cabin Photos

Operator Cabin Overall	3 - Normal Wear & Tear
Operator Cabin Overall Condition	Good cabin appearance, solid floors, panels, and ceiling
Operator Seat	3 - Normal Wear & Tear
Operator Seat Condition	Seat(s) in good condition, no stains or tears in upholstery, Seat(s) have minor surface staining or small tears
Cabin Lights	0
Safety Lock Out / Stop	3 - Normal Wear & Tear
Safety Lock Out / Stop Condition	Safety lock out device is present, in good condition, and functional

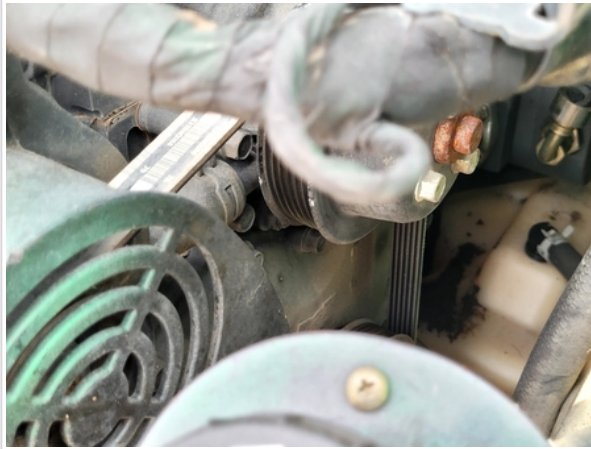
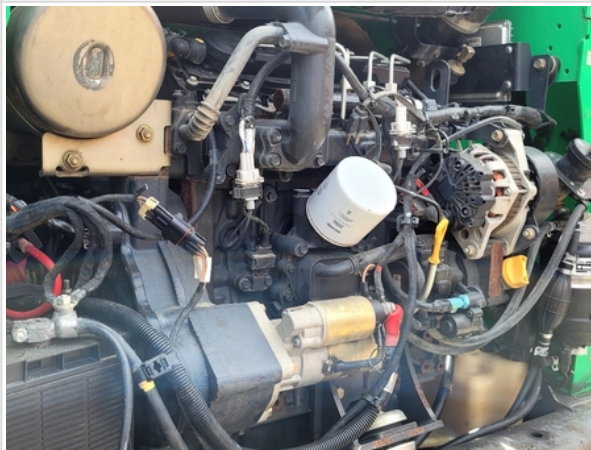
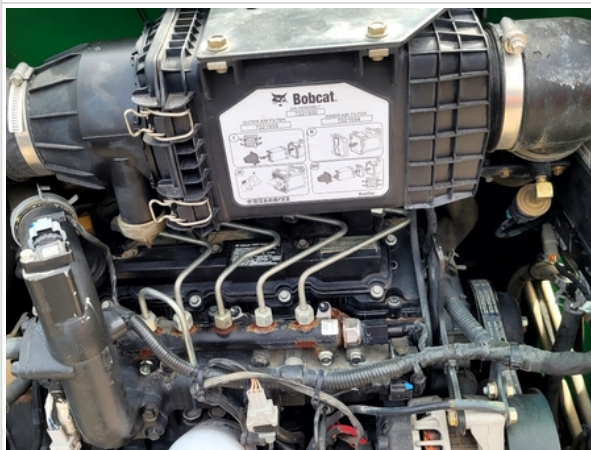
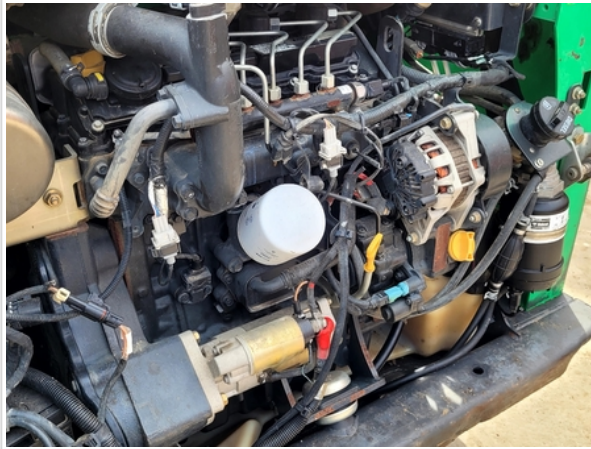
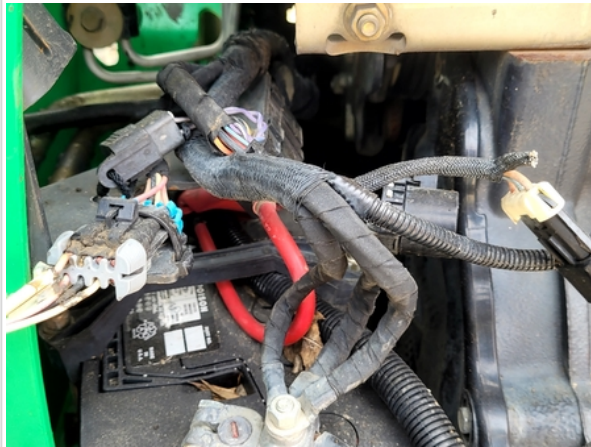
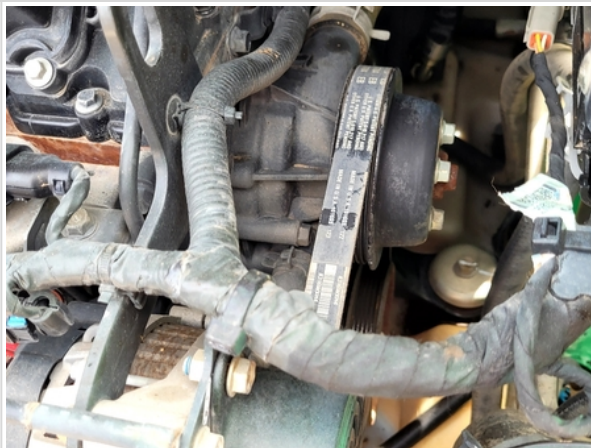
Engine Photos

Blow-by (Visual Observation Check)	No
Unusual Noises (Upon Start-up, Idle, Shutdown)	No
Unusual Noise Notes	No unusual noises heard
Engine Smoke (Upon Start-up, Idle, Shutdown)	No
Engine Smoke Notes	No engine smoke issues observed
Engine Exhaust Color	Clear
Battery	3 - Normal Wear & Tear
Battery Condition	Clean & dry appearance, tight connections, Other (see comments)
Radiator	3 - Normal Wear & Tear
Radiator Condition	Radiator fins & components appear to be in good working order, no signs of damage or leaks
Belts	3 - Normal Wear & Tear
Belt Condition	Belts appear in good condition & alignment with proper tension
Hoses	3 - Normal Wear & Tear
Hose Condition	Firm, pliant hoses with no signs of wear or leaks

Water Pump	3 - Normal Wear & Tear
Water Pump Condition	No unusual pump noises heard
Cooling System Leaks	No
Coolant Color / Appearance	3 - Normal Wear & Tear
Coolant Color/Appearance Notes	Normal Translucent appearance, no visual signs of contamination
Oil Leaks	No
Oil Color / Appearance	3 - Normal Wear & Tear
Oil Color / Appearance Notes	Clean oil appearance, no signs of cross contamination, Appropriate oil level
Fuel Leaks	No
Requires DEF (Diesel Exhaust Fluid)	No
Overall Engine Appearance	Clean & dry
Overall Engine Comments	Engine in good condition with no active leaks observed during the inspection.

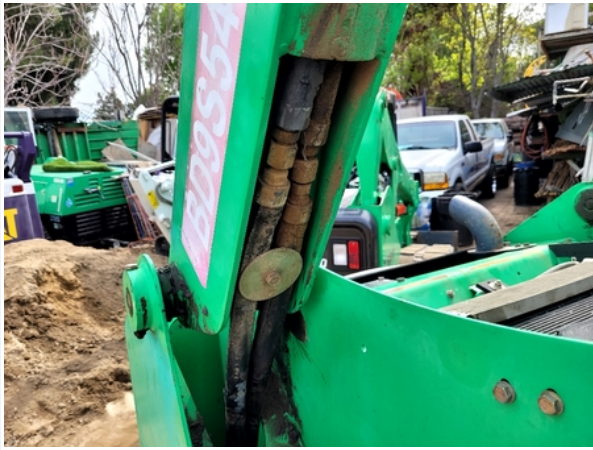
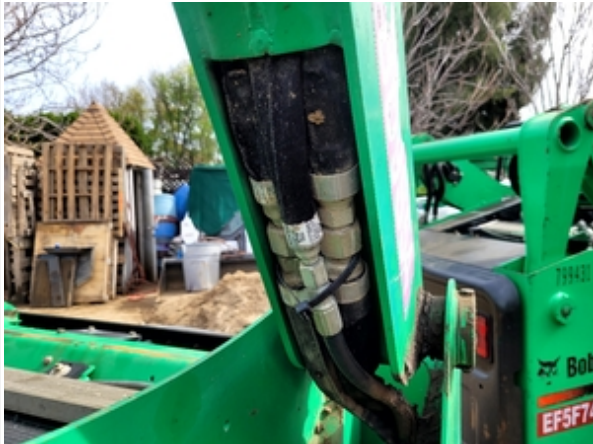
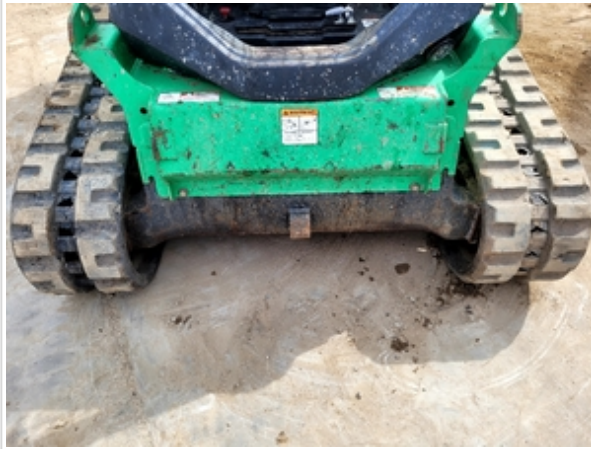
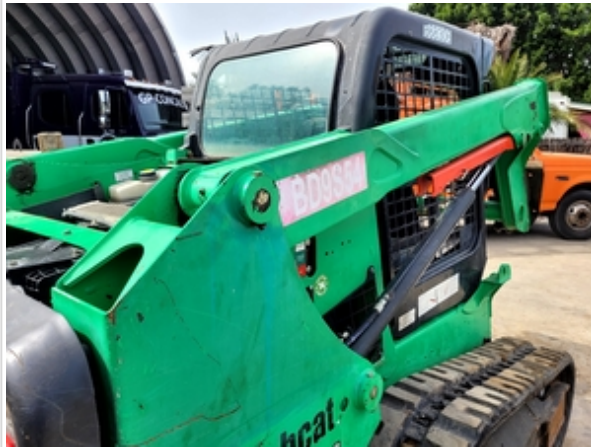
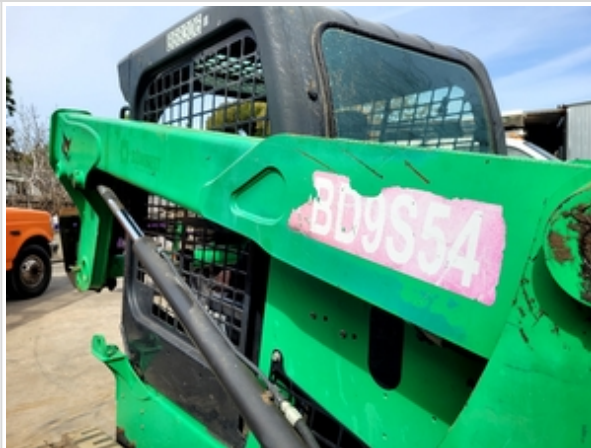
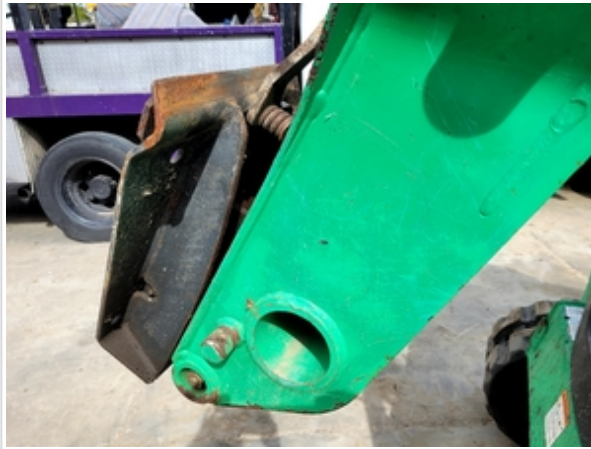
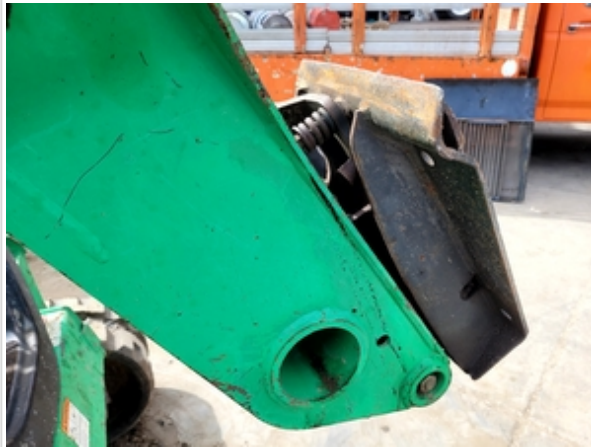
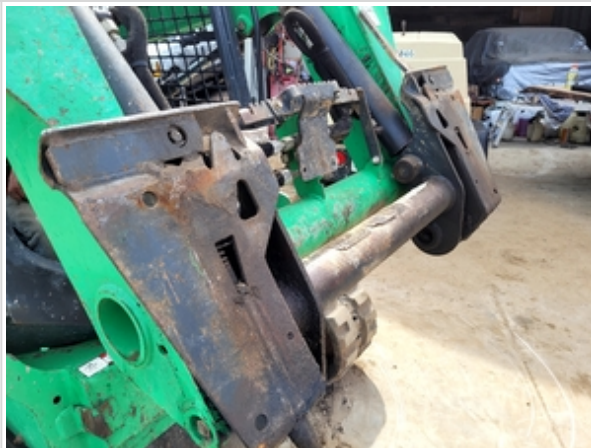
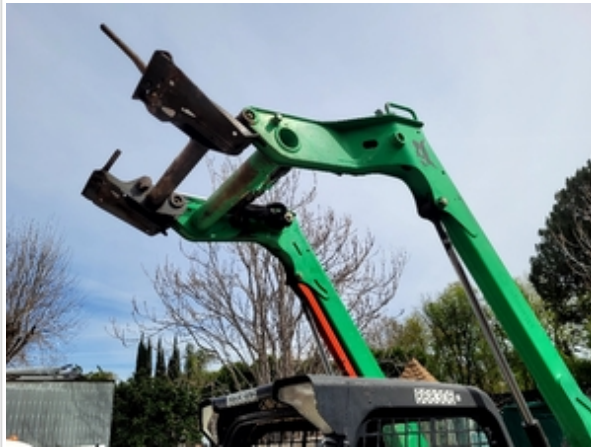
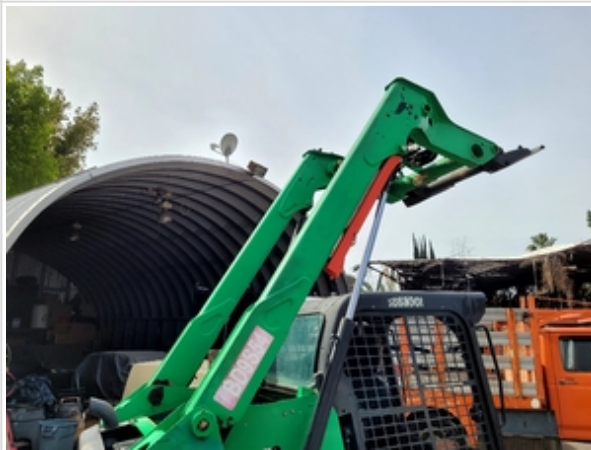
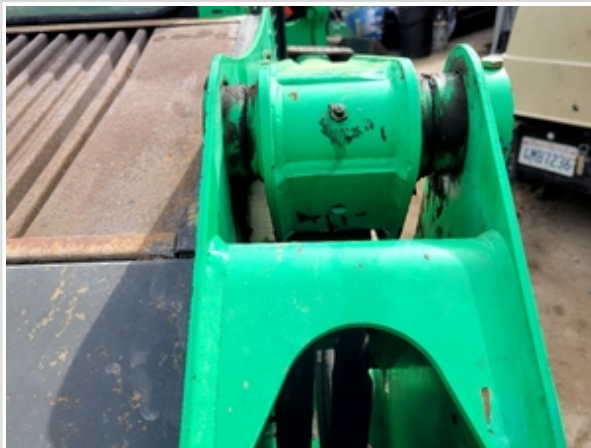
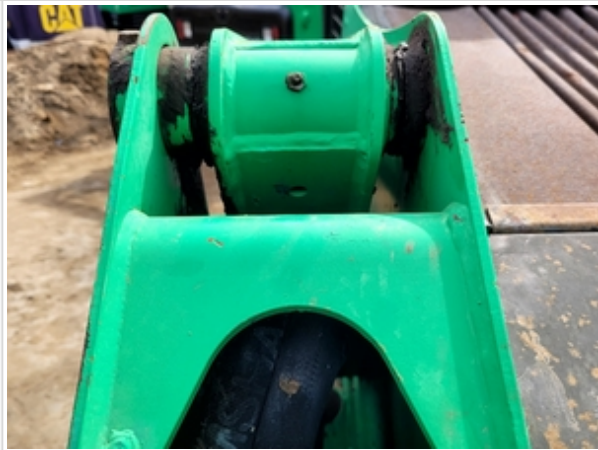
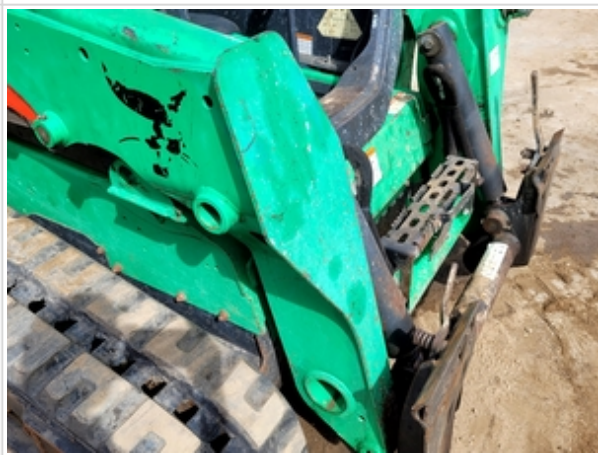
Chassis Photos	Take photos of the entire chassis and all relevant components including frame, stance, lift arm, and quick coupler.
Chassis Photos

Frame	3 - Normal Wear & Tear	
Stance	3 - Normal Wear & Tear	
Lift Arm	3 - Normal Wear & Tear	
Chassis to Arm Pins	3 - Normal Wear & Tear	
Quick Coupler	3 - Normal Wear & Tear	
Quick Coupler to Arms Pins	3 - Normal Wear & Tear	
Overall Chassis	3 - Normal Wear & Tear	
Overall Chassis Comments	Overall chassis in good shape with no excessive play seen during operation.

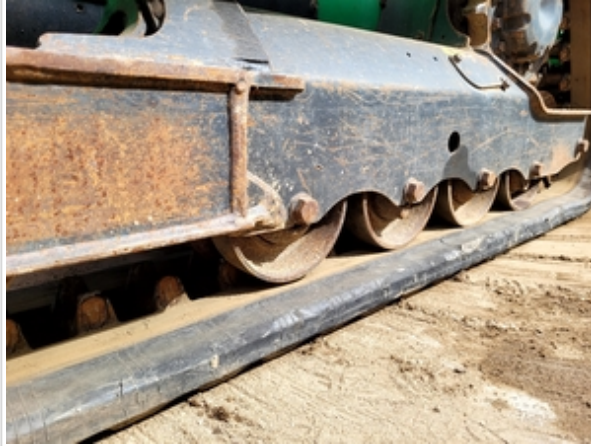
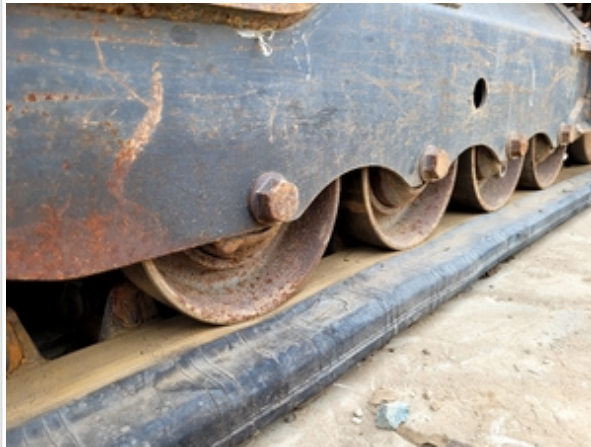
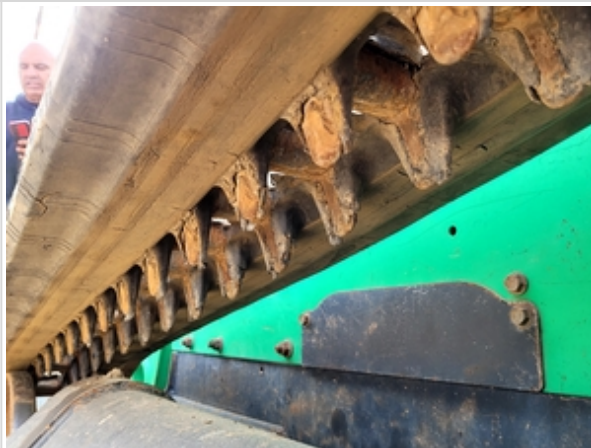
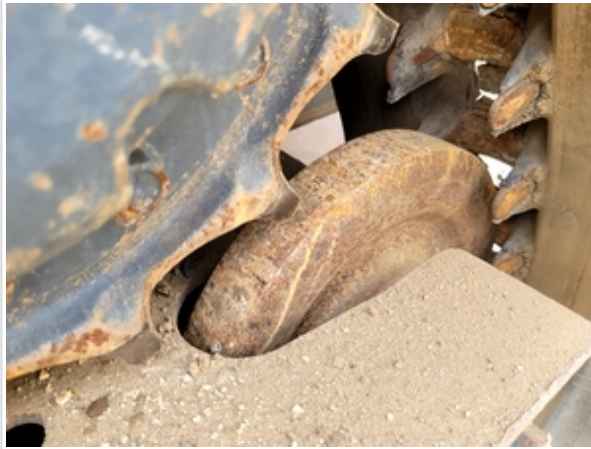
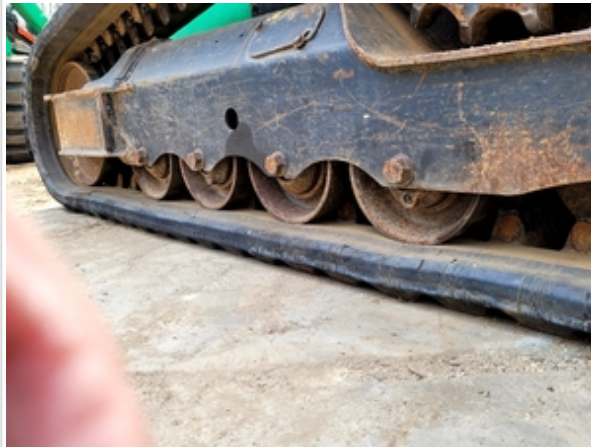
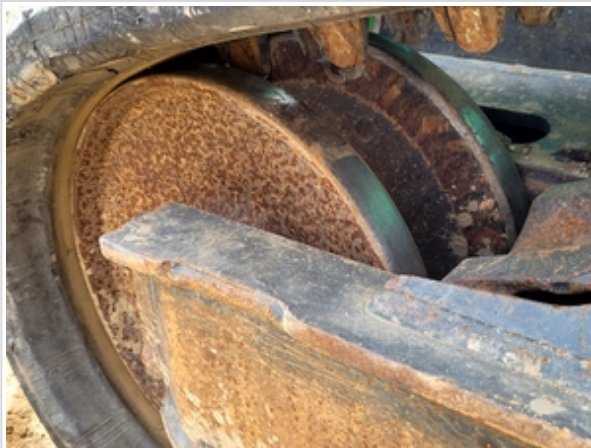
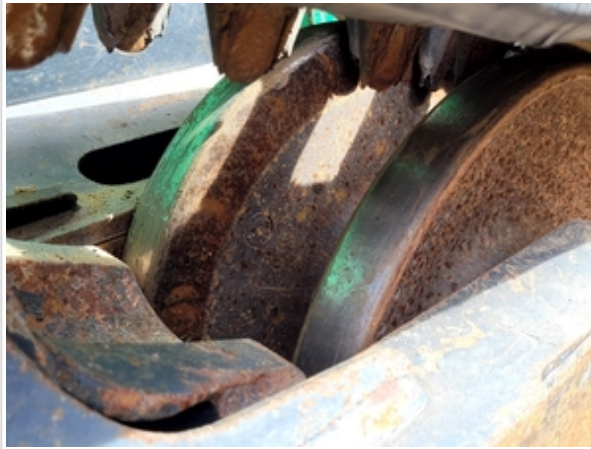
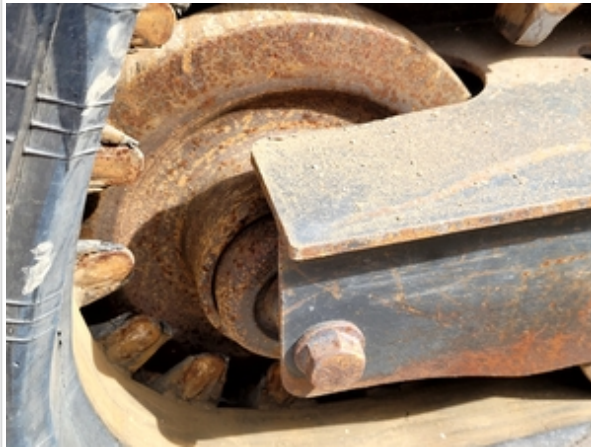
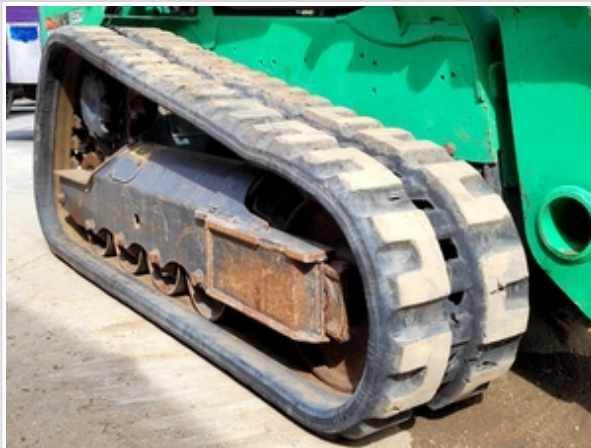
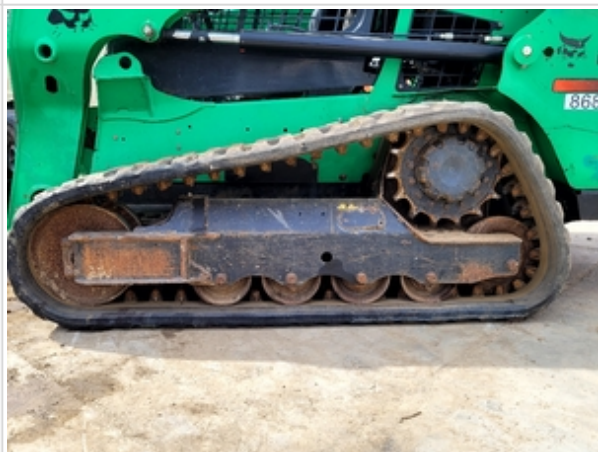
Undercarriage Photos

Roller Frames	3 - Normal Wear & Tear	
Track Belt	3 - Normal Wear & Tear	
Rubber Belt Drive Lugs	3 - Normal Wear & Tear	
Track Tensioners	3 - Normal Wear & Tear	
Front Idlers	3 - Normal Wear & Tear	
Rear Idlers	3 - Normal Wear & Tear	
Track Rollers	3 - Normal Wear & Tear

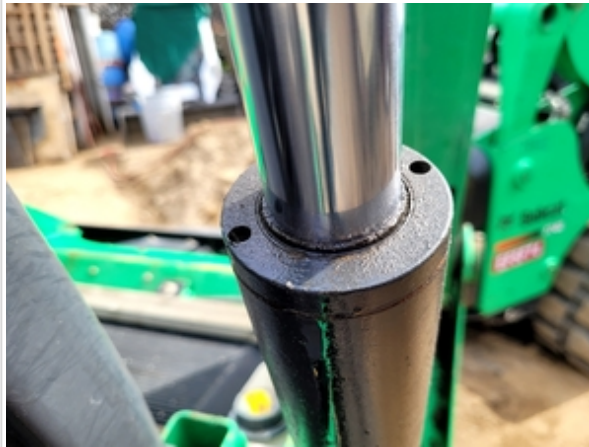
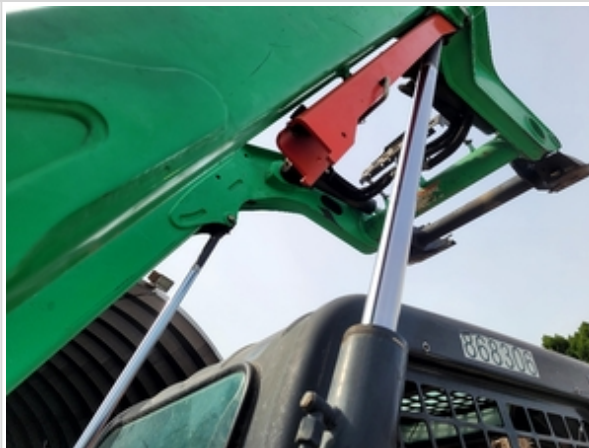
Lift Cylinder & Mounting Pin
Photos

Lift Cylinder	Check the lift cylinder. Note any wear, pitting, discoloration, etc. Take photos.	
Lift Cylinder & Mounting Pin	3	
Lift Cylinder: Oil Leaks	Yes	
Comments	left side cylinder leaking at rid seal

Overall Assessment	
Exterior Rating	3 - Normal Wear & Tear
Interior Rating	3 - Normal Wear & Tear
Safety Rating	3 - Normal Wear & Tear
Quality Rating	3 - Normal Wear & Tear
Functionality Rating	3 - Normal, Operating as Expected
Overall Rating	3 - Normal Wear & Tear
What's Great About the Machine	All core functions work great and machine is well maintained inside and out.
What Needs Work	Some cylinders need to be resealed soon. Sprockets segments need to be replaced soon.
Date/Time	02-16-2023
