Inspection Report (Skid Steer)

Year	2017
Make	CAT
Model	236D
Serial Number	BGZ02819
Hour Meter Reading	842 Hours
Previous Application (e.g., earth moving, mining, demolition, etc)	Masonry General Construction

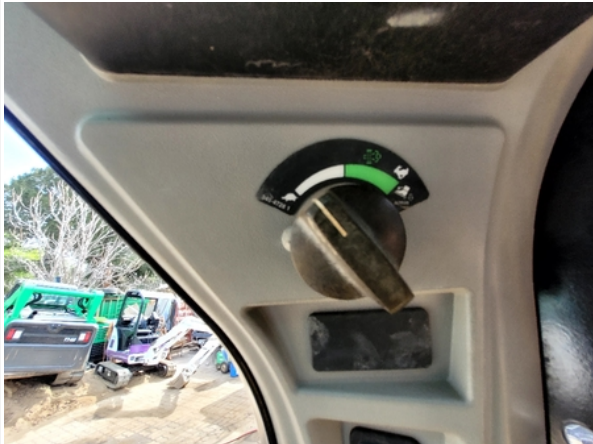
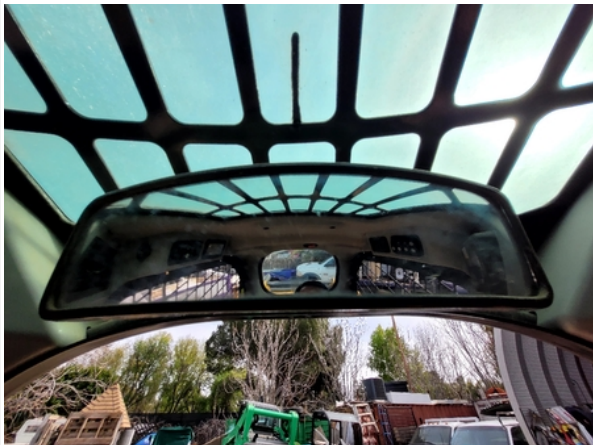
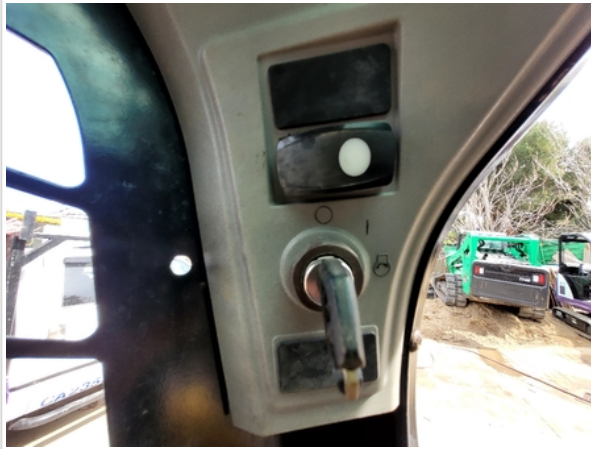
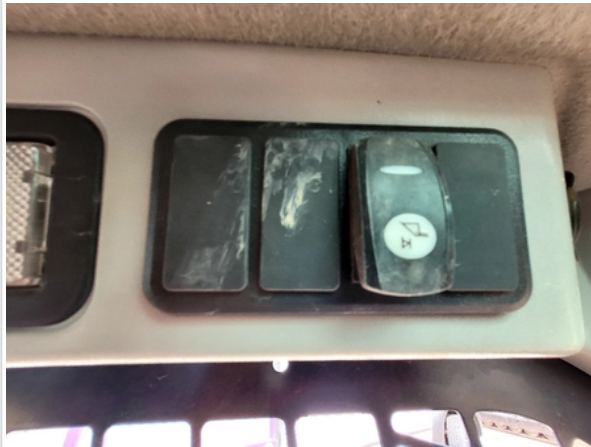
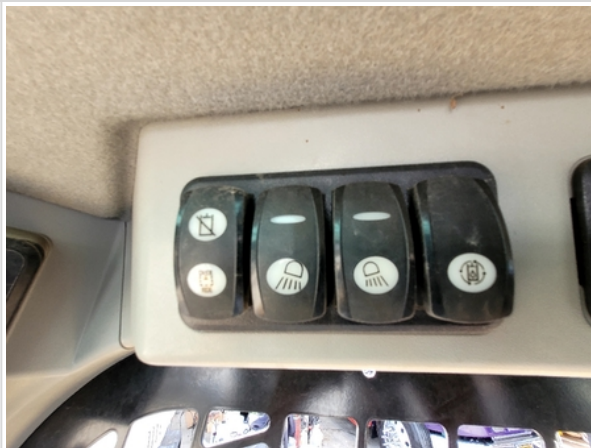
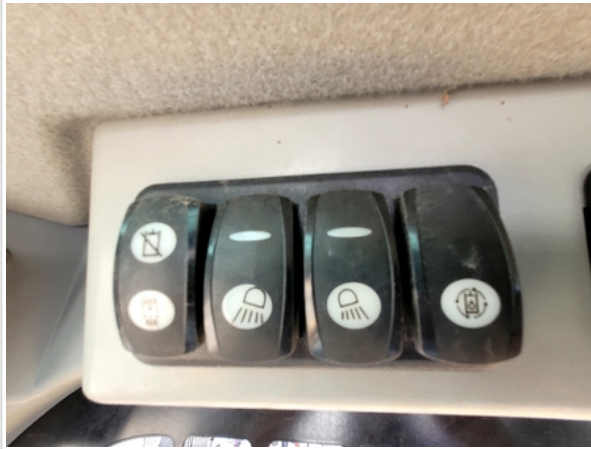
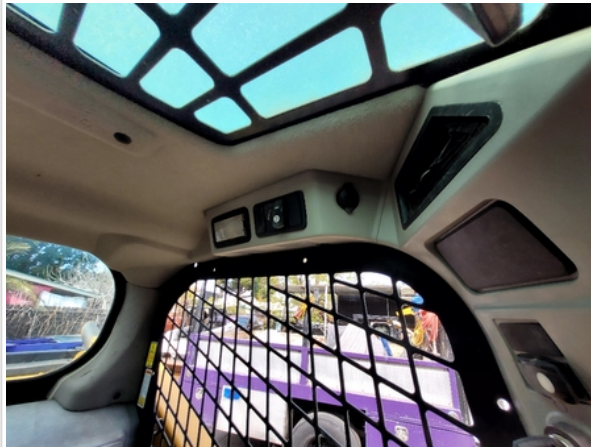
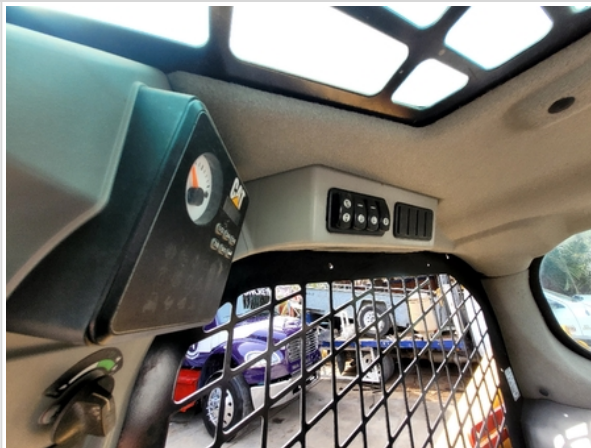
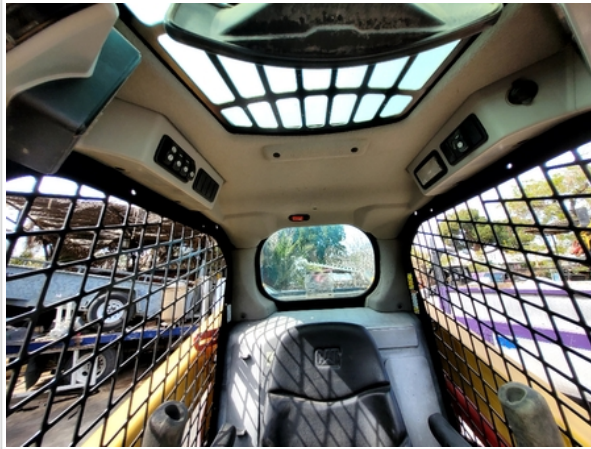
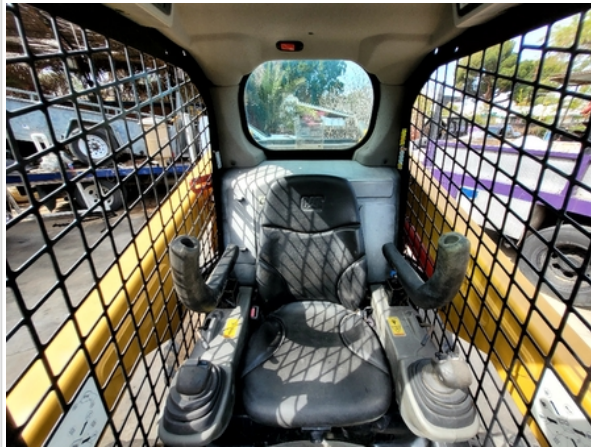
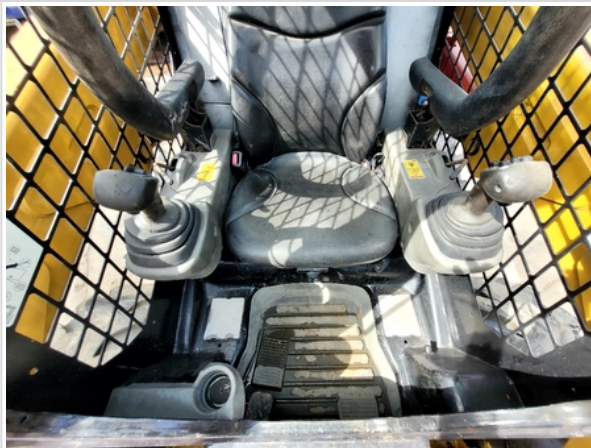
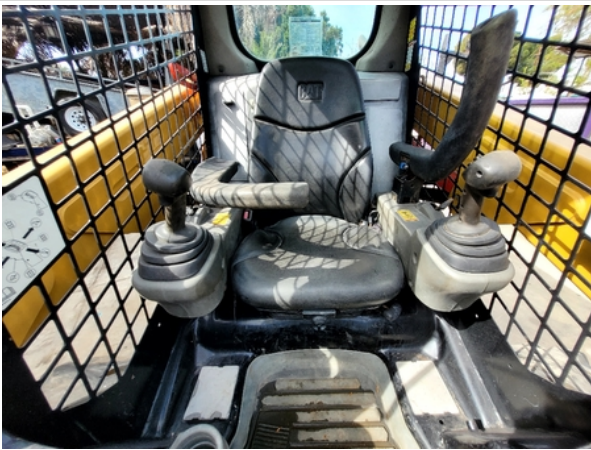
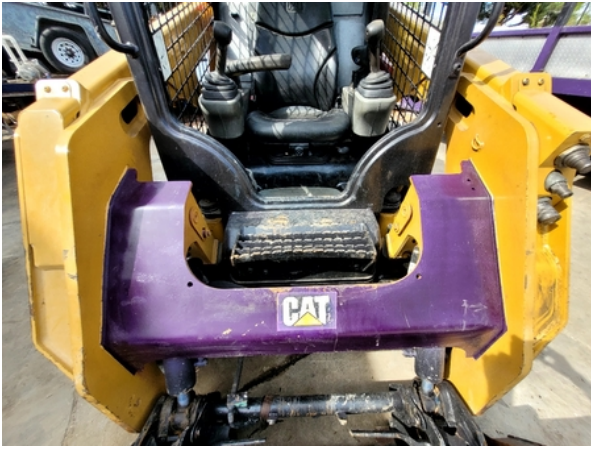
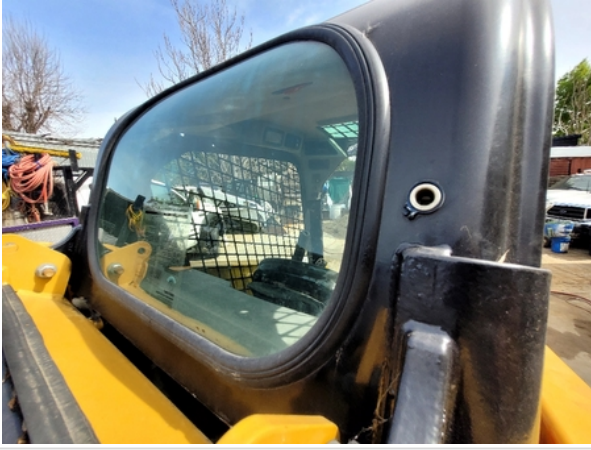
Operator Cabin Overall	3 - Normal Wear & Tear	
Operator Cabin Overall Condition	Good cabin appearance, solid floors, panels, and ceiling	
Operator Seat	3 - Normal Wear & Tear	
Operator Seat Condition	Seat(s) in good condition, no stains or tears in upholstery	
Cabin Lights	3 - Normal Wear & Tear	
Cabin Lights Condition	Cabin lights are installed with all light covers in place, bulbs are installed and working properly	
Safety Lock Out / Stop	3 - Normal Wear & Tear

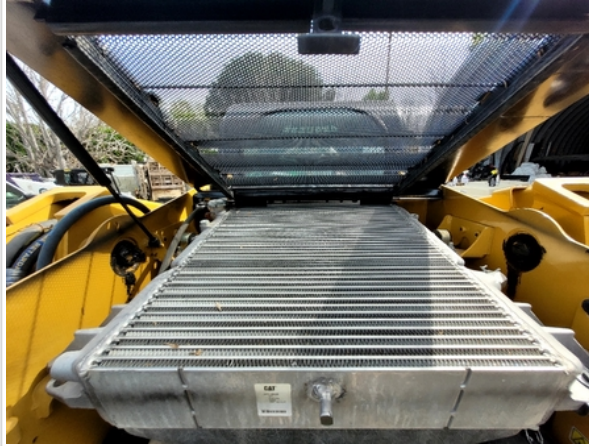
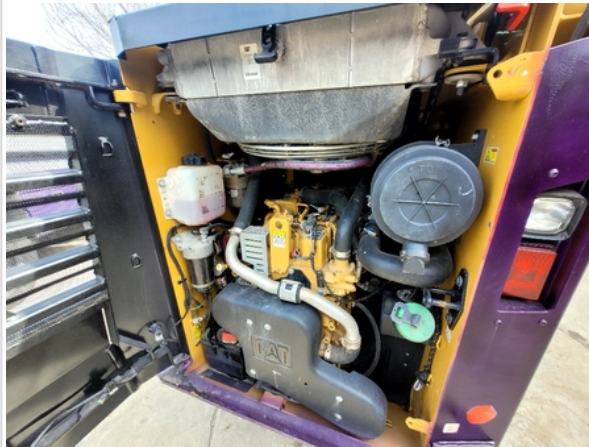
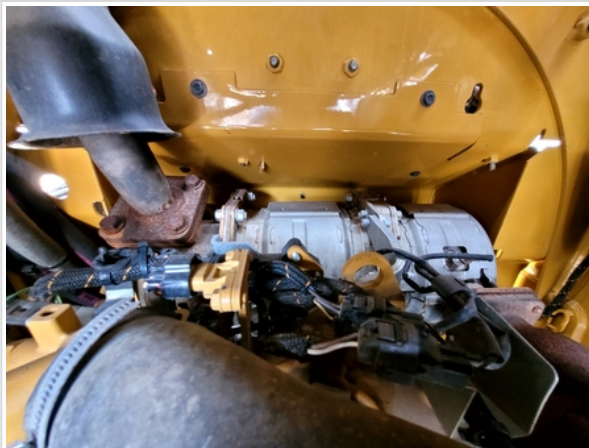
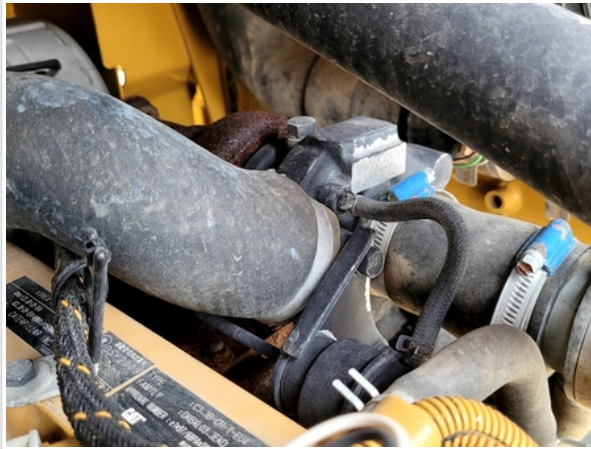
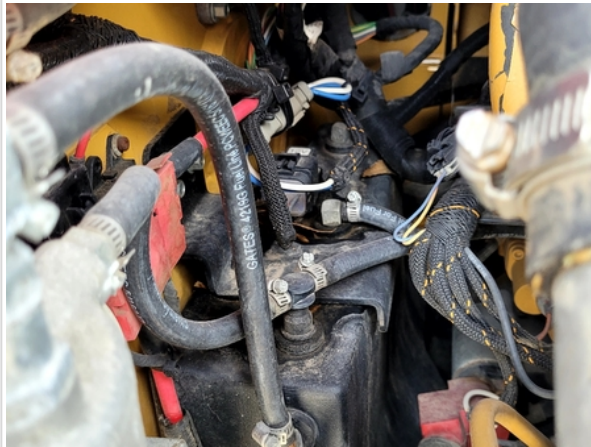
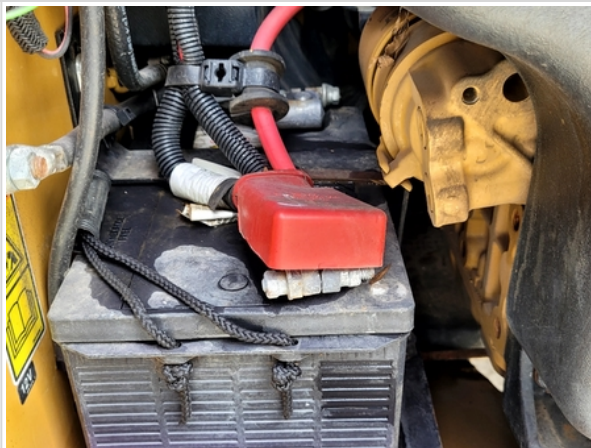
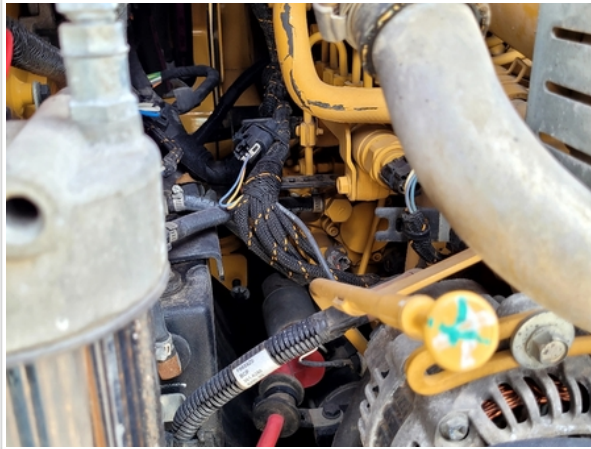
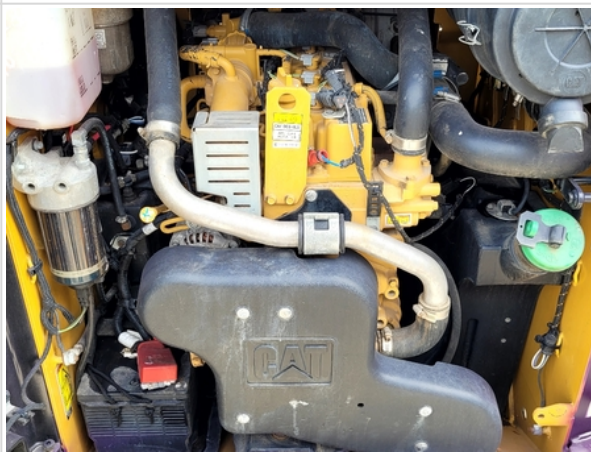
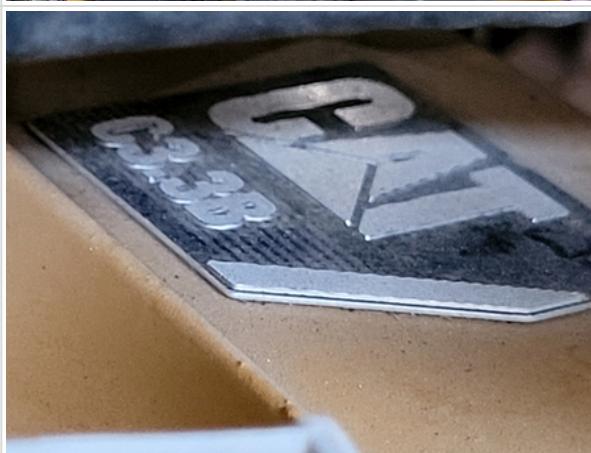
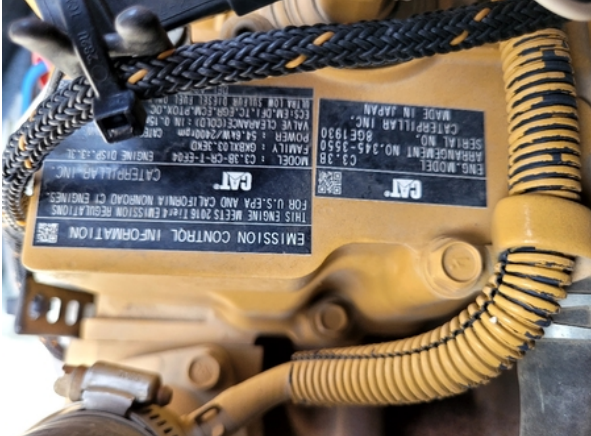
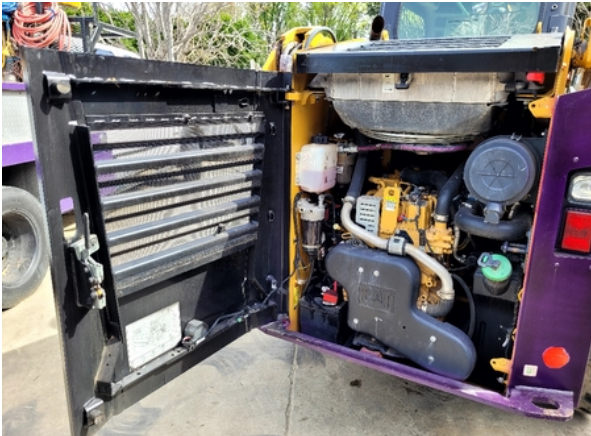
Engine Photos

Blow-by (Visual Observation Check)	No
Unusual Noises (Upon Start-up, Idle, Shutdown)	No
Unusual Noise Notes	No unusual noises heard
Engine Smoke (Upon Start-up, Idle, Shutdown)	No
Engine Smoke Notes	No engine smoke issues observed
Engine Exhaust Color	Clear
Battery	3 - Normal Wear & Tear
Battery Condition	Clean & dry appearance, tight connections
Radiator	3 - Normal Wear & Tear
Radiator Condition	Radiator fins & components appear to be in good working order, no signs of damage or leaks
Belts	3 - Normal Wear & Tear
Belt Condition	Belts appear in good condition & alignment with proper tension
Hoses	3 - Normal Wear & Tear
Hose Condition	Firm, pliant hoses with no signs of wear or leaks

Water Pump	3 - Normal Wear & Tear
Water Pump Condition	No unusual pump noises heard
Cooling System Leaks	No
Coolant Color / Appearance	3 - Normal Wear & Tear
Coolant Color/Appearance Notes	Normal Translucent appearance, no visual signs of contamination
Oil Leaks	No
Oil Color / Appearance	3 - Normal Wear & Tear
Oil Color / Appearance Notes	Appropriate oil level, Clean oil appearance, no signs of cross contamination
Fuel Leaks	No
Requires DEF (Diesel Exhaust Fluid)	No
Overall Engine Appearance	Clean & dry
Overall Engine Comments	Overall Engine appearance in well maintained condition with no obvious issues or active leaks observed during the inspection.

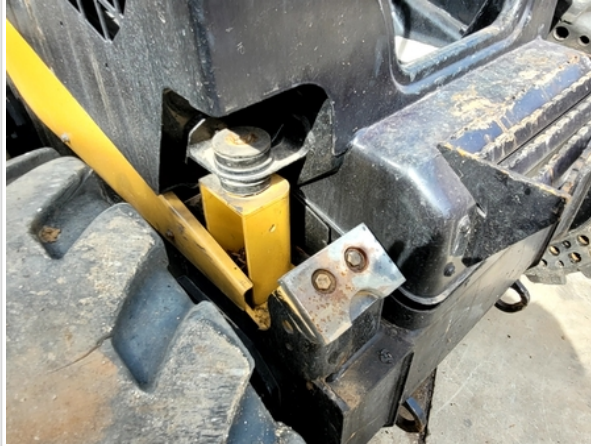
Frame Photos

Frame	3 - Normal Wear & Tear
-------	------------------------

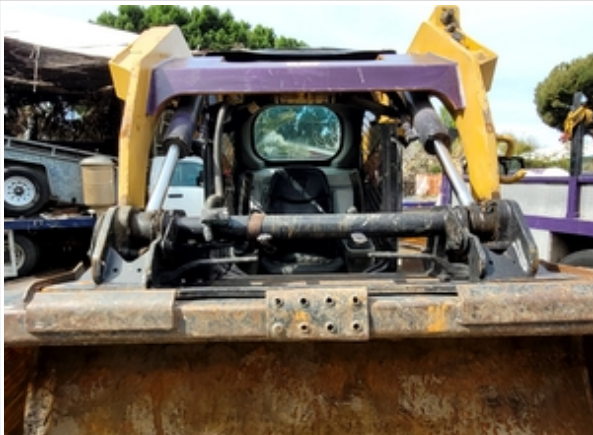
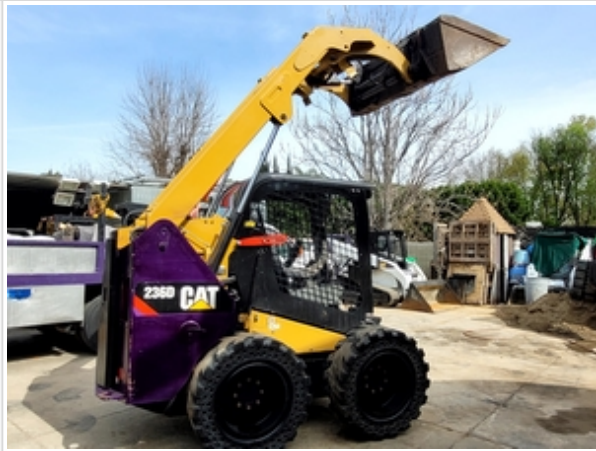
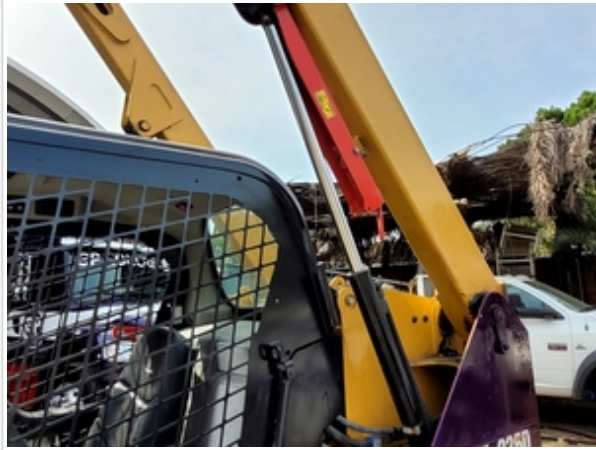
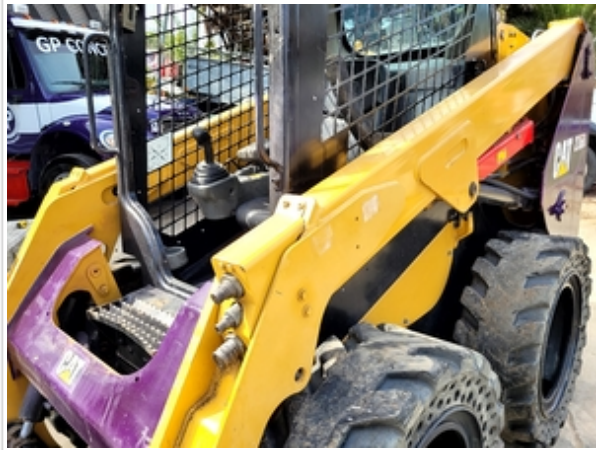
Tire Brand	N/A
Tire Size	N/A
Front Left Tire - Ratio Remaining	30%
Rear Left Tire - Ratio Remaining	30%
Front Right Tire - Ratio Remaining	30%
Rear Right Tire - Ratio Remaining	30%
Lift Arm	3 - Normal Wear & Tear
Lift Arm Photos

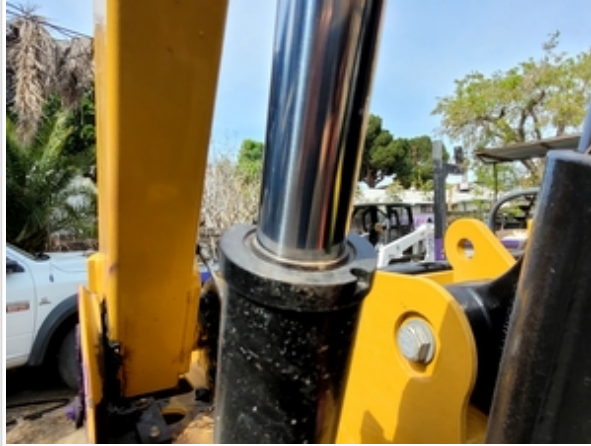
Lift Cylinder Photos

Lift Cylinder	Check the lift cylinder. Note any wear, pitting, discoloration, etc. Take photos.
Lift Cylinder: Mounting Pin	3
Lift Cylinder: Oil Leaks	No
