Inspection Report (Vibratory Compactor)

Year	2017
Make	Wacker
Model	RTSC3
Serial Number	4630202290
Hour Meter Reading	539.8 Hours
Previous Application (e.g., earth moving, mining, demolition, etc)	Masonry General Construction

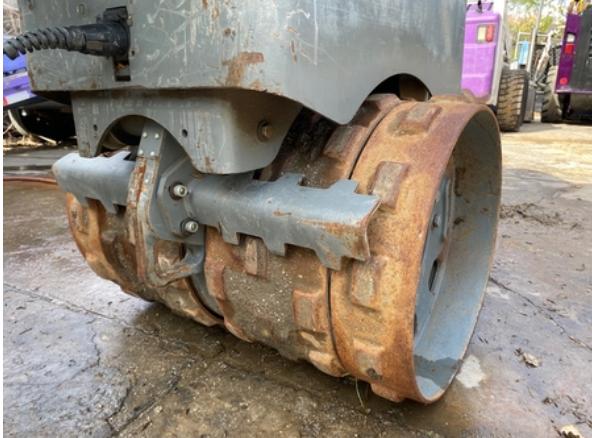
Body Panels	3 - Normal Wear & Tear
Body Panel Condition	No visible damage, good paint condition and panel fitment
Doors / Canopy Latches	3 - Normal Wear & Tear
Doors / Canopy Latches Condition	No visible damage, Other (see comments)
Comments	Normal wear and tear and scuff marks all around exterior
Steps / Ladders	0
Handrails	0
Glass	0
Mirrors	0
Exterior Lights	0

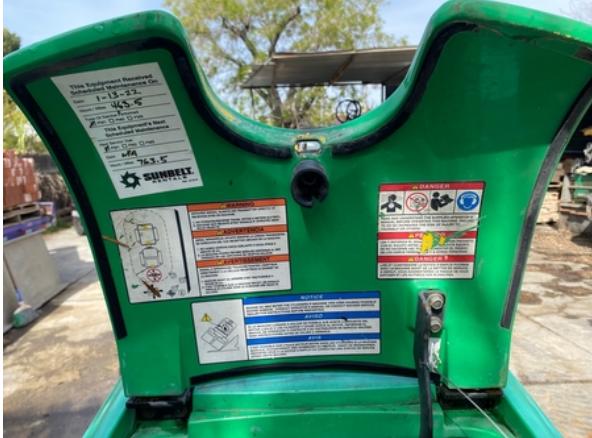
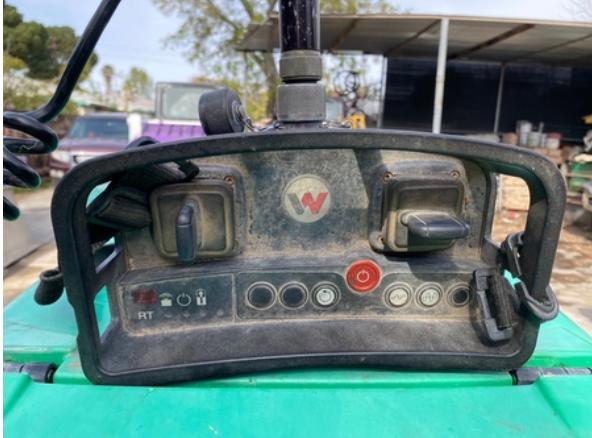
Operator Cabin Overall	3 - Normal Wear & Tear
Operator Cabin Overall Condition	Good cabin appearance, solid floors, panels, and ceiling
Operator Seat	0
Cabin Lights	0
Safety Lock Out / Stop	3 - Normal Wear & Tear
Safety Lock Out / Stop Condition	Safety lock out device is present, in good condition, and functional
Controls & Switches	3 - Normal Wear & Tear
Controls & Switches Condition	All switches are installed and functional
