## Inspection Report (Skid Steer)

Year	2016
Make	Bobcat
Model	S450
Serial Number	AUVB12760
Hour Meter Reading	1,148 Hrs.
Previous Application (e.g., earth moving, mining, demolition, etc)	Masonry General Construction

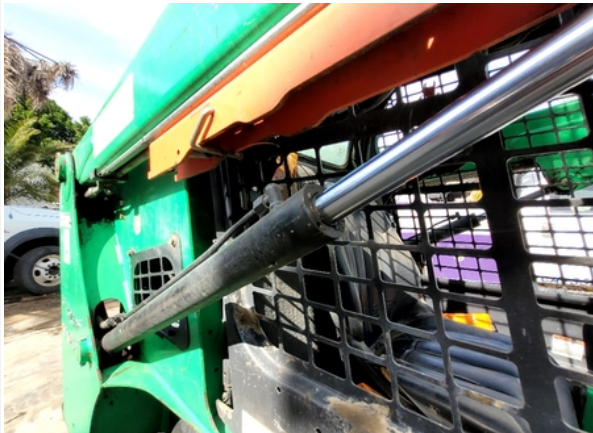
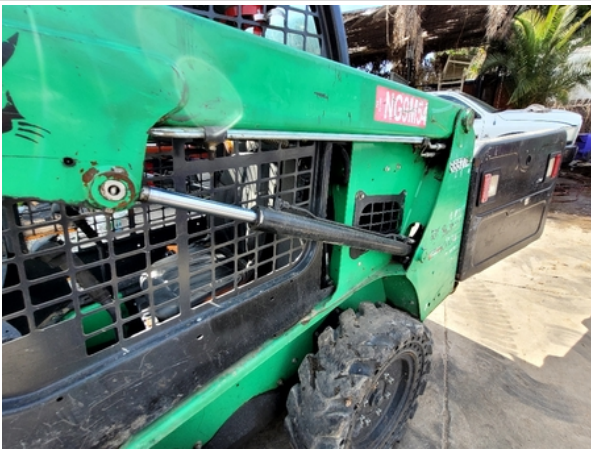
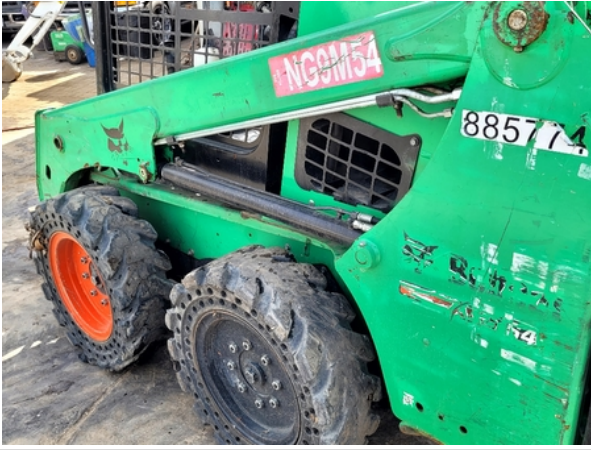
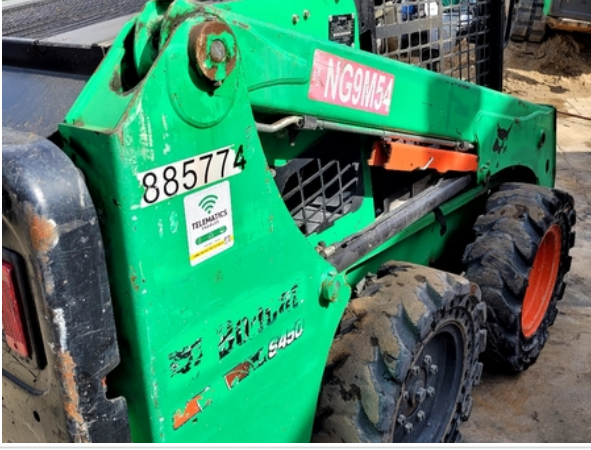
Tire Brand	N/A
Tire Size	N/A
Front Left Tire - Ratio Remaining	10%
Rear Left Tire - Ratio Remaining	10%
Front Right Tire - Ratio Remaining	10%
Rear Right Tire - Ratio Remaining	10%
Lift Arm	3 - Normal Wear & Tear
Lift Arm Photos

<b>Chassis to Arm Pins</b>	3 - Normal Wear & Tear	
<b>Quick Coupler</b>	3 - Normal Wear & Tear

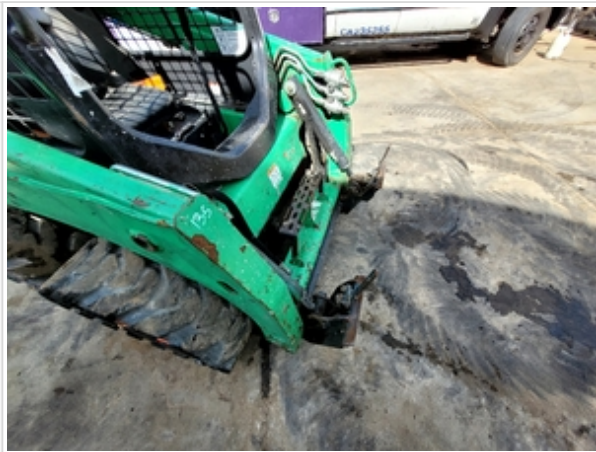
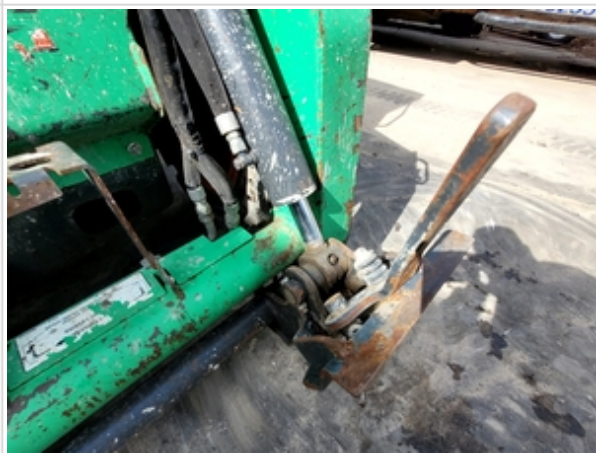
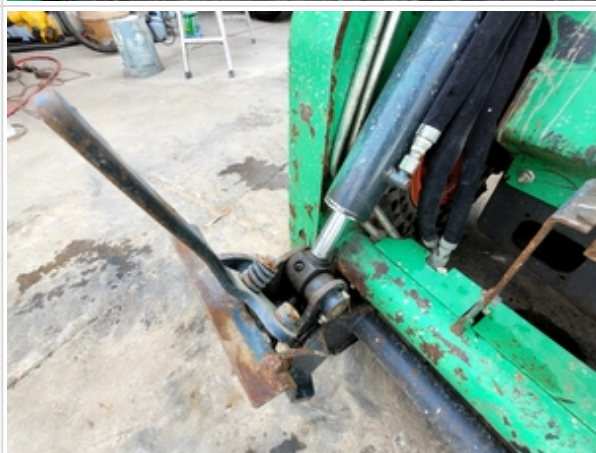
Quick Coupler Photos

Quick Coupler to Arms Pins	3 - Normal Wear & Tear
Overall Chassis	3 - Normal Wear & Tear
Overall Chassis Comments	Chassis in good shape. All implements in side shape with no obvious problems observed.

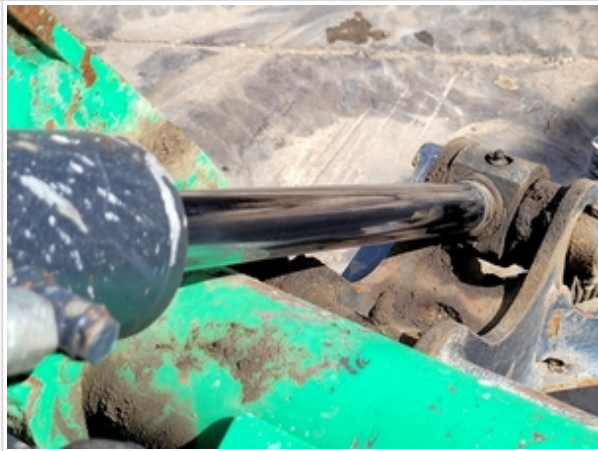
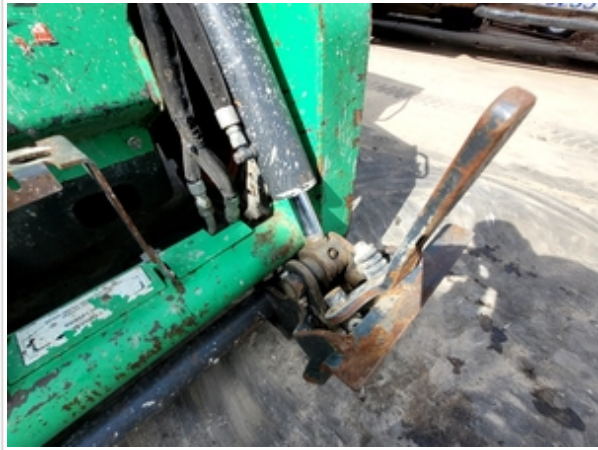
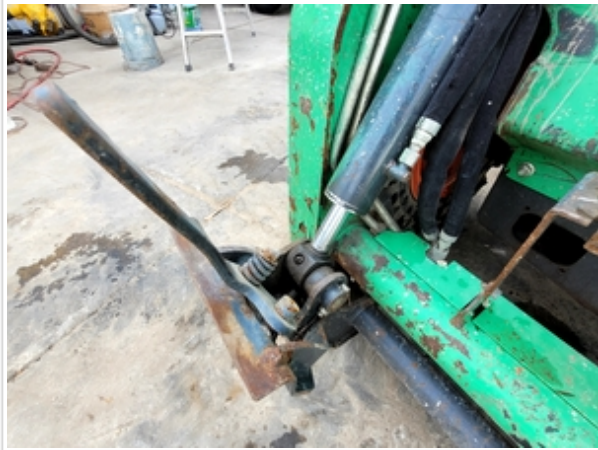
<b>Bucket Cylinder</b>	Check the bucket cylinder. Note any wear, pitting, discoloration, etc. Take photos.
<b>Bucket Cylinder: Mounting Pin</b>	3
<b>Bucket Cylinder: Oil Leaks</b>	No
