## Inspection Report (Material Handler)

Year	2019
Make	Sennebogen
Model	718E
Serial Number	718.0.2074
Hour Meter Reading	547 Hrs.
Previous Application (e.g., earth moving, mining, demolition, etc)	General Tree Services

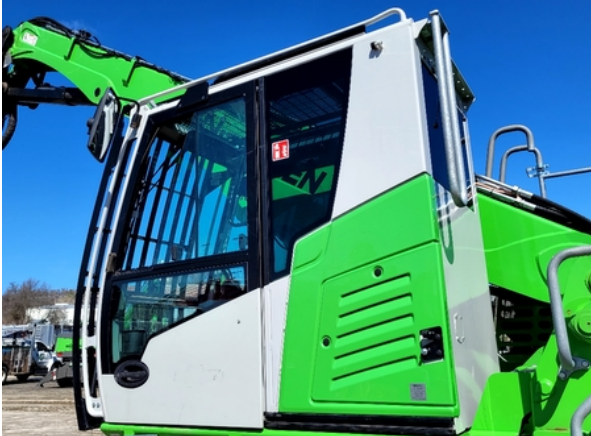
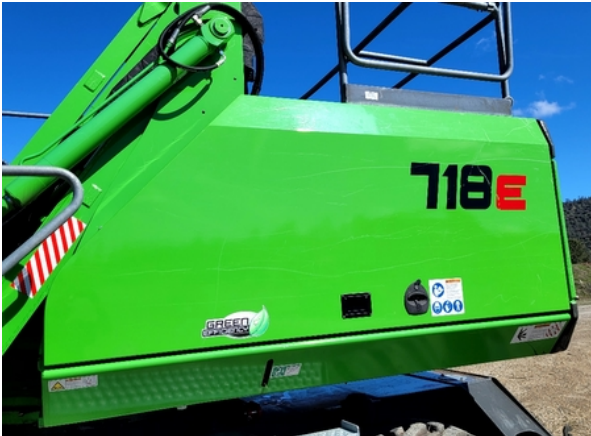
<b>Body Panels</b>	3 - Normal Wear & Tear
<b>Body Panel Condition</b>	Other (see comments)
<b>Comments</b>	Small damage on R/S engine enclosure door. Scuff marks all around exterior panels.
<b>Body Panels Photos</b>

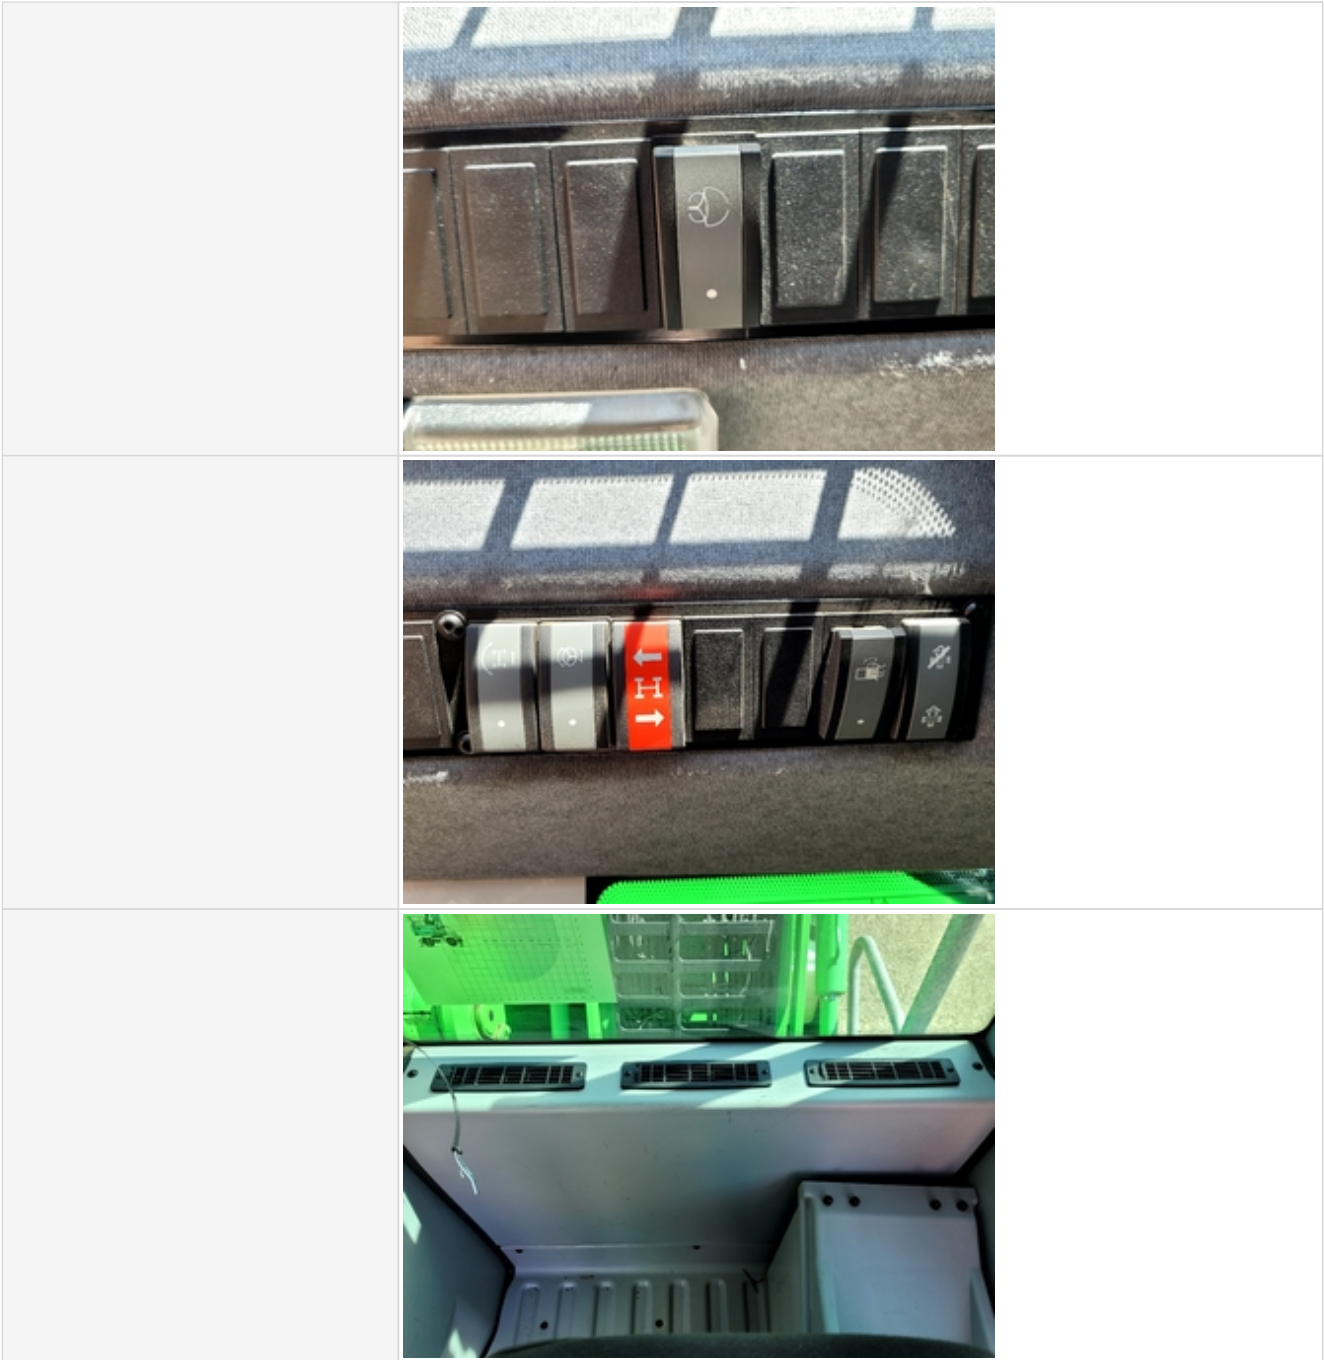
<b>Control Station Overall Rating</b>	4 - Like New, Recently Replaced
<b>Control Station Overall Condition</b>	Good cabin appearance, solid floors, panels, and ceiling
<b>Operator Seat</b>	4 - Like New, Recently Replaced
<b>Operator Seat Condition</b>	Seat(s) in good condition, no stains or tears in upholstery
<b>Cabin Lights</b>	4 - Like New, Recently Replaced
<b>Cabin Lights Condition</b>	Cabin lights are installed with all light covers in place, bulbs are installed and working properly
<b>Safety Lock Out / Stop</b>	4 - Like New, Recently Replaced
<b>Safety Lock Out / Stop Condition</b>	Safety lock out device is present, in good condition, and functional
<b>Controls &amp; Switches</b>	4 - Like New, Recently Replaced
<b>Controls &amp; Switches Condition</b>	All switches are installed and functional, Switches have good functionality, minor cosmetic damage observed
<b>Comments</b>	Top of Cab Tilt switch in cab missing cover (switch lights exposed)

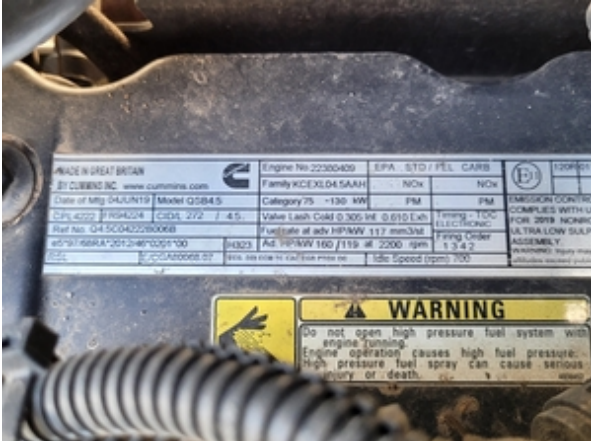
Engine	
Engine Type (Make, Model, Cylinders, Hp)	Cummins - 4Cyl. - QSB4.5 - 160HP
Emissions Tier	Tier 4F
Engine Serial Number	22380409
Engine Fuel Type	Diesel
Engine Photos

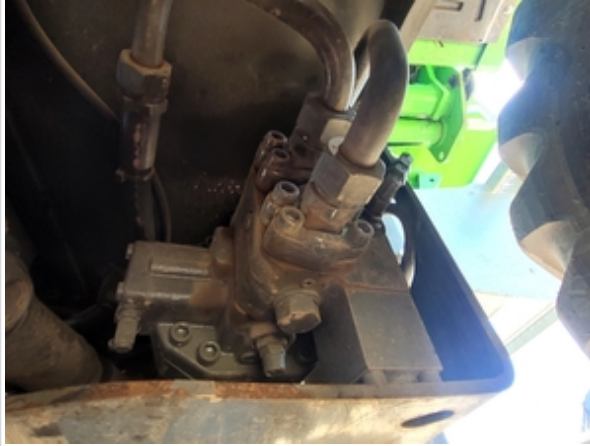
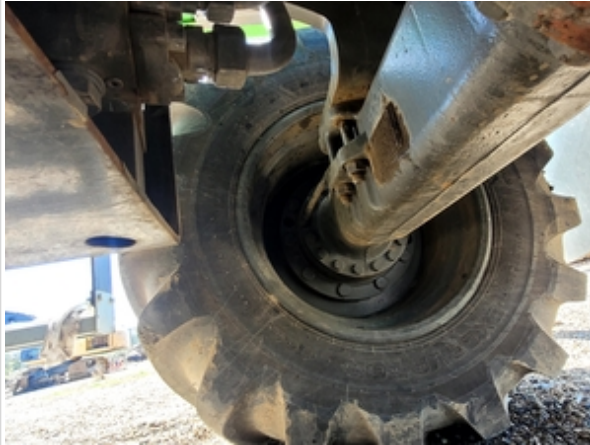
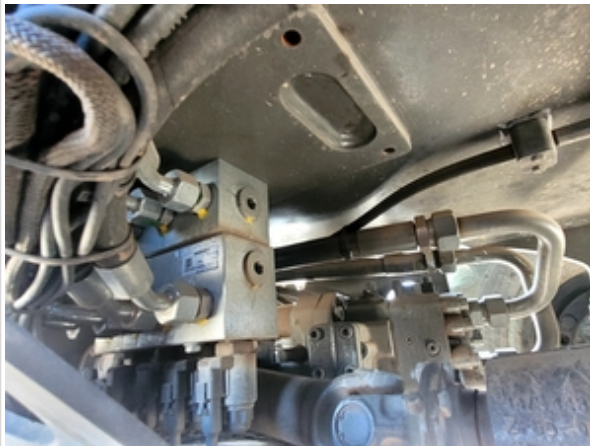
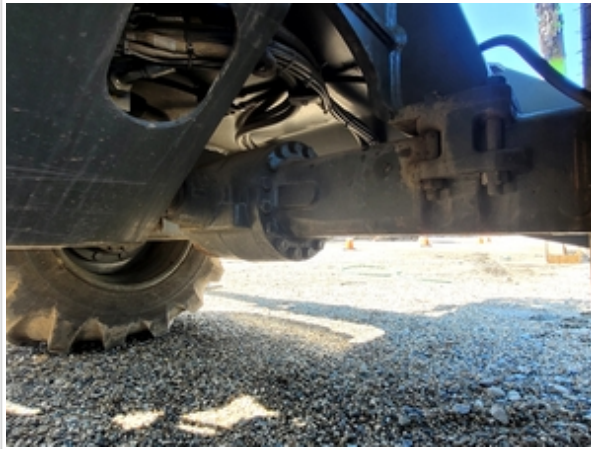
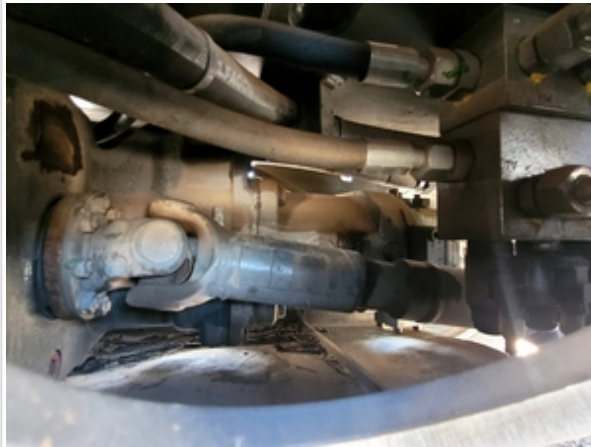
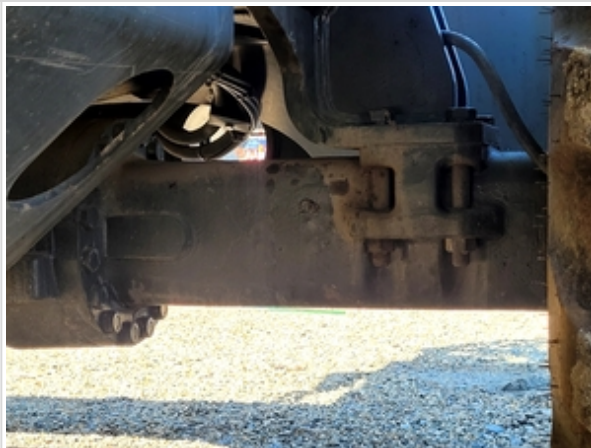
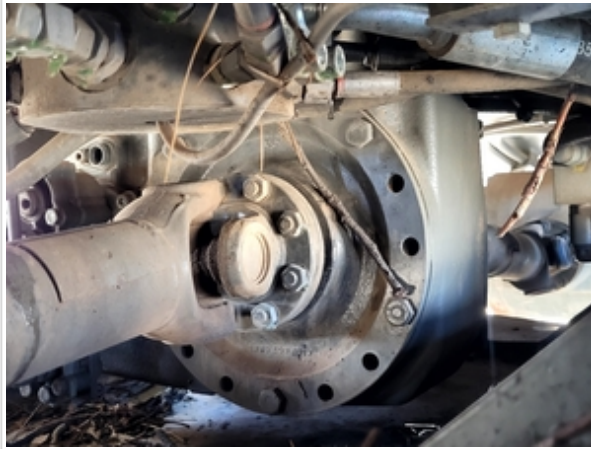
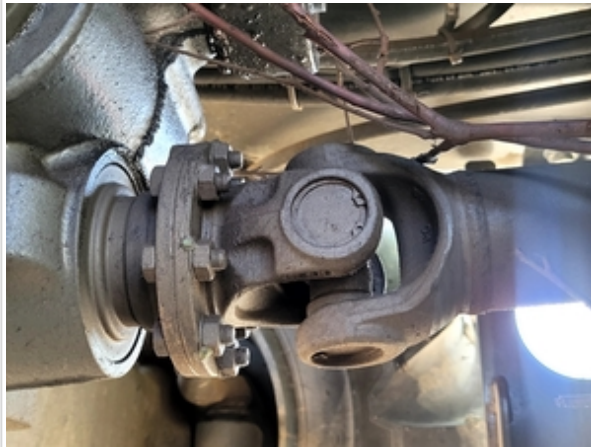
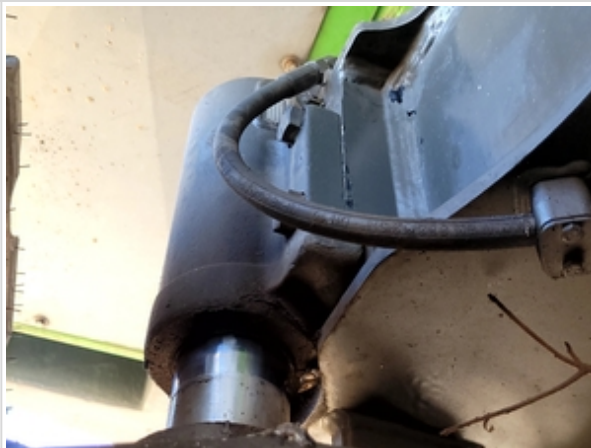
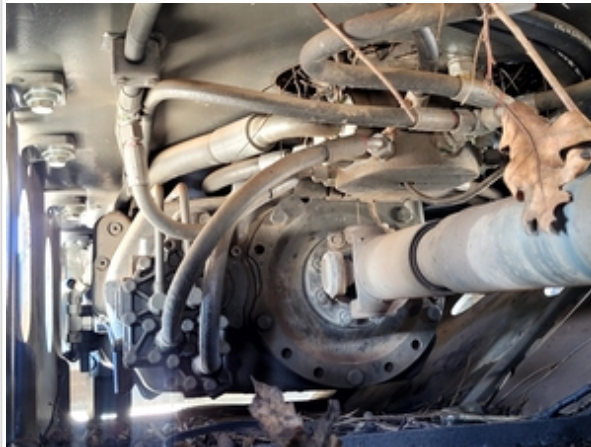
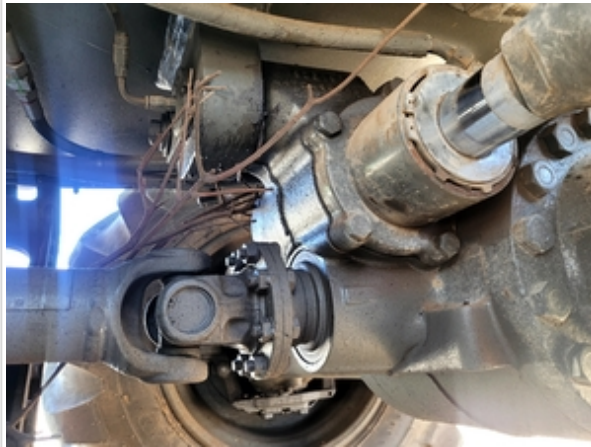
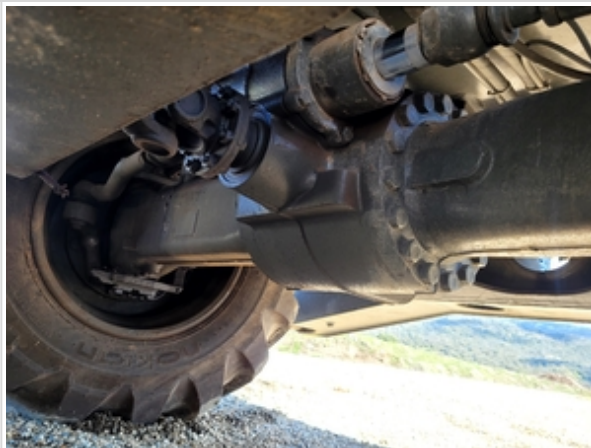
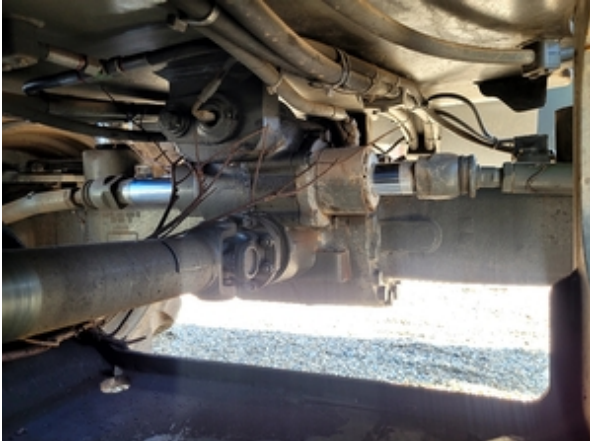
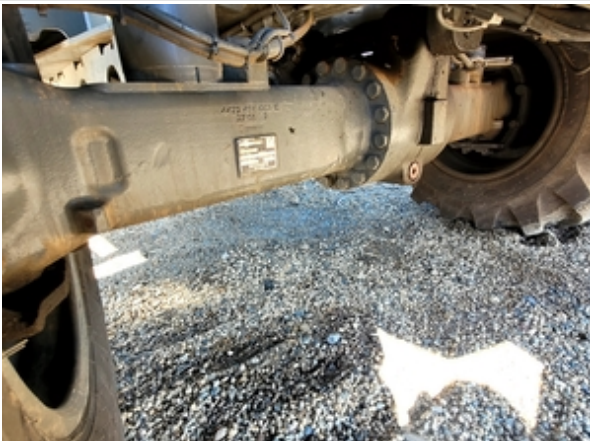
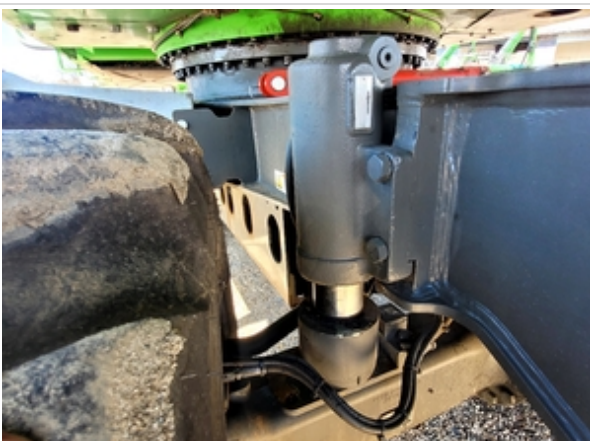
Drivetrain Photos

<b>Hydrostatic Transmission?</b>	Yes	
<b>2 Speed?</b>	Yes	
<b>Hydrostatic Drive Configuration</b>	Split Transmission	
<b>Transmission Components</b>	4 - Like New, Recently Replaced	
<b>Transmission Condition</b>	Good forward and reverse function	
<b>Drive Motors</b>	0	
<b>Parking Brake</b>	4 - Operating Within Factory Specs

Parking Brake Function	Good brake function
Overall Drivetrain Comments	Overall drivetrain in great working condition. No issues or active leaks observed.

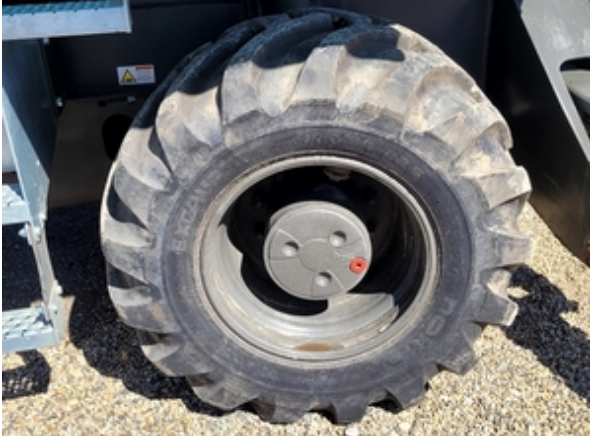
Wheels & Hub Condition	4
Comments	Tires may be water filled and have above 90%
Wheels & Hub Photos

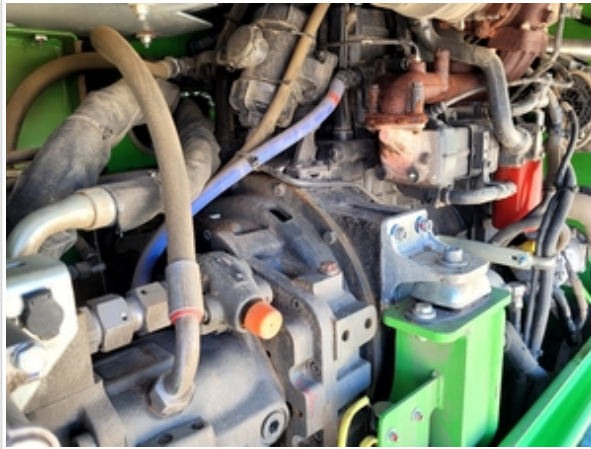
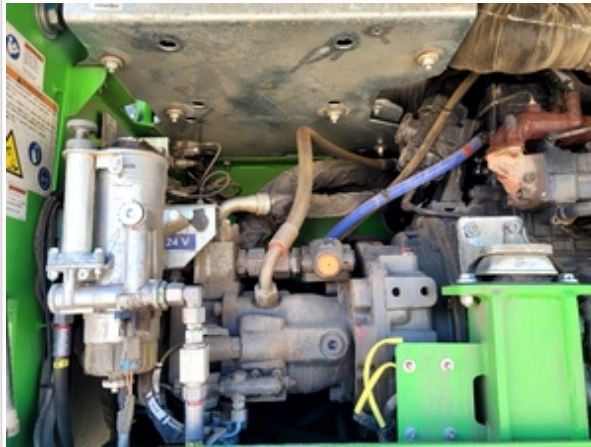
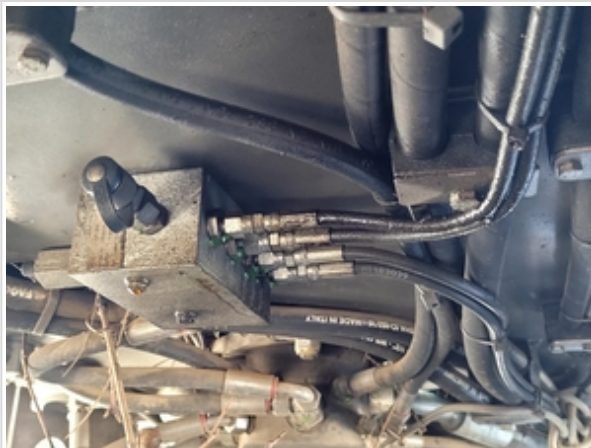
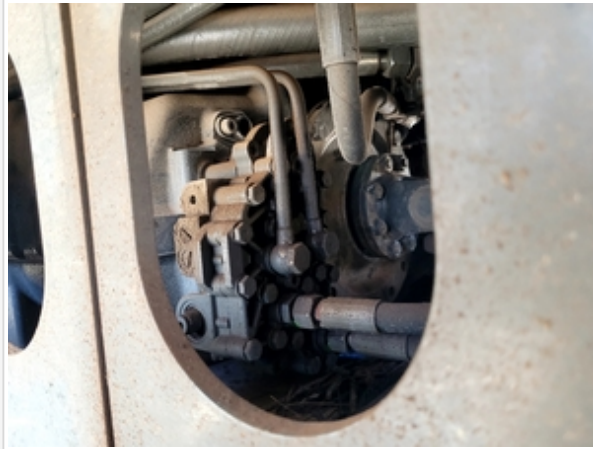
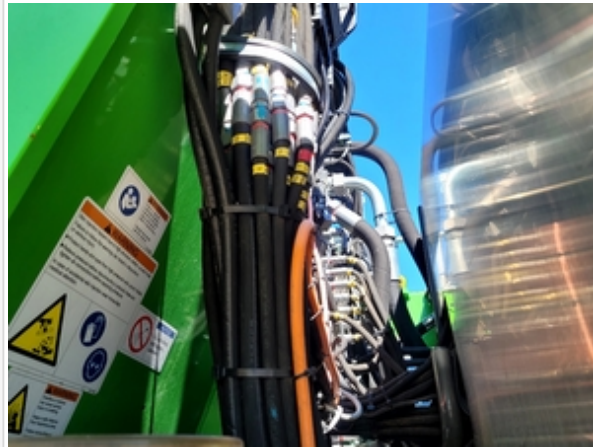
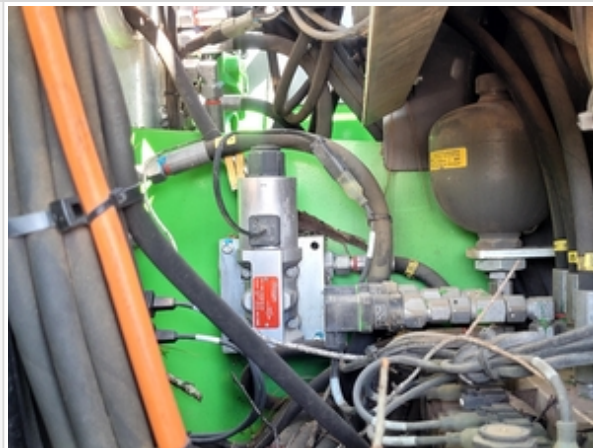
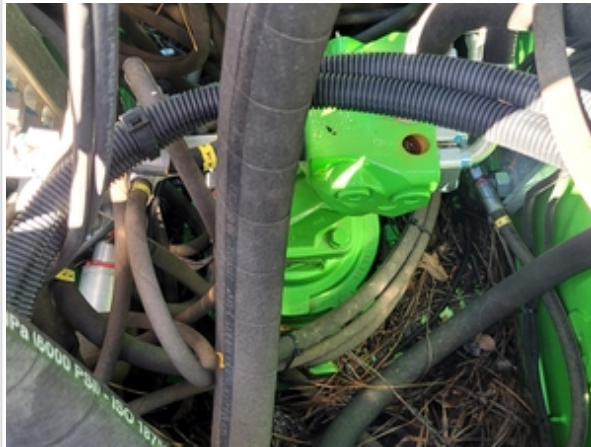
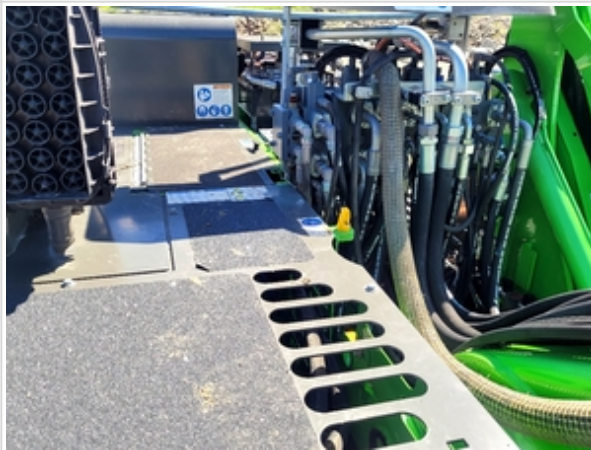
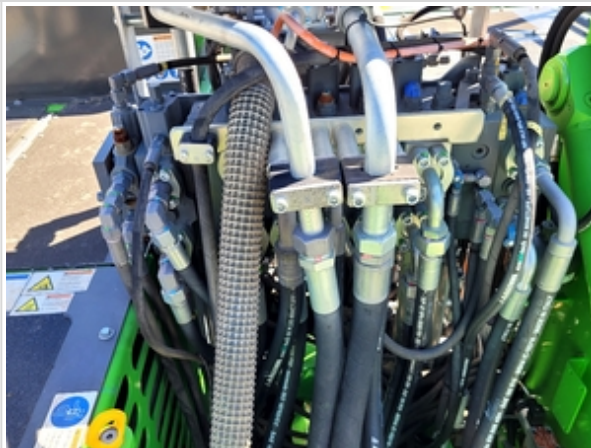
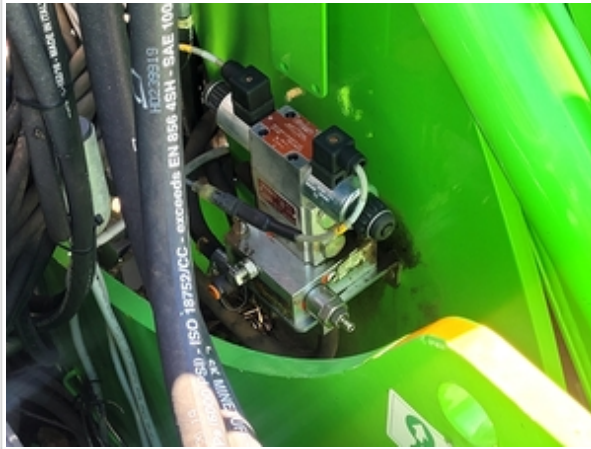
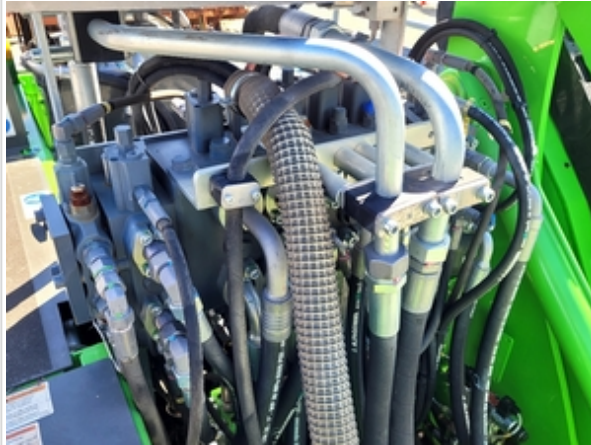
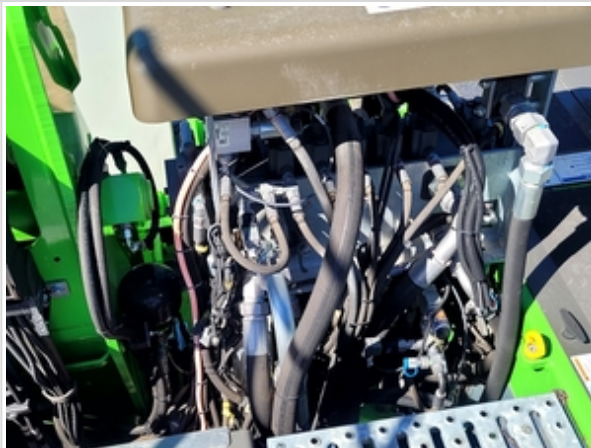
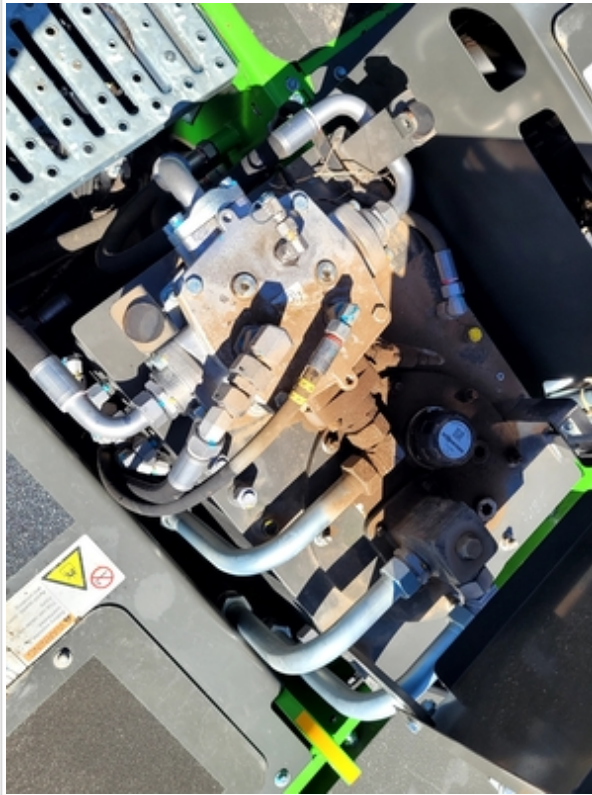
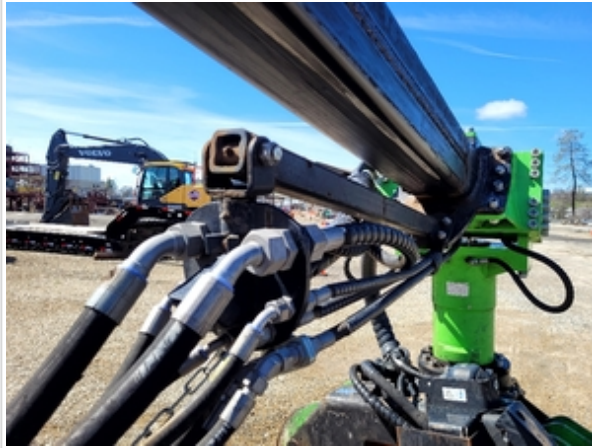
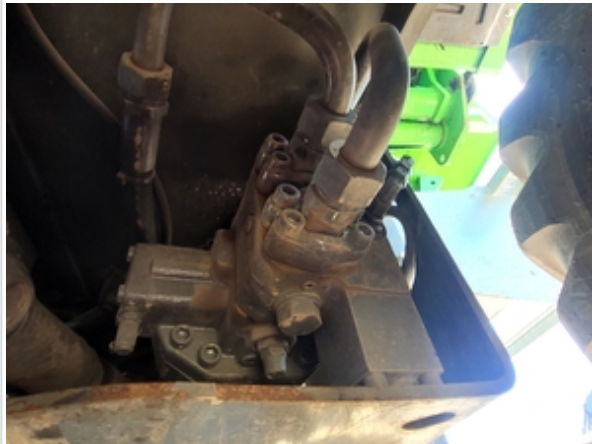
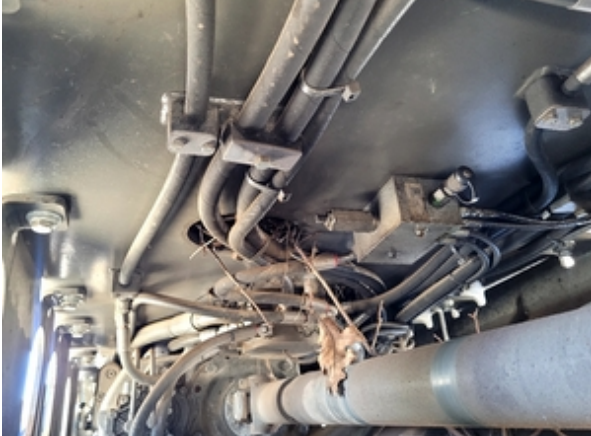
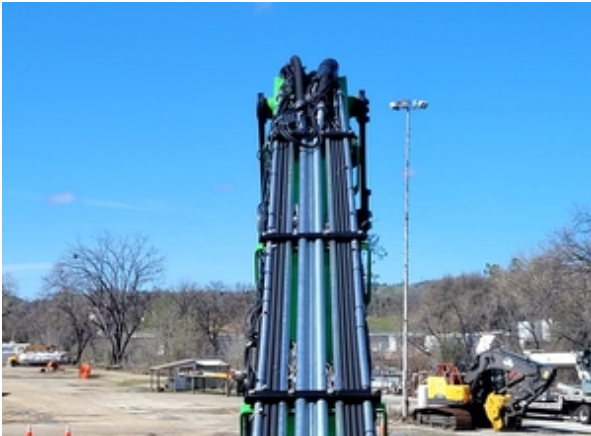
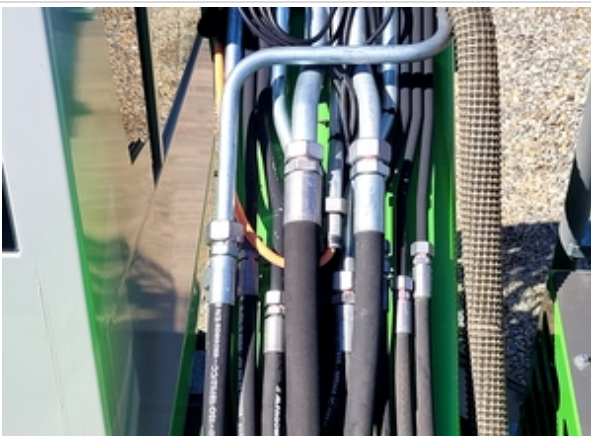
Hydraulic System	Take close-up photos of the hydraulic components including the pump, lines, fittings, controls, and levers. Note any damage, wear, or leaks.
Hydraulic System Photos

<b>Wet or Damp Hydraulic Lines / Fittings</b>	No
<b>Appearance of Hydraulic Lines / Fittings</b>	4 - Like New, Recently Replaced
<b>Hydraulic Lines / Fittings Condition</b>	Hydraulic lines & fittings are clean and in good condition
<b>Unusual Noises (Hydraulic Pump)</b>	No
<b>Hydraulic Pump Notes</b>	No unusual noises heard during operation
<b>Swing Motor</b>	4 - Like New, Recently Replaced

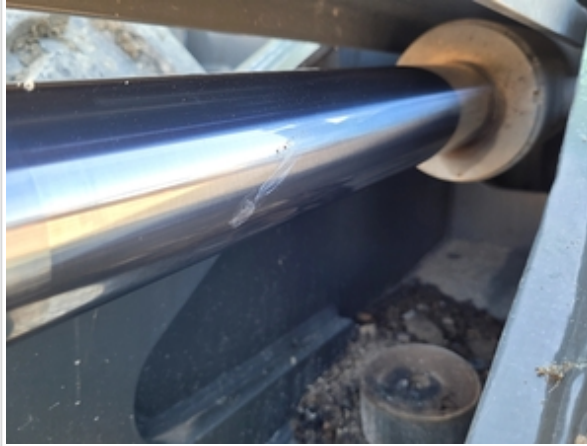
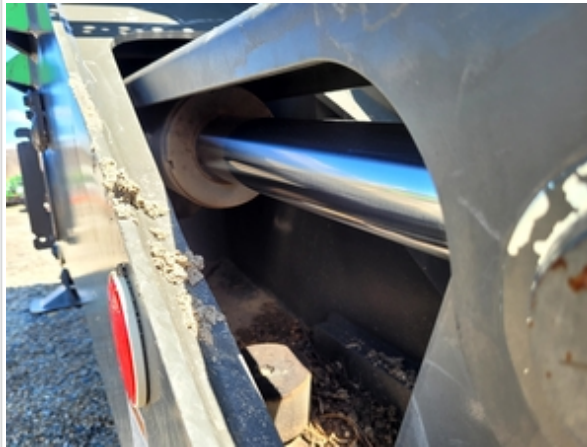
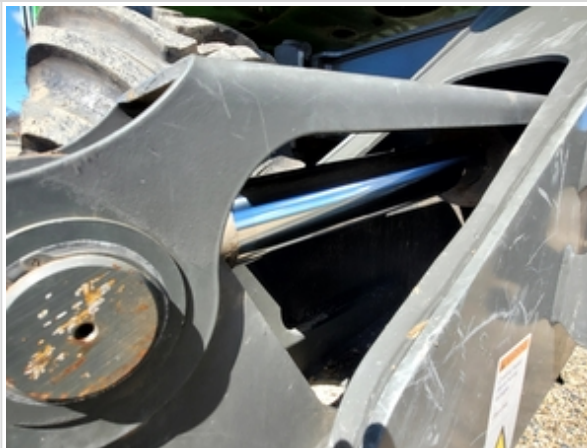
Outrigger Cylinder(s) Photos

<b>Outrigger Cylinder(s): Mounting Pins</b>	4 - Like New, Recently Replaced
<b>Outrigger Cylinder(s): Oil Leaks</b>	No
