Inspection Report (Material Handler)

Year	2017
Make	Sennebogen
Model	825M
Serial Number	825.0.2446
Hour Meter Reading	10,882
Previous Application (e.g., earth moving, mining, demolition, etc)	Scrap Yard Work

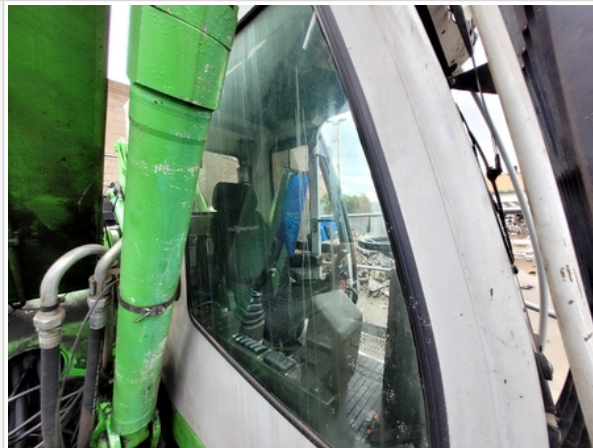
R/S Cab Exterior Handrail slightly bent.

Handrails	3 - Normal Wear & Tear	
Handrails Condition	Bent or broken railings	
Comments	All handrails intact and some are bent

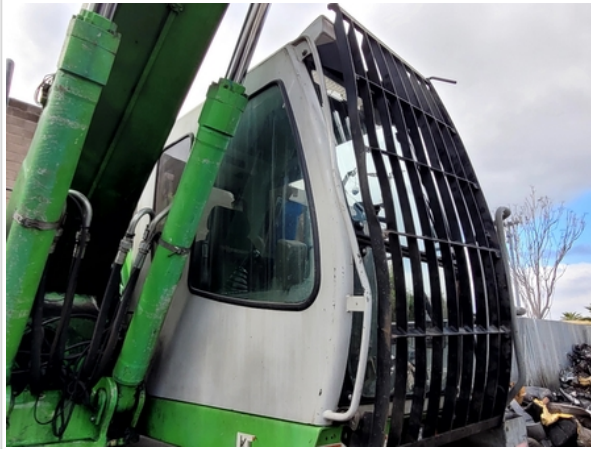
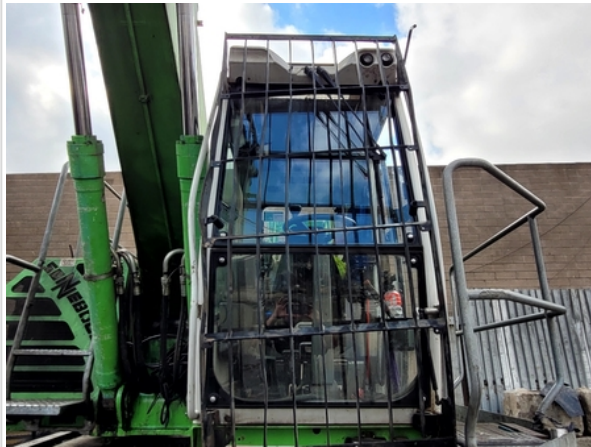
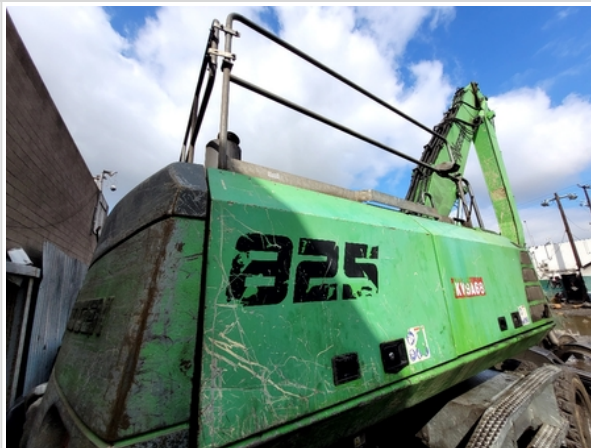
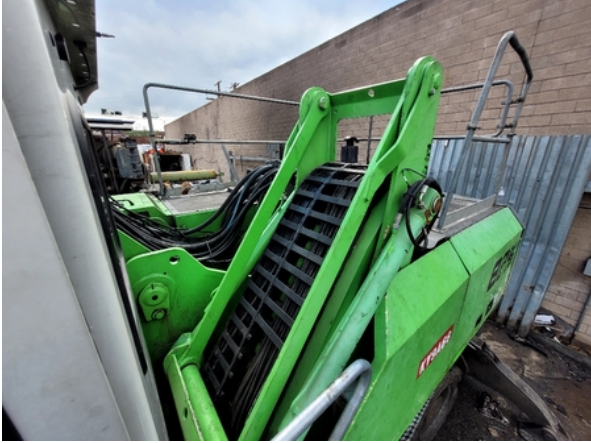
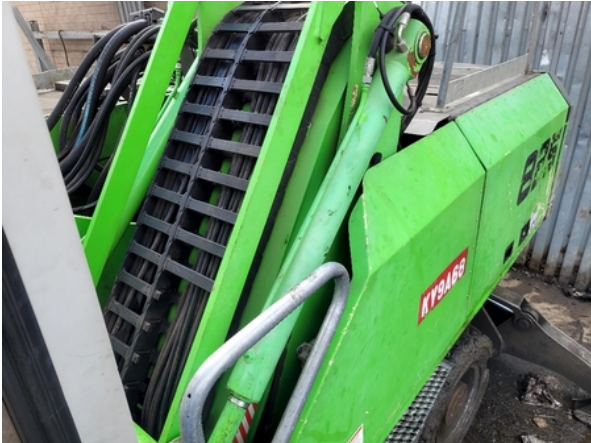
Body Panels	3 - Normal Wear & Tear
Body Panel Condition	Some panel misalignment observed, Visible chipped paint or dents, Other (see comments)
Comments	Main body panels in decent condition with minor dents and scuff marks.
Doors / Canopy Latches	2 - Above Average Wear
Doors / Canopy Latches Condition	Loose or missing latches, hinges or handles, Intermittent sticking observed on one or more latches/doors, Bent or damaged frame/components, Other (see comments)
Comments	Cab door latch inoperable from inside. Outer door latch works properly.
Steps / Ladders	2 - Above Average Wear
Steps / Ladders Condition	Steps/ladders are fully intact and appear structurally sound, Bent or broken steps or rungs, Steps or rungs are not structurally sound, Other (see comments)
Comments	Some step areas in good shape. Side steps have major damage. Ladder next to boom, to top of machine broken and missing steps. Some handrails are bent.

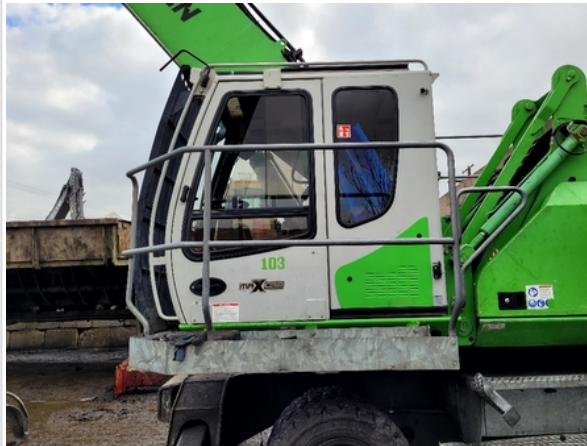
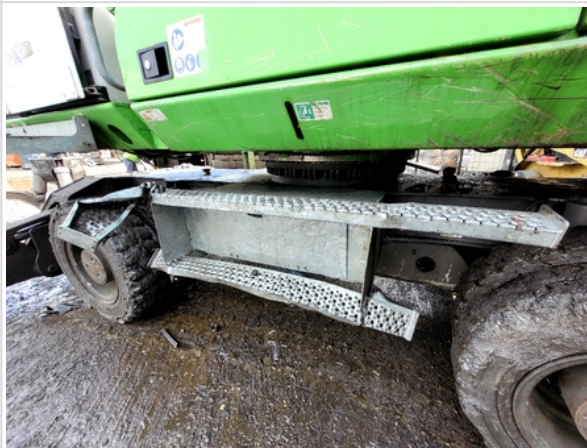
Steps Missing

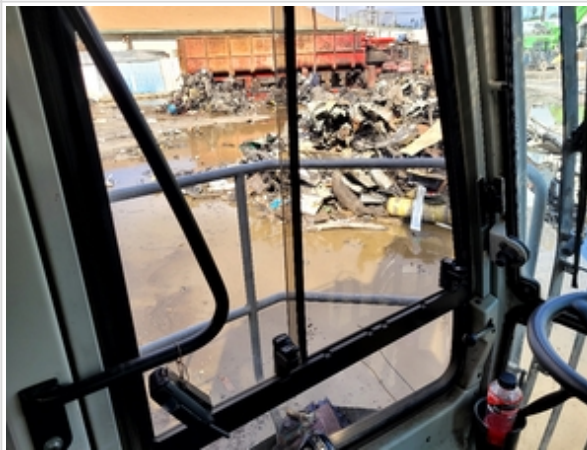
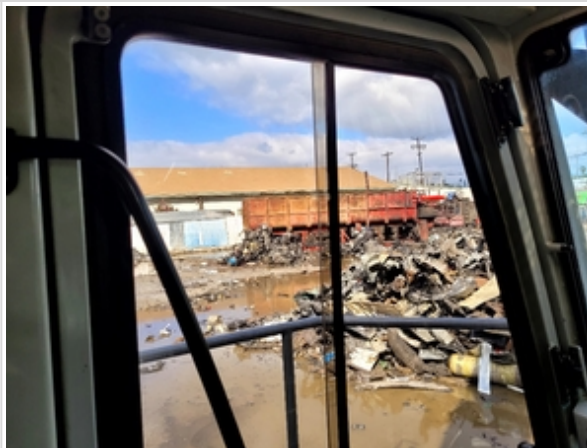
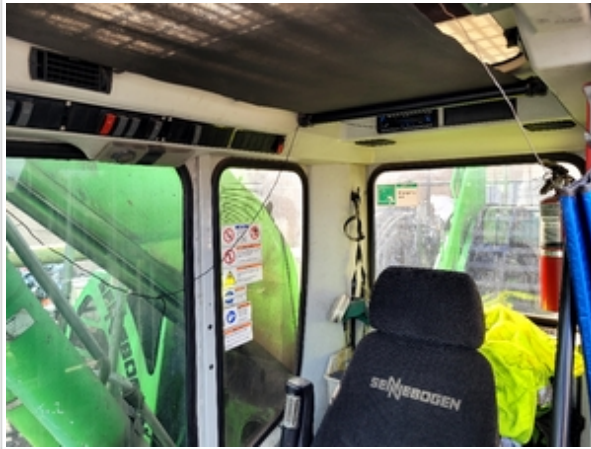
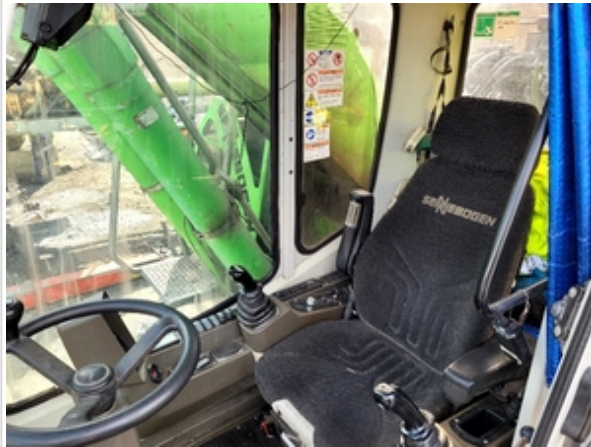
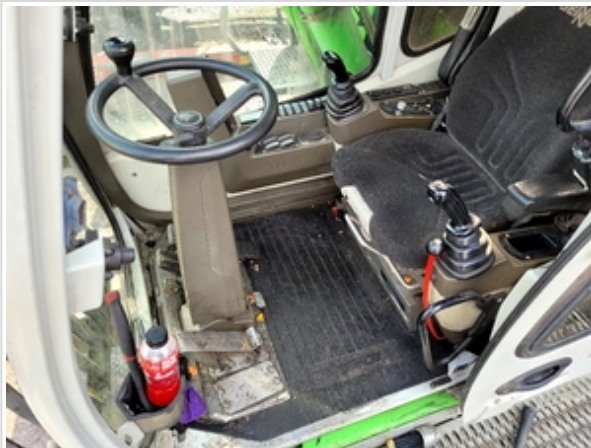
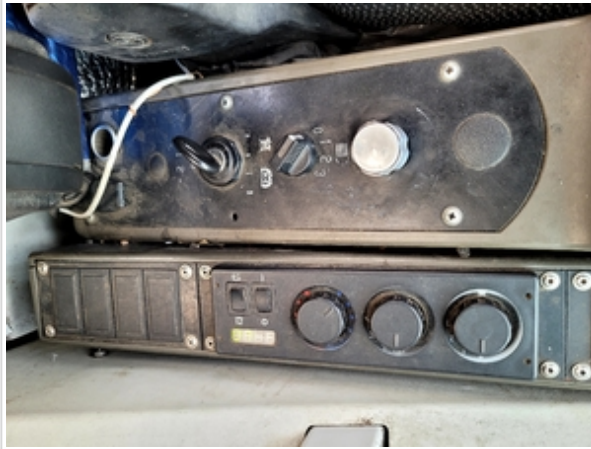
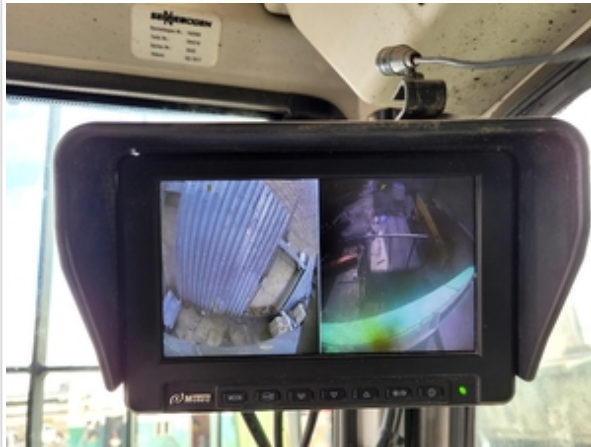
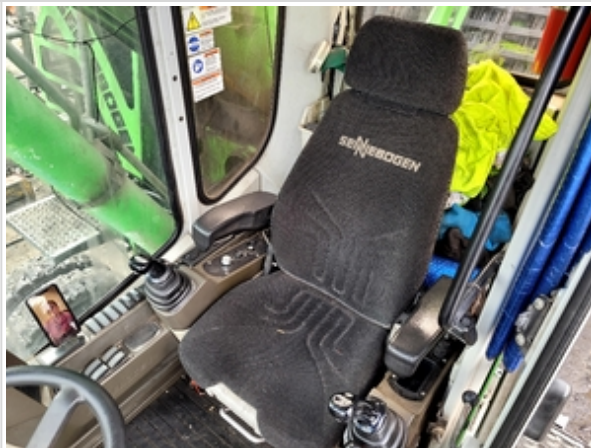
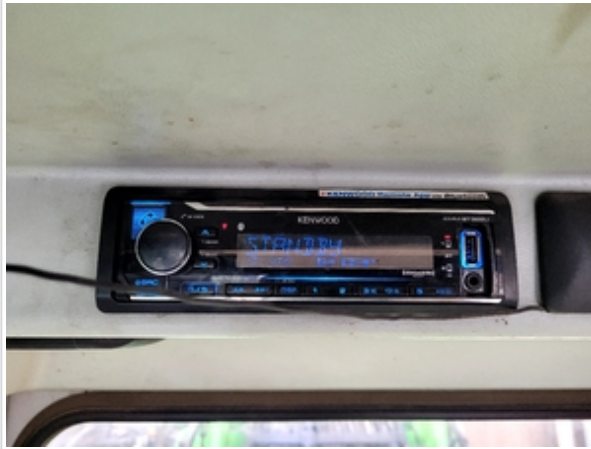
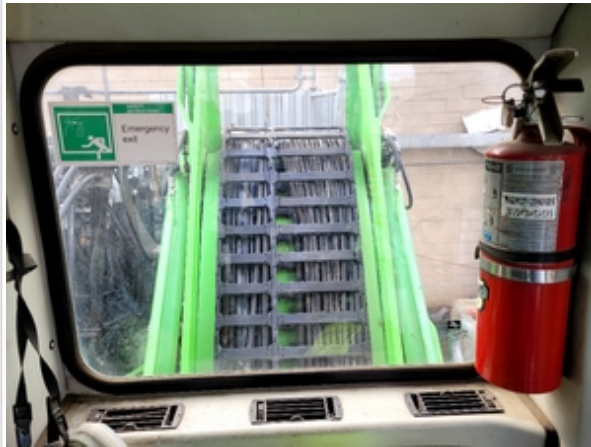
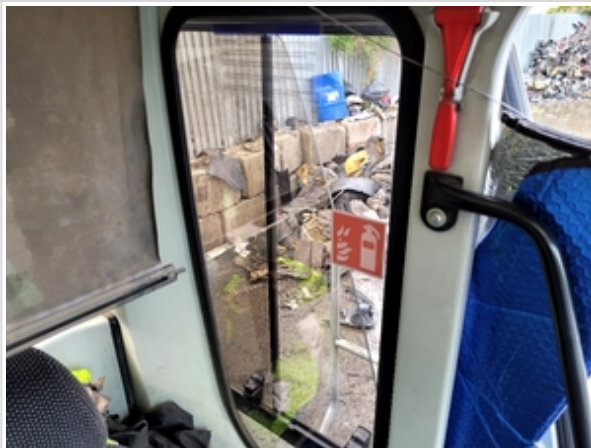
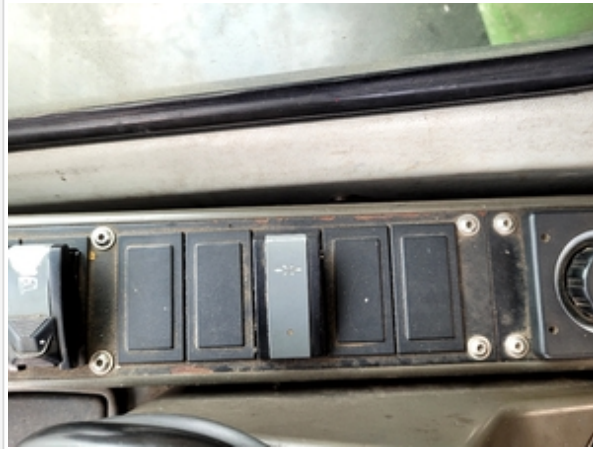
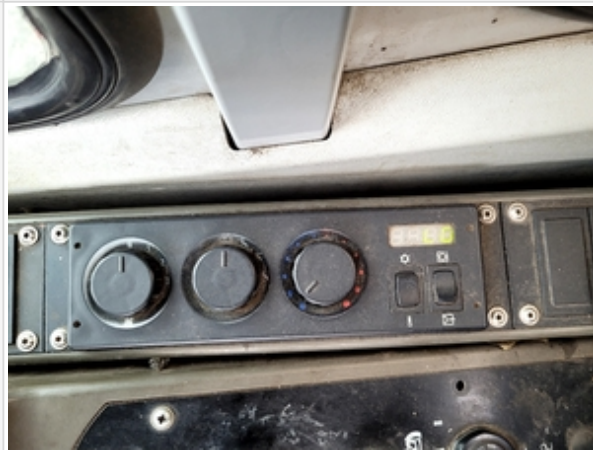
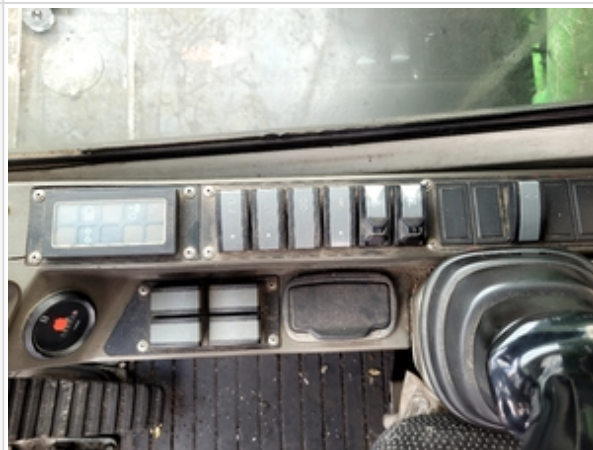
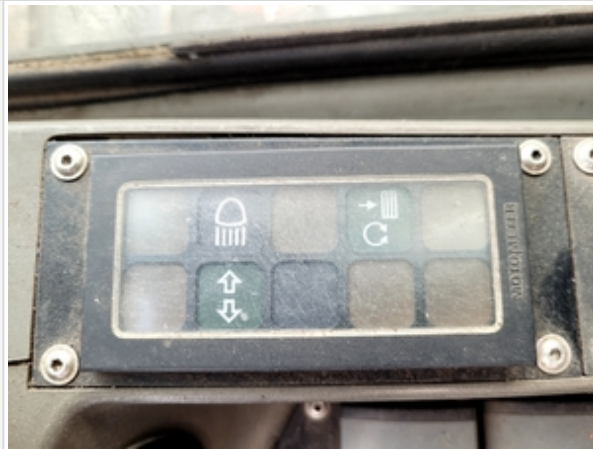
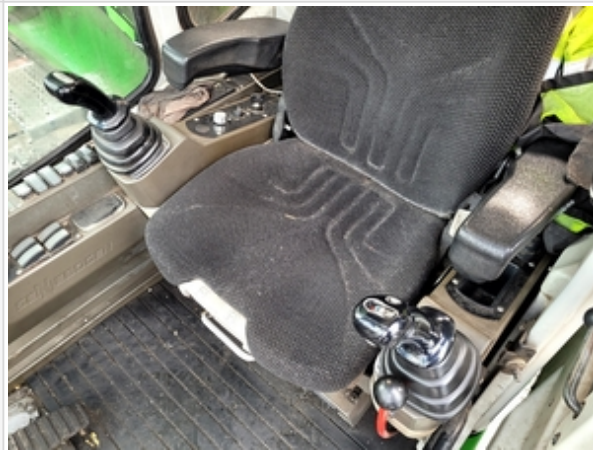
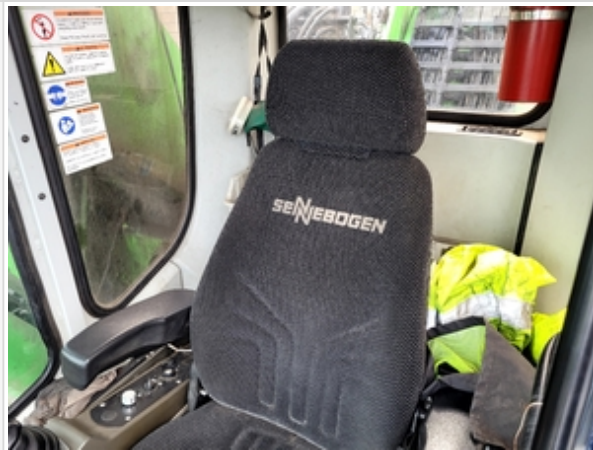
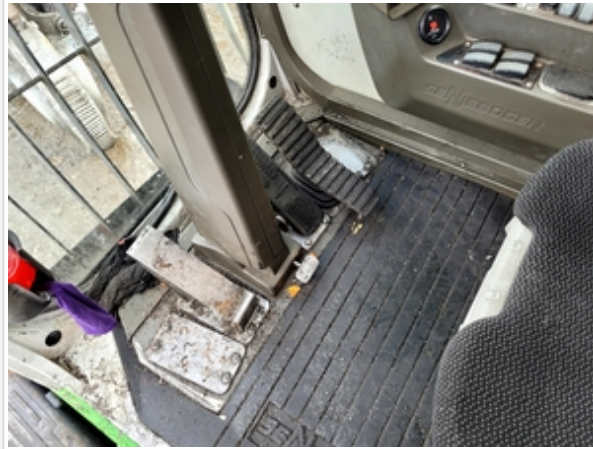
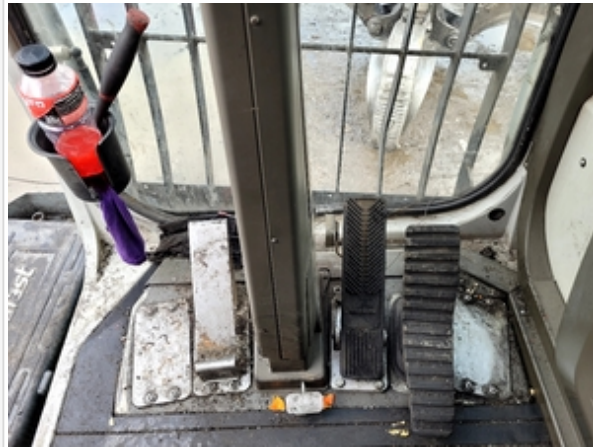
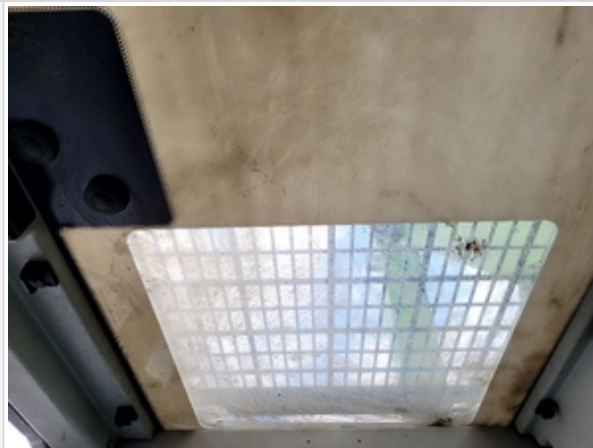
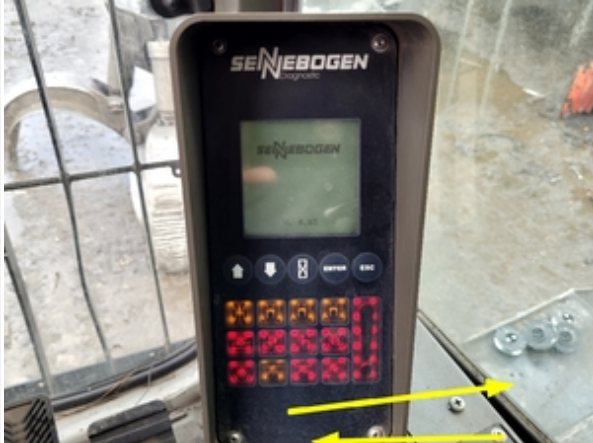
Control Station Photos

Control Station Overall Rating	2 - Above Average Wear
Control Station Overall Condition	Minor cosmetic wear to cabin surfaces, floors, panels, and ceiling, Other (see comments)
Comments	Could use a good cleaning, A/C & Heater Non Operational
Operator Seat	3 - Normal Wear & Tear
Operator Seat Condition	Seat(s) have minor surface staining or small tears
Comments	Cab Fan Switches may be inoperable or fan faulty
Cabin Lights	3 - Normal Wear & Tear
Cabin Lights Condition	Cabin lights are installed with all light covers in place, bulbs are installed and working properly
Safety Lock Out / Stop	3 - Normal Wear & Tear
Safety Lock Out / Stop Condition	Safety lock out device is present, in good condition, and functional
Controls & Switches	3 - Normal Wear & Tear
Controls & Switches Condition	One or more switches are inoperative or missing
Hour Meter Activity	3 - Normal Wear & Tear
Hour Meter Condition	Hour meter is functional and in good condition

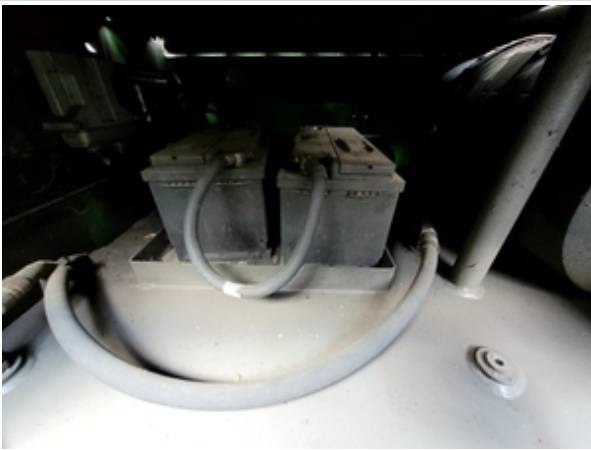
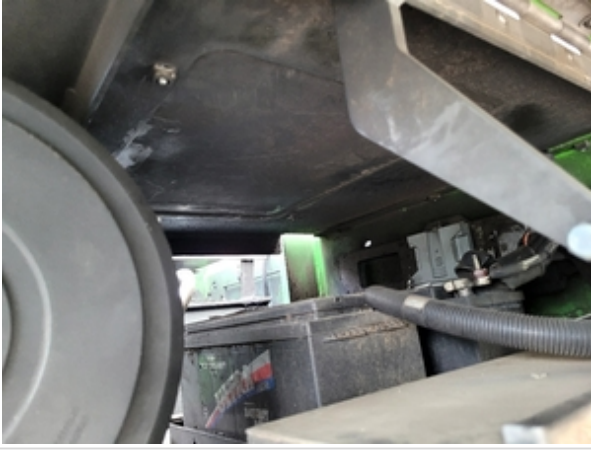
Battery Condition Photos

Blow-by (Visual Observation Check)	No
Unusual Noises (Upon Start-up, Idle, Shutdown)	No
Unusual Noise Notes	No unusual noises heard
Engine Smoke (Upon Start-up, Idle, Shutdown)	No
Engine Smoke Notes	No engine smoke issues observed
Engine Exhaust Color	Clear
Battery	3 - Normal Wear & Tear
Battery Condition	Other (see comments), Dusty & dirty appearance
Comments	Batteries missing hold down bracket

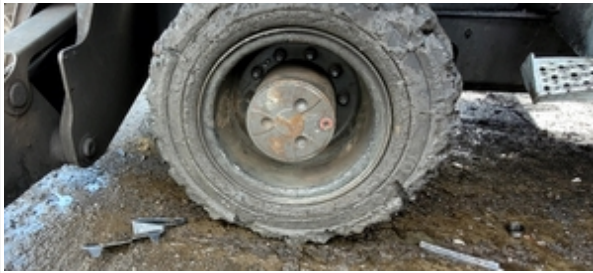
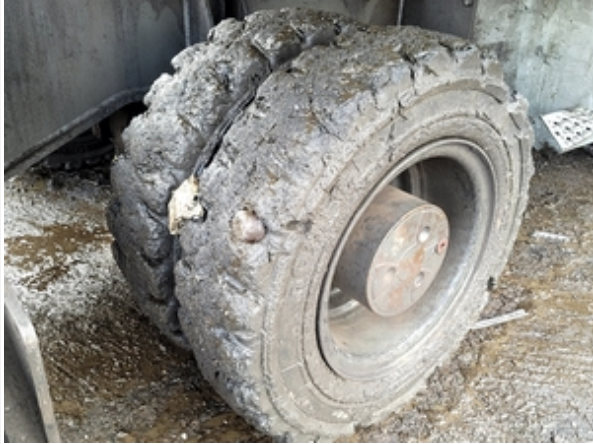
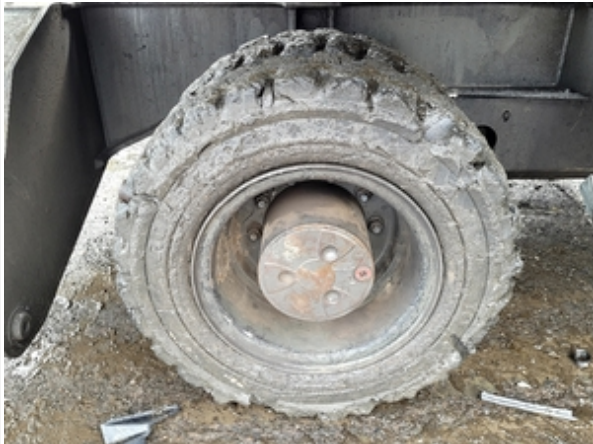
Wheels & Hub Condition	3
Comments	Wheels & Hubs in good condition (no obvious signs of wheel seal leaks but unable to get a closeup, clear view due to debris buildup around inner wheel. Some tires missing large pieces of solid rubber
Wheels & Hub Photos

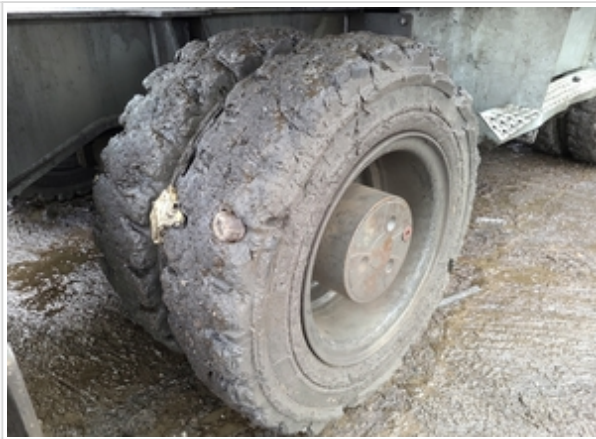
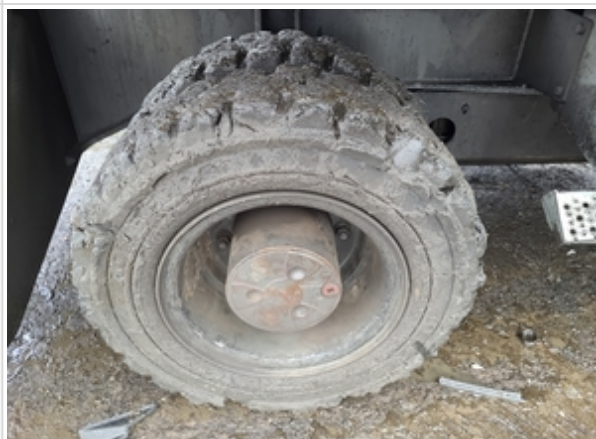
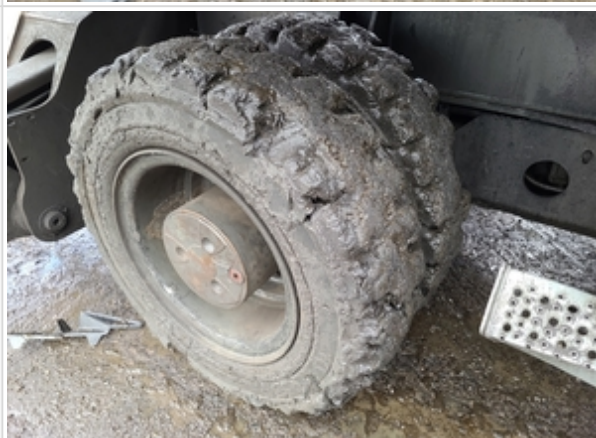
<p>Front Left Tire Photos</p>

Wheel Seal Leaks	N/A
Tire Brand	Bomber
Tire Size	10.00-20
Front Left Tire - Ratio Remaining	50%

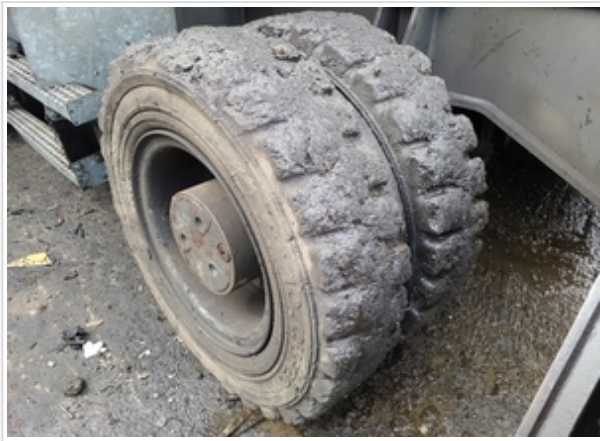
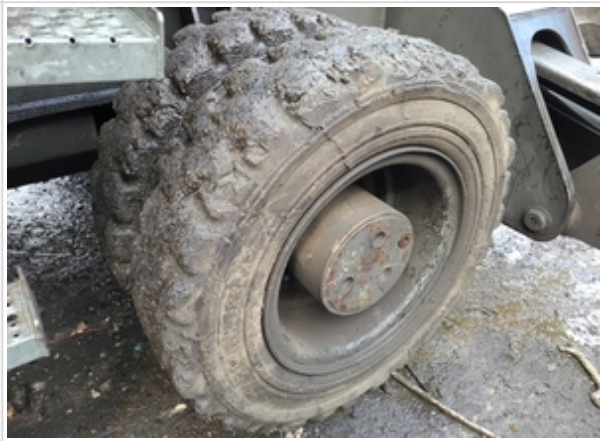
<p>Front Right Tire Photos</p>

<p>Front Right Tire - Ratio Remaining</p>	<p>50%</p>

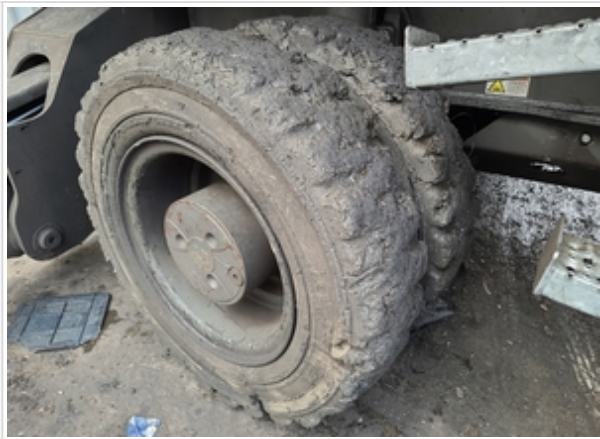
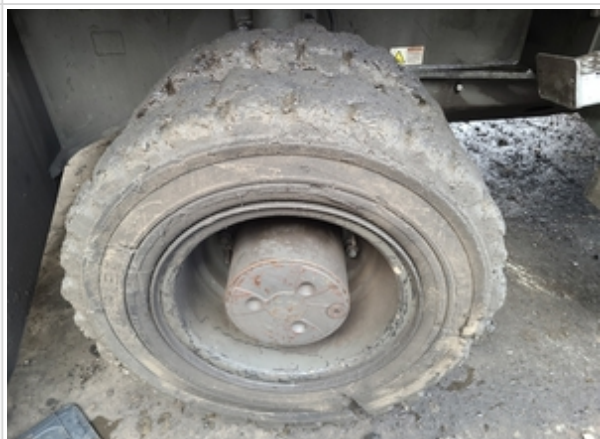
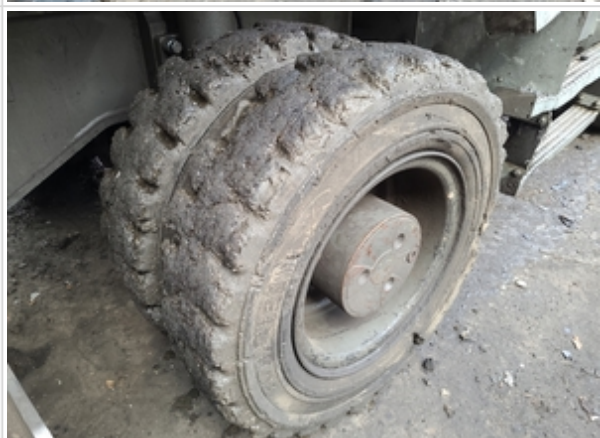
<p>Rear Right Tire Photos</p>

<p>Rear Right Tire - Ratio Remaining</p>	<p>50%</p>

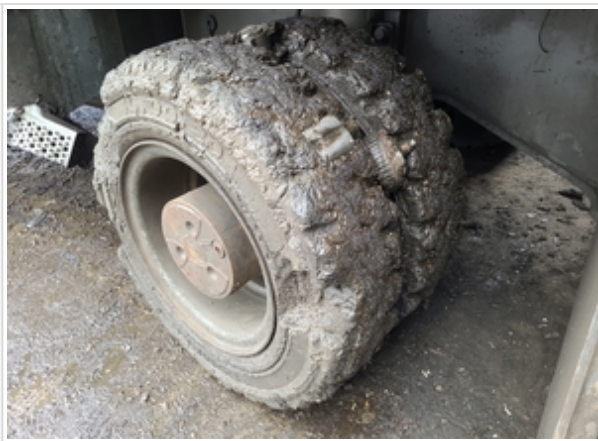
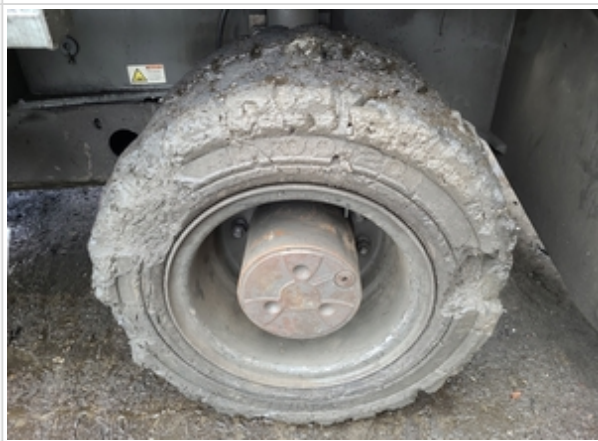
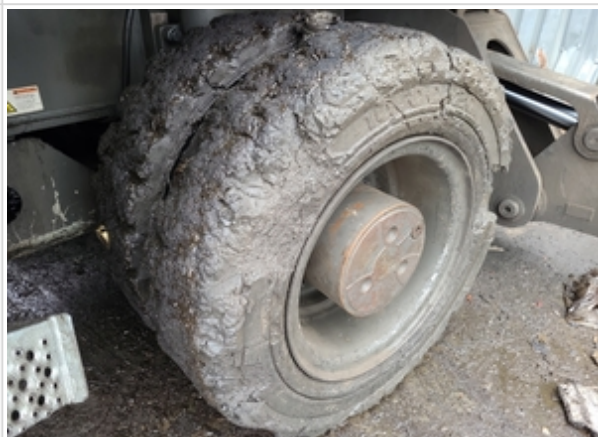
<p>Rear Left Tire Photos</p>

<p>Rear Left Tire - Ratio Remaining</p>	<p>30%</p>

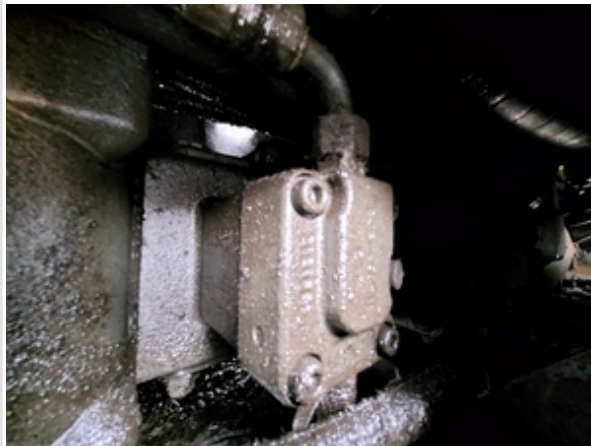
The circled area has minor hydraulic oil buildup. Minor active leak present at swivel.

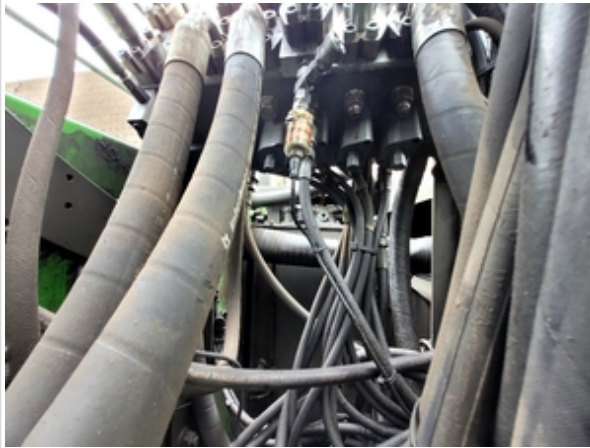
Bottom of Main control valve

Hydrostatics Pump main area, beneath center of machine has minor oil buildup on surface of bottom machine guards.

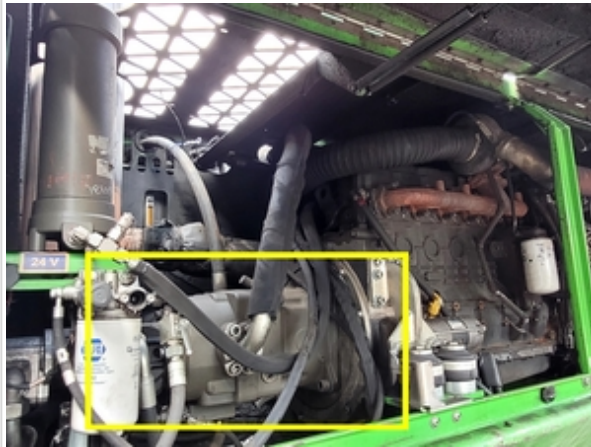
Main hydraulic pump

Main Hydraulic Pump Has well maintained appearance.

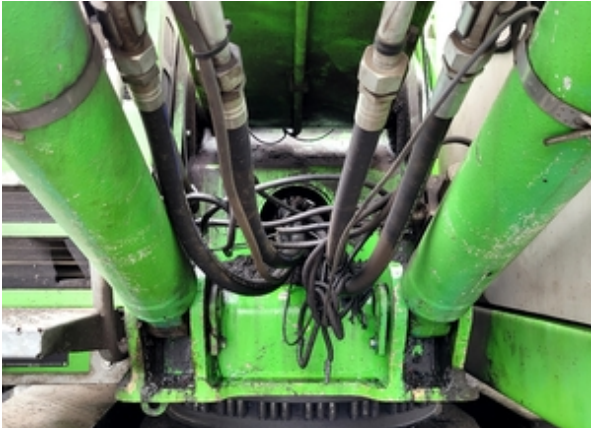
Wet or Damp Hydraulic Lines / Fittings	Yes
Appearance of Hydraulic Lines / Fittings	3 - Normal Wear & Tear
Hydraulic Lines / Fittings Condition	Hydraulic lines & fittings are clean and in good condition, Active leaks in hoses or fittings observed, Other (see comments), Worn, cut, or damaged hose covering
Comments	Most hydraulic hoses in good shape with some hoses showing signs of minor active leaks. Auxiliary hyd. hoses missing mount bracket on stick, above Grapple. Grapple Hydraulic hoses damaged and may need to be replaced soon. Some minor active hyd. oil buildup seen on Grapple surface.
Appearance of Hydraulic Lines / Fittings Photos

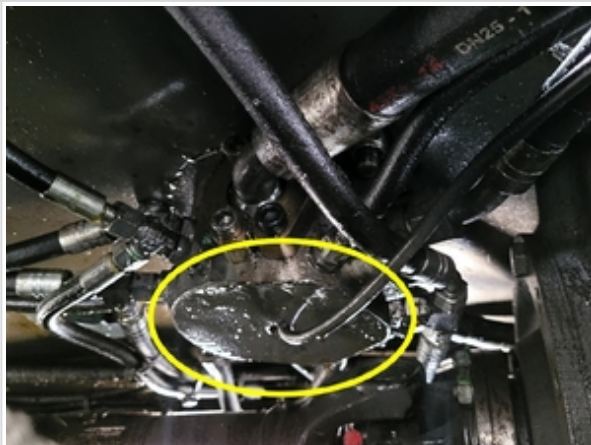
Minor hydraulic fluid seen at bottom of hydraulic swivel

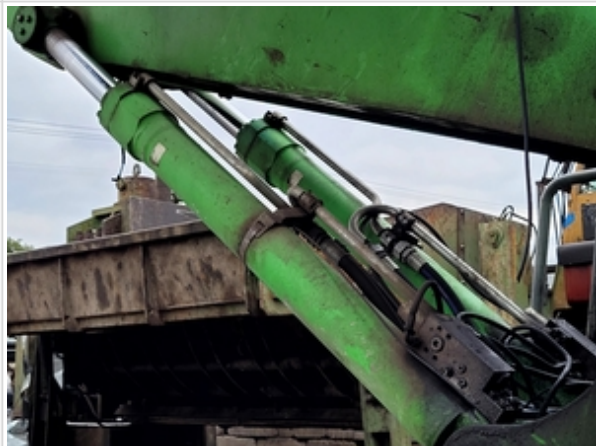
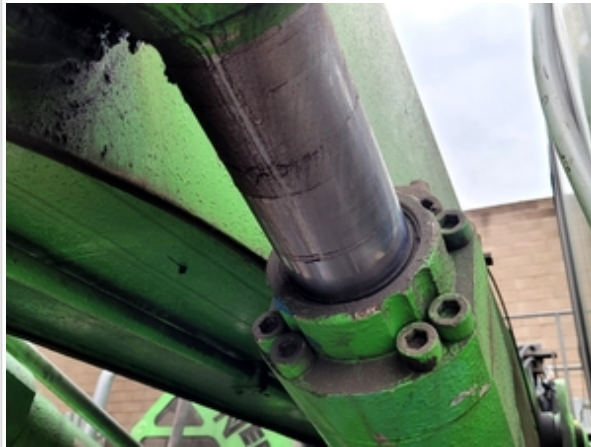
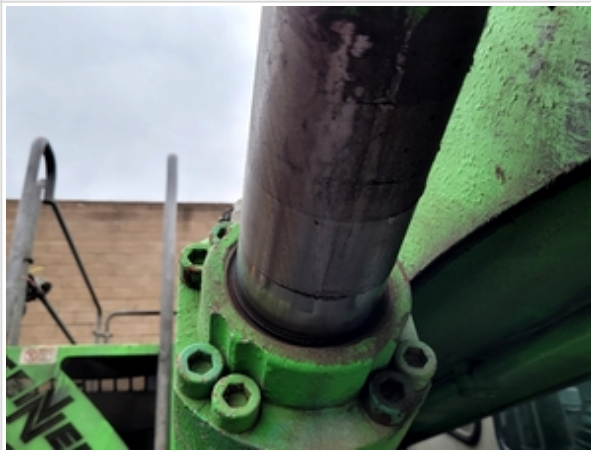
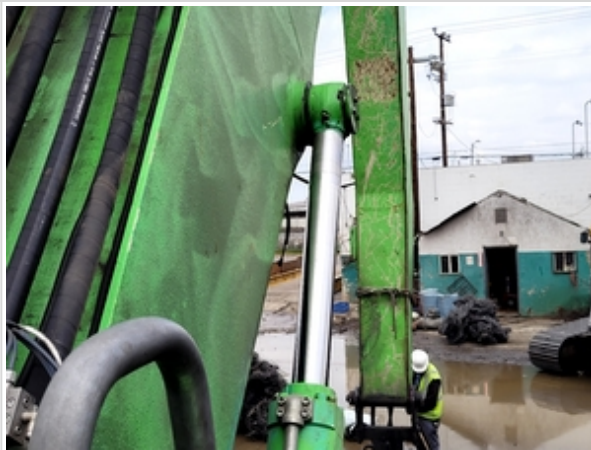
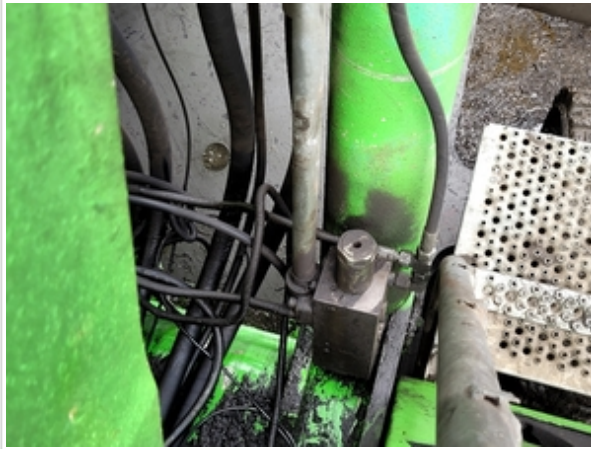
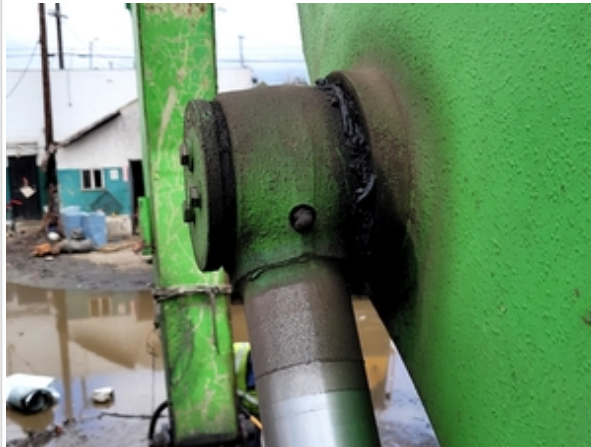
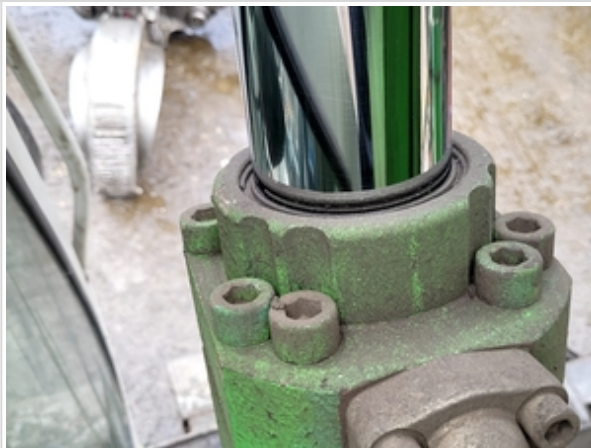
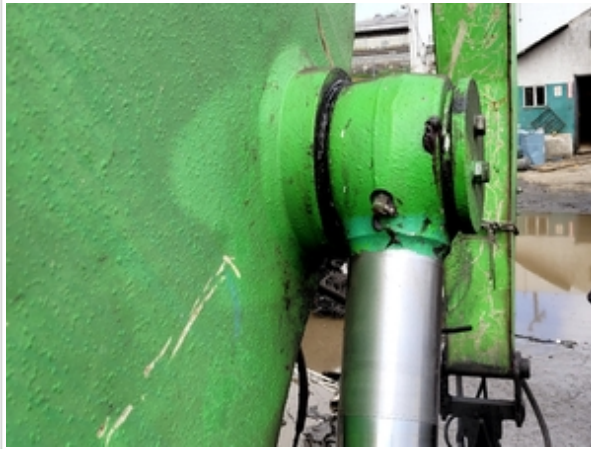
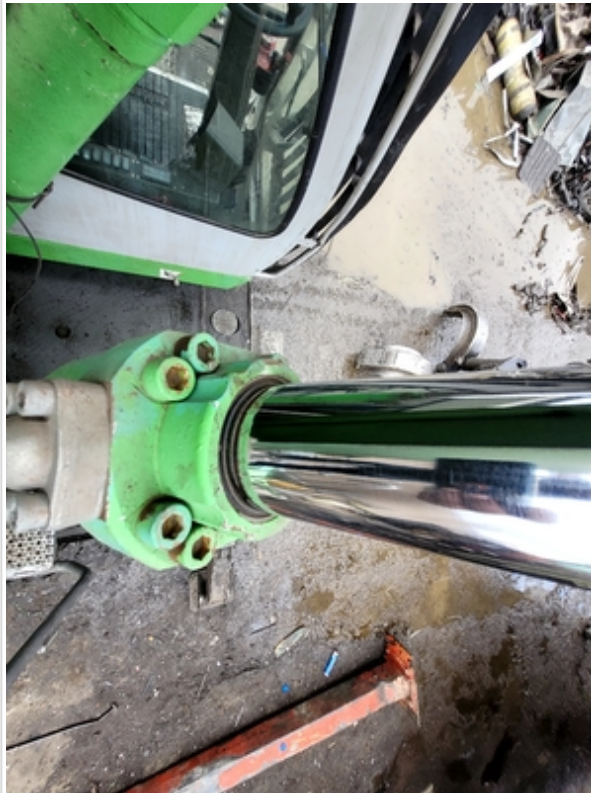
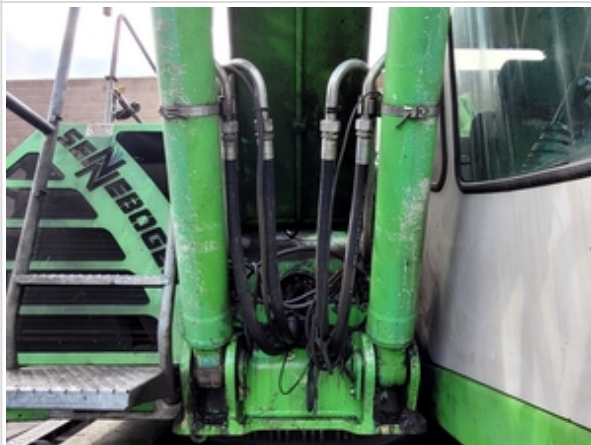
Boom Cylinder: Mounting Pins	3 - Normal Wear & Tear
Boom Cylinder: Oil Leaks	No
Boom Cylinder Photos

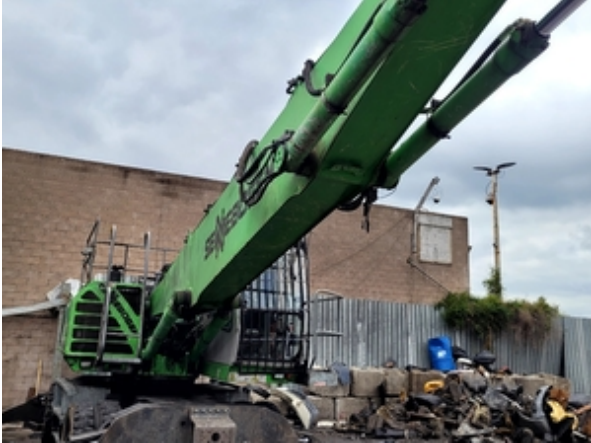
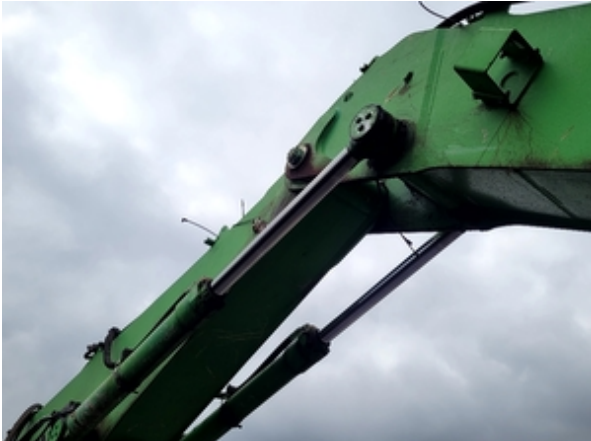
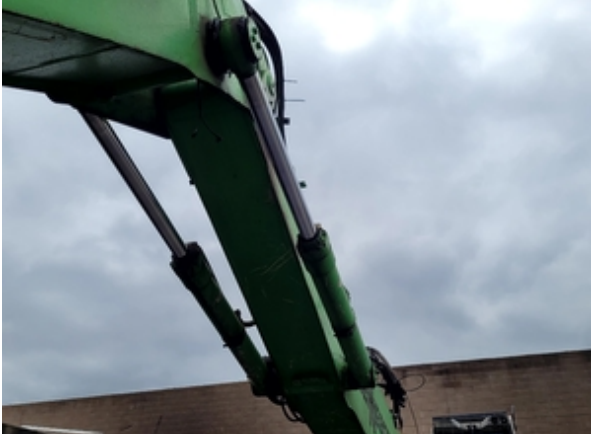
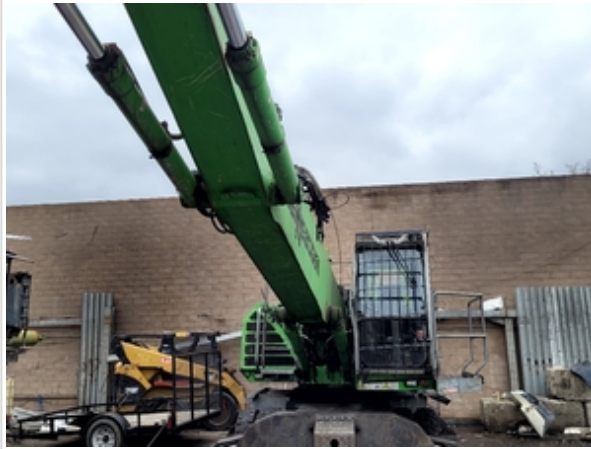
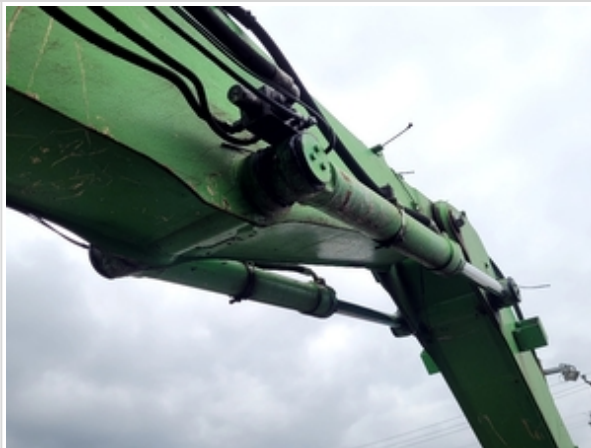
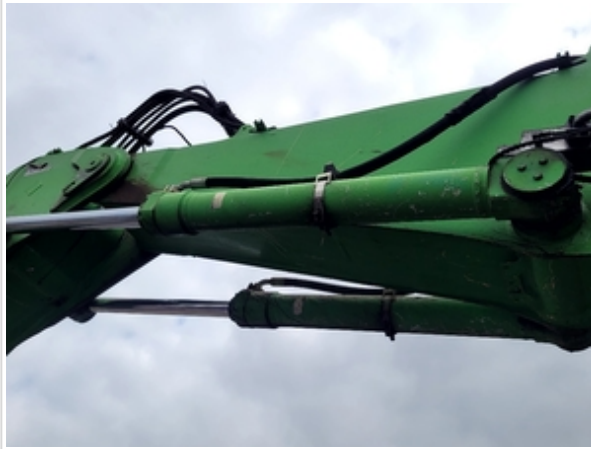
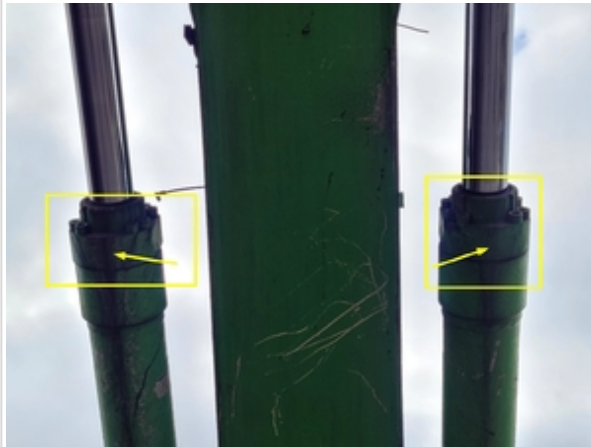
Stick Cylinder: Mounting Pins	3 - Normal Wear & Tear
Stick Cylinder: Oil Leaks	Yes
Comments	No active leaks seen but minor signs of seepage may be present from both cylinders
Stick Cylinder Photos

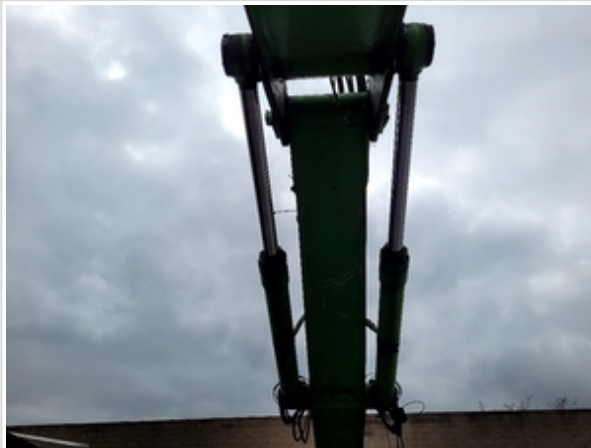
Could be old grease lyquifyin down cylinder from rod end.

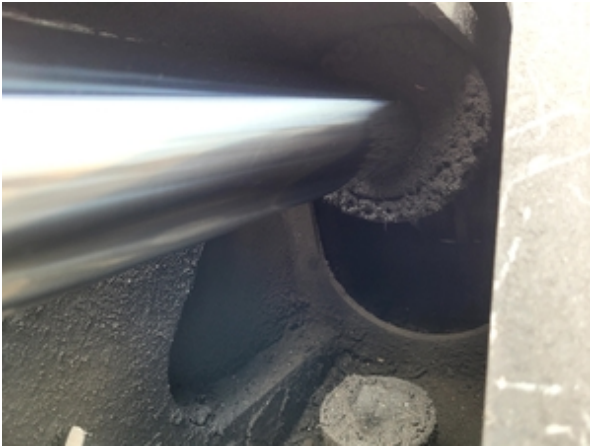
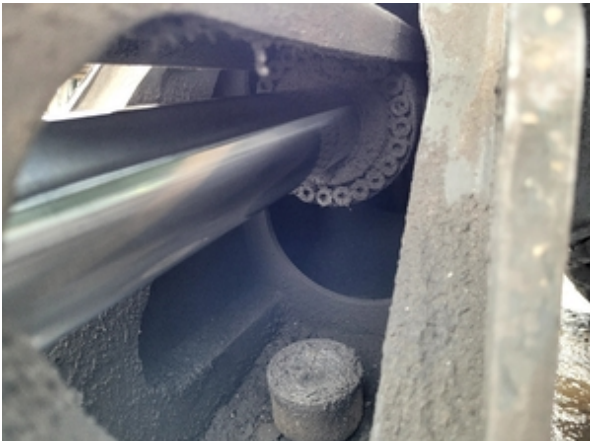
Outrigger Cylinder(s): Mounting Pins	4 - Like New, Recently Replaced	
Outrigger Cylinder(s): Oil Leaks	No	
Outrigger Cylinder(s) Photos
