Inspection Report (On-Highway Truck Cab + Chassis)

Year	2012
Make	Kenworth
Model	T800
Serial Number	1XKDDP9X4CJ335277
Truck Odometer Reading	321,622
Current Inspection / State Cert / DOT	DOT Annual Inspection Performed 10/2022 per accordance with 49CFR, Part 396, FMCSR
Previous Application (e.g., earth moving, mining, demolition, etc)	Equipment Rental Hauler

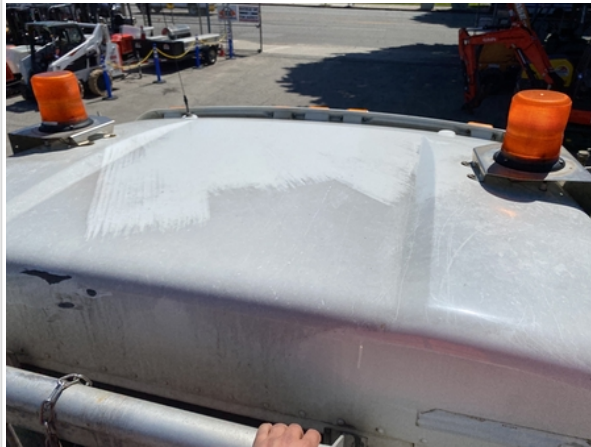
Exhaust shield damaged and pressed up against cab

Minor damage part of exhaust shield impact	
Body Panels	3 - Normal Wear & Tear	
Body Panel Condition	No visible damage, good paint condition and panel fitment, Other (see comments)	
Comments	Only observed one area behind Exhaust Stack with minor damage.	
Doors / Canopy Latches	3 - Normal Wear & Tear	
Doors / Canopy Latches Condition	No visible damage	
Steps / Ladders	3 - Normal Wear & Tear	
Steps / Ladders Condition	Steps/ladders are fully intact and appear structurally sound	
Handrails	3 - Normal Wear & Tear	
Handrails Condition	Handrails are fully intact and appear structurally sound	
Glass	3 - Normal Wear & Tear	
Glass Condition	Glass intact, no visible damage	
Mirrors	3 - Normal Wear & Tear	
Mirror Condition	Mirrors present and intact, no visible damage, Other (see comments)	
Comments	Electric mirror adjustable control function inoperable on driver side and partially inoperable for passenger side.

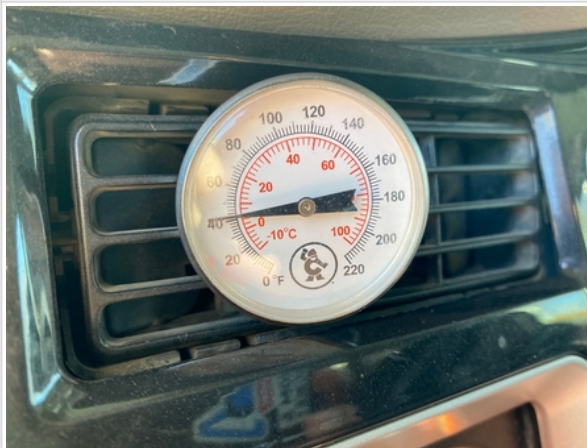
A/C functioning well

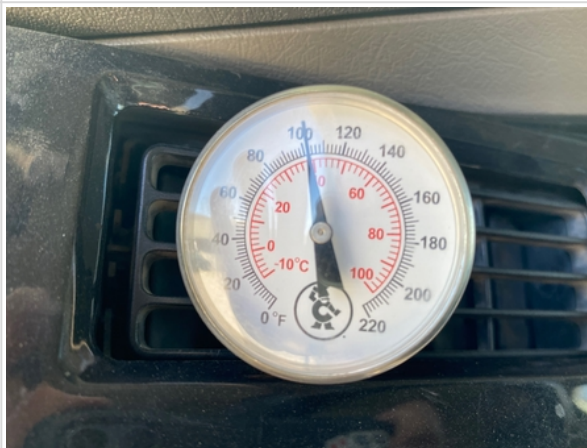
Heater functioning well

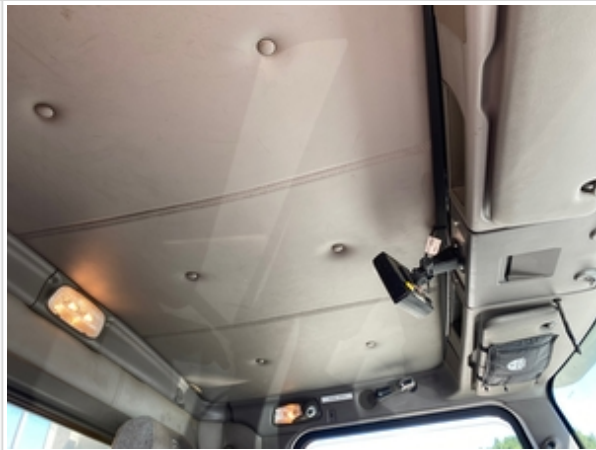
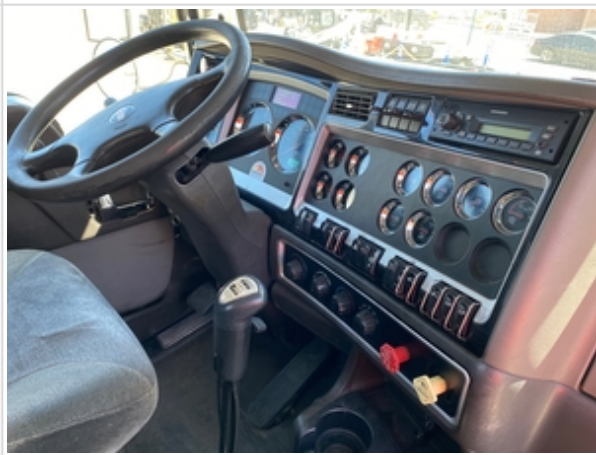
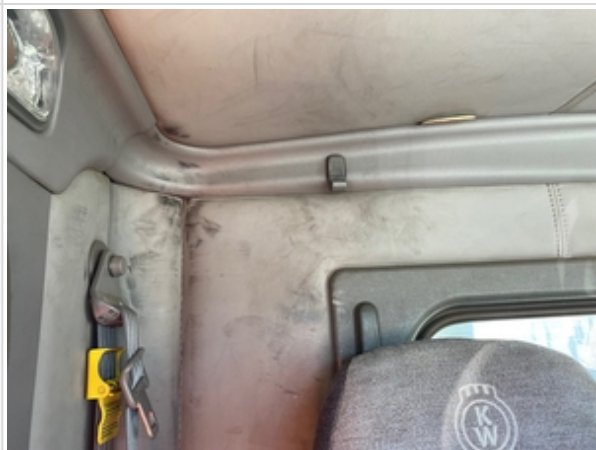
<p>Minor grease/oil stain marks observed</p>
Odometer Activity	3 - Normal Wear & Tear
Odometer Condition	Odometer is working and in good condition
Controls/Switches/Gauges	3 - Normal Wear & Tear
Controls/Switches/Gauges Condition	All switches/gauges are in good condition and functioning
Brake System Type	Air Brakes
Air Brakes Build Correct Pressure	Yes

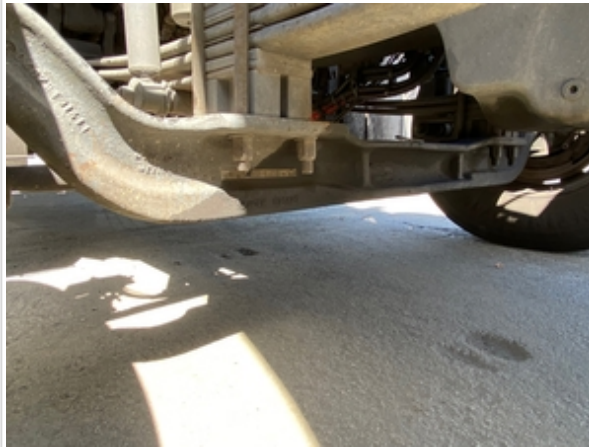
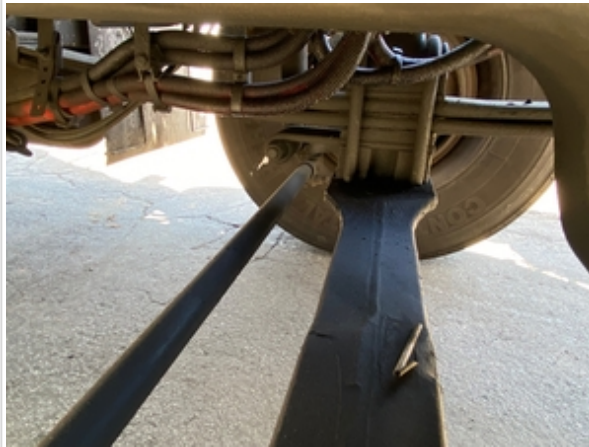
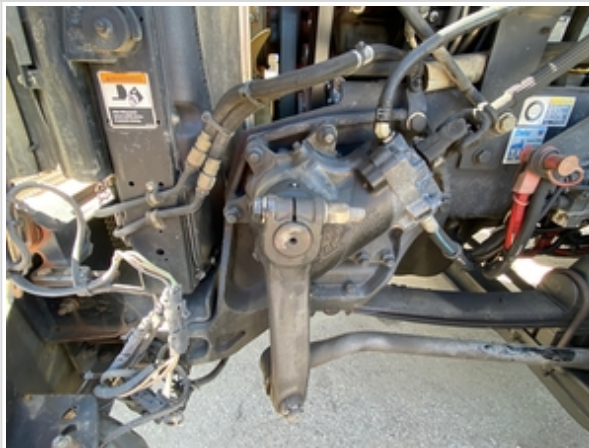
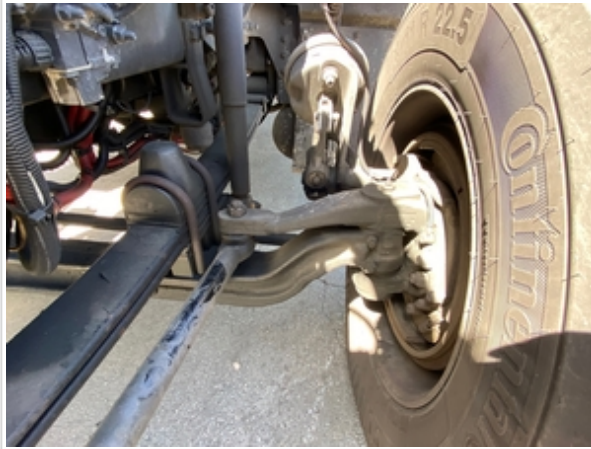
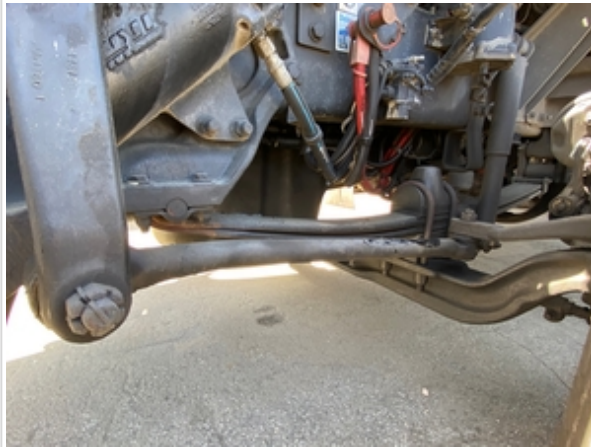
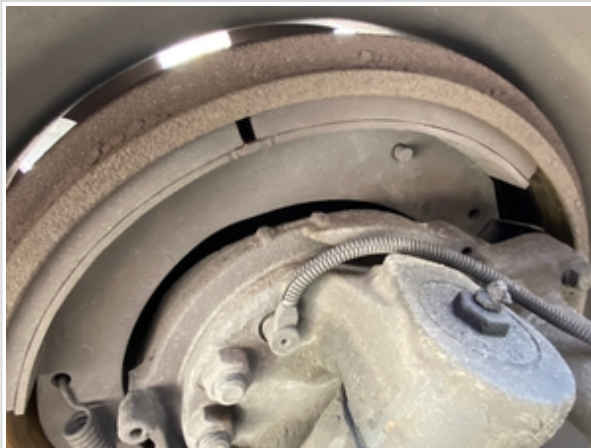
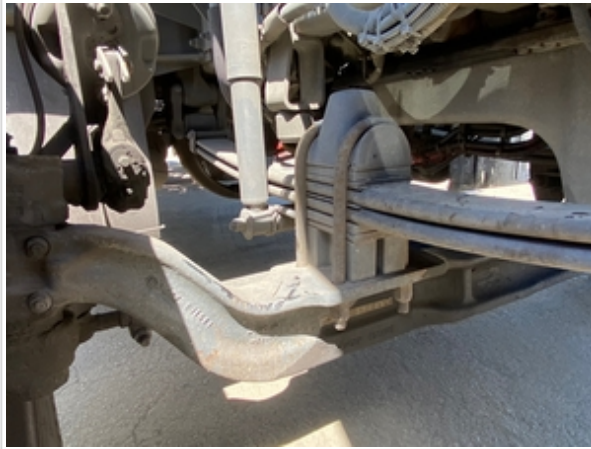
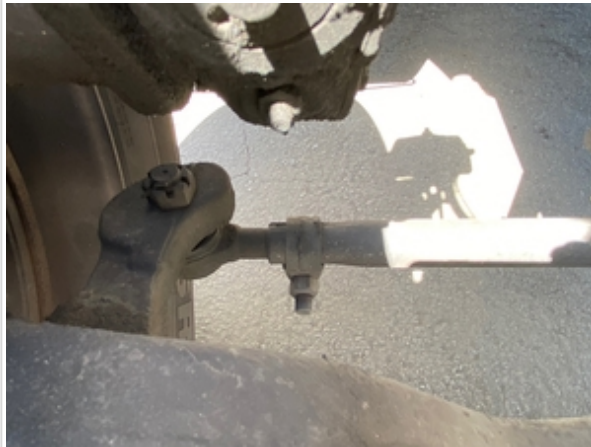
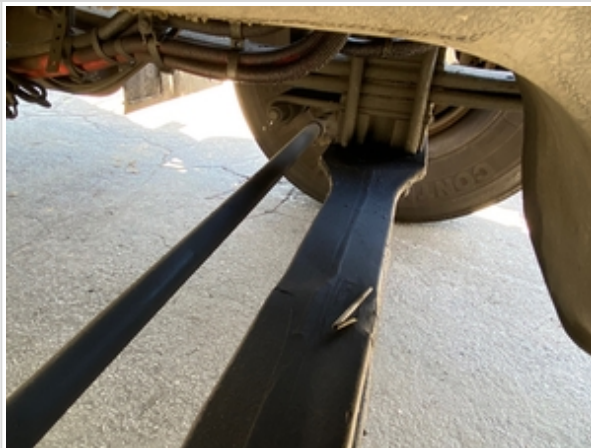
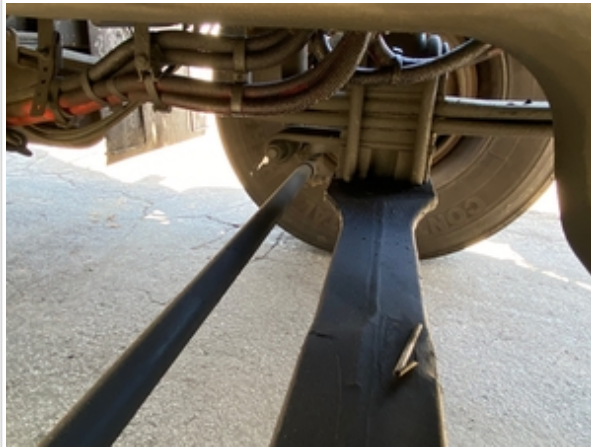
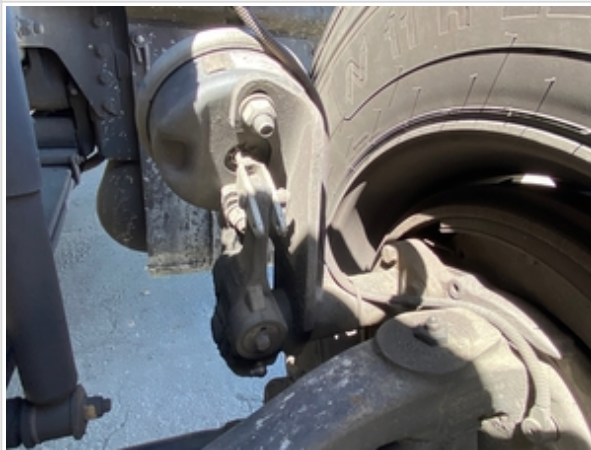
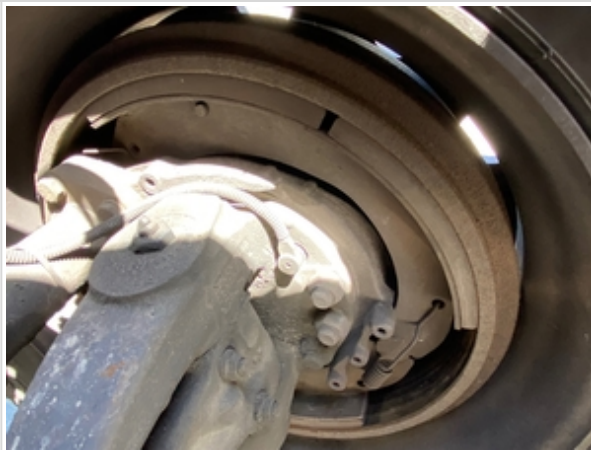
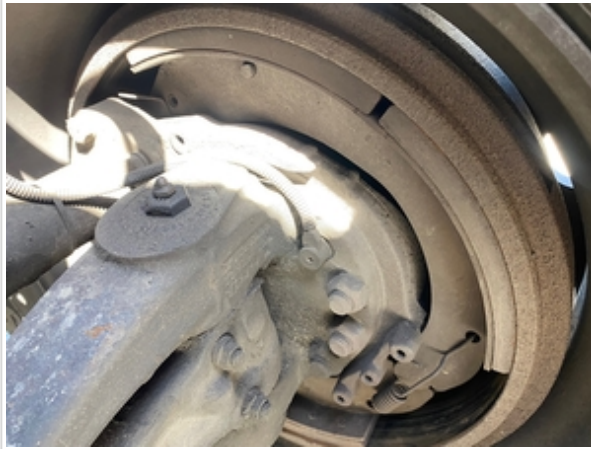
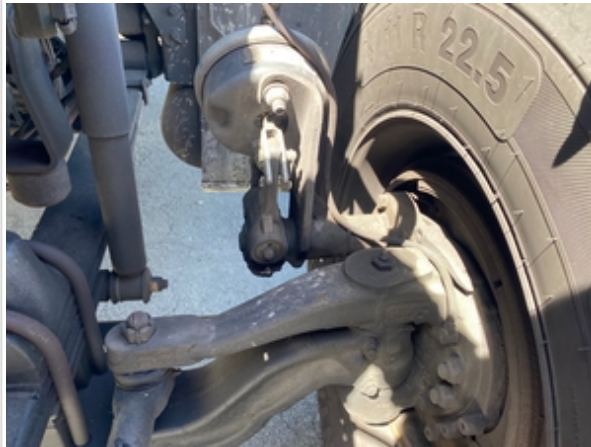
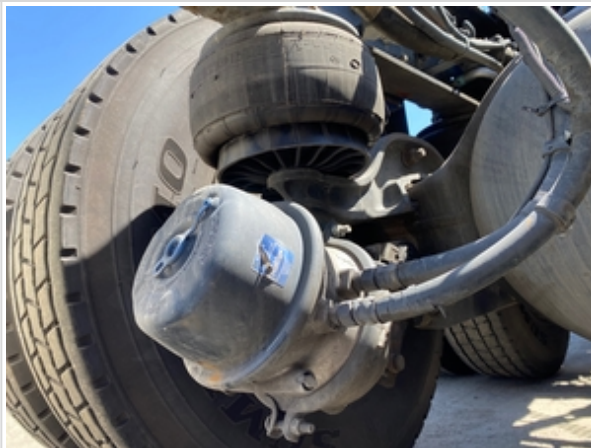
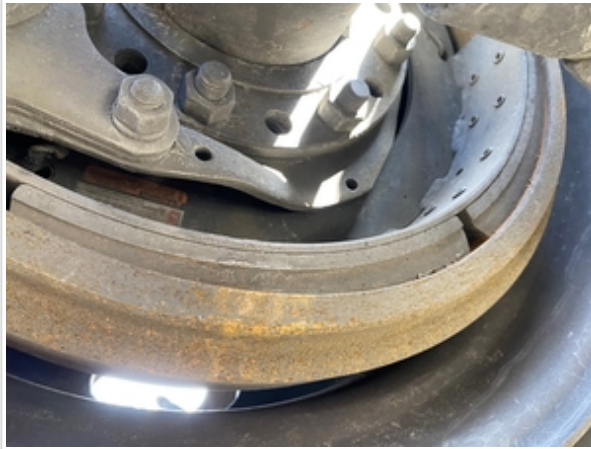
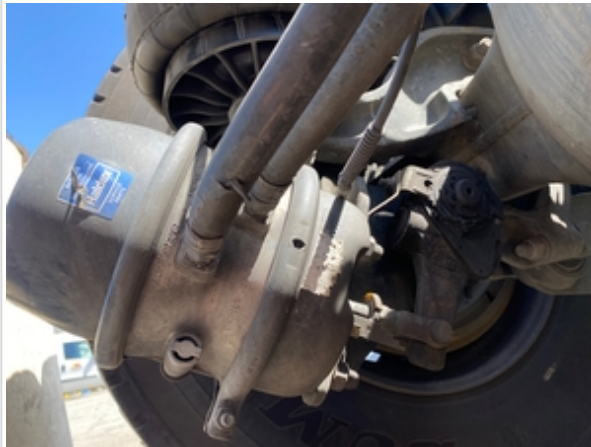
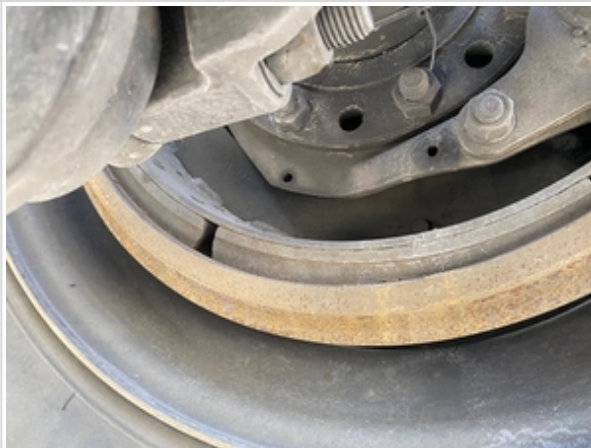
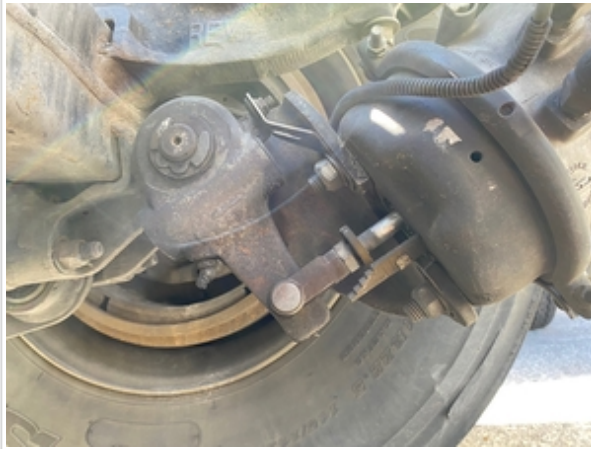
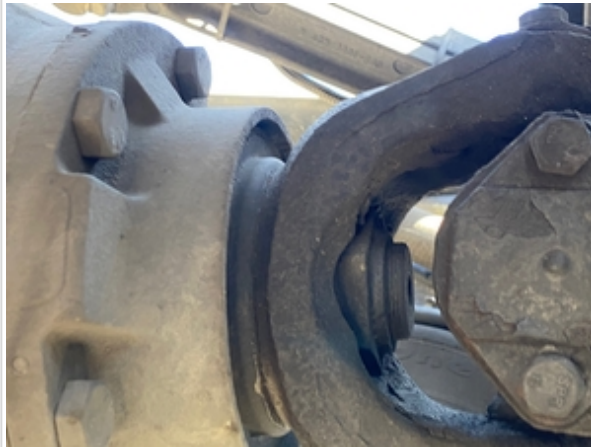
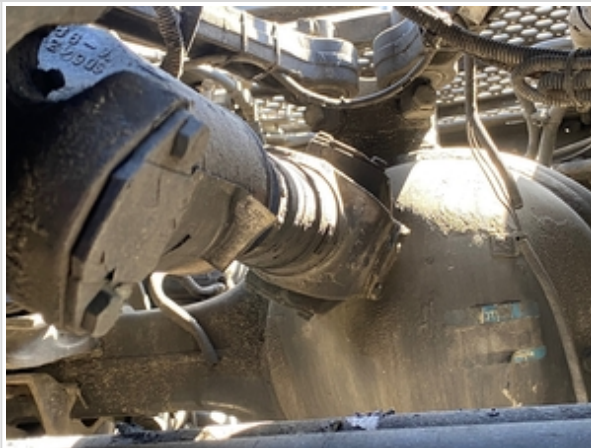
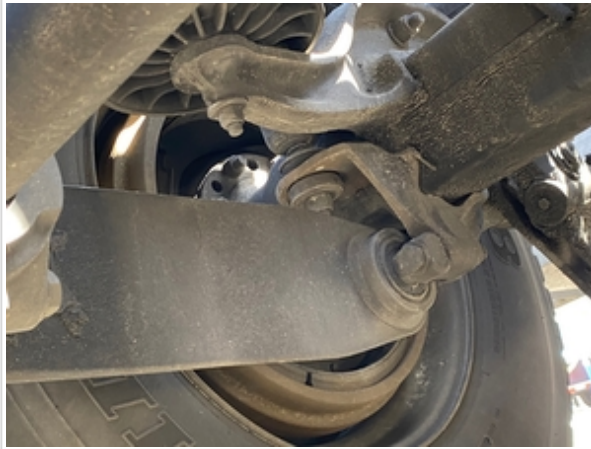
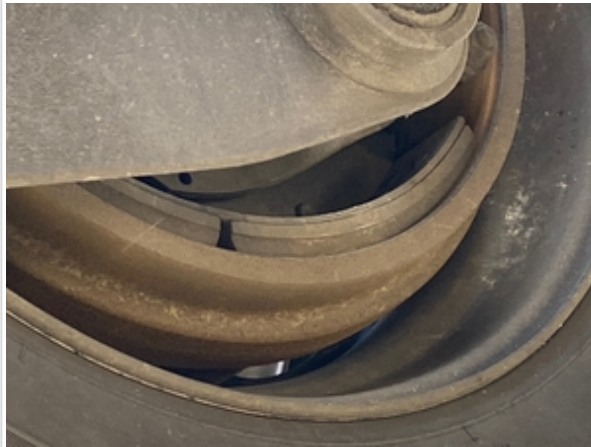
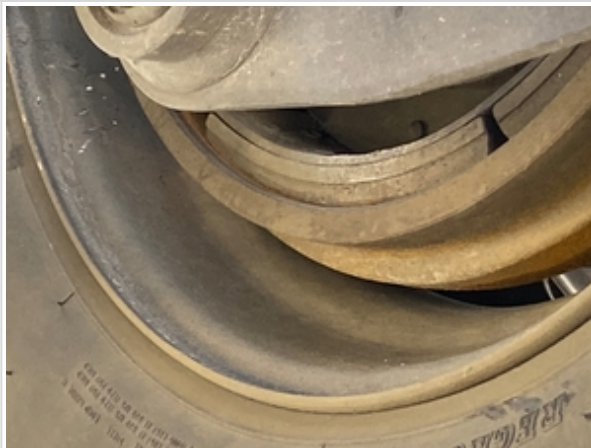
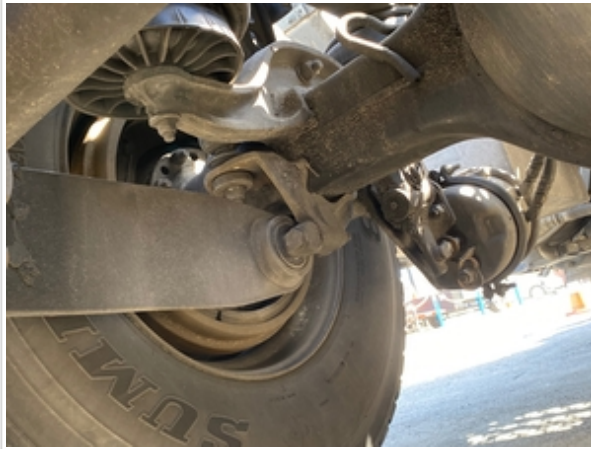
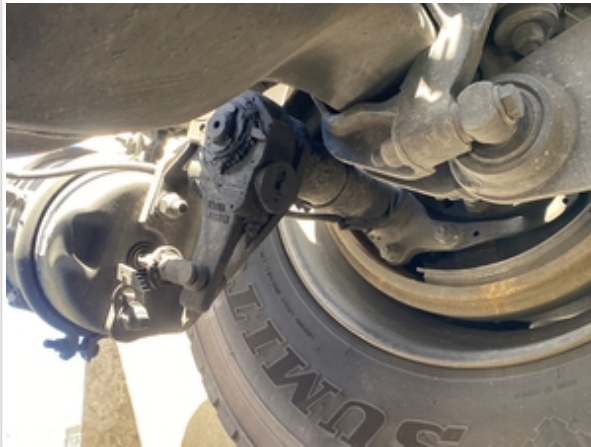
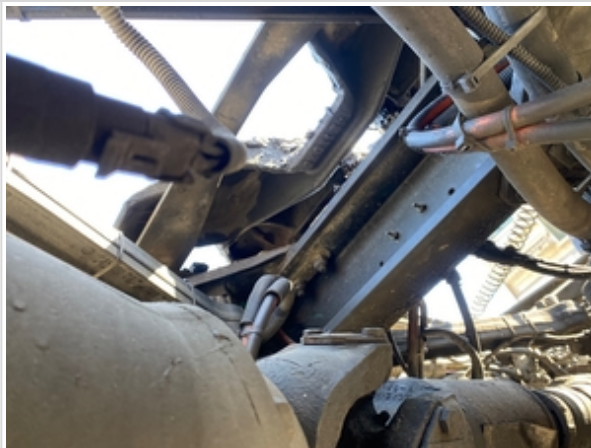
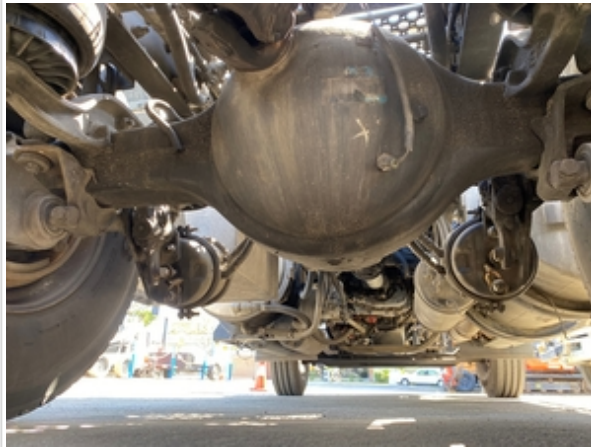
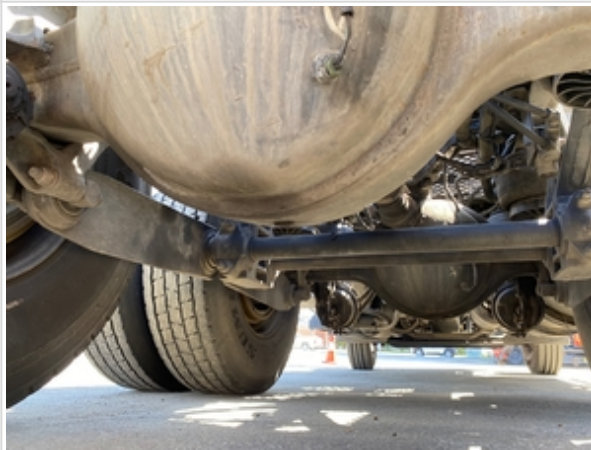
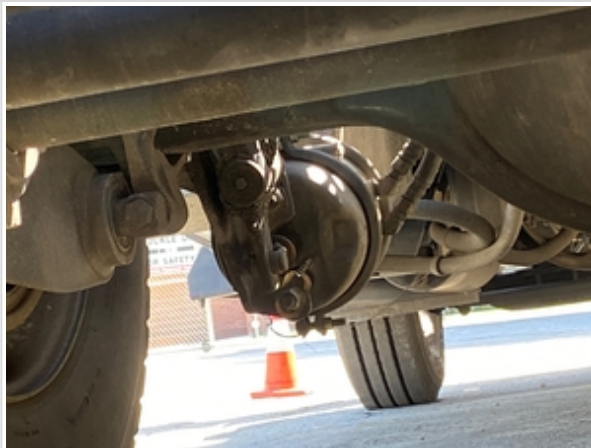
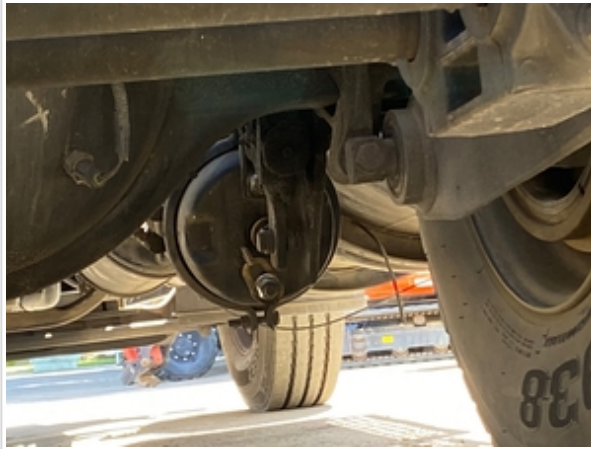
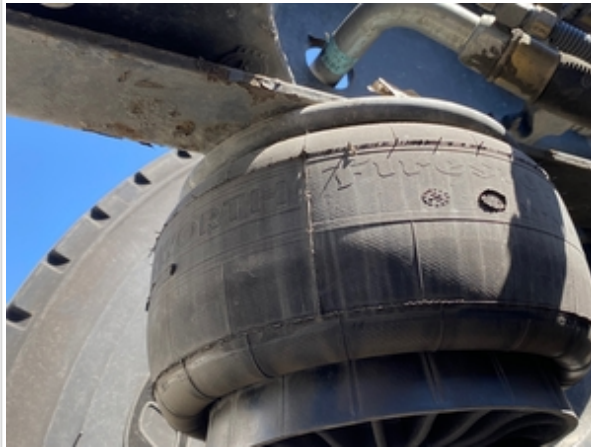
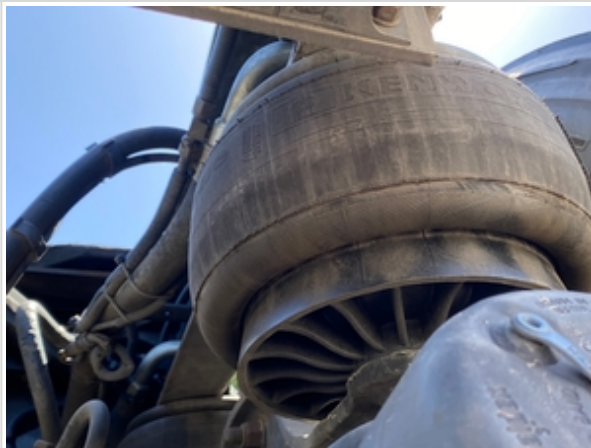
Chassis & Undercarriage Photos

Frame	3 - Normal Wear & Tear
Suspension	3 - Normal Wear & Tear
Steer Axle Condition	3 - Normal Wear & Tear
Steering Components	3 - Normal Wear & Tear
Overall Chassis Condition	3 - Normal Wear & Tear
Overall Chassis Comments	No obvious issues observed with Chassis. Suspension, steering, frame and brakes in good condition.

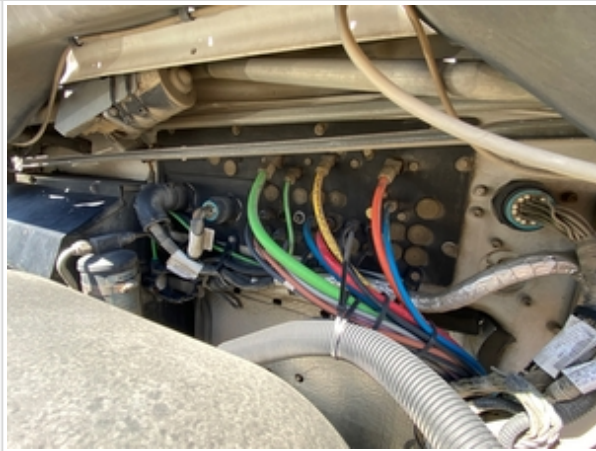
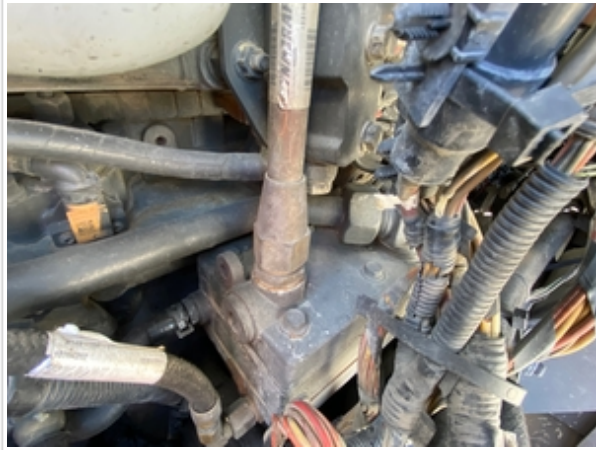
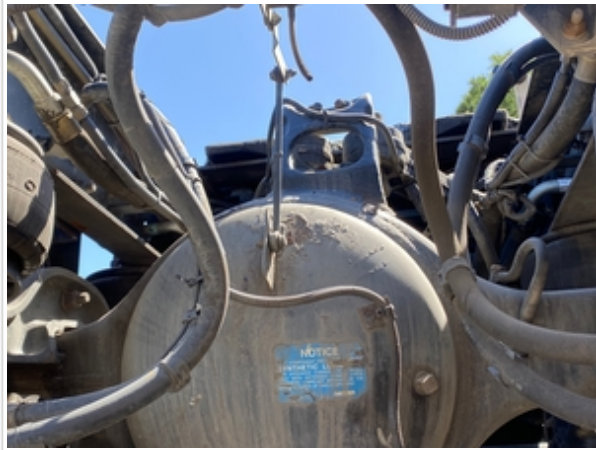
Air Brake System Photos

Transmission Info (Make/Model)	Eaton 13 Speed Manual Transmission
Transmission	3 - Normal Wear & Tear
Transmission Condition	No unusual noises or vibrations
PTO	3 - Normal Wear & Tear
Differential	Check condition of the differential(s). Take photos and notes as relevant.
Rear Differential	3 - Normal Wear & Tear
Rear Differential Condition	Dry housing appearance, no unusual noises heard during operation
Front Differential	3 - Normal Wear & Tear
Front Differential Condition	Dry housing appearance, no unusual noises heard during operation
Brake Shoe Thickness	70%
Comments	All brakes shoes have plenty of brake shoe material left
Air Brake System Leaks	No
Air Brake Hose Condition	3 - Normal Wear & Tear

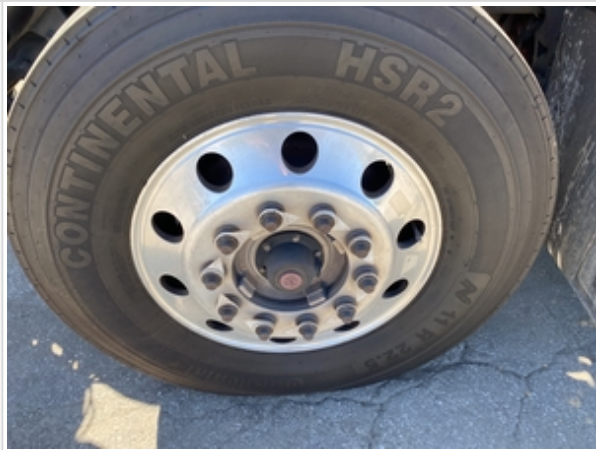
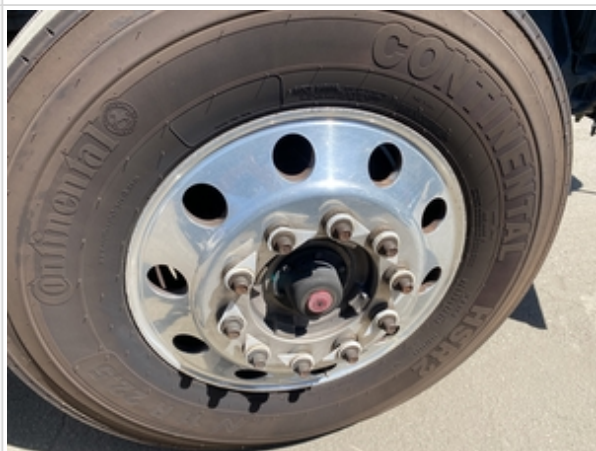
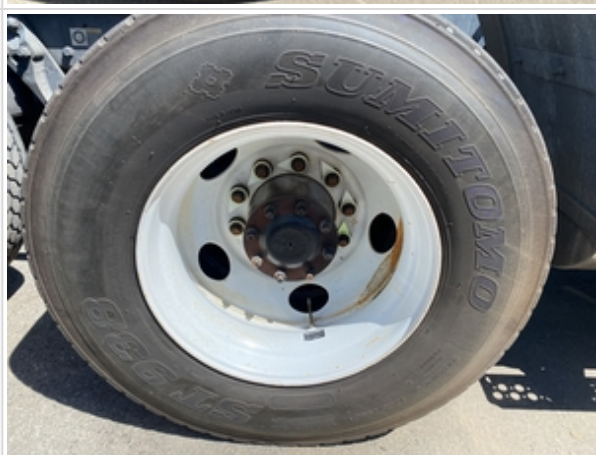
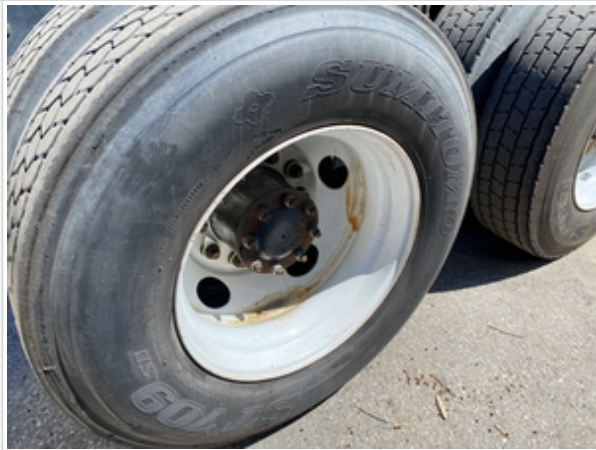
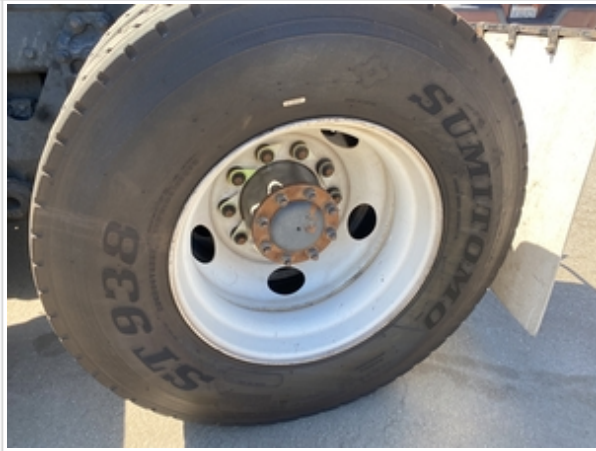
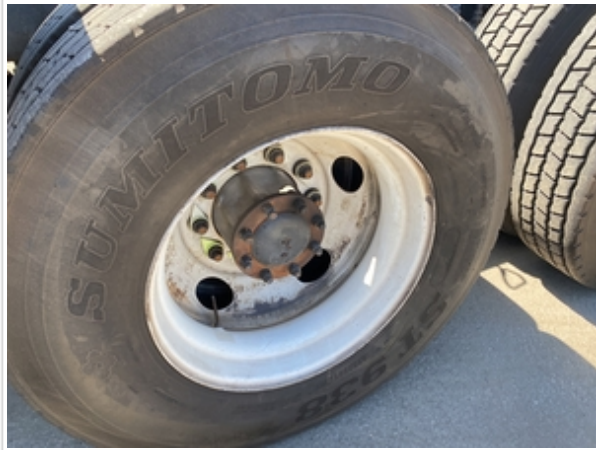
Wheels & Hub Condition	3
Wheels & Hub Photos

Wheel Seal Leaks	No
Tire Brand	Front - Continental Rear - Sumitomo (Recaps)
Tire Size	11R22.5
Front Left Tire - Ratio Remaining	70%

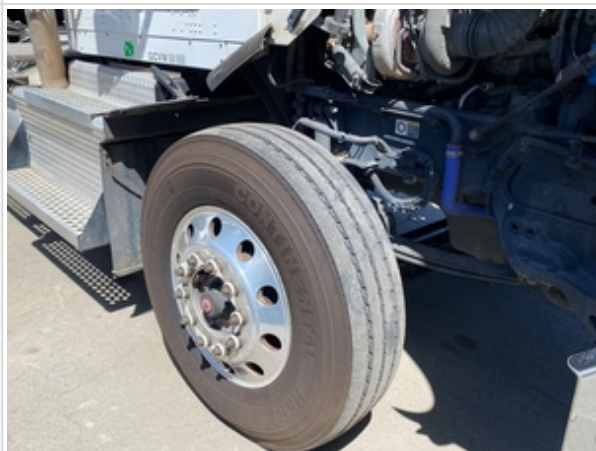
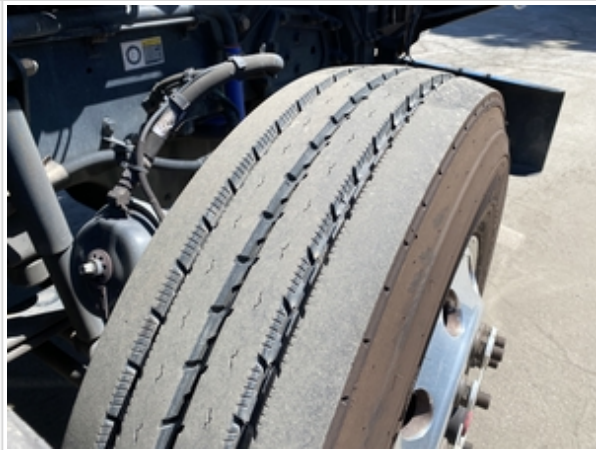
<p>Front Right Tire - Ratio Remaining</p>	<p>70%</p>
<p>Front Right Tire Photos</p>

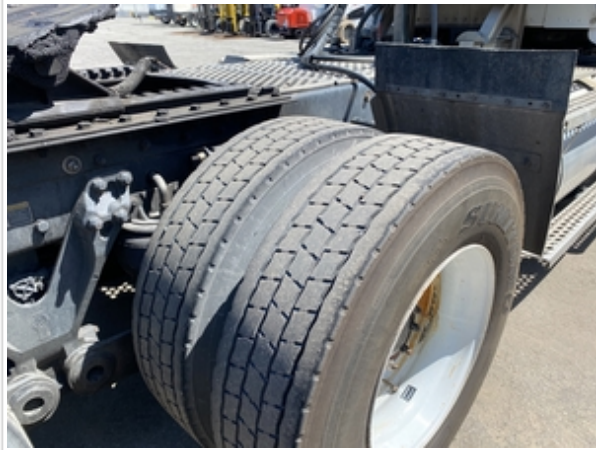
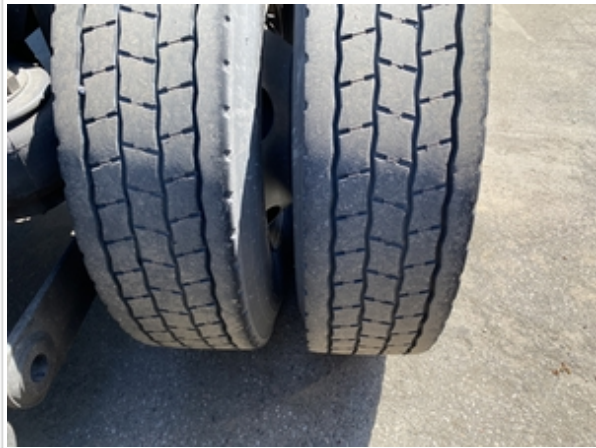
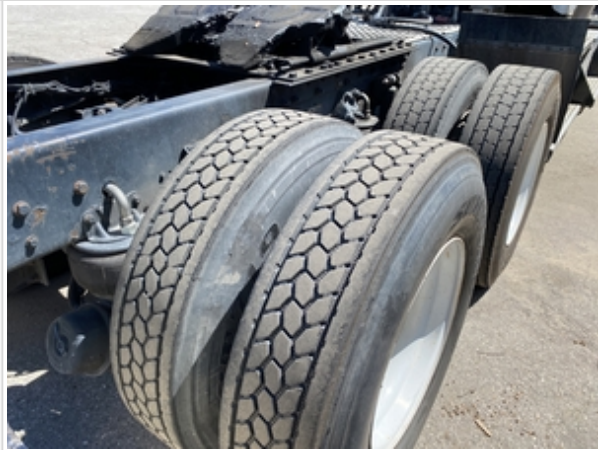
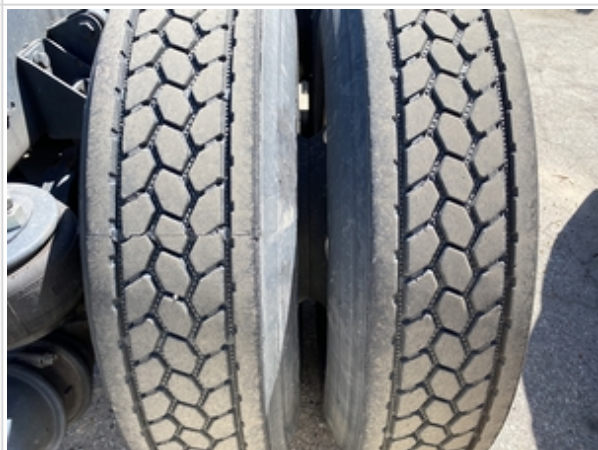
<p>Rear Right Tire - Ratio Remaining</p>	<p>50%</p>
<p>Rear Right Tire Photos</p>

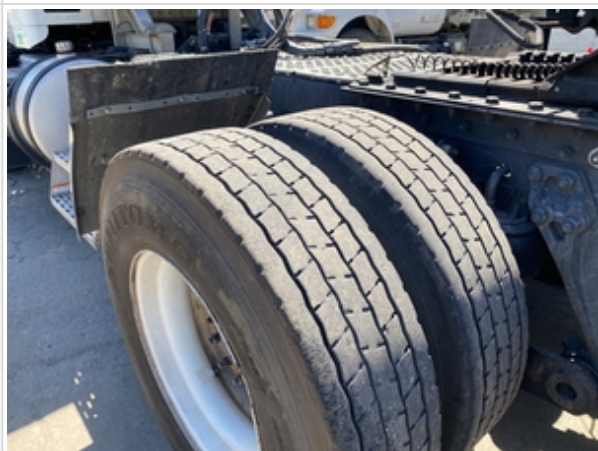
Rear Left Tire - Ratio Remaining	50%	
Rear Left Tire Photos
