Inspection Report (Skip Loader)

Year	2006
Make	John Deere
Model	210 LE
Serial Number	T0210LE885081
Hour Meter Reading	4,488 Hrs.
Previous Application (e.g., earth moving, mining, demolition, etc)	Water Treatment General Construction

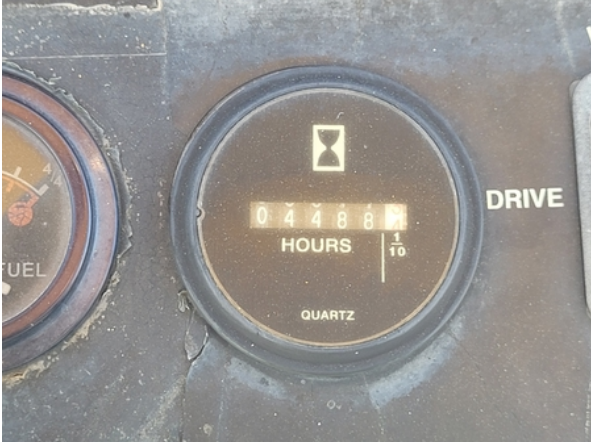
Other Gauge Activity	2 - Above Average Wear
Other Gauge Condition	Other (see comments), One or more gauges are unreadable or not functioning (specify in comments)
Comments	Fuel Gauge Inoperable

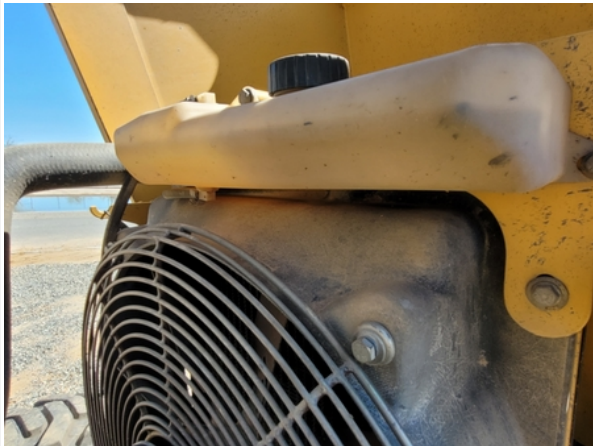
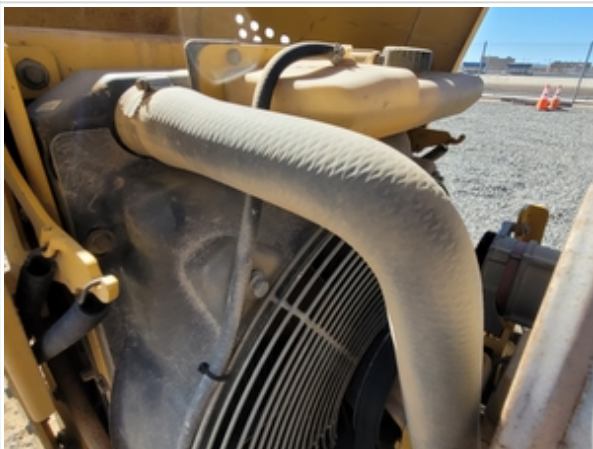
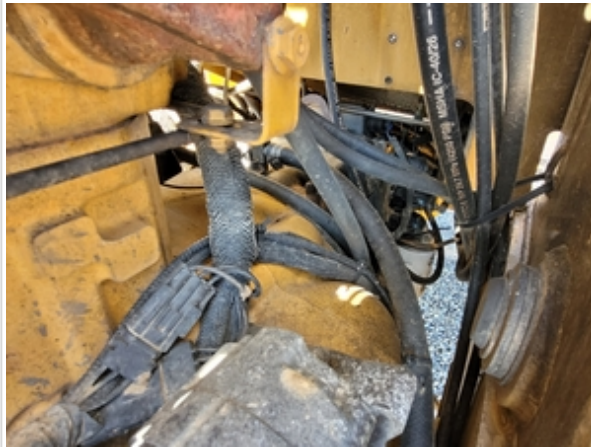
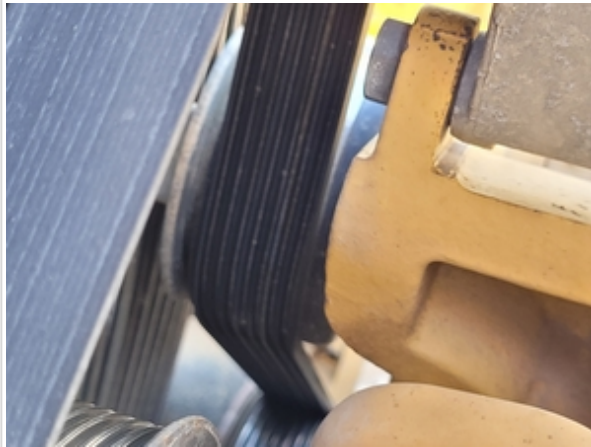
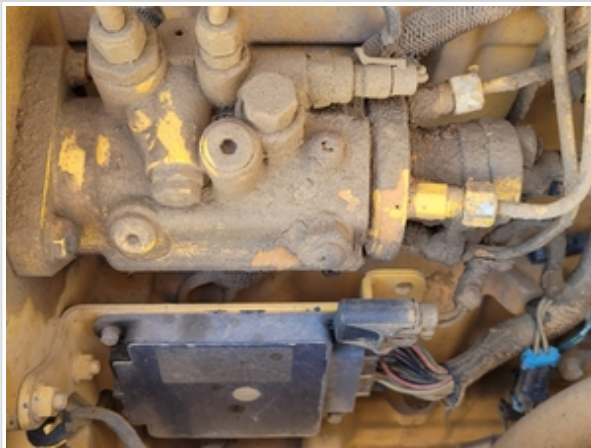
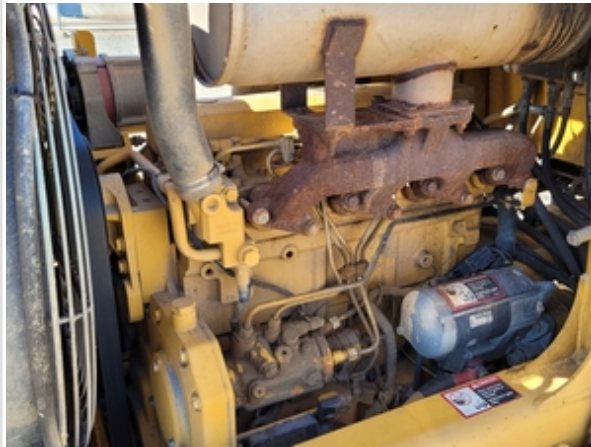
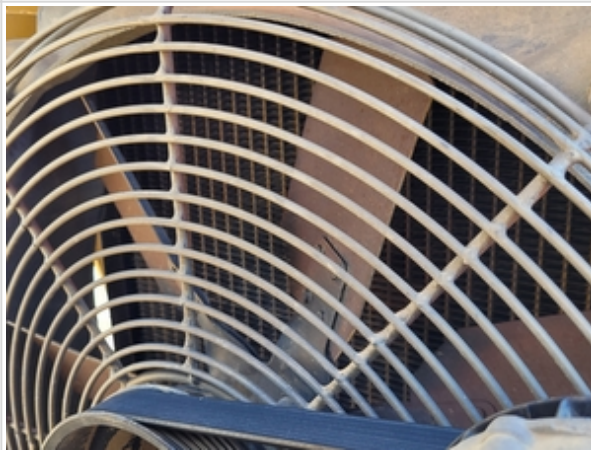
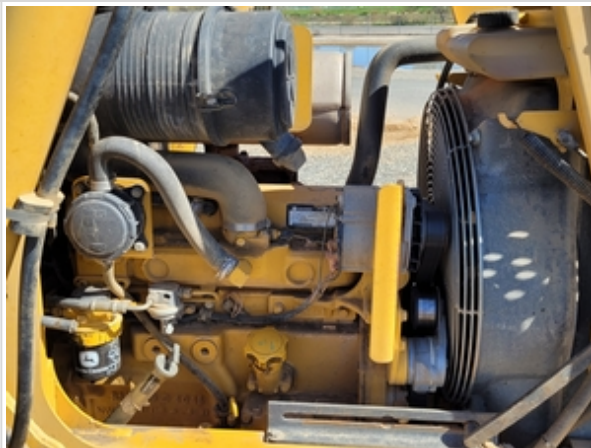
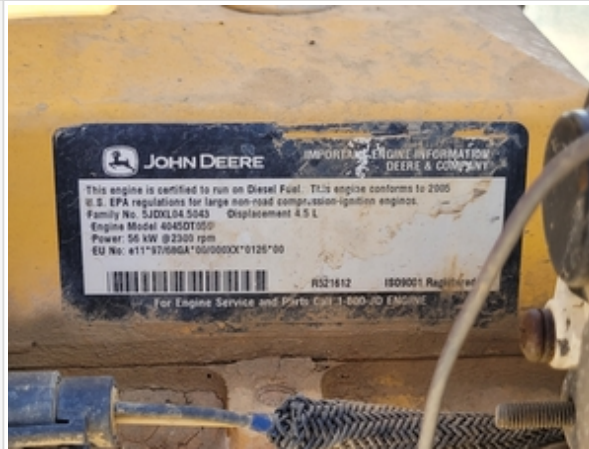
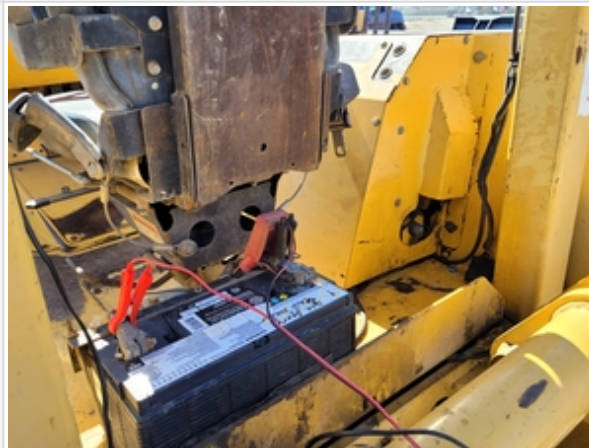
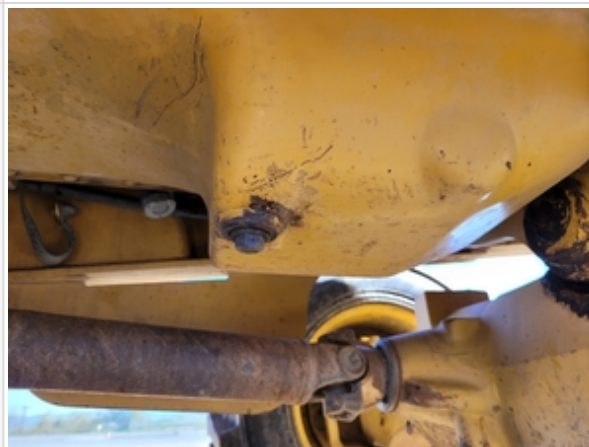
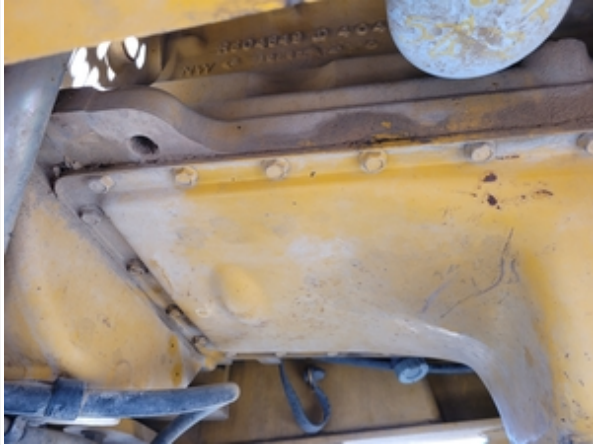
Engine Type (Make, Model, Cylinders, Hp)	John Deere - 4045DT - 4Cyl. - 4.5L - 78HP
Emissions Tier	Tier 2
Engine Serial Number	N/A
Engine Fuel Type	Diesel
Engine Photos

Blow-by (Visual Observation Check)	No
Unusual Noises (Upon Start-up, Idle, Shutdown)	No
Unusual Noise Notes	No unusual noises heard
Engine Smoke (Upon Start-up, Idle, Shutdown)	Yes
Engine Smoke Notes	Engine smoke observed upon start up, Other (see comments)
Engine Exhaust Color	Other (see comments)
Comments	Normal engine exhaust smoke observed
Battery	3 - Normal Wear & Tear
Battery Condition	Like new, recently replaced
Radiator	3 - Normal Wear & Tear
Radiator Condition	Radiator fins & components appear to be in good working order, no signs of damage or leaks
Belts	3 - Normal Wear & Tear
Belt Condition	Belts appear in good condition & alignment with proper tension
Hoses	3 - Normal Wear & Tear
Hose Condition	Firm, pliant hoses with no signs of wear or leaks
Water Pump	3 - Normal Wear & Tear
Water Pump Condition	No unusual pump noises heard
Cooling System Leaks	No
Coolant Color / Appearance	3 - Normal Wear & Tear

Coolant Color/Appearance Notes	Normal Translucent appearance, no visual signs of contamination
Oil Leaks	No
Oil Color / Appearance	3 - Normal Wear & Tear
Oil Color / Appearance Notes	Clean oil appearance, no signs of cross contamination, Appropriate oil level

Fuel Leaks	No
Requires DEF (Diesel Exhaust Fluid)	No
Overall Engine Appearance	Clean & dry
Overall Engine Comments	Overall engine has well maintained appearance with no active leaks or obvious issues observed.

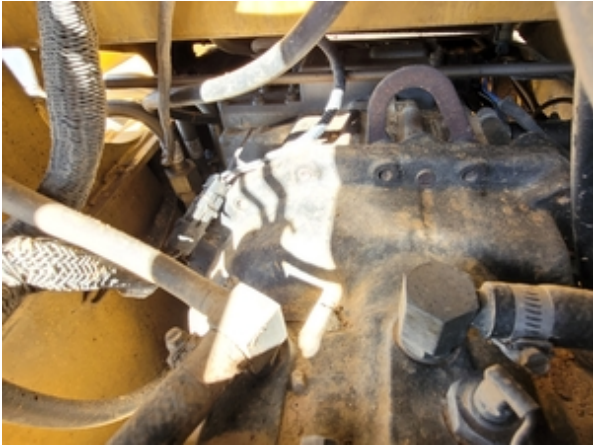
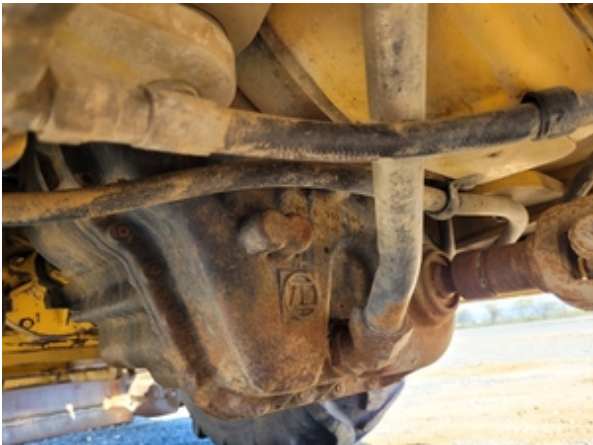
Hydrostatic Transmission?	No	
Transmission Info (Make/Model/Speeds)	4 Speed Powershift with MFWD (AWD)	
Transmission	3 - Normal Wear & Tear	
Transmission Condition	No unusual noises or vibrations, Other (see comments)	
Comments	Transmission	
Transmission Photos

Shift Lever Condition	Good forward and reverse function
Foot Brake	3 - Normal Wear & Tear
Foot Brake Condition	Good brake function
Inching Brake	0
Parking Brake	3 - Normal Wear & Tear
Parking Brake Condition	Good brake function
Overall Drivetrain Comments	Overall drivetrain components in good condition with possible minor leak seen at rear axle area. Parking brake working properly. Transmission shifts okay through all gears. Transmission not working at optimal performance. Transmission hesitation observed through 2nd, 3rd, and 4th gear to reach full speed. Further transmission diag. Recommended.

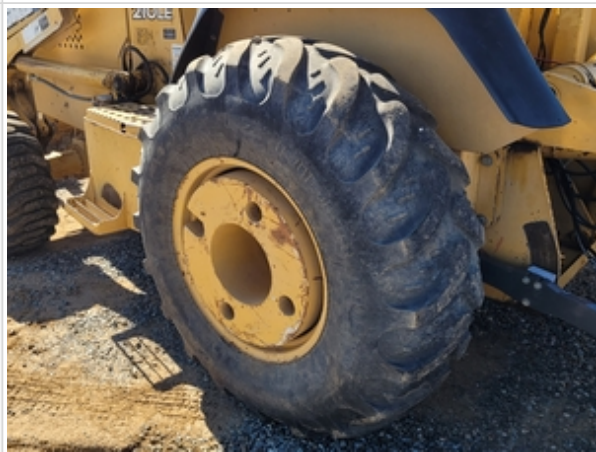
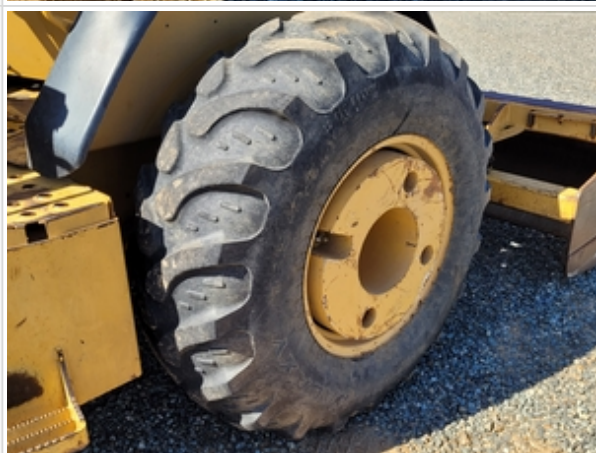
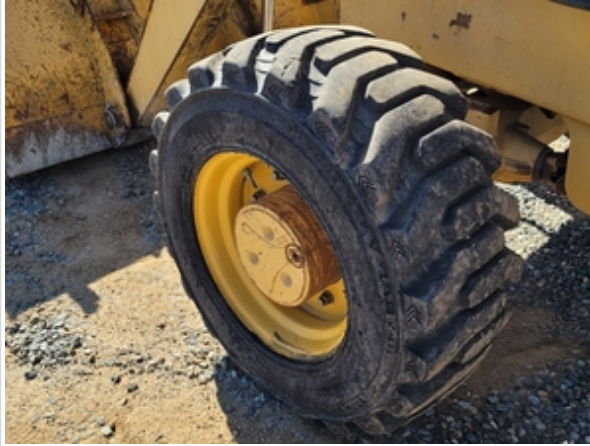
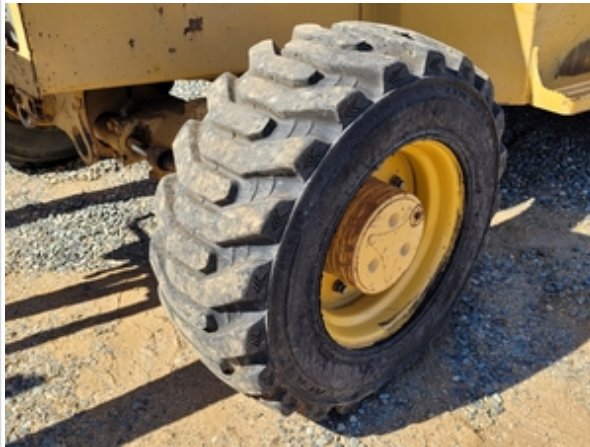
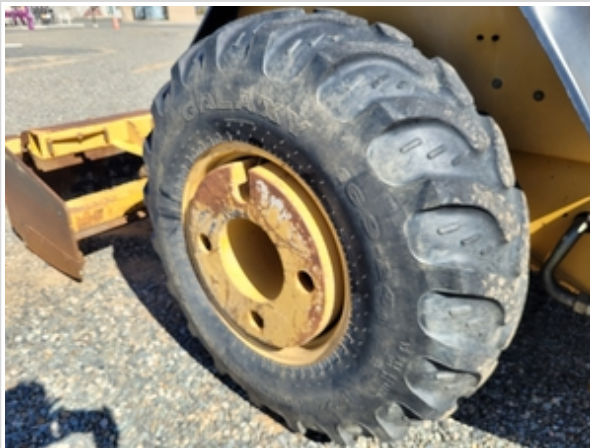
Wheels & Tires	3 - Normal Wear & Tear
Wheels & Tires Photos

Tire Brand	Front & Rear - Galaxy	
Tire Size	Front - 12x16.5. Rear - 16.9-24	
Front Left Tire - Ratio Remaining	70%	
Rear Left Tire - Ratio Remaining	30%	
Front Right Tire - Ratio Remaining	70%	
Rear Right Tire - Ratio Remaining	30%	
Lift Arm	3 - Normal Wear & Tear	
Lift Arm Photos

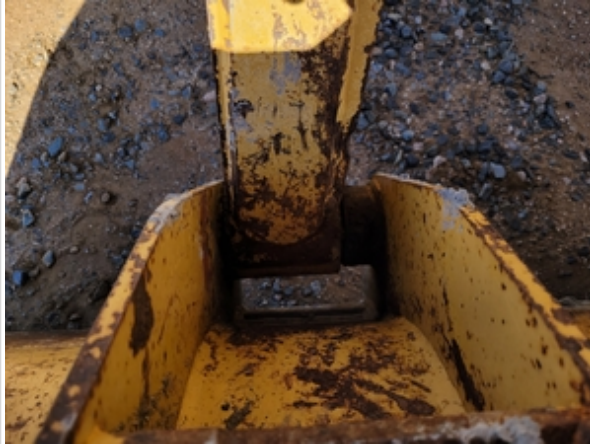
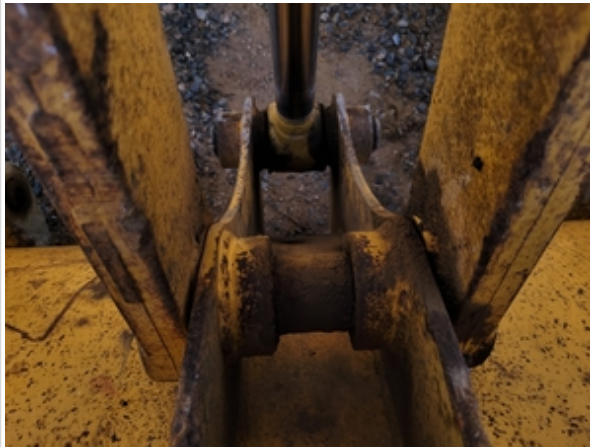
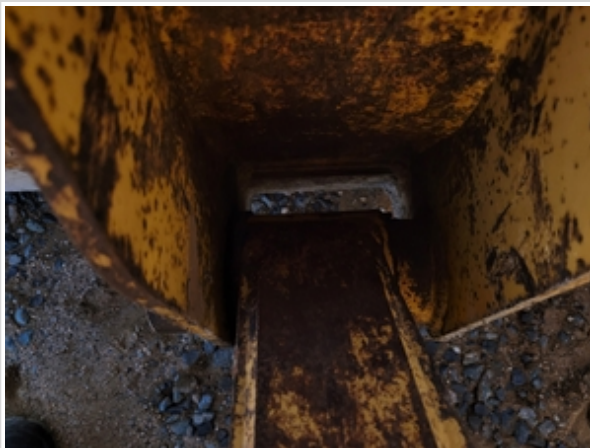
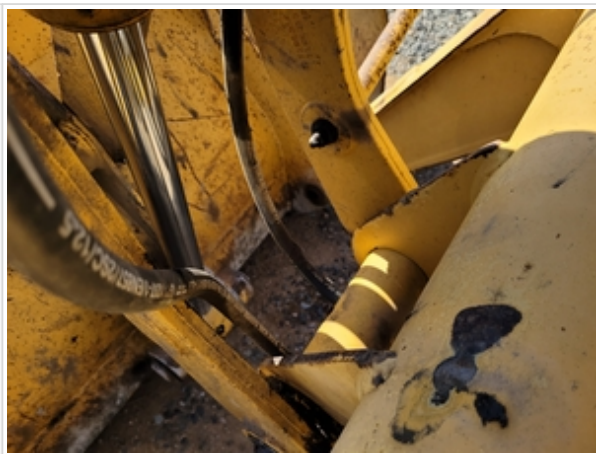
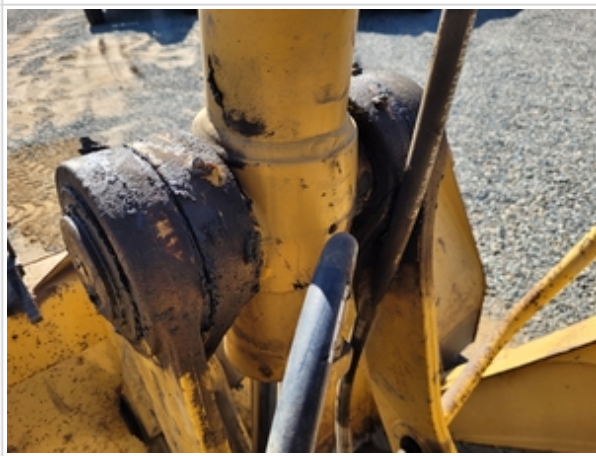
Chassis to Arm Pins Photos

Chassis to Arm Pins	3 - Normal Wear & Tear

Tilt Linkage	3 - Normal Wear & Tear
Tilt Linkage Pins & Bushings	3 - Normal Wear & Tear
Bucket to Arm Pins	3 - Normal Wear & Tear
Overall Chassis	3 - Normal Wear & Tear
Overall Chassis Comments	Overall Chassis has healthy appearance with no obvious issues seen or excessive play observed in implements.

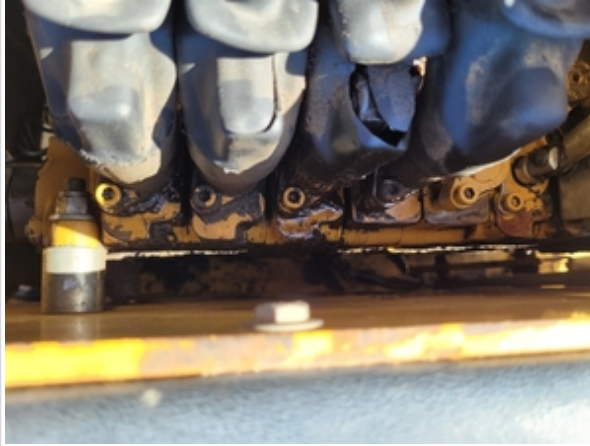
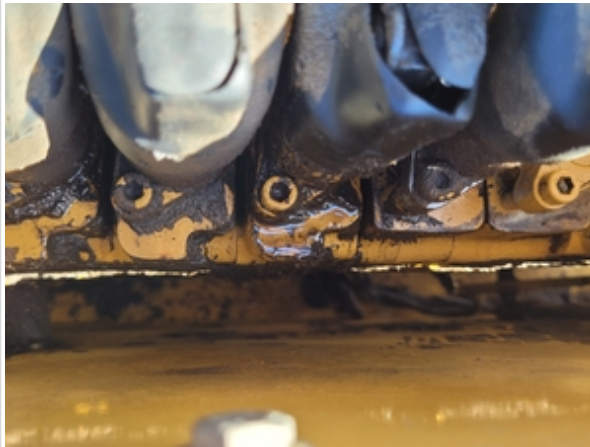
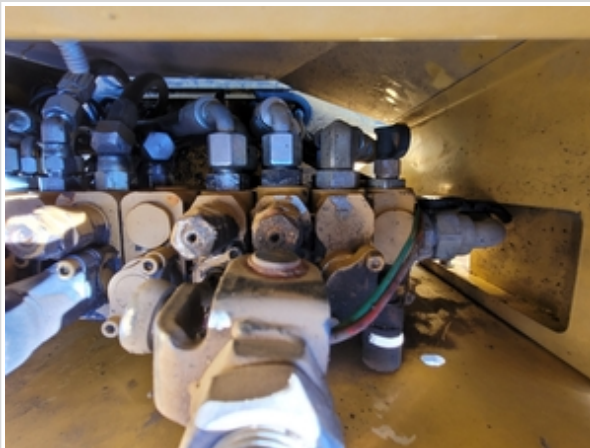
Hydraulic System Photos

Wet or Damp Hydraulic Lines / Fittings	Yes	
Appearance of Hydraulic Lines / Fittings	3 - Normal Wear & Tear	
Hydraulic Lines / Fittings Condition	Hydraulic lines & fittings are clean and in good condition, Other (see comments)	
Comments	Small leak observed at rear Gannon (Box) control valve	
Unusual Noises (Hydraulic Pump)	No	
Hydraulic Pump Notes	No unusual noises heard during operation	
Comments	Hydraulics operating well with main functions.

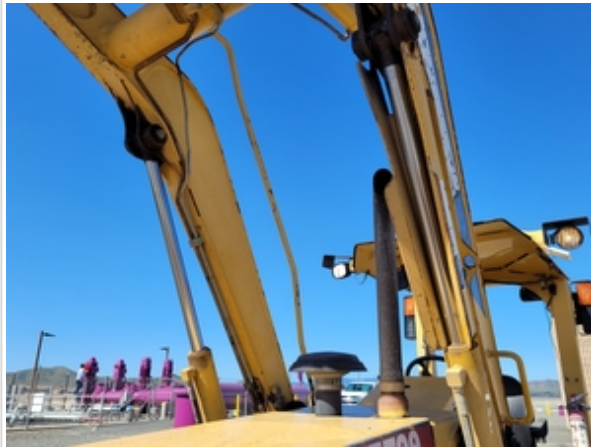
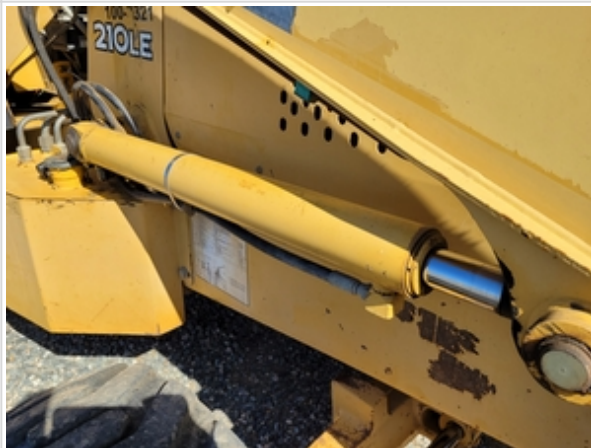
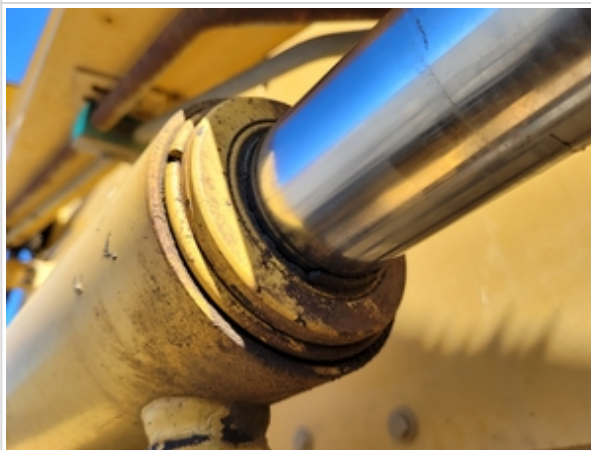
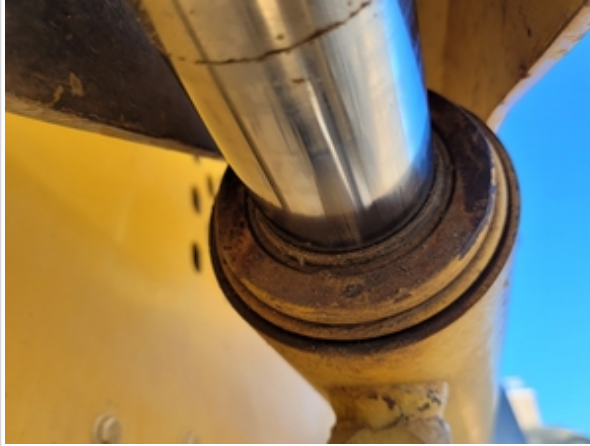
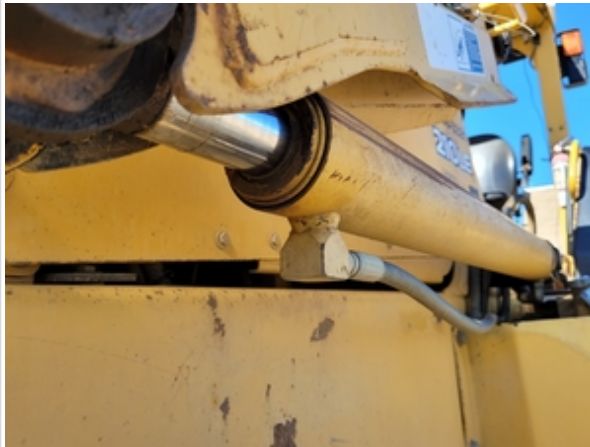
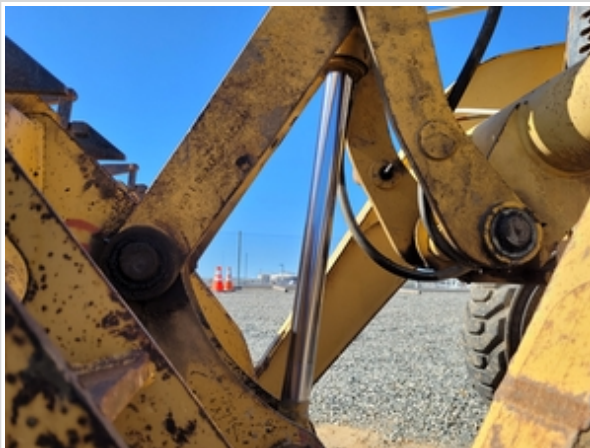
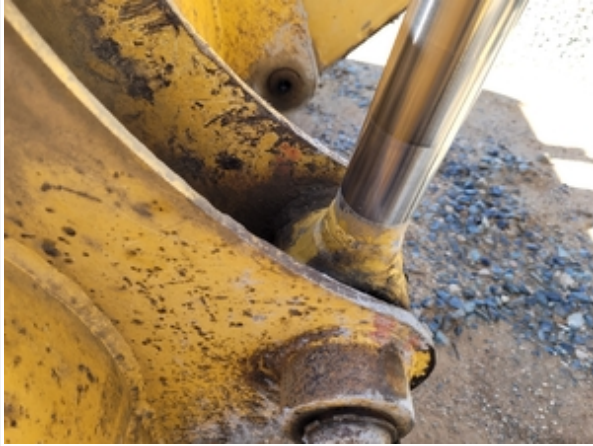
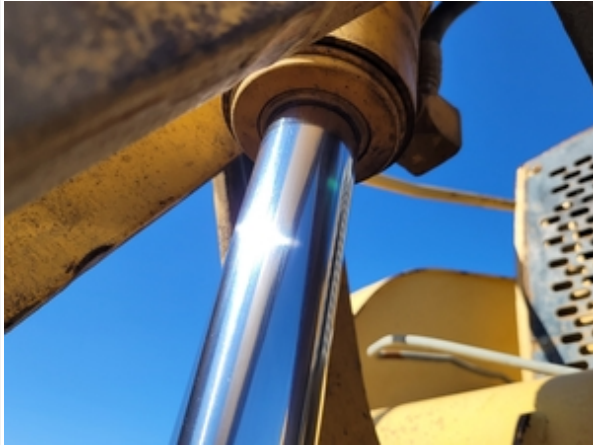
Bucket Lift / Tilt Cylinders Photos

Bucket Lift / Tilt Cylinders	Check the bucket lift and tilt cylinders. Note any wear, pitting, discoloration, etc. Take photos.
Bucket Lift / Tilt Cylinders: Mounting Pin	3
Bucket Lift / Tilt Cylinders: Oil Leaks	No

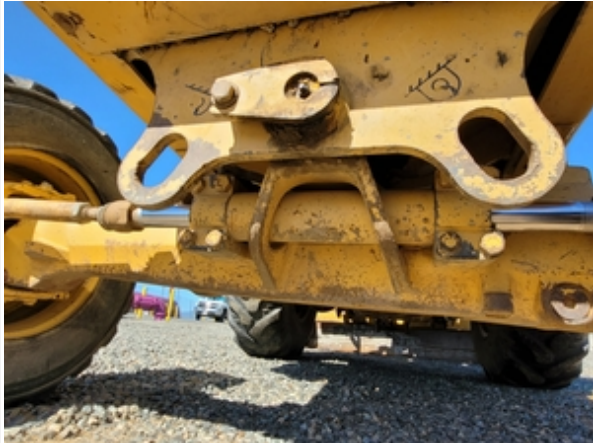
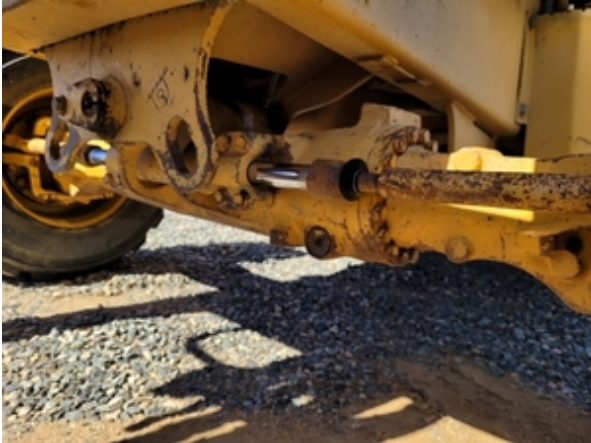
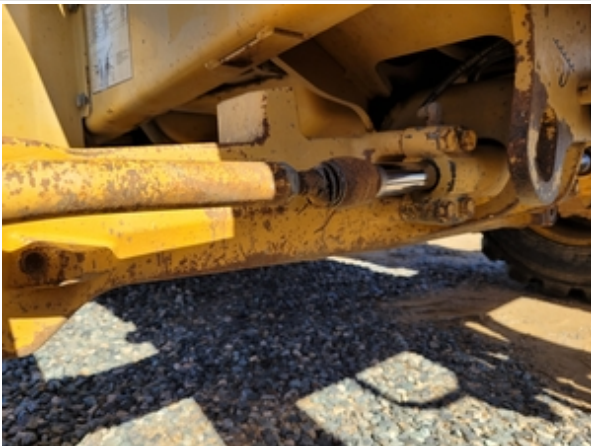
Steering Cylinder	Check the steering cylinder. Note any wear, pitting, discoloration, etc. Take photos.	
Steering Cylinder: Mounting Pin	3	
Steering Cylinder: Oil Leaks	No	
Steering Cylinder Photos

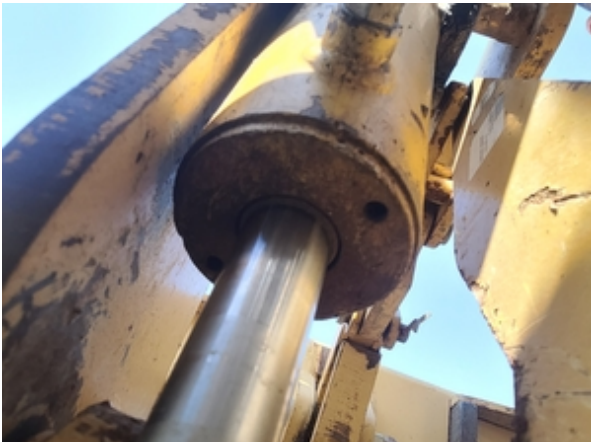
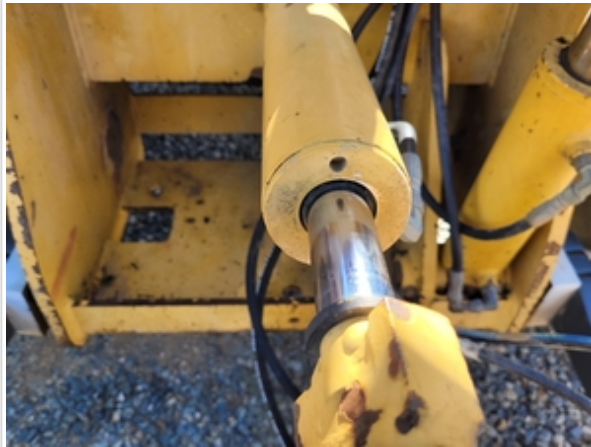
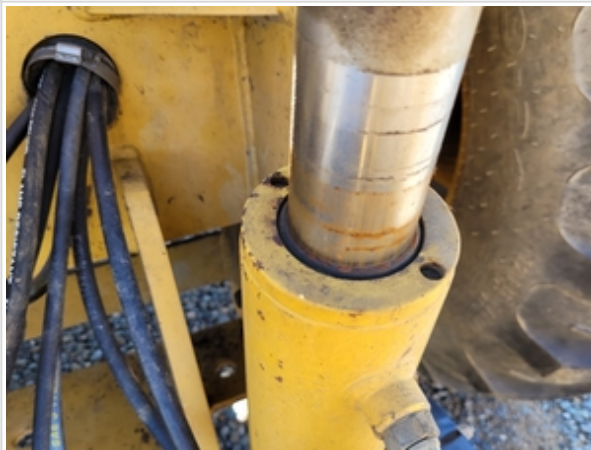
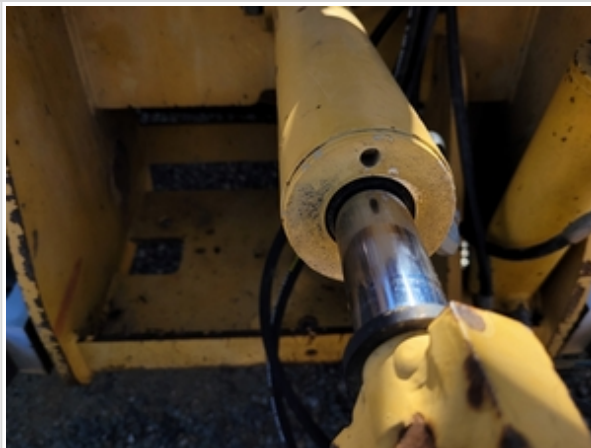
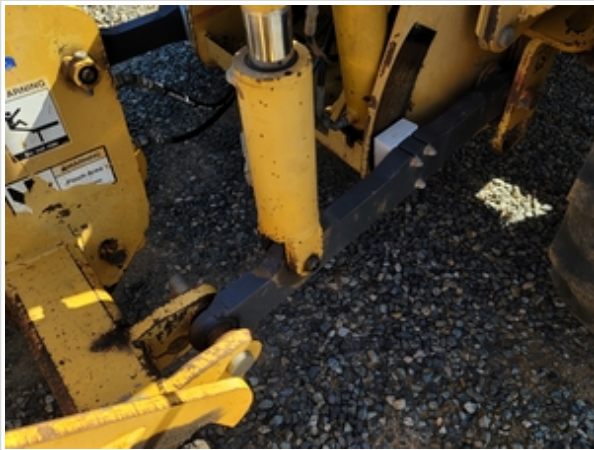
Box Cylinders	Check the box blade cylinders. Note any wear, pitting, discoloration, etc. Take photos.	
Box Cylinders: Mounting Pin	3	
Box Cylinders: Oil Leaks	No	
Box Cylinders Photos

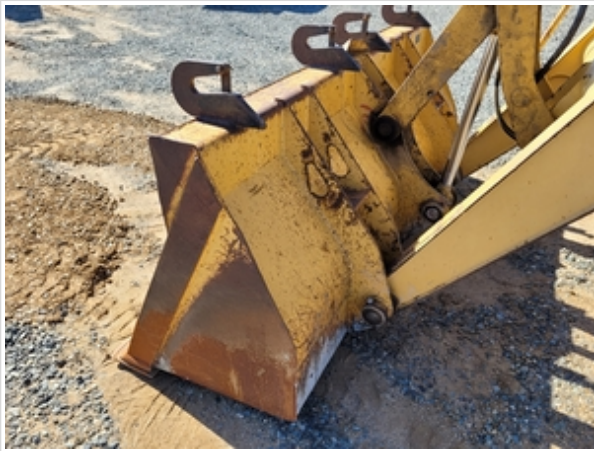
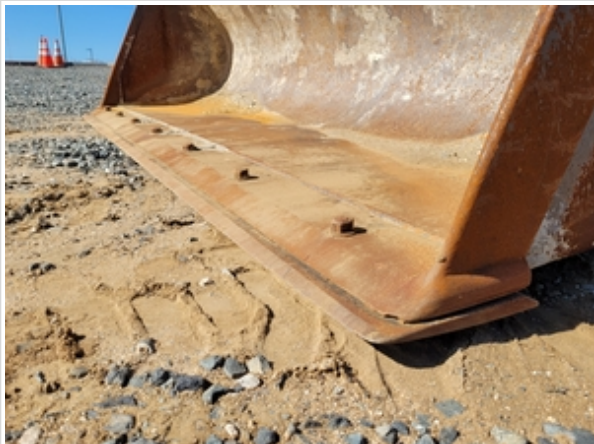
Bucket	3 - Normal Wear & Tear
Bucket Photos

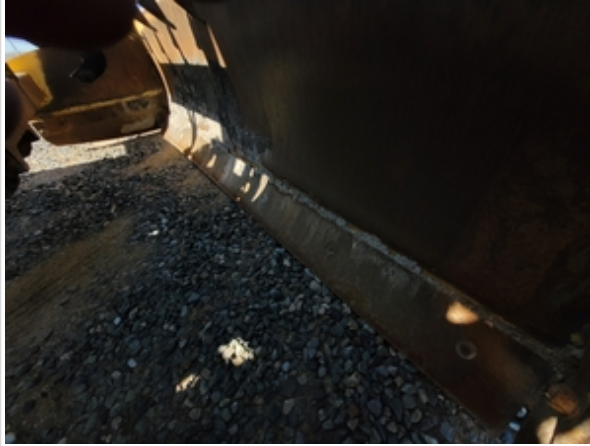
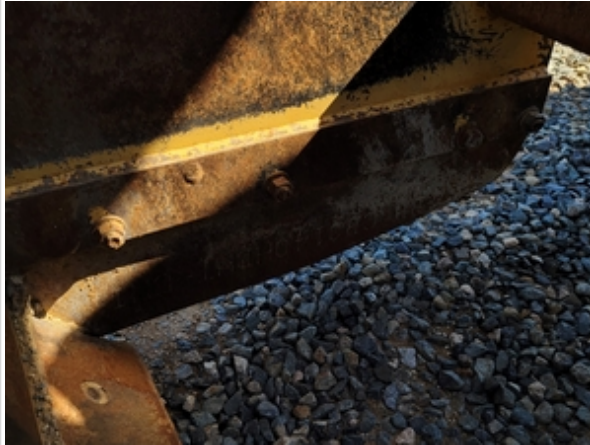
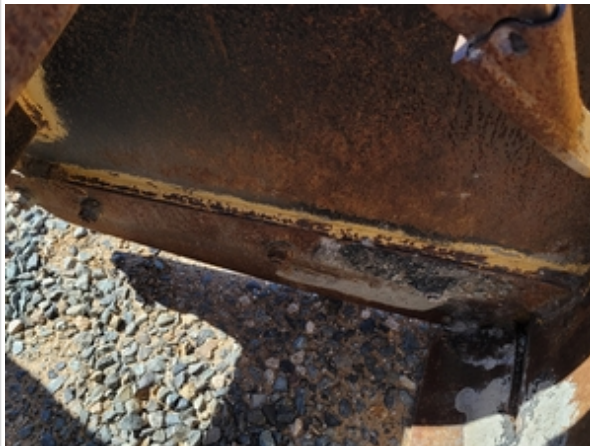
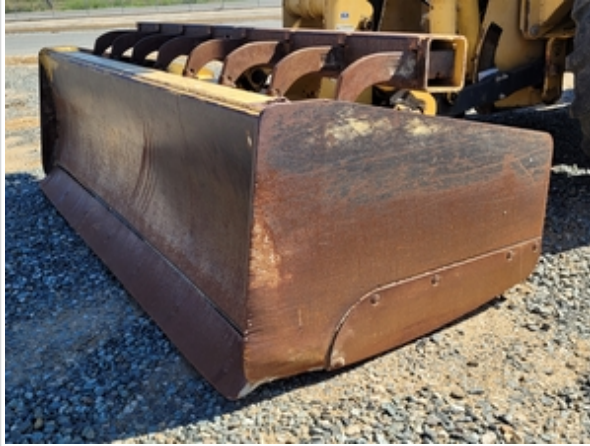
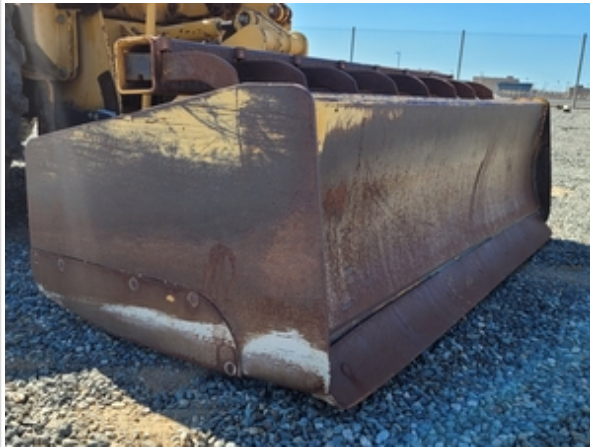
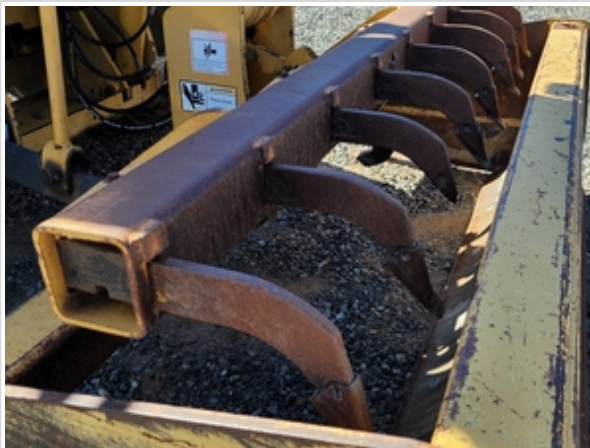
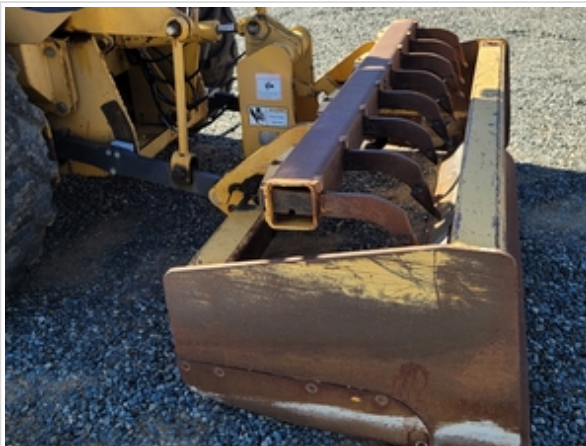
Box	3 - Normal Wear & Tear	
Comments	1 Scarifier Tip missing, Cutting edges okay, Side cutters worn	
Box Photos
