Inspection Report (On-Highway Lube Truck)

Year	2012
Make	Ford
Model	F750
Serial Number	3FRNF7FA9CV417953
Truck Odometer Reading	9,282 Miles
Current Inspection / State Cert / DOT	Performed 2/2023 In accordance with 49 CFR, Part 396, FMCSR
Previous Application (e.g., earth moving, mining, demolition, etc)	Equipment Rental

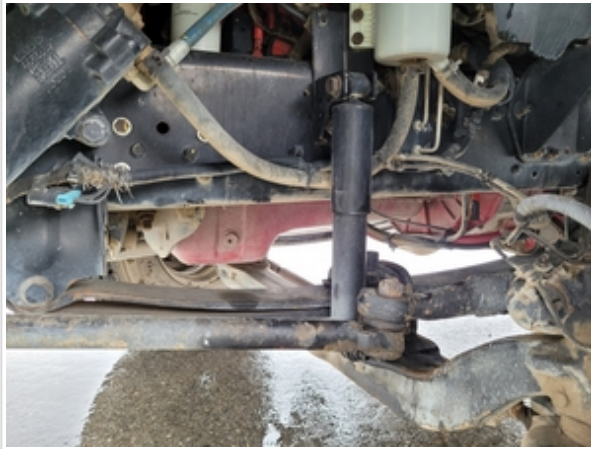
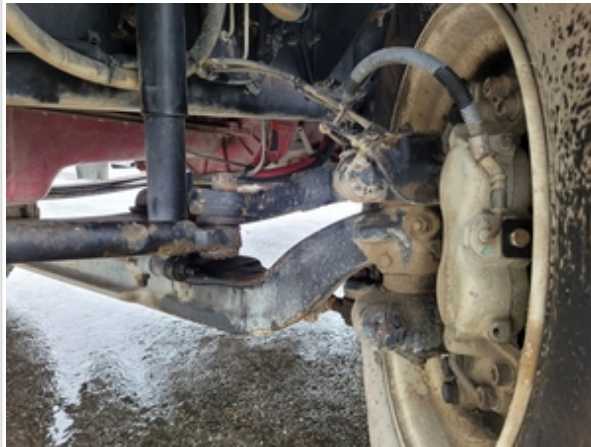
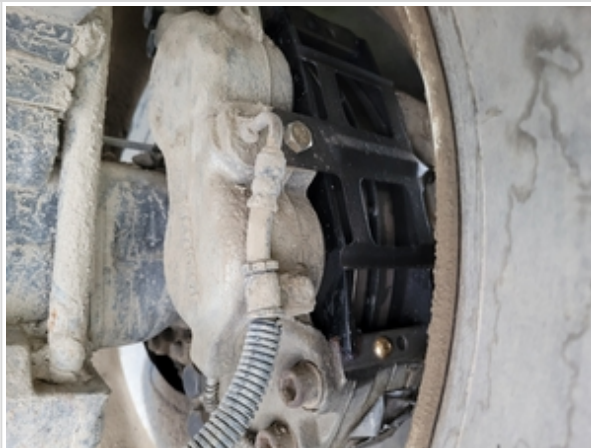
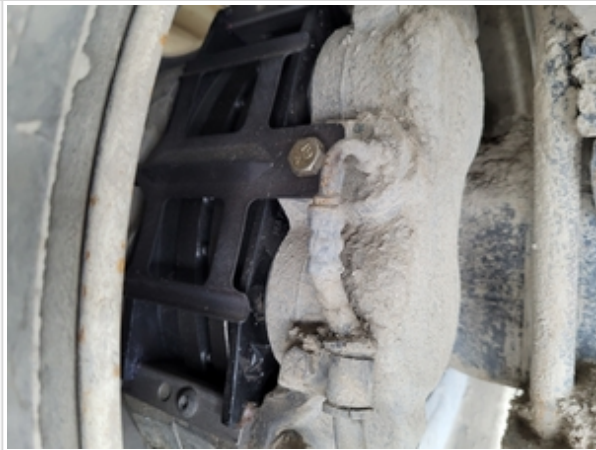
Frame	3 - Normal Wear & Tear	
Suspension	3 - Normal Wear & Tear	
Steer Axle Condition	3 - Normal Wear & Tear	
Steering Components	3 - Normal Wear & Tear	
Overall Chassis Condition	3 - Normal Wear & Tear

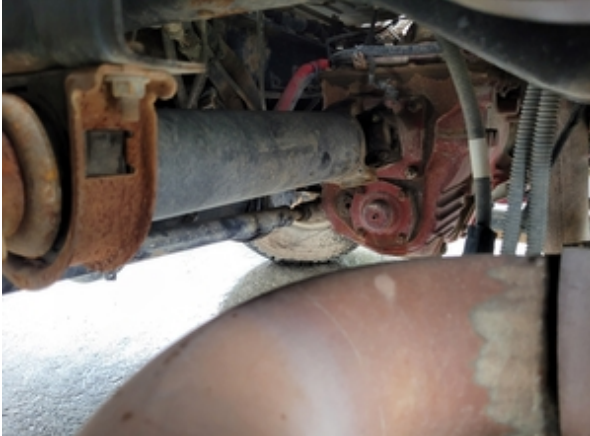
PTO	1 - Service Required	
Comments	PTO sounds like it's engaging but driveshaft to water pump not turning	
PTO Photos

Truck Hydraulics	Check the condition of the vehicle's hydraulic system
Hydraulic PTO	No
PTO Condition	2
Comments	Issue between PTO connection to outputshaft
Unusual Noises Heard	Yes
Comments	Noise seems to be related to PTO issue
Leaks Found	N/A
Hydraulic Hoses & Fittings	3
Comments	Visually okay (unable to test with water PSI)

Exterior Rating	3 - Normal Wear & Tear
Interior Rating	3 - Normal Wear & Tear
Safety Rating	3 - Normal Wear & Tear
Quality Rating	3 - Normal Wear & Tear
Functionality Rating	2 - Operable, but Diagnosis Needed
Overall Rating	3 - Normal Wear & Tear
What's Great About the Machine	Water truck is well equipped with a Valew spray system and has additional suction plumbing built in. Rear water hose reel also installed. The F750 has a durable, well maintained Cummins engine and no active leaks observed. The tires have good amount of tread left and the brakes are like new.
What Needs Work	Transmission should be further inspected for abnormal noise. The PTO system not working properly. Unable to test water truck system. Engine cranked longer than expected after sitting for a while without being started. Further diagnosis recommended to determine issue.
Any Additional Info from the Seller?	PTO system will be further inspected to determine issue.

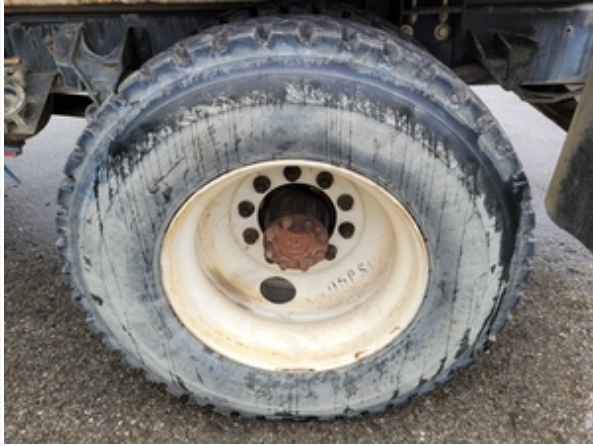
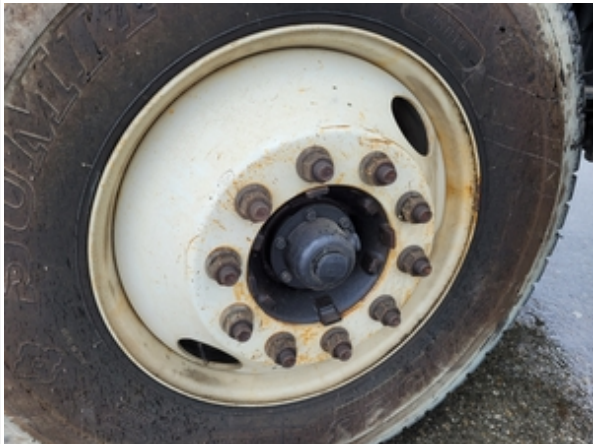
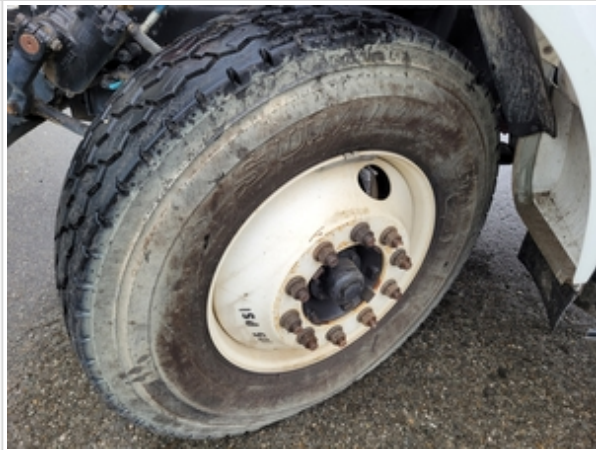
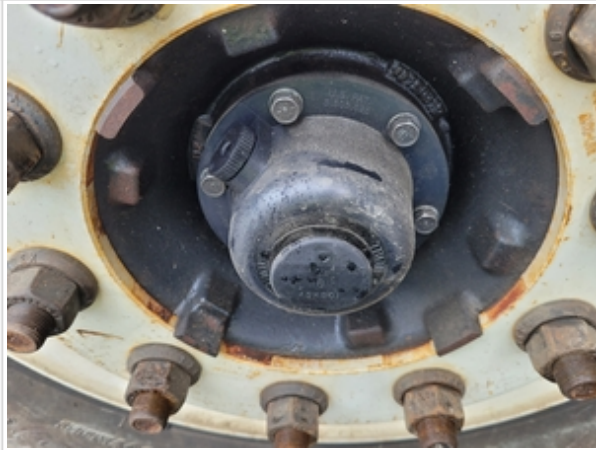
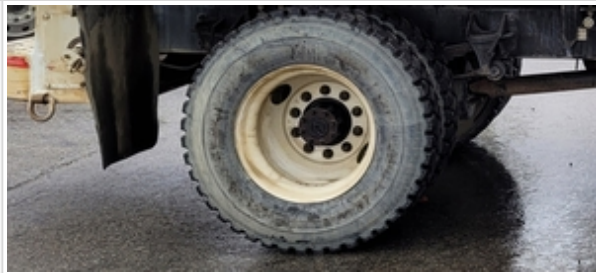
Wheels & Hub Condition	3
Wheels & Hub Photos

Wheel Seal Leaks	No
Tire Brand	Sumitomo
Tire Size	Front&Rear - 11R22.5
Front Left Tire - Ratio Remaining	50%

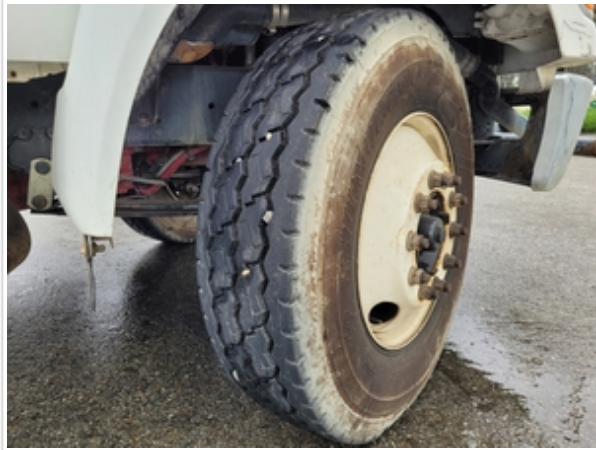
Front Right Tire - Ratio Remaining	50%
Front Right Tire Photos

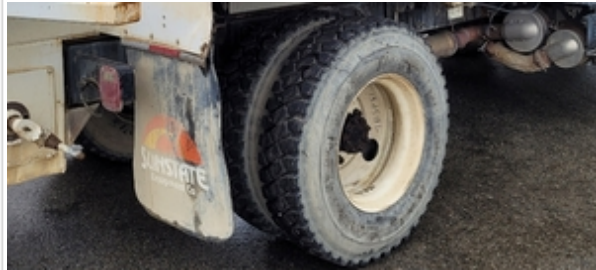
Rear Right Tire - Ratio Remaining	50%
Rear Right Tire Photos

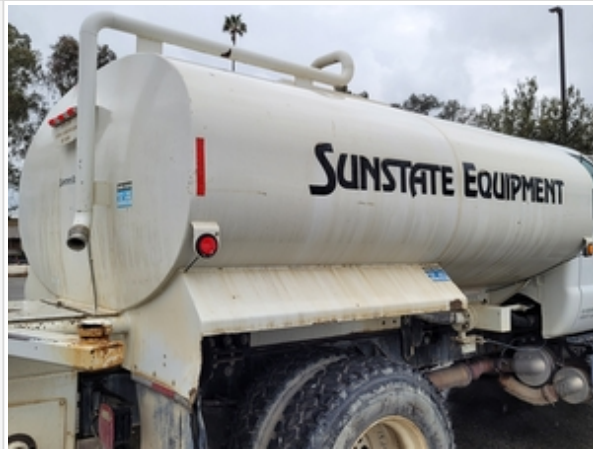
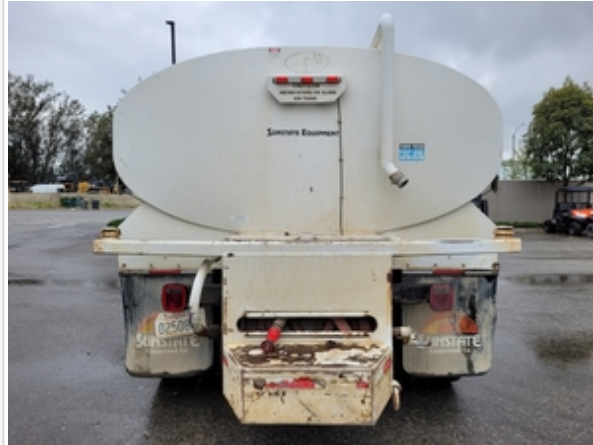
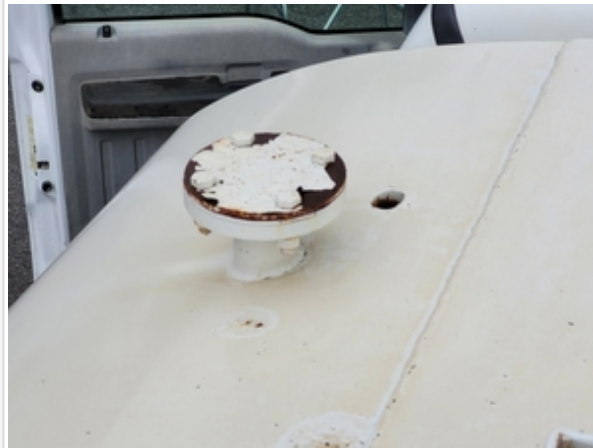
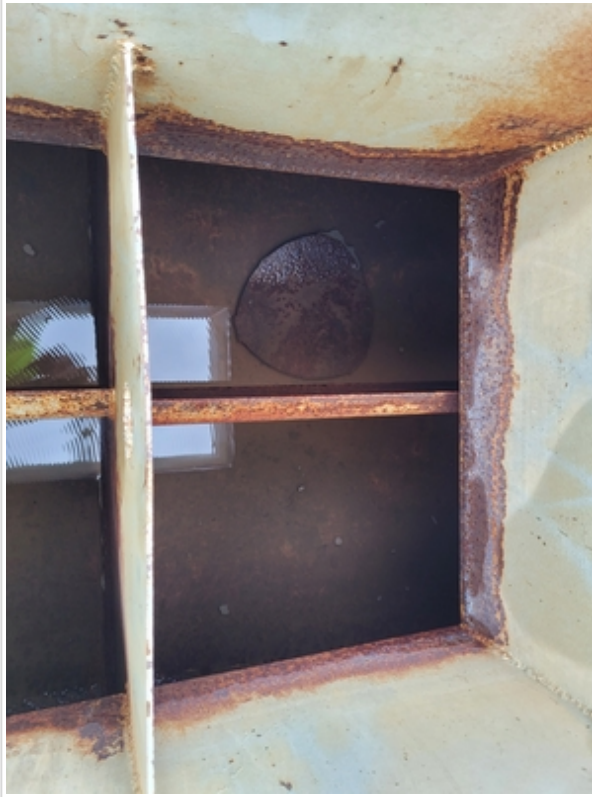
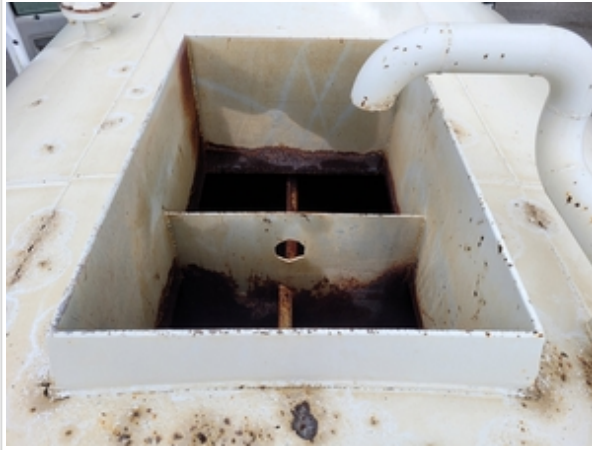
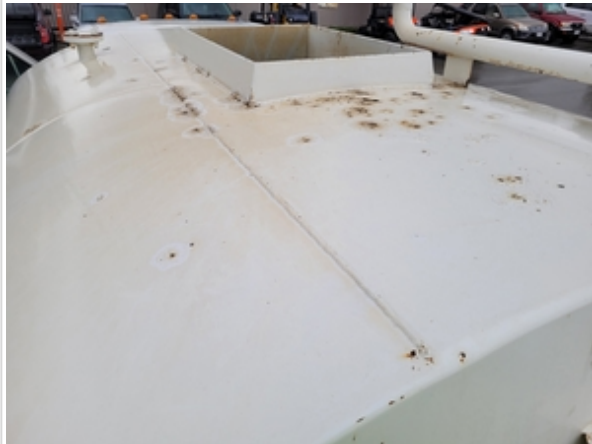
Exterior Tank(s) Photos	 
-------------------------	--

Oil & Fluid Reservoirs	Check the condition of the vehicle's hydraulic system
Number of Tanks	1
Pumps Installed on Tanks	Yes
Number of Pumps	1
Tank Configuration (Contents, Capacities)	Valew 2,000 Gal. Water Tank with 5 sprayers and suction plumbing. Rear hose reel installed. Spray system is manually/cable operated.
Exterior Tank(s) Condition	3
Comments	Some small areas of rust buildup observed

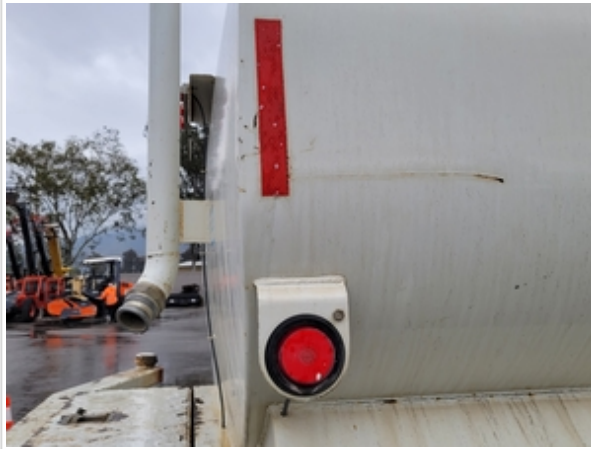
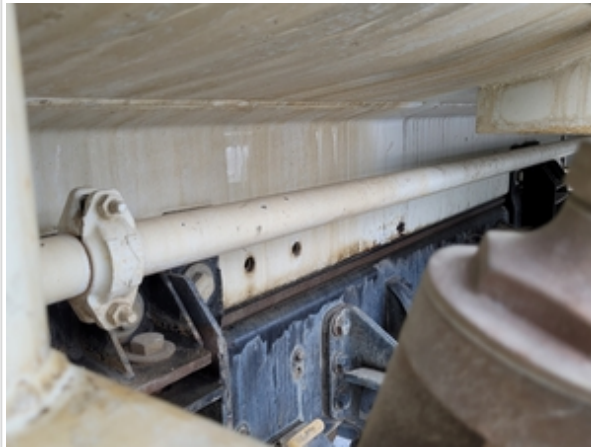
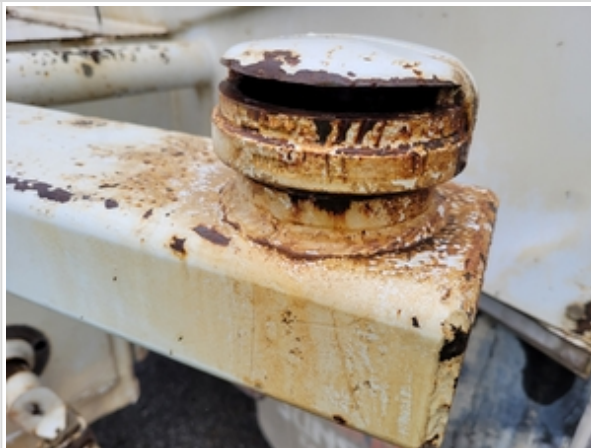
Rust on front lower side of water tank (Behind left side of Cab)

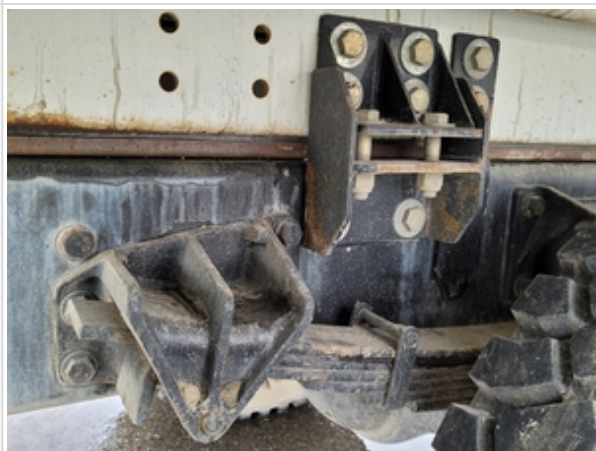
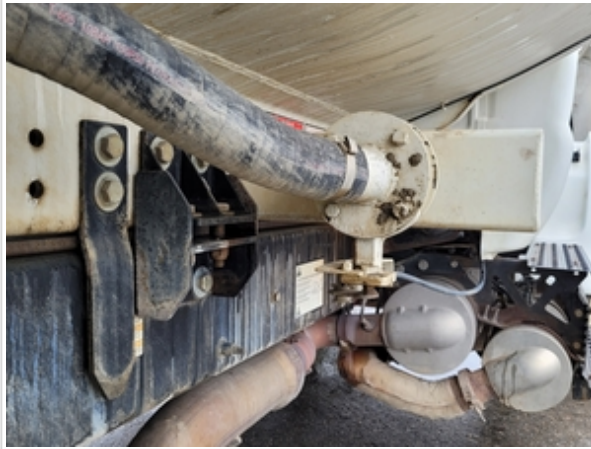
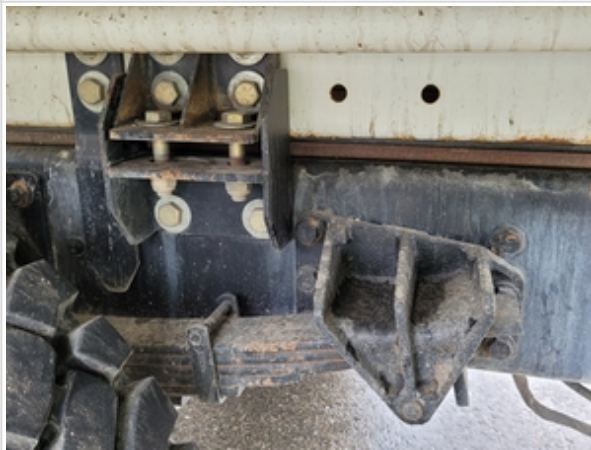
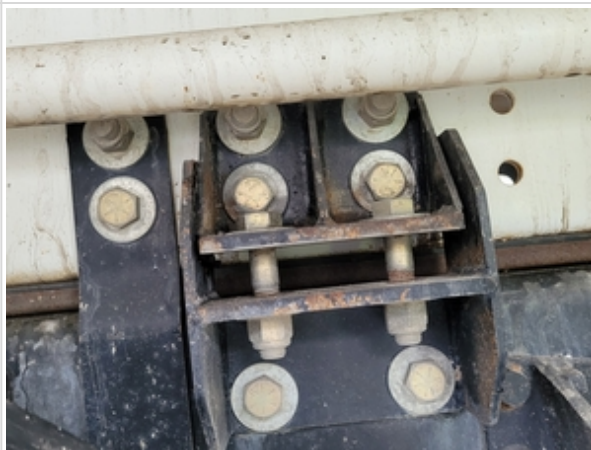
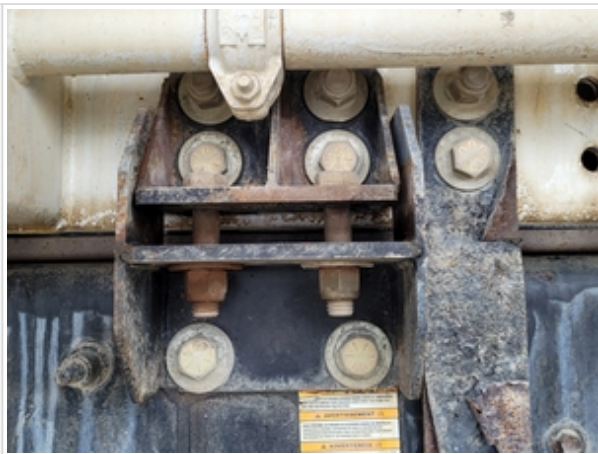
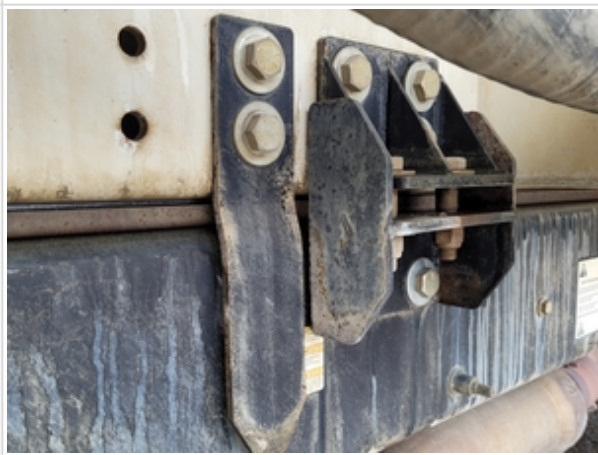
<p>Mounting Bolts</p>	<p>3</p>	
<p>Mounting Bolts Photos</p>

Interior Tank(s) Condition	3	
Comments	Normal wear and tear

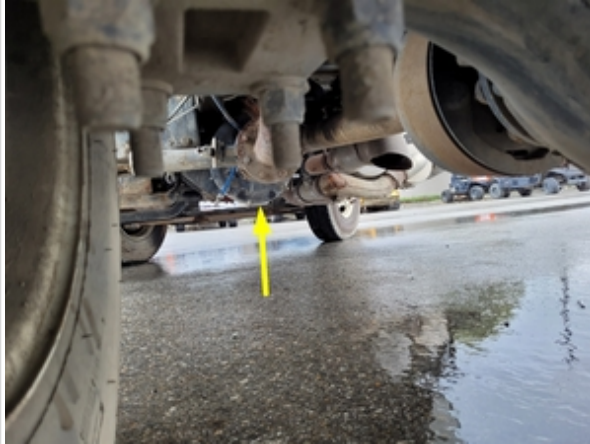
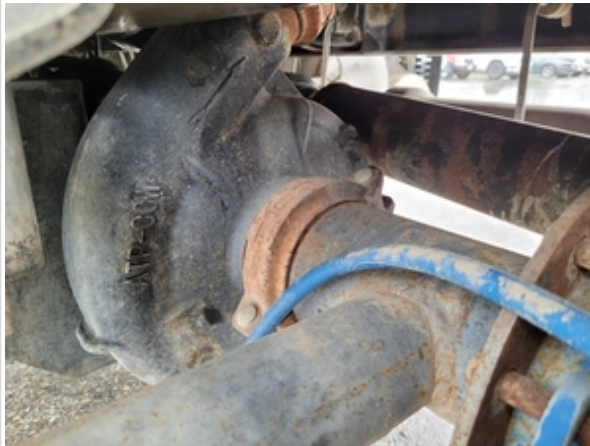
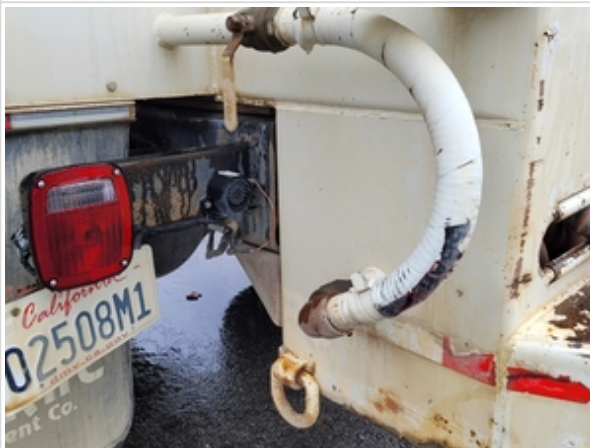
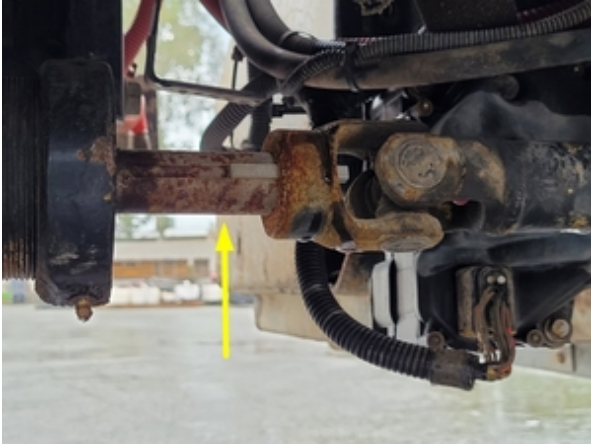
Water pump

PTO Driveshaft	
Pump(s) Functionality	1	
Comments	Unable to test spray system due to PTO issue	
Grease Pump Installed	N/A	
Hose Reels & Nozzles	3	
Comments	Rear manual hose reel installed in custom storage compartment behind tank with 1&1/2" hose	
Hose Reels & Nozzles Photos
