Inspection Report (On-Highway Dump Truck)

Year	2015
Make	Ford
Model	F550
Serial Number	FDUF5GTOFEB04931
Truck Odometer Reading	70,633
Current Inspection / State Cert / DOT	Performed 3/2023
Previous Application (e.g., earth moving, mining, demolition, etc)	Equipment Rental

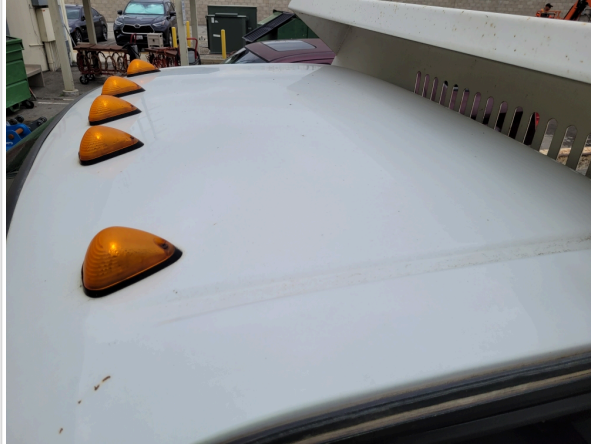
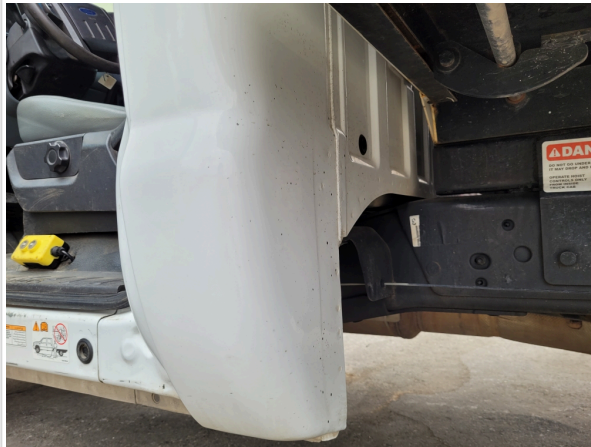
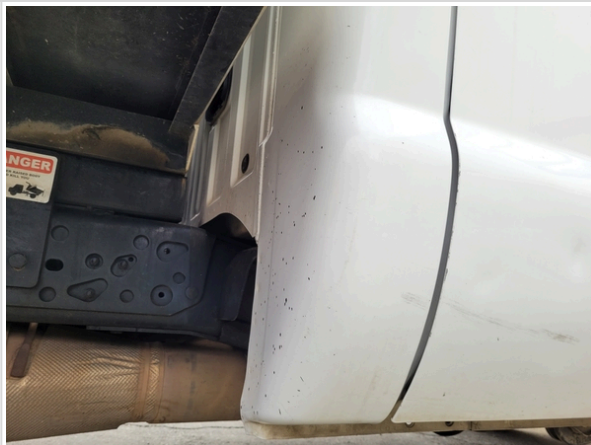
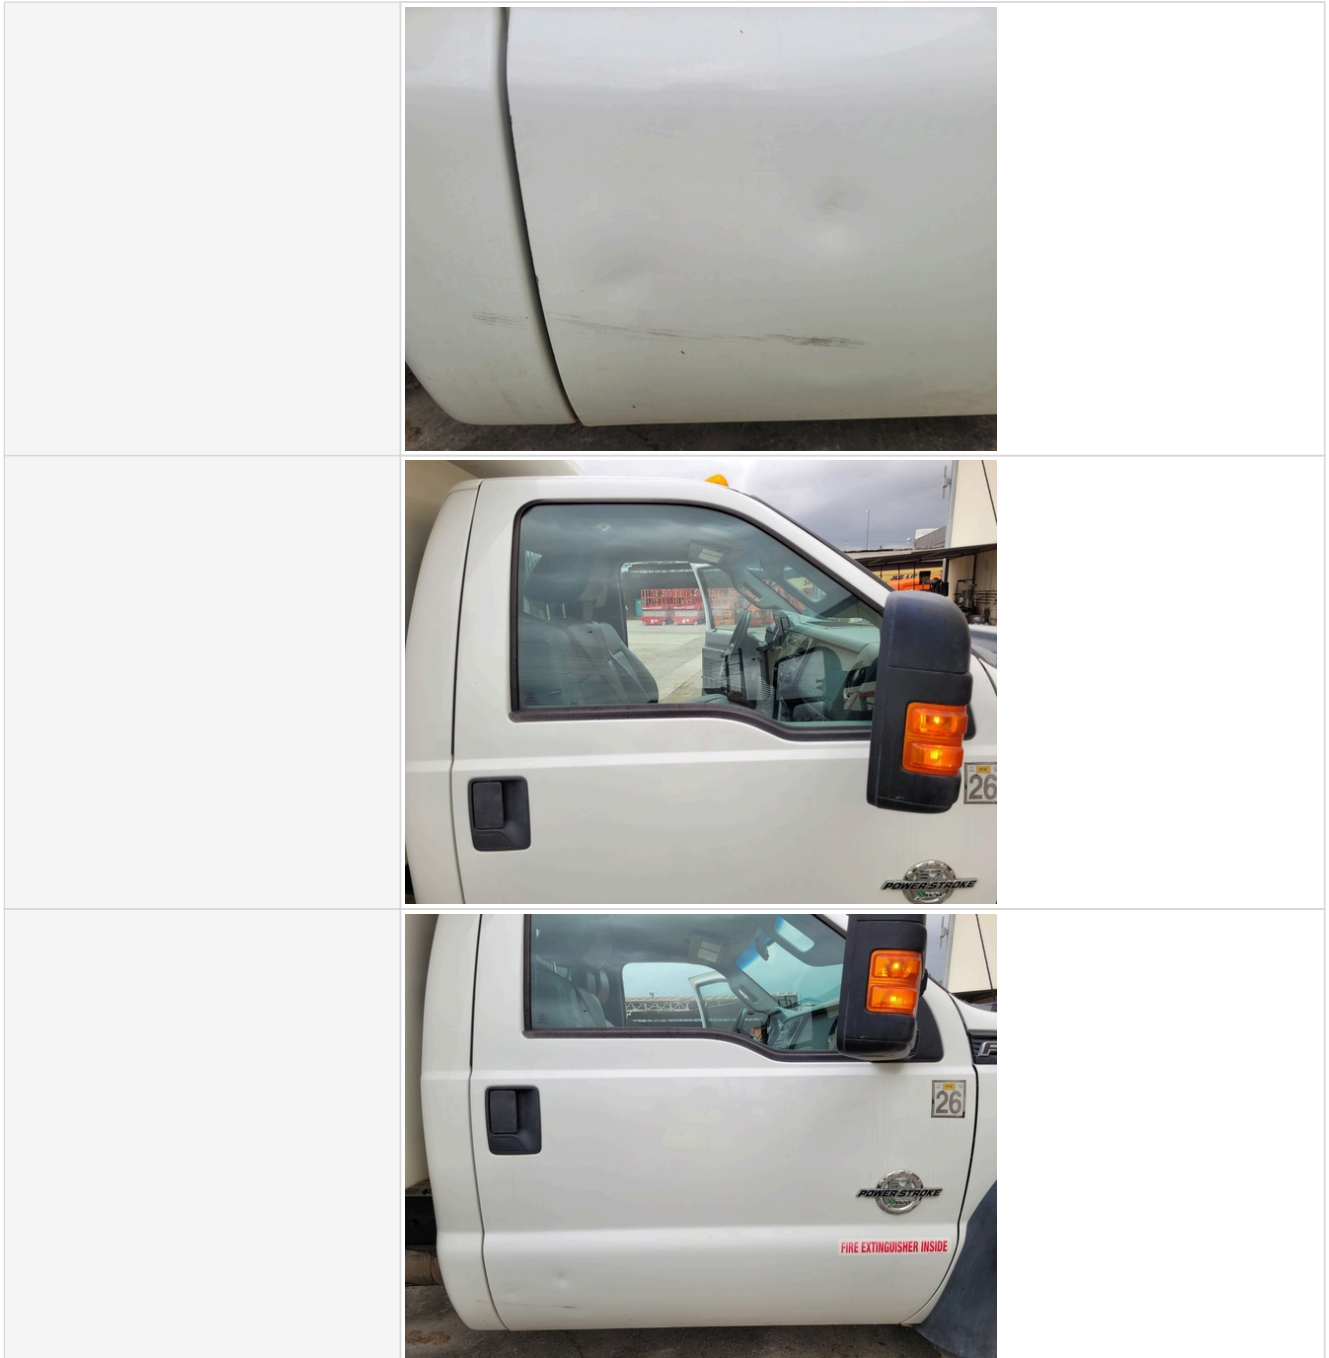
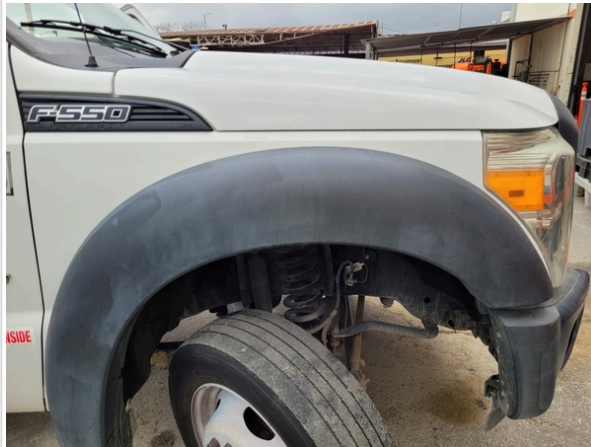
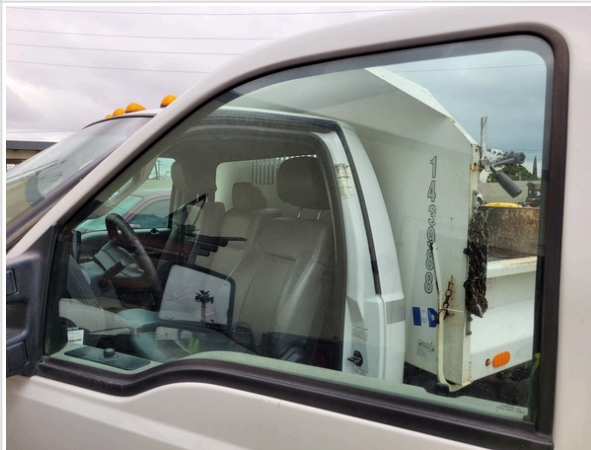
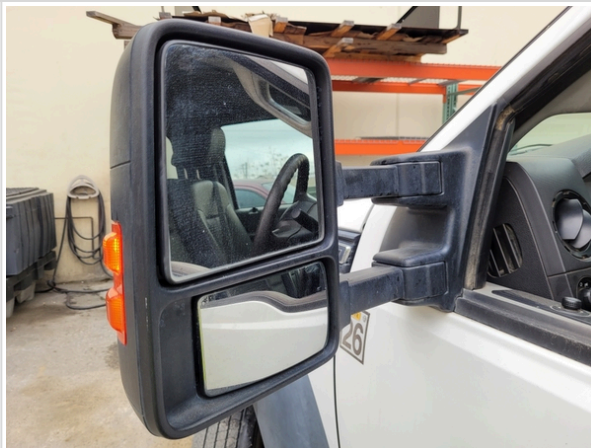
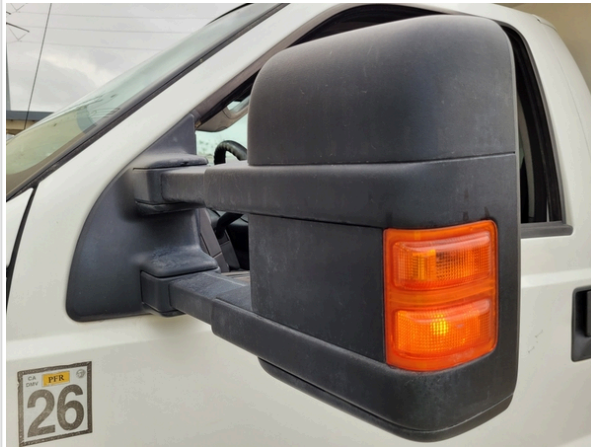
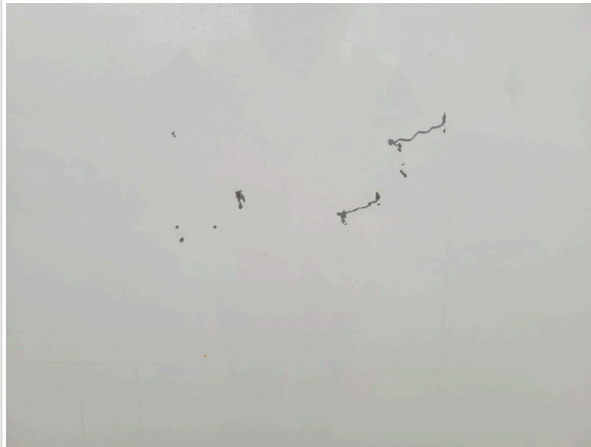
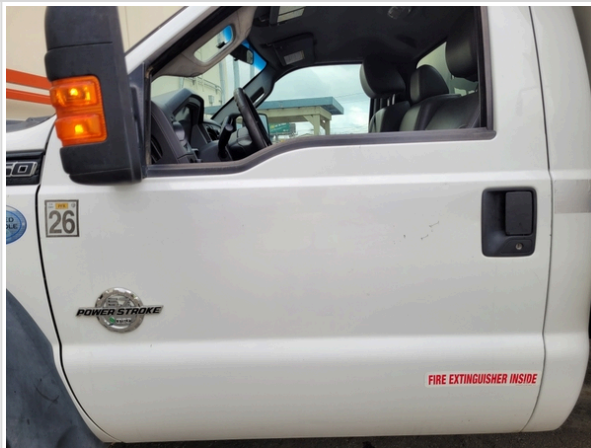
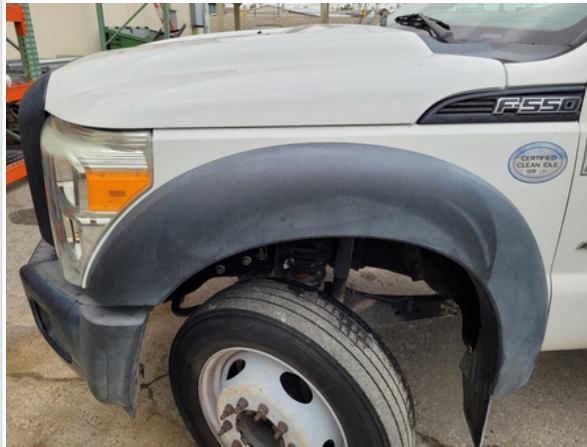
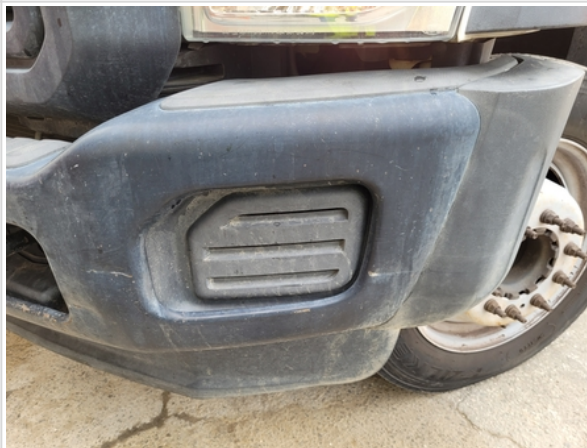
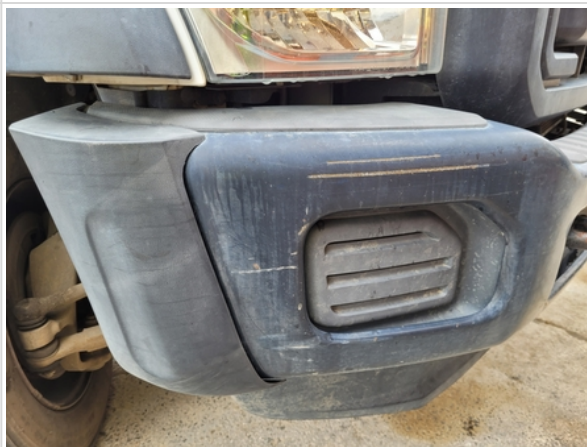
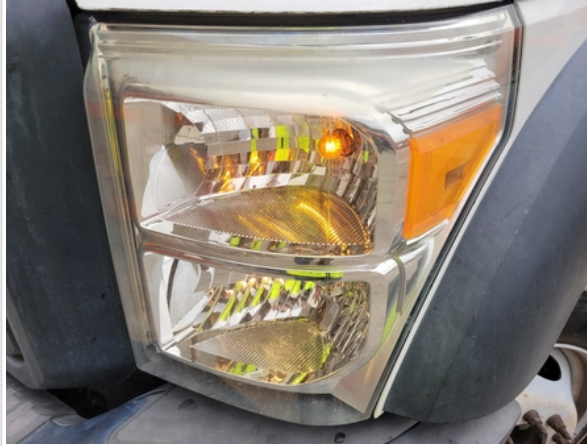
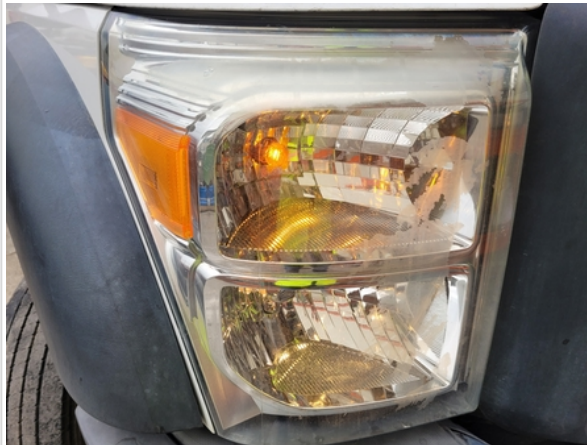
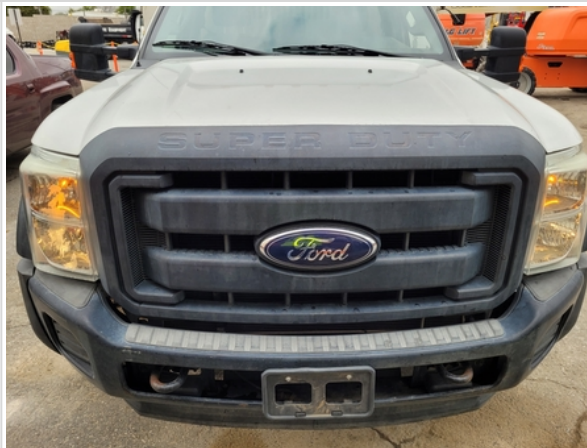
Close-up Exterior Photos

Body Panels	3 - Normal Wear & Tear
Body Panel Condition	No visible damage, good paint condition and panel fitment
Doors / Canopy Latches	3 - Normal Wear & Tear
Doors / Canopy Latches Condition	No visible damage
Steps / Ladders	0
Handrails	3 - Normal Wear & Tear
Handrails Condition	Handrails are fully intact and appear structurally sound

Glass	3 - Normal Wear & Tear
Glass Condition	Glass intact, no visible damage
Mirrors	3 - Normal Wear & Tear
Mirror Condition	Mirrors present and intact, no visible damage
Exterior Lights	3 - Normal Wear & Tear
Exterior Lights Condition	No visible damage, lighting system is operational

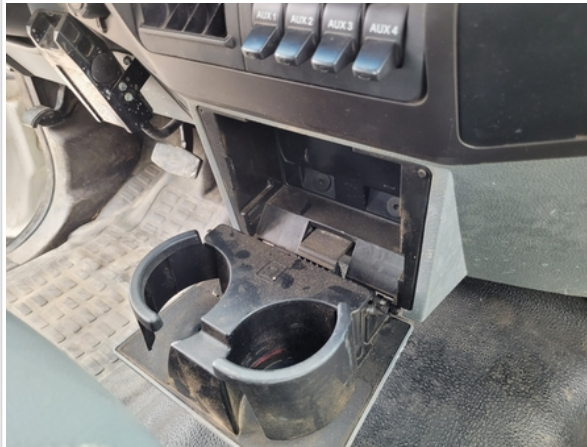
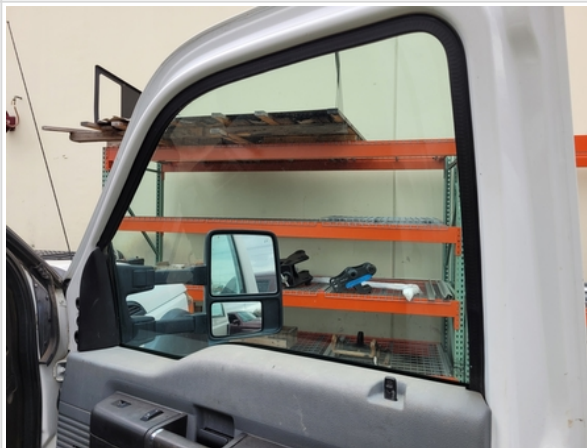
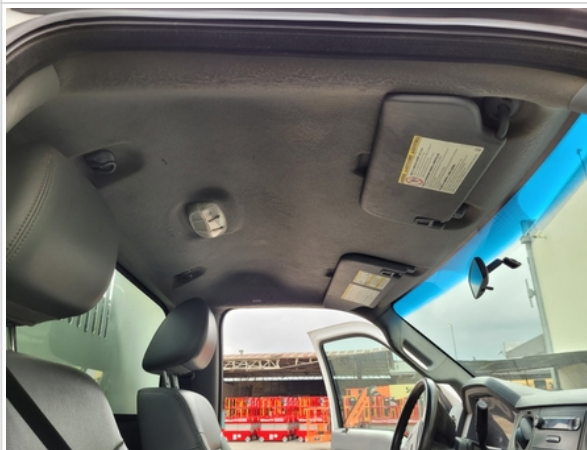
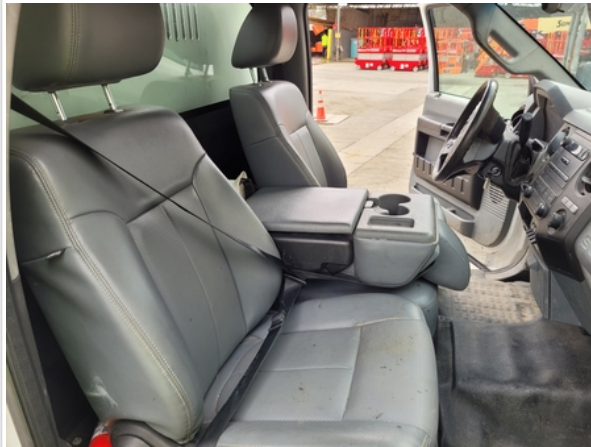
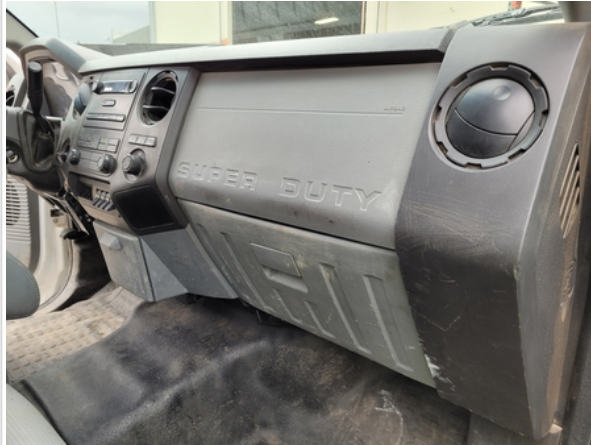
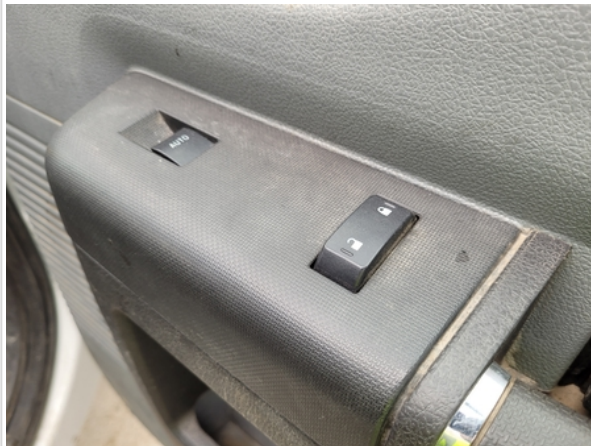
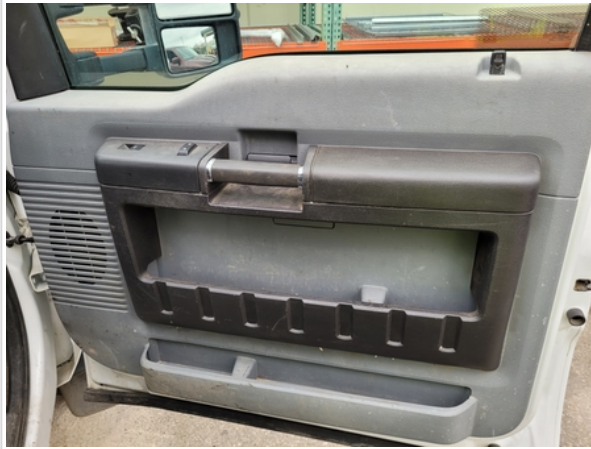
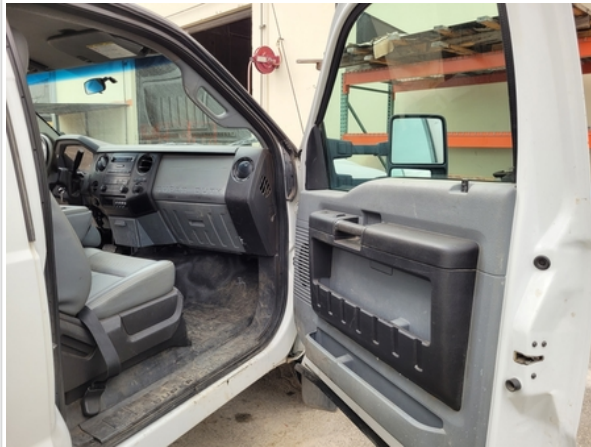
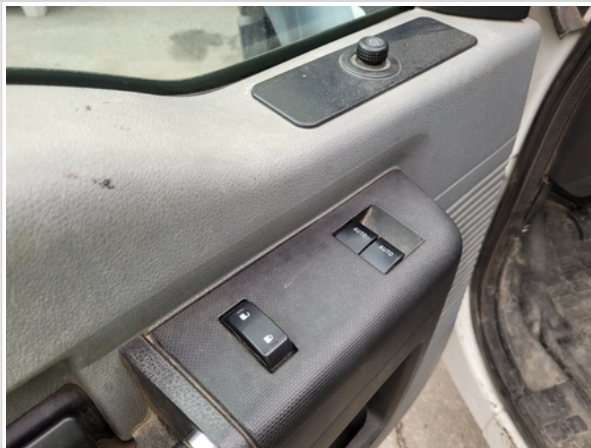
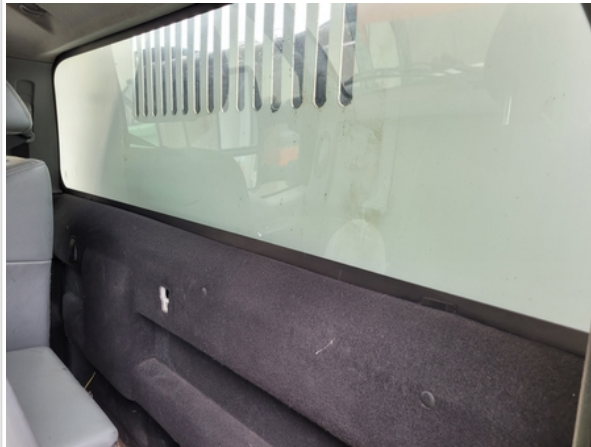
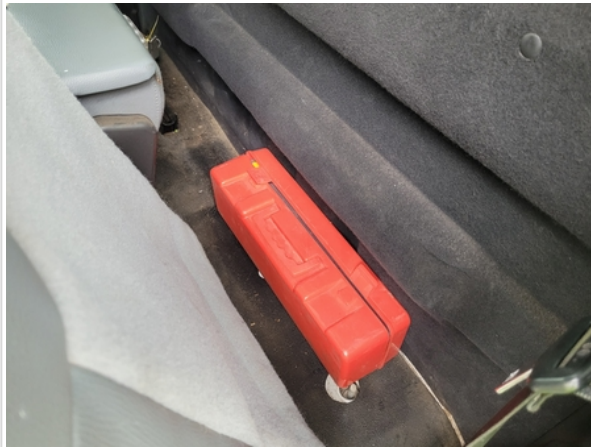
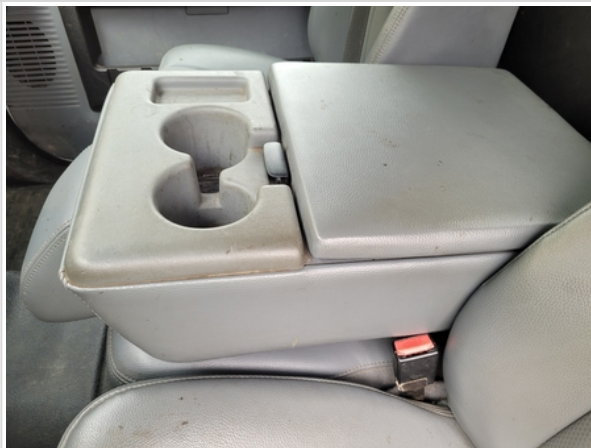
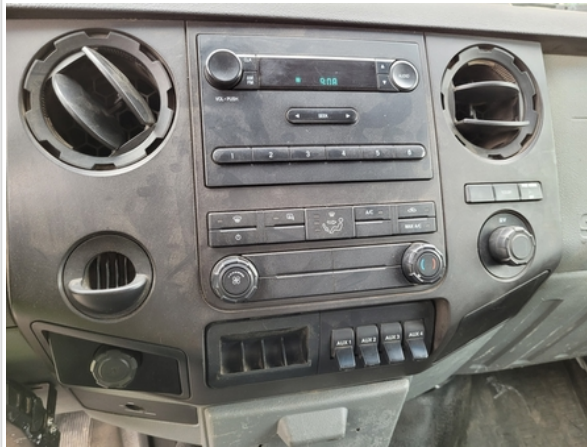
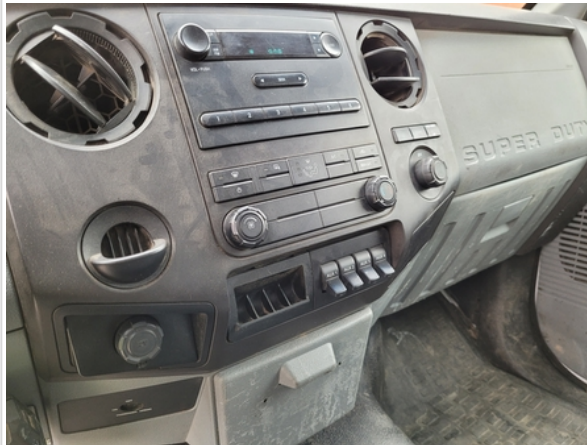
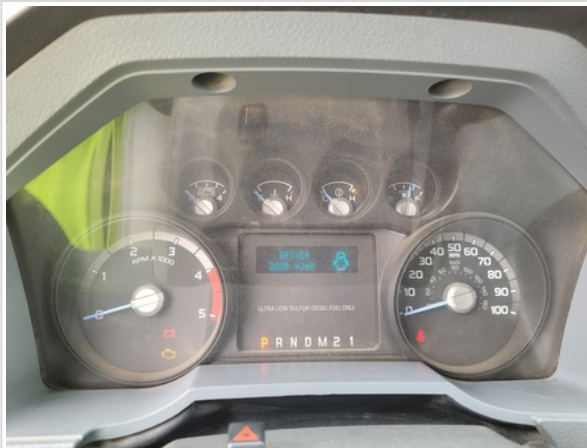
Cab Interior Photos

Odometer Activity	3 - Normal Wear & Tear
Odometer Condition	Odometer is working and in good condition
Controls/Switches/Gauges	3 - Normal Wear & Tear
Controls/Switches/Gauges Condition	All switches/gauges are in good condition and functioning
Brake System Type	Hydraulic
Clutch	0
Horn	3 - Normal Wear & Tear

Horn Condition	Horn is functioning as expected
Reverse Alarm / Backup Camera	3 - Normal Wear & Tear
Reverse Alarm / Backup Camera Condition	Reverse alarm working as expected
Heater & A/C	3 - Normal Wear & Tear
Heat & A/C Condition	Heater and A/C work as expected
Interior Lights	3 - Normal Wear & Tear
Interior Lights Condition	All interior lights are installed and functioning
Seats/Seat Belts	3 - Normal Wear & Tear
Seats/Seat Belt Condition	Seat(s) in good condition, no stains or tears in upholstery, Other (see comments), Seat belt secures properly
Comments	Minor stains on upholstery
Cab Interior Overall Rating	3 - Normal Wear & Tear

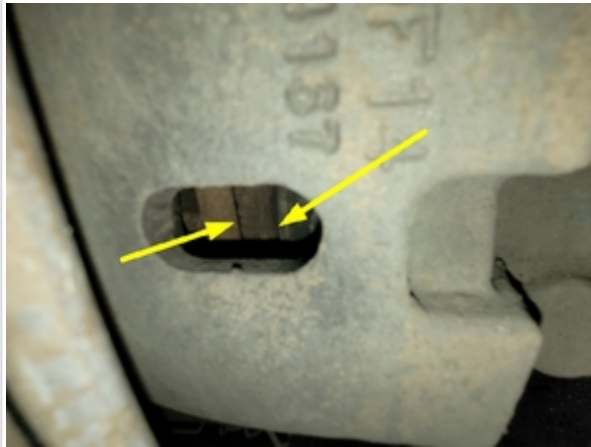
brake pad

Front Differential	0	
Brake Shoe Thickness	30%	
Comments	Front brake pads between 40 & 50%. Rear brake pads below 40%	
Air Brake System Leaks	N/A	
Air Brake Hose Condition	0	
Overall Drivetrain Condition	3 - Normal Wear & Tear

Exterior Rating	3 - Normal Wear & Tear
Interior Rating	3 - Normal Wear & Tear
Safety Rating	3 - Normal Wear & Tear
Quality Rating	3 - Normal Wear & Tear
Functionality Rating	3 - Normal, Operating as Expected
Overall Rating	3 - Normal Wear & Tear
What's Great About the Machine	Truck has well maintained appearance and dump truck hydraulics working well. No active leaks observed.
What Needs Work	Mirror adjustment control motor hesitation observed on driver side. Tires need to be replaced soon. Rear brakes getting low.
Date/Time	04-14-2023

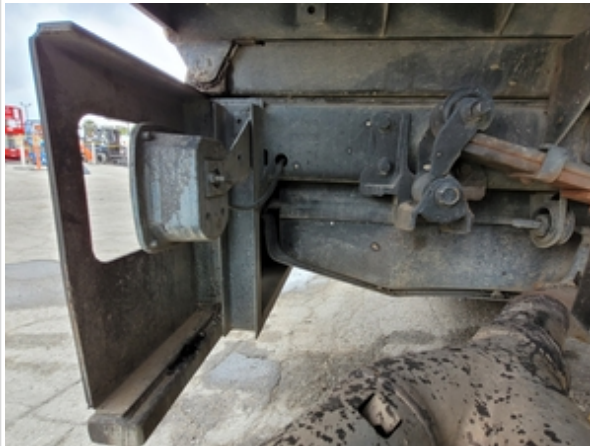
Trailer Connection Cover Broken

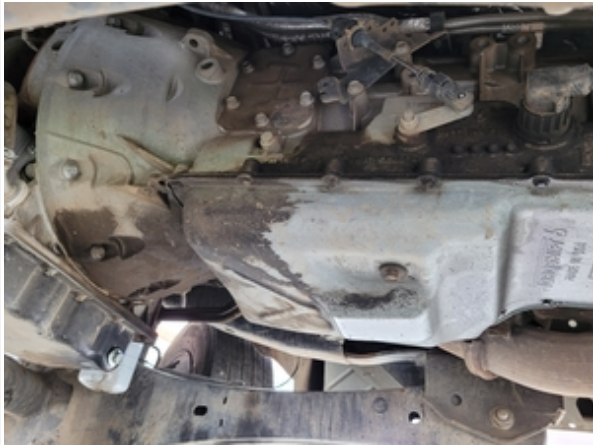
Transmission Info (Make/Model)	Automatic - 6 Speed Transmission	
Transmission	3 - Normal Wear & Tear	
Transmission Condition	No unusual noises or vibrations	
Transmission Condition Photos

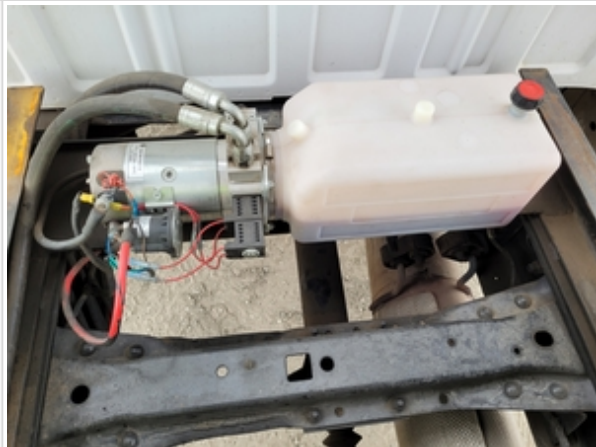
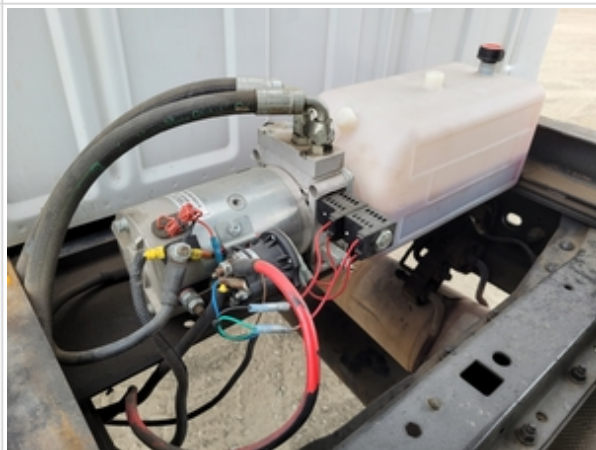
PTO Photos

PTO	3 - Normal Wear & Tear

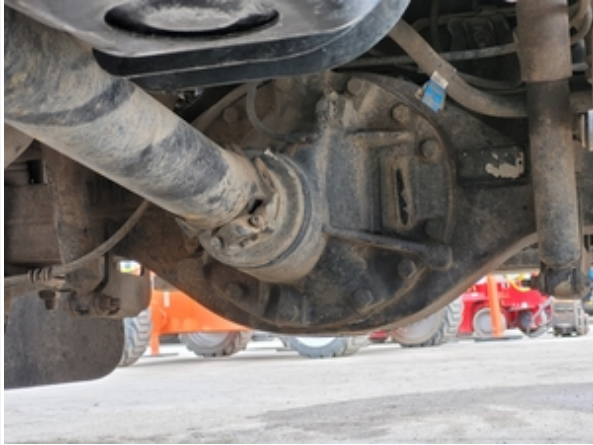
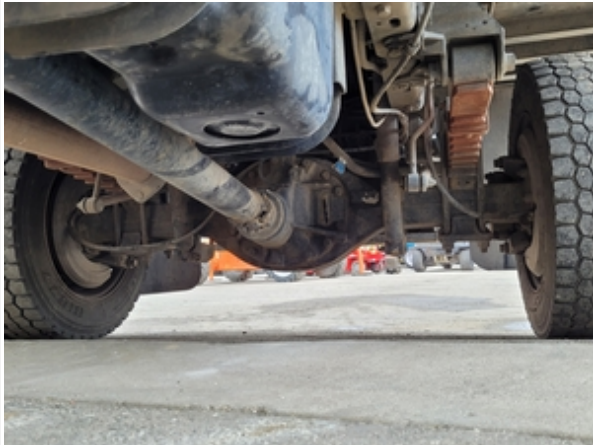
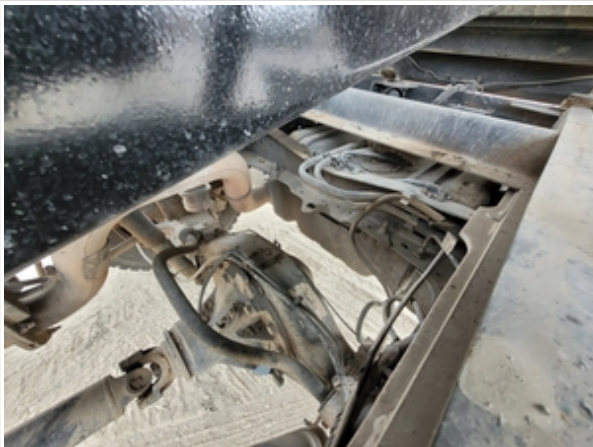
Differential	Check condition of the differential(s). Take photos and notes as relevant.
Rear Differential	3 - Normal Wear & Tear
Rear Differential Condition	Dry housing appearance, no unusual noises heard during operation
Rear Differential Photos

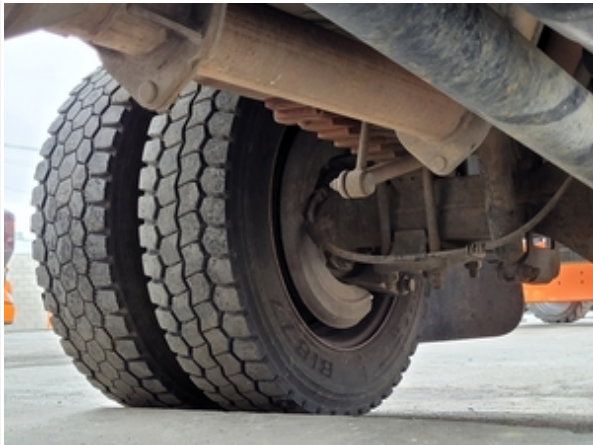
Rear Right Tire Photos

Rear Right Tire - Ratio Remaining	30%

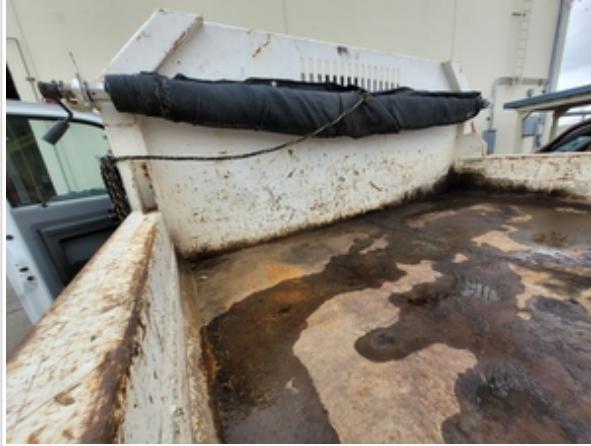
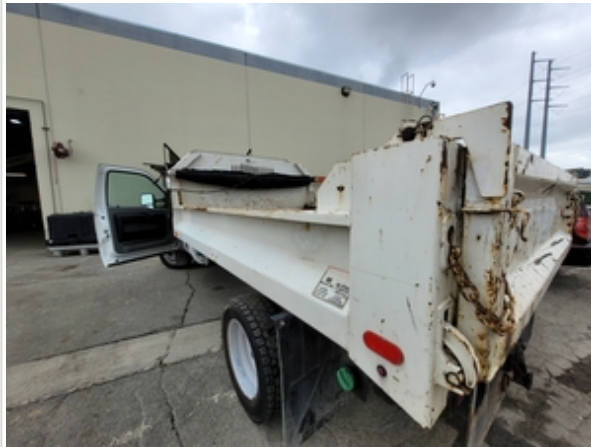
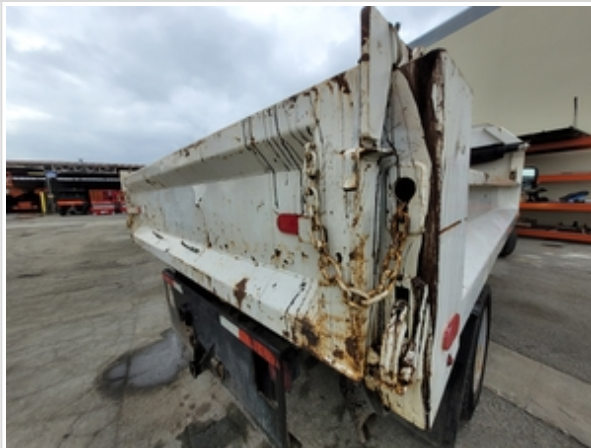
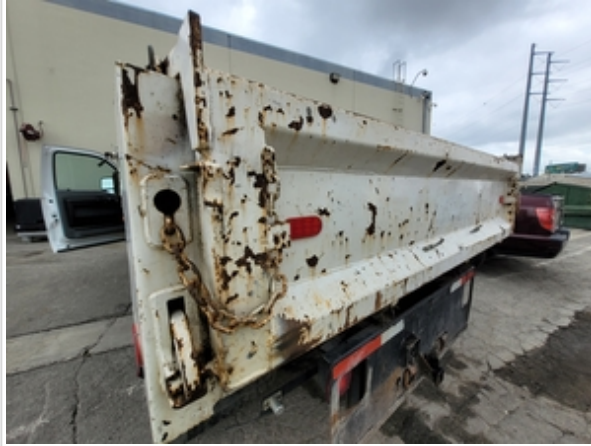
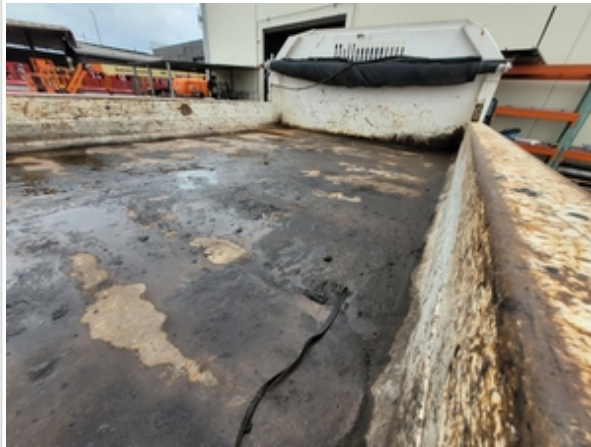
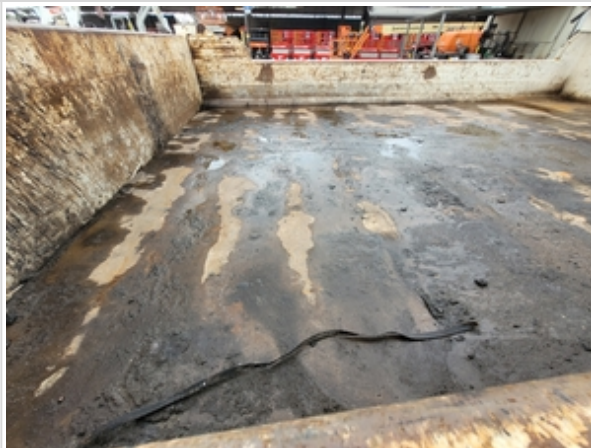
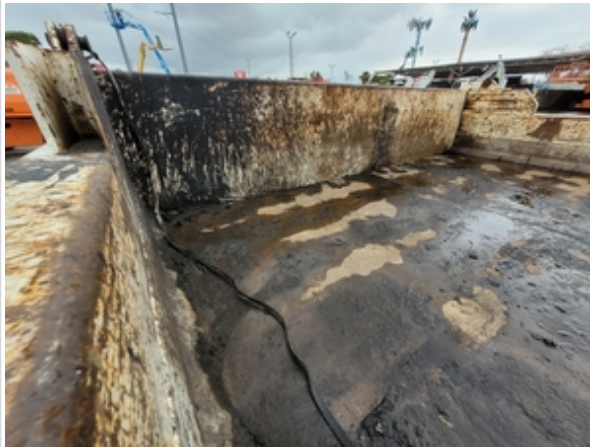
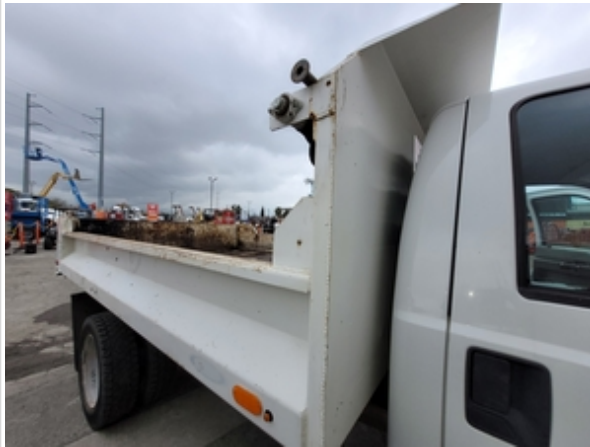
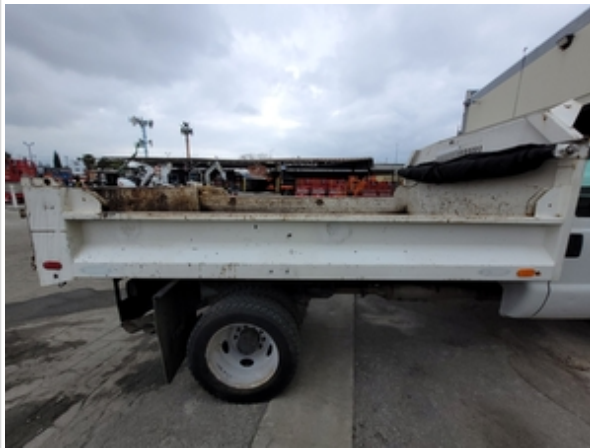
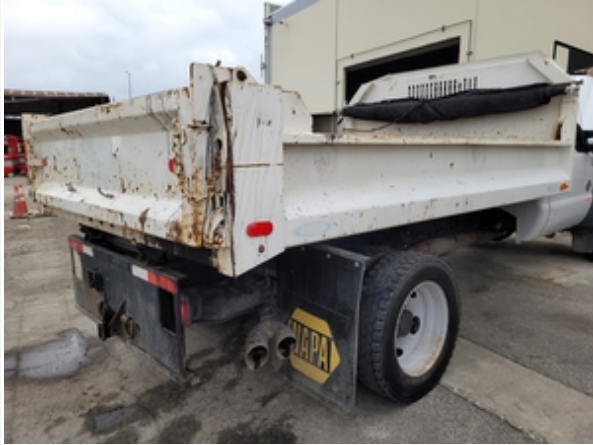
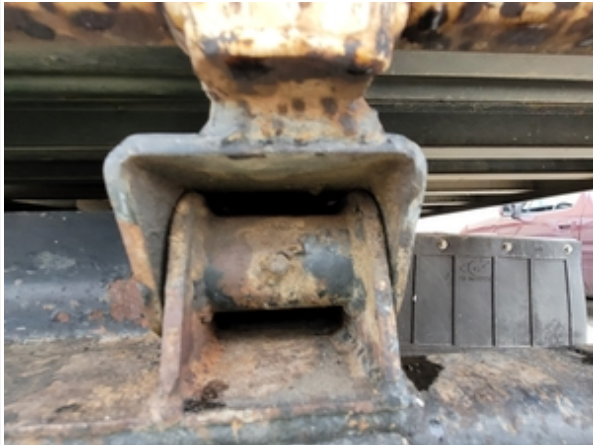
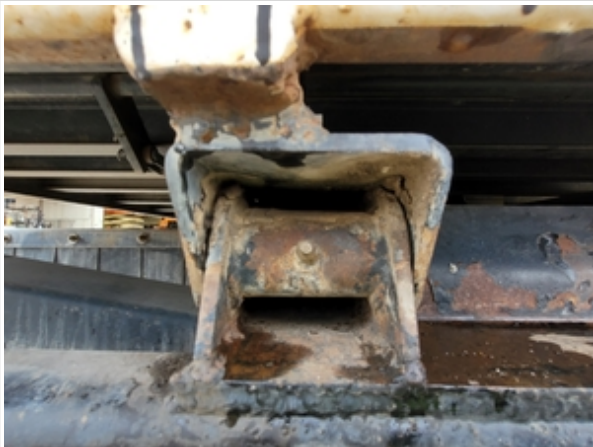
Bed Body	3 - Normal Wear & Tear
Bed Body Photos

Tailgate	3 - Normal Wear & Tear	
Tailgate Latch	3 - Normal Wear & Tear	
Support Frame	3 - Normal Wear & Tear	
Hinge Points	3 - Normal Wear & Tear	
Tarp	3 - Normal Wear & Tear
