Inspection Report (Bulldozer)

Year	2008
Make	John Deere
Model	850JR
Serial Number	T0850JR160387
Hour Meter Reading	8,298 Hrs.
Previous Application (e.g., earth moving, mining, demolition, etc)	General Construction

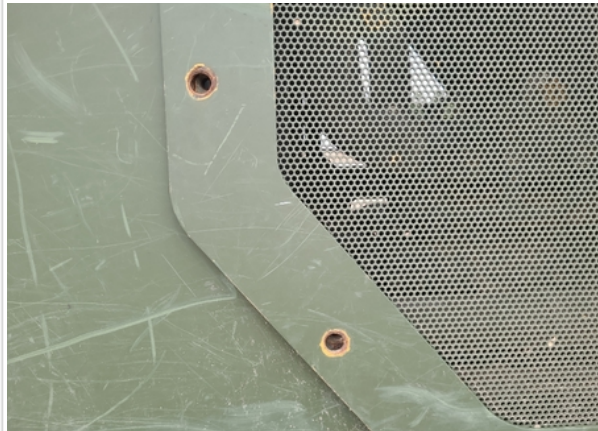
Body Panels	3 - Normal Wear & Tear
Body Panel Condition	No visible damage, good paint condition and panel fitment, Other (see comments)
Comments	Left side engine panel missing hardware

<p>850J</p> <p>Missing Hardware</p>

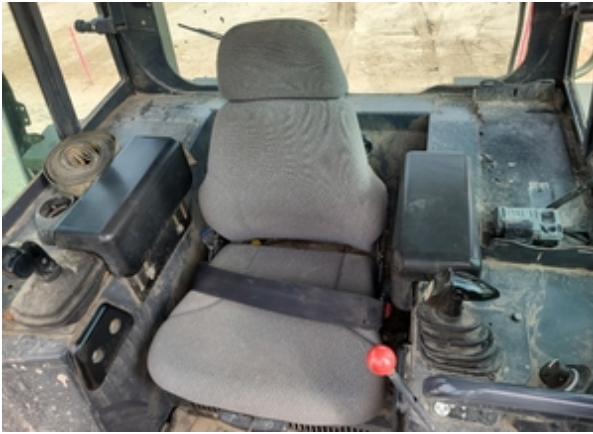
Control Station Overall Rating	3 - Normal Wear & Tear
Control Station Overall Condition	Minor cosmetic wear to cabin surfaces, floors, panels, and ceiling, Other (see comments)
Comments	Air Conditioner Inop., Wipers inop., Cab could use a detail wash
Operator Seat	3 - Normal Wear & Tear
Operator Seat Condition	Seat(s) have minor surface staining or small tears, Seat(s) in good condition, no stains or tears in upholstery, Seat adjustment controls move through full range of travel, Seat belt secures properly, Seat belt is intact and in good condition, Other (see comments)
Operator Seat Photos

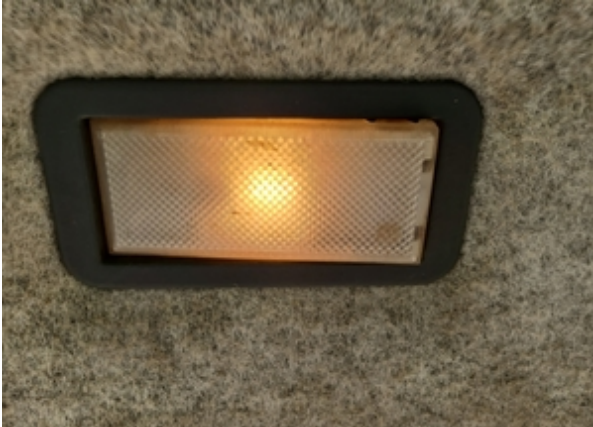
Cabin Lights Photos

Cabin Lights	3 - Normal Wear & Tear
Cabin Lights Condition	Cabin lights are installed with all light covers in place, bulbs are installed and working properly

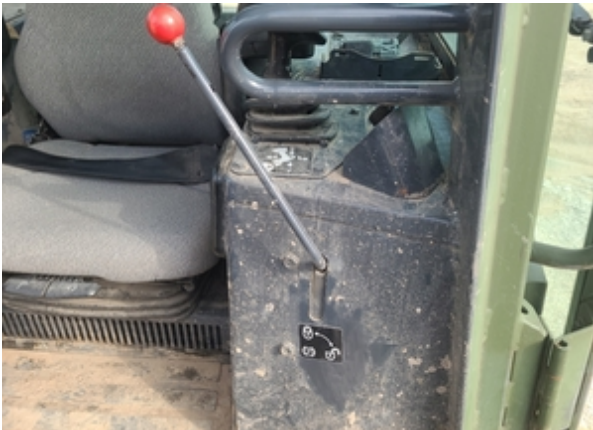
Safety Lock Out / Stop	3 - Normal Wear & Tear
Safety Lock Out / Stop Condition	Safety lock out device is present, in good condition, and functional
Safety Lock Out / Stop Photos

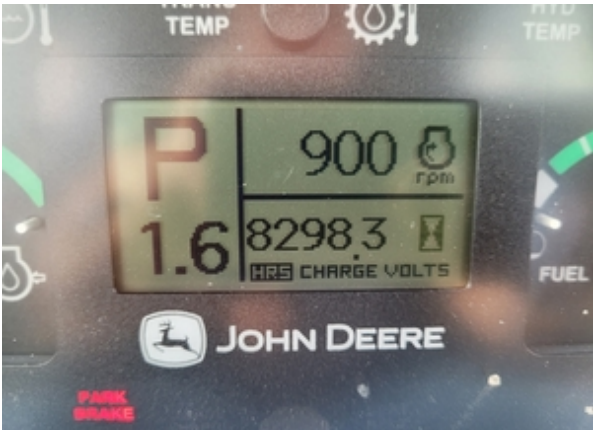
Controls & Switches	3 - Normal Wear & Tear
Controls & Switches Condition	Switches have good functionality, minor cosmetic damage observed, One or more switches are inoperative or missing, Other (see comments)
Comments	Front and rear wipers not responding to switch (may or not be part of switch), Switch decals worn
Hour Meter Activity	3 - Normal Wear & Tear
Hour Meter Condition	Hour meter is functional and in good condition
Hour Meter Activity Photos

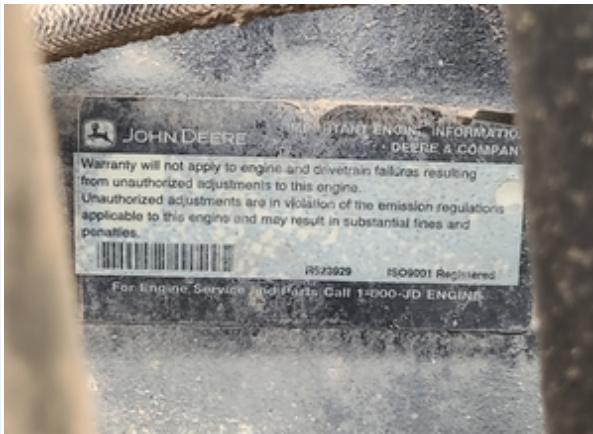
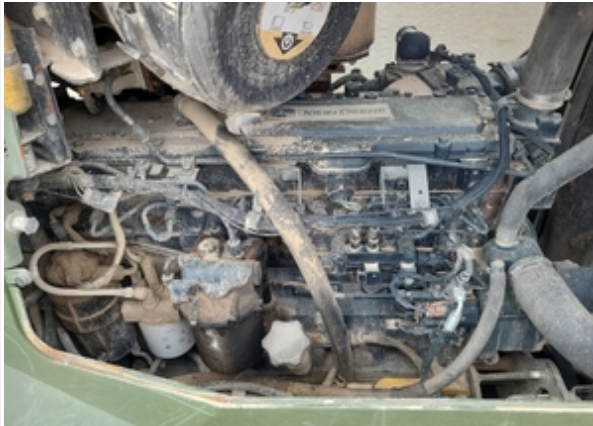
Engine Type (Make, Model, Cylinders, Hp)	John Deere - 6090 - 6Cyl. - 200HP - 9.0L
Emissions Tier	Tier 3
Engine Serial Number	RG6090L058874
Engine Fuel Type	Diesel
Engine Photos

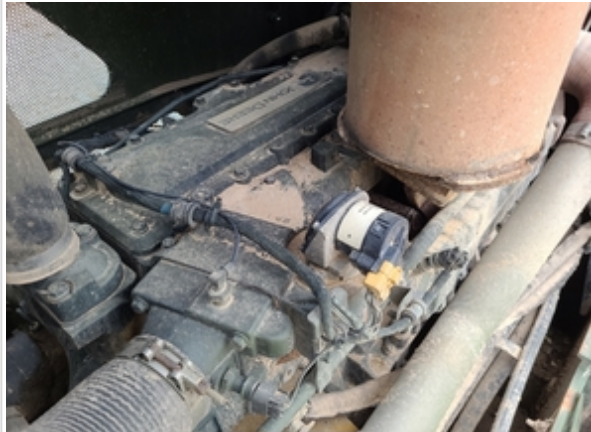
Minor engine oil leak at mounted seal

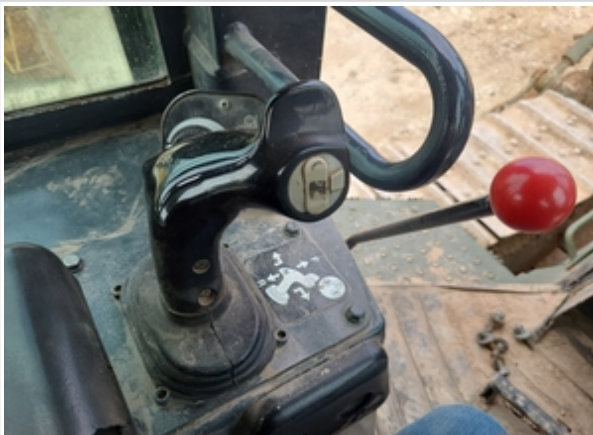
Transmission Info	Hydrostatic
Clutch	0
Transmission	3 - Normal Wear & Tear
Comments	Transmission travels well in all directions
Shift Lever	3 - Normal Wear & Tear
Shift Lever Photos

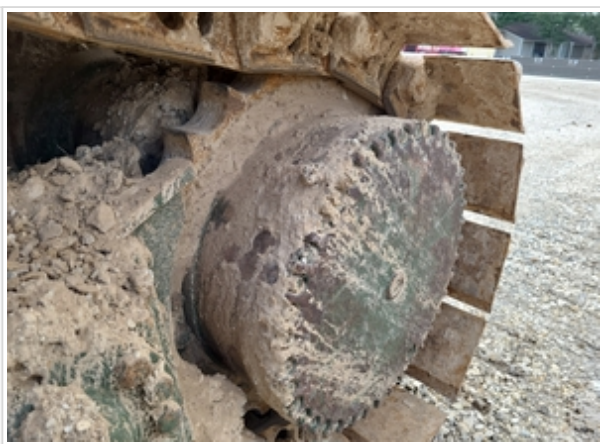
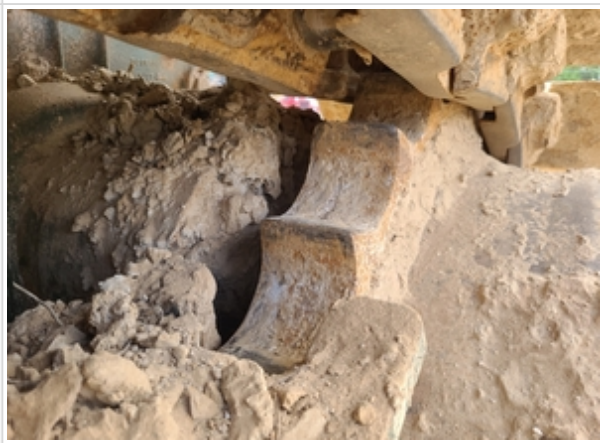
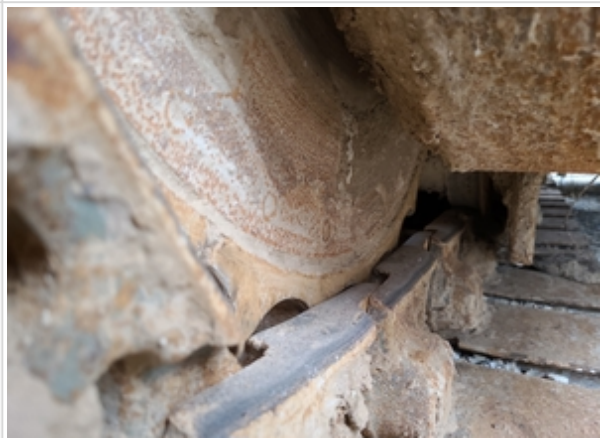
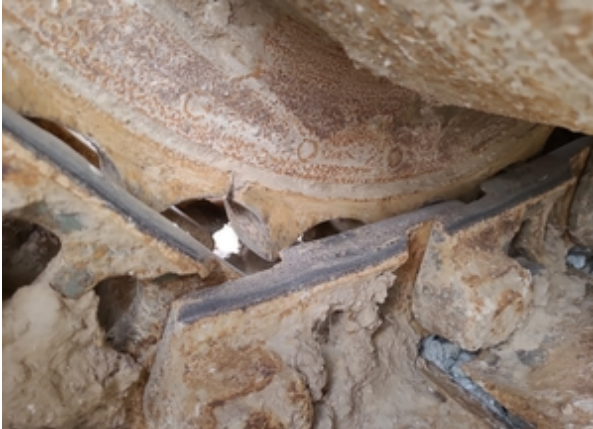
<p>Left Final Drive Photos</p>

Left Drive Motor	0
Left Final Drive	3 - Normal Wear & Tear
Comments	Did not view drive motors due to panels not being removed

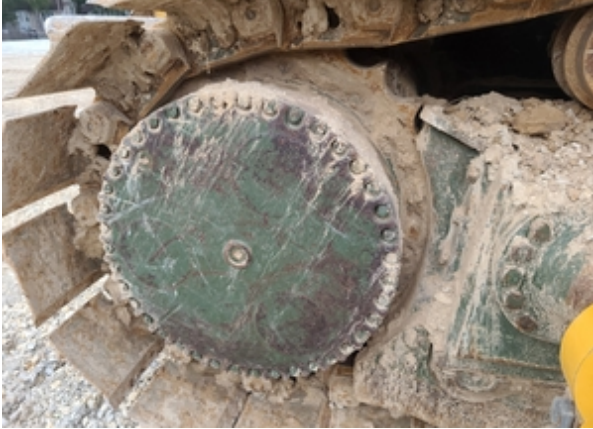
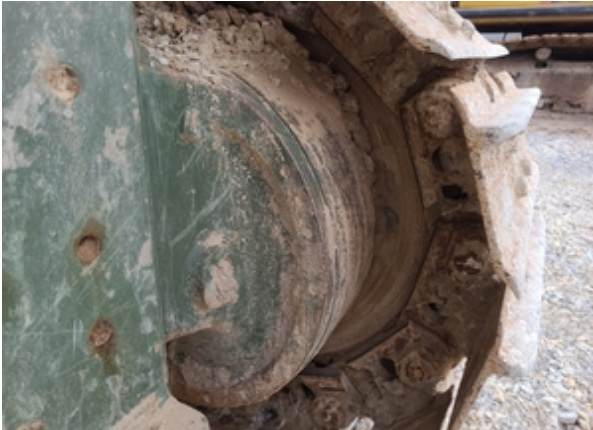
Left High Drive	0	
Right Drive Motor	0	
Right Final Drive	3 - Normal Wear & Tear	
Comments	Did not view drive motors due to panels not being removed	
Right Final Drive Photos

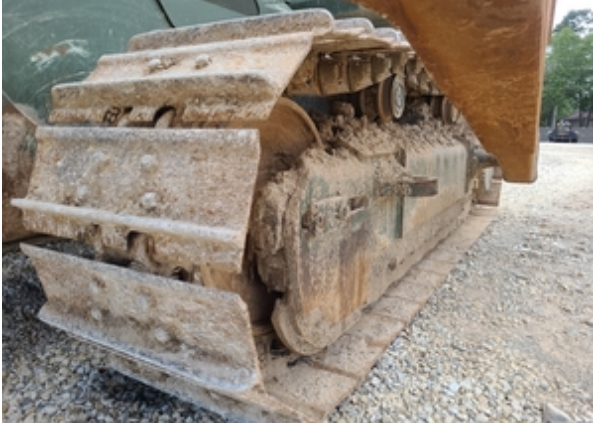
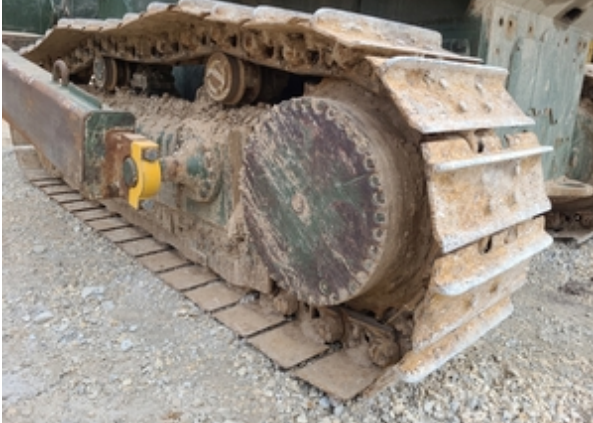
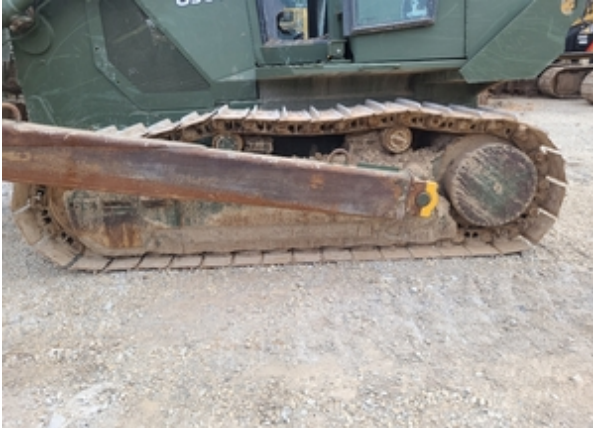
Undercarriage Overall Condition	3 - Normal Wear & Tear
Comments	Overall undercarriage worn below 40 percent, Tracks loose and track adjuster should be further inspected for proper operation. .
Undercarriage Overall Photos

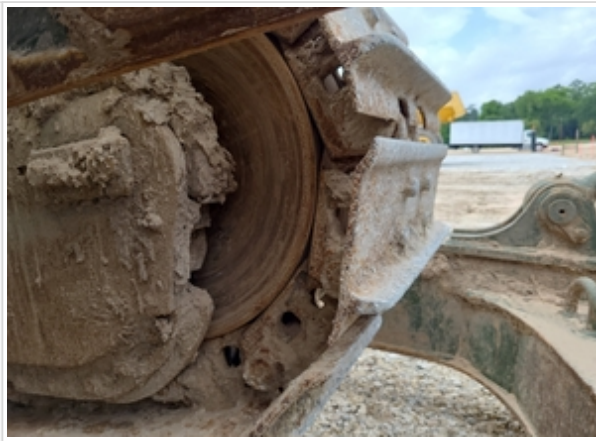
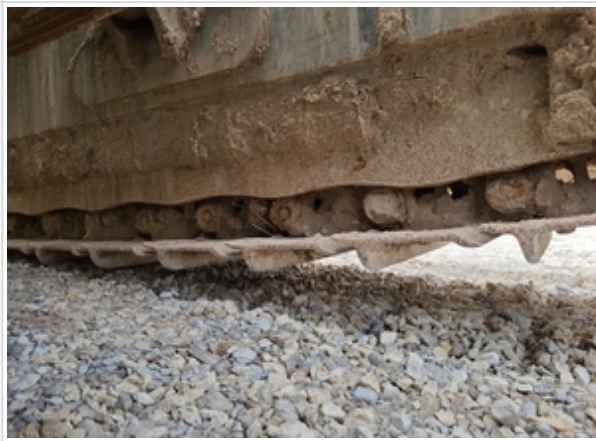
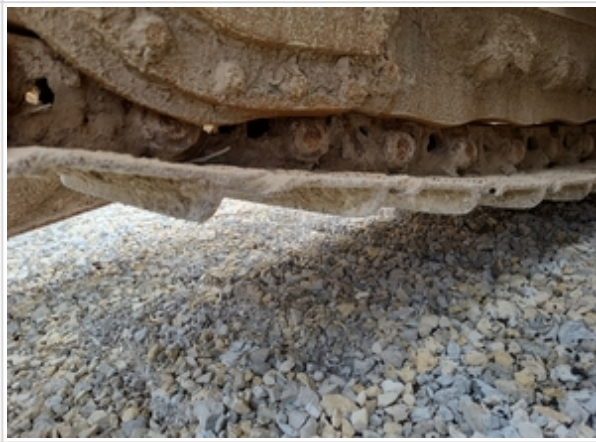
Tracks Photos

Pin & Bushings	3 - Normal Wear & Tear	
Tracks	3 - Normal Wear & Tear

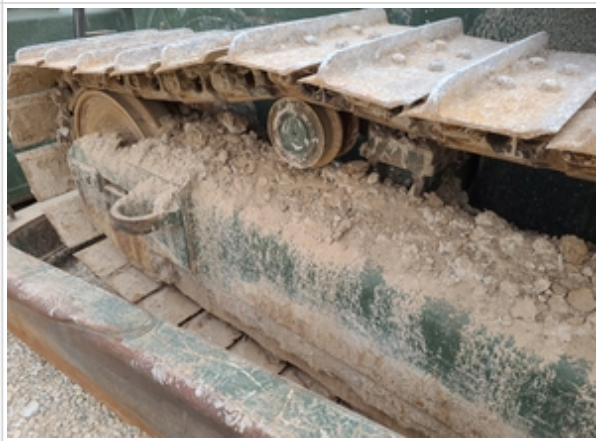
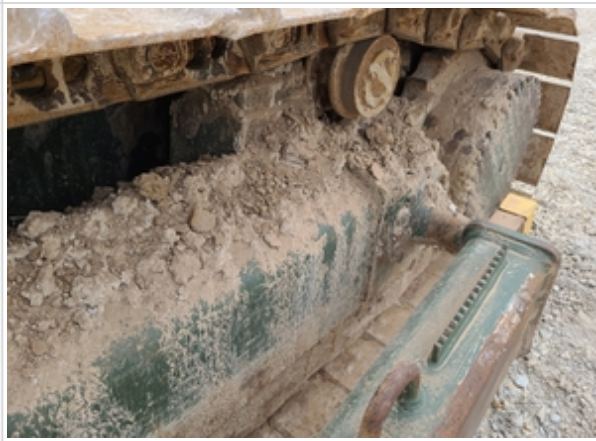
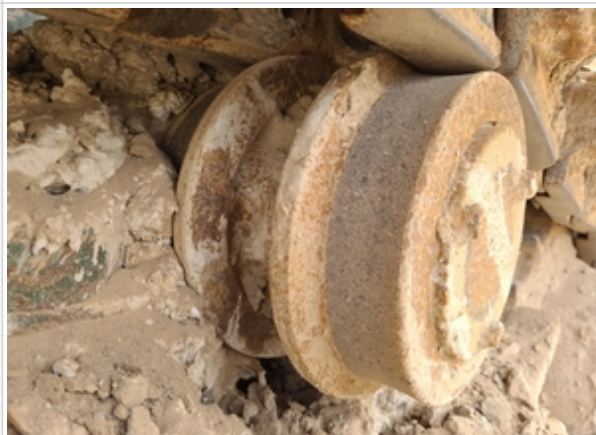
Left Side: Link Bushings / Drive Sprocket / Shoe Condition	3 - Normal Wear & Tear
Left Side: Upper & Lower Roller / Front Idler Condition	2 - Above Average Wear
Track Condition: Left Front	30%
Track Condition: Left Rear	30%

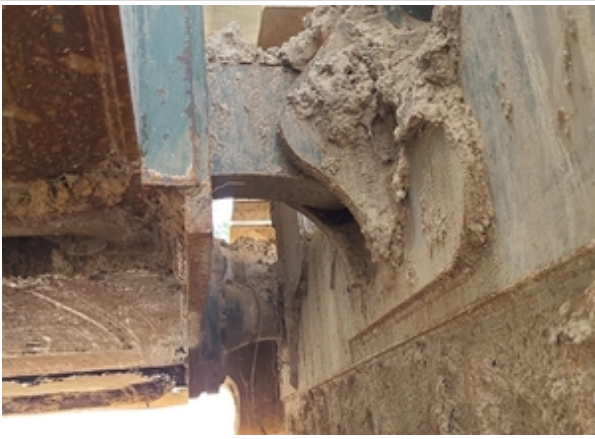
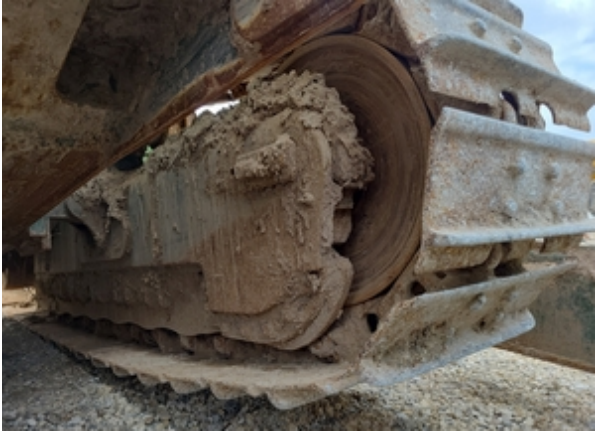
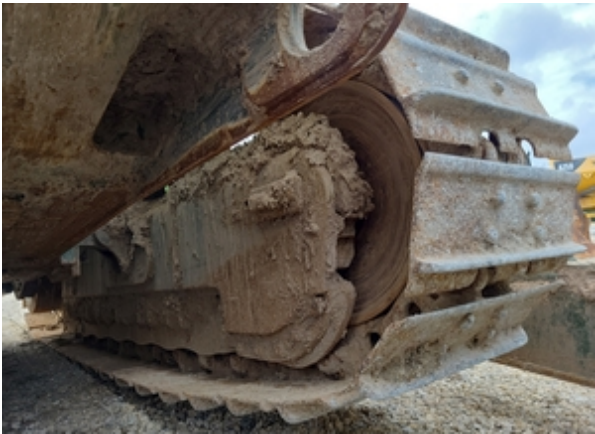
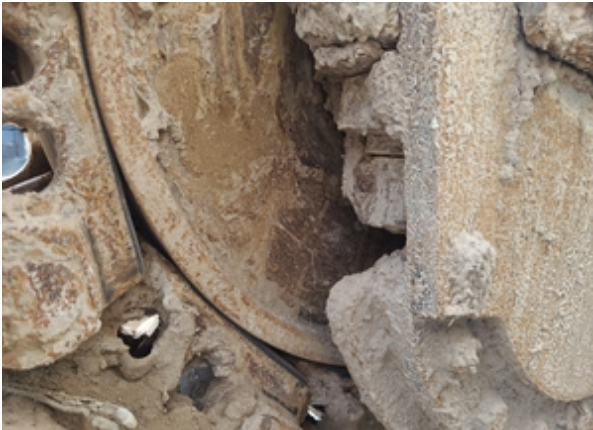
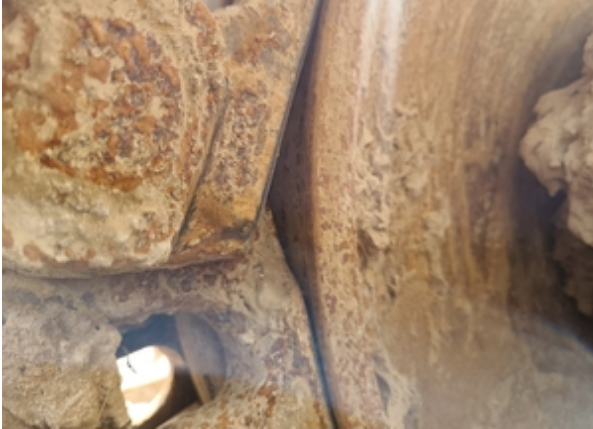
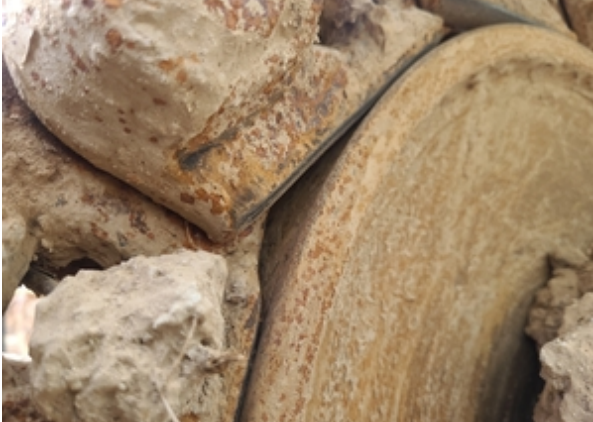
Right Side: Link Bushings / Drive Sprocket / Shoe Condition	3 - Normal Wear & Tear	
Right Side: Upper & Lower Roller / Front Idler Condition	2 - Above Average Wear	
Track Condition: Right Front	30%	
Track Condition: Right Rear	30%

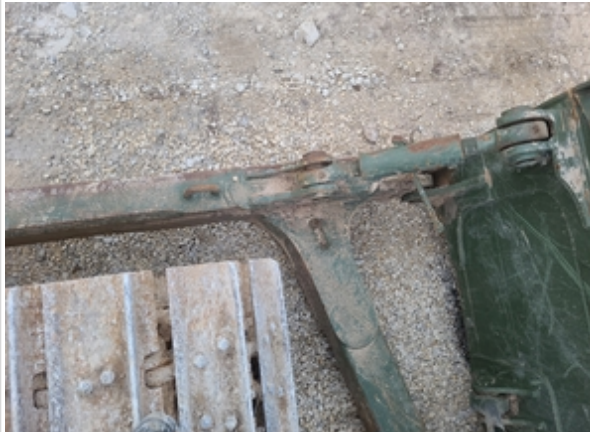
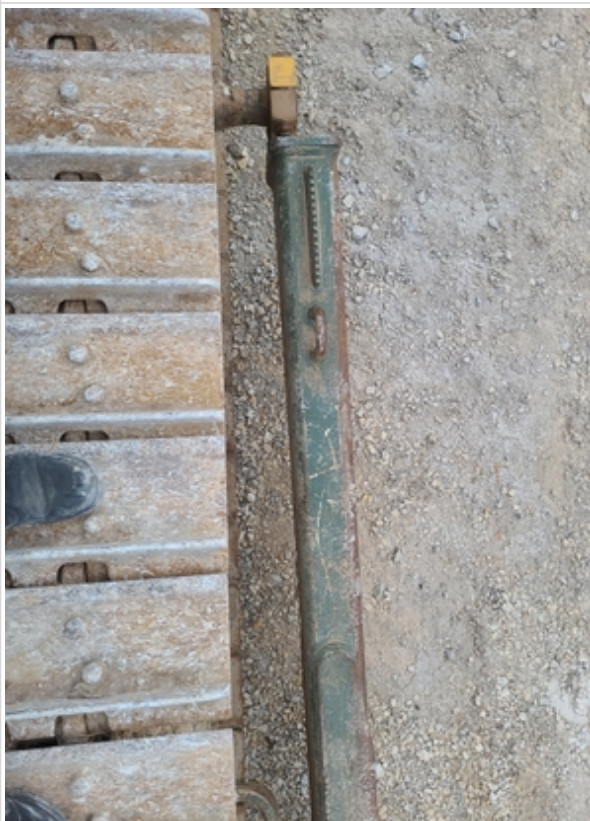
Push Arm / C-Frame Condition	2 - Above Average Wear
Comments	Bushing/Bearing that connects to front blade worn and have improper mounting pins

Left side blade bracket has improper retaining hardware

Recommend further inspection at all blade to arm connections for excess play.

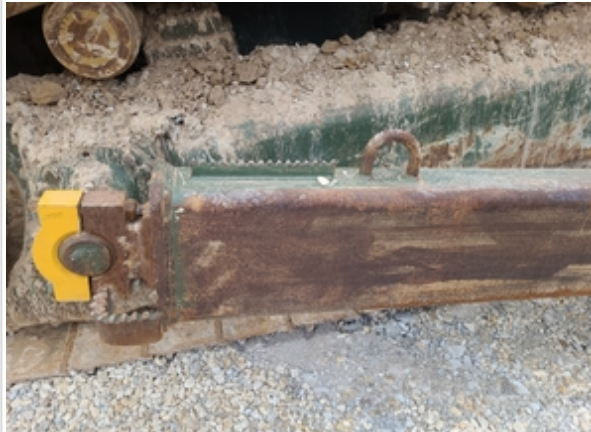
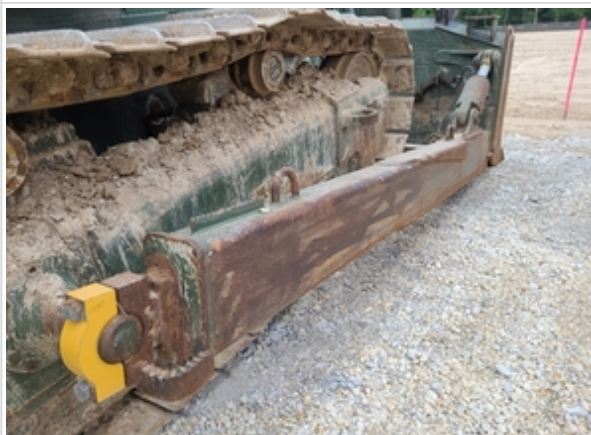
Right side arm retaining pin incorrect and bearing missing

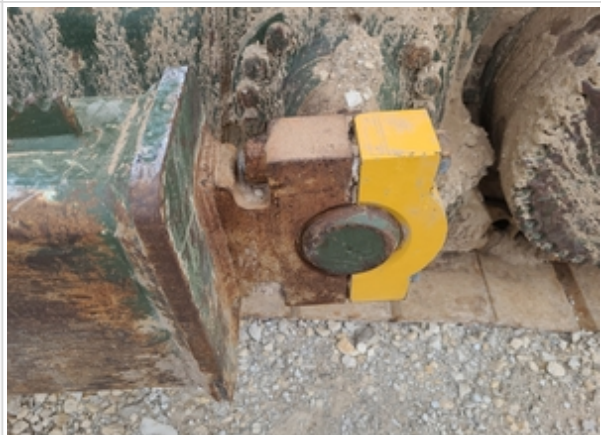
<p>Push Arm Pivot / C-Frame Trunnions Condition</p>	<p>3 - Normal Wear & Tear</p>	
<p>Comments</p>	<p>Rear trunnion caps recently replaced and look to be in good condition</p>	
<p>Push Arm Pivot / C-Frame Trunnions Photos</p>

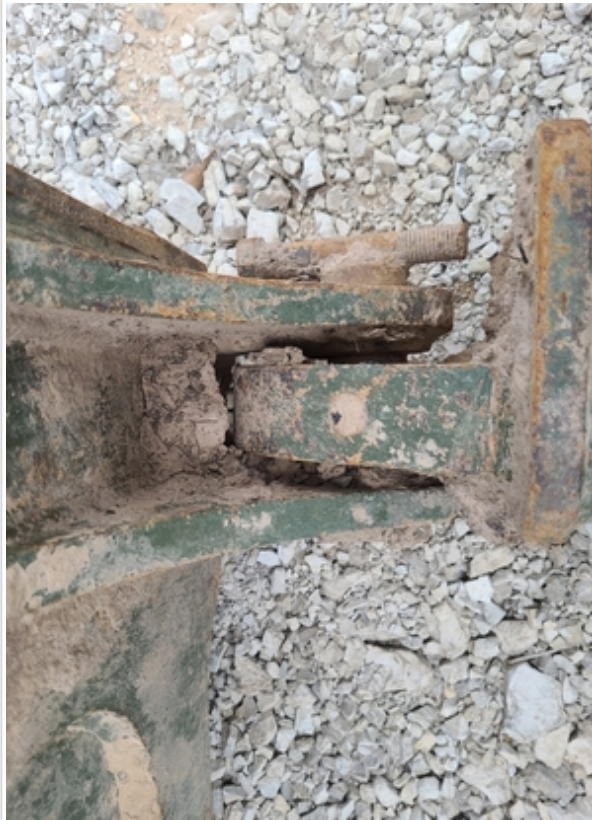
R/S Arm Bearing missing

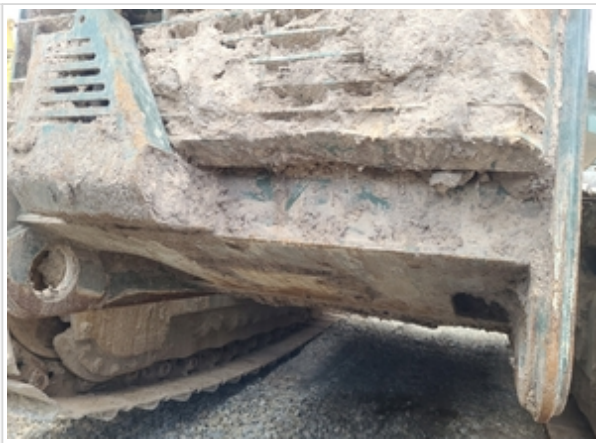
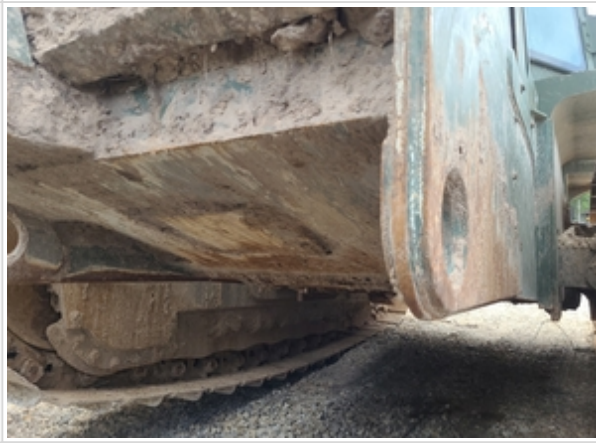
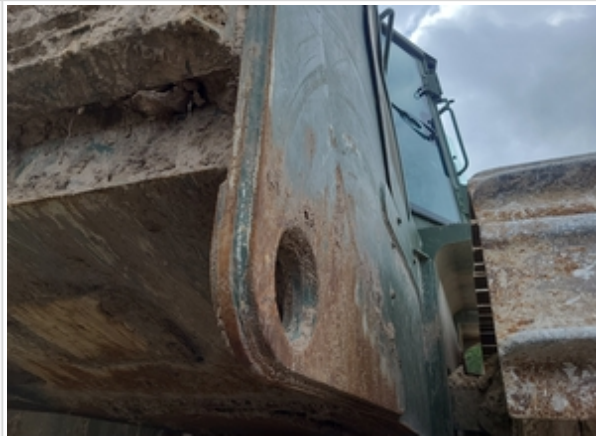
<p>Frame Photos</p>

<p>Frame Condition</p>	<p>3 - Normal Wear & Tear</p>

Overall Chassis	Oil leaking out of belly pan from center of machine.	
Overall Chassis Comments	3 - Normal Wear & Tear Overall Main Frame in good shape, but Blade push arm bores and bushings worn and should be further inspected.

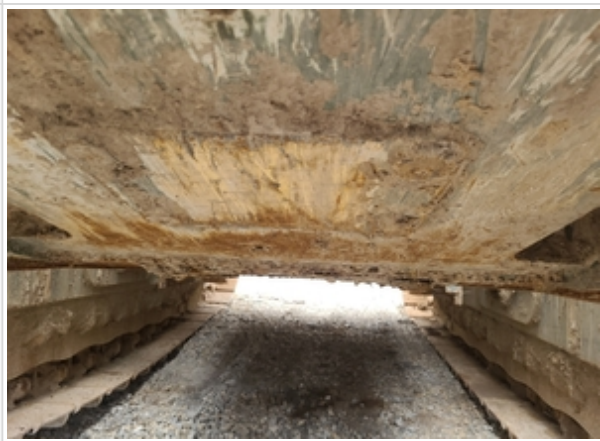
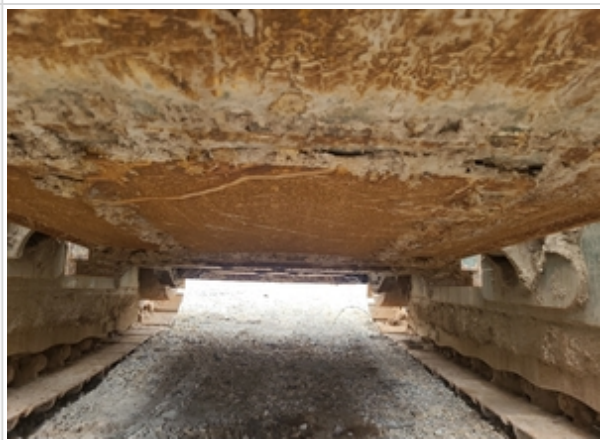
<p>Belly Pans</p>	<p>3 - Normal Wear & Tear</p>	
<p>Belly Pans Photos</p>

<p>Active Oil leak seen dripping from bottom belly pan. May be Engine or Hydraulic Oil. Further inspection recommended.</p>
Wet or Damp Hydraulic Lines / Fittings	Yes
Appearance of Hydraulic Lines / Fittings	3 - Normal Wear & Tear
Hydraulic Lines / Fittings Condition	Other (see comments)
Comments	Signs of hydraulic leaks observed around right side of Cab hydraulic filter area and beneath bellypans
Unusual Noises (Hydraulic Pump)	No
Hydraulic Pump Notes	No unusual noises heard during operation
Comments	Pumps and drive motors underneath cab not inspected. Visually unaware of conditions of hydraulic system underneath cab.

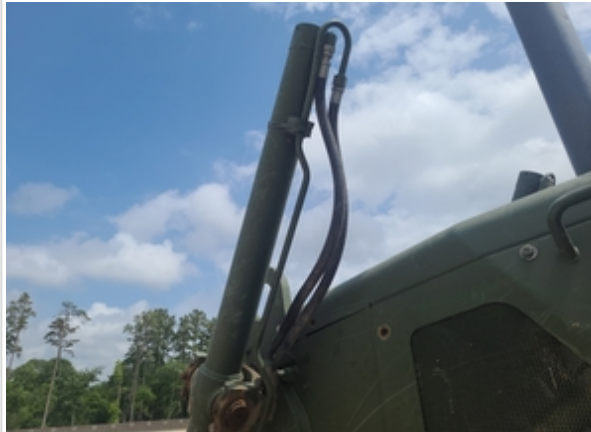
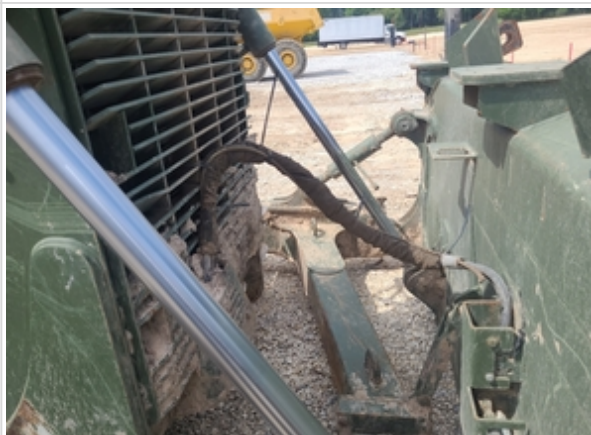
Possible small leak at hydraulic hose

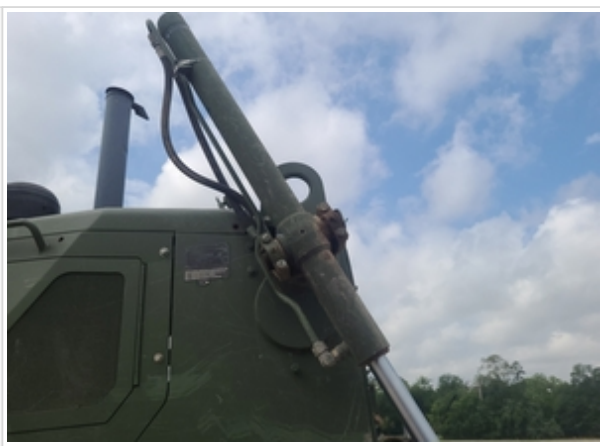
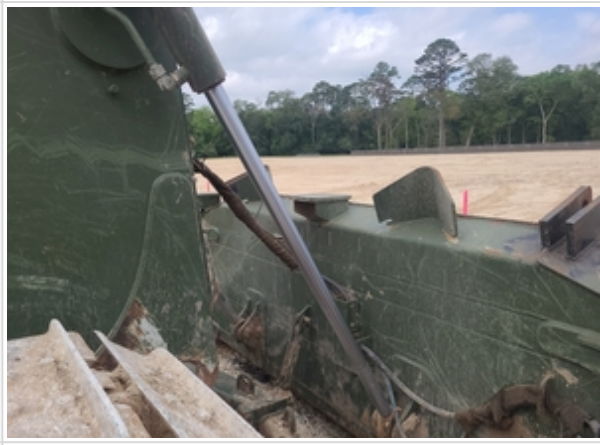
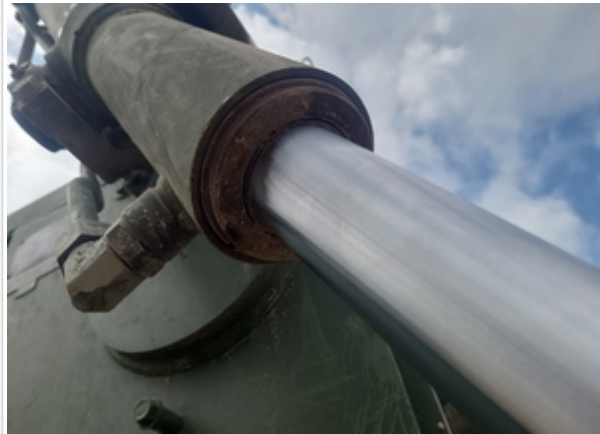
<p>Lift Cylinder Photos</p>

Lift Cylinder	Check the lift cylinder. Note any wear, pitting, discoloration, etc. Take photos.
Lift Cylinder: Mounting Pin	3
Lift Cylinder: Oil Leaks	No

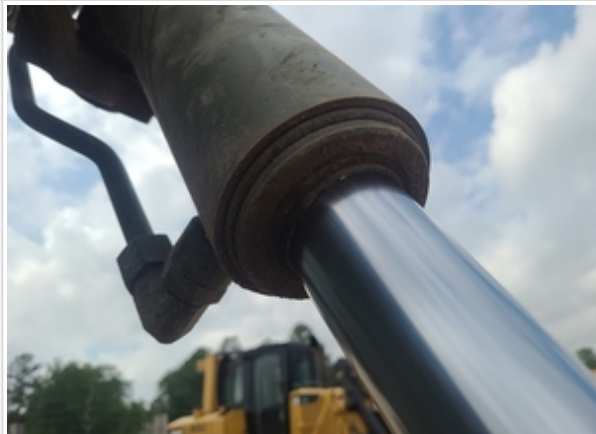
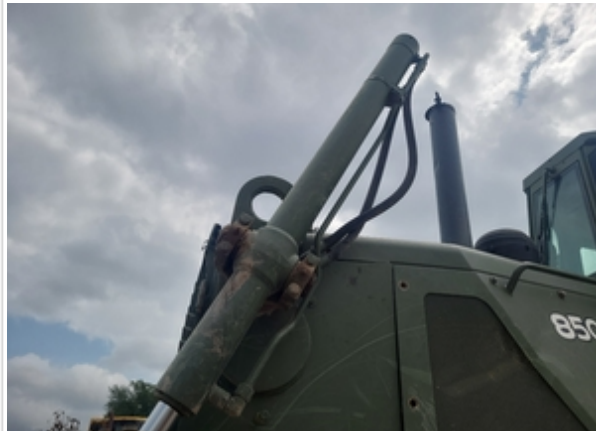
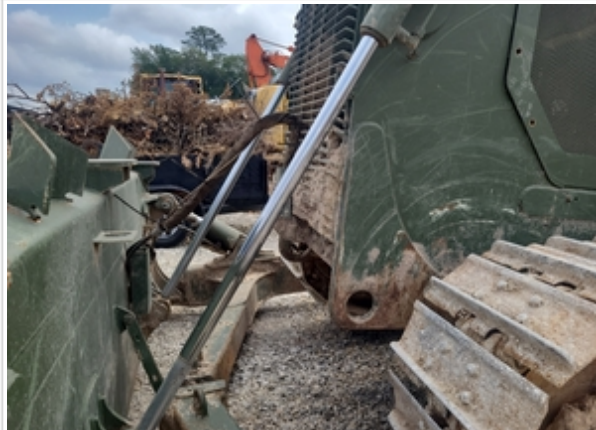
Tilt Cylinder	Check the tilt cylinder. Note any wear, pitting, discoloration, etc. Take photos.
Tilt Cylinder: Mounting Pin	3
Tilt Cylinder: Oil Leaks	Yes
Comments	Active leak seen at rod seal

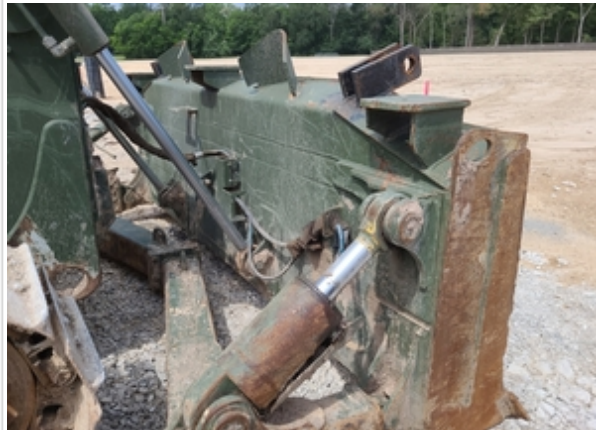
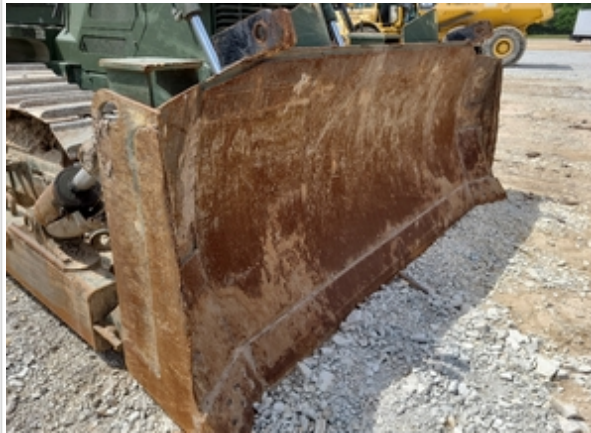
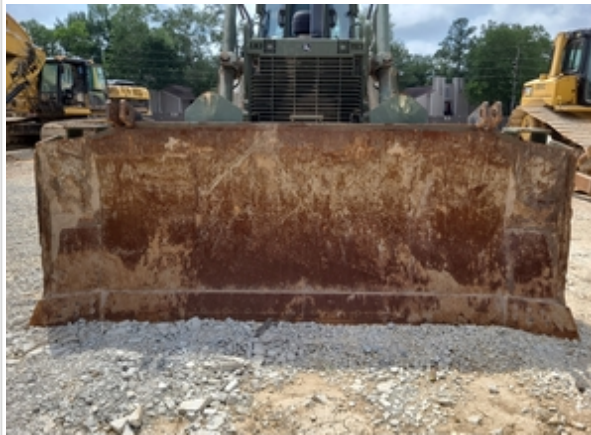
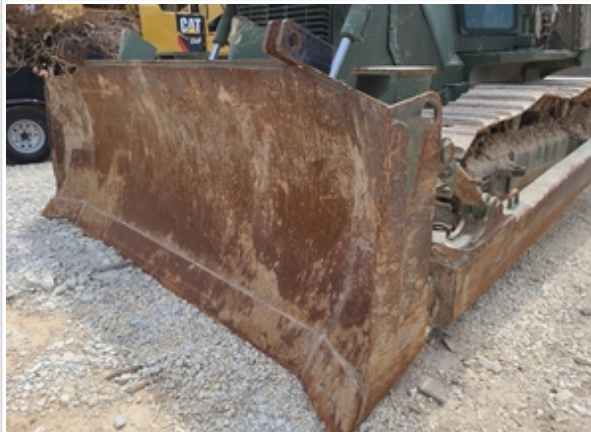
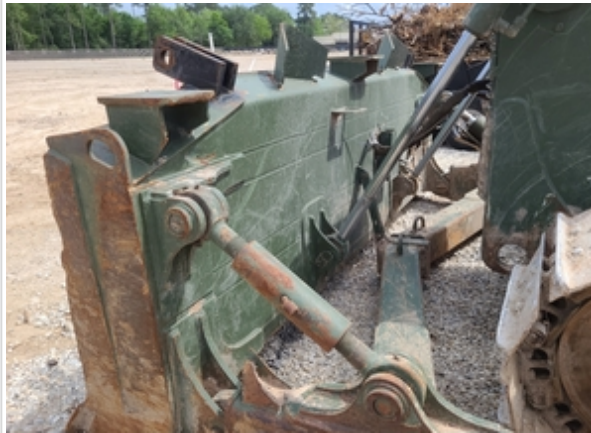
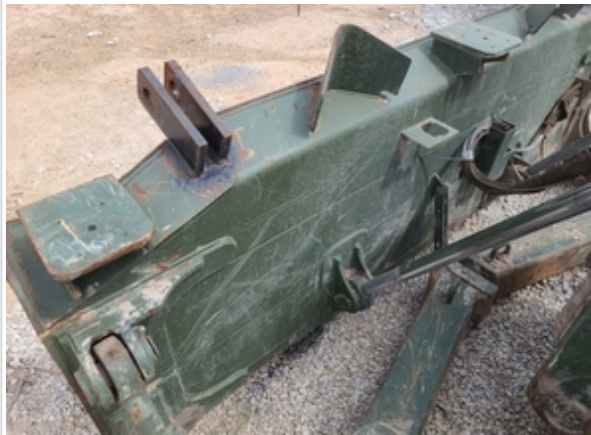
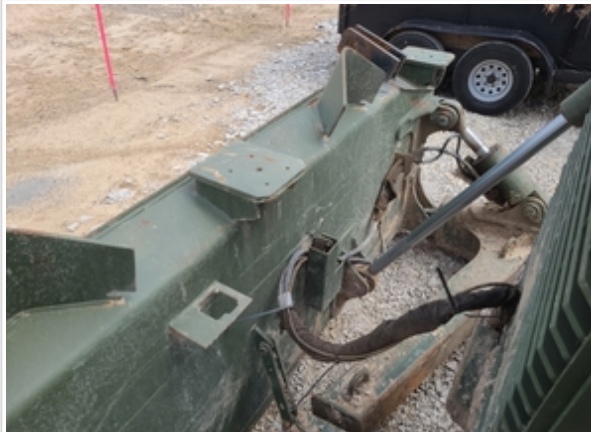
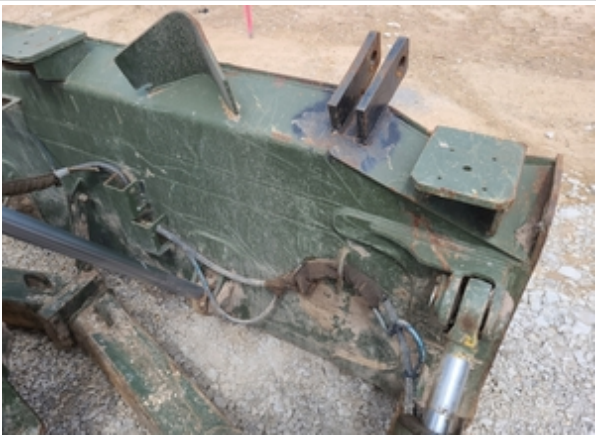
Blade Condition	3 - Normal Wear & Tear
Blade Photos

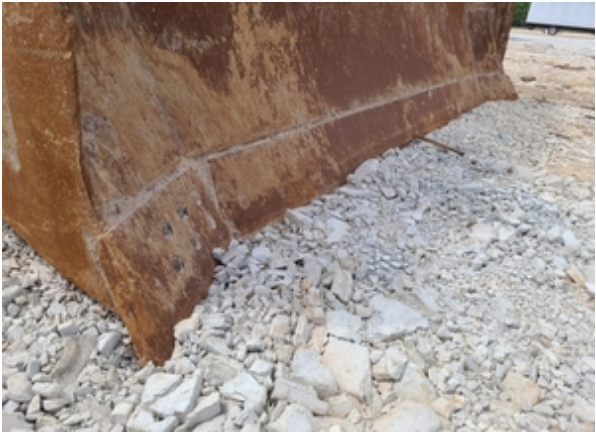
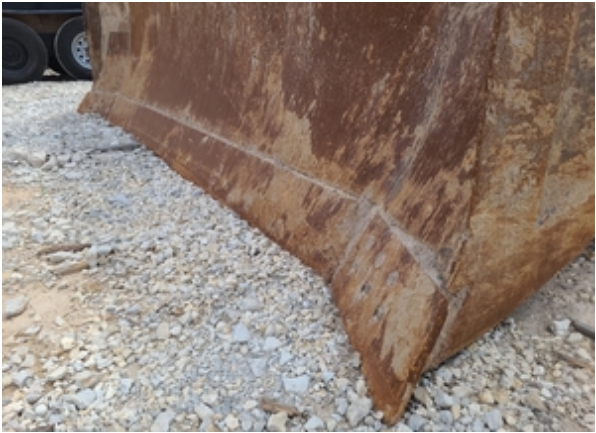
Blade Edge	3 - Normal Wear & Tear	
Blade Edge Photos
