Inspection Report (Bulldozer)

Year	2013
Make	CAT
Model	D6T
Serial Number	ZJB01163
Hour Meter Reading	12,207 Hrs.
Previous Application (e.g., earth moving, mining, demolition, etc)	General Construction

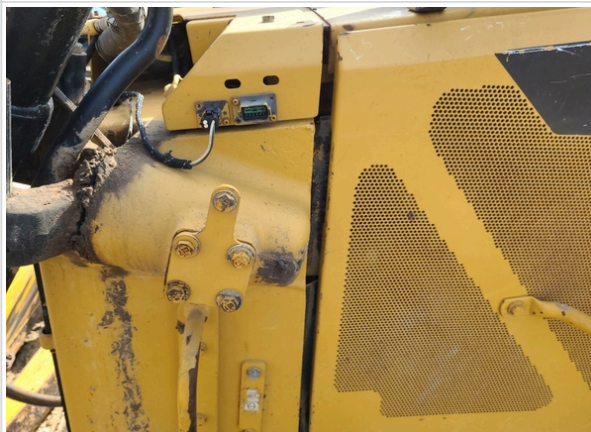
Hardware slightly loose

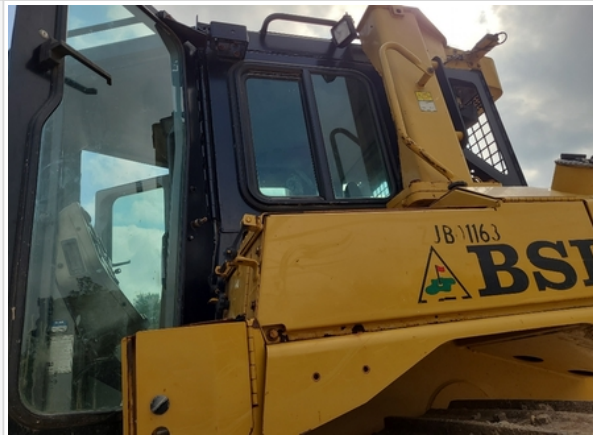
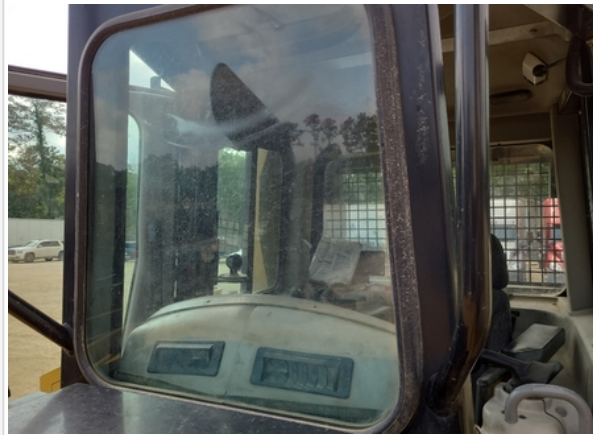
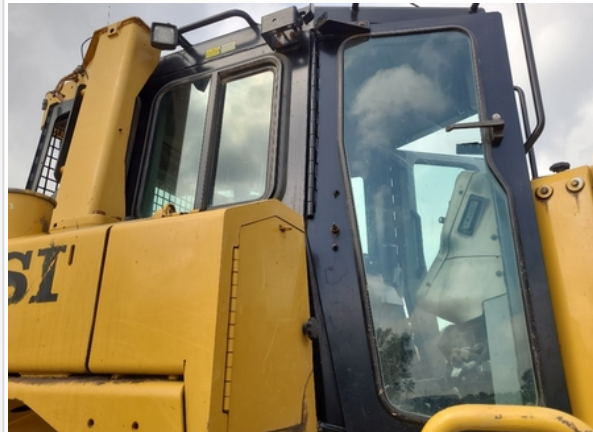
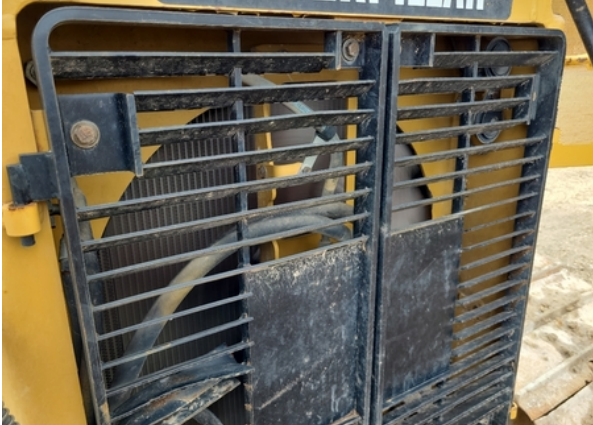
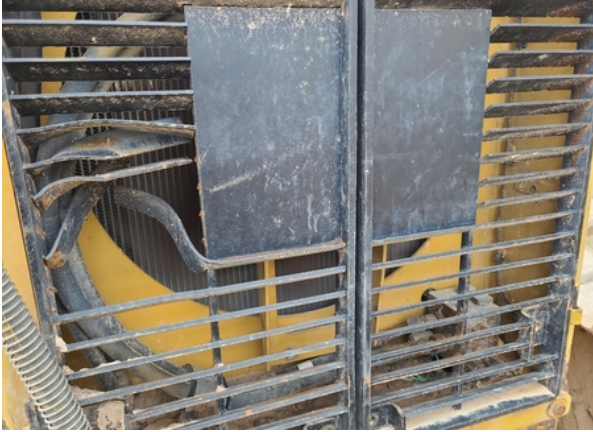
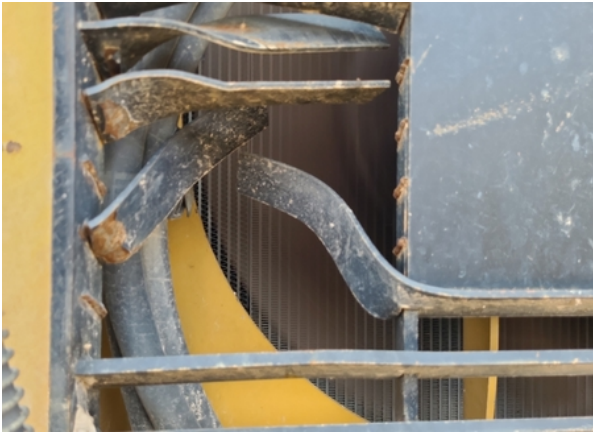
Body Panels	3 - Normal Wear & Tear
Body Panel Condition	Some panel misalignment observed, Other (see comments)
Comments	Normal wear and tear scuff marks and minor surface rust all around, Some Engine panels slightly loose
Doors / Canopy Latches	3 - Normal Wear & Tear
Doors / Canopy Latches Condition	No visible damage
Steps / Ladders	3 - Normal Wear & Tear
Steps / Ladders Condition	Steps/ladders are fully intact and appear structurally sound
Handrails	3 - Normal Wear & Tear

Handrails Condition	Handrails are fully intact and appear structurally sound
Glass	3 - Normal Wear & Tear
Glass Condition	Glass intact, no visible damage
Mirrors	3 - Normal Wear & Tear
Mirror Condition	Mirrors present and intact, no visible damage
Exterior Lights	3 - Normal Wear & Tear
Exterior Lights Condition	No visible damage, lighting system is operational

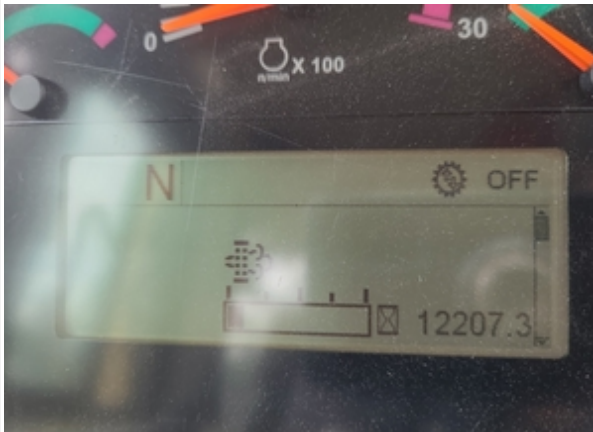
Cabin Lights Condition	Cabin lights are installed with all light covers in place, bulbs are installed and working properly
Safety Lock Out / Stop	3 - Normal Wear & Tear
Safety Lock Out / Stop Condition	Safety lock out device is present, in good condition, and functional
Controls & Switches	3 - Normal Wear & Tear
Controls & Switches Condition	All switches are installed and functional, Switches have good functionality, minor cosmetic damage observed
Hour Meter Activity	3 - Normal Wear & Tear
Hour Meter Condition	Hour meter is functional and in good condition
Hour Meter Activity Photos

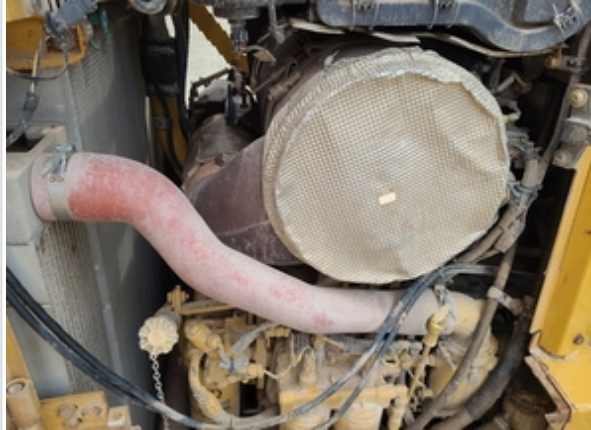
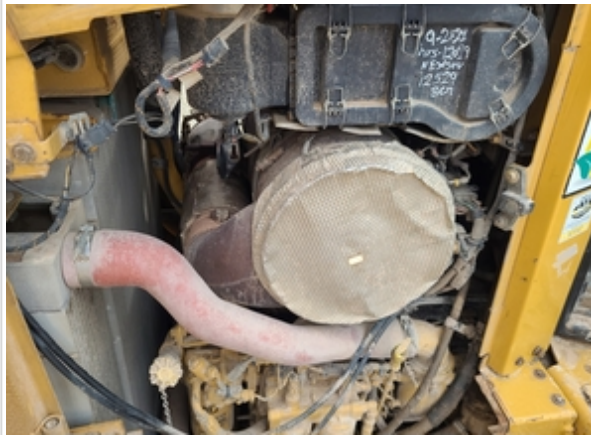
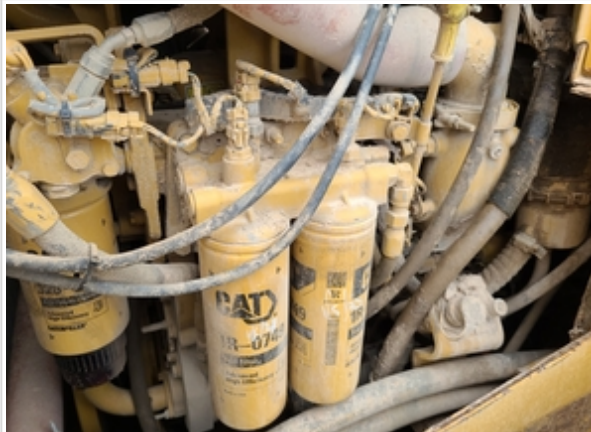
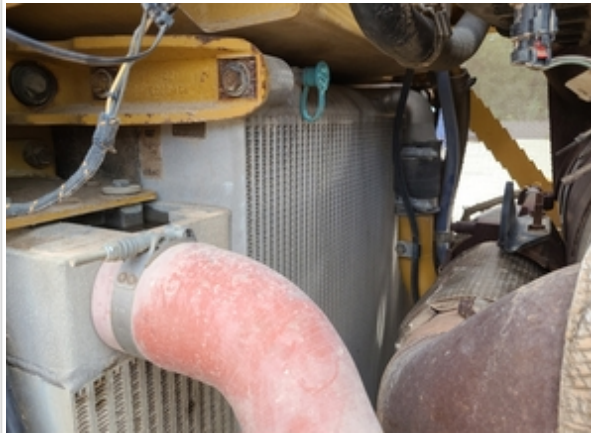
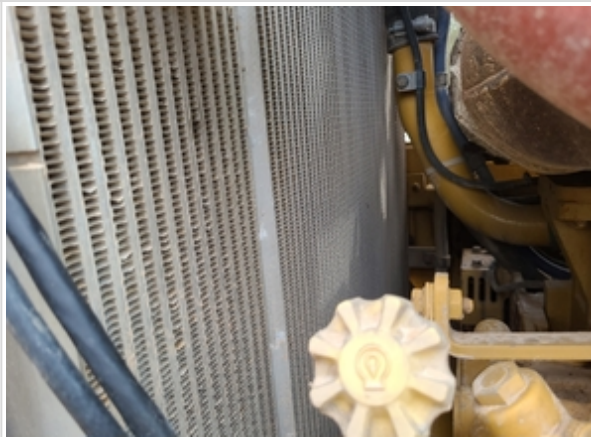
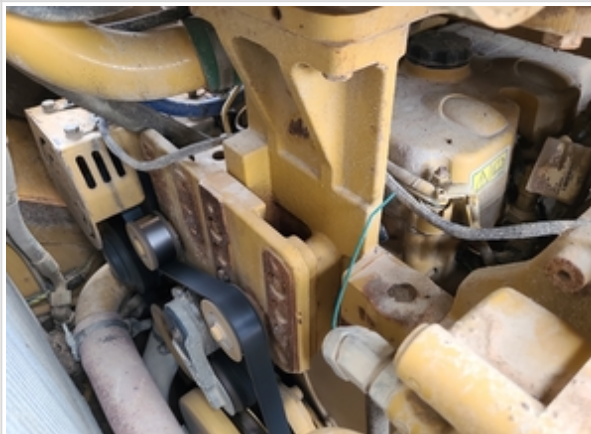
Engine Photos

Blow-by (Visual Observation Check)	N/A
Unusual Noises (Upon Start-up, Idle, Shutdown)	No
Unusual Noise Notes	No unusual noises heard
Engine Smoke (Upon Start-up, Idle, Shutdown)	No
Engine Smoke Notes	No engine smoke issues observed
Engine Exhaust Color	Clear
Battery	3 - Normal Wear & Tear
Battery Condition	Dusty & dirty appearance, Clean & dry appearance, tight connections
Comments	Batteries missing mounting hardware
Radiator	3 - Normal Wear & Tear
Radiator Condition	Radiator fins & components appear to be in good working order, no signs of damage or leaks
Belts	3 - Normal Wear & Tear
Hoses	3 - Normal Wear & Tear
Hose Condition	Firm, pliant hoses with no signs of wear or leaks
Water Pump	3 - Normal Wear & Tear

Water Pump Condition	No unusual pump noises heard
Cooling System Leaks	No
Coolant Color / Appearance	3 - Normal Wear & Tear
Coolant Color/Appearance Notes	Normal Translucent appearance, no visual signs of contamination
Oil Leaks	No
Oil Color / Appearance	3 - Normal Wear & Tear
Oil Color / Appearance Notes	Clean oil appearance, no signs of cross contamination, Appropriate oil level
Fuel Leaks	No
Equipped with DPF (Diesel Particulate Filter)	Yes
DPF Condition	3 - Normal Wear & Tear
DPF Condition Notes	Filter housing is intact with no signs of damage or malfunction, DPF indicator is not illuminated
Requires DEF (Diesel Exhaust Fluid)	No
Overall Engine Appearance	Dusty & dry
Overall Engine Comments	Engine fires right up and sounds healthy at idle and under load. No major active leaks observed. One minor leak may be present at rear of engine. (Observed through floorboard area from cab)

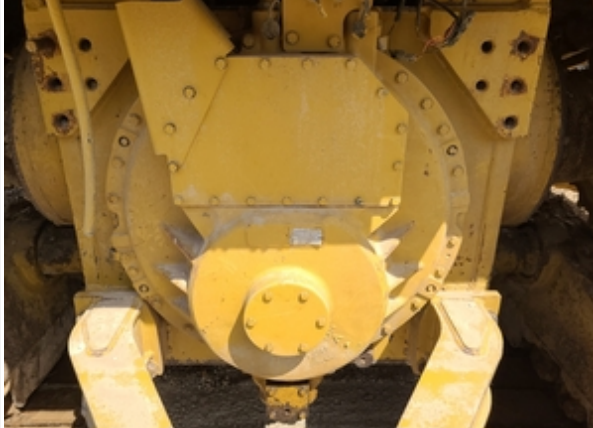
Transmission Info	Automatic 4 Speed
Clutch	0
Transmission	3 - Normal Wear & Tear
Comments	Transmission works well through all gears, in all directions
Transmission Photos

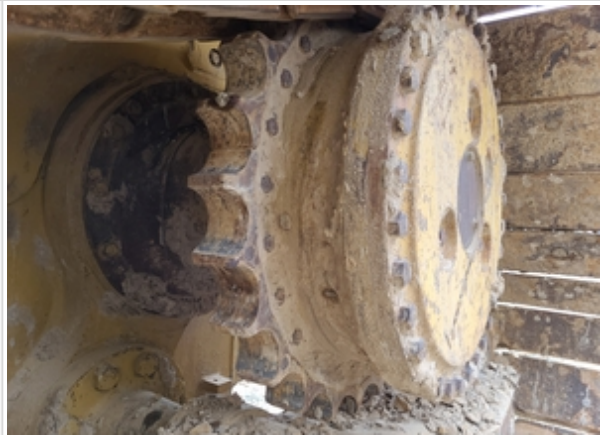
Shift Lever	3 - Normal Wear & Tear	
Left Drive Motor	0	
Left Final Drive	0	
Left High Drive	3 - Normal Wear & Tear	
Left High Drive Photos

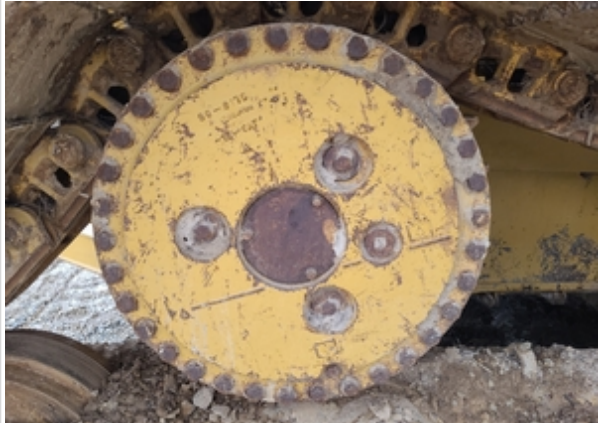
Right Drive Motor	0	
Right Final Drive	0	
Right High Drive	3 - Normal Wear & Tear	
Right High Drive Photos

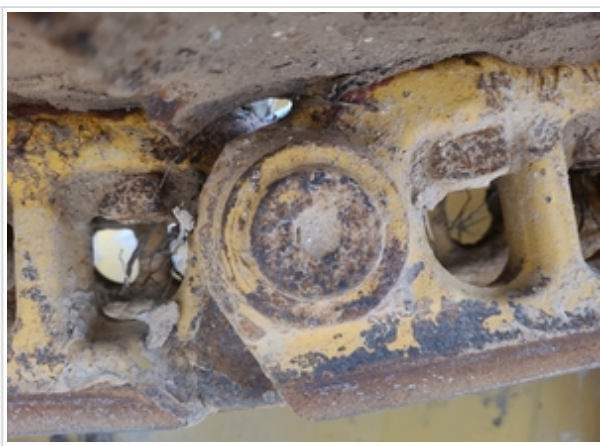
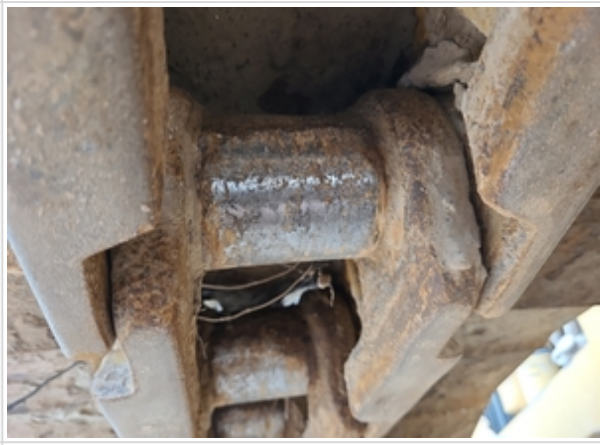
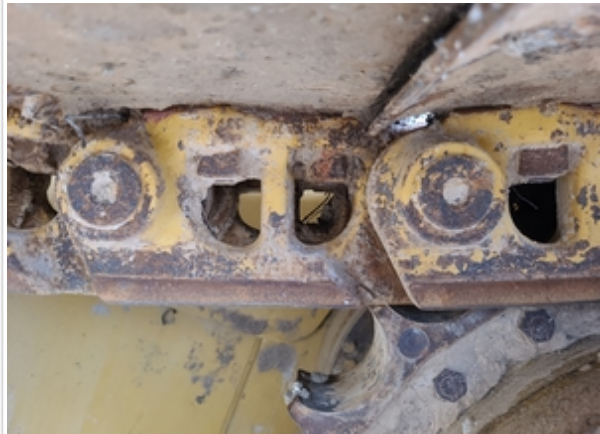
<p>Pin & Bushings Photos</p>

<p>Pin & Bushings</p>	<p>3 - Normal Wear & Tear</p>

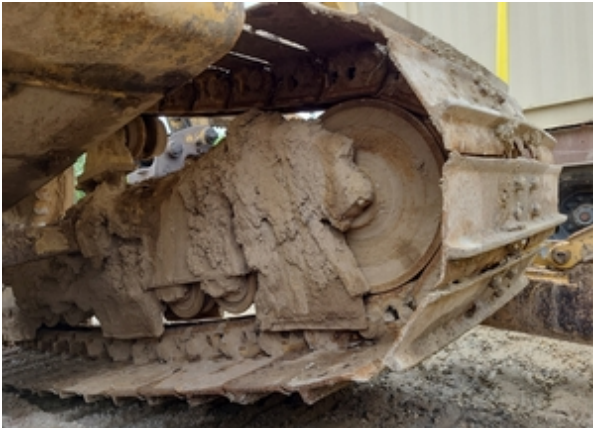
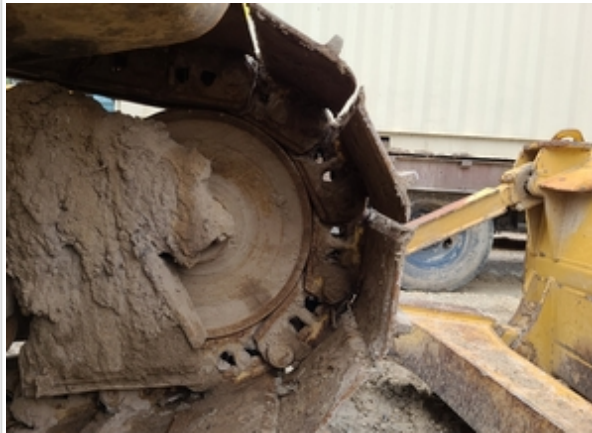
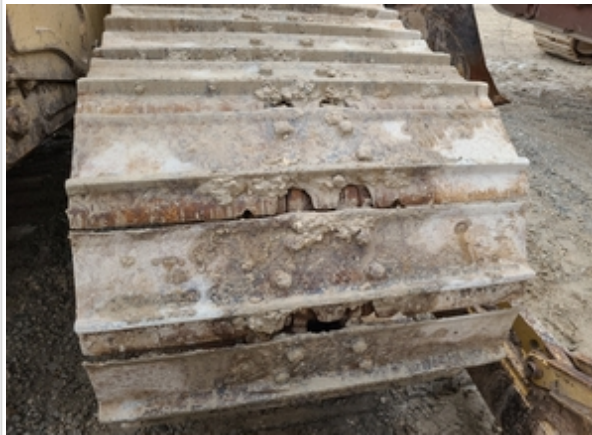
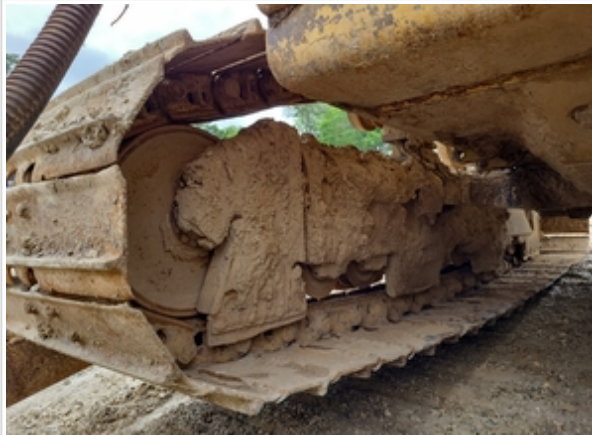
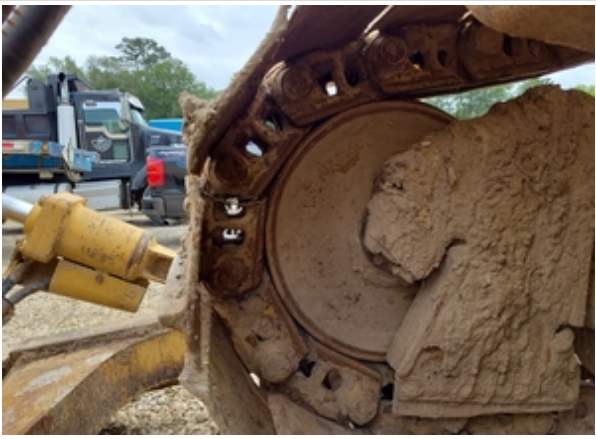
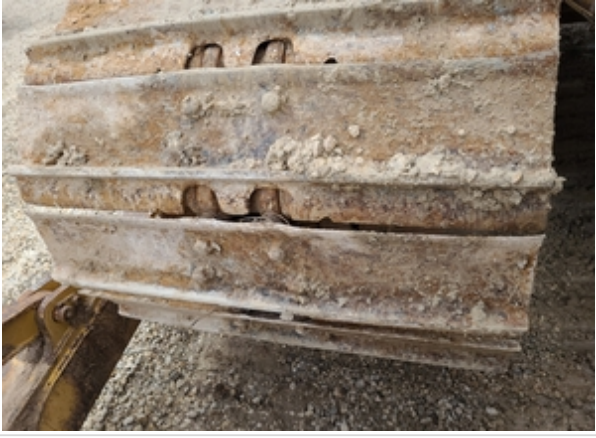
Tracks	2 - Above Average Wear	
Comments	Track links and Sprocket segments in good condition. Track pads, rollers and idlers will need to be replaced soon.	
Tracks Photos

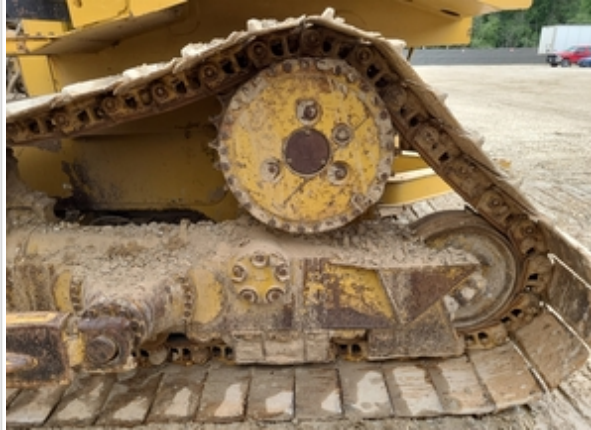
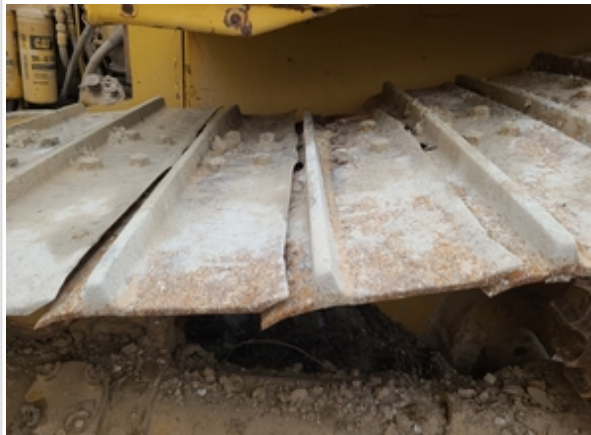
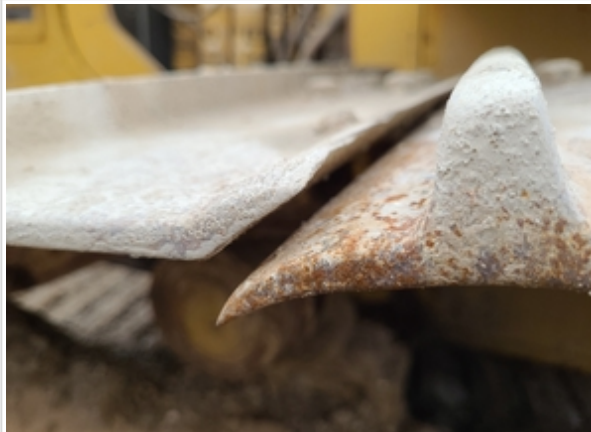
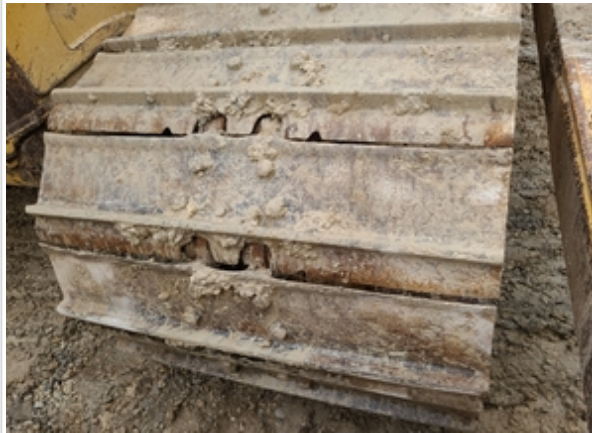
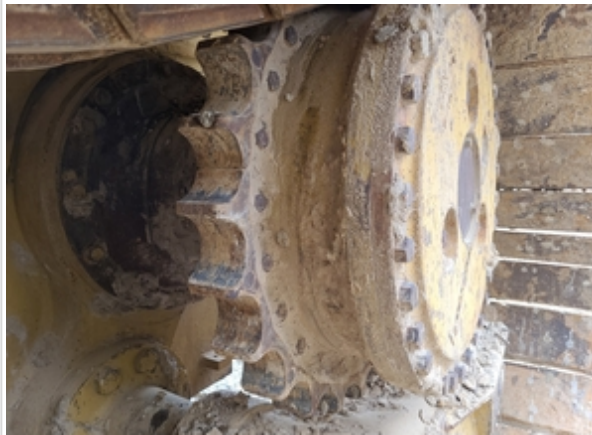
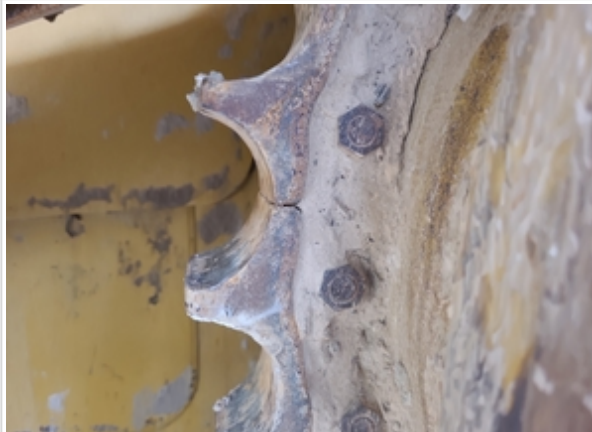
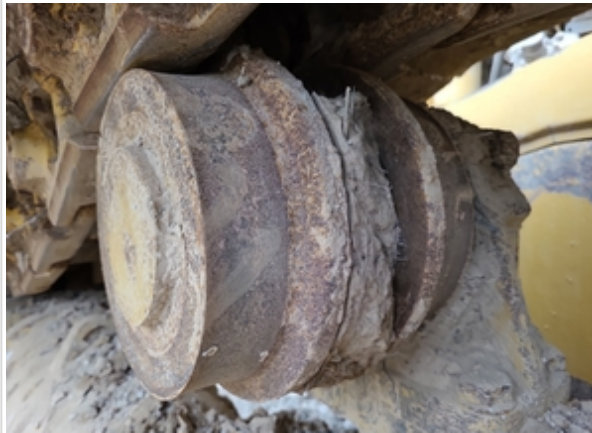
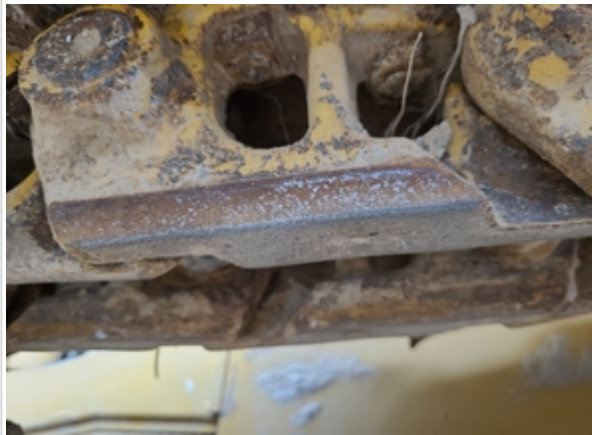
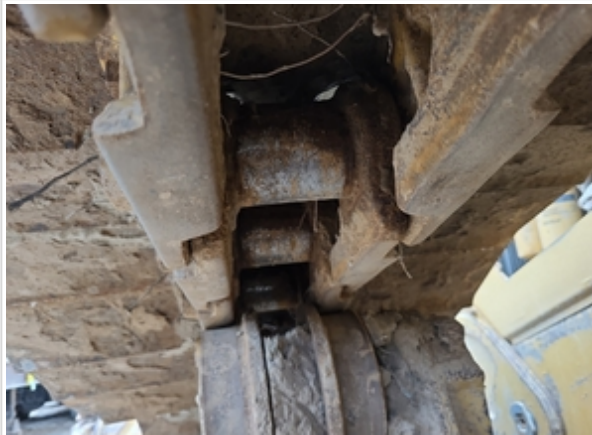
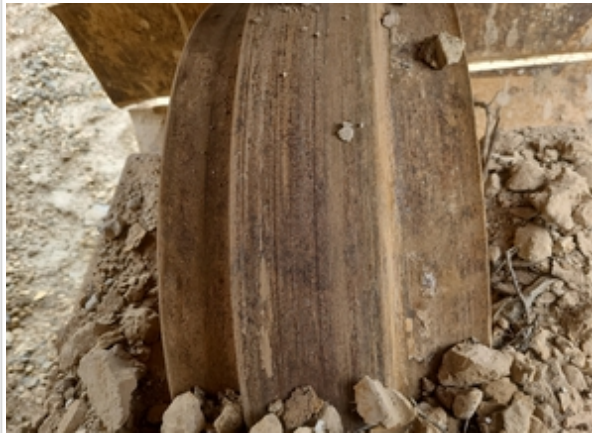
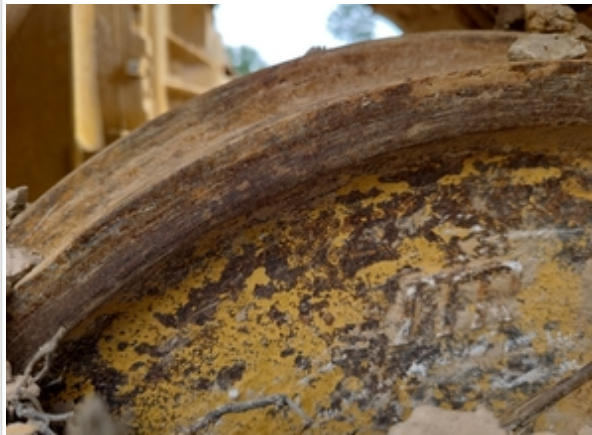
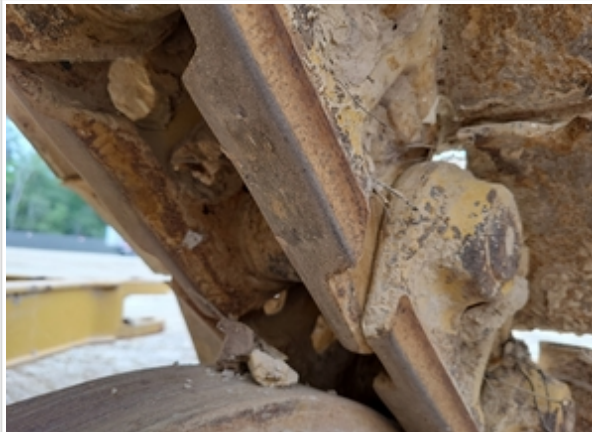
Undercarriage Left Side Photos

Left Side: Link Bushings / Drive Sprocket / Shoe Condition	3 - Normal Wear & Tear	
Comments	Track links and Sprocket segments have been replaced (Approximate usage unknown)	
Left Side: Upper & Lower Roller / Front Idler Condition	2 - Above Average Wear	
Comments	Upper, front and rear idlers about halfway through its life,	
Track Condition: Left Front	30%	
Track Condition: Left Rear	30%	
Undercarriage Left Side Photo Instructions	Take photos of the undercarriage of this piece of equipment. Must have shots to capture: <ul style="list-style-type: none"> - Roller Frame (left) - Track Tensioner (left) - Track Pads (left) - Grouser Height (left) - Track Links (left) - Track Bushings (left) - Carrier Rollers (left) - Track Rollers (left) - Front Idler (left) - Rear Idler (left) - Sprocket (left)

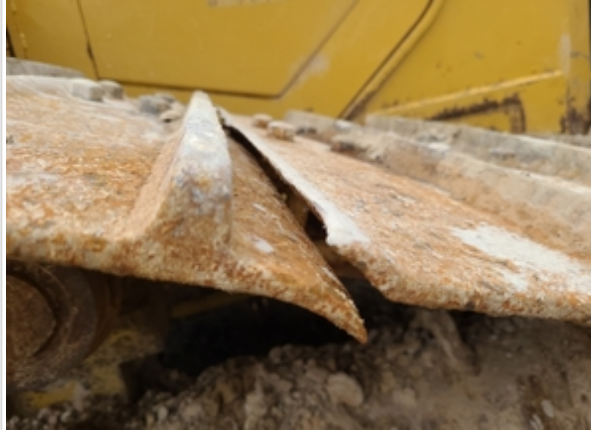
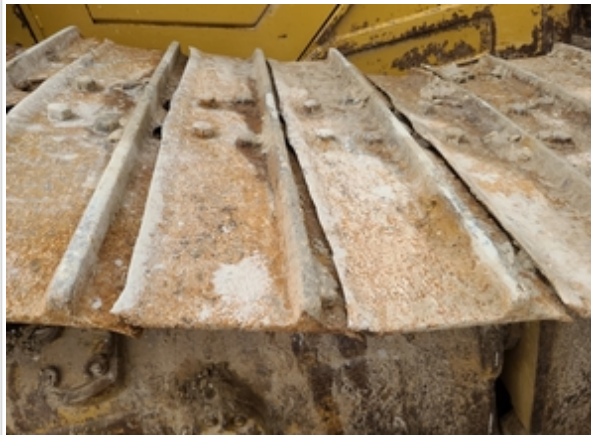
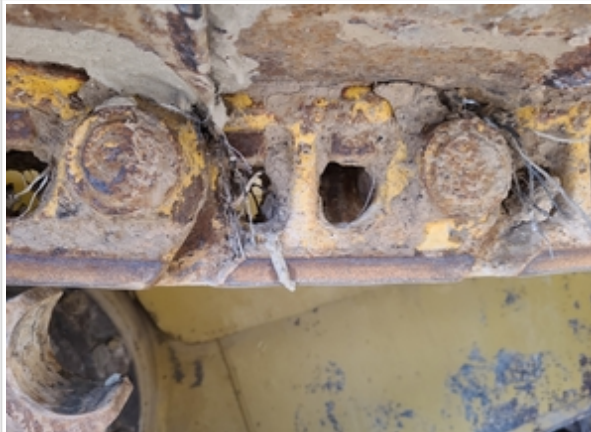
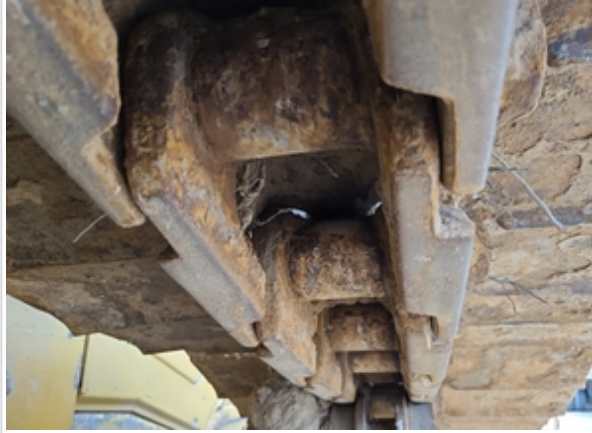
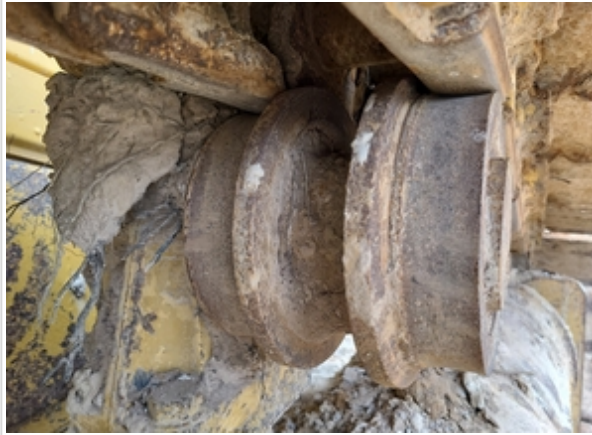
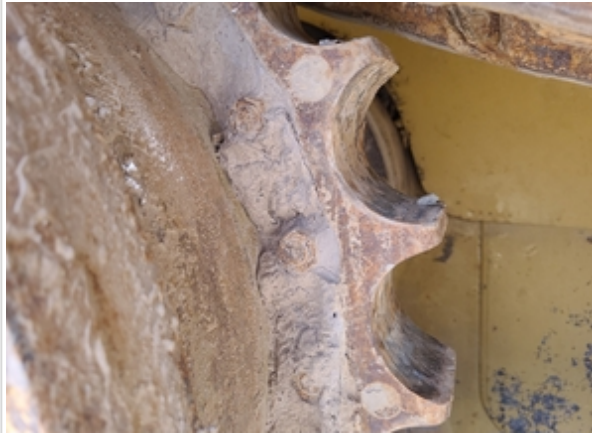
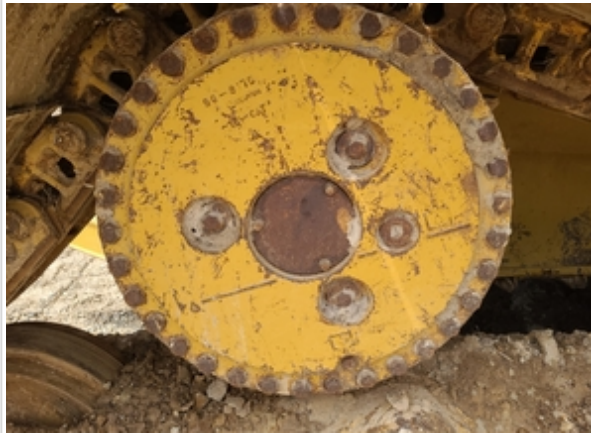
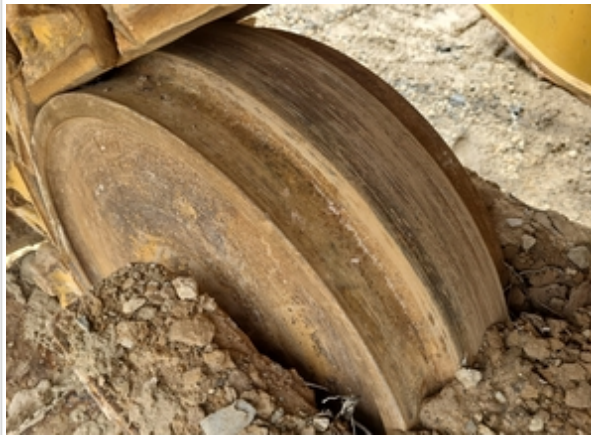
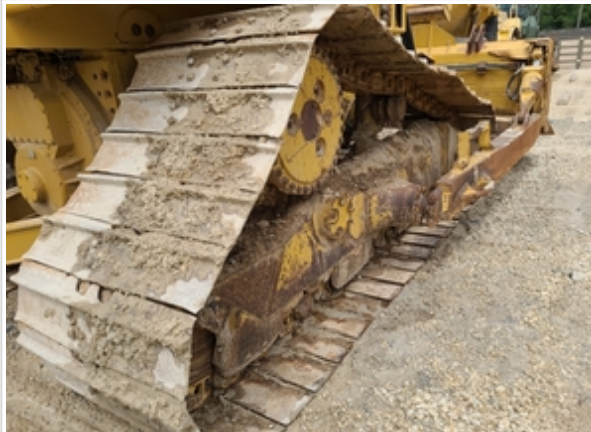
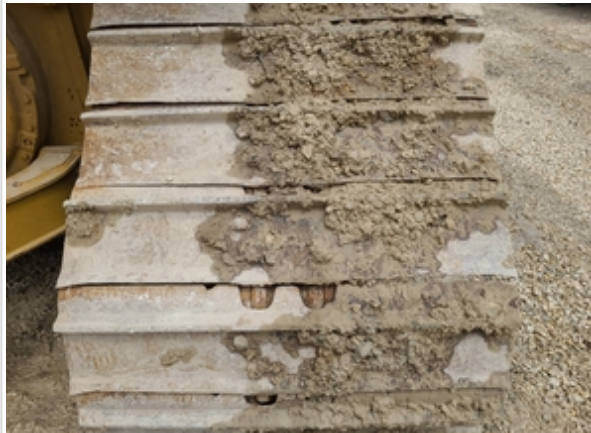
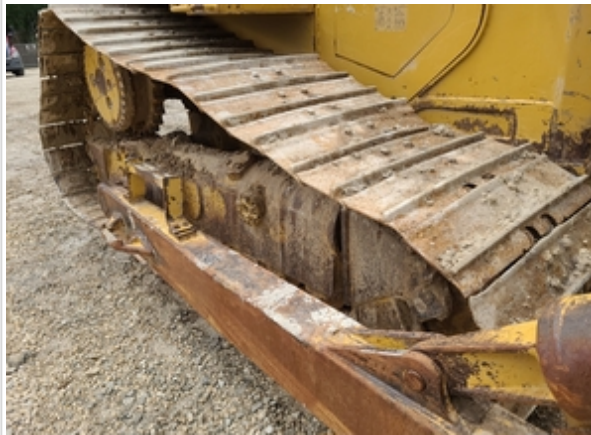
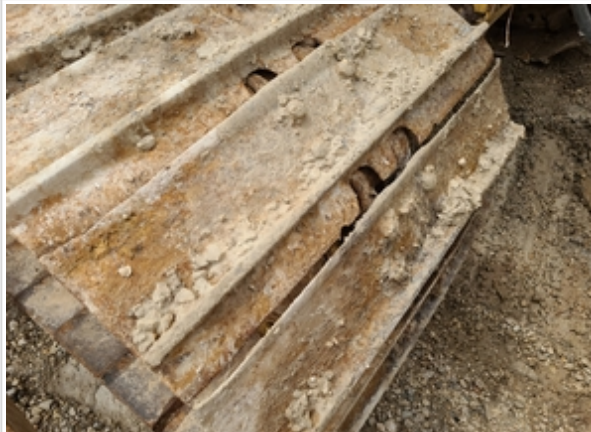
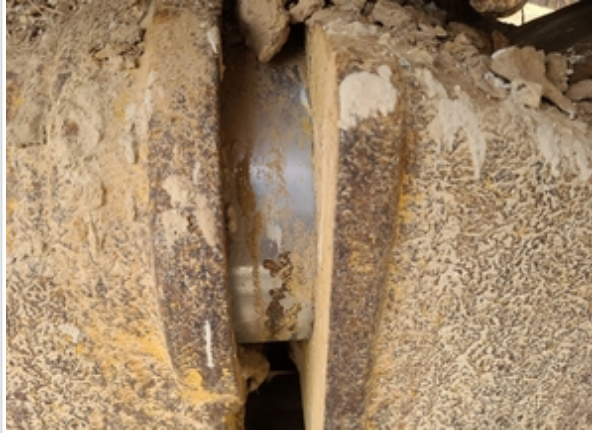
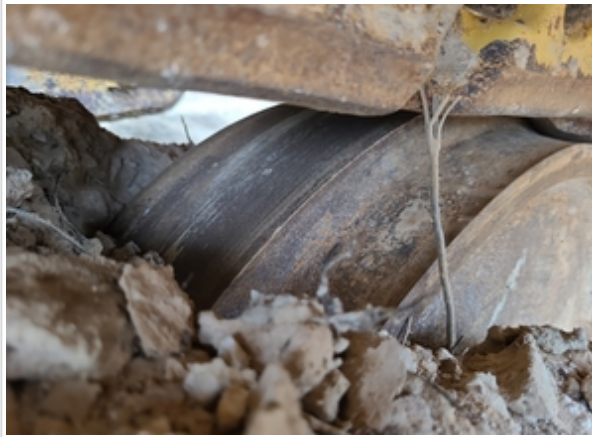
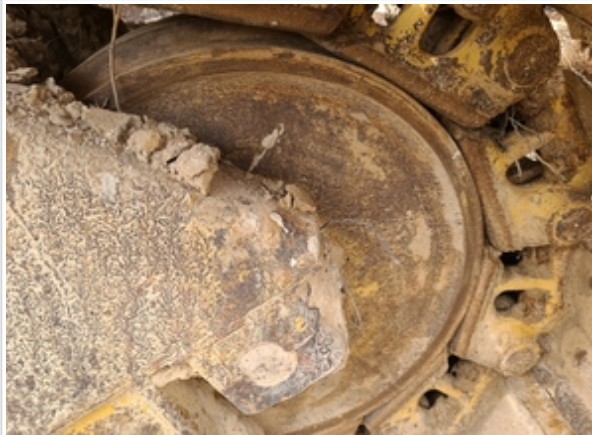
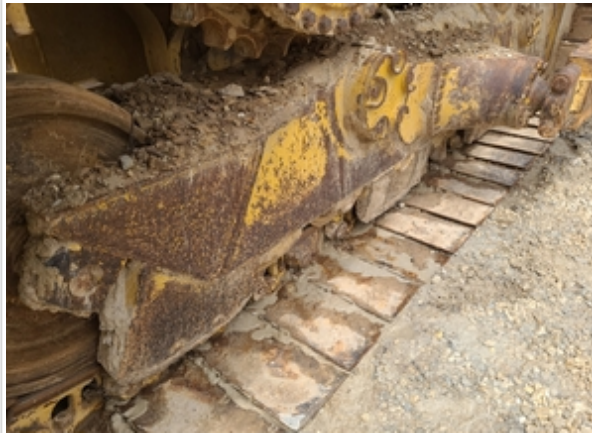
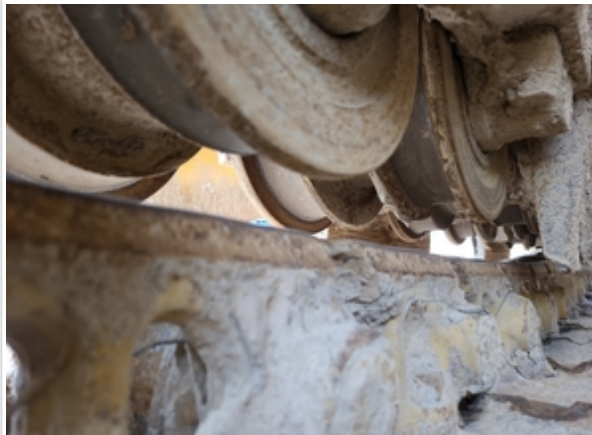
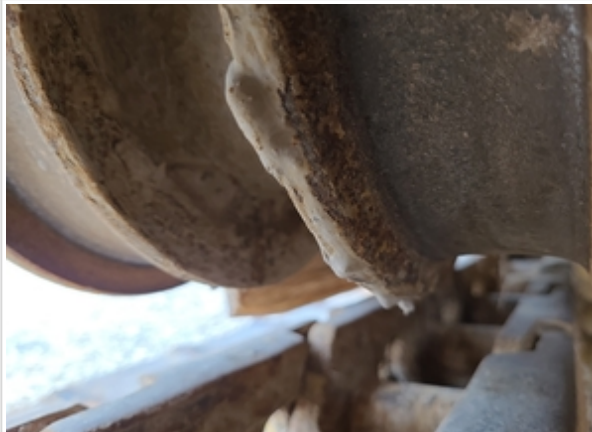
Undercarriage Right Side Photos

Right Side: Link Bushings / Drive Sprocket / Shoe Condition	3 - Normal Wear & Tear
Comments	Track links and Sprocket segments have been replaced
Right Side: Upper & Lower Roller / Front Idler Condition	2 - Above Average Wear
Comments	Track links and Sprocket segments have been replaced (Approximate usage unknown)
Track Condition: Right Front	30%
Track Condition: Right Rear	30%
Undercarriage Right Side Photo Instructions	Take photos of the undercarriage of this piece of equipment. Must have shots to capture: <ul style="list-style-type: none"> - Roller Frame (right) - Track Tensioner (right) - Track Pads (right) - Grouser Height (right) - Track Links (right) - Track Bushings (right) - Carrier Rollers (right) - Track Rollers (right) - Front Idler (right) - Rear Idler (right) - Sprocket (right)

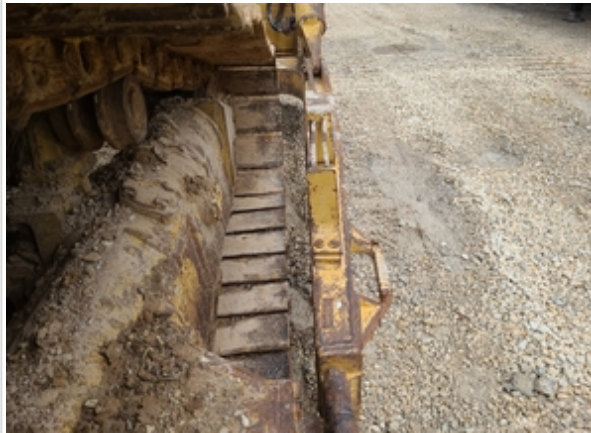
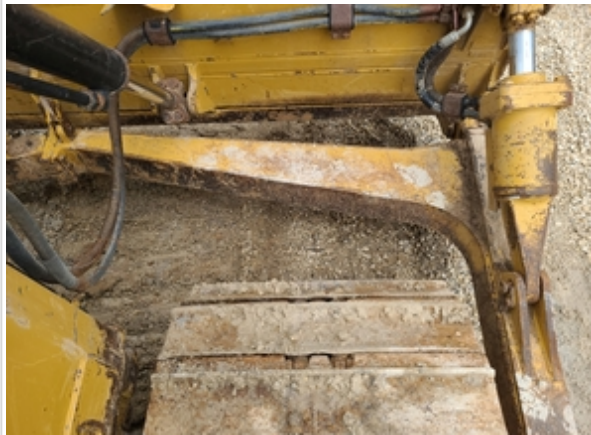
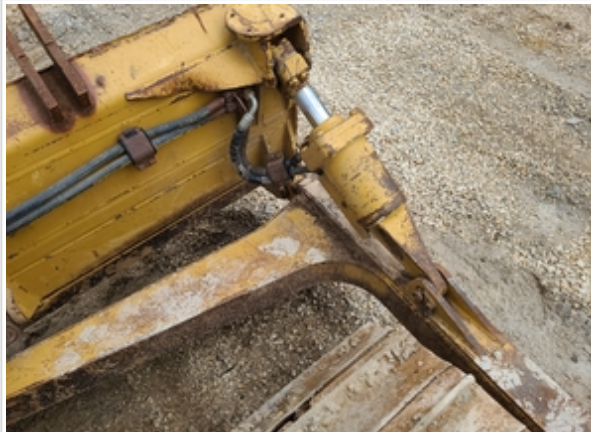
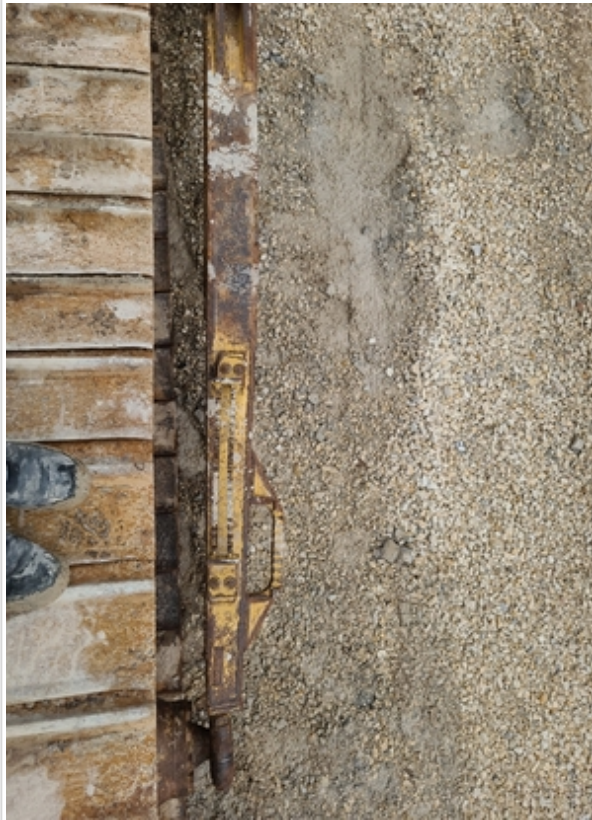
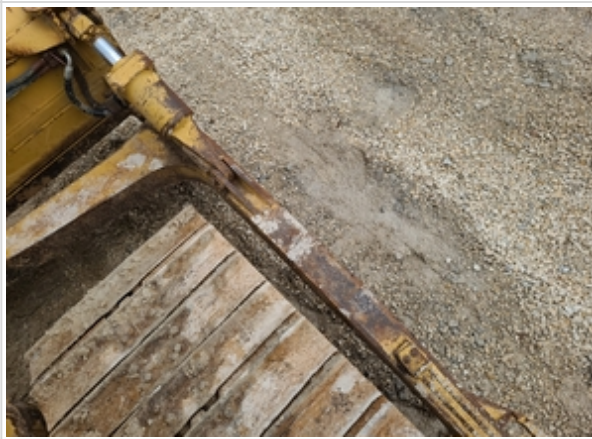
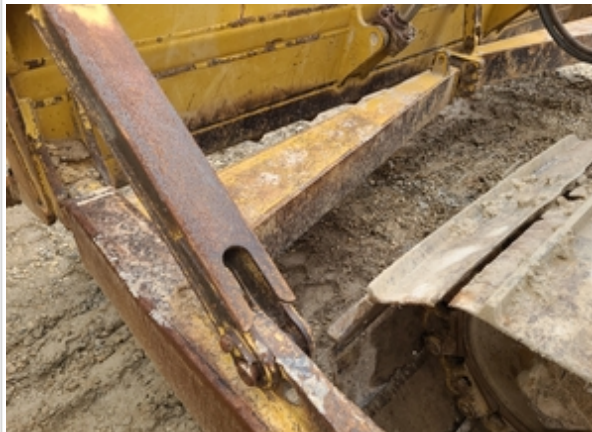
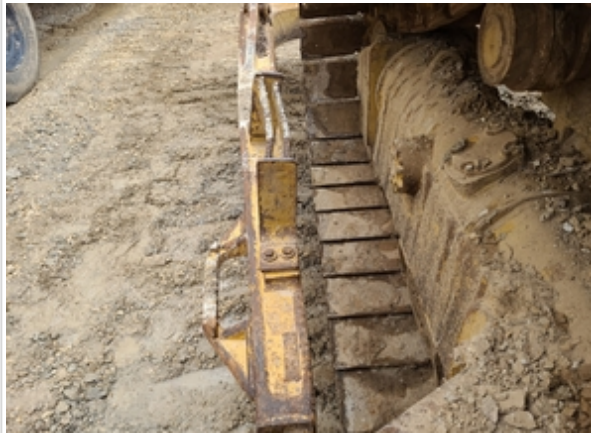
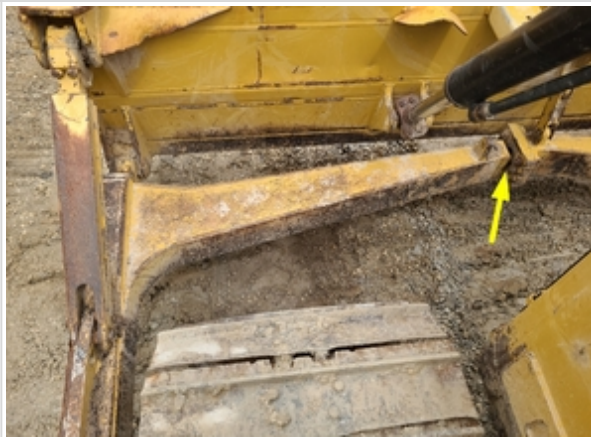
Push Arm / C-Frame Condition	3 - Normal Wear & Tear
Comments	Main Frame in good shape. Connection Points Worn
Push Arm / C-Frame Photos

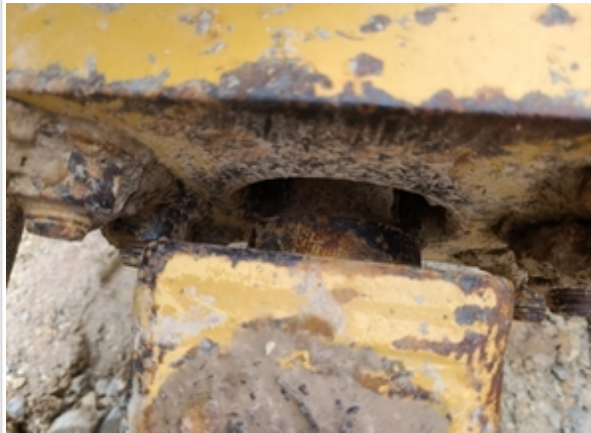
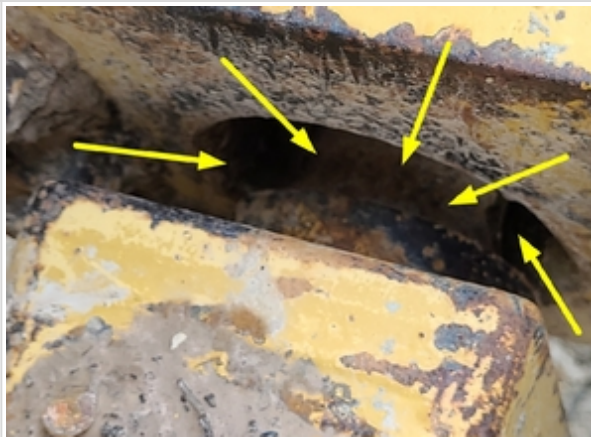
Connection Worn

Bushings, bores, & pins should be further inspected for proper repair procedures. Excess play observed during the inspection.

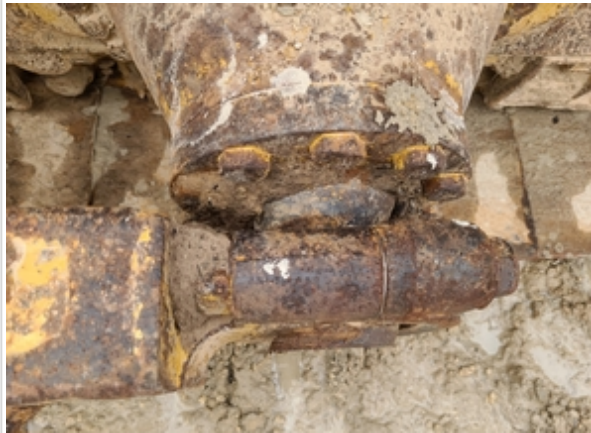
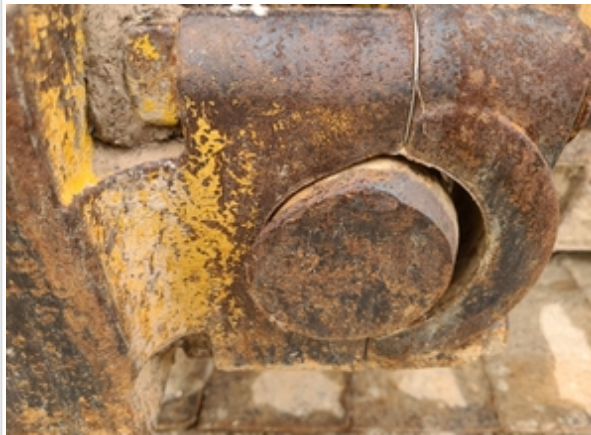
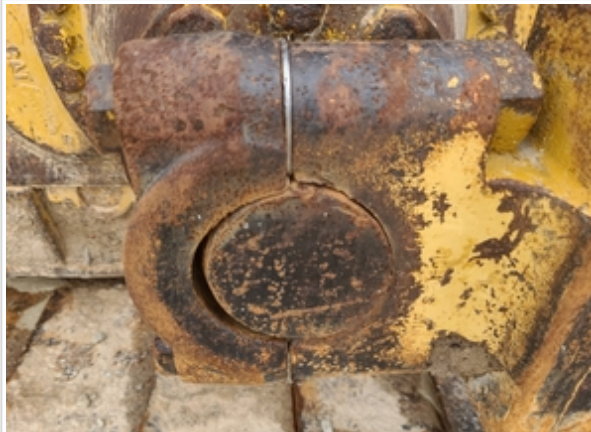
Push Arm Pivot / C-Frame
Trunnions Photos

<p>Machine trunnions to push blade arms excessively worn and should be replaced.</p>
<p>Push Arm Pivot / C-Frame Trunnions Condition</p>	<p>2 - Above Average Wear</p>	
<p>Comments</p>	<p>Trunnion connections worn</p>

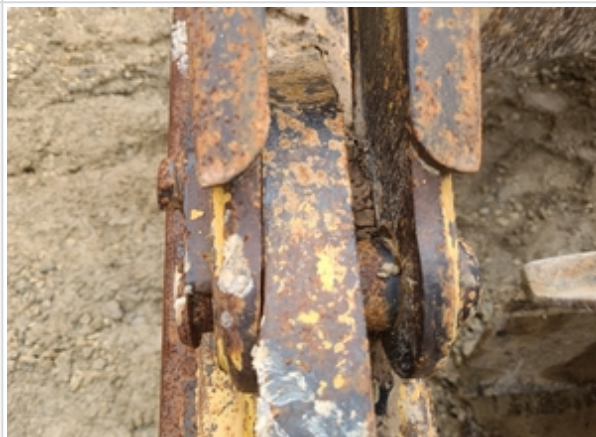
<p>Tilt Linkage Pin & Bushings</p>	<p>2 - Above Average Wear</p>
<p>Tilt Linkage Pin & Bushings Photos</p>

<p>Left Side Bore Worn</p>

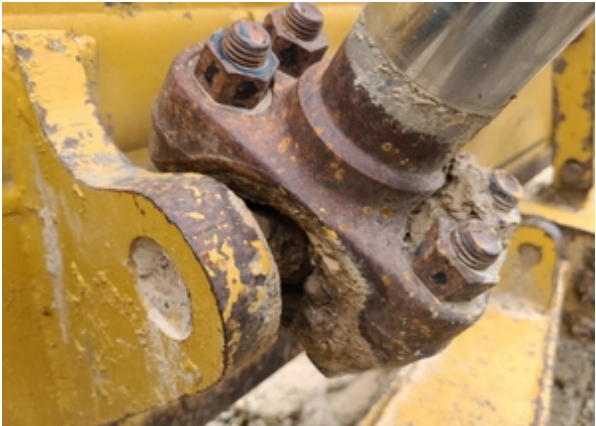
Blade Trunnions / Bushings	2 - Above Average Wear	
Comments	All trunnions and bushings should be further inspected for excessive play.	
Blade Trunnions / Bushings Photos

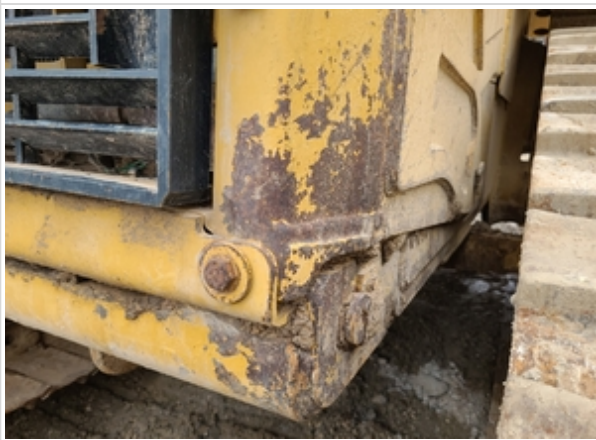
<p>Frame Condition</p>	<p>3 - Normal Wear & Tear</p>
<p>Frame Photos</p>

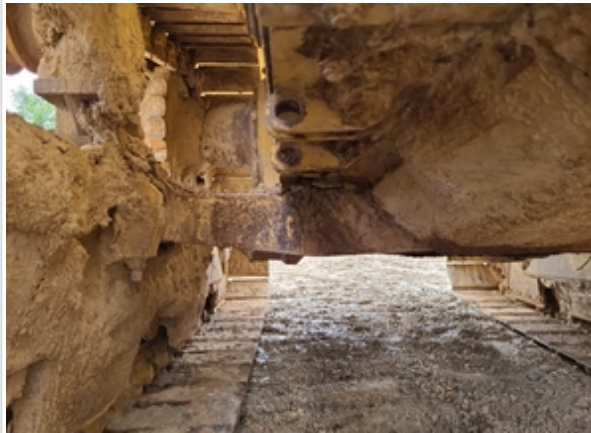
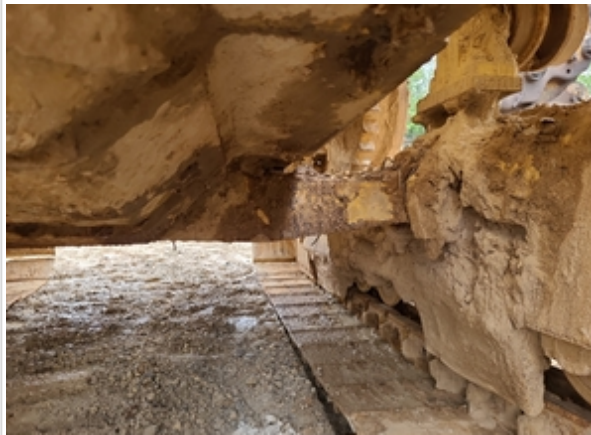
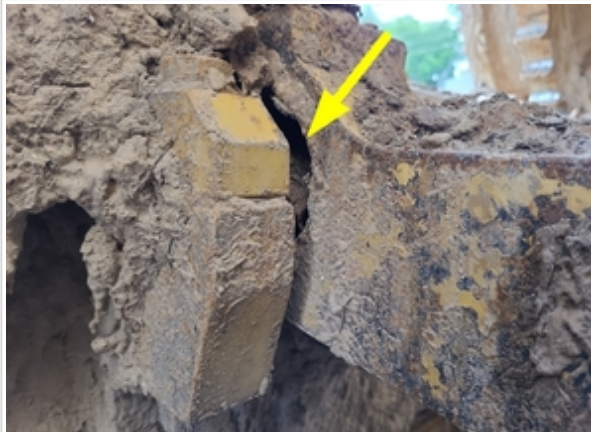
EQ Bar has excessive play

Overall Chassis	3 - Normal Wear & Tear	
Overall Chassis Comments	Overall main machine frame okay. Equalizer bar worn to roller frames

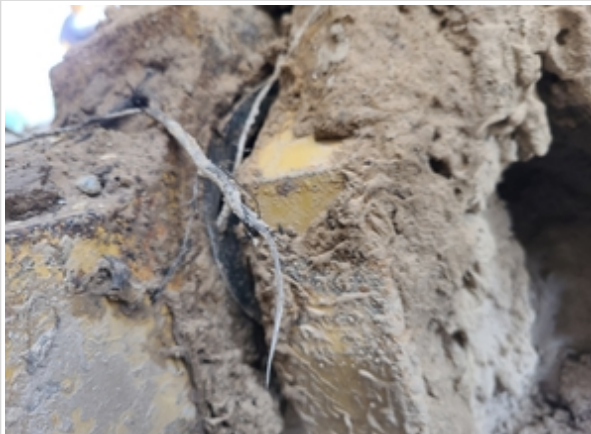
EQ Bar has excessive play

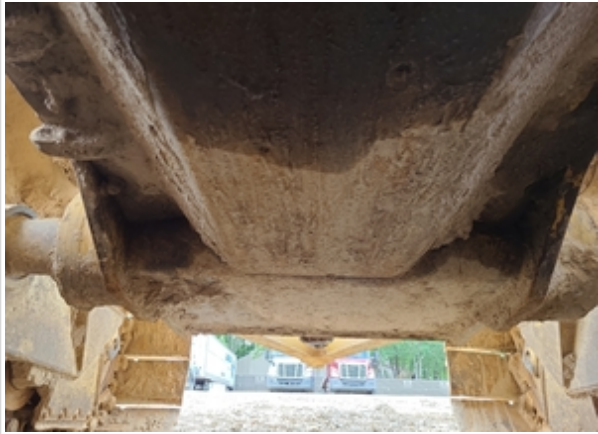
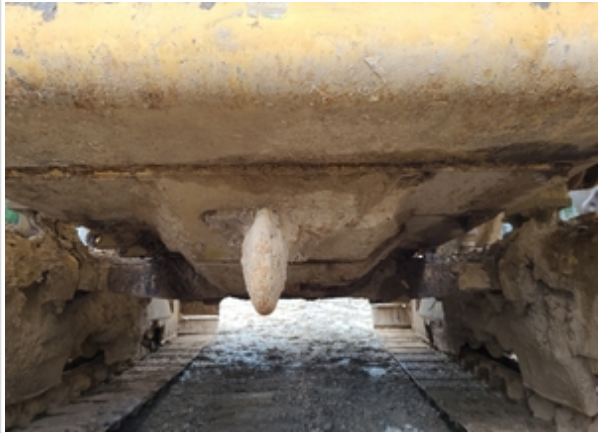
<p>Belly Pans</p>	<p>3 - Normal Wear & Tear</p>	
<p>Belly Pans Photos</p>

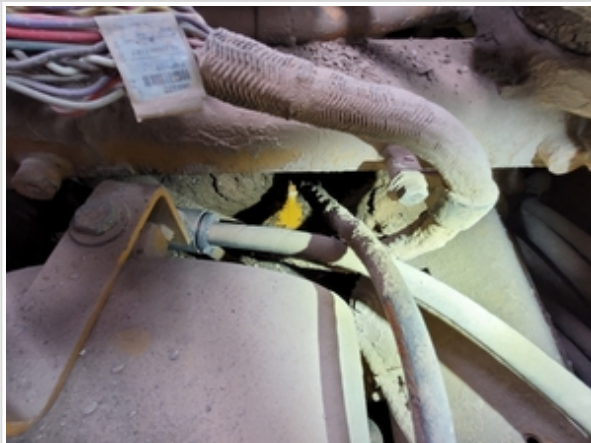
Image displays hydraulics underneath Cab

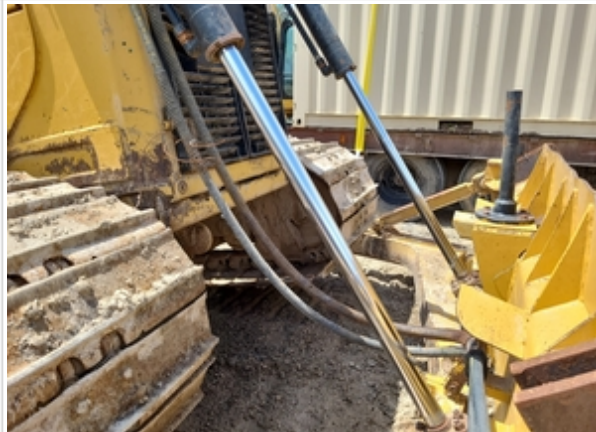
Lift Cylinder	Check the lift cylinder. Note any wear, pitting, discoloration, etc. Take photos.
Lift Cylinder: Mounting Pin	3
Lift Cylinder: Oil Leaks	No
Lift Cylinder Photos
